ASM HANDBOOK®

VOLUME  
12

Fractography

*Fractography*, was published in 1987 as Volume 12 of the *ASM Handbook*. The Volume was prepared under the direction of the ASM Handbook Committee.

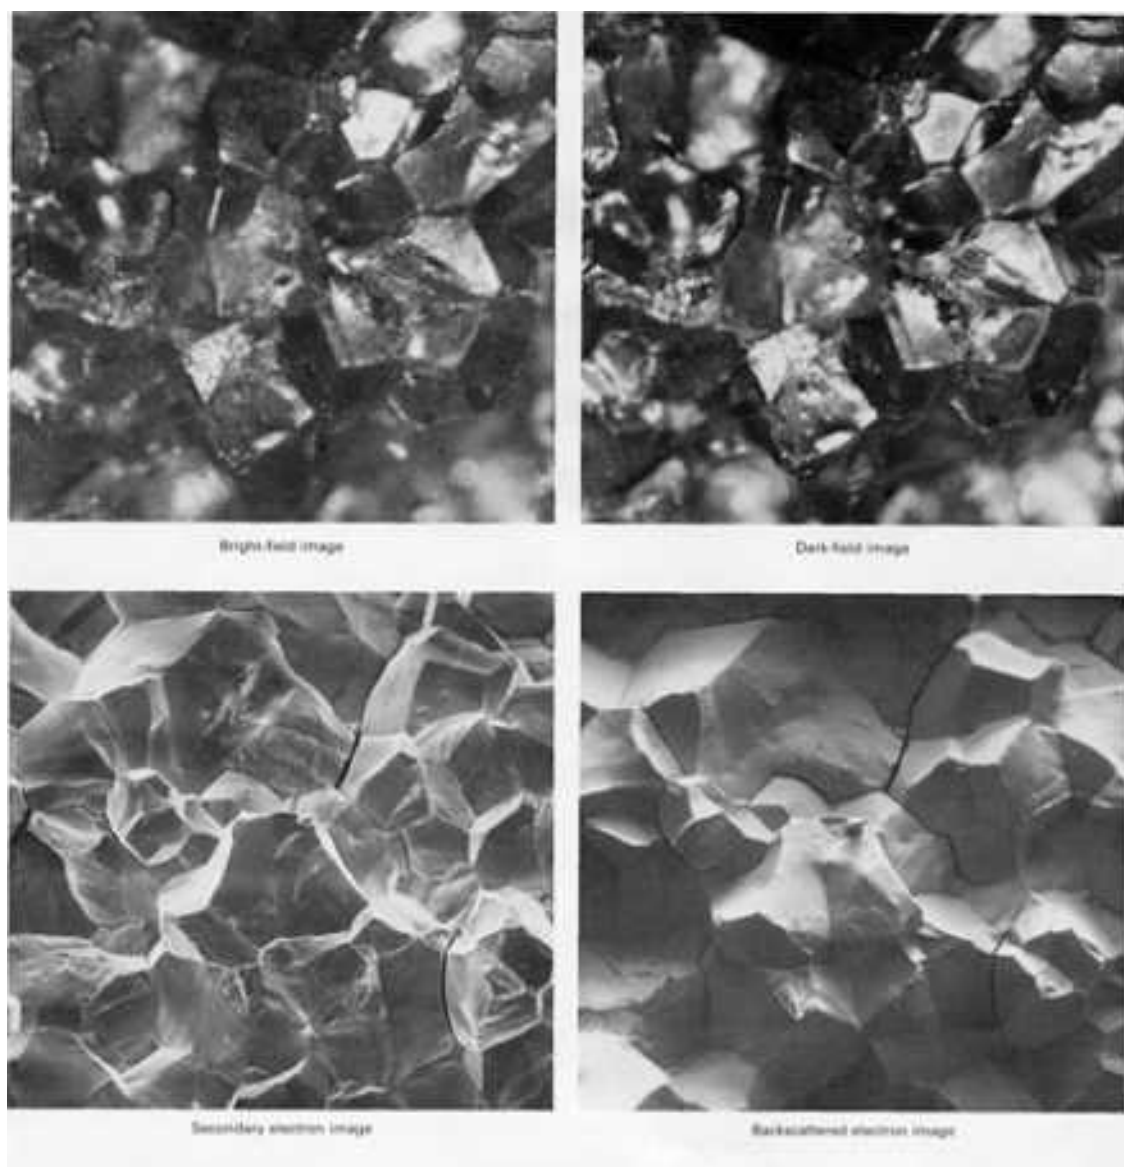
**Fig. 1 Comparison of light microscope (top row) and scanning electron microscope (bottom row) fractographs showing the intergranular fracture appearance of an experimental nickel-base precipitation-hardenable alloy**

*rising-load test specimen that was tested in pure water at 95 °C (200 °F). All shown at 50×. Courtesy of G.F. Vander Voort and J.W. Bowman, Carpenter Technology Corporations. Additional comparisons of fractographs obtained by light microscopy and scanning electron microscopy can be found in the article "Visual Examination and Light Microscopy" in this Volume.*

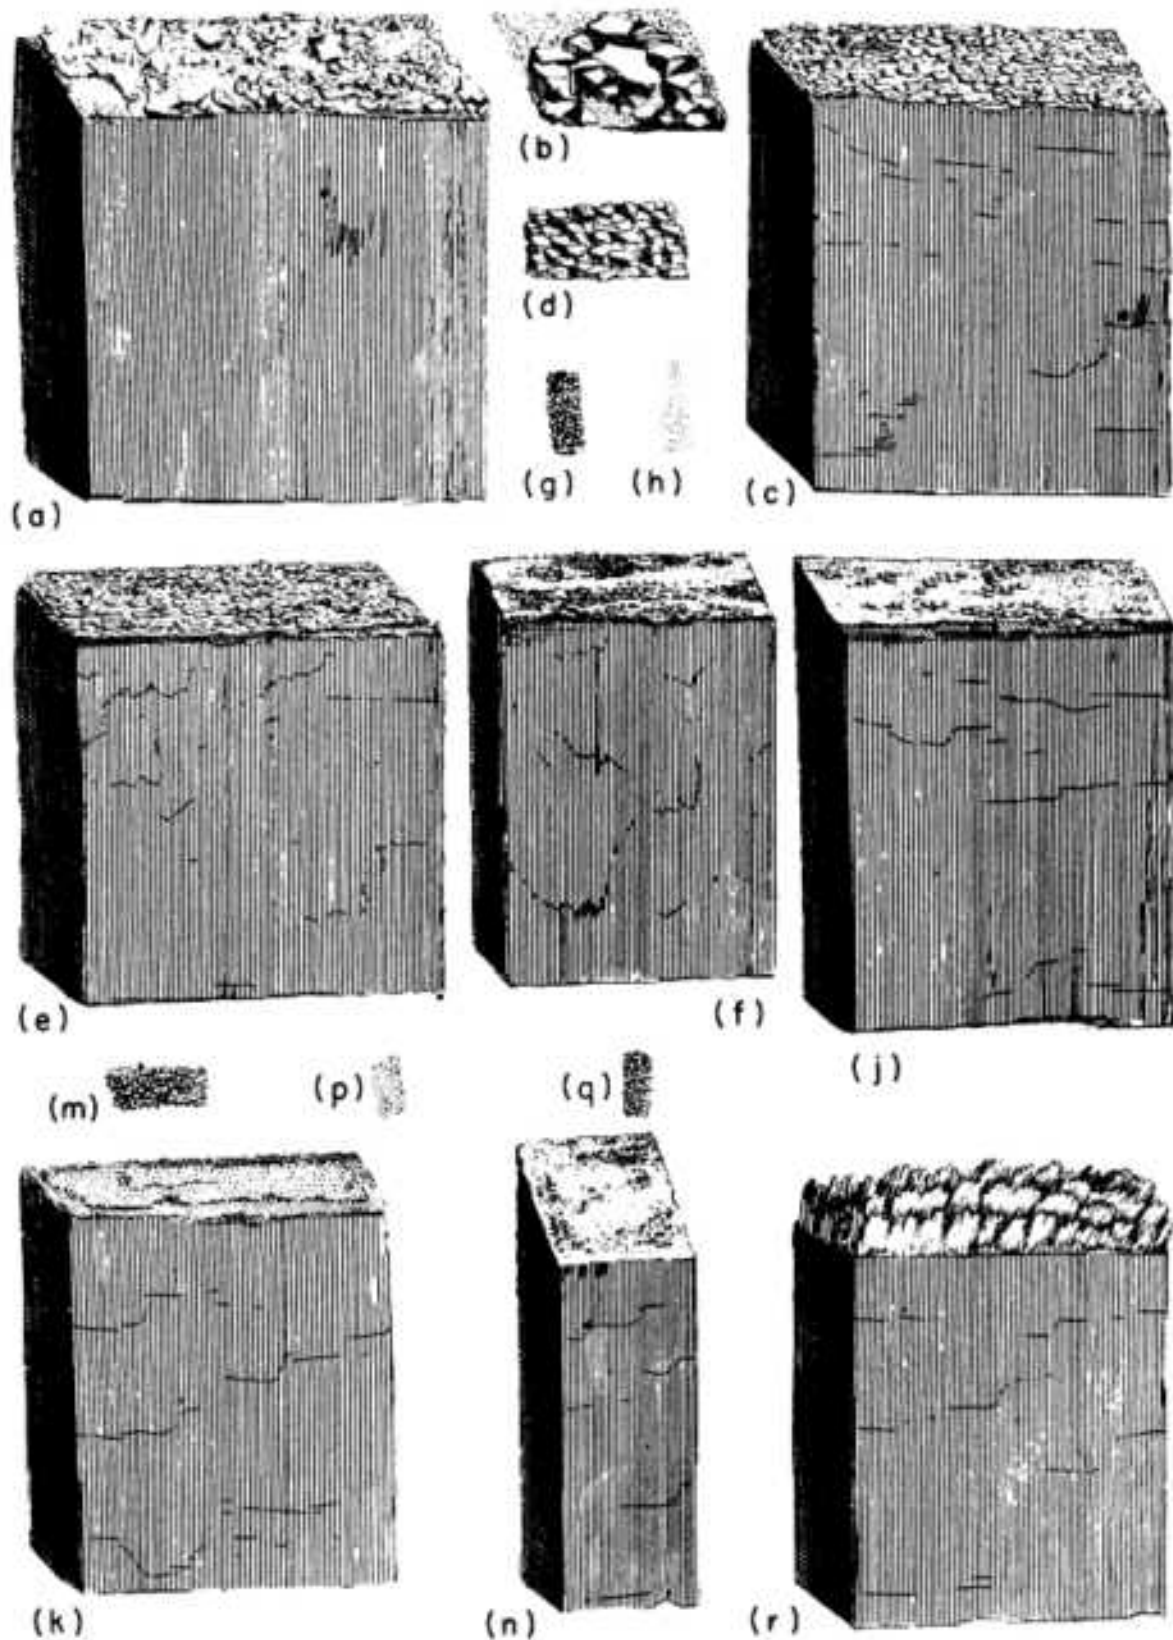
Fig. 1 Sketches from R.A.F. de Réaumur (Ref 10) depicting seven categories of fracture appearance in iron and steel. (a) Type I fracture; large mirrorlike facets. (b) Same as (a), but as viewed with a hand lens. (c) Type II fracture; smaller facets and more regular distribution. (d) Same as (c), but as viewed with a hand lens. (e) Another type II fracture, but improved in regularity of distribution and reduced facet size compared with (c). (f) type III fracture; advantageous occurrence of interposed areas of fibrous metal between facets. (g) Detail of

facets in (f). (h) Detail of fibrous metal in (f). (j) Type IV fracture; fibrous with very few reflecting facets. (k) Type V fracture; framelike area surrounding an entirely fibrous center. (m) Same as (k), but as viewed with a hand lens; a type VI fracture would look like this, except for finer grain size. (n) Type VI fracture; an unusual type, with tiny facets in a fibrous background. (p) Detail of fibrous area in (n). (q) Detail of a small facets in (n). (r) Type VII fracture; woody appearance.

One of the most significant early contributions to the study of metal fractures was by de Réaumur (Ref 10), who published a book in 1722 that contained engravings illustrating both the macroscopic and microscopic appearance of fracture surfaces of iron and steel (although the microscope was invented *circa* 1600, at the time of de Réaumur it was necessary to sketch what one saw and then transfer the sketch to metal, wood, or stone by engraving). In this classical work, de Réaumur listed and illustrated seven classes of fracture appearance in iron and steel. These are described below and shown in Fig. 1:

- *Type I fracture*: Large, irregularly arranged, mirrorlike facets, indicating inferior metal (Fig. 1a and b)
- *Type II fracture*: More regular distribution and smaller facets, indicating a slightly improved metal (Fig. 1c to e)
- *Type III fracture*: Interposed areas of fibrous metal between facets (Fig. 1f to h).
- *Type IV fracture*: Fibrous metal, with very few reflecting facets (Fig. 1j)
- *Type V fracture*: Framelike area surrounding an entirely fibrous center (Fig. 1k and m)
- *Type VI fracture*: An unusual type, with a few small facets in a fibrous background (Fig. 1n, p, and q)

- *Type VII fracture*: Characterized by a woody appearance (Fig. 1r)

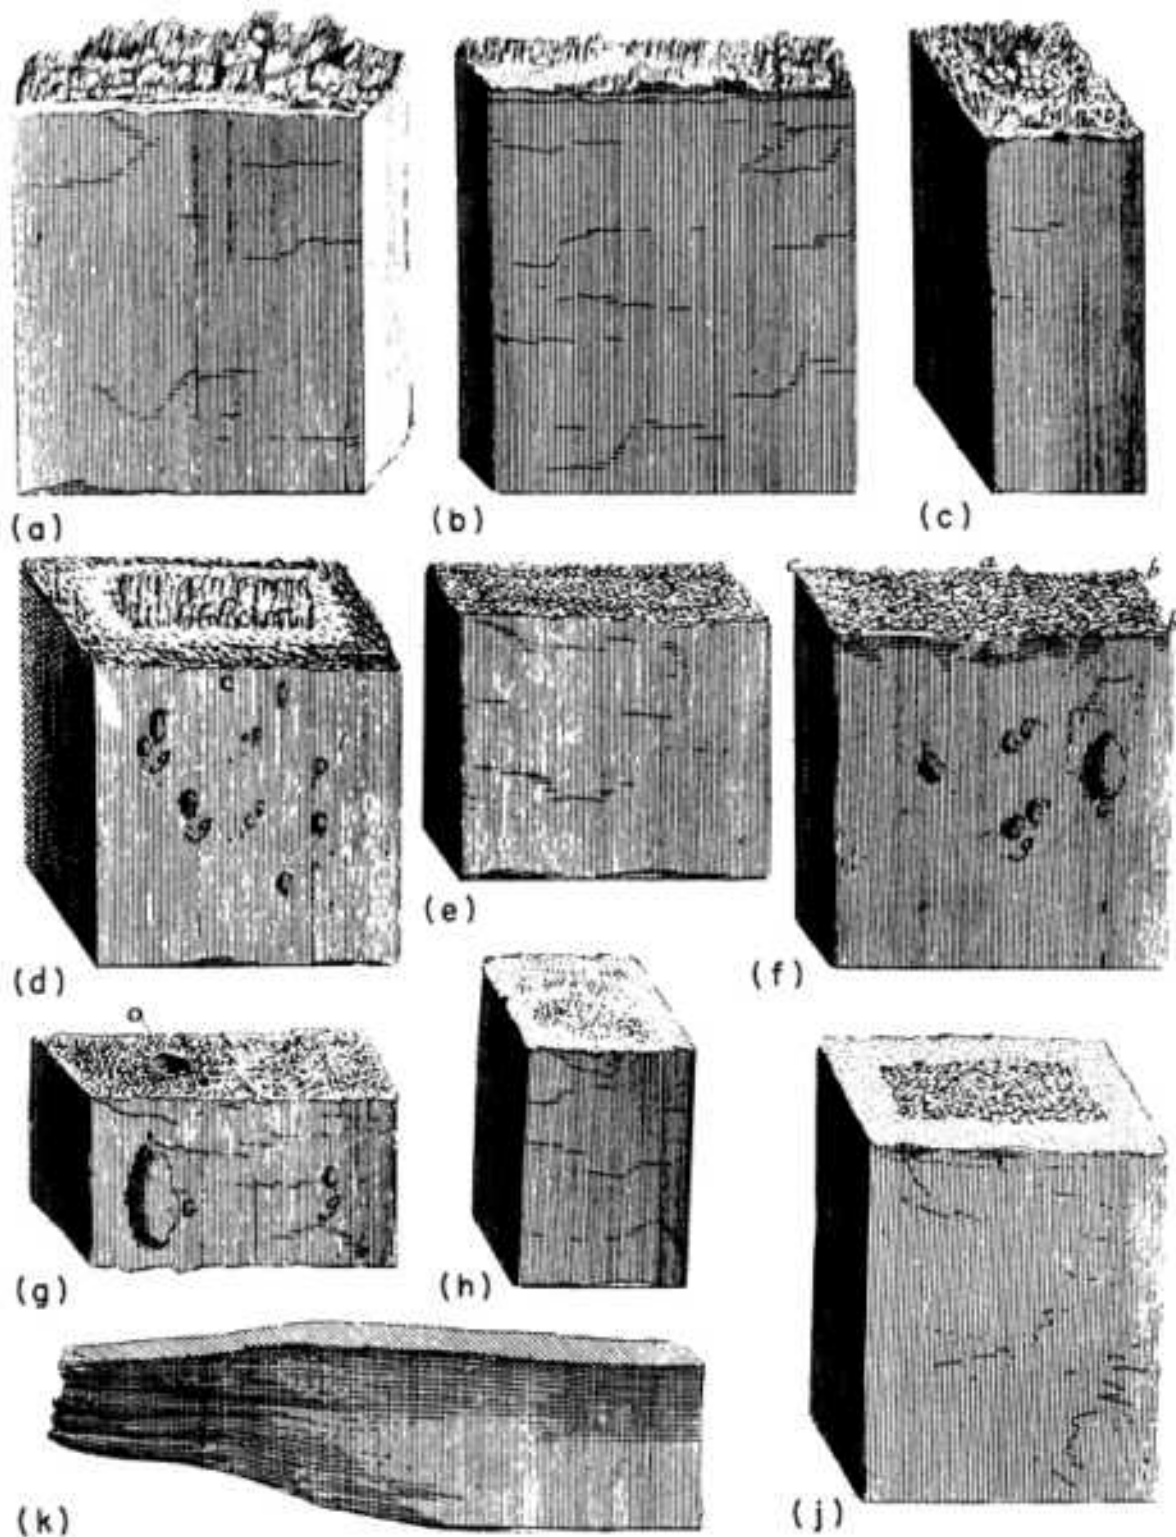
Fig. 2 Sketches from R.A.F. de Réaumur (Ref 10) defining fracture aspects that give evidence of the degree of conversion of iron to steel by the cementation process. (a) Woody fracture, but without the distinctly clustered appearance of the fracture in Fig. 1(r). (b) Woody fracture combined with minutely granular areas. (c) Fracture exhibiting a combination of brittle facets, woody texture, and minutely granular areas. These fractures are typical of iron. (d) Fracture in iron bar partly converted to steel, the outer minutely granular zone giving way to an inner framework of brittle facets, which in turn surround the woody center. (e) Fracture in steel produced from iron by cementation, showing a mass of small facets throughout the fracture, those in the center being somewhat larger. (f) Fracture in iron bar converted to steel only from *a-a* to *b-b* and remaining as iron from *a-a* to *c-c* because of overheating in the furnace. (g) Fracture in steel; the lusterless, rough facets resulted from holding the specimen too long in the furnace. (h) Fracture in a type of iron that always produces very small facets when converted to steel. (j) A type II fracture in iron (see Fig. 1), indicating that the iron will fail to

convert to steel in the center and will also produce an inferior fracture frame. (k) Fracture in forged steel showing folding at left end, which could later cause cracking during heat treatment. In (d), (f), and (g), small blisters are indicated by the letter *g*, large blisters by the letter *G*, and porosity by the letter *O*.

A second plate from de Réaumur's book (Fig. 2) concerns the use of fracture surfaces in appraising the completeness of conversion of iron to steel by the then current process of cementation (carburization). In his meticulous reproduction of detail, he included phenomena still bothersome to metallurgists today, such as blistering, burning (overheating) brittle fracture, and woody fracture. Descriptions of the fractures characteristics of the various stages of conversion are given with Fig. 2. In summary, they are:

- Woody fractures characteristics of iron (Fig. 2a to c)
- Fractures characteristics of partly converted metal (Fig. 2d, f, and j)
- Fractures characteristics of steel (Fig. 2e and g)

Figure 2(h) shows a fracture that is typical of an iron that will convert easily to steel Fig. 2(j), a fracture typical of an iron that will not convert to steel.

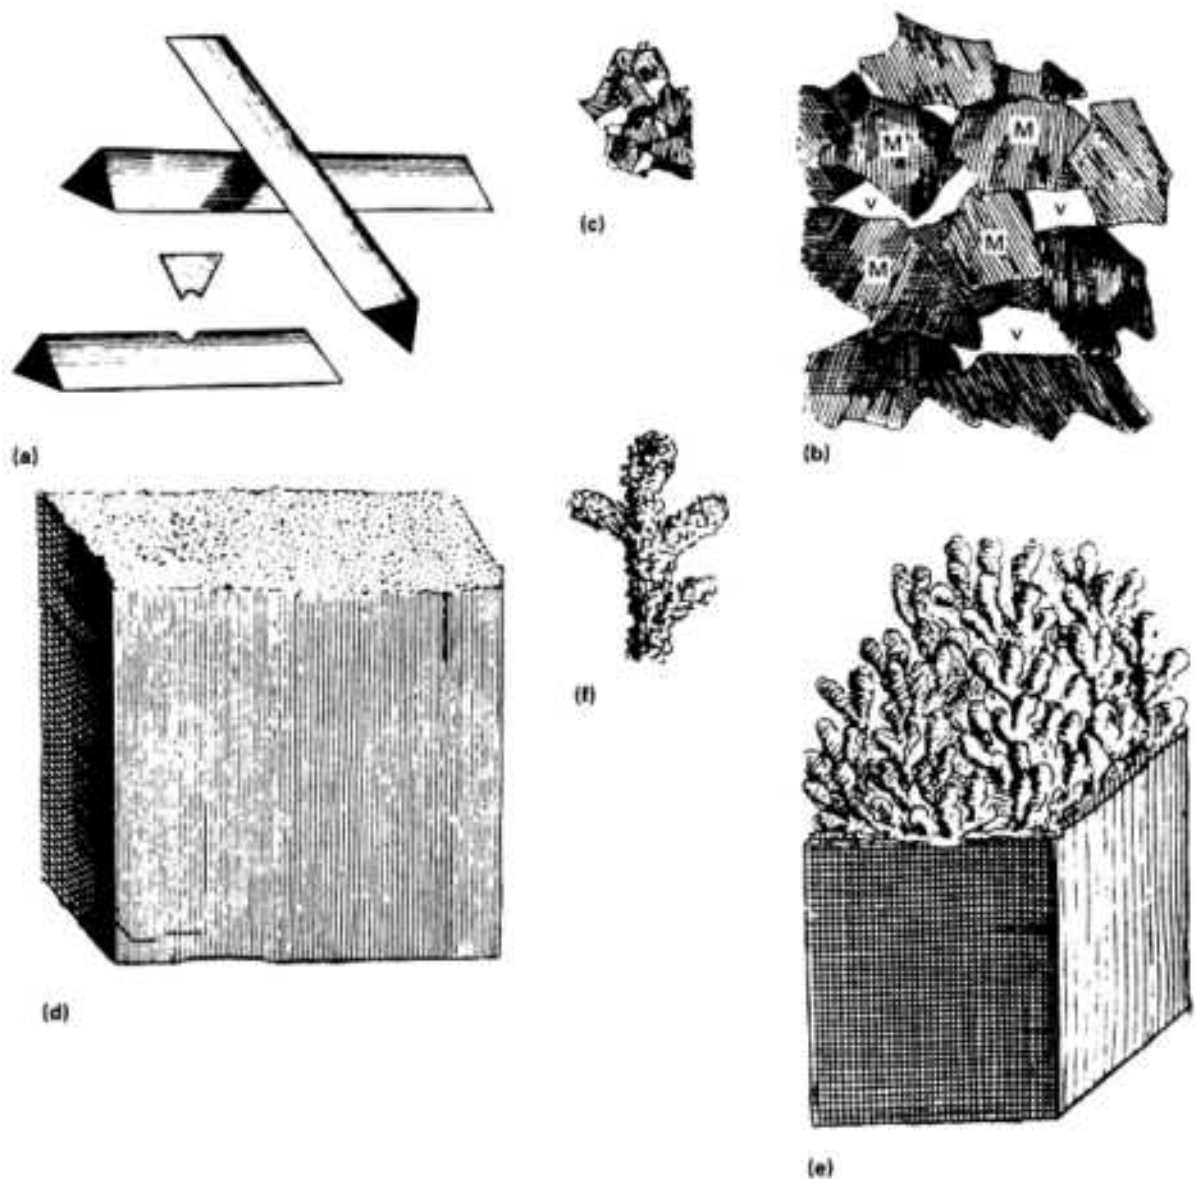
**Fig. 3** Sketches from R.A.F. de Réaumur (Ref 10) showing notched-bar fracture test specimen, enlarged view of grains, and details of fracture in cast iron. (a) A notched-bar fracture test, which allows two identical steel bars to be broken with a single blow. (b) Grain ". . . prodigiously magnified [i.e., of the order of 50×] showing the voids *V* and molecules *M*. . ." (probably crystallites) of which the grain is composed. (c) One of the individual molecules of (b) showing the units of which it is composed. (d) Fracture in gray iron, strongly resembling one in steel, except that the surface is brownish and the grains are coarser. (e) Detail of (d) at high magnification showing the fracture to comprise". . . an infinity of branches. . ." Here de Réaumur's magnification clearly exceeded 100×, although some of the enlargement may have been contributed to drawing what he saw. (f) Detail of an individual branch (dendrite) showing structure of minute platelets (possibly or cementite) placed one on another

A third plate from de Réaumur (Fig. 3) displays his fracture studies at high magnifications and his fracture test. The minute platelets shown in Fig. 3(f), which may have been pearlite or cementite in some form, were recorded a full century and a half before the founding of metallography.

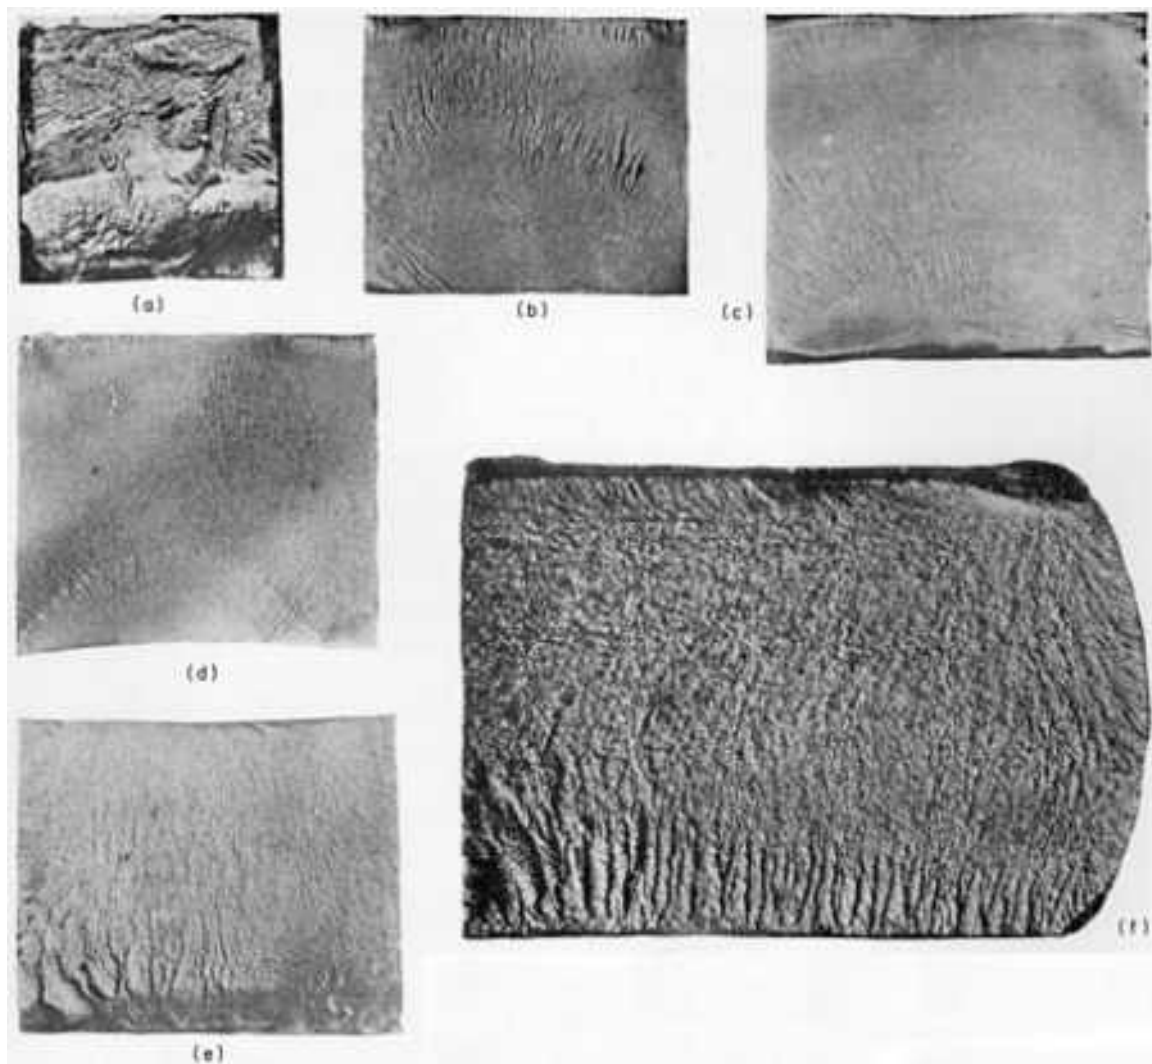
**Fig. 4 Steel fractures recorded by A. Martens (Ref 25, p 237, Plate X). Martens called attention to the radial fracture marks in these fractographs, terming them Bruchlinien (fracture lines). (a) Ingot steel; tensile strength, 765 MPa (111 ksi). (b) through (e) Tool steels from Böhler Bros. of Vienna and others: (b) extra hard; (c) very hard, special; (d) moderately hard; (e) ductile. (f) Chisel steel with fracture lines. (a)through (e) Actual size. (f) 6×**

A plate from a later article (1887) by Martens is shown in part in Fig. 4. This plate consists of fractographs produced by photography and then printed by a photogravure process. The fractures shown in Fig. 4 illustrate features that Martens

termed Bruchlinien (fracture lines), which today would be called radial marks. The description of this fracture form by Martens predates reports by other investigators who are usually credited for first treatment of this fracture feature.

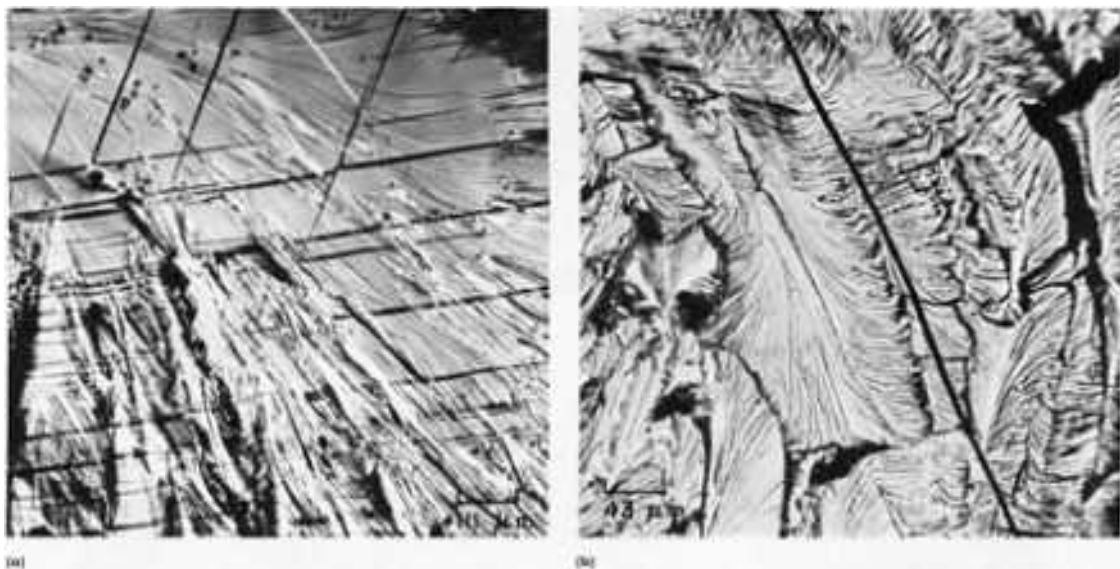
**Fig. 5 Cleavage fractures in room-temperature impact specimens examined by C.A. Zapffe. (a) Cast polycrystalline antimony (99.83Sb-0.04S-0.035As-0.035Pb-0.015Fe-0.01Cu) (b) Vacuum-arc-cast high oxygen**

## molybdenum

Although bothered by the relatively small depth of focus of the light microscope, Zapffe and his co-workers were able to orient the facets of a fracture relative to the axis of the microscope so that examinations could be made at relatively high magnifications. (Zapffe routinely took fractographs with magnifications as high as 1500 to 2000 $\times$ .) Most of Zapffe's work was done on brittle fractures in ingot iron and steels (notably welded ship plate, Ref 48), bismuth (Ref 35), zinc (Ref 37), antimony (Ref 42), molybdenum (Ref 44), and tungsten (Ref 45), from which he described in considerable detail the appearance and crystallography of cleavage facets. Figures 5(a) and 5(b) are examples of Zapffe's early work.

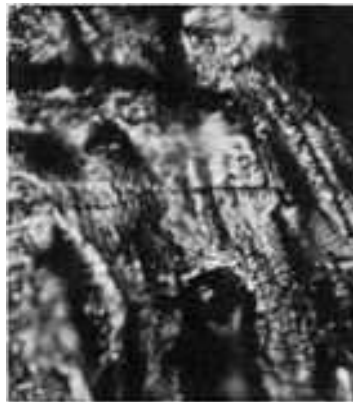
**Fig. 6 Fatigue striations observed by Zapffe (Ref 50) in an aluminum alloy specimen tested in completely reversed bending, at a maximum stress of 172 MPa (25 ksi) at room temperature, to failure at  $336 \times 10^3$  cycles**

According to Henry and Plateau (Ref 51), Zapffe and his colleagues were also the first to observe striations on fatigue fracture surfaces (Ref 50). In describing the striations, observed in an aluminum alloy 75S-T6 (equivalent to present-day 7075). Zapffe wrote, "This fine lamellar structure seems clearly to be a fatigue phenomenon, suggesting a stage of minute structural ordering advanced beyond the grosser platy structure, and apparently favored by an increasing number of stress cycles. The lamellae are approximately parallel to the platy markings; and both sets of markings lie approximately in the bending plane perpendicular to the stress motion, as one would expect for a structural rearrangement due to this type of flexion." Figure 6 shows one of the fractographs included in Zapffe and Worden's 1951 paper "Fractographic Registrations of Fatigue" (Ref 50).

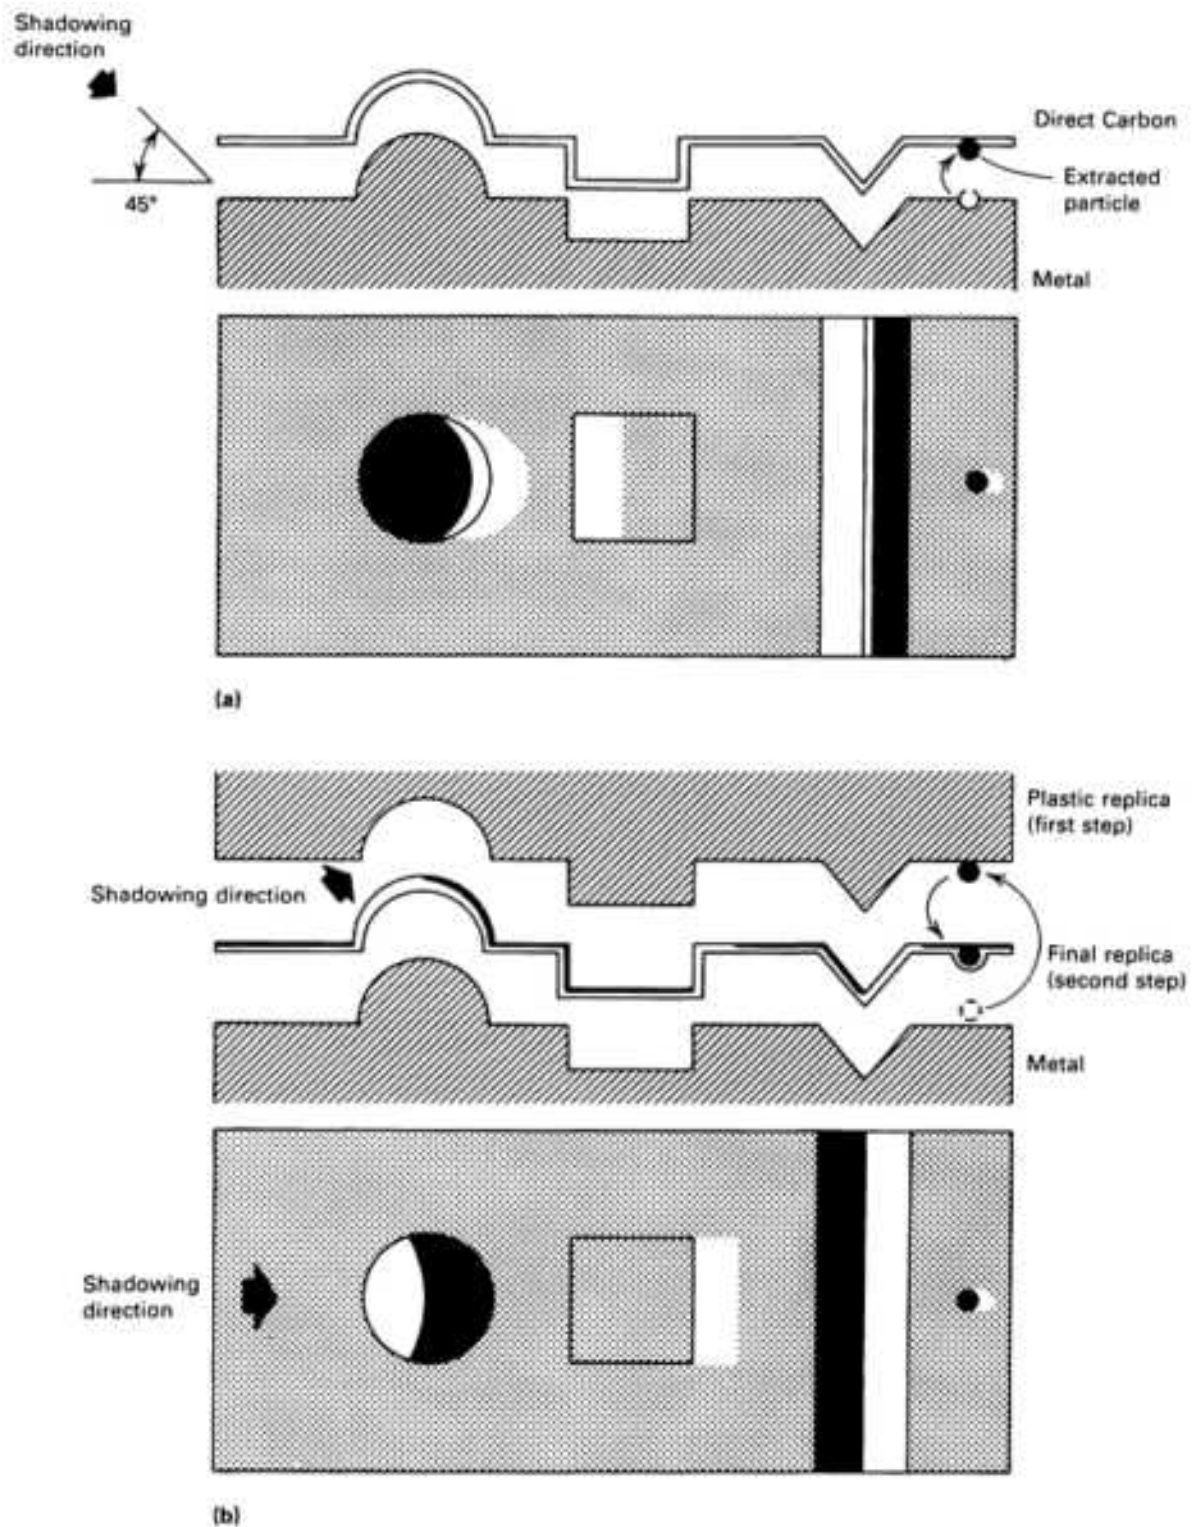
**Fig. 7 Schematic of the two types of replicas. (a) One-step replica. (b) Two-step replica**

**One-step replicas** are the most accurate of the replicating techniques (Fig. 7a). The carbon film is directly evaporated onto the fracture surface and released by dissolving the base metal. The shadowing angle is usually not critical, because of the roughness of the surface (shadowing is discussed below). The continuity of the carbon film is ensured by the surface diffusion of the evaporated carbon. Direct carbon replicas can be extracted electrolytically or chemically.

**In two-step replicas**, the details of the fracture surface are transferred to a plastic mold, which is easy and convenient to dissolve in order to release the final carbon replica (Fig. 7b). The plastic mold can be obtained by applying successive layers of a varnish or Formvar or by simply pressing a softened piece of cellulose acetate to the fracture surface.

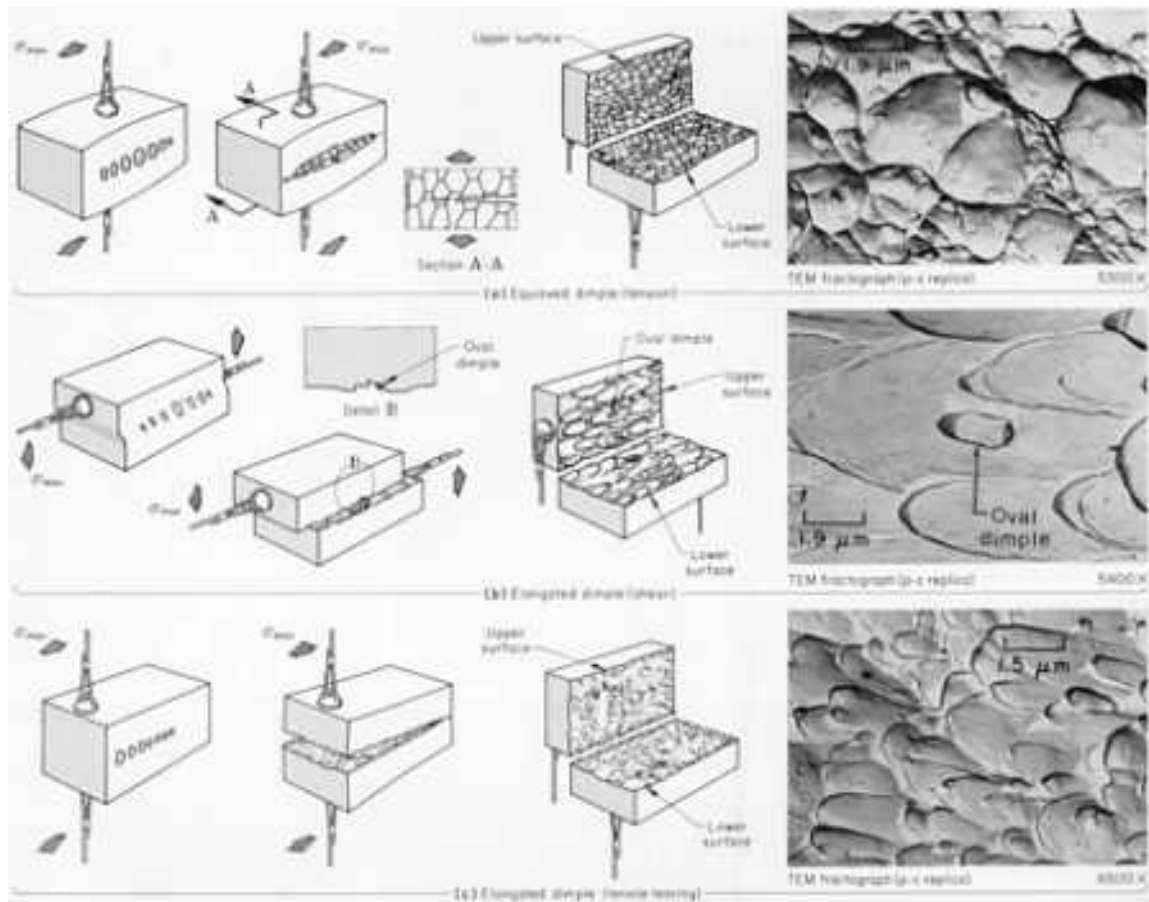
**Fig. 1 Influence of direction of maximum stress ( $\sigma_{\max}$ ) on the shapes of dimples formed by microvoid coalescence. (a) In tension, equiaxed dimples are formed on both fracture surfaces. (b) In shear, elongated dimples point in opposite directions on matching fracture surfaces. (c) In tensile tearing, elongated dimples point toward fracture origin on matching fracture surfaces**

Dimple shape is governed by the state of stress within the material as the microvoids form and coalesce. Fracture under conditions of uniaxial tensile load (Fig. 1a) results in the formation of essentially equiaxed dimples bounded by a lip or rim (Fig. 3 and 4a). Depending on the microstructure and plasticity of the material, the dimples can exhibit a very deep, conical shape (Fig. 4a) or can be quite shallow (Fig. 4b). The formation of shallow dimples may involve the joining of microvoids by shear along slip bands (Ref 1).

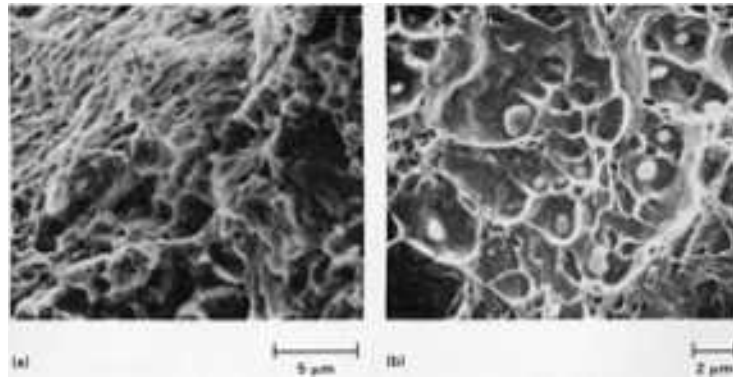
**Fig. 2 Examples of the dimple rupture mode of fracture. (a) Large and small dimples on the fracture surface of a martempered type 234 tool steel saw disk. The extremely small dimples at top left are nucleated by numerous, closely spaced particles. (D.-W. Huang, Fuxin Mining Institute, and C.R. Brooks, University of Tennessee). (b) Large and small sulfide inclusions in steel that serve as void-nucleating sites. (R.D. Buchheit, Battelle Columbus Laboratories)**

The distribution of the microvoids nucleation sites can significantly influence the fracture surface appearance. In some alloys, the nonuniform distribution of nucleating particles and the nucleation and growth of isolated microvoids early in the loading cycle produce a fracture surface that exhibits various dimple sizes (Fig. 2). When microvoids nucleate at the grain boundaries (Fig. 3), intergranular dimple rupture results.

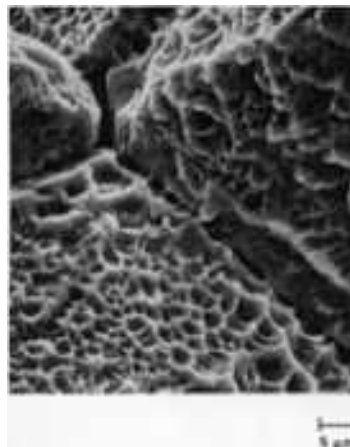
**Fig. 3 Intergranular dimple rupture in a steel specimen resulting from microvoid coalescence at grain boundaries.**

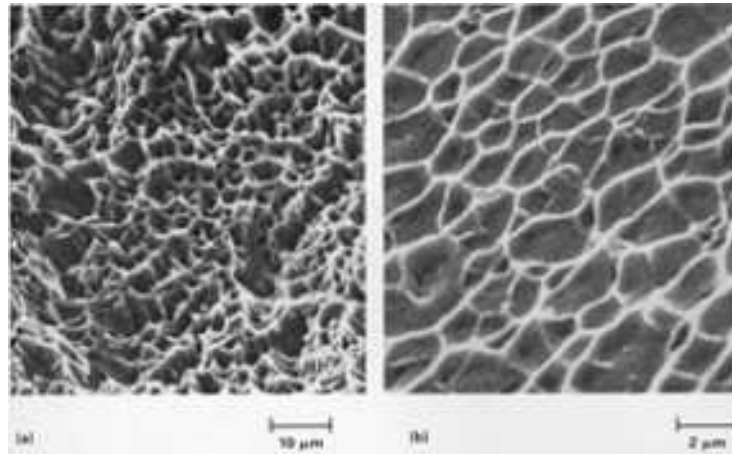
**Fig. 4 Different types of dimples formed during microvoid coalescence. (a) Conical equiaxed dimples in a spring steel specimen. (b) Shallow dimples in a maraging steel specimen**

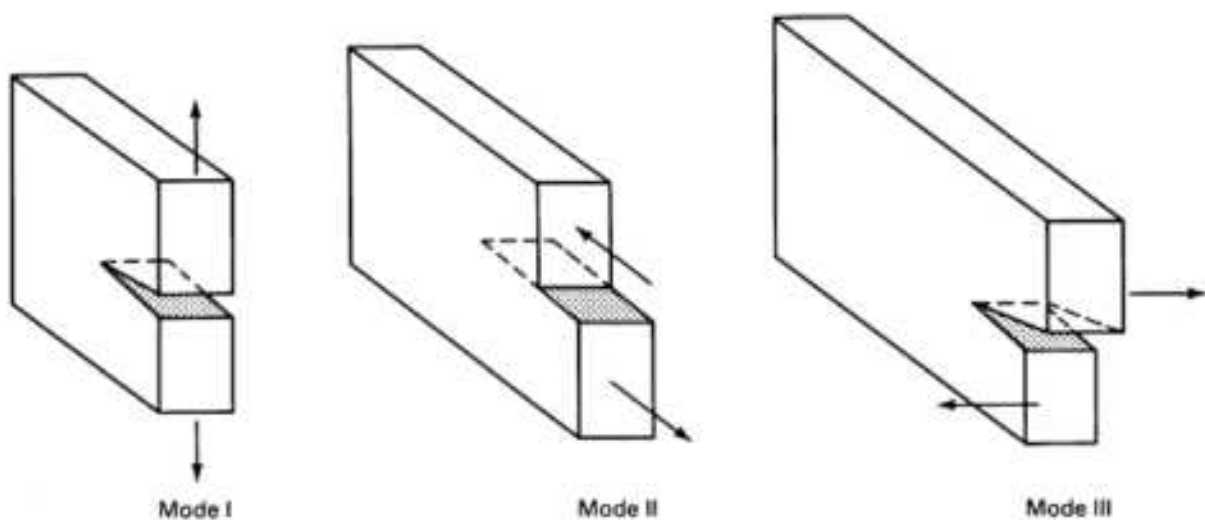
**Fig. 5 Fracture loading modes. Arrows show loading direction and relative motion of mating fracture surfaces.**

Fracture surfaces that result from tear (Mode I) or shear (Modes II and III) loading conditions (Fig. 5) exhibit elongated dimples (Ref 2, 3). The characteristics of an elongated dimple are that it is, as the name implies, elongated (one axis of the dimple is longer than the other) and that one end of the dimple is open; that is, the dimple is not completely surrounded by a rim. In the case of a tear fracture (Fig. 6a), the elongated dimples on both fracture faces are oriented in the same direction; and the closed ends point to the fracture origin. This characteristic of the tear dimples can be used to establish the fracture propagation direction (Ref 4) in thin sheet that ruptures by a full-slant fracture (by combined Modes I and III), which consists entirely of a shear lip and exhibits no macroscopic fracture direction indicators, such as chevron marks. A shear fracture, however, exhibits elongated dimples that point in opposite directions on mating fracture faces (Fig. 6b). Examples of typical elongated dimples are shown in Fig. 7.

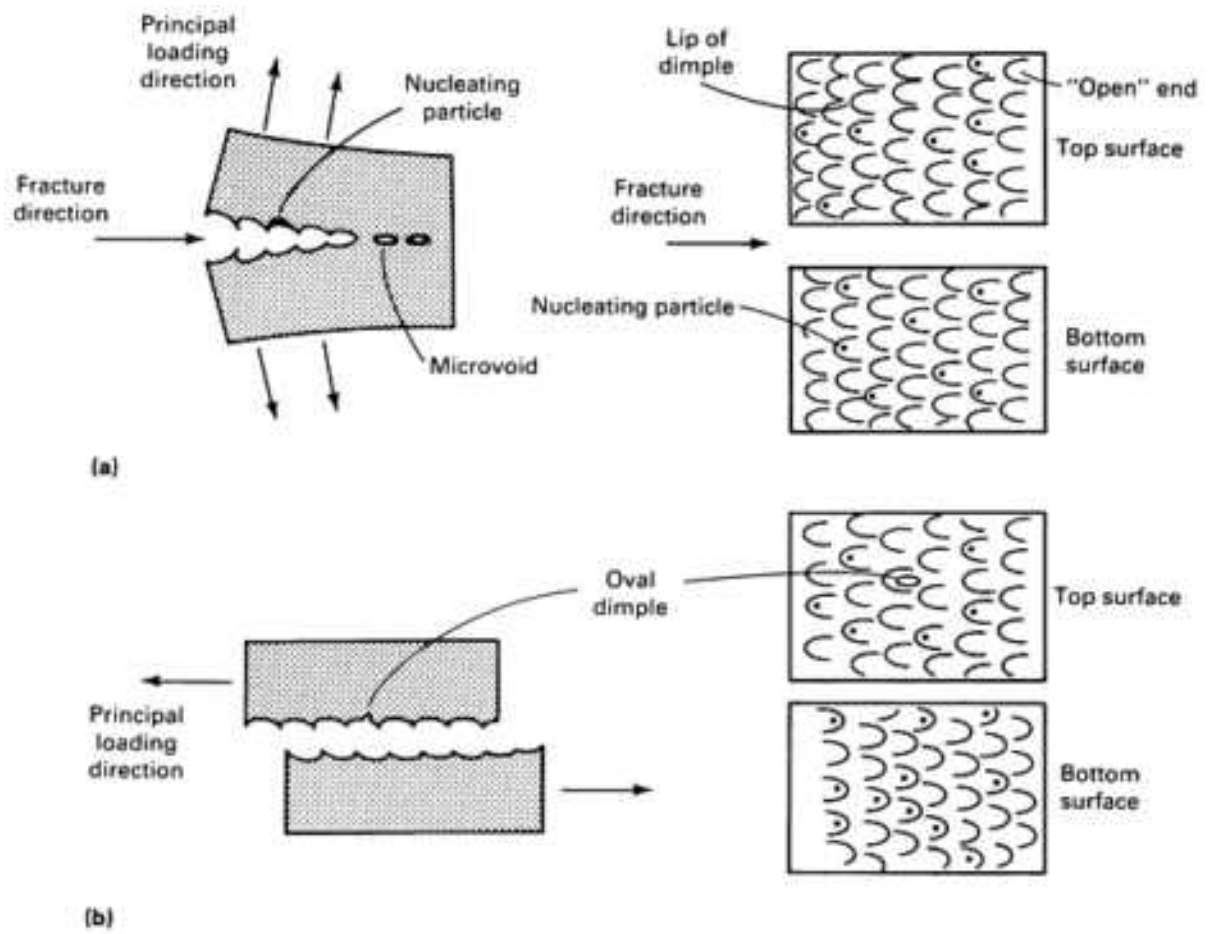
**Fig. 6 Formation of elongated dimples under tear and shear loading conditions. (a) Tear fracture. (b) Shear fracture**

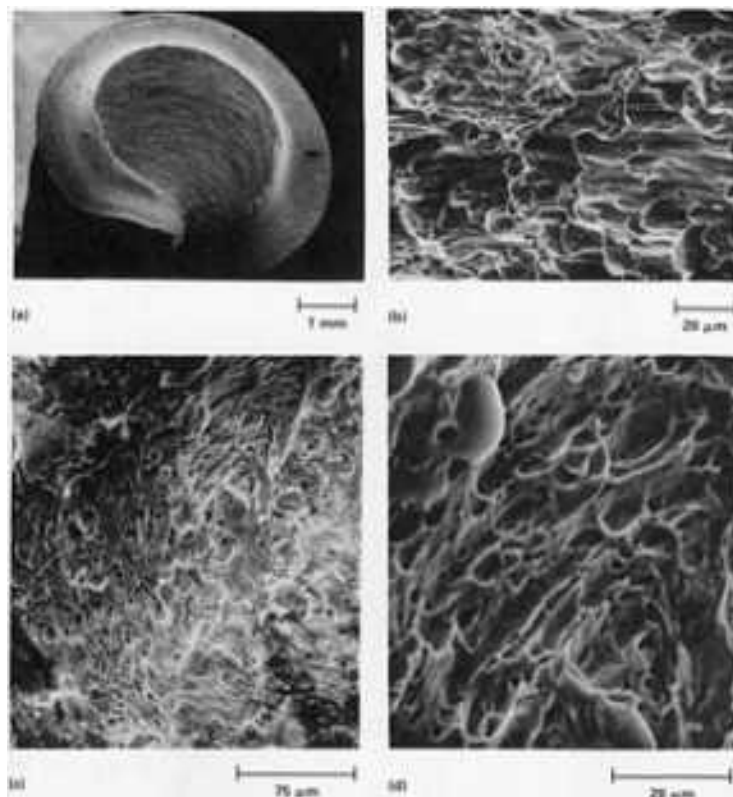
**Fig. 7 Elongated dimples formed on shear and torsion specimen fracture surfaces. (a) Shear fracture of a commercially pure titanium screw. Macrofractograph shows spiral-textured surface of shear-of screw. Typical deformation lines are fanning out on the thread. (b) Higher-magnification view of (a) shows uniformly distributed elongated shear dimples. (O.E.M. Pohler, Institut Straumann AG). (c) Elongated dimples on the surface of a fractured single-strand copper wire that failed in torsion. (d) Higher-magnification view of the elongated dimples shown in (c). (R.D. Lujan, Sandia National Laboratories)**

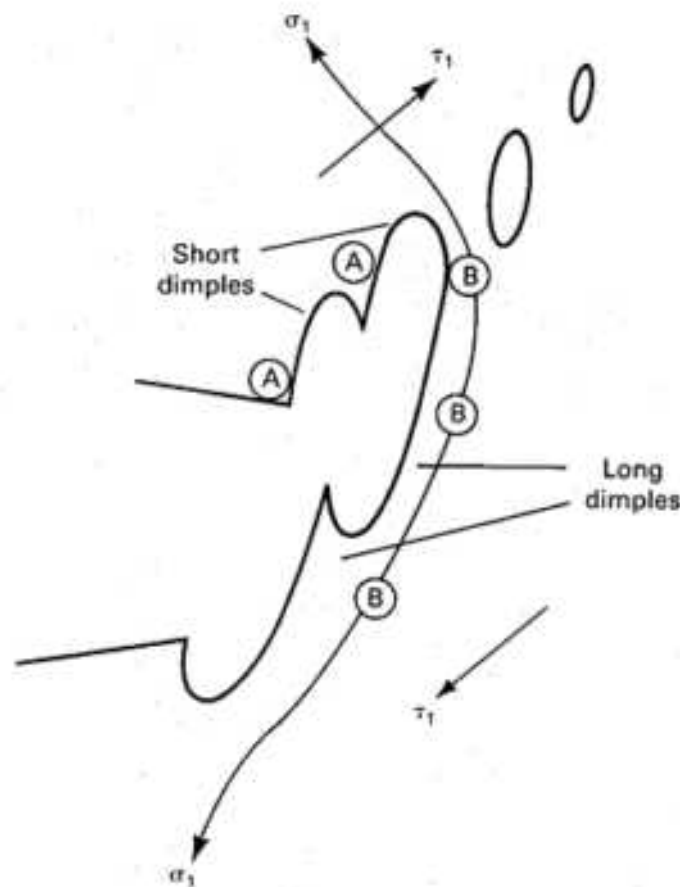
**Fig. 8 Effect of asymmetry on dimple size**

Figure 8 shows the effect of such asymmetry on dimple size. The surface (B) that is strained after fracture exhibits longer dimples than its mating half (A). When fracture occurs by a combination of Modes I and II, examination of the dimples on mating fracture surfaces can reveal the local fracture direction (Ref 5). As illustrated in Fig. 8, the fracture plane containing the longer dimples faces the region from which the crack propagated, while the mating fracture plane containing the shorter dimples faces away from the region. With the different combinations of Modes I, II, and III, there could be as many as 14 variations of dimple shapes and orientation on mating fracture surfaces (Ref 5.)

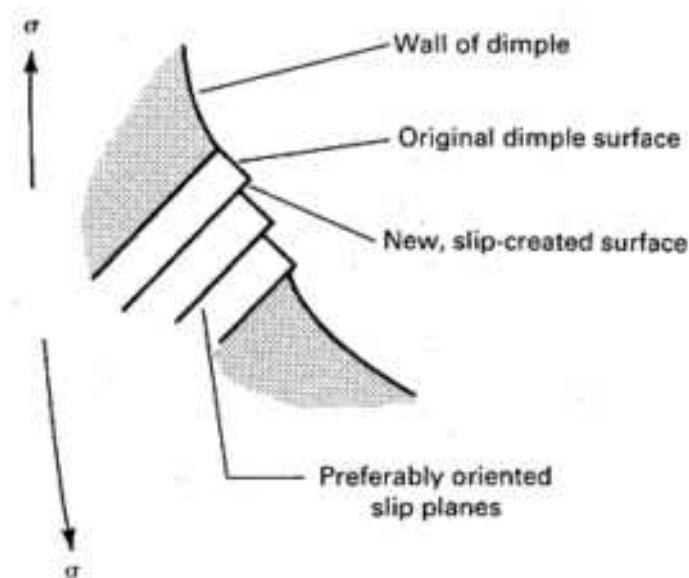
**Fig. 9 Slip step formation resulting in serpentine glide and ripples on a dimple wall**

Metals that undergo considerable plastic deformation and develop large dimples frequently contain deformation markings on the dimple walls. These markings occur when slip-planes at the surface of the dimples are favorably oriented to the major stress direction. The continual straining of the free surfaces of the dimples as the microvoids enlarge produces slip-plane displacement at the surface of the dimple (Ref 6), as shown in Fig. 9. When first formed, the slip traces are sharp, well defined, and form an interwoven pattern that is generally referred to as serpentine glide (Fig. 10). As the slip process proceeds, the initial sharp slip traces become smooth, resulting in a surface structure that is sometimes referred to as ripples.

(Ref 29) (for an analogy, see Fig. 9). Thus, one fracture surface may show well-developed striations, while its counterpart exhibits shallow, poorly formed striations.

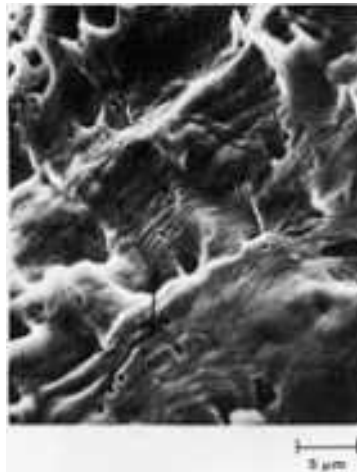
**Fig. 10 Serpentine glide formation (arrow) in oxygen-free high-conductivity copper specimen**

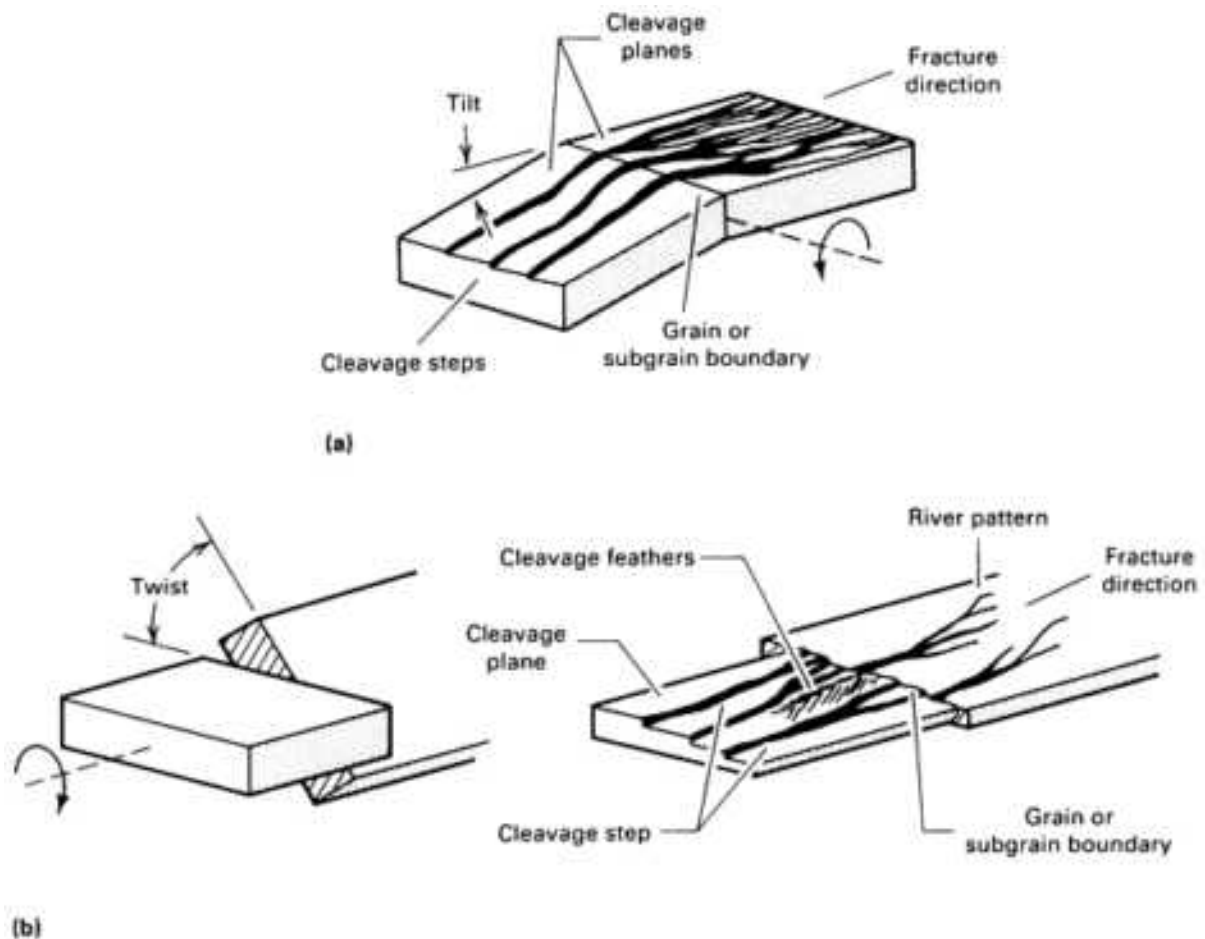
**Fig. 11 Schematic of cleavage fracture formation showing the effect of subgrain boundaries. (a) Tilt boundary. (b) Twist boundary**

As shown schematically in Fig. 11, cleavage fractures frequently initiate on many parallel cleavage planes. As the fracture advances, however, the number of active planes decreases by a joining process that forms progressively higher cleavage steps. This network of cleavage steps is known as a river pattern. Because the branches of the river pattern join in the direction of crack propagation, these markings can be used to establish the local fracture direction.

A tilt boundary exists when principal cleavage planes form a small angle with respect to one another as a result of a slight rotation about a common axis parallel to the intersection (Fig. 11a). In the case of a tilt boundary, the cleavage fracture path is virtually uninterrupted, and the cleavage planes and steps propagate across the boundary. However, when the principal cleavage planes are rotated about an axis perpendicular to the boundary, a twist boundary results (Fig. 11b). Because of the significant misalignment of cleavage planes at the boundary, the propagating fracture reinitiates at the boundary as a series of parallel cleavage fracture connected by small (low) cleavage steps. As the fracture propagates away from the boundary, the numerous cleavage planes join, resulting in fewer individual cleavage planes and higher steps. Thus, when viewing a cleavage fracture that propagates across a twist boundary, the cleavage steps do not cross but initiate new steps at the boundary (Fig. 11b). Most boundaries, rather than being simple tilt or twist, are a combination of both types and are referred to as tilt-twist boundaries. Cleavage fracture exhibiting twist and tilt boundaries are shown in Fig. 12(a) and 13, respectively.
