ASM HANDBOOK®

VOLUME  
12

Fractography

*Fractography*, was published in 1987 as Volume 12 of the *ASM Handbook*. The Volume was prepared under the direction of the ASM Handbook Committee.

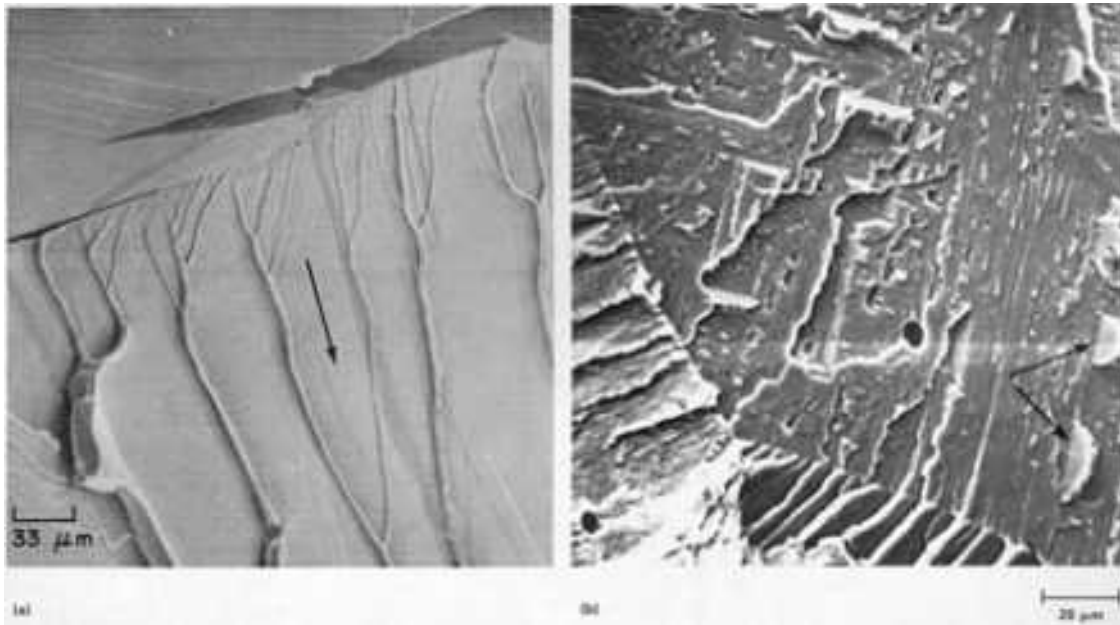
**Fig. 12** Examples of cleavage fractures. (a) Twist boundary, cleavage steps, and river patterns in an Fe-0.01C-0.24Mn-0.02Si alloy that was fractured by impact. (b) Tongues (arrows) on the surface of a 30% Cr steel weld metal that fractured by cleavage

A tilt boundary exists when principal cleavage planes form a small angle with respect to one another as a result of a slight rotation about a common axis parallel to the intersection (Fig. 11a). In the case of a tilt boundary, the cleavage fracture path is virtually uninterrupted, and the cleavage planes and steps propagate across the boundary. However, when the principal cleavage planes are rotated about an axis perpendicular to the boundary, a twist boundary results (Fig. 11b). Because of the significant misalignment of cleavage planes at the boundary, the propagating fracture reinitiates at the boundary as a series of parallel cleavage fracture connected by small (low) cleavage steps. As the fracture propagates away from the boundary, the numerous cleavage planes join, resulting in fewer individual cleavage planes and higher steps. Thus, when viewing a cleavage fracture that propagates across a twist boundary, the cleavage steps do not cross but initiate new steps at the boundary (Fig. 11b). Most boundaries, rather than being simple tilt or twist, are a combination of both types and are referred to as tilt-twist boundaries. Cleavage fracture exhibiting twist and tilt boundaries are shown in Fig. 12(a) and 13, respectively.

Tongues are occasionally observed on cleavage fracture (Fig. 12b). They are formed when a cleavage fracture deviates from the cleavage plane and propagates a short distance along a twin orientation (Ref 8).

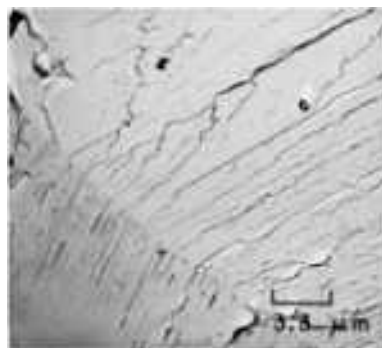
**Fig. 13** Cleavage fracture in Armco iron showing a tilt boundary, cleavage steps, and river patterns. TEM p-c replica

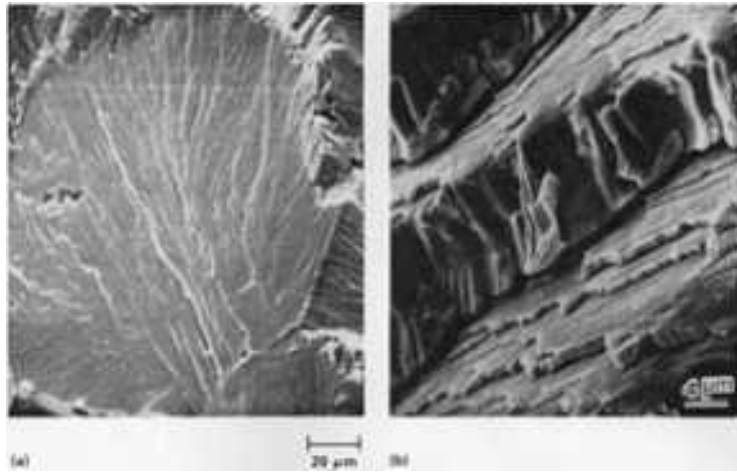
**Fig. 14 Examples of cleavage fractures. (a) Feather pattern on a single grain of a chromium steel weld metal that failed by cleavage. (b) Cleavage steps in a Cu-25 at.% Au alloy that failed by transgranular stress-corrosion cracking. (B.D. Lichter, Vanderbilt University)**

Feather markings are a fan-shaped array of very fine cleavage steps on a large cleavage facet (Fig. 14a). The apex of the fan points back to the fracture origin. Large cleavage steps are shown in Fig. 14(b).

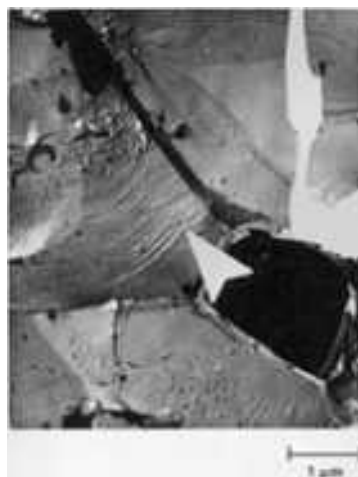
**Fig. 15 Wallner lines (arrow) on the surface of a fractured WC-Co specimen. TEM formvar replica. Etched with 5% HCl. (S.B. Luyckx, University of the Witwatersrand)**

Wallner lines (Fig. 15) constitute a distinct cleavage pattern that is sometimes observed on fracture surfaces of brittle nonmetallic materials or on brittle inclusions or intermetallic compounds. This structure consist of two sets of parallel cleavage steps that often intersect to produce a crisscross pattern. Wallner lines result from the interaction of a simultaneously propagating crack front and an elastic shock wave in the material (Ref 9).

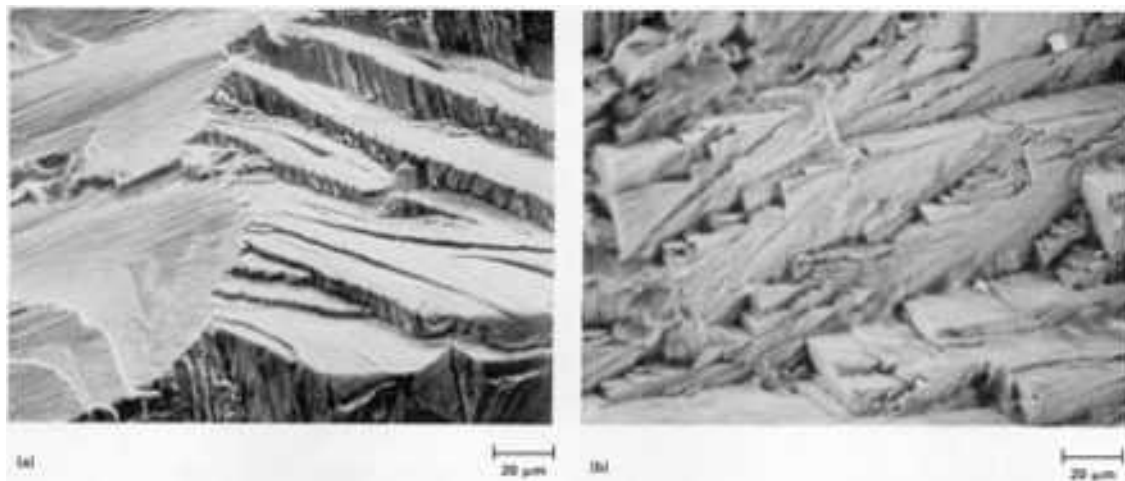
**Fig. 16 Stage I fatigue appearance. (a) Cleavagelike, crystallographically oriented Stage I fatigue fracture in a cast Ni-14Cr-4.5Mo-1Ti-6Al-1.5Fe-2.0(Nb + Ta) alloy. (b) Stair-step fracture surface indicative of Stage I fatigue fracture in a cast ASTM F75 cobalt-base alloy. SEM. (R. Abrams, Howmedica, Div. Pfizer Hospital Products Group Inc.)**

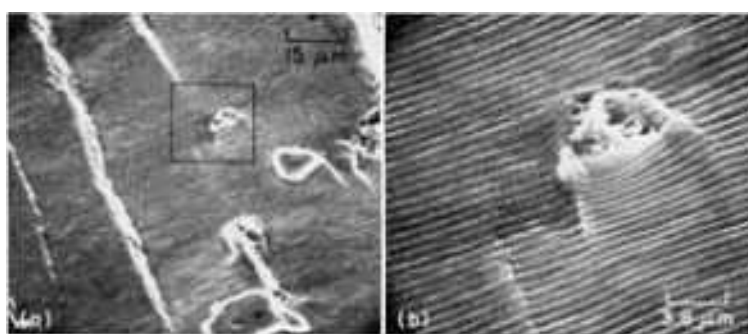
**Fig. 17 Uniformly distributed fatigue striations in an aluminum 2024-T3 alloy. (a) Tear ridge and inclusion (outlined by rectangle). (b) Higher-magnification view of the region outlined by the rectangle in (a) showing the continuity of the fracture path through and around the inclusion. Compare with Fig. 18.**

Large second-phase particles and inclusions in a metal can change the local crack growth rate and resulting fatigue striation spacing. When a fatigue crack approaches such a particle, it is briefly retarded if the particle remains intact or is accelerated if the particle cleaves (Fig. 18). In both cases, however, the crack growth rate is changed only in the immediate vicinity of the particle and therefore does not significantly affect the total crack growth rate. However, for low-cycle (high-stress) fatigue, the relatively large plastic zone at the crack tip can cause cleavage and matrix separation at the particles at a significant distance ahead of the advancing fatigue crack. The cleaved or matrix-separated particles, in effect, behave as cracks or voids that promote a tear or shear fracture between themselves and the fatigue crack, thus significantly advancing the crack front (Ref 33, 34). Relatively small, individual particles have no significant effect on striation spacing (Fig. 17b).

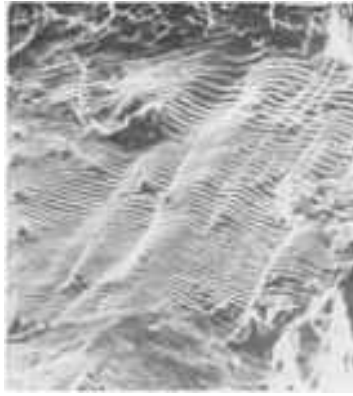
**Fig. 18** Local variations in striation spacing in a Ni-0.04C-21Cr-0.6Mn-2.5Ti-0.7Al alloy that was tested under rotating bending conditions. Compare with Fig. 17(b).

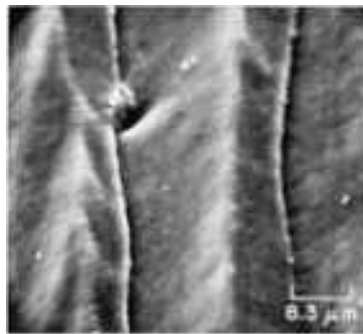
**Fig. 19** Fatigue striations in a 2024-T3 aluminum alloy joined by tear ridges

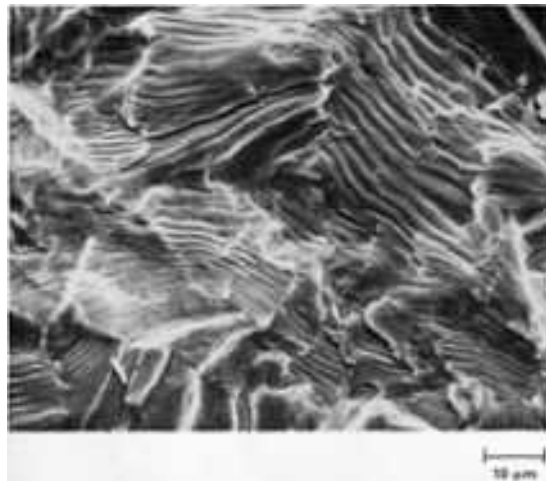
**Fig. 20** Fatigue striations on adjoining walls on the fracture surface of a commercially pure titanium specimen. (O.E.M. Pohler, Institut Straumann AG)

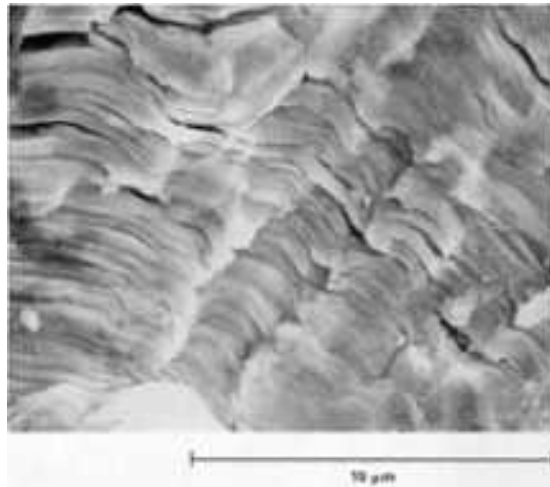
**Fig. 21** Fatigue striations on the fracture surface of a tantalum heat-exchanger tube. The rough surface appearance is due to secondary cracking caused by high-cycle low-amplitude fatigue. (M.E. Blum, FMC Corporation)

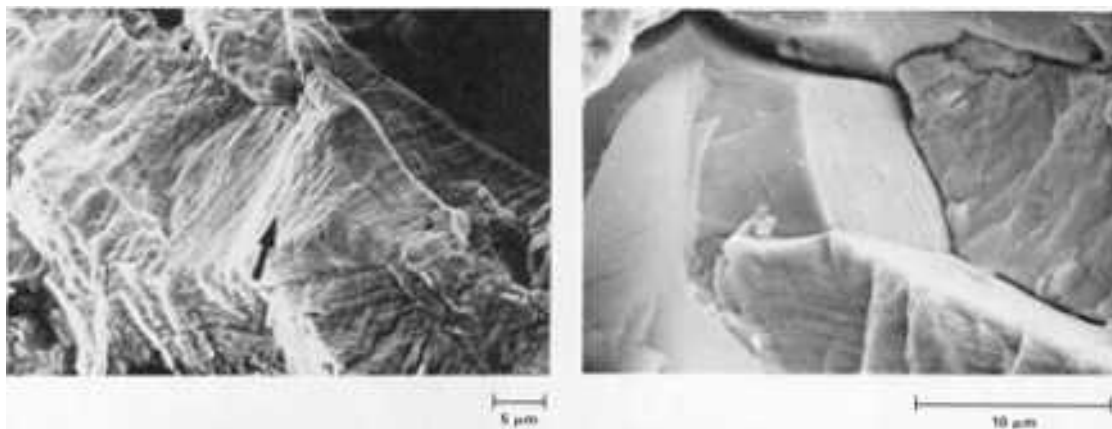
**Fig. 22** High-magnification views of fatigue striations. (a) Striations (arrow) on the fracture surface of an austenitic stainless steel. (C.R. Brooks and A. Choudhury, University of Tennessee). (b) Fatigue striations on the facets of tantalum grains in the heat-affected zone of a weldment. (M.E. Blum, FMC Corporation)

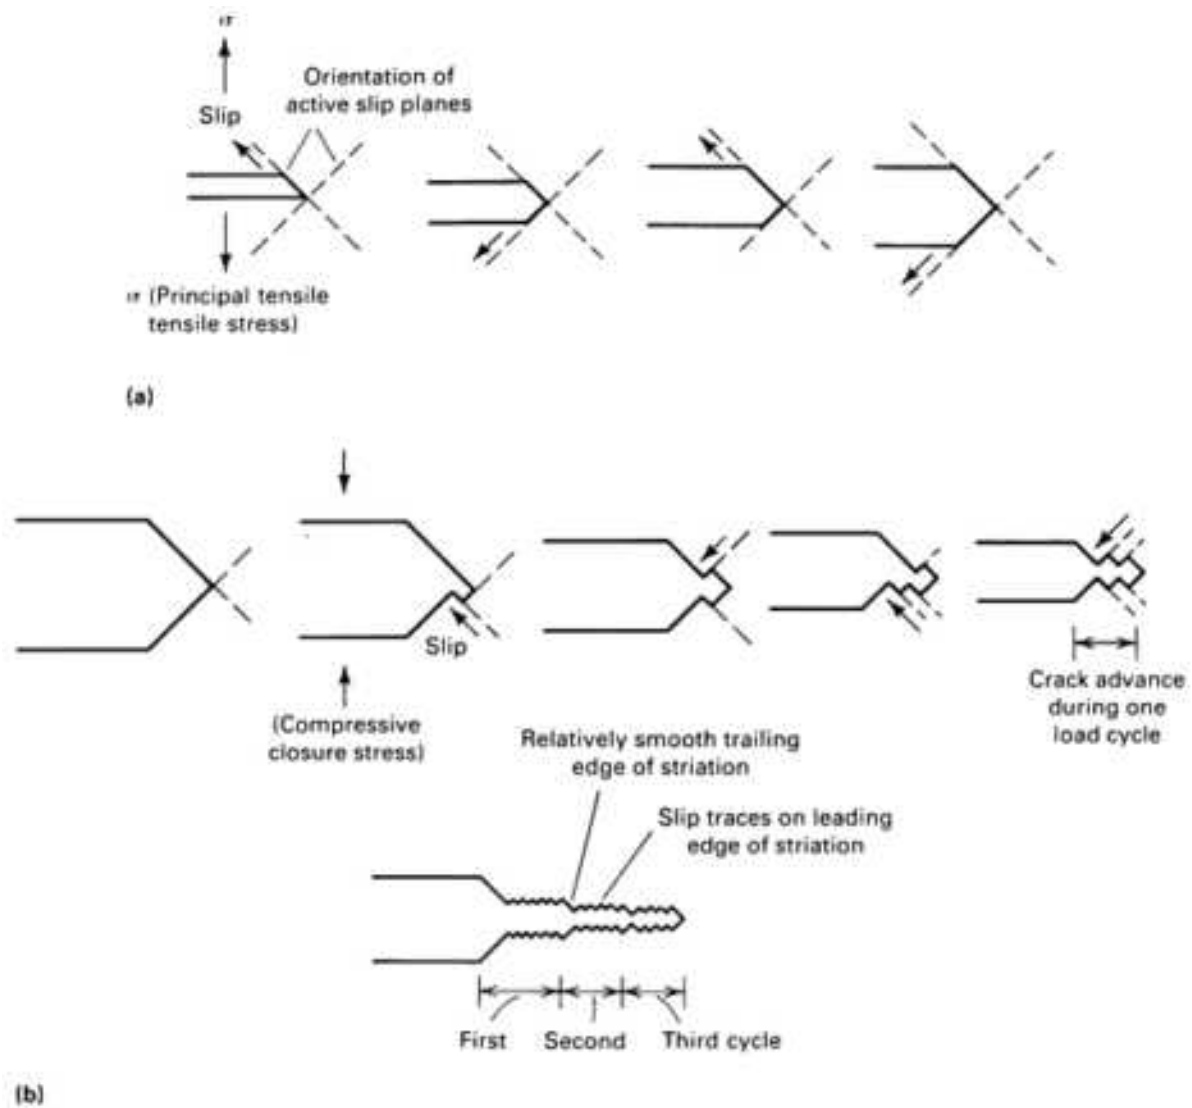
**Fig. 23 Mechanism of fatigue crack propagation by alternate slip at the crack tip. Sketches are simplified to clarify the basic concepts. (a) Crack opening and crack tip blunting by slip on alternate slip planes with increasing tensile stress. (b) Crack closure and crack tip resharpener by partial slip reversal on alternate slip planes with increasing compressive stress**

The other model, which is based on slip at the crack tip, accounts for conditions where slip may not occur precisely at the crack tip due to the presence of lattice or microstructural imperfections (Ref 19, 20, 21). This model (Fig. 23) is more successful in explaining the mechanism by which Stage II fatigue cracks propagate. The concentration of stress at a fatigue crack results in plastic deformation (slip) being confined to a small region at the tip of the crack while the remainder of the material is subjected to elastic strain. As shown in Fig. 23(a), the crack opens on the rising-tension portion of the load cycle by slip on alternating slip planes. As slip proceeds, the crack tip blunts, but is resharpener by partial slip reversal during the declining-load portion of the fatigue cycle. This results in a compressive stress at the crack tip due to the relaxation of the residual elastic tensile stresses induced in the uncracked portion of the material during the rising load cycle (Fig. 23b). The closing crack does not reweld, because the new slip surfaces created during the crack-opening displacement are instantly oxidized (Ref 24), which makes complete slip reversal unlikely.

The essential absence of striations on fatigue fracture surfaces of metals tested in vacuum tends to support the assumption that oxidation reduces slip reversal during crack closure, which results in the formation of striations (Ref 19, 25, 26). The lack of oxidation in hard vacuum promotes a more complete slip reversal (Ref 27), which results in a smooth and relatively featureless fatigue fracture surface. Some fracture surfaces containing widely spaced fatigue striations exhibit slip traces on the leading edges of the striation and relatively smooth trailing edges, as predicted by the model (Fig. 23). Not all fatigue striations, however, exhibit distinct slip traces, as suggested by Fig. 23, which is a simplified representation of the fatigue process.

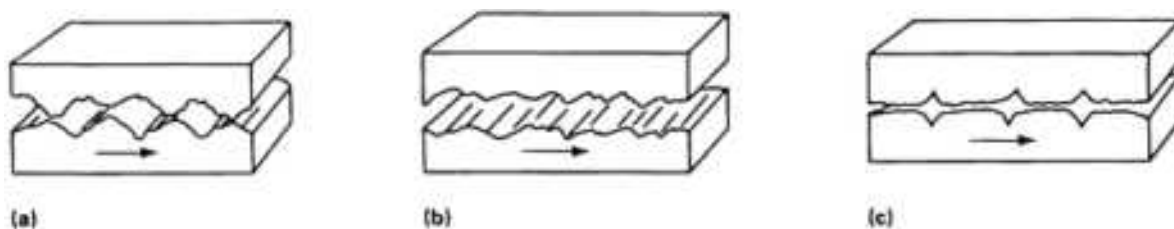
**Fig. 24 Sawtooth and groove-type fatigue fracture profiles. Arrows show crack propagation direction. (a) Distinct sawtooth profile (aluminum alloy). (b) Poorly formed sawtooth profile (steel). (c) Groove-type profile (aluminum alloy). Source: Ref 23**

As shown schematically in Fig. 24, the profile of the fatigue fracture can also vary, depending on the material and state of stress. Materials that exhibit fairly well-developed striations display a sawtooth-type profile (Fig. 24a) with valley-to-valley or groove-to-groove matching (Ref 23, 28). Low compressive stresses at the crack tip favor the sawtooth profile; however, high compressive stresses promote the groove-type fatigue profile, as shown in Fig. 24(c) (Ref 23, 28). Jagged, poorly formed, distorted, and unevenly spaced striations (Fig. 24b), sometimes termed quasi-striations (Ref 23), show no symmetrical matching profiles. Even distinct sawtooth and groove-type fatigue surfaces may not show symmetrical matching. The local microscopic plane of a fatigue crack often deviates from the normal to the principal stress. Consequently, one of the fracture surfaces will be deformed more by repetitive cyclic slip than its matching counterpart

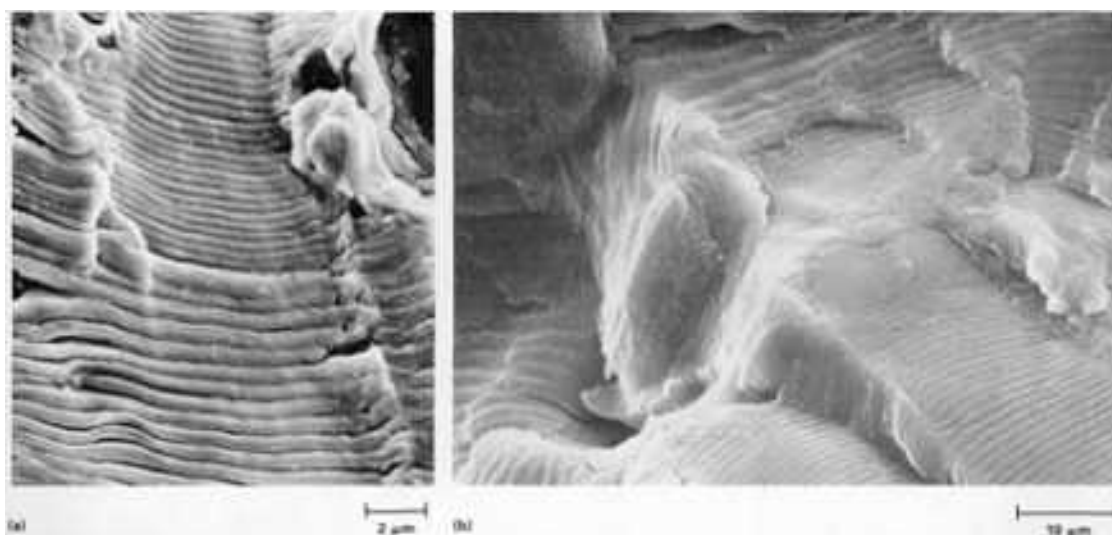
**Fig. 25 Variations in fatigue striation spacing. (a) Spectrum-loaded fatigue fracture in a 7475-T7651 aluminum alloy test coupon showing an increase in striation spacing due to higher alternating stress. (b) Local variation in fatigue striation spacing in a spectrum-loaded 7050-T7651 aluminum alloy extrusion. (D. Brown, Douglas Aircraft Company)**

Fatigue crack propagation and therefore striation spacing can be affected by a number of variables, such as loading conditions, strength of the material, microstructure, and the environment, for example, temperature and the presence of corrosive or embrittling gases and fluids. Considering only the loading conditions--which would include the mean stress, the alternating stress, and the cyclic frequency--the magnitude of the alternating stress ( $\sigma_{\max} - \sigma_{\min}$ ) has the greatest effect on striation spacing. Increasing the magnitude of the alternating stress produces an increase in the striation spacing (Fig. 25a). While rising, the mean stress can also increase the striation spacing; this increase is not as great as one for a numerically equivalent increase in the alternating stress. Within reasonable limits, the cyclic frequency has the least effect on striation spacing. In some cases, fatigue striation spacing can change significantly over a very short distance (Fig. 25b). This is due in part to changes in local stress conditions as the crack propagates on an inclined surface.

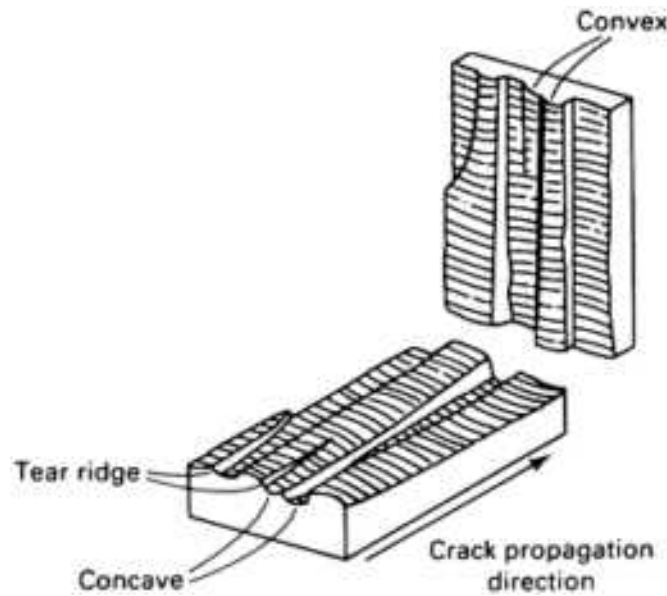
**Fig. 26 Schematic illustrating fatigue striations on plateaus**

**Characteristics of Fractures With Fatigue Striations.** During Stage II fatigue, the crack often propagates on multiple plateaus that are at different elevations with respect to one another (Fig. 26). A plateau that has a concave surface curvature exhibits a convex contour on the mating fracture face (Ref 29). The plateaus are joined either by tear ridges or walls that contain fatigue striations (Fig. 19 and 20a). Fatigue striations often bow out in the direction of crack propagation and generally tend to align perpendicular to the principal (macroscopic) crack propagation direction. However, variations in local stresses and microstructure can change the orientation of the plane of fracture and alter the direction of striation alignment (Fig. 27).

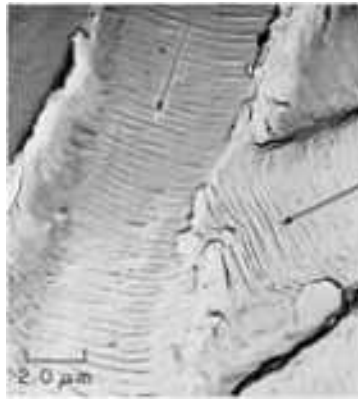
**Fig. 27 Striations on two joining, independent fatigue crack fronts on a fracture surface of aluminum alloy 6061-T6. The two arrows indicate direction of local crack propagation. TEM p-c replica**

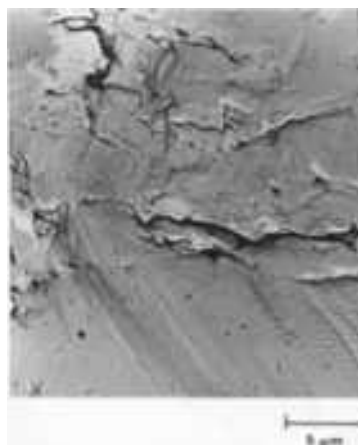
**Fig. 28 Tire tracks on the fatigue fracture surface of a quenched-and-tempered AISI 4140 steel. TEM replica. (I. Le May, Metallurgical Consulting Services Ltd.)**

The distinct, periodic markings sometimes observed on fatigue fracture surfaces are known as tire tracks, because they often resemble the tracks left by the tread pattern of a tire (Fig. 28). These rows of parallel markings are the result of a particle or a protrusion on one fatigue fracture surface being successively impressed into the surface of the mating half of the fracture during the closing portion of the fatigue cycle (Ref 23, 29, 34). Tire tracks are more common for the tension-compression than the tension-tension type of fatigue loading (Ref 23). The direction of the tire tracks and the change in spacing of the indentations within the track can indicate the type of displacement that occurred during the fracturing process, such as lateral movement from shear or torsional loading. The presence of tire tracks on a fracture surface that exhibits no fatigue striations may indicate that the fracture occurred by low-cycle (high-stress) fatigue (Ref 35).

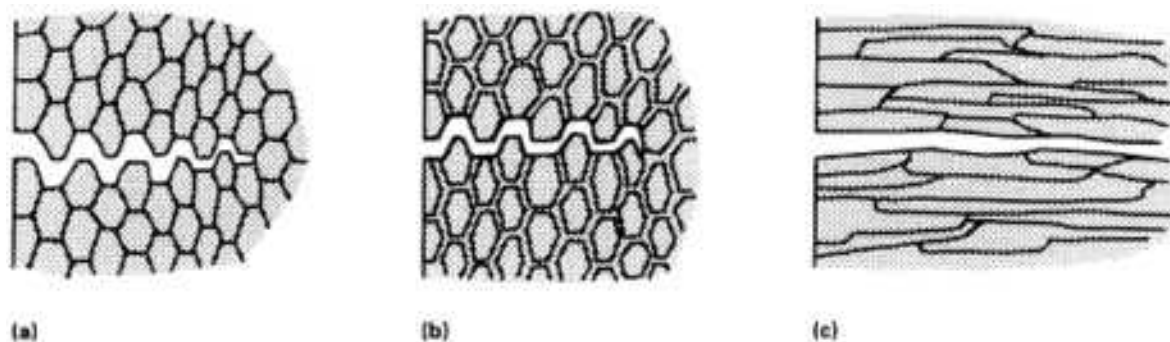
**Fig. 29 Schematic illustrating decohesive rupture along grain boundaries. (a) Decoherence along grain boundaries of equiaxed grains. (b) Decoherence through a weak grain-boundary phase. (c) Decoherence along grain boundaries of elongated grains**

A fracture is referred to as decohesive rupture when it exhibits little or no bulk plastic deformation and does not occur by dimple rupture, cleavage, or fatigue. This type of fracture is generally the result of a reactive environment or a unique microstructure and is associated almost exclusively with rupture along grain boundaries. Grain boundaries contain the lowest melting point constituents of an alloy system. They are also easy paths for diffusion and sites for the segregation of such elements as hydrogen, sulfur, phosphorus, antimony, arsenic, and carbon; the halide ions, such as chlorides; as well as the routes of penetration by the low melting point metals, such as gallium, mercury, cadmium and tin. The presence of these constituents at the boundaries can significantly reduce the cohesive strength of the material at the boundaries and promote decohesive rupture (Fig. 29).

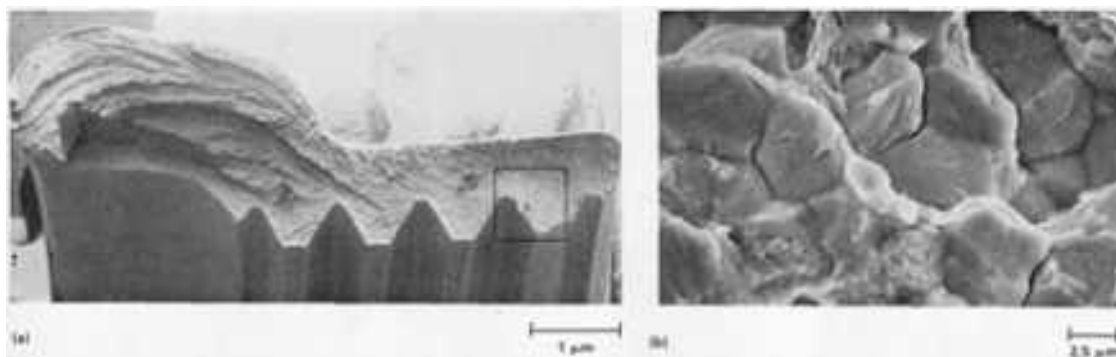
**Fig. 30** Decohesive rupture in an AISI 8740 steel nut due to hydrogen embrittlement. Failure was due to inadequate baking following cadmium plating; thus, hydrogen, which was picked up during the plating process, was not released. (a) Macrograph of fracture surface. (b) Higher-magnification view of the boxed area in (a) showing typical intergranular fracture. (W.L. Jensen, Lockheed Georgia Company)

The source of hydrogen may be a processing operation, such as plating (Fig. 30) or acid cleaning, or the hydrogen may be acquired from the environment in which the part operates. If hydrogen absorption is suspected, prompt heating at an elevated temperature (usually about 200 °C, or 400 °F) will often restore the original properties of the material.

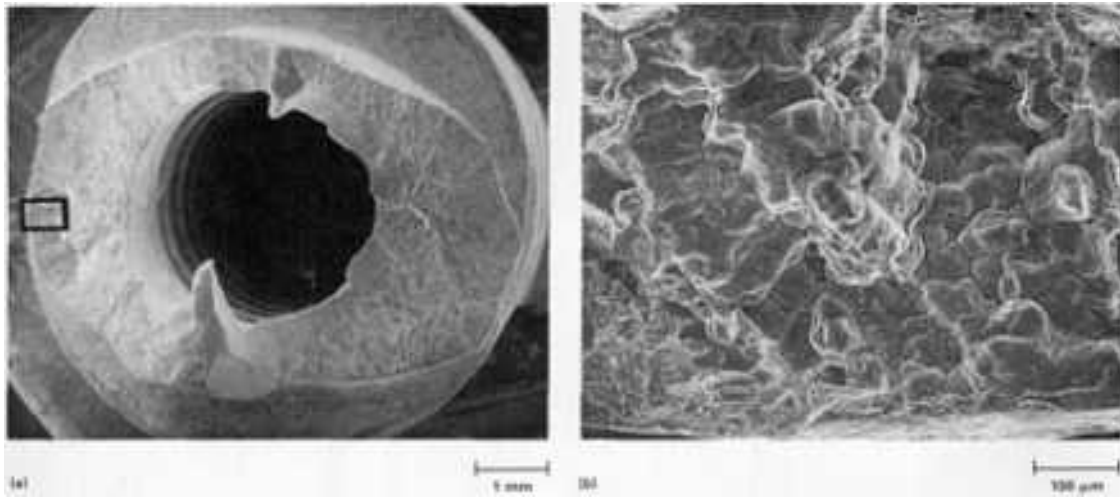
**Fig. 31** 17-4 PH stainless steel main landing-gear deflection yoke that failed because of intergranular SCC. (a) Macrograph of fracture surface. (b) Higher-magnification view of the boxed area in (a) showing area of intergranular attack. (W.L. Jensen, Lockheed Georgia Company)

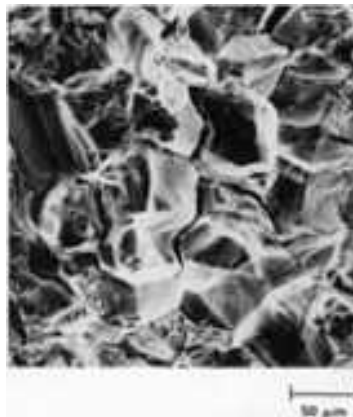
**Fig. 32** Fracture surface of a Monel specimen that failed in liquid mercury. The fracture is predominantly intergranular with some transgranular contribution. (C.E. Price, Oklahoma State University)

Smaller grain size should reduce embrittlement because of reduced stress concentration at grain-boundary dislocation pile-ups (Ref 189); however, in the embrittlement of Monel 400 by mercury, maximum embrittlement is observed at an approximate grain size of 250  $\mu\text{m}$  (average grain diameter), and the embrittlement decreases for both the smaller and the larger grain sizes (Ref 112). The decrease in embrittlement at the smaller grain sizes was attributed to a difficulty in crack initiation, and for the larger grain sizes, the effect was due to enhanced plasticity (Ref 112). An example of a Monel specimen embrittled by liquid mercury is shown in Fig. 32.

Examples of low-melting metal embrittlement fractures are shown in Fig. 32, 59, 60, and 61. Figure 59 shows fractures in AISI 4140 steel resulting from testing in argon and in liquid lead. Figure 60 shows the embrittlement of a 7075-T6 aluminum alloy by mercury and Fig. 61 shows the embrittlement of AISI 4140 steel by liquid cadmium. The articles "Liquid-Metal Embrittlement" and "Embrittlement by Solid-Metal Environments" in Volume 11 of *ASM Handbook*, formerly 9th edition of *Metals Handbook* provide additional information on the effect of exposure to low melting point metals.

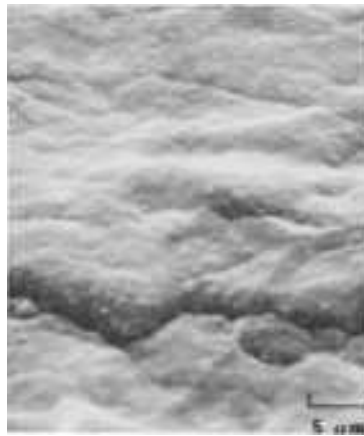
**Fig. 33 Stress-corrosion fracture that occurred by decohesion along the parting plane of an aluminum alloy forging**

The fracture of weak grain-boundary films (such as those resulting from grain-boundary penetration by low melting point metals), the rupture of melted and resolidified grain-boundary constituents (as in overheated aluminum alloys), or the separation of melted material in the boundaries (Ref 44) before it solidifies (as in the cracking at the heat-affected zones, HAZs, of welds, a condition known as hot cracking) can produce a decohesive rupture. Figures 30, 31, and 32 show examples of decohesive rupture. A decohesive rupture resulting from hydrogen embrittlement is shown in Fig. 30, Figure 31 shows a decohesive rupture in a precipitation-hardenable stainless steel due to SCC. A fracture along a low-strength grain-boundary film resulting from the diffusion of liquid mercury is shown in Fig. 32. More detailed information on hydrogen embrittlement, SCC, and liquid-metal embrittlement can be found later in this article in the section "Effect of Environment." When a decohesive rupture occurs along flattened, elongated grains that form nearly uninterrupted planes through the material, as in severely extruded alloys and along the parting planes of some forgings, a relatively smooth, featureless fracture results (Fig. 33).

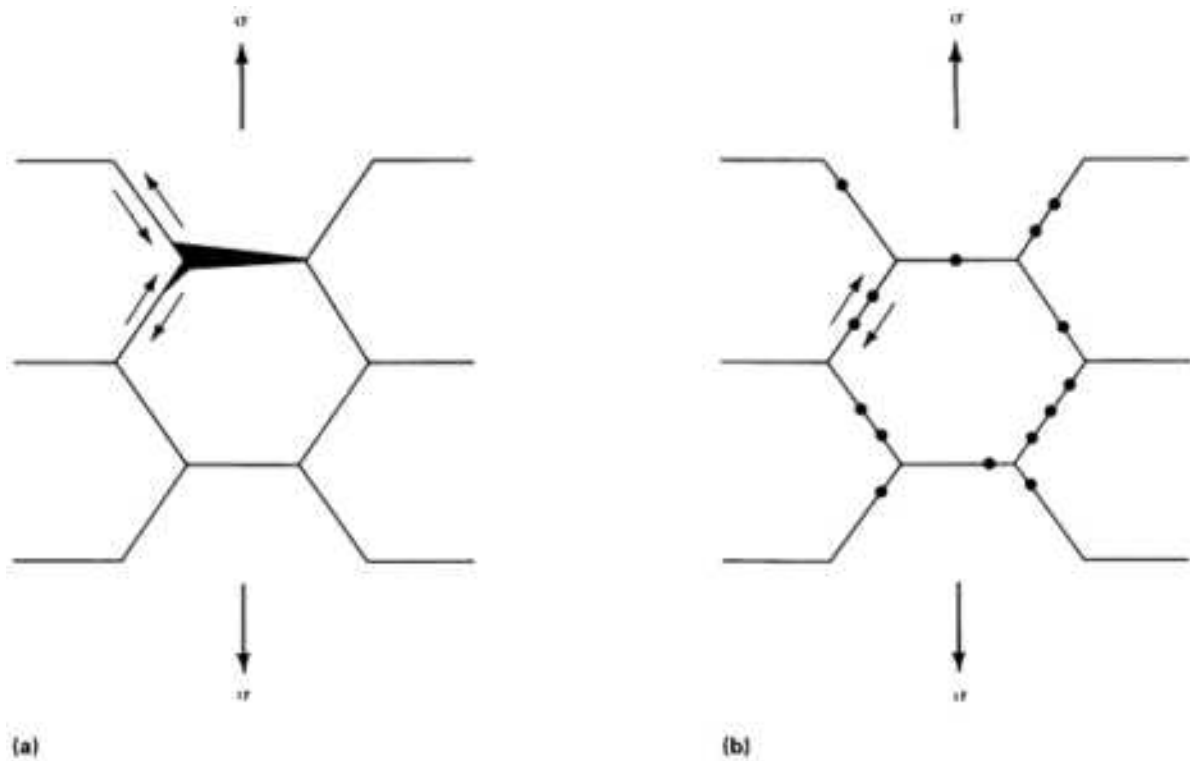
**Fig. 34 Triple-point cracking (a) and cavitation (b) in intergranular creep rupture. Small arrows indicate grain-boundary sliding.**

As shown schematically in Fig. 34, intergranular creep ruptures occur by either of two fracture processes: triple-point cracking or grain-boundary cavitation (Ref 50, 51, 52, 53, 54, 55, 56, 57, 58, 59, 60, 61, 62, 63). The strain rate and temperature determine which fracture process dominates. Relatively high strain rates and intermediate temperatures promote the formation of wedge cracks (Fig. 34a). Grain-boundary sliding as a result of an applied tensile stress can produce sufficient stress concentration at grain-boundary triple points to initiate and propagate wedge cracks (Ref 50, 51, 52, 55, 56, 58, 59, 60, 61). Cracks can also nucleate in the grain boundary at locations other than the triple point by the interaction of primary and secondary slip steps with a sliding grain boundary (Ref 61). Any environment that lowers grain-boundary cohesion also promotes cracking (Ref 59). As sliding proceeds, grain-boundary cracks propagate and join to form intergranular decohesive fracture (Fig. 35a and b).

At high temperatures and low strain rates, grain-boundary sliding favors cavity formation (Fig. 34b). The grain-boundary cavities resulting from creep should not be confused with microvoids formed in dimple rupture. The two are fundamentally different; the cavities are principally the result of a diffusion-controlled process, while microvoids are the result of complex slip. Even at low strain rates, a sliding grain boundary can nucleate cavities at irregularities, such as second-phase inclusion particles (Ref 54, 57, 63, 64). The nucleation is believed to be a strain-controlled process (Ref 63, 64), while the growth of the cavities can be described by a diffusion growth model (Ref 65, 66, 67) and by a power-law growth relationship (Ref 68, 69). Irrespective of the growth model, as deformation continues, the cavities join to form an intergranular fracture. Even though the fracture resulting from cavitation creep exhibits less sharply defined intergranular facets (Fig. 35c), it would be considered a decohesive rupture.

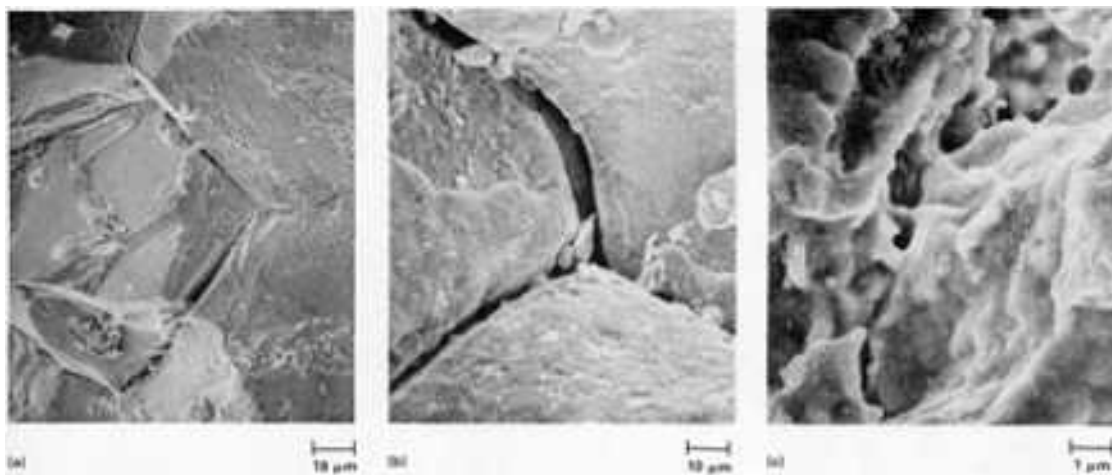
**Fig. 35 Examples of intergranular creep fractures. (a) Wedge cracking in Inconel 625. (b) Wedge cracking in Incolay 800. (c) Intergranular creep fracture resulting from grain-boundary cavitation in PE-16. Source: Ref 59**

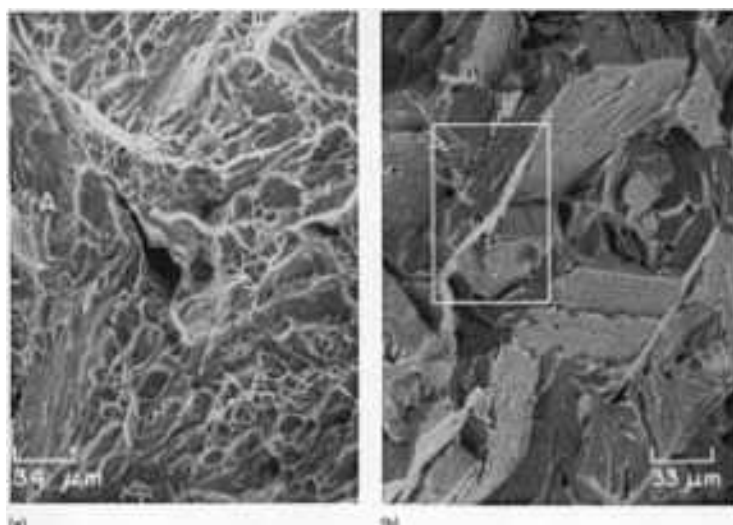
**Fig. 36 Examples of quasi-cleavage. (a)** Fracture surface of an austenitized Fe-0.3C-0.6Mn-5.0Mo specimen exhibiting large quasi-cleavage facets, such as at A; elsewhere, the surface contains rather large dimples. **(b)** Charpy impact fracture in on Fe-0.18C-3.85Mo steel. Many quasi-cleavage facets are visible. The rectangle outlines a tear ridge.

**Quasi-cleavage fracture** is a localized, often isolated feature on a fracture surface that exhibits characteristics of both cleavage and plastic deformation (Fig. 36 and 37). The term quasi-cleavage does not accurately describe the fracture, because it implies that the fracture resembles, but is not, cleavage. The term was coined because, although the central facets of a quasi-cleavage fracture strongly resembled cleavage (Ref 75), their identity as cleavage planes was not established until well after the term had gained widespread acceptance (Ref 76, 77, 78, 79, 80, 81, 82, 83). In steels, the cleavage facets of quasi-cleavage fracture occur on the  $\{100\}$ ,  $\{110\}$ , and possibly the  $\{112\}$  planes. The term quasi-cleavage can be used to describe the distinct fracture appearance if one is aware that quasi-cleavage does not represent a separate fracture mode.

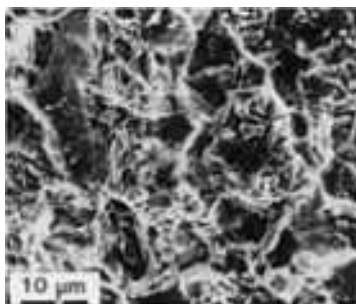
**Fig. 37 Small and poorly defined quasi-cleavage facets connected by shallow dimples on the surface of a type**

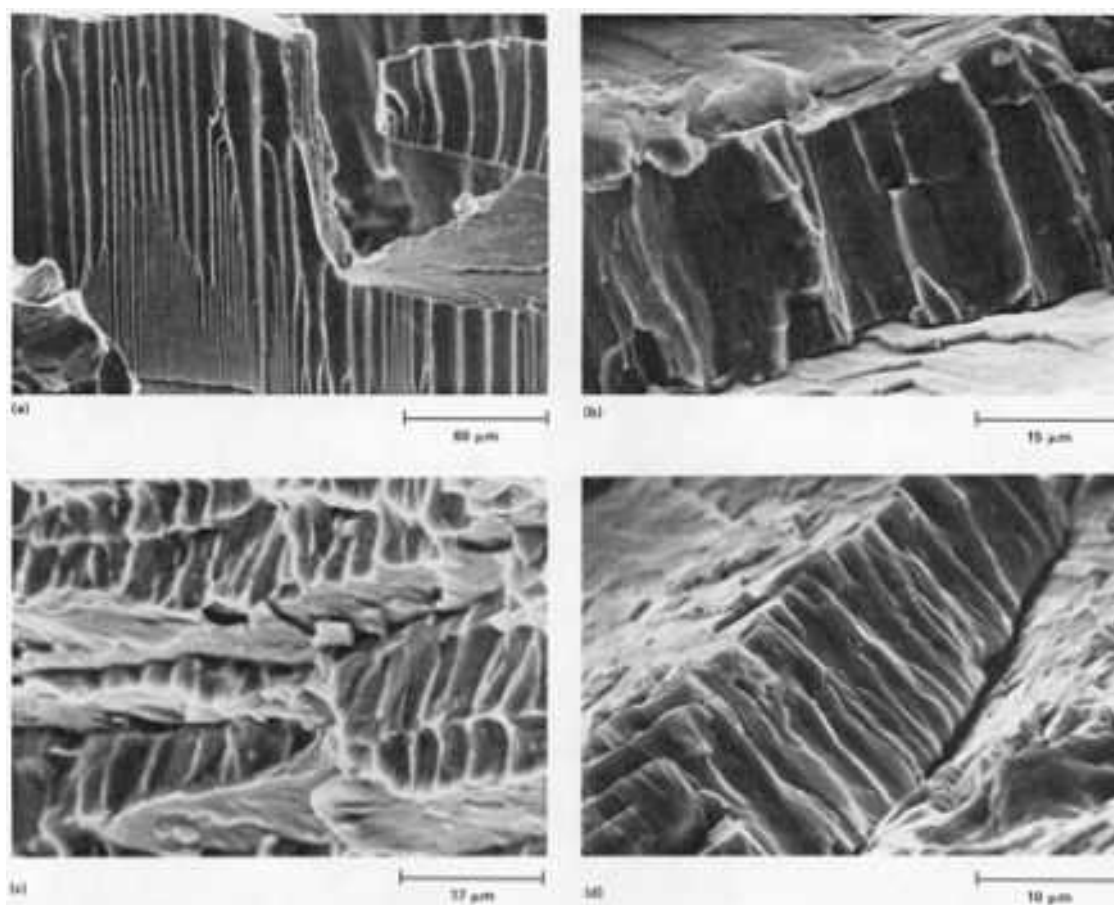
**Fig. 38** Example of fluting. (a) Flutes and cleavage resulting from a mechanical overload of a Ti-0.35O alloy. (b) Flutes and cleavage resulting from SCC at  $\beta$ -annealed Ti-8Al-1Mo-1V alloy in methanol. (c) Flutes cleavage Ti-8Al-1Mo-1V resulting from sustained-load cracking in vacuum. (d) Flutes occurring near the notch on the fracture surface of mill-annealed Ti-8Al-1Mo-1V resulting from fatigue in saltwater. Source: Ref 89

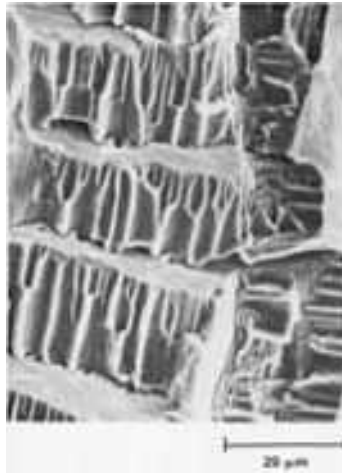
**Fig. 39 Flutes and cleavage from SCC of  $\beta$ -annealed Ti-8Al-1Mo-1V in methanol. Source: Ref 89**

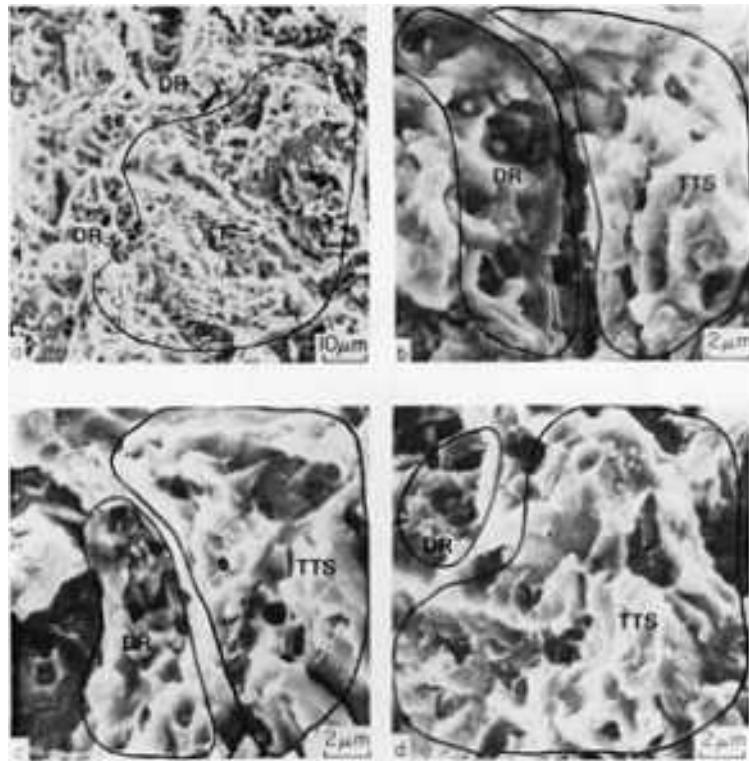
**Fig. 40** Appearance of TTS fracture in bainitic HY-130 steel. (a) Areas of complex tearing (T) and dimple rupture (DR). (b) Detail from upper left corner of (a) showing particle-nucleated dimples (DR) and regions of TTS. SEM fractographs in (c) and (d) show additional examples of TTS fractures. Source: Ref 91, 93

A tentative fracture mode called tearing topography surface (TTS) has been identified and described (Ref 91). The TTS fracture occurs in a variety of alloy systems, including steels, aluminum, titanium, and nickel alloys, and under a variety of fracture conditions, such as overload, hydrogen embrittlement (Ref 92), and fatigue. Examples of TTS fractures are shown in Fig. 40, 41, and 42.

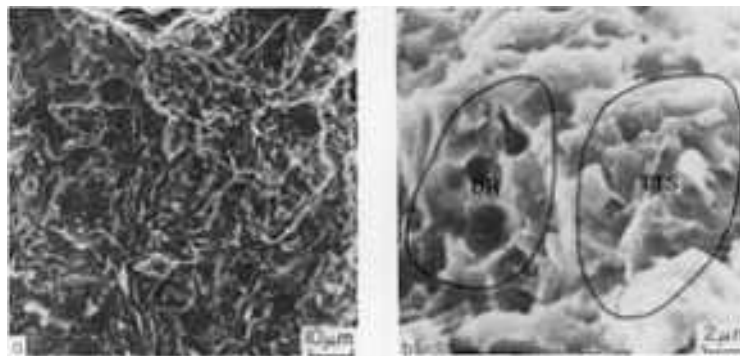
**Fig. 41** Appearance of TTS fracture. (a) An essentially 100% pearlitic eutectoid steel (similar to AISI 1080) where fractures propagate across pearlite colonies. (b) Fractographs showing dimple rupture (DR) and TTS fracture in a quenched-and-tempered (martensitic) HY-130 steel. Source: Ref 91, 93

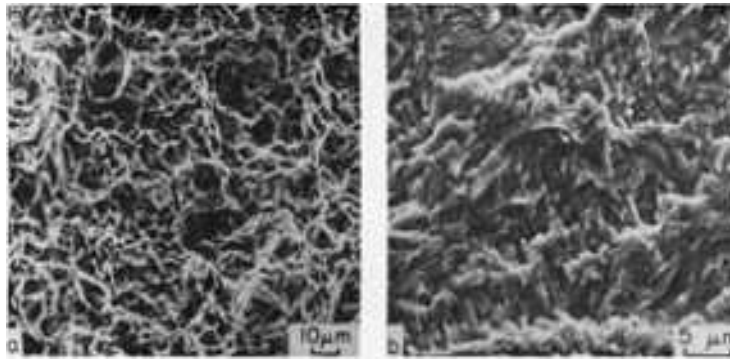
**Fig. 42 Examples of TTS fracture in Ti-6Al-4V  $\alpha$ - $\beta$  alloys. (a) Solution treated and aged microstructure consisting of about 10- $\mu$ m diam primary  $\alpha$  particles in a matrix of about 70 vol% of fine Widmanstätten  $\alpha$  and  $\beta$ . The microstructural constituents are not evident on the fracture surface as verified by the plateau-etching technique (Ref 91, 94). (b) Fractograph of a  $\beta$ -quenched Ti-6Al-4V alloy consisting of a fine Widmanstätten martensitic microstructure. The tearing portions of the fracture surface exhibit TTS.**

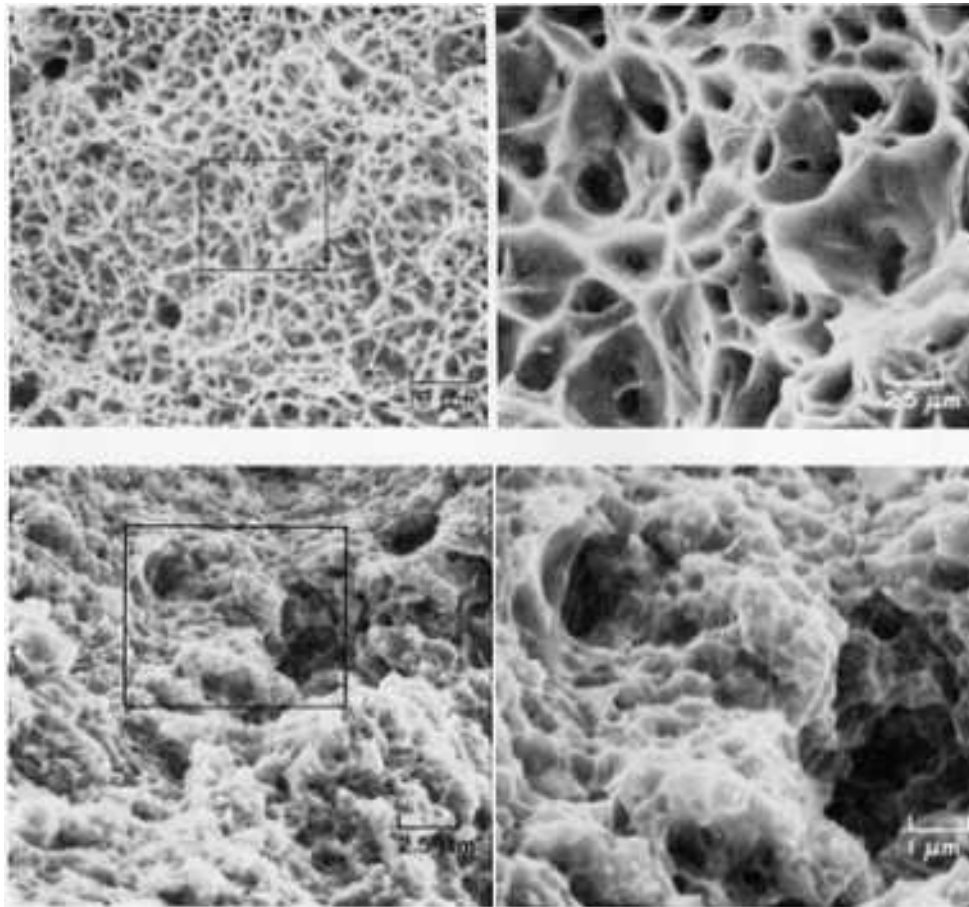
**Fig. 43 Effect of hydrogen on fracture appearance in 13-8 PH stainless steel with a tensile strength of MPa (237 ksi). Top row: SEM fractographs of a specimen not embrittled by hydrogen. Bottom row: SEM fractographs of a specimen charged with hydrogen by plating without subsequent baking.**

If the effect of hydrogen is subtle, such as when there is a slight decrease in the reduction of area at fracture as a result of a tensile test, there is no perceivable change in the dimple rupture fracture appearance. However, the dimples become more numerous but are more shallow at a greater loss in ductility (Fig. 43).

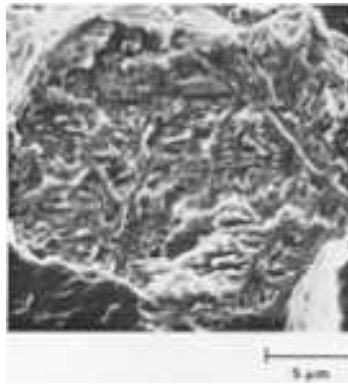
**Fig. 44** Quasi-cleavage fracture in a hydrogen-embrittled AISI 4340 steel heat treated to an ultimate tensile strength of 2082 MPa (302 ksi). Source: Ref 138

**Hydrogen Embrittlement of Steels.** At low strain rates or when embrittlement is more severe, the fracture mode in steels can change from dimple rupture to quasi-cleavage, cleavage, or intergranular decohesion. These changes in fracture mode or appearance may not occur over the entire fracture surface and are usually more evident in the region of the fracture origin. Figure 44 shows an example of a hydrogen-embrittled AISI 4340 steel that exhibits quasi-cleavage.

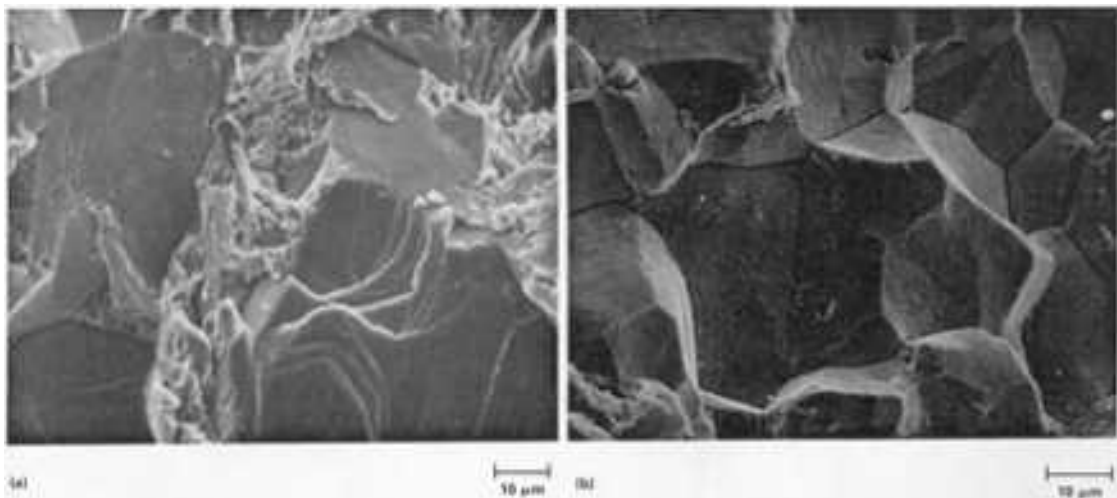
**Fig. 45** Examples of hydrogen-embrittled steels. (a) Cleavage fracture in a hydrogen-embrittled annealed type 301 austenitic stainless steel. Source: Ref 98. (b) intergranular decohesive fracture in an AISI 4130 steel heat treated to an ultimate tensile strength of 1281 MPa (186 ksi) and stressed at 980 MPa (142 ksi) while being charged with hydrogen. Source: Ref 111

When an annealed type 301 austenitic stainless steel is embrittled by hydrogen, the fracture occurs by cleavage (Fig. 45a). An example in which the mode of fracture changed to intergranular decohesion in a hydrogen-embrittled AISI 4130 steel is shown in Fig. 45b.

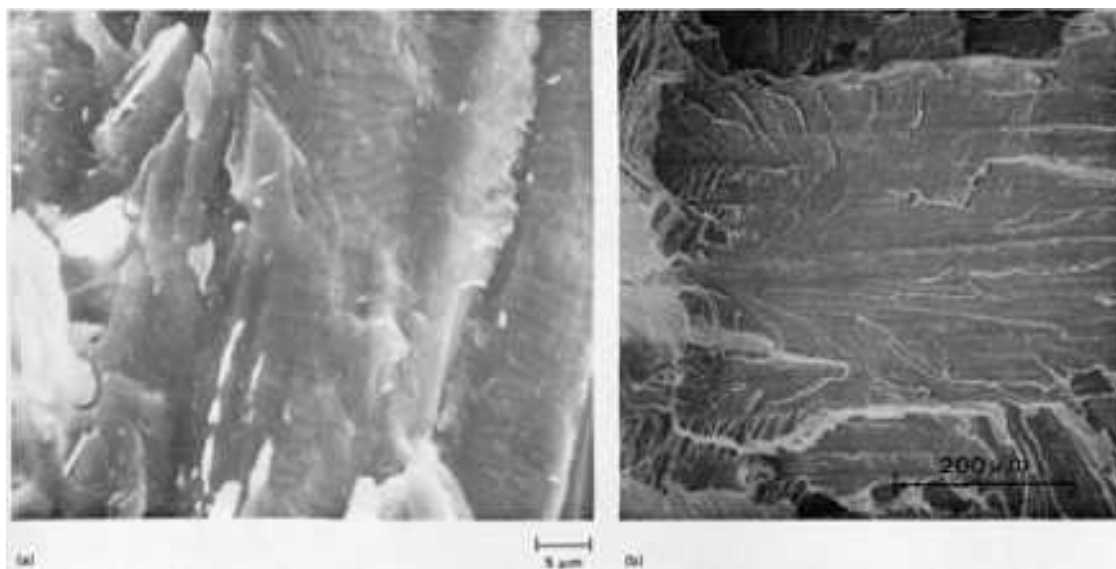
**Fig. 46 Examples of hydrogen-embrittled titanium alloys. (a) Hydrogen embrittlement fracture in a Ti-8Al-1Mo-1V alloy in gaseous hydrogen. Note crack-arrest marks. Source: Ref 137. (b) Cleavage fracture in hydrogen-embrittled Ti-5Al-2.5Sn alloy containing 90 ppm H. Source: Ref 141**

**Hydrogen Embrittlement of Titanium.** Although titanium and its alloys have a far greater tolerance for hydrogen than high-strength steels, titanium alloys are embrittled by hydrogen. The degree and the nature of the embrittlement is strongly influenced by the alloy, the microstructure, and whether the hydrogen is present in the lattice before testing or is introduced during the test. For example, a Ti-8Al-1Mo-1V alloy that was annealed at 1050 °C (1920 °F), cooled to 850 °C (1560 °F), and water quenched to produce a coarse Widmanstätten structure exhibited cracking along the  $\alpha$ - $\beta$  interfaces when tested in 1-atm hydrogen gas at room temperature (Ref 137). The fracture surface, which exhibited crack-

arrest markings, is shown in Fig. 46(a). The arrest markings are believed to be due to the discontinuous crack propagation as a result of the repeated rupture of titanium hydride phase at the crack tip (Ref 137). Also, Fig. 46(b) shows a hydrogen embrittlement fracture in a Ti-5Al-2.5Sn alloy containing 90 ppm H that was  $\beta$  processed at 1065 °C (1950 °F) and aged for 8 h at 950 °C (1740 °F). The fracture occurred by cleavage.

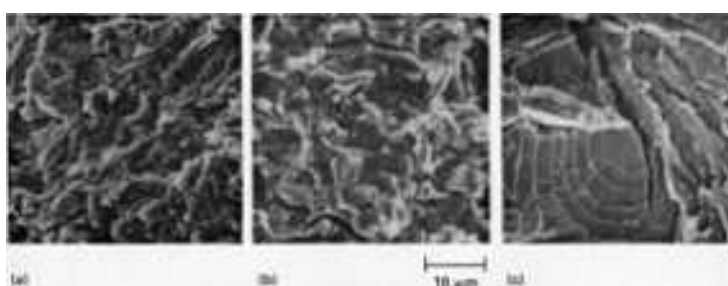
**Fig. 47 Influence of heat treatment and resulting microstructure on the fracture appearance of a hydrogen-embrittled Ti-6Al-4V alloy. Specimens tested in gaseous hydrogen at a pressure of 1 atm. (a) Transgranular fracture in a specimen heat treated at 705 °C (1300 °F) for 2 h, then air cooled. (b) Intergranular decohesion along  $\alpha$  - $\beta$  boundaries in a specimen heat treated at 955 °C (1750 °F) for 40 min, then stabilized. (c) Coarse acicular structure resulting from heating specimen at 1040 °C (1900 °F) for 40 min, followed by stabilizing. The relatively flat areas of the terraced structure are the prior- $\beta$  grain boundaries. See text for a discussion of the microstructures of these specimens. Source: Ref 142.**

Cleavage was also the mode of fracture for a Ti-6Al-4V alloy having a microstructure consisting of a continuous, equiaxed  $\alpha$  phase with a fine, dispersed  $\beta$  phase at the  $\alpha$  grain boundaries embrittled by exposure to hydrogen gas at a pressure of 1 atm (Fig. 47a). However, when the same Ti-6Al-4V alloy having a microstructure consisting of a medium, equiaxed  $\alpha$  phase with a continuous  $\beta$  network was embrittled by 1-atm hydrogen gas, the fracture occurred by intergranular decohesion along the  $\alpha$ - $\beta$  boundaries (Fig. 47b and c).
