ASM HANDBOOK®

VOLUME  
12

Fractography

*Fractography*, was published in 1987 as Volume 12 of the *ASM Handbook*. The Volume was prepared under the direction of the ASM Handbook Committee.

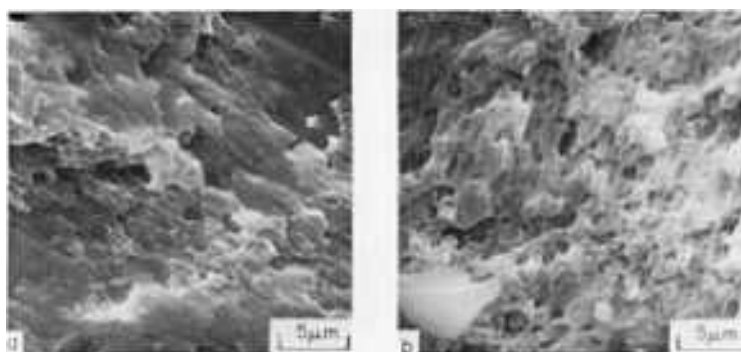
**Fig. 48 Hydrogen-embrittled 2124-UT aluminum alloy that shows no significant change in the fracture appearance. (a) Not embrittled. (b) Hydrogen embrittled. Source: Ref 99**

The effect of hydrogen on the fracture appearance in aluminum alloys can vary from no significant change in an embrittled 2124 alloy (Ref 99) to a dramatic change from the normal dimple rupture to a combination of cleavagelike transgranular fracture and intergranular decohesion in the high-strength 7050 (Ref 106) and 7075 (Ref 105) aluminum alloys. Figure 48 shows an example of a fracture in a hydrogen-embrittled (as measured by a 21% decrease in the reduction of area at fracture) 2124-UT (underaged temper: aged 4 h at 190 °C, or 375 °F) aluminum alloy. It can be seen that there is little difference in fracture appearance between the nonembrittled and embrittled specimens. However, when a low-copper (0.01%) 7050 in the peak-aged condition (aged 24 h at 120 °C, or 245 °F) is hydrogen embrittled, a cleavagelike transgranular fracture results (Fig. 49a). This same alloy in the underaged condition (aged 10 h at 100 °C, or 212 °F) fails by a combination of intergranular decohesion and cleavagelike fracture (Fig. 49b).

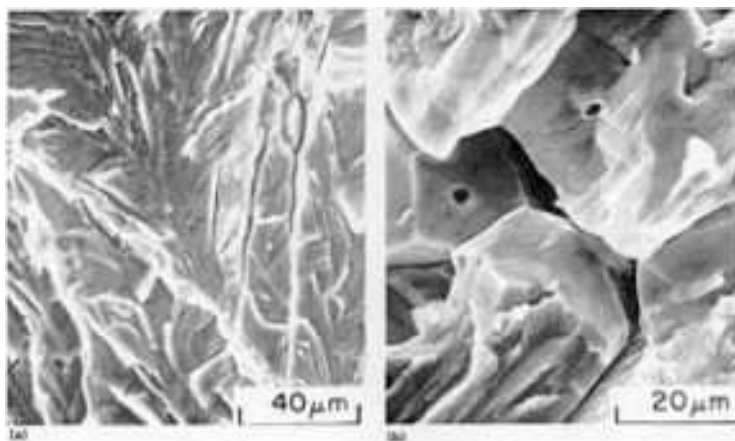
**Fig. 49 Effect of heat treatment on the fracture appearance of a hydrogen-embrittled low-copper 7050 aluminum alloy. (a) Transgranular cleavagelike fracture in a peak-aged specimen. (b) Combined intergranular decohesion and transgranular cleavagelike fracture in an underaged specimen. Source: Ref 106**

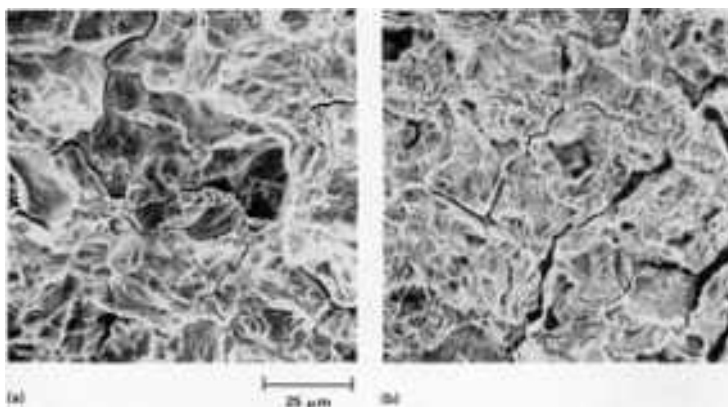
**Fig. 50 Stress-corrosion fractures in HY-180 steel with an ultimate strength of 1450 MPa (210 ksi). The steel was tested in aqueous 3.5% sodium chloride at an electrochemical potential of  $E = -0.36$  to  $-0.82 V_{SHE}$  (SHE, standard hydrogen electrode). Intergranular decohesion is more pronounced at lower values of stress intensity,  $K_I = 57 \text{ MPa } \sqrt{m}$  ( $52 \text{ ksi } \sqrt{in.}$ ) (a), than at higher values,  $K_I = 66 \text{ MPa } \sqrt{m}$  ( $60 \text{ ksi } \sqrt{in.}$ ) (b). Source: Ref 154**

**SCC of Steels.** Examples of known stress-corrosion fractures are shown in Fig. 50, 51, 52, 53, 54, 55, and 56. Steels, including the stainless grades, stress corrode in such environments as water, sea-water, chloride- and nitrate-containing solutions, and acidic as well as basic solutions, such as those containing sodium hydroxide or hydrogen sulfide. Stress-corrosion fractures in high-strength quench-and-temper hardenable or precipitation-hardenable steels occur primarily by intergranular decohesion, although some transgranular fracture may also be present.

Figure 50 shows a stress-corrosion fracture in an HY-180 quench-and temper hardenable steel tested in aqueous 3.5% sodium chloride. The stress-corrosion fracture was believed to have occurred predominantly by hydrogen embrittlement (Ref 154). Increasing the stress intensity coefficient,  $K_I$ , resulted in a decreased tendency for intergranular decohesion; however, the opposite was true for a cold-worked type 316 austenitic stainless steel tested in boiling aqueous magnesium chloride (Ref 181). It was shown that increasing  $K_I$  or increasing the negative electrochemical potential resulted in an increased tendency toward intergranular decohesion (Fig. 51). When the 300 type stainless steels are sensitized--a condition that results in the precipitation of chromium carbides at the grain boundaries, causing depletion of chromium in the adjacent material in the grains--the steel becomes susceptible to SCC, which occurs principally along grain boundaries.

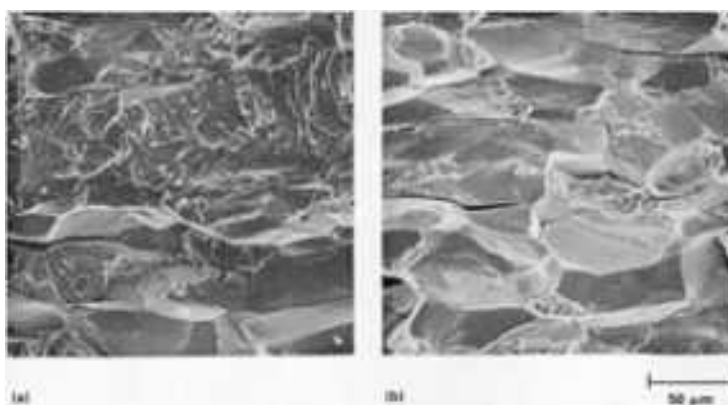
**Fig. 51 Stress-corrosion fractures in a 25% cold-worked type 316 austenitic stainless steel tested in a boiling ( $154^\circ\text{C}$ , or  $309^\circ\text{F}$ ) aqueous 44.7% magnesium chloride solution. At low ( $14 \text{ MPa } \sqrt{m}$ , or  $12.5 \text{ ksi } \sqrt{in.}$ )  $K_I$  values, the fracture exhibits a combination of cleavage and intergranular decohesion (a). At higher ( $33 \text{ MPa } \sqrt{m}$ , or  $30 \text{ ksi } \sqrt{in.}$ ) values of  $K_I$  the principal mode of fracture is intergranular decohesion (b). Source: Ref 181**

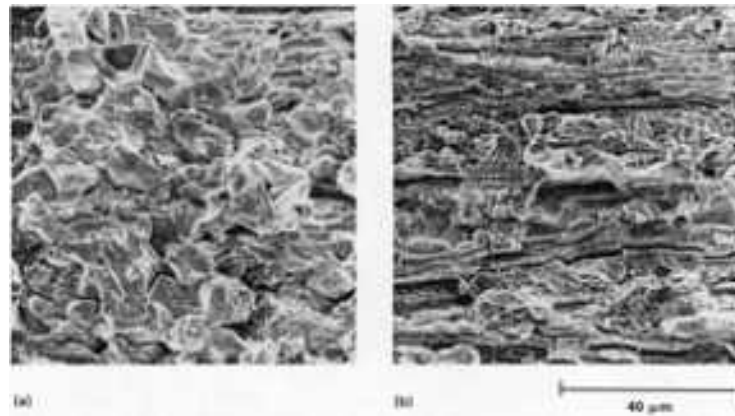
**Fig. 52** Effect of electrochemical potential on the stress-corrosion fracture path in a cold-worked AISI C-1018 low-carbon steel with a 0.2% offset yield strength of 63 MPa (9 ksi). The steel was tested in a 92- °C (198- °F) aqueous 33% sodium hydroxide solution. At a potential of  $E = -0.76 V_{SHE}$ , the fracture propagates along grain boundaries (a) by a metal dissolution process; however, at a freely corroding potential of  $E = -1.00 V_{SHE}$ , the fracture path is transgranular and occurs by a combination of hydrogen embrittlement and metal dissolution (b). Source: Ref 182

Figure 52 shows the effect of the electrochemical potential,  $E$ , on the fracture path in a cold-worked AISI C-1018 low-carbon steel that stress corroded in a hot sodium hydroxide solution. At an electrochemical potential of  $E = -0.76V_{SHE}$ , the fracture path is predominantly intergranular; at a freely corroding potential of  $E = -1.00 V_{SHE}$ , the fracture path is transgranular (Ref 182).

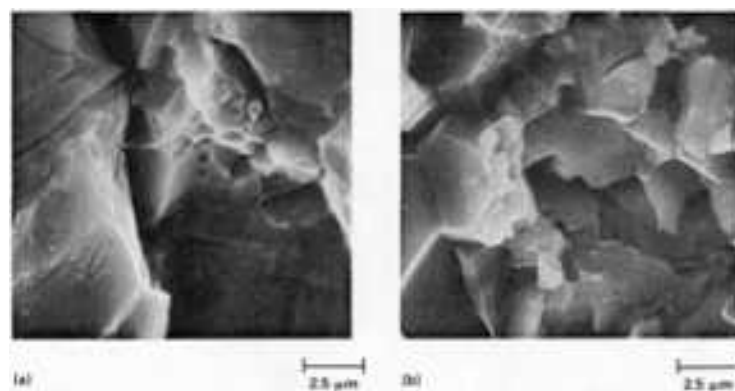
**Fig. 53** Stress-corrosion fractures from two different areas in a 7075-T6 aluminum alloy specimen exposed to water at ambient temperature. The fracture exhibits intergranular decohesion, although same dimple rupture is present near center of fracture in (a).

**SCC Aluminum.** Aluminum alloys, especially the 2000 and 7000 series, that have been aged to the high-strength T6 temper or are in an underaged condition are susceptible to SCC in such environments as moist air, water, and solutions containing chlorides. The sensitivity to SCC depends strongly on the grain orientation with respect to the principal stress, the short-transverse direction being the most susceptible to cracking. Figure 53 shows examples of stress-corrosion fractures in a 7075-T6 (maximum tensile strength: 586, MPa, or 85 ksi) aluminum alloy that was tested in water. The fracture occurred primarily by intergranular decohesion.

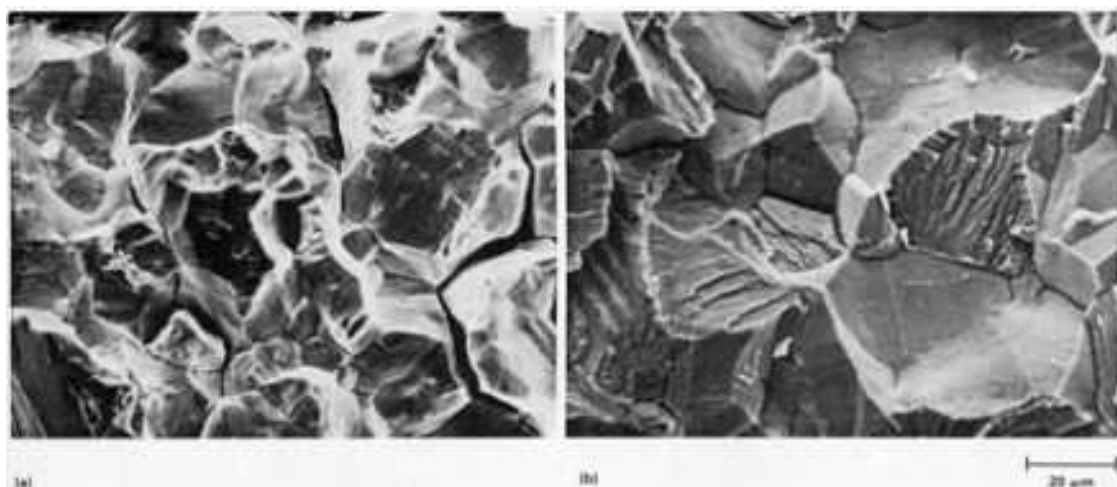
**Fig. 54** Stress-corrosion fractures in a Cu-30Zn brass tested in distilled water at a potential of  $E = 0 V_{SCE}$  (SCE,

saturated calomel electrode). Brass containing 0.002% As fails by predominantly intergranular decohesion (a), and one with 0.032% As fails by a combination of cleavage and intergranular decohesion (b). Source: Ref 176

**SCC of brass** in the presence of ammonia and moist has long been recognized. The term season cracking was used to describe the SCC of brass that appeared to coincide with the moist weather in the spring and fall. Environments containing nitrates, sulfates, chlorides, ammonia gas and solutions, and alkaline solutions are known to stress corrode brass. Even distilled water and water containing as little as  $5 \times 10^{-3}\%$  sulfur dioxide have been shown to attack brass (Ref 176, 178). Depending on the arsenic content of the Cu-30Zn brass, SCC in distilled water occurs either by intergranular decohesion by a combination of cleavage and intergranular decohesion (Fig. 54). When brass containing 0.032% As in stress corrode in water containing minute amounts of sulfur dioxide, it exhibits a unique transgranular fracture containing relatively uniformly spaced; parallel markings (Fig. 55). These distinct periodic marks apparently represent the stepwise propagation of the stress-corrosion fracture.

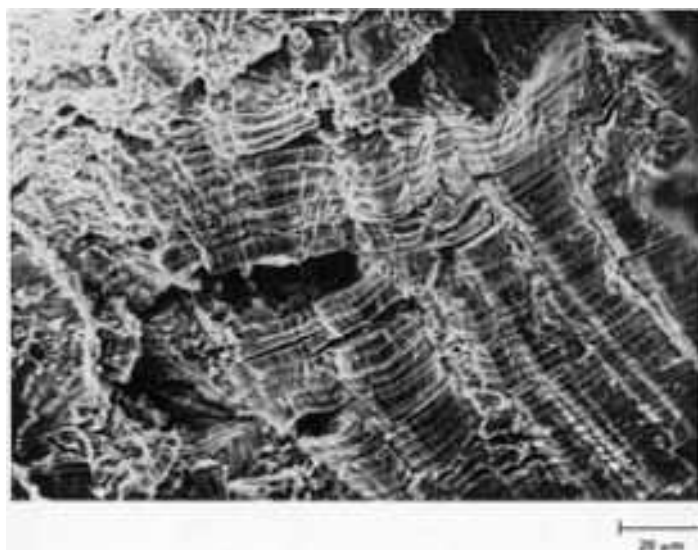
**Fig. 55 Stress-corrosion fracture in a Cu-30Zn brass with 0.032% As tested in water containing  $5 \times 10^{-3}\%$  sulfur dioxide at a potential of  $E = 0.05 V_{SCE}$ . The periodic marks are believed to be the result of a stepwise mode of crack propagation. Source: Ref 176**

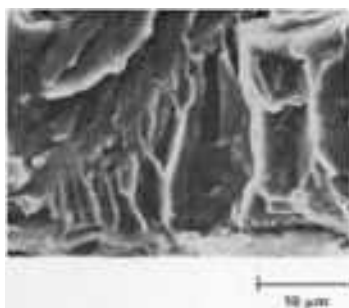
**Fig. 56 Stress-corrosion fracture in an annealed Ti-8Al-1Mo-1V alloy tested in aqueous 3.5% sodium chloride. The fracture surface exhibits cleavage and fluting. Source: Ref 89**

Figure 56 shows a stress-corrosion fracture in an annealed Ti-8Al-1Mo-1V alloy that was tested in aqueous 3.5% sodium chloride. The stress-corrosion fractures in titanium alloys exhibit both cleavage (along with fluting) and quasi-cleavage.

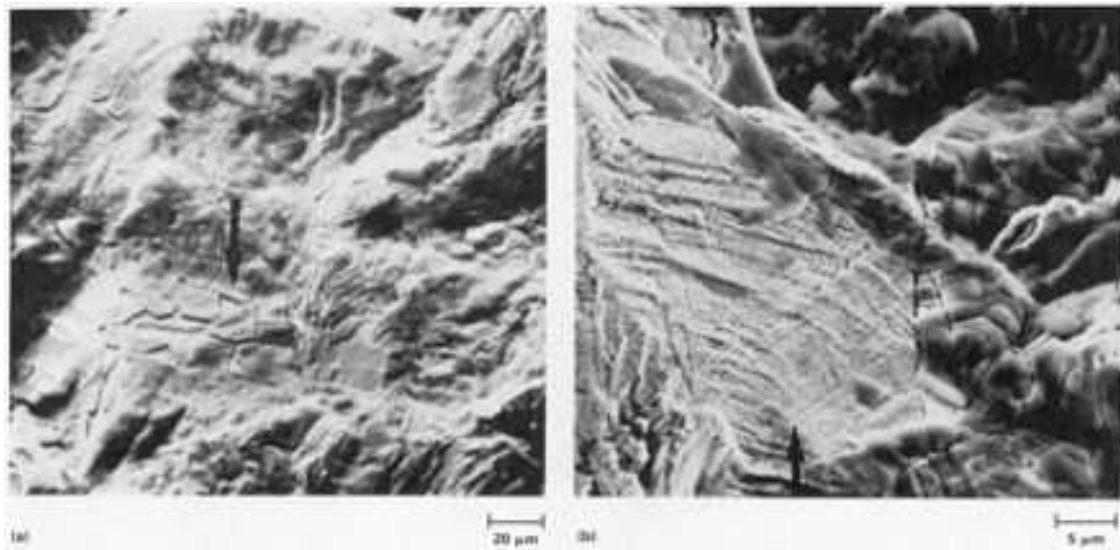
**Fig. 57 Corrosion products observed on an austenitic stainless steel hip implant device. (a) View of the fracture surface showing a mud crack pattern (arrow) that obscures fracture details. (b) Surface after cleaning in acetone in an ultrasonic cleaner. Arrow points to region exhibiting striations and pitting. (C.R. Brooks and A. Choudhury, University of Tennessee).**

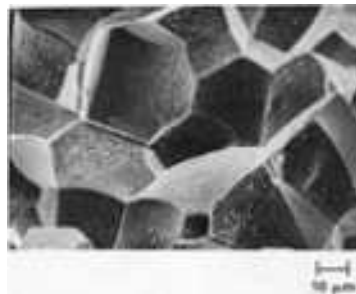
**Fig. 58 Corrosion products on the intergranular fracture surface of an Nb-106 alloy. These corrosion products, which are residues from acid cleaning, contributed to failure by SCC. (L. Kashar, Scanning Electron Analysis Laboratories, Inc.)**

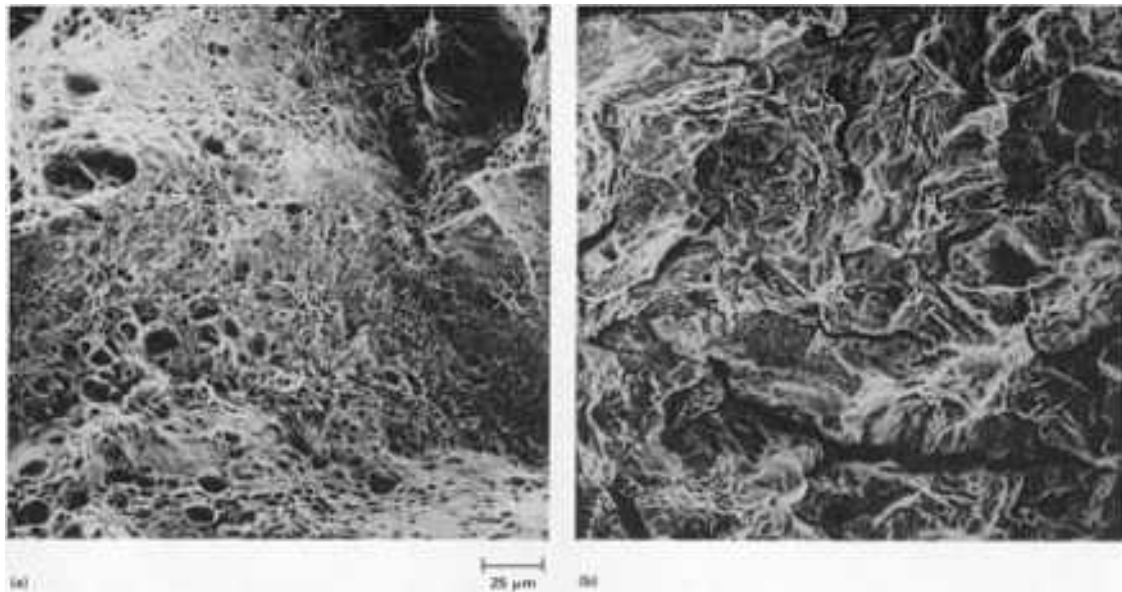
**Fig. 59** Influence of lead on the fracture morphology of an AISI 4340 steel. (a) Ductile failure after testing in argon at 370 °C (700 °F). (b) Same steel tested in liquid lead at 370 °C (700 °F) showing brittle intergranular fracture

Examples of low-melting metal embrittlement fractures are shown in Fig. 32, 59, 60, and 61. Figure 59 shows fractures in AISI 4140 steel resulting from testing in argon and in liquid lead. Figure 60 shows the embrittlement of a 7075-T6 aluminum alloy by mercury and Fig. 61 shows the embrittlement of AISI 4140 steel by liquid cadmium. The articles "Liquid-Metal Embrittlement" and "Embrittlement by Solid-Metal Environments" in Volume 11 of *ASM Handbook*, formerly 9th edition of *Metals Handbook* provide additional information on the effect of exposure to low melting point metals.

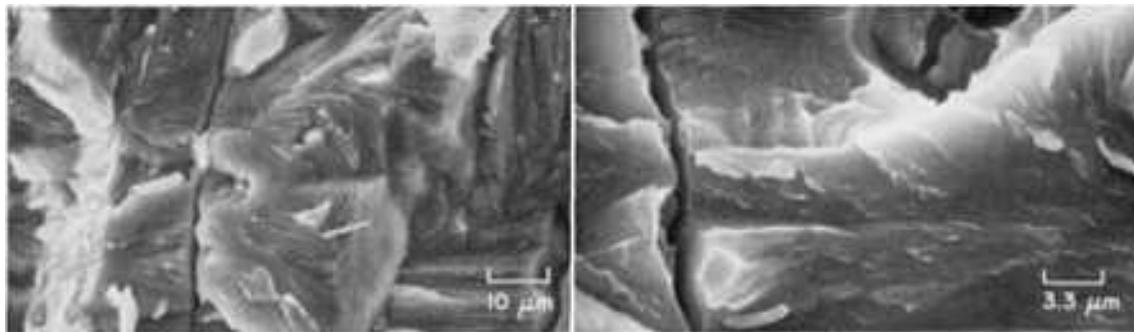
**Fig. 60** Cleavage fracture resulting from exposure of a 7075-T6 aluminum alloy to mercury vapor during a slow-bend fracture toughness test. Both (a) and (b), which is at a higher magnification, clearly show cleavage facets and secondary cracking.

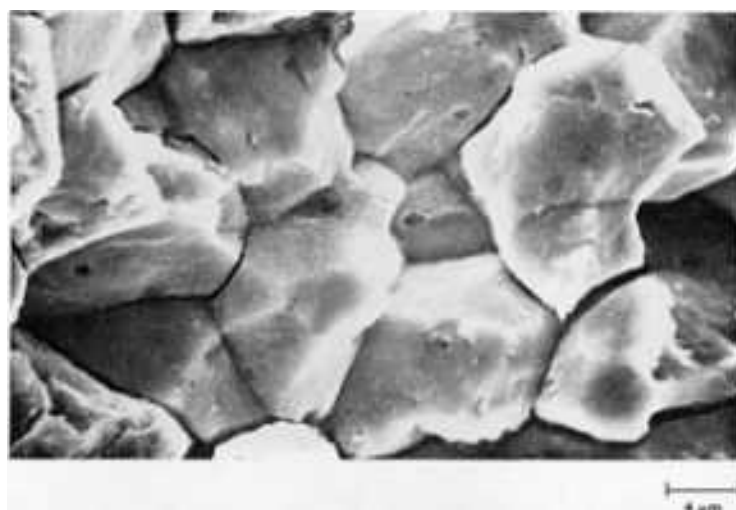
**Fig. 61 Intergranular fracture surface of an AISI 4140 low-alloy steel nut that failed because of embrittlement by liquid cadmium**

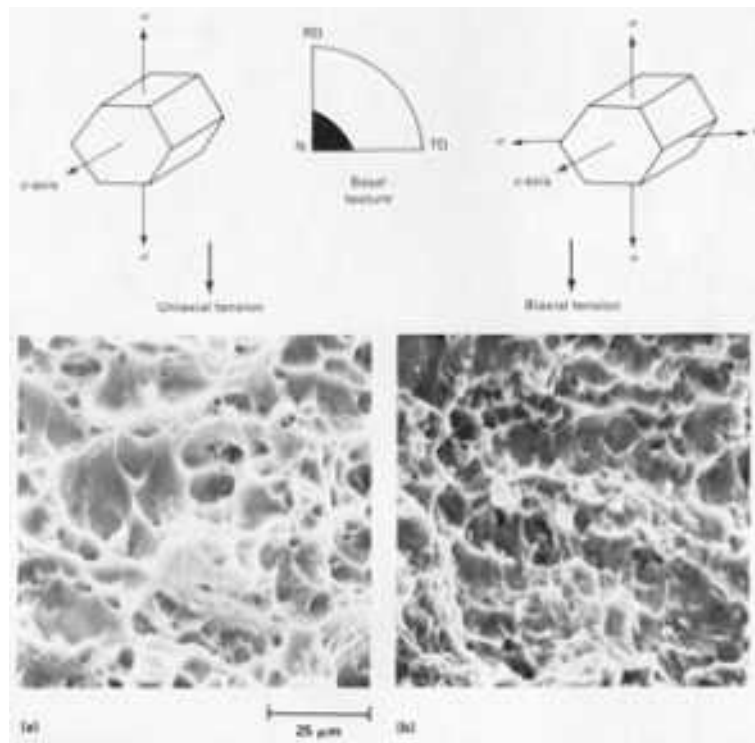
**Fig. 62 Effect of balanced biaxial tension on dimple rupture in a hot-rolled basal-textured Ti-6Al-4V alloy. The dimples on the biaxially fractured specimen (b) are smaller and more shallow when compared to the uniaxially fractured specimen (a). Source: Ref 196**

Figure 62 shows the effect of a biaxial state of stress on dimples in a basal-textured Ti-6Al-4V alloy. Under a biaxial state of stress, the size and the depth of the dimples decreased. For a pearlitic AISI 4130 steel (Ref 198) and a PH 13-8 precipitation-hardenable stainless steel, a triaxial state of stress resulting from the presence of a notch with a stress concentration factor of at least  $K_t = 2.5$  can change the fracture mode from dimple rupture to quasi-cleavage (Fig. 63). When a high-strength AISI 4340 steel is subjected to a triaxial stress, the mode of fracture can change from dimple rupture to intergranular decohesion.

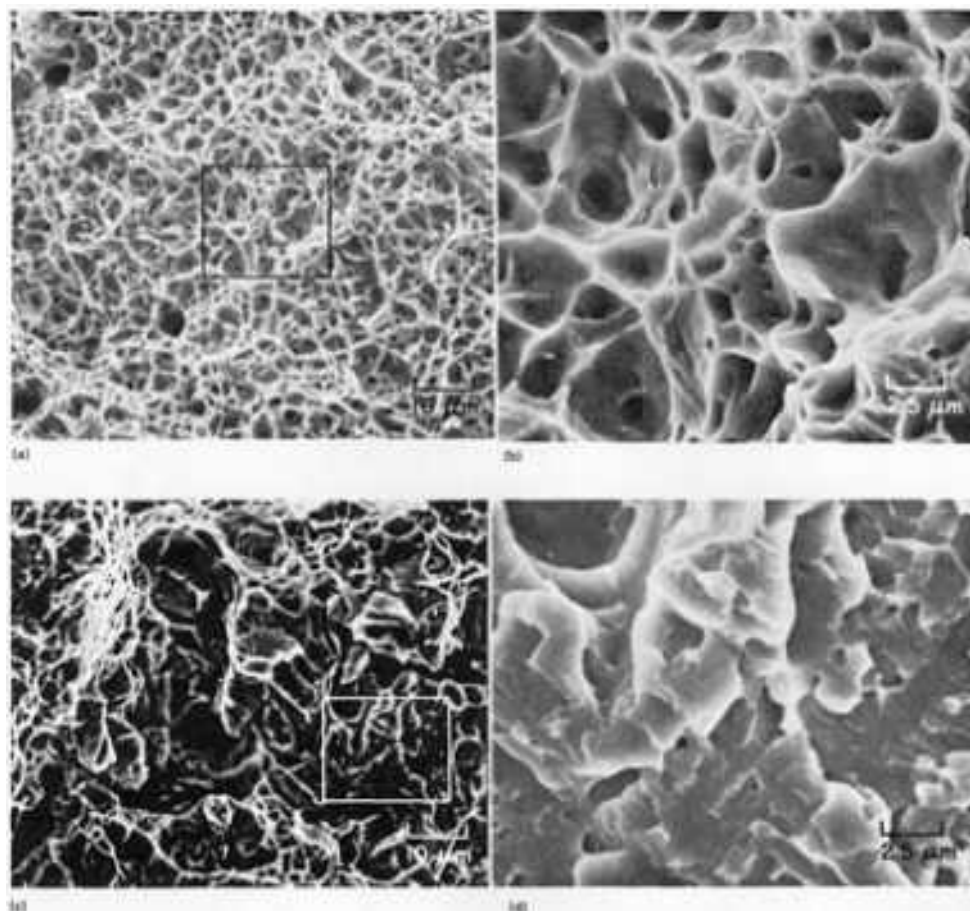
**Fig. 63 Effect of a triaxial state of stress on the fracture mode in 13-8 pH stainless steel heat treated to an ultimate tensile strength of 1634 MPa (237 ksi). (a) and (b) Equiaxed dimples on the fracture surface of an unnotched specimen. (c) and (d) The quasi-cleavage fracture appearance if a notched specimen**

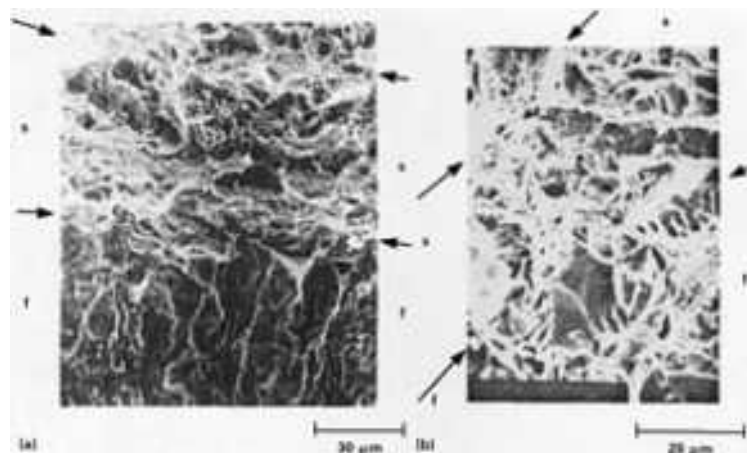
**Fig. 64 Effect of Charpy impact strain rate on the fracture appearance of an AISI 5140 H steel tempered at 500 °C (930 °F) and tested at room temperature. (a) Fatigue-precracked specimen tested at a strain velocity of  $5 \times 10^{-2}$  mm/s ( $2 \times 10^{-3}$  in./s) (b) Fatigue-precracked specimen tested at a strain velocity of 5400 mm/s (17.7 ft/s). The more rapid strain rate results in a reduction in the width of the stretched zone adjacent to the crack and the presence of some intergranular decohesion with ductile tearing on the facets. f, fatigue crack; s, stretched zone. Source: Ref 199**

A moderately high strain rate either alters the size and depth of the dimples or changes the mode of fracture from dimple rupture to quasi-cleavage or intergranular decohesion. For example, when an AISI 5140 H steel that was tempered at 500 °C (930 °F) was tested at Charpy impact rates, it exhibited a decrease in the width of the stretched zone adjacent to the precrack and an increase in the amount of intergranular decohesion facets (Fig. 64). The same steel tempered at 600 °C (1110 °F) showed no significant effect of the Charpy impact test (Ref 199).

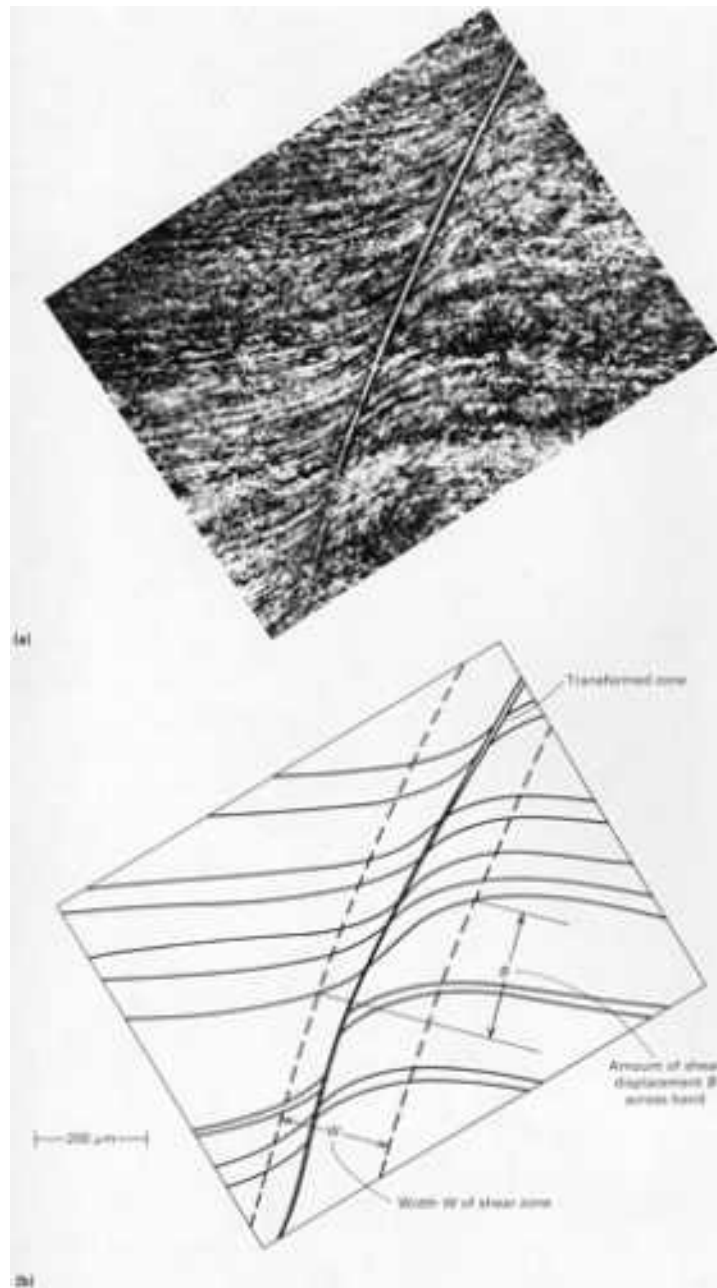
**Fig. 65 Micrograph (a) and schematic (b) of a shear band in a plate of rolled medium carbon steel produced by ballistic impact showing the transformed zone and the zone of strain localization. (D.A. Shockey, SRI International)**

The extremely high strain rates within the adiabatic shear bands result in a rapid increase in temperature as a large portion of the energy of deformation is converted to heat. It has been estimated that the temperature can go high enough to melt the material within the bands (Ref 205, 206). The heated material also cools very rapidly by being quenched by the large mass of the cool, surrounding matrix material; therefore, in quench-and-temper hardenable steels, the material within the bands can contain transformed untempered martensite. This transformed zone is shown schematically in Fig. 65(b).

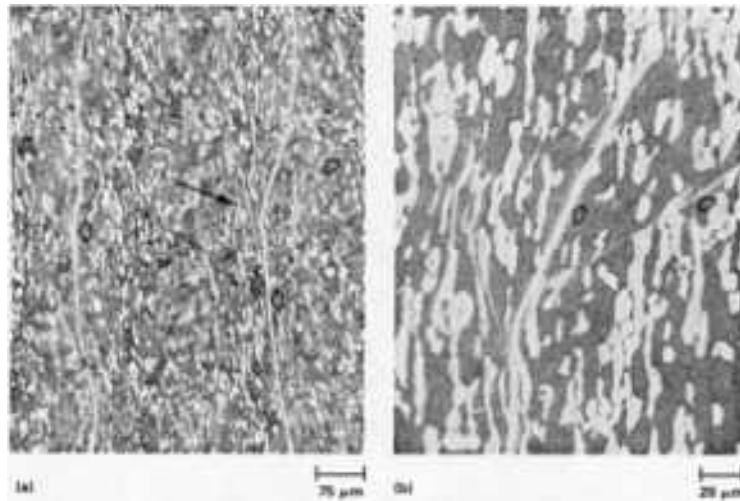
**Fig. 66 Appearance of adiabatic shear bands in an explosively ruptured Ti-6Al-4V STA alloy rocket motor. The material exhibits multiple, often intersecting, shear bands (open arrows). Slender arrow points to portion of shear band shown in more detail in (b). Note that the intense deformation has obliterated the  $\alpha$ - $\beta$  microstructure within the band. The 1.9-mm (0.075-in.) sheet thickness direction is left to right. (V. Kerlins, McDonnell Douglas Astronautics Company)**

material. The adiabatic shear bands in an 80-HV material exhibited an average peak hardness of about 100 HV, while those in a 150-HV material had an average peak hardness of about 215 HV (Ref 208). For the Ti-6Al-4V STA alloy shown in Fig. 66, there was no significant difference in hardness between the shear bands and the matrix. In materials that do not exhibit a phase transformation, or if the temperature generated during deformation is not high enough for the transformation to occur, the final hardness of the adiabatic shear band is the net result of the competing effects of the increase in hardness due to the large deformation and the softening due to the increase in temperature.

The width of the adiabatic shear bands depends on the hardness (strength) of the material (ref 206, 208). Generally, the harder the material, the narrower the shear bands. In a 7039 aluminum alloy aged to a hardness of 80 HV, the average band width resulting from projectile impact was 90  $\mu\text{m}$ , while in a 150-HV material, the band width was only 20  $\mu\text{m}$  (Ref 208). The average width of the shear bands observed in a Ti-6Al-4V STA alloy (average hardness, 375 HV<sub>1kg</sub>) was 3 to 6  $\mu\text{m}$ .

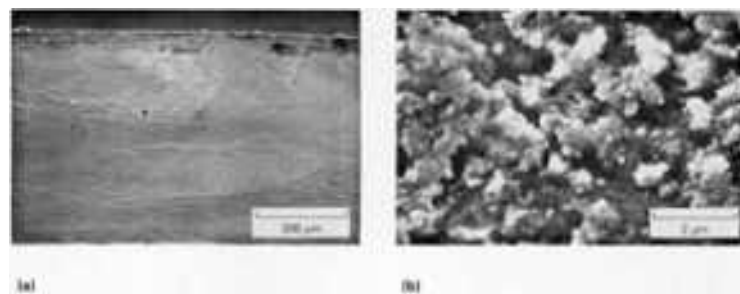
**Fig. 67 Low-magnification (a) and higher-magnification (b) views of a failure surface produced in vacuum-arc remelted AISI 4340 steel (40 HRC) by dynamically shearing in a split Hopkinson torsion bar at a nominal shear strain rate of  $6000 \text{ s}^{-1}$ . The knobby fracture surface suggests that local melting occurred. (J.H. Giovanola, SRI International)**

When an adiabatic shear band cracks or separates during deformation, the fractured surfaces often exhibit a distinct topography referred to as knobbly structure (Ref 205, 206, 207, 208). The name is derived from the surface appearance, which resembles a mass of knoblike structures. The knobbly structure, which has been observed in 2014-T6 and 7039-T6 aluminum alloys, as well as in an AISI 4340 steel (Fig. 67) and AISI 1060 carbon steel, is believed to be the result of melting within the shear bands (Ref 205, 206). Although the cracked surfaces of adiabatic shear bands can exhibit a unique appearance, adiabatic shear failure is easiest to identify by metallographic, rather than fractographic, examination.

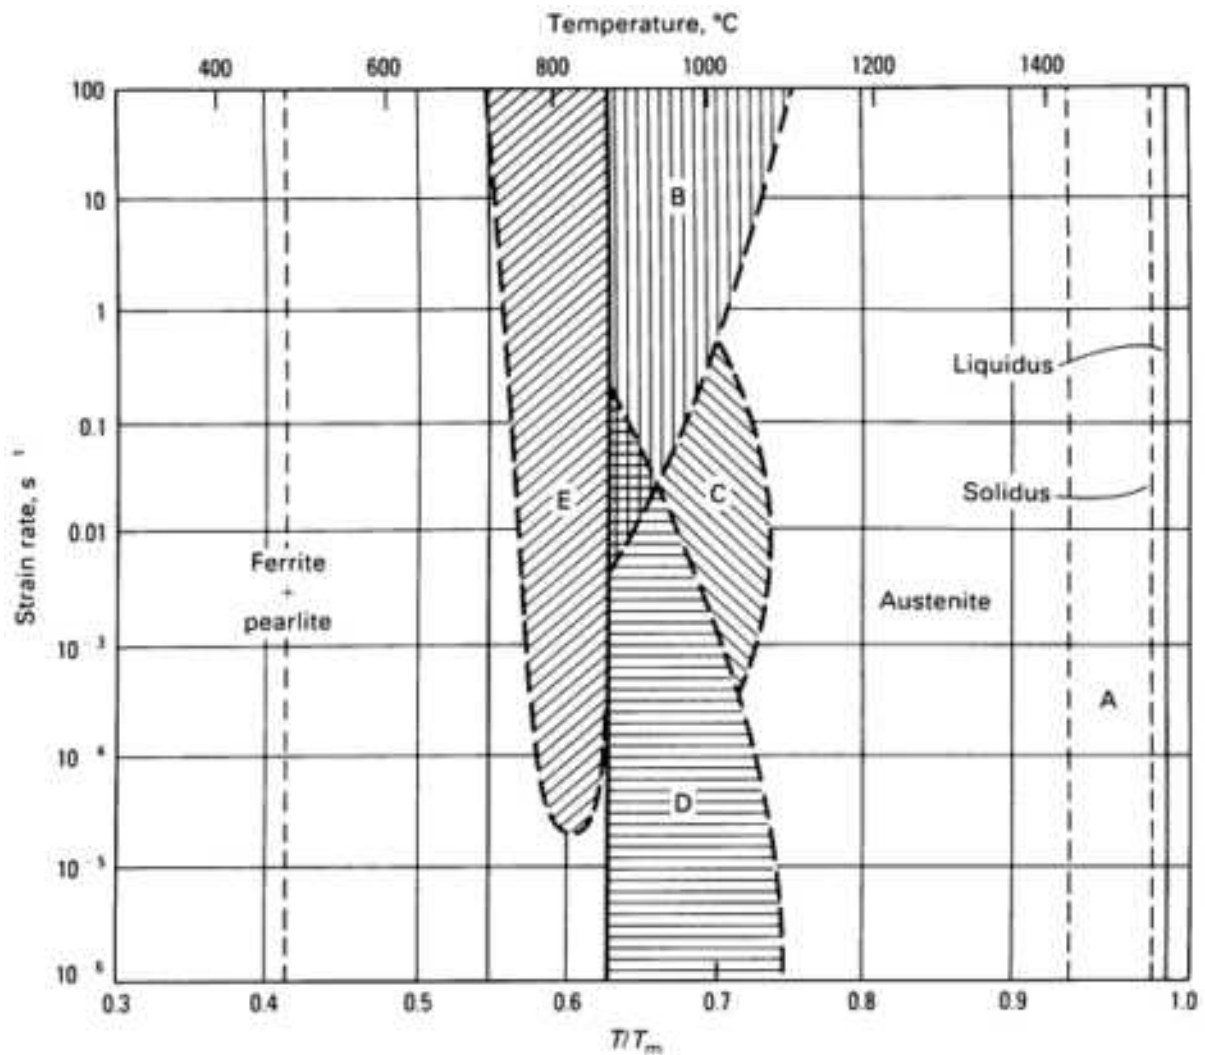
**Fig. 68 Possible fracture zones mapped for a 0.2% C plain carbon steel in strain rate temperature space.  $T$ , testing temperature;  $T_m$ , melting temperature. The zones, which are shaded in the diagram, are as follows: A, subsolidus intergranular fracture due to segregation of sulfur and phosphorus; B, high strain rate intergranular fracture associated with MnS; C, ductile intergranular fracture--may or may not be preceded by B or D; D, low strain rate intergranular fracture; E, two-phase mixture with fracture at second-phase particles in the weaker preferentially strained ferrite. Source: Ref 209**

A convenient means of displaying the fracture behavior of a specific material is a fracture map. When sufficient fracture mode data are available for an alloy, areas of known fracture mode can be outlined on a phase diagram or can be plotted as a function of such variables as the test temperature and strain rate (Fig. 68). Similar maps can also be constructed for low-temperature fracture behavior.

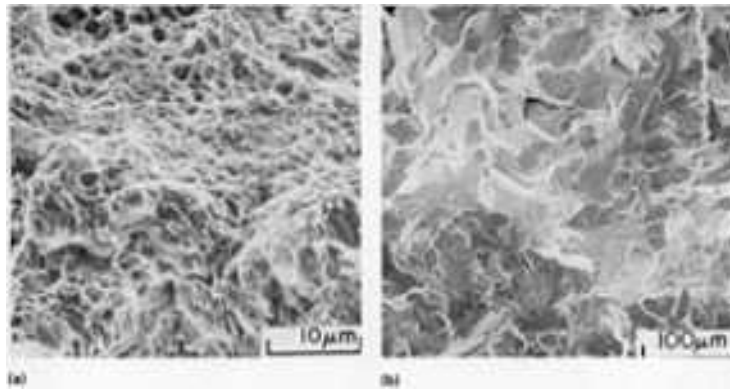
**Fig. 69 Effect of test temperature on a fully pearlitic AISI 1080 carbon steel. Smooth cylindrical specimens tensile tested at a strain rate of  $3.3 \times 10^{-4} \text{ s}^{-1}$ . Specimens tested at 125 °C (225 °F) show fractures consisting entirely of dimple rupture (a), while at -125 °C (-195 °F), the fractures exhibit 99% cleavage (b). The size of the cleavage approximates the prior-austenite grain size. Source: Ref 210**

**Effect of Low Temperature.** Similar to the effect of the state of stress, low temperatures affect the bcc metals far more than the fcc or hcp metal systems (see the section "Effect of the State of Stress" in this article). Although lower temperatures can result in a decrease in the size and depth of dimples in fcc and hcp metals, bcc metals often exhibit a change in the fracture mode, which generally occurs as a change from dimple rupture or intergranular fracture to cleavage. For example, a fully pearlitic AISI 1080 carbon steel tested at 125  $^{\circ}C$  (255  $^{\circ}F$ ) showed a fracture that consisted entirely of dimple rupture; at room temperature, only 30% of the fracture was dimple rupture, with 70% exhibiting cleavage. At -125  $^{\circ}C$  (-195  $^{\circ}F$ ), the amount of cleavage fracture increased to 99% (Ref 210). This transition in fracture mode is illustrated in Fig. 69.

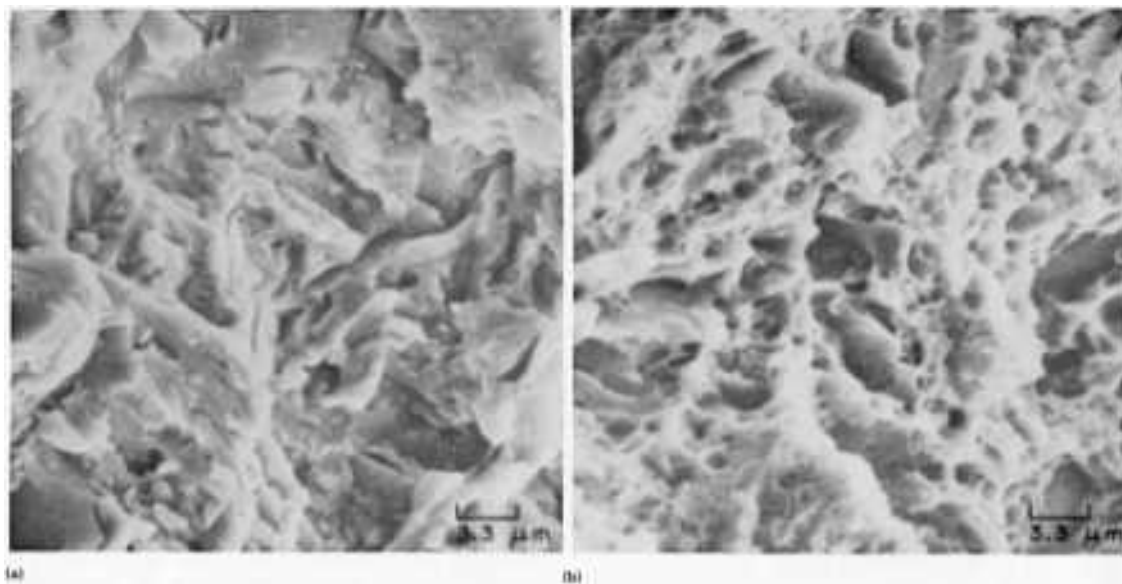
**Fig. 70 Effect of test temperature on an AISI 1042 carbon steel with a slightly tempered martensitic (660 HV) microstructure that was Charpy impact tested at -196 and 100 °C (-320 and 212 °F). The fracture at -196 °C (-320 °F) consists entirely of cleavage (a), and at 100 °C (212 °F), it is dimple rupture (b).**

Charpy impact testing of an AISI 1042 carbon steel whose microstructure consisted of slightly tempered martensite (660 HV) as well as one containing a tempered martensite (335 HV) microstructure at 100 °C (212 °F) and at -196 °C (-320 °F) produced results essentially identical to those observed for the AISI 1080 steel. In both conditions, the fracture mode changed from dimple rupture at 100 °C (212 °F) to cleavage at -196 °C (-320 °F), as shown in Fig. 70. Similar changes in the fracture mode, including a change to quasi-cleavage, can be observed for other quench-and-temper and precipitation-hardenable steels.

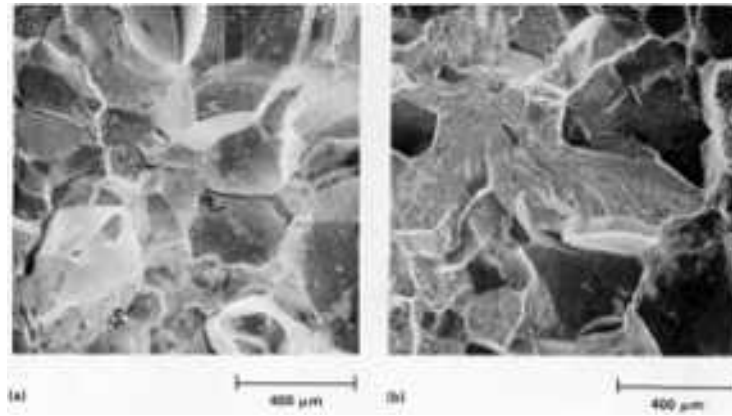
**Fig. 71** Effect of test temperature on a 0.39C-2.05Si-0.005P-0.005S steel that was heat treated to a hardness of 30 HRC and Charpy impact tested at room temperature at -85 °C (-120 °F). The fracture at room temperature occurs by intergranular fracture (a) and by a combination of intergranular fracture and cleavage (b) at -85 °C (-120 °F). Source: Ref 211

A unique effect of temperature was observed in a 0.39C-2.05Si-0.005P-0.005S low-carbon steel that was tempered 1 h at 550 °C (1020 °F) to a hardness of 30 HRC and Charpy impact tested at room temperature and at -85 °C (-120 °F) (Fig. 71). In this case, the fracture exhibited intergranular decohesion at room temperature and changed to a combination of intergranular decohesion and cleavage at -85 °C (-120 °F). This behavior was attributed to the intrinsic reduction in matrix toughness by the silicon in the alloy, because when nickel is substituted for the silicon the matrix toughness is increased and no cleavage is observed (Ref 211).

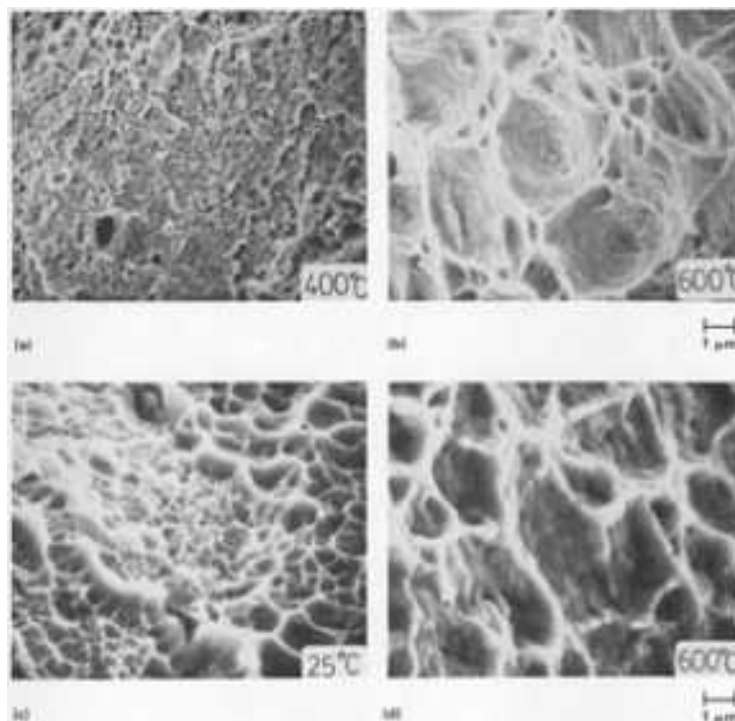
**Fig. 72 Effect of temperature on dimple size in a 0.3C-1Cr-1.25Mo-0.25V-0.7Mn-0.04P steel that was heat treated to an ultimate strength level of 880 MPa (128 ksi). (a) and (b) Dimples on transgranular facets. (c) and (d) Dimples on intergranular facets. Note that dimple size increased with temperature. Source: Ref 213**

**The effects of high temperature** on fracture are more complex because solid-state reactions, such as phase changes and precipitation, are more likely to occur, and these changes affect bcc as well as fcc and hcp alloys. As shown in Fig. 72, the size of the dimples generally increases with temperature (Ref 209, 212, 213). The dimples on transgranular fractures and those on intergranular facets in a 0.3C-1Cr-1.25Mo-0.25V-0.7Mn-0.04P steel that was heat treated to an ultimate strength of 880 MPa (128 ksi) show an increase in size when tested at temperatures ranging from room temperature to 600 °C (1110 °F) (Ref 213).

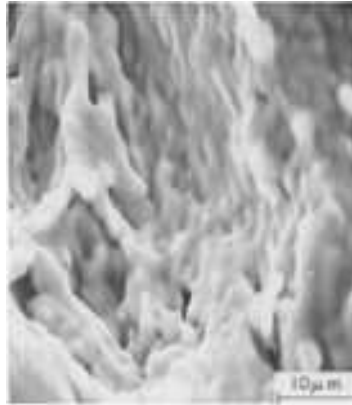
**Fig. 73 Effect of temperature on the fracture of an ultralow-carbon steel. The 0.05C-0.82Mn-0.28Si steel containing 180 ppm S was annealed for 5 min at 1425 °C (2620 °F), cooled to 950 °C (1740 °F), and held for 3 min before tensile testing at a strain rate of  $2.3 \times 10^{-4} \text{ s}^{-1}$ . The fracture, which occurs by dimple rupture when tested at room temperature, exhibits intergranular decohesion at 950 °C (1740 °F). Source: Ref 209**

Figure 73 shows the effect of temperature on the fracture mode of an ultralow-carbon steel. The steel, which normally fractures by dimple rupture at room temperature, fractured by intergranular decohesion when tensile tested at a strain rate of  $2.3 \times 10^{-2} \text{ s}^{-1}$  at 950 °C (1740 °F). The change in fracture mode was due to the precipitation of critical submicron-size MnS precipitates at the grain boundaries. This embrittlement can be eliminated by aging at 1200 °C (2190 °F), which coarsens the MnS precipitates (Ref 209).

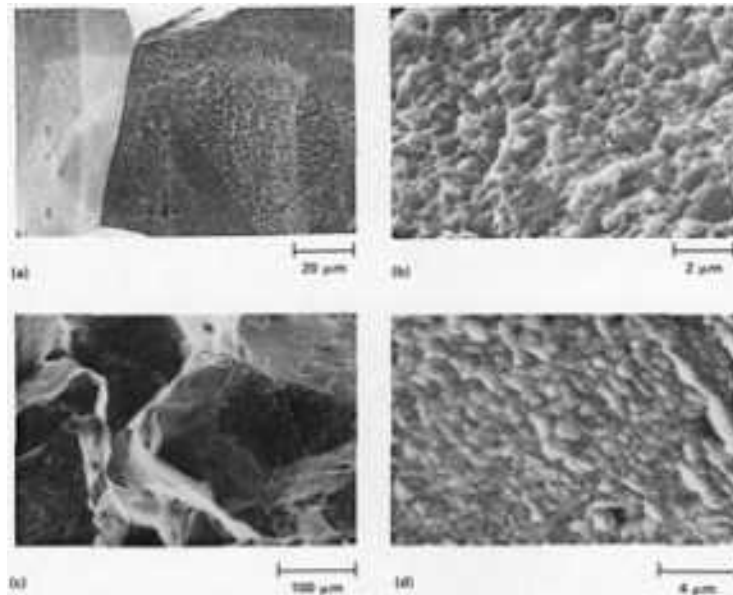
**Fig. 74 Effect of temperature on double-aged Inconel X-750 that was tested at a nominal strain rate of  $3 \times 10^{-5} \text{ s}^{-1}$ . (a) and (b) The fracture at room temperature occurs by intergranular dimple rupture. Note the evidence of dimple rupture network on the intergranular walls. (c) and (d) At 816 °C (1500 °F), the fracture shows intergranular decohesion with no dimple rupture. However, the intergranular facets are roughened by the presence of  $\text{M}_{23}\text{C}_6$  carbides. Source: Ref 214.**

A similar effect was observed for Inconel X-750 nickel-base alloy that was heat treated by a standard double-aging process and tested at a nominal strain rate of  $3 \times 10^{-5} \text{ s}^{-1}$  at room temperature and at 816 °C (1500 °F). The fracture path was intergranular at room temperature and at 816 °C (1500 °F), except that the room-temperature fracture exhibited dimples on the intergranular facets and those resulting from fracture at 816 °C (1500 °F) did not (Fig. 74). The fracture at room temperature exhibited intergranular dimple rupture because the material adjacent to the grain boundaries is weaker due to the depletion of coarse  $\gamma'$  precipitates. The absence of dimples at 816 °C (1500 °F) was the result of intense dislocation activity along the grain boundaries, producing decohesion at  $\text{M}_{23}\text{C}_6$  carbide/matrix interfaces within the boundaries (Ref 214).

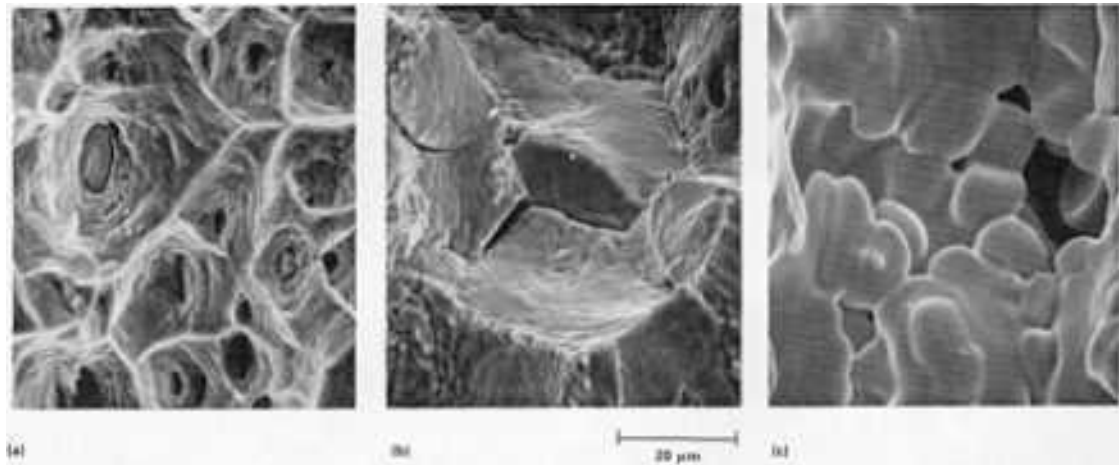
**Fig. 75 Effect of test temperature on the fracture of Haynes 556, which was tensile tested at a strain rate of  $1 \text{ s}^{-1}$  at increasing temperature. (a) Dimple rupture fracture at 1015 °C (1860 °F). At the bottom of many of the dimples are TaC inclusions, which initiated microvoid coalescence. (b) Intergranular decohesion at 1523 °C (2287 °F). Secondary intergranular cracks are also visible. (c) Local eutectic melting of TaC + austenite at 1333 °C (2431 °F). (J.J. Stephens, M.J. Cieslak, R.J. Lujan, Sandia National Laboratories)**

Three specimens were tested at a strain rate of approximately  $1 \text{ s}^{-1}$  at increasing temperatures. At 1015 °C (1860 °F), specimen 1 underwent a 72% reduction of area and fractured by dimple rupture (Fig. 75a). At 1253 °C (2287 °F), specimen 2 exhibited an 8% reduction of area. Fracture occurred intergranularly by grain-boundary decohesion (Fig. 75b). Specimen 3, which was tested at 1333 °C (2431 °F), fractured because of local eutectic melting of TaC + austenite, with 0% reduction of area (Fig. 75c).

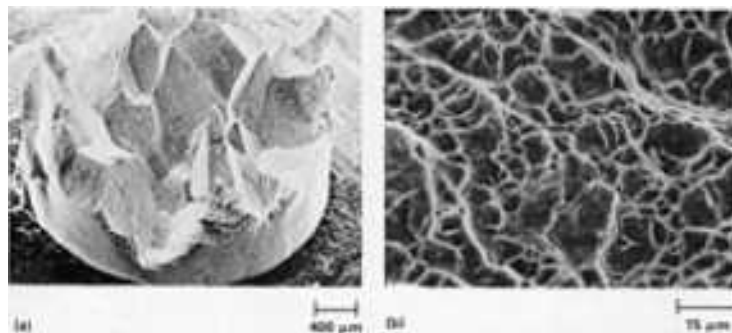
**Fig. 76 Intergranular dimple rupture in a Ti-6Al-2Nb-1Ta-0.8Ta alloy tested at 800 °F (1470 °F). The fracture path in this alloy, tensile tested at a strain rate of about  $3.3 \times 10^{-4} \text{ s}^{-1}$ , changes at 800 °C (1470 °F) from a predominantly transgranular dimple at room temperature (not shown) to intergranular dimple rupture. Source: Ref 215**

A final example of the effect of temperature on the fracture process is the behavior of a titanium alloy when tested at room temperature and at 800 °C (1470 °F). At room temperature, the fracture in a Ti-6Al-2Nb-1Ta-0.8Mo alloy (heat treated to produce a basket-weave structure consisting of Widmanstätten  $\alpha + \beta +$  grain-boundary  $\alpha$  with equiaxed prior- $\beta$  grains) that was tested at an approximate strain rate of  $3.3 \times 10^{-4} \text{ s}^{-1}$  occurred predominantly by transgranular dimple rupture. At 800 °C (1470 °F), however, the alloy exhibited low ductility, which is associated with an intergranular dimple rupture (Fig. 76). The low ductility can be explained by void formation and coalescence along prior- $\beta$  grain boundaries because of strain localization in the  $\alpha$  phase within the grain boundaries (Ref 215).

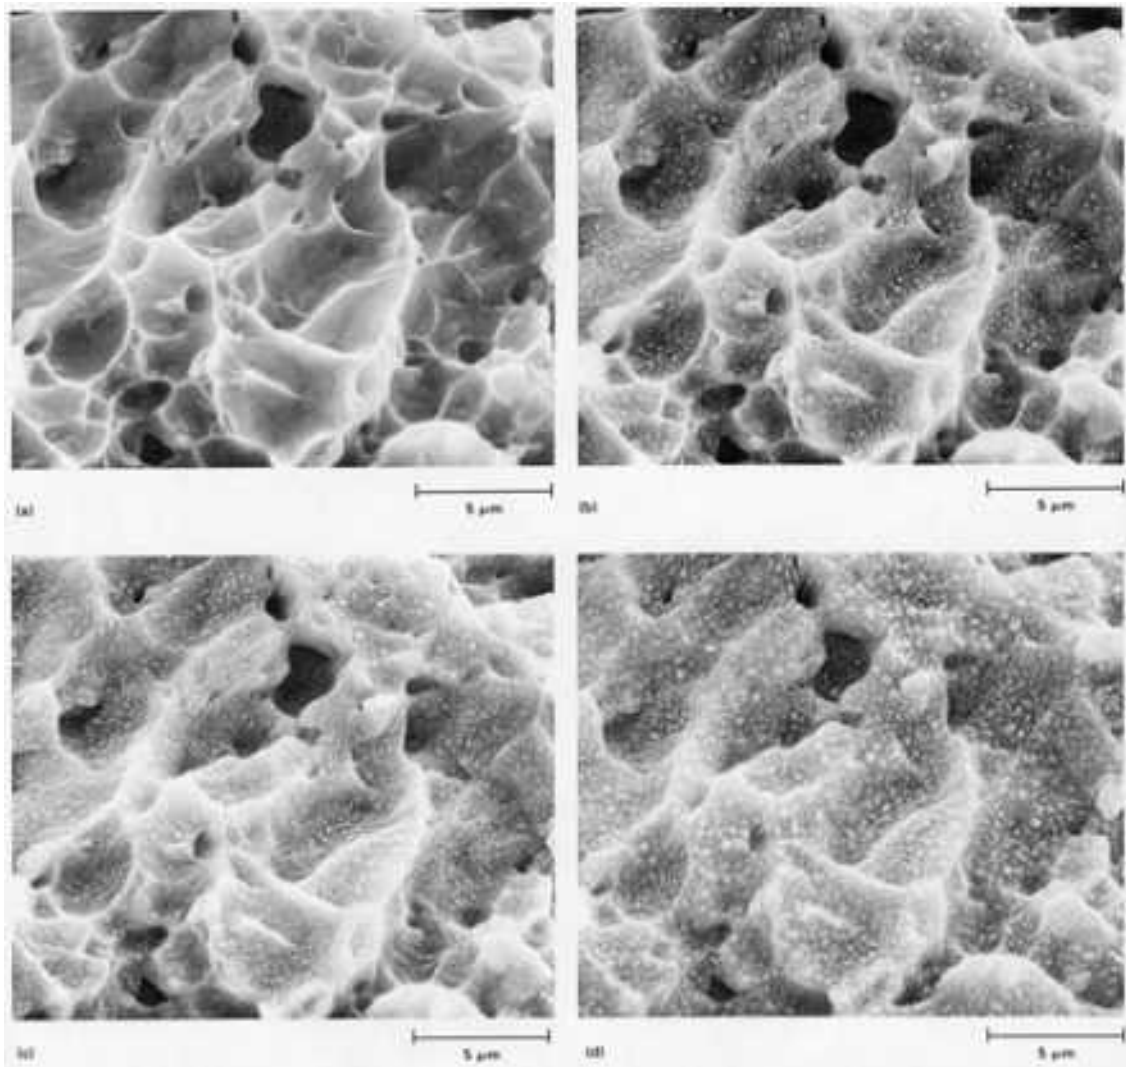
**Fig. 77 Effect of a 700- °C (1290- °F) air exposure on an annealed Ti-6Al-2Sn-4Zr-6Mo alloy dimple rupture overload fracture. (a) As fractured. (b) The identical area as in (a) except exposed for 3 min (c) 10 min. (d) 30 min. As time at temperature increases, the fracture surface becomes progressively more obscured by the oxide. (V. Kerlins, McDonnell Douglas Astronautics Company)**

Figures 77, 78, and 79 show the effects of high-temperature air exposure on the overload fracture surfaces of two titanium alloys and a steel. The progressive deterioration of the fracture surface of an annealed Ti-6Al-2Sn-4Zr-6Mo alloy exposed for various times at 700 °C (1290 °F) in air is illustrated in Fig. 77. As seen in Fig. 77(b), the oxide formed after only a 3-min exposure already obscured the fine ridges of the smaller dimples. An example of an extremely severe oxidation attack is shown in Fig. 78. The oxide cover is so complete that it is not possible to identify the fracture mode. A similar result was observed for a 300M high-strength steel fracture exposed for only 5 min at 700 °C (1290 °F) (Fig. 79). The relatively short exposure formed an oxide film that completely covered the fracture surface and rendered even the most prominent features unrecognizable.

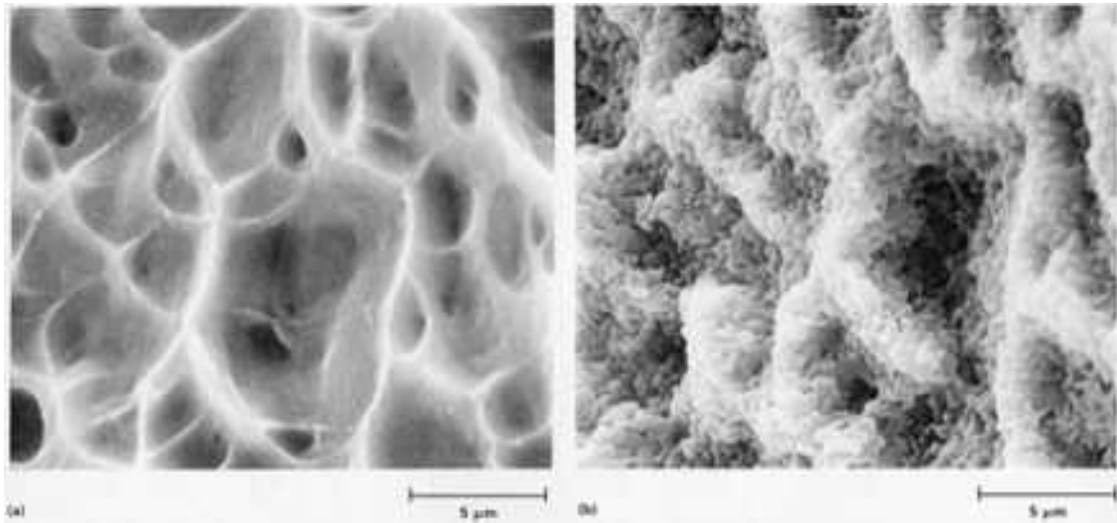
**Fig. 78** Effect of a 15-min 800- °C (1470- °F) air exposure on a dimple rupture fracture surface of an annealed Ti-6Al-6V-2Sn alloy. (a) Fracture appearance before exposure. (b) The identical fracture surface after exposure. The oxide buildup is so great that it is impossible to identify the fracture mode. (V. Kerlins, McDonnell Douglas Astronautics Company)
