ASM HANDBOOK®

VOLUME  
12

Fractography

*Fractography*, was published in 1987 as Volume 12 of the *ASM Handbook*. The Volume was prepared under the direction of the ASM Handbook Committee.

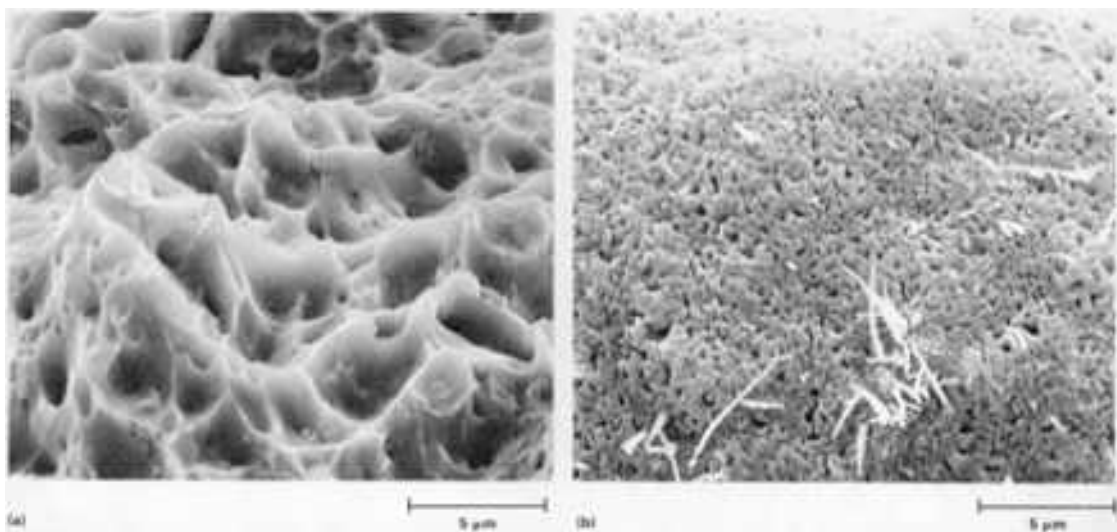
**Fig. 79** Effect of a 5-min 700- °C (1290- °F) air exposure on a 300M (2028 MPa, or 294 ksi) high-strength steel overload fracture. (a) Fracture appearance before exposure. (b) The same area after exposure. The entire fracture, which exhibited dimple rupture, was covered by an oxide that obscured all fracture detail. Some areas on the oxidized surface contained needlelike whiskers, which are probably an iron oxide. (V. Kerlins, McDonnell Douglas Astronautics Company)

Figures 77, 78, and 79 show the effects of high-temperature air exposure on the overload fracture surfaces of two titanium alloys and a steel. The progressive deterioration of the fracture surface of an annealed Ti-6Al-2Sn-4Zr-6Mo alloy exposed for various times at 700 °C (1290 °F) in air is illustrated in Fig. 77. As seen in Fig. 77(b), the oxide formed after only a 3-min exposure already obscured the fine ridges of the smaller dimples. An example of an extremely severe oxidation attack is shown in Fig. 78. The oxide cover is so complete that it is not possible to identify the fracture mode. A similar result was observed for a 300M high-strength steel fracture exposed for only 5 min at 700 °C (1290 °F) (Fig. 79). The relatively short exposure formed an oxide film that completely covered the fracture surface and rendered even the most prominent features unrecognizable.

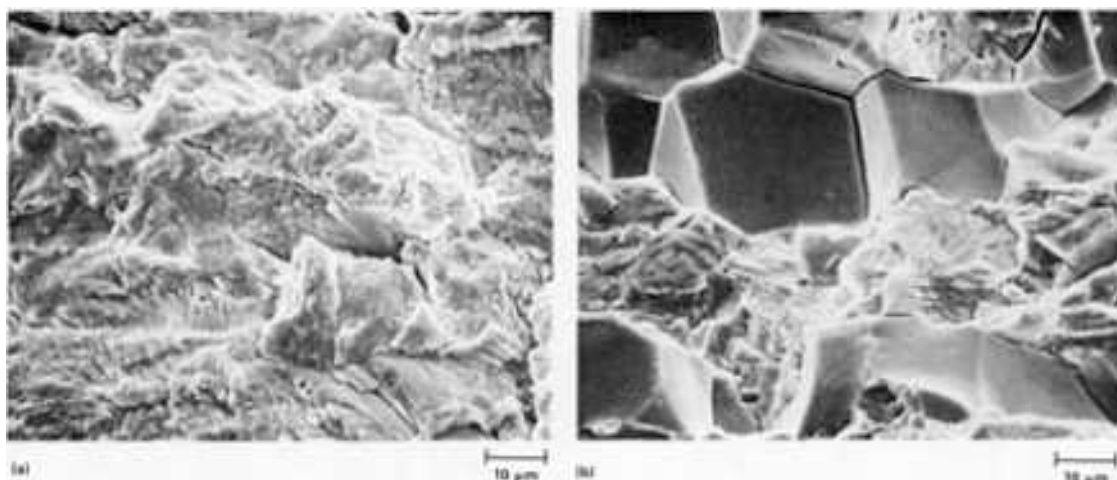
**Fig. 80 Effect of hydrogen on the fatigue fracture appearance of a grade X42 pipeline steel. (a) Tested in dry nitrogen gas at a stress intensity range of  $\Delta K = 20 \text{ MPa } \sqrt{m}$  (18 ksi  $\sqrt{in}$ ), a load ratio of  $R = 0.1$ , and a cyclic frequency of 5 Hz. (b) Tested in dry hydrogen gas at a stress intensity range of  $\Delta K = 10 \text{ MPa } \sqrt{m}$  (9 ksi  $\sqrt{in}$ ), a load ratio of  $R = 0.1$ , and a cyclic frequency of 1 Hz. Both room-temperature fatigue tests resulted in a fatigue crack growth rate of approximately  $2 \times 10^{-4} \text{ mm/cycle}$ . The fatigue fracture in nitrogen exhibited principally a serrated transgranular fracture, along with occasional bands of intergranular decohesion (not shown); however the fracture in hydrogen exhibited fewer regions of serrated fracture and more bands of intergranular decohesion. Source: Ref 218**

**Effect of Gases on Steels.** Fatigue testing of an API-5LX, grade X42 (0.26C-0.82Mn-0.014 Si-0.02Cu), 511-MPa (74-ksi) ultimate strength pipeline steel in hydrogen resulted in up to a 300-fold increase in the fatigue crack growth rate as compared to the crack growth rate in nitrogen gas (Ref 218). The fatigue tests were conducted at room temperature in dry nitrogen and dry hydrogen atmospheres (both at a pressure of 6.9 MPa, or 1 ksi), using a stress intensity range of  $\Delta K = 6$  to 20 MPa  $\sqrt{m}$  (5.5 to 18 ksi  $\sqrt{in}$ ), a load ratio of  $R = 0.1$  to 0.8, and a cyclic frequency of 1 to 5 Hz. An example of the effect of hydrogen on the fracture appearance is illustrated in Fig. 80. The fatigue fracture in hydrogen showed more bands of intergranular decohesion, which was associated with the ferrite in the microstructure, and fewer regions of a serrated fracture than the specimens tested in nitrogen. The mechanism responsible for the serrated fracture was not established; however, more than one mechanism may be involved. Compared to nitrogen, the serrated fracture in hydrogen exhibited little deformation, and at high values of  $\Delta K$ , the serrated areas resembled cleavage or quasi-cleavage (Ref 218).

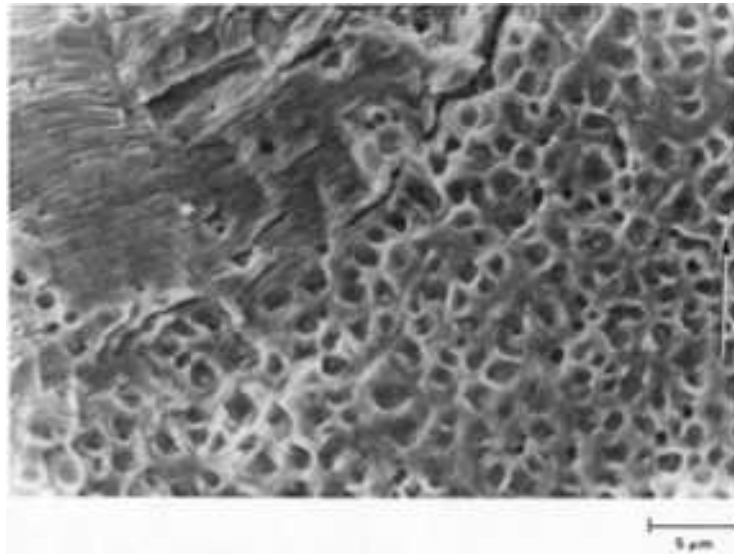
**Fig. 81 Effect of severe hydrogen attack on the fatigue fracture appearance of an ASTM 533B pressure vessel steel. The severely charged material was tested at room temperature at a stress intensity range of  $\Delta K = 20 \text{ MPa}\sqrt{m}$  ( $18 \text{ ksi}\sqrt{in}$ ), a load ratio of  $R = 0.1$ , and a cyclic frequency of 50 Hz. The fracture exhibited fatigue striations (upper left) as well as cavitated intergranular facets resulting from methane gas bubble formulation at grain boundaries. Arrow indicates crack growth direction. Source: Ref 223**

Compared to uncharged material, the lightly charged specimens were found to show only a moderate increase in the fatigue crack growth rate and only at crack propagation rates of less than  $10^{-6} \text{ mm/cycle}$ . There was no significant change in fracture appearance. The severely charged material showed a large decrease in mechanical properties: the 0.2% yield strength decreased from 660 to 242 MPa (96 to 35 ksi), the ultimate tensile strength from 790 to 315 MPa (115 to 46 ksi), the percent elongation from 22.4 to 9%, and the percent reduction of area from 73 to 5%. However, there was only a slight increase in the fatigue crack growth rate at growth rates of less than  $10^{-6}$  and greater than  $10^{-5} \text{ mm/cycle}$ , although the fatigue fracture surfaces showed evidence of substantial hydrogen attack in the form of cavitated intergranular fracture (Fig. 81). The cavities on the intergranular facets were due to the formation of methane gas bubbles or cavities at the grain boundaries.

The reaction of hydrogen with the carbon in the steel results in methane gas production and depletion of carbon from the matrix (decarburization). The surprisingly small effect that the severe hydrogen damage had on the fatigue crack growth rate was due to the competing effects of two opposing processes. The accelerating effect of the hydrogen damage was nearly offset by the decarburization softening-induced enhancement of crack closure (the premature contact between crack walls during the declining-load portion of the fatigue cycle), which lowers the crack tip stress intensity (Ref 223). Another factor that contributed to a lowering of the crack propagation rates was the tortuous crack path resulting from grain-boundary cavitation.

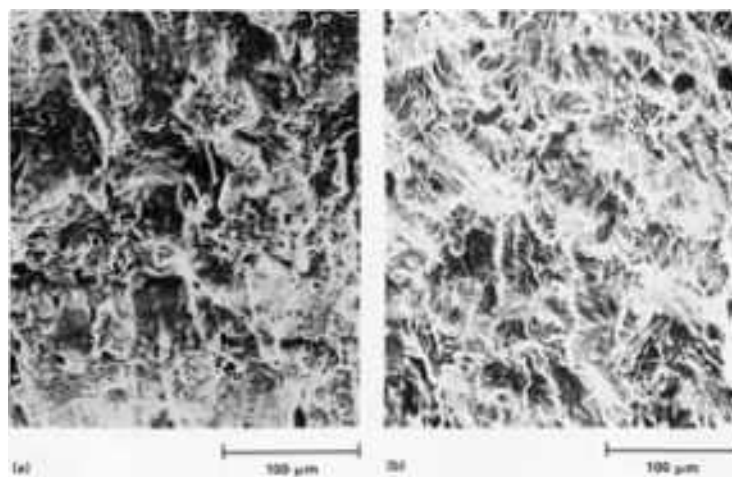
**Fig. 82 Fatigue fracture surfaces of annealed type 301 and type 302 stainless steels tested at 25 °C (75 °F) in 1 atm hydrogen gas. The type 302 stainless steel (a) showed well-developed fatigue striations. The type 301 stainless steel (b) showed a more brittle-appearing fracture surface with few striations but containing flat, cleavagelike facets and small, parallel facets at different elevations joined by tear ridges. Source: Ref 217**

The fracture surfaces of annealed type 301 and 302 austenitic stainless steels are shown in Fig. 82. The type 302 stainless steel exhibited fatigue striations in all atmospheres, but the type 301 stainless steel formed few striations under any fatigue condition. In the presence of hydrogen gas, however, the type 301 stainless steel fatigue fractures exhibited a significant number of relatively flat, cleavagelike facets and smaller, parallel plateaus of facets, each at a different elevation, forming a stepped structure. The difference in the response between the two stainless steels was due to the presence of unstable austenite in the type 301 stainless steel, which could transform to martensite as a result of strain at the crack tip. Also, cold-worked (19 to 40% reduction in thickness) material of both stainless steels was more susceptible to the effects of hydrogen than the annealed material. This was also due to the presence of strain-induced martensite in the cold-worked stainless steels, which showed no fatigue striations under any testing condition (Ref 217).

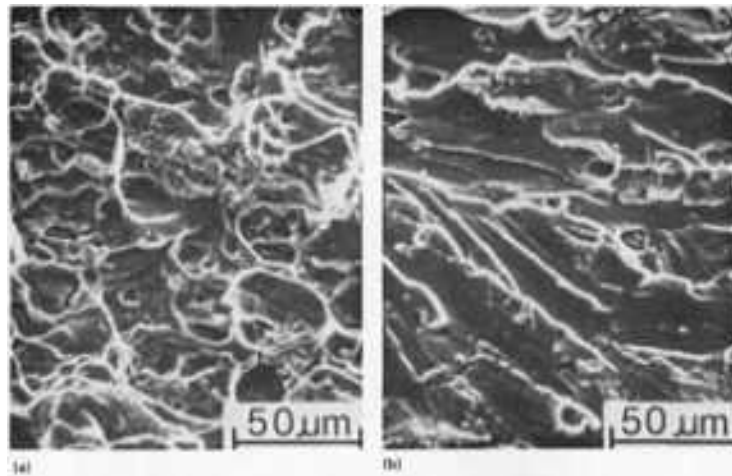
**Fig. 83 Effect of water vapor on the fatigue fracture appearance of a 2219-T851 aluminum alloy tested at room temperature. (a) 760-torr dry argon,  $\Delta K = 16.5 \text{ MPa}\sqrt{m}$  ( $15 \text{ ksi}\sqrt{in}$ ),  $R = 0.05$ , and  $f = 20 \text{ Hz}$ . (b) 0.2-torr water vapor,  $\Delta K = 16.5 \text{ MPa}\sqrt{m}$  ( $15 \text{ ksi}\sqrt{in}$ ),  $R = 0.05$ , and  $f = 5 \text{ Hz}$ . The magnifications are too low to resolve the fatigue striations clearly, but the general change in the fracture morphology is apparent. The crack propagation direction is from left to right. Source: Ref 225**

**Effect of Gases on Nonferrous alloys.** Steels are not the only alloys affected by gaseous environments; some aluminum alloys are also susceptible. When a 2219-T851 aluminum alloy was fatigue tested at room temperature within a stress intensity range of  $\Delta K = 10$  to  $24 \text{ MPa}\sqrt{m}$  ( $9$  to  $22 \text{ ksi}\sqrt{in}$ ), a load ratio of  $R = 0.05$ , and a cyclic frequency of the 5 Hz in 0.2-torr water vapor and 760-torr (1-atm) dry argon gas (at a cyclic test frequency of 20 Hz), the fatigue crack growth rate in the water vapor was three times greater than that in the argon gas (Ref 225). The increase in the crack propagation rate was attributed to hydrogen embrittlement and was essentially equivalent to the fatigue rates observed when the 2219-T851 aluminum alloy is tested in 40 to 60% humidity air, distilled water, and even a 3.5% sodium chloride solution (Ref 225, 226). A significant change in the fatigue fracture appearance (Fig. 83) accompanies the increase in the fatigue crack growth rate.

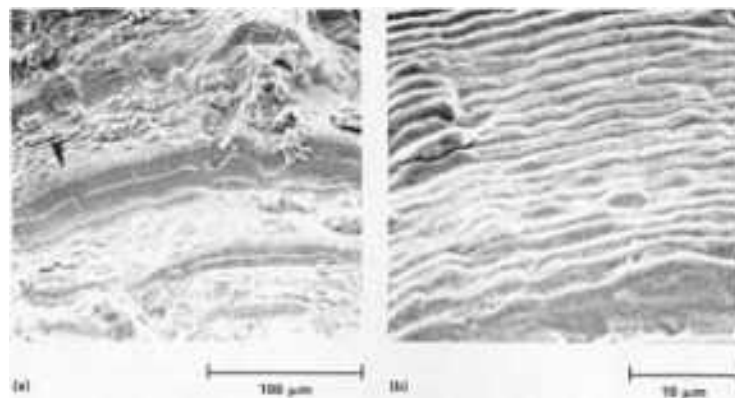
**Fig. 84 Typical ridges and fatigue striations on the fracture surface of an annealed Incoloy 800 specimen tested in a sulfidizing atmosphere in the  $316$ - to  $427$ -  $\text{°C}$  ( $600$ - to  $800$ -  $\text{°F}$ ) temperature range. (b) Higher-magnification fractograph of the area indicated by arrow in (a). Note the width of the smooth stretched areas at the ridges. Source: Ref 228**

In the  $316$ - to  $427$ -  $\text{°C}$  ( $600$ - to  $800$ -  $\text{°F}$ ) temperature range (the fracture surfaces were obscured at higher temperatures), the fatigue fracture surfaces produced in sulfur-containing atmospheres exhibited ridges and fatigue striations (Fig. 84). The ridges and stretched zones were probably formed by a localized, rapid advance of the crack front. This effect is believed to be due to the periodic local arrest of the crack by the formation of sulfide particles in the sulfur enrichment zone at the crack tip. Although the crack front as a whole is accelerating, the crack may slow down locally. When this occurs, sulfide particles have time to form in the enrichment zone. The sulfide particles (Fig. 85) appear to blunt and stop the growth of the crack, and when it finally propagates past the particle, it does so by sudden fracture, which results in a ridge and a stretched zone and locally accelerated fatigue growth, as indicated by the increase in the striation spacing immediately adjacent to the ridge-type structures. Unlike Inconel 718, no significant intergranular fracture was observed, and testing in air had no appreciable effect on the fatigue crack growth rate.

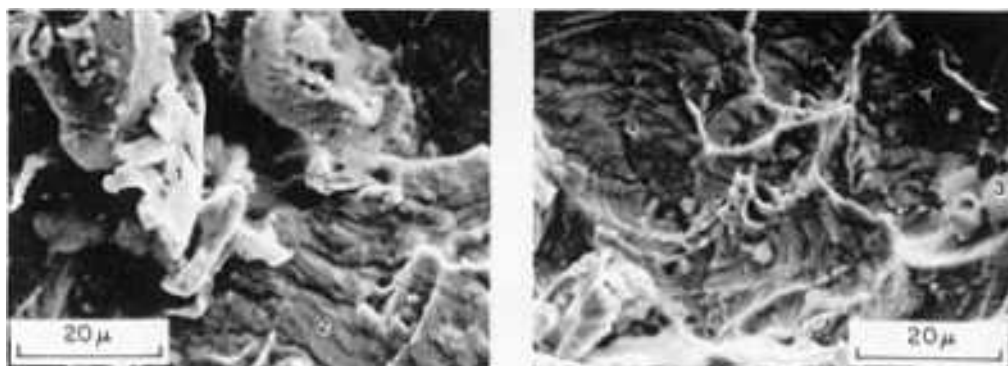
**Fig. 85 Discrete sulfide particles on fracture surfaces of an Incoloy 800 tested in a sulfidizing atmosphere. Energy-dispersive x-ray analysis indicated that sulfur was present at particles 1 and 3 and that no sulfur was**

detected on surfaces 2 and 4. The sulfur-containing particles are believed to be responsible for locally arresting the fatigue crack. Source: Ref 228.

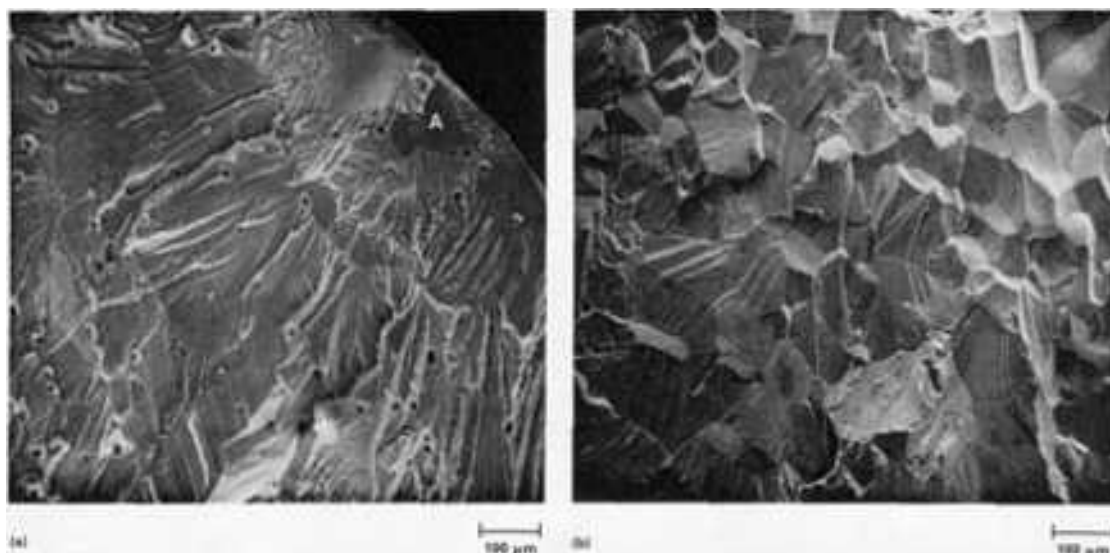
**Fig. 86 Effect of environment on the fatigue fracture appearance in a 7075-T6 aluminum alloy tested at room**

temperature. (a) Fatigue tested in dry air; cyclic stress ( $\Delta\sigma$ ) =  $\pm 110$  MPa (16 ksi), cycles to failure ( $N_f$ )  $\cong 6 \times 10^5$ . (b) Corrosion fatigue tested in a 3% sodium chloride solution,  $\Delta\sigma = \pm 68$  MPa (9.9 ksi),  $N_f \cong 6 \times 10^5$ . Note that the fatigue fracture in air initiated at a grain boundary (A) but propagated by cleavagelike fracture, with river patterns emanating from the origin. The corrosion fatigue fracture in the salt solution initiated and propagated some distance by intergranular decohesion. However, as the crack depth increased ( $\Delta K$  increased), the fracture changed to a primarily transgranular, cleavagelike fracture with river patterns. Source: Ref 235

**Corrosion Fatigue of Aluminum Alloys.** A decrease in the fatigue strength was observed for a 7075-T6 high-strength aluminum alloy tested at room temperature in dry air and in a 3% sodium chloride solution at a constant mean stress of 207 MPa (30 ksi), a load ratio of  $0 < R < 0.7$ , and a cyclic frequency of 30 Hz (Ref 235). At a constant  $3 \times 10^6$  cycles to failure, the fatigue strength in air was 115 MPa (17 ksi) (cyclic stress;  $\Delta\sigma = \pm 115$  MPa, or 17 ksi) and 50 MPa (7.25 ksi) in the saline solution. This difference in fatigue strength was reflected in the fracture appearance (Fig. 86).

The fatigue fracture in air initiated along grain boundaries, but changed immediately to a cleavagelike fracture with river patterns reminiscent of Stage I fatigue (Fig. 86a). In the saline solution, the crack exhibited substantial intergranular decohesion at the fracture origin and for some distance from the origin before the crack size had increased ( $\Delta K$  increased) sufficiently to result in the crack changing to a principally cleavagelike fracture with distinct river patterns (Fig. 86b). The cleavagelike transgranular fracture in air exhibited finer, feathery river pattern lines, and the fracture extended over a number of grains before changing direction. In the 3% sodium chloride solution, the river pattern lines were generally coarser and more distinct, and a set of lines was confined to a single grain; a new set of lines initiated at the grain boundary as the fracture entered the adjacent grain. In the fatigue striation forming portions of the fatigue cracks, the striations in air were ductile, while the striations that formed in the saline solution had a brittle character. Although the reduction in the fatigue life of the specimens tested in the 3% sodium chloride solution was reflected in the fracture appearance, the mechanism responsible for the decrease was hydrogen embrittlement. The embrittlement attack was enhanced by the cyclic mechanical rupture of the passive film and the prevention of repassivation by the presence of the chloride ion (Ref 235).

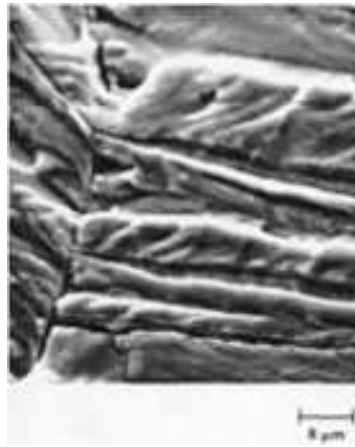
**Fig. 87 Furrow-type fatigue fracture in a commercially pure titanium alloy IMI 155 tested at room temperature in laboratory air.  $\Delta K = 16 \text{ MPa}\sqrt{\text{m}}$  ( $14.5 \text{ ksi}\sqrt{\text{in}}$ ),  $da/dN = 10^{-8} \text{ m/cycle}$ . Source: Ref 236**

Furrow-type fatigue fractures (Fig. 87) are of interest because they occurred in both environments and were the dominant fracture type in air above a  $\Delta K$  of  $10 \text{ MPa}\sqrt{m}$  ( $9 \text{ ksi}\sqrt{in}$ ). As the name suggests, furrows are grooves or trenches in the fracture surface. The furrows, which were about  $1 \mu\text{m}$  wide and  $1 \mu\text{m}$  deep and exhibited a separation of about  $5$  to  $10 \mu\text{m}$  between the grooves, were always oriented parallel to the crack growth direction. The fracture between the furrows exhibited very fine lines that made an angle of  $30^\circ$  with the furrows. From electron channeling patterns and metallography, it was concluded that the furrow fracture was the result of shear on secondary slip systems in the titanium metal (Ref 236). Furrow-type fracture apparently occurs when the fatigue crack approaches a grain that is not favorably oriented for either cleavage or a striation mode of fracture.

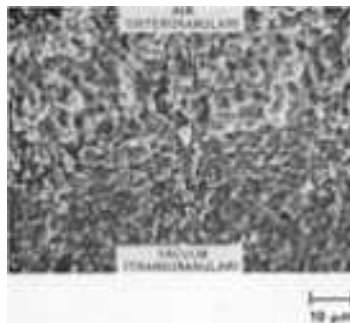
**Fig. 88 Typical fatigue fracture appearance of Astroloy tested in air and vacuum at 650 °C (1200 °F). In air (upper portion of fractograph) the fracture exhibits a predominantly intergranular character; in vacuum (lower half of fractograph) the fracture is transgranular. Source: Ref 244**

**Effect of Vacuum on Astroloy.** The nickel-base superalloy Astroloy also exhibits a lower fatigue crack growth rate in vacuum ( $5 \times 10^{-6}$  torr) than in air. Fatigue testing of Astroloy, aged at 845 °C (1555 °F) and having an average grain size of 5  $\mu\text{m}$ , within a stress-intensity range of  $\Delta K = 20$  to 50  $\text{MPa}\sqrt{m}$  (18 to 45.5  $\text{ksi}\sqrt{in}$ ), a load ratio of  $R = 0.05$ , and using a triangular wave form with a cyclic frequency of 0.33 Hz at 650 °C (1200 °F) reduced the fatigue crack growth rate in vacuum by a factor of three at  $\Delta K = 50 \text{ MPa}\sqrt{m}$  (45.5  $\text{ksi}\sqrt{in}$ ) and by a factor of ten at  $\Delta K = 20 \text{ MPa}\sqrt{m}$  (18  $\text{ksi}\sqrt{in}$ ) (Ref 244). Along with the reduction in the crack growth rate, the fracture path changed from predominantly intergranular in air to transgranular in vacuum. Figure 88 shows the typical fracture appearance when tested in air and vacuum. The decrease in the fatigue crack growth rate in vacuum was believed to be due to the change in the fracture path; in air, the loss of oxide-forming elements at the grain boundaries during high-temperature oxidation attack weakened or embrittled the boundaries, resulting in easier intergranular crack propagation (Ref 244).

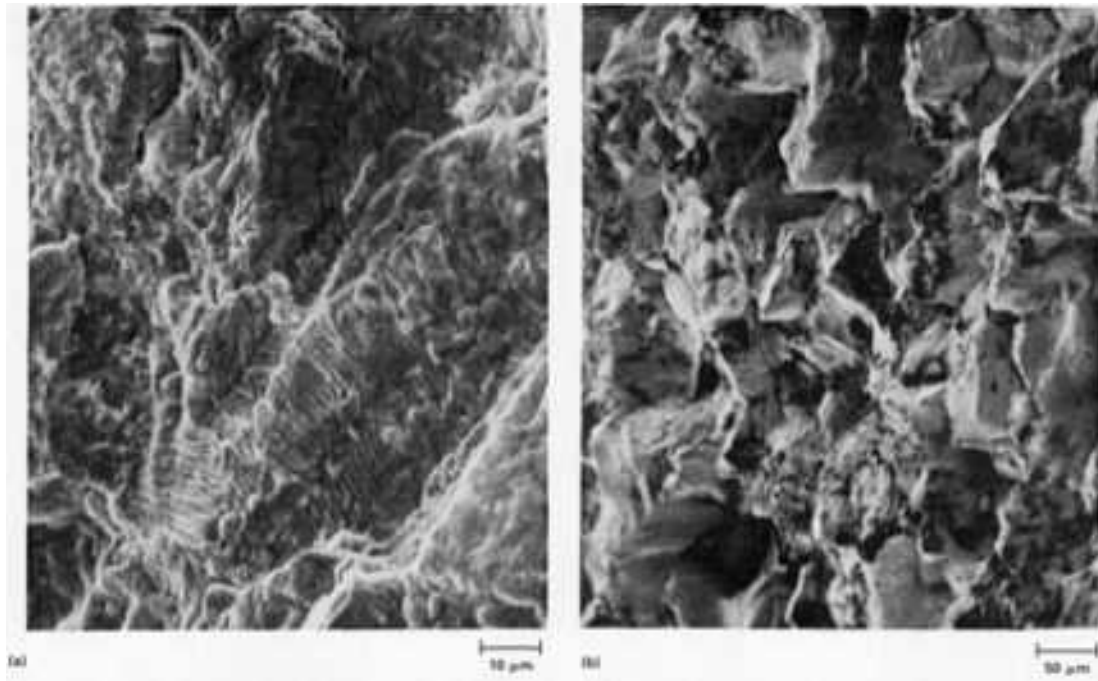
**Fig. 89 Typical fatigue fracture appearance in a cold-worked type 316 stainless steel tested at 593 °C (1100 °F) in air and vacuum. (a) The fracture in air was primarily transgranular with distinct fatigue striations. (b) The fracture in vacuum was predominantly intergranular with no distinct fatigue striations. Source: Ref 242**

**Effect of Vacuum on Type 316 Stainless Steel.** A different effect was observed when a 20% cold-worked type 316 stainless steel was fatigue tested in air and vacuum (better than  $10^{-6}$  torr) at a temperature of 593 °C (1100 °F), a stress intensity range of  $\Delta K = 28$  to 80  $\text{MPa}\sqrt{m}$  (25.5 to 73  $\text{ksi}\sqrt{in}$ ), a load ratio of  $R = 0.05$ , and a cyclic frequency of 0.17 Hz. In this stainless steel, the fatigue fractures in air were predominantly transgranular with distinct fatigue striations; the fractures in vacuum exhibited a more intergranular appearance with little evidence of striations (Fig. 89). No specific discussion on the fracture process in air or vacuum was presented because this work was principally concerned with the effect of temperature and hold times on the fatigue of the stainless steel.

**Fig. 94** Fracture appearance of a cold-worked type 316 stainless steel fatigue tested in vacuum of 593 °C (1100 °F) under a 1-min dwell time. Note the more intergranular nature of this fracture when compared to Fig. 89(b), which shows the fracture appearance of the same alloy tested under the same conditions, except at zero dwell time. Source: Ref 242

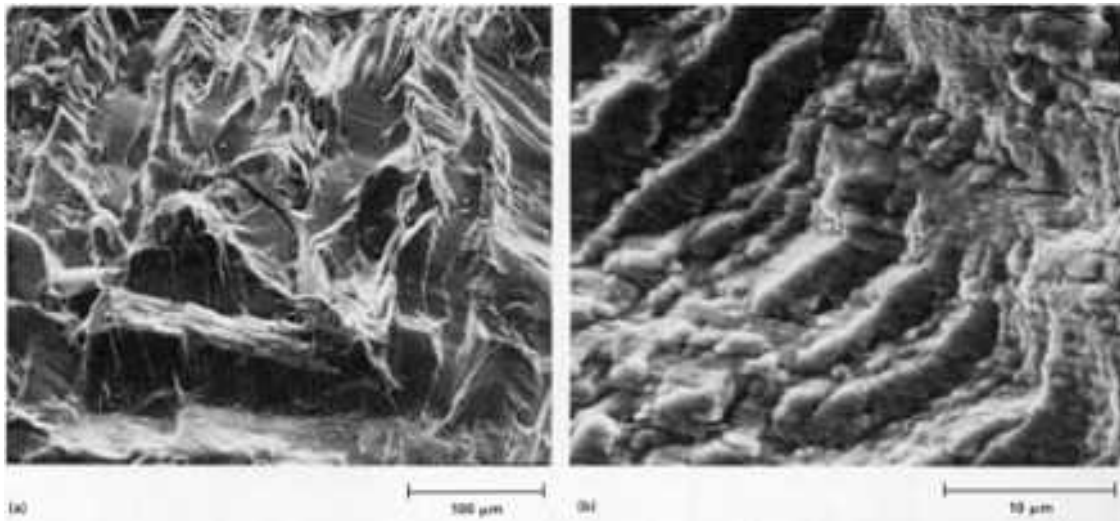
**Fig. 90** Fatigue fractures in Inconel X-750 tested at a stress intensity of  $\Delta K = 20 \text{ MPa}\sqrt{m}$  ( $18 \text{ ksi}\sqrt{in}$ ) in air and vacuum at  $650^\circ\text{C}$  ( $1200^\circ\text{F}$ ). The crack propagation direction is from bottom to top. The fracture in air (a) exhibited a faceted, crystallographic appearance; the vacuum fracture (b) was less faceted and contained distinct, periodic crack front markings. Source: Ref 245

The largest decrease in the fatigue crack growth rate in vacuum at 650 °C (1200 °F) occurred at the lower  $\Delta K$  testing levels. Figure 90 shows the air and vacuum fatigue fractures produced at a stress intensity range of  $\Delta K = 20 \text{ MPa}\sqrt{m}$  ( $18 \text{ ksi}\sqrt{in}$ ). The fractures in both environments were predominantly transgranular. The air fatigue fractures exhibited a more crystallographic, faceted appearance than those in vacuum. The vacuum fractures contained periodic marking that were believed to be due to slip offsets resulting from stress gradients produced by crack front jumps (Ref 245, 246). The large decrease in the fatigue crack growth rate in vacuum at 650 °C (1200 °F) was attributed to the absence of oxygen, which can diffuse along slip bands to embrittle the material ahead of the crack tip and increase the rate at which a fatigue crack propagates. No reason was given for the identical fatigue propagation rates in air and vacuum at 25 °C (75 °F), although the high oxidation and corrosion resistance of this alloy at ambient temperatures rendered it immune to any adverse effects of air.

The fatigue crack growth rate at  $\Delta K = 50 \text{ MPa}\sqrt{m}$  ( $45.5 \text{ ksi}\sqrt{in}$ ) was 110 times greater at 25 °C (75 °F) and 30 times greater at 650 °C (1200 °F) than at  $18 \text{ MPa}\sqrt{m}$  ( $16.5 \text{ ksi}\sqrt{in}$ ). The effect of  $\Delta K$  on the fracture appearance of Inconel X-750 tested at 650 °C (1200 °F) in air can be seen by comparing Fig. 90(a) ( $\Delta K = 20 \text{ MPa}\sqrt{m}$ , or  $18 \text{ ksi}\sqrt{in}$ ) with Fig. 92 ( $\Delta K = 35 \text{ MPa}\sqrt{m}$ , or  $32 \text{ ksi}\sqrt{in}$ ).

**Fig. 92 Fatigue fracture appearance of Inconel X-750 tested in air at 650 °C (1200 °F) at  $\Delta K = 35 \text{ MPa}\sqrt{m}$  (32 ksi  $\sqrt{in}$  ). The fracture path is transgranular with ductile fatigue striations. The crack propagation direction is indicated by arrow. Compare with the fracture appearance of the same alloy shown in Fig. 90(a), which was tested at  $\Delta K = 20 \text{ MPa}\sqrt{m}$  (18 ksi  $\sqrt{in}$  ). Source: Ref 245**

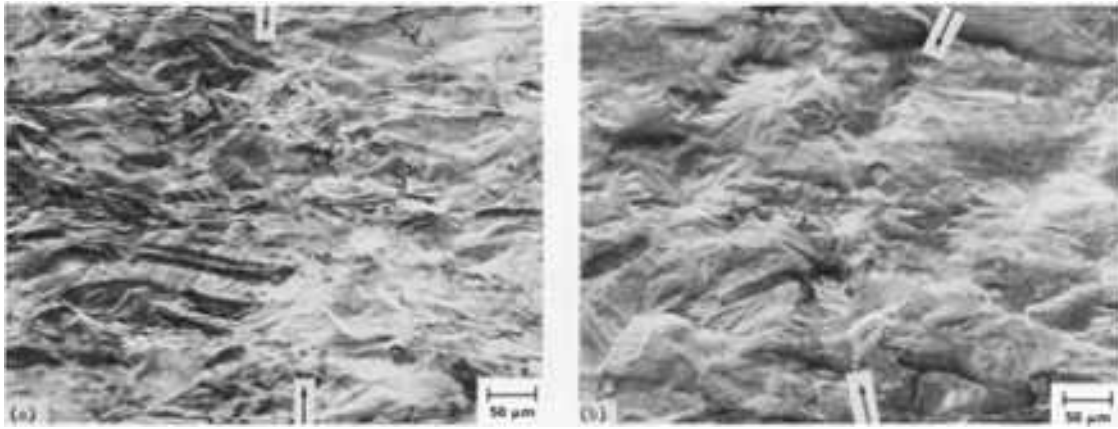
**Fig. 91 Typical fatigue fracture appearance of an annealed type 316 stainless steel tested in vacuum at 25 °C (75 °F) (a) and 593 °C (1100 °F) (b). The crack propagation direction is from left to right. Small arrows point to the interface between the precracked region and the propagating fatigue crack. Both fractures were transgranular and contained crystallographically oriented facets. Source: Ref 242.**

**Effect of Temperature on Austenitic Stainless Steels.** Increasing the temperature from  $25$  to  $593^\circ\text{C}$  ( $75$  to  $1100^\circ\text{F}$ ) for an annealed type 316 austenitic stainless steel increased the fatigue crack growth rate by a factor of 3.5 when tested in vacuum (better than  $10^{-6}$  torr) at a stress intensity range of  $\Delta K = 34$  to  $60 \text{ MPa}\sqrt{m}$  ( $31$  to  $54.5 \text{ ksi}\sqrt{in}$ ), a load ratio of  $R = 0.05$ , and a cyclic frequency of 0.17 Hz (Ref 242). The increase in temperature had no significant effect on the fracture appearance; both fractures, especially at the lower  $\Delta K$  values, were transgranular and contained crystallographic facets (Fig. 91). The absence of fatigue striations was probably the result of testing in a vacuum environment. The increase in the fatigue crack growth rate was attributed to the decrease in the elastic modulus at elevated temperature.

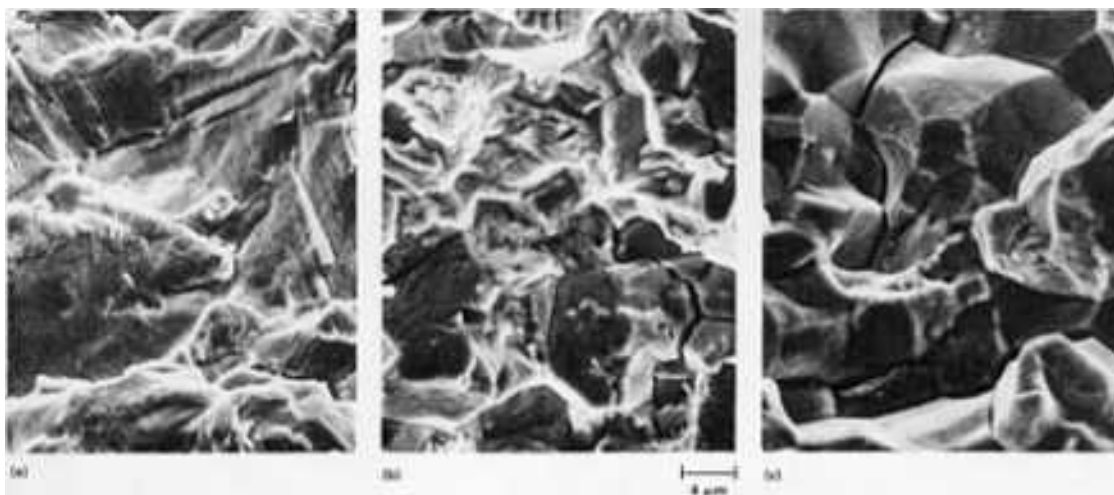
**Fig. 93 Effect of frequency on the fracture appearance of an IN-718 nickel-base superalloy that was creep fatigue tested at 650 °C (1200 °F):  $R = 0.1$ ,  $K_{\max} = 40$  MPa  $\sqrt{m}$  36.5 ksi  $\sqrt{in}$  ). (a) Striation formation at 10 Hz. (b) Mixture of intergranular and transgranular cracking at 0.5 Hz. (c) Fully intergranular cracking at 0.001 Hz**

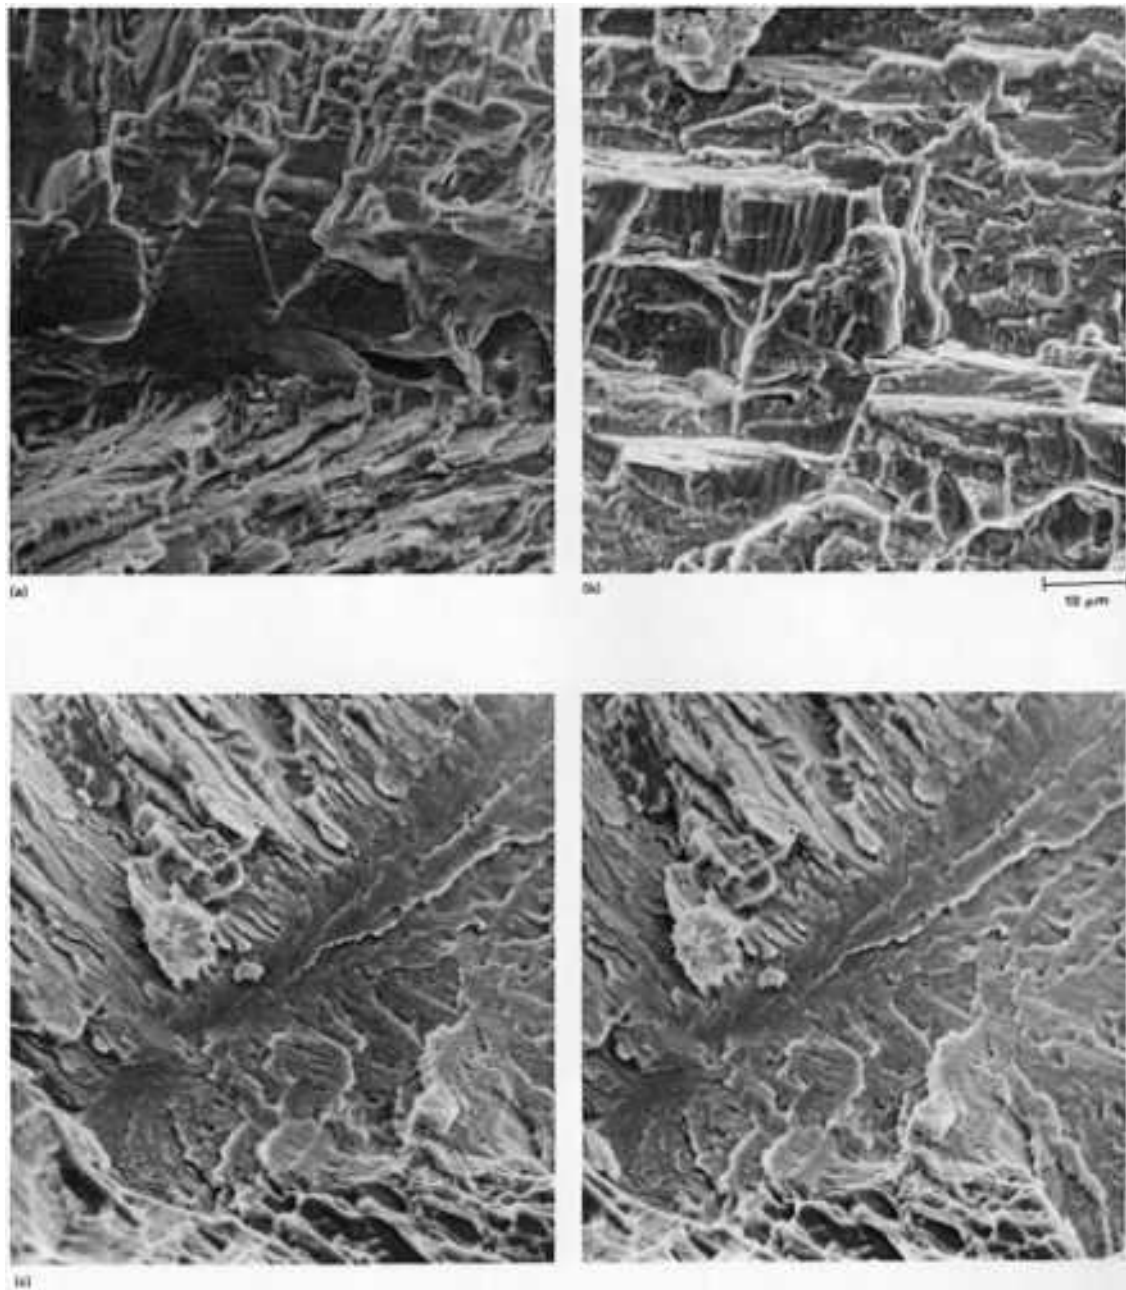
**Fig. 95** Changes in the principally fatigue-striated fracture appearance of a Ti-6Al-5Zr-0.5Mo-0.25Si alloy as a result of a 5-min dwell at maximum tensile stress. The changes included a local increase in the striation spacing after the dwell period (a); a change in the local fracture direction, as indicated by the orientation of the fatigue striations (central portion of photograph), which are normal to the macroscopic fracture propagation direction (b); and the introduction of cleavage fracture shown in the stereo pair in (c). The macroscopic crack growth direction is vertical. Source: Ref 257

Because of appreciable scatter in the dwell test data, no specific numerical results will be given; however, the 5-min dwell at maximum tensile stress produced at least an order of magnitude increase in the fatigue crack growth rate. This increase was accompanied by changes in the fracture appearance. These changes to the predominantly fatigue-striated fracture included a large increase over a short distance immediately after the dwell period, changes in the local fracture direction (local cracks often propagated at right angles to the macroscopic fracture direction), and the introduction of quasi-cleavage and cleavage fractures (Fig. 95). Although the nondwell fractures also exhibited some quasi-cleavage and cleavage regions, the dwell fractures contained more of these features. Both the local increase in the striation spacing and the changes in the local fracture direction resulted from the link-up of the fatigue crack with the dwell-induced nonfatigue cracked areas ahead of the main crack front. The increase in the fatigue crack growth rate and the changes in the fracture mode were due to the combined action of creep and hydrogen embrittlement ahead of the crack tip that occurred during the dwell period (Ref 257).

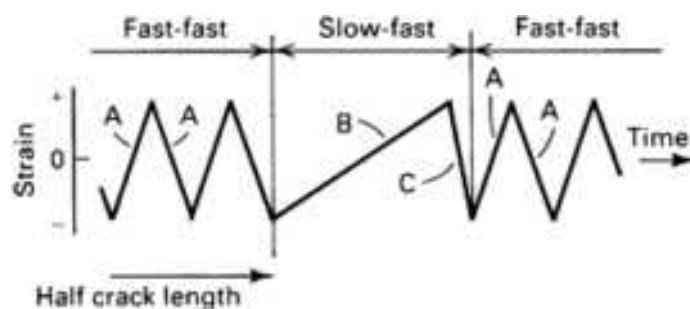
**Fig. 96** Fatigue test strain wave form. A, strain, rate =  $50 \times 10^{-5} \text{ s}^{-1}$  (fast-fast cycles); B, strain rate =  $1.4 \times 10^{-5} \text{ s}^{-1}$  (the slow-rising strain ramp of the slow-fast cycle); C, strain rate =  $28 \times 10^{-5} \text{ s}^{-1}$  (the fast-declining strain ramp of the slow-fast cycle). Source: Ref 255

**Example 26.** An annealed SUS 304 stainless steel (SUS 304 is the Japanese equivalent of AISI type 304 stainless steel) with ultimate tensile strengths of 648 MPa (94 ksi) and 356 MPa (52 ksi) at room temperature and 600 °C (1110 °F), respectively, was tested to determine the effect of the type of cyclic load on the fatigue crack growth rate (Ref 255). Through-thickness cracks in thin-wall cylindrical test specimens were grown to half crack lengths ranging from 0.55 to 1.23 mm (0.02 to 0.048 in.) using fast-fast strain cycling. At the predetermined half length, one slow-fast cycle was introduced, and the fast-fast strain cycling was resumed. The fatigue test wave form is illustrated in Fig. 96. The wave form was triangular, fully reversed, with a total strain range of 0.8 to 1.5%. The fast-fast cycles were applied at a strain rate of  $\pm 50 \times 10^{-5} \text{ s}^{-1}$ , and the slow-fast cycle consisted of a  $1.4 \times 10^{-5} \text{ s}^{-1}$  rising strain ramp and  $28 \times 10^{-1} \text{ s}^{-1}$  declining strain ramp. All test were conducted in air at a temperature of 600 °C (1110 °F).

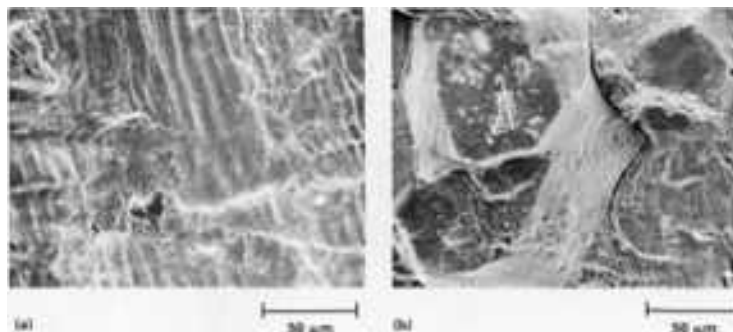
**Fig. 97** Effect of one slow-fast cycle on the fracture appearance of an SUS 304 stainless steel that was fatigue tested in air at 600 °C (1110 °F). (a) Increase in fatigue striation spacing after the introduction of the slow-fast cycle at a half crack length = 0.97 mm (0.038 in.) (b) Intergranular fracture after the application of one slow-fast cycle at a half crack length of 1.0 mm (0.039 in.). Crack growth direction in both figures is right to left. Source: Ref 255

The introduction of one slow-fast cycle always increased the fatigue crack growth rate, sometimes by up to a factor of two. When the fast-fast cycling was resumed after the slow-fast cycle, the crack propagated by a fatigue striation forming mechanism, in which case there was a local increase in the striation spacing, or by intergranular fracture (Fig. 97). Where the crack propagated by a striation-forming mechanism or by intergranular fracture was determined by the ratio  $\Delta J_c / \Delta J_f$ , where  $\Delta J_c$  = range of the creep  $J$ -integral and  $\Delta J_f$  = range of the cycle  $J$ -integral. The values of  $\Delta J_c$  and  $\Delta J_f$  can be determined from plots of load versus crack-opening displacement at half crack length for the slow-fast cycle,  $\Delta J_c$ , and the fast-fast cycle,  $\Delta J_f$  (Ref 255). When the value of  $\Delta J_c / \Delta J_f$  is less than 0.1, the crack propagates by a striation-forming mechanism; if the value exceeds 0.1, the crack propagates by intergranular fracture when fast-fast cycling is resumed. In

From a material standpoint, the factors that determined whether the cracking occurred by striation fatigue or intergranular fracture were the degree of creep damage and the size of the damaged zone produced during the slow-fast cycle. If the creep-damaged zone ahead of the crack tip was smaller than the stain-deformed region resulting from the fast-fast cycling before the slow-fast cycle, the crack propagated by striation-forming fatigue. However, if the creep-damaged zone was larger than that of the fast-fast cycling and if wedge cracks were produced at the grain boundaries adjacent to the crack tip, intergranular fracture resulted. Regardless of the cracking mechanism, the fatigue crack growth rate is accelerated until the fatigue crack escapes the creep-damaged zone (Ref 255).

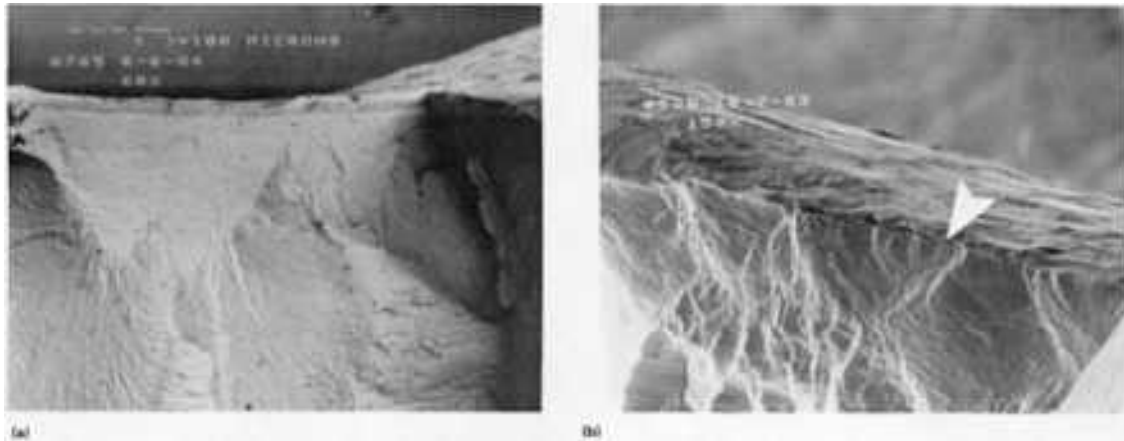
**Fig. 99 Fractures in AISI 5160 wire springs that originated at seams. (a) Longitudinal fracture originating at a seam. (b) Fracture origin at a very shallow seam, the arrow indicates the base of the seam. (J.H. Maker, Associated Spring)**

Failures in valve springs that originated at a seam are shown in Fig. 99. The failure shown in Fig. 99(a) began at the seam that extended more than 0.05 mm (0.002 in.) below the spring wire surface. The fatigue fracture front progressed downward from several origins. Each one of these fronts produces a crack that is triangular in outline and is without fine detail due to sliding of the opposing surfaces during the later stages of fracture. This occurs when the fracture plane changes to an angle with the wire axis in response to the torsional strain. These surfaces are visible in the lower part of Fig. 99(a).

The failure shown in Fig. 99(b) has many of the characteristics of that shown in Fig. 99(a), except that the seam is scarcely deeper than the folding of the surface that results from shot peening. Observation of it requires close examination of the central portion of the fractograph. This spring operated at a very high net stress and failed at less than  $10^6$  cycles.

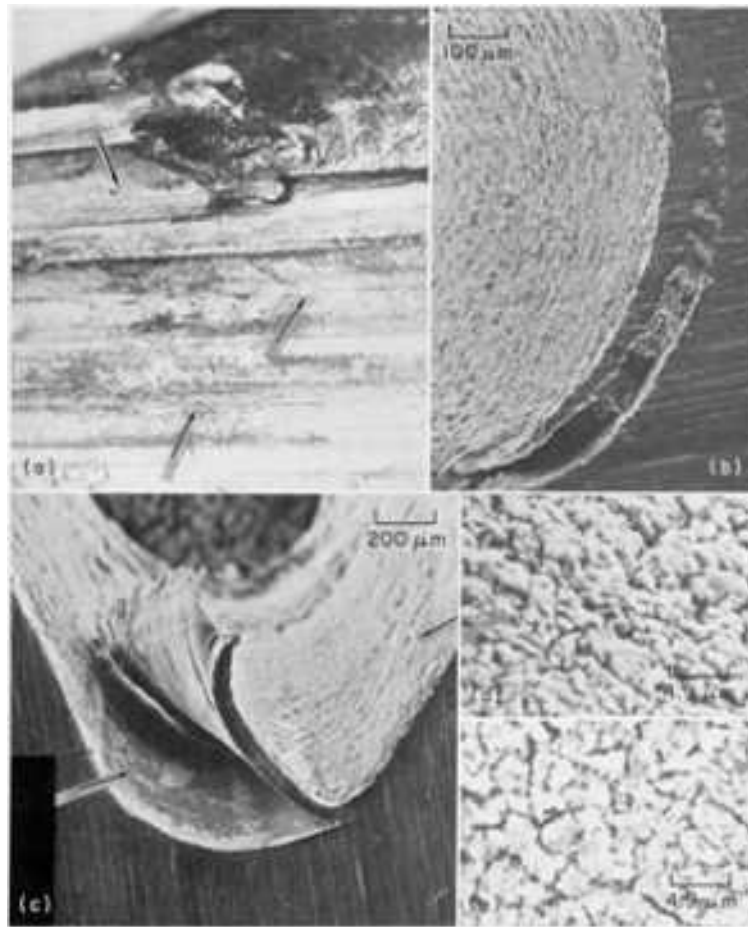
**Fig. 100 Laps formed during thread rolling of a 300M steel stud. (a) Light fractograph showing laps (arrows). (b) SEM fractograph giving detail of a lap. (c) SEM fractograph showing heavily oxidized surfaces of a lifted lap; the oxidation indicates that the lap was present before heat treatment of the stud. Arrow at right points to area shown in fractograph (d), and arrow at left points to area shown in fractograph (e). (d) and (e) SEM fractographs showing oxidized surfaces of the lifted lap in fractograph (c). See Fig. 101 for views of the stress-corrosion crack initiated by the laps.**

The fractographs in Fig. 100 show laps that had been rolled into the thread roots of a 300M high-strength steel stud during thread rolling. The laps served as origins of a stress-corrosion crack that partially severed the stud. Both surfaces of a lifted lap (Fig. 100c) were heavily oxidized (Fig. 100d and e), indicating that the lap was formed before the stud was heat treated (to produce a tensile strength of 1930 to 2070 MPa, or 280 to 300 ksi). The stress-corrosion crack near the origin is shown in Fig. 101.

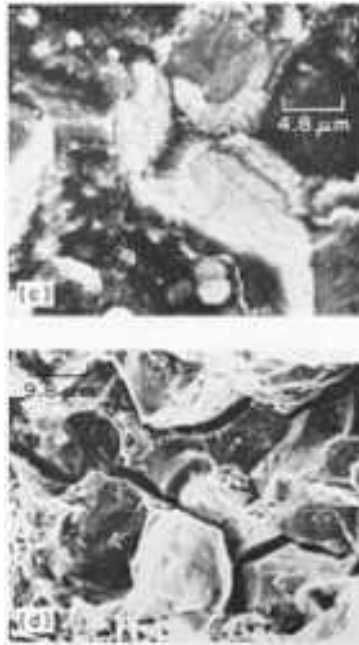
**Fig. 101 SEM views of the corrosion products (a) and the intergranular fracture and secondary grain-boundary cracks (b) that were the result of the laps shown in Fig. 100**

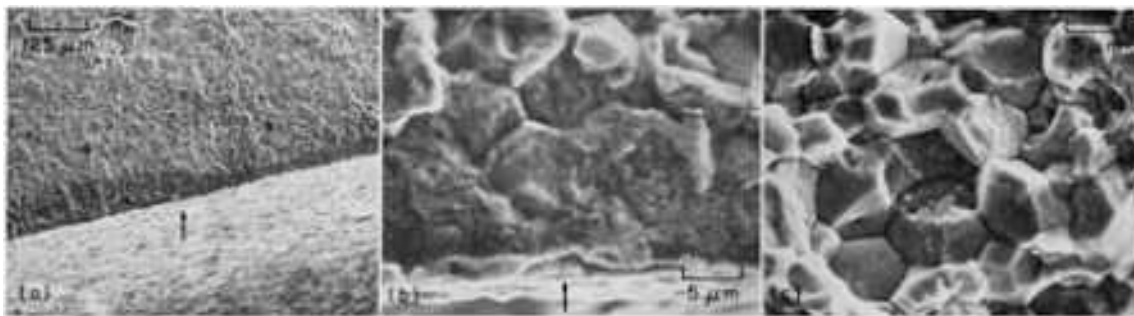
**Fig. 102 Fracture caused by a portion of a pre-existing intergranular stress-corrosion crack that was not removed in reworking. The part was made of AISI 4340 steel that was heat treated to a tensile strength of 1790 to 1930 MPa (260 to 280 ksi). (a) and (b) Remains of an old crack along the edge of the surface of the part (arrows); note dark zone in (a) and extensively corroded separated grain facets in (b). (c) Clean intergranular portion of crack surface that formed at the time of final fracture**

**Cracks.** The cause and size of a pre-existing crack are of primary importance in fracture mechanics, as well as in failure analysis, because of their relationship to the critical crack length for unstable crack growth. Figure 102 shows a fracture in a highly stressed AISI 4340 steel part. A narrow zone of corroded intergranular fracture at the surface of the part is adjoined by a zone of uncorroded intergranular fracture, which is in turn adjoined by a dimpled region. The part had been reworked to remove general corrosion products shortly before fracture. It was concluded that the rework failed to remove about 0.1 mm (0.004 in.) of a pre-existing stress-corrosion crack, which continued to grow after the part was returned to service.

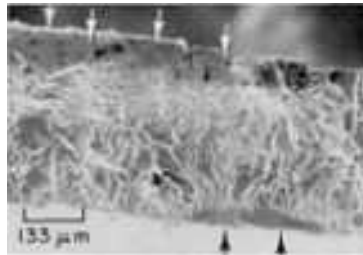
**Fig. 103 Fracture in a weld in commercially pure titanium showing incomplete fusion. Unfused regions, on both surfaces (arrows), served as nuclei of fatigue cracks that developed later under cyclic loading.**

Incomplete fusion or inadequate weld penetration can produce a material discontinuity similar to a crack. Subsequent loading can cause the discontinuity to grow, as in Fig. 103, which shows a fracture in a weld in commercially pure titanium that broke by fatigue from crack nuclei, on both surfaces, that resulted from incomplete fusion during welding.

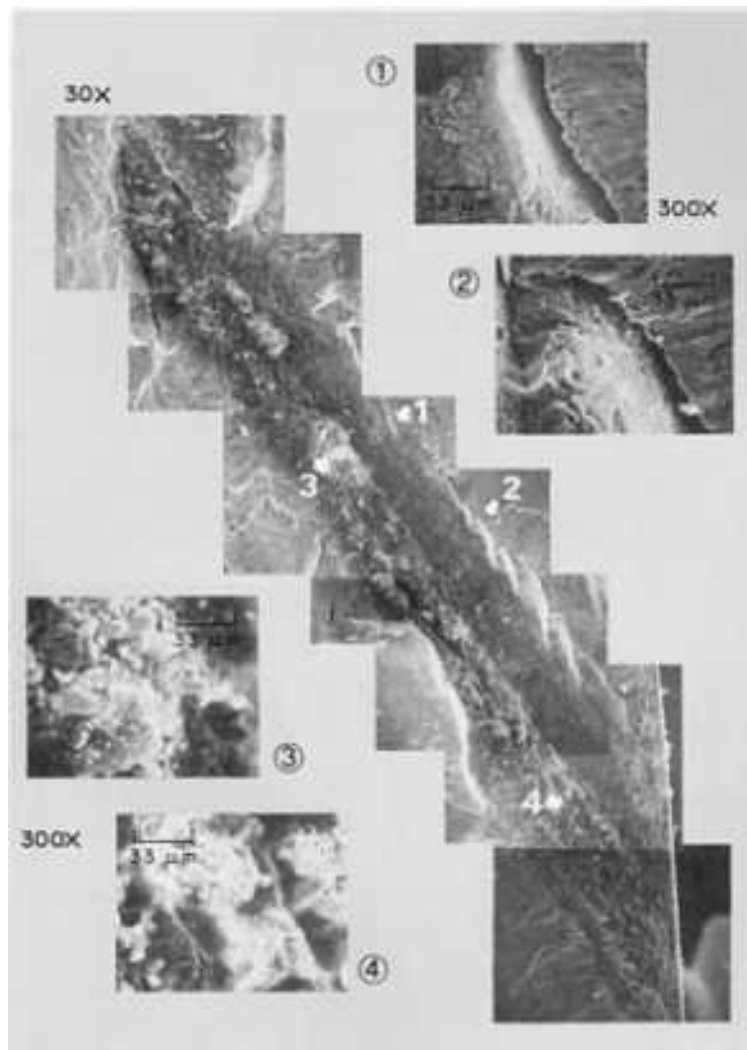
**Fig. 104** Inclusion in a surface of a service fracture in a case-hardened AISI 9310 steel forging. The diagonal view is a composite of several fractographs showing a very large inclusion, which was a fragment of the pouring-ladle firebrick lining. Fractographs 1 to 4 are higher-magnification views of areas indicated by arrows 1 to 4, respectively, in the diagonal view.

The very large inclusion shown in Fig. 104 was found in the fracture surface of a case-hardened AISI 9310 steel forging that broke in service. X-ray analysis of the inclusion led to the deduction that it was a fragment of the firebrick lining of the pouring ladle.

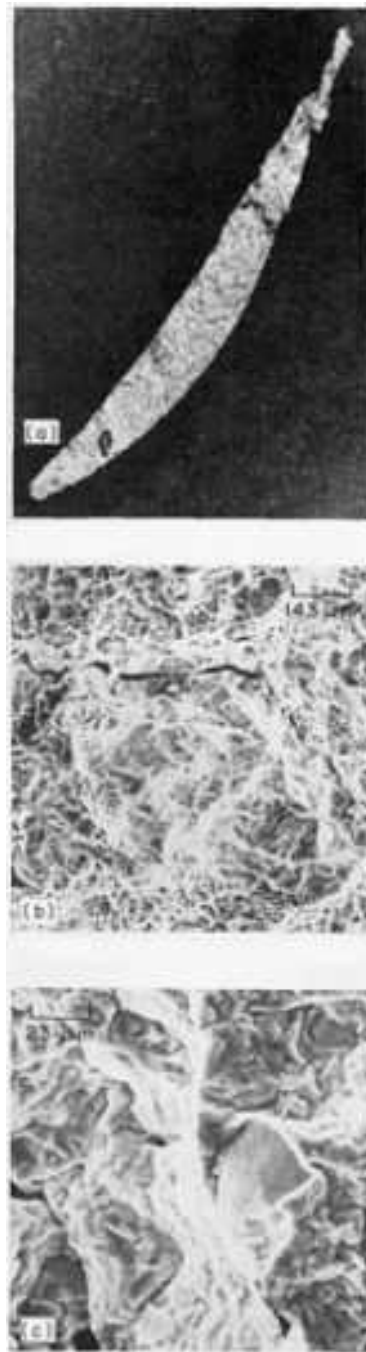
Figure 105 shows a large inclusion in a fracture surface of a cast aluminum alloy A357-T6 blade of a small, high-speed air turbine and two views of the fracture-surface features around this inclusion.

**Fig. 105 Fracture surface of a cast aluminum alloy A357-T6 air-turbine blade. (a) Overall view of the fracture surface showing a large inclusion (dark) near the tip of the blade. Approximately 0.4×. (b) and (c) Decohesion at the interfaces between the inclusion and the aluminum matrix**

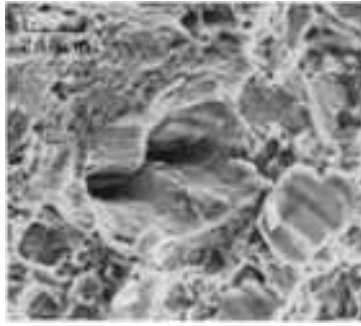
Figure 106 shows the fracture features associated with inclusions in AISI 4340 steel with a tensile strength of 1790 to 1930 MPa (260 to 280 ksi). Entrapped flux in a brazed joint can effectively reduce the strength of the brazement and also can create a long-term corrosion problem. A 6061 aluminum alloy attachment bracket was dip brazed to an actuator of the same alloy in a flux consisting of a mixture of sodium, potassium and lithium halides, then heat treated to the T6 temper after brazing. The flux inclusion, shown in Fig. 107, reduced the cross section of the joint, and a overload fracture occurred in the Al-12Si brazing alloy.

**Fig. 106** Fracture surface of an AISI 4340 steel that was heat treated to a tensile strength of 1790 to 1930 MPa (260 to 280 ksi) showing deep dimples containing the inclusions that initiated them. (J. Kilpatrick, Delta Air Lines)

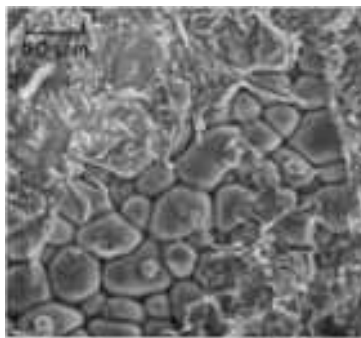
**Fig. 107** Halide-flux inclusion (rounded granules) in the joint between an actuator and an attachment bracket of aluminum alloy 6061 that were joined by dip brazing using an Al-12Si brazing alloy

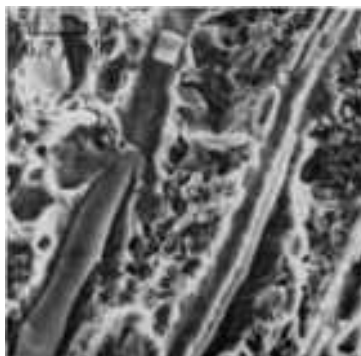
Stringers are elongated nonmetallic inclusions, or metallic or nonmetallic constituents, oriented in the direction of working. Nonmetallic stringers usually form from deoxidation products or slag, but may also result from the intentional addition of elements such as sulfur to enhance machinability. Figure 108 shows unidentified stringers on the fracture surface of an AISI 4340 steel forging. Overload cracking occurred during straightening after the forging had been heat treated to a tensile strength of 1380 to 1520 MPa (200 to 220 ksi).

**Fig. 108** Stringers on the surface of a fracture that occurred during straightening of an AISI 4340 steel forging that had been heat treated to a tensile strength of 1380 to 1520 MPa (200 to 220 ksi). Stringers are visible as parallel features inclined about 30° to right of vertical. They were not identified as to composition, but may be accidentally entrapped slag that was elongated in the major direction of flow during forging.

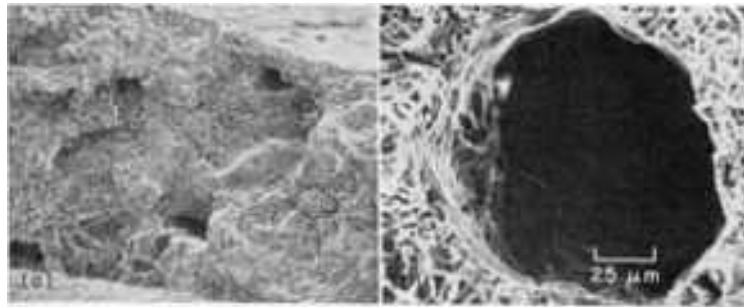
Figure 109 shows random porosity (with pores surrounded by dimples) in a fracture of a cast aluminum alloy A357 air-turbine blade. Fracture was caused by overload from an impact.

**Fig. 109 Porosity in a fracture of a cast aluminum alloy A357 blade from a small air turbine. The blade fractured by overload from an impact to its outer edge.**

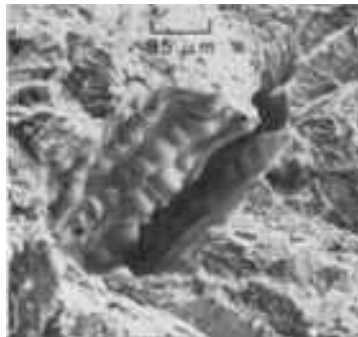
Figure 110 shows a shrinkage void intersected by the fracture surface of a cast aluminum alloy A357-T6 gear housing. The dendrite nodules in the void indicate that the cavity was caused by unfavorable directional solidification during casting. The fracture was caused by overload.

**Fig. 110 Shrinkage void with dendrite nodules on a fracture surface of a cast aluminum alloy A357-T6 gear housing that broke by overload**
