ASM HANDBOOK®

VOLUME  
12

Fractography

*Fractography*, was published in 1987 as Volume 12 of the *ASM Handbook*. The Volume was prepared under the direction of the ASM Handbook Committee.

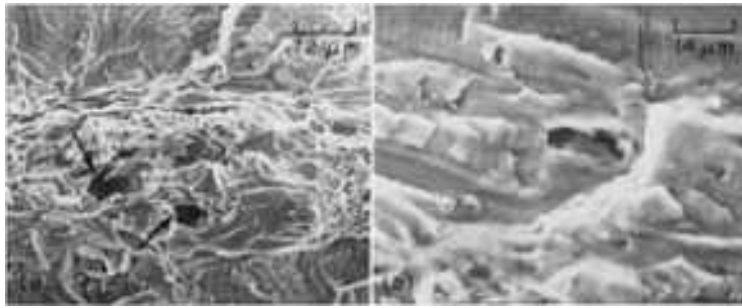
Figure 111 shows SEM fractographs of the surface of a fatigue fracture in a resistance spot weld that broke during bond testing of an aluminum alloy 7075-T6 specimen. The voids in the weld nugget are apparent in both fractographs. The fatigue path appears to favor the voids.

**Fig. 111 Fatigue fracture surface of a resistance spot weld that broke during bond testing of an aluminum alloy 7075-T6 specimen. (a) Note voids (arrows) caused by molten-metal shrinkage in the weld nugget. (b) Both fatigue striations and shrinkage voids are evident, which indicates that the fracture path favored the porous areas.**

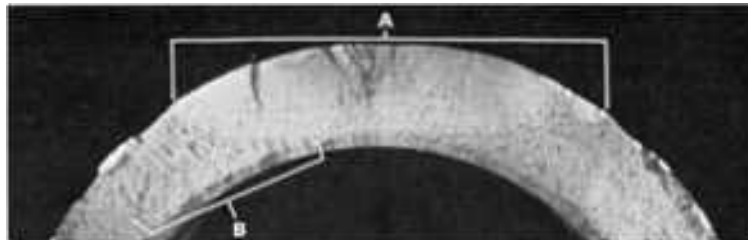
**Unfavorable Grain Flow.** Grain flow in an unfavorable direction may be indicated by a woody fracture in some materials and by a flat, delaminated appearance in others. An area of woody fracture is indicated in region B in Fig. 112, which shows a fatigue fracture in a forged AISI 4340 steel aircraft landing-gear axle. The fatigue fracture occurred in an area where the resistance of the material to fatigue cracking was low because the fluctuating loads were applied nearly perpendicular to the direction of grain flow. In high-strength aluminum alloys extrusions and hot-rolled products, tension loads are occasionally applied perpendicular to the flow direction, which may cause splitting along flow lines. This somewhat resembles the pulling apart of laminated material. Splitting may also appear as secondary cracks perpendicular to the primary fracture when these materials are broken by bending loads.

**Fig. 112 Fatigue fracture through a region of unfavorable grain flow and large inclusions in an aircraft landing-gear axle forged from AISI 4340 steel. Several fatigue crack origins were found in region A. Numerous small discontinuous marks nearly perpendicular to the direction of crack propagation were determined by metallographic examination to be related to forging flow lines and large, elongated sulfide inclusions. Woody appearance outside fatigue zones, region B, also suggests unfavorable grain flow. Light fractograph. 1.8×**

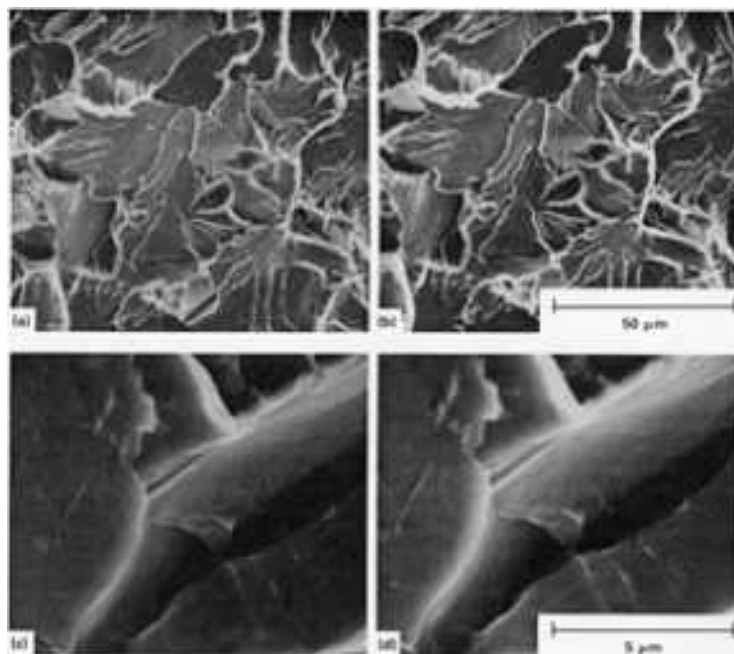
Initially, steel Charpy samples and nodular iron samples were fractured in the laboratory by single-impact overload and fatigue, respectively. Representative fracture areas were photographed in the scanning electron microscope at various magnifications in the as-fractured condition. The fracture surfaces were then coated with Tectyl 506, exposed to 100% relative humidity at 38 °C (100 °F) for 14 days, and cleaned before scanning electron microscopy (SEM) evaluation by ultrasonically removing the coating in a naphtha solution. Figure 1 shows a comparison of identical fracture areas in the steel at increasing magnifications in the as-fractured condition and after coating, exposing, and cleaning. These fractographs show that the solvent-cutback petroleum-base compound prevented chemical attack of the fracture surface from the environment and that the compound was completely removed in the appropriate solvent. It is interesting to note that Tectyl 506 is a rust-inhibiting compound that is commonly used to rustproof automobiles.

**Fig. 1 Comparison of identical fracture areas of steel Charpy specimens at increasing magnifications. (a) and (c) show the as-fractured surface; (b) and (d) show the same fracture surface after coating with Tectyl 506, exposing**

to 100% relative humidity for 14 days, and cleaning with naphtha.

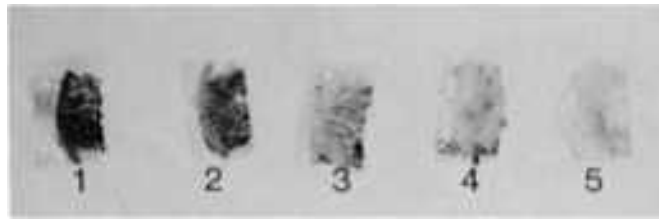
**The replica-stripping cleaning** technique is very similar to that described in the section "Preservation Techniques" in this article. However, instead of leaving the replica on the fracture surface to protect it from the environment, it is stripped off of the fracture surface, removing debris and deposits. Successive replicas are stripped until all the surface contaminants are removed. Figure 2 shows successive replicas stripped from a rusted steel fracture surface and demonstrates that the first replicas stripped from the fracture surface contain the most contaminants and that the last replicas stripped contain the least. Capturing these contaminants on the plastic replicas, relative to their position on the fracture surface, can be a distinct advantage. The replicas can be retained, and the embedded contaminants can be chemically analyzed if the nature of these deposits is deemed important.

**Fig. 2 Successive replicas (numbered 1 to 5) stripped from a rusted steel fracture surface. Note that the first replica stripped contains the most surface contaminants, while the last replica stripped is the cleanest. Actual size**

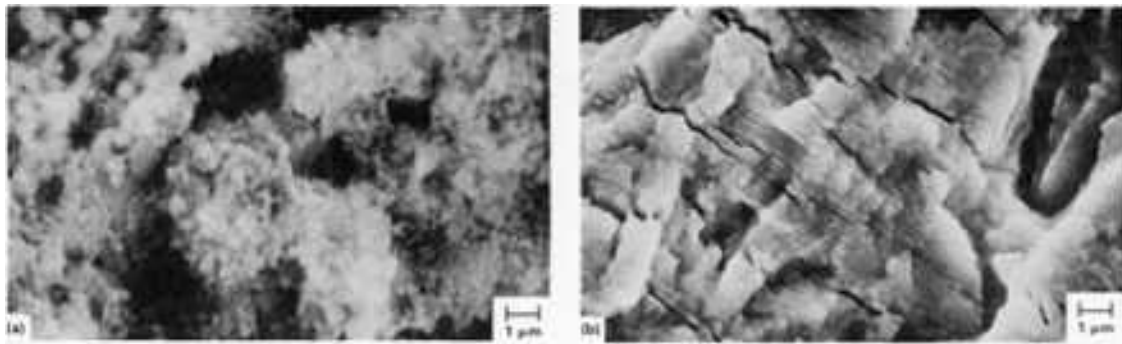
**Fig. 4 Fatigue precrack region shown in Fig. 3. (a) Before ultrasonic cleaning in a heated Alconox solution for 30 min. (b) After ultrasonic cleaning**

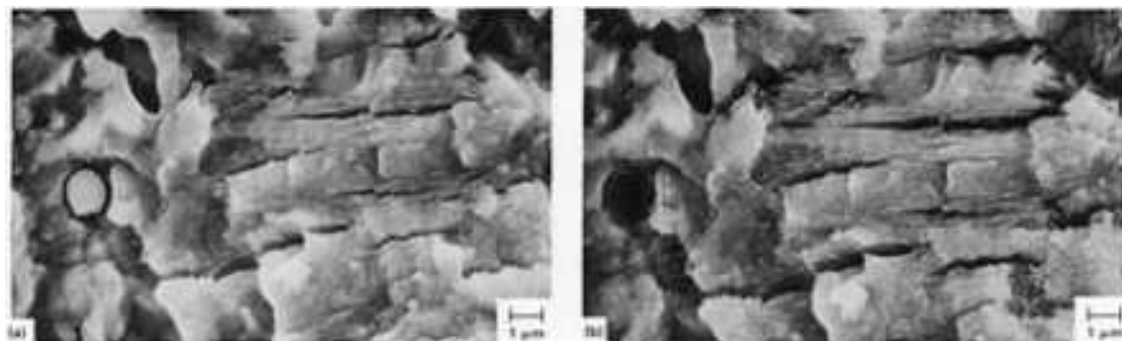
The effect of prolonged ultrasonic cleaning in the Alconox solution is demonstrated in Fig. 5(a) and 5(b), which show identical views of an area in the fatigue precrack region after cleaning for 30 min and 3.5 h, respectively. Figure 5(b) reveals that the prolonged exposure has not only chemically etched the fracture surface but has also dislodged the originally embedded inclusions. Any surface corrosion products not completely removed within the first 30 min of water-base detergent cleaning are difficult to remove by further cleaning; therefore, prolonged cleaning provides no additional benefits.

**Fig. 5 Effect of increasing the ultrasonic cleaning time in a heated Alconox solution. (a) 30 min. (b) 3.5 h. Note the dislodging of the inclusion (left side of fractograph) and chemical etching of the fracture surface.**

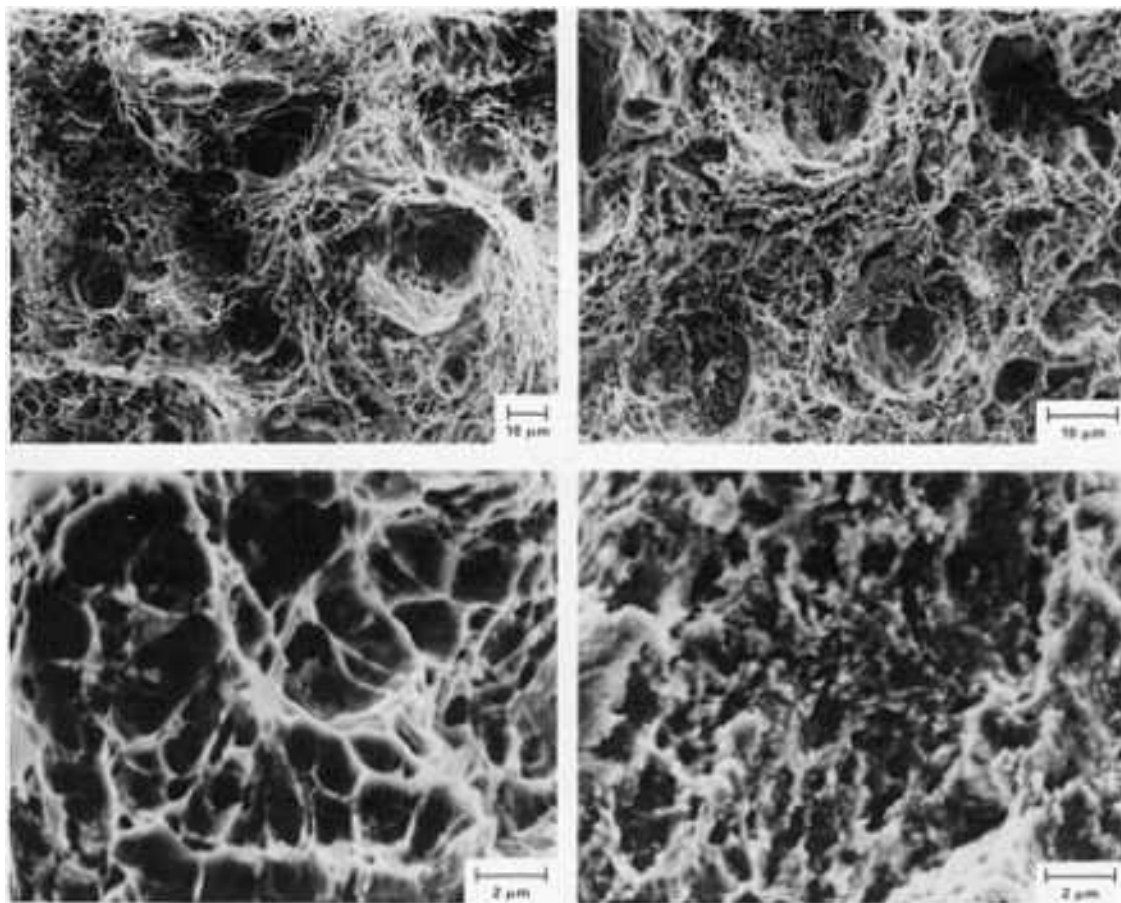
Figure 6 shows a comparison of an asfractured surface with a corroded and cathodically stable ductile cracking region in a quenched-and-tempered 1085 carbon steel. The relatively low magnification (1000 ×) shows that the dimpled topography characteristic of ductile tearing was unchanged as a result of the corrosion and cathodic cleaning. High magnification (5000 ×) shows that the perimeters of the small interconnecting dimples were corroded away.

**Fig. 6 Comparison of stable ductile crack growth areas from quenched-and-tempered 1085 carbon steel at increasing magnifications. The fractographs on the left show the as-fractured surface; those on the right show the fracture surface after corrosion exposure and cathodic cleaning.**

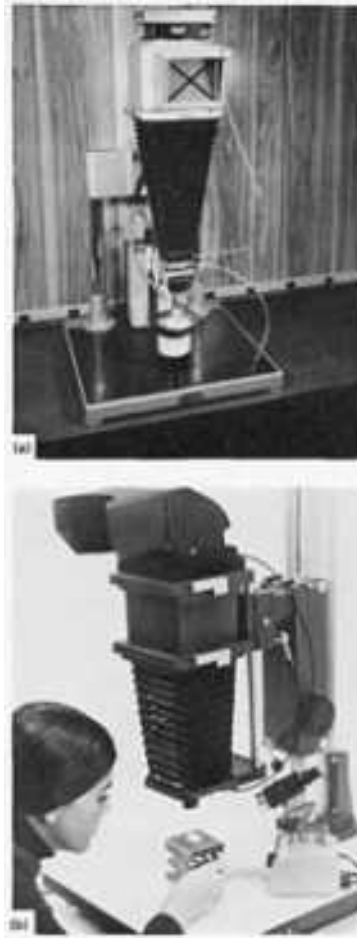
For laboratories doing frequent analyses of fractures, a camera with a 4- × 5-in. (100- × 125-mm) Polaroid back is almost a necessity, because it provides immediate availability of prints with suitable sizes for most applications. Inadequacies in illumination or exposure can be quickly detected and corrected. Specialized view camera systems for photomacrography are commonly used for fractography (Fig. 1). These cameras are mounted on very rigid stands needed for higher-magnification photomacrography. These photomacrography systems lack the tilts and swings of conventional view cameras. The tilts are generally not needed for fractography, because a viewing direction perpendicular to the fracture is normally used for fractographs. The conventional view camera can be mounted on a rigid stand for high-magnification fractography and on a tripod for oblique photography of parts. The tilts and swings can be useful in the latter application.

**Fig. 1 Specialized view camera systems for photomacrography. (a) System with a bifurcated fiber optic source. Courtesy of Nikon, Inc. (b) View camera system. Courtesy of Polaroid Corporation**

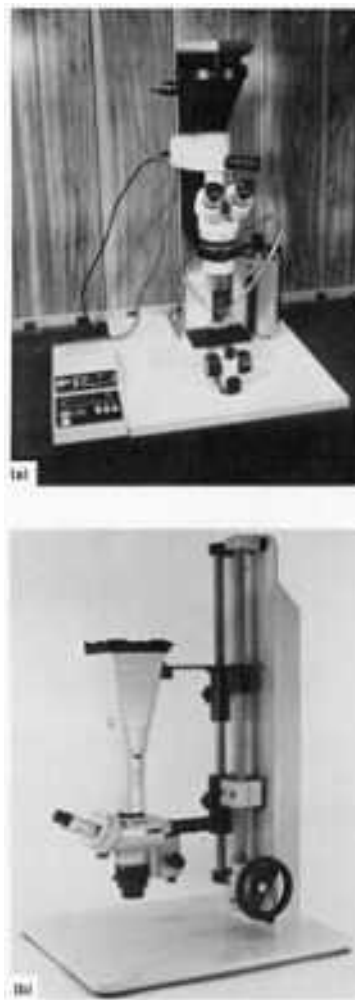
Stereomicroscopes equipped for photography are available from many microscope suppliers (Fig. 2). They are well suited for magnifications above about  $3\times$  on a 4- × 5-in. (100- × 125-mm) format. A macroscope designed especially for photomacrography is shown in Fig. 2(b). The binocular viewing in this instrument is not stereo, because it uses a single, central optical path for photomacrography over a wide magnification range-- $3.2$  to  $64\times$  in the 4- × 5-in. (100- × 125-mm) format.

**Fig. 2** Microscope systems equipped for photography. (a) Stereomicroscope equipped with an 80- × 105-mm ( $3\frac{1}{4}$  - ×  $4\frac{1}{4}$  -in.) camera back mounted on a rigid stand. Courtesy of Nikon, Inc., and Frank Fryer Company. (b) Macroscope mounted on a rigid stand. Courtesy of Wild Heerbrugg

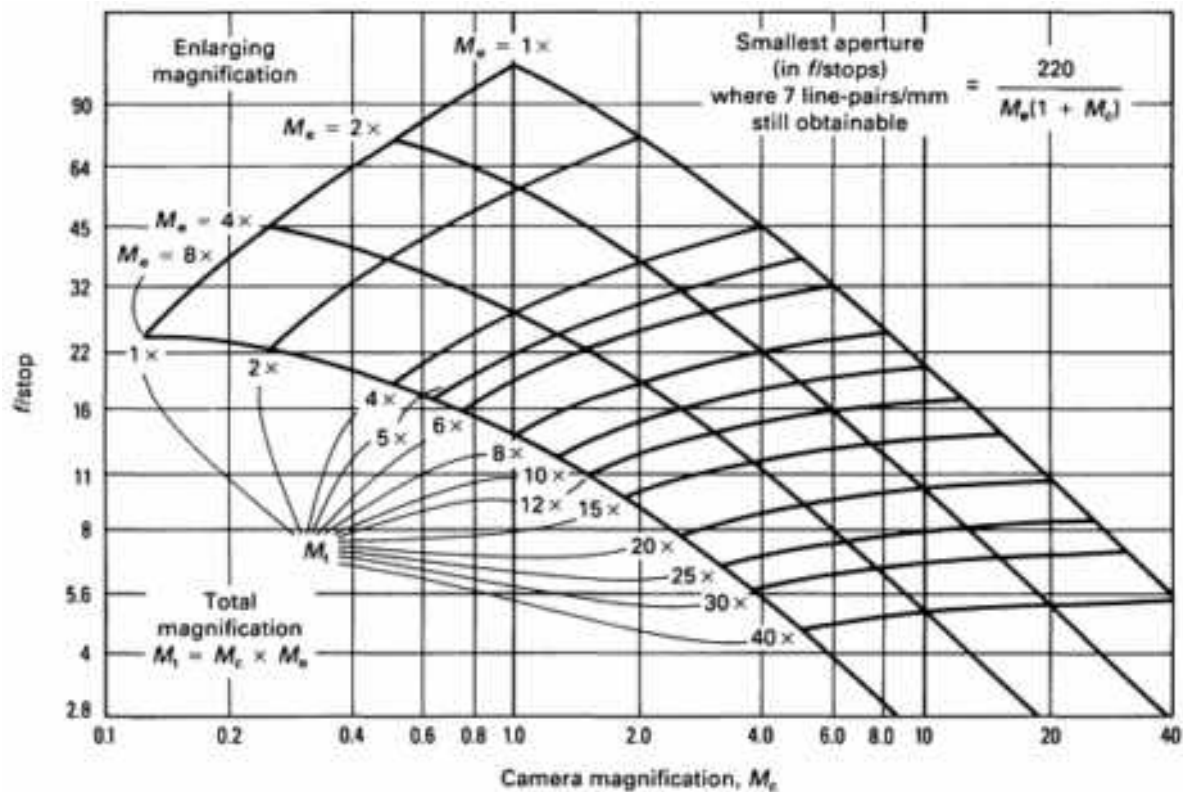
**Fig. 3 Recommended  $f$ /numbers for optimum depth of field with high resolution. See Table 1. Source: Ref 4**

The optimum-aperture concept, at higher magnification, is equivalent to 500 $\times$  numerical aperture. Equations 5, 6, and 7 are plotted in more useful form in Table 1 and Fig. 3. The region of critical interest on the fracture should lie in the object plane of focus, with the fracture oriented to make optimum use of the zone of useful magnification, which is divided evenly above and below the object plane of focus. The focusing is usually done at maximum lens aperture because of the dim viewfinder image when the lens is stopped down to the optimum aperture for recording. The high illuminating intensity of fiber optic light sources often permits focusing with the lens stopped down.

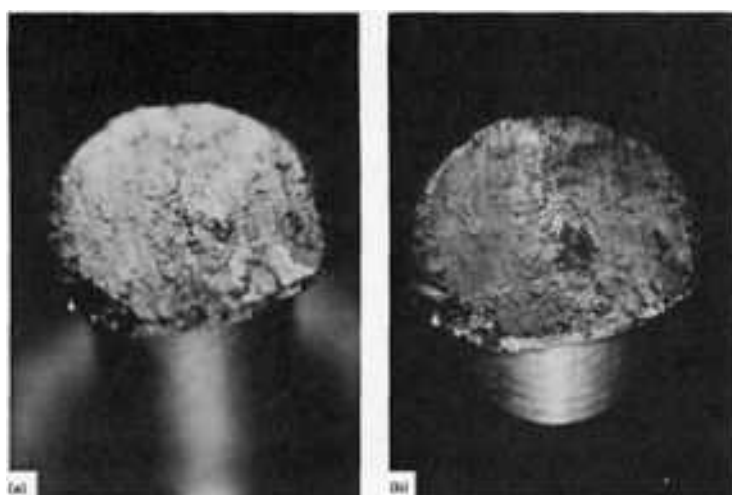
**Fig. 4 Photographs of a fractured valve stem. (a) Conventional photography. (b) Scanning light photography. Both 10×. Courtesy of Irvine Optical Corporation.**

Scanning light photomacrography was invented and patented in 1968 (Ref 6). Figure 4 compares fractographs obtained by conventional photography and scanning light photomacrography. The entire fracture surface is in sharp focus when scanning light photomacrography is used. This could not be accomplished in any other way except in a scanning electron microscope, which cannot record the colors of the object. Figure 5 shows a commercially available system that uses scanning light photomacrography.

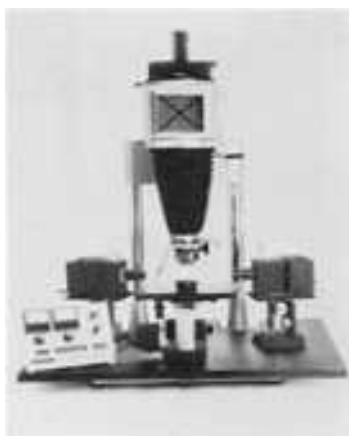
**Fig. 5 View camera with a scanning light photomacrography system. Courtesy of Irvine Optical Corporation.**

Scanning light photomacrography functions by scanning the object, at a slow and constant velocity, through a thin sheet of light that illuminates a zone on the object that is thinner than the depth of field of the recording lens. The optical axis is normal to the sheet of light formed by light sources that image a thin slit source of light on the object. The convergence and

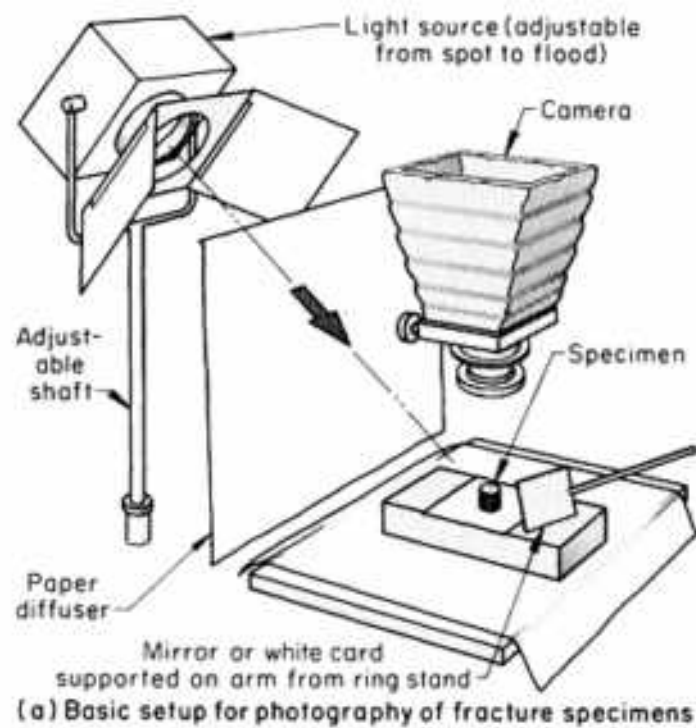
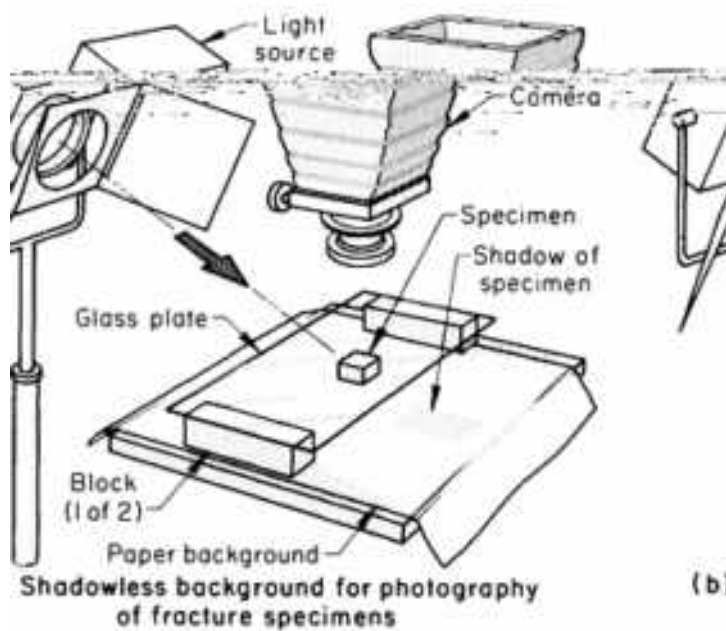
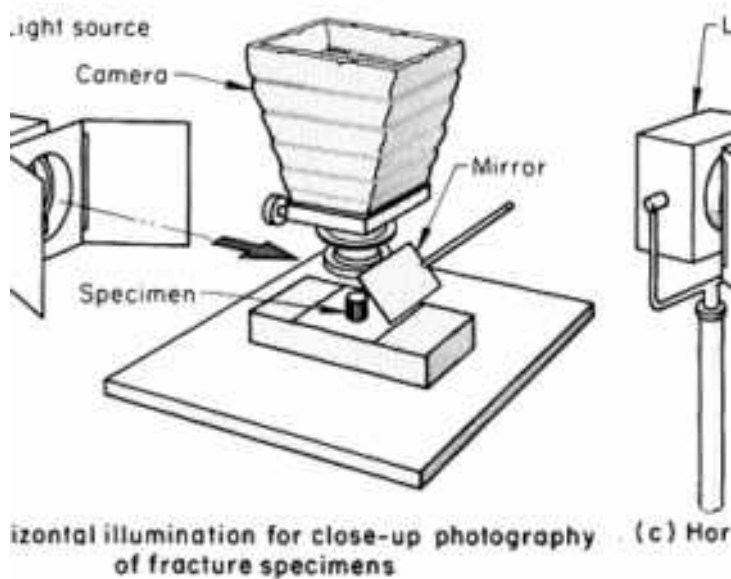
**Fig. 6 Basic setups and lighting used to photograph fracture specimens and small parts. (a) General arrangement of camera, light source with diffuser, and specimen. Size and angle of the beam of light should be adjusted to give the best display of texture. A reflecting mirror or white card can be used to fill in shadows. (b) Placing the specimen on a raised glass plate will throw the shadow beyond the view range of the camera and provide a shadowless background. (c) If the magnification desired requires the close approach of the camera to the specimen, a horizontal light beam reflected by a small mirror positioned near the camera lens will provide the proper angle of illumination.**

Basic lighting for photographing fracture surfaces and small parts is shown in Fig. 6. Three other illumination setups are shown in Fig. 7, 8, and 9. Shadowless lighting of a surface can be obtained with a white background by supporting the specimen on a piece of glass above the white background paper. For basic lighting, one spotlight is suggested. A piece of tracing paper placed between the light and the specimen will diffuse the light. The light is then raised or lowered and the beam adjusted from flood to spot to obtain the exact quality of lighting desired. Fracture texture is best illuminated when the light is placed at a relatively low angle. A spotlight beam without a diffuser or a bare bulb with a small filament will give

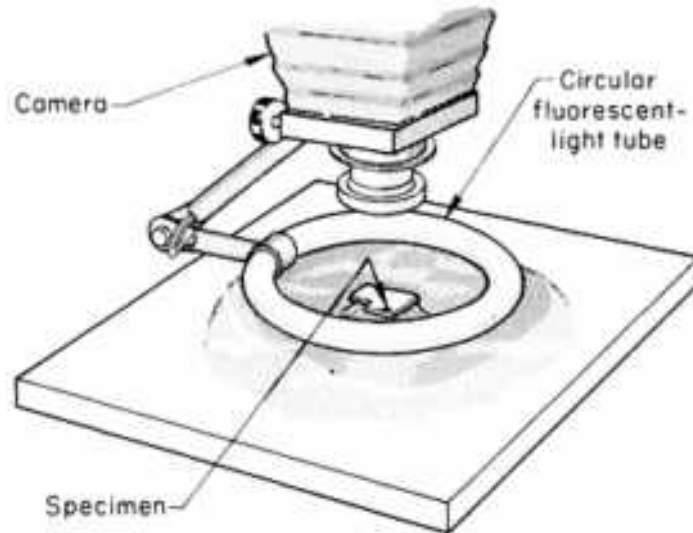
**Fig. 7 Ring illumination by a circular fluorescent-light tube. This setup provides a soft, low-contrast, uniform illumination for 360 ° and generates a minimum of heat.**

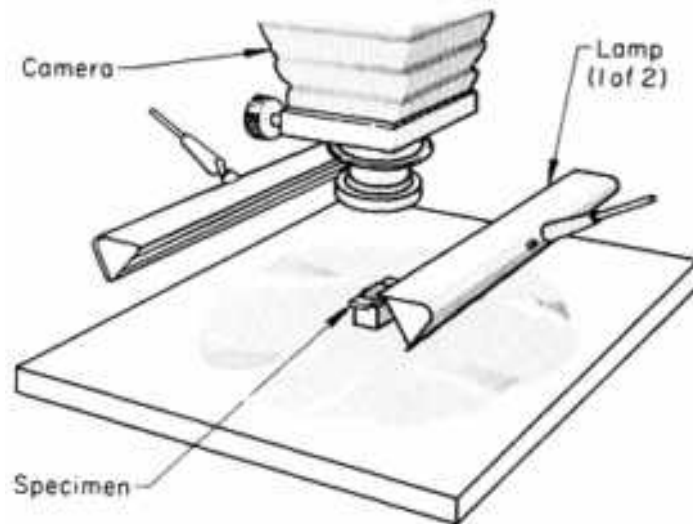
**Fig. 8 Parallel lighting. With this setup, oblique lighting comes from two directions. It may be desirable to make one fluorescent lamp the principal source and to light the shadows it casts by positioning the other lamp farther from the specimen.**

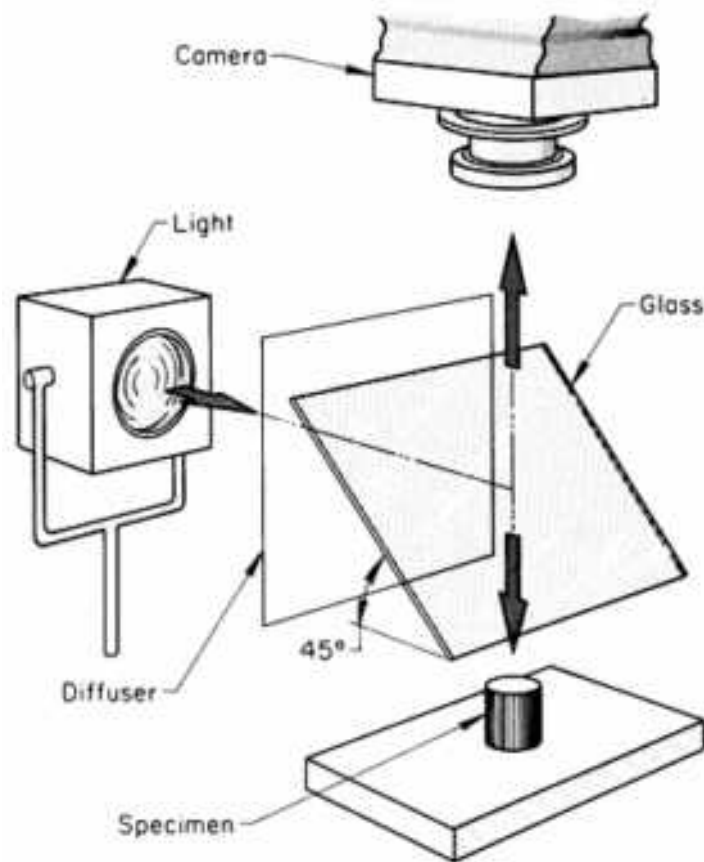
**Fig. 9 Vertical illumination.** The glass plate below the lens is set at a 45° angle. It reflects the light beam to the specimen surface. A portion of this light is reflected from the specimen back through the glass plate to the camera lens. This results in two losses of light: a portion of the incident beam passes through the plate, and a portion of the reflected light is returned toward the source. About one-quarter of the light (or even less, depending on the reflectance of the glass) reaches the lens.

Vertical illumination is achieved by placing a glass plate below the lens at a 45° angle to reflect the incident light to the specimen and the back through the glass plate to the lens (Fig. 9). The effect is to convert light from a side source to illumination in the direction of the lens. This technique is especially useful for photographing the bottoms of cavities. Room lights be dimmed to avoid extraneous reflections.

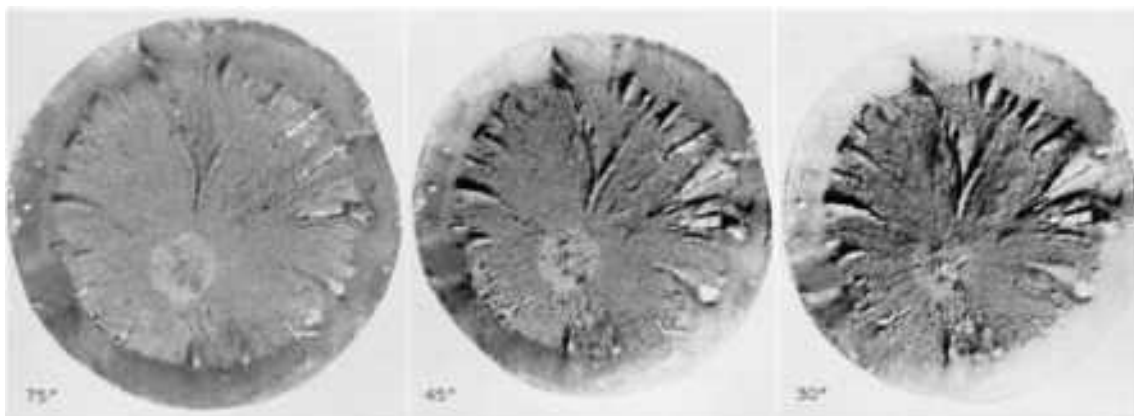
**Fig. 10 Light fractographs showing effect of angle of incident light in delineating texture of a fracture surface of an unnotched laboratory tensile-test specimen of 4340 steel. The microstructure was tempered martensite. As the angle of illumination approaches 90°, the surface becomes featureless. The precise optimum angle of obliquity depends on the nature of the markings. 7×**

high-contrast lighting. The advantages of this technique for revealing texture are illustrated in Fig. 10 for three different illumination angles. The angle of the incident light is much more important than its intensity.

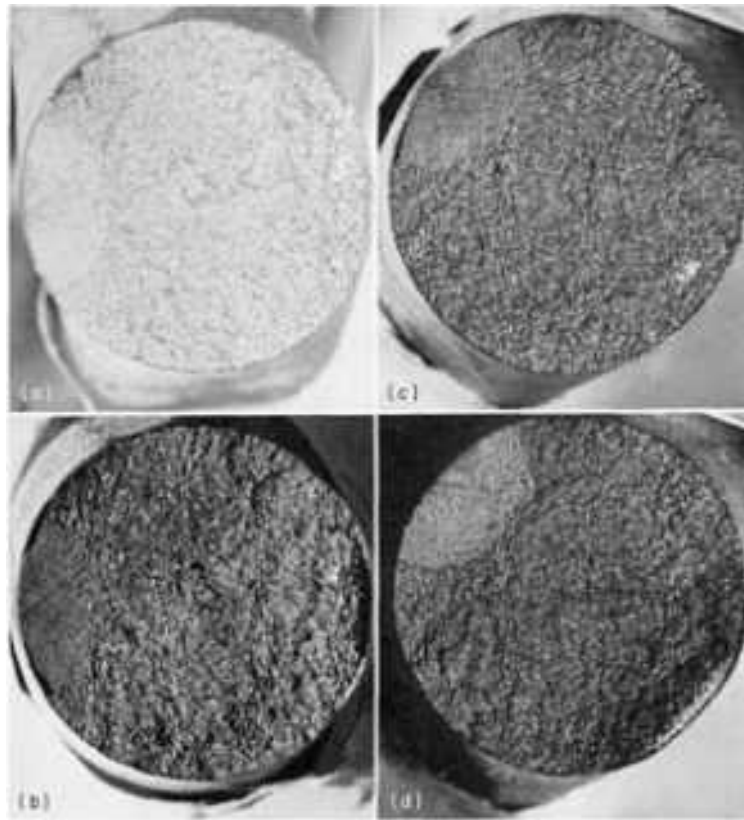
**Fig. 11 Effect of illumination technique on appearance of a fracture surface of a laboratory fatigue test specimen of 1039 steel quenched and tempered to a hardness of 42 HRC. (a) Photographed with fluorescent-tube ring illumination; note low contrast and overexposure. (b) Photographed with oblique light from a point source lamp. General fracture area exhibits more contrast than (a), but fatigue zone is not well defined. (c) Photographed with illumination from a mirror at camera lens. Quality is about the same as in (b). (d) Photographed with vertical illumination. For this particular fracture surface, vertical illumination gave the best contrast and detail of all features. Light fractographs. All 2×.**

Figure 11 gives further examples of the effect of different methods of illumination on the appearance of a fracture surface. For this particular surface, ring illumination (Fig. 11a) is poorest and vertical illumination (Fig. 11d) provides the best overall detail, primarily because of the greater reflectivity of the fatigue zone.

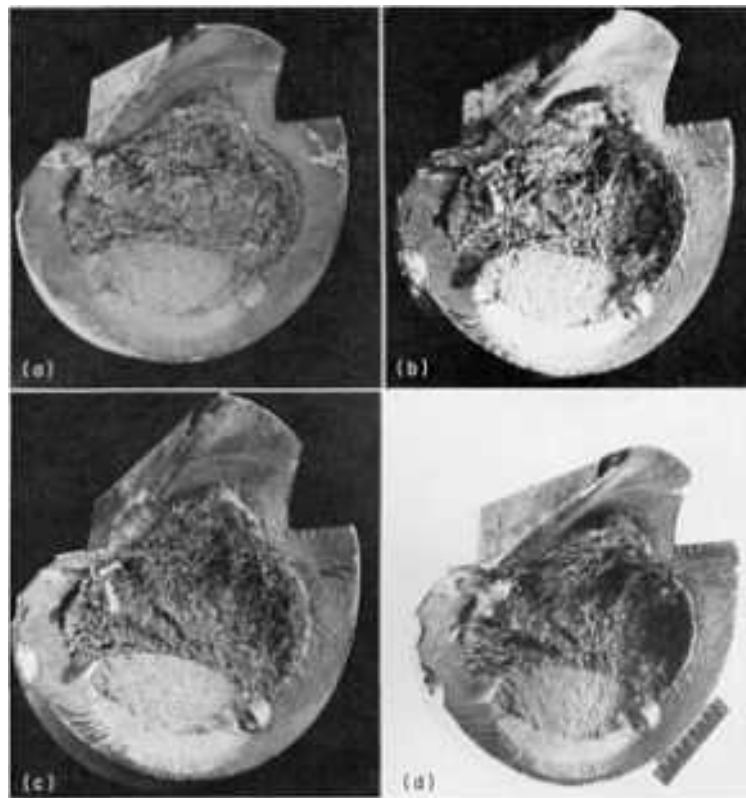
**Fig. 12** Effect of illumination technique on appearance of a surface of a fatigue fracture in induction-hardened 15B28 steel. The fatigue crack originated at the hardened zone/core interface. (a) Illumination provided by a circular flash tube around the lens, resulting in a flat appearance. (b) Oblique illumination provided by photoflood lamp, highlighting the fatigue zone strongly. (c) Parallel oblique illumination provided by fluorescent tubes, resulting in less highlighting. (d) Ring lighting: 360° oblique illumination by circular fluorescent tubes, which gives good detail except in the central shadows. Light fractographs. All 0.5×

Another comparison of illumination techniques is provided in Fig. 12, which shows the difference in fracture surface appearance produced by a circular flashtube around the lens, by oblique photoflood illumination, by parallel oblique fluorescent illumination, and by 360° oblique illumination by circular fluorescent tubes.

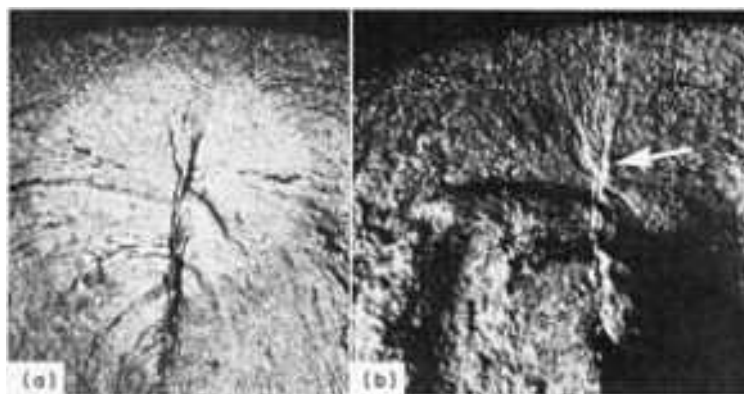
**Fig. 13** Effect of illumination technique on appearance of a fracture surface of a laboratory fatigue test specimen of carburized-and-hardened 8620 steel. (a) Floodlight plus glass plate to give vertical illumination. Fatigue zone is well defined. (b) Oblique spotlight with crossed polarization. Fatigue zone is not shown, but a large silicate inclusion (arrow) is highlighted at the crack origin. Light fractographs. Both 1.5×

Figure 13 shows a further illustration of the effects of different lighting. In Fig. 13(a), for which vertical illumination was used, the fatigue zone below the carburized case is clearly shown. In Fig. 13(b), for which oblique spotlighting with crossed polarization was used, the fatigue zone is not shown at all, but a large silicate inclusion at the fatigue crack origin is highlighted.

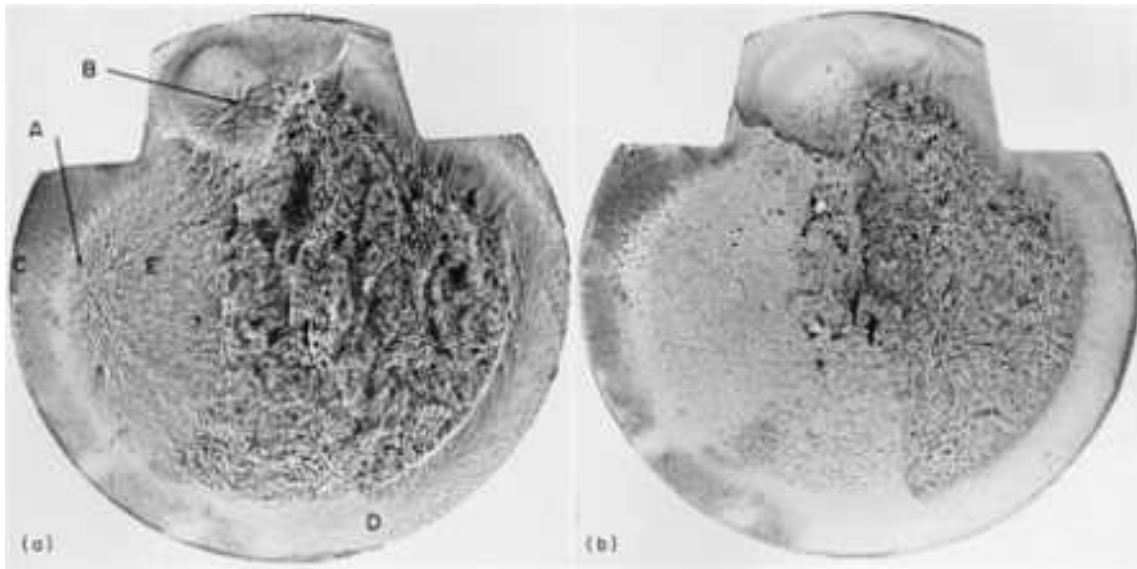
**Fig. 14 Change in fracture detail that resulted from a shift in the position of the light source. Illumination was by a circular fluorescent-light tube. The details in the surface are well revealed in (a) but are missing in (b), for which the light was moved up 25 mm (1 in.). These fractographs are of the surface of a fatigue fracture in a 1541 steel axle that was induction hardened to 50 HRC and tested in rotating bending. The better-detailed fractograph at left shows that two fatigue cracks (one at A and the other at B) originated at the interface between the hardened zone and the soft core. The crack that began at A progressed around the hardened zone by fatigue in area C and by fast fracture in area D, before meeting the crack that began at B. The fatigue crack from A also penetrated the soft core, at area E. Final fast fracture occurred in the soft core, at area F. Light fractographs. Both 1.15×**

Figure 14 shows the importance of the position of the light source. The fracture was illuminated by a circular fluorescent-light tube for both photographs. For Fig. 14(a), the incident light had proper obliquity to reveal all details of the

fracture surface. For Fig. 14(b), the light was moved up 25 mm (1 in.), which changed the degree of obliquity, with consequent loss of detail.

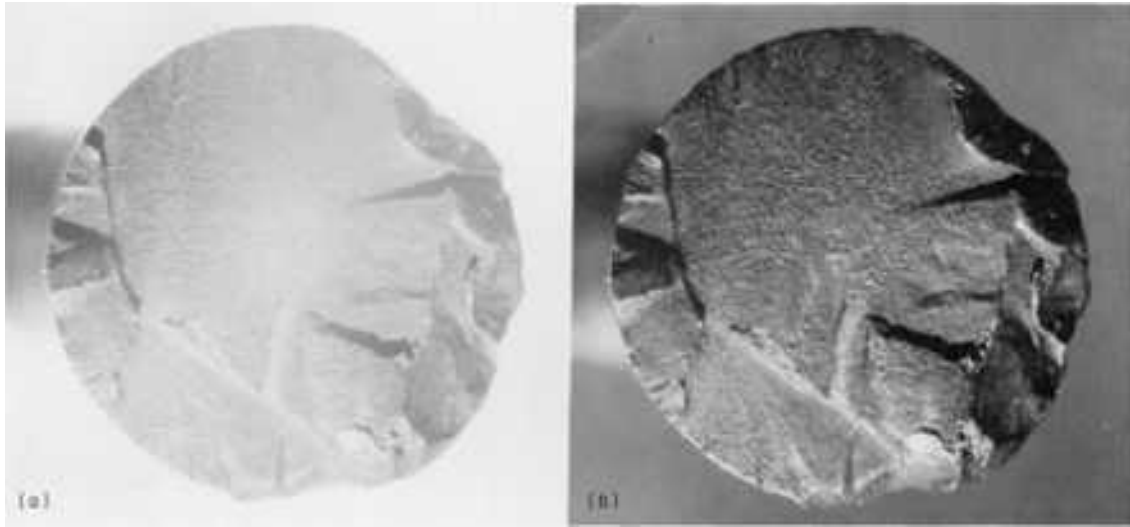
**Fig. 15** Surface of a fracture in an exhaust-valve stem of 21-4N (SAE EV 8) steel photographed with a 40-mm lens and with the specimen resting on (a) white paper and (b) black paper. In (a), lens flare and overexposure from the white background obscured some of the detail. A clear picture resulted when the specimen was placed on black paper (b), which eliminated the lens flare. Light fractographs. Both 10×

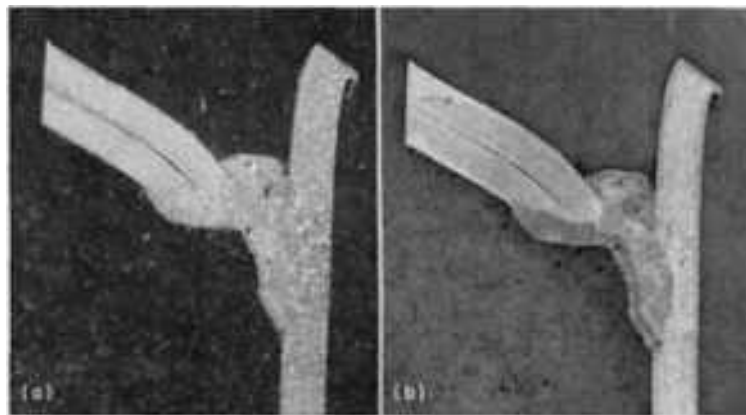
**Fig. 16** Effect of oblique and vertical lighting on structures revealed in a macroetched section through a multiple-pass weld in 1008 steel strip. (a) Oblique lighting reveals the grain structure of the steel base metal but no detail of the weld beads. (b) Vertical lighting shows the weld beads and the rim of the steel, but the grain structure is less distinct. Photomicrographs. Etched in ammonium persulfate. Both 4×

**Lighting of Etched Sections.** Etched sections are best photographed with vertical illumination, which is perpendicular at the center or hardened cases obliquely usually result in tone reversal, with dark areas appearing white and white areas appearing dark. Steel weld specimens etched in ammonium persulfate solution can sometimes be photographed with an oblique spotlight, but vertical lighting usually provides more information. The photomicrographs shown in Fig. 16 compare oblique and vertical lighting for revealing the structure of a weld; Fig. 17 shows a photograph of a properly illuminated weld.

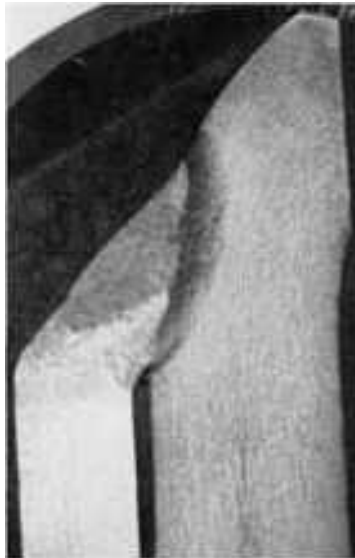
**Fig. 17** A properly illuminated section through a weld. Vertical lighting was used to reveal flow lines in the base metal, the heat-affected zone, and the successive weld beads. Base metal was 1018 steel, component, an axle housing. Photomicrograph. Etched in ammonium persulfate. 4×

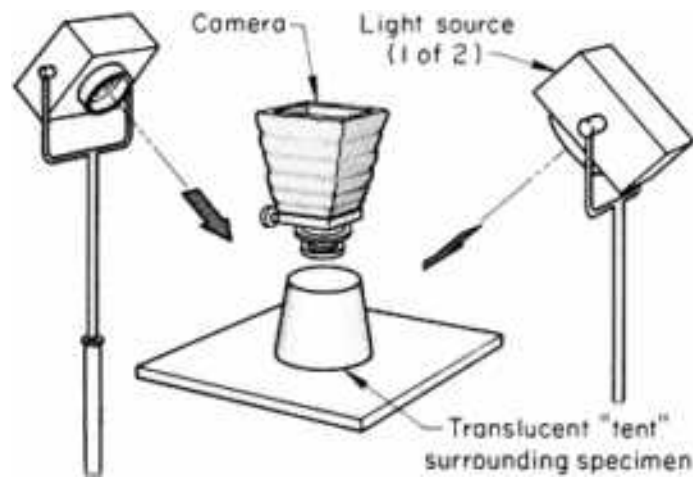
**Fig. 18** Tent lighting used in photographing highly reflective parts

**Lighting of Highly Reflective Parts.** Because of their high reflectivity, such parts as bearings, plated surfaces, and highly polished or ground objects require special lighting techniques. It is recommended that they be entirely encircled by a cone of cylinder of tracing paper to diffuse incident light (Fig. 18). This tent is translucent and can be illuminated by several lights from the sides. Because they obscure details, sprays and powders should not be used to reduce reflections.

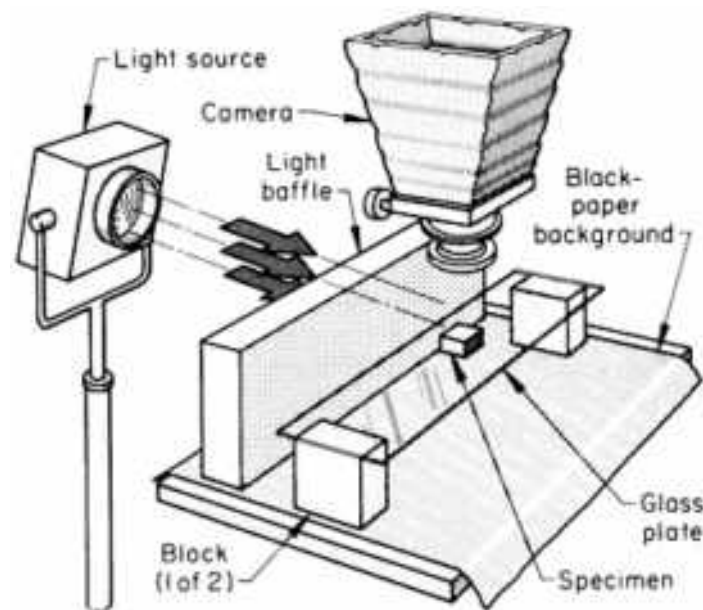
**Fig. 19** Lighting for deeply etched specimens to show grain flow and inclusions

**Lighting of Deeply Etched Specimens to Show Grain Flow.** Deeply etched specimens are photographed with a vertical setup and a single spotlight at a low angle (Fig. 19). The specimen can be supported on a glass plate over a piece of black paper to provide a black background. The light should be shielded such that it does not illuminate the background paper. The direction of incident light must be across the grain flow to show texture properly (Fig. 20). Greater contrast is obtained if all room lights are off.

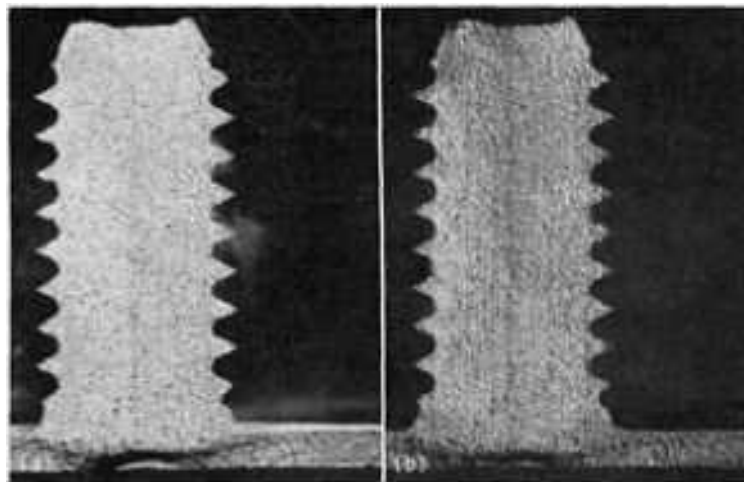
**Fig. 20** Effect of direction of lighting in revealing grain flow in a deeply etched section through a 1010 steel stud that was attached to another part by resistance welding. Direction of grain flow was vertical. (a) With illumination from the top, parallel with the grain flow, little detail is shown. (b) With illumination from the side, across the grain flow, flow lines are revealed. Photomicrographs. Etched in ammonium persulfate. Both 3.5×

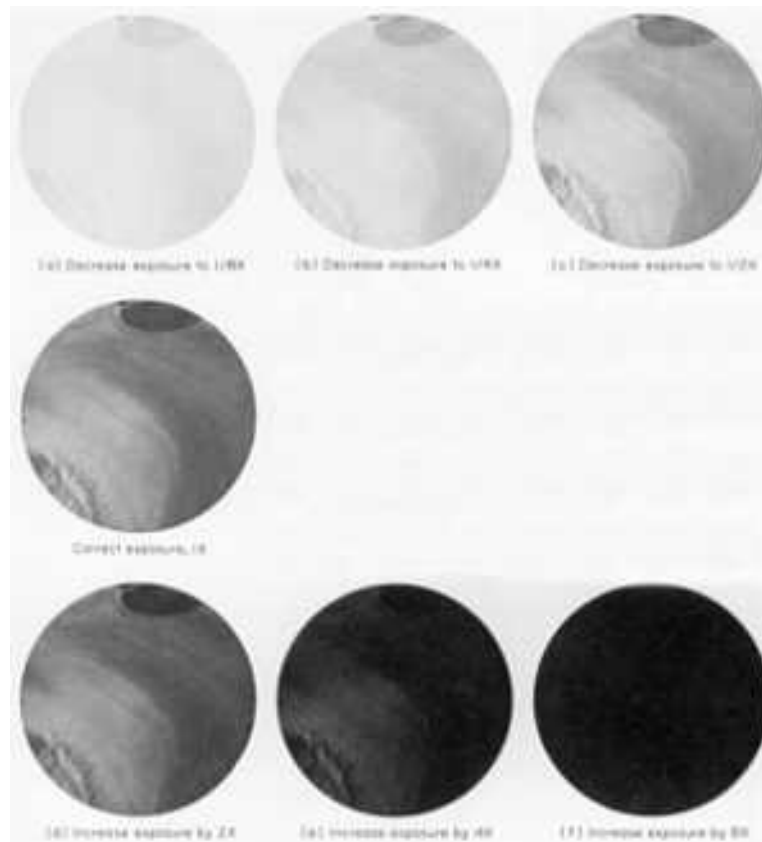
**Fig. 21 Exposure guide for Polaroid photographs of fracture surfaces.** The photograph at left was made with the correct exposure. If a trial photograph happens to resemble one of those in the top row, the film was overexposed and the next exposure should be decreased to one-eighth (a), one-fourth (b), or one-half (c) of the trial exposure. This can be done either by stopping down the lens from the *f*/stop setting for the trial exposure (three stops to decrease to  $\frac{1}{8}$  of the trial exposure, two stops for  $\frac{1}{4}$  of the trial exposure, and one for  $\frac{1}{2}$  of the trial exposure) or by reducing the exposure time to  $\frac{1}{8}$ ,  $\frac{1}{4}$ , or  $\frac{1}{2}$  of that used for the trial exposure. If a trial photograph resembles one of those in the bottom row, the film was underexposed and the next exposure should be two times (d), four times (e), or eight times (f) the trial exposure. These exposure increases can be made by appropriate adjustments of the *f*/stop or the exposure time. Exposure must be further adjusted if film of a different speed is to be used for the final photograph.

Assuming that a relatively long exposure is to be used, a step exposure should be produced by starting the exposure and then inserting the dark slide about 18 mm (0.7 in.) at intervals of 1, 2, 4, 8, 16, and 32 s with the shutter on the bulb setting. The film should then be processed and the most nearly correct exposure noted. If exposures are short, the shutter settings can be used. Exposure can be estimated from the image brightness, based on previous experience. After an exposure is made using that setting, the results can be compared with a previously prepared set of prints illustrating correct exposure, plus the results of one, two, and three *f*/stops over and under that exposure (Fig. 21). Corrections in exposure should be made and a second trial picture taken. If the film used in the test does not have the same ISO rating as the film to be used for the final picture, the exposure must be changed to account for the difference in film speeds. Alternatively, rather than change aperture or shutter settings, a neutral-density filter can be used. For example, if an ND4 filter with 400 ISO Polaroid film is used to make the test, it can be removed for exposures on 100 ISO cut film.

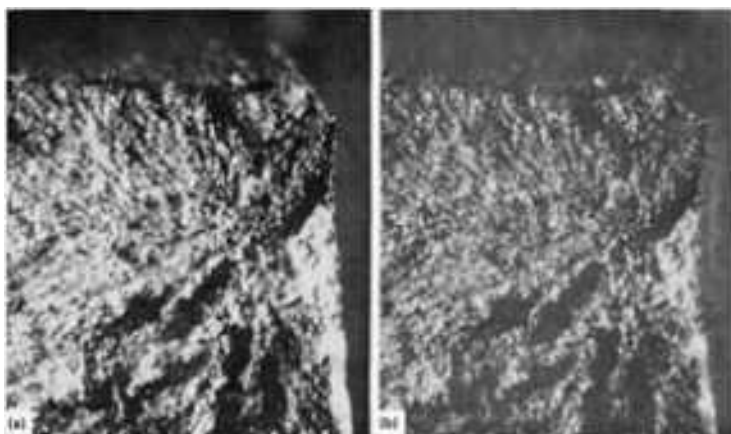
**Fig. 22 Stereo-pair photographs of a slow-bend single-overload fracture of 1085 steel austempered to an upper-bainite microstructure. Note the thin shear lips and the elevation difference of the cleavage facts. Both 13 $\times$**

Figure 2(a) shows the only stereomicroscope currently in production designed for the rapid recording of stereo pairs. Figure 22 shows light stereo-pair fractographs obtained with the instrument shown in Fig. 2(a).

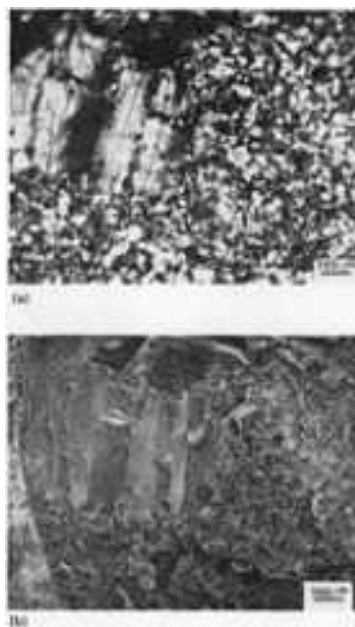
**Fig. 1 Comparison of dark-field light microscope fractograph (a) and an SEM secondary electron image (b) of the same area in an iron-chromium-aluminum alloy. Both 50×**

Figures 1 and 2 show two areas observed on the fracture of an iron-chromium-aluminum alloy. Figure 1 shows the same area using dark-field light microscopy and by SEM using secondary electrons. The dark-field image reveals several parallel steplike flat features surrounded by fine cleavage facets. The bright-field image was very poor and is not shown. The SEM image shows the same area more clearly because of the greater depth of field. The SEM negative was printed upside down so that the details are oriented in the same manner as those of the light micrograph. Figure 2 shows bright-field and dark-field light fractographs of similar steplike cleavage fractures in this iron-chromium-aluminum sample and the same

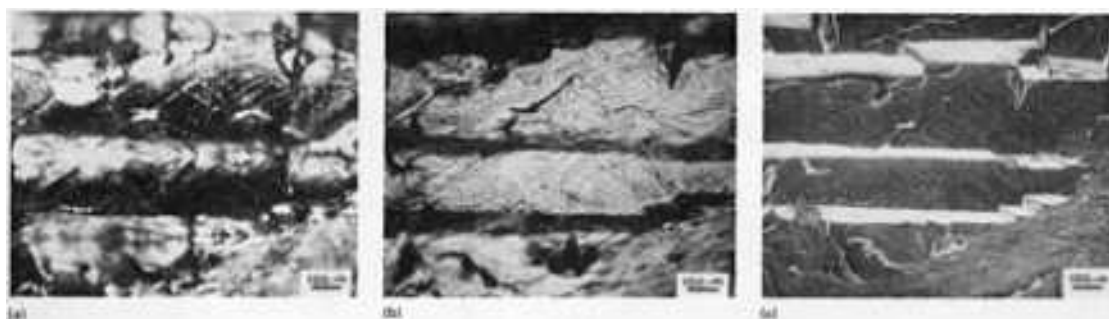
**Fig. 2 Comparison of light microscope and SEM fractographs of the same area of an iron-chromium-aluminum alloy. (a) Bright-field light fractograph. (b) Dark-field light fractograph. (c) SEM secondary electron image. All 50×**

area using secondary electron imaging. It is apparent that the dark-field image is superior to the bright-field image, but neither reveals the stepped nature as well as the SEM image, although the observer could see this effect by focusing in and out.

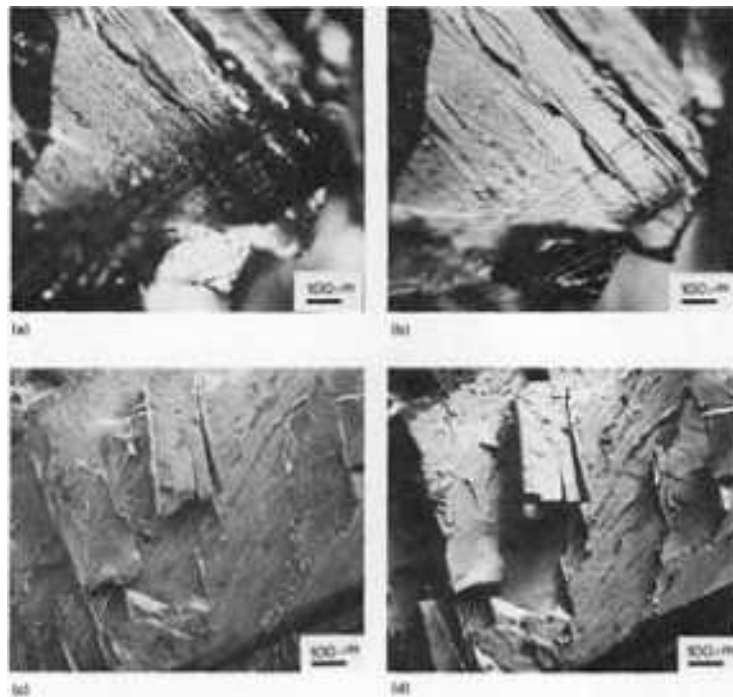
**Fig. 3 Comparison of light microscope (a and b) and SEM (c and d) fractographs of cleavage of faces in a coarse-grain Fe-2.5Si alloy broken at -195 °C (-320 °F). (a) Bright-field illumination. (b) Dark-field illumination. (c) Secondary electron image. (d) Everhart-Thornley backscattered electron image. All 60×**

Figures 3, 4, and 5 show coarse cleavage facets to a fractured Fe-2.5Si sample that was broken after cooling in liquid nitrogen. The SEM views are not of the same areas as the light fractographs. Figure 3 shows bright-field and dark-field images of a coarse facet. Certain areas are best observed on one or other image because of the different light collection procedures. The two SEM views show a different area observed using secondary electrons and by backscattered electrons with the Everhart-Thornley detector. The latter procedure, because of its sensitivity to the specimen-detector orientation, provides greater height contrast compared to secondary electron images. Features that are not in a direct line with the detector are dark or are in shadow. Comparison of the secondary electron and Everhart-Thornley backscattered electron images shows that the latter often reveals detail that is not as obvious in the secondary electron image. The secondary electron image is fully illuminated. Therefore, again, a combined presentation of both images reveals additional information.
