ASM HANDBOOK®

VOLUME  
12

Fractography

*Fractography*, was published in 1987 as Volume 12 of the *ASM Handbook*. The Volume was prepared under the direction of the ASM Handbook Committee.

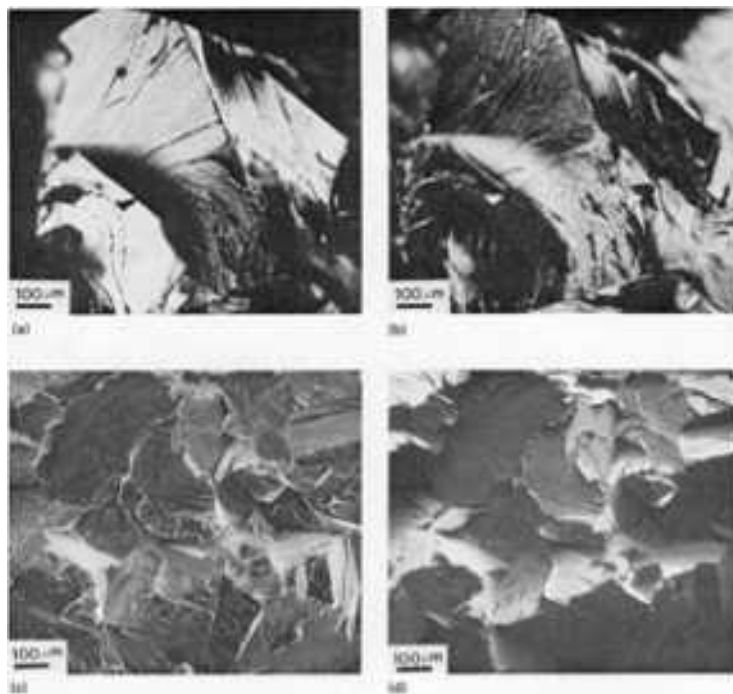
**Fig. 4 Comparison of light microscope (a and b) and SEM (c and d) fractographs of cleavage facets in a coarse-grain Fe-2.5Si alloy impact specimen broken at -195 °C (-320 °F). (a) Bright-field illumination. (b) Dark-field illumination. (c) Secondary electron image. (d) Everhart-Thornley backscattered electron image. All 60×**

Figure 4 shows similar bright-field and dark-field light fractographs of cleavage facets in the Fe-2.5Si alloy as well as secondary electron and Everhart-Thornley backscattered electron images of another area. The images shown in Fig. 4 are similar to those shown in Fig. 3. Figure 5 shows higher-magnification bright-field light fractographs of coarse cleavage facets in the Fe-2.5Si specimen and SEM secondary electron images at the same magnification. All four fractographs are of different areas.

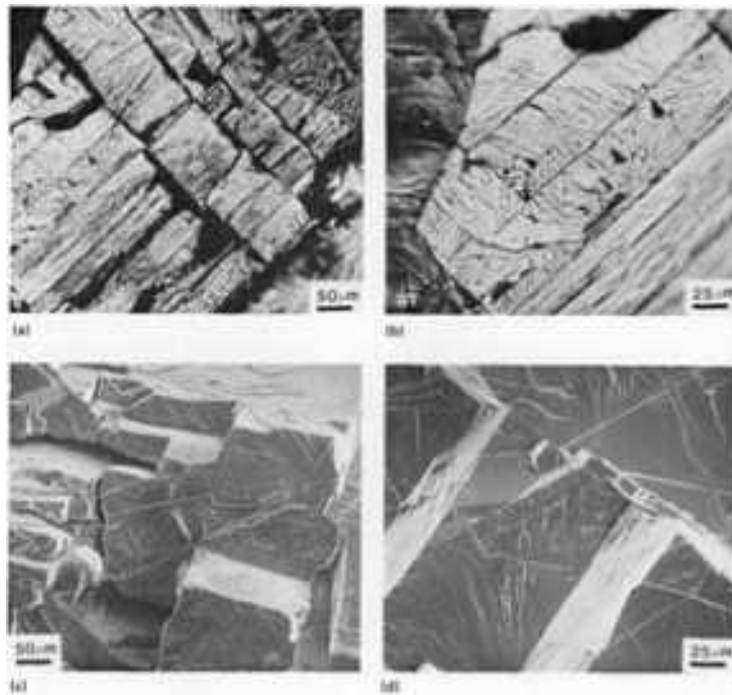
**Fig. 5 Comparison of light microscope (a and b) and SEM (c and d) fractographs of cleavage facets in a coarse-grain Fe-2.5Si alloy impact specimen broken at -195 °C (-320 °F). (a) Bright-field illumination. (b) Dark-filled illumination. (c) Secondary electron image. (d) Secondary electron image. (a) and (c) 120×. (b) and (d) 240×**

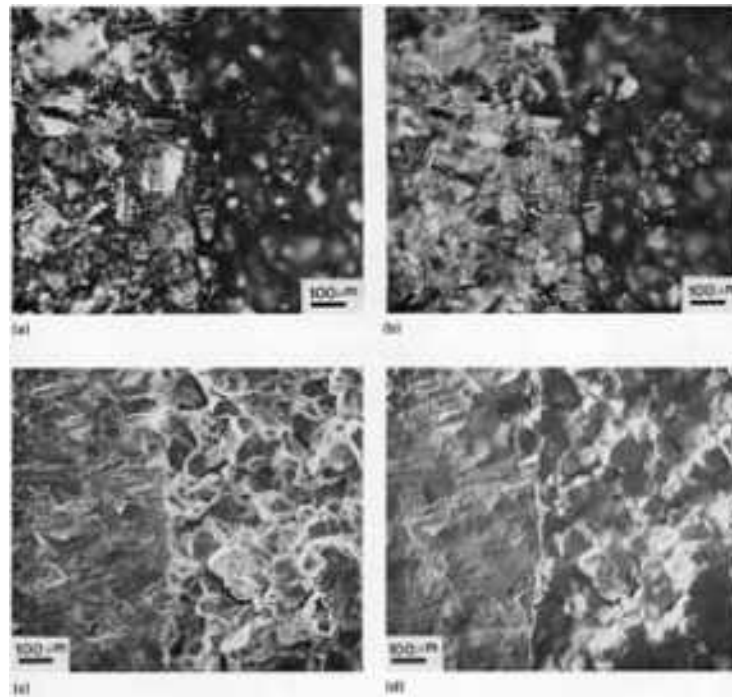
**Fig. 6 Comparison of light microscope (a and b) and SEM (c and d) fractographs of the interface between the fatigue-precracked region and the test fracture in an X-750 nickel-base superalloy rising-load test specimen. The test was performed in pure water at 95 °C (200 °F). Note the intergranular nature of the fracture. (a) Bright-field illumination. (b) Dark-field illumination. (c) Secondary electron image. (d) Everhart-Thornley backscattered electron image. All 60×**

Figure 6 shows the interface between the fatigue precrack and test fracture of an X-750 nickel-base superalloy subsize Charpy rising-load test specimen after testing in pure water at 95 °C (200 °F). The interface region is shown by bright-field and dark-field light microscopy (same areas) and by secondary electron and Everhart-Thornley backscattered electron images (different location, same areas). At the magnification used, evidence of fatigue striations in the precracked region is barely visible in the light microscope images compared to the SEM images. The test fracture region is intergranular, but this is not obvious in the light fractographs, Figure 7 shows bright-field and dark-field fractographs of the fatigue-precracked region, in which the striation are more easily observed than in Fig. 6. Figure 8 shows secondary electron SEM fractographs of the striations in the precrack region at the same magnifications as in Fig. 7. Figure 9 shows bright-field and dark-field light fractographs of the intergranular region. The intergranular nature of this zone is more obvious in Fig. 9 than in Fig. 6. Figure 9 also shows corresponding secondary electron and Everhart-Thornley backscattered electron fractographs of the intergranular test fracture.

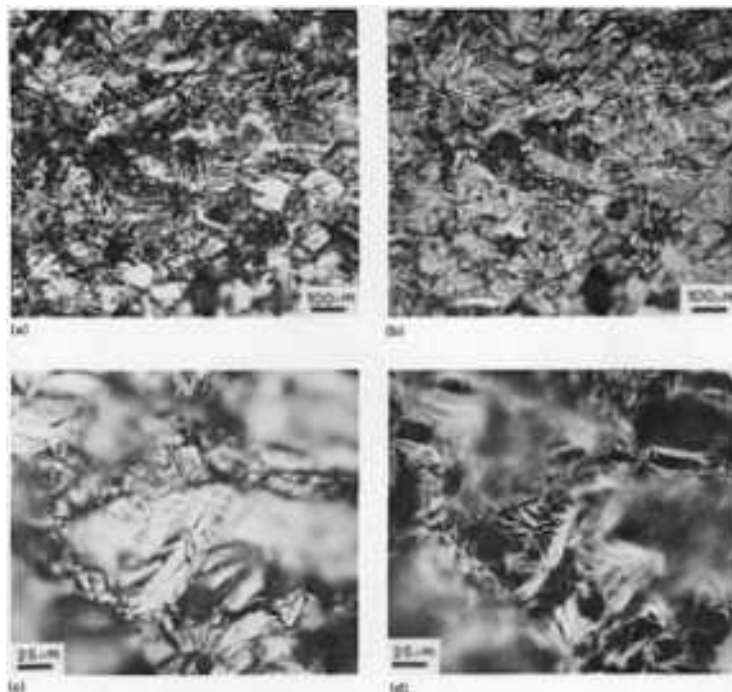
**Fig. 7 Light microscope fractographs of the fatigue-precracked region of an alloy X-750 rising load test specimen. (a) Bright-field image. (b) Dark-field image. (c) Bright-field image. (d) Dark-field image. (a) and (b) 60×. (c) and (d) 240×.**

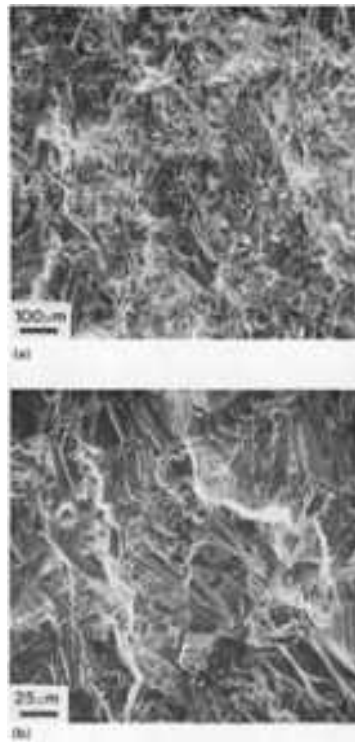
**Fig. 8 Secondary electron images of the fatigue-precracked region of an alloy X-750 test specimen. (a) 65 $\times$ . (b) 260 $\times$**

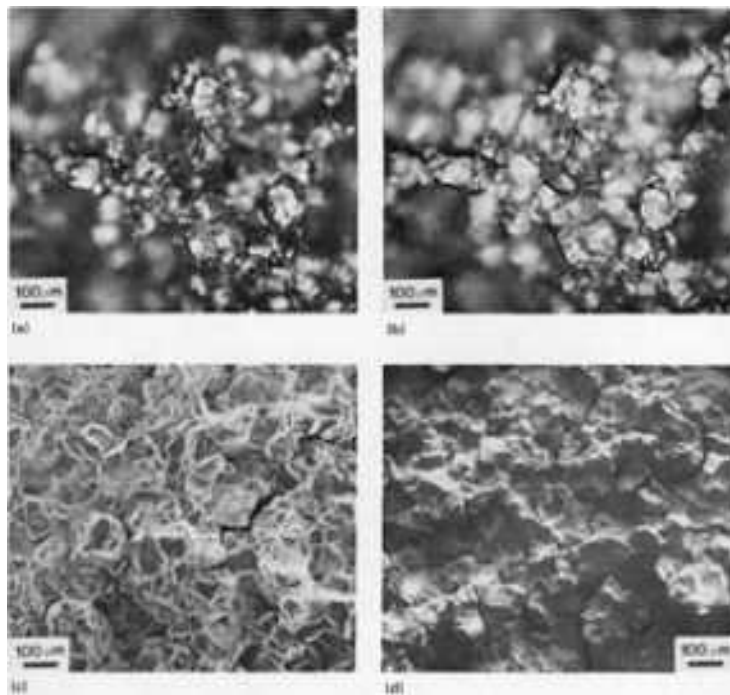
**Fig. 9 Comparison of light microscope (a and b) and SEM (c and d) fractographs of the test fracture in an alloy X-750 rising-load test specimen. Test was performed in pure water at 95 °C (200 °F). Note the intergranular appearance of the fracture. (a) Bright-field image. (b) Dark-field image. (c) Secondary electron image. (d) Everhart-Thornley backscattered electron image. All 60  $\times$**

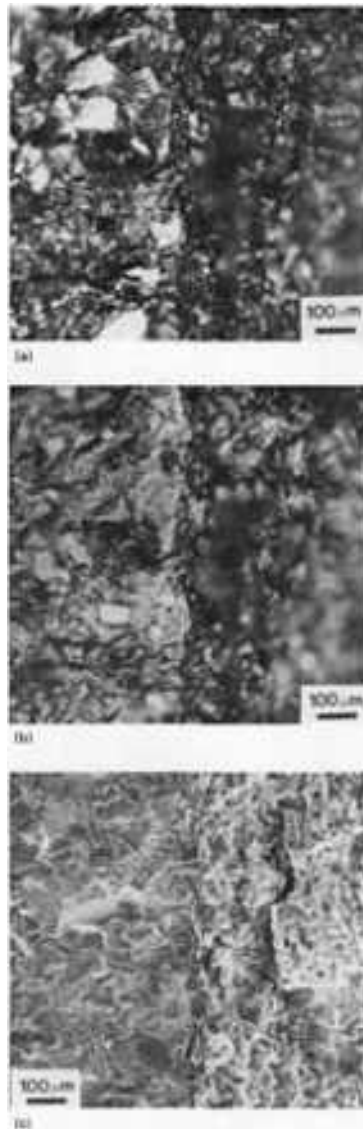
**Fig. 10 Comparison of light microscope (a and b) and SEM (c) images of the interface between the fatigue-precrack area (left) and the test fracture region (right) of an alloy X-750 rising-load test specimen broken in air. The test fracture is ductile. (a) Bright-field image. (b) Dark-field image. (c) Secondary electron image. All 68×**

For comparison, Fig. 10 shows a similar X-750 rising-load specimen tested in air in which the test fracture is ductile. Figure 10 shows bright-field and dark-field light fractographs of the interface between the fatigue precrack and the ductile fracture.

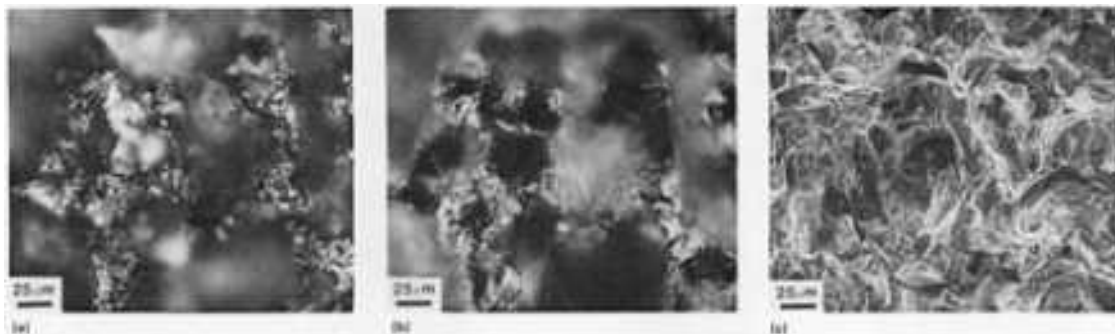
**Fig. 11 Comparison of light microscope (a and b) and SEM (c) images of a ductile fracture in an alloy X-750**

**rising-load test specimen broken in air. (a) Bright-field image. (b) Dark-field image. (c) Secondary electron image. All 240×**

A secondary electron fractograph is also included for comparison. Figure 11 shows high-magnification bright-field and dark-field light fractographs and a secondary electron fractograph of the ductile region of the test fracture at the same magnification. Microvoid coalescence (dimples) can be observed in all the fractographs, but the limited depth of field of the light fractographs is obvious.

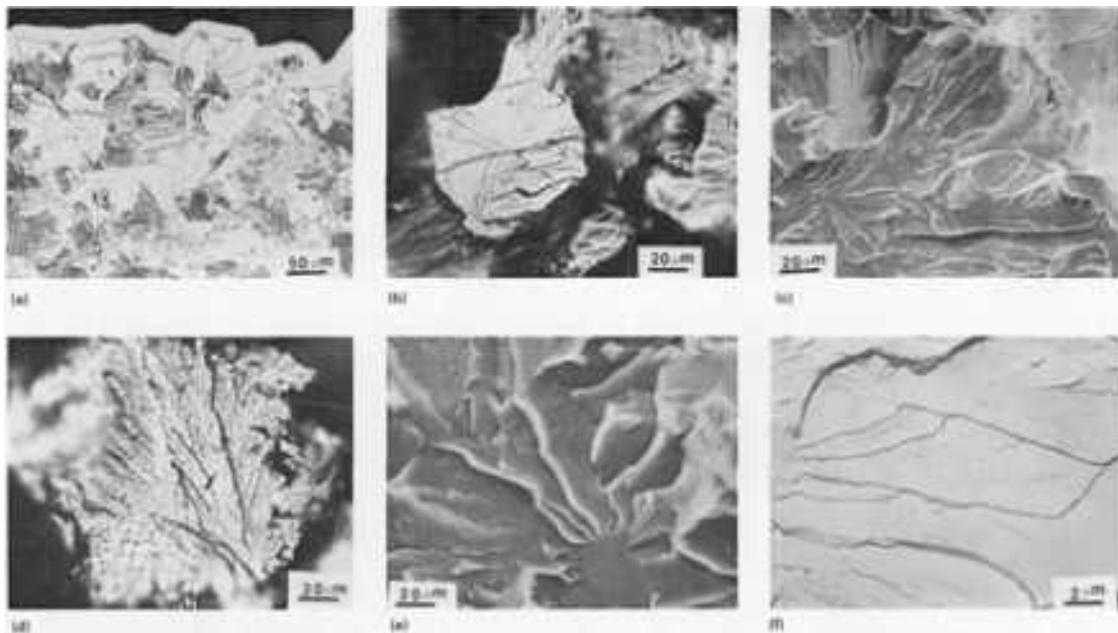
**Fig. 12 Examples of three direct (a to c) and three replication procedures (d to f) for examination of a cleavage fracture in a low-carbon martensitic steel. (a) Light microscope cross section with nickel plating at top. (b) Direct light fractograph. (c) Direct SEM fractograph. (d) Light fractograph of replica. (e) SEM fractograph of replica. (f) TEM fractograph of replica**

As a further note on the use of the light microscope to examine fractures, Fig. 12 shows a cleavage fracture in a low-carbon martensitic steel examined by using three direct and three replica procedures. Figure 12(a) shows an example of the examination of the fracture profile after nickel plating the surface. The flat, angular nature of the fracture surface is apparent. Figures 12(b) and 12(d) show a light microscope direct view the cleavage surface and a light microscope view of a replica. Figures 12(c) and 12(e) shows a direct SEM view of the fracture and a view of a replica of the fracture by SEM, respectively. Lastly, Fig. 12(f) shows a TEM replica of the fracture, but at a much higher magnification. The transmission electron microscope cannot be used at magnifications below about 2500×

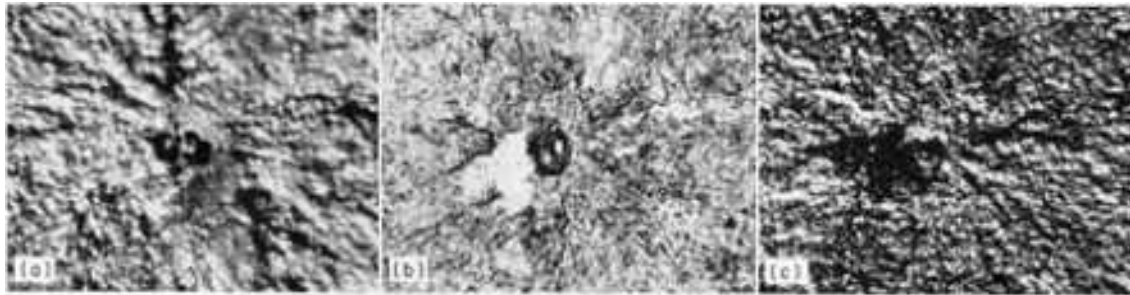
**Fig. 14 Comparison of replica fractographs of a fatigue fracture in an induction-hardened 15B28 steel shaft. Fracture was initiated at the large inclusion in the center of the views during rotating bending. (a) Oblique illumination from a point source lamp. (b) Same area as (a), photographed using transmitted light. (c) Replica shadowed with a vapor-deposited coating and photographed using oblique illumination from a point source lamp. All 30×**

Additional contrast can be obtained by shadowing the replica with either carbon or a heavy metal, such as chromium, molybdenum, gold, or gold-palladium, as is normally done in TEM fractography. Some fractographers also coat the back side of the replica with a reflective metal, such as aluminum, for reflected-light examination, or they tape the replica to a mirror surface. With an inverted microscope, some fractographers place the replica over the stage plate and then place a polished, unetched specimen against the tape to hold it flat and to reflect the light. Others prefer to examine the tape with transmitted light, but not all metallographers have access to a microscope with transmitted-light capability. Figure 14 illustrates low-power examination procedures for examination of replicas by light microscopy. Figure 14(a) shows the replica photographed with oblique illumination from a point source lamp, and Fig. 14(b) shows the same area using transmitted light. Carbon was then vapor deposited onto the replica, and it was photographed again using oblique light from a point source (Fig. 14c). Figure 14(c) exhibits the best overall contrast and sharpest detail. Figure 12(d) illustrates examination of a fracture replica by light microscopy using high magnification. This replica was shadowed with gold-palladium.

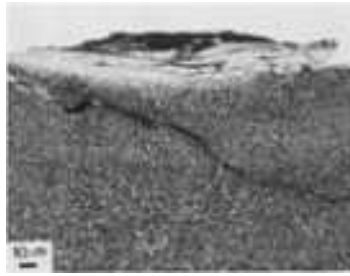
**Fig. 15 Example of the use of electroless nickel plating to provide edge retention. The micrograph shows wear damage at the surface of a forged alloy steel Medart roll. Etched with 2% nital. 285×**

The safest procedure is to cut the sample to one side of the origin, but only after all prior nondestructive examinations have been completed. Cutting must be done in such a manner that damage is not produced. A water-cooled abrasive cutoff machine or a low-speed diamond saw is typically used. For optimum edge retention, it is recommended that the surface be plated, generally with electroless nickel, although some metals cannot be plated in this manner (Ref 9) and require other plating procedures. Figure 15 demonstrates the excellent edge retention that can be obtained with electroless nickel. A number of other edge retention procedures can also be used (Ref 9).

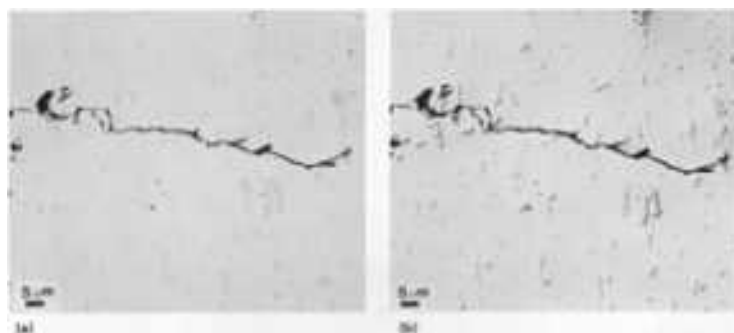
**Fig. 16 Comparison of bright-field (a) and Nomarski DIC (b) illumination for examination of a fatigue crack in an as-polished aluminum alloy. See also Fig. 71. Both 600×**

As-polished samples should be examined first with bright-field illumination and then with dark-filled illumination, differential interference contrast (DIC) or oblique light, and polarized light, if the specimen will respond to such illumination. Dark-field illumination is very useful and is highly suited to the examination of cracks and voids. Photography in dark field is more difficult, but not impossible if an automatic exposure device is available. Oblique light and DIC are very useful for revealing topographic (relief) effects. For example, Fig. 16 shows a fatigue crack in an aluminum alloy viewed with bright-field illumination and DIC where the specimen was not etched. Although the second-phase precipitates can be seen in both views, they are more clearly revealed with DIC (compare these views with the bright-field etched micrograph of this specimen shown in Fig. 71).

Figure 71(a) shows the same fatigue crack in an aluminum alloy as shown in Fig. 16, but after etching. The roughness of the crack pattern and the interaction with the intermetallic particles are evident. Figure 71(b) shows a similar fatigue crack in the same aluminum alloy after etching; but in this case, the specimen was completely broken, and only one side of the fracture can be observed. Comparison of Fig. 71(a) and 71(b) clearly shows that the nature of the crack pattern is much easier to observe in a partially broken specimen where both sides of the fracture can be observed. Figure 72 shows a fatigue crack in a ferrite-pearlite carbon steel after etching in which both sides of the crack can be observed. The irregular path of the crack through the ferrite phase is evident in Fig. 72 as compared to the nature of cleavage cracks in ferrite shown in Fig. 47.

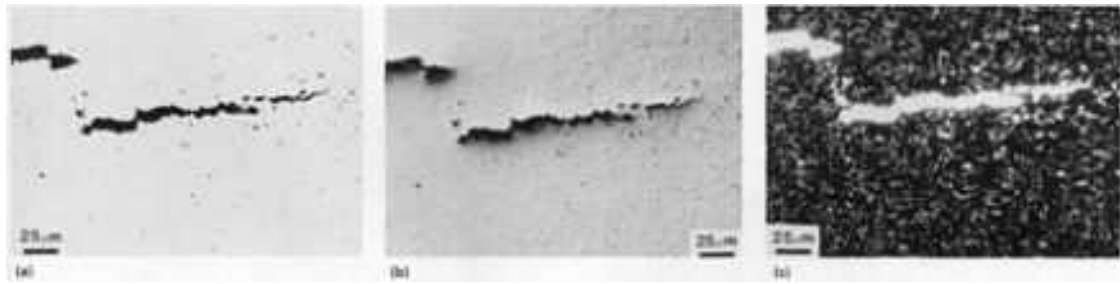
**Fig. 17 Comparison of bright-field (a), DIC (b), and dark-field (c), illumination for viewing a partially fractured (by impact) specimen of AISI type 312 weld metal containing substantial  $\sigma$  phase. All 240 $\times$**

Another example of the examination of fracture profiles is shown in Fig. 17, which illustrates an impact fracture in an austenitic weld containing  $\sigma$  phase. This sample is in the as-polished condition and is shown examined with bright-field, DIC, and dark-field illumination. It is clear that full use of the light microscope can provide a better description of the relationship of the crack path to the microstructure.

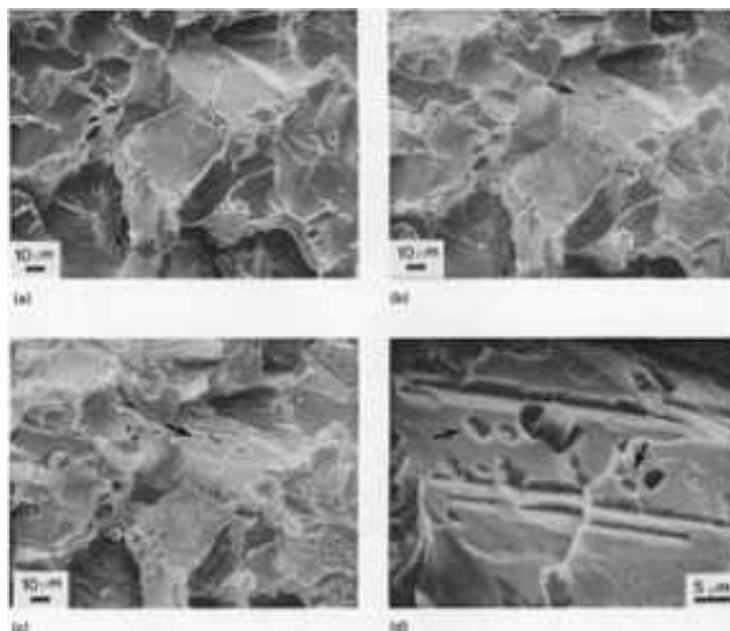
**Fig. 18 Example of the use of etching to produce etch pits (arrows) on a cleavage fracture. (a) As-fractured. 320 $\times$ . (b) Etched 60 s with nital. 320 $\times$ . (c) Etched 360 s with nital. 320  $\times$ . (d) Etched 360 s with nital. 1280 $\times$**

Zapffe (Ref 2) and others (Ref 32, 33, 34, 35, 36, 37) have etched fracture surfaces in order to gain additional information. In general, etching is used to reveal the microstructure associated with the fracture surface (Ref 2, 36) or to produce etch pit attack to reveal the dislocation density and the crystallographic orientation of the fracture surfaces. Figure 18 shows an example of fracture surface etching of a cleavage fracture in a carbon steel sample. Although the etched fractures can be examined by light microscopy, SEM is simpler and produces better results.

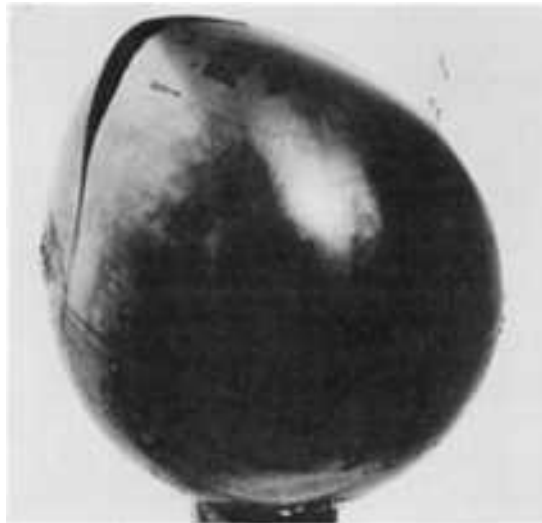
**Fig. 19 Macrograph showing ductile overload fracture of a high-pressure steel vessel tested at room temperature. See also Fig. 20.**

The macroscopic appearance of a ductile fracture is shown by the controlled laboratory fracture of a spherical steel pressure vessel measuring 187 mm ( $7\frac{3}{8}$  in.) outside diameter and 3.2 mm ( $\frac{1}{8}$  in.) in wall thickness that was made from quenched-and-tempered AISI 1030 aluminum-killed fine-grain steel with an impact transition temperature below -45 °C (-50 °F). At room temperature, ductile rupture occurred when the vessel was pressurized to 59 MPa (8500 psig) (Fig. 19). Figure 20 shows an identical vessel pressurized to failure at -45 °C (-50 °F) at 62 MPa (9000 psig). Greater pressure was required because the strength of the steel was greater at -45 °C (-50 °F) than at room temperature. Both failures are ductile. This vessel was designed to contain gas at 31 MPa (4475 psig). Therefore, the failures occurred by overloading.

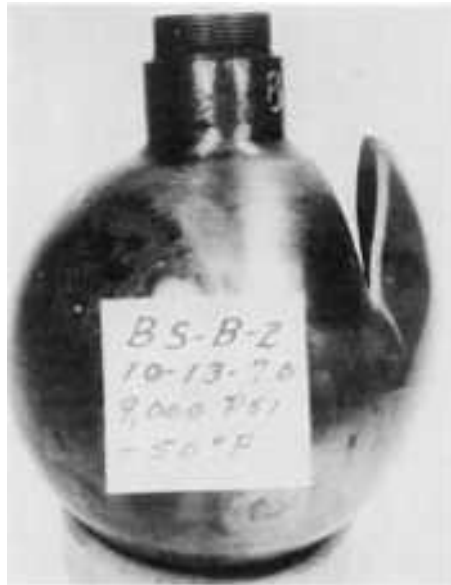
**Fig. 20 Macrograph showing ductile overload fracture of a high-pressure steel vessel tested at  $-45^{\circ}\text{C}$  ( $-50^{\circ}\text{F}$ ). See also Fig. 19.**

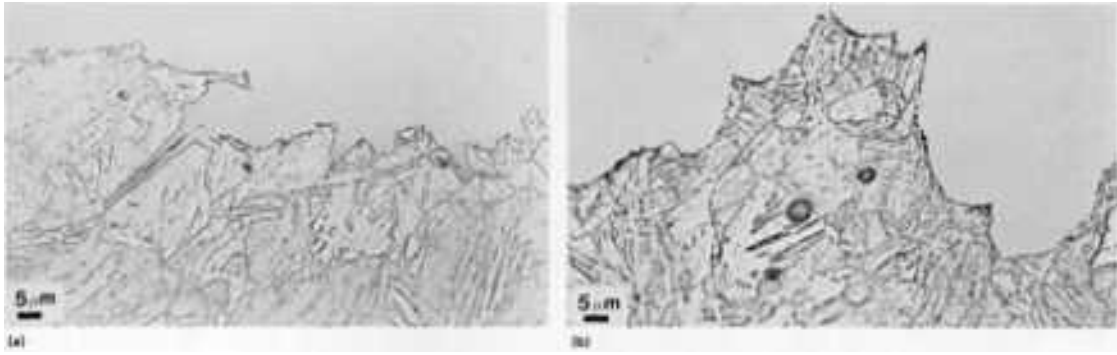
**Fig. 21 Brittle (a) and ductile (b) crack paths in a fractured quenched-and-tempered low-alloy steel. Both etched with 2% nital. 800×**

Although light microscopy has rather limited value for the examination of ductile dimples (as shown in Fig. 10 and 11), dimples can be easily observed by using metallographic cross sections. Figure 21 compares the appearance of ductile and brittle fractures of a quenched-and-tempered low-alloy steel using nickel-plated cross sections. The ductile fracture consists of a series of connected curved surfaces, and it is easy to envision how this surface would appear if viewed directly. Also, near the fracture surface, small spherical voids, particularly at inclusions, are often seen that have opened during the fracture process. These should not be interpreted as pre-existing voids. The brittle fracture, by comparison, is much more angular, and crack intrusions into the matrix on cleavage planes can be observed (Fig. 21). The problems associated with the measurement of dimples are discussed in the article "Quantitative Fractography" in this Volume.

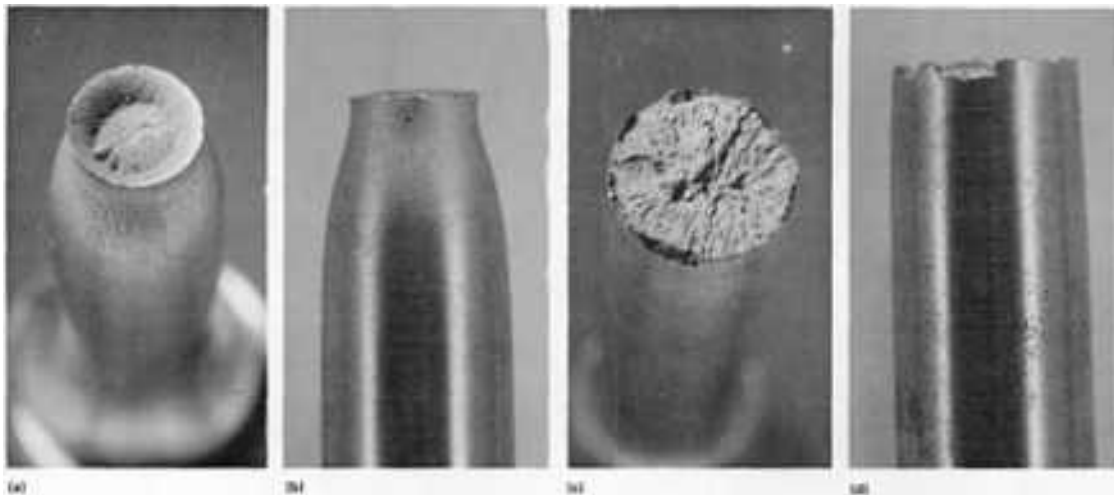
**Fig. 22 Macroscopic appearance of ductile (a) and brittle (b) tensile fractures**

The ideal tensile fracture is the classic cup-and-cone type (Fig. 22a). This type of fracture occurs in highly ductile materials. Pronounced necking is evident in Fig. 22(a). In comparison, in the brittle tensile fracture shown in Fig. 22(b), no necking has occurred, and the percent elongation and % RA values are nearly zero. In this type of tensile fracture, the yield and tensile strengths are essentially identical.

The classic cup-and-cone tensile fracture exhibits three zones: the inner flat fibrous zone where the fracture begins, an intermediate radial zone, and the outer shear-lip zone where the fracture terminates. Figure 22(a) shows each of these zones; the flat brittle fracture shown in Fig. 22(b) has no shear-lip zone.

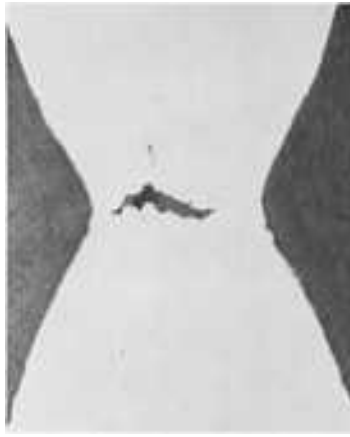
**Fig. 23 Initiation of fracture in a tensile-test specimen. Note that the fracture initiated at the center of the specimen 4.75 ×**

In one investigation, the classic cup-and-cone tensile fracture was studied by optical examination and by etch pitting (Ref 47). Shear-type fracture was found to be present all across the specimen, even in the flat central portion of the fracture. The approximate magnitude and distributions of longitudinal, radial, and circumferential stresses were determined in unfractured tensile bars strained at various amounts. The triaxial stresses in the necked section develop the highest shear stress at the center, not at the surface of the specimen. Shear fracture in cup-and-cone fractures begins at the interior of the specimen (Fig. 23) and progresses to the surface.

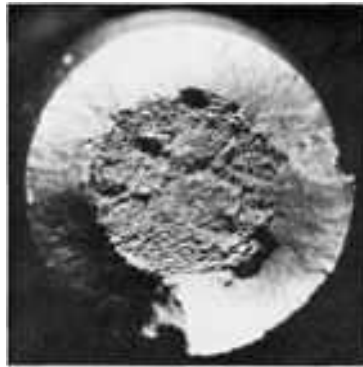
**Fig. 24 Tensile fracture of a 4340 steel specimen tested at 120 °C (250 °F). The fracture contains a fibrous zone and a shear-lip zone. The steel microstructure consisted of tempered martensite; hardness was 46 HRC. The fracture started at the center of the fibrous zone, which shows circumferential ridges. The outer ring is the shear-lip zone. About 11×**

The fibrous zone is a region of slow crack growth at the fracture origin that is usually at or very close to the tensile axis. The fibrous zone has either a random fibrous appearance or may exhibit a series of fine circumferential ridges; the latter is illustrated in Fig. 24. These ridges are normal to the direction of crack propagation from the origin to the surface of the specimen. The presence of such ridges indicates stable, subcritical crack growth that requires high energy (Ref 61). The fracture origin is usually located at or near the center of the fracture and on the tensile axis; it can often be observed to initiate at a hard second-phase constituent, such as an inclusion or a cluster of inclusions. Inspection of tensile fractures at low magnification--for example, with a stereomicroscope--will frequently reveal the initiating microstructural constituents (Ref 62).

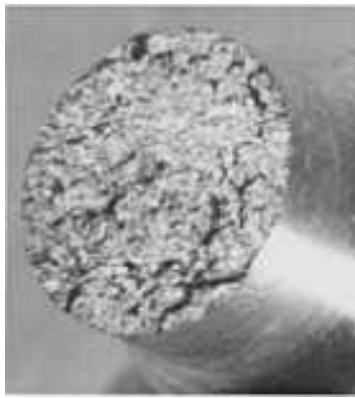
**Fig. 25 Macrograph showing a granular brittle fracture in a cast iron tensile bar. Note the large cleavage facets. 2x**

The appearance of the radial marks is partly the result of the ductility of the material. When tensile ductility is low, radial marks are fine with little relief. If a material is quite brittle with a coarse grain size, the amount of tensile ductility is extremely low, and the crack path will follow the planes of weakness in directions associated with each grain. Thus, cracking will be by cleavage, will be intergranular, or a combination of these. Figure 25 illustrates such a fracture in a cast iron tensile bar.

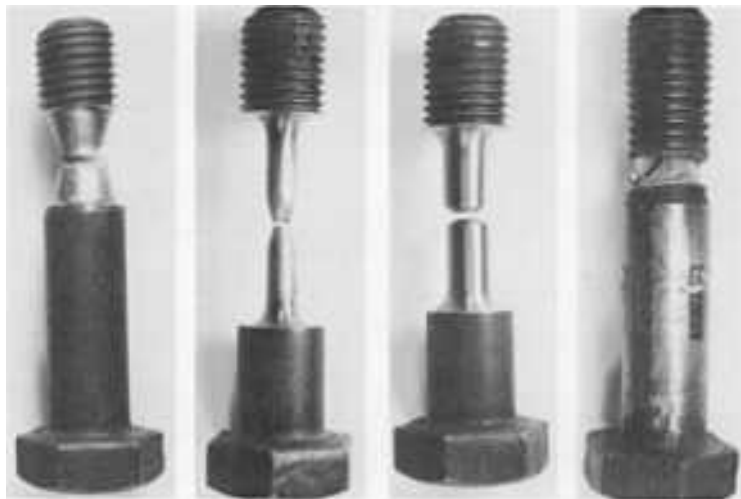
**Fig. 26 Side views of four types of ASTM A490 high-strength steel bolt tensile specimens. See also Fig. 27. Left to right: bolts 1, 4, 6, and 7**

An example of the influence of changes in the section size, the presence of notches, and the manner of loading on the appearance of fractures of round tensile specimens is provided by tests of 25-mm (1-in.) diam, 114-mm ( $4\frac{1}{2}$  in.) long ASTM A490 high-strength bolts (Fig. 26 and 27). Bolt 1 was a full-size bolt with a portion of the shank turned to a diameter just smaller than the thread root diameter. Bolt 4 had a major portion of the shank turned down to a diameter of 9 mm (0.357 in.). Bolt 6 had a major portion of the shank turned down to 13 mm (0.505 in.) in diameter and was then notched (60°) to 9 mm (0.357 in.) in diameter in the center of the turned section. Bolt 7 was a full-size bolt tested with a 10° wedge under the head. Bolts 1, 4, and 6 were axially loaded. Figure 26 shows side views of the four bolts after testing, and Fig. 27 shows their fracture surfaces. The fractures for bolts 1 and 4 exhibit the rosette star-type pattern, which is more fully developed in bolt 1. Bolt 6, which is notched, exhibits a flat brittle fracture with a small split; bolt 7 has a slanted brittle fracture and a large split.

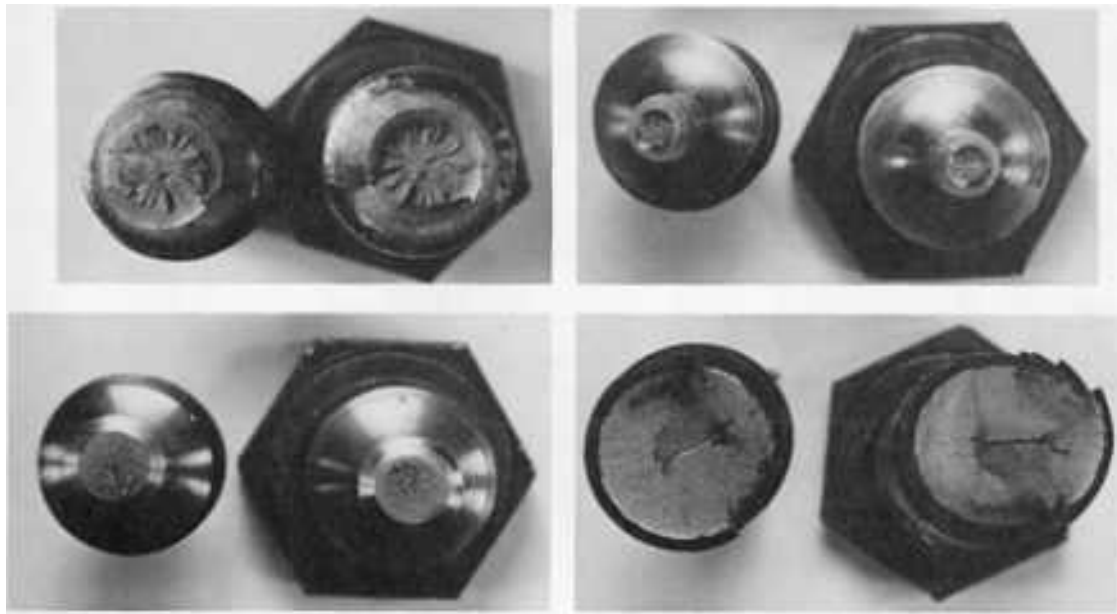
**Fig. 27 Macrographs of fracture surfaces of ASTM A490 high-strength bolt tensile specimens shown in Fig. 26. Top left to right: bolts 1 and 4; bottom left to right: bolts 6 and 7**

Another unique macroscopic tensile fracture appearance is the star or rosette fracture, which exhibits a central fibrous zone, an intermediate region of radial shear, and an outer circumferential shear-lip zone (Ref 64, 65, 66, 67, 68, 69, 70, 71). The nature and size of these zones can be altered by heat treatment, tensile size, and test temperature. Figure 27 shows two examples of this type of tensile fracture.

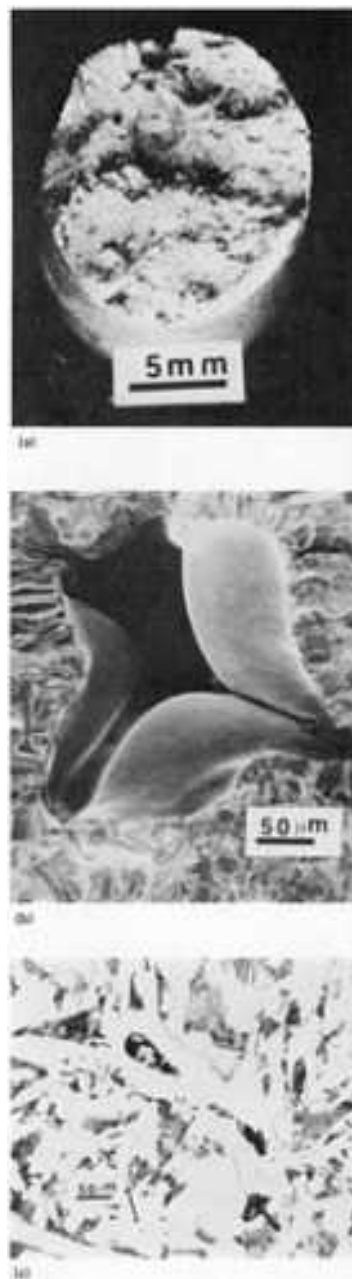
**Fig. 28 Three views of an unusual tensile fracture from a carbon steel casting. (a) Macrograph of the fracture surface. (b) SEM view of voids on the fracture surface. (c) Light micrograph showing shrinkage cavities. (c) Etched with 2% nital**

The presence of voids, such as microshrinkage cavities, can alter the fracture appearance. Figure 28 shows a tensile fracture from a carbon steel casting with a slant fracture due to the voids present.

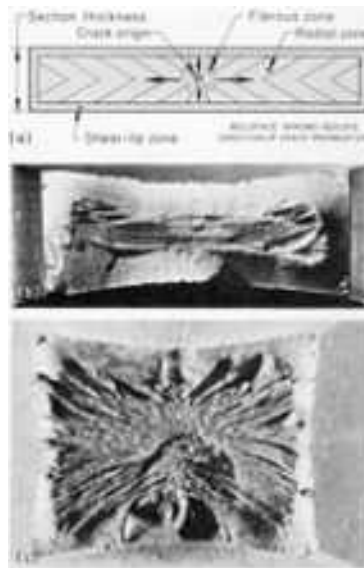
**Fig. 29** Appearance of fracture surfaces in rectangular steel tensile specimens. (a) Schematic of tensile fracture features in a rectangular specimen. (b) Light fractograph with fracture features conforming to those of the schematic. (c) Light fractograph of a fracture similar to (b) but having a much narrower shear-lip zone. Source: Ref 63

Because the shape and size of the tensile specimen influence the stress state, fracture zones will be different for square or rectangular sections compared to those with the round cross sections discussed previously. For an unnotched, rectangular test specimen, for example, the fibrous zone may be elliptical in shape, with the major axis parallel to the longer side of the rectangle. Figure 29 shows a schematic of such a test specimen, as well as two actual fracture faces. The radial zone of the test fracture is substantially altered by the shape of the specimen, particularly for the example in Fig. 29(c). As shown by the schematic illustrations in Fig. 30, as the section thickness decreases, the radial zone is suppressed in favor of a larger shear-lip zone (Ref 72). For very thin specimens (plane-stress conditions), there is no radial zone.

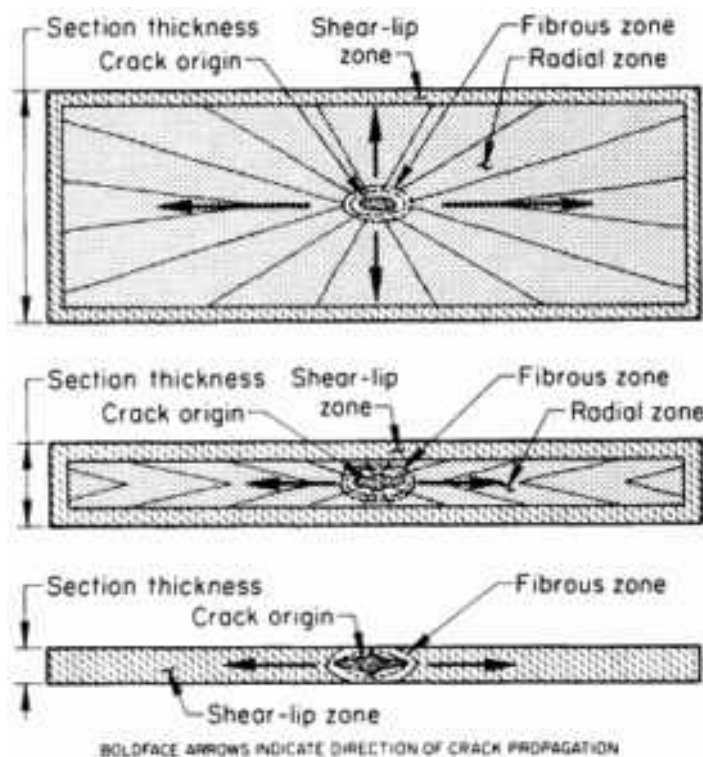
**Fig. 30** Effect of section thickness on the fracture surface markings of rectangular tensile specimens. Schematics show the change in size of the radial zone of specimens of progressively decreasing section thickness. The thinnest of the three examples has a small fibrous zone surrounding the origin and a shear-lip zone, but no radial zone. Source: Ref 63

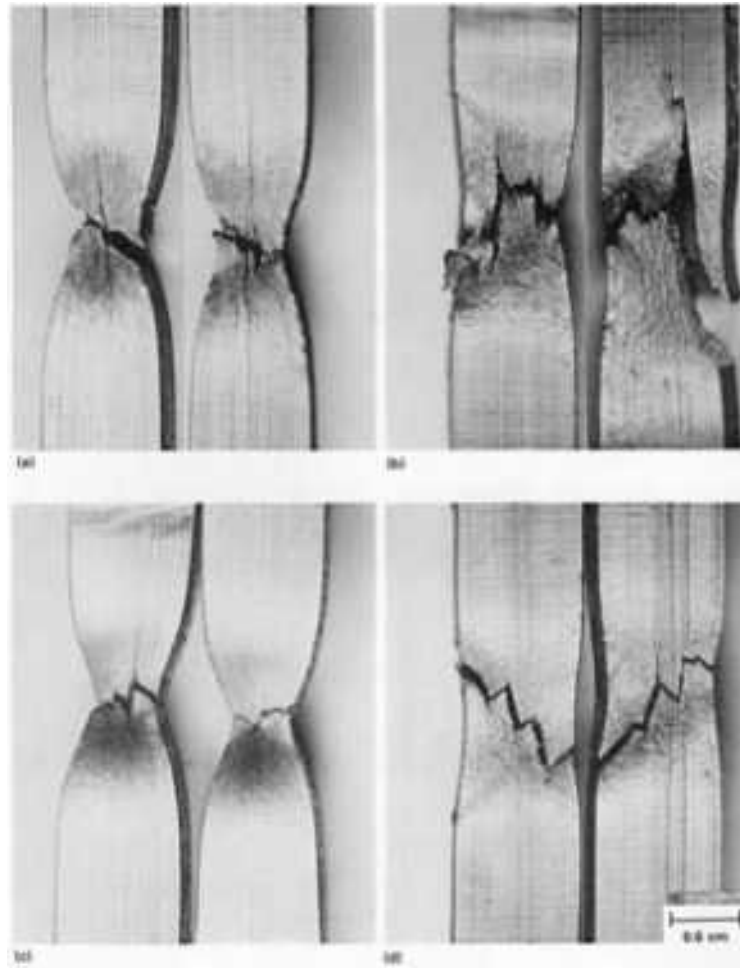
**Fig. 32 Macrographs of fractured longitudinal and transverse tensile specimens from plates finish-rolled at two temperatures. (a) Longitudinal specimen finished at 315 °C (600 °F). (b) Transverse specimen finished at the same temperature. (c) Longitudinal specimen finished at 150 °C (300 °F). (d) Transverse specimen finished at the same temperature. Source: Ref 83**

In a study of a relatively pure Fe-1Mn alloy that was essentially free of carbides and inclusions, delaminations were observed along grain boundaries; splitting occurred when the ferrite grains were deformed beyond a certain degree by controlled rolling (Ref 83). Examples of splitting in 12.7-mm<sup>2</sup> (0.02-in.<sup>2</sup>) tensile specimens from this study are shown in Fig. 32, which illustrates splitting on longitudinal and transverse tensile specimens where the hot-rolling finishing temperatures were 315 and 150 °C (600 and 300 °F). Splitting was observed in transverse and longitudinal specimens when the plates were finish rolled at 480 °C (895 °F) and below and at 370 °C (700 °F) and below, respectively. The splits were in

This study revealed that splitting followed the ferrite grain boundaries (Ref 83). The aspect ratio of the deformed ferrite grains was found to be related to the occurrence of splitting. Material that was susceptible to splitting continued to exhibit splitting after annealing until the ferrite grains were almost completely recrystallized.

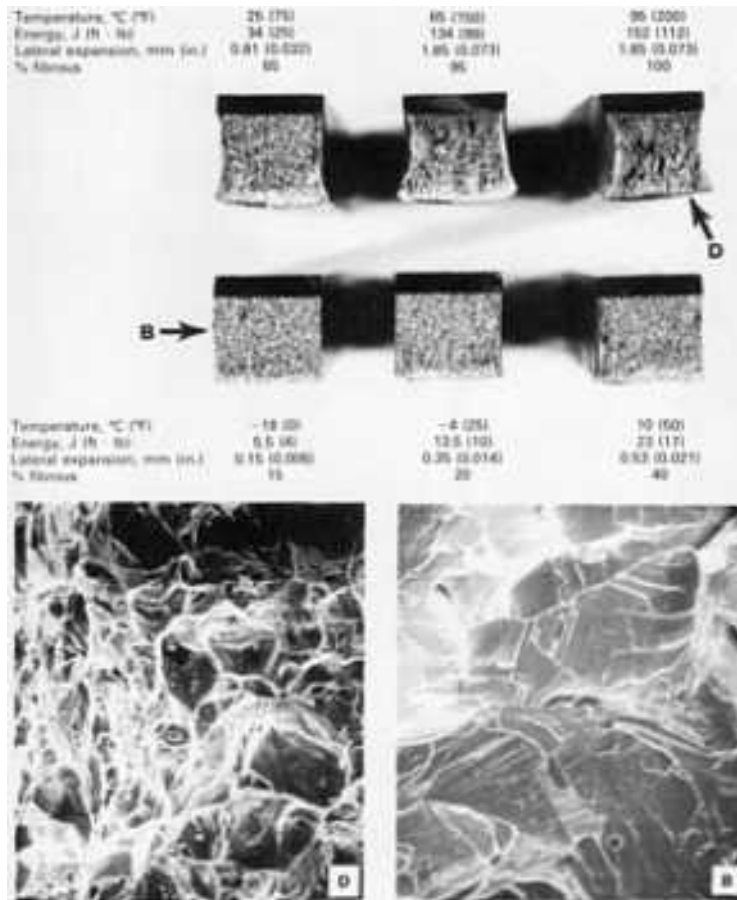
**Fig. 33 SEM fractographs of ductile (D) and brittle (B) fractures in Charpy V-notch impact specimens shown at top. Both 400×**

examination of the fracture surfaces is used to assess the percentages of ductile and brittle fracture on the specimens as a function of test temperature. Figure 33 shows fractures of six Charpy V-notch impact specimens of a low-carbon steel tested between -18 and 95 °C (0 and 200 °F), along with the test data (absorbed energy, lateral expansion, and percent ductile, or fibrous, fracture). Figure 33 also shows SEM views of the fractures resulting from testing at -18 and 95 °C (0 and 200 °F) that illustrate cleavage and microvoid coalescence, respectively.

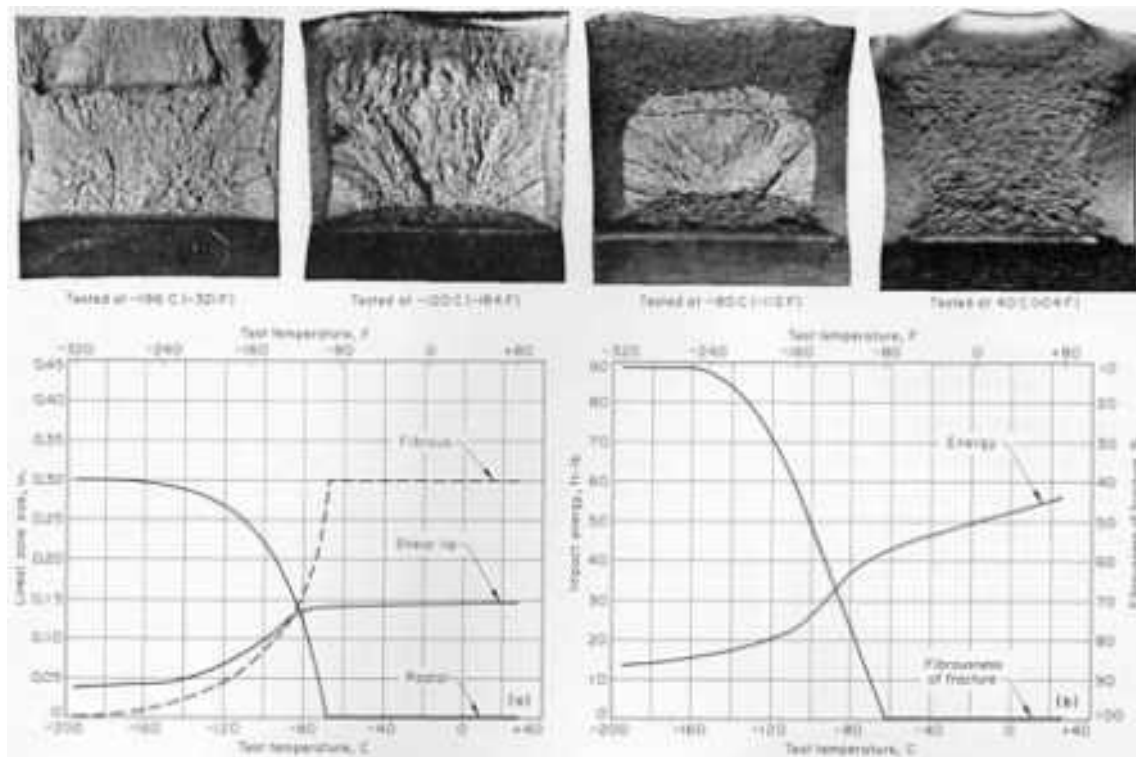
**Fig. 34 Transition curves for fracture appearance and impact energy versus test temperature for specimens of 4340 steel.** Light fractographs at top show impact specimens tested at various temperatures. Linear measurements were made parallel to the notch for the shear-lip zones, perpendicular to the notch for the fibrous zone, and perpendicular to the notch for the radial zone. The measurements yielded the three curves shown in (a). The curve of percentage of fibrousness of fracture (b) was constructed from visual estimates of the fibrous-plus-shear-lip zones. This curve, together with the impact energy curve shown in (b), shows that the transition temperature for fracture appearance is essentially the same as for impact energy. Source: Ref 63

Another example of the macroscopic appearance of Charpy V-notch impact specimens is given in Fig. 34, which shows four specimens of heat-treated AISI 4340 tested between -196 and 40 °C (-321 and 104 °F), as well as plots of the test data (Ref 63). The test specimen at -80 °C (-112 °F), which is near the ductile-to-brittle transition temperature, shows a well-defined ductile zone surrounding an inner brittle zone. Such clear delineation between the ductile and brittle zones is not always obtained, as was the case with the samples shown in Fig. 33.

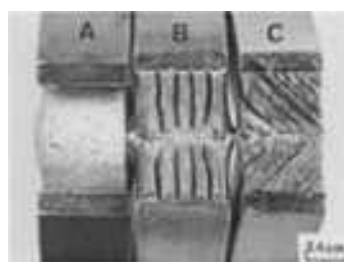
**Fig. 35 Macrograph illustrating the influence of specimen orientation (with respect to the hot-working direction) on splitting observed in Charpy V-notch impact specimens.** A, notch parallel to the plate surface; B, notch perpendicular to the plate surface; C, notch 45° to the plate surface. Source: Ref 83

Splitting has been observed in Charpy V-notch specimens, as well as on tensile specimens, as discussed previously. One investigation (Ref 83) has shown that the orientation of the splits is always parallel to the rolling plane of plate in the longitudinal direction (Fig. 35). Therefore, splitting is always associated with planes of weakness in the rolling direction.

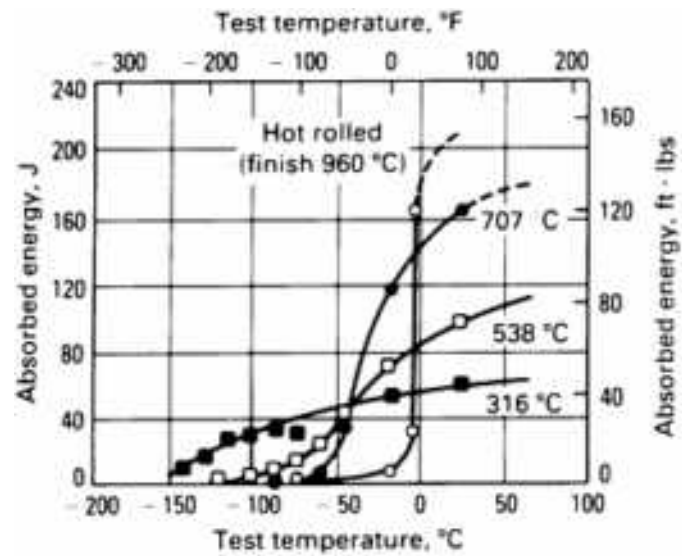
Fig. 36 Plot of absorbed-energy Charpy V-notch test data for Fe-1Mn steels finished at different temperatures (indicated on graph). Source: Ref 83

Figure 36 shows Charpy V-notch absorbed-energy curves for Fe-1Mn steel that was finish rolled at temperatures for 960 to 316 °C (1760 to 600 °F) from the study discussed in Ref 83. As the finishing temperature decreased, the absorbed-energy transition temperature (temperature for a certain level of absorbed energy, for example, 20 or 34 J, or 15 or 25 ft · lb) decreased, but the upper shelf energy also decreased. Figure 37 shows the fracture appearance of Charpy V-notch specimens used to produce the curves in Fig. 36. This demonstrates that the occurrence of splitting increased as the finishing temperature decreased. In general, lowering the test temperature for a given finishing temperature increased the number of splits unless the test temperature was low enough to produce a completely brittle cleavage fracture, for example, the -73- °C (-100- °F) samples of the plates finish rolled at 707 and 538 °C (1305 and 1000 °F).

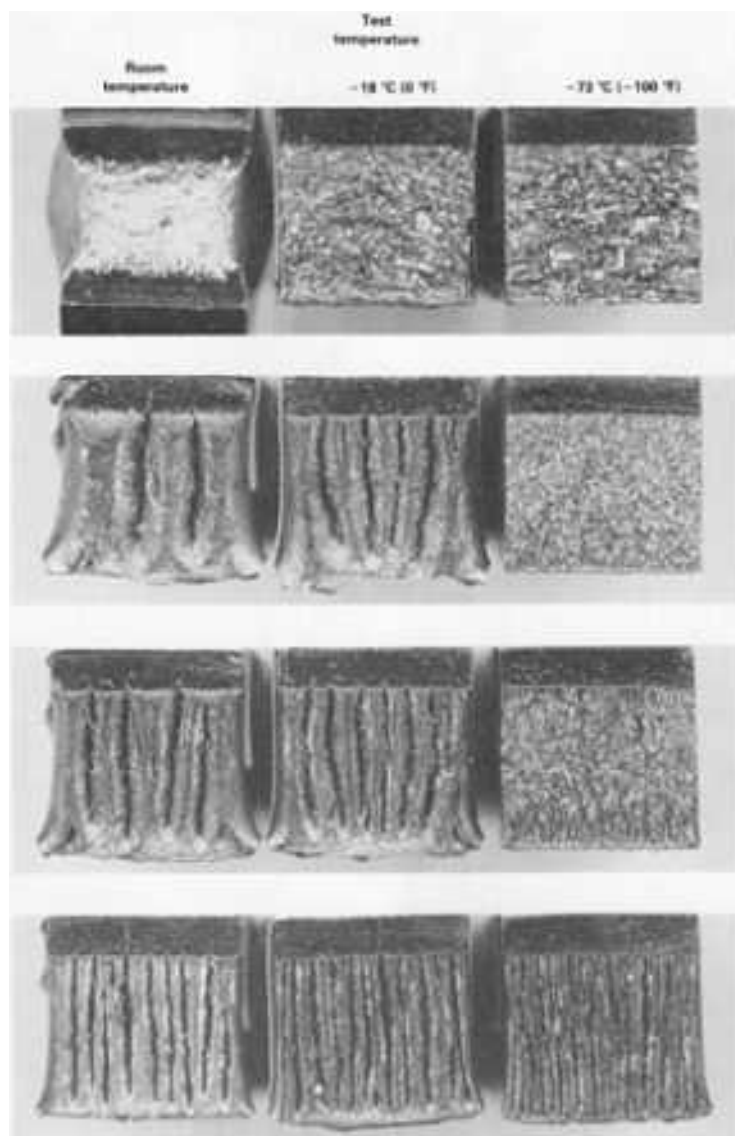
**Fig. 37 Macrographs showing Charpy V-notch impact specimens from Fe-1Mn steels finish-rolled at four different temperatures and tested at three different temperatures. Top row, finished at 960 °C (1760 °F); second row, finished at 705 °C (1300 °F); third row, finished at 540 °C (1000 °F); bottom row, finished at 315 °C (600 °F). Source: Ref 83**

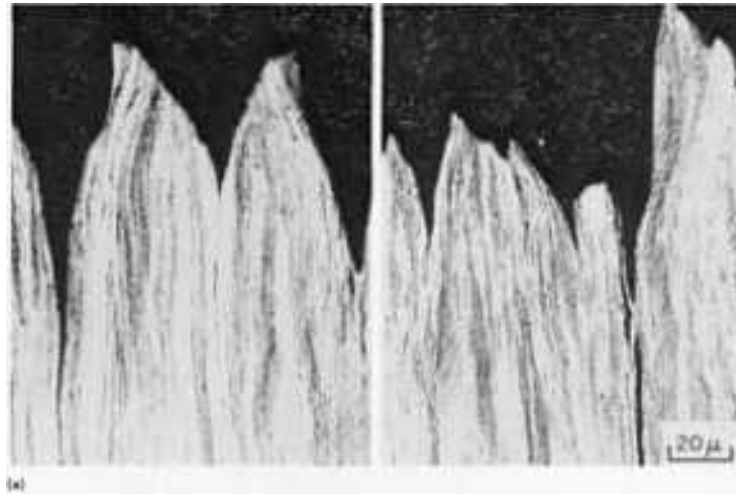
**Fig. 38 The microstructure of Fe-1Mn steel finish rolled at 315 °C (600 °F) and impact tested at two temperatures. A, tested at -18 °C (0 °F); B, tested at -135 °C (-210 °F). Source: Ref 83**

Figure 38 shows the microstructural appearances of the splitting in two Charpy V-notch specimens in plate that was finish rolled at 315 °C (600 °F). The regions between the splits resemble a cup-and-cone tensile fracture.

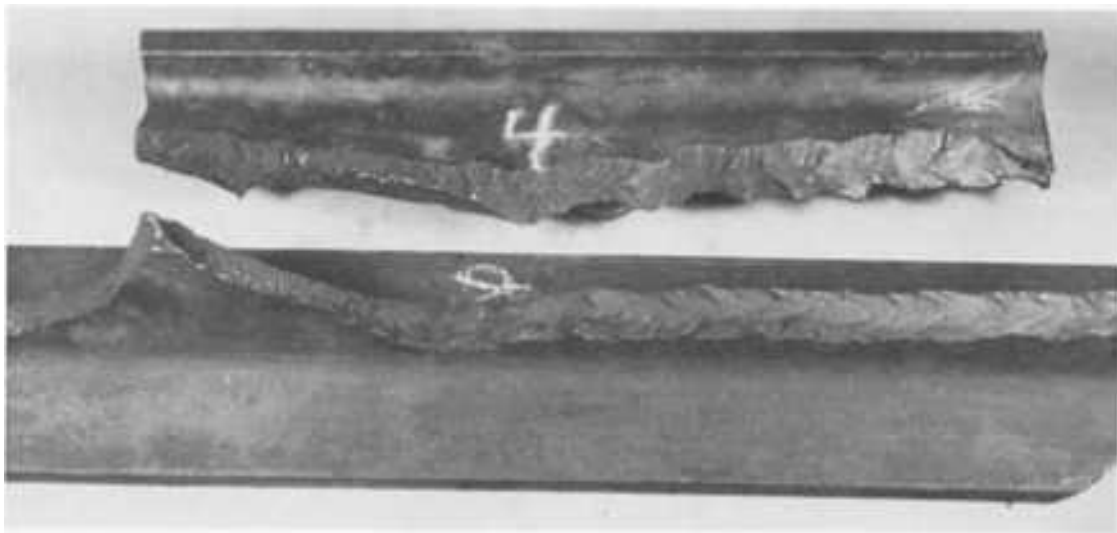
**Fig. 39 Classic appearance of chevrons on a brittle fracture of a steel railroad rail. The fracture origin is not on the section shown.**

Figure 39 shows an example of a well-developed chevron fracture pattern in a railroad rail. This type of brittle fracture pattern is frequently observed in low-strength steels, such as structural steels. The origin of the chevron fracture is easy to find because the apexes of the chevrons point back to the origin. The origin is not on the sections shown in Fig. 39. Such fractures can propagate for some distance before being arrested. The wavy nature of the fracture edge is evident in Fig. 39. In general, the more highly developed the chevron pattern, the greater the edge waviness. Such patterns are not observed on more brittle materials.
