ASM HANDBOOK®

VOLUME  
12

Fractography

*Fractography*, was published in 1987 as Volume 12 of the *ASM Handbook*. The Volume was prepared under the direction of the ASM Handbook Committee.

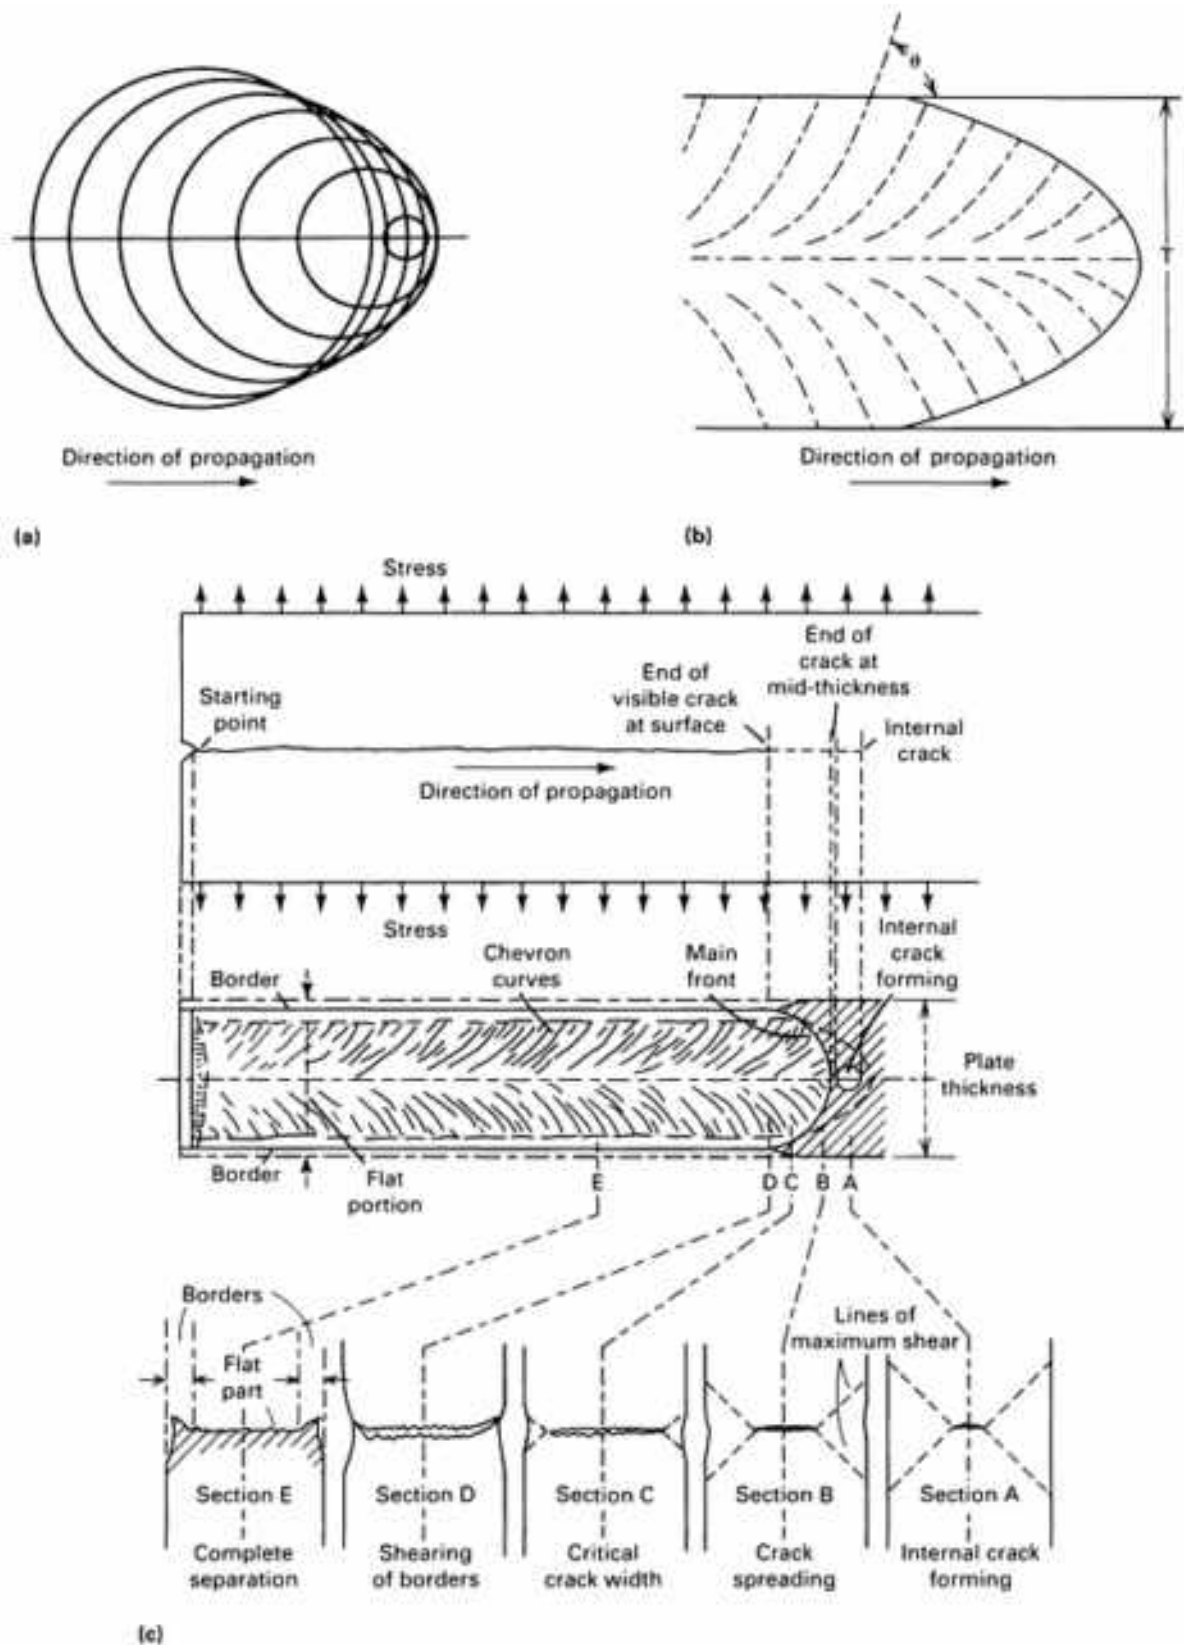
**Fig. 40 Schematics showing a model for chevron crack formation. (a) Crack front propagation model. (b) Crack front at any given time. (c) Analogy between chevron formation in plate and cup-and-cone fracture. Source: Ref 108**

The growing crack front in chevron fractures can be considered a parabolic envelope enclosing a number of individually initiated cracks that spread radially (Ref 108). Figure 40 shows a model for chevron formation and the analogy between chevron formation and cup-and-cone type tensile fracture. This model predicts that the angle  $\theta$  (Fig. 40b) will be  $72^\circ$  and that this angle is independent of material thickness and properties. To construct this model, 161 measurements were made on 20 fracture surfaces, and a mean angle of  $69^\circ$  was observed, which varied somewhat depending on the presence and size

In Fig. 40(c), locations A to E demonstrate the close resemblance between chevron fractures and the cup-and-cone tensile

fracture. Fracture begins along the centerline and spreads as a disk-shaped crack toward the surfaces. However, before reaching the surface, the fracture mode changes, and rupture occurs on the conical surfaces of maximum shear, approximately  $45^\circ$  from the tensile axis (dotted lines in A, B, and C, Fig. 40c).

As necking progresses, plastic deformation (shaded area, Fig. 40c) occurs ahead of the crack front, with lines of maximum shear strain approximately  $45^\circ$  to the plate axis. If this plastic zone is large enough, fracture will progress by shear only. However, if necking is limited, thus limiting the extent of plastic deformation, many small shear fractures of differing orientation will form, resulting in a rough or serrated appearance.

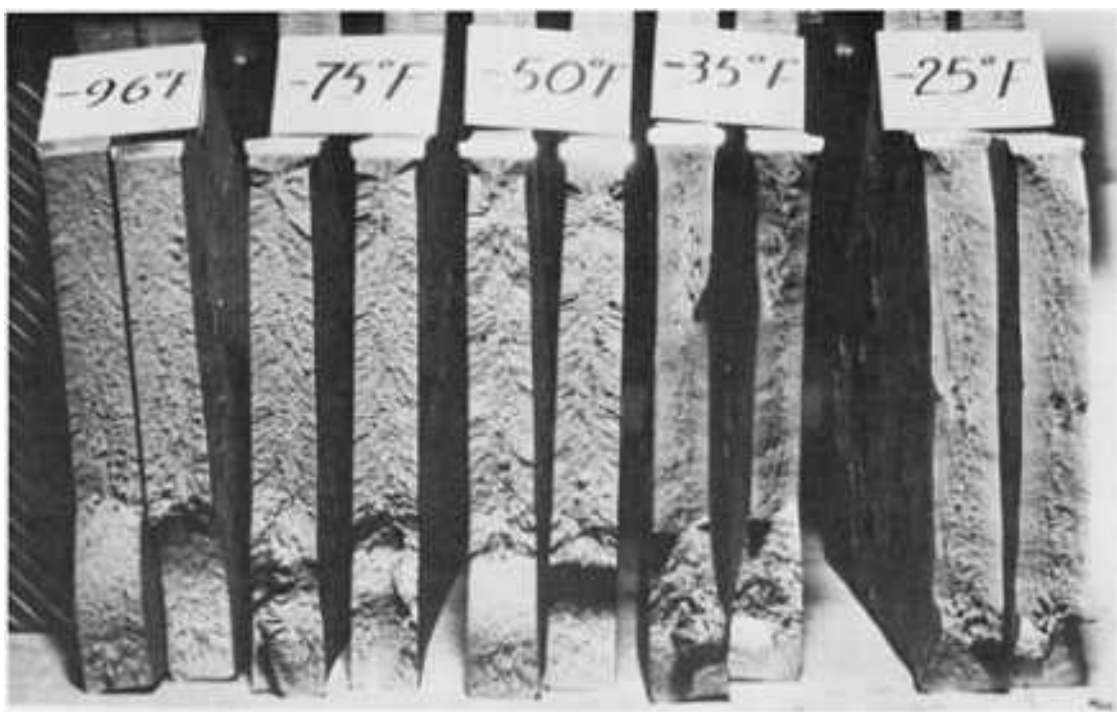
**Fig. 41** Mating drop-weight tear test fractures in ship steel showing the influence of test temperature of fracture appearance. Note that chevrons are most clearly developed at  $-45^\circ\text{C}$  ( $-50^\circ\text{F}$ ). The fractures were located by the notch at the top of each specimen.

This description reveals that chevron fractures are intermediate between completely brittle and completely ductile (shear) fractures. Figure 41 shows five ship steel fractures produced by drop-weight testing at temperatures from  $-30$  to  $-70^\circ\text{C}$  ( $-25$  to  $-96^\circ\text{F}$ ). The mating halves of each fracture are shown with the fracture starting at the notches at the top of each specimen. The specimen broken at  $-45^\circ\text{C}$  ( $-50^\circ\text{F}$ ) has the best definition of the chevron pattern. Testing at higher temperatures produced shear fractures, but testing at  $-70^\circ\text{C}$  ( $-90^\circ\text{F}$ ) produced a nearly flat brittle fracture with only a hint of the chevron pattern. This same trend is also demonstrated in Fig. 42, which shows sections of line pipe steel tested at four temperatures from  $-3$  to  $40^\circ\text{C}$  ( $27$  to  $104^\circ\text{F}$ ). Chevron patterns are observed in the samples tested at  $-3$  and  $16^\circ\text{C}$  ( $27$  and  $60^\circ\text{F}$ ) and are most clearly developed in the latter. Testing at higher temperatures resulted in 100% shear fractures.

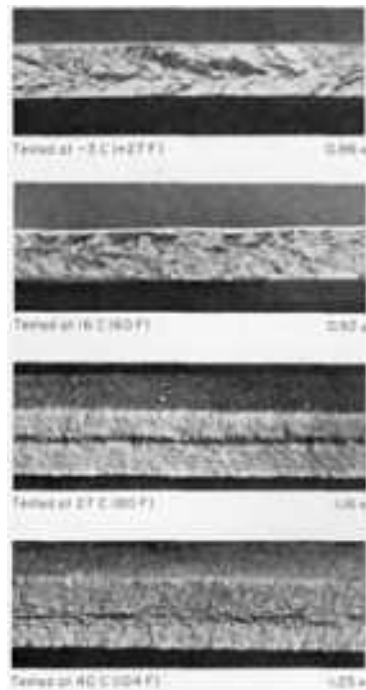
**Fig. 42 Transition of fracture appearance with change in test temperature. Light fractographs show four specimens cut from a single length of low-carbon steel pipe that were burst by hydraulic pressure at the temperatures indicated. Note the increasing size of the shear-lip zone as test temperature increases.**

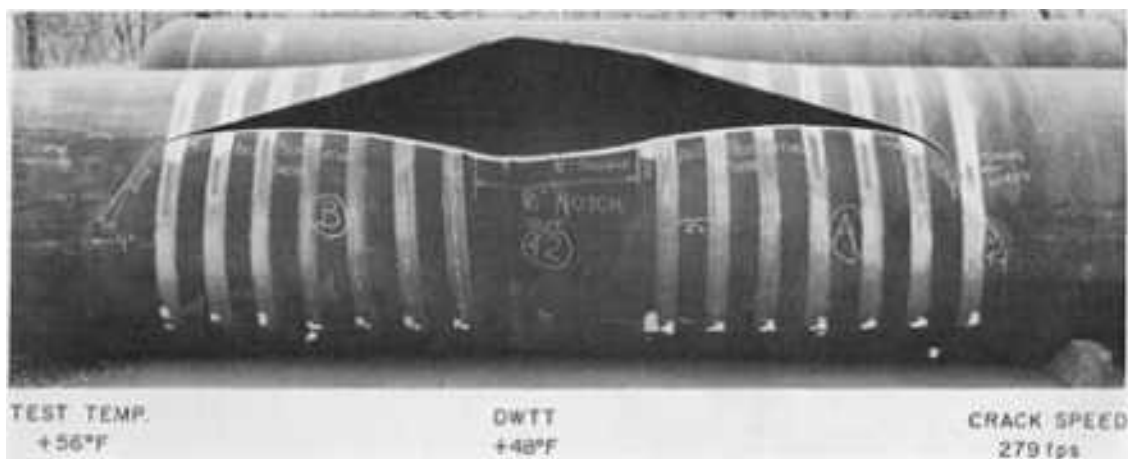
**Fig. 43 Fracture of API grade X-60 line pipe tested 5 °C (8 °F) above the 50% shear area drop-weight tear test transition temperature. See also Fig. 44, 45, 46 and text for details.**

Full-scale testing of line pipe, as shown in Fig. 43, 44, 45, and 46, revealed a good correlation between the crack speed and the 50% shear area transition temperature as determined by the Battelle drop-weight tear test (DWTT). The fracture appearance of the pipe reflects the crack speed, for example:

Figures 43, 44, 45, and 46 show full-scale test results of American Petroleum Institute (API) grade X-60 line pipes in which the test temperature was varied with respect to the 50% shear area DWTT transition temperature. In each test, the pipe was loaded to 40% of its yield strength, and a 30-grain explosive charge was detonated beneath a 460-mm (18-in.) long notch cut in the pipe while the entire pipe was maintained at the desired test temperature.

Figure 43 shows a completely ductile fracture in a line pipe tested at 5 °C (8 °F) above the 50% shear area DWTT transition temperature; the resultant crack speed was 85 m/s (279 ft/s). From the 460-mm (18-in.) notch, the crack propagated 840 mm (33 in.) in full shear and then 460 mm (18 in.) in tearing shear before stopping.

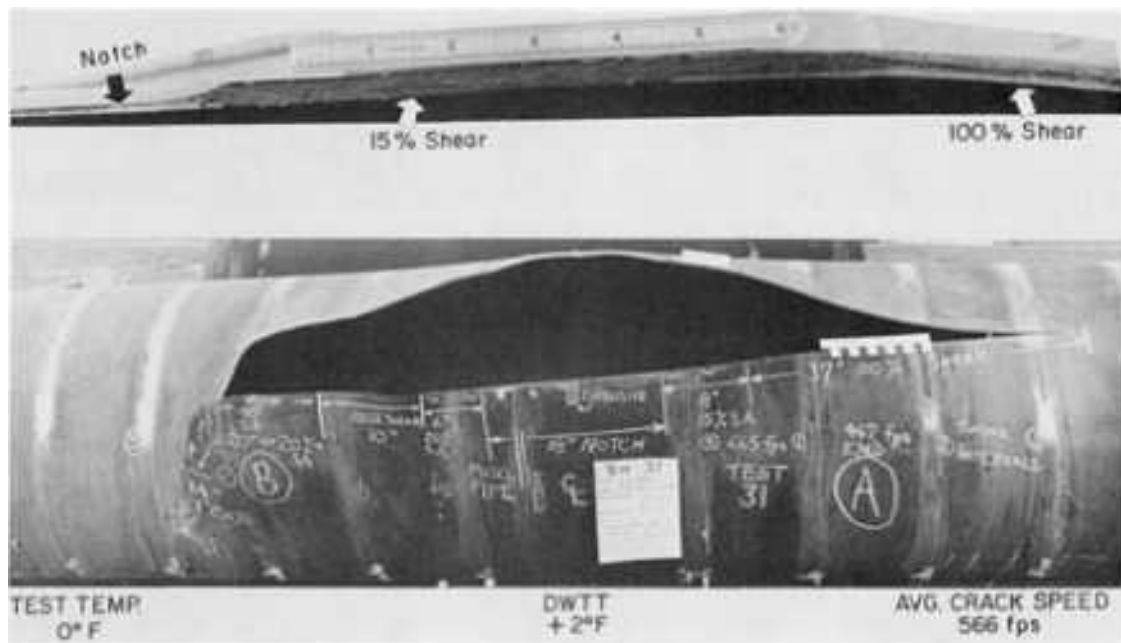
**Fig. 44** Fracture of API grade X-60 line pipe tested 1 °C (2 °F) below the 50% shear area drop-weight tear test transition temperature. See also Fig. 43, 45, and 46.

Figure 44 shows the result of testing at 1 °C (2 °F) below the 50% shear area DWTT transition temperature; the average crack speed was 172 m/s (566 ft/s). The crack began by brittle cleavage with a 15% shear area and progressed 200 mm (8 in.) in this manner before changing to 100% shear. The shear fracture ran 940 mm (37 in.) before stopping. The macrograph shows the initial fracture area.

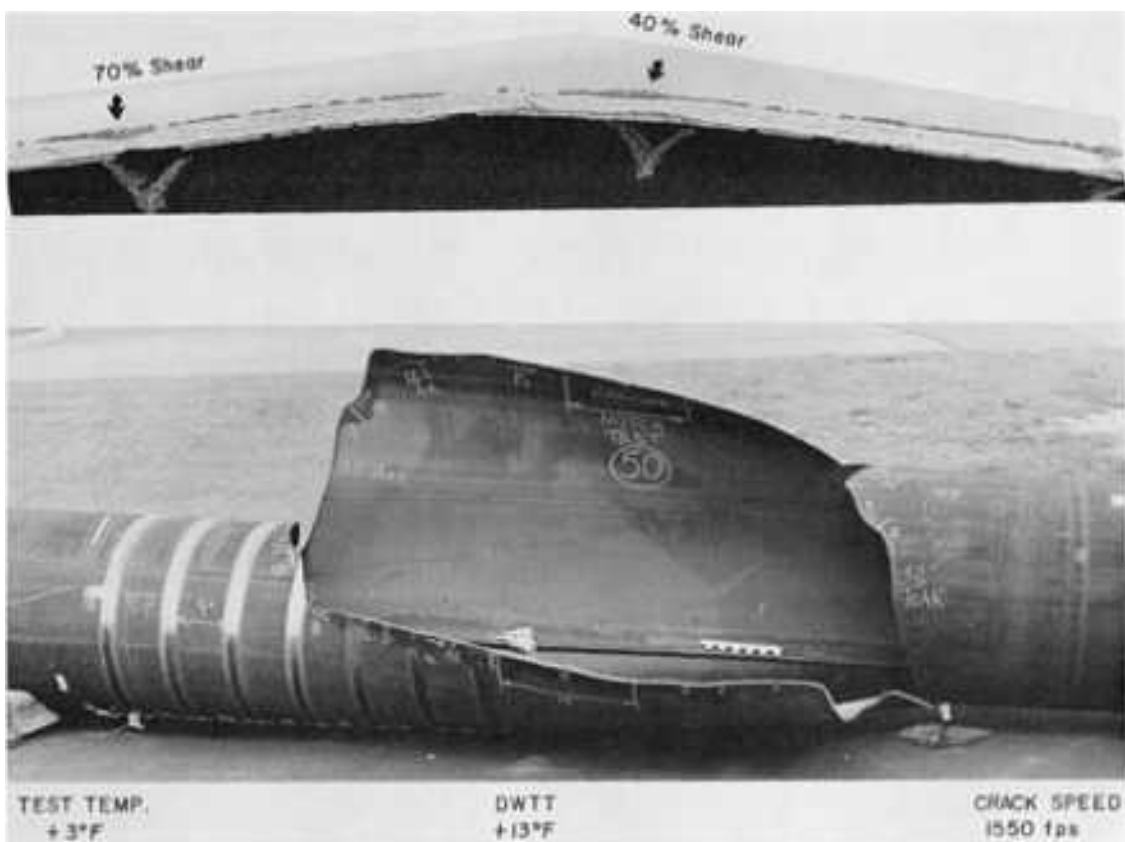
**Fig. 45** Fracture of API grade X-60 line pipe tested 6 °C (10 °F) below the 50% shear area drop-weight tear test transition temperature. See also Fig. 43, 44, and 46.

Figure 45 shows the result of testing a line pipe at 6 °C (10 °F) below the 50% shear area DWTT transition temperature; the resultant crack speed was 470 m/s (1550 ft/s). From the notch, the fracture propagated by cleavage with a 15 to 18% shear area, with some small patches having shear areas as high as 70% (see macrograph of fracture. Fig. 45). The crack propagated straight along the top of the pipe for 685 mm (27 in.) and then developed a wave pattern. Only a half wave was completed before the crack changed to 100% shear and then tore circumferentially for 840 mm (33 in.) before stopping. Although the actual crack speed was 470 m/s (1550 ft/s), the straight line crack speed was 380 m/s (1250 ft/s).

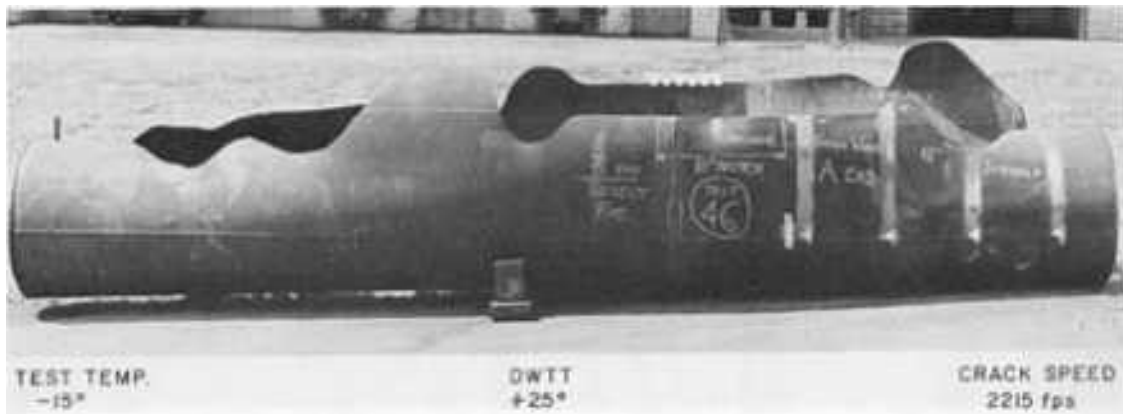
**Fig. 46 Fracture of API grade X-60 line pipe tested 22 °C (40 °F) below the 50% shear area drop-weight tear test transition temperature. Temperature given in °F. See also Fig. 42, 43, 44, and 45.**

Figure 46 shows the result of testing a pipe at 22 °C (40 °F) below the 50% shear area DWTT transition temperature; the crack speed was 675 m/s (2215 ft/s) (maximum straight line crack speed was 535 m/s, or 1760 ft/s). From the notch, the fracture traveled in a wave pattern for a full wave by cleavage with less than 10% shear areas present and then changed to full shear and tore circumferentially for 480 mm (19 in.) before stopping.

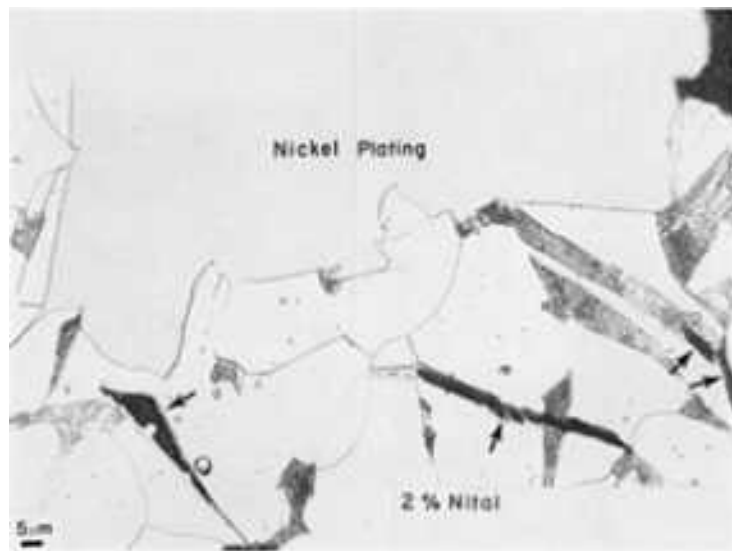
**Fig. 47 Cleavage crack path in a ferritic-pearlitic low-carbon steel. Note the subsurface cracks (arrows). One crack has been partially filled by nickel plating. Etched with 2% nital. 1000×**

Engineering alloys are polycrystalline with randomly oriented grains (or some form of preferred texture). Because cleavage occurs along well-defined crystallographic planes within each grain, a cleavage fracture will change directions when it crosses grain or subgrain boundaries. Engineering materials contain second-phase constituents; therefore, true featureless cleavage is difficult to obtain, even within a single grain. Examples of cleavage fractures, as examined with the light microscope and SEM, are shown in Fig. 1, 2, 3, 4, 5, 12, and 18, while light microscope views on cross section are shown in Fig. 12 and 21(a). Figure 47 shows an additional example of a cleavage fracture in a low-carbon steel with a ferrite-pearlite microstructure using a light microscope cross section. The orientation of the cleavage planes can be seen to vary in the different ferrite grains.

Figure 71(a) shows the same fatigue crack in an aluminum alloy as shown in Fig. 16, but after etching. The roughness of the crack pattern and the interaction with the intermetallic particles are evident. Figure 71(b) shows a similar fatigue crack in the same aluminum alloy after etching; but in this case, the specimen was completely broken, and only one side of the fracture can be observed. Comparison of Fig. 71(a) and 71(b) clearly shows that the nature of the crack pattern is much easier to observe in a partially broken specimen where both sides of the fracture can be observed. Figure 72 shows a fatigue crack in a ferrite-pearlite carbon steel after etching in which both sides of the crack can be observed. The irregular path of the crack through the ferrite phase is evident in Fig. 72 as compared to the nature of cleavage cracks in ferrite shown in Fig. 47.

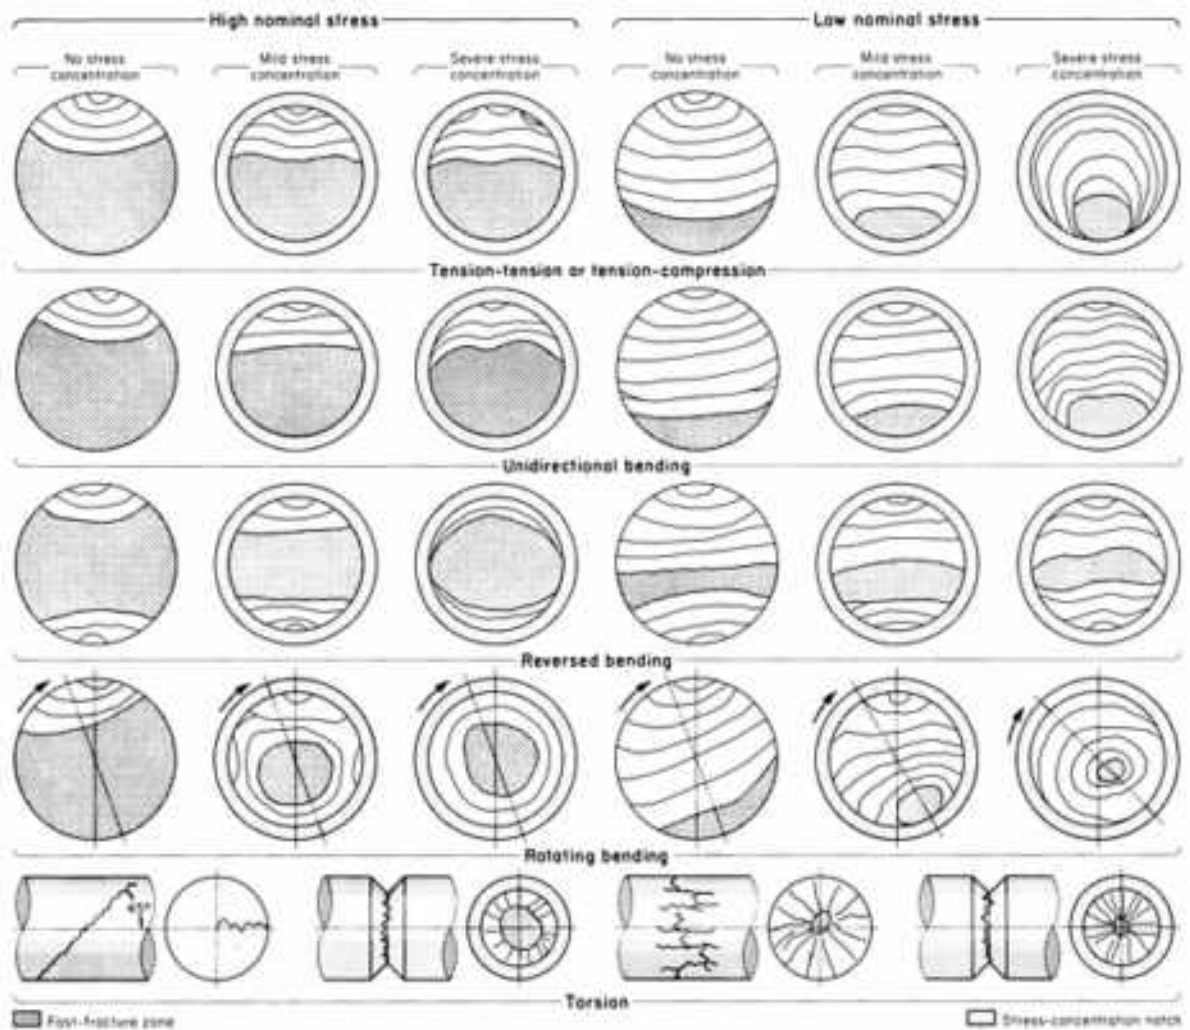
**Fig. 48 Schematic representation of fatigue fracture surface marks produced on smooth and notched components with circular cross sections under various loading conditions**

The presence of beach marks is fortuitous, at least for the investigator, because beach marks permit the origin to be easily determined and provide the analyst with other information concerning the manner of loading, the relative magnitude of the stresses, and the importance of stress concentration. Guides for interpreting fatigue fracture markings have been shown schematically (Ref 113, 114) and have been discussed by others (Ref 63, 115, 116, 117, 118, 119, 120, 121, 122). The most comprehensive schematics for interpreting fatigue fractures are shown in Fig. 48 for round cross sections and in Fig. 49 for rectangular cross sections. Each consists of examples of high and low nominal stress with three degrees of stress concentration and five types of loading: tension-tension or tension-compression, unidirectional bending, reversed bending, rotating bending, and torsion.

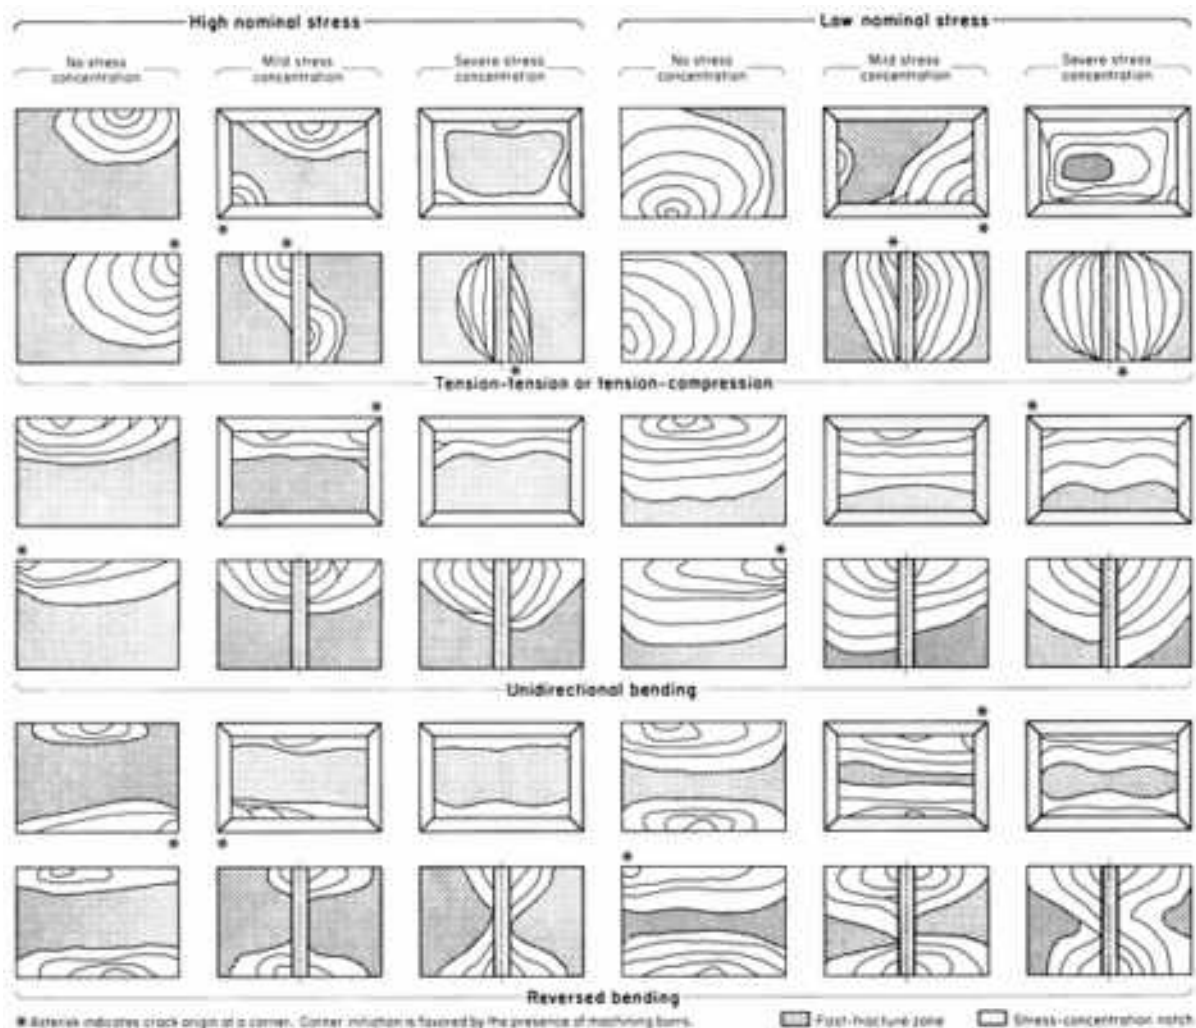
**Fig. 49 Schematic representation of fatigue fracture surface marks produced in square and rectangular components and in thick plates under various loading conditions**

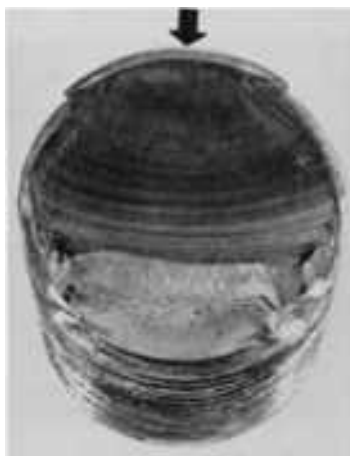
**Fig. 50 Fatigue failure of a bolt due to unidirectional cycling bending loads. The failure started at the thread root (arrow) and progressed across most of the cross section before final fast fracture. Actual size.**

Figure 50 shows a bolt that failed by fatigue. The arrow indicates the origin, which was the root of the first thread, the location of greatest stress concentration. The overload portion of the fracture (side opposite the arrow) is rather small compared to the overall cross section; this indicates that the loads were rather low. Comparison of Fig. 50 to the schematics in Fig. 48 suggests that loading was tension-tension or tension-compression with a mild stress concentration at low nominal

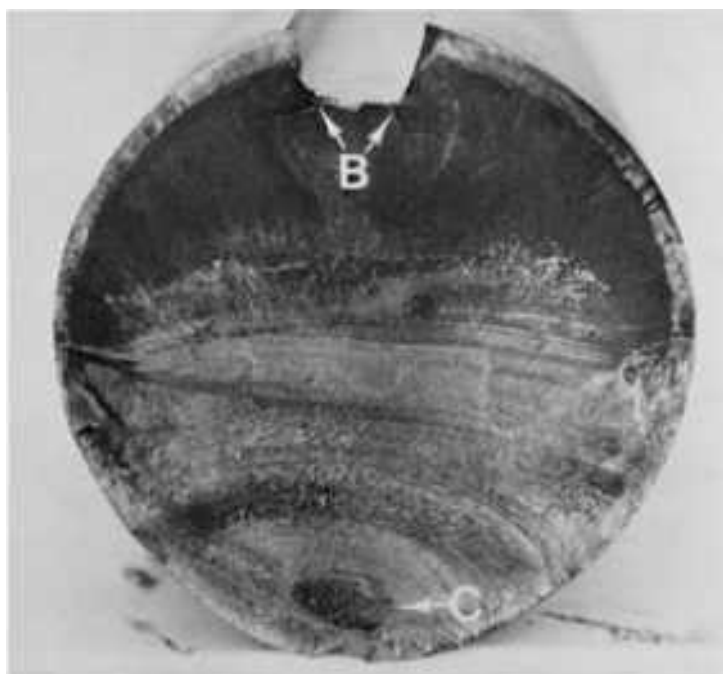
**Fig. 51 Macrograph of the fracture face of an AISI 4320 drive shaft that failed by fatigue. The failure began at the end of a keyway that was machined without fillets (B) and progressed to final rupture at (C). The final rupture zone is small, indicating that loads were low.**

Figure 51 shows the fracture of a drive shaft that failed by fatigue. The fracture started at the end of the keyway (B), which was not filletted; that is, the corners were sharp. Final rupture occurred at C, a very small zone. The slight curvature of the beach marks becomes substantial near the final rupture zone. Comparison of Fig. 51 to the schematics shown in Fig. 48 indicates that the failure occurred by rotating-bending stresses, which would be expected in a drive shaft, with the direction of rotation clock-wise looking at the fracture and with a mild stress concentration and low nominal stresses.

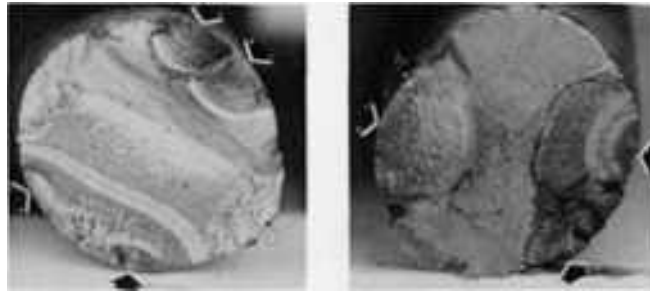
**Fig. 52 Two examples of fatigue fractures in AISI 9310 quenched-and-tempered coupling pins caused by reversed cyclic bending loads. Arrows indicated the fracture origins. Actual size**

Figure 52 shows two fractures in AISI 9310 coupling pins that failed by fatigue. Both were subjected to reversed-bending alternating stresses. These pins actually failed by low-cycle fatigue (<10,000 cycles). High nominal stresses were applied, and stress concentration was either absent or mild. Multiple origins are frequent (arrows).

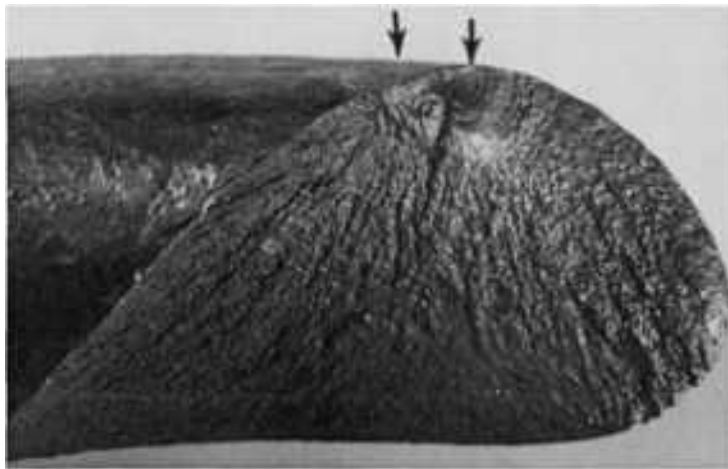
**Fig. 53 Torsion failure of an AISI 51B60 railroad spring. The failure began by fatigue at the abraded area at the top (arrows).**

Figure 53 shows a torsion failure of a railroad spring that began at a small fatigue crack (right arrow) that was initiated at an abraded region (left arrow) at the top of the spring. The abrasion probably resulted from rubbing of the coil spring when it was fully compressed. In this case, the fatigue crack is small, and the overload portion is quite large, suggesting high nominal stresses.

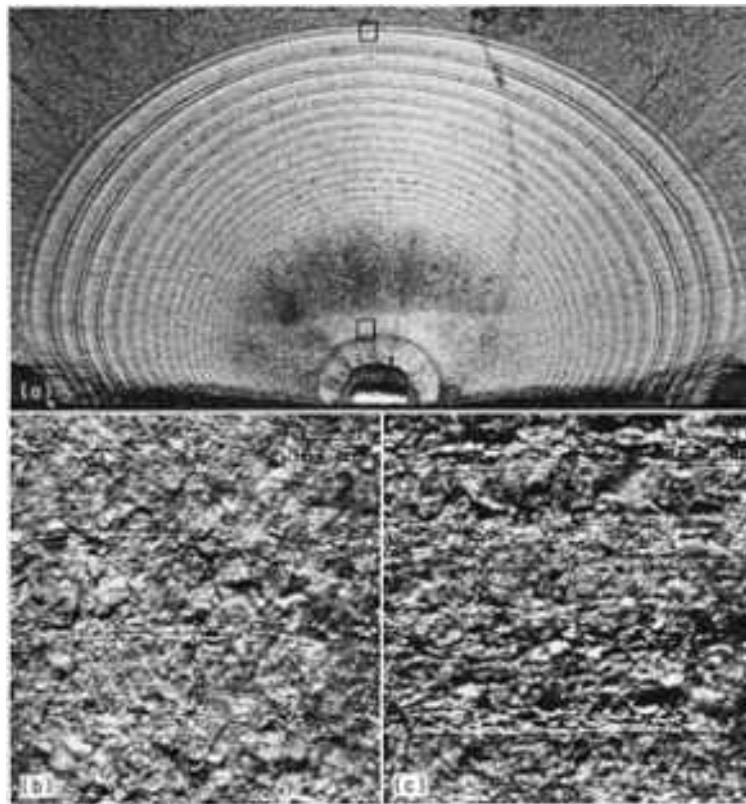
**Fig. 54 Three views of a fatigue fracture in D6AC steel plate, showing beach marks. (a) Plate subjected to a series of varied loading cycles in the laboratory. The crack origin, at the bottom center, was at a starter notch formed by electrical discharge machining. (b) Area in lower square in (a), just above beach mark registering the first change in loading. (c) Area in upper square in (a), just ahead of the zone of final fast fracture. Both (b) and (c) contain faintly resolved, fine beach marks. (a) About 5 $\times$ . (b) and (c) 60 $\times$ . Source: Ref 124**

Figure 54 shows the fatigue fracture of a plate of D6AC high-strength steel. The part was fractured in the laboratory under block loading, which produced a beach mark pattern. Because of the uniformity of the load cycles, the resultant beach marks are extremely uniform in appearance. The pattern increases in spacing and clarity as the crack grows because, as the crack grows, the stresses are increasing even though the applied loads are the same. The two macrographs (b and c) of the regions shown in (a) illustrate the progression of the fracture at the lower loads, that is, for the very fine marks in (a) rather than the high-load coarse marks.

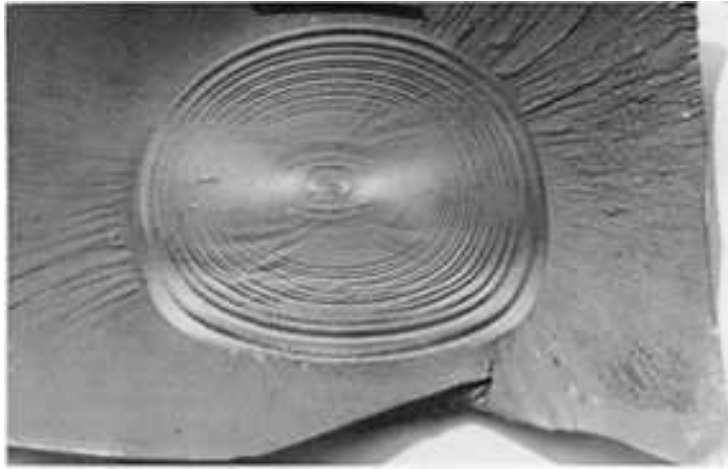
**Fig. 55 Circular spall that began at a large subsurface inclusion in a hardened steel roll**

Figure 55 shows a classic example of a circular spall that formed beneath the surface in a hardened steel roll. The very clear development of the fatigue marks out to the overload zone is evident. Radial marks can be observed all around the overload portion starting from the last fatigue mark.

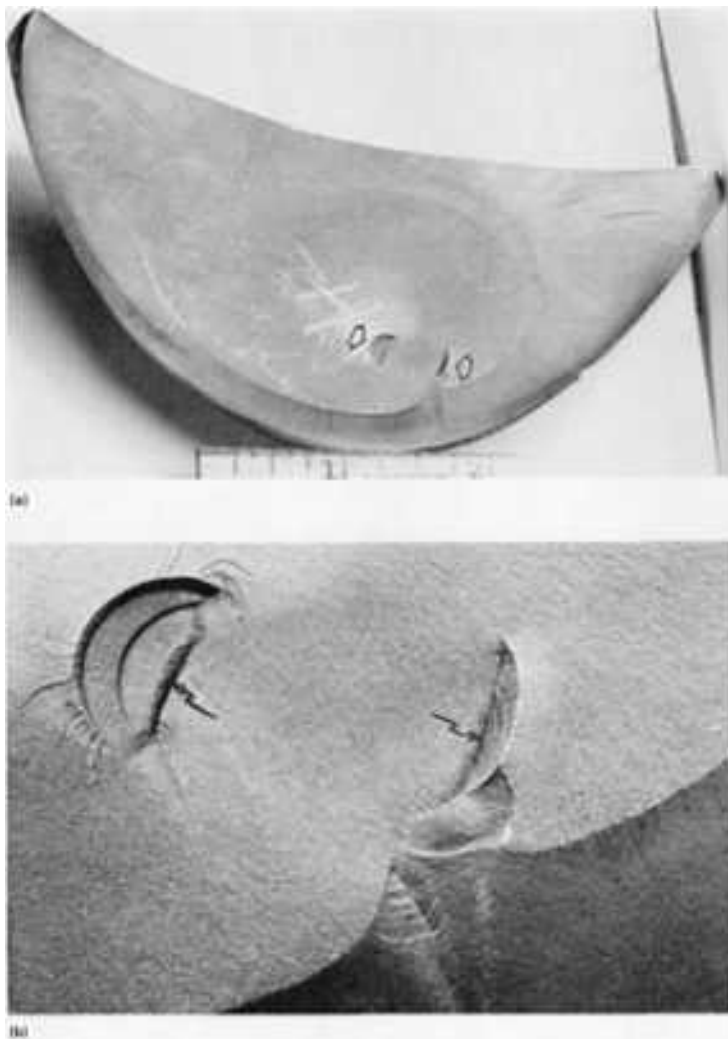
**Fig. 56 Circular spall from the shoulder of a forged, hardened alloy steel mill roll with two small fatigue origins. A subsurface crack connected the two fatigue zones. Note that the spall surface is relatively featureless. (a) About**

**actual size. (b) 5.5×**

Figure 56 shows a circular spall that formed at the body shoulder of a forged hardened steel roll. Two small thumbnail-shaped fatigue cracks (see enlarged view) served as the origin. These two origins were connected by subsurface cracks (not shown). The overall view of the spall shows that the region around the two origins is relatively featureless. However, a faint ring around the two origins suggests that the crack propagated outward from the two origins, stopped, and then fractured by overload.

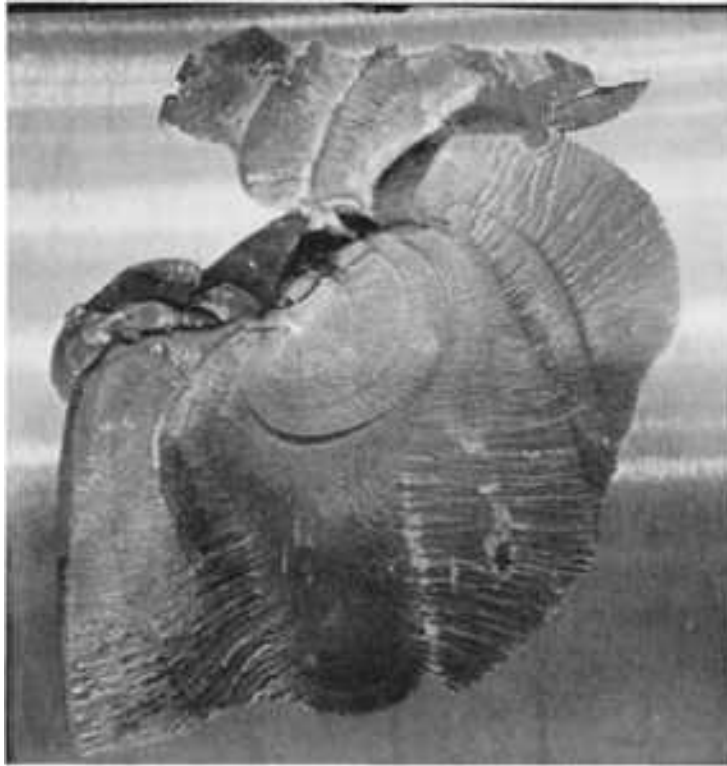
**Fig. 57 Circular spall on the surface of a forged, hardened alloy steel mill roll. The arrow indicates the fracture origin. Note the fatigue marks showing the growth away from the origin, followed by brittle fracture. 0.68×**

Figure 57 shows another circular spall--the mating fracture on the roll body rather than the spalled portion. The well-defined fatigue origin (arrow) and beach marks are visible. The overload portion of the fracture exhibits much more detail than the previous failure. The overload portion exhibits a high density of ridge marks, and it appears to have grown cyclically in that there are a number of arrest points in its growth.

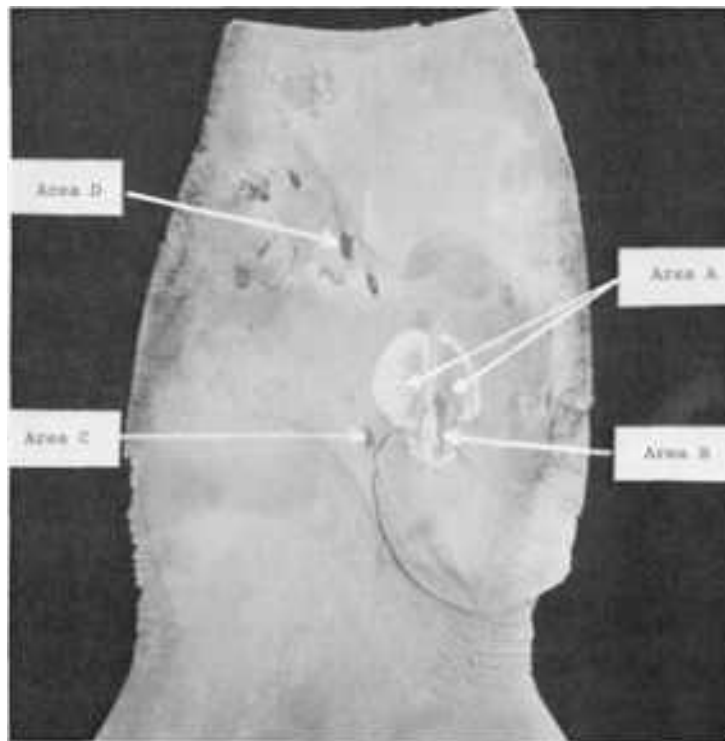
**Fig. 58** Spalled section from a forged, hardened alloy steel mill roll showing three regions with fatigue beach marks. The large, shiny region appears to be the origin. See Fig. 59 and 60 for close-up views of areas A, B, C, and D. 0.73x

Figure 58 shows a circular spall from a forged hardened steel roll with well-defined fatigue origins (areas A and B) and other regions, such as areas C and D, away from the origin that exhibit beach marks. Enlargements of areas A to D are shown in Fig. 59 and 60. It is clear that the spall originated from the multiple fatigue origins in the light-colored area (A and B) near the center. However, it appears that other fatigue origins, such as at areas C and D, were also growing when the overload fracture occurred.

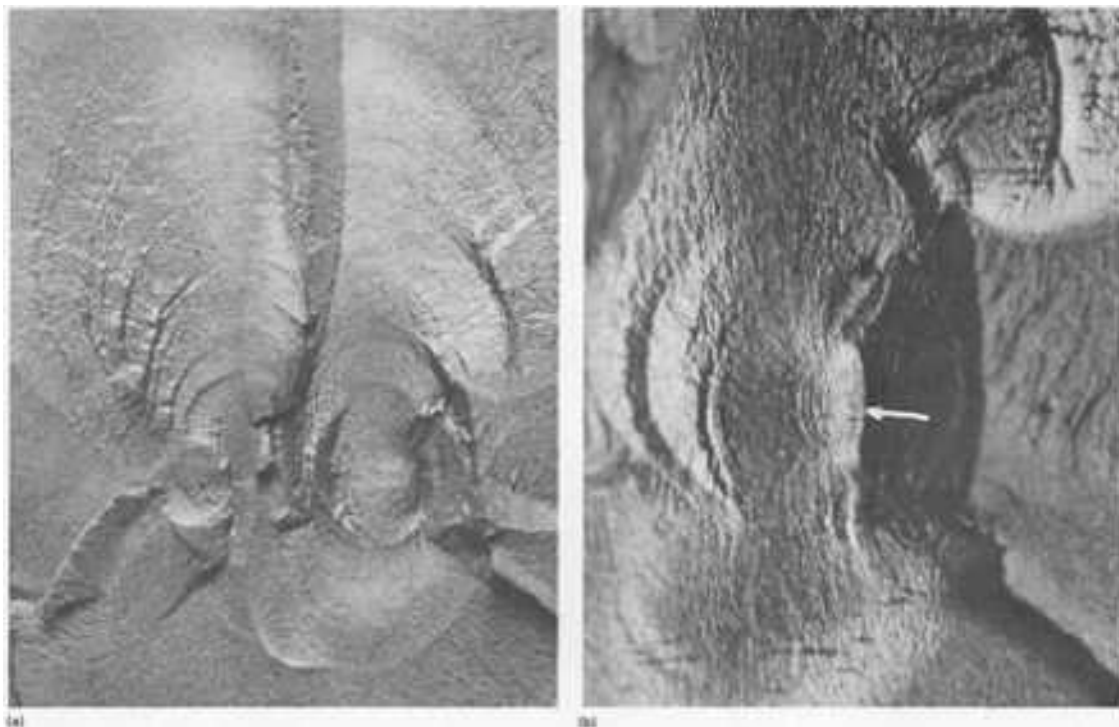
**Fig. 59** Close-ups of the primary initiation site of the spall shown in Fig. 58. (a) Area A. 4x. (b) Area B. 8x. See also Fig. 60.

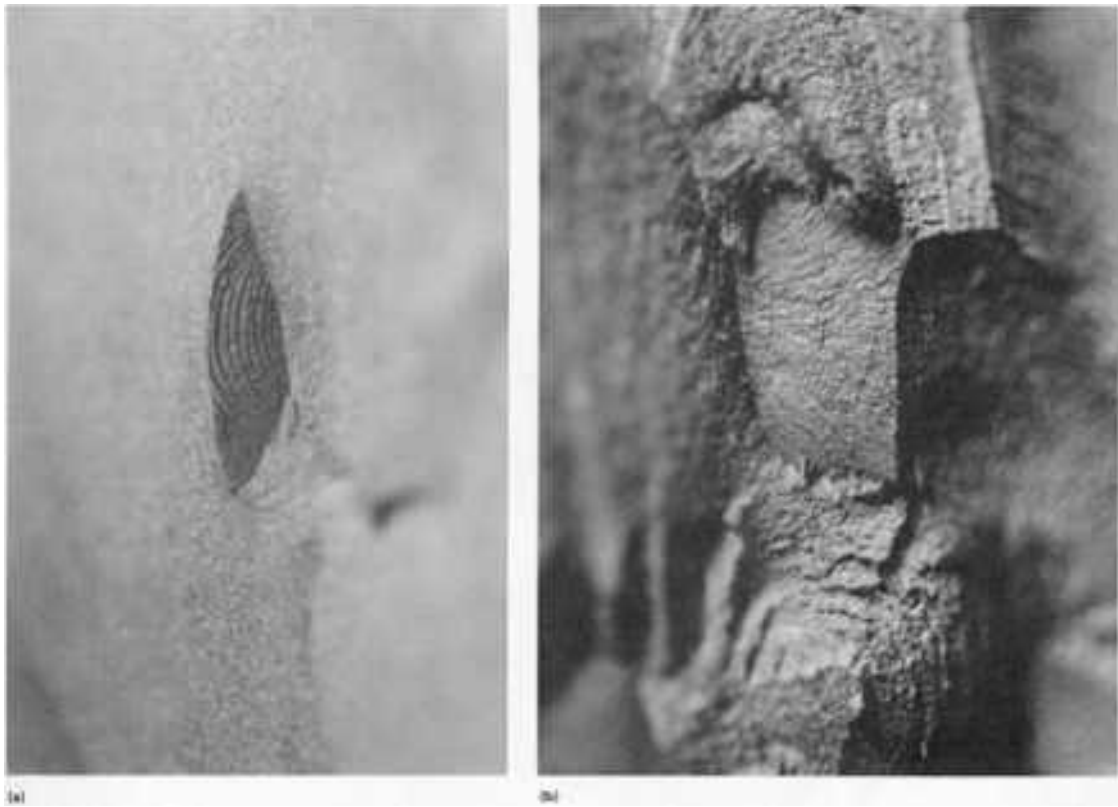
**Fig. 60 Close-ups of two regions of the spall surface shown in Fig. 58 that exhibited fatigue beach marks. (a) Area C. 10×. (b) Area D. 9×. See also Fig. 59.**

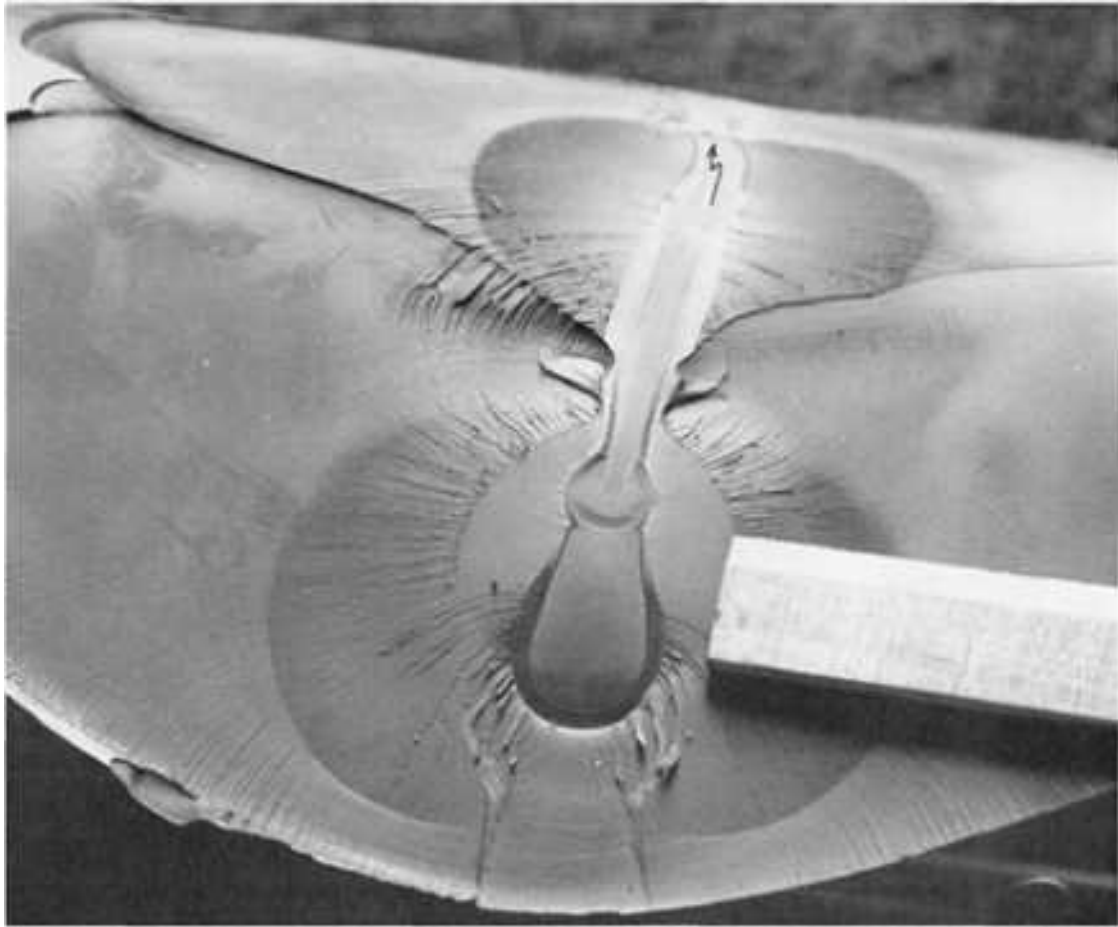
**Fig. 61** Example of a line spall in a forged, hardened alloy steel mill roll. Note that the portion that spalled off broke as two sections, with the fractures propagating from the two circular fatigue regions growing from the line spall. The arrow at the top indicates that the spall continued under the unbroken roll surface. Ultrasonic examination showed that it progressed another 137 mm ( $5\frac{3}{8}$  in.) under the surface at a maximum depth of 11 mm ( $\frac{7}{16}$  in.). The subsurface, unspalled portion of the roll is shown in Fig. 63; Fig. 62 is another view of the line spall.

Figures 61 and 62 show two views of a line spall fracture in a 545-mm ( $21\frac{1}{2}$ -in.) diam forged hardened steel roll. The term line spall comes from the linear shape of the fatigue portion of the fracture that initiated rupture. In a line spall, the linear fatigue portion often runs part way around the periphery; the overload portion and the overall shape of the spalled section need not be linear. The arrows in Fig. 61 and 62 indicate the portion of the line spall that extended under the unbroken portion of the roll body. This area was opened and is shown in Fig. 63, along with an enlarged view of the fatigue marks at the origin of the line spall. Figures 61 and 62 show that the spalled portion broke off as two pieces. The radial marks around the two spalled regions (Fig. 61 and 62) show how the overload portion of the fracture formed around the line spall.

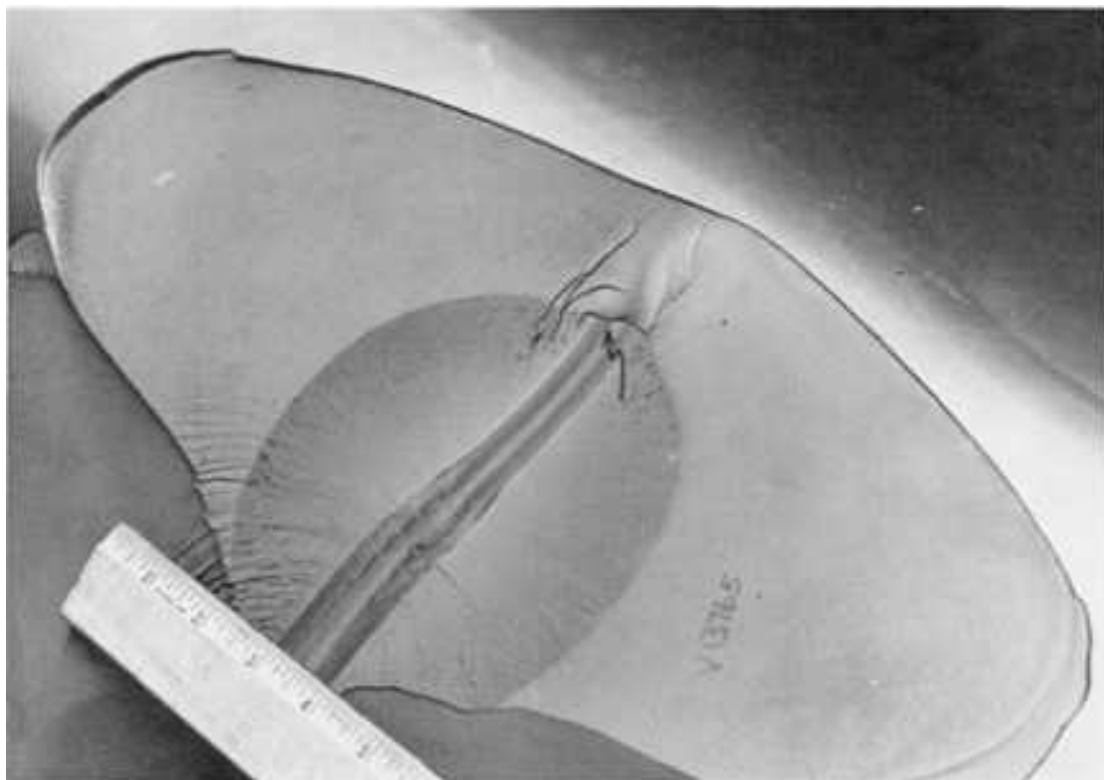
**Fig. 62** Another view of the line spall shown in Fig. 61. The arrow indicates the location of the line spall under the unfractured surface. See also Fig. 61 and 63. 0.6×

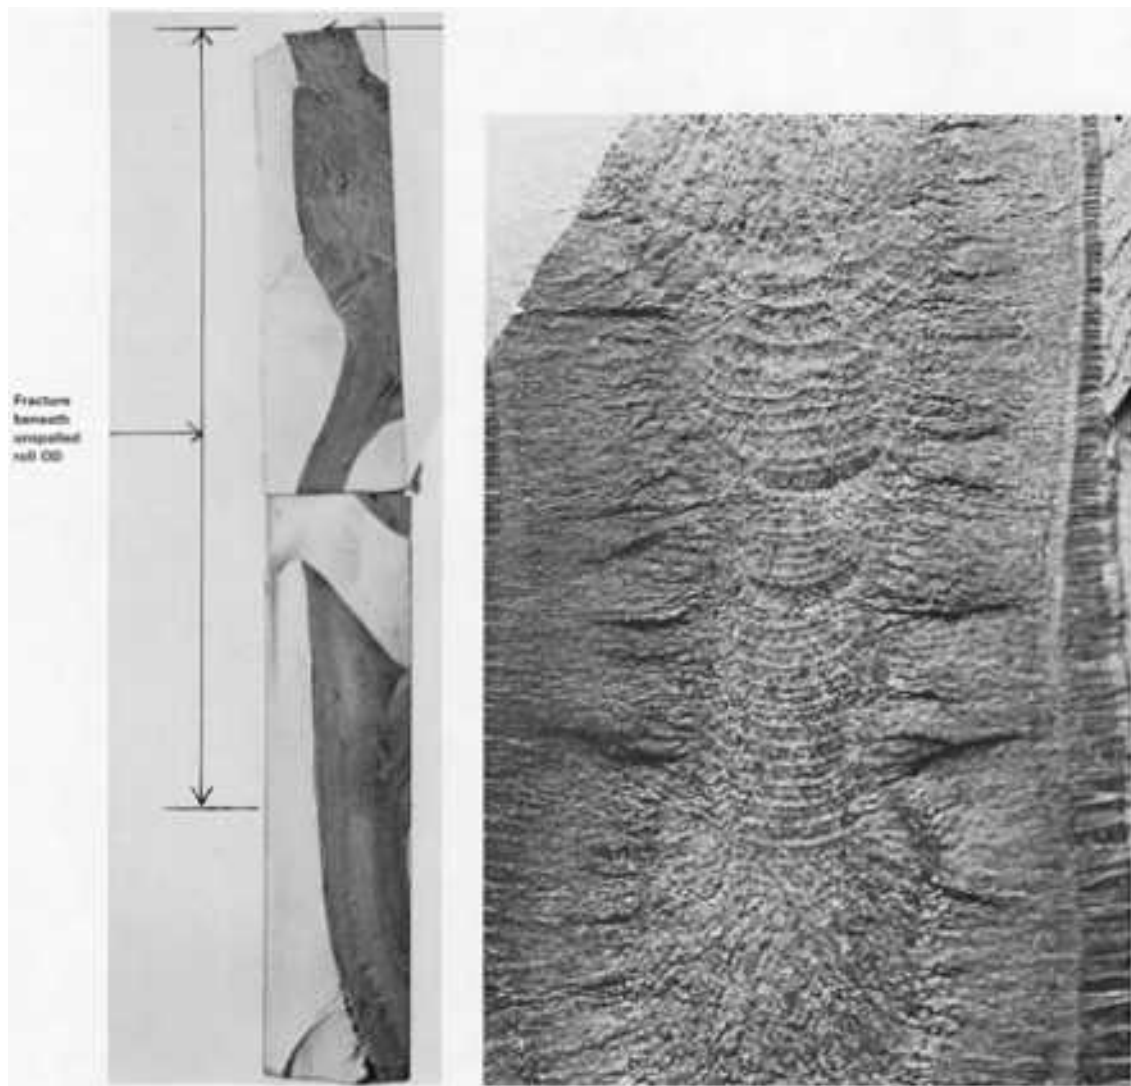
**Fig. 63 The line spall fracture surface beneath the unspalled roll surface (see Fig. 61 and 62), revealed by sectioning and fracturing. The smooth, white fracture region formed when the spall was opened. The arrow at the top indicates the origin, shown at the right at higher magnification, which revealed beach marks.**
