ASM HANDBOOK®

VOLUME  
12

Fractography

*Fractography*, was published in 1987 as Volume 12 of the *ASM Handbook*. The Volume was prepared under the direction of the ASM Handbook Committee.

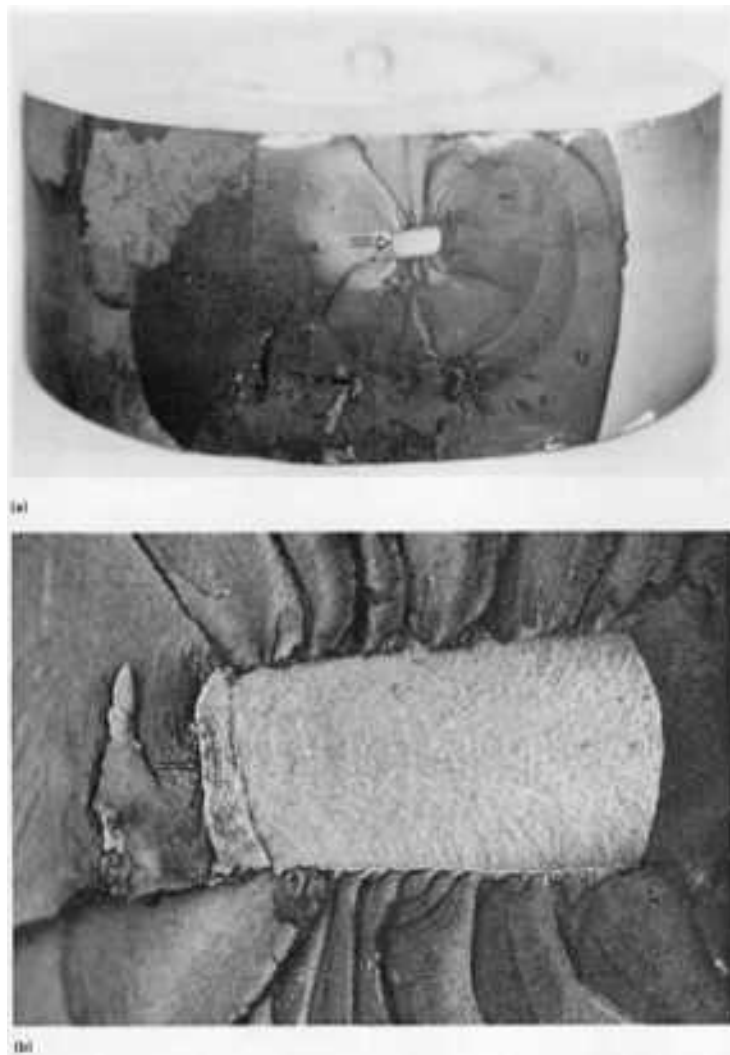
**Fig. 64 Example of a line spall in a forged, hardened steel roll. (a) Section containing the spall cut from the roll. The arrow indicates the origin of the fracture, about 6 mm (0.25 in.) below the roll surface. (b) The fracture origin at 6.5 $\times$ . Fatigue beach marks originate at the arrow; gross fracture marks can be seen radiating from the fatigue zone.**

Figure 64 shows another example of a line spall on a hardened steel roll body. In this case, the spall is rather small and did not progress far before the section spalled off. The enlarged view shows a well-defined fatigue origin (arrow). The ridge marks emanating from the fatigue area clearly reveal the crack growth direction in the overload portion.

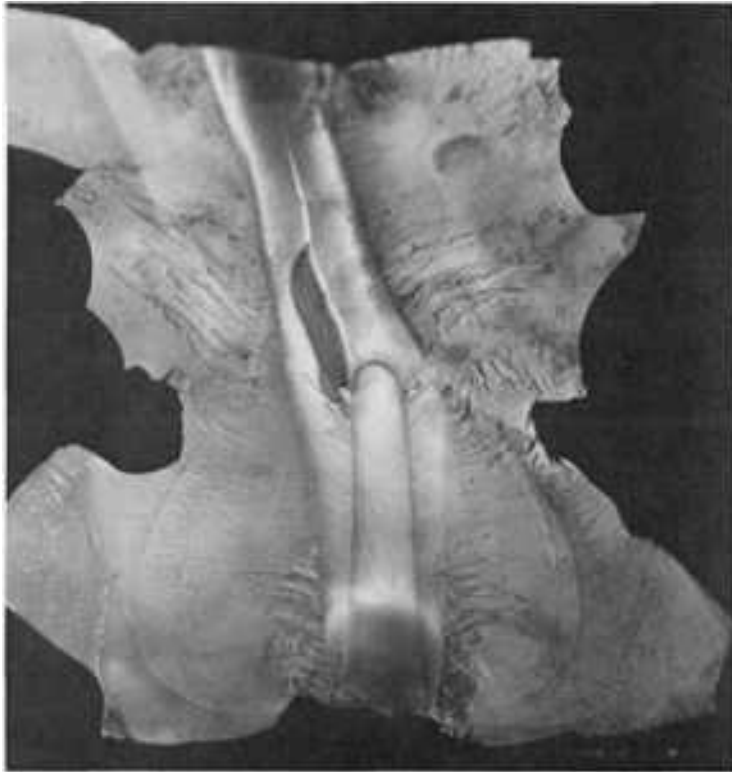
**Fig. 65 Macrograph showing a line spall that broke off a forged, hardened alloy steel roll. The central region of the fracture shows evidence of crack growth by fatigue. Final rupture occurred by brittle fracture. See also Fig. 66. 0.65×**

Figure 65 shows another example of a line spall fracture from a hardened steel roll. Fine fatigue marks can be seen in the finger-shaped portion of the line spall fracture at the bottom of the macrograph. The marks indicate that the crack growth direction was from the arrow at the bottom of the picture and toward the top. After the linear portion in the center of the spall formed, final rupture occurred from the linear portion outward, as indicated by the ridge marks in the overload zone and their origin at the boundary of the linear portion of the spall. Figure 66 shows the outer roll surface of the spall, that is, the reverse side shown in Fig. 65. Macroetching of the surface revealed two intersecting craze crack patterns indicative of abusive service conditions.

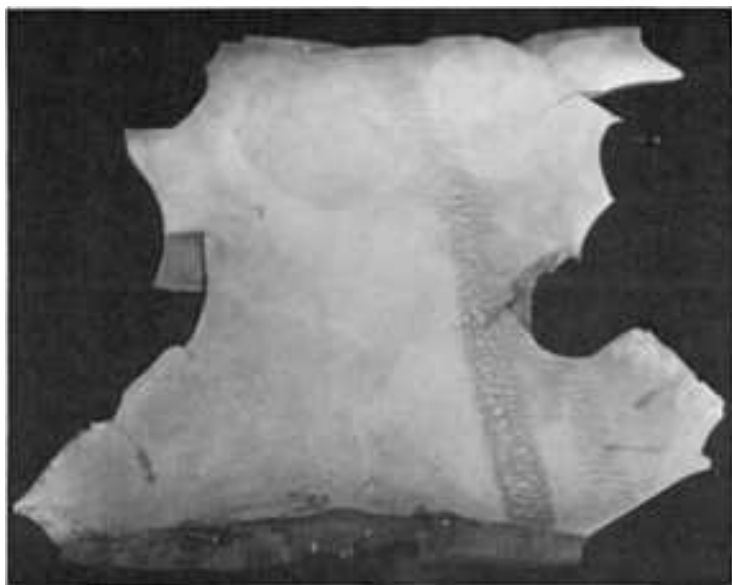
**Fig. 66 The roll surface of the spall shown in Fig. 65 after macroetching with 10% aqueous  $\text{HNO}_3$ . Etching revealed a craze crack pattern similar to heat checks, caused by abusive service conditions. About 0.5×**

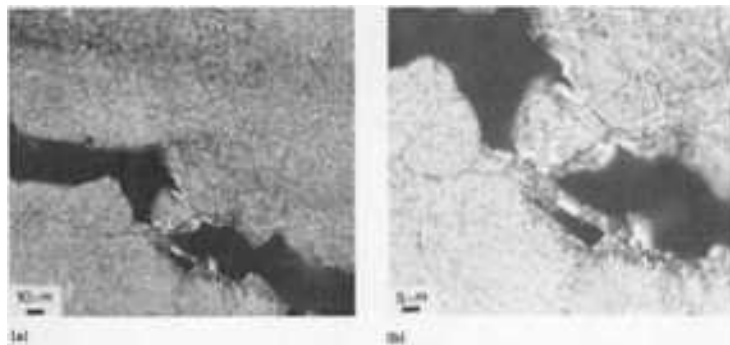
**Fig. 67 Two views of white-etching deformation bands, termed butterflies, that formed at a growing fatigue crack in a forged, hardened alloy steel mill roll. The crack would have led to spalling in later service. These white-etching zones form from the original tempered martensite due to cyclic service stresses and are often observed at the initiation sites of spalls.**

Although loaded in compression, bearings will fail by rolling-contact fatigue after long life even when the inclusion content is extremely low. The high applied loads alter the surface microstructure, generally by localized strain hardening around a hard oxide inclusion, producing a white-etching region referred to as a butterfly. Figure 67 shows an example of such a white-etching feature in a hardened steel roll. These features never form around sulfide inclusions, which are softer and more ductile than oxides. Butterflies nucleated at spherical primary carbides in M50 bearing steel have also been observed (Ref 155). In some cases, lenticular carbides form at the interface between the butterfly and the matrix, and they can also act as nucleation sites. The hardness of the white-etching butterflies is considerably greater than that of the matrix.

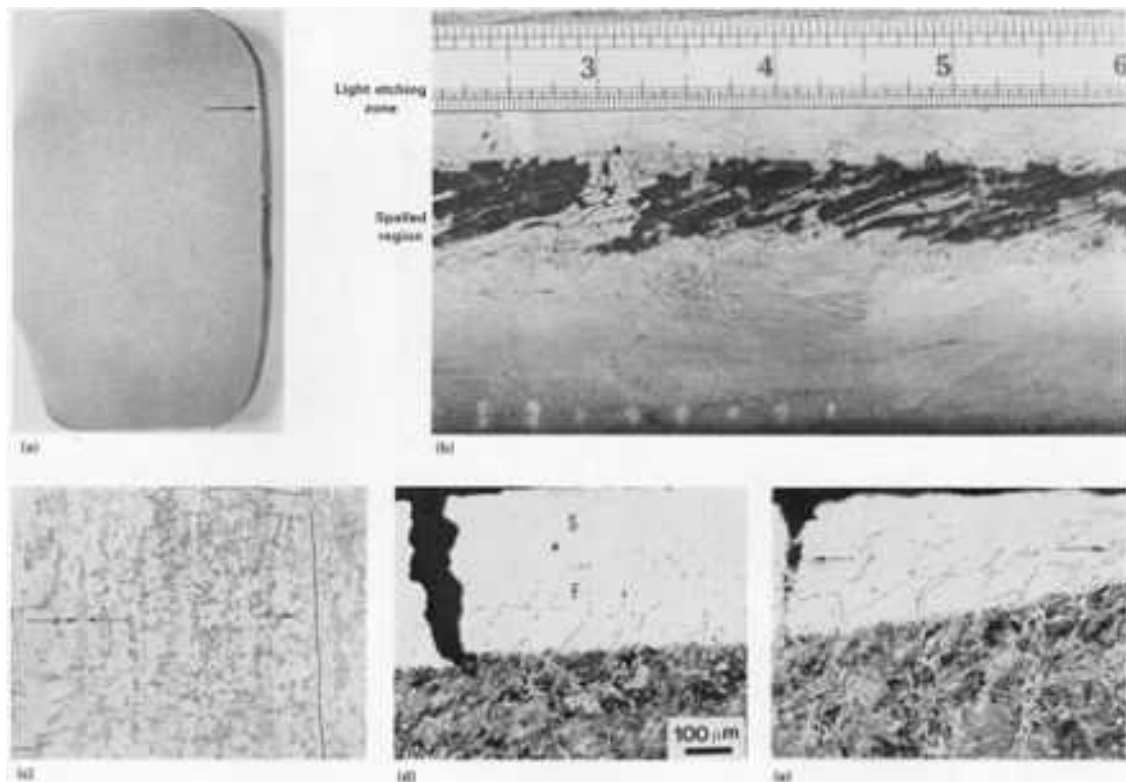
**Fig. 68 Spalling of the hard surface region of a rail head was caused by rolling-contact fatigue in service. The hard area was formed by localized overheating, probably by spinning locomotive wheels. (a) Section through rail head, with field side at top and gage side at bottom. (b) Rail surface. 1.2×. (c) Rail surface. 9×. (d) Area adjacent to spall showing featureless surface zone (S), featureless zone with ferrite (F), and pearlite matrix (P). 7×. (e) Section from near field side. Etched with 4% picral. 80×**

An example of such a problem is shown in Fig. 68. The particular steel rail was a 67-kg/m (136-lb/yd) rail with 0.74% C and 0.90% Mn. Top and side views of the spalled regions are shown. X-ray diffraction analysis of the spalled area revealed the presence of iron oxides ( $\text{Fe}_2\text{O}_3$  and  $\text{Fe}_3\text{O}_4$ ) and sand (sand is sometimes used to improve traction). Spinning locomotive wheels can generate enough frictional heat to re-austenitize the surface of a rail head. The mass of the rail acts as a heat sink to provide cooling rates high enough to form as-quenched martensite. Microhardness testing of the white-etching layer found in the spalled region (Fig. 68) revealed a hardness of 60 HRC. The interior hardness was 28 HRC, typical of an as-rolled fully pearlitic rail.

The maximum depth of the white-etching layer was 0.4 mm (0.0175 in.). Surface regions away from the spall (Fig. 68) exhibited a heat-checked crack pattern and scorch marks. The white-etching layer consisted of two zones, the outer, featureless zone (S) and an inner zone with a ferrite network (F). These micrographs were taken in the heat-checked region near the spall. Beneath the S and F zones is the normal pearlitic rail microstructure. Tempering of the specimen at 540 °C (1000 °F) precipitated spheroidized carbides in the white-etching layer. The distortion of the ferrite in the F zone near the rail head field side (outside) occurred before formation of the white-etching layer because of deformation of the microstructure by heavy wheel loads. This deformed structure was then austenitized by the spinning locomotive wheels. Martensite subsequently formed with cooling. Later, spalling in the white-etching layer occurred because of subsequent train traffic.

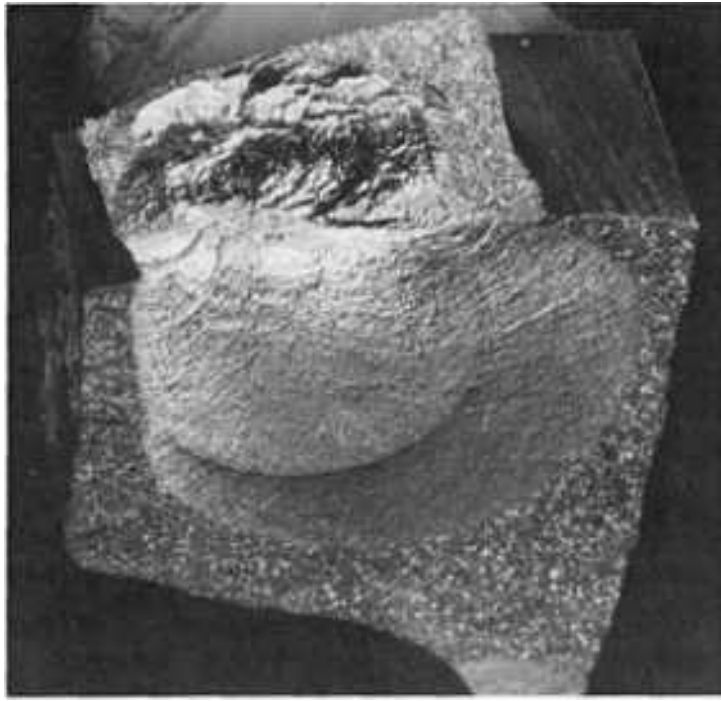
**Fig. 69 Macrograph of broken rail showing the interconnection between the shell fracture (across the top) and the detail fracture (on the transverse plane). 3.5×. (R. Rungta, Battelle Columbus Laboratories)**

The shell-type fracture on the rail head forms on the plane of maximum residual tensile stress and may be aided by the presence of large inclusions or clusters of inclusions at this location. Another type of rail fracture, called a detail fracture, can form as a perturbation from the shell crack under cyclic loading. The detail crack is constrained and exists as an internal flaw during the early stages of its growth because it is impeded at the gage side (inside edge) of the rail and at the rail head by longitudinal compressive stresses. The detail crack forms perpendicular to the shell fracture and is connected to the shell fracture (Fig. 69). Such defects are relatively rare; only about  $3\frac{1}{2}\%$  of 30,000 of all defects were detail cracks (Ref 137).

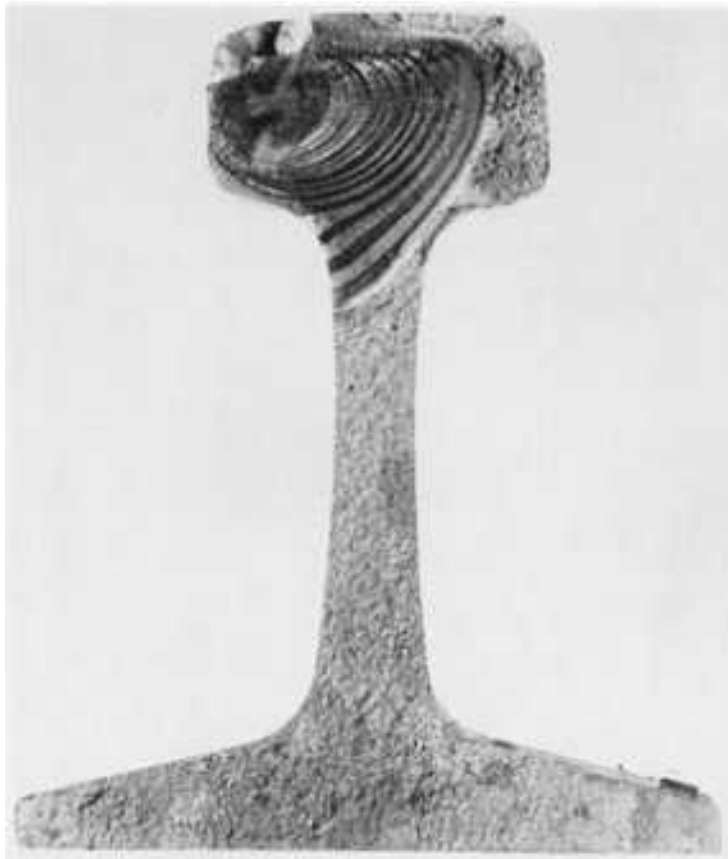
**Fig. 70 Macrograph of a rail that contained a detail fracture (upper left, beneath the rail head surface) that was placed in service in the FAST test track. Note the fatigue fracture that grew from the detail fracture. 0.75×. (R. Rungta, Battelle Columbus Laboratories)**

However, they can grow with cyclic loading and can lead to gross fracture of the rail (Fig. 70). Figure 70 shows the fracture face of a rail with a detail crack that was used under controlled conditions at the Faculty for Accelerated Service Testing (FAST). The fracture face shows well-defined fatigue marks growing from the detail fracture.

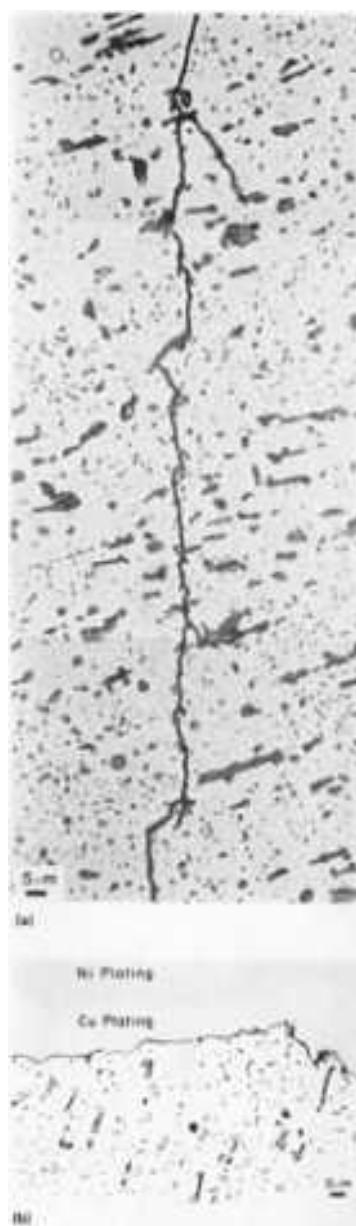
**Fig. 71 Fatigue cracks in an unbroken (a) and completely broken (b) aluminum alloy. (a) Etched with Kroll's reagent. 680× (b) Etched with Keller's reagent. 510×**

As-polished samples should be examined first with bright-field illumination and then with dark-filled illumination, differential interference contrast (DIC) or oblique light, and polarized light, if the specimen will respond to such illumination. Dark-field illumination is very useful and is highly suited to the examination of cracks and voids. Photography in dark field is more difficult, but not impossible if an automatic exposure device is available. Oblique light and DIC are very useful for revealing topographic (relief) effects. For example, Fig. 16 shows a fatigue crack in an aluminum alloy viewed with bright-field illumination and DIC where the specimen was not etched. Although the second-phase precipitates can be seen in both views, they are more clearly revealed with DIC (compare these views with the bright-field etched micrograph of this specimen shown in Fig. 71).

**Fig. 16 Comparison of bright-field (a) and Nomarski DIC (b) illumination for examination of a fatigue crack in an as-polished aluminum alloy. See also Fig. 71. Both 600×**

Figure 71(a) shows the same fatigue crack in an aluminum alloy as shown in Fig. 16, but after etching. The roughness of the crack pattern and the interaction with the intermetallic particles are evident. Figure 71(b) shows a similar fatigue crack in the same aluminum alloy after etching; but in this case, the specimen was completely broken, and only one side of the fracture can be observed. Comparison of Fig. 71(a) and 71(b) clearly shows that the nature of the crack pattern is much easier to observe in a partially broken specimen where both sides of the fracture can be observed. Figure 72 shows a fatigue crack in a ferrite-pearlite carbon steel after etching in which both sides of the crack can be observed. The irregular path of the crack through the ferrite phase is evident in Fig. 72 as compared to the nature of cleavage cracks in ferrite shown in Fig. 47.

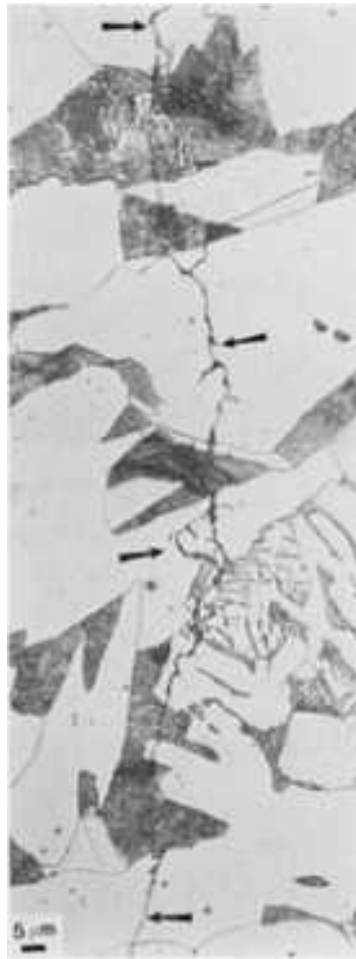
**Fig. 72 Fatigue crack (arrows) in a ferrite-pearlite microstructure in a carbon steel. Etched with 2% nital. 800×**

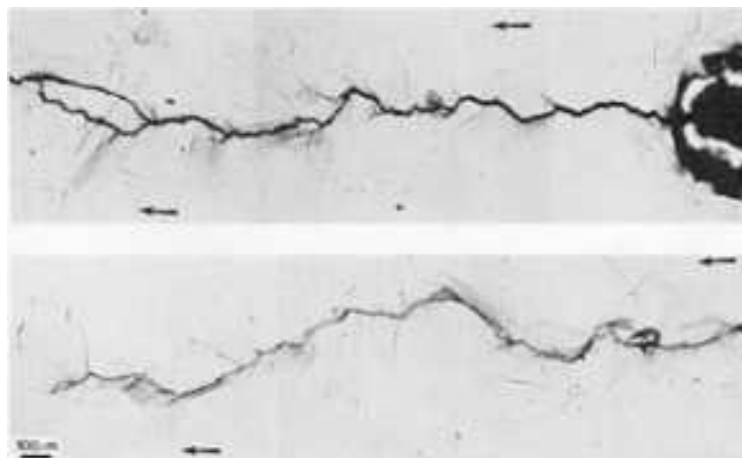
**Fig. 73 Fatigue crack appearance in an austenitic stainless steel specimen polished before fatigue loading, revealing slip lines on surfaces associated with crack formation and growth. Arrows indicate the direction of crack**

As a final note on the microscopic aspects of fatigue, the use of DIC illumination to study the progression of slip during cyclic loading will be briefly discussed. The sensitivity of DIC for revealing the progression of slip and microcrack formation has been demonstrated by using polished specimens of Nickel 200 examined after cyclic loading (Ref 190). When the Wollaston prism is fully inserted to produce a dark blue-green image, the surface deformation from slip is vividly revealed. Slip can also be observed by using bright-field illumination (Fig. 73), but DIC is more sensitive, particularly in the early stages of slip.

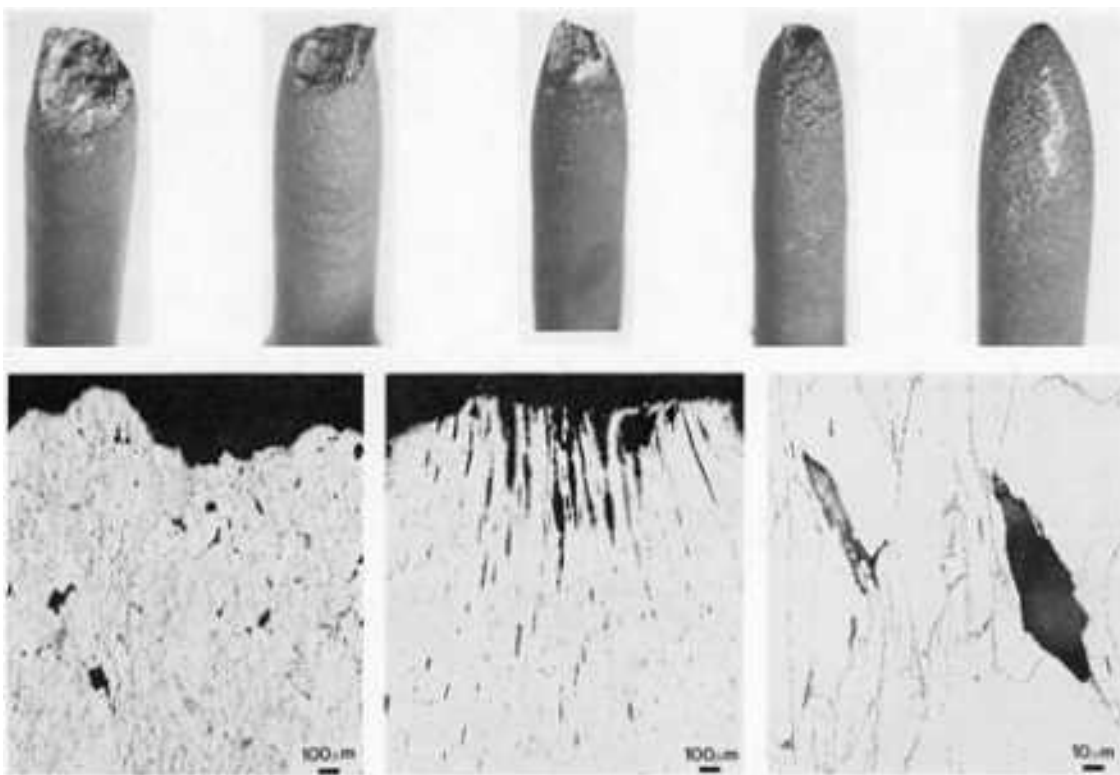
**Fig. 74 Macrographs (top) and microstructures (bottom) of short-time type 316 stainless steel tensile specimens tested at various temperatures. Top, from left: specimens tested at 760 °C (1400 °F), 815 °C (1500 °F), 870 °C (1600 °F), 925 °C (1700 °F), and 980 °C (1800 °F). Bottom, from left: Specimen tested at 760 °C (1400 °F). 35 ×. Specimen tested at 980 °C (1800 °F) 35 ×. Specimen tested at 815 °C (1500 °F). 350 ×. Specimens at bottom etched with mixture of HCl, HNO<sub>3</sub>, and H<sub>2</sub>O.**

The simplest measure of high-temperature properties is provided by the use of short-time tensile tests. Hot hardness tests are also quite useful. Figure 74 shows fractures of short-term high-temperature tensile specimens of type 316 stainless steel tested at 760 to 980 °C (1400 to 1800 °F). The reduction of area of the tensile fractures shown increases with temperature. Cup-and-cone fractures are not observed, however. The microstructures shown illustrate the formation of voids at the grain boundaries, which is typical of high-temperature tests. Precipitation of grain-boundary carbides (sensitization) can be clearly seen in the high-magnification view of the specimen tested at 815 °C (1500 °F). This is an example of a change in microstructure caused by high-temperature exposure.

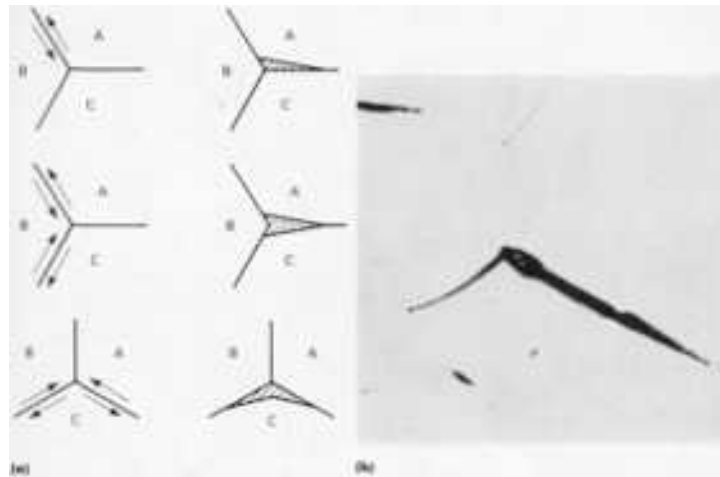
**Fig. 75 One mechanism of intergranular cracking. (a) Schematic showing cracking due to grain-boundary sliding. Arrows along a grain boundary indicate that this boundary underwent sliding. (b) Cracks and voids in Al-5.1 Mg that was stress rupture tested at 260 °C (500 °F). Electrolytically polished. 60 ×. Source: Ref 194**

Tests at temperatures above the equicohesive temperature have revealed two types of intergranular fracture. When grain-boundary sliding occurs, wedge-shaped cracks may form at grain-boundary triple points (as observed on a plane-of-polish) if the tensile stresses normal to the boundaries exceed the boundary cohesive strength. In the literature, these cracks are referred to as wedge or w-type, or as triple point or grain-corner, cracks. High stresses promote this type of crack formation. One of the ways in which such cracks can form is shown in Fig. 75.

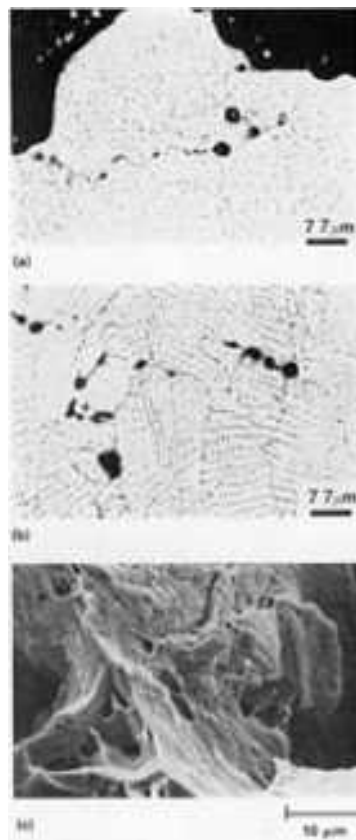
**Fig. 76 Microstructure and fracture appearance of type 316 stainless steel tested in creep to fracture in air at 800 °C (1470 °F) at a load of 103 MPa (15 ksi). Time to rupture: 808 h. Light micrographs (a and b) illustrate r-type cavities caused by vacancy condensation on boundaries perpendicular to the stress axis. Both 90 × and electrolytically etched with oxalic acid. The SEM fractograph (c) illustrates the formation of the r-type cavities at the grain boundaries. 1260 ×. (W.E. White, Petro-Canada Ltd.)**

Figure 76 illustrates r-type cavities at grain boundaries in type 316 stainless steel tested under creep conditions. The SEM fractograph shows the r-type cavities on the fracture surface, while the etched cross sections reveal the cavities at and behind the fracture face and their relationship to the grain boundaries. Figure 77 shows w-type cracks in type 316L stainless steel tested under creep conditions. The w-type cracks and the orientation to the stress axis (vertical in the micrograph) are easily observed in the light micrograph, but are not obvious in the SEM fractograph. Figure 78 shows grain-boundary triple-point cracking and extensive deformation in type 316 stainless steel tested at a slightly lower temperature. It is interesting to compare the three SEM fractographs in Fig. 76, 77, and 78. Figure 79 shows crack nucleation in a type 316 stainless steel specimen with heavy carbide precipitation. Cracking has occurred along the grain-boundary carbides, and the SEM fractography reveals a heavy concentration of carbides on the intergranular fracture surface.

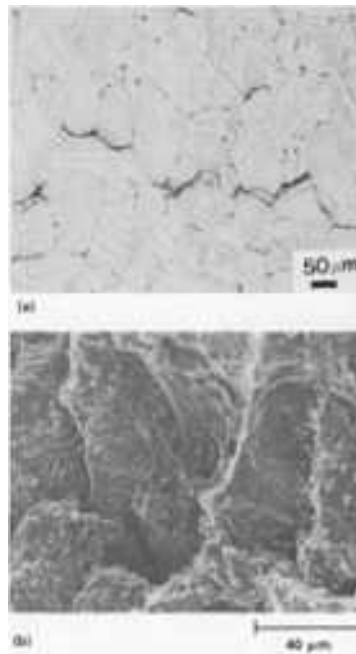
**Fig. 77 Microstructure and fracture appearance of type 316L stainless steel tested in creep to fracture in air at 800 °C (1470 °F), using a 53-MPa (7.7-ksi) load. Time to rupture: 839 h. The light micrograph (a) illustrates w-crack coalescence by slow shearing along grain boundaries. The SEM fractograph (b) shows the fracture appearance characterized by poorly formed shear dimples and particle dragging. (a) Electrolytically etched with oxalic acid. 84 ×. (b) 420 ×. (W.E. White, Petro-Canada Ltd.)**

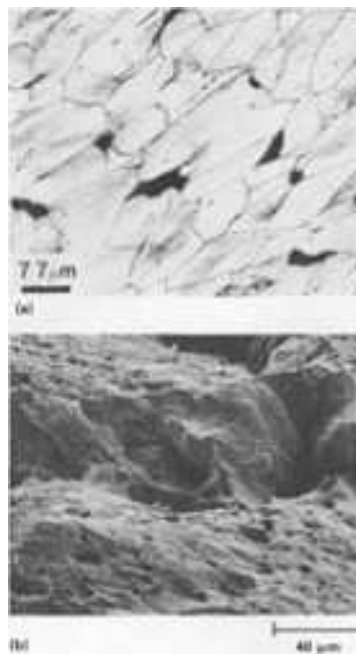
**Fig. 78 Microstructure and fracture appearance of type 316 stainless steel tested in creep to fracture in air at 685 °C (1265 °F) at a load of 123 MPa (17.9-ksi). Time to rupture: 710 h. The light micrograph (a) shows triple boundary cracking with extensive bulk deformation and grain elongation. The SEM fractograph (b) illustrates classic shear dimple topography. (a) Electrolytically etched with oxalic acid. 110 ×. (b) 380 ×. (W.E. White, Petro-Canada Ltd.)**

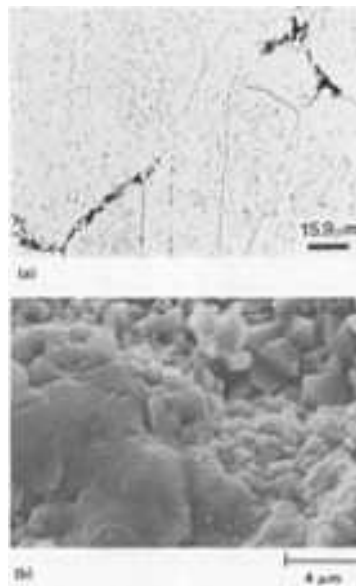
**Fig. 79 Microstructure and fracture appearance of type 316 stainless steel tested in creep to fracture at 770 °C (1420 °F) using a 62-MPa (8.95-ksi) load. Time to rupture: 808 h. (a) Optical micrograph showing crack nucleation and growth by decohesion along the carbide/matrix interfaces. Etched with dilute aqua regia. 440 ×. (b) SEM fractograph illustrating carbide morphology at the fracture surface. 3150 ×. (W.E. White, Petro-Canada Ltd.)**

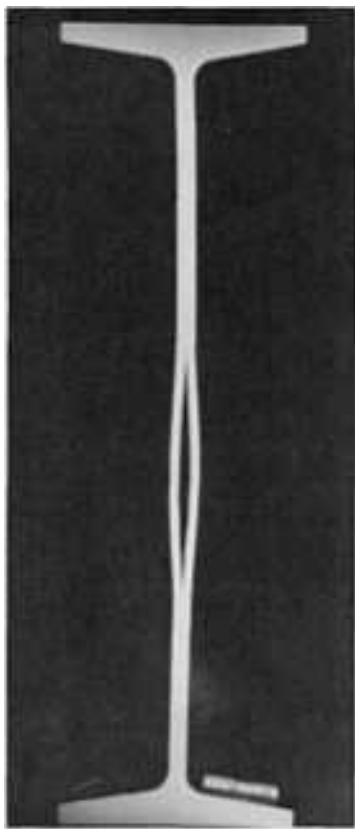
**Fig. 81 Hydrogen blister in the web of a structural steel section. About 0.3 ×**

In addition to flaking, blisters can be produced by excess hydrogen (Fig. 81). Hydrogen can also be introduced into steels during other processes, such as welding, pickling, bluing, enameling, or electroplating. Consequently, it is necessary to bake the material after such processes if the material is prone to hydrogen damage.

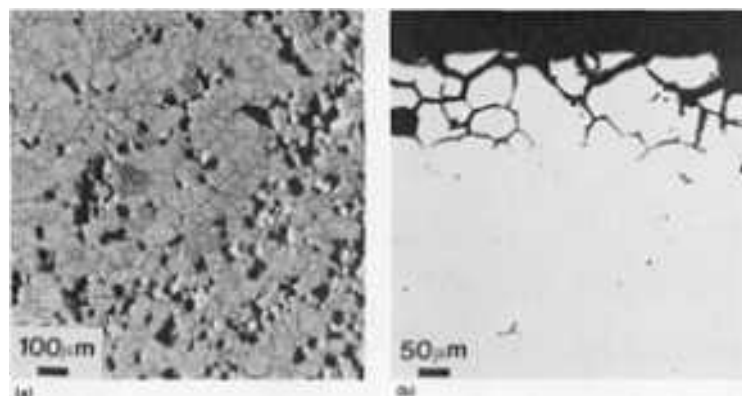
**Fig. 82 Planar (a) and cross sectional (b) views of intergranular corrosion (grain dropping) in a sensitized austenitic stainless steel. As-polished. (a) 50×. (b) 100×**

Figure 82 shows two views of an austenitic stainless steel exhibiting intergranular corrosion. Figure 82(a) shows the surface of the sample. The grain structure is visible due to the attack, and some grains have fallen out (referred to as grain dropping). The cross-sectional view (Fig. 82b) shows the depth of penetration of the attack along the grain boundaries.

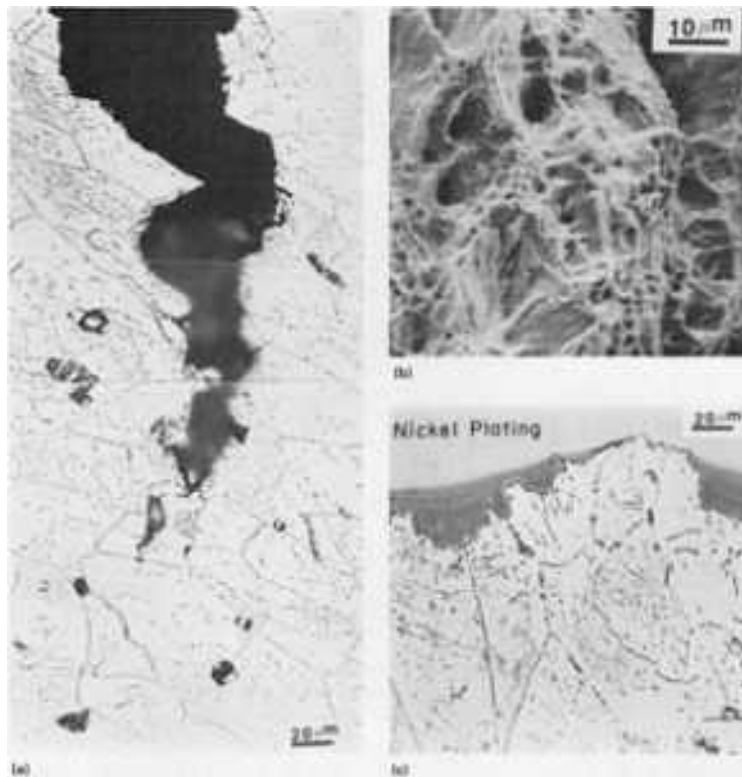
**Fig. 83 Three views of a fractured sensitized specimen of type 304 stainless steel. (a) Partially broken specimen. Etched with mixed acids. (b) SEM view of fracture; specimen broken at  $-195^{\circ}\text{C}$  ( $-320^{\circ}\text{F}$ ). (c) Cross section of fracture. Etched with acetic glyceric acid**

Figure 83 shows the fracture of sensitized type 304 austenitic stainless steel broken in a noncorrosive environment. The micrograph of the partially broken specimen shows that the fracture is not totally intergranular. There are microvoids in the matrix beside and ahead of the crack. These often nucleate at large carbides. In the completely broken specimen, shown by SEM and with a cross section, there is little evidence for intergranular fracture in the traditional form. There are some tendencies, but the fracture surface is covered with fine dimples that form around the carbides.

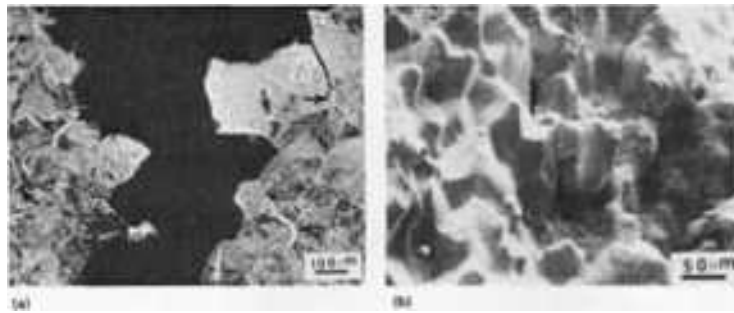
**Fig. 84 Eutectoid carbon steel specimen embrittled by liquid copper at 1100 °C (2010 °F). (a) Micrograph of partially broken specimen; arrows point to grain-boundary copper penetration. Etched with 4% picral. (b) SEM fractograph of completely broken specimen**

Figure 84 shows a metallographic cross section of eutectoid rail steel embrittled by liquid copper and an SEM view of the fracture surface. Tensile specimens were heated to  $2110^{\circ}\text{F}$  ( $1100^{\circ}\text{C}$ ) and loaded at 12.5 to 50% of the normal tensile strength at this temperature. Liquid copper was present at the base of a V-notch machined into the specimen. Fracture occurred in a few seconds at 50% of the tensile strength (SEM view of this sample), and the time to fracture increased with decreasing load.

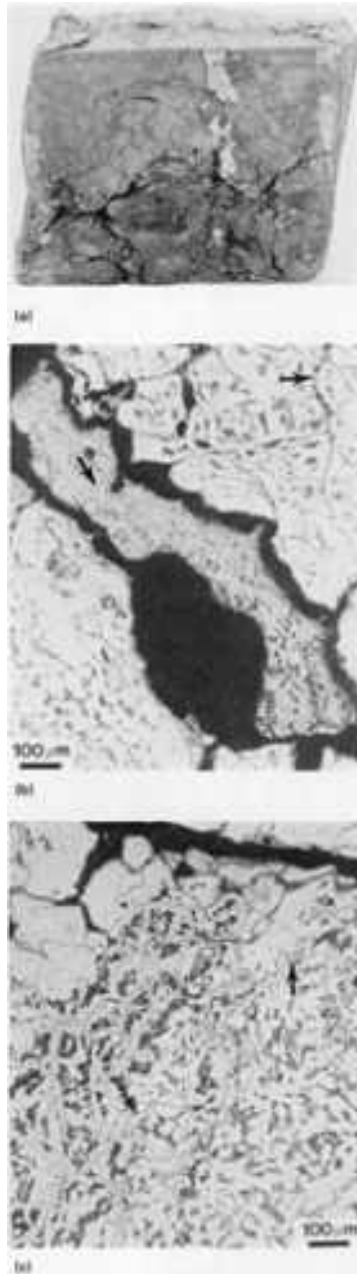
**Fig. 85 Hot shortness in a structural steel caused during rolling by internal LME due to copper segregation. (a) Macrograph of section from toe of flange. 0.4 ×. (b) and (c) Micrographs showing grain-boundary copper films that were molten during rolling. (b) and (c) Etched with 2% nital. Both 70×**

Hot shortness in steels can be caused by copper segregation in steels alloyed with copper. Figure 85 shows an example of hot shortness in a structural steel section in a copper-containing grade. At the rolling temperature, the segregated, elemental copper was molten. When the section was rolled, it broke up because the liquid copper wetted the austenite grain boundaries.

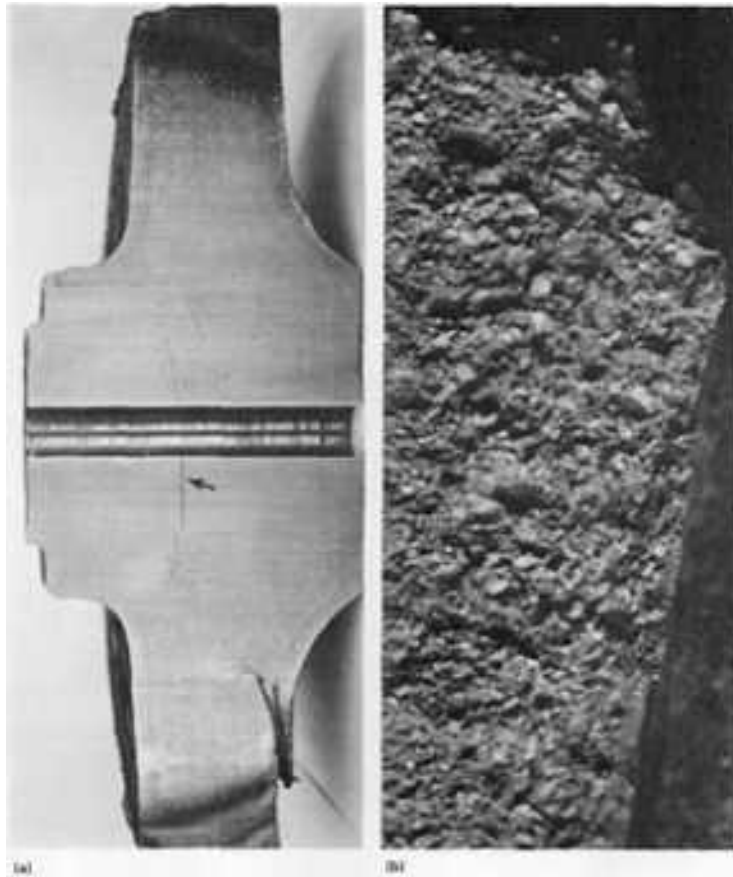
**Fig. 86 Alloy steel compressor disk that cracked from overheating during forging. (a) Macrograph of disk (cracking at arrow). 0.4 $\times$ . (b) Fracture surface of a specimen from the disk that was normalized, quenched, and tempered to 321 to 341 HB. The treatment revealed facets indicative of overheating. 5 $\times$**

Figure 86 shows a section through the center of an alloy steel compressor disk that cracked during forging because of overheating. A specimen was cut from the disk and normalized, quenched and tempered (to a hardness of 321 to 341 HB), and fractured, revealing facets indicative of overheating (Fig. 86). Figure 87, which shows another example of facets, illustrates the fracture of a vanadium-niobium plate steel slab due to overheating. The accompanying micrograph shows that substantial carbon segregation and grain growth were present in the overheated region.

As discussed earlier, fracture tests are commonly used to detect overheating. A test specimen of appropriate size for subsequent fracturing is normalized, austenitized, quenched and tempered to about 321 HB, and fractured, usually at room temperature. The appearance of coarse-grain facets on the fracture, as shown in Figures 86, 87, and 88, is taken as proof of overheating.

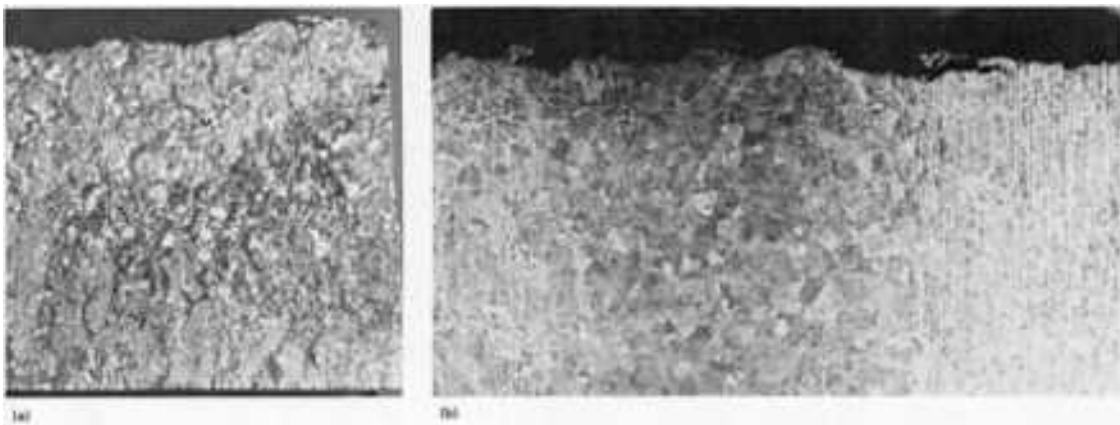
**Fig. 87 Fracture (a) of a slab that was rolled from a vanadium-niobium plate steel. The coarse fracture facets indicate overheating before hot rolling. 1.25 $\times$ . The etched section (b, with fracture along the top edge) shows carbon segregation in the center, as evidenced by the greater amount of pearlite. Note also the coarseness of the pearlite in the center. Etched with 2% nital. 3.5 $\times$**

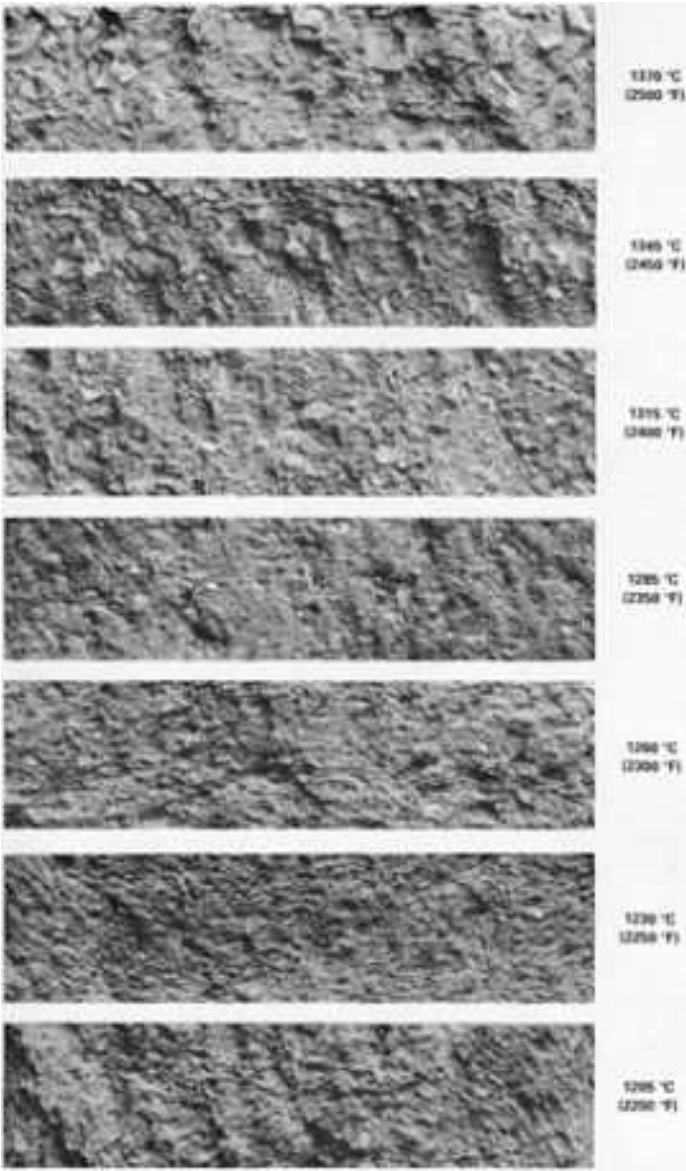
**Fig. 88 Macrographs of specimens of ASTM A508 class II steel heated to the indicated temperatures, normalized, quenched, tempered to about 37 to 39 HRC, and fractured. Overheating facets are observed in all samples, but are not excessively large until the steel is heated to 1260 ° (2300 °F) or above. Source Ref 390**

Another investigation showed interesting features of fractures of overheated ASTM A508 class II forging steel (Ref 390). The number of facets per square inch of test fracture depended on both the overheating temperature and the tempering temperature for the fracture test (also shown in Ref 392). For a given soak temperature, the number of facets per square inch decreased as the tempered hardness decreased. For the same tempered hardness, the facet density increased as the soaking temperature increased. Figure 88 shows a series of test fractures of ASTM A508 class II material soaked at 1205 to 1370 °C

(2200 to 2500 °F) and then quenched and tempered to a hardness of 37 to 39 HRC. Figure 89 shows SEM views of typical facets in samples soaked at 1205 and 1370 °C (2200 and 2500 °F). The sulfides in the dimples in the 1370- °C (2500- °F) specimen are clearly visible, but those in the 1205- °C (2200- °F) specimen are extremely fine. This difference arises from the greater dissolution of the original sulfides at the higher temperature. Because more of the sulfides are dissolved at higher temperatures, more are available for reprecipitation in the austenite grain boundaries upon cooling.

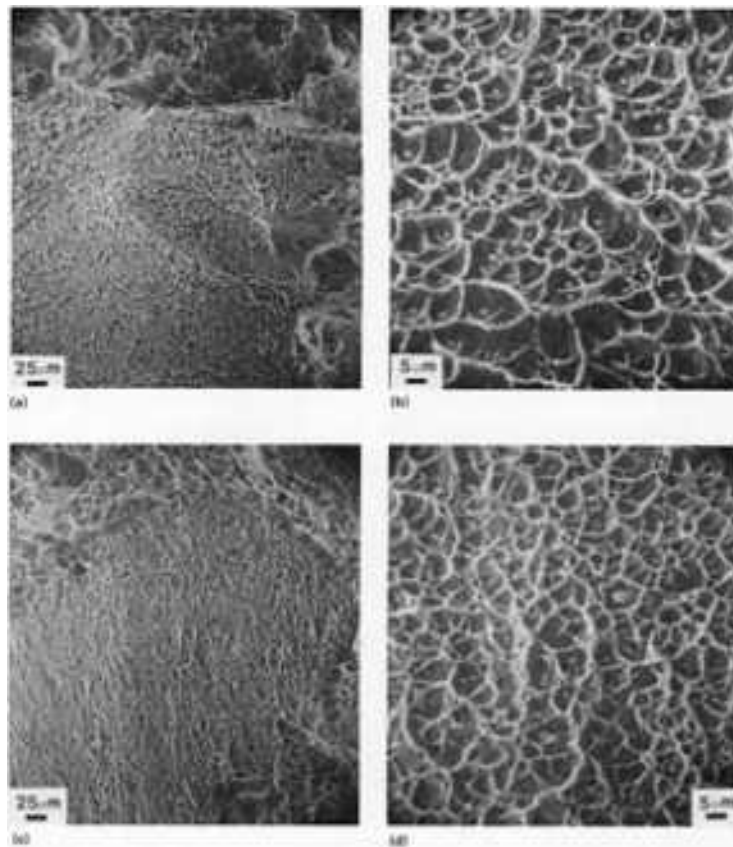
**Fig. 89 SEM fractographs of the appearance of facets in specimens heated to 1205 and 1370 °C (2200 and 2500 °F). (a) and (b) Specimens heated to 1370 °C (2500 °F). (c) and (d) Specimens heated to 1205 °C (2200 °F). (a) 135 ×. (b) 680 ×. (c) 135 × (d) 680 ×. Source: Ref 390**

The number of facets in these specimens varied from  $4/\text{cm}^2$  ( $24/\text{in.}^2$ ) at 1205 °C (2200 °F) to  $121/\text{cm}^2$  ( $783/\text{in.}^2$ ) at 1370 °C (2500 °F). The facet size also increased with temperature because of grain growth at the soaking temperature. The facet fracture appearance has been referred to as intergranular microvoid coalescence due to the presence of dimples on the intergranular surfaces. Although some early researchers tried to study the facets using light fractography, subsequent investigators have used electron metallographic techniques.

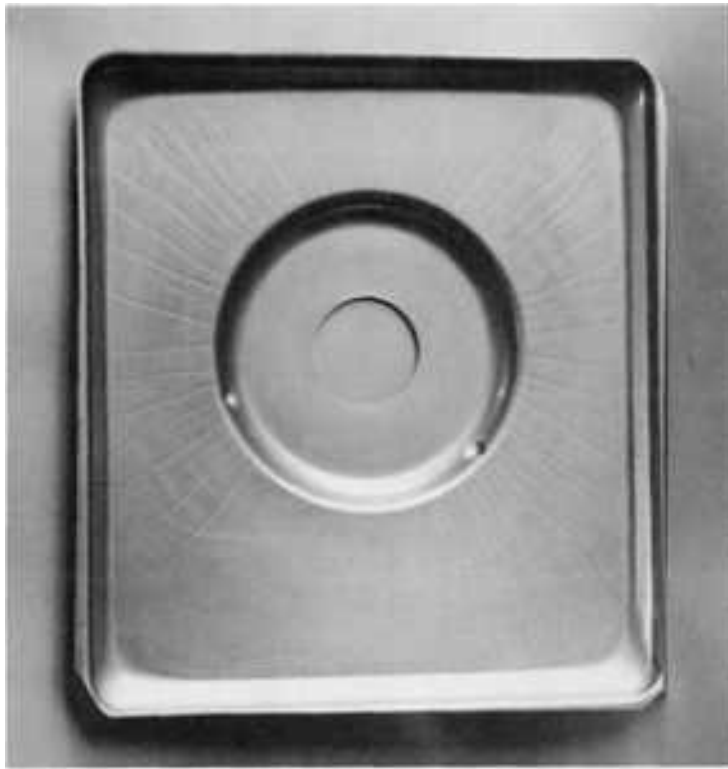
**Fig. 90 Stretcher-strain marks (Lüders bands) on the surface of a range component after forming 0.25 ×.**

Strain aging can also lead to stretcher-strain formation (Lüders bands) on low-carbon sheet steels. These marks are cosmetic defects rather than cracks, but the formed parts are unacceptable (Fig. 90). During tensile loading, such a sheet steel exhibits

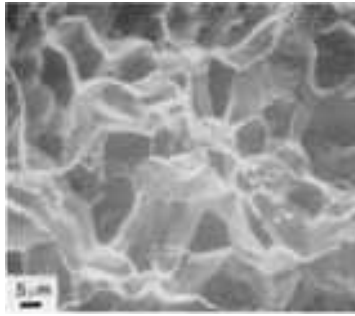
**Fig. 91 SEM fractograph of a quench crack surface in AISI 5160 alloy steel showing a nearly complete intergranular fracture path. 680×**

The fracture surfaces of quench cracks are always intergranular. Macroscopic examples of quench cracks are shown in Ref 407. Quench crack surfaces are easiest to observe using SEM (Fig. 91). In quenched-and-tempered steels, proof of quench cracking is often obtained by opening the crack and looking (visually) for temper color typical for the temperature used (Ref 414). Figure 92 shows a guide for predicting temper colors as a function of temperature and time for carbon steels. Table 1 lists temperatures at which different temper colors occur for a carbon tool steel and a stainless steel. The microstructure adjacent to the crack will not be decarburized unless a specimen with an undetected quench crack is rehardened. Quench cracks always begin at the part surface and grow inward and are most commonly oriented longitudinally or radially unless located by a change in section size.

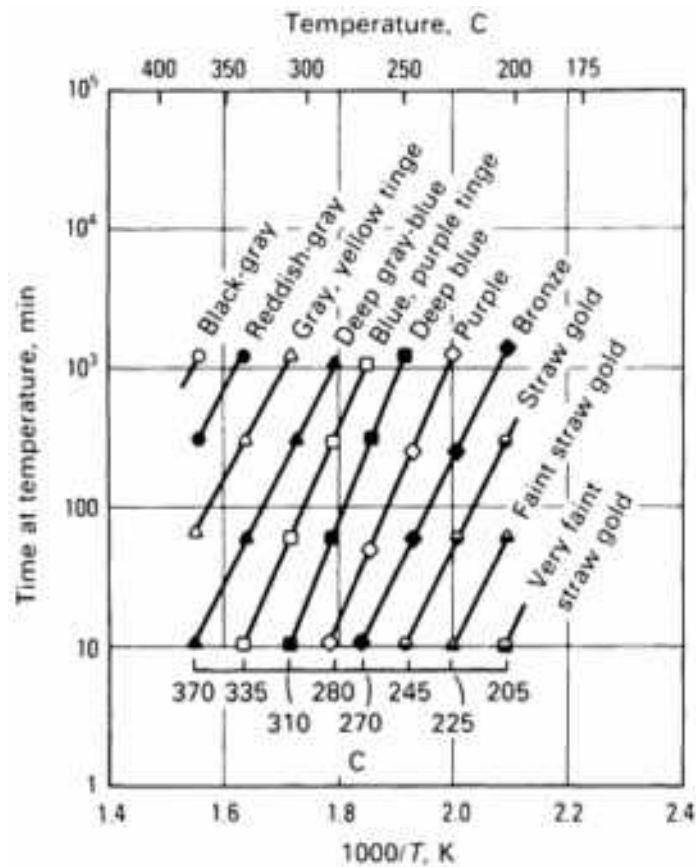
**Fig. 92 Temper colors as a function of time at heat for AISI 1035 steel. Source: Ref 414**

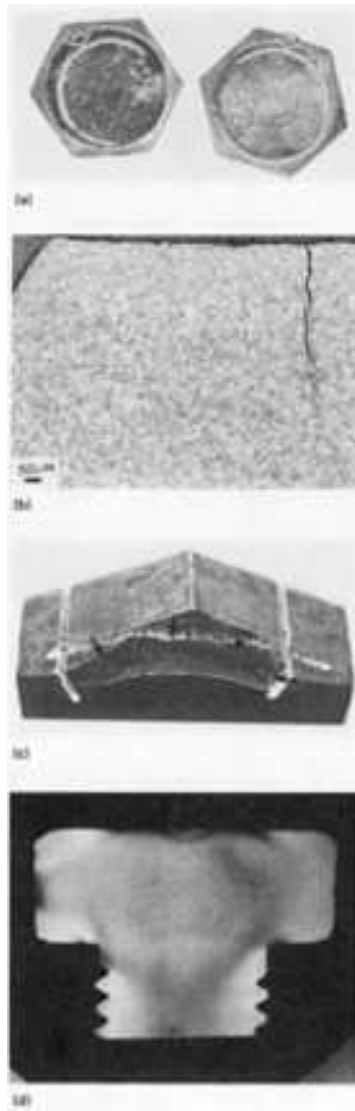
**Fig. 93 Example of quench cracks on the head of AISI 1040 steel bolts. Cracks were caused by incomplete development of the case. (a) Bolt heads at 0.72 $\times$ ; cracks accentuated using magnetic particles. (b) Quench crack near a corner. Etched with 2% nital. 54 $\times$ . (c) Opened quench crack with arrows indicating temper color. 1.5 $\times$ . (d) Macrograph showing lack of complete case hardening around head. Actual size**

Figure 93 shows an interesting example of quench cracking on ASTM A325 bolts heat treated in an automated, high production rate furnace system. Quench cracks in bolts usually occur longitudinally, often due to the presence of seams. These cracks, however, were circumferential, running part way around the head of the bolts, as shown in Fig. 93 (magnetic particles show the cracks). The furnace had not been used for about 2 years, and no cracking had occurred in the past. During the time the furnace was not in use, two factors had occurred that influenced the problem. First, a cooling tower was installed so that the quench water was recirculated rather than used once and discharged. Therefore, the quench water was typically about 10 to 35 °C (20 to 60 °F) warmer, depending on the time of the year. Second, basic oxygen furnace (BOF) steel (AISI 1040) was now being used rather than electric furnace (EF) steel. Basic oxygen furnace steel has a lower residual alloy content than electric furnace steel. Both of these factors reduced the hardenability.

Metallographic examination (Fig. 93) showed that the bolt heads were not uniformly hardened. The outer surface of the bolts from the wrench flats inward were hardened, but the middle of the top surface was not. Bolts from the same heats treated in other furnaces were uniformly case hardened across the heads and did not crack. The quench cracks were observed to form in the hardened region, near the interface of the unhardened surface zone. The furnace atmosphere in the line where cracking occurred had a reducing atmosphere, while the others had oxidizing atmospheres. This difference in atmospheres is known to reduce the cooling rate during quenching. When the furnace atmosphere was made oxidizing, cracking stopped. Higher-hardenability bolts treated in the furnace did not crack even when the reducing atmosphere was used.

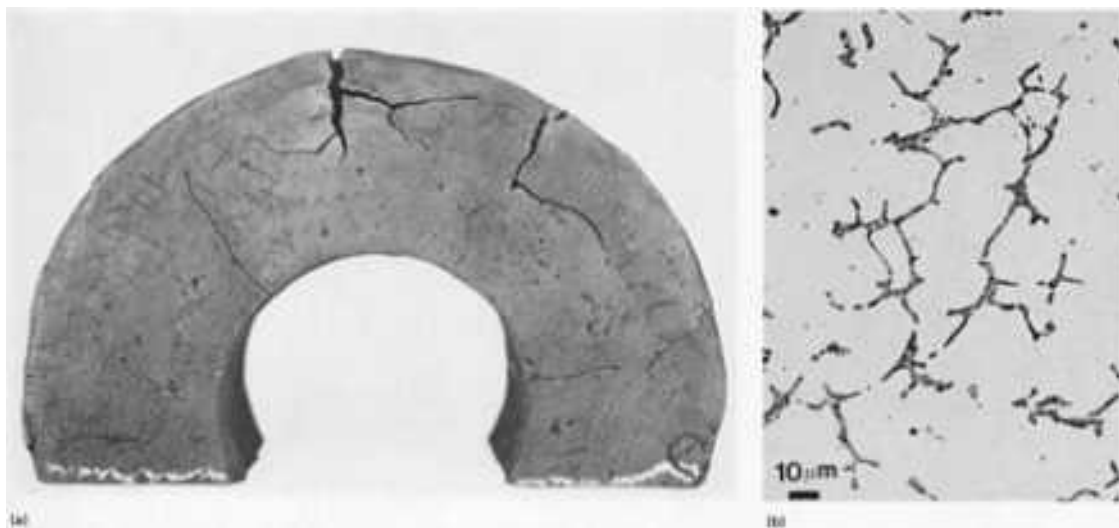
**Fig. 94 Cracked 25Cr-12Ni cast stainless quenching fixture. (a) Macrograph of part of the fixture. (b) Microstructure showing substantial  $\sigma$  phase. Electrolytically etched with 10 N KOH. 500×**

Figure 94 shows part of a broken hook used to hold a heat treatment basket during austenitization and quenching. The hook was made from cast 25Cr-12Ni heat-resisting steel; but the composition was not properly balanced, and a higher-than-normal  $\delta$ -ferrite content was present in the hook. The  $\delta$ -ferrite transformed to  $\sigma$  during the periods that the hook was in the austenitizing furnace (temperatures from 815 to 900 °C, or 1500 to 1650 °F, generally). The micrograph shows a very heavy, nearly continuous grain-boundary  $\sigma$  network.
