ASM HANDBOOK®

VOLUME  
12

Fractography

*Fractography*, was published in 1987 as Volume 12 of the *ASM Handbook*. The Volume was prepared under the direction of the ASM Handbook Committee.

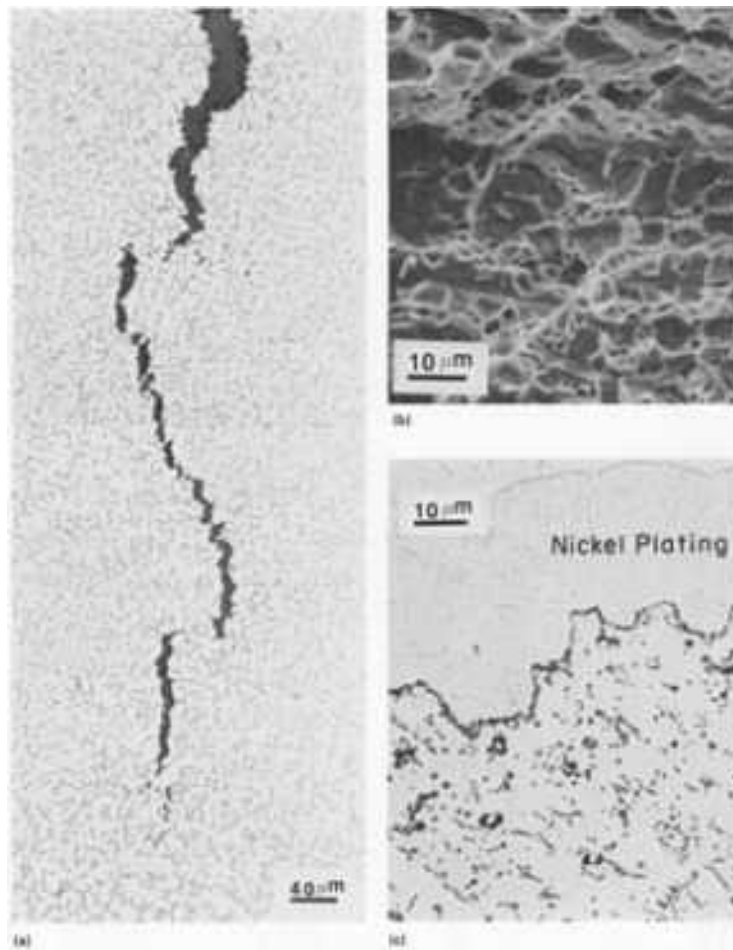
**Fig. 95 Three views of a fractured specimen of type 312 weld metal that was exposed to high temperatures to transform the  $\delta$  ferrite to  $\sigma$  phase. The specimen was subsequently broken by impact at room temperature. (a) Partially broken specimen. Etched with mixed acids. (b) SEM view of fracture. (c) Cross section of fracture. Etched with acetic glyceric acid**

Figure 95 shows three views of impact-formed cracks in type 312 stainless steel weld metal that had been heated at 815 °C (1500 °F) for 160 h before breaking. The micrographs show both partially broken and completely broken fractures to illustrate the nature of the crack path. This sample has a rather high  $\sigma$  content. The SEM fractograph shows the rather brittle fracture appearance, a mixture of fine dimples around the  $\sigma$  and quasi-cleavage. The impact energy was only 7% of that of a similar specimen without  $\sigma$  present.

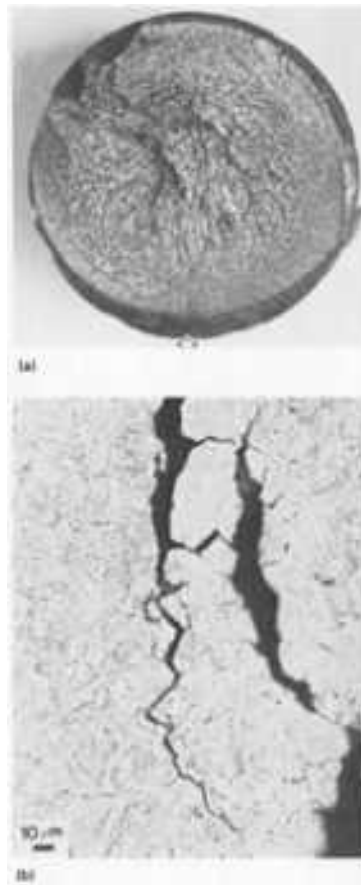
**Fig. 96 Broken 25-mm (1-in.) diam AISI 1040 steel bolt. (a) Macrograph of fracture surface; corrosion products obscure most of the surface. 2 $\times$ . Intergranular secondary cracks (b) were observed in the region near the surface of the bolt shown by the arrow in (a). The bolt was not tempered (surface hardness was 53 to 57 HRC) and probably failed by SCC. (b) Etched with 2% nital. 340 $\times$**

Figure 96 shows a macrograph of an ASTM A325 bolt that fractured in a bridge. The fracture surface is covered by rust, but it is apparent that the fracture began at the root of the threads in the region near the arrow. Examination of the microstructure in this region revealed intergranular secondary cracks, as shown. Due to a heat treatment error, the bolt was not tempered, and the hardened surface was in the as-quenched condition (53 to 57 HRC). This made the bolt susceptible to SCC.

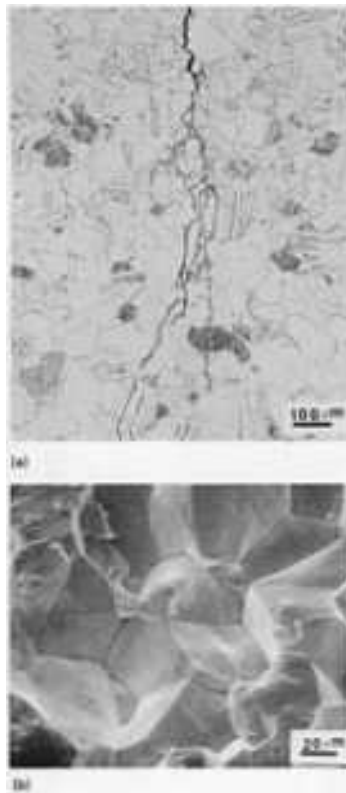
**Fig. 97 Type 304 stainless steel specimen after testing in boiling  $\text{MgCl}_2$ . (a) Cross section of partially broken specimen. Etched with mixed acids. (b) SEM fractograph of completely broken specimen**

Figure 97 shows the fracture and microstructure of a type 304 stainless steel wire (solution annealed) that failed by SCC in boiling  $\text{MgCl}_2$ . The wire was bent around a 13-mm (0.5-in.) diam pin before being placed in the solution. Therefore, the region where cracking occurred was cold worked. The fracture is predominantly intergranular.

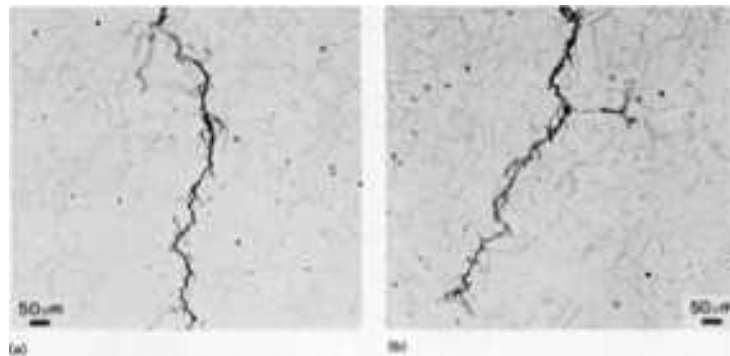
**Fig. 98 Two views of the crack path, which was predominantly transgranular, in an austenitic manganese-chromium stainless steel drill collar alloy. The SCC was caused by chlorides in the drilling fluid. Cracking began at the inside bore surface. Etched with acetic glyceric acid. Both 65×**

Figure 98 shows a micrograph of a predominantly transgranular stress-corrosion crack in a manganese-chromium austenitic drill collar alloy. The crack occurred at the inner diameter of the drill collar where residual stresses were high. The cracking was caused by the chloride ion concentration in the drilling fluid.

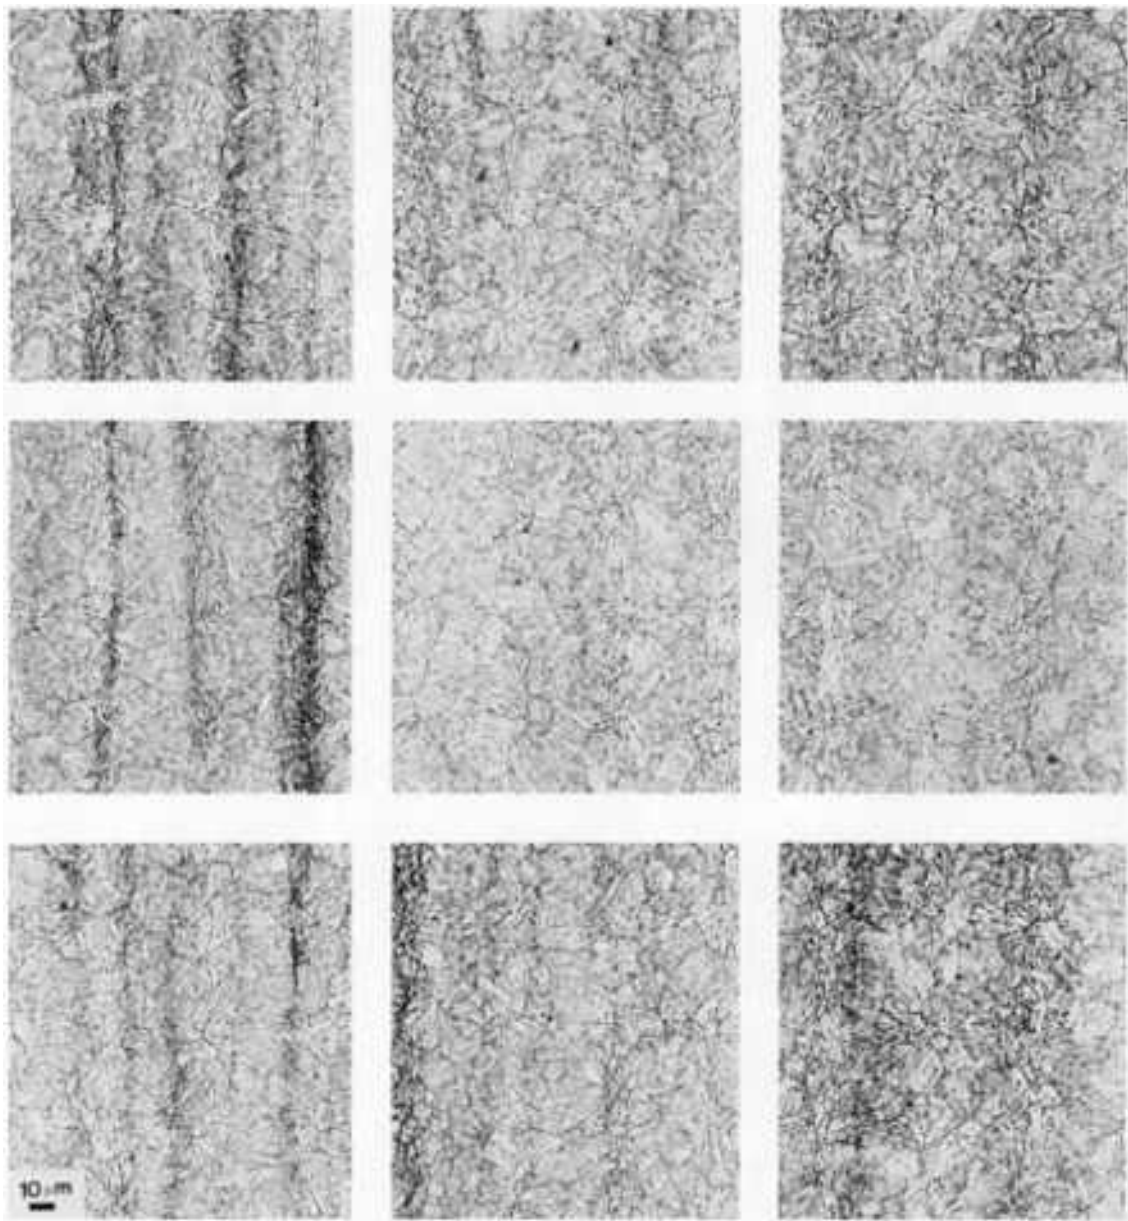
**Fig. 99 Microstructures of AISI 4140 steel with 0.004% P (left column), 0.013% P (center column), and 0.022% P (right column). Specimens were etched with the ethereal-picral etchant described in Ref 442 (top row) and Ref 444 (middle row) and with saturated aqueous picric acid plus a wetting agent (bottom row). All 425×**

Scanning electron microscopy examination revealed no intergranular fracture in the samples containing 0.004% P, considerable intergranular fracture in the samples with 0.013% P, and predominantly intergranular fracture in the samples containing 0.022% P. Etching of all of the sample types with the reagents described in Ref 442 and 444 revealed prior-austenite grain boundaries in all samples. Etching of the samples with the saturated aqueous picric acid reagent described in Ref 443, using sodium tridecylbenzine sulfonate as the wetting agent, also revealed the grain boundaries in all samples. Micrographs of these samples are shown in Fig. 99. All samples were then deembrittled by tempering at 620 °C (1150 °F), followed by water quenching. Next, they were repolished and etched with each of the three reagents. The ethereal-picric etchants described in Ref 442 and 444 did not reveal any grain boundaries. However, with the saturated aqueous picric acid etchant, grain boundaries were not visible in samples containing 0.004% P, a few were visible in samples with 0.013% P, and most were visible in the samples containing 0.022% P. This etchant is known to be very sensitive to segregated phosphorus, but will not reveal prior-austenite grain boundaries in temper-embrittled steels free of phosphorus, that is, if embrittlement is due only to segregated antimony, tin, or arsenic.

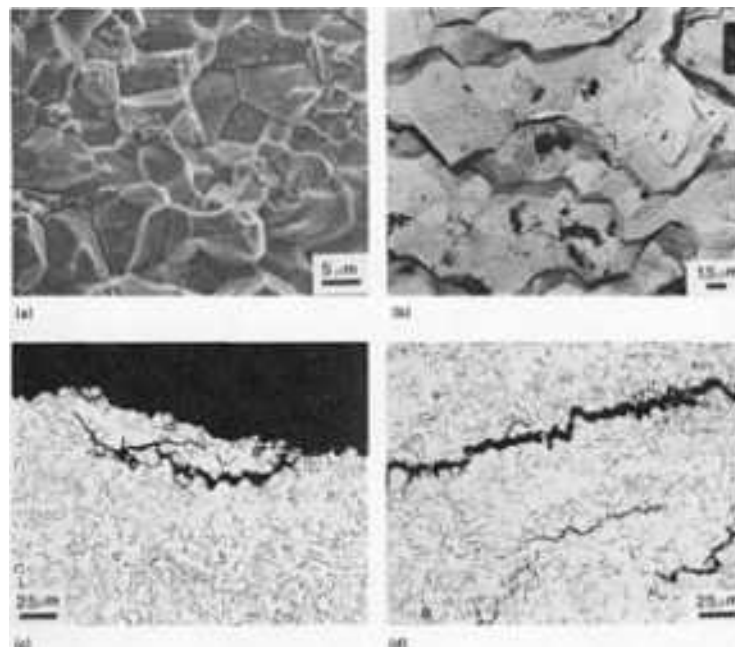
**Fig. 100 Fracture in a thermally embrittled cobalt-free high-titanium maraging steel. (a) Secondary electron image of fracture surface, 1300 ×. (b) TEM extraction fractograph, 2150 ×. (c) Light micrograph of fracture edge, 260 ×. (d) Light micrograph of internal cracks, 260 ×. Light micrograph specimens etched with modified Fry's reagent**

Figure 100 shows the fracture of a cobalt-free high-titanium maraging steel specimen that fractured because of thermal embrittlement. The light micrographs of the fracture profile and a secondary crack reveal the intergranular nature of the fracture. This is more easily observed by direct SEM examination of the fracture, but the TiC and Ti(C,N) on the intergranular fracture is more clearly revealed by the extraction fractograph. Analysis of the extracted grain-boundary precipitates is not hindered by detection of the matrix around the precipitate, as might occur with SEM-EDS analysis.

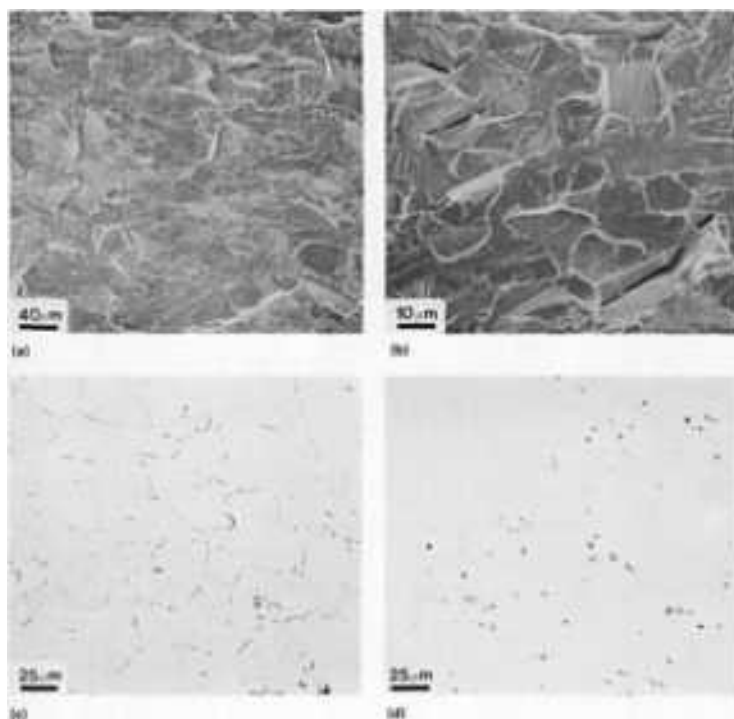
**Fig. 101** Example of the fracture appearance and microstructure of a duplex stainless steel (similar to type 329) in the embrittled condition after heating at 370 °C (700 °F) for 1000 h. (a) and (b) SEM fractographs at 165 and 650 ×, respectively, showing cleavage fracture with some splitting. (c) Light micrograph showing dark-etching ferrite-ferrite grain boundaries in a specimen subjected to the embrittling treatment. (d) Light micrograph of a hot-rolled and annealed nonembrittled specimen, which shows only carbides. (c) and (d) Etched with Vilella's reagent. Both at 260 ×

As an example of 885- °F embrittlement, Figure 101 shows the fracture of a duplex alloy similar in composition to type 329 stainless steel. This material was aged for 1000 h at 370 °C (700 °F), products a substantial hardness increase and a dramatic loss in toughness. Room-temperature half-size Charpy V-notch impact test revealed 1.36 J (1 ft · lb) of absorbed energy compared to 64 J (47 ft · lb) for the same alloy in the hot rolled and annealed condition. The fracture is by cleavage with some dark-etching ferrite grain boundaries in the embrittled specimen, but the same etch (Vilella's reagent) does not reveal the ferrite grain boundaries in the annealed nonembrittled specimen.

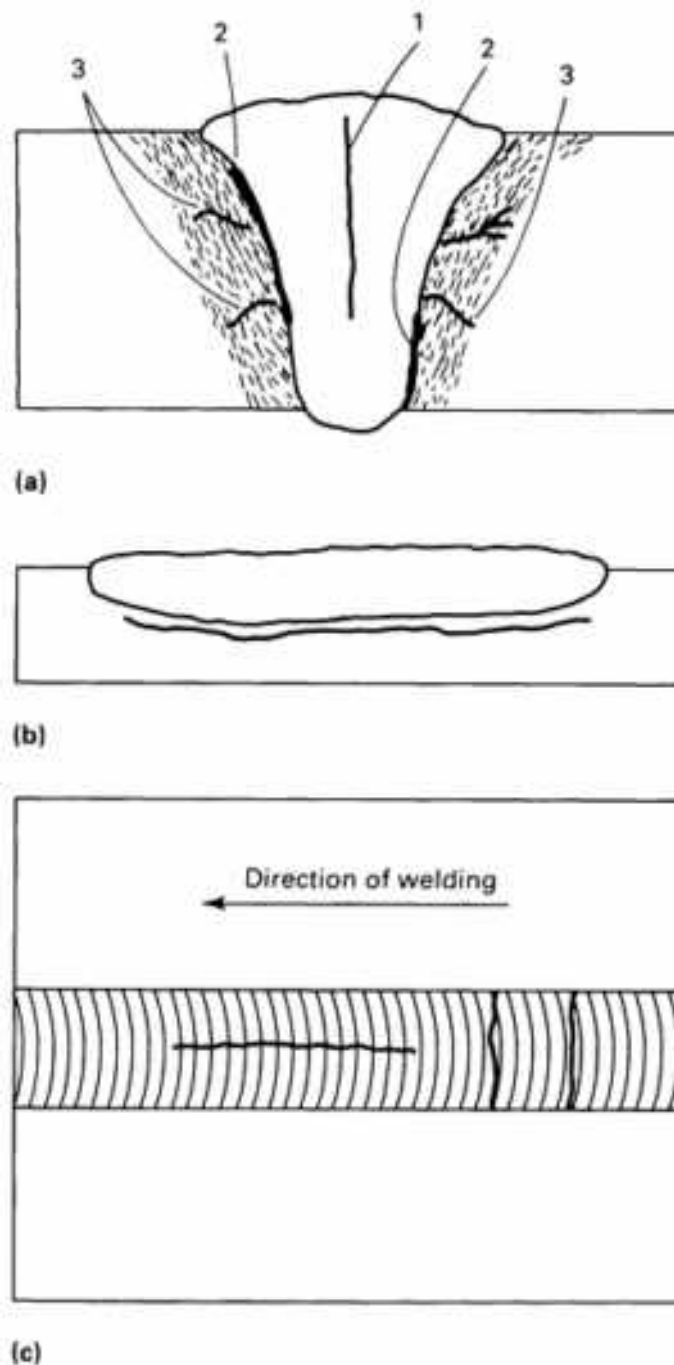
**Fig. 102 Schematics illustrating the nomenclature used to describe weldment cracks. (a) Weld metal (1), fusion line (2), and HAZ (3) cracks. (b) Underbead crack. (c) Longitudinal and transverse weld metal cracks. Source: Ref 480**

at higher temperatures and then grow to a detectable size at lower temperatures (Ref 470, 471, 472, 473, 474, 475, 476, 477, 478, 479). Cracking may occur during cooling to room temperature or a short time after reaching room temperature, or it may occur after a considerable time delay. Cold cracks may be found in the weld metal or in the HAZ (Fig. 102). Both transgranular and intergranular fracture paths have been observed.

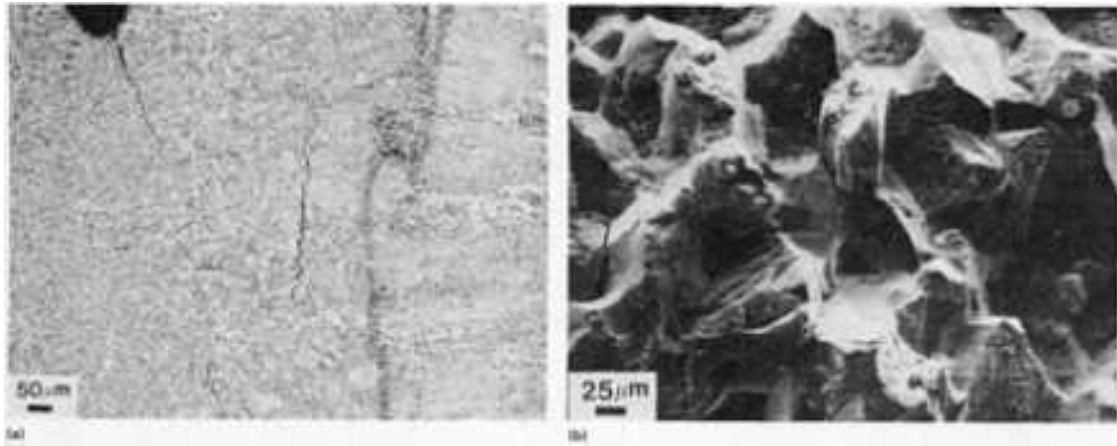
**Fig. 103 Cold cracks in an RQC-90 steel plate welded with a high-hydrogen electrode. The sample was an implant specimen loaded to 193 MPa (28 ksi) during solidification. (a) Light micrograph showing cracking. Etched with nital. 80×. (b) SEM fractograph showing the intergranular nature of the cracks. 200×. (J.P. Snyder, Bethlehem Steel Corporation)**

Three factors combine to produce cold cracks: stress, hydrogen, and a susceptible microstructure. Stresses may be due to thermal expansion and contraction, or they may be due to a phase transformation, such as the austenite-to-martensite transformation. High-carbon (plate) martensite microstructures are most susceptible to cold cracking. Low-carbon (lath) martensite microstructures are less susceptible, while ferritic and bainitic microstructures are least susceptible. Hydrogen must be present above some critical level for cracking to occur. Figure 103 shows a metallographic cross section of a cold crack in a plate steel implant specimen welded with a high-hydrogen content electrode and an SEM view of the fracture after sectioning to open the crack.

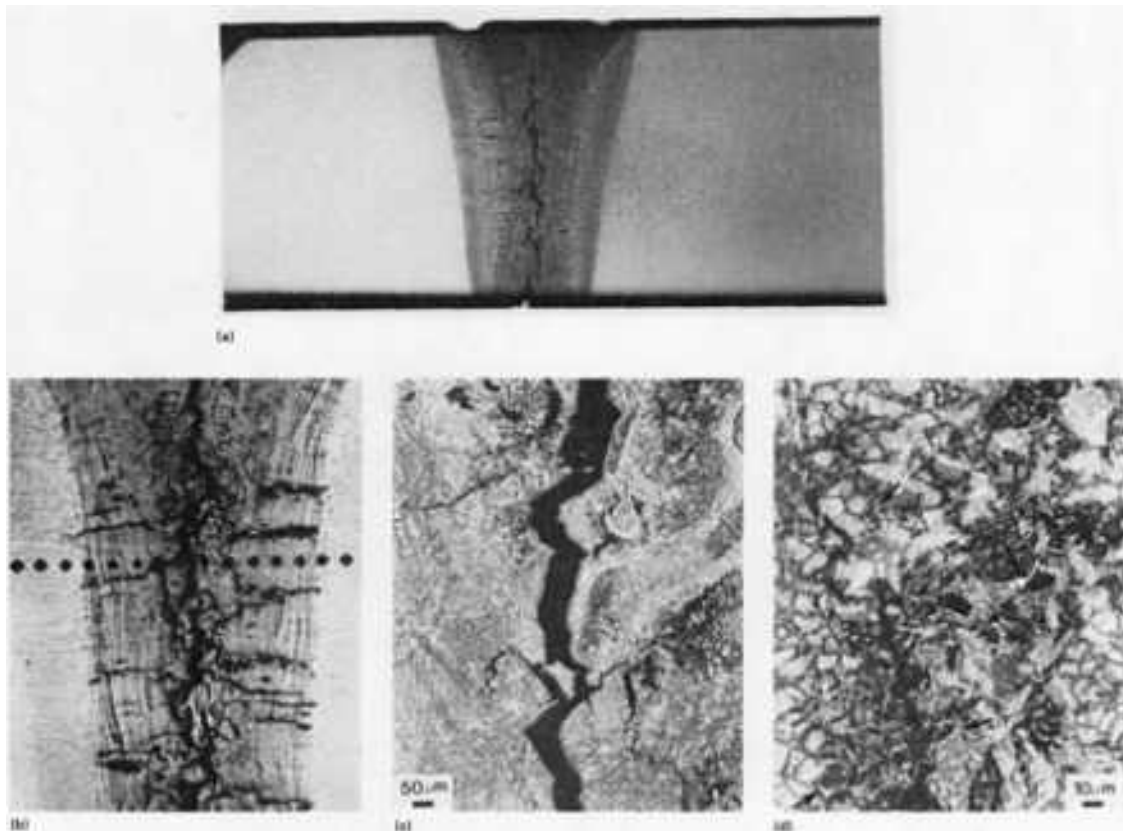
**Fig. 104** Hot cracking of an electron beam weld due to accidental melting of the copper backing plate. Note the extensive intergranular cracking and the grain-boundary copper film. (a) 4 ×. (b) 13 ×. (c) 68 ×. (d) 340 ×

Light microscopy examination of cross sections is a very important aspect of diagnosing hot cracking. Figure 104 illustrates the use of light microscopy in the study of extensive hot cracking in an electron beam weld that was contaminated by liquid copper by accidental melting of the copper back-up plate. The cracks are clearly intergranular, and elemental copper can be found throughout the region in the prior-austenite grain boundaries. Figure 105 shows two examples of fine hot tears in the

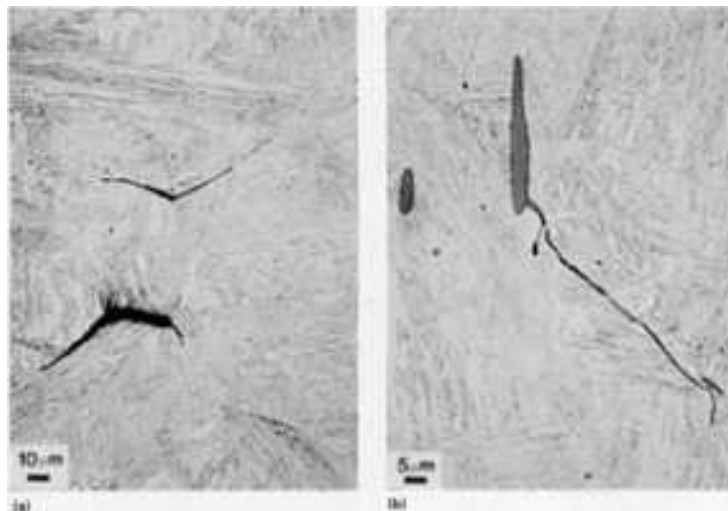
**Fig. 105** Two examples of hot tears in the HAZ of gas-metal arc welded HY-80 steel. Note the crack associated with the manganese sulfide inclusion (b). Both etched with 1% nital. (a) 370×. (b) 740×. Courtesy of C.F. Meitzner, Bethlehem Steel Corporation

HAZ of a welded HY-80 plate steel.

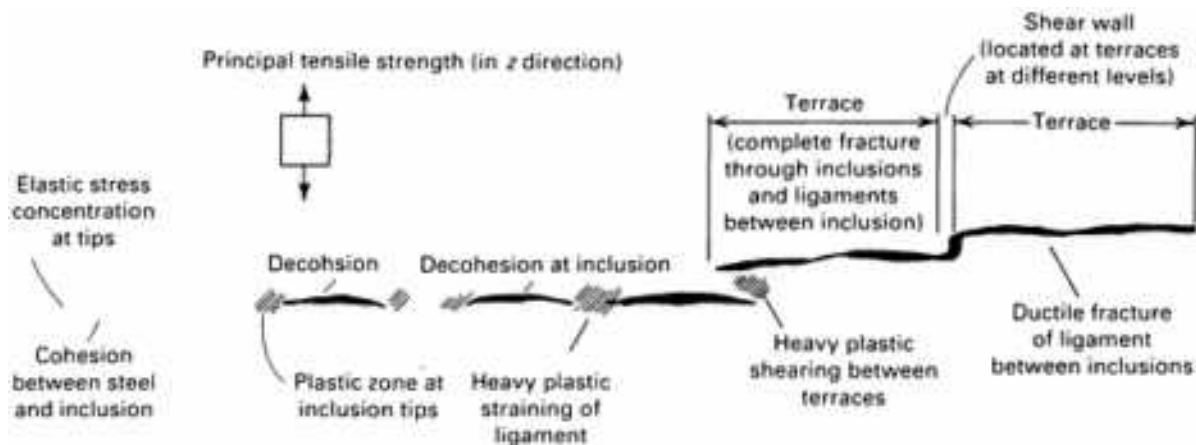
**Fig. 106 Schematic illustrating the formation of lamellar tears. Source: Ref 499**

Cracking begins at the inclusion/matrix interfaces, as shown schematically in Fig. 106. The cracked interfaces that lie in the same plane grow and link together to form terraces. The high strain level, due to thermal contraction and joint restraint, produces ductile tearing of the matrix between the inclusion/matrix interfacial cracks. Further straining connects terrace cracks on different parallel planes by ductile shearing (Fig. 106). These shear walls produce the characteristic steplike appearance of lamellar tears (Fig. 107).

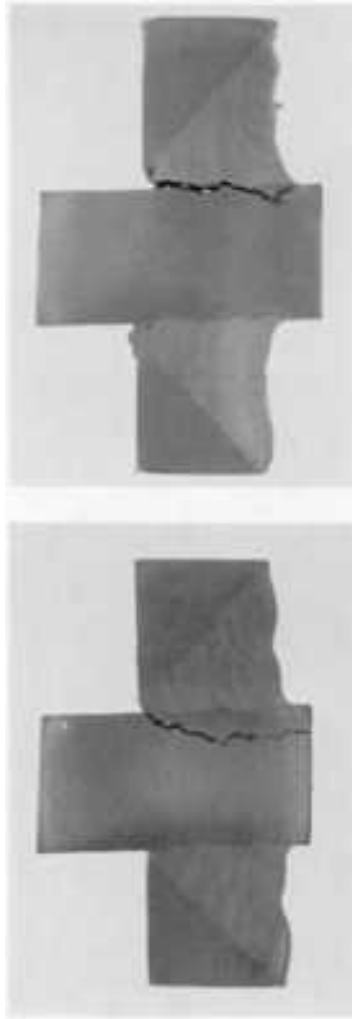
**Fig. 107 Macrographs showing typical lamellar tears in structural steel**

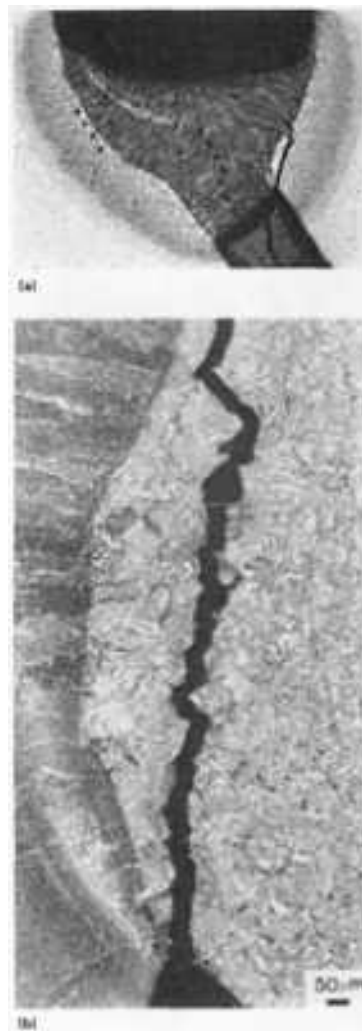
**Fig. 108 Stress-relief crack in plate steel Lehigh restraint sample. The crack is intergranular, but the high restraint level suppresses crack branching. The square marks in the weld HAZ in (a) are hardness impressions. (a) 9 $\times$ . (b) Etched with 2% nital. 74 $\times$**

Steel microstructures that promote stress-relief cracking usually contain fine carbides that have precipitated within the grains in the HAZ; the grain boundaries are frequently denuded of carbides. This concentrates the creep strain at the weakened grain boundaries, producing extensive deformation, which is often accommodated by grain-boundary sliding, and intergranular cracking. Carbides may also lie along the grain boundaries, which promotes cracking. Alloy steels containing carbide-forming elements, such as chromium, molybdenum, and vanadium, are most susceptible. A metallographic example of the nature of stress-relief cracks is shown in Fig. 108.

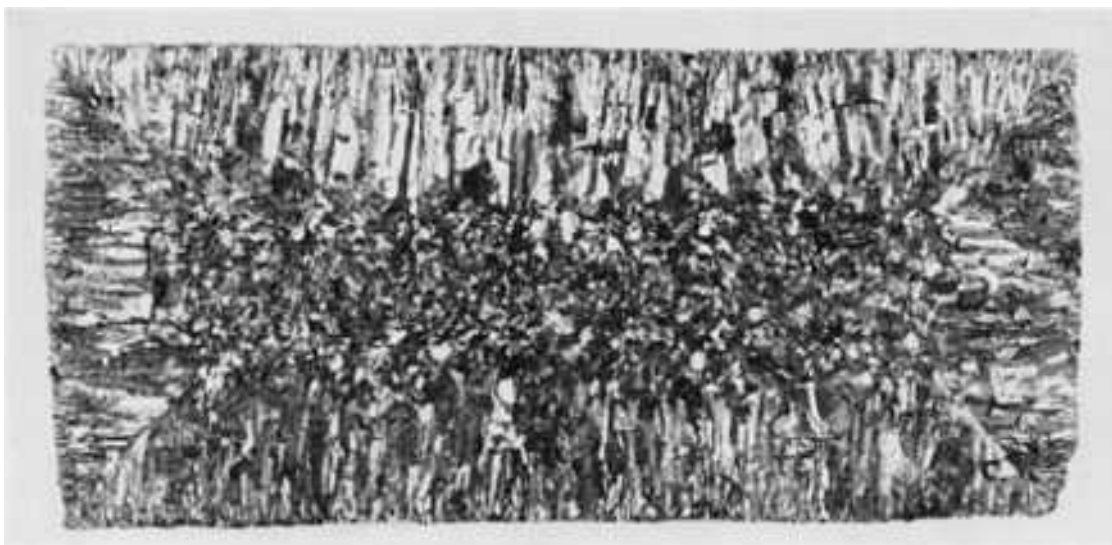
**Fig. 109** Fracture surface of a small ingot of iron-chromium-aluminum alloy. The as-cast solidification pattern is clearly revealed. 0.57×

The examination of fractures often provides information about microstructure or quality, and fracture tests have been used for such purposes since antiquity and are invaluable in failure analysis work. Fractures can often provide the metallurgist with interesting information. For example, Figure 109 shows a fractured ingot of an iron-chromium-aluminum alloy in which the solidification structure is clearly revealed. A related example is shown in Fig. 110, which illustrates a fatigue fracture located by a shrinkage cavity. The dendritic nature of solidification is observed in the shrinkage cavity.

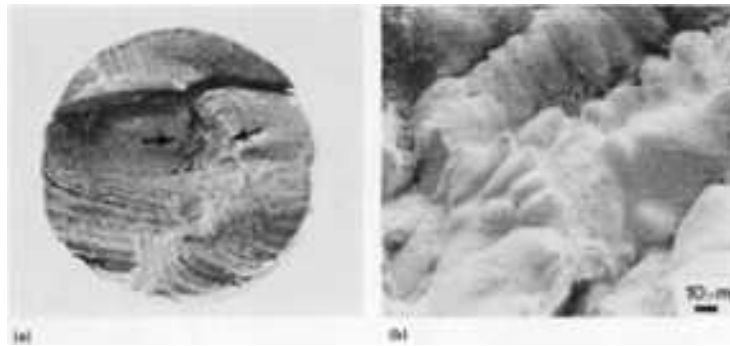
**Fig. 110 Macrograph (a) of defect in test bar that initiated fatigue failure. 1.5×. (b) SEM fractograph showing that the defect was a shrinkage cavity. Note the dendritic appearance. 375×**

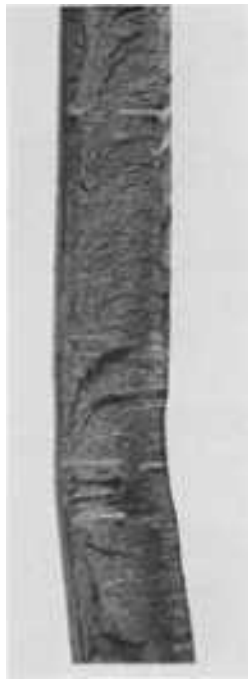
**Fig. 111 Example of inclusion stringers (white streaks against the dark background) on a longitudinal test fracture. The specimen was blued to reveal the stringers.**

Inclusion stringers of macroscopic size can be readily detected on a fractured specimen after heat tinting in the blue heat range (Ref 516, 517, 518). Several ASTM standards (A 295, A 485, A 535, and A 711) include test limitations for macroscopic inclusion stringers detected in this type of test. In most work with this test, the macroetch billet disks are hardened, fractured, and blued on a hot plate or in a laboratory furnace. Heating to 260 to 370 °C (500 to 700 °F) is usually adequate. The fracture face should be a longitudinal plane. The lengths of any visible stringers, which appear white against the blue fracture, are measured. Figure 111 shows an example of inclusion stringers detected by this procedure.

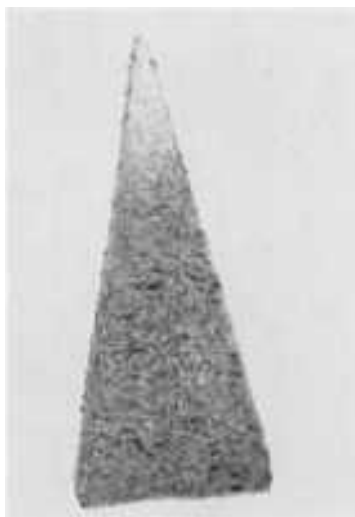
**Fig. 112 Example of a fractured wedge test specimen used to assess the carbide stability in a cast iron melt. Note the change in fracture appearance in the tip (white fracture due to the presence of carbide) compared to the base of the wedge (dark due to the presence of graphite). Actual size**

Chill and wedge tests have been extensively used in the manufacture of gray and white irons to reveal carbide stability or the tendency of an iron to solidify as white iron rather than gray iron (Ref 519, 520, 521). These tests show the combined effect of melting practice and composition on carbide stability, but are not a substitute for chemical analysis. The chill test uses a small rectangular casting in which one face is a chill plate, while the wedge test employs a wedge-shaped mold in which the cooling rate varies with the wedge thickness. After a casting is made with either type of mold, it is broken and the fracture is examined. Figure 112 shows an example of a wedge test fracture. In the wedge test, the distance from the wedge tip to the end of the white fracture is measured; in the chill test, the depth of the white iron chill is measured.

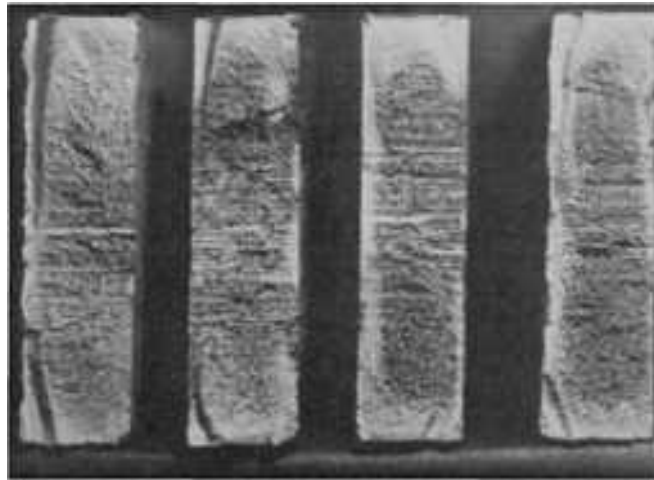
**Fig. 113 Four fractured, hardened etch disks of a high-carbon (1.3% C) tool steel that contained excessive graphite (dark regions) due to an accidental aluminum addition. About 0.5×**

In the production of tool steels, the fracture test can be used to detect graphitization in tool steels that should contain graphite, such as AISI 06, or in high-carbon tool steels that should be free of graphite. Figure 113 shows four fractured test disks of a high-carbon tool steel that contained considerable undesired graphite due to accidental addition of aluminum.

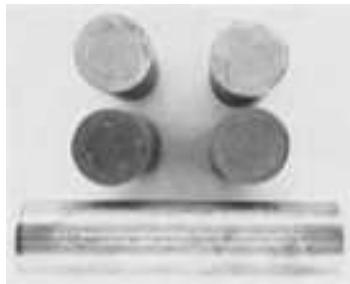
**Fig. 114 Example of specimens used in the Shepherd P-F test. The 19-mm ( $\frac{3}{4}$ -in.) diam, 100-mm (4-in.) long specimen is shown at the bottom. The test consists of fracturing an austenitized and brine-quenched specimen. Case depth can be observed on the fracture. After fracture grain size is rated, the fracture surface is carefully ground off. Macroetching then reveals the depth of hardening. Superficial hardness tests are used to determine the case depth to a particular hardness.**

The depth of hardening in case-hardened steels, such as carbon tool steels, can be easily assessed by using fractured specimens. The P-F test is commonly used for this purpose (Ref 522). Figure 114 shows P-F test specimens. A 19-mm ( $\frac{3}{4}$ -in.) diam, 100-mm (4-in.) long specimen is austenitized at the recommended temperature and brine quenched. After fracturing, one fracture face is ground and macro-etched, as shown. The sample is then hardness tested with the Rockwell superficial test to determine the depth to 55 HRC, that is, the location for 50% martensite. This depth correlates well with the case/core transition depth on the test fracture.

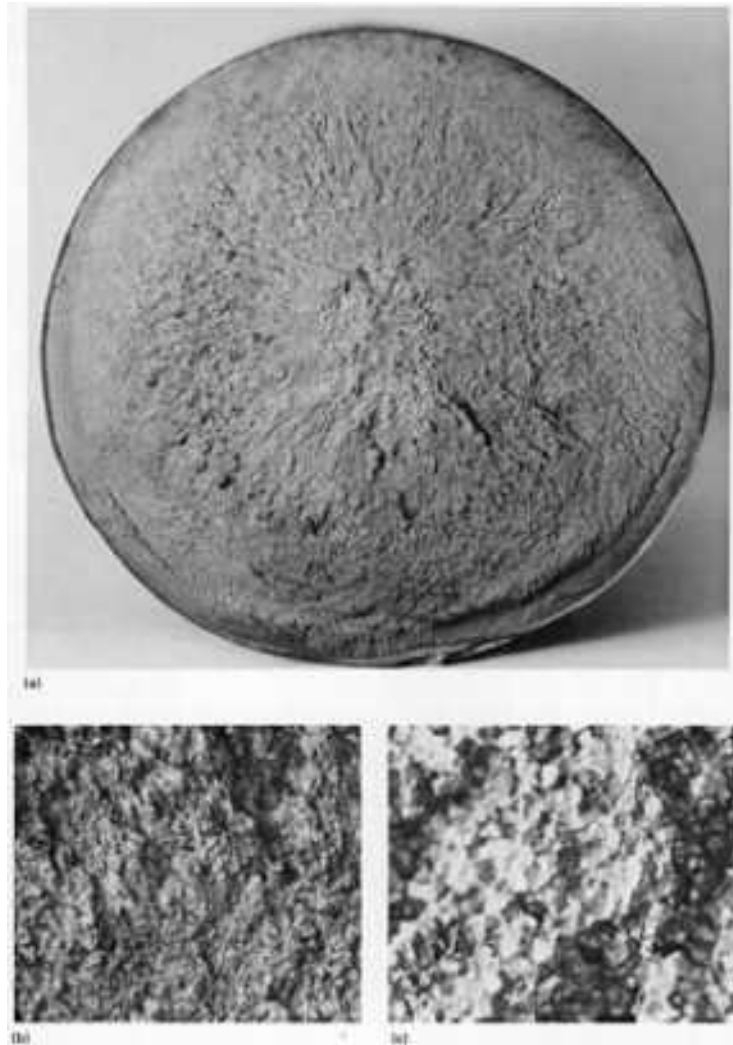
**Fig. 115 AISI 1070 steel bar that broke during heat treatment due to gross chemical segregation. (a) Macrograph at actual size. (b) Fracture near the outside surface of the bar. 8 $\times$ . (c) Fracture near the center of the bar. 8 $\times$ . Note the coarse grain structure of the center region.**

Figure 115 shows an example of the transverse fracture of an AISI 1070 steel bar that broke during heat treatment due to gross chemical segregation and overheating. The transverse fracture reveals a fine-grain appearance at the hardened outer periphery of the bar. The coarse intergranular appearance of the fracture in the interior is evident in Fig. 115. Radial marks can be seen emanating from the coarse-grain central region of the bar.

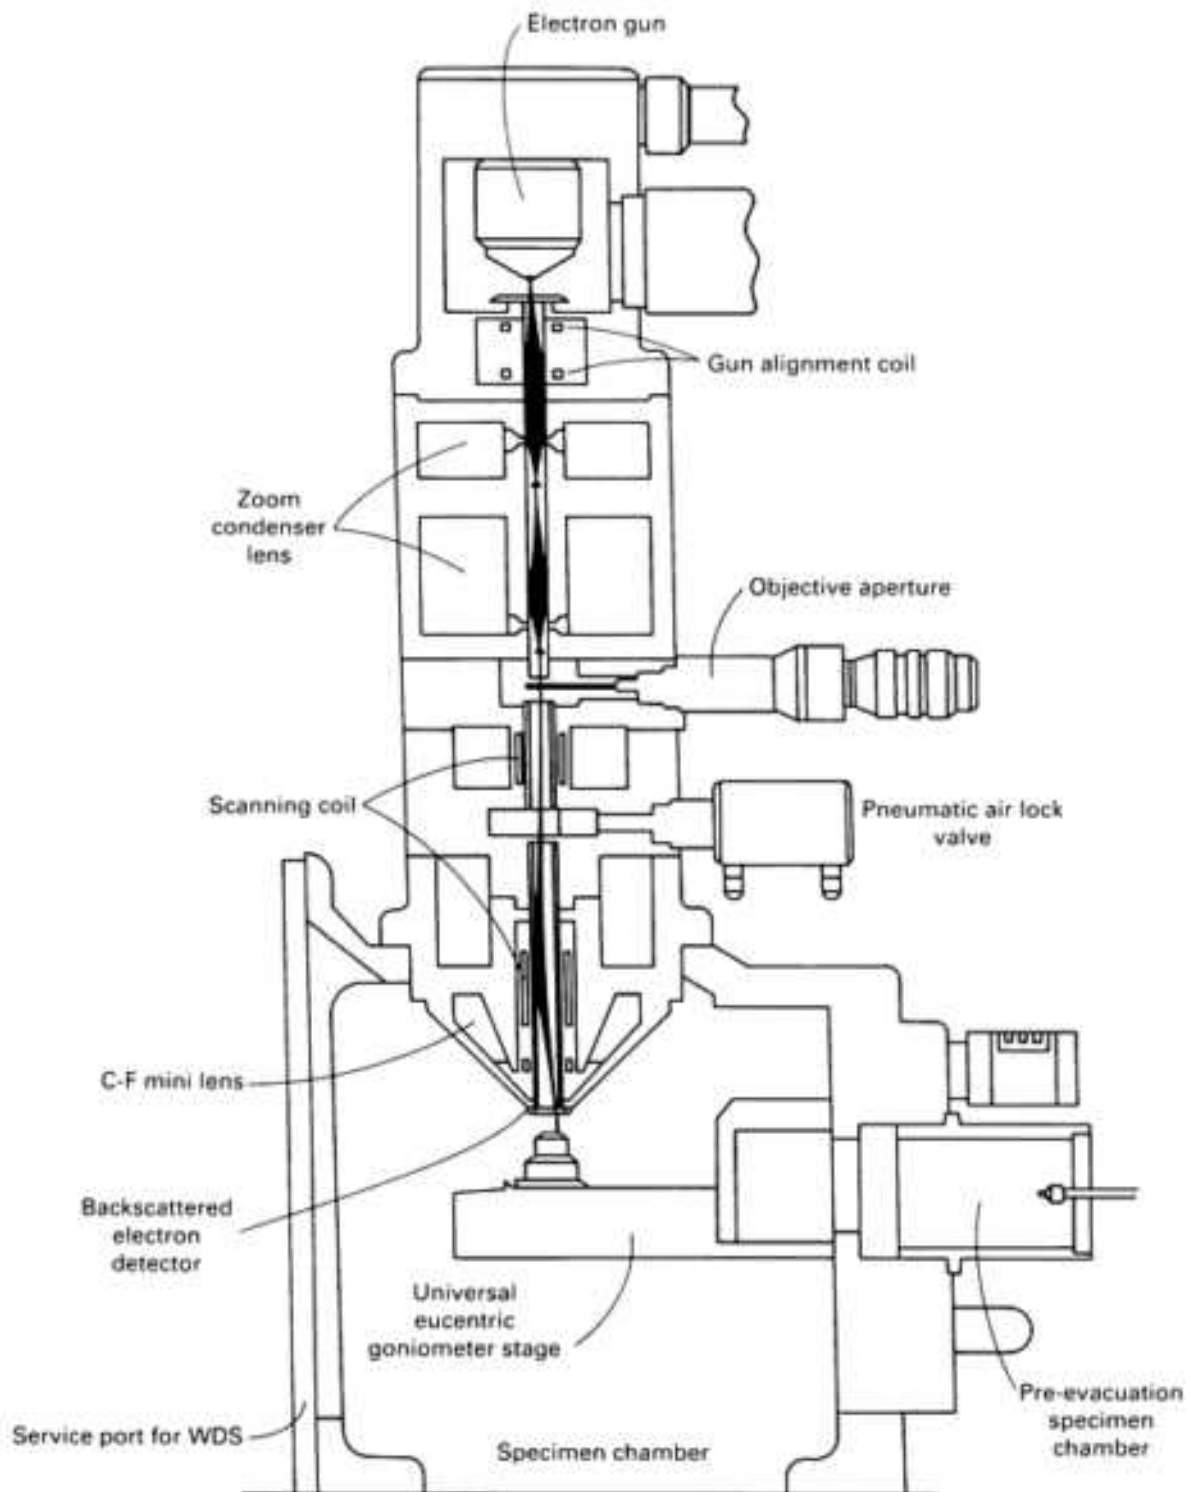
**Fig. 1 Schematic cross section of a commercially available scanning electron microscope. Courtesy of JEOL**

The scanning electron microscope (Fig. 1) can be subdivided into four systems. The illuminating/imaging system consist of an electron source and a series of lenses that generate the electron beam and focus it onto the specimen. The information system comprises the specimen and data signals released during irradiation as well as a series of detectors that discriminate among and analyzes the data. The display system is simply a cathode ray tube (CRT) synchronized with the electron detectors such that the image can be observes and recorded on film. Lastly, the vacuum system removes gases that would otherwise interfere with operation of the scanning electron microscope column. These four systems are described below in more detail. Supplementary information on the principles and instrumentation associated with SEM can be found in the article "Scanning Electron Microscopy" in Volume 10 of *ASM Handbook*, formerly 9th Edition *Metals Handbook*.

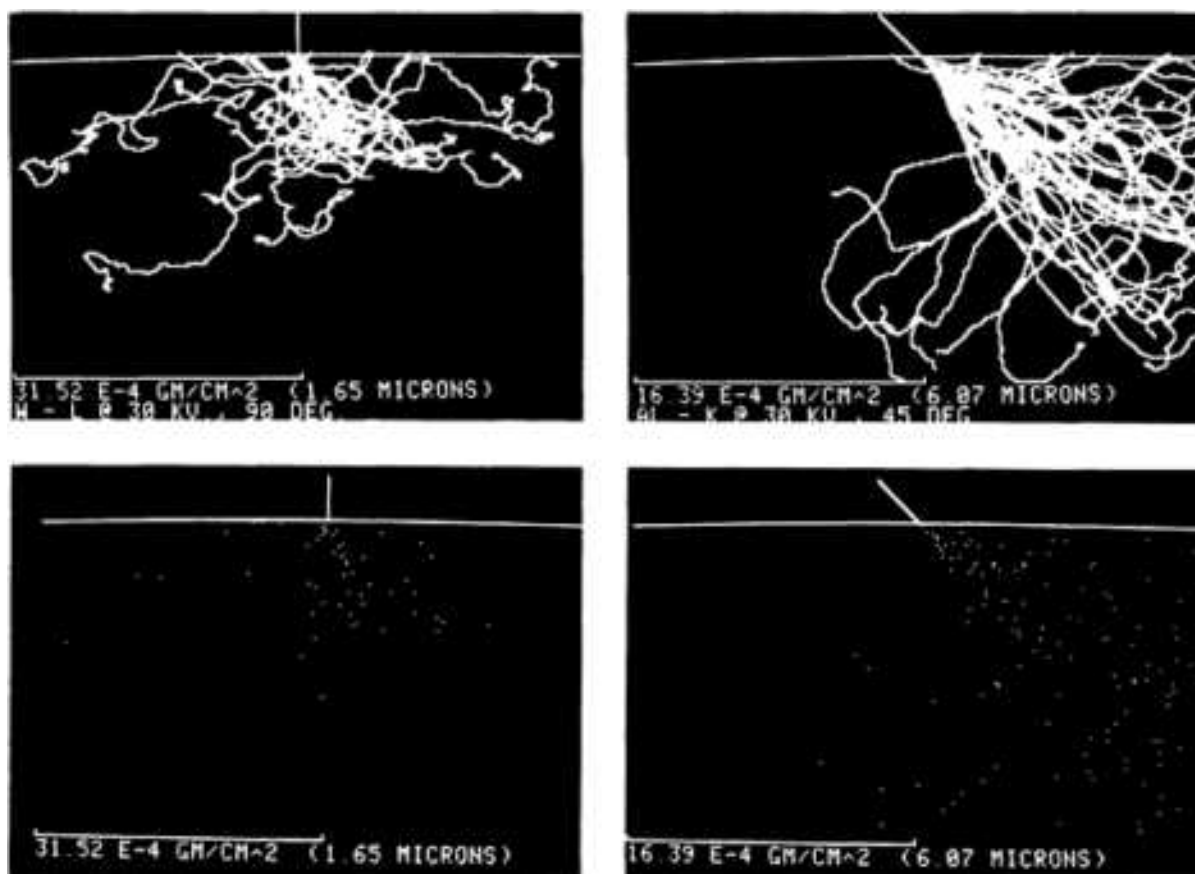
**Fig. 2** Monte Carlo projections of the trajectory of incident electrons (top) and emitted x-rays (bottom). Projections are for tungsten (left) and aluminum (right). Note the effect of specimen tilt on the location of the

**excitation volume.**

Image clarity is also affected by specimen tilt. Secondary electron and x-ray collection can be maximized by tilting the specimen toward the detector. The optimum angle depends on specimen topography; in general, larger angles are required for smoother specimens. As shown in Fig. 2, the degree of tilt will affect the position of the excitation volume. This is crucial for valid interpretation of point x-ray analysis because the data may originate from a position that does not correspond exactly to the SEM image.

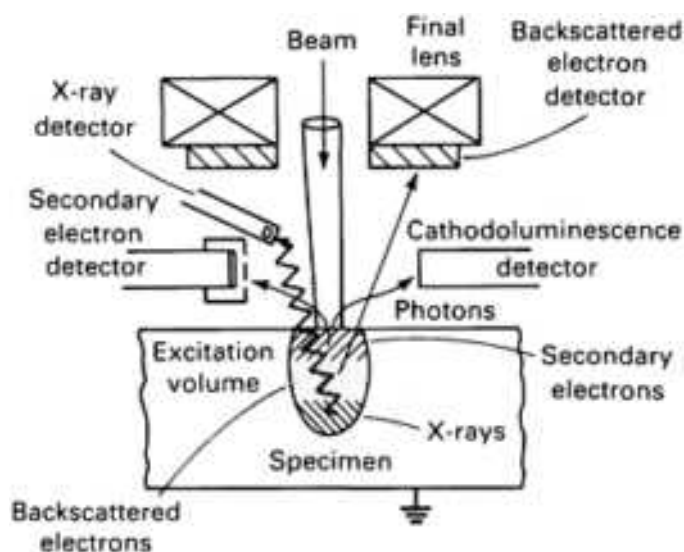
**Fig. 3 Origin and detection of data signals**

**Electron Signals.** Various data signals are simultaneously released by an irradiated specimen, and in the presence of appropriate detectors, the signals can be analyzed (Fig. 3). Data signals arise from either elastic (electron-nucleus) or inelastic (electron-electron) collisions. Elastic collisions produce backscattered electrons carrying topographic and compositional data (Ref 5, 6). Inelastic collisions deposit energy within the specimen, which then returns to the ground state by releasing secondary electrons, x-rays, and heat phonons.

The conventional SEM image consists of more secondary electrons than backscattered electrons. An important difference between these types of electrons is their relative energy; backscattered electrons retain 80% of the incident beam energy, whereas secondary electrons are of low energy ( $\sim 4$  eV). Therefore, backscattered electrons follow a line-of-sight trajectory and are detected only if they intersect the electron detector. In comparison, secondary electrons are attracted toward the detector by a positively charged Faraday cage and can follow a curved trajectory. The conventional Everhart-Thornley electron detector is ideal for analyzing secondary electrons, but its geometry within the scanning electron microscope is such that it detects only a fraction of the backscattered electrons emitted by the specimen (Ref 7). This secondary electron detector is positioned  $90^\circ$  relative to the optical axis, and the specimen is tilted  $10$  to  $30^\circ$  to enhance electron collection. In contrast, backscattered electron detectors, such as the Robinson detector (Ref 8), are located immediately beneath the final pole piece, and the specimen is perpendicular to the optical axis (Fig. 3).

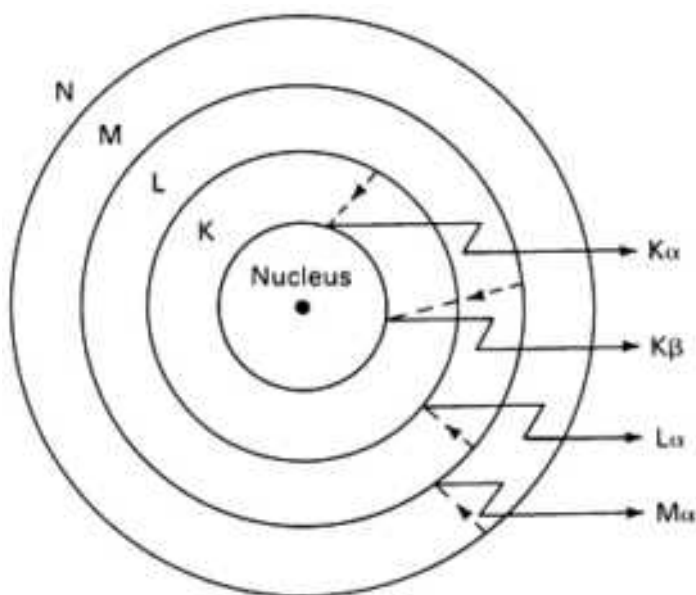
$K\alpha$  x-rays are the most intense x-rays and originate from L-shell  $\rightarrow$  K-shell transitions.

**X-Ray Signals.** Characteristic x-rays are distinct quanta of energy released from excited atoms. Specimen composition is analyzed by measuring x-ray energy or wavelength. X-rays arise from electron transitions within the orbitals of an atom (Fig. 4). Although there is some overlap among x-ray energies, all atoms generally possess at least one x-ray, or spectrum of x-rays, that is unique to that element.

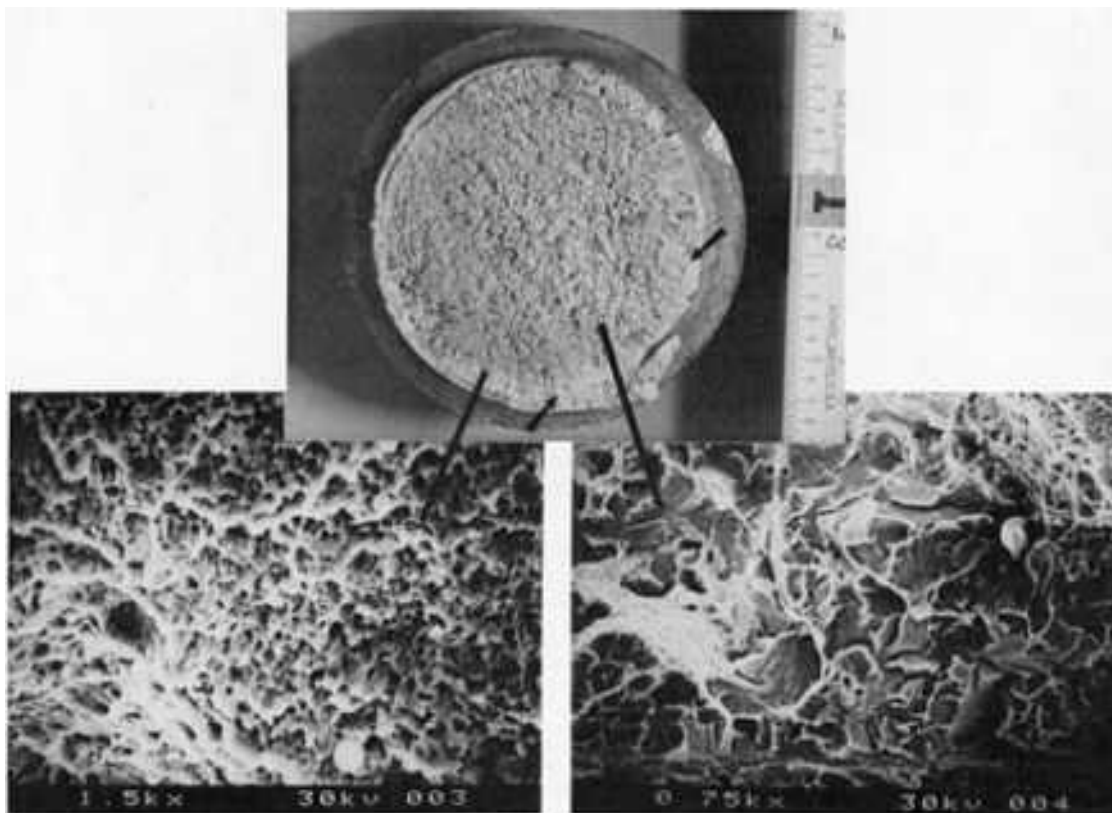
**Fig. 5 Radial marks (arrows) in the fibrous zone of a bolt fractured under conditions of tensile overload. The morphologies of the different texture zones are shown in the SEM fractographs: ductile fracture (left) and transgranular fracture (right).**

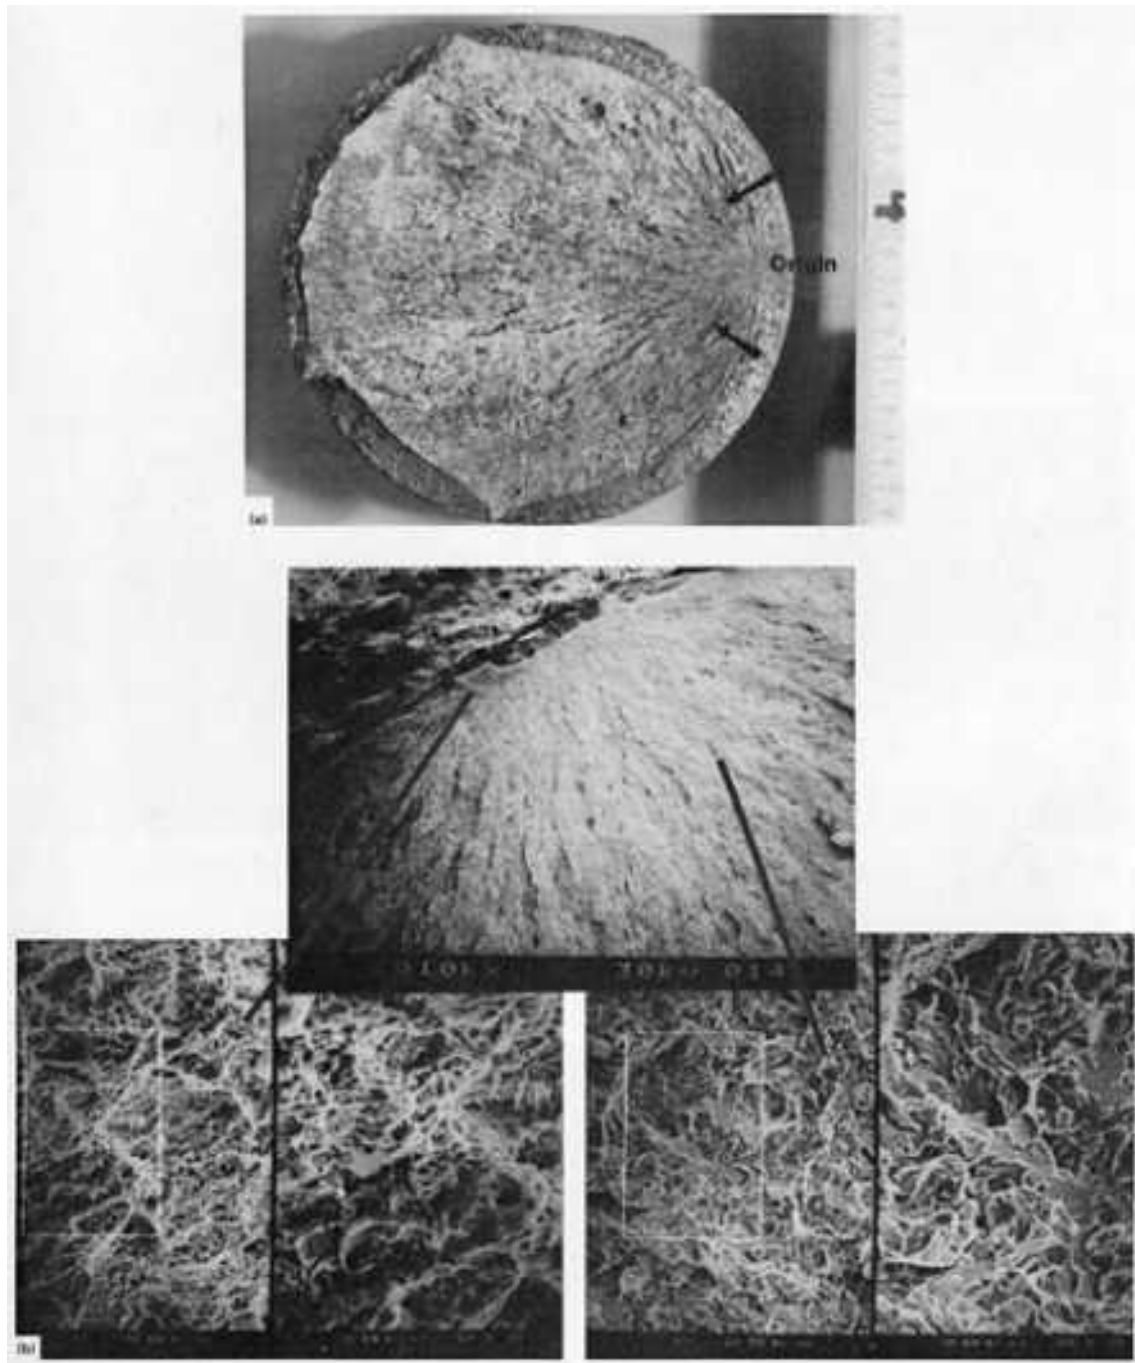
**Fig. 6 (a) Chevrons (arrows) emanating from the fracture origin in a bolt that failed under conditions of bending overload. (b) SEM fractographs of the origin and fracture surface shown in (a)**
