ASM HANDBOOK®

VOLUME  
12

Fractography

*Fractography*, was published in 1987 as Volume 12 of the *ASM Handbook*. The Volume was prepared under the direction of the ASM Handbook Committee.

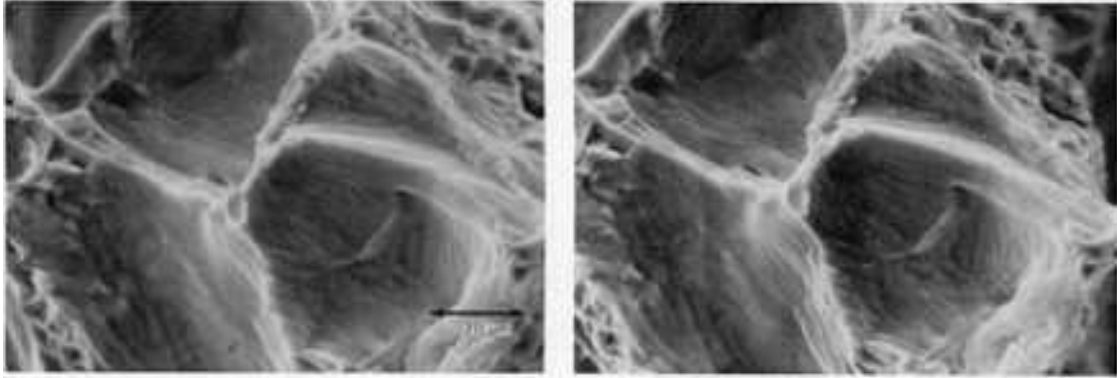
**Fig. 7 Stereo pair showing deep dimples in the fracture surface of commercially pure titanium. Average grain size is 46  $\mu\text{m}$ . Large dimples originated at grain-boundary triple points. Note small dimples at rim that nucleated at dislocation cell walls. (M. Erickson-Natishan, University of Virginia)**

Figure 7 illustrates the tilt method for stereo SEM. Stereo pairs are viewed using simple pocket viewers, double-prism viewers, or a mirror stereoscope (Ref 31). Methods of stereo projection are discussed in Ref 32 and 33.

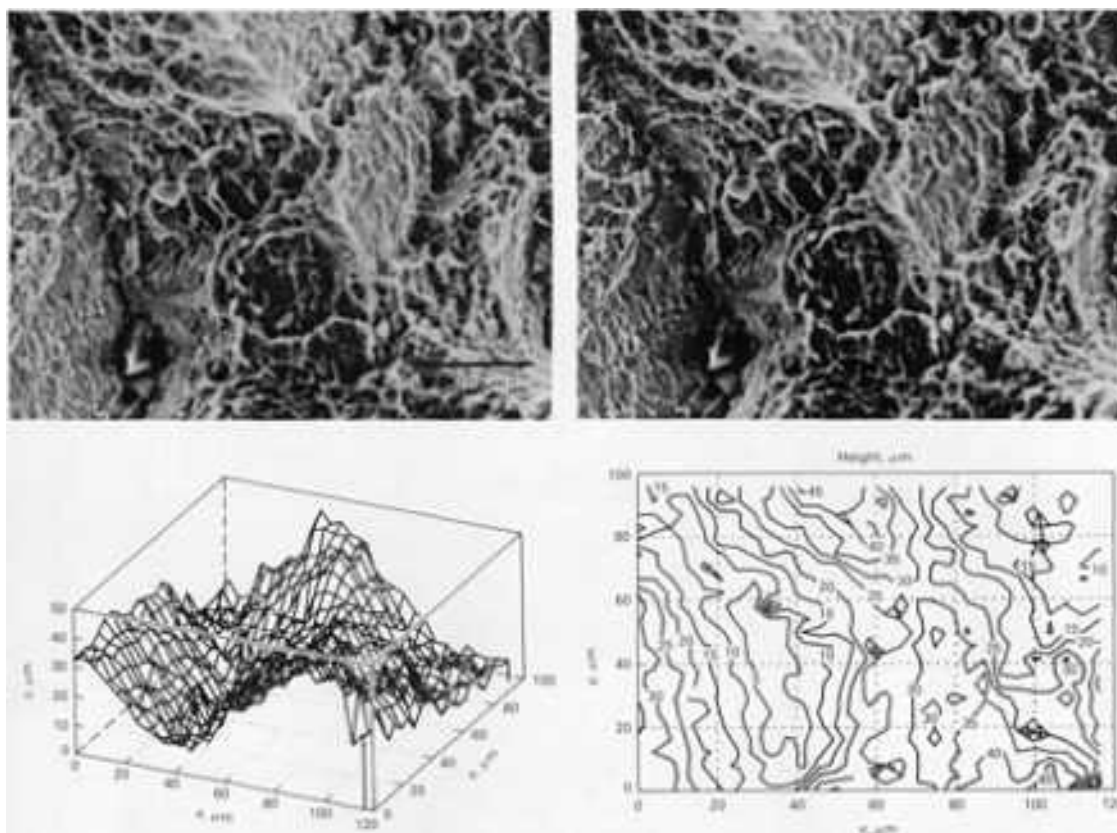
**Fig. 8 Stereo pair (top left and right) of a fractured Ti-10V-2Fe-3Al alloy that was heat treated at 780 °C (1435 °F) for 3 h, water quenched, and aged for 1 h at 500 °C (930 °F). The corresponding carpet plot (bottom left) and contour plot (bottom right) of the fracture surface are also shown. (J.D. Bryant, University of Virginia)**

The voltage signals of the transducers are processed through an analog-digital conversion board and recorded on the microcomputer. The arrays are then calibrated and normalized using user-supplied information on magnification and parallax angle. The array of calibrated  $x$ -,  $y$ -, and  $z$ -files can then be used to generate graphical output in various forms: carpet plots, hidden line plots, or contour plots, depending on the need. Figure 8 shows a stereo pair of the fracture surface of a Ti-10V-2Fe-3Al alloy and the corresponding carpet plot and contour plot.

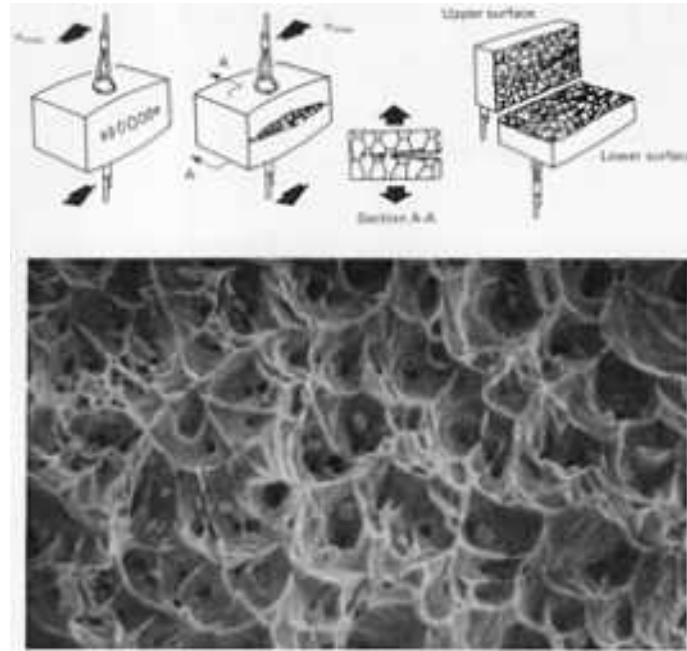
**Fig. 9 Formation of dimples under conditions of tension using a copper test specimen. Note that the dimples are equiaxed. 750×**

Equiaxed or hemispheroidal dimples are cupshaped, and they form under conditions of uniform plastic strain in the direction of applied tensile stress; equiaxed dimples are typically produced under conditions of tensile overload (Fig. 9). In comparison, elongated dimples shaped like parabolas result from nonuniform plastic-strain conditions, such as bending

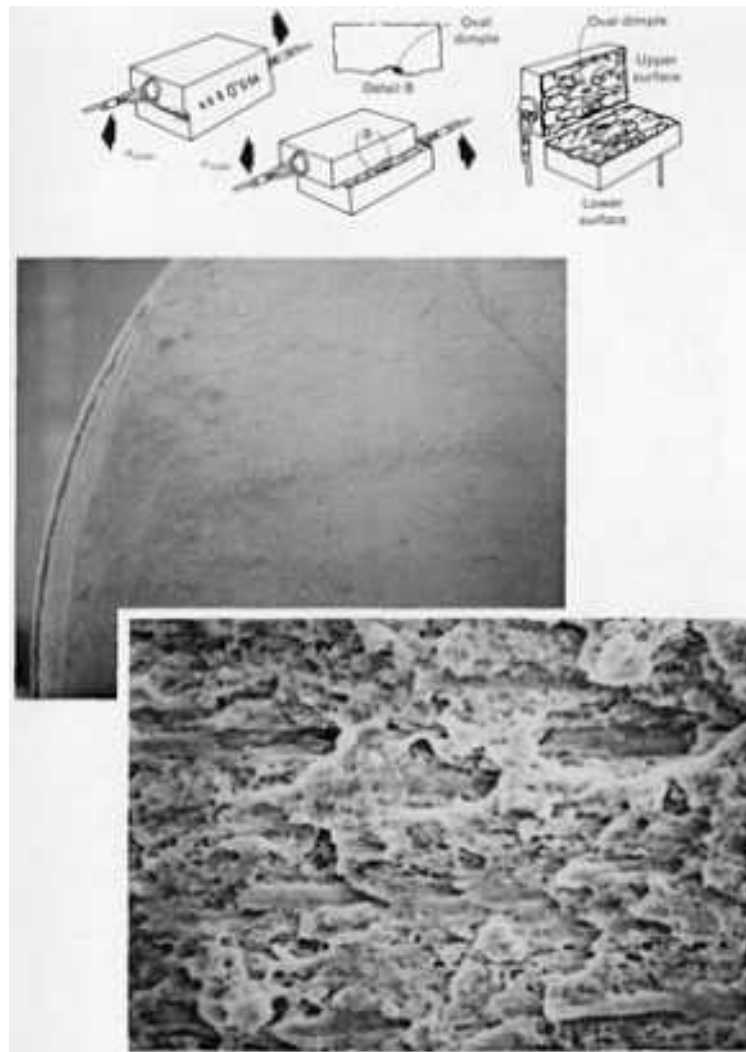
**Fig. 10 Fracture of a high-strength steel under conditions of transverse shear overload. Fractographs at 25× (top) and 1000× (bottom)**

or shear overloads (Fig. 10). These dimples are elongated in the direction of crack extension and reveal the origin of the fracture. Orientation is critical in this fracture mode; the microscopist should observe the conditions described earlier regarding mapping macro- and micro-fractographs. Similar conditions should be observed when examining fractures due to torsional shear and bending overloads.

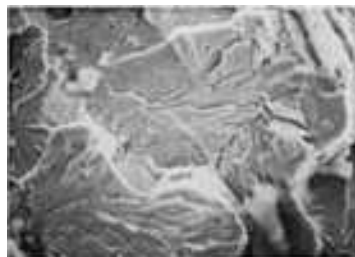
**Fig. 12 Cleavage in a low-carbon steel specimen that was impact fractured at liquid-nitrogen temperatures. 385×**

**Cleavage.** A visual examination of a cleavage fracture reveals brightly reflecting facets, which appear in the scanning electron microscope as very flat surfaces (Fig. 12). At higher magnifications, the facets reveal features related to the direction of local crack propagation, which can in turn be related to the origin of the primary crack (Fig. 13). River patterns represent steps between different local cleavage facets at slightly different heights but along the same general cleavage plane. Because local crystallographic structure can modify the local direction of crack propagation, the overall direction is assigned only after confirming the orientation of the river patterns in several areas on the fracture surface. The same criteria used for characterizing ductile fractures apply in this case.

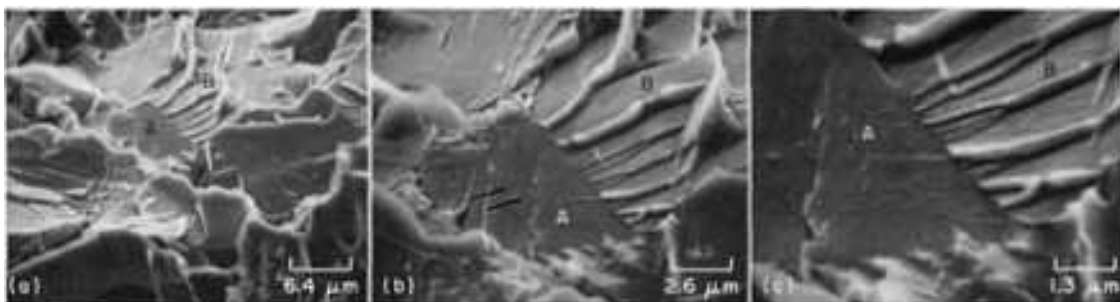
**Fig. 13** Cleavage fracture in a notched impact specimen of hot-rolled 1040 steel broken at  $-196\text{ }^{\circ}\text{C}$  ( $-320\text{ }^{\circ}\text{F}$ ), shown at three magnifications. The specimen was tilted at an angle of  $40^{\circ}$  to the electron beam. The cleavage planes followed by the crack show various alignments, as influenced by the orientations of the individual grains. Grain A, at center in fractograph (a), shows two sets of tongues (see arrowheads in fractograph b) as a result of local cleavage along the  $\{112\}$  planes of microtwins created by plastic deformation at the tip of the main crack on  $\{100\}$  planes. Grain B and many other facets show the cleavage steps of river patterns. The junctions of the steps point in the direction of crack propagation from grain A through grain B, at about  $22^{\circ}$  to the horizontal plane. The details of these forks are clear in fractograph (c).

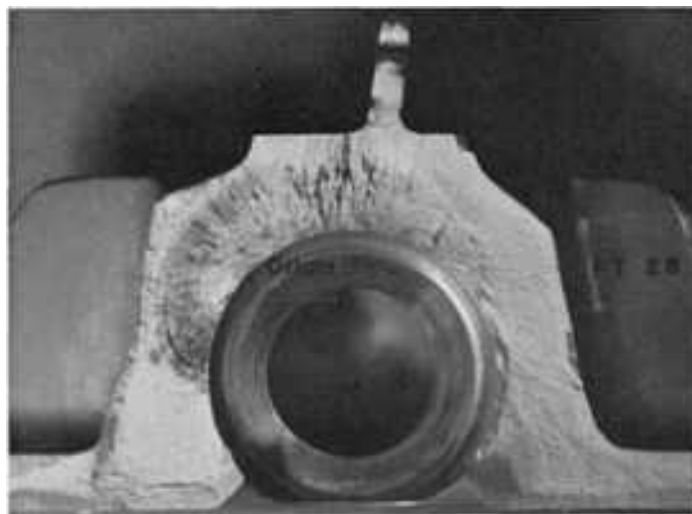
**Fig. 14** Forged aluminum alloy 2014-T6 aircraft component that failed by fatigue. Characteristic beach marks are evident. See also Fig. 15.

The location of the origin is defined by interpreting features of the stage II crack propagation zone. Macroscopic beach marks, or clamshell markings, radiate away from the origin in concentric semicircles (Fig. 14). These are a special form of progression mark commonly associated with fatigue. When the propagation zone is examined by SEM at progressively higher magnifications, the beach marks can be resolved into hundreds or thousands of fatigue striations (Fig. 15).

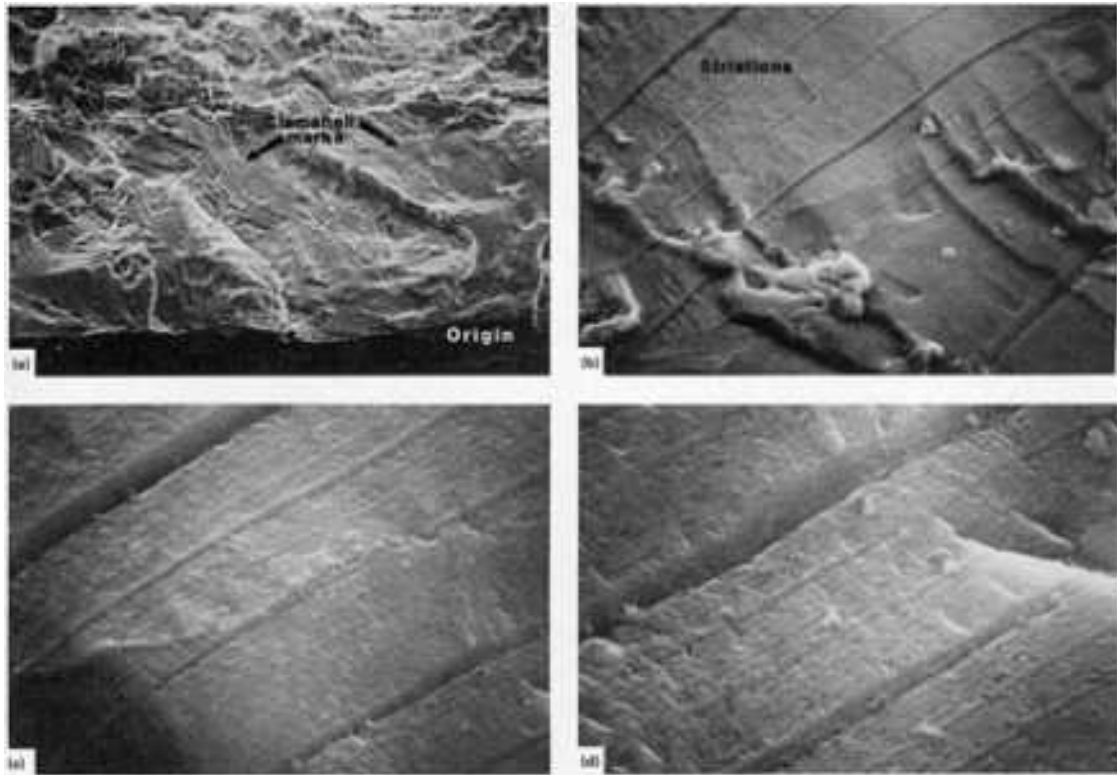
**Fig. 15 A series of low- to high-magnification micrographs of the specimen shown in Fig. 14. Note that as magnification is increased, progressively finer striations are resolved. (a) 80 $\times$ . (b) 800 $\times$ . (c) 4000 $\times$ . (d) 8000 $\times$ .**

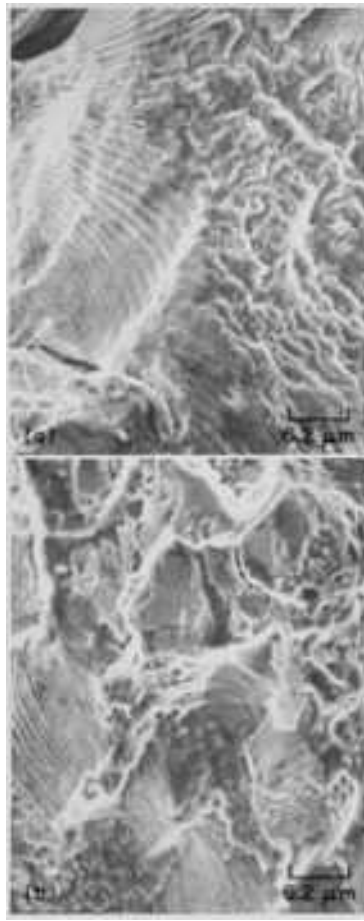
**Fig. 16 Intermingled dimples and fatigue striations in low-cycle fatigue test fractures in aluminum alloy 2024-T851 at a high range of stress intensity ( $\Delta K$ ) at the crack tip. Orientation of fatigue striations differs from patch to patch, particularly in fractograph (a). Dimples in fractograph (b) are associated with inclusions. Both 1600×**

However, if the loading is nonuniform, there are wide variations between a given stress cycle series and the spacing of the striations; each stress cycle does not necessarily produce a striation. For example, overload cycles can produce zones of microvoid coalescence interspersed among bands of striations (Fig. 16). Because the area of the fracture surface occupied by dimples does not exhibit striations, there are wide variations between the pattern of striations and the applied cyclic stress (Ref 67, 68). Further, under nonuniform loading conditions, the lower-amplitude stress cycles may not be of sufficient magnitude to produce resolvable striations. *In situ* fracture devices are one possible solution to this problem (Ref 69, 70).

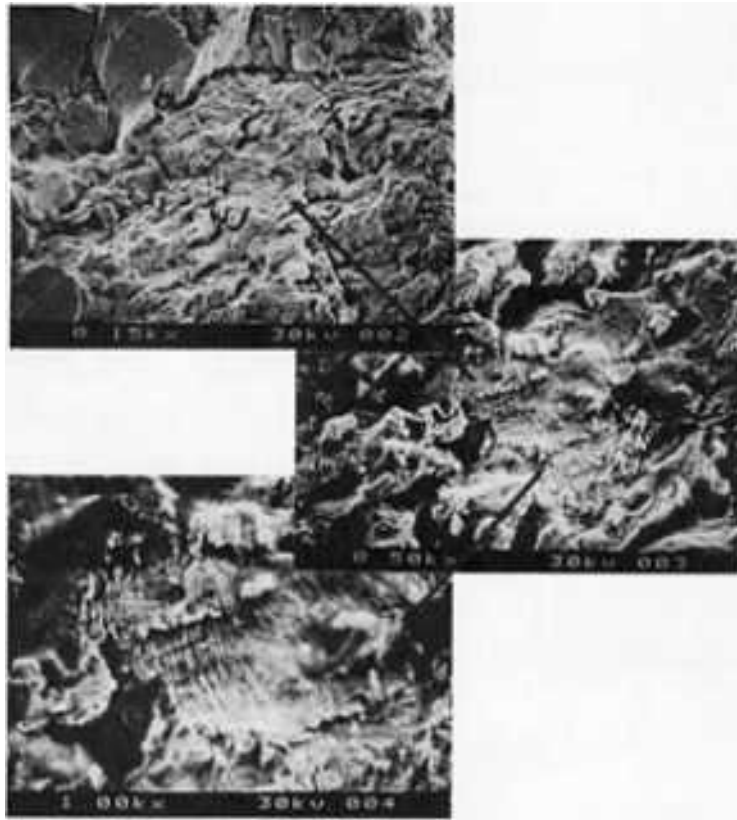
**Fig. 17 Poorly defined fatigue striations in a low-carbon steel specimen**

A different type of complication is that not all fatigue fractures exhibit striations. Although the presence of striations establishes fatigue as the mode of failure, their absence does not eliminate fatigue as a possibility. For example, striations are usually well defined in aluminum alloys fatigued in air, but do not form if the component is tested under vacuum (Ref 71); the same holds true for titanium alloys (Ref 72). Further, the fidelity of the striations changes with composition. For example, striations are often prominent in aluminum alloys (Fig. 15), but are often poorly defined in ferrous alloys (Fig. 17). Oxidation, corrosion, or mechanical damage can obliterate striations.

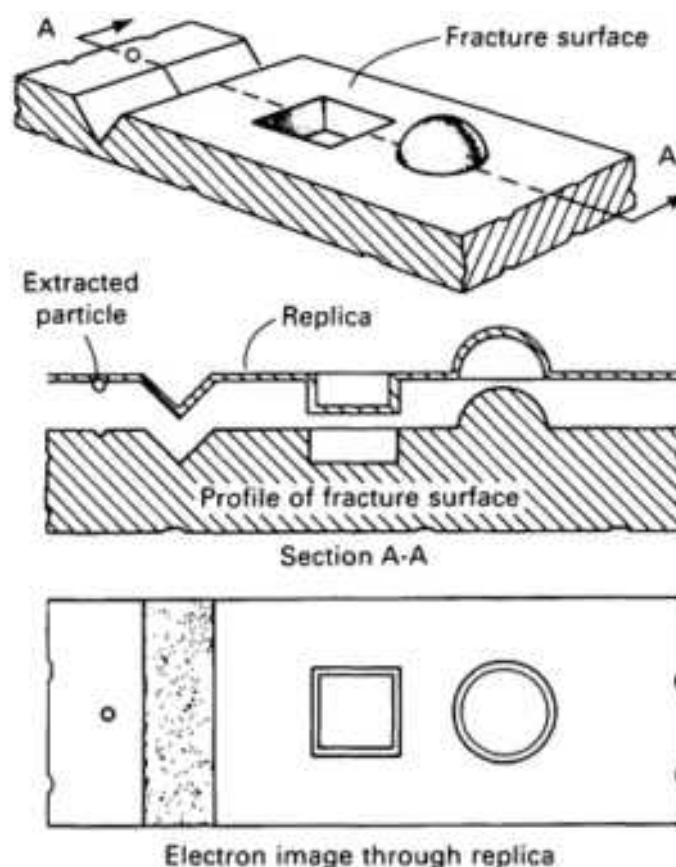
**Fig. 1 Schematic views illustrating the single-stage replication technique**

**Thin Single-Stage Plastic Replicas.** The formation of a single-stage replica is shown schematically in Fig. 1. The contrast obtained with single-stage replicas in a transmission electron microscope derives solely from the greater effective thickness (the greater distance the electrons travel perpendicularly through the film) of the replica in regions corresponding to the sides of hills and valleys in the fracture surface, resulting in relatively more absorption or scattering of the electrons and darkening in the electron image. An inadequate degree of contrast is usually provided by the use of plastic only; therefore, a shadowing technique involving the vacuum vapor deposition of a heavy metal is implemented to enhance contrast.

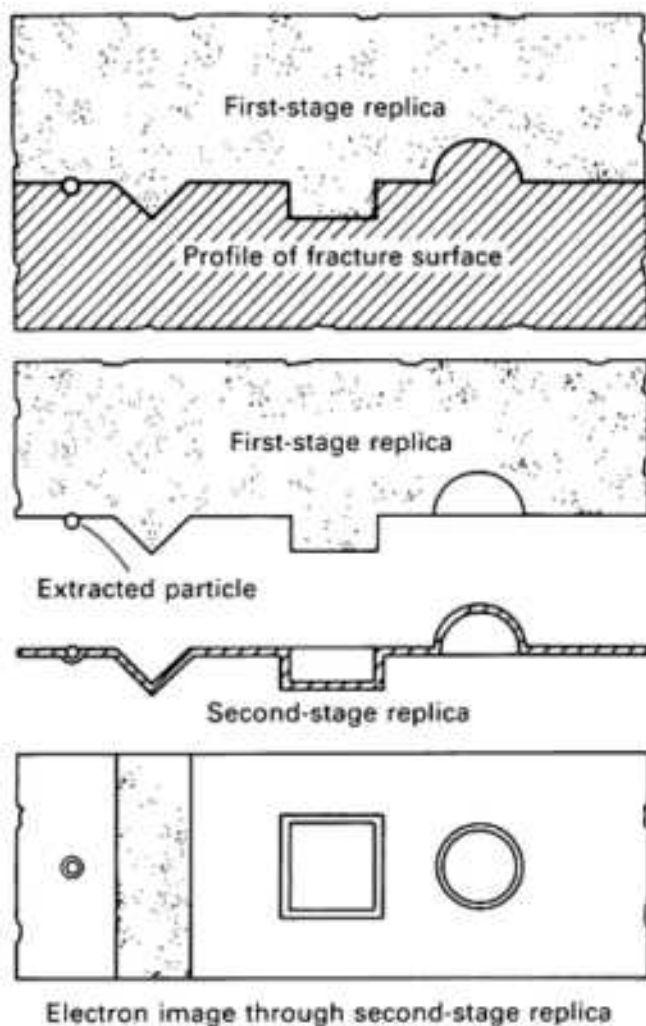
**Fig. 2 Schematic views illustrating the two-stage replication technique**

Two methods are commonly used to prepare a final replica from a first-stage plastic replica. In the first method, a carbon replica is formed by vacuum vapor deposition of carbon on a first-stage plastic replica. In the second method, a plastic is formed by applying to a first-stage plastic replica a softened strip (or a solution) of a second, chemically different plastic; this plastic should not be soluble in the solvent or solvents used to prepare the first plastic replica, and its solvent should not affect the first plastic replica. Because of the superior characteristics of carbon replicas in transmission electron microscope examinations and because the equipment for producing them is usually available, carbon replicas have replaced plastic replicas for the second stage of replication; a plastic second stage is used only in very special applications. Figure 2 shows chemically the formation of a two-stage replica.

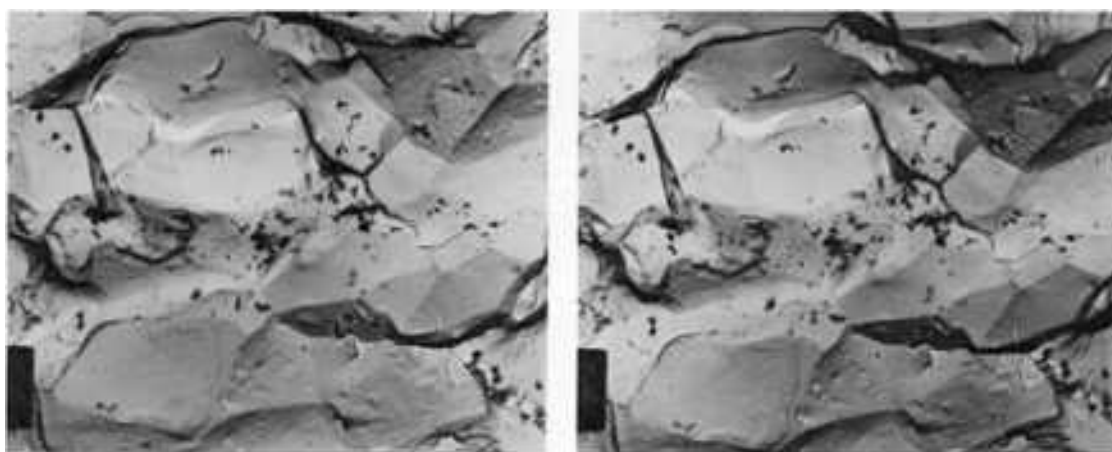
**Fig. 4 Transmission electron stereo pair at 3300 × showing grain-boundary precipitates in an extraction replica taken from the fracture surface of a cobalt-free maraging steel that was solution annealed at 815 °C (1500 °F) for 1 h and air cooled, followed by aging at 480 °C (900 °F) for 3 h and air cooling. The specimen fractured several hours after aging. The particles shown ranged from 0.1 to 4 μm. The smallest were titanium-rich and also contained a small amount of molybdenum. These are probably TiC carbides. A few small (0.2 to 0.3 μm) iron-titanium-molybdenum-rich particles were also observed. The larger particles were either titanium- or zirconium-rich, and these may also be an MC-type precipitate. Such grain-boundary precipitates lower the notch toughness of steels. (G.F. Vander Voort, Carpenter Technology Corporation)**

An alternative procedure that has proved successful for investigating the notch toughness of steels (Ref 4) involves cleaning the fracture surface in an ultrasonic cleaner by using an Alconox-water solution and an alcohol solution (Ref 5). Next, the specimen is heavily carbon coated at various angles. The surface, except the fracture area to be examined, is then painted with an acid-resistant lacquer. After the lacquer has been dried, the specimen is extracted in a 10% hydrochloric acid-90% methanol electrolyte, freeing the carbon film from the surface of the fracture for subsequent examination. Figure 4 shows the range of particle sizes and a typical distribution of particles from a fracture surface of an Fe-0.03C-18.5Ni-3Mo-1.4Ti-0.1Al maraging steel specimen that was prepared by this method.

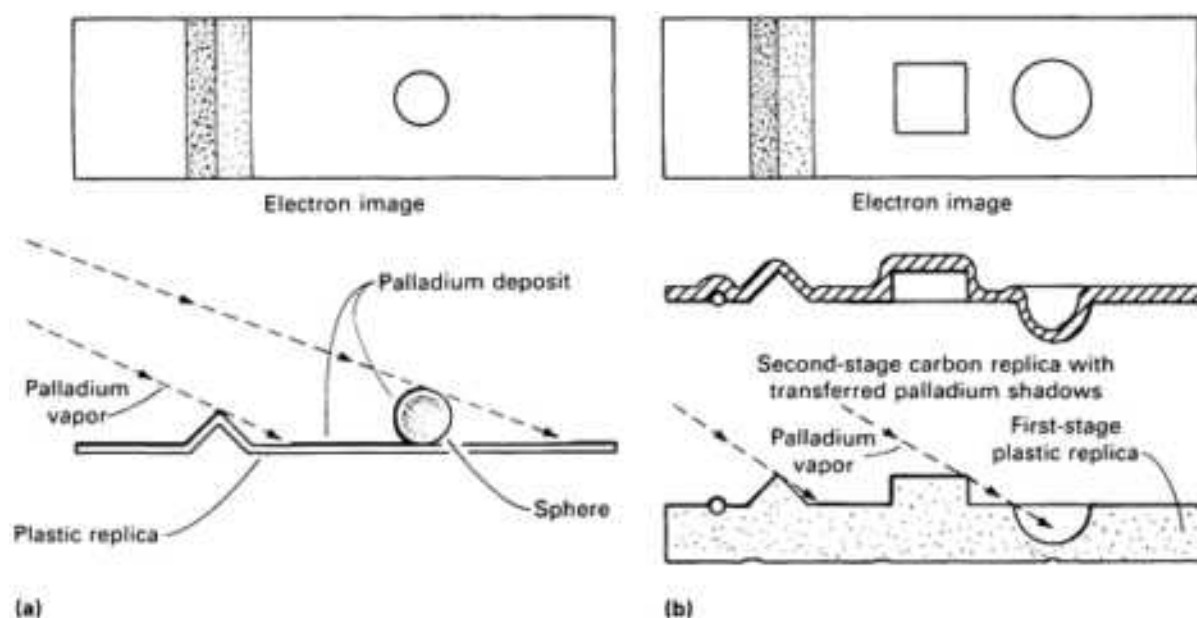
**Fig. 5 Shadowing processes for single-stage plastic replicas (a) and two-stage plastic-carbon replicas (b). A sphere of known size can be placed on a replica, as in (a), to calibrate shadow length.**

When viewing a fractograph of a shadowed replica, it should be remembered that the dark portions in the print represent regions where the shadowing layer is thick, and shadows on the print represent regions where less shadowing metal was deposited. Because shadowing metal will not deposit in thick layers at the bottoms of depressions, it can be deduced that features that appear as light regions were depressions in the surface.

If the shadowing metal is deposited directly on the fracture surface, as in single-stage direct carbon replicas, a light region observed in the replica was depression on the fracture surface. On the other hand, if the shadowing metal is deposited on a thick first-stage plastic replica, a light region inside a feature on a second-stage carbon replica shows that it was a hill on the actual fracture surface. For this reason, sound interpretation of a fractograph depends on knowing the replication procedure used.

The shadowing of replicas and of fracture surfaces is carried out in a laboratory vacuum evaporator fitted with holders for tilting and rotating the replica or specimen and with fixtures for supporting the evaporation sources, which are connected to electrical vacuum lead-throughs for resistance heating. Special spring-loaded devices are used for continuously feeding opposed carbon rods (electrodes) into contact. Spiral tungsten filaments, in the form of baskets, are used for resistance heating and evaporation of the metals used for shadowing (except for platinum, which alloys readily with tungsten). Evaporation is carried out at a pressure of less than  $10^{-4}$  torr ( $1.3 \times 10^{-2}$  Pa) to prevent oxidation of the vaporized metal and to avoid deposition of a granular shadow.

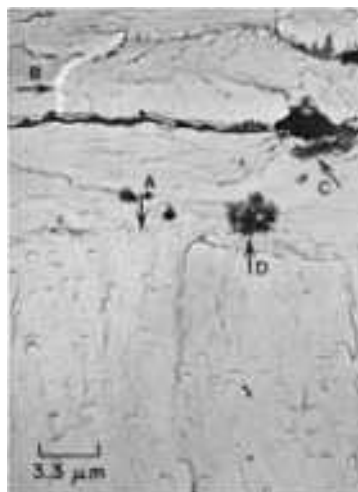
**Fig. 6 Four types of artifacts found on two-stage plastic-carbon replicas. The appearance of the bottom half of**

**the fractograph (below arrow A) is the result of tears in the first-stage plastic replica and is not representative of the fracture surface. Arrow B indicates a crack in the carbon second-stage replica; arrow C, a particle from the improperly cleaned fracture surface; and arrow D, residual plastic from incomplete dissolution of the first stage. 3000×**

The disadvantage most often encountered with any replication process is the presence of features on the replica that do not accurately reflect the details of the fracture surface, such as the artifacts shown in Fig. 6.

Poor technique in the formation of the first-stage plastic replica is a principal cause of artifacts in two-stage replicas. If the fracture surface is not cleaned properly, foreign material is likely to appear in the replica (arrow C, Fig. 6.) If the plastic solution for the first-stage replica is not flowed into all recesses of the fracture surface, air or solvent vapor may become trapped and will appear in the replica as smooth, rounded areas. Many fractographers avoid this problem by applying solvent to the fracture surface immediately before forcing a piece of presoftened plastic strip onto it. During the 10-to 15-s interval before the plastic begins to set, the dry top of the piece of plastic is pressed, using tweezers, to remove visible bubbles from the area to be replicated.

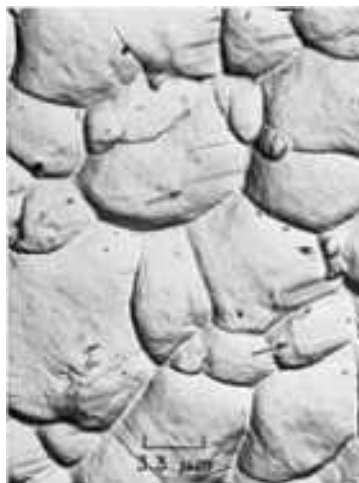
**Fig. 7 Scraping artifacts (as at arrows) which resemble linear striations, on the sides of dimples. TEM plastic-carbon replica. 3000×**

Artifacts that arise during removal of the replica from the fracture surface are of three types. In single-stage direct carbon replicas, holes occur if the carbon adheres to the fracture surface. In plastic single-stage or first-stage replicas, some of the plastic is usually trapped in deep crevices and remains there when the remainder of the replica is removed. This results in a characteristic torn-plastic feature, such as that shown in the lower half of Fig. 6. Another common artifact develops when the plastic scrapes against the fracture surface as it is pulled off. This gives rise to linear marks such as those indicated by arrows in Fig. 7. These linear marks usually occur at several neighboring features. When viewed in stereo, they are seen to be on the sides of hills on the replica (all on one side or the other, depending on the direction of stripping and scraping). This type of replica artifact is particularly troublesome because it closely resembles valid linear striations.

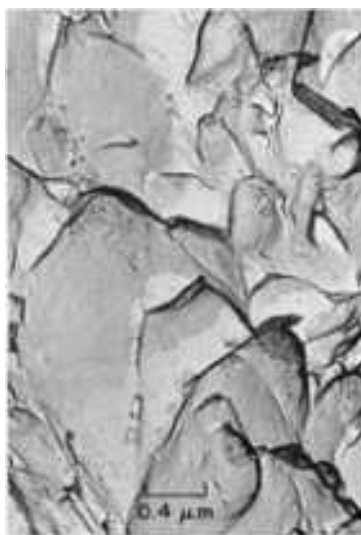
**Fig. 8 Palladium-shadowed plastic-carbon replica of a fracture in nickel showing reticulated shadowing metal on dimples. Reticulation was caused by the melting of the shadowing metal in the microscope and the formation of globules. 22,500×**

Artifacts that arise after a replica is inserted in the microscope include contamination, reticulation, and melting of materials contained in the replica. Contamination resulting from the action of the electron beam is unavoidable and increases with exposure time. Reticulation occurs when the shadowing metal gets hot enough to melt and form globules, such as those shown in Fig. 8. Reticulation can be avoided by using a less finely focused electron beam or by using platinum as the shadowing metal. Use of a less finely focused beam also avoids melting of other materials contained in the replica.

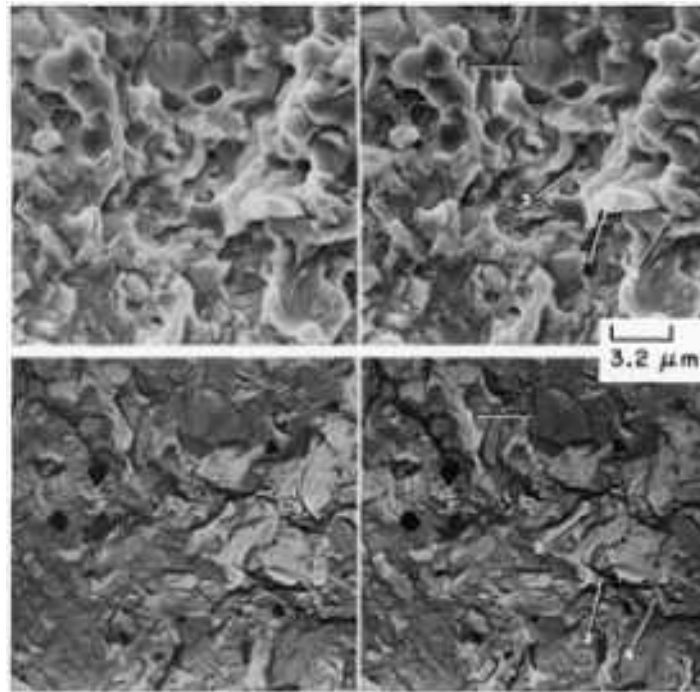
**Fig. 9** Surface of a room-temperature impact fracture in a specimen of AISI T2 high-speed tool steel having a nominal composition of 18W-4Cr-2V-1C. The specimen had been heat treated for 5 min at 1200 °C (2190 °F) and oil quenched, and tempered for 30 min at 500 °C (930 °F) and air cooled, yielding a hardness of 64 HRC. Surface shows quasi-cleavage facets and scattered dimples. In some of the features, the two fractographic techniques provide exact duplicates; in others, some details are missing from the TEM view. The region around the quasi-cleavage facet at arrow 1 is an example of quite good, detailed conformance between SEM and TEM, including the deep hole below (arrow 2). At arrow 3, stereo viewing of the SEM pair reveals a very high prong that is not found in the TEM; this bears evidence that the replica tore very locally. Compare, however, the fine details that appear in both pairs at arrow 4, as well as at other points of duplication. See also Fig. 10 and 10. Fig. 9 (top): SEM stereo pair. Fig. 9 (bottom): TEM stereo pair. Both 3100×

The most severe damage often occurs during drying of the final carbon replica, when surface tensions are very high. The folding and tearing that occur during drying are major limitations of the replication technique. They can be avoided by freeze-drying the replica, although this is a complicated procedure. The smoother the surface, the less damage that occurs in drying. Replicas of flat, fatigue fracture surfaces and of the intergranular surfaces of fine-grain metals are barely affected, but replicas of irregular cleavage fracture surfaces and surfaces including large ridges and valleys undergo severe distortion (see Fig. 9, 14, 15, and 16 in the following section for examples of folding and tearing artifacts).

The following comparison of TEM and SEM fractographs (Fig. 9, 10, 11, 12, 13, 14, 15, 16, 17, 18, 19, and 20) represent point-by-point comparisons of identical fields of view, giving a one-to-one correspondence. Additional TEM replicas are shown in the "Atlas of Fractographs" in this Volume. Additional information is available in the article "Interpretation of

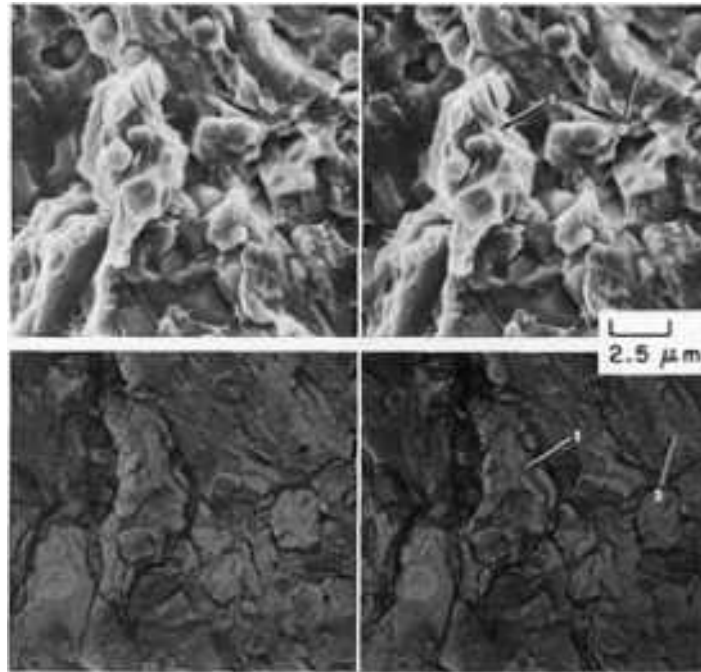
**Fig. 10** Views of a different area, and at higher magnification, of the fracture surface shown in Fig. 9 and. This is a remarkably complex area, containing many small and varied quasi-cleavage facets and exhibiting a number of spheroidal inclusions. The most prominent feature is the high peak at arrow 1, which is reproduced in very faithful and identical detail in both stereo pairs. Note that the two inclusions between the twin tips of the peak are shown in both pairs but that similar inclusions slightly nearer the top of the SEM pair are missing in the TEM because of damage to the replica. The top center area of the SEM view appears to record a greater number of surface complexities than the same area in the TEM view; at arrow 2, however, the TEM view displays very fine fracture marks that cannot be found in the same location in the SEM view. Fig. 10 (top): SEM stereo pair. Fig. 10 (bottom): TEM stereo pair. Both 4000×

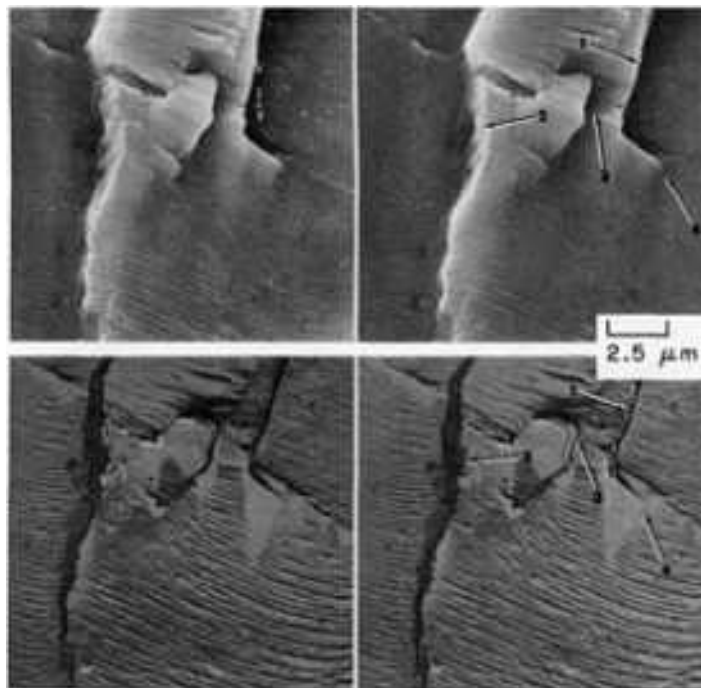
**Fig. 11** The first of two sets of views at increasing magnification showing four areas of the surface of a low-cycle fatigue test fractured in aluminum alloy 7075-T6 obtained with a maximum loading of 117 MPa (17 ksi) at 1900 cpm. Fracture occurred at 600,000 cycles. The tensile strength of the material was 586 MPa (85 ksi). In

this area, the fracture surface shows well-defined fatigue striations that are clearly visible in both the SEM and the TEM pairs but with more detail and contrast in the TEM. Note the excellent match of the reproductions made by the two techniques. The vertical surface at arrow 1 is quite accurately registered in the TEM fractograph, but at the other side (arrow 2), the replica has been torn. The detail in the crevices marked by arrows 1 and 3 is more clearly displayed in the TEM pair, but could be matched in the SEM if the exposure were adjusted for this purpose. The sharp line at arrow 4 in the TEM fractograph bears some resemblance to a replica tear, but it is also visible in the SEM and is actually a secondary crack in the aluminum. See also Fig. 12. Fig. 11 (top): SEM stereo pair. Fig. 11 (bottom): TEM stereo pair. Both 4000×

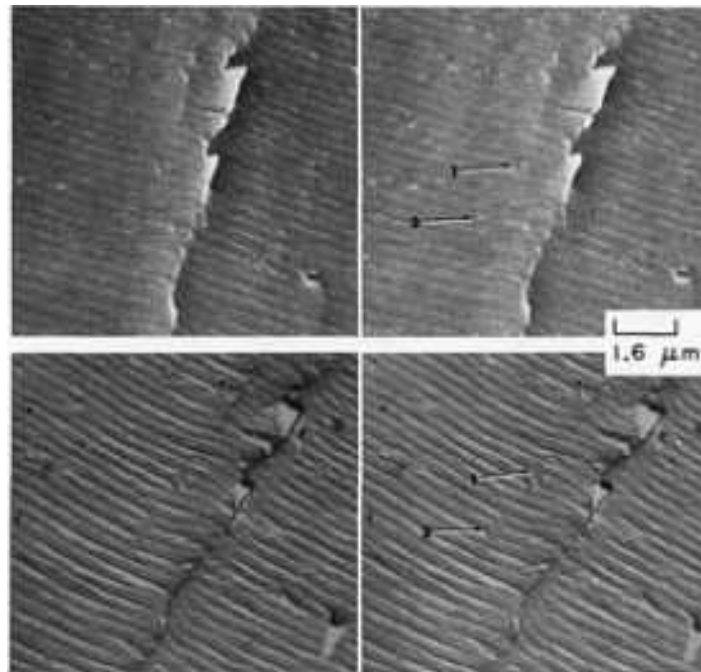
Fig. 12 A second set of views, again at higher magnification, showing a fourth area of the surface of the low-cycle fatigue test fracture in aluminum alloy 7075-T6 in Fig. 11. This region of the fracture surface shows portions of two fatigue patches separated by a sizable step. At this magnification, much of the detail of the striations is visible in both the SEM and the TEM fractographs. Note the slight indentation marks at arrows 1 and 2; these are of course much more clearly defined in the TEM pair. The gray mark below the cavity at lower right in the TEM was produced during shadowing of the replica, a negative surface in which the cavity in the specimen was reproduced as a projection. The height of the step at the juncture of the two fatigue patches is shown to be much greater in the SEM than in the TEM pair; this is the result of replica collapse. Fig. 12 (top): SEM stereo pair. Fig. 12 (bottom): TEM stereo pair. Both 6400×

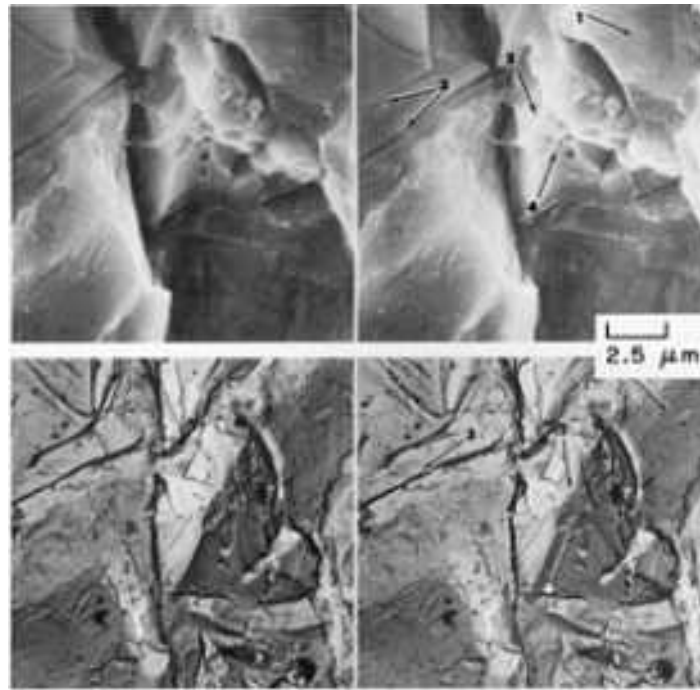
**Fig. 13** The first of two sets of views at increasing magnification of four areas of the surface of a fracture resulting from stress-corrosion cracking in aluminum alloy 7075-T6 exposed to water at room temperature and to stress (maximum not reported) by hydrostatic pressure. The tensile strength of the material was 586 MPa (85 ksi). In this area, the fracture surface is markedly intergranular, contains several secondary cracks (some of which appear to be transgranular), exhibits some corrosion pits but little corrosion debris, and contains local regions of moderate-size dimples. In general, the reproduction of surface contours in the TEM pair matches very closely that in the SEM. However, mismatch is evident at regions affected by replica collapse; for example, the region at arrow 1 (as viewed in three dimensions) appears to be higher than the region at arrow 2 in the SEM pair but lower than the region at arrow 2 in the TEM. Note the excellent agreement between the two techniques in registering the secondary cracks at arrow 3 and the details of the dimples at arrow 4. However, very few corrosion pits are resolved in the SEM pair. See also Fig. 14. Fig. 13 (top): SEM stereo pair. Fig. 13 (bottom): TEM stereo pair. Both 4000×

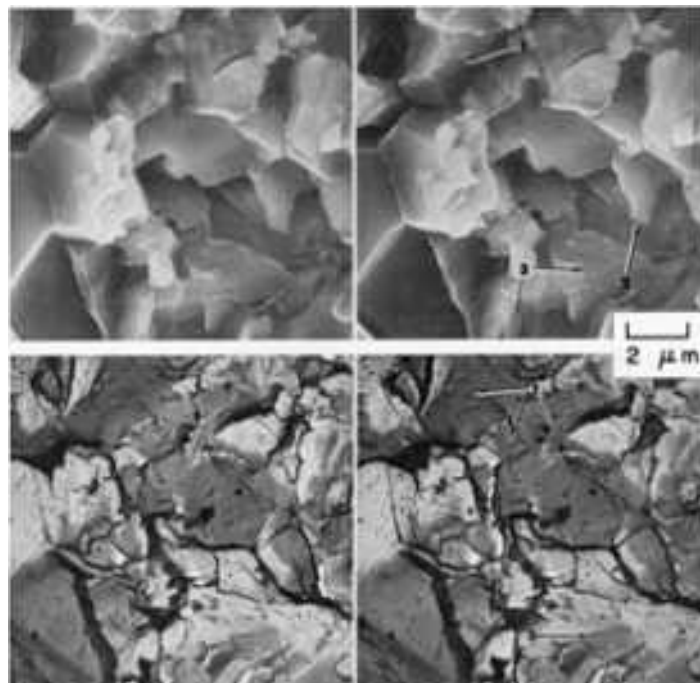
**Fig. 14** A second set of views at higher magnification showing another area of the stress-corrosion cracking fracture in aluminum alloy 7075-T6 in Fig. 13. Similar to the preceding set, this set of views shows a variety of grain surfaces resulting from intergranular rupture. The TEM fractograph shows many minute corrosion pits on these separated-grain surfaces, none of which are resolved in the SEM pair. The dark zones between grains in the TEM pair are caused by folding of the replica at secondary cracks. Observe the excellent agreement between the SEM and TEM pairs as to contour and detail, particularly in the region at arrow 1. Arrow 2 marks a feature in the SEM that does not appear in the TEM, which is unusual. Again, differences in elevation are minimized in the TEM; the region at arrow 3 appears to be at the same level as the ridge above arrow 1, but the SEM shows that the region at arrow 3 is much lower. Fig. 14 (top): SEM stereo pair. Fig. 14 (bottom): TEM stereo pair. Both 5000×

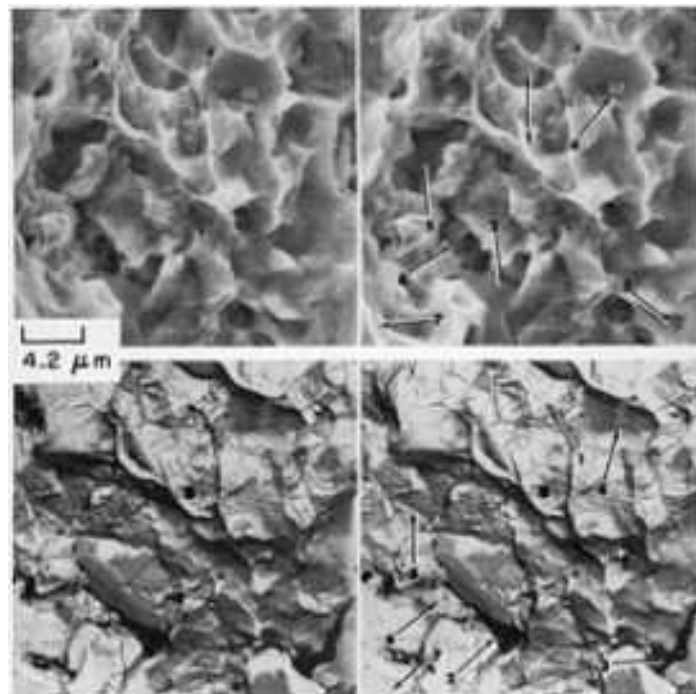
**Fig. 15** Surface of a tension overload fracture in a notched specimen of annealed Ti-8Al-1Mo-1V alloy that was broken at room temperature. The tensile strength of the material was 1000 MPa (145 ksi). The fracture surface consists of dimples of various sizes, a few of which show some sidewall stretching. The SEM and TEM pairs are in close agreement as to details of contour; compare, for example, the contours in and around the depression at arrow 1. In the TEM fractograph, tears and folds in the replica obscure the surface in the crevices at arrows 2 and 3. Note that the cube-shaped second-phase particle at arrow 4 in the SEM is missing entirely from the TEM. Many superficial surface features clearly visible in the TEM pair are not resolved in the SEM. Some replica collapse is evident when the elevations at arrows 5 to 7 in the TEM fractograph are compared with those in the SEM. See also Fig. 16, Fig. 15 (top): SEM stereo pair, Fig. 15 (bottom): TEM stereo pair. Both 2400×

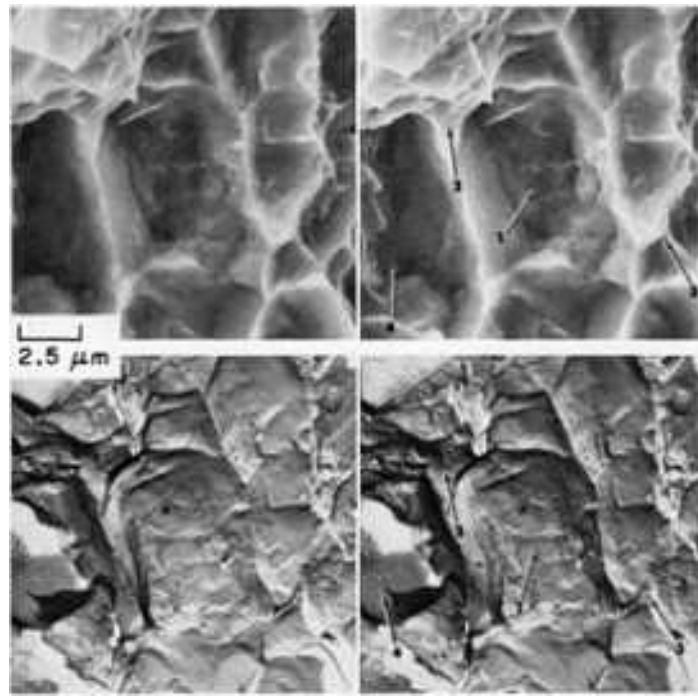
**Fig. 16** A more highly magnified set of views of a different area of the surface of the tension overload fracture in annealed Ti-8Al-1Mo-1V alloy shown in Fig. 15. This area shows rather large dimples. For the most part, the topographic agreement between the SEM and TEM pairs is very close, as can be seen by comparing the contours at arrows 1 to 3. Note that the stretch marks on the left side of the cavity at arrow 2 are clearly visible in both pairs. Elsewhere, however, similar marks are largely unresolved in the SEM fractograph. The feature at arrow 4 in the TEM is not a fracture contour but an artifact caused by a bubble entrapped in the plastic replica. The dark regions above and below this artifact are the result of folds in the carbon replica. The SEM fractograph shows the true surface at arrow 4. Fig. 16 (top): SEM stereo pair. Fig. 16 (bottom): TEM stereo pair. Both 4000×

The most frequently encountered artifact is the small-bubble artifact, that is, a bubble embedded in the plastic (see Fig. 16, 19 and 20 in the section "Comparison of TEM and SEM Fractographs" in this article). Small-bubble artifacts result from release of solvent vapors at the fracture surface. They occur at irregularities on the fracture surface and resemble bubbles that arise from scratches on the bottom of a beaker when water is being boiled. They are caused by the high vapor pressure of excess solvent as it attempts to diffuse out of the plastic. They can be avoided by using plastic strip that is thick enough to allow the dry back (or top) side to act as an absorbent sink for the solvent. Ideally, the plastic strip is softened on one side only and no more than necessary to make it conform to the fracture surface.

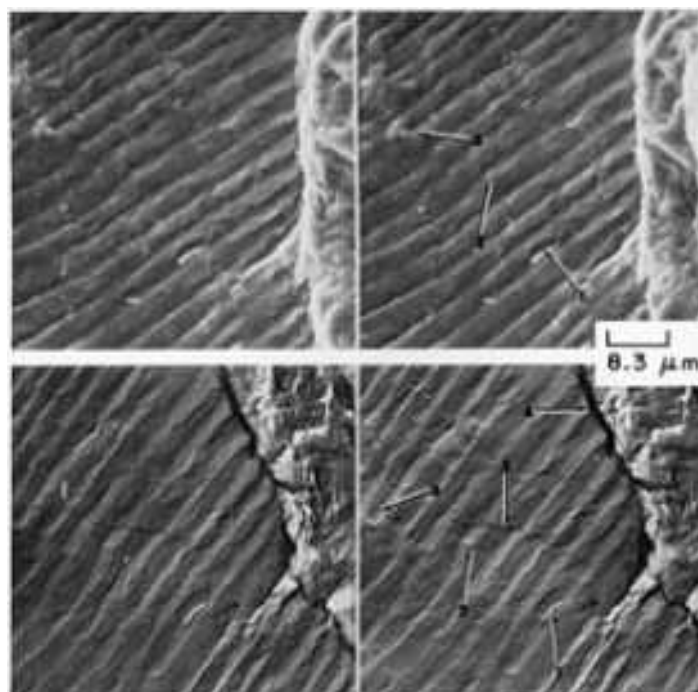
**Fig. 17** Surface of high-cycle fatigue fracture produced at room temperature in a specimen of the same annealed Ti-8Al-1Mo-1V alloy shown in Fig. 15 and 16. Shown here is a portion of a fatigue patch with widely spaced well-defined fatigue striations bounded on the right by a high step to the next patch. There is good

agreement between the SEM and TEM pairs, as evidenced by the details in the two views at arrows 1 to 3, which are readily recognized in both fractographs. The TEM replica has been torn and folded at the step at right, resulting in the dark band at arrow 4 and the simulation of a crack at arrow 5. The apparent elevation of the step is much reduced in the TEM fractograph compared to the true elevation shown in the SEM pair. Note also that the contours of the striations appear much flatter in the TEM than in the SEM but that the fine marks on the ridges, which are in sharp focus in the TEM are not well resolved in the SEM. See also Fig. 18. Fig. 17 (top): SEM stereo pair. Fig. 17 (bottom): TEM stereo pair. Both 1200 ×

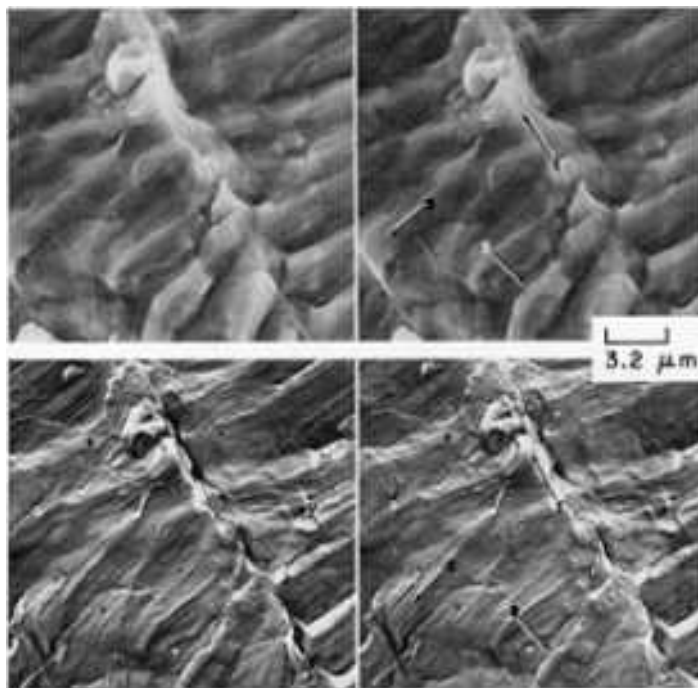
Fig. 18 A more highly magnified set of views of another area of the surface of the high-cycle fatigue fracture in annealed Ti-8Al-1Mo-1V alloy in Fig. 17. These stereo-fractographs show the junction of two adjacent fatigue striation patches that exhibit considerable irregularity in striation orientation in the neighborhood of the step separating the patches. Comparison of the SEM and TEM pairs shows good agreement in registry of contours, as can be seen at arrows 1 to 3. The fine marks along the ridges of the striations are sufficiently pronounced for many to be shown in the SEM fractograph, but others are not resolved there and are shown much more distinctly in the TEM pair. Fig. 18 (top): SEM stereo pair. Fig. 18 (bottom): TEM stereo pair. Both 3100 ×

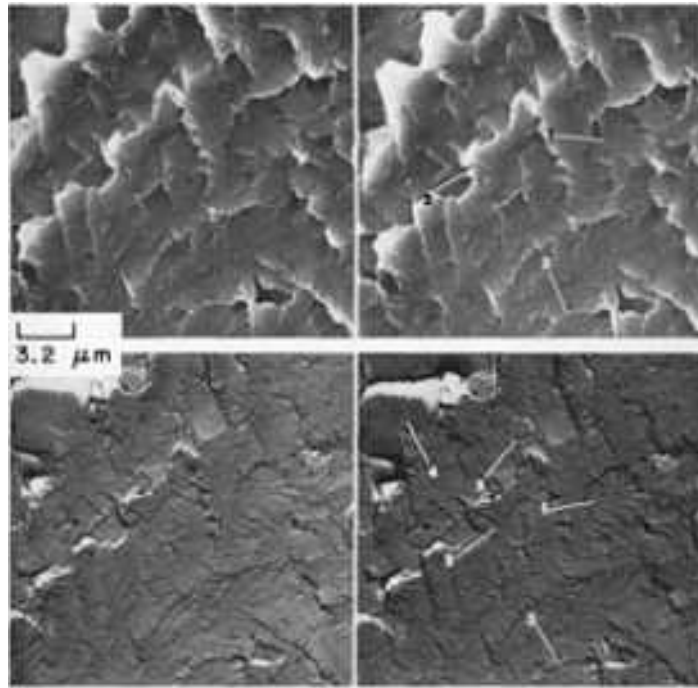
**Fig. 19 Stress-corrosion fracture in a specimen of the same annealed titanium alloy Ti-8Al-1Mo-1V shown in Fig. 15 16 17 18. This specimen was subjected to a maximum stress of 170 MPa (25 ksi) while exposed to an environment of 3.5% NaCl in water at room temperature. The fracture surface possesses many small and slightly offset facets, such as those at arrows 1 and 2, that appear to be quasi-cleavage facets. Many of the features along the edges of these facets, however, show dimple-like characteristics. Serrated ranks of the facets are separated by large steps, although the fracture surface area here is not large enough to show how repetitive these tiers can be. Agreement in contour details between the SEM view and the TEM view is very good, as can be seen by comparing the surfaces at arrows 1 to 3. The feature in the upper-left corner of the TEM stereo pair (arrow 4) is an artifact created by entrapment of a gas bubble in the plastic replica medium. Another feature not common to both the SEM and the TEM views is the apparent artifact at arrow 5 in the TEM. See also Fig. 20. Fig. 19 (top): SEM stereo pair. Fig. 19 (bottom): TEM stereo pair. Both 3100×**
