ASM HANDBOOK®

VOLUME  
12

Fractography

*Fractography*, was published in 1987 as Volume 12 of the *ASM Handbook*. The Volume was prepared under the direction of the ASM Handbook Committee.

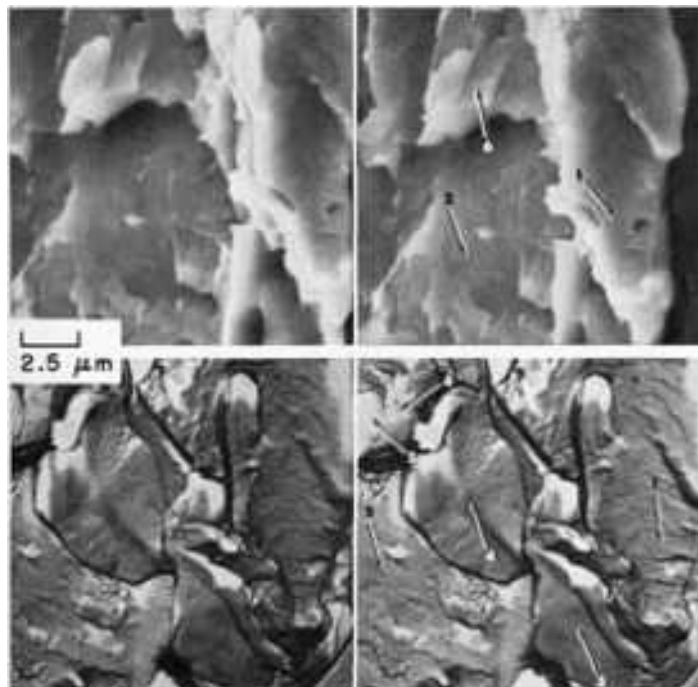
**Fig. 20 A higher-magnification set of views in another area of the stress-corrosion fracture of the annealed Ti-**

8Al-1Mo-1V specimen shown in Fig. 19. This area is somewhat similar to that shown at the lower magnification in the above fractographs, exhibiting rows of modest-size quasi-cleavage facets at different levels. Some of these facets, as at right, are separated by steps of appreciable height. There is excellent agreement in surface features between the SEM and TEM pairs in the high-level region at arrow 1 (at right) and in the lower-level region at arrow 2. The surface details at arrows 3 to 5 in the TEM view, however, are artifacts resulting either from bubbles or foreign material trapped by the replica. The small facet at arrow 6 is the portion of this region that is common to both the SEM and the TEM fractographs. The surfaces that are real show essentially no accumulation of corrosion debris. Fig. 20 (top): SEM stereo pair. Fig. 20 (bottom): TEM stereo pair. Both 4000×

The most frequently encountered artifact is the small-bubble artifact, that is, a bubble embedded in the plastic (see Fig. 16, 19 and 20 in the section "Comparison of TEM and SEM Fractographs" in this article). Small-bubble artifacts result from release of solvent vapors at the fracture surface. They occur at irregularities on the fracture surface and resemble bubbles that arise from scratches on the bottom of a beaker when water is being boiled. They are caused by the high vapor pressure of excess solvent as it attempts to diffuse out of the plastic. They can be avoided by using plastic strip that is thick enough to allow the dry back (or top) side to act as an absorbent sink for the solvent. Ideally, the plastic strip is softened on one side only and no more than necessary to make it conform to the fracture surface.

**Method of Preparation.** In each case, the preparation of these fractographs began with a careful scan of the fracture surface under a low-power binocular microscope to select an area of maximum interest. This was then marked by an identifying scratch in the center of the selected area.

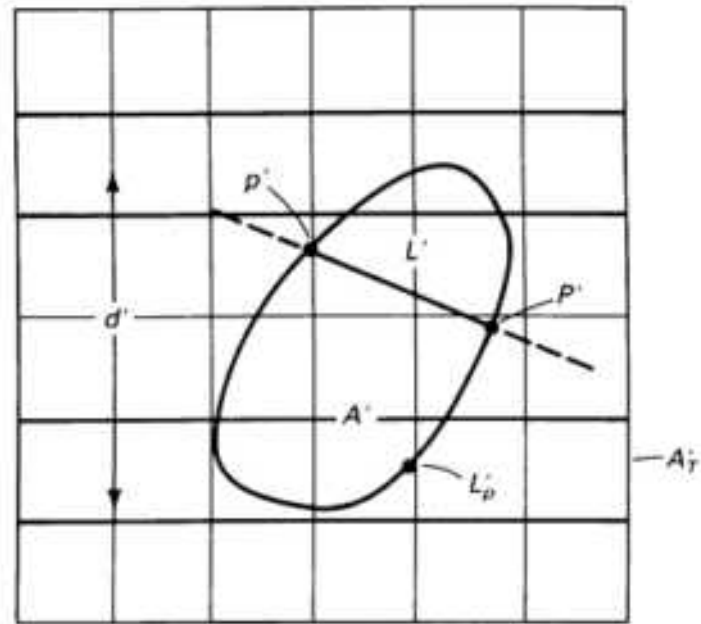
**Fig. 1 Basic quantities for a convex figure in a projection plane**

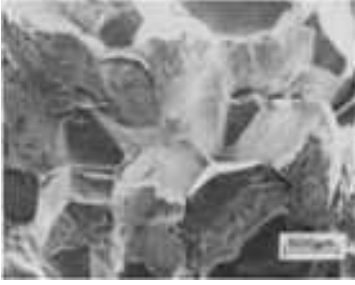
**Fig. 2 SEM projection of facets in fractured Al-4Cu alloy**

When many individual measurements are required on a system of features, such as for a size distribution, more labor is involved. If appropriate or available, semiautomatic image analysis equipment can be used in such cases. For example, the areal size distribution of the facets shown in Fig. 2 was determined by tracing the perimeter of each facet in the SEM photomicrograph with an electronic pencil (Ref 18). With a typical semiautomatic image analysis system, a printout can be produced with the data in the form of a histogram, along with other statistics.

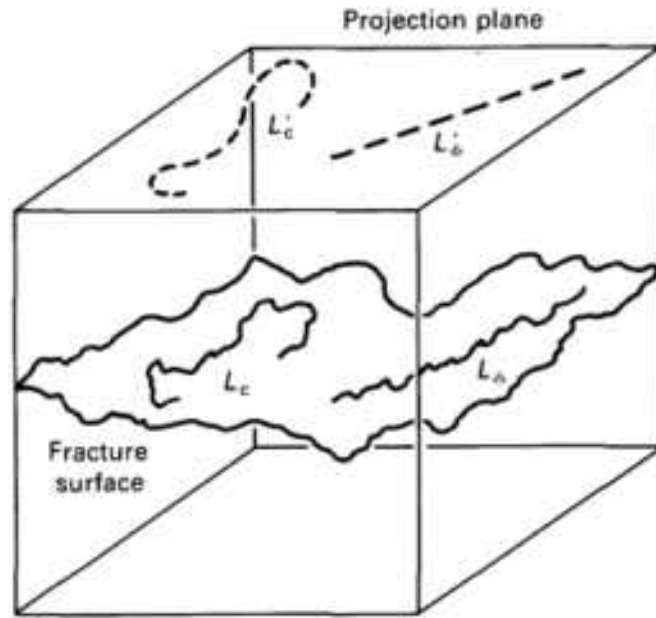
**Fig. 3** Relation of curved and straight lines in the projection plane to lines in the fracture surface.  $L_c = (4/\pi) \bar{L}$  and  $L_f = (\pi/2) \bar{L} \cdot f$ .

Figure 3 shows the differences between  $L f$  and  $L_c$  in the fractures surface. The value  $L f$  corresponds to a straight line  $L' f$  with fixed direction in the projection plane, while  $L_c$  relates to a curved line  $L'_c$  with variable direction in the projection plane. Statistically, the angular dependence of  $L f$  is averaged in a vertical plane defined by  $L f$ , while  $L_c$  must be averaged in three dimensions, amounting to a difference of up to 23%. This elementary distinction has not been recognized in work purported as three-dimensional fractography (Ref 42). Other quantities in Table 2 can be used as they are or can be combined into more complicated functions as required.

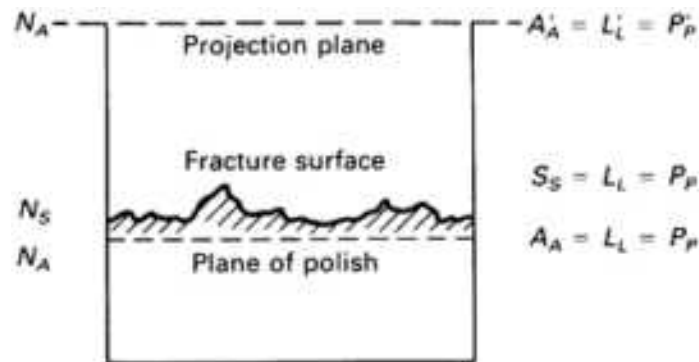
**Fig. 4** Correlation among plane of polish, fracture surface, and projection plane

**Correlation of Fracture Path and Microstructure.** It is possible to relate bulk microstructural properties to the fracture path only if there is no correlation between the configuration of the surface and the underlying structure. However, in general, a correlation does exist. Frequently, the fracture path passes preferentially through particles, or some feature of the microstructure, rather than along an independent path through the material. This correlation results in a statistically higher concentration of particles in the fracture surface,  $N_s$ , than the metallographic plane of polish,  $N_A$ . Figure 4 shows the relationship of the fracture surface to a horizontal plane of polish and to the SEM projection plane. The interrelationship of particles and dimples among these three planes has been thoroughly investigated (Ref 49).

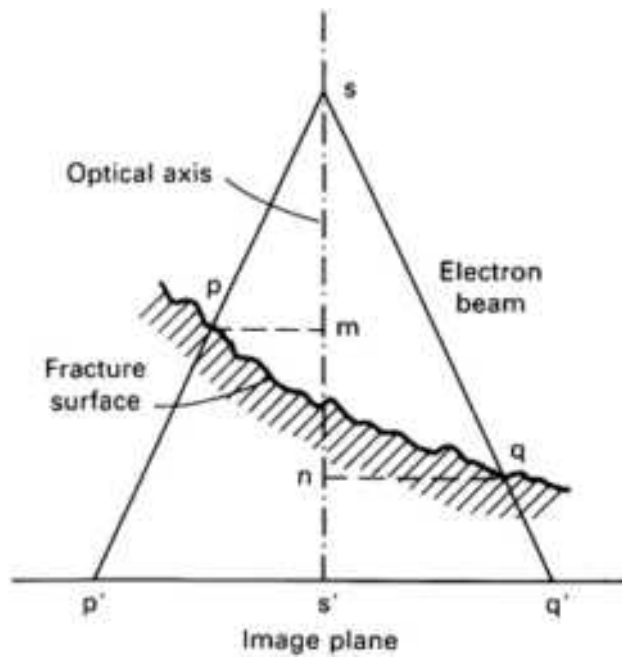
**Fig. 5 Geometry of image formation in the scanning electron microscope**

**Stereoscopic Imaging.** Stereoscopic pictures can be readily taken by SEM and TEM (Ref 52). In any SEM picture, there are two main types of distortion: perspective error due to tilt of the surface and magnification error arising from surface irregularities. The first type of error can be minimized by keeping the beam close to perpendicular to the fracture surface. The second error can be understood by reference to Fig. 5, which is the rectilinear optical equivalent of the SEM image (Ref 50).

The magnification is defined as the ratio of the image distance to the object distance. In the case of an irregular surface, the object distance is not constant. Consequently, high points have higher magnification than low points on the surface. For example, at point  $p$  in Fig. 5, the magnification is proportional to  $ss'/sm$ , but at point  $q$ , it is proportional to  $ss'/sn$ .

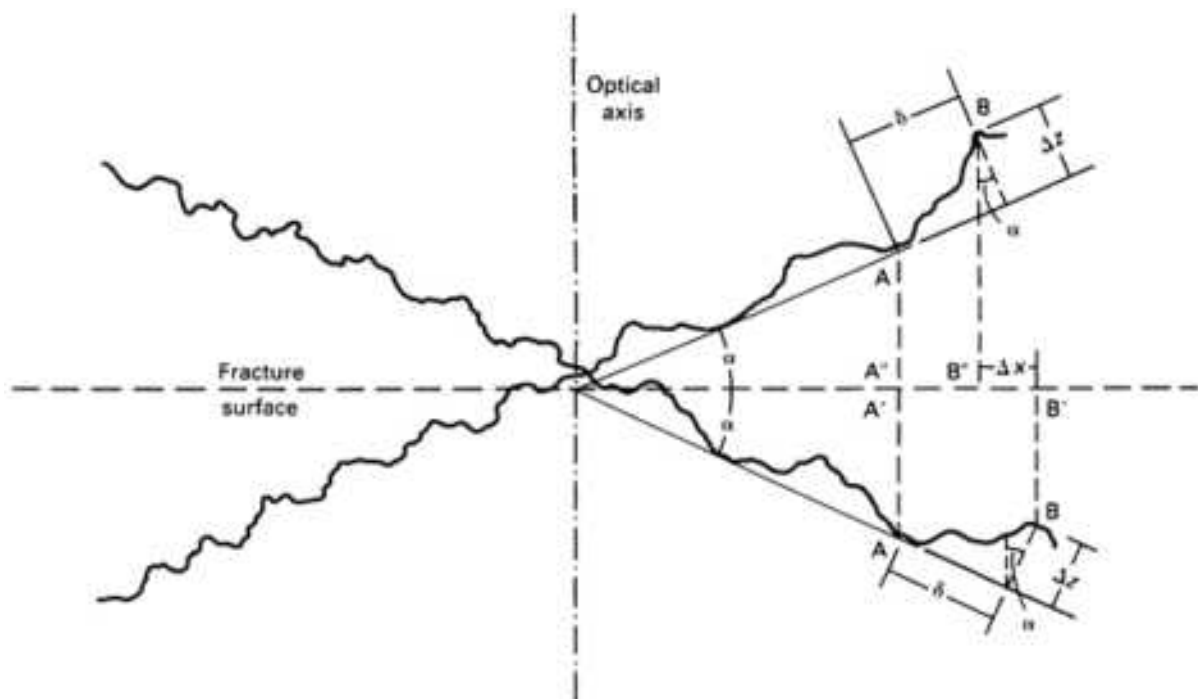
**Fig. 6 Determination of parallax  $\Delta x$  from stereo imaging**

The coordinates of the points in the fracture surface are usually measured by stereo SEM pairs, that is, two photographs of the same field taken at small tilt angles with respect to the normal. The geometry of this case is shown in Fig. 6, in which the points  $A$ ,  $B$  appear at  $A'B'$  and  $A''B''$  in stereo pictures taken at tilt angles  $\pm\alpha$ . The lengths  $A'B'$  and  $A''B''$  can be measured either from the two photos separately or from the stereo image directly (Ref 53). The difference  $A'B' - A''B''$  is called the parallax,  $\Delta x$ .

According to the geometry shown in Fig. 6:

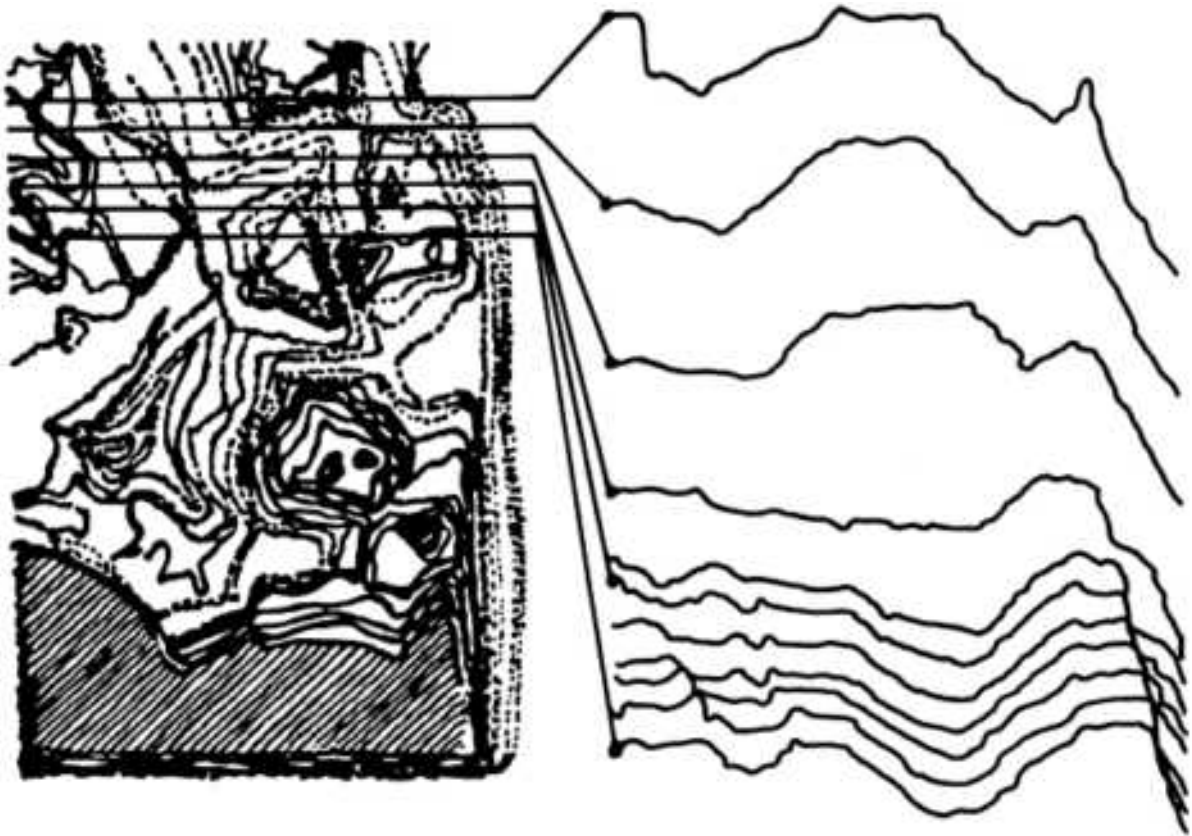
**Fig. 7 Contour map and profiles obtained by stereophotogrammetry. Source: Ref 58**

Stereo pair photographs with symmetrical tilts about the normal incident position are used to generate the stereoscopic image. The built-in floating marker (a point light source) of the stereometer is adjusted to lie at the level of the fracture surface at the chosen  $(x',y')$  position. Small changes in height are recognized when the marker appears to float out of contact with the fracture surface. The accuracy with which the operator can place the marker depends on his stereo acuity and amount of practice. When the floating marker is positioned in the surface, a foot switch sends all three spatial coordinates to the computer. Thus, the operator can take a sequence of observations without interrupting the stereo effect. A FORTRAN program then calculates the three-dimensional coordinates and produces the corresponding profile or contour map on the plotter or screen.

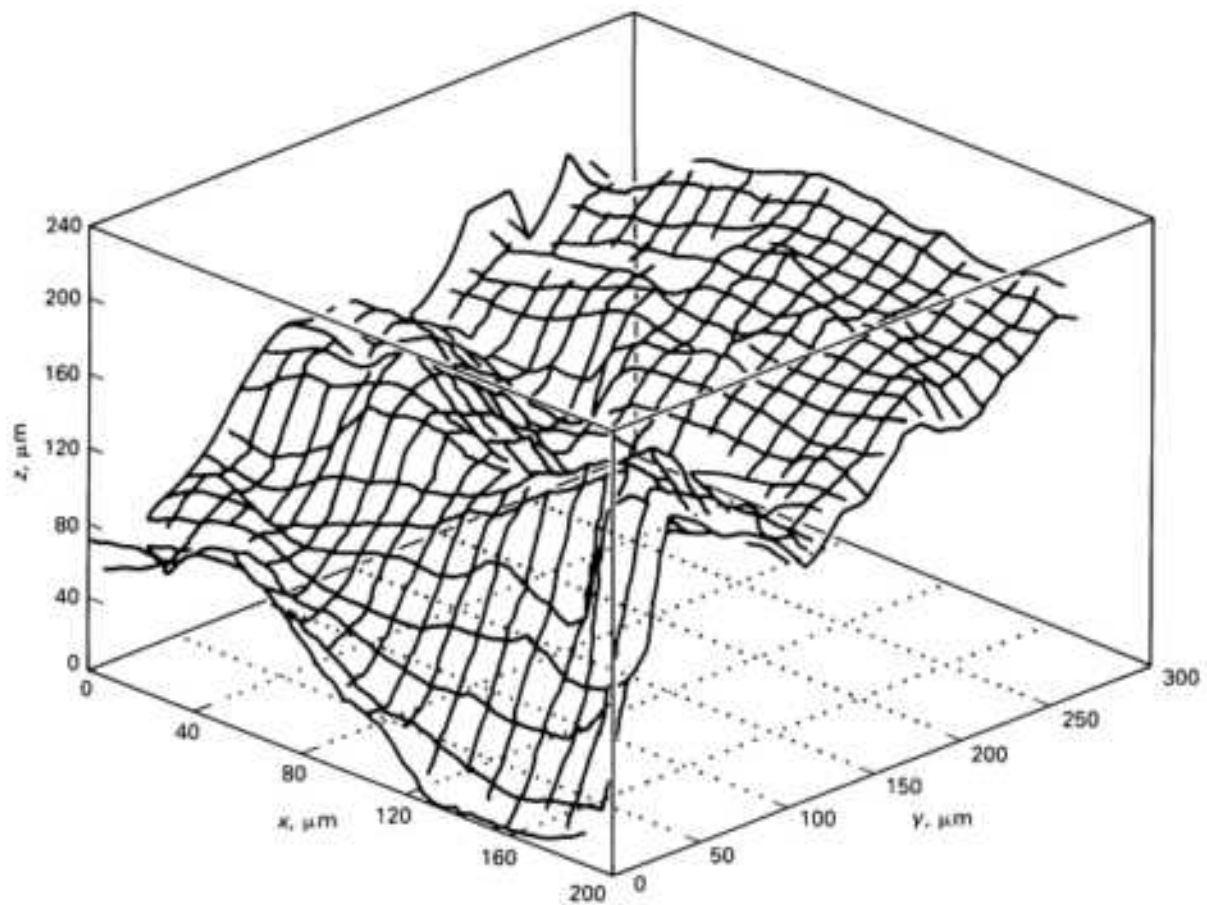
**Fig. 8 Fracture surface map (carpet plot) of a Ti-10V-2Fe-3Al specimen by stereophotogrammetry. Source: Ref 57**

In another research program having the objective of mapping fracture surfaces, a standard Hilger-Watts stereophotogrammetry viewer was modified so that the operator does not have to take his eyes from the viewer to record the micrometer readings (Ref 57). The graphic output is based on a matrix of 19 by 27 data points and is in the form of contour plots, profiles, or carpet plots. Figure 8 shows an example of the latter for a fractured Ti-10V-2Fe-3Al tensile specimen.

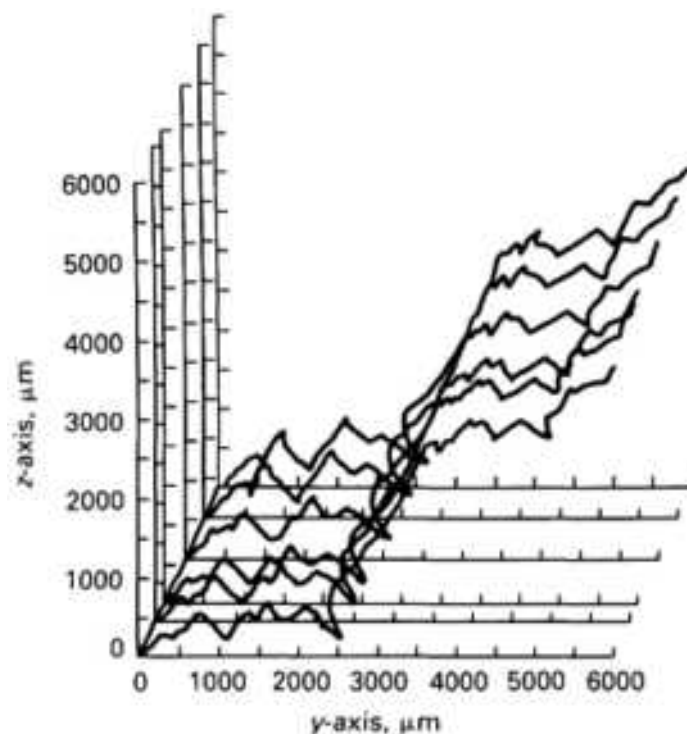
**Fig. 9 Profiles obtained by serial sectioning of a fractured Al-4Cu alloy**

**Metallographic Sectioning Methods.** Although many kinds of sections have been investigated—for example, vertical (Ref 16, 62, 63), slanted (Ref 64, 65, 66), horizontal (Ref 22, 47, 49, 67), and conical (Ref 20, 64, 68)—this discussion will be confined to planar sections. The major experimental advantages of planar sections are that they are obtained in ordinary metallographic mounts and that any degree of complexity or overlap of the fracture profile is accurately reproduced. Moreover, serial sectioning (Ref 18, 45, 47) is quite simple and direct (Fig. 9). In addition, planar sections reveal the underlying microstructure and its relation to the fracture surface (Ref 16, 62, 63), the standard equations of stereology are rigorously applicable on the flat section (Ref 33), and the angular characteristics of the fracture profile (Ref 36) can be mathematically related to those of the surface facets (Ref 39).

A plot of these curves on  $R_s$ ,  $R_L$  coordinates has been made, on which all known experimental data points have been superimposed (Ref 23). An updated version of this plot is shown in Fig. 17. The curves labeled A to D represent the following: curve A, Eq 28; curve B, Eq 32; curve C, Eq 26; and curve D, Eq 31. Experimental roughness data are entered for 4340 steels (Ref 43, 69), Al-4Cu alloys (Ref 18, 69), Ti-28V alloys (Ref 16), and an  $\text{Al}_2\text{O}_3 + 3\%$  glass ceramic (Ref 14). The horizontal bars intersecting the data points in Fig. 17 represent the 95% confidence limits of  $R_L$  values from six serial sections for each of the Al-4Cu alloys studied (see Fig. 9).

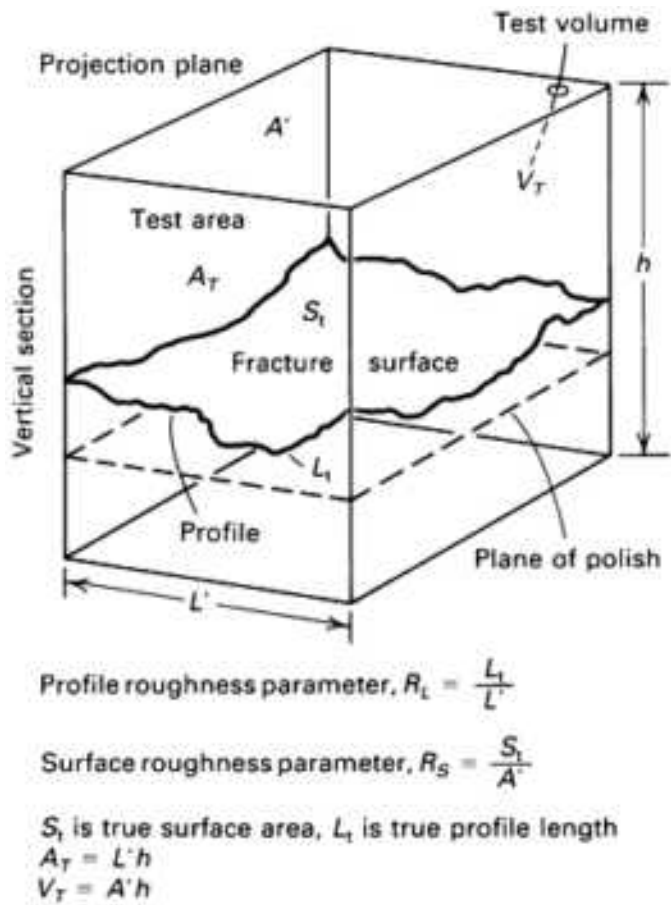
**Fig. 10** Arbitrary test volume enclosing a fracture surface

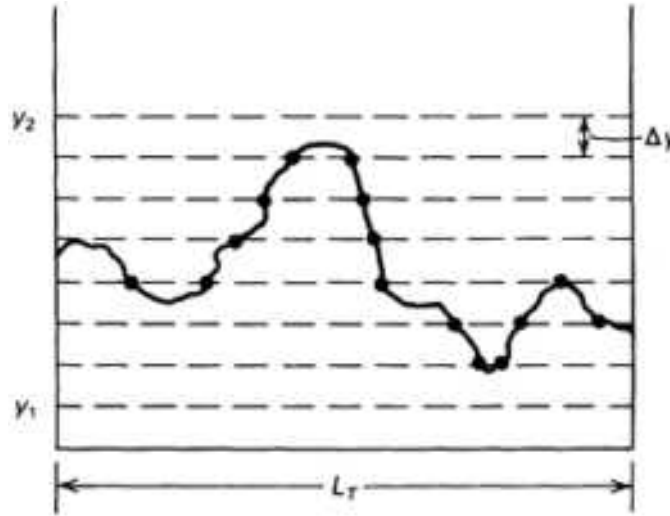
**Fig. 11 Profile configuration parameter,  $R_p$ , which is the ratio of average peak height to average peak spacing**

**Profile Parameter 2.** A profile configuration parameter,  $R_p$ , described in Ref 83 is equal to the average height divided by the average spacing of peaks, or:

which is equivalent to twice the average peak height over the average peak spacing; thus,  $R_v = 2R_p$ .

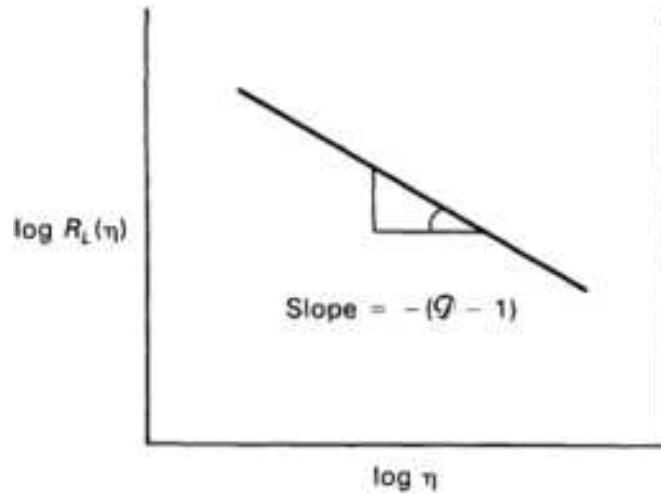
**Fig. 12 Fractal dimension  $D$  and its relationship to slope of log-log plot of  $R_L(\eta)$  versus  $\eta$**

where the (negative) slope is equal to  $-(D - 1)$ . Figure 12 shows the essential relationship of these quantities. This approach has been reanalyzed for the case of fracture surfaces and profiles (Ref 24).

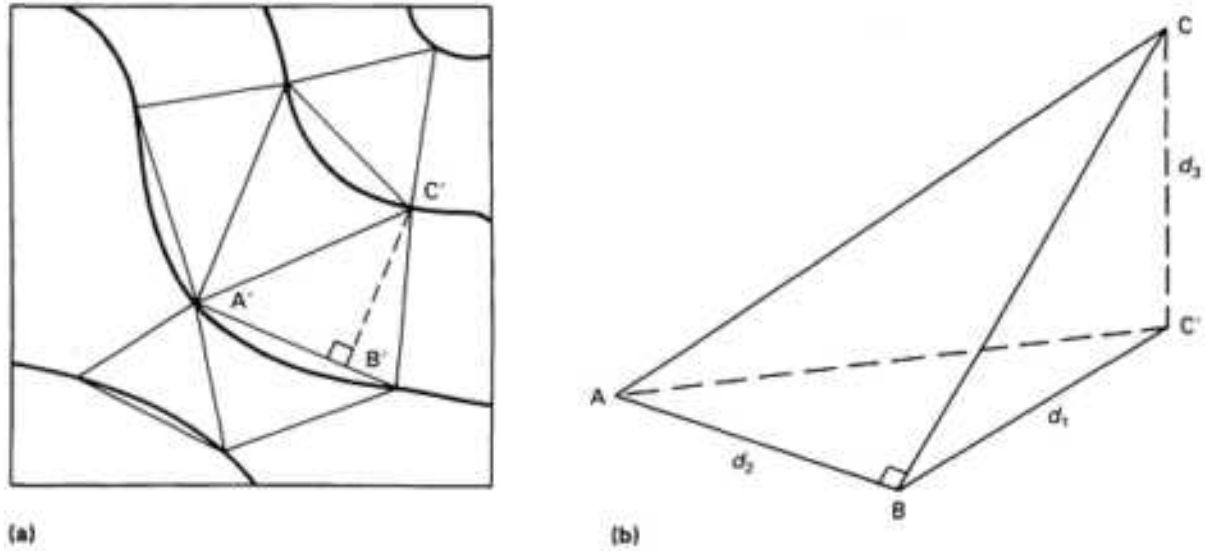
**Fig. 13 Representation of a fracture surface with triangular elements between contour lines. (a) Projection of contours and triangles. (b) Three-dimensional view of triangle ABC**

Another approximate surface composed of triangular elements has been proposed, but this approach uses a contour map rather than serial sections to form the triangles (Ref 13). The triangles are connected between adjacent contour lines, then divided into right angle subtriangles ( $A'B'C'$ ) as shown in Fig. 13. The area of the triangular element ABC can be calculated because the sides  $\overline{AB}$  and  $\overline{BC}$  can be determined. The area of the entire model surface is then obtained by summation.

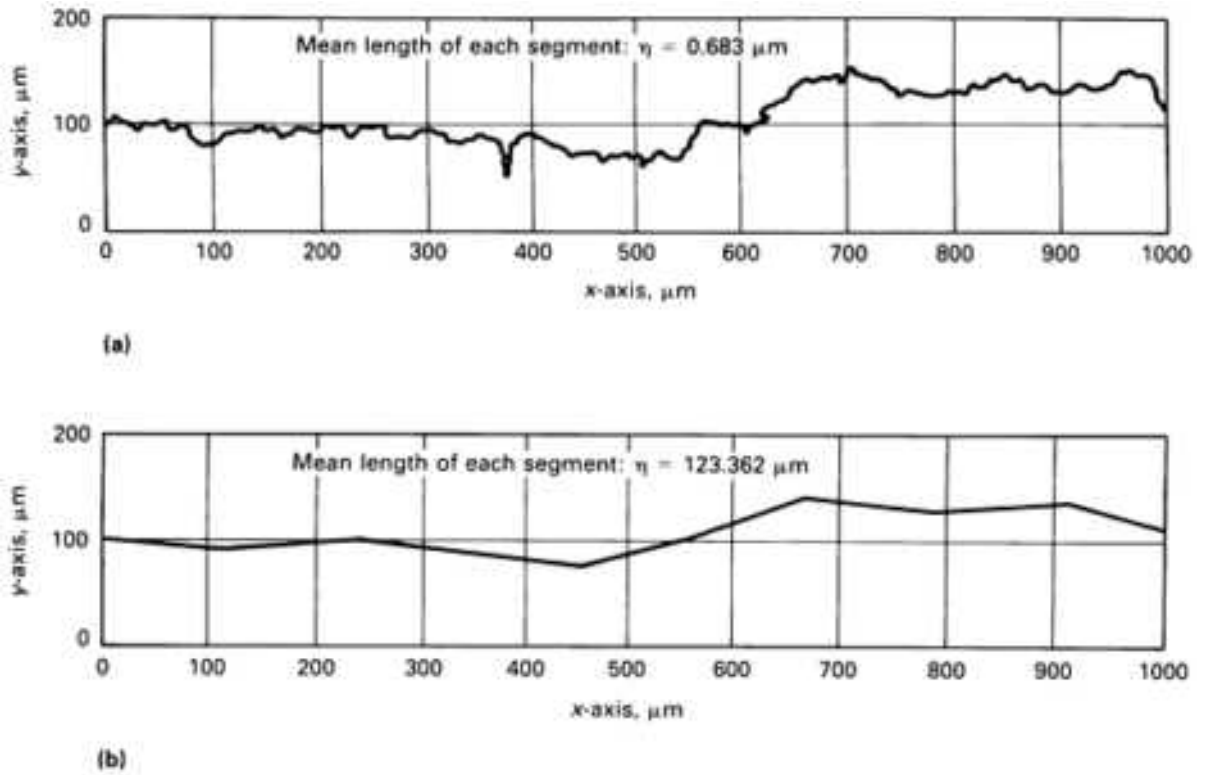
**Fig. 14 Profiles for 4340 steel. (a) Dimpled fracture surface. (b) Prototype faceted fracture surface. Compare with Fig. 15**

To illustrate this procedure, two profiles representing two important types of fracture surfaces are selected (Ref 36). The first profile (Fig. 14a) comes from an actual dimpled fracture surface for 4340 steel. Figure 14(b) shows to prototype profile of a fracture surface representing 100% cleavage or intergranular facets. The experimental data for these two extreme cases were obtained simply by tracing the profile image (once) with a cursor on a digitizing tablet. The measuring distance  $\eta$  between coordinates on the dimple fracture profile was  $0.68 \mu\text{m}$ . A very large value of  $\eta = 123.4 \mu\text{m}$  was selected to generate the prototype facet profile.

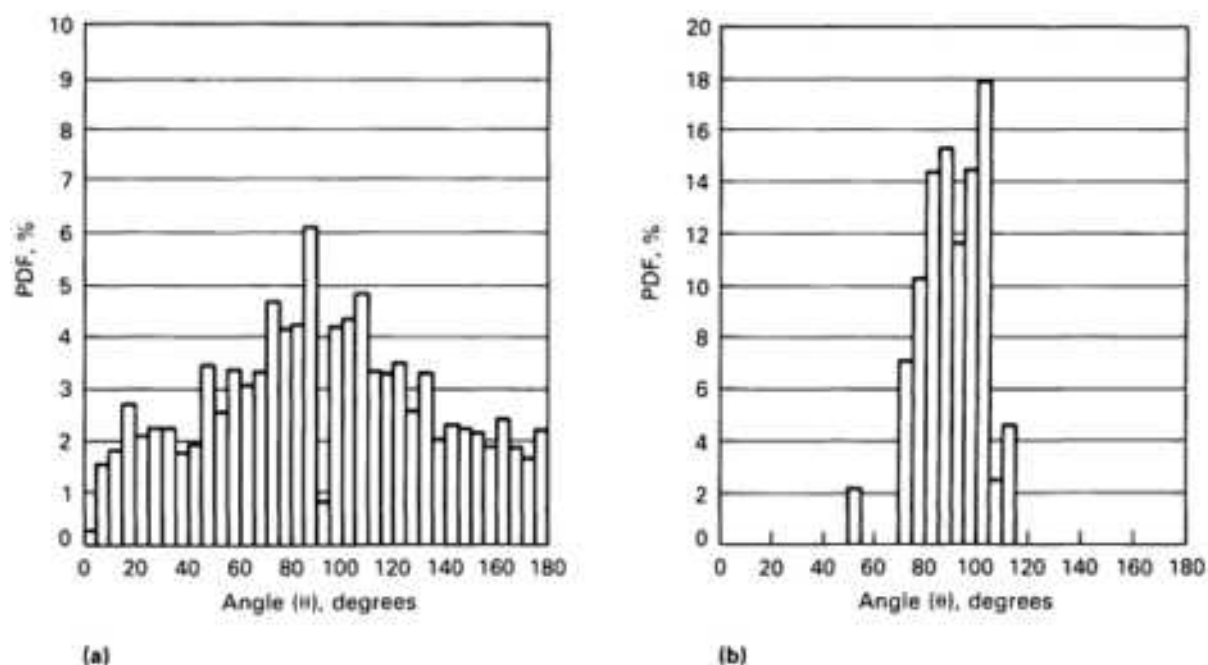
**Fig. 15 Histograms of angular distributions for profiles of 4340 steel. (a) Dimpled fracture surface. (b) Prototype faceted fracture surface. PDF, probability density function. Compare with Fig. 14.**

The two histograms for the angular distribution of segment normals along the two profiles are shown in Fig. 15(a) and 15(b). As expected, there is a much broader angular distribution in Fig. 15(a) than in (b). The distributions for the dimple fracture profile is extremely broad; which might seem to justify the assumption of angular randomness. To verify this

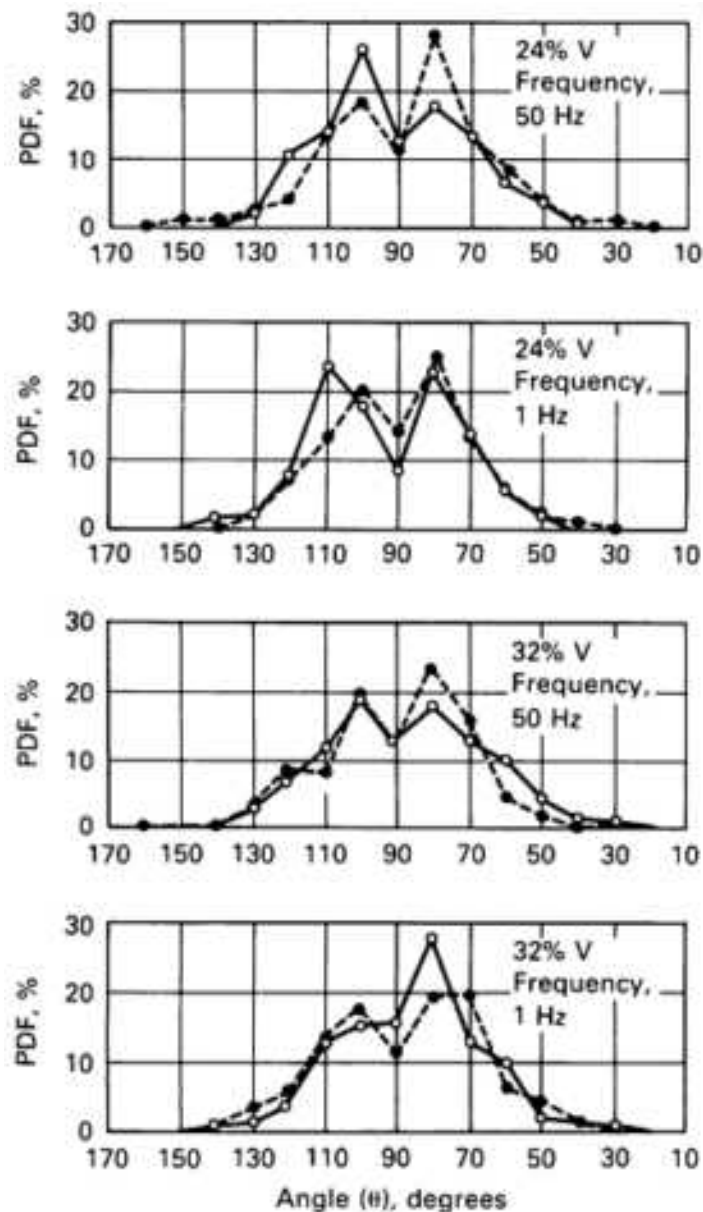
**Fig. 16 Experimental angular distribution curves for profiles of Ti-24V and Ti-32V alloys fractured in fatigue. Longitudinal sections made along edge (solid lines) or through center (dashed lines) of compact tensile specimens. Angles measured counterclockwise from horizontal to segment normals**

The type of angular distribution observed is essentially bimodal, showing symmetry about the normal to the macroscopic fracture plane. The experimental angular distribution curves for two-titanium-vanadium alloys (compact tensile specimens) shown in Fig. 16 illustrate this bimodal behavior clearly. Similar distributions were obtained for both longitudinal and transverse sections, which establishes the three-dimensional angular symmetry about the macroscopic normal. Three-dimensional bimodality was also confirmed clearly with the computer-simulated fracture surface (Ref 35). Bimodal behavior also appears to a greater or lesser extent in other surface studies, in which histograms of two-dimensional angular distributions reveal a relative decrease in the density function at or near 90° (Ref 14, 59). The conclusion to be drawn from this combined evidence is that there is a symmetry axis about the normal to the macroscopic fracture plane. Thus, the mathematical transform procedures that require an axis of symmetry may be more applicable to metallic fracture surfaces than originally thought.

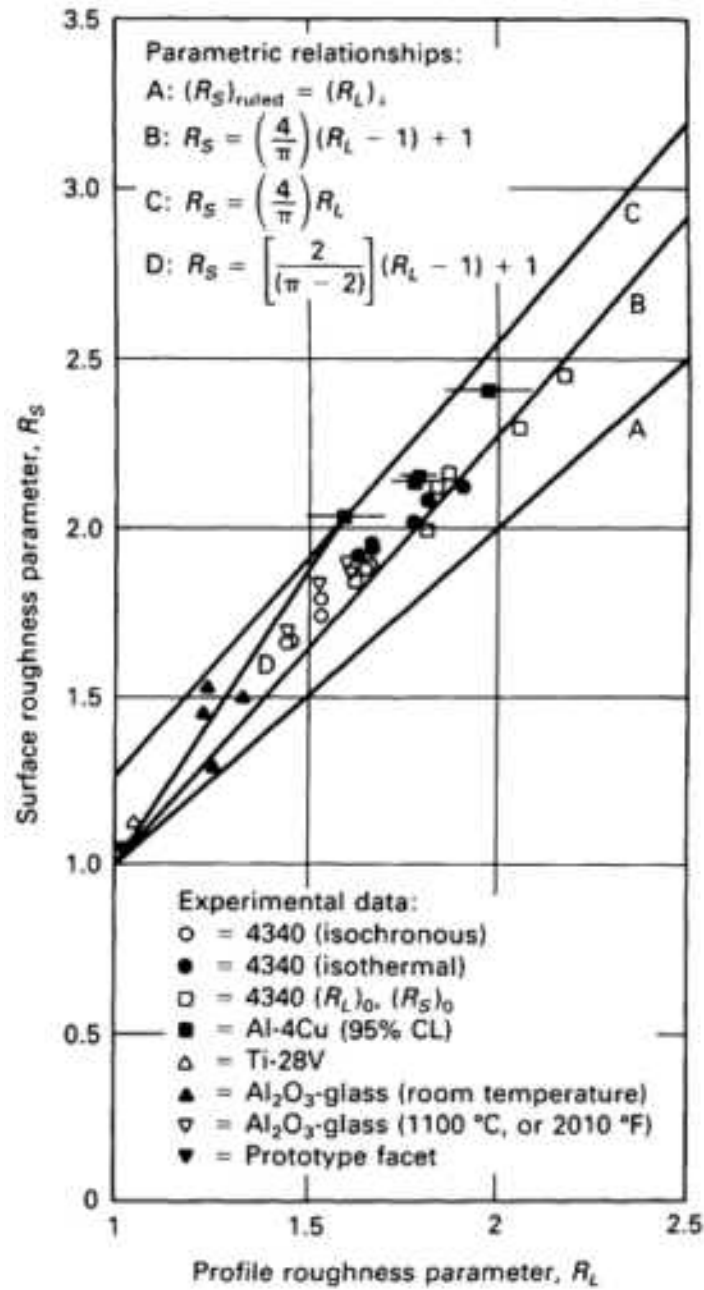
**Fig. 17 Plot of all known experimental pairs of  $R_S$ ,  $R_L$  with respect to Eq 32 and upper and lower limits. CL, confidence limits**

Almost all the experimental data points fall between curves B and C. However, the locations of these points depend on the accuracy of  $R_L$ , which in turn depends on the accuracy with which  $L_t$ , the true length of the profile, is determined. The same considerations apply to  $R_S$ , which can be considered a dependent variable of  $R_L$ . The true length of the profile,  $L_t$ , is measured by coordinate points spaced a distance  $\eta$  apart. Most values of  $R_L$  are based on the minimum value of  $\eta = 0.68 \mu\text{m}$ . As an example, see the data points for the isochronous 4340 alloy data shown in Fig. 17.

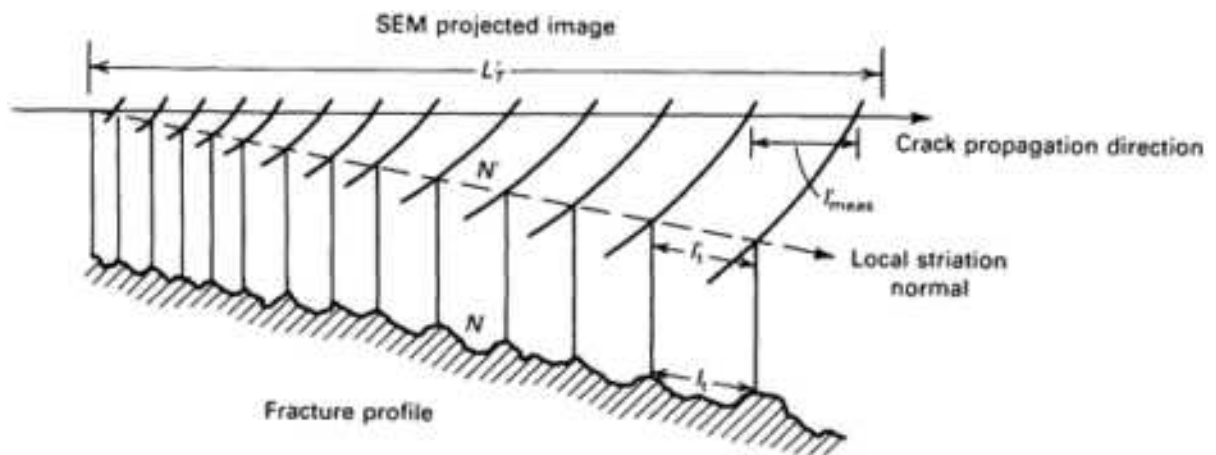
**Fig. 18 Relationship of fatigue striation spacings to their projected images.**  $L'_T$ : test line length;  $N$ : number of striations;  $l_t$ : true striation spacing;  $l'_{meas}$ : measured striation spacing in crack propagation direction. Primes indicate quantities in projection planes.

$$\overline{l'_{meas}} = \left( \frac{p}{2} \right) \overline{l'_t} \quad (\text{Eq 34})$$

where  $\overline{l'_t}$  is the mean striation spacing.

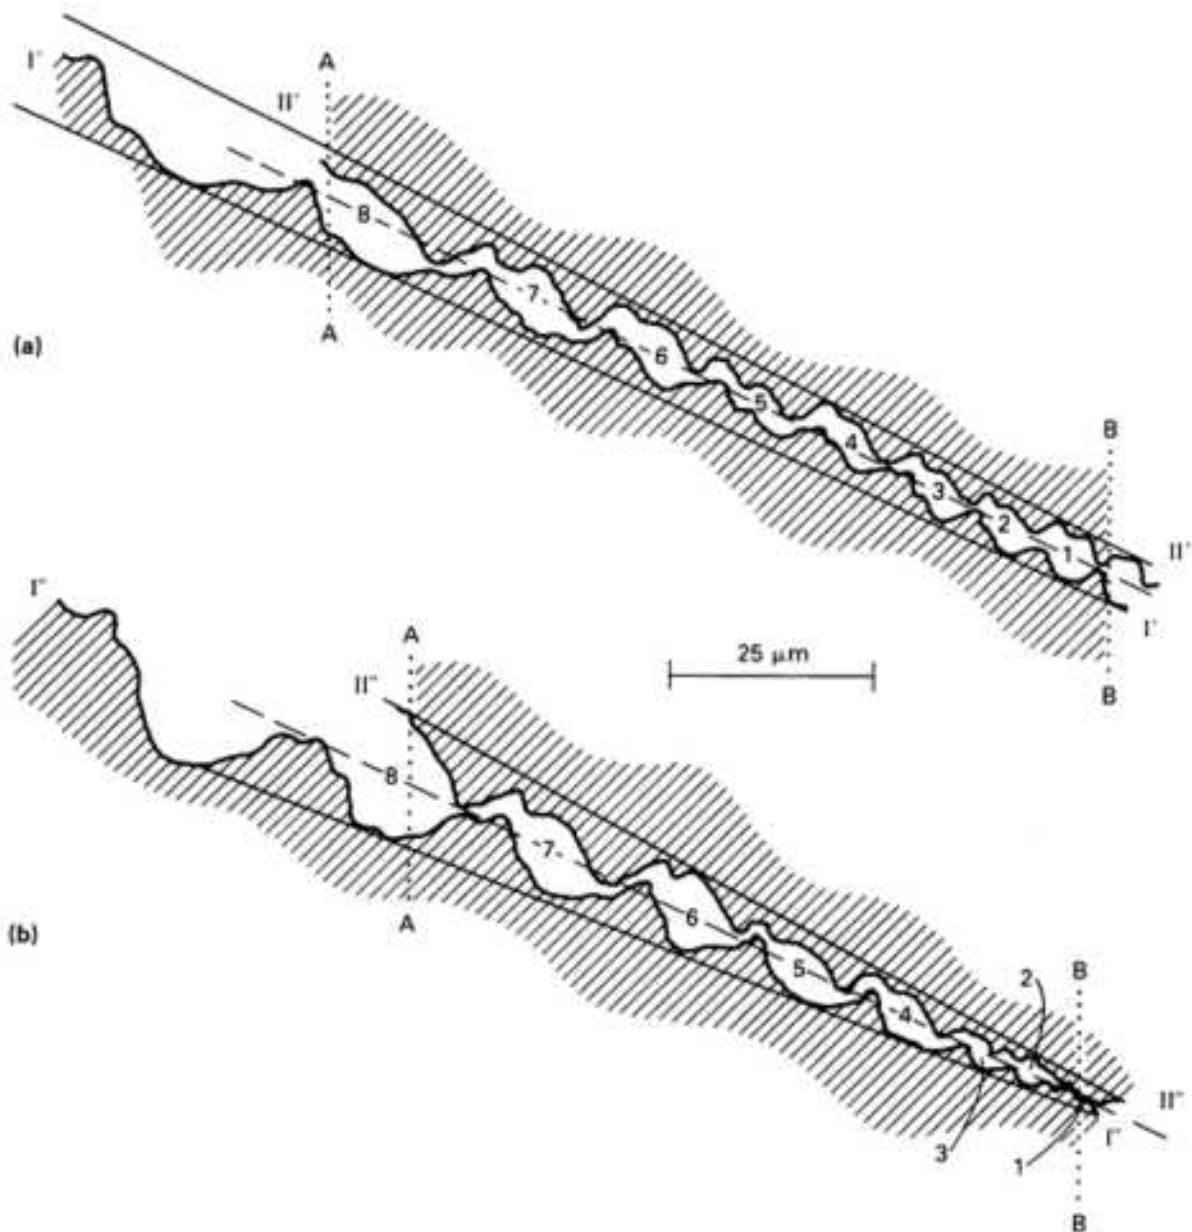
This technique is occasionally implemented and requires extremely precise experimental controls (Ref 80, 94, 95). An unusually careful and well-documented fractographic investigation is described in Ref 96, which discusses a precision matching study of fatigue striations in nickel. Two pairs of matching profiles were obtained using a stereoscopic method. Illustrations of these four curves are shown in Fig. 19, with the pairs of matching profiles identified as I'I' and II'II' in (a) and I''I'' and II''II'' in (b).

**Fig. 19 Precision matching of fatigue striation profiles in nickel. (a) Matching profile of I'I' and II'II'. (b) Matching profile of I'I' and II'II'. Source: Ref 96**

To assess the degree of matching,  $R_L$  was measured on all profiles. The results are given in Table 6, including duplicate values for the same curves that appeared elsewhere in Ref 97. Of major interest is the correspondence between (ostensibly) matching profile curves. Other than one pair, matching values of  $R_L$  agreed within about 2%, which can be considered quite good, especially because measurements were made on illustrations of the curves. Another profile parameter,  $R_p$ , was also used in the analysis of these curves, with percent deviations about three times greater than those for  $R_L$  (Ref 23). This is probably due to the fact that only the line length is involved with  $R_L$ , while  $R_p$  depends more on the tortuosity of the profile (Ref 37).

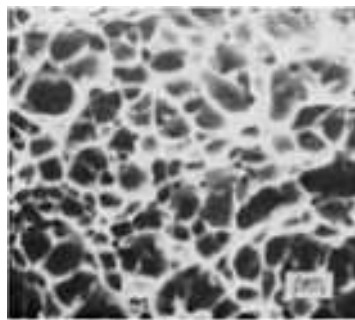
**Fig. 20 SEM fractograph of dimples in fractured 4340 steel**

One approach toward a quantitative study of dimple characteristic was made recently with 4340 steel (Ref 43, 69). The outlines of 514 dimples were traced individually on SEM fractographs, using the digitizing tablet of an image analysis system that records areas and perimeter lengths automatically. Also measured were  $N_A$  and  $N_L$ , the areal and lineal dimple densities, respectively. An SEM fractograph of dimples in the fractured 4340 steel is shown in Fig. 20.

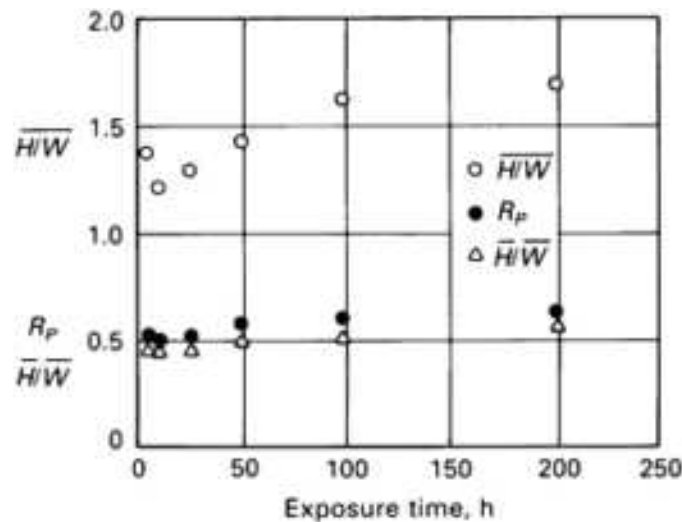
**Fig. 21 Height and width measurements of dimples in fractured 4340 steel**

A new method for obtaining  $\overline{\overline{H}}/\overline{\overline{W}}$  and  $\overline{H}/\overline{W}$  was developed based solely on digitized profiles (Ref 69). Six 4340 steel specimens, held for different times at 650 °C (1200 °F), were fractured at room temperature. Profiles were prepared and mounted metallographically as described above, then digitized by tracing the image with the cursor of an image analysis system (Ref 43). Dimensions extracted directly from the coordinate file by a suitable filtering algorithm gave values of  $\overline{\overline{H}}/\overline{\overline{W}}$  and  $\overline{H}/\overline{W}$ , as well as  $R_p$ , the profile configuration parameter. The results are plotted in Fig. 21 versus exposure time at 650 °C (1200 °F). It is seen that  $\overline{\overline{H}}/\overline{\overline{W}}$  is about three times greater than  $\overline{H}/\overline{W}$  and  $R_p$ , which also represents the mean peak height divided by the mean spacing. The latter two parameters differ by only about 13% and bear a linear relationship to each other. Because of the large discrepancy between the two types of ratios, models that incorporate dimple dimensions should explicitly identify which ratio is being used.

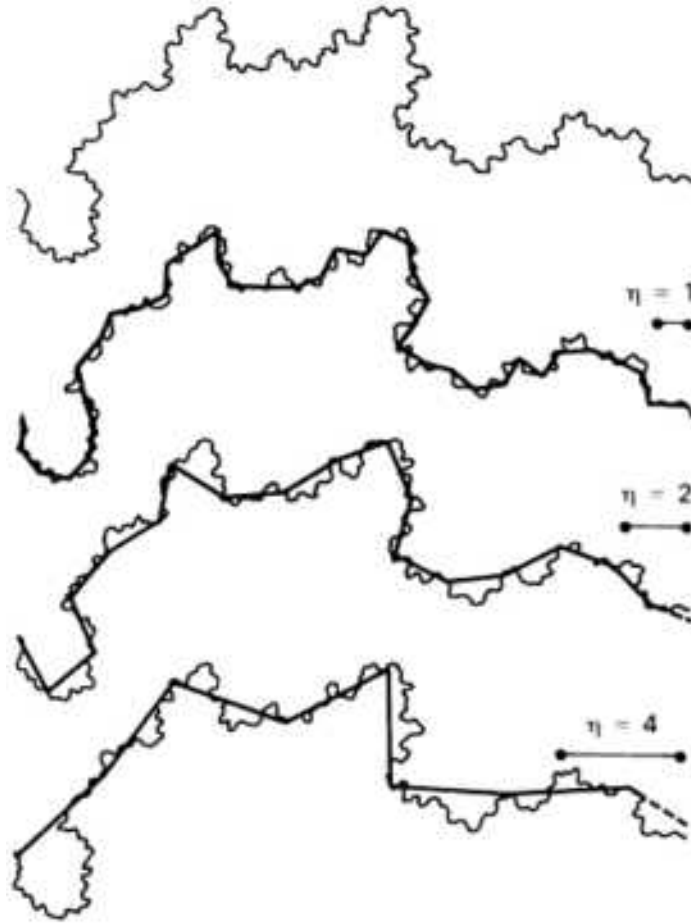
**Fig. 1 Interaction of an irregular curve and the measuring unit  $\eta$ . (Ref 12)**

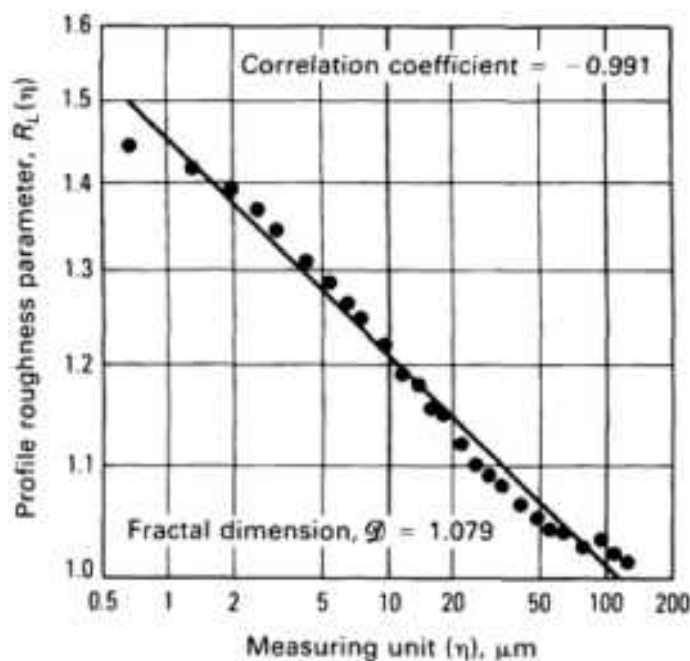
Figure 2 shows typical fractal data obtained from the profile of an AISI 4340 steel fractured at room temperature (Ref 8). The profile image is first digitized as described above. More than 12,000 coordinate points are registered along this profile at a spacing of 0.683  $\mu\text{m}$ . This value represents the minimum  $\eta$  size. The successively larger values of  $\eta$  are obtained merely by skipping more coordinate points each time, until the largest size of 123.5  $\mu\text{m}$  is reached.\* The retained coordinate points are used to calculate the 26 values of apparent profile lengths  $L(\eta)$  shown in Fig. 2.

**Fig. 2 Fractal plot for AISI 4340 steel tempered at 700 °C (1290 °F) for 1.5 h and fractured at room temperature showing RSC behavior**

It is clear that a curve through the data points shown in Fig. 2 is not linear as postulated, even though the fitted regression line shows a correlation exceeding 99%. In fact, a tendency toward asymptotic behavior is evident at both termini of the curve. In an effort to clarify this situation, fracture profiles were obtained from a series of six AISI 4340 steel specimens tempered for 1.5 h at various temperatures between 200 and 700 °C (390 and 1290 °F). The upper limit of  $\eta$  was extended to 426.5  $\mu\text{m}$ , making the spread in values greater than 645 times. The fractal plots for the six profiles are shown in Fig. 3, which clearly reveals the RSC shape. The curves are definitely not linear.

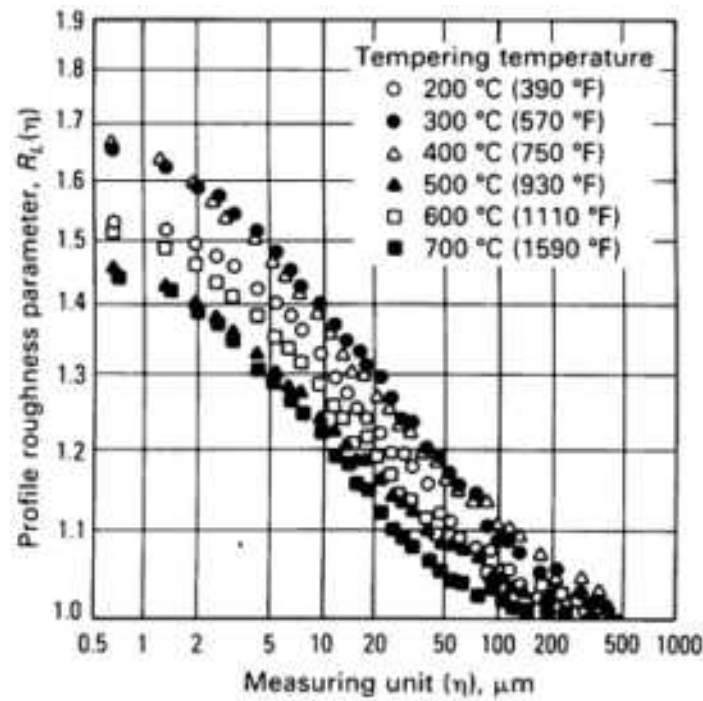
**Fig. 3 Fractal plots for AISI 4340 steel specimens tempered at temperatures between 200 and 700 °C (390 and 1290 °F) for 1.5 h and fractured at room temperature showing RSC behavior**

Conventional  $D$  values were calculated for each of the six curves shown in Fig. 3. Average slopes were determined by linear regression using the central portion of each curve. The  $D$  values obtained are given in Table 1 for comparison with other results. A minimum is apparent at 500 °C (930 °F). The significance of this minimum has been discussed in relation to microstructural and fractographic factors (Ref 8, 9).

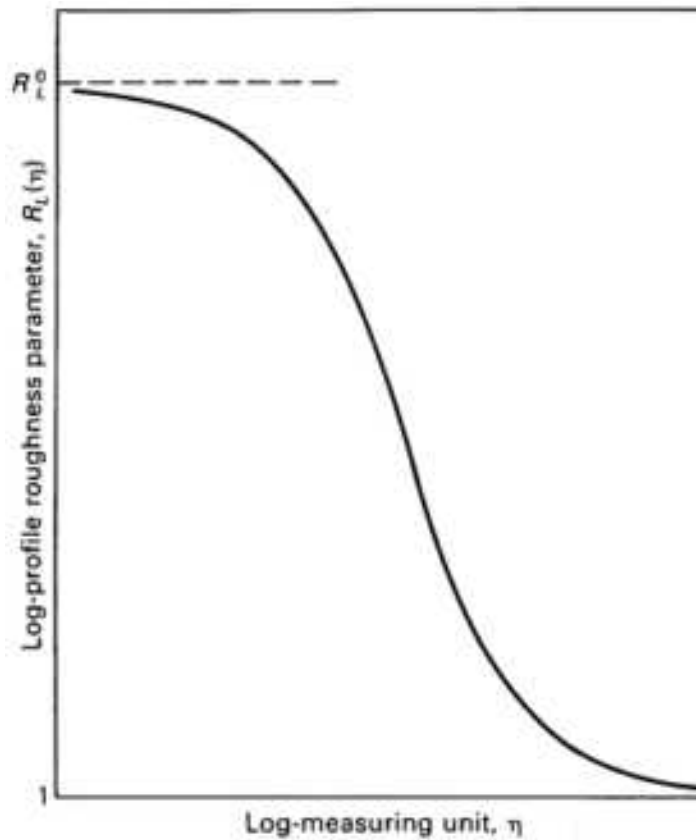
**Fig. 4 Upper and lower asymptotic limits to fractal plot showing RSC behavior**
