ASM HANDBOOK®

VOLUME  
12

Fractography

*Fractography*, was published in 1987 as Volume 12 of the *ASM Handbook*. The Volume was prepared under the direction of the ASM Handbook Committee.

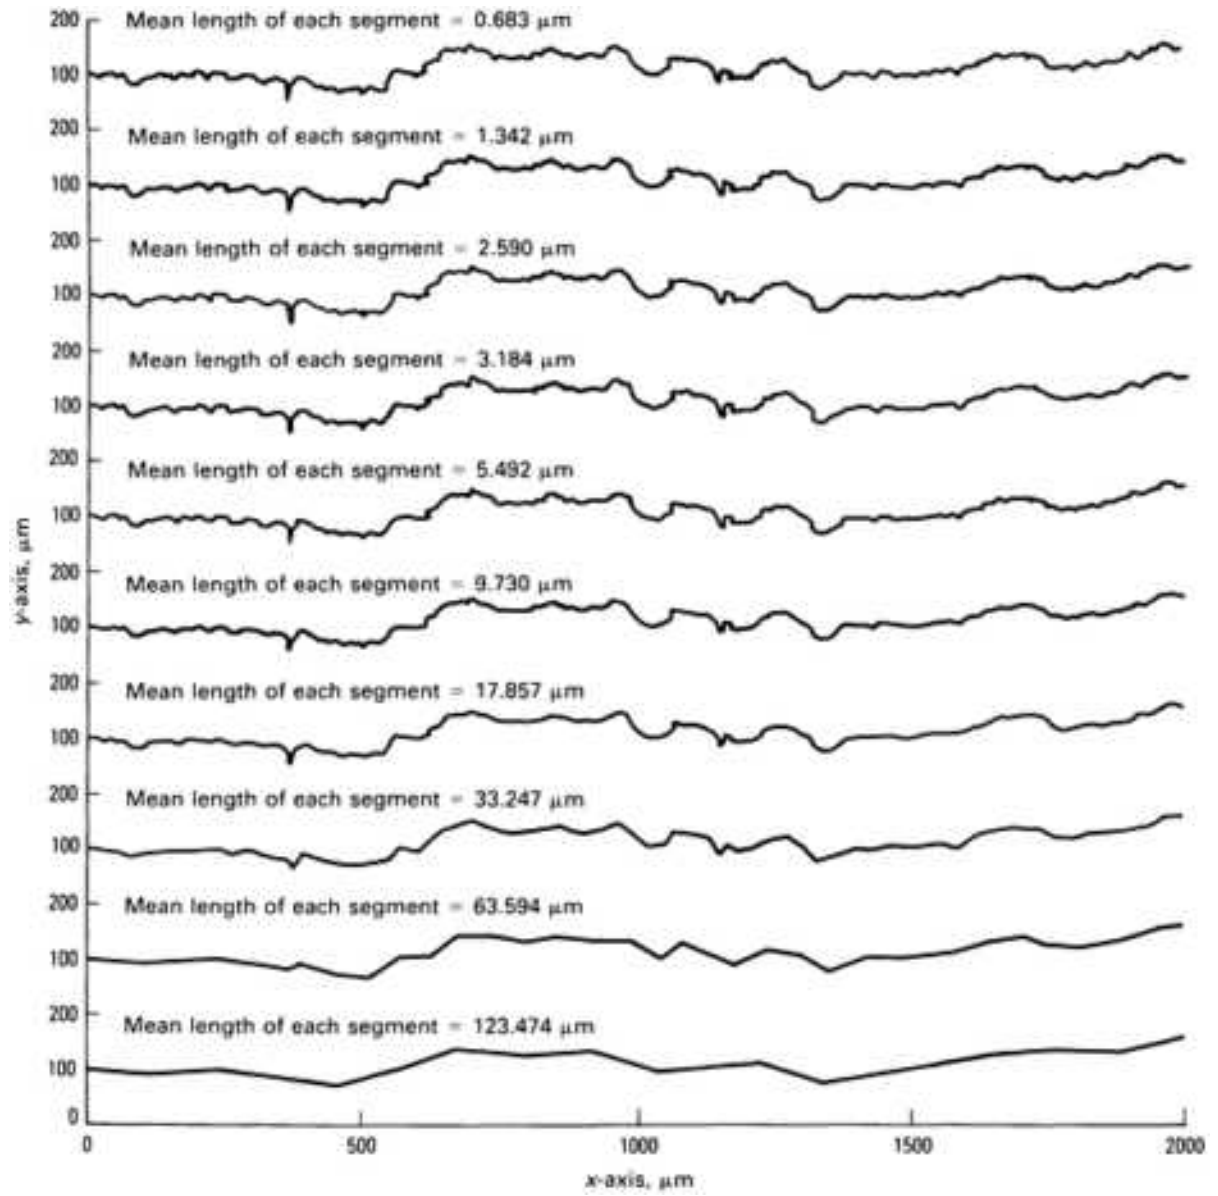
Figure 5 shows ten profiles generated from the same profile from an AISI 4340 steel specimen (Ref 9). Varying the size of  $\eta$ , as indicated on the curves, reveals the gradual loss of detail as the value of  $\eta$  increases from 0.683 to 123.474  $\mu\text{m}$ . Each curve represents a different length  $L(\eta)$  as a function of a particular  $\eta$  size. The data pairs are then plotted as shown in Fig. 3.

**Fig. 5 Fracture profile of AISI 4340 steel specimen plotted with increasing lengths of measuring unit  $\eta$ . The numbers on the curves indicate the value of  $\eta$ .**

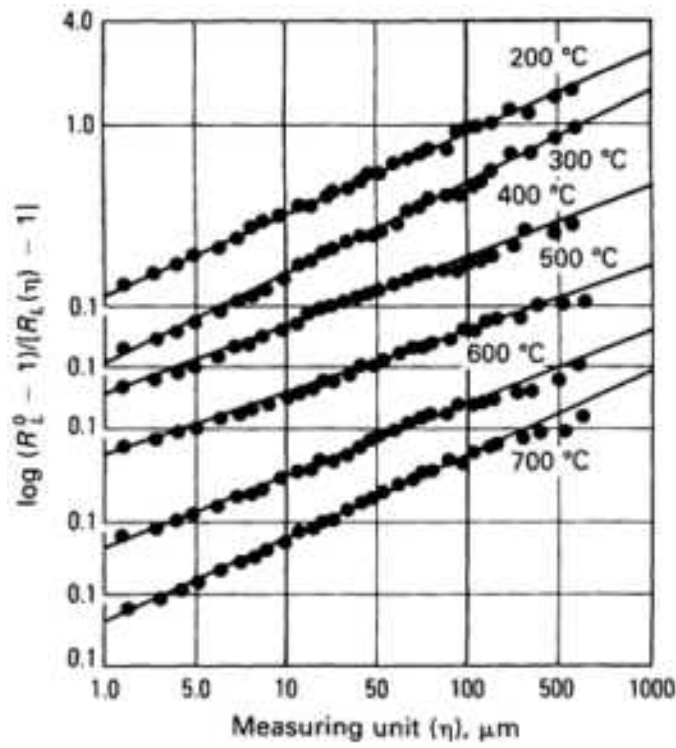
Fig. 6 Linearized RSCs as a function of  $R_L(\eta)$  for AISI 4340 steel specimens fractured at room temperature

Next, the experimental data for the series of six AISI 4340 fractured specimens are plotted according to Eq 11 and 12 (Ref 10). The RSCs for profiles and surfaces are linearized quite well, as shown in Fig. 6 and 7. These curves yield the  $\beta$  and  $\gamma$  slopes used to calculate  $D\beta$  and  $D\gamma$  according to Eq 13 and 14. Values of  $D\beta$  and  $D\gamma$  are given in Table 1, along with corresponding values of  $R_L^0$  and  $R_S^0$ . In addition, both  $D\beta$  and  $D\gamma$  are plotted versus tempering temperature in Fig. 8, showing minima at 500 °C (930 °F).

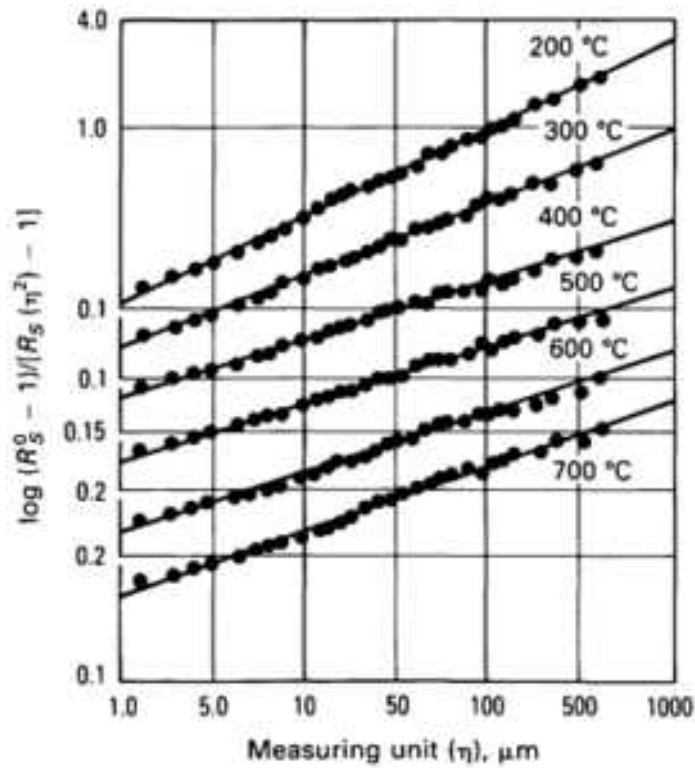
Fig. 7 Linearized RSCs as a function of  $R_S(\eta^2)$  for AISI 4340 steel specimens fractured at room temperature

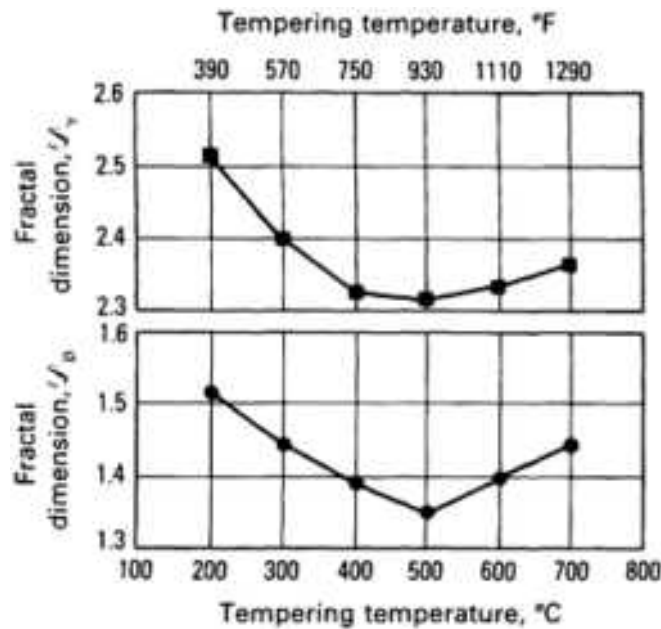
**Fig. 8 Modified profile and surface fractal dimensions  $D_\beta$  and  $D_\gamma$  versus tempering temperature from RSCs for AISI 4340 steel specimens fractured at room temperature**

Minima at 500 °C (930 °F) are apparent from all the data listed in Table 1. It can be seen that  $D_\beta$  is an order of magnitude larger than  $D_\gamma$ . Moreover,  $D_\beta$  is based on all data points, but  $D_\gamma$  involves only a selected central portion of the fractal plot. Thus,  $D_\beta$  is considered more reliable than the conventional  $D$ . The modified fractal dimensions and the roughness parameters appear capable of detecting subtle differences in fracture behavior not readily apparent by more conventional means.

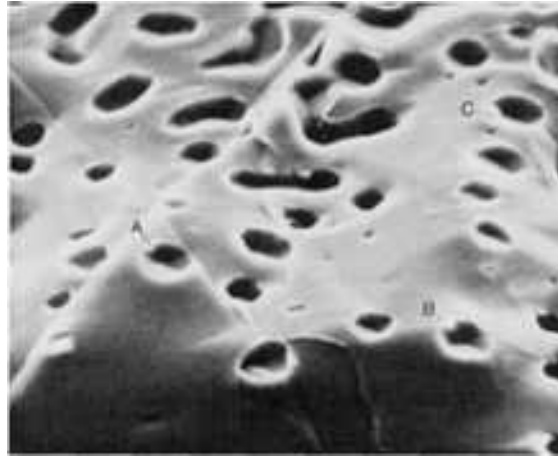
**Fig. 1 Grain-boundary cavitation in iron.** This is the mechanism by which metals typically fail when subjected to elevated temperatures and low strain rates. Composition, in parts per million: 70 C, 60 S, 54 O, 11 N, 40 P. Rod, 13 mm (0.5 in.) in diameter, was made by vacuum induction melting, chill casting, and swaging. Heat treatment: recrystallize for 30 min at 850 °C (1560 °F), austenitize for 1 h at 1100 °C (2010 °F), air cool. Sample was tensile tested at 700 °C (1290 °F) and an initial strain rate of  $1.1 \times 10^{-6}$ /s. Test was interrupted other 12 h, and the sample was then broken by impact at -100 °C (-150 °F). Fracture surface reveals cavitated grain boundaries. The intergranular cavities nucleated on second-phase (iron sulfide) particles, examples of which are shown at A, B, and C. SEM, 4500× (E.P. George and D.P. Pope, University of Pennsylvania)

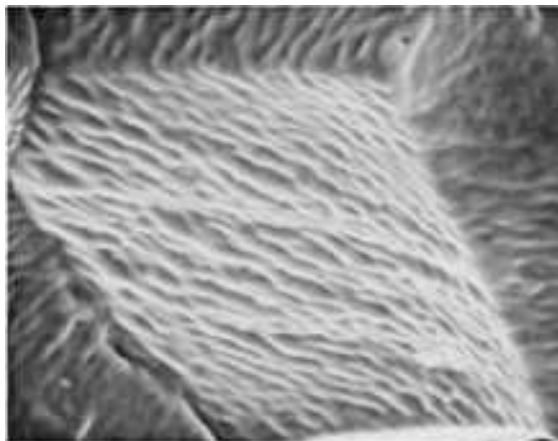
**Fig. 2 Slip lines in iron.** Composition, in parts per million: 160 C, 40 S, 13 O, 6 N, 30 P. Rod, 13 mm (0.5 in.) in diameter, was made by vacuum induction melting, chill casting, and swaging. Heat treatment: recrystallize for 30 min at 850 °C (1560 °F), austenitize for 1 h at 1100 °C (2010 °F), air cool. Sample was tensile tested to failure at 700 °C (1290 °F) and an initial strain rate of  $4.4 \times 10^{-5}$ /s. Slip lines, smoothened by diffusional flow, are visible on grain boundaries of the elevated-temperature fracture surface. Failure was intergranular and resulted from the nucleation, growth, and eventual coalescence of grain-boundary cavities (see Fig. 1). In this case, however, cavity outlines were masked by the slip steps created on grain boundaries due to severe plastic deformation within the grains. The wavy nature of the slip lines is a characteristic of body-centered cubic iron.

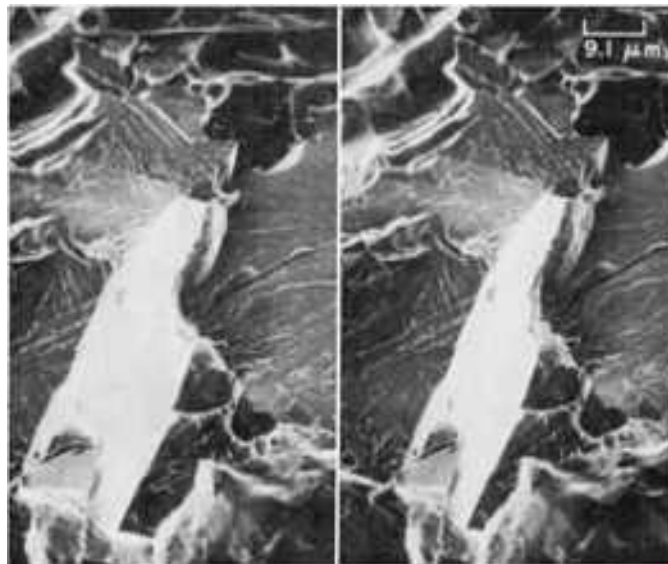
**Fig. 3** Stereo pair of scanning electron microscope views of the fracture surface of a Charpy impact test bar of high-purity iron. The specimen was broken after being cooled to equilibrium in liquid nitrogen ( $-196\text{ }^{\circ}\text{C}$ , or  $-321\text{ }^{\circ}\text{F}$ ). Flat cleavage has taken place on a variety of sharply divergent crystal planes. There are fine river patterns evident on nearly all of the facets. The cleavage steps that delineate the "river" systems are, however, very minute in height, providing only very small departures from a single crystallographic plane of crack growth. Characteristic of iron when fractured at low temperature is the formation of "tongues," one of which is located at the lower end of the very bright facet. There even appears to be a river pattern on the left-hand portion of the "tongue." A second, smaller tongue projects from the facet shown obliquely at top left. 1100×

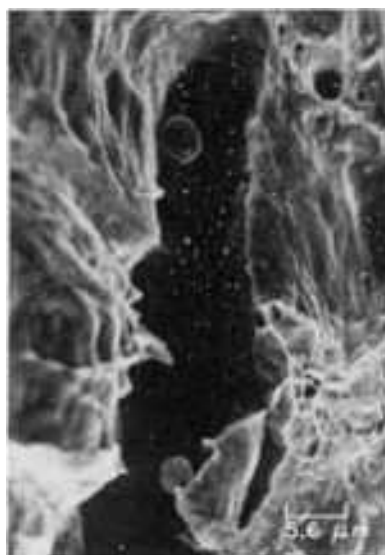
**Fig. 4** Surface of a room-temperature tensile-test fracture in a specimen taken from an ingot prepared by adding  $\text{Fe}_2\text{O}_3$  to pure iron in a vacuum melt equilibrated at  $1550\text{ }^{\circ}\text{C}$  ( $2820\text{ }^{\circ}\text{F}$ ) in a silica crucible. The ingot contained 0.07% O in the form of FeO. The fracture surface contains dimples that initiated at globular FeO inclusions averaging  $5.2\text{ }\mu\text{m}$  in diameter. SEM, 1800×

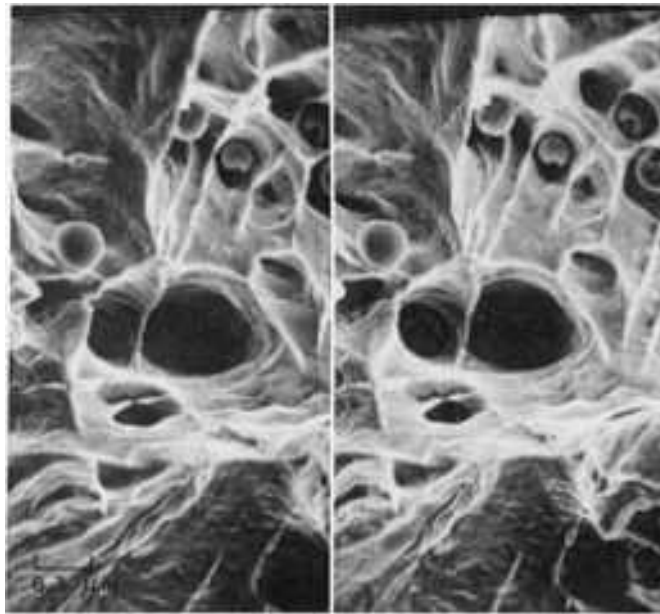
**Fig. 5 Stereo pair of scanning electron microscope fractographs of the surface of a tensile-test fracture obtained at room temperature. The alloy was a low-carbon iron to which an appreciable amount of  $\text{Fe}_2\text{O}_3$  had been added to form an aggregate of FeO inclusions. The dimples that are characteristics of ductile rupture are evident here, and many of these dimples contain one or more globular oxide inclusions that are readily apparent. There appear to be two sizes of these oxide inclusions--some being about  $6\ \mu\text{m}$  in diameter and other about  $3\ \mu\text{m}$  in diameter. Unlike many inclusions displayed in other fractographs, which have relatively smooth, unbroken contours several of the particles shown here possess sizable surface defects. Some of these defects may be exposed internal shrinkage cavities. The surfaces of the dimples show contours that vaguely resemble fatigue-striation marks. The differences in topographic contours of the dimples displayed in this stereo pair of fractographs can be appreciated by viewing the fractographs stereographically, which provides a three-dimensional effect. It then becomes apparent that the dimples are chimneylike cavities with nearly vertical walls in many instances and with bottoms at great depth that appear black and without detail. The FeO inclusions appear to cling to the cavity walls, many at a point part way to the bottom of the "chimney." Most of the separating walls between adjacent chimneys are extremely thin, which makes it surprising that these walls did not rupture at a point closer to the bottom of the chimney.  $1200\times$**

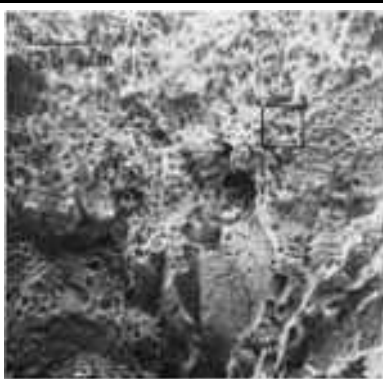
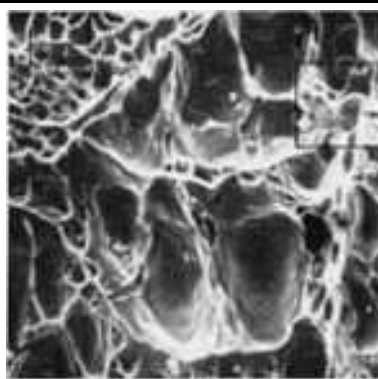
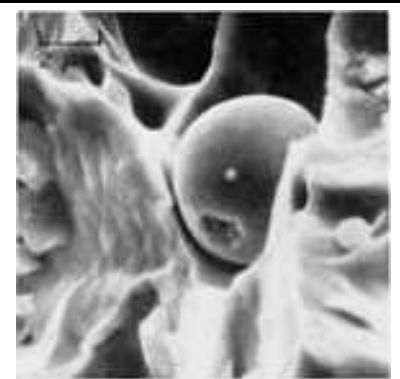
Sequence of SEM fractographs, at increasing magnifications ( $80\times$ ,  $950\times$ , and  $5000\times$ , respectively), that show a fracture in an iron alloy containing 0.14% S and 0.04% O. The fracture was obtained by bending at room temperature. Several spheroidal oxide inclusions are visible, most of them having diameters in the range of 1 to  $3\ \mu\text{m}$ . The rectangle in Fig. 6 indicates the area that is shown at higher magnification in Fig. 7, and the rectangle in Fig. 7 indicates the area that is shown at still higher magnification in Fig. 8. The  $6\text{-}\mu\text{m}$ -diam oxysulfide particle in Fig. 8 shows a shrinkage cavity plus a white spot from an electron beam impingement in fluorescent x-ray analysis. It is quite evident that, during the process of microvoid coalescence, the iron matrix has become detached from the globular inclusions at the metal-to-oxide and metal-to-sulfide interfaces, leaving these inclusions unaffected by

the applied stresses and severe deformation taking place around them.

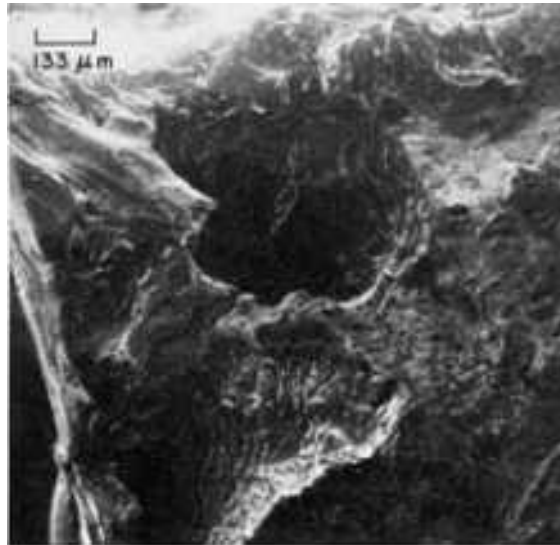
**Fig. 9** Fracture produced at room temperature by bending iron containing 0.02% C, 0.14% S, and 0.04% O cast in a 7 × 7 × 20 cm (2.75 × 2.75 × 8 in.) ingot mold. A carbon-FeO reaction caused blowholes such as shown at top. Note the fine lamellar structure at bottom. See also Fig. 10. SEM, 75×

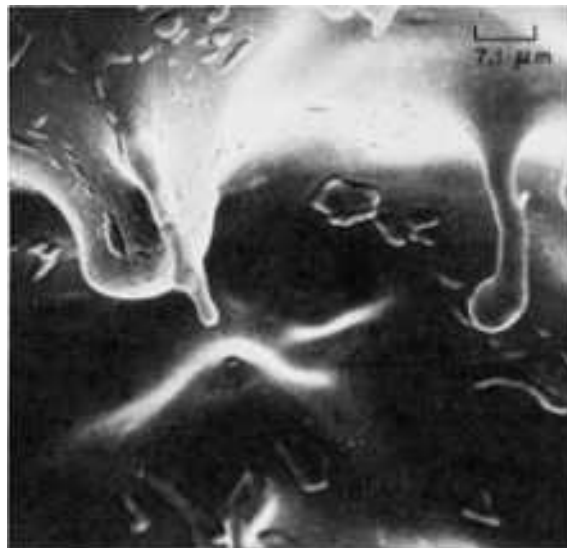
**Fig. 10** Higher-magnification view of the blowhole shown at the top in Fig. 9, showing the interior of the blowhole that resulted from the carbon-FeO reaction. The pendants are droplets of a liquid oxysulfide that spread over the surface of the blowhole during freezing of the ingot. SEM, 1400×

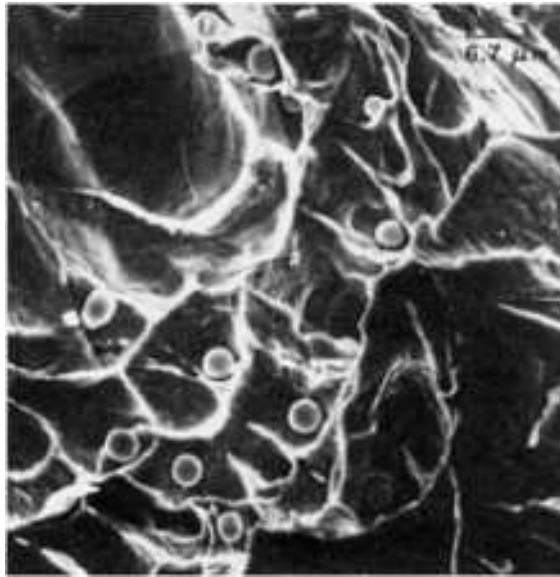
**Fig. 11** Fracture by room-temperature bending in casting of similar composition to that of casting in Fig. 9, but containing 1.1% Mn. The numerous inclusions contained within the dimples are particles of manganese oxide and manganese sulfide trapped between growing dendrite branches. SEM, 1500×

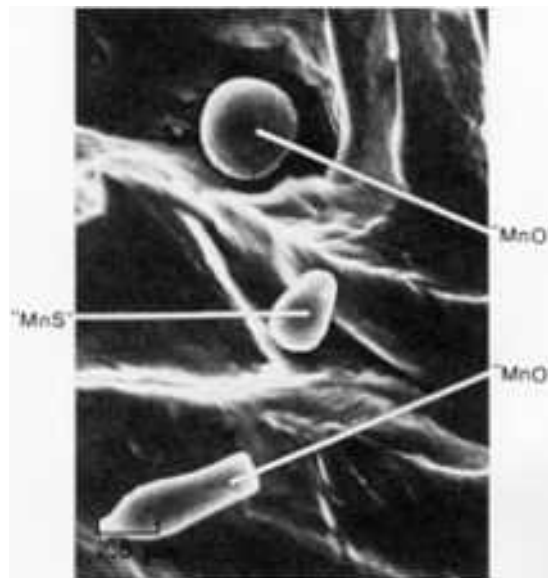
**Fig. 12** Higher-magnification view of the same fractured specimen shown in Fig. 11. X-ray fluorescent analysis of the inclusions indicates that some of them are Mn(Fe)O and that others are Mn(Fe)S, but the exact amount of contained iron was not determined. SEM, 4000×

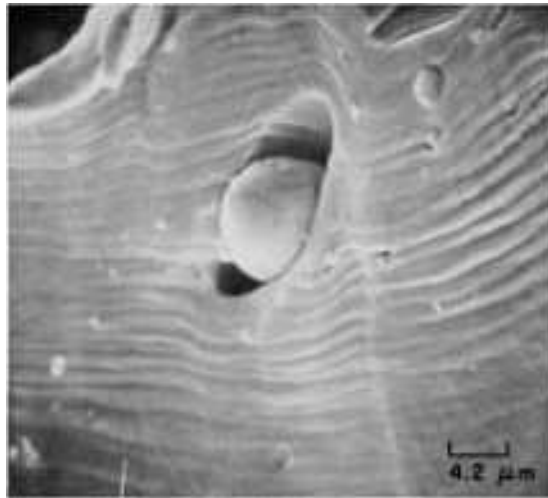
**Fig. 13** Low-carbon iron containing a high percentage of oxygen, fractured in fatigue at room temperature. A large oxide inclusion has been nearly completely disengaged from its original pocket. Fatigue striations detour around, or extend into, the pocket. Crack propagation was from bottom to top. SEM, 2400×

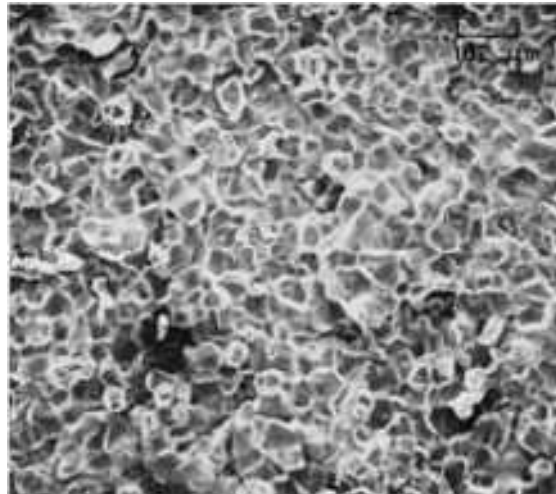
**Fig. 14** Intergranular fracture that was generated in a specimen of oxygen-embrittled Armco iron by a Charpy impact test at room temperature. The grain facets appear sharp and clean. Note the secondary cracks, which follow grain boundaries. See also Fig. 15 and 16 for views of other regions of this fracture. SEM, 55×

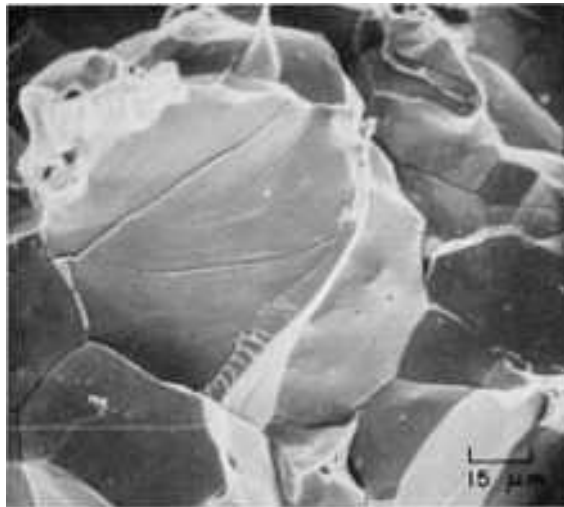
**Fig. 15** View of another region of the surface of the impact fracture shown in Fig. 14, showing facets that resulted from a combination of intergranular rupture and transcrystalline cleavage. Note the array of small river patterns at the bottom edge of the large facet at center. See also Fig. 16. SEM, 655×

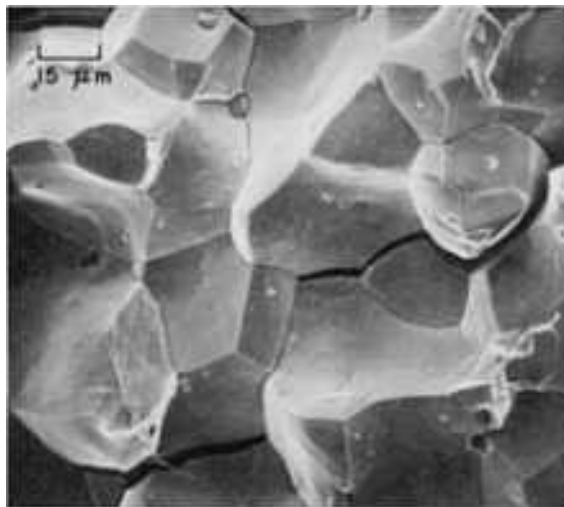
**Fig. 16** View of a third region of the surface of the impact fracture shown in Fig. 14 and 15. Note the almost perfect grain-boundary surfaces and the sharp edges and points at which the separated-grain facets meet. The secondary cracks are equally clean separations. SEM, 670×

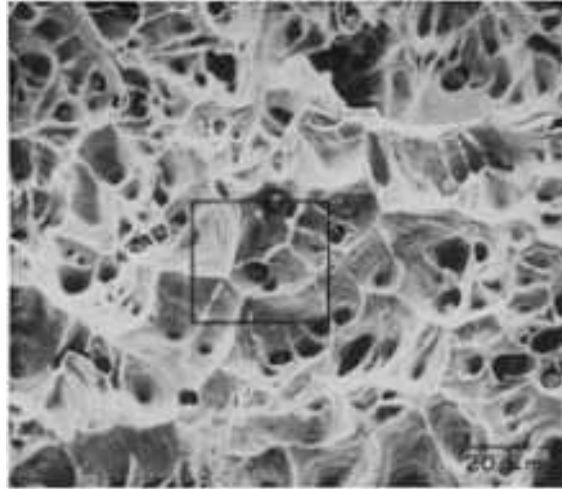
**Fig. 17** Surface of tensile-test fracture in specimen of low-carbon, high-oxygen iron that was broken at room temperature. Many of the equiaxed dimples contain spheroidal particles of FeO. The rectangle marks the area shown at higher magnification in Fig. 18 and 19. SEM, 500×

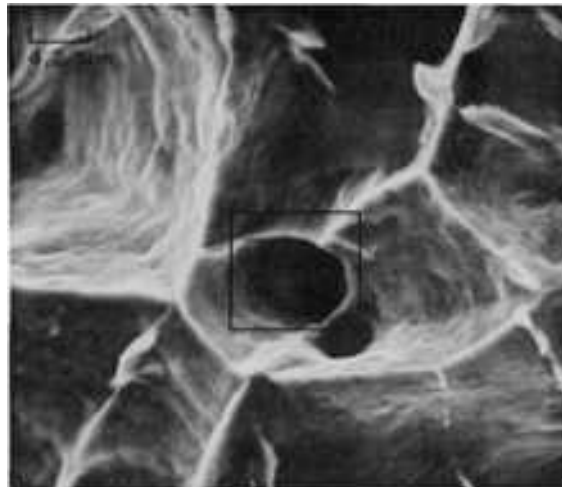
**Fig. 18** Enlargement of the area within the rectangle in Fig. 17, showing the surface contours of the dimple cavities of the very ductile fracture. Dimly visible in the central dimple is a globular particle of FeO; the particle is shown more clearly in Fig. 19. SEM, 2400×

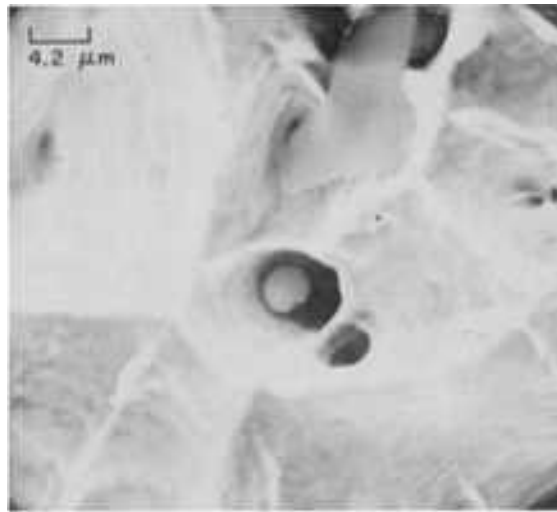
**Fig. 19** Same fracture-surface area as that shown in Fig. 18, but processed with a different exposure to bring out the shape and size of the globular particles of FeO in the central dimple. The small dark spot at the lower right on the FeO particle is a shrinkage area. SEM, 2400×

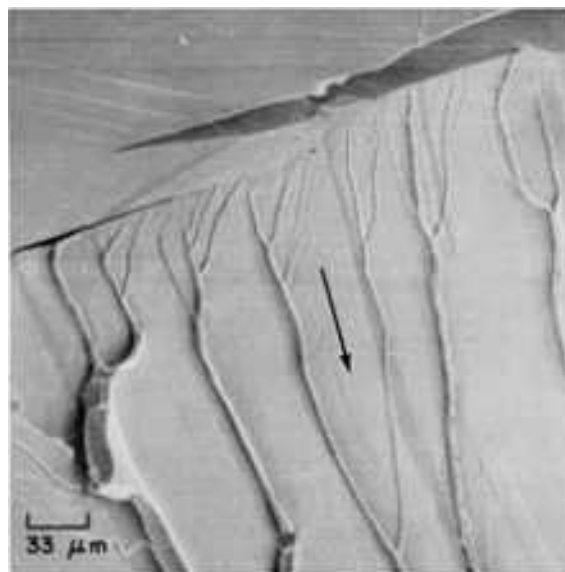
**Fig. 20** Fe, 0.01% C, 0.24% Mn, and 0.02% Si, heat treated at 950 °C (1740 °F)  $\frac{1}{2}$  h, air cooled. The structure is ferrite. Hardness, 62 HV. The fracture was generated by impact at -196 °C (-321 °F). Cleavage steps beginning at the twin at top form a sharply defined river pattern. Crack propagation was in direction of arrow. SEM, 300×

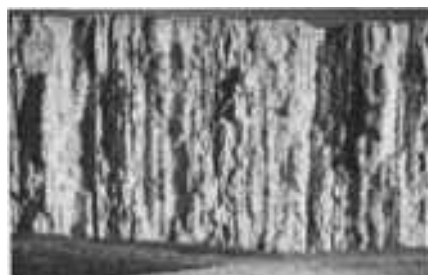
**Fig. 21** Surface of an impact fracture in a notched specimen of wrought iron. The longitudinal stringers of slag in the material are parallel to the direction of fracture, which gives the surface this typically "woody" appearance. Compare with Fig. 22. 6×

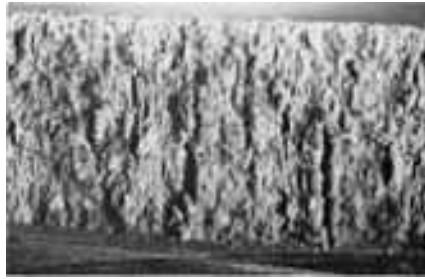
**Fig. 22** A companion notch-impact fracture to the one shown in Fig. 21, but here the longitudinal stringers of slag are normal to the fracture surface. Individual particles of slag are not readily visible at this magnification, but they cause the speckled appearance. 6×

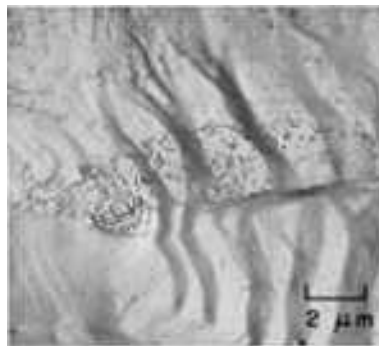
**Fig. 23** External surface of a specimen of Armco iron that had been etch-pitted and then subjected to tension during one cycle of a 2.5° bend test. Note the slip steps. See also Fig. 24. TEM p-c replica, 5000×

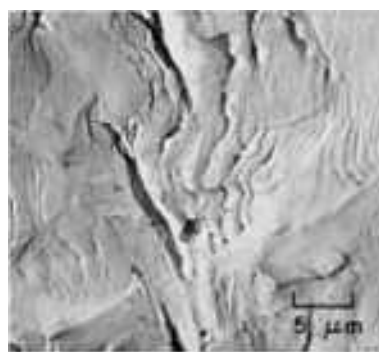
**Fig. 24** Same specimen as in Fig. 23 after 5.5 cycles of 2.5° bending. At center is the same area as in Fig. 23 (reversed left to right) showing slip-band cracks that have grown at slip steps. TEM p-c replica, 2000×

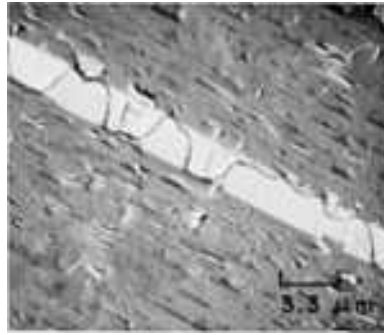
**Fig. 25** Cleavage fracture in Armco iron broken at dry-ice temperature (-78.5 °C, or -109.3 °F). The light band shows where cleavage followed a twin-matrix interface. The black meandering line is a shear step through the thickness of the twin. TEM p-c replica, 3000×

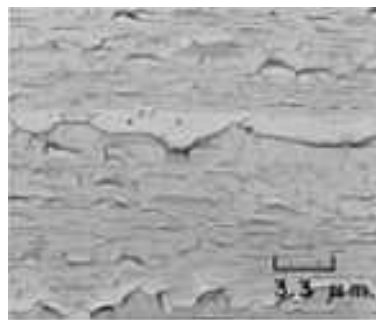
**Fig. 26** Cleavage fracture in Armco iron broken at dry-ice temperature (-78.5 °C, or -109.3 °F), showing facets of which most have the same orientation. Facets that depart from the general orientation appear lighter or darker than the majority. TEM direct carbon replica, 3000×

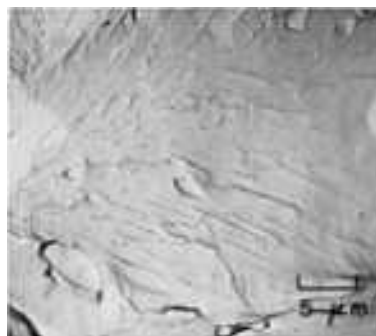
**Fig. 27** Cleavage fracture in Armco iron broken at -45 °C (-49 °F). Instead of cleavage steps, tear ridges (occasionally forming river patterns) were produced here by microscopic plastic flow. TEM p-c replica, 2000×

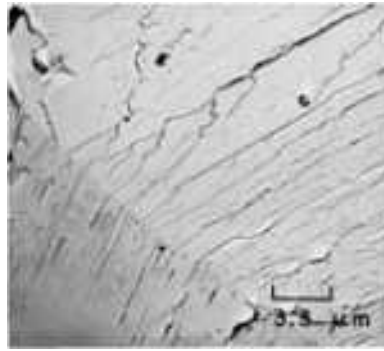
**Fig. 28** Cleavage fracture in Armco iron broken at -196 °C (-321 °F), showing river patterns, tongues, and (from bottom right to top left) a grain boundary. TEM p-c replica, 3000×

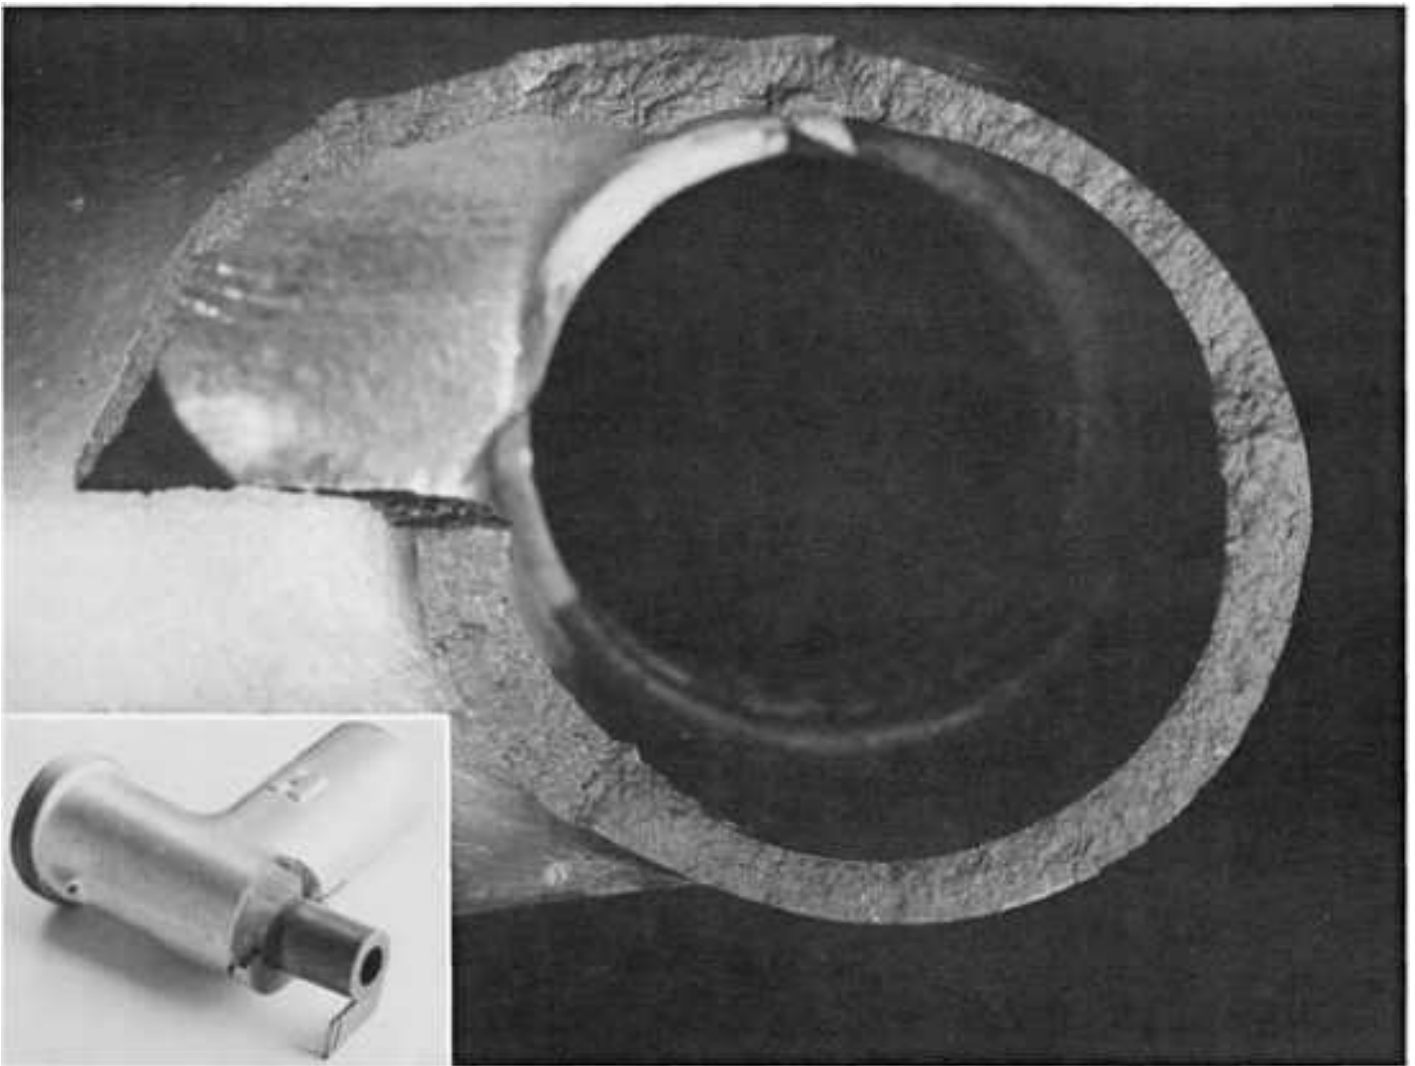
**Fig. 29** Fatigue fracture of sand-cast gray iron bread-crumble grinder. The ASTM A159 part was machined and hot dip galvanized after casting. Also, a lockpin hole (not visible) was drilled through the casting in a region containing type C, size 3 graphite flakes. Cause of failure was traced to a crack that initiated at one of these

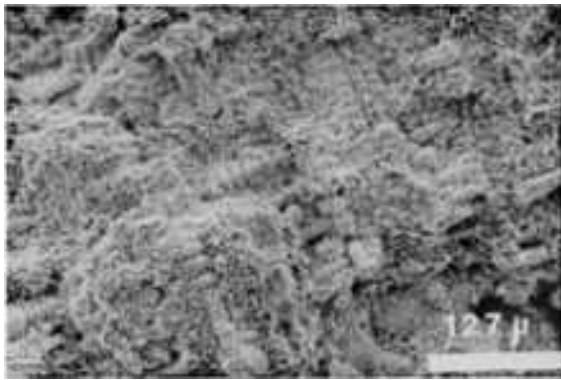
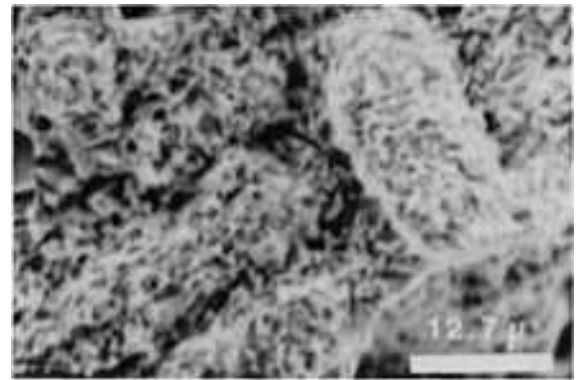
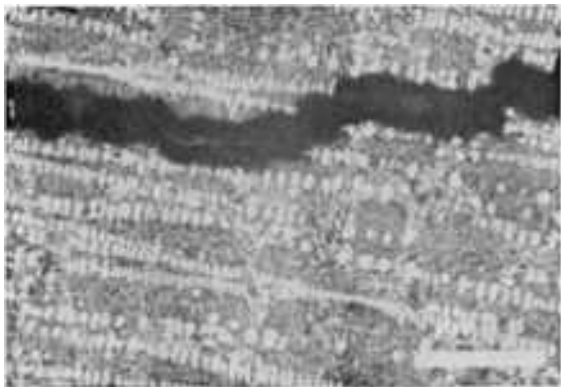
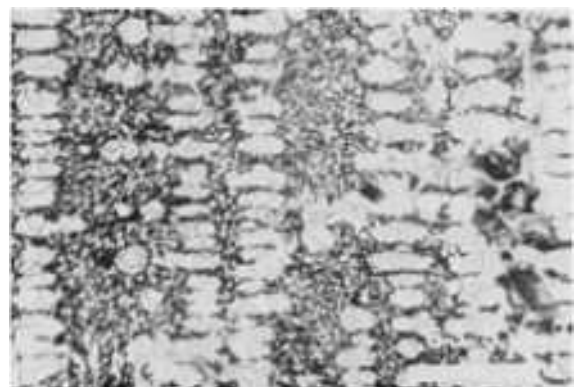
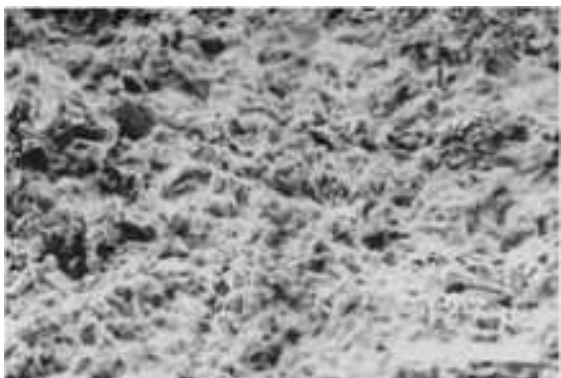
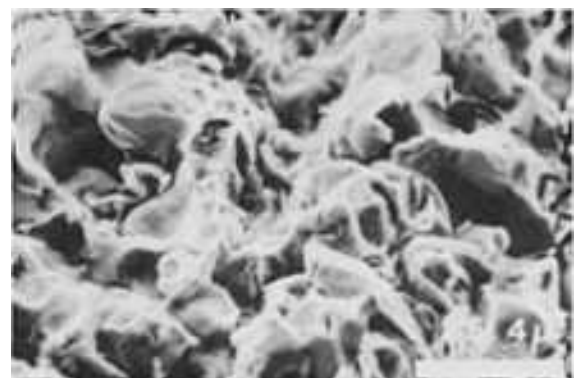
Effect of graphite morphology on fracture of permanent mold cast, hypereutectic gray iron (4.5 to 4.8% carbon equivalent). Permanent mold castings are typically small--15 kg (30 lb) max--and thus their as-cast mechanical properties are particularly sensitive to solidification structure and size, shape, and distribution of graphite. In this study, cylindrical samples were cast in a cold, 230 °C (450 °F) mold and allowed to air cool. Typical microstructure: undercooled (type D) graphite in a ferrite matrix. Initially cracked (nil ductility) and crack-free (normal ductility) samples were compared. Fig. 30 and 31: Fracture surface of nil-ductility sample that cracked during casting or machining. Fracture initiated at and propagated from graphite-ferrite interfaces. SEM, 190× and 1900×. Fig. 32 and 33: Solidification structure and graphite morphology of permanent mold cast, gray iron sample with nil ductility. The crack propagated along the preferred orientation of solidification. Dendrite spacing was a narrow 50 μm. Graphite was fine tipped, roughly cylindrical, and isolated from ferrite cells--a morphology that apparently has an adverse effect on ductility and is also a major contributor to graphite-ferrite interface cracking. 2% nital, 82× and 330×. Fig. 34 and 35: Fracture surface of sample having normal ductility. Fracture was artificially generated by impact. Note how material resisted graphite-ferrite interface cracking. Microstructure (not shown) was more isotropic than that of the nil-ductility casting, with a wider dendrite spacing (85 μm). Graphite was medium sized, interconnected,

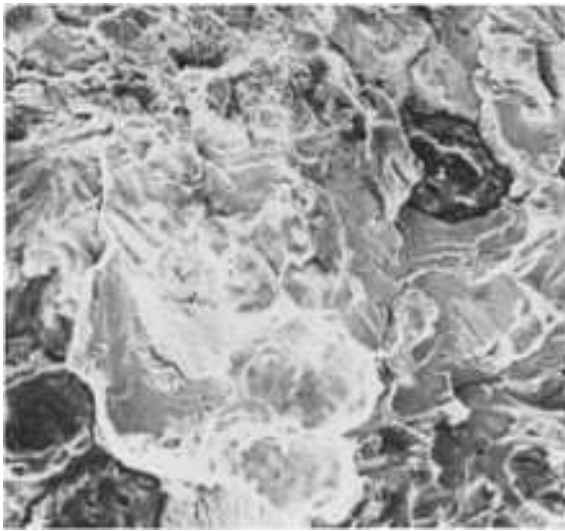
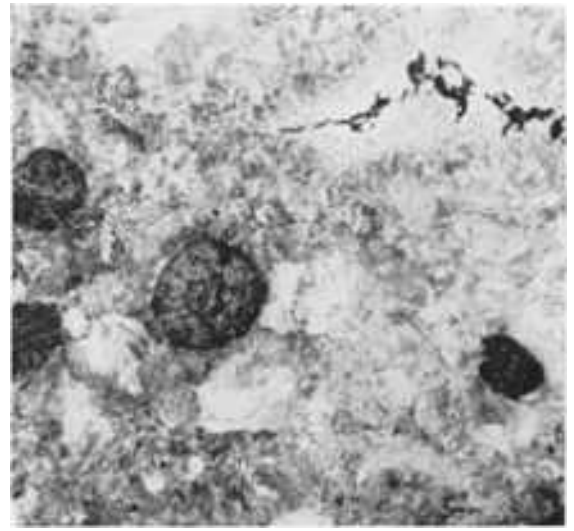
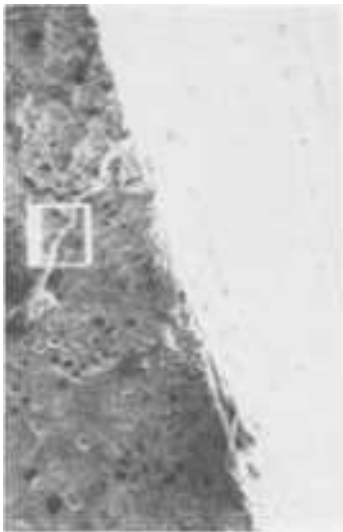
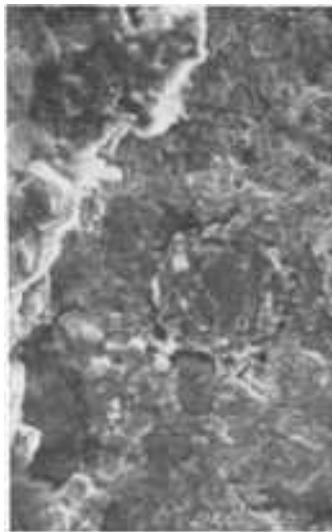
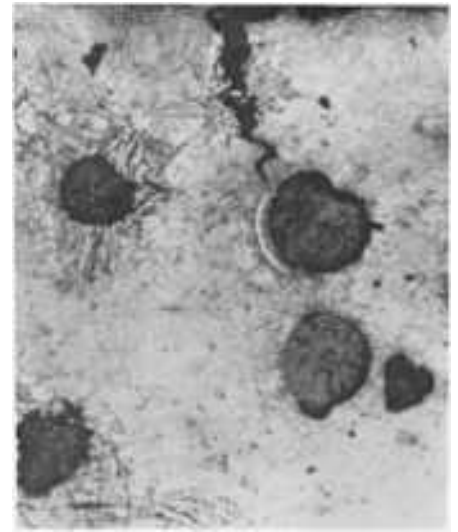
Brittle cleavage fracture of ductile iron spur gear (ASTM A536, grade 100-70-03) due to improper heat treatment. Tensile strength was 544 MPa (78.9 ksi), much less than the 690 MPa (100 ksi) required by the specification. Elongation was nil; the specification called for 3% min. The induction-hardened case on the teeth was shallower and harder than specified (50 + HRC versus 46 HRC), and the martensitic microstructure had not been tempered as specified. Direct cause of fracture was the presence of inverse chill (carbides in thick sections of the casting) associated with microporosity. This carbidic material, which formed at thermal centers due to segregation of carbide-forming elements, increased hardness, decreased tensile strength, and promoted brittle fracture. Proper heat treatments would have corrected the deficiencies in case structure and properties and would also have prevented the occurrence of inverse chill. Fig. 36: Fracture surface at core of gear directly below origin. Note transcrystalline (cleavage) mode of fracture. SEM, 200×. Fig. 37: Photomicrograph of core. Matrix is 100% pearlite. Note presence of inverse chill (carbides) and associated porosity. 2% nital, 200×. Fig. 38: Fracture face at casting surface and in the induction-hardened case. SEM, 20×. Fig. 39: Boxed area in Fig. 38. Note cleavage fracture appearance and nodule surrounded by cracked material believed to be carbidic. SEM, 200×. Fig. 40: Microstructure directly below fracture surface and in case. There is a carbide-appearing envelope around each nodule of temper carbon that formed as the inverse chill

decomposed. The two nodules at upper left also have retained austenite around them. Note the secondary crack extending between the casting surface and the carbide envelope of a temper nodule. 2% nital, 200× (G.M. Goodrich, Taussig Associates Inc.)

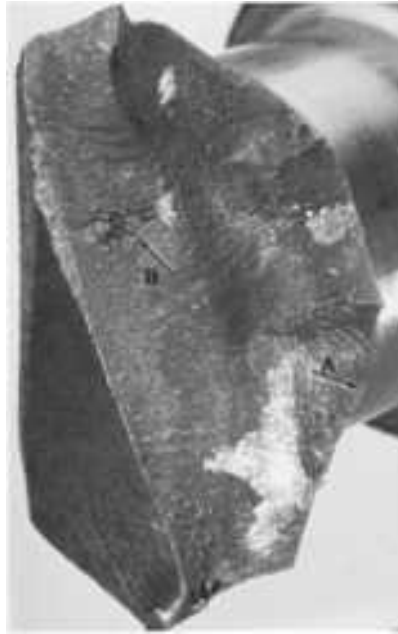
**Fig. 41** Surface of a fatigue-test fracture in an experimental crankshaft of induction-hardened 80-60-03 ductile iron with a hardness of 197 to 225 HB. Fatigue-crack origin is at arrow A. Porosity at arrow B was unrelated to fracture initiation. 2.5×

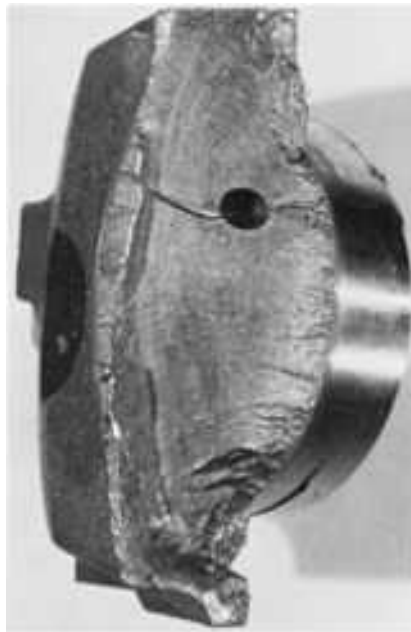
**Fig. 42** Surface of a fatigue-test fracture in an experimental crankshaft of ductile-iron with a hardness of 241 to 255 HB. Note the multiple fatigue-crack origins at the journal edge (at right). Fatigue beach marks are evident, which is unusual in cast iron. Actual size

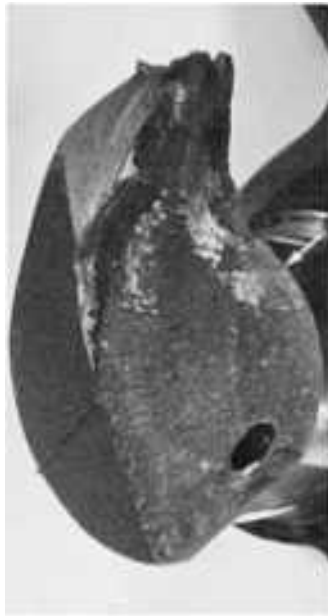
**Fig. 44**

**Fig. 43** Surface of a fatigue fracture in an experimental crankshaft broken in a fatigue test. The material is ductile iron with a hardness of 241 HB. The origin of the fatigue crack is at the edge of the journal, at arrow. Actual size

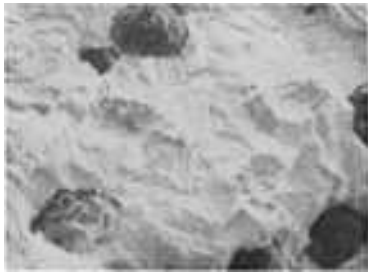
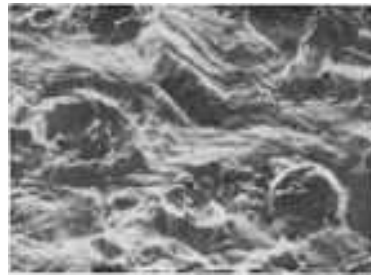
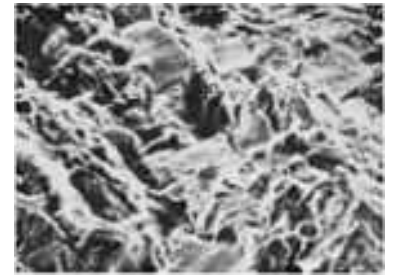
Fatigue fracture surfaces of pearlitic and ferritic ductile irons. Compositions of pearlitic irons: 3.63 to 3.80% C, 0.34% Mn, 2.02 to 2.66% Si. Compositions of ferritic iron: 3.75 to 2.82% C, 0.34% Mn, 2.30 to 2.66% Si. Striations noted in all cases. Fig. 47 and 48: Mixture of striations and fractured pearlite lamellae on fracture surfaces of commercial pearlitic ductile irons. Striations are the fine steplike features, not the macroscopic waviness or undulations. SEM, 207 $\times$  and 198 $\times$ . Fig. 49: A high load fatigue fracture surface of a ferritic ductile iron. SEM, 375 $\times$  (F.J. Worzala, University of Wisconsin)

Comparisons of fatigue and monotonic (tension, bending, impact) fracture surfaces for various ferritic ductile iron microstructures. Fatigue fractures are characterized by striations (see Fig. 47, 48, and 49), by relatively little opening up or stretching of matrix material around nodules, and by nodules that appear to have had large pieces of graphite broken off of them. Mode of crack propagation in monotonic fractures is very ductile with considerable stretching of nodule-bearing cavities. The demarcation line between fatigue (FAT) and monotonic (FRA) fracture is noted in each of the three fractographs. Fig. 50: Commercial ferritic iron (2.30 to 2.66% Si) tested at room temperature. SEM, 90 $\times$ . Fig. 51: Same material as in Fig. 50, but during tensile portion of test at -40 °C (-40 °F). SEM, 90 $\times$ . Fig. 52: High-silicon ferritic ductile iron (3.5% Si). SEM, 90 $\times$  (F.J. Worzala, University of

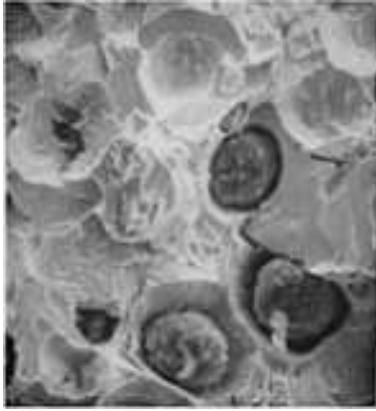
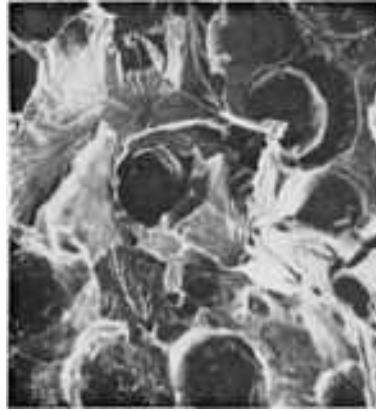
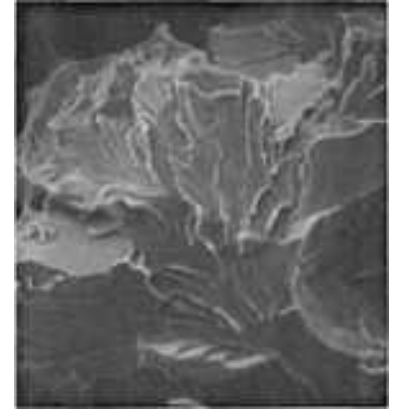
Fracture modes in slow monotonic loading (tension or bending) of pearlitic ductile irons. These cast irons consist of a pearlitic matrix with ferritic rings of varying thickness surrounding graphite nodules. They exhibit predominantly brittle fracture with river patterns in pearlitic areas. However, ductile fracture can occur in areas where several graphite nodules are closely spaced. Fig. 53: Typical slow monotonic fracture surface of pearlitic ductile iron. Note river patterns and both constrained and opened ferritic rings (areas of brittle and ductile fracture, respectively). SEM, 230 $\times$ . Fig. 54: Fracture surface with isolated graphite nodules. Brittle fracture results because the ferritic rings are under severe mechanical constraint due to the surrounding stronger and nondeformable matrix. SEM, 260 $\times$ . Fig. 55: Fracture surface at cluster of graphite nodules. Note the considerable deformation of the unrestrained ferrite. Fracture occurs here by ductile tearing and microvoid coalescence. SEM, 385 $\times$ . Fig. 56: River patterns indicative of brittle failure on fracture surface of a pearlitic ductile iron. SEM, 385 $\times$  (F.J. Worzala, University of Wisconsin)

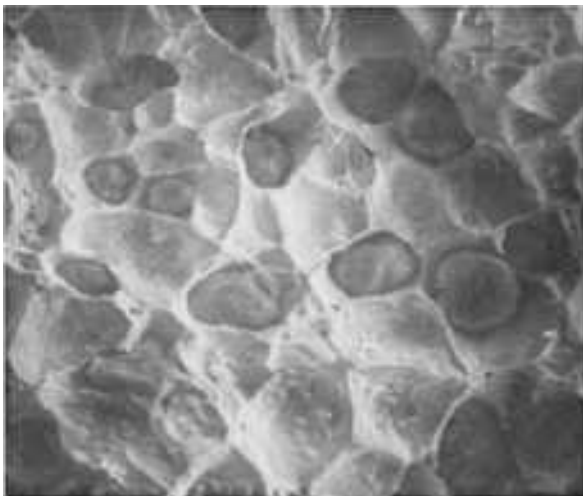
**Fig. 60**

modes operative at ambient temperature are ductile tearing and microvoid coalescence. The propagating crack will cut through any "lumps" of nonspheroidal graphite that may be present. Fig. 60: Fracture surface of ferritic ductile iron subjected to slow monotonic loading is characterized by ductile tearing and microvoid coalescence. Internodular ferrite undergoes a substantial amount of deformation. SEM, 300 $\times$ . Fig. 61: Fracture surface of ferritic ductile iron with nonspheroidal graphite shows how crack cuts through the irregularly shaped graphite lumps while leaving graphite nodules intact. SEM, 534 $\times$  (F.J. Worzala, University of Wisconsin)

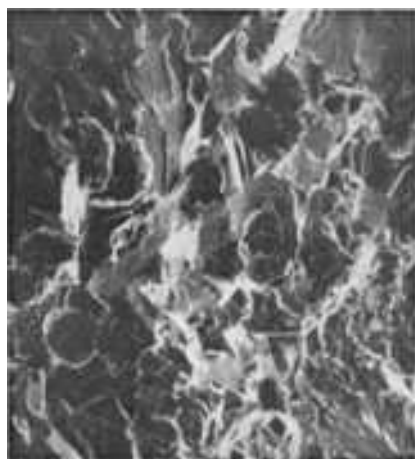
Fig. 62

As test temperature falls below ambient, the slow monotonic fracture mode for ferritic ductile irons undergoes a gradual ductile-to-brittle transition. Fig. 62: Fracture surface of ferritic ductile iron tested at -40 °C (-40 °F). Note river patterns and plateaus characteristic of brittle fractures. SEM, 150 $\times$ . Fig. 63 and 64: High-magnification views compare internodular areas of ferritic ductile irons tested at room temperature and at -40 °C (-40 °F), respectively. SEM, ~1900 $\times$  (F.J. Worzala, University of

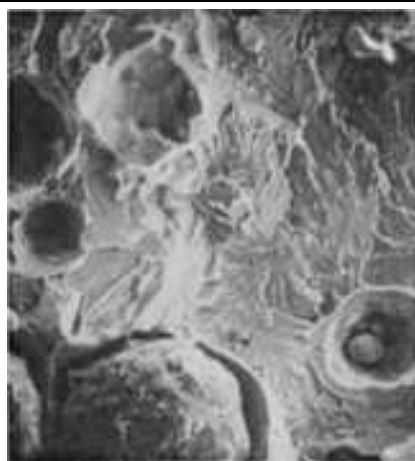
Fig. 65

Slow monotonic (tension or bending) fracture characteristics of heat-treated ductile irons. Fig. 65: Normalized high-nodularity ductile iron tested at room temperature. Note cleavage facets extending to the nodule, secondary cracking, and evidence of nodule cavity elongation. This material is not as tough as ferritic or pearlitic ductile iron. SEM, 550 $\times$ . Fig. 66: Fracture surface of normalized low-nodularity iron. Presence of nonspheroidal graphite fosters the creation of long ridges and valleys. These graphitic "lumps" apparently upset and redirect the crack plane. SEM, 550 $\times$ . Fig. 67: Austempered ductile iron, with a microstructure of bainite and tempered martensite, is stronger but less ductile than ferritic or pearlitic ductile iron. Note fine cleavage features. When viewed macroscopically, the fracture surface is very flat and reflective. SEM, 270 $\times$  (F.J. Worzala, University of Wisconsin)

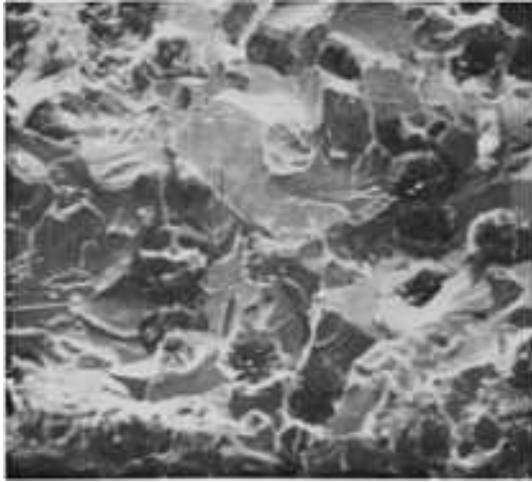
Fig. 68

Fracture modes in impact (fast monotonic) loading of a ferritic ductile iron tested at  $-45\text{ }^{\circ}\text{C}$  ( $-50\text{ }^{\circ}\text{F}$ ). Fig. 68: Fracture surface reveals little deformation with no stretching around graphite nodules. Several nodules appear to have been broken. Also, the matrix failed in an entirely brittle mode, as evidenced by the numerous river patterns and cleavage and quasi-cleavage steps. Compare with the slow monotonic (tension or bending) fracture in Fig. 62. Although they generally resemble each other, the fast fracture exhibits no graphite cavity stretching or microvoids, and nodules remain intact in the slow fracture. SEM,  $220\times$ . Fig. 69: Internodular area of impact-loaded specimen in Fig. 68. Fracture in this region was entirely brittle. Microtongues lie on the iron {112} plane and intersect the cleavage
