ASM HANDBOOK®

VOLUME  
12

Fractography

*Fractography*, was published in 1987 as Volume 12 of the *ASM Handbook*. The Volume was prepared under the direction of the ASM Handbook Committee.

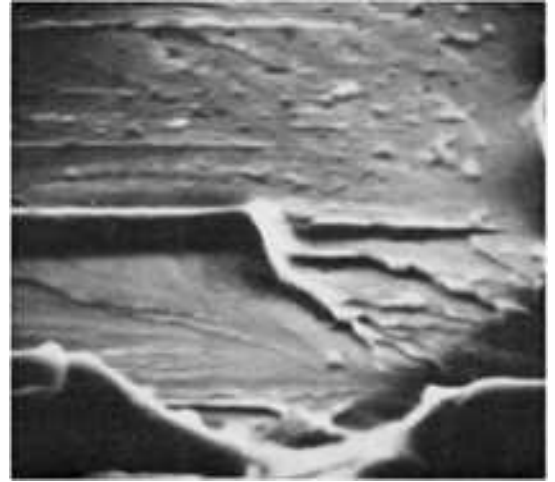
Fig. 69

Fracture modes in impact (fast monotonic) loading of a ferritic ductile iron tested at  $-45\text{ }^{\circ}\text{C}$  ( $-50\text{ }^{\circ}\text{F}$ ). Fig. 68: Fracture surface reveals little deformation with no stretching around graphite nodules. Several nodules appear to have been broken. Also, the matrix failed in an entirely brittle mode, as evidenced by the numerous river patterns and cleavage and quasi-cleavage steps. Compare with the slow monotonic (tension or bending) fracture in Fig. 62. Although they generally resemble each other, the fast fracture exhibits no graphite cavity stretching or microvoids, and nodules remain intact in the slow fracture. SEM,  $220\times$ . Fig. 69: Internodular area of impact-loaded specimen in Fig. 68. Fracture in this region was entirely brittle. Microtongues lie on the iron {112} plane and intersect the cleavage

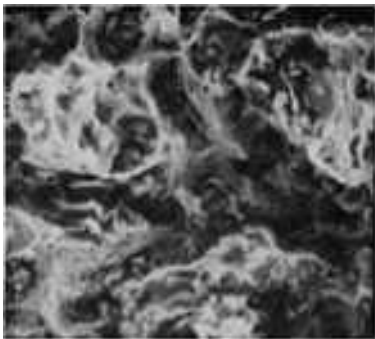
Fig. 70

Presence of nonspheroidal graphite affects impact fracture of ductile irons by producing a rough fracture surface with continuous change in crack path direction even at low test temperatures. Fig. 70: Fracture surface of ferritic ductile iron tested at  $-18\text{ }^{\circ}\text{C}$  ( $0\text{ }^{\circ}\text{F}$ ). SEM,  $240\times$ . Fig. 71: Fracture surface of pearlitic ductile iron impact tested at  $-75\text{ }^{\circ}\text{C}$  ( $-100\text{ }^{\circ}\text{F}$ ). SEM,  $100\times$  (F.J. Worzala, University of Wisconsin)

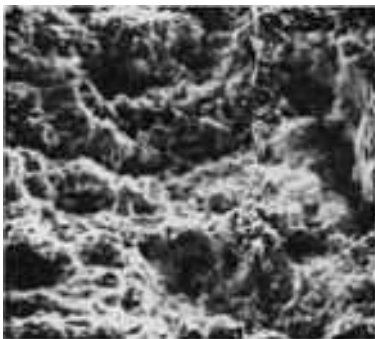
Fig. 72

Impact fracture of ductile irons at test temperatures above the nil-ductility transition (NDT) temperature is accompanied by gross plastic deformation (ductile behavior). Fig. 72: Fracture surface of low-nodularity ferritic ductile iron tested at  $65\text{ }^{\circ}\text{C}$  ( $150\text{ }^{\circ}\text{F}$ ). SEM,  $80\times$ . Fig. 73: Pearlitic ductile iron

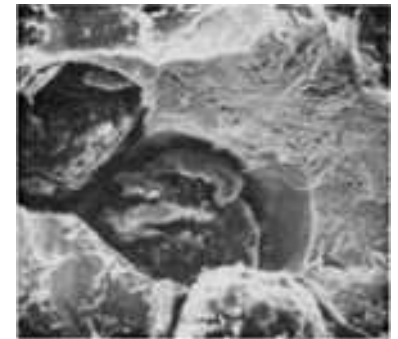
Fig. 73

tested at 205 °C (400 °F). Note microvoid coalescence and ductile tearing. SEM, ~400× (F.J. Worzala, University of Wisconsin)

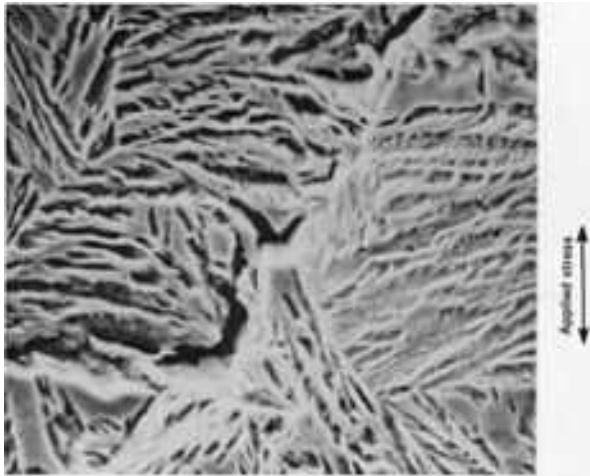
**Fig. 74**

Microcrack initiation and propagation ahead of the primary crack front in an austempered ductile iron (3.6% C, 2.3% Si, 0.9% Mn). Heat treatment: austenitize for 2 h at 870 °C (1600 °F), austemper for 40 min at 400 °C (750 °F). Samples were polished, etched in 2% nital, and then strained (arrow indicates direction of applied stress). Austempered matrix (shown here) consists of ferrite (dark) and stabilized austenite (light). Microcracks, initiate and propagate in the low-strength ferrite, avoiding regions of strong and tough austenite. SEM, 2500× (R.C. Voigt and L.M. Eldoky, University of Kansas)

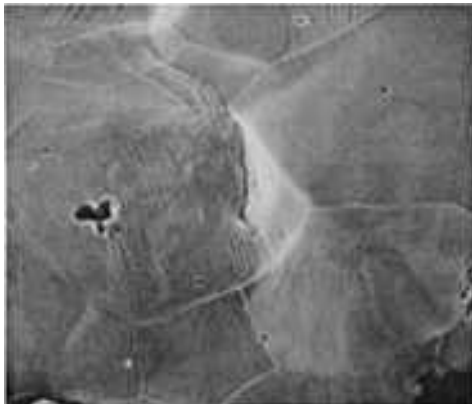
**Fig. 77**

Microcrack initiation and growth in an annealed ferritic ductile iron (3.6% C, 2.2% Si, 0.3% Mn, 0.7% Ni, 0.2% Mo). Sample polished, etched in 2% nital, and then plastically deformed by amount indicated. Tensile load applied horizontally. Fig. 76 and 77: After 610 and 670 strain units, respectively. SEM, both at 1200×. Fig. 78 and 79: After 700 and 760 strain units, respectively. SEM, both at 600× (R.C. Voigt and L.M. Eldoky, University of Kansas)

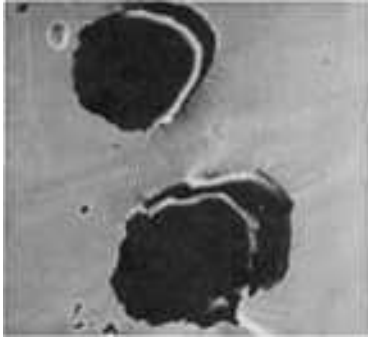
**Fig. 80**

**Effects of plastic deformation on internodule bridges in ferritic ductile iron. Material and sample preparation same as in Fig. 76, 77, 78, and 79. Fig. 80: Surface plastic deformation and microcracking ahead of the primary crack front. Note strain concentration at narrow internodule bridge. Tensile load applied horizontally. SEM, 950 $\times$ . Fig. 81: Severe plastic deformation associated with tearing of internodule bridge. Note separation of secondary graphite ring from both the primary graphite and**

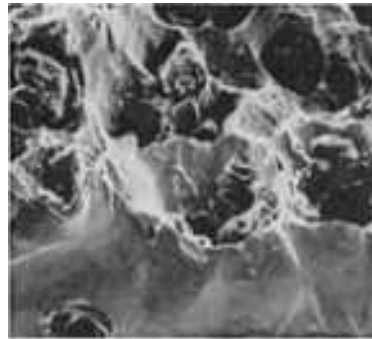
**Fig. 82 Microvoids and microtearing common to fractures of wide internodule bridges in ferritic ductile iron. Material same as in Fig. 76, 77, 78, and 79. Surface perpendicular to fracture surface and polished and etched in 2% nital. SEM, 300 $\times$  (R.C. Voigt and L.M. Eldoky, University of Kansas)**

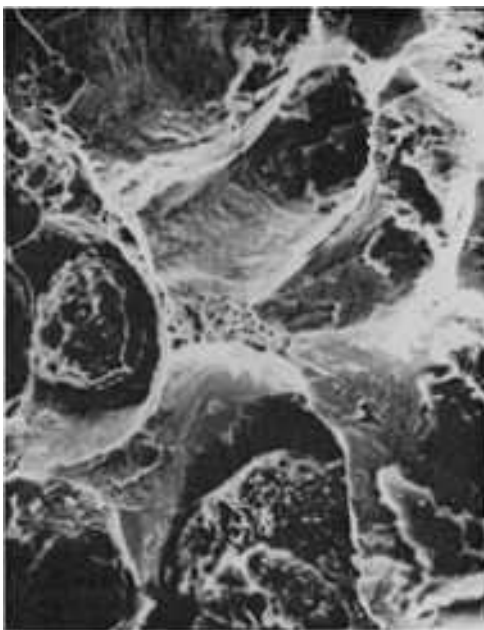
**Fig. 83**

**Typical fracture surface morphologies for an annealed ferritic ductile iron. Composition: 3.6% C, 2.2% Si, 0.3% Mn, 0.7% Ni, 0.2% Mo (same as in Fig. 76, 77, 78, 79, 80, 81, and 82). Fig. 83: Dimpled rupture (ductile fracture) at room temperature. SEM, 800 $\times$ . Fig. 84: Quasi-cleavage (brittle fracture)**

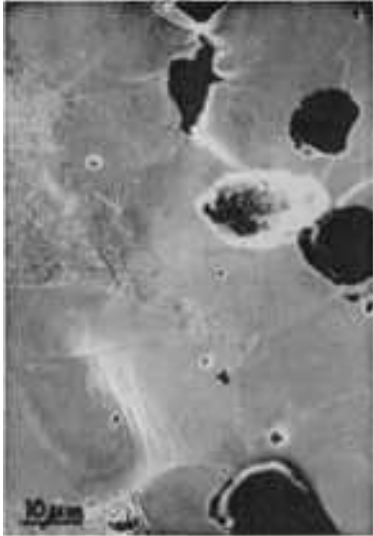
Fig. 85

Microcracking in an as-cast ferritic-pearlitic ductile iron (3.6% C, 2.2% Si, 0.3% Mn, 0.7% Ni, 0.2% Mo). SEM fractographs show localized plastic deformation and microcrack initiation and propagation in the plastic zone ahead of the primary crack. Samples were polished, etched in 2% nital, and then strained. (Tensile stress applied horizontally; direction of crack growth is toward the bottom.) The high-strength pearlite initially resists microcrack initiation. With sufficient plastic strain, however, the pearlite fractures, and the resultant microcracks are then blunted by the surrounding ferrite. 1030× (R.C. Voigt and L.M. Eldoky, University of Kansas).

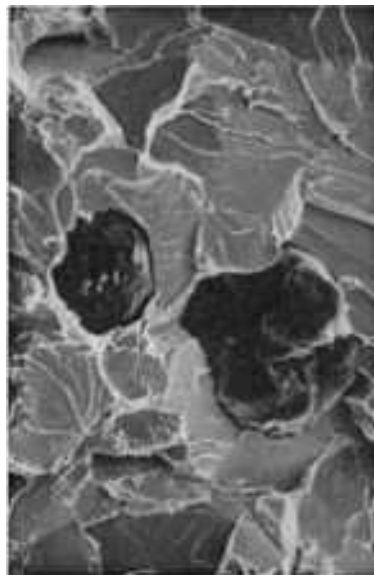
Fig. 87 Fracture surface of ferritic-pearlite ductile iron in Fig. 85 and 86. The low-temperature fracture occurred via a brittle, quasi-cleavage mode. SEM, 715× (R.C. Voigt and L.M. Eldoky, University of Kansas)

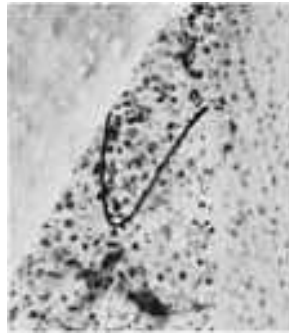
**Fig. 88** Ductile-to-brittle transition in an annealed ferritic ductile iron (same alloy as in Fig. 83 and 84). Above demarcation line is region of dimpled rupture (the ductile fracture surface of the test sample after partial fracture at room temperature). Below line is region of quasi-cleavage (the brittle fracture surface of the test sample after final fracture at low temperature). SEM, 30 $\times$  (R.C. Voigt and L.M. Eldoky, University of Kansas)

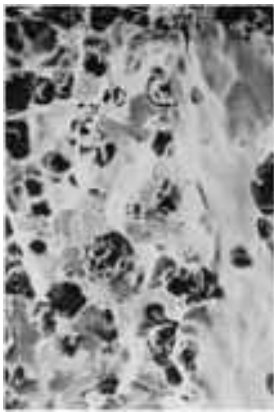
**Fig. 89**

Fracture transition zone at center of the ferritic ductile iron sample in Fig. 88. Fig. 89: Subsurface fracture transition zone. SEM, 140 $\times$ . Fig. 90: Higher magnification view of Fig. 89. Note how far microcracks formed at room temperature had propagated by time of final low-temperature fracture. SEM, 275 $\times$ . Fig. 91: High magnification view of transition zone. Visible features include nodule decohesion and microplastic deformation and tearing ahead of the primary crack front. SEM, 1,100 $\times$

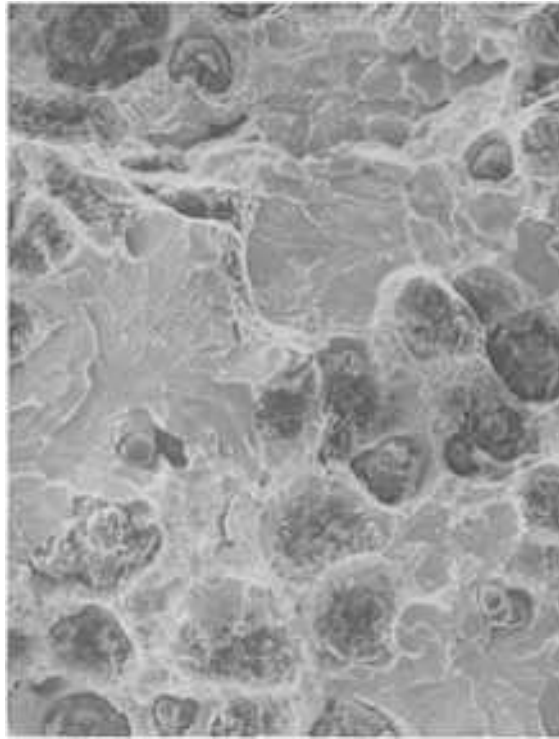
**Fig. 92 Fracture surface of a ferritic-pearlitic ductile iron. Note ductile fracture of ferrite in matrix around nodules and cleavage (brittle) fracture of pearlite in matrix. SEM, 50× (W.L. Bradley, Texas A&M University)**

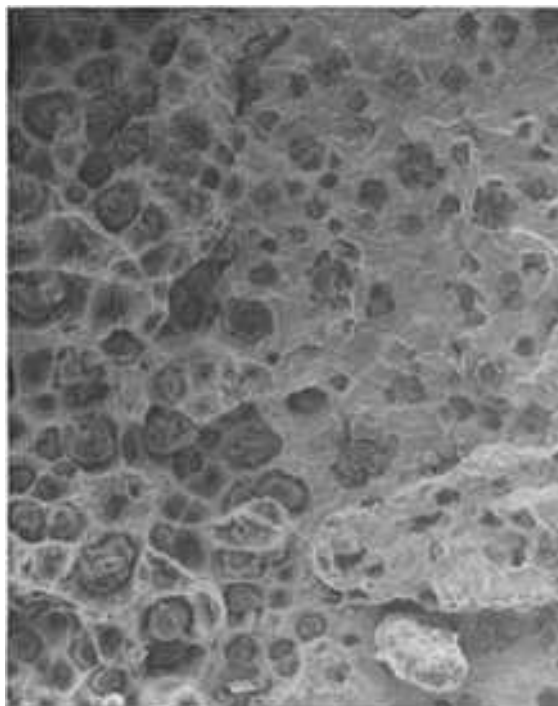
**Fig. 93 Regions of fatigue precracking (at right) and crack extension or fracture (at left) in the fracture surface of a ferritic ductile iron compact tension specimen. Note how crack ignores nodules in fatigue and grows almost exclusively through nodule-nucleated voids during ductile fracture. ~80× (W.L. Bradley, Texas A&M University)**

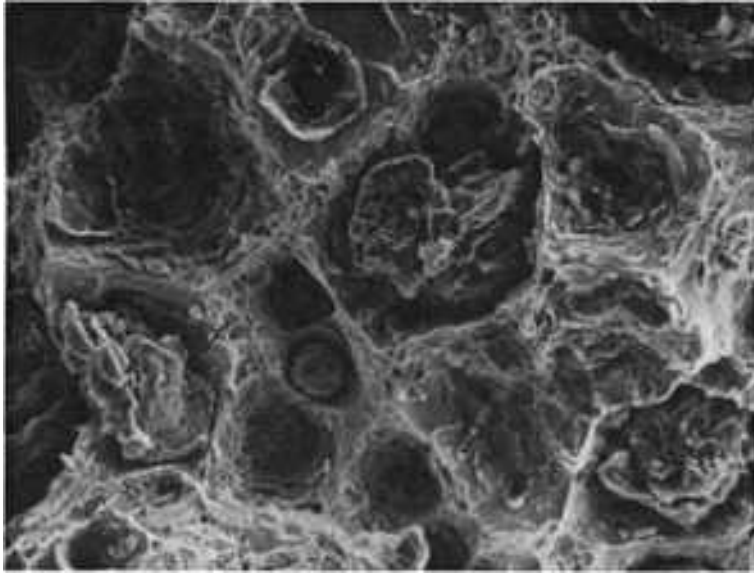
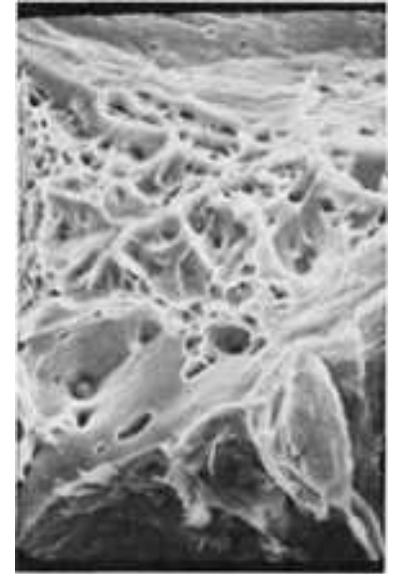
**Fig. 94**

**Ductile fracture in ferritic ductile iron. Fig. 94: SEM, 160 $\times$ . Fig. 95: Example of the finely dimpled ductile fracture that occurs between the much larger voids nucleated at graphite nodules. SEM, 2000 $\times$**

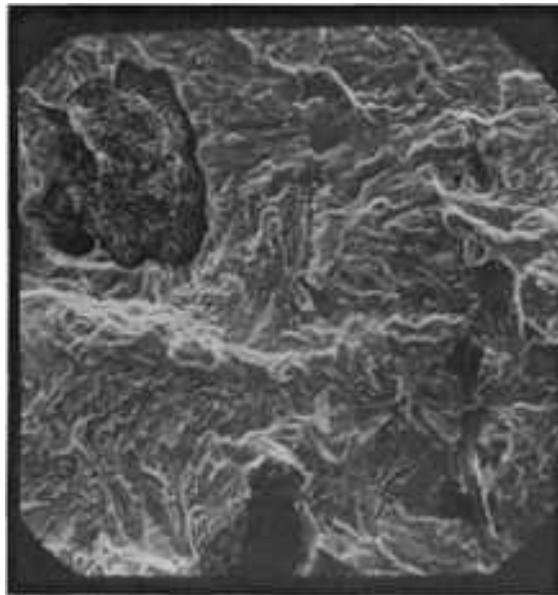
**Fig. 96 Fatigue precracked region on the fracture surface of a ferritic ductile iron compact tension specimen. Morphology is typical of fatigue fractures in this material. SEM, 500 $\times$  (W.L. Bradley, Texas A&M University)**

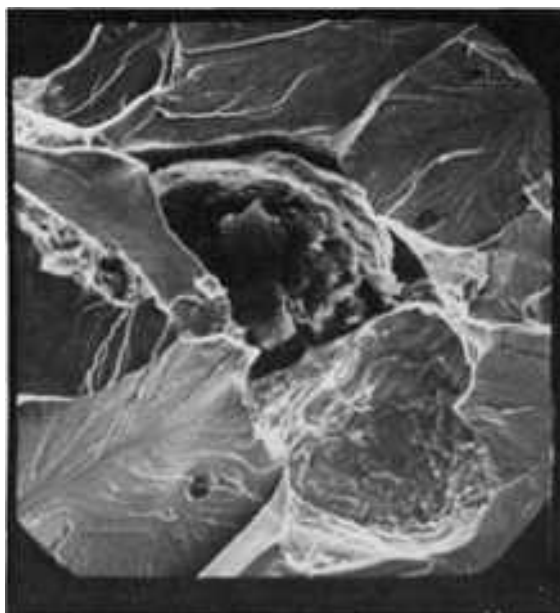
**Fig. 97 Brittle cleavage fracture in ferritic ductile iron. SEM, 1000× (W.L. Bradley, Texas A&M University)**

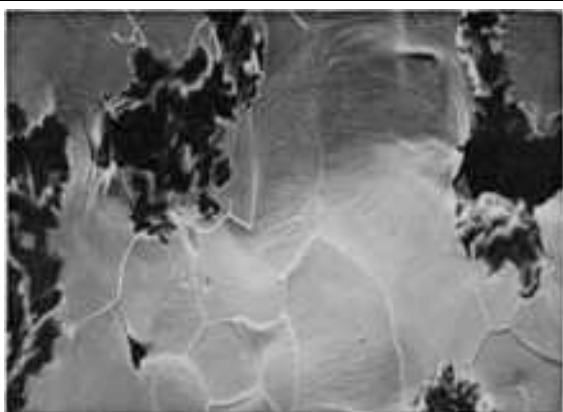
**Fig. 98**

**Fracture sequence (increasing strain) illustrating localized plastic deformation and microcrack initiation and propagation ahead of the primary crack in a ferritic malleable iron (ASTM A47, grade**

32510). Heat treatment was standard (graphitizing anneal, furnace cool). Hardness: 140 HB. Samples were polished, etched in 4% nital, and then strained. Figures 98, 99, 100, and 101 are in order of increasing amounts of strain. Note how cracks propagate through the graphite rather than around it as is the case for ductile iron (see Fig. 76, 77, 78, 79, Fig. 85, and 86). SEM, all at 580× (R.C. Voigt and B. Pourlaidian, University of Kansas)

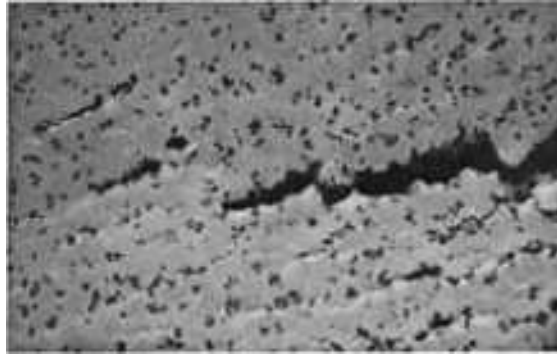
Fig. 102 Crack initiation and propagation in a ferritic malleable iron. Same material and test conditions as in Fig. 98, 99, 100, and 101, but at low magnification. Note that preferential sites for crack initiation and propagation are in interdendritic regions defined by the observed alignment of temper carbon (graphite). SEM, 4% nital, 40× (R.C. Voigt and B. Pourlaidian, University of Kansas)

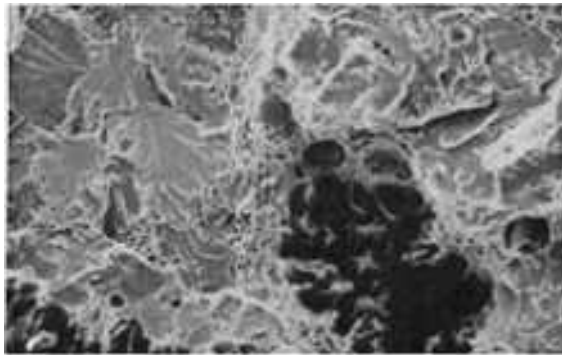
Fig. 103 Fracture surface of ferritic malleable iron after impact loading at -196 °C (-320 °F). Same material as in Fig. 98, 99, 100, 101, and 102. Regions of dimpled rupture can still be observed even at this low temperature. Primary fracture mode is brittle quasi-cleavage. SEM, 830× (R.C. Voigt and B. Pourlaidian, University of Kansas)

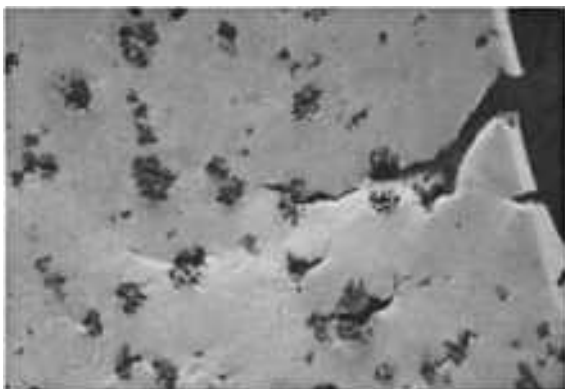
Fig. 104

Microcracking in a pearlitic malleable iron (ASTM A220, grade 50005). Heat treatment: graphitize anneal, then quench and temper to 223 HB. Samples polished, etched in 4% nital, and then strained. Fig. 104: Low-magnification view shows crack propagating through temper carbon, and localized

plastic deformation and microcracking ahead of the primary crack front. SEM, 150×. Fig. 105: Microcracking occurring between adjacent temper carbon sites. Also note small microcracks through sulfide inclusions. SEM, 1,150×. (R.C. Voigt and B. Pourlaidian, University of Kansas)

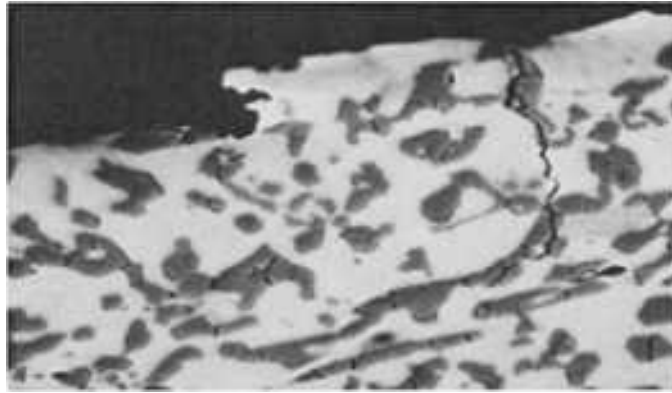
Fig. 106

Cracking in 75-mm (3-in.) diam balls made of a high-chromium white iron when subjected to severe, repeated impacts in a laboratory test. Fig. 106: Cracks through eutectic  $M_7C_3$  carbides near the surface (dark region) of the ball. SEM, 2000× Fig. 107: Cracks parallel to the surface of the ball and extending through carbides located several millimeters beneath the surface. These cracks were caused by a combination of shear stress and the tensile stress due to rebounding. SEM, 2000×. Fig. 108: Crack path of an imminent near-surface spall. SEM, 1000× (H.W. Leavenworth, Jr., U.S. Bureau of Mines)

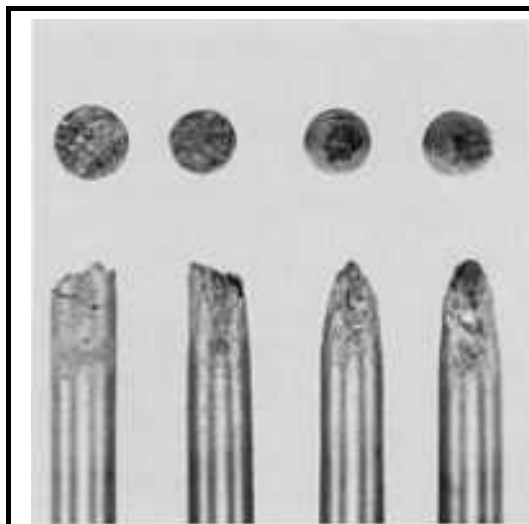
Fractures obtained in tension in low-carbon steel specimens that were tested at elevated temperature. The specimens were taken from a series of 225-kg (500-lb) laboratory heats melted to yield a range of carbon contents (0.04 to 0.08%) and a range of Mn:S ratios (11:1 to 68:1). The ingots were rolled to 19- and 16-mm ( $\frac{3}{4}$ - and  $\frac{5}{8}$ -in.) plate at 1175 °C (2150 °F). The specimens shown in Fig. 109 were machined, placed within a silica sleeve in a Gleeble test unit, and remelted in the central region of the gage length. They were then solidified *in situ*, cooled to 1425 °C (2600 °F) at 14 °C (25 °F) per second, cooled to either 1095 °C (2000 °F) or 925 °C (1700 °F) at 5.5 °C (10 °F) per second, and then pulled to rupture. From left to right, the Mn:S ratios were 11, 22, 38, and 63 to 1, and the reductions of area were 6, 37, 63, and 83%. The specimens shown in Fig. 110 were "sensitized" in the Gleeble test unit by heating to 1425 °C (2600 °F), holding for 300 s, and then cooling at 5.5 °C (10 °F) per second to 1095 °C (2000 °F), and were broken in tension at the latter temperature. From left to right, the Mn:S ratios were 14, 22, 36, and 62 to 1, and the reductions of area were 4, 47, 74, and 99%. Both at 0.75×

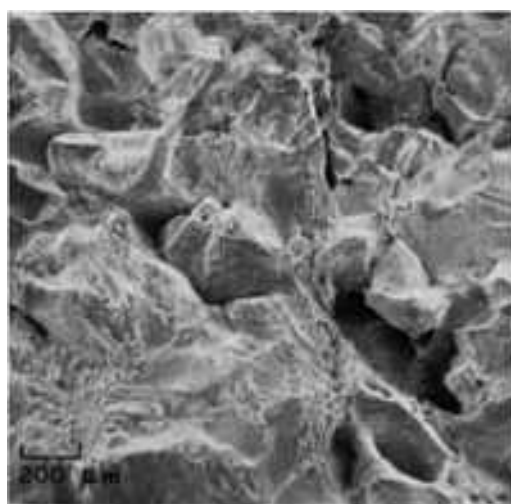
Fig. 111 Fracture in low-carbon steel containing 0.065% C, 0.52% Mn, 0.01% P, 0.022% S, and 0.076% Si (Mn:S ratio, 23.6:1). The specimen was "sensitized," and broken in tension, as described for Fig. 110. Under these conditions, a low Mn:S ratio would result in a completely intergranular fracture. However, because of the intermediate ratio here (23.6:1), the grain-boundary facets show dimples in many areas, indicating ductility.

Reduction of area was 33%, which agrees with the appearance of the fracture surface. SEM, 50×

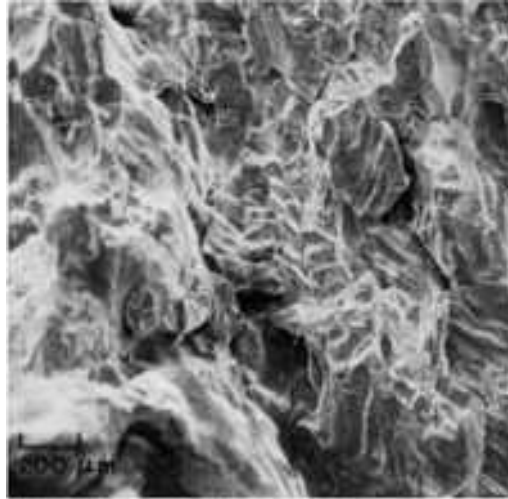
**Fig. 112** Surface of fracture obtained in test bar of low-carbon steel containing 0.041% C, 0.62% Mn, 0.008% P, 0.028% S, and 0.032% Si (Mn:S ratio, 22.1:1). The test bar was remelted in its central zone in a Gleeble test unit, solidifying *in situ* in its quartz sleeve. Following controlled cooling from the freezing point, the test bar was pulled in tension at 925 °C (1700 °F). Although the path of this fracture was largely intergranular, there is also transgranular cleavage, and some facets show very fine dimples. SEM, 50×

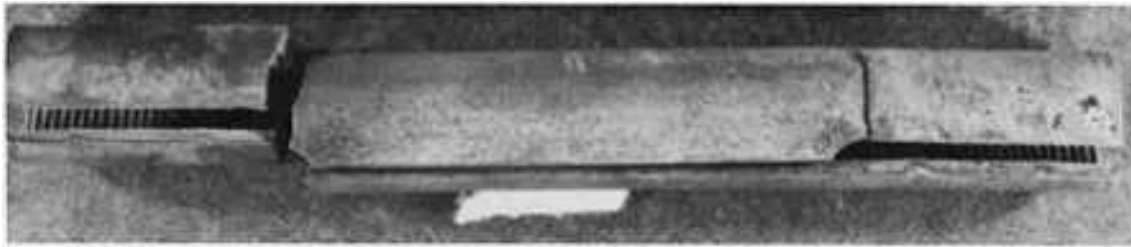
**Fig. 113**

**In-service fatigue fracture of SAE 1010 tie rod adjusting sleeve for automobile steering system. Fig. 113: Tubular part was made by cold forming cold-rolled sheet. 1.8×. Fig. 114: Macrograph reveals fracture progressed at 90° to surface. (General Motors Research Laboratories)**

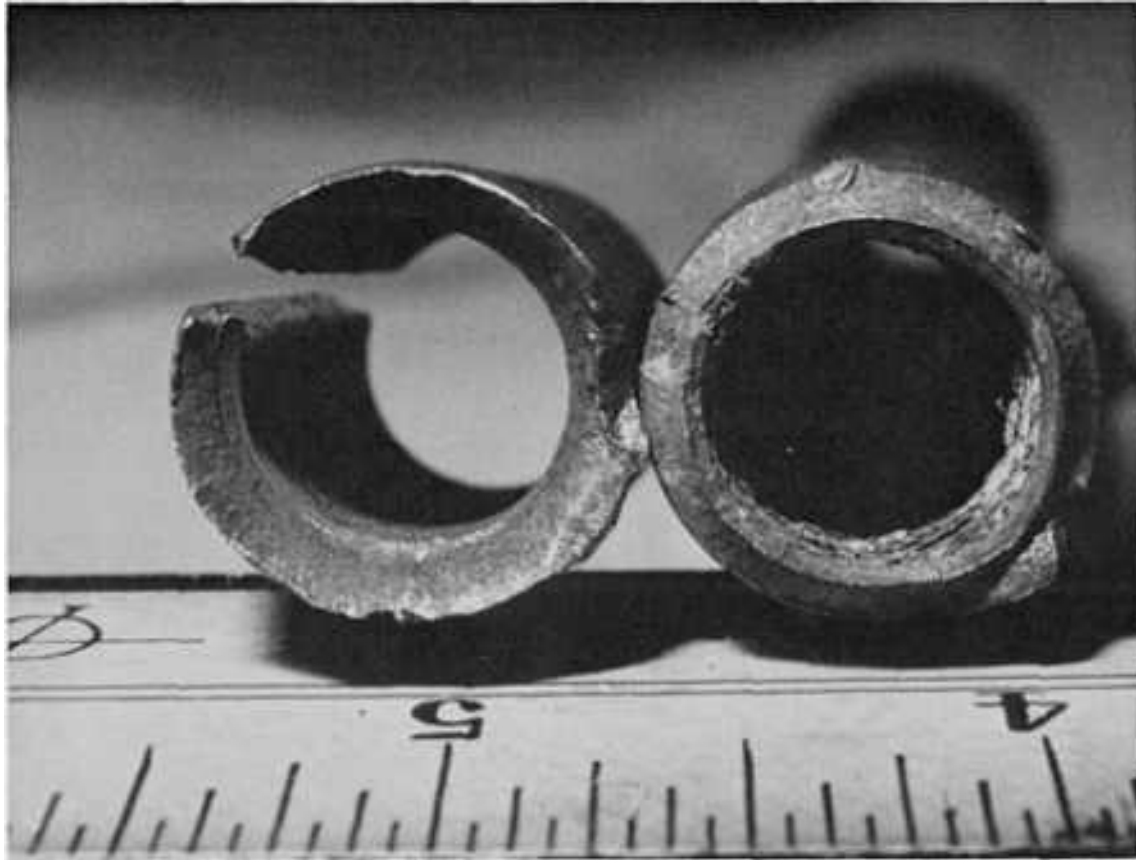
**Fig. 115**

**Bending impact fracture of SAE 1010 tie rod adjusting sleeve for automobile steering system. This part, unlike that in Fig. 113 and 114, was made of cold-drawn seamless tubing. Compressive forces produced when wheel was struck during an accident caused sleeve failure. Fig. 115: Macrograph of mating fracture surfaces shows impact fracture progressed at 45° to surface. 2×. Fig. 116: Photomicrograph near point of origin reveals dimpled structure characteristic of a ductile, single load**

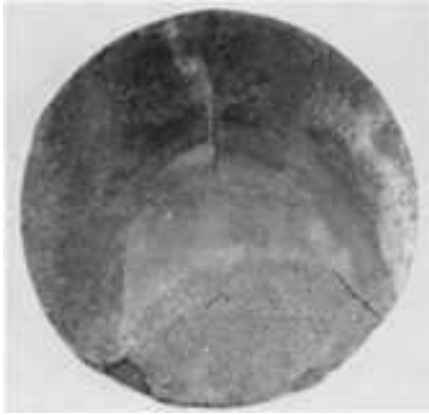
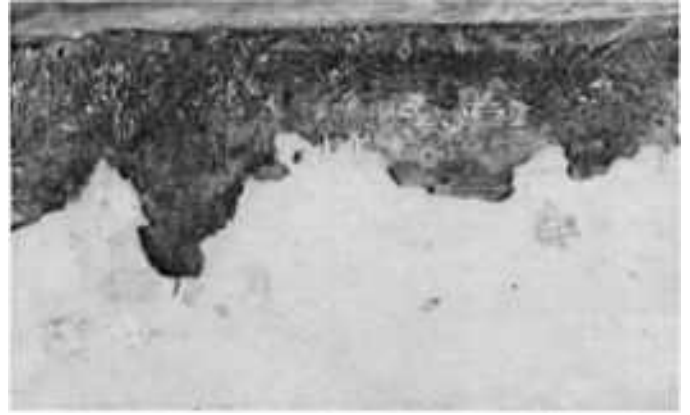
**Fig. 117**

Fatigue fracture of journal for felt press roll. The 180-mm (7-in.) diam AISI 1019 shaft (88 HRB) had been in service 2 years at 20 °C (70 °F) and 100% relative humidity. Rust-preventive coating flaked off in file, resulting in pitting corrosion. Fatigue cracks initiated at pit bottoms. Fig. 117: Fracture surface. Fig. 118: Macrograph of shaft outer surface. Regions visible, top to bottom: fracture surface, corroded portion of shaft where coating had delaminated, and coated surface. 2.5×. (Z. Flanders,

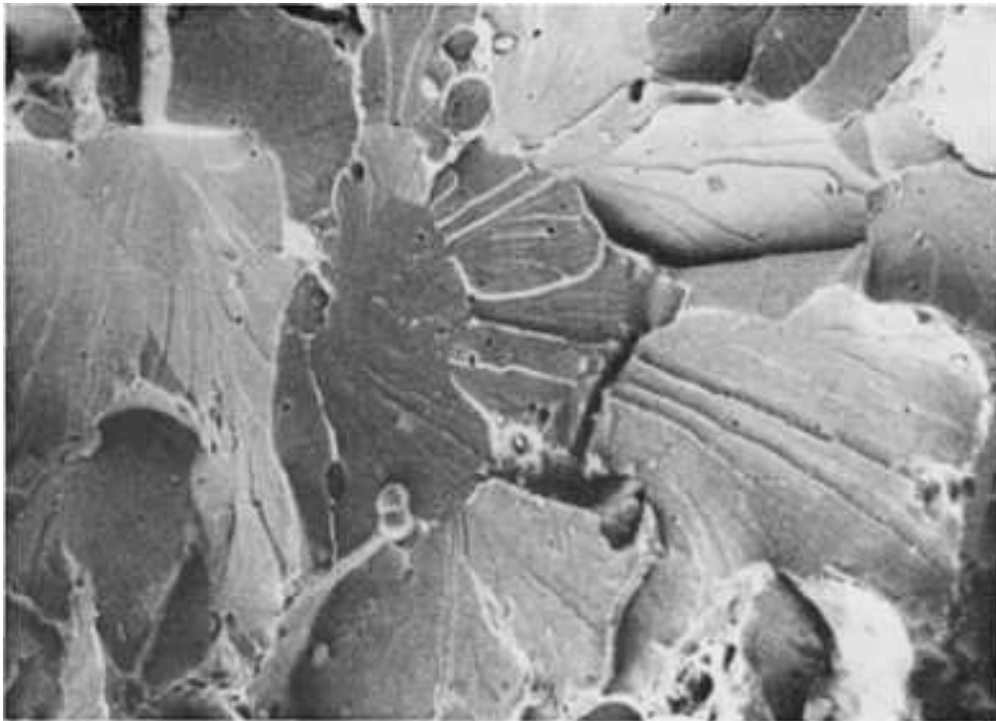
**Fig. 119** Brittle fracture of AISI 1020 hydraulic jack shaft. Failure originated at root of machined thread. Corrosion (evident on part) and fatigue (due to repeated loading of shaft) may also have played roles in the failure. Photomicrograph of fracture surface shows transgranular cleavage with individual grains identified by changes in fracture plane orientation. The apparent grain size of 100 to 125  $\mu\text{m}$  corresponds to a ductile-to-brittle transition temperature of approximately 100 °C (212 °F). SEM, 450× (J.M. Rigsbee, University of Illinois)

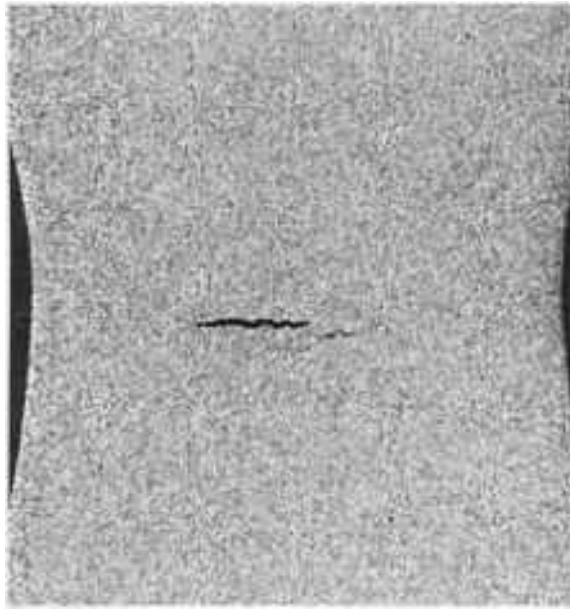
**Fig. 120** Polished and etched section taken longitudinally through a 13-mm (0.505-in.) diam tensile-test specimen of AISI 1020 steel. The tensile test was halted after the centerline cracks shown here were formed, but before complete fracture occurred. See also Fig. 121 and 122. Nital etch, 10×

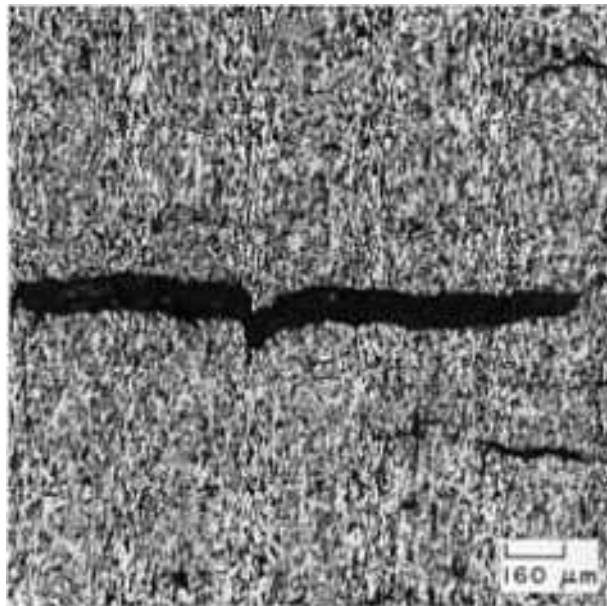
**Fig. 121** Higher-magnification view of one of the centerline cracks in the specimen shown in Fig. 120, demonstrating that the cracks are transgranular. Secondary cracks also are visible at right, above and below the main crack. See Fig. 122. Nital etch, 62.5×

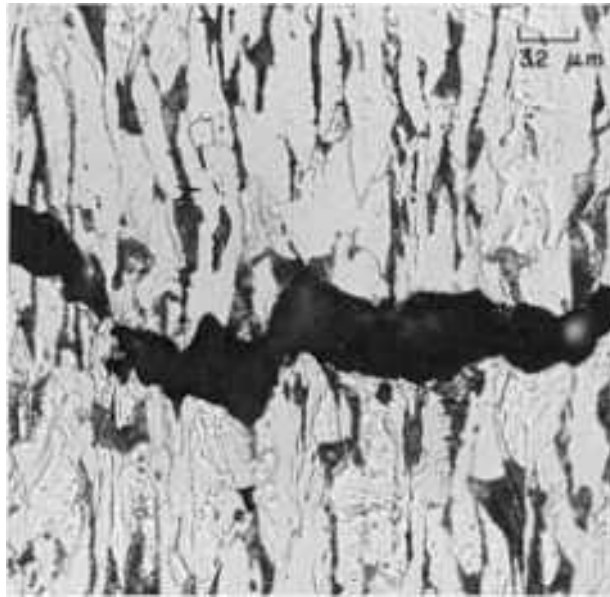
**Fig. 122** A further enlargement of a centerline crack in the AISI 1020 steel tensile-test specimen shown in Fig. 120 and 121. Note that the crack crosses alternate plates of ferrite and pearlite; note also the longitudinal deformation of the original equiaxed structure. Nital etch, 312.5×

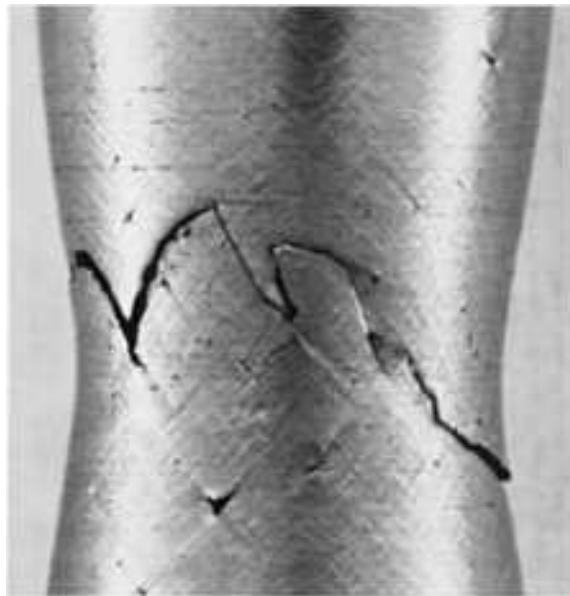
**Fig. 123** Tensile-test fracture in a 13-mm (0.505-in.) diam specimen of cast 0.20% C steel with hardness of 255 HB. Note that pronounced 45° shear deformation has produced shear lips and also numerous secondary cracks, which formed at pores. 7.5×

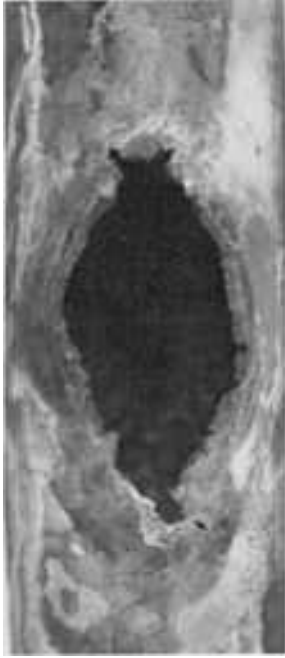
Fig. 133

Failure of ASTM A178 grade B boiler tubes due to grain-boundary embrittlement by copper. Thick waterside deposits on tube inner-diameter surfaces impaired heat transfer, causing overheating of the steel during boiler start-up. Underneath the scale was a layer of metallic copper, an element often present as a feedwater impurity and which can plate out on the inner-diameter surfaces of boiler tubes. Overheating of the tubes to above 815 °C (1500 °F) caused accelerated diffusion of the copper along grain boundaries in the steel, in some cases reaching the tube outer-diameter surface. The copper-embrittled grain boundaries could not withstand both the high temperature and internal tube pressure. Either a longitudinal rupture (Fig. 133) or circumferential cracking (Fig. 134) resulted, depending on the orientation of maximum copper infiltration. (F.W. Tatar, Factory Mutual Research Corporation)

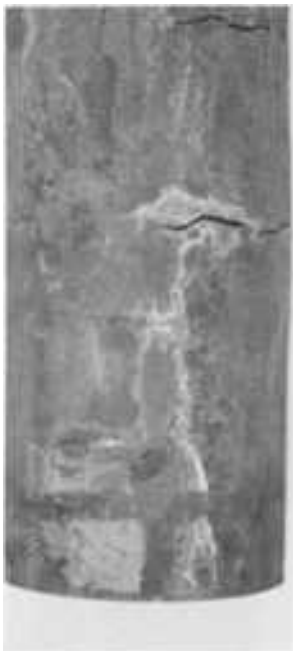
Fig. 135

SEM photomicrographs at inner-diameter surface of circumferentially cracked ASTM A178 grade B boiler tube in Fig. 134. Fig. 135: Note intergranular penetration by copper; some oxidation is present near surface. 100×. Fig. 136: Higher-magnification photomicrograph reveals a 25-μm (1-mil) thick

layer of metallic copper on the tube inner diameter. 2% nital. 300× (F.W. Tatar, Factory Mutual Research Corporation)

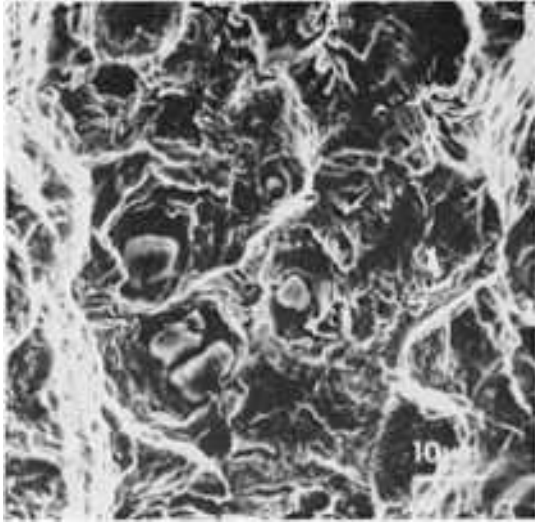
Fig. 137

Fractographs show how calcium treatment affects inclusion morphology and fatigue crack propagation (FCP) in ASTM A516-70. Fracture surfaces are of FCP test specimens of calcium-treated (43 ppm Ca) electric furnace steel normalized at 900 °C (1650 °F) and air cooled. Both are in the S-L (through-thickness) orientation,  $\Delta K = 43 \text{ MPa}\sqrt{m}$  (39 ksi $\sqrt{in}$ ). Calcium treatment reduces the number and size of inclusions and minimizes the formation of groups of Type II manganese sulfide inclusions and alumina inclusions via desulfurization (to 0.010% S max) and inclusion shape control. Positive results include improved levels and isotropy of FCP resistance. Fig. 137: Note round, calcium-modified, duplex inclusions of sulfide and aluminate phases. Fig. 138: Another fracture surface shows formation of ductile fatigue striations, the principal mode of fracture in this steel and in other calcium-treated grades. This mode is also exhibited by conventionally melted steels when fracture occurs remote from inclusion formations. Direction of macroscopic FCP is from bottom to top in both figures. SEM, 1200× (A.D. Wilson, Lukens Steel Company)

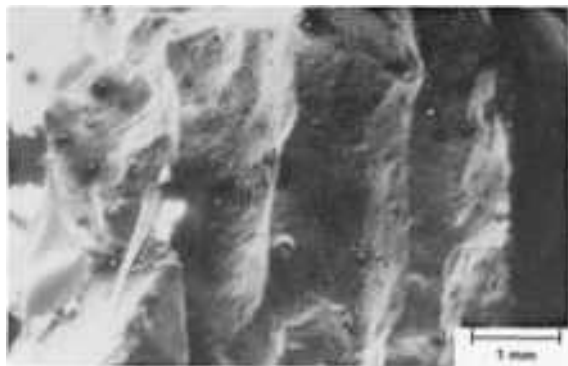
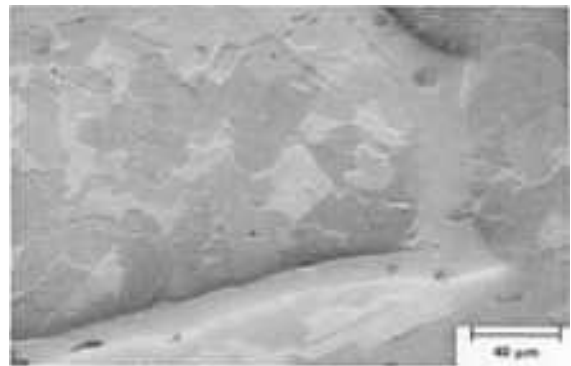
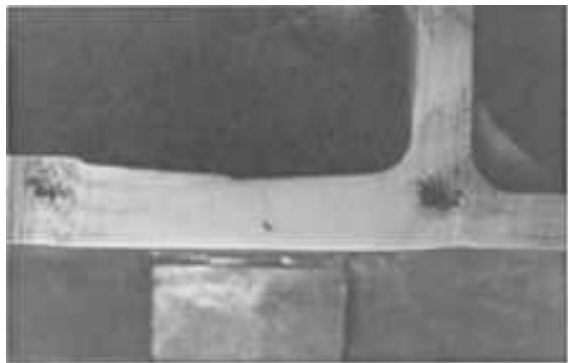
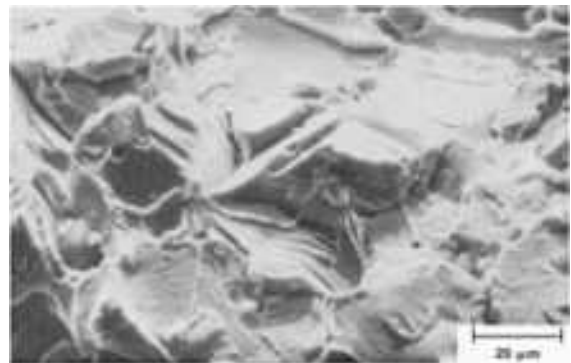
Copper contamination introduced during casting led to brittle fracture of a normalized 0.25% C carbon steel part. The boxcar side frame failed during a freight train derailment. The foundry mold had accidentally been contaminated with copper. During solidification of the casting, some of the copper dissolved in the steel while the remainder was entrapped as liquid metal and either penetrated austenite grain boundaries or solidified as copper inclusions. Dissolved oxygen in the grain-boundary copper reacted with iron to form a black scale consisting largely of  $\text{Fe}_3\text{O}_4$  and  $\text{Fe}_2\text{O}_3$ . Fracture initiated during the derailment, and upon reaching the copper-contaminated region it followed the scale network, delineating prior-austenite grain boundaries. Under repeated impacts, the fracture advanced further by low-cycle fatigue until part failure occurred by cleavage. Fig. 146: "Rock candy" portion of fracture surface where fracture followed scale network, defining copper-contaminated prior-austenite grain boundaries. SEM, 1100×. Fig. 147: Vein of copper along prior-austenite grain boundary near rock candy portion of fracture surface. Section polished and etched with 2% nital. SEM, 275×. Fig. 148: Transverse crack emanating from copper inclusion is visible at center of photo. Large shrinkage cavities at left and right played no role in fracture. Fig. 149: Region on fracture surface exhibiting cleavage. SEM, 550× (A. Johnson, University of Louisville)

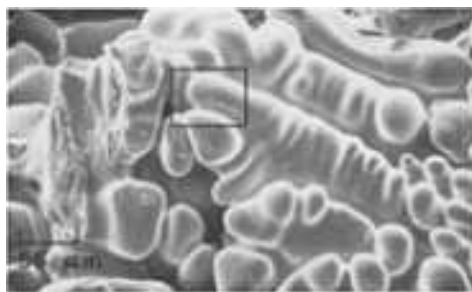
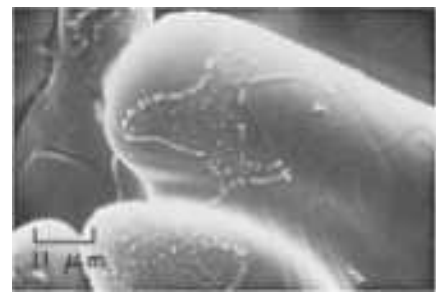
Surface of a brittle fracture in a specimen of low-carbon steel whose central zone was remelted in a Gleeble test unit, resolidified, cooled *in situ* to 1425 °C (2600 °F) and held for 20 s at that temperature, and then fractured in tension. This specimen contained 0.024% P. Figure 150 (shown at 180×) indicates that the fracture followed an interdendritic path through regions that had not yet solidified at 1425 °C (2600 °F). The rounded dendrite surfaces thus exposed are obvious, and the only evidence

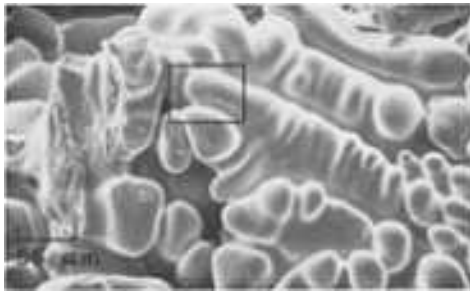
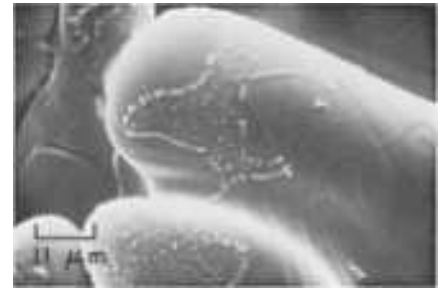
Surface of a brittle fracture in a specimen of low-carbon steel whose central zone was remelted in a Gleeble test unit, resolidified, cooled *in situ* to 1425 °C (2600 °F) and held for 20 s at that temperature, and then fractured in tension. This specimen contained 0.024% P. Figure 150 (shown at 180 $\times$ ) indicates that the fracture followed an interdendritic path through regions that had not yet solidified at 1425 °C (2600 °F). The rounded dendrite surfaces thus exposed are obvious, and the only evidence of a torn surface is in a small area at extreme left. Figure 151, which is a higher-magnification view (900 $\times$ ) of the area within the rectangle in Fig. 150, shows patterns of what were confirmed by x-ray fluorescent analysis to have been, at the moment of fracture, liquid droplets of manganese oxysulfide on the dendrite surfaces. These patterns were the only evidence of segregation that was discovered within the fracture.

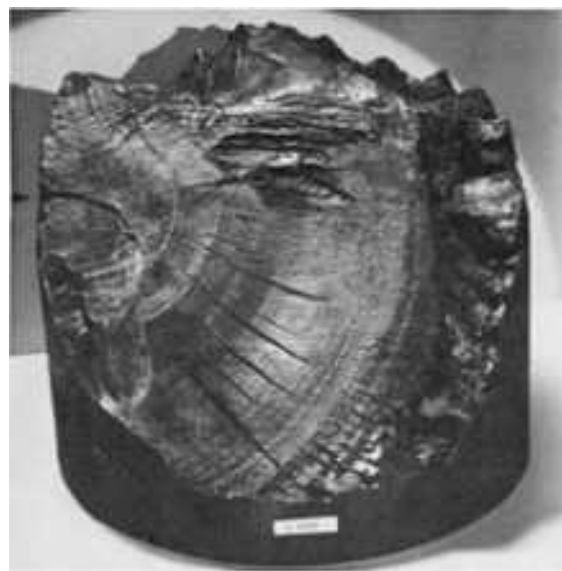
Fig. 152 Fracture surface of a carbon steel drive shaft of a 180-Mg (200-gross-ton) marine tug. The shaft failed by corrosion fatigue after seawater displaced the lubricant between the shaft and the stern tube. Beach marks indicate that the fracture origin was at left (arrow). See also Fig. 153, 154, 155, and 156. 0.8 $\times$

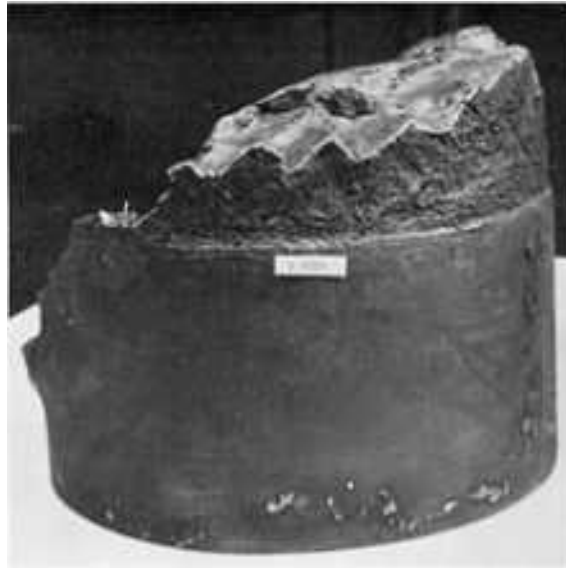
**Fig. 153** Side view of the fractured drive shaft in Fig. 152. Note the serrated profile (retouched for clarity) of this edge of the fracture surface and the diagonal cracks on the shaft surface. The cracks were caused by corrosion fatigue from the combination of reversed shaft torsion, perhaps some bending, and seawater attack. 0.8x

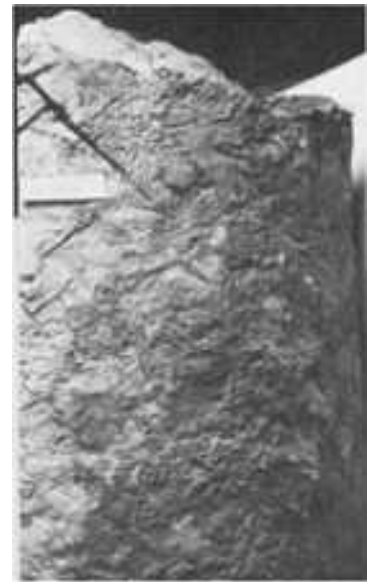
Figure 154 shows a macroetched section of the fractured shaft in Fig. 152. Fig. 155 is a view at 90° to that in Fig. 154 and shows the shaft surface, containing diagonal cracks (Fig. 154 shows depths of these cracks). Note in Fig. 155 that the seawater produced not only corrosion-fatigue cracking but also

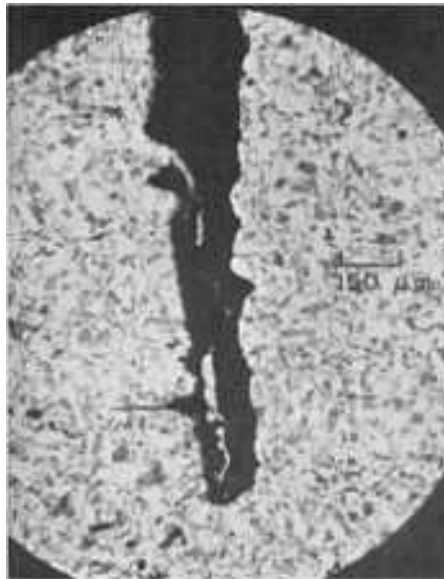
**Fig. 156** Section of the fractured shaft shown in Fig. 151, revealing the bottom of one of the corrosion-fatigue cracks. Note that corrosion blunted the tip of the main crack but not the tip of the sharp secondary crack at left, which formed later. Picral etch, 67×

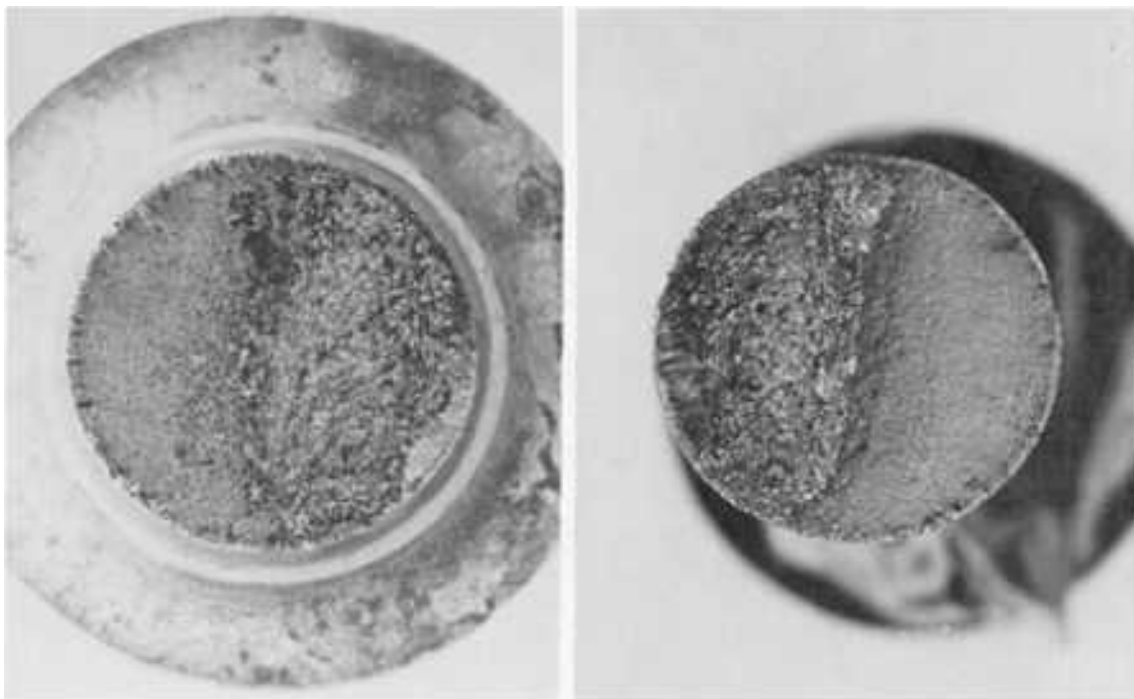
**Fig. 157** Mating fracture surfaces of carburized and hardened low-carbon (0.08% C) steel bicycle pedal axle. The in-service fatigue failure initiated at quench cracks in the thin carburized case. 5× (R. Goco, California Polytechnic State University)

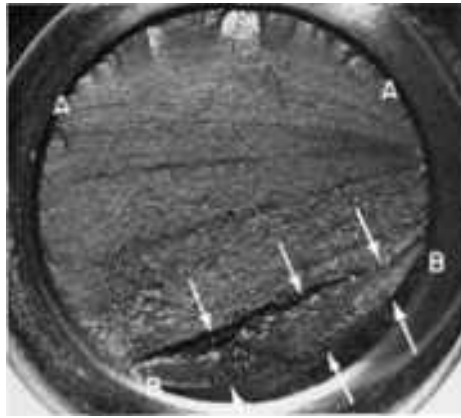
**Fig. 158** Surface of a fracture in a lift-truck hydraulic-piston rod of low-carbon steel that broke at a fillet by fatigue. Several fatigue-crack nuclei are evident at top edge (between A's), and there is another at the bottom edge (between B's). Fracture was by reversed bending. Final fast fracture was in the small region indicated by the arrows. See also Fig. 159. 3×

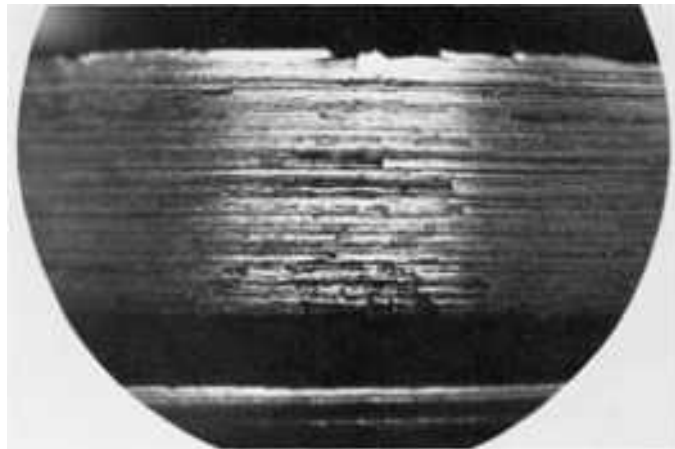
**Fig. 159** A view of coarse machining marks that were found in the fillet in Fig. 158 between the larger-diameter portion of the piston rod and the threaded end. A secondary crack that follows a machining mark is visible at top center. These surface marks are considered to be areas of local stress concentrations, which led to fatigue cracking. 10×

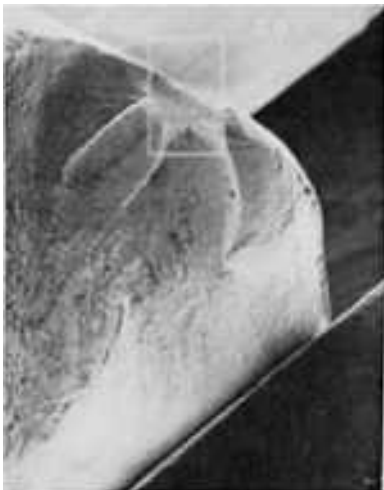
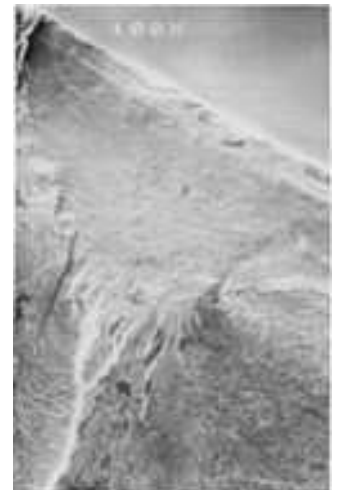
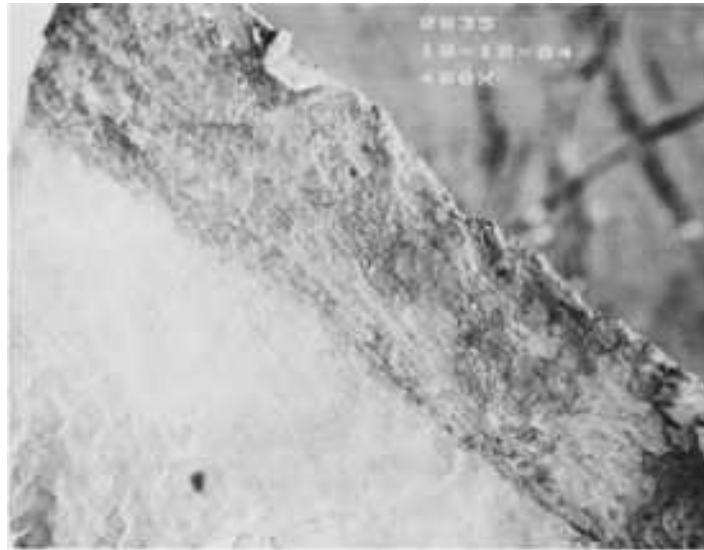
**Fracture of low-carbon steel spring due to a lap. The defect was most likely introduced during rolling of the wire rod. Unlike seams, penetration of a lap below the wire surface is more tangential than radial. Like seams, laps tend to induce failures in springs by first initiating a longitudinal shear crack. Fig. 160: Fracture surface. SEM, 70×. Fig. 161: Boxed area in Fig. 160. SEM, 100×. Fig. 162: Higher-magnification view shows the dark, nonuniformly textured lap and the lighter, more uniformly textured shear crack. SEM, 400× (J.H. Maker, Associated Spring, Barnes Group Inc.)**

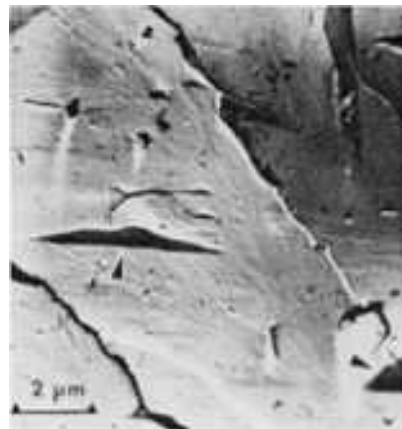
**Fig. 163 Fractograph of cleavage fracture in low-carbon steel shows tongue (arrow) formed by local fracture along twin-matrix interfaces. Tongue formation occurs as a result of the high velocity at which a cleavage crack propagates (it has limiting velocity between 0.4 and 0.5 of the speed of sound). The high-speed crack produces a local strain rate too high for slip processes to provide all the accommodation required; thus, many twins are normally formed just ahead of the moving crack tip. TEM replica, 6500× (I. Le May, Metallurgical Consulting Services Ltd.)**

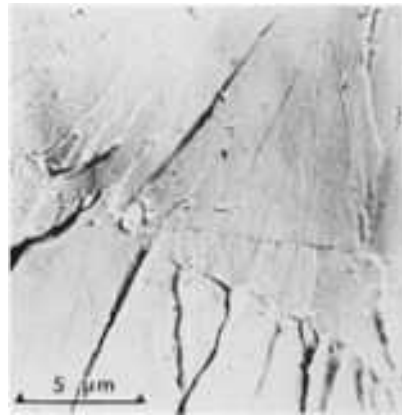
**Fig. 164** River pattern on cleavage fracture surface of low-carbon steel bolt. When a crack crosses a twist boundary, many small parallel cracks may form with cleavage steps between them. These steps run together, forming larger ones and leading to the river patterns characteristic of cleavage fracture in polycrystalline metals. TEM replica, 4000× (I. Le May, Metallurgical Consulting Services Ltd.)
