ASM HANDBOOK®

VOLUME  
12

Fractography

*Fractography*, was published in 1987 as Volume 12 of the *ASM Handbook*. The Volume was prepared under the direction of the ASM Handbook Committee.

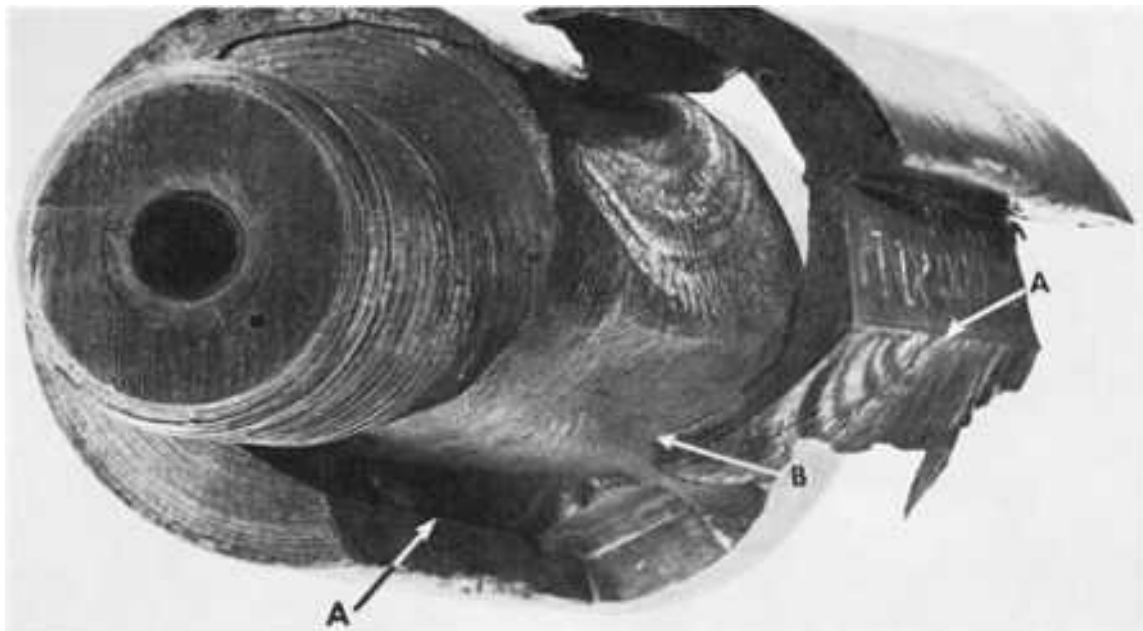
**Fig. 165** Torsional fatigue fracture in an 86-mm ( $3\frac{3}{8}$ -in.) diam keyed tapered shaft of 1030 steel, commonly termed a "peeling" type of fracture. A loose nut had reduced the frictional force on the tapered portion of the shaft, transferring the torsional load to the key. The fatigue crack originated at a corner in the keyway (arrows A) and progressed completely around the shaft in a clockwise circular path, returning beneath the keyway to the location marked by arrow B, where final fracture occurred. 1.2×

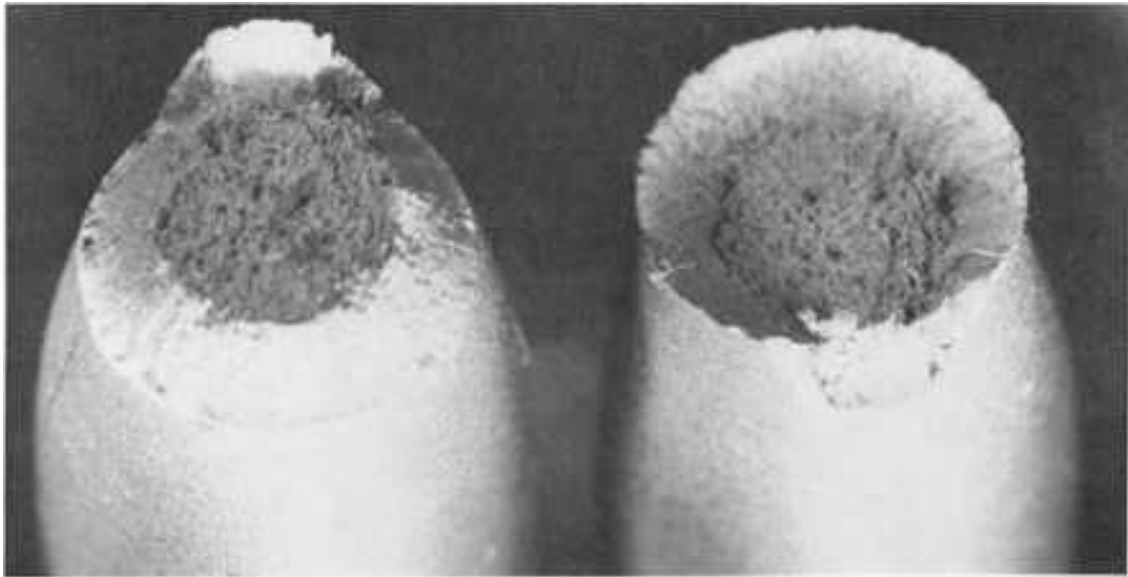
**Fig. 166 "Cup and cone" tensile fracture of cylindrical test specimen is typical for ductile metals; in this case, annealed AISI 1035. Fracture originates near the center of the section with multiple cracks that join and spread outward. When cracks reach a region near the surface, the stress state changes from tension to macroshear, forming a fracture at approximately 45° to the plane of the major fracture--the familiar "shear lip." (D.J. Wulpi, Consultant)**

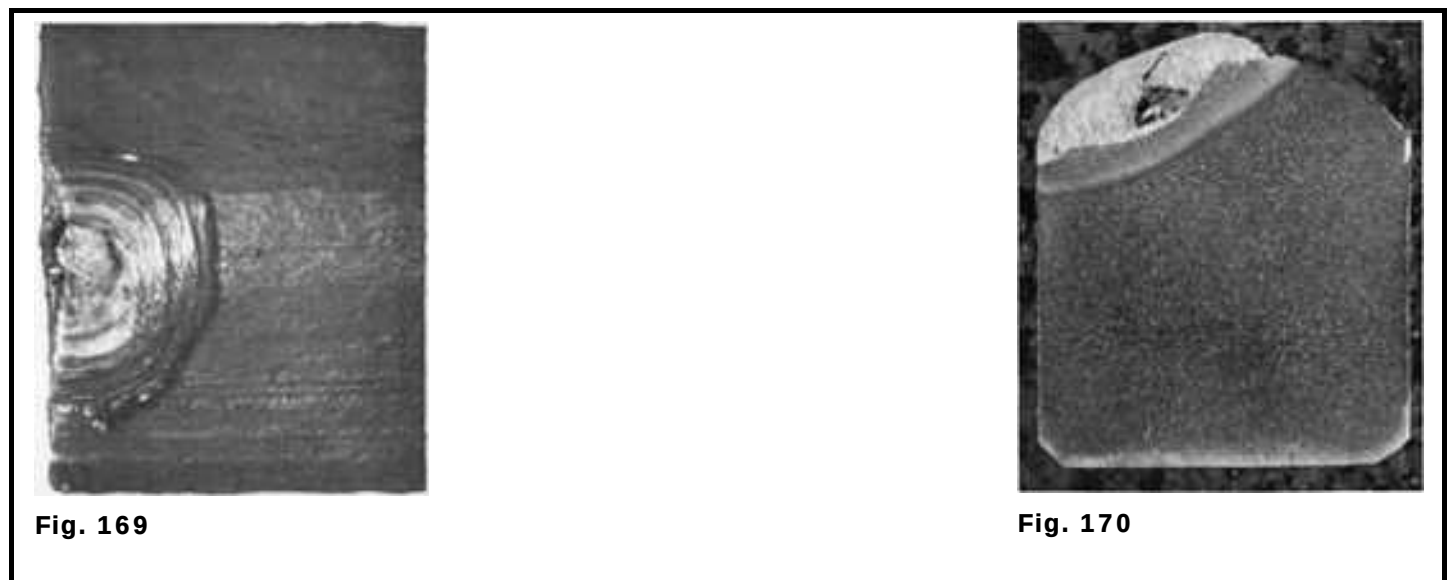
Figure 169 is a view of the weld at arrow in Fig. 167. Note that the fracture (in profile at left) passes through the center of the weld. Figure 170 is a portion of the fracture surface at the weld, after polishing and etching (2% nital). A crack is visible (at arrow) at the tip of the cavity. Hardness was 187 HB in the base metal, 516 HB in the heat-affected zone, and 363 to 534 HB in the weld. Both at 5×

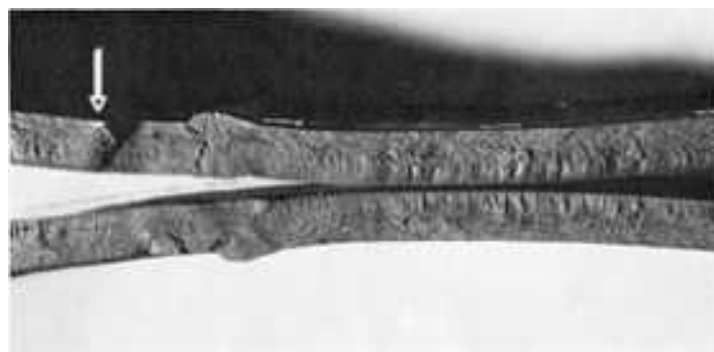
**Fig. 171** Mating surface of a crack in a shell plate of an ASTM A515, grade 70, steel pressure vessel used in dehydration of natural gas. Normally, operating pressure was 1.5 MPa (220 psi) and operating temperature was -12 to +4 °C (10 to 40 °F). The crack was exposed by sectioning after a leak was discovered. See Fig. 172, 173, 174, 175, and 176 for views of the portion near arrow at left. 0.4×

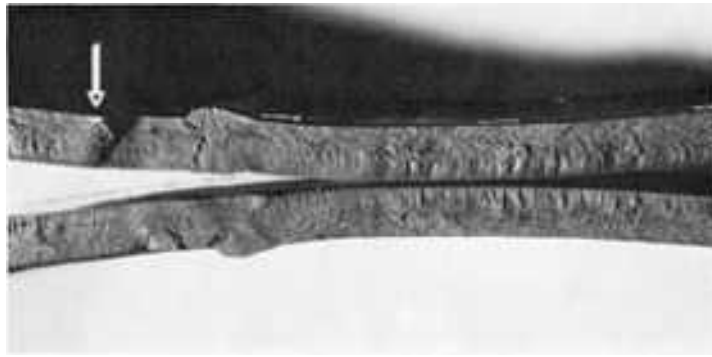
**Fig. 171** Mating surface of a crack in a shell plate of an ASTM A515, grade 70, steel pressure vessel used in dehydration of natural gas. Normally, operating pressure was 1.5 MPa (220 psi) and operating temperature was -12 to +4 °C (10 to 40 °F). The crack was exposed by sectioning after a leak was discovered. See Fig. 172, 173, 174, 175, and 176 for views of the portion near arrow at left. 0.4×

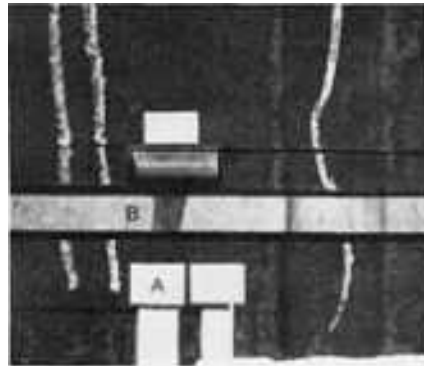
**Fig. 172** Portion of the fracture shell plate in Fig. 171 near arrow. A and B indicate where sections were cut for further study. Fracture surface is shown in profile at bottom. 0.57×

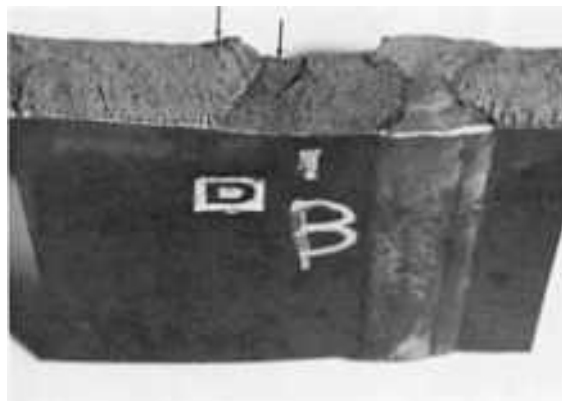
**Fig. 173** Same portion of the shell plate as in Fig. 172, but before sectioning and at a different orientation. The two dark crescents partly visible at top edge of the fracture surface (at arrows) were caused by arc strikes and served as crack nuclei. 0.7×

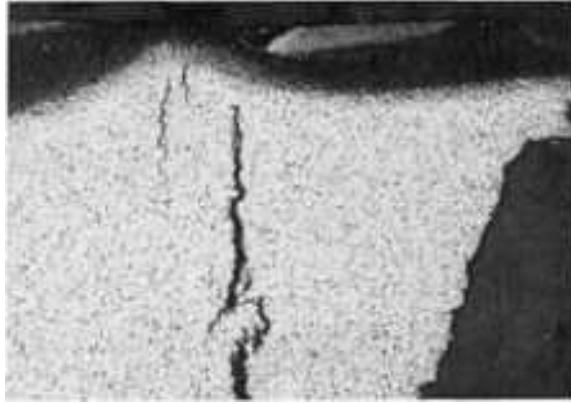
**Fig. 174** Polished and etched section taken from location A in Fig. 172, showing the arc strike visible at the left arrow in Fig. 173. The large cracks present here are extensions of the fracture, which is visible in profile at right. Nital etch, 7×

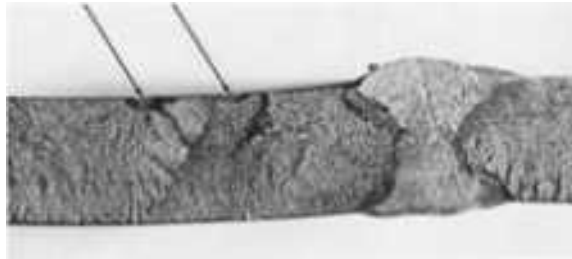
**Fig. 175** Another view of the fracture surface in Fig. 173, displaying clearly the two dark arc-strike crescents that are indicated in both views by arrows at the top edge of the fracture surface. Chevron marks pointing to these crescents (which are the crack nuclei) are visible both here and in Fig. 171. ~0.9×

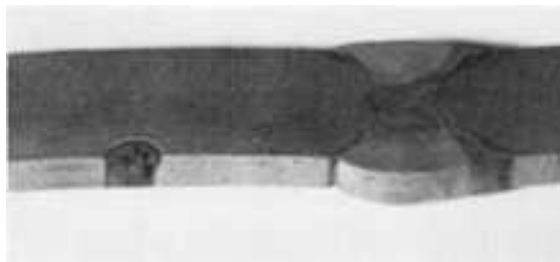
**Fig. 176** Polished and etched shell-plate section marked B in Fig. 172. Note that the smaller arc strike, visible at the arrow at right in Fig. 173 and 175, does not extend this far from the fracture. Note also the surface damage caused by the arc strike, in contrast to the excellent condition of the weld deposit. 0.95×

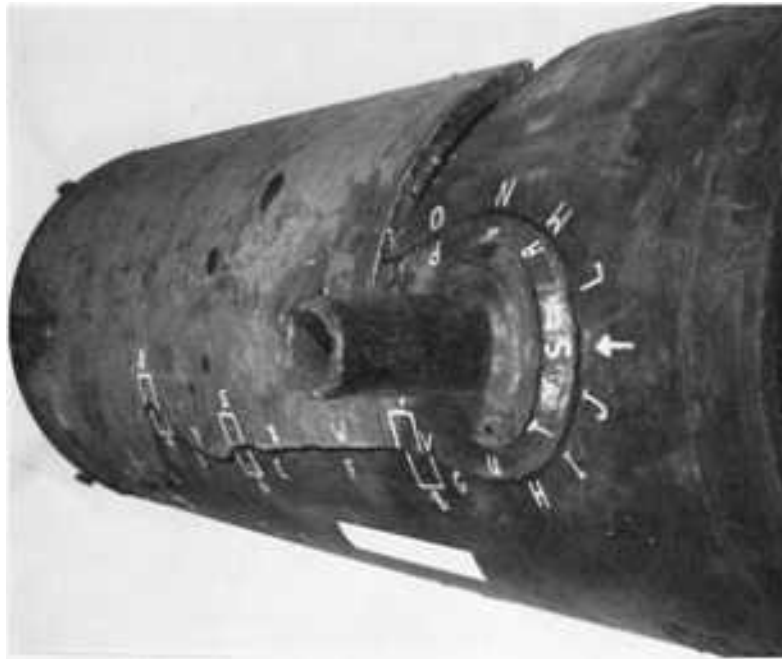
**Fig. 177** Fractured shell of an 865-mm (34-in.) diam pressure vessel fabricated from a 32 by 2440 by 9145 mm ( $1\frac{1}{4}$  by 96 by 360 in.) plate of ASTM A515, grade 70, steel for pressure vessels. The shell broke during testing at an internal gage pressure of 8.3 MPa (1.2 ksi). The fracture, which originated adjacent to a flange (arrow at S), followed a very complex path. See also Fig. 178, 179, 180, 181, 182, 183, 184, 185, and 186. ~0.17x

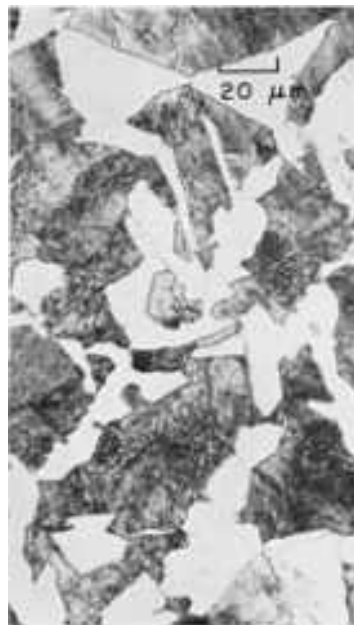
**Fig. 178** Polished and etched section through the shell in Fig. 177, showing an as-rolled microstructure consisting of a mixture of ferrite and fine pearlite, which resulted in a maximum hardness of 86 HRB. Nital etch, 500x

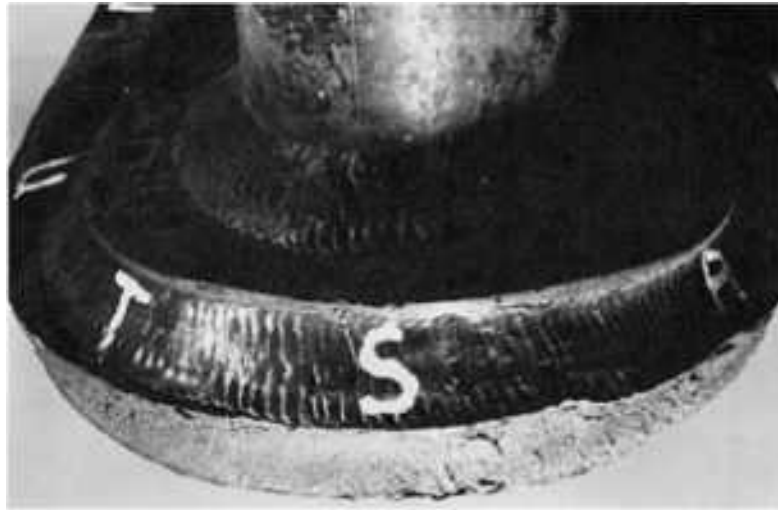
**Fig. 179** View of the flange in Fig. 177, showing an adjacent area of the fracture surface of the pressure-vessel shell. Although not as discernible here as in Fig. 184, chevron marks throughout the fracture surface clearly point toward the area at S, and subsequent examination identified the toe of the flange weld at S as the crack nucleus. ~0.3×

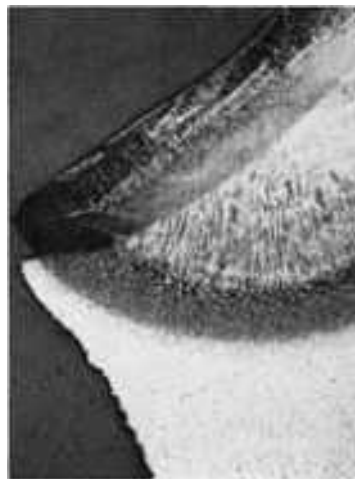
**Fig. 180** Polished and etched section through the toe of the flange weld at S (crack nucleus) in Fig. 179, taken normal to the fracture surface (at left). The toe of the weld had a maximum hardness of 45 HRC. Nital etch, 6×

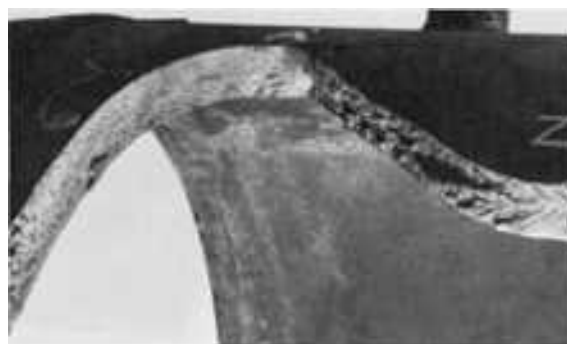
**Fig. 181** View of the far left end of the top segment of the fractured pressure-vessel shell in Fig. 177, showing chevron marks. The chevron marks were smeared subsequent to fracture, but can be clearly identified as

pointing to the right. 0.3×

**Fig. 182** View of the top segment of the fractured pressure-vessel shell in Fig. 177, showing an area just to the right of the area in Fig. 181. Again, chevron marks are visible and consistently point to the right. 0.25×

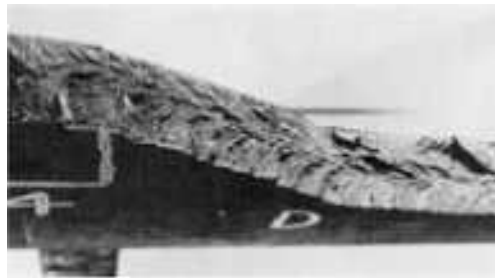
**Fig. 183** View of the bottom segment of the fractured shell in Fig. 177, showing an area opposite the one in Fig. 182. This view also reveals sharply defined chevron marks that point to the right. 0.45×

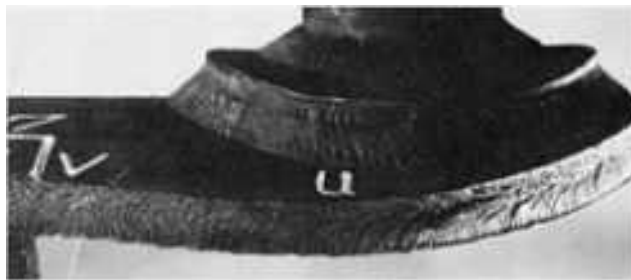
**Fig. 184** View of the top segment of the fractured shell in Fig. 177, showing an area just to the left of the fracture origin. The continuity of the chevron marks that point toward location S (at right end) is much more perceptible here than in Fig. 179 because of a difference in illumination. 0.28×

**Fig. 185** Section through the flange weld in Fig. 179 and 184, taken at the fracture origin and normal to the fracture surface, shown in profile at bottom right (arrow 1). Heat-affected zones (arrows 2) appear as shadows here.  $\sim 0.9\times$

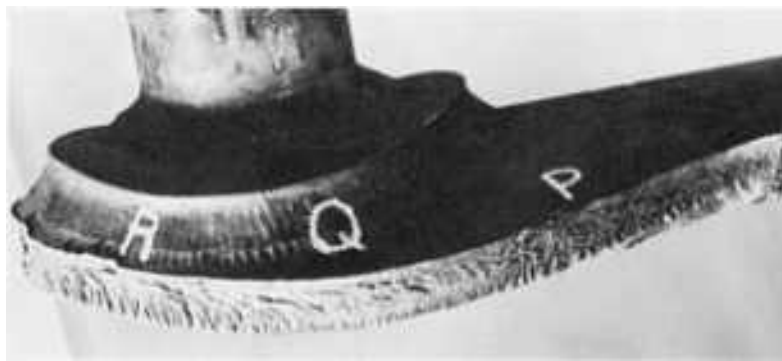
**Fig. 186** View of the top segment of the fractured pressure-vessel shell in Fig. 177, showing an area of the fracture surface just to the right of the crack nucleus. Note that here the chevron marks clearly point to the left, toward the fracture origin. The crack ends at far right, where a section was removed for testing.  $0.28\times$

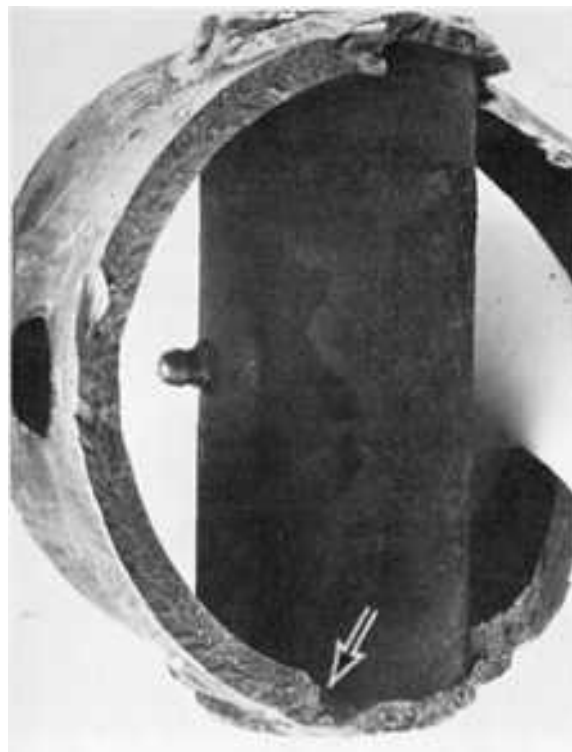
**Fig. 188** Surface of a fatigue fracture in a shaft of medium-carbon steel (composition approximately that of AISI 1035) with a hardness of 143 HB. The fracture occurred under rotating bending. Fatigue cracks began at several locations within a sharp tool mark in a fillet that had an adequate radius and joined around the circumference as they penetrated to the center. 1.13×

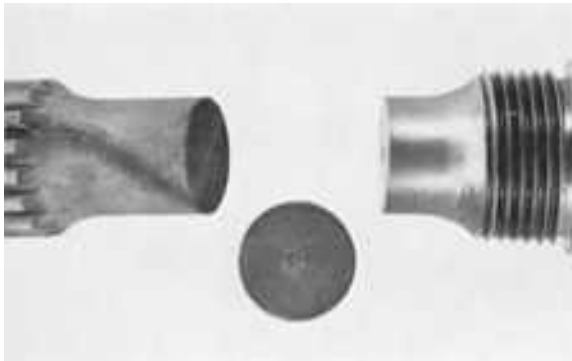
**Fig. 189**

Figure 189 is a view of a drive shaft (actual size shown) of AISI 1035 steel, with a hardness of 34 HRC, that fractured under torsional overload, twisting off in a fashion that produced a surface almost as flat as if it had been machined. The threaded portion, at right, contains a fracture surface. A thin slice containing the mating fracture surface was cut from the portion at left; this slice is shown at center, with the fracture surface up. Shaft portion at left, including cut fracture surface, was hot etched in equal parts of hydrochloric acid and water to reveal deformation flow and forging flash lines. The plastic deformation is characteristic of torsional overload in ductile metals and is not typical of rotating fatigue. Figure 190 is a higher-magnification view (2×) of the threaded portion of the fractured drive shaft in Fig. 189 and the mating surface of the fracture.

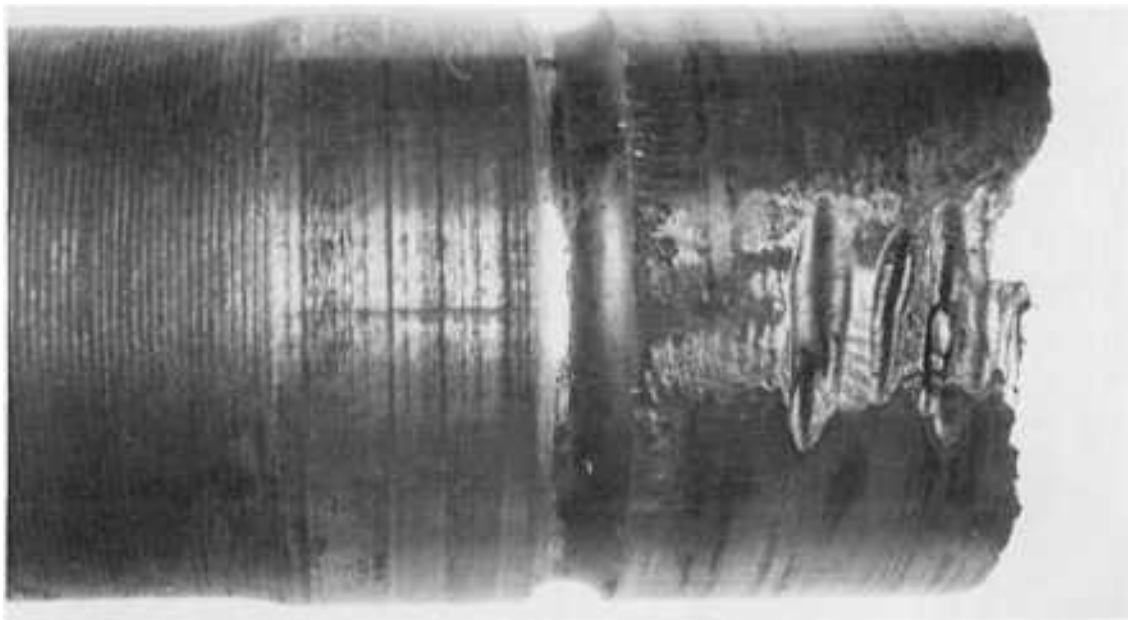
**Fig. 192**

Fatigue fracture of automotive axle shaft due to improper wheel bearing removal. Material: modified AISI 1038. Heat treatment: induction hardened and tempered to a surface hardness of 50 to 58 HRC. Replacement of a press-fit wheel bearing was accomplished with the aid of a cutting torch. Fatigue failure initiated in subsequent service at one of the pitlike defects created by the intense flame of the torch. Fig. 191: Fracture surface of axle shaft. Note extend of fatigue and relatively small final fracture area, indicating that operating loads were normal. Fig. 192: Axle surface with bearing removed (edge of fracture surface at right). Visible are several of the burn/melt defects caused by use of a cutting torch to assist in bearing removal. The procedure is not recommended. (Z. Flanders, Packer

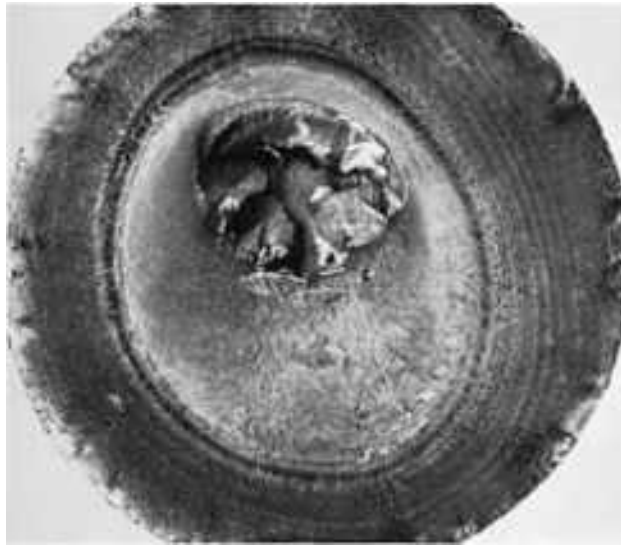
**Fig. 193** Surface of a fatigue fracture in a shaft of AISI 1040 steel with a hardness of approximately 30 HRC. The shaft was fractured when subjected to rotating bending. The oval shape of the central region of final fast fracture indicates that two mutually perpendicular, unequal bending stresses were present. The ratchet marks around the perimeter of the shaft indicate that fracture began at several points. 1.63×

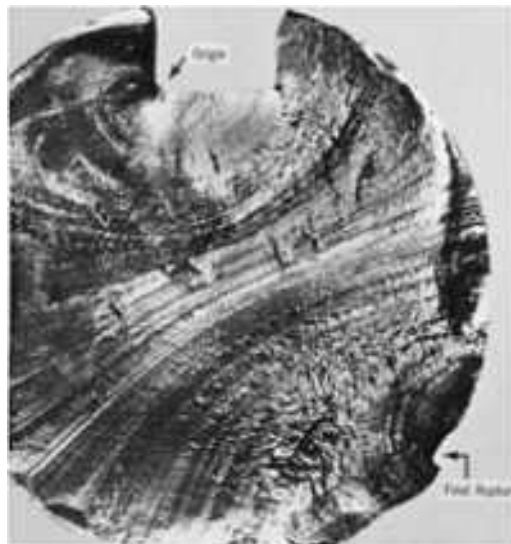
**Fig. 194** Fatigue-fracture surface of a keyed shaft of AISI 1040 steel (~30 HRC). The fatigue crack originated at the left bottom corner of the keyway and extended almost through the entire cross section before final fast rupture occurred. Beach marks are visible; these swing counterclockwise because the direction of rotation was clockwise. 1.88×

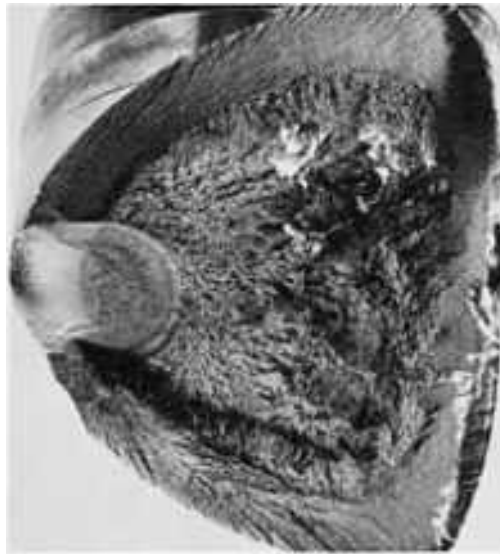
**Fig. 195** Surface of a fatigue fracture in an induction-hardened axle of AISI 1041 steel with a hardness of 46 HRC in the hardened zone. The fatigue crack originated at a fillet (with a radius smaller than specified) at a change in shaft diameter near a keyway runout. Note the two sets of chevron marks along the hardened perimeter, each set pointing to the crack origin at left. Actual size

**Fig. 196** Surface of a bending-plus-torsional-fatigue fracture in an experimental 89-mm ( $3\frac{1}{2}$ -in.) diam tractor axle of AISI 1041 steel that had been induction hardened. Fracture occurred after 1212 h on an endurance-test track. Note beach marks fanning out from the fatigue-crack origin (slightly to left of center, at top). Beyond the beach marks, cracking progressed by fast fracture along the hardened perimeter, producing two sets of chevron marks pointing toward the crack origin (like the chevron marks in Fig. 195). See also Fig. 197. 1.25×

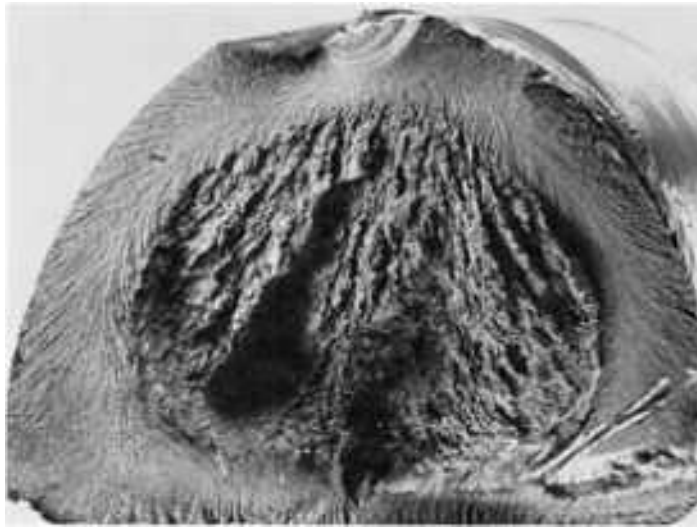
**Fig. 197** Surface of a torsional-fatigue fracture in an induction-hardened AISI 1041 steel experimental tractor axle same as in Fig. 196. Hardness in the hardened zone was 50 HRC at 11 to 12 mm ( $\frac{7}{16}$  to  $\frac{15}{32}$  in.) beneath the axle surface at the crack origin. This axle fractured after 450 h of endurance testing. In this axle, as in the axle in Fig. 196, crack origin is near top, at a sharp corner of a keyway runout. 1.25×

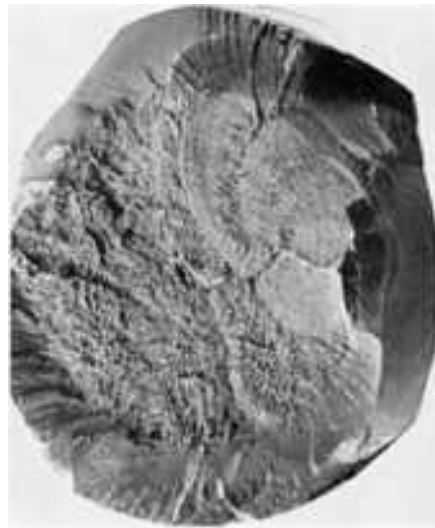
**Fig. 198** Surface of a fatigue fracture in a truck axle of AISI 1041 steel induction hardened to 55 HRC. The axle broke after 490 h of service. Crack origin was subsurface, near a keyway. Note that fatigue crack progressed in steps. Actual size.

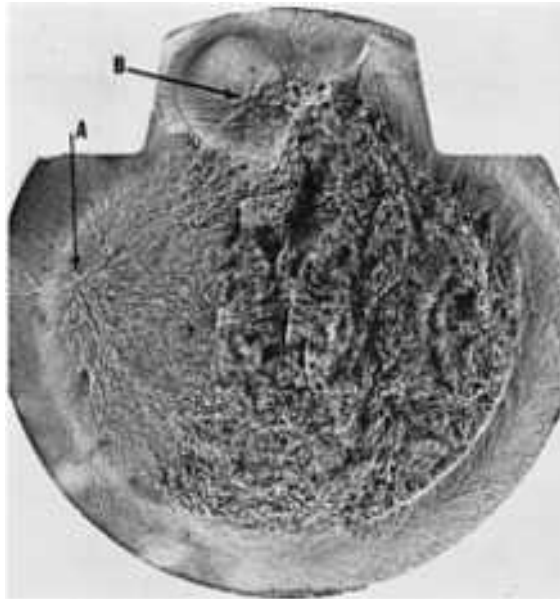
**Fig. 199 Fatigue fracture in an AISI 1041 steel axle induction hardened to 50 HRC and tested in rotating bending. Two cracks are evident; one began at A and progressed around most of the perimeter by fatigue, then by fast fracture, before meeting a smaller crack, which began by fatigue at B. Chevron marks in hardened zone point to both origins. 1.2×**

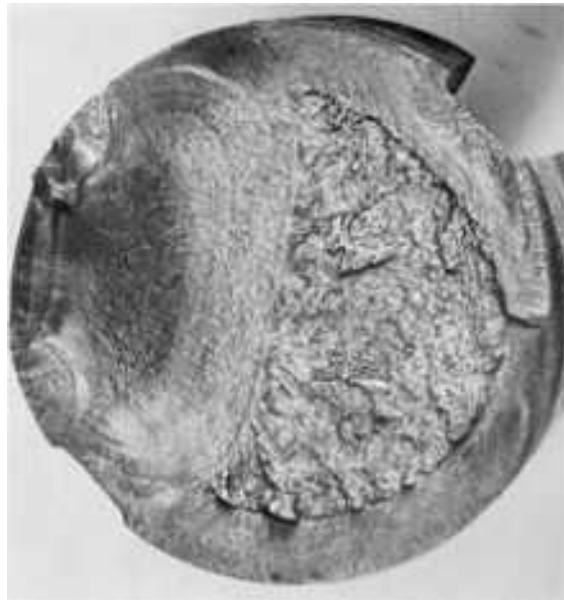
**Fig. 200 Surface of a fatigue fracture in a keyed axle of AISI 1041 steel induction hardened to 50 HRC. An accidental arc strike on the axle surface, at left, initiated a fatigue crack, which grew about halfway through the cross section before fast fracture occurred in the hardened zone; fast fracture progressed from both sides of the fatigue crack, as shown by chevron marks. 1.3×**

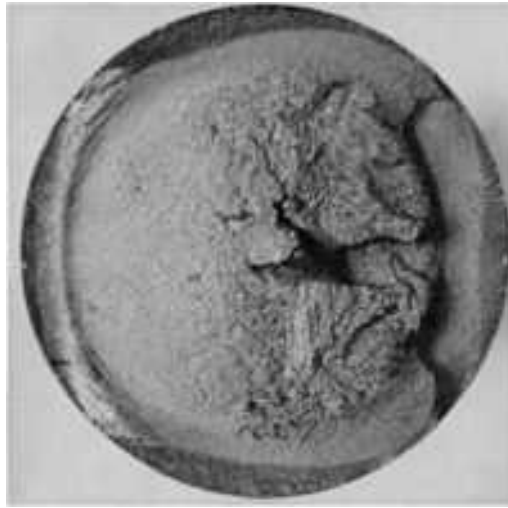
**Fig. 201 Fatigue-fracture surface of a case-hardened AISI 1039 steel shaft. Case hardness, 50 HRC; core, 19 HRC. Note that fracture of the case was nearly complete before the fatigue cracks penetrated into the core. 2×**

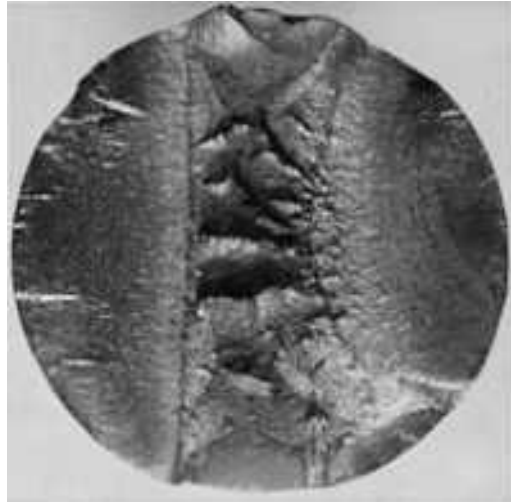
**Fig. 202 Surface of a fatigue fracture in a shaft of AISI 1041 steel with a hardness of 302 HB. The shaft was broken by reversed stressing. Note the two fatigue-crack origins at right edge and the third origin at left. 2×**

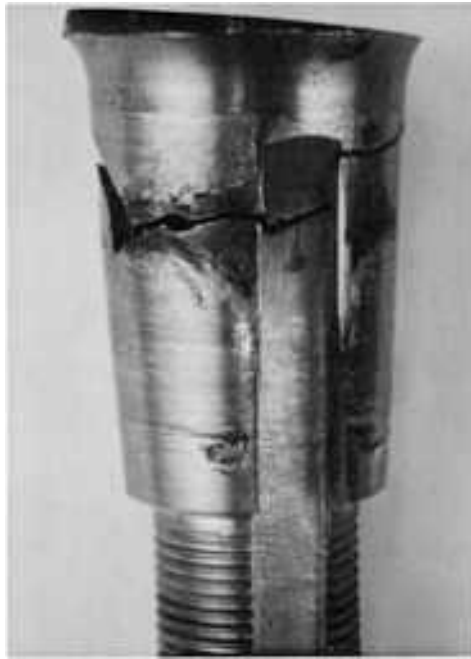
**Fig. 203 View of a broken keyed spindle of AISI 1041 steel with a hardness of 333 HB. A large amount of fretting is visible on both sides of the fracture. Note that the radius of the keyway edge seems small near the fracture. See also Fig. 204. 1.5×**

**Fig. 204 Surface of the fracture in Fig. 203. Note that the radii of the keyway edges have acted as origins for fatigue cracks. A second fatigue zone is visible on the side opposite the keyway. The region between the fatigue zones underwent fast fracture. 2×**

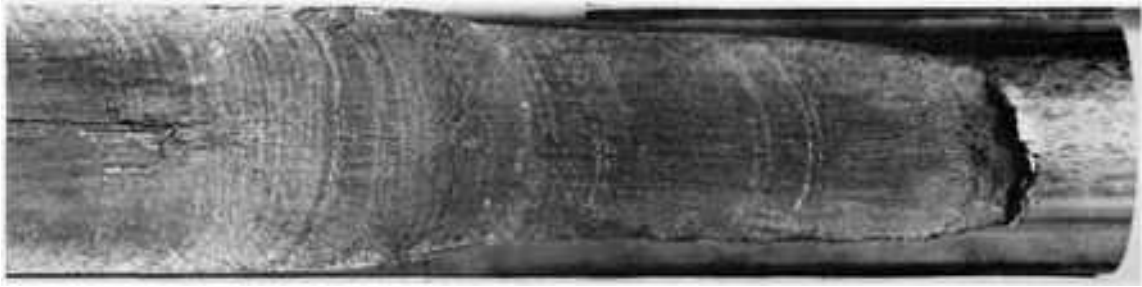
**Fig. 205** Fatigue-fracture surface of the shaft of a forging hammer of AISI 1144 steel containing 0.45% C, 1.60% Mn, and 0.28% S. The fatigue crack began at a heavily abraded surface area (out of view to the left), penetrated to the center of the shaft, then turned 90° and propagated longitudinally to the point of termination at right (about 635 mm, or 25 in.). See also Fig. 206. ~0.5×

**Fig. 206** Mating fracture surface to the one shown in Fig. 205. This piece of the shaft broke away during service. It is believed that the crack propagated a long distance in the longitudinal direction because of weaknesses associated with the presence of longitudinal bands of elongated manganese sulfide inclusions. ~0.5×

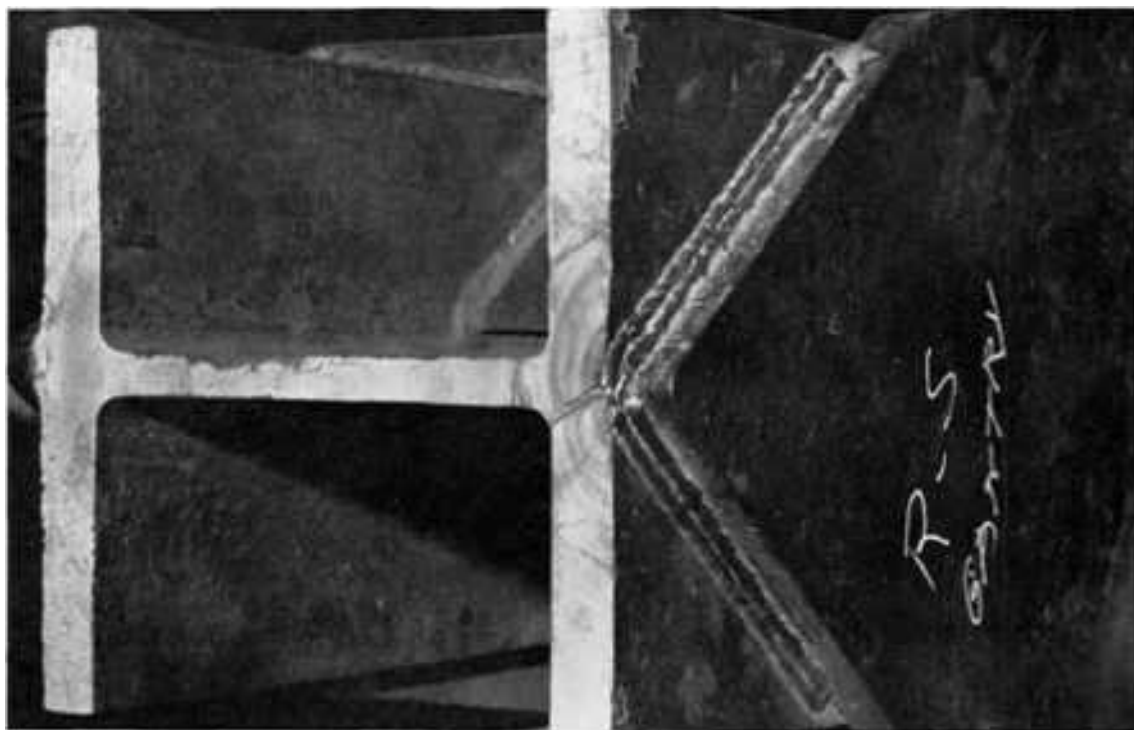
**Fig. 207** Surface of a fatigue fracture in a medium-carbon steel I-beam, with a flange 400 by 400 by 40 mm

( $15\frac{3}{4}$  by  $15\frac{3}{4}$  by  $1\frac{9}{16}$  in.) and a 25-mm (1-in.) thick web, that was part of a dragline-excavator A-frame. Each flange of the I-beam was reinforced by a plate (such as that at right) joined by a double-pass weld. There are two fatigue-crack nuclei, separated by a cleavage step, at the toe of the weld at the outer edge of the flange at right. See also Fig. 208, 209, and 210. 0.3×

**Fig. 208** Another view of the fatigue-fracture surface of the medium-carbon steel I-beam in Fig. 207. The fracture origins are clearly evident in the flange at bottom, where two nuclei are situated at the toe of the weld joining a reinforcement plate to the flange. It is remarkable that the fatigue crack penetrated the entire flange at bottom, the entire web, and part of the flange at top before final fast fracture occurred. See also Fig. 209 and 210. 0.5×

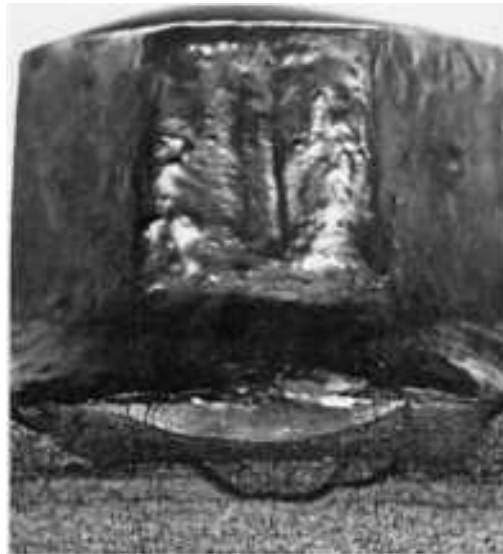
**Fig. 209** View of the weld joining the flange and reinforcement plate at top in Fig. 208, showing a crack at the toe of the weld. This crack was present before the fatigue crack, which led to fracture, formed at the toe of the weld in the other flange. See also Fig. 210. 2×

**Fig. 210** Polished and etched section through the weld in Fig. 209, at a position just to the left of the area shown there. Like that in Fig. 209, the crack shown here was present prior to formation of the fatigue crack in the opposing flange. The weld metal (light) is at upper left. 2% nital etch, 100×

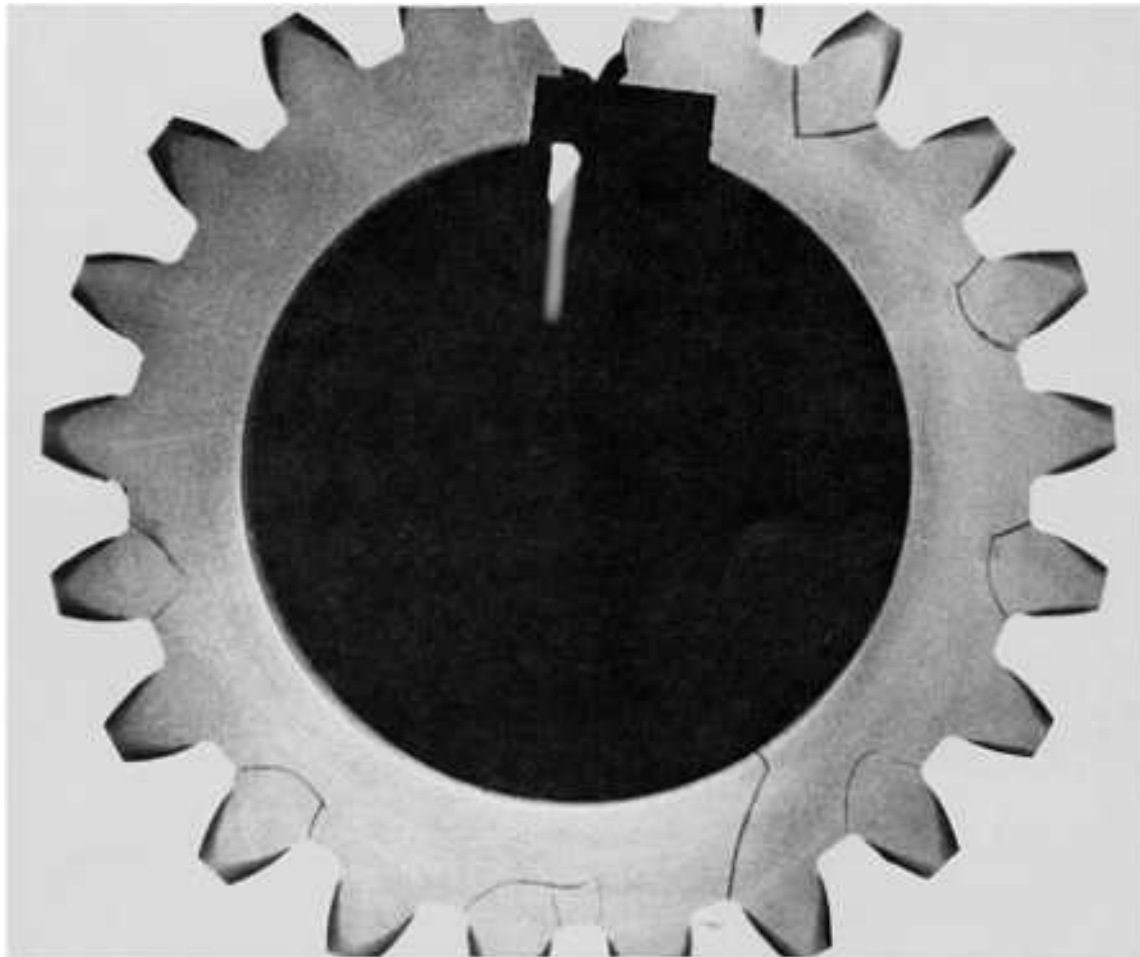
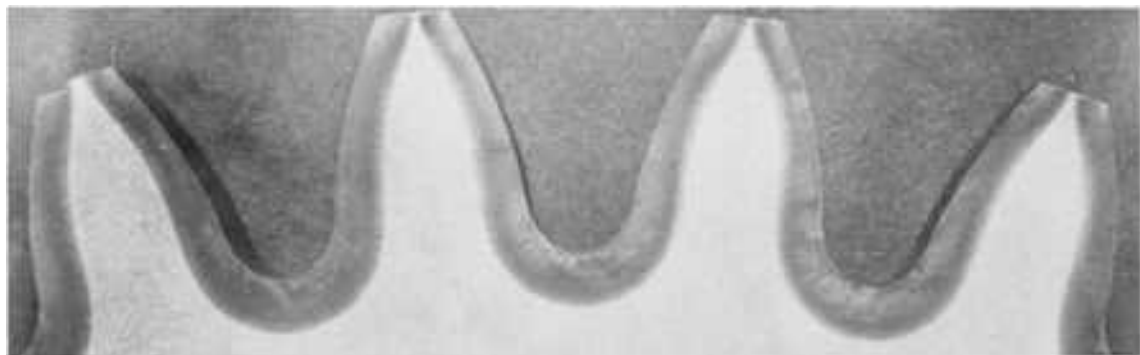
**Fig. 211**

Figure 211 is a polished and etched cross section of a partially flame-hardened crane gear of AISI 1045 steel in which fatigue cracks formed at the roots of many teeth after one year of service. The cracks have been sharply delineated by etching. Note that hardening did not extend even to the root fillet of any tooth. Figure 212 is a polished and etched cross section of a portion of a gear that was subjected to full-contour flame hardening; note the better tooth form, with fully radiused tooth roots. Both etched

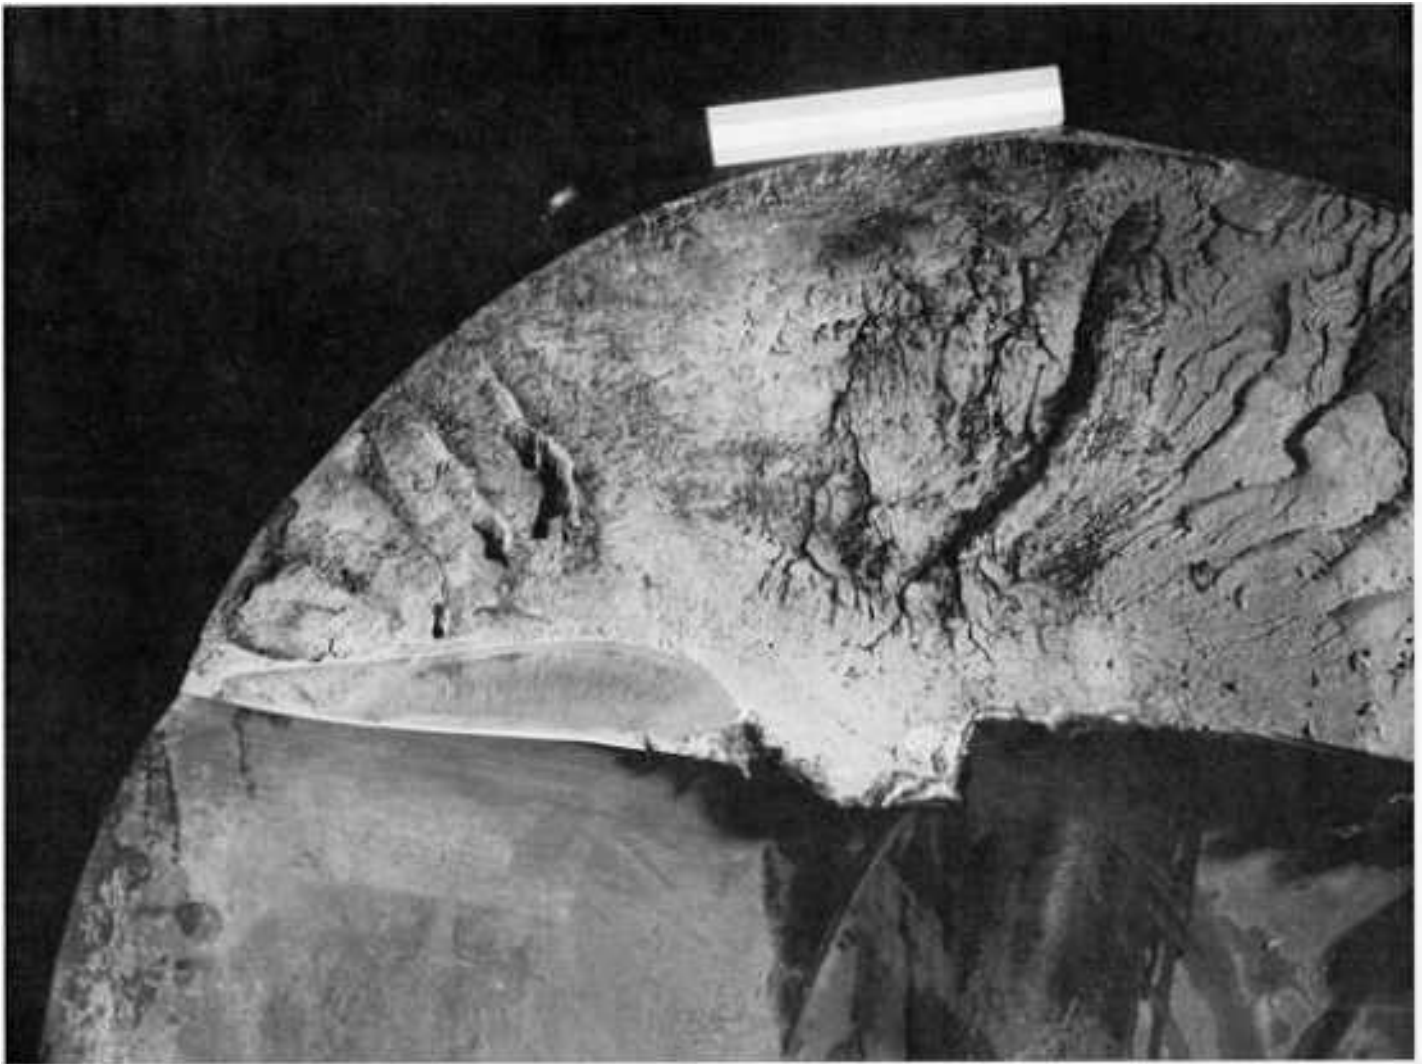
**Fig. 213** Fracture surface in the jaw end of a blooming-mill spindle of forged AISI 1045 steel. This spindle was 8.2 m (27 ft) long, 890 mm (35 in.) in diameter at the jaw end, and 1065 mm (42 in.) in diameter at the drive end. The white 6-in. rule at top indicates the massive size of the spindle. After the spindle had been normalized, the inner surface of the jaw was flame hardened. The fracture originated at the jaw surface, at the lower edge of the fatigue zone (left of center). See also Fig. 214. 0.4×

**Fig. 214** Enlarged view of the fatigue zone of the AISI 1045 steel blooming-mill spindle fracture shown in Fig. 213. Note the radial marks originating at the surface of the jaw. A few beach marks are faintly visible at the top edge of the fatigue zone. Note the sharpness of the terminating edge of the fatigue zone at the transition to final fast fracture. Note also the tongues of metal near the rule in the zone of final fast fracture. 0.83×

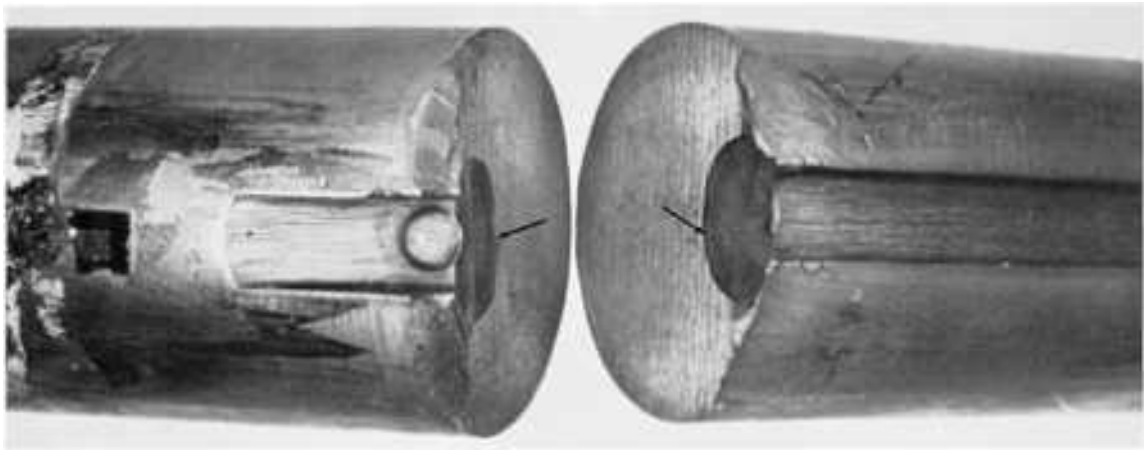
**Fig. 215** View of the mating surfaces of a fatigue crack (dark areas) exposed by sectioning an AISI 1045 steel shaft quenched and tempered to a hardness of approximately 40 HRC. The crack, which was discovered before it could penetrate the entire cross section of the shaft, originated at a weld deposit that served as a stop in a

keyway. 1.7×

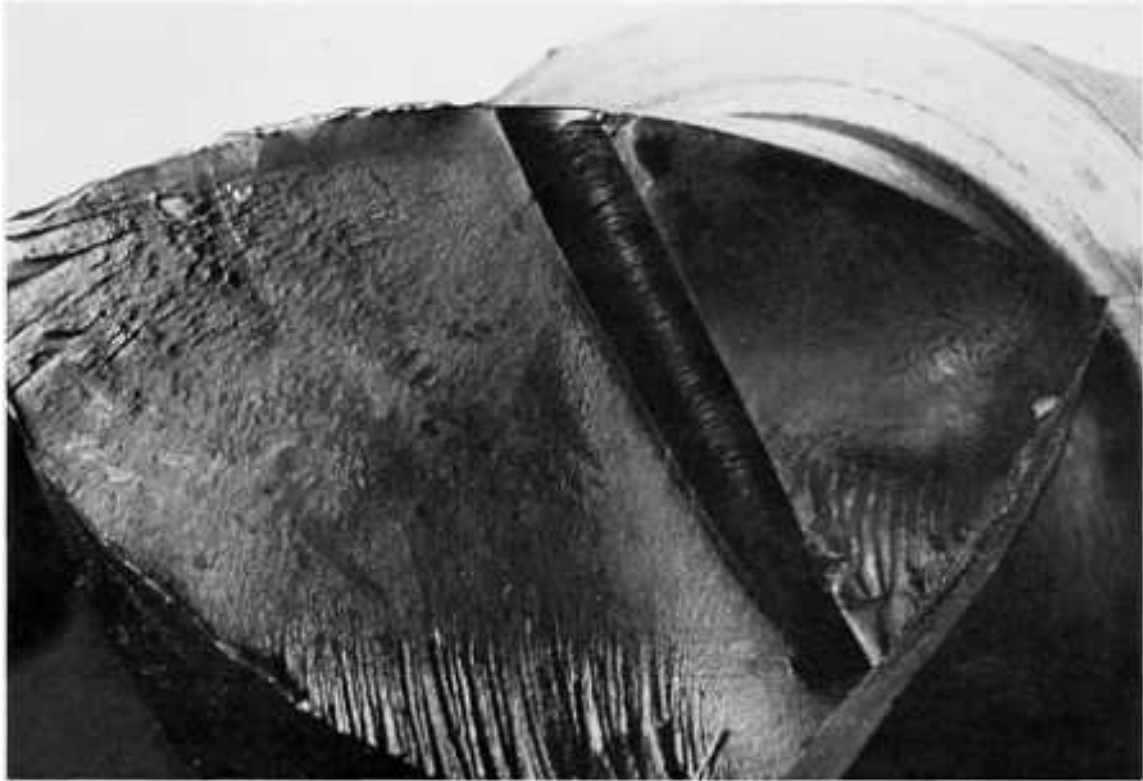
**Fig. 216 Surface of a torsional-fatigue fracture in an AISI 1045 steel crankshaft induction hardened to 55 HRC. The crack originated at the edge of an oil hole. Although it is not clearly evident in this view, the crack grew at a 45° angle to the axis of the crankshaft because of tensile-stress components caused by the torsional loading. 2.5×**

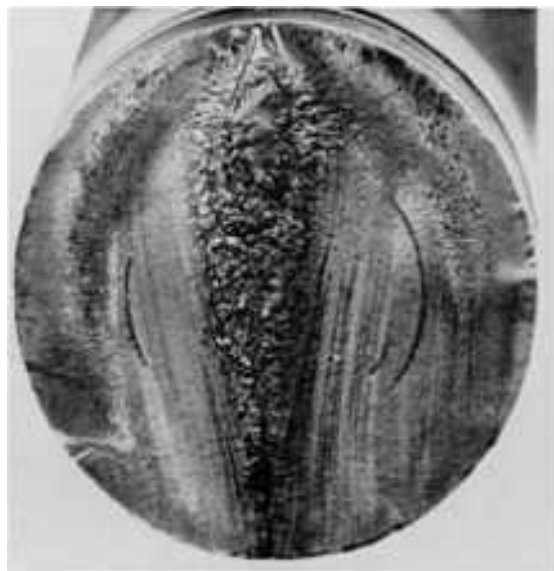
**Fig. 217 Reversed bending fatigue of a 40-mm (1.6-in.) diam AISI 1046 steel shaft (30 HRC). Note the symmetrical fatigue pattern of beachmarks on each side, with the final rupture on the diameter. This indicates that each side of the shaft was subjected to the same maximum stress and to the same number of load applications. (D.J. Wulpi, Consultant)**

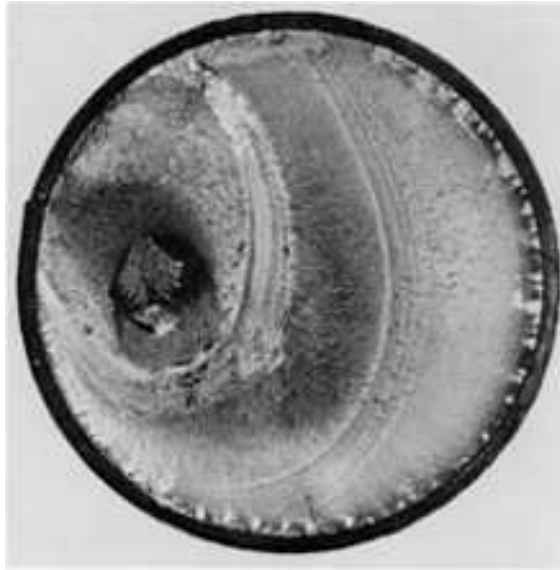
**Fig. 218** Fatigue-fracture surface of an AISI 1050 shaft (35 HRC) subjected to rotating bending. Numerous ratchet marks (small shiny areas at surface) indicate that fatigue cracks were initiated at many locations along a sharp snap-ring groove. The eccentric pattern of oval beachmarks indicates that the load on the shaft was not balanced. The final rupture area is near the left (low stress) side, where there may have been no fatigue action. (D.J. Wulpi, Consultant)

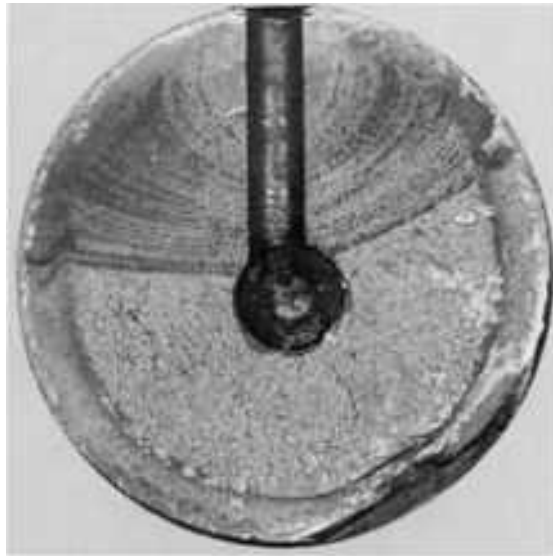
**Fig. 219** Fractograph of fatigue failure in SAE 1050 pin, induction hardened to a depth of 5 mm ( $\frac{3}{16}$  in.) and surface hardness of 55 HRC. Core hardness: 21 HRC. Fatigue initiated inside the grease hole at the metallurgical notch created by the very sharp case-core hardness gradient. 1.8× (K. Marden, California Polytechnic State University)

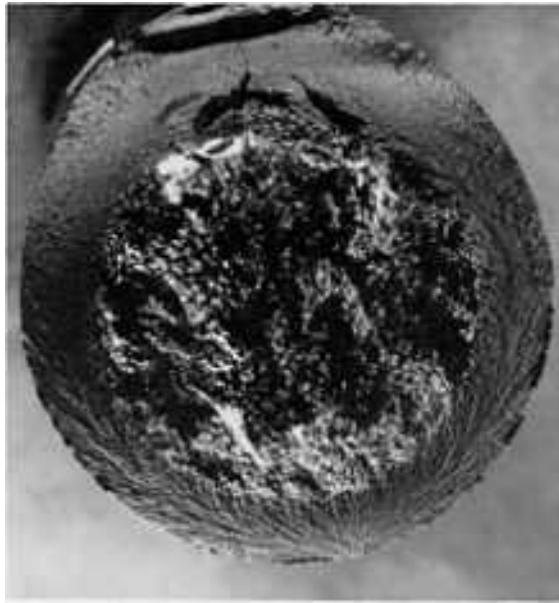
**Fig. 220 Fracture surface of the modified SAE 1050 axle shaft shown in Fig. 221. Note chevrons pointing to fracture origin in the fine structured case. See also Fig. 222, 223, 224, 225, 226, and 227. 2.75×**
