ASM HANDBOOK®

VOLUME  
12

Fractography

*Fractography*, was published in 1987 as Volume 12 of the *ASM Handbook*. The Volume was prepared under the direction of the ASM Handbook Committee.

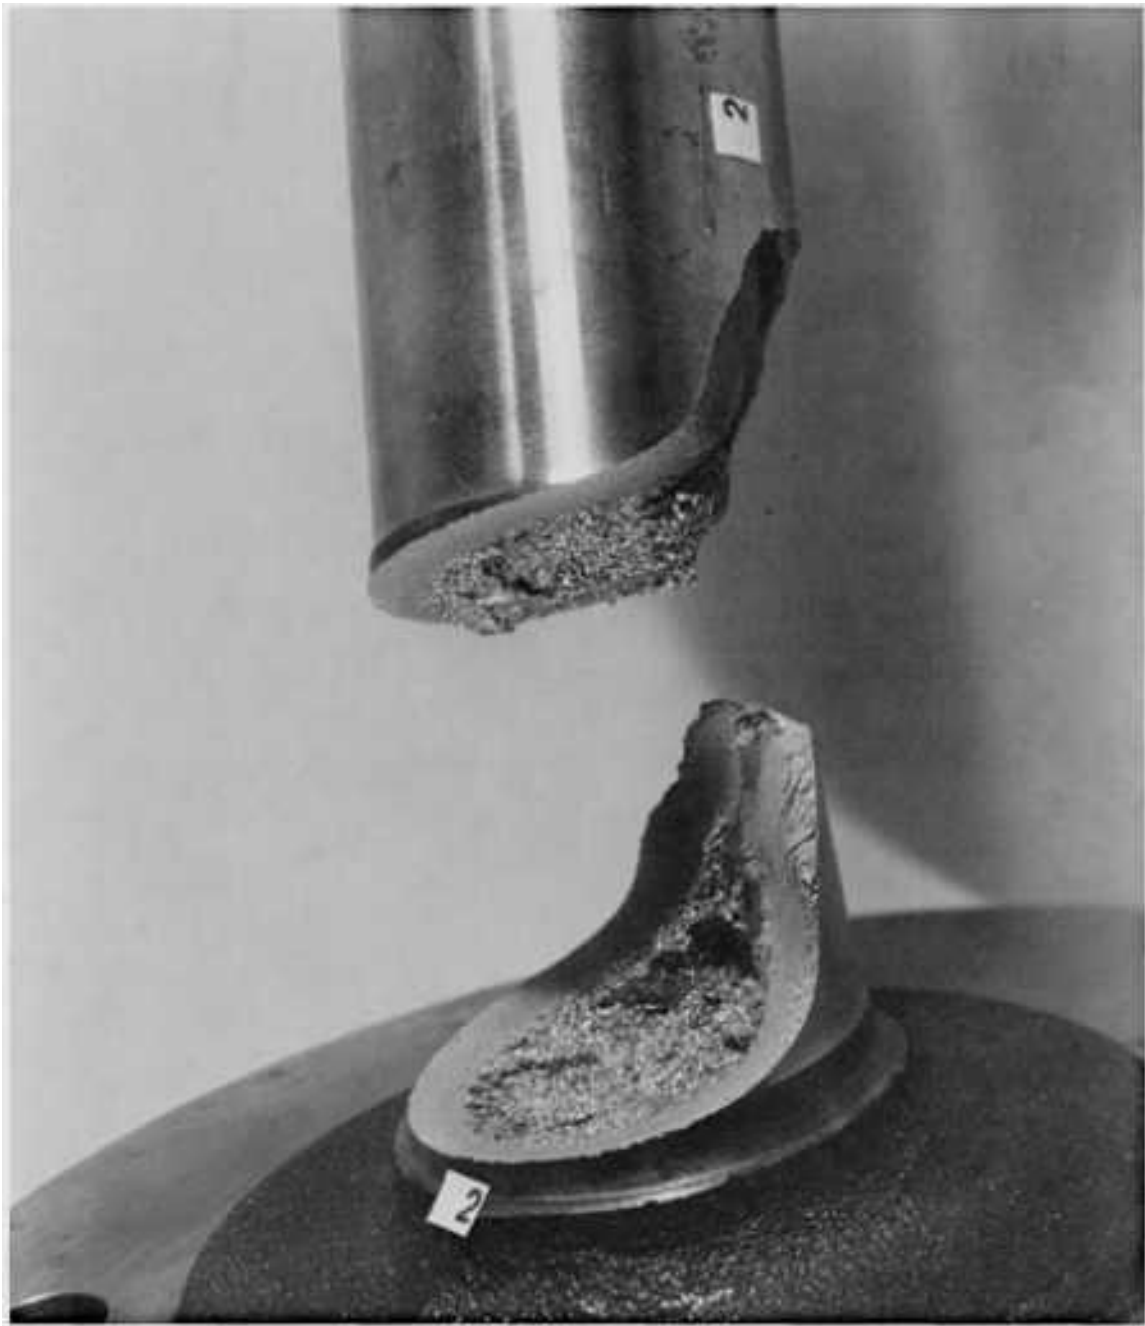
**Fig. 221 Brittle fracture of a modified SAE 1050 axle shaft due to single bending impact load. Steel nominal composition: 0.50% C, 0.95% Mn, 0.25% Si, 0.01% S, and 0.01% P. The hot-rolled and upset shaft had an induction-hardened martensitic case (60 HRC) and a pearlite-ferrite core (20 HRC). Failure occurred at the flange end. Part was broken in the laboratory. Shown in this fractograph are the fracture surfaces, including a compression chip. See also Fig. 220, 222, 223, 224, 225, 226, and 227. Actual size (General Motors Research Laboratories)**

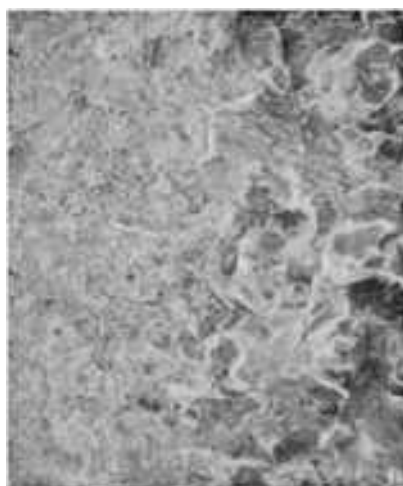
**Fig. 225**

Fractographs of core structure on shaft side of axle failure in Fig. 220 and 221. Fig. 225: Case-core transition zone. SEM, 50×. Fig. 226 (Core structure at transition zone (see Fig. 225) showing primarily cleavage fracture. SEM, 1000×. Fig. 227: Same as Fig. 226, but at higher magnification. SEM, 2000× (General Motors Research Laboratories)

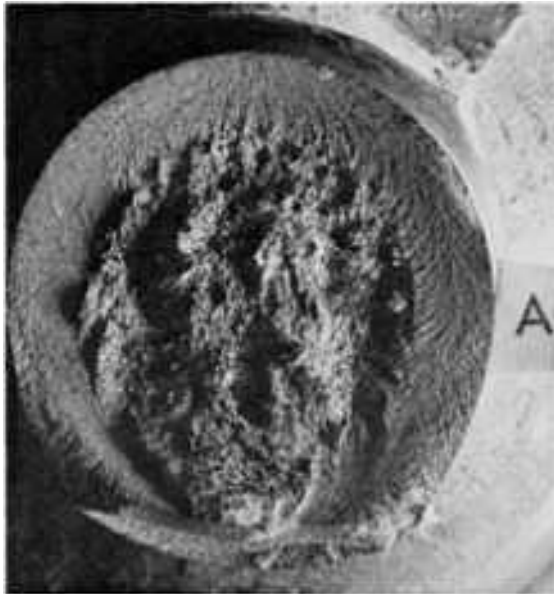
**Fig. 228**

Classic bending overload fracture of automotive axle shaft (direct-on bearing design). Material and heat treatment: modified AISI 1050, induction hardened and tempered to 60 HRC at the bearing diameter. The part was broken in the laboratory. Fig. 228: Fracture surface with chevrons in case-hardened zone pointing to single origin at top. Fine- and coarse-grained structures in case and core regions, respectively, indicate that heat treatment was properly performed. Fig. 229: Side view of fractured axle shaft in Fig. 228. (Z. Flanders, Packer Engineering Associates, Inc.)

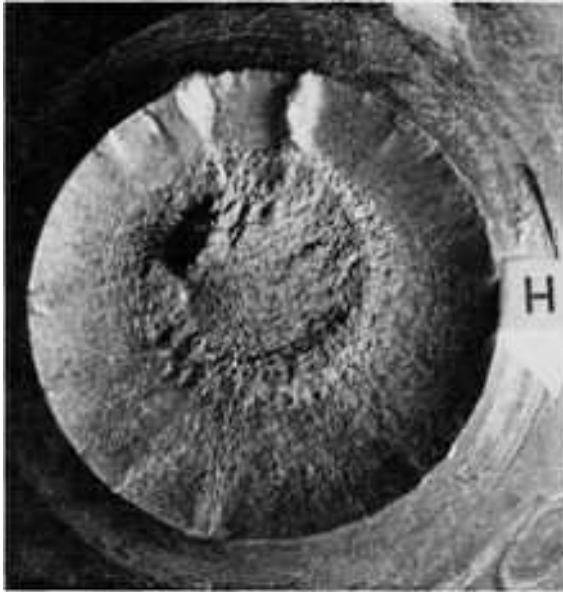
**Fig. 230**

**In-service rotary bending fatigue fracture of automotive axle shaft (direct-on bearing design) due to improper heat treatment. The modified AISI 1050 part was induction hardened and tempered to 60 HRC min at the bearing diameter. However, the hardened zone did not extend into the flange fillet radius. Fig. 230: Fracture surface. Note ratchet marks at several locations around circumference indicating multiple fatigue origins. Fig. 231: Side view of axle shaft in Fig. 230. (Z. Flanders, Packer**

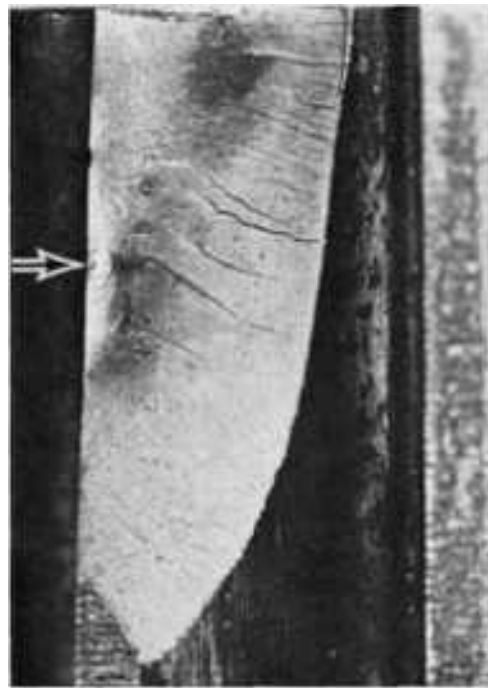
**Fig. 232 Surface of a fatigue fracture in a tooth of an AISI 1050 steel gear with a hardness of 55 HRC. The fatigue crack originated at a forging defect (at arrow). Fatigue beach marks are visible near the fatigue-crack origin. Beyond these marks are the steps of a river pattern, caused by cleavage.  $\sim 2.5\times$**

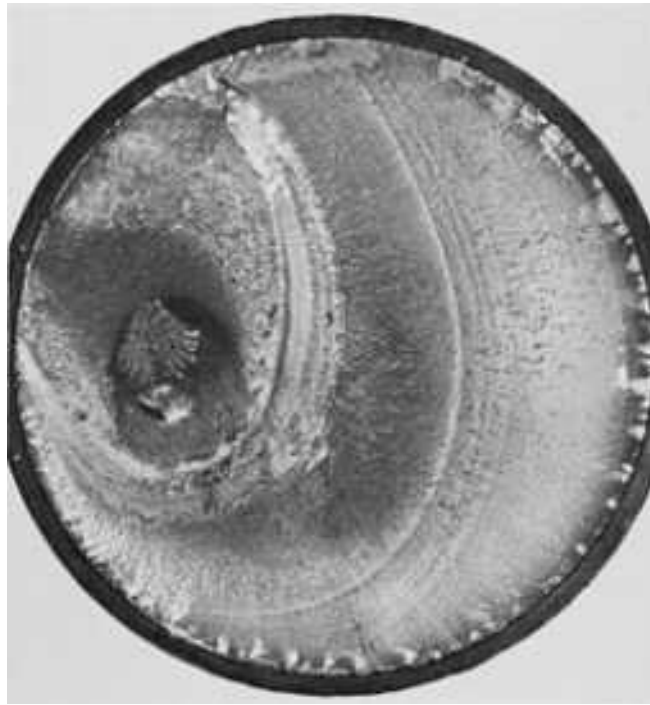
**Fig. 233** Surface of a fatigue fracture in an AISI 1050 steel shaft, with a hardness of about 35 HRC, that was subjected to rotating bending, showing ratchet marks indicating that fatigue cracks were initiated at many locations along a sharp snap-ring groove. An eccentric pattern of oval beach marks is visible, the presence of which suggests an imbalance in loading.  $\sim 2.4\times$

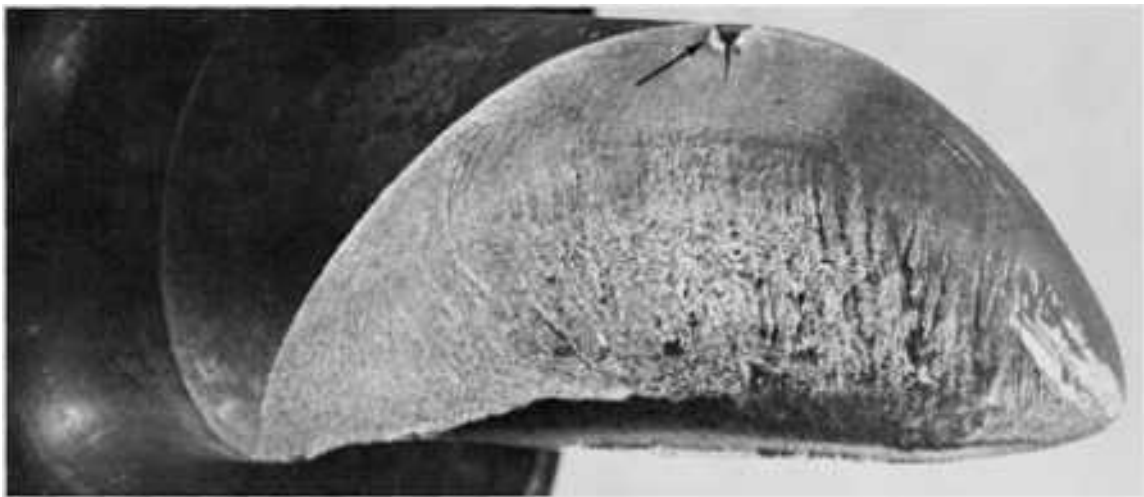
**Fig. 234** Surface of a fatigue fracture in a full-floating axle of an AISI 1050 steel induction hardened to about 50 HRC. The axle was tested in reversed torsion. The arrow indicates the origin of the fatigue crack, which grew by shear fatigue to the small, circular beach mark. Subsequent crack growth was by tension fatigue until final fracture (brittle tensile) occurred under a single torsional load.  $\sim 2\times$

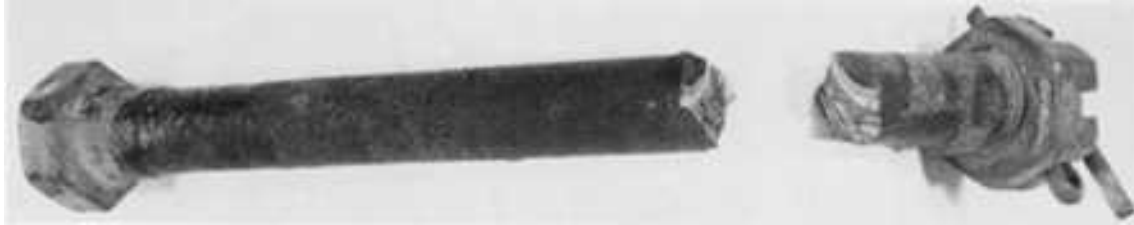
**Fig. 235**

Fatigue failure of a heat-treated automotive bolt (30 HRC). The medium-carbon steel part had been slightly bent prior to onset of fatigue. Fig. 235: Fractured bolt. 0.9 $\times$ . Fig. 236 and 237: Matching fracture faces. 3 $\times$  (General Motors Research Laboratories)

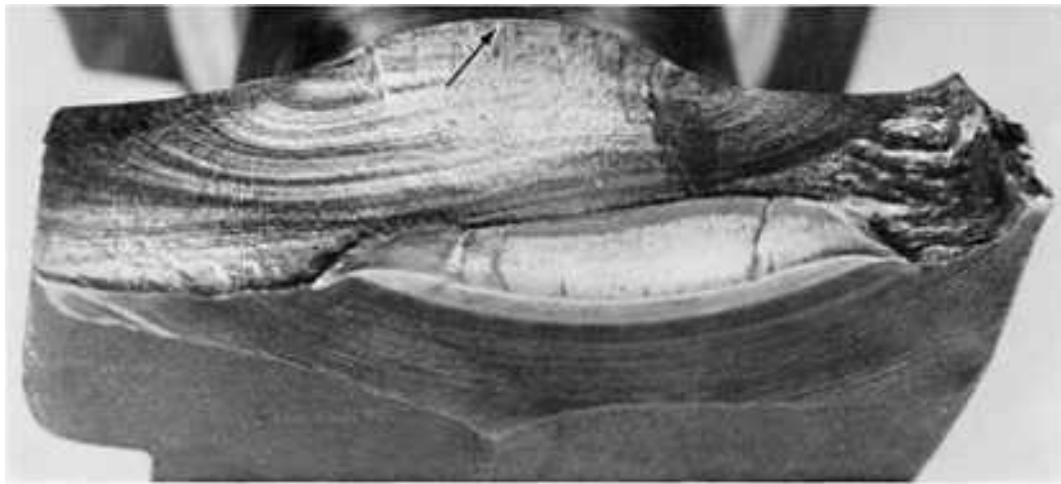
**Fig. 238** Surface of a fatigue fracture in a crankshaft of AISI 1046 steel with a hardness of 25 HRC in the region of fracture. Two cracks were generated under a bending stress; one crack started in the journal fillet at the arrow and progressed through the cheek until it met the second crack, which began in the fillet on the opposite side of the cheek. Note the sharply defined beach marks in the upper portion of the fracture surface. ~0.75 $\times$

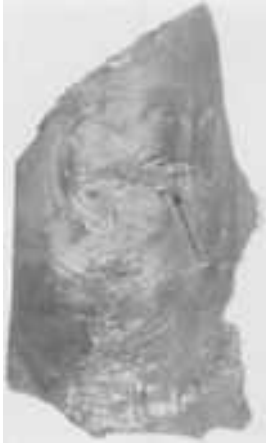
**Fig. 239**

**Fatigue failure of crane wheel by spalling of a section of its selectively hardened tread. Failure of the quenched and tempered medium-carbon steel forging occurred after 2 years of operation on a crane serving an open-hearth furnace. Fig. 239: Spalled section of tread. Fatigue crack originated at a forging defect (arrow). 3×. Fig. 240: Close-up of failure origin. 0.75×. Fig. 241: Oblique lighting reveals texture of fracture surface (compare with Fig. 240). Note beach marks associated with fatigue crack**

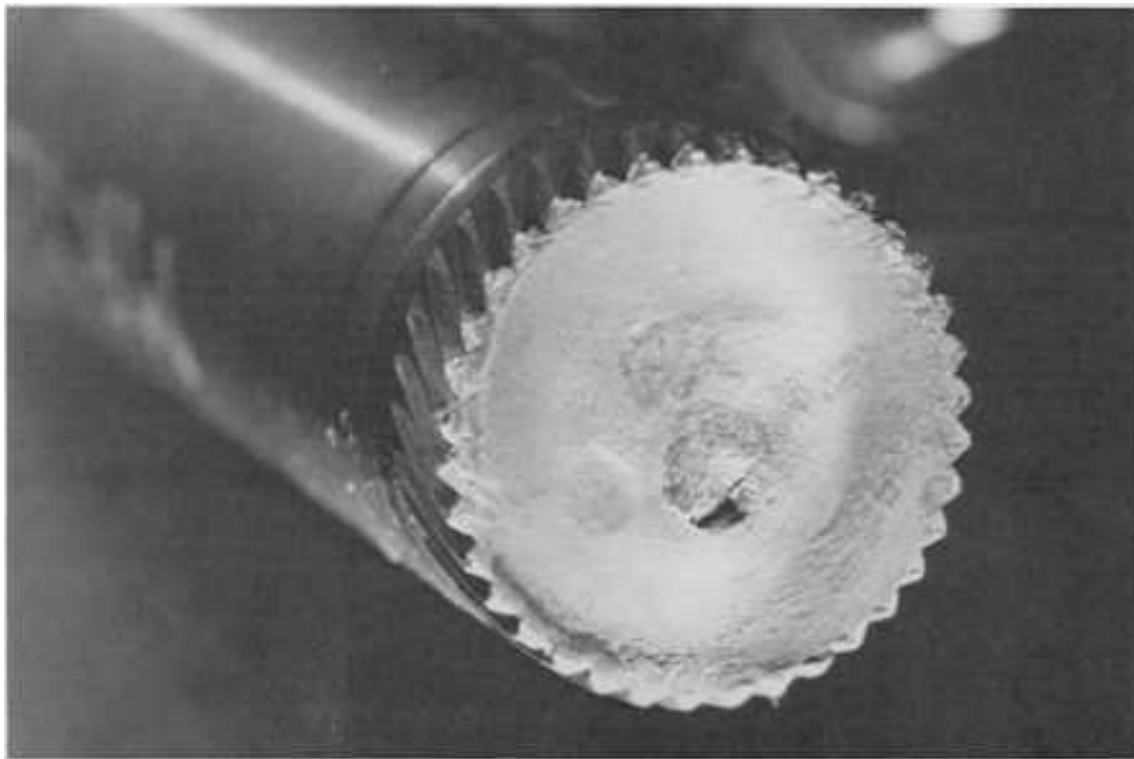
**Fig. 242 Single-overload torsional fracture on transverse shear plane of a medium-carbon steel shaft of moderate hardness. Degree of torsional deformation preceding fracture is indicated by counterclockwise twisting of originally straight splines. Final rupture was slightly off-center because of the presence of a relatively low bending force in addition to the torsional force. Fracture face has been severely rubbed and distorted in a circular direction due to contact with the mating fracture surface at the moment of separation. (D.J. Wulpi, Consultant)**

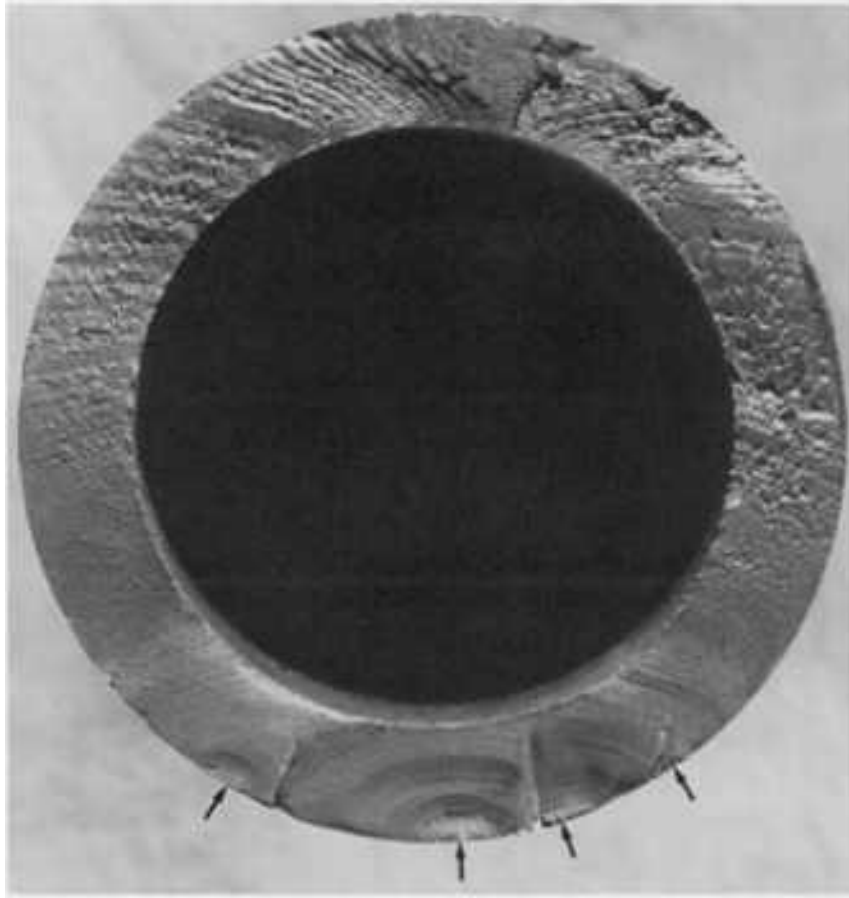
**Fig. 243**

Fatigue fracture of 90-mm (3.6-in.) diam medium-carbon steel axle housing (217 to 229 HB). The part was subjected to unidirectional bending stresses normal for the application. Fig. 243: Fracture surface showing four major fatigue crack origins (arrows). Cracks progressed up both sides of the tube and joined at the small final rupture area at top. Note increasing coarseness of fracture surface as cracks grew. Fig. 244: Higher-magnification view of origin area in Fig. 243. Note beach marks. A small

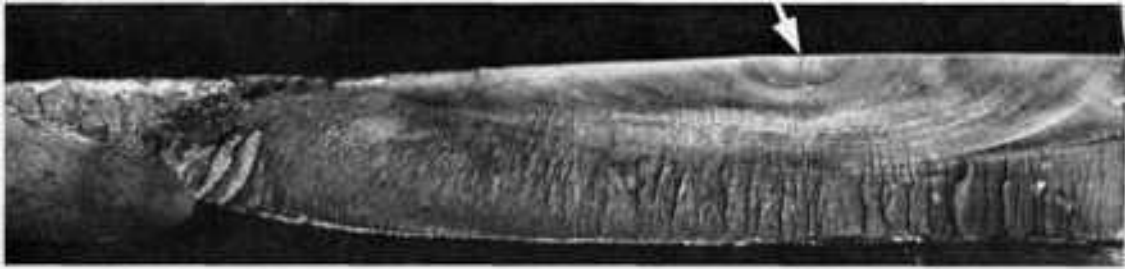
**Fig. 245** Surface of a fatigue fracture that occurred, after 732 h of service, in a tooth of the induction-hardened AISI 1053 steel left-side bull gear of a tractor. Hardness of the tooth was 57 HRC at the tip and 50 HRC at a depth of 13.3 mm (0.52 in.). Hardness in the root fillet was approximately 56 HRC near the surface and 50 HRC at a depth of 11.5 mm (0.45 in.). The arrow indicates the origin of the fatigue crack. See also Fig. 246, 247, and 248. ~2.5×

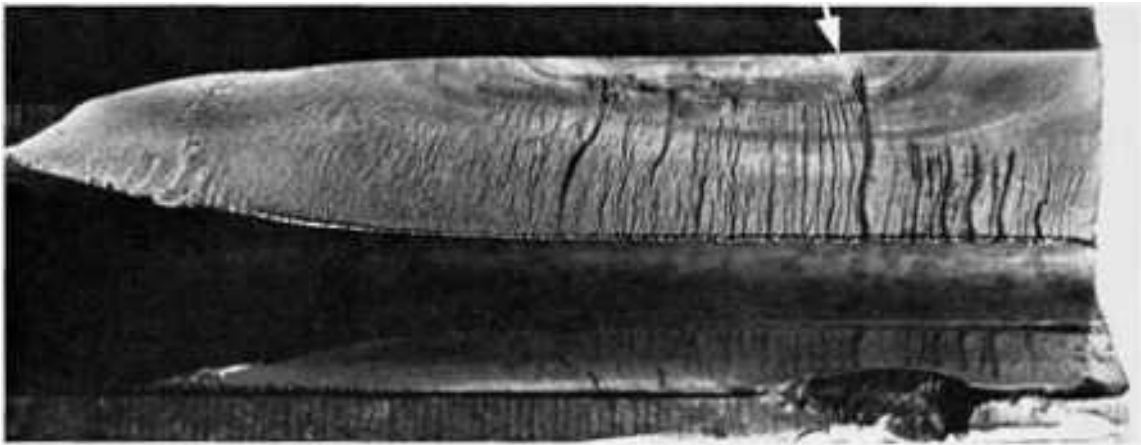
**Fig. 246** Surface of a fatigue fracture (similar to that in Fig. 245) that occurred, after 841 h of service, in a tooth of the right-side bull gear of the same tractor. This gear also was made of AISI 1053 steel and induction hardened. Hardness of this gear was similar to that of the gear in Fig. 245 except that the depths at which hardness was 50 HRC were 12.2 mm (0.48 in.) below the tip of the tooth and 9.5 mm (0.37 in.) below the surface of the root fillet. The arrow indicates the fatigue-crack origin. The damage to the tooth just below the one that fractured probably resulted from jamming by a fragment from the fracture. ~2.5×

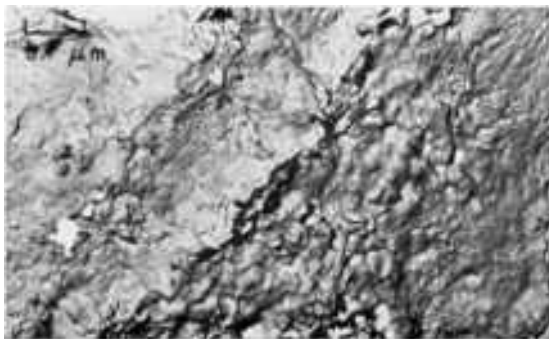
**Fig. 247** Area of the fracture surface of the left-side bull gear in Fig. 245, taken near the fatigue-crack origin. Visible are several inclusions believed to have contributed to the formation of the fatigue crack. See also Fig.

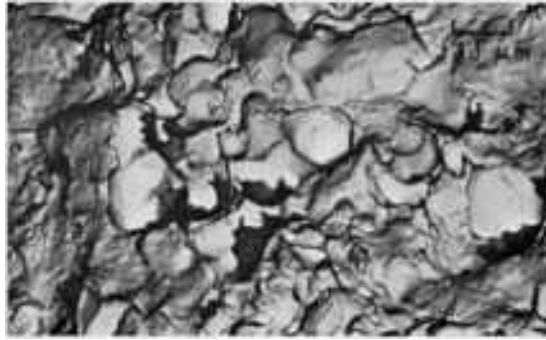
Fig. 248 Portion of the area in Fig. 247, but at higher magnification, showing the inclusions more clearly. Similar inclusions were found near the crack origin in the fracture surface of the right-side bull gear in Fig. 246. TEM p-c replica, 3200×

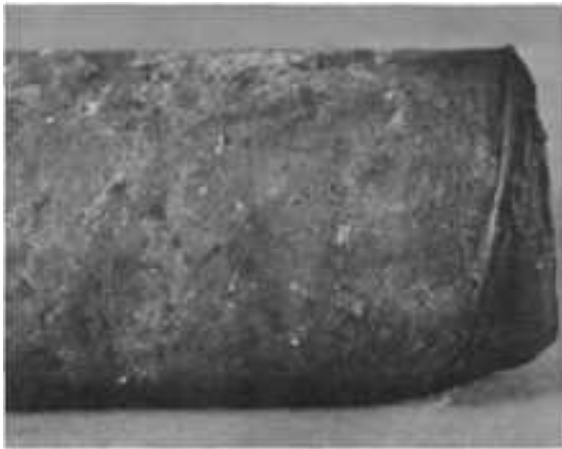
Torsional overload fracture of AISI 1060 drive shaft for power boiler stoker grate. Service temperature: 370 °C (700 °F). Boiler had a history of fractured shafts. This particular grate had jammed twice before, and each time a new key had to be machined due to twisting of the shaft. Mechanical properties at surface of shaft: yield strength, 348 MPa (50.5 ksi); tensile strength, 556 MPa (80.6 ksi); elongation, 31%. Core properties: yield, 300 MPa (43.5 ksi); tensile, 620 MPa (89.9 ksi); elongation, 25%. Fig. 249 and 250: One half of broken shaft and its fracture surface. Fig. 251 and 252: Mating half of shaft (two of three keyways are visible) and its fracture surface (note twisting and smearing). All at ~0.5× (Z. Flanders, Packer Engineering Associates, Inc.)

Ferrite at prior-austenite grain boundaries and spheroidized pearlite characterize microstructure of drive shaft in Fig. 249, 250, 251, and 252. All etched in 2% nital. Fig. 253 and 254: Structure at surface of shaft (radial orientation). 100× and 400×. Fig. 255 and 256: Transverse microstructure. 100× and

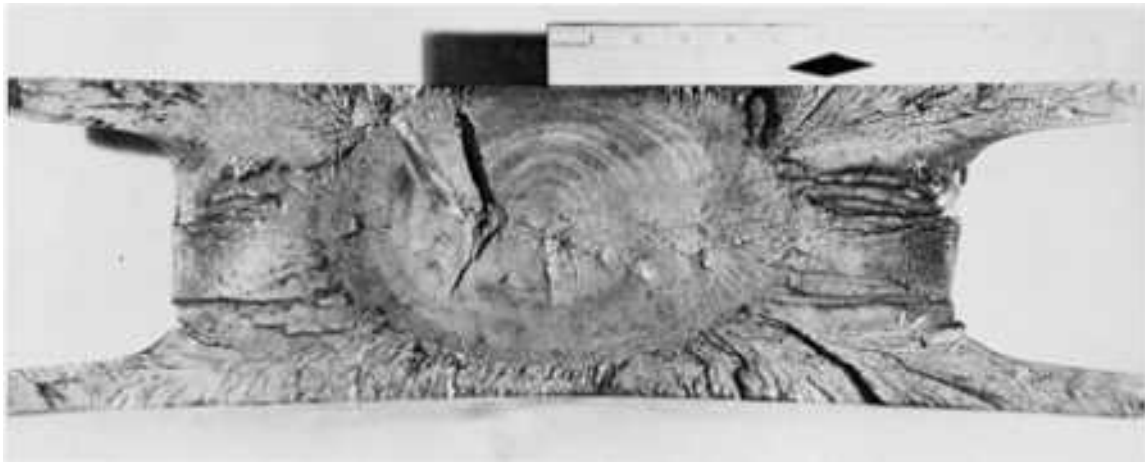
**Fig. 257** Surface of a fatigue fracture that occurred, after approximately 1 year of service, in an AISI 1055 steel wheel of a 545-Mg (600-ton) stripper crane. Visible in the center of the fracture is a fatigue zone showing beach marks that are concentric around the fatigue-crack origin, which evidently was an internal flaw approximately 38 mm ( $1\frac{1}{2}$  in.) beneath the wheel-tread surface. The chemical analysis of the steel was 0.60% C, 0.82% Mn, 0.009% P, 0.024% S, and 0.24% Si, which was acceptably close to specification. Note the chevron patterns in the area of final fast fracture that surrounds the fatigue zone. 0.3×

**Fig. 258** Surface of a fatigue fracture that developed in the flange of an AISI 1055 steel wheel of an open-hearth crane after nearly 20 years of service. The fracture surface was exposed by arc cutting the adjacent metal. This fatigue fracture, like the one shown in Fig. 257, was initiated by an internal flaw and propagated outward radially; no external defect was found to be involved in either this fracture in Fig. 257. 0.44×

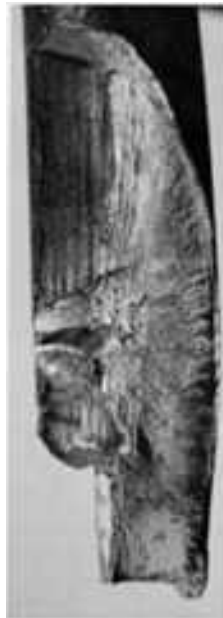
**Fig. 259** Fatigue fracture in AISI 1060 steel spring wire, 4.6-mm (0.18-in) diam, originating at two or more crack nuclei at and above lower shoulder at left edge. 7×

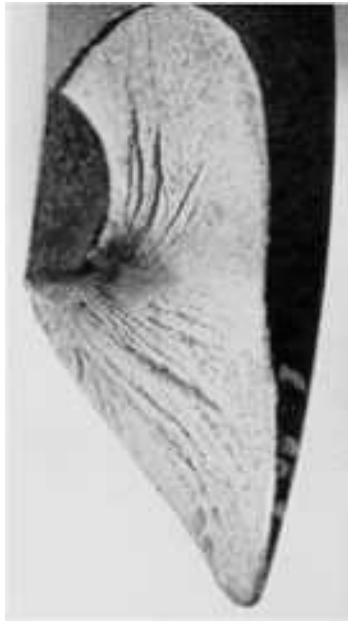
**Fig. 260** Surface of a fatigue fracture in 16-mm ( $\frac{5}{8}$ -in) diam spring wire of AISI 1060 steel. The crack origin, which undoubtedly was a surface flaw, generated a fatigue zone (dark area at upper left). The fatigue crack grew slowly, and beach marks became obscured by oxide.  $\sim 3\times$

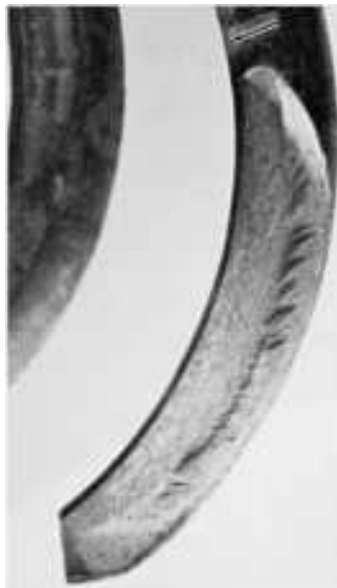
**Fig. 261** Fatigue-fracture surface of a suspension spring of AISI 10B62 steel wire with a hardness of 460 HB. Note the fine seam (at arrow), which is the fatigue-crack origin.  $2\times$

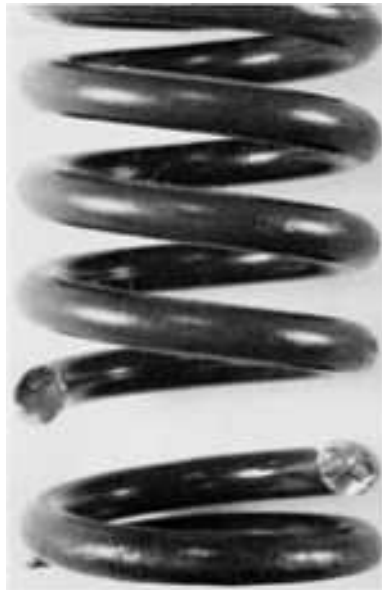
**Fig. 262 Fatigue-fractured valve spring of 4.8-mm ( $\frac{3}{16}$ -in.) diam AISI 1060 steel wire. The wire appears to be free of surface defects, a conclusion that is supported by the evidence in Fig. 263. 2×**

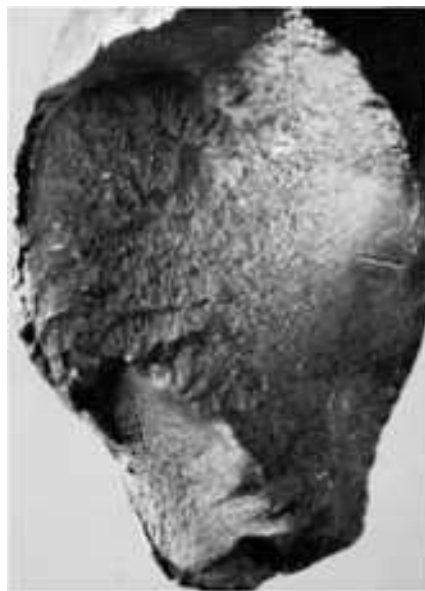
**Fig. 263 Higher-magnification view of fracture surface in Fig. 262. The fatigue crack began at subsurface origin (at arrow), not at a surface defect. Final fast fracture formed shear lips at top, at left, and at bottom. 15×**

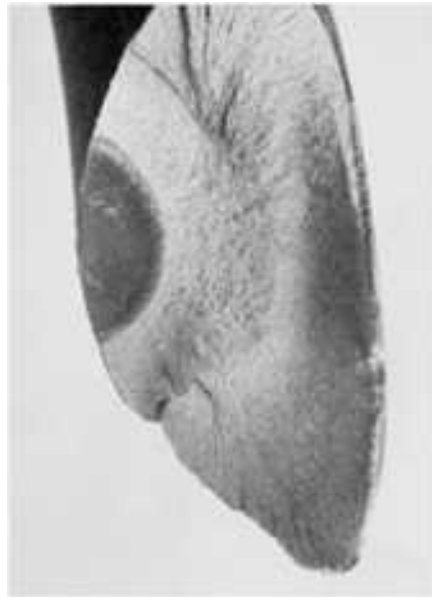
**Fig. 264 Fatigue fracture in a 16-mm ( $\frac{5}{8}$ -in.) diam suspension spring of AISI 10B62 steel wire. The fatigue crack probably originated at a surface defect and grew so slowly that oxidation occurred (note darkness of fatigue zone at left). 3×**

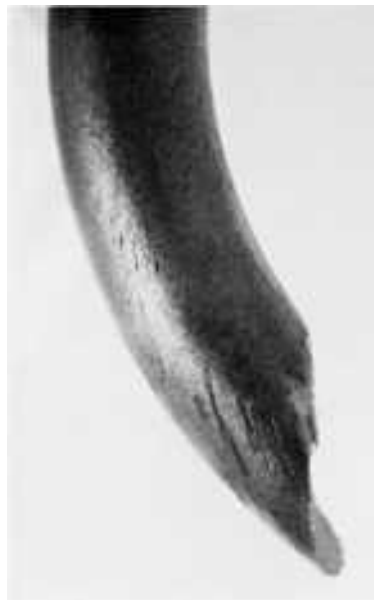
**Fig. 265 Fractured 13-mm ( $\frac{1}{2}$ -in.) diam spring of AISI 10B62 steel wire with a hardness of 477 HB. Note the spiral gouges, which are screw marks that were generated during coiling. See also Fig. 266. 2×**

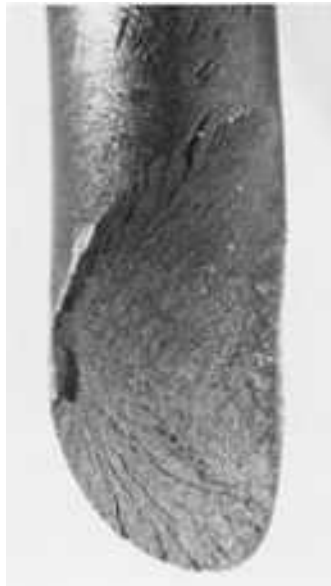
**Fig. 266** Fracture surface of the spring in Fig. 265. The crack originated at a screw mark. The small size of the fatigue zone (at left) indicates that final fast fracture occurred soon after crack initiation. 3×

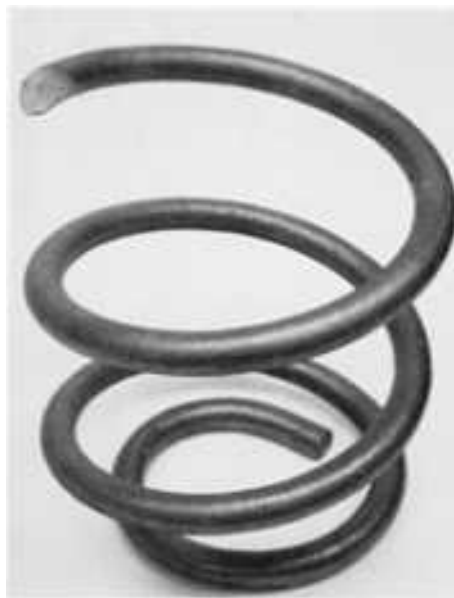
**Fig. 267** Fatigue-fractured spring formed from 16-mm ( $\frac{5}{8}$ -in.) diam AISI 1060 steel wire. The seam on the back side of the top turn enters the fracture surface at the dark spot at left edge. See Fig. 268 for a view of the fracture surface. 0.5×

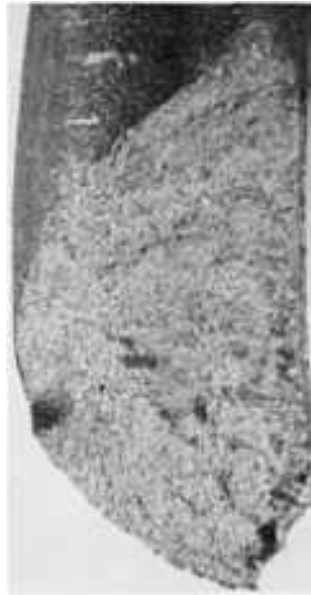
**Fig. 268** Fracture surface of the spring in Fig. 267. The fatigue-crack origin is at the seam at left edge. The surface of the wire was gouged after fracture. 3×

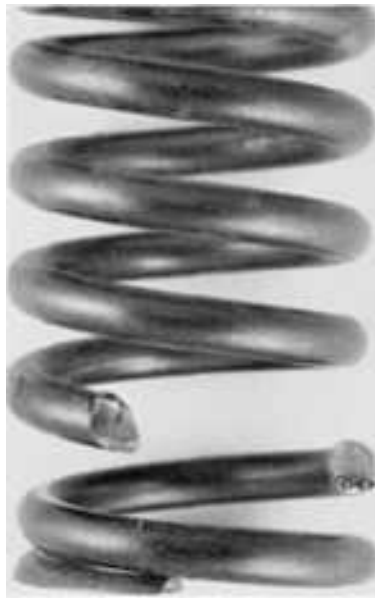
**Fig. 269** Fatigue-fractured spring of 5-mm (0.200-in.) diam AISI 1060 steel wire (hardness, 43 to 48 HRC). This fracture, unlike that of the similar spring in Fig. 261, originated at the surface (see Fig. 270). 1.7×

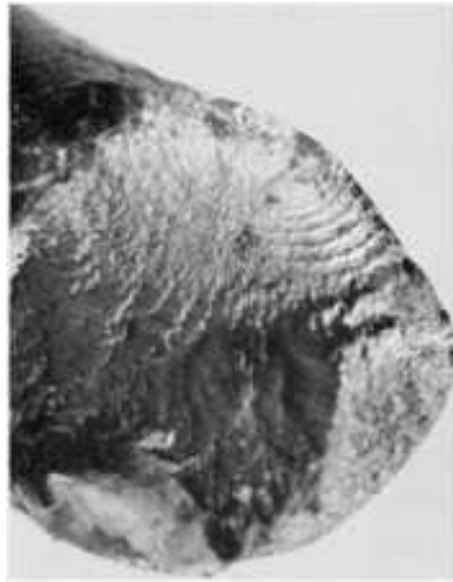
**Fig. 270** Fracture surface of spring at right side in Fig. 269, shown at higher magnification. The nucleus of the fatigue crack is clearly visible on the wire surface at top, with a succession of beach marks fanning out below it. The surface of the zone of final fast fracture appears to be quite woody. 15×

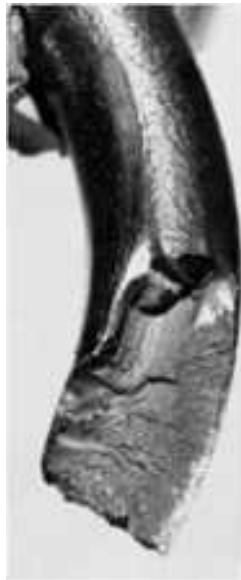
**Fig. 271** Surface of a complex fatigue fracture in a valve spring formed from AISI 1070 steel wire, showing two facets at right angles. 8×

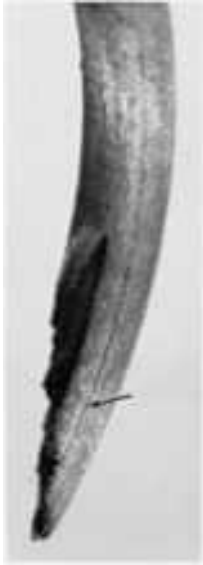
Fig. 272

Fatigue fracture in a spring of AISI 1070 steel wire with a hardness of 54 HRC. Fig. 272: Side view of one fracture surface, deep etched to show a long seam (at arrow). 10×. Fig. 273: Frontal view of the mating fracture surface, showing the fatigue-crack origin (at right), which is at a second seam. 10×

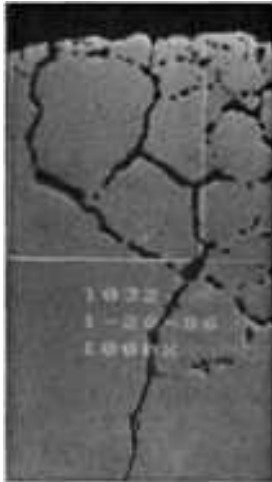
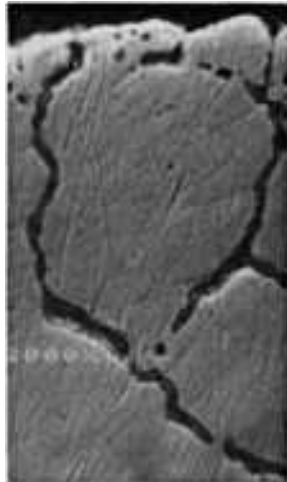
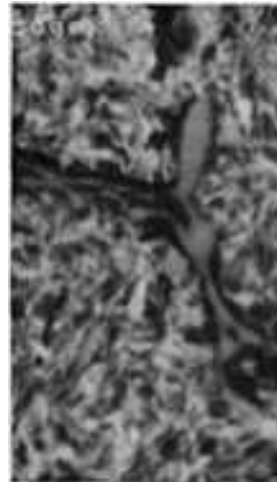
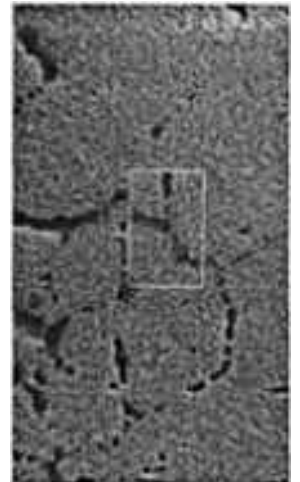
Cause of brittle behavior in a small percentage of flat spring parts made of annealed AISI 1070 was traced to a nitrided/nitrogenized layer, 0.25 mm (0.010 in.) thick, produced during heat treating. The heat-treating operation included a 5-min stay in a shaker hearth furnace having a dissociated ammonia atmosphere. However, some of the parts stuck to the furnace hearth, which increased their residence time to as long as 30 min or more. The extended heating time, plus the presence of a small amount of undissociated ammonia, led to formation of the embrittling layer. Fig. 274 and 275: Grain-boundary damage at surface of AISI 1070 spring part. SEM, 1000× and 2000×. Fig. 276 and 277: Nitrides (or carbonitrides) in grain boundaries. SEM, 1000× and 5000× (J.H. Maker, Associated Spring, Barnes Group Inc.)

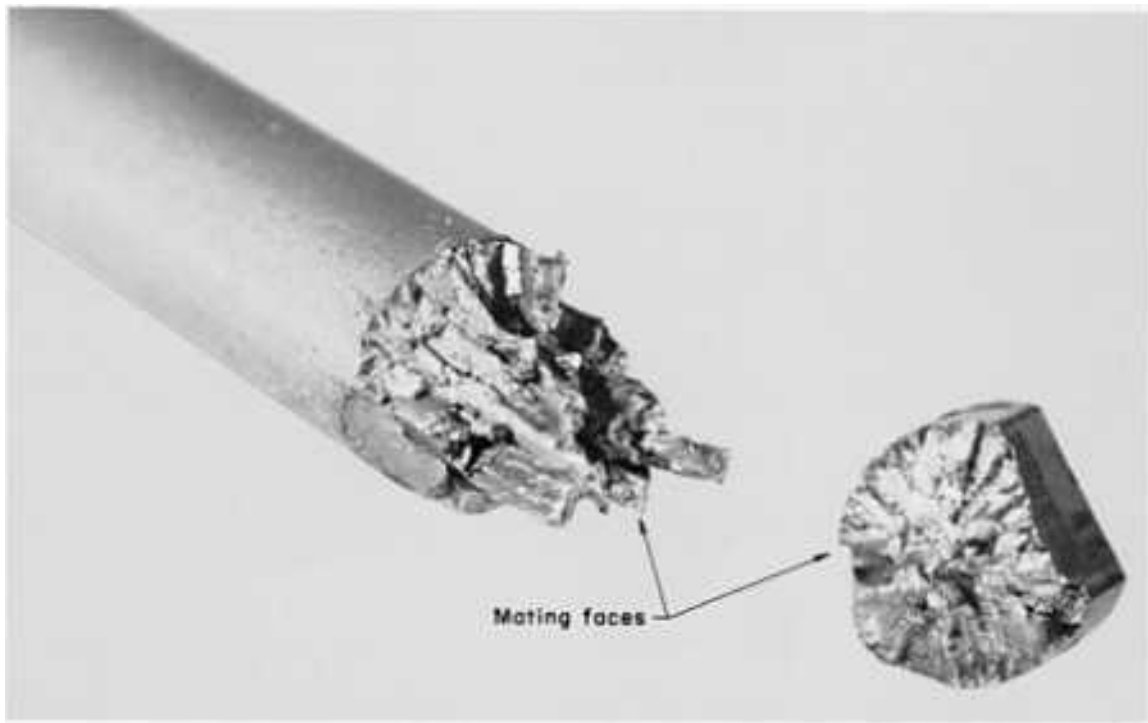
**Fig. 278** Torsional fatigue fracture in an 8-mm ( $\frac{5}{16}$ -in.) diam torsion bar of AISI 1070 steel that was quenched and tempered to a hardness of 45 HRC. Cracking occurred along both longitudinal and transverse shear planes. 5.6×

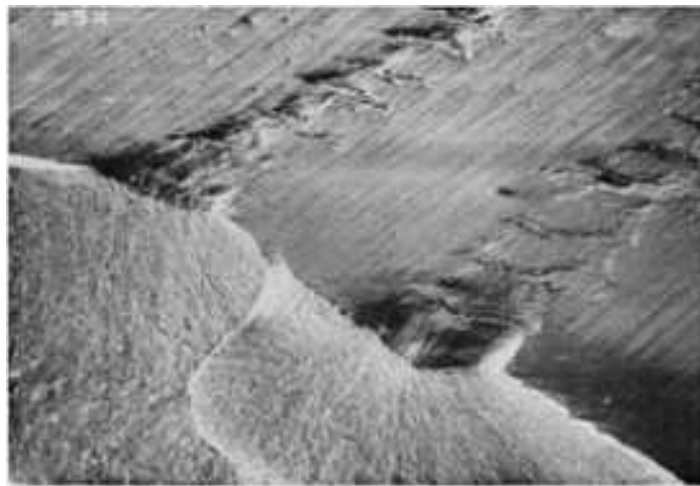
**Fig. 279**

**Power spring made of tempered AISI 1074 strip that fractured during coiling. Note significant surface damage. These defect were probably caused by mechanical action or lubrication breakdown during strip production while the material was in the annealed condition. Fig. 279: SEM, 25×. Fig. 280: Same as Fig. 279, but at higher magnification. SEM, 100× (J.H. Maker, Associated Spring, Barnes Group Inc.)**

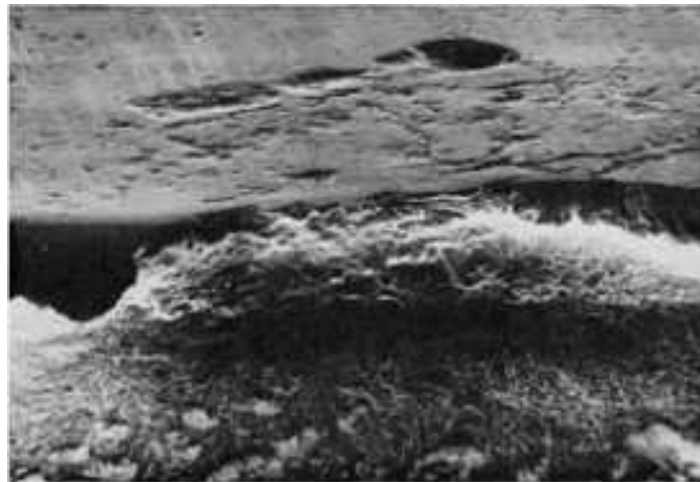
**Fig. 281**

Low-cycle fatigue fracture of AISI 1074 strip. Failure initiated at defects that were probably formed during hot rolling of the band. Binocular examination of defects revealed dark (oxidized) areas. Metallographic sections contained decarburized regions intimately associated with the defects. Fig. 281; SEM, 50×. Fig. 282: Same as Fig. 281, but at higher magnification. SEM, 250× (J.H. Maker, Associated Spring, Barnes Group, Inc.)

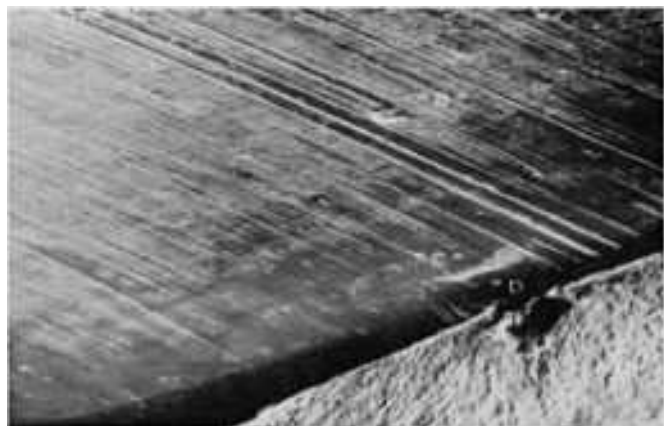
Fracture of power spring made of tempered AISI 1074. Initially, a "scab" or some other type of mechanical damage was suspected as the cause of failure because of the surface appearance of the steel. However, SEM examination revealed that fracture was due to a large nonmetallic inclusion (probably alumina, type B) located within 6 to 13  $\mu\text{m}$  (0.25 to 0.50 mils) of the surface. Fig. 283: Surface of fractured power spring and portion of fracture area showing origin. Note surface damage near "C" and prominent feature, "D," at edge near fracture origin. SEM, 50×. Fig. 284: Close-up of feature at fracture edge in Fig. 283 reveals the subsurface inclusion at "D" and its effects on surface appearance ("C"). SEM, 400×. Fig. 285: Longitudinal microsection near origin. SEM, 200× (J.H. Maker, Associated Spring, Barnes Group Inc.)

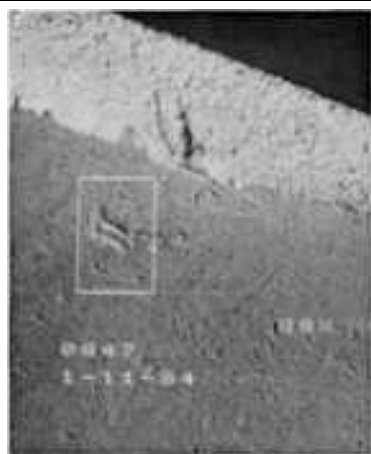
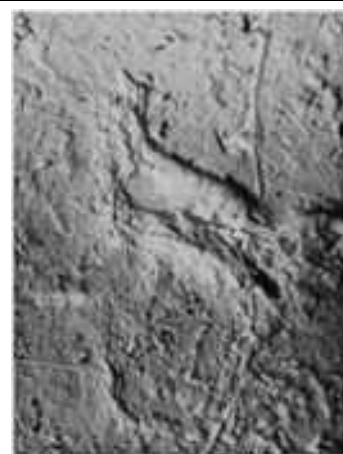
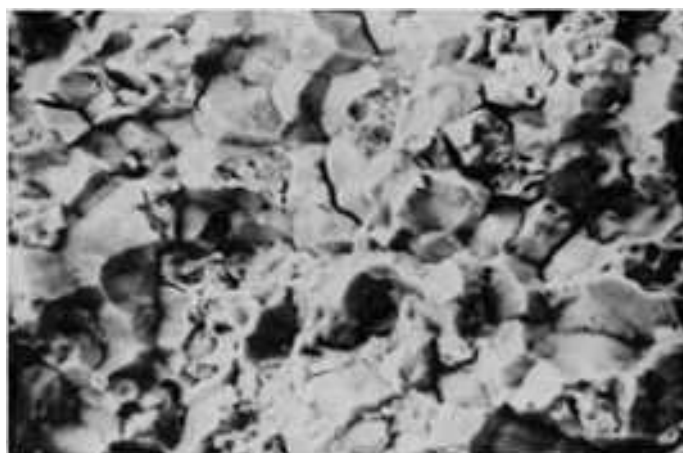
Hydrogen embrittlement fracture of AISI 1074 part. The part was formed in the annealed condition, quenched and tempered to 48 HRC, and then electroplated. A surface imperfection in the steel was initially thought to have played a key role in the fracture. However, SEM examination revealed an intergranular fracture mode indicative of hydrogen embrittlement due, in this case, to insufficient postplate baking. Fig. 286: Fractured part after stripping of electroplated coating. Note surface imperfection (boxed) near edge. SEM, 30× Fig. 287: Close-up of boxed area in Fig. 286. SEM, 150×. Fig. 288: High-magnification view of fracture surface reveals that part actually failed intergranularly due to hydrogen embrittlement. Note secondary cracking. SEM, 1500× (J.H. Maker, Associated Spring, Barnes Group Inc.)

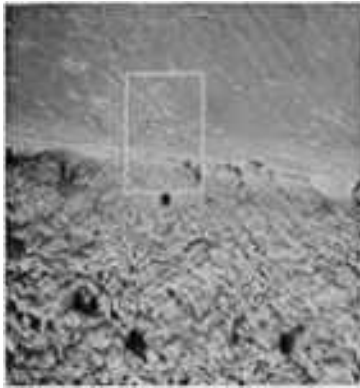
**Fig. 289**

Failure of tempered AISI 1074 power spring due to galling. Power springs should be lubricated between coils and should not be wound too tight. When these requirements are not met, the resultant abrasion between overlapping coils can produce galling and, occasionally, frictionally induced, untempered martensite. Maximum stress also rises sharply under these conditions. In this case, galling is the only visible cause of failure. Fig. 289: SEM 80×. Fig. 290: SEM, 400× (J.H. Maker, Associated Spring, Barnes Group Inc.)

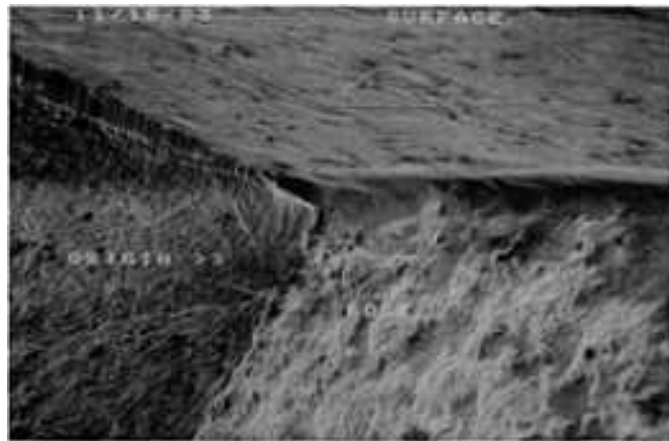
**Fig. 291** Fatigue failure of flat, cantilever-type AISI 1070 spring due to inadequate removal of blanking fracture. Failure initiated at a point on the edge of the spring. SEM, 100× (J.H. Maker, Associated Spring, Barnes Group Inc.)

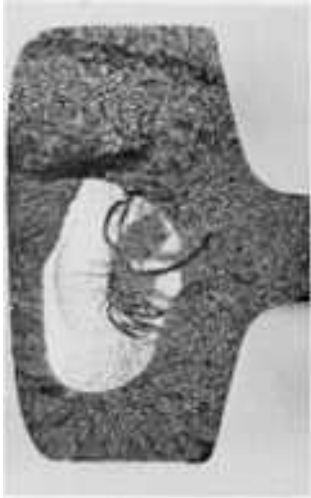
Fig. 292

Figure 292, 293, and 294 show surfaces of "transverse fissures" that occurred in the heads of AREA 59-kg (131-lb) railroad rails made of AISI 1075 steel. All three fissures were caused by the presence of hydrogen-induced flakes (or "fisheyes"), which appear as dark gray areas within the bright zones. These bright zones are fatigue cracks that were initiated by the flakes. Beach marks are visible in the fatigue zones, particularly near the initiations of final fast fracture. Figure 295 shows the surface of a longitudinal fracture in an AREA 59-kg (131-lb) rail of AISI 1075 steel that had been hydrogen embrittled. That white arrowhead points to an unusually large nonmetallic stringer that acted as a site for hydrogen segregation. All shown at actual size

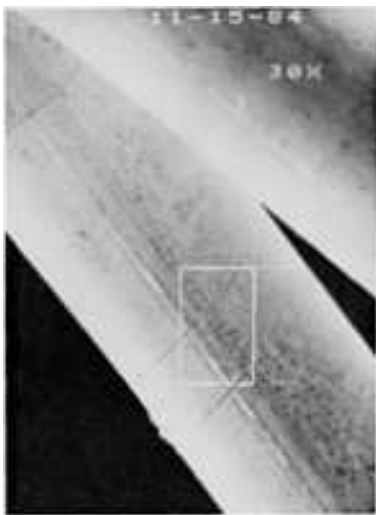
Fig. 296

Premature fatigue failures of springs due to hydrogen embrittlement. Cause was traced to a combination of inadequate stress relieving and use of an acid cleaning process. Material: ASTM A228 (0.70 to 1.0% C). Fig. 296: Three hydrogen/residual tensile stress induced cracks on wire surface. SEM, 30×. Fig. 297: Boxed area in Fig. 296. SEM, 150×. Fig. 298: Surface of one wire fracture. Hydrogen crack is at upper left and is 0.35 mm (0.014 in.) deep. At lower right is region of fatigue. SEM, 100×. Fig. 299: High-magnification view of intergranular hydrogen crack on fracture surface of ASTM A228 wire in Fig. 298 (compare with Fig. 300). SEM, 2000×. Fig. 300: Morphology of fatigue crack on fracture surface of ASTM A228 wire in Fig. 298 (compare with Fig. 299). SEM, 2000× (J.H. Maker, Associated Spring, Barnes Group Inc.)

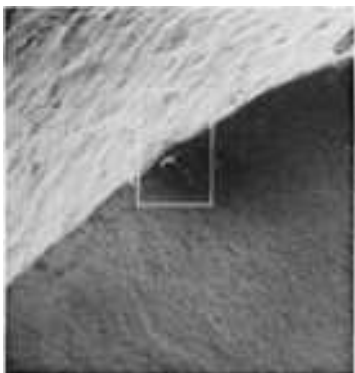
**Fig. 301**

Fatigue failure of spring made of oil-tempered carbon valve spring wire (ASTM A230). Failure occurred after 10,000 cycles of engine operation. Fracture surface morphology is atypical. One possible cause of failure: a ribbonlike subsurface inclusion. Fig. 301: SEM, 40×. Fig. 302: Higher-magnification view of boxed area in Fig. 301 SEM, 200×. See also Fig. 303 and 304. (J.H. Maker, Associated Spring, Barnes Group Inc.)

Higher-magnification views of the fractured ASTM A230 spring wire shown in Fig. 301 and 302. Fig. 303: Secondary electron SEM image, 500 $\times$ . Fig. 304: Backscattered electron SEM image, 300 $\times$ . See the article "Scanning Electron Microscopy" in this volume for additional information on secondary and backscattered electron images. (J.H. Maker, Associated Spring, Barnes Group Inc.)

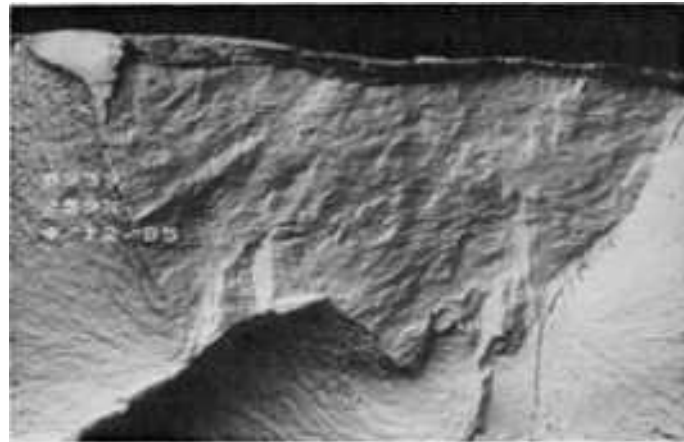
**Fig. 305** Fatigue failure of an automotive engine valve spring made of a steel similar to ASTM A230. The spring was shot peened; service stresses were very high. Cause of fracture was a seam 15  $\mu\text{m}$  (0.5 mils) deep. The surface defect initiated a longitudinal shear crack that propagated to a depth of 75 to 100  $\mu\text{m}$  (3 to 4 mils), where the crack root then induced stage I fatigue. SEM, 250 $\times$  (J.H. Maker, Associated Spring, Barnes Group Inc.)

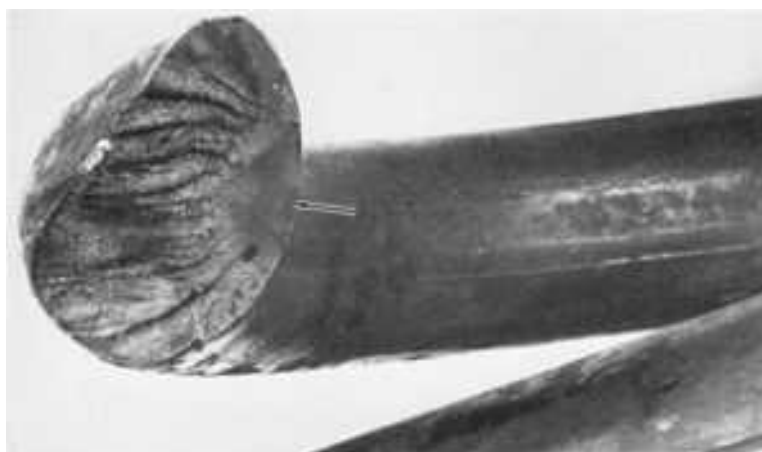
**Fig. 306** Surface of a fatigue fracture, which occurred after about 1 year of service, in an AISI 1095 steel

spring of a 225-Mg (250-ton) shear. A fatigue zone is evident at the inner (right) edge of the fracture surface (at arrow). This is a normal location for a fatigue-crack origin in a coiled spring, and the fracture may be rated as typical. The fatigue crack penetrated a distance of approximately 13 mm ( $\frac{1}{2}$  in.) into the spring before final fast fracture occurred. See also Fig. 307. Actual size

**Fig. 307** Polished and etched section through the spring in Fig. 306, taken adjacent to the fracture. Visible is a cracklike defect that probably nucleated the fatigue crack. Decarburization (white zone) around the defect indicates that the defect is a seam, which existed prior to service. Nital etch, 100×

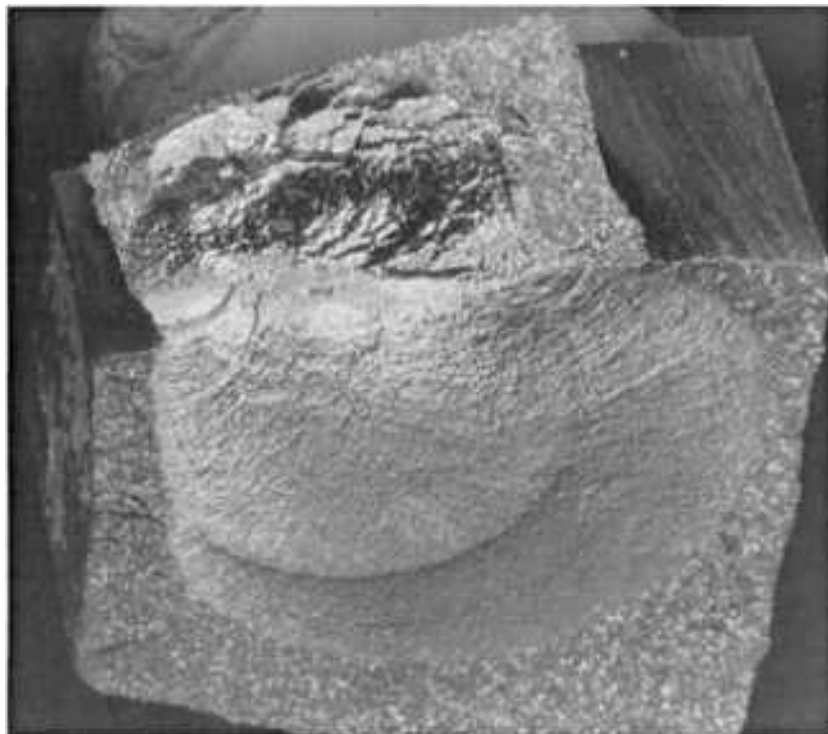
**Fig. 308** Deep "shell crack" and "detail fracture" in head of railroad rail removed from service. Composition of standard carbon rail steel: 0.60 to 0.82% C, 0.70 to 1.00% Mn, and 0.10 to 0.23% Si. Gage side of rail is at left. A 5- to 10-mm ( $\frac{1}{4}$ - to  $\frac{3}{8}$ -in.) thick layer has been removed from the running surface to expose the shell crack (top). Deep shells such as this one typically nucleate at stringers or microinclusions and propagate approximately parallel to the running surface. Some shells form a branch crack, or detail fracture, in the transverse plane (lower portion of figure) that can cause a service break if not detected in time. Detail fractures typically have featureless crack propagation surfaces, but may exhibit beach marks (as in this example) that reflect the traffic pattern or temperature (thermal stress) changes during service. See also Fig. 309 and 310.

**Detail fracture (see Fig. 308) in head of railroad rail that had been removed from revenue track and installed in test track to determine crack growth rate under heavy train traffic. Material: high-carbon rail steel (0.69 to 0.82% C.). Fig. 309: Featureless region inside contour 1 outlines crack at time of removal from service. Contours 1 through 9 and the unlabeled contours that follow identify crack propagation steps during testing. Contours separate inclined ridges that result from the unique traffic pattern on the test track. The detail fracture grew in fatigue to 80% of rail head area before breaking under the test train. 2.4×. Fig. 310: Longitudinal section along diagonal line in Fig. 309. Contours 1 through 9 are identified. Note ridge structure of crack surface that results from combined stage I and stage II fatigue crack propagation. The less prominent, horizontal ridges in Fig. 309 result from combined stage I/stage III propagation. 13× (J.M. Morris, U.S. Department of Transportation)**
