ASM HANDBOOK®

VOLUME  
12

Fractography

*Fractography*, was published in 1987 as Volume 12 of the *ASM Handbook*. The Volume was prepared under the direction of the ASM Handbook Committee.

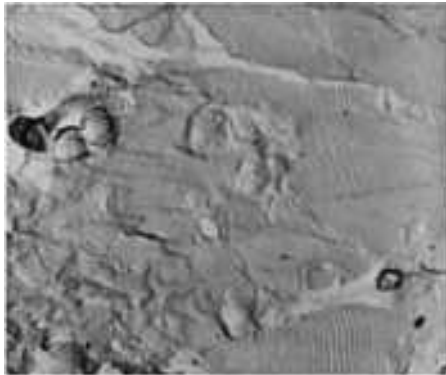
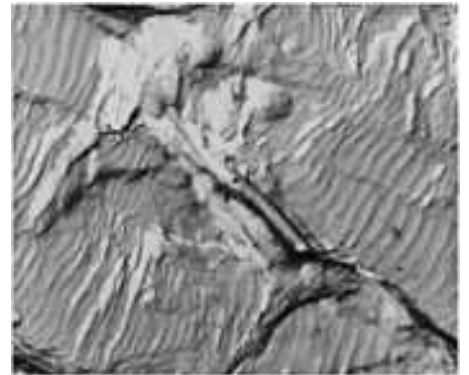
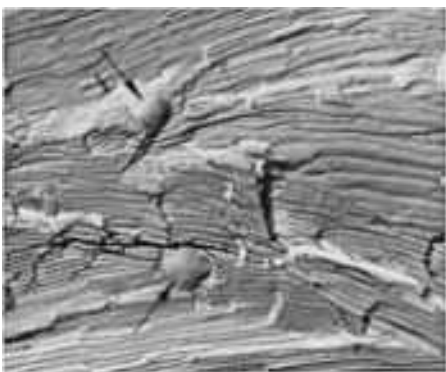
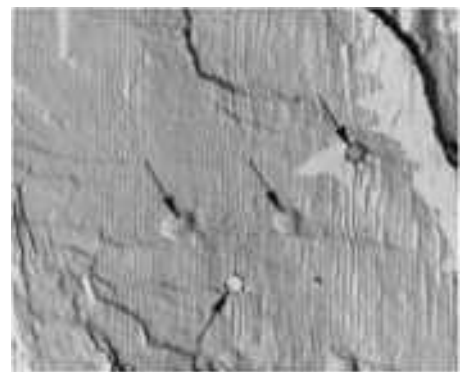
**Fatigue crack propagation in compact tension test specimen of rail steel (0.69 to 0.82% C). Fig. 311: Fracture surface of typical specimen from rail head. Crack plane lies in the cross section. First two circles at top identify precracked region. Fatigue crack propagation extends from second to sixth circle (from top to bottom). Bottom one third of surface is region of fast fracture. 1.66×. Fig. 312 and 313: Fractographs of fatigue propagation region in Fig. 311 illustrate typical fatigue striations. Note wavelike crests and variations of wavelength near inclusion sites. TEM replicas, 4900× and 4000×. Fig. 314 and 315: Two additional fractographs of fatigue crack propagation region in Fig. 311. Sharp crest outlines and lack of wavelength change near inclusion sites (arrows) identify these features as lamellar pearlite structure (see Fig. 316). TEM replicas, both at 4000× (J.M. Morris, U.S. Department of Transportation)**

**Fig. 316** Photomicrograph shows typical lamellar pearlite structure in railroad rail steel (0.69 to 0.82% C). The interlamellar spacing is approximately 300 nm. This structure is sometimes mistaken for fatigue crack growth striations in SEM and TEM fractographs (see Fig. 311, 312, 313, 314, and 315). 5000 $\times$  (J.M. Morris, U.S. Department of Transportation)

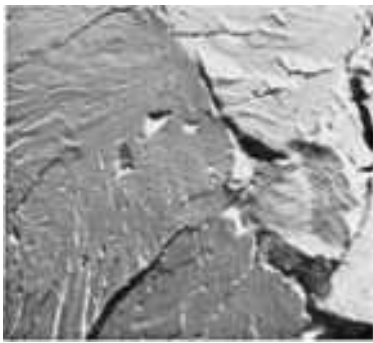
**Fig. 317**

Fractographs of fast fracture region in rail steel (0.69 to 0.82% C) compact tension specimen similar to that in Fig. 311. Fig. 317: Typical transgranular cleavage. At right-center is a cleavage region that follows steps along pearlite lamellae. TEM replica, 5000 $\times$ . Fig. 318: Comparison of transgranular cleavage (left) with intergranular cleavage (right). TEM replica, 5000 $\times$  (J.M. Morris, U.S. Department of Transportation)

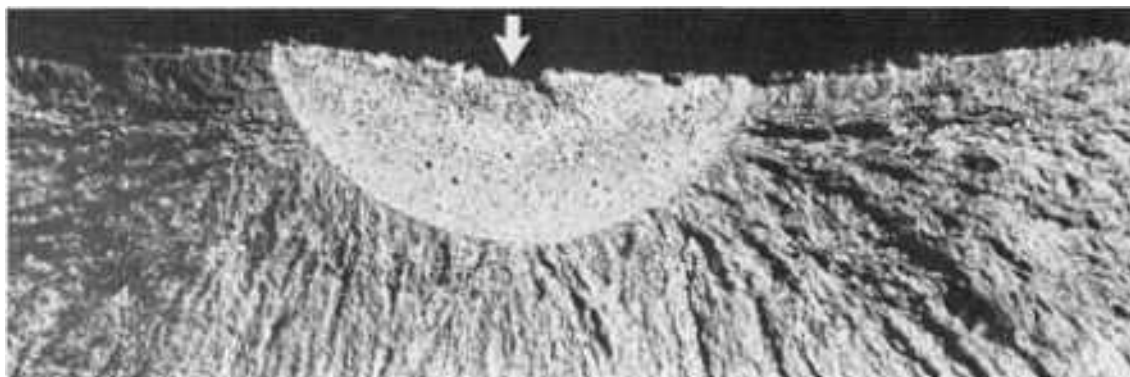
**Fig. 319** Fracture due to corrosion fatigue of a 115-mm (4.5-in.) diam API 5A, grade E, seamless drill pipe. The fine-grained 0.4C-Mn alloy steel (~AISI 1340) was used in the normalized condition in an oil-field application where chlorides and sulfides were present in the strata being drilled. Fracture initiated at a corrosion pit (arrow) on the inside diameter of the pipe. 5.5× (E.V. Bravenec, Anderson & Associates, Inc.)

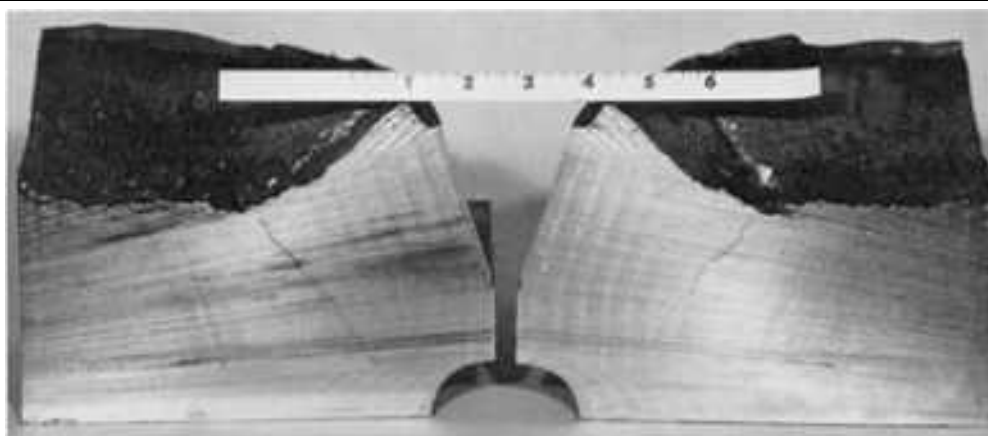
**Fig. 320**

Brittle fractures of AISI 4130 hitch post shafts due to thermal stresses from welding imposed on an improperly heat-treated region. The tapered shaft had a maximum diameter of about 305 mm (12 in.) and a length of approximately 1 m (40 in.). It was forged, rough machined, heat treated--845 °C (1550 °F), water quench, temper at 595 °C (1100 °F)--and a small bracket was welded to the larger diameter end. Fracture occurred after a short time in service or, in some cases, immediately after welding. Cause: Incomplete austenitization left a coarse structure at the shaft center characterized by a high residual stress level and low ductility. Thermal stresses accompanying welding initiated brittle cracks in this region, which then propagated to the surface. Fig. 320: Transverse section of field failure. Fig. 321: Fracture surface near center

Metallographic study of hitch post shaft failure in Fig. 320, 321, and 322. All etched in 2% nital. Fig. 323: Coarse, as-forged structure of AISI 4130 shaft. 100 $\times$ . Fig. 324, 325, 326, and 327: Microstructures at increasing depths beneath surface of fractured shaft. Gradual coarsening is evidence of superficial austenitization. Fig. 324: 4 mm (0.15 in.). 150 $\times$ . Fig. 325: 11 mm (0.45 in.). 150 $\times$ . Fig. 326: 30 mm (1.2 in.). 150 $\times$ . Fig. 327: 75 mm (3 in.). 225 $\times$  (R.W. Bohl, University of Illinois)

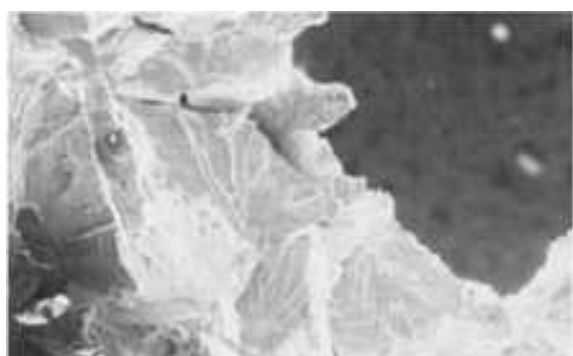
**Fig. 321**

of shaft. Failure mode is brittle fracture. Note river patterns. SEM, 100 $\times$ . Fig. 322: Fractograph of near-surface region of shaft. Failure mode: dimple rupture. SEM, 100 $\times$  (R.W. Bohl, University of Illinois)

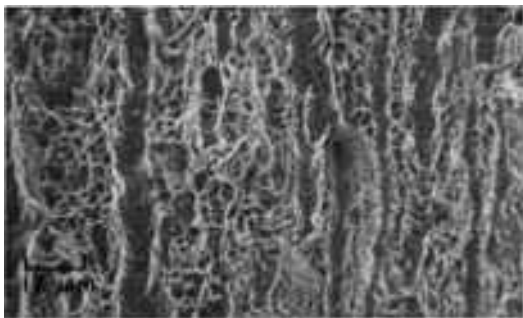
**Fig. 328**

Two SEM views, at different magnifications, of the surface of a fracture in a specimen of AISI 4130 steel that was austenitized at 845  $^{\circ}\text{C}$  (1550  $^{\circ}\text{F}$ ), oil quenched, and tempered for 2 h at 250  $^{\circ}\text{C}$  (480  $^{\circ}\text{F}$ ). The fracture was produced in a toughness test in air; the rate of crack growth was in the range of rapid, unstable fracture. Dimples in an extremely wide variety of sizes and channels formed by linear coalescence of voids are evident. See Fig. 330, 331, 332, 333, 334, and 335 for the fracture behavior of this material when tested in a hydrogen atmosphere. Fig. 328: 600 $\times$ . Fig. 329: 2400 $\times$

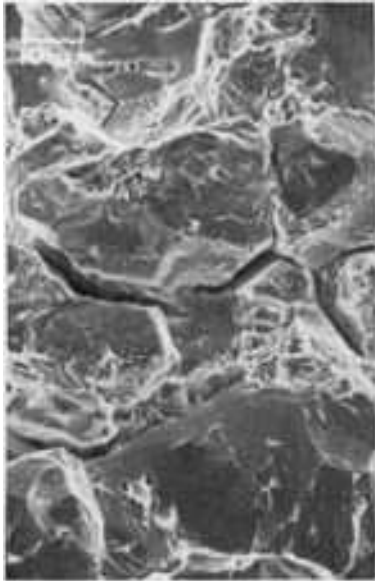
**Fig. 330**

Fracture surfaces of two specimens of AISI 4130 steel that were given the same heat treatment as described in Fig. 328 and 329. The specimen shown in Fig. 330 was tested in 1 atm of hydrogen at 25 °C (75 °F); the specimen shown Fig. 331 and Fig. 332 was tested in 1 atm of hydrogen at 80 °C (175 °F). Note that the area within the rectangle in Fig. 331 is shown at higher magnification in Fig. 332. In contrast to those in Fig. 328 and 329, these fracture surfaces show completely intergranular fractures with deep secondary cracks between the grains. The fracture in Fig. 331 and 332 also shows a considerable number of dimples that were formed by microvoid coalescence. See Fig. 333, 334, and 335 for the fracture behavior of this material in an atmosphere of partially dissociated hydrogen. Fig. 330: SEM, 1000×. Fig. 331: SEM, 2350×. Fig. 332: SEM, 5600×

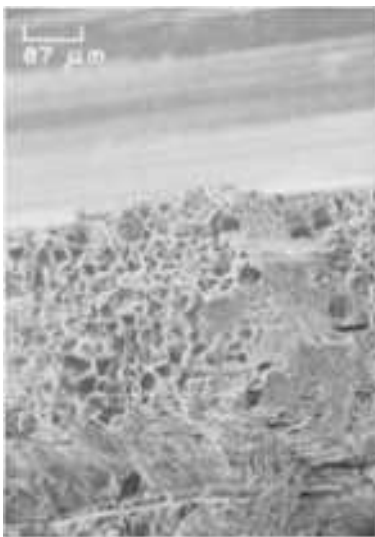
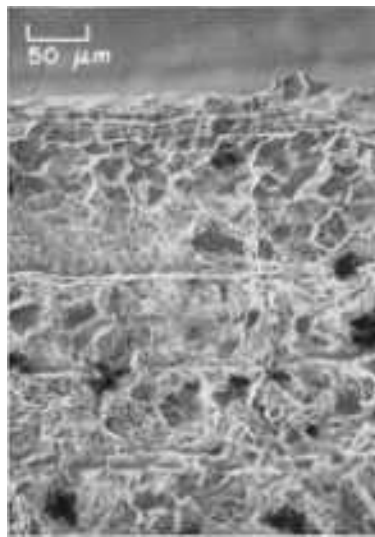
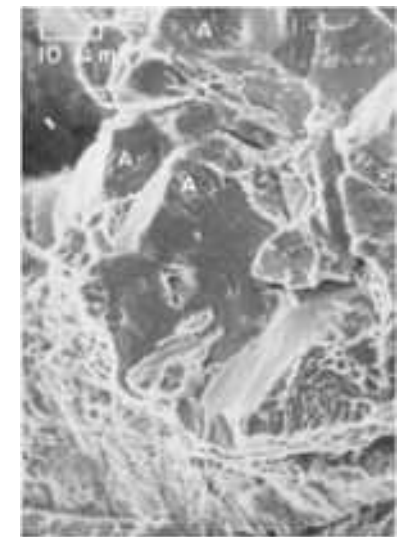
Three SEM views, at different magnifications, of the surface of a fracture in a specimen of the same steel and heat treatment as in Fig. 328, 329, 330, 331, and 332, tested for stable crack-growth rate in 0.1 atm of partially dissociated hydrogen at 80 °C (175 °F). Similar to the fracture in Fig. 331 and 332, this fracture shows facets of intergranular rupture intermingled with areas of dimples. The bottom of the notch in the specimen is visible at top in Fig. 333 and Fig. 334. The horizontal marks in the fracture surface parallel with the notch could be indications of temporary arrests of crack penetration. The hairline indications (marked A) visible in Fig. 335 are fine tear ridges typical of hydrogen embrittlement. Fig. 333: 115×. Fig. 334: 200×. Fig. 335: 1000×

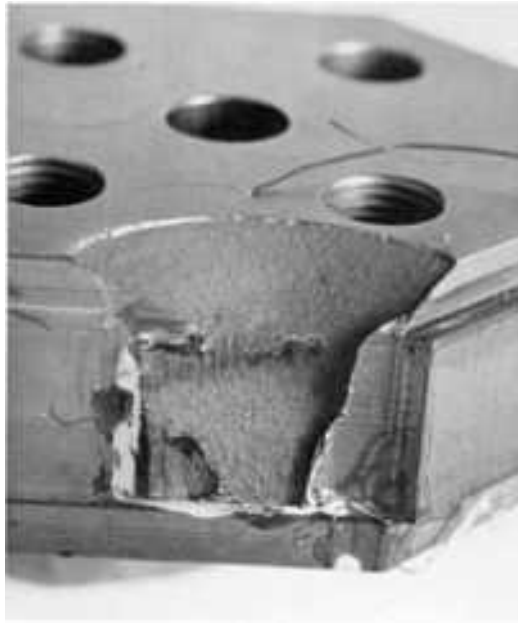
**Fig. 336** Fracture surface of a broken AISI 4140 steel load cell. The radial marks indicate that two crack origins formed at the bottom surface of the cell, apparently near the toe of a weld. Note the continuous shear lip around the top edge. See also Fig. 337 and 338. Actual size

**Fig. 337** Mating fracture surface to that shown in Fig. 336. There appears to be no evidence of fatigue marks; however, fatigue cracking may have taken place within a very small area at the crack origins. Fracture was evidently caused by a sudden overload. See also Fig. 338. Actual size

**Fig. 338** Magnified view of the fracture surface in Fig. 336, taken at an area away from the edge, and showing the dimples that are typical of transgranular fast fracture. Vertical marks are sulfide stringers. SEM, 100×

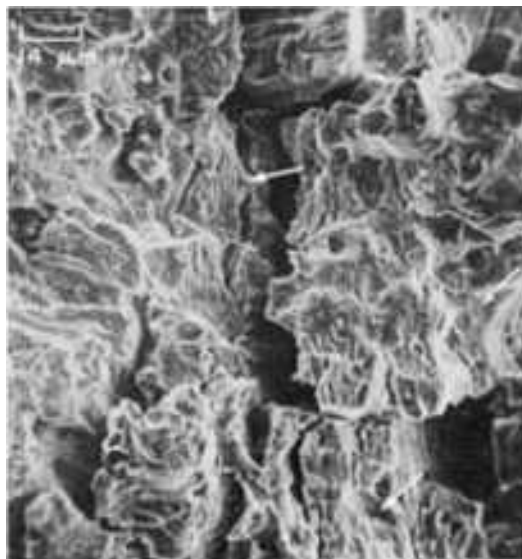
**Fig. 339** Fracture surface of an AISI 4140 steel specimen that was heat treated to high strength and broken in fatigue. Deep secondary cracks are present. Features that appear to be fatigue striations (such as at arrows) may actually be fissures. SEM, 720×

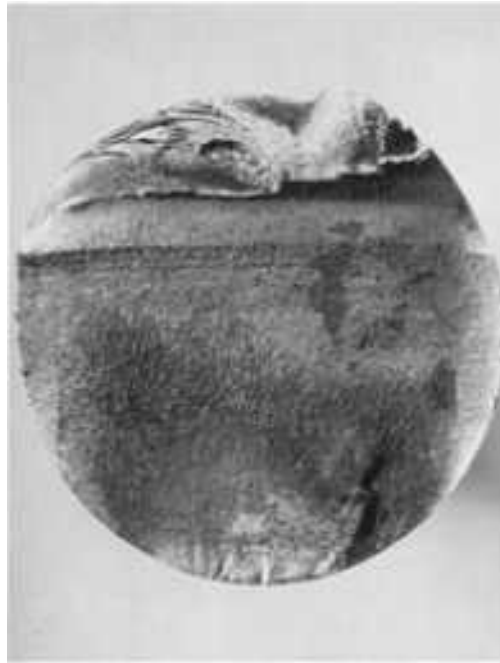
**Fig. 340** Surface of a fatigue fracture in a stud of AISI 4140 steel with hardness of 34 HRC in the core and 45 HRC at the surface. The crack originated at the bottom in this view, in a well-rubbed fatigue zone, and penetrated nearly 90% of the cross section of the stud before final fast fracture occurred. 2×

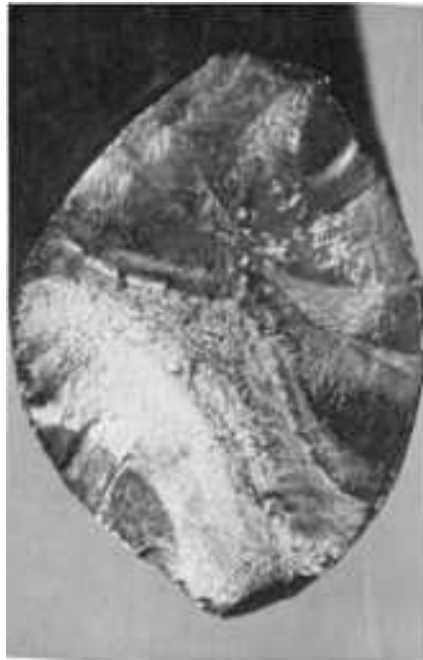
**Fig. 341** Surface of a fatigue fracture in a suspension component of AISI 4140 steel heat treated to a hardness of 273 HB. Two fatigue zones are evident, at lower left and at upper right; the remainder of the fracture surface is the zone of final fast fracture. 5×

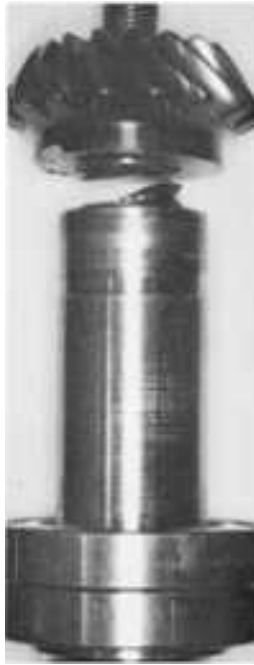
**Fig. 342** Fatigue fracture in an AISI 4140 steel tail-rotor drive-pinion shaft of a helicopter, heat treated to a hardness of 35 HRC. See also Fig. 343, 344, 345, and 346. Actual size

Figure 343 is a view of the threaded end of the fractured shaft in Fig. 342, after removal of the pinion gear. Figure 344 is a view of the bore of the pinion gear. Both photographs display severe galling damage of the contacting surfaces, which resulted in the gear being frozen on the shaft; the gear was removed by cutting through it from both sides. The appearance of the gouge marks indicates that most of the galling damage was done in forcing the gear onto the shaft. Figure 343 also shows a keyway and an oblique view of a fracture surface; the fracture originated at a location on the keyway edge that is not visible here. Both at 5×

Two views of a surface of the fatigue fracture in the tail-rotor drive-pinion shaft in Fig. 342, taken with the key and the pinion gear in place. The fatigue-crack origin (arrows) is in the keyway, slightly to the right of the corner formed by the edge of the keyway and the outside surface of the shaft. Not visible here are deep tool marks and machining tears on the inside of the keyway, which were the sources of the stress concentrations responsible for initiation of the fatigue crack. The smooth fracture surface shown in these views is typical of those produced by high-cycle fatigue in combined bending and torsion. Fig. 345: 2 $\times$ . Fig. 346: 10 $\times$

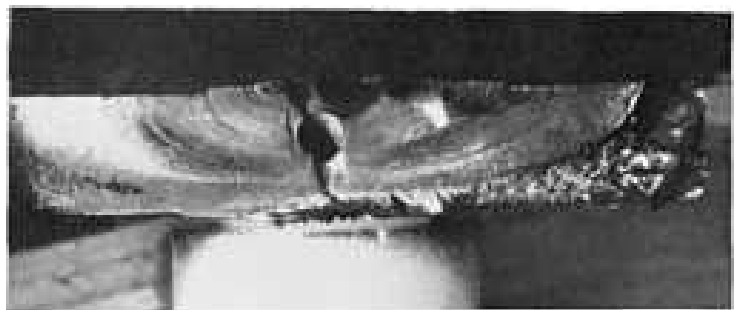
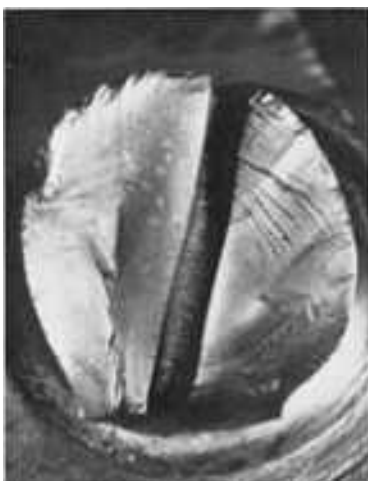
**Fig. 349**

Figure 349 is a view of the surface of the fracture in Fig. 348, showing several small crack nuclei above the oil hole. Fatigue cracks from these nuclei merged to form a single crack front, which nearly penetrated the entire cross section of the throw before final fast fracture occurred. Figure 350 is another view of the surface of the fracture in Fig. 348, photographed using illumination that reveals more of the details of the area of final fast fracture than does Fig. 349. The fatigue crack was initiated at a bottom fillet of the No. 2 main-bearing journal, which was chromium plated. Fig. 349: ~1.7 ×. Fig. 350: ~1.3×

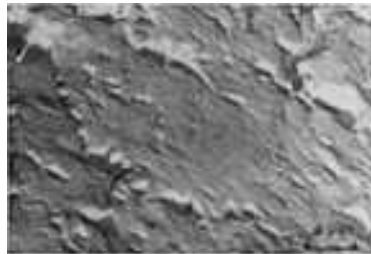
**Fig. 354 Ductile fracture of quenched and tempered AISI 4140 showing elongated dimples on fracture surface. Dimple shape is related to mode of fracture--in this case, either shearing or tearing. Matching replicas from adjacent surfaces are needed to distinguish between the two. TEM replica,  $8000\times$  (I. Le May, Metallurgical Consulting Services Ltd.)**

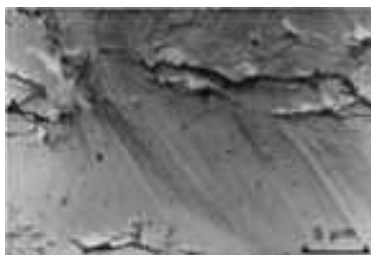
**Fig. 355 Slip band cracks on quenched and tempered AISI 4140. The cracks form most often in more ductile metals during fatigue crack growth on multiple slip planes. Their formation is due to the restraint imposed on reverse slip by large carbides or other second-phase particles in conjunction with the large amount of forward slip taking place at high stress levels. TEM replica,  $2000\times$  (I. Le May, Metallurgical Consulting Services Ltd.)**

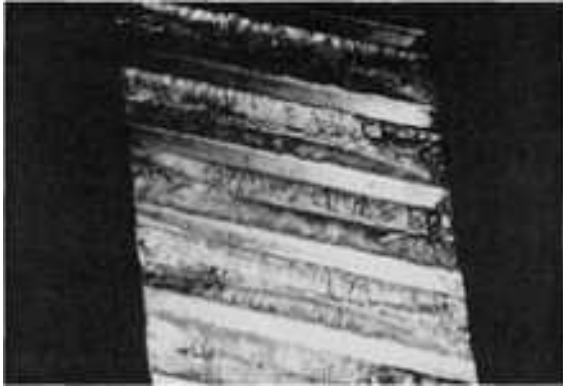
**Fig. 356 Tire tracks on fatigue fracture surface of AISI 4140 quenched and tempered at  $700\text{ }^{\circ}\text{C}$  ( $1290\text{ }^{\circ}\text{F}$ ). This feature is unique to fatigue fractures and is frequently observed in cases where crack propagation rate was high and few or no striations formed (as in low-cycle fatigue). In these instances, tire tracks represent valuable evidence that fatigue was indeed the operative failure mode. TEM replica,  $2080\times$  (I. Le May, Metallurgical Consulting Services Ltd.)**

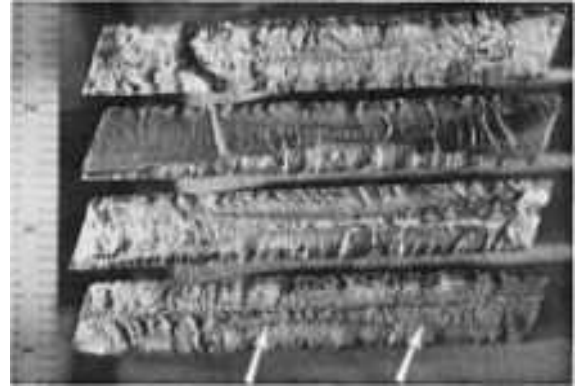
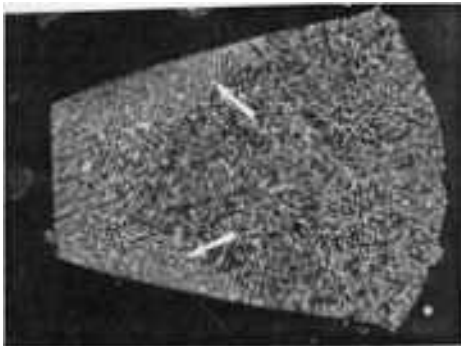
**Fig. 357**

Fatigue fracture of AISI 4140 bull gear due to improper heat treatment. The one-of-a-kind replacement gear had a service life of just 2 weeks. Heat treatment did not produce full hardness in gear teeth. Hardness at tooth face, 15 HRC; at tooth core, 82 HRB. Fig. 357: Outside diameter of gear showing where teeth broke off. Fatigue pattern on fracture surfaces is typical of reversed bending even though the gear was driven in only one direction. 0.6×. Fig. 358: Fracture surfaces of four teeth. Fatigue cracks propagated from both roots of each tooth. Arrows point to area of final overload on one tooth. 0.84× (Z. Flanders, Packer Engineering Associates, Inc.)

Structure of fractured tooth from AISI 4140 bull gear in Fig. 357 and 358. Fig. 359: Tooth cross section. Arrows show depth to which temperature exceeded  $A_{c1}$  during heat treatment. Fig. 360: Near-surface hardened region of tooth. Large ferrite indicates that complete austenitization was not obtained during heat treating. 2% nital, 200× (Z. Flanders, Packer Engineering Associates, Inc.)

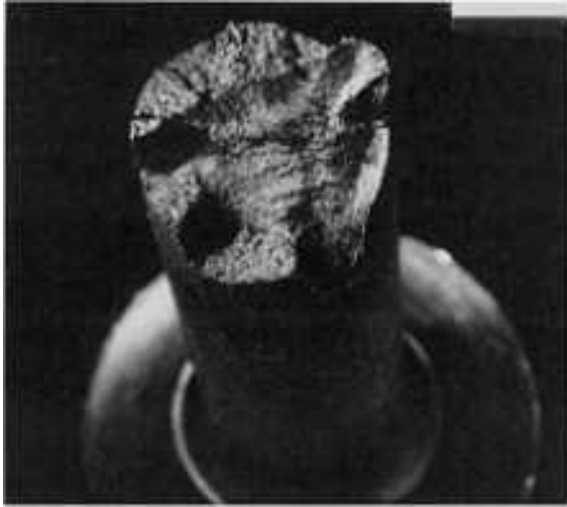
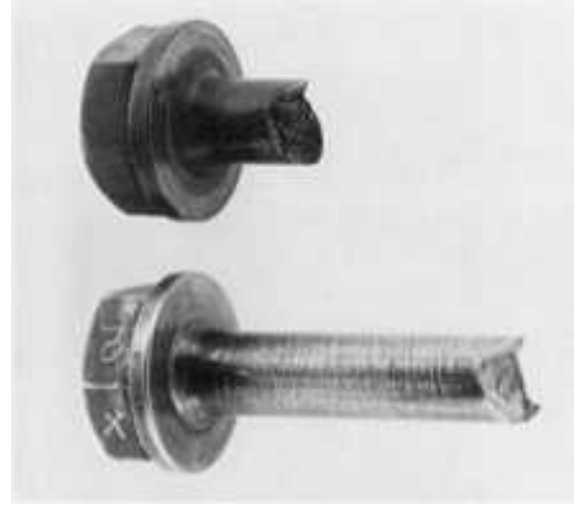
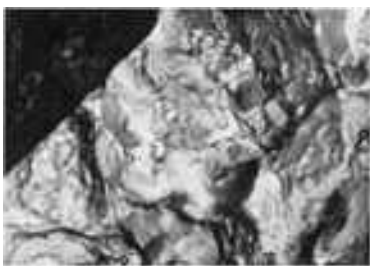
**Fig. 361**

Spontaneous rupture of high-strength diesel engine bearing cap bolts due to sulfide stress-corrosion cracking. Bolts were made of 42 CrMo 4 (~AISI 4140), quenched and tempered to 38 to 40 HRC. Parts were supplied by two vendors. Only bolts from one vendor failed, and all failures were bolts from main bearing caps 2 and 4 of the four-cylinder engine (those removed from bearing inspection after engine run-in and before final assembly). The vendor whose bolts were failure-free finish machined the parts after heat treating. This produced high compressive residual stresses on their surface and rendered them resistant to stress corrosion by effectively reducing the applied tensile stress on the shank. The vendor whose bolts failed heat treated the parts after machining--bolt surfaces were essentially free of beneficial residual stresses. The aggressive environment needed for stress-corrosion cracking was provided by water containing hydrogen sulfide. The  $H_2S$  derived from chemical breakdown of an engine oil additive. The moisture was admitted to the normally sealed bearing cap chamber surrounding the bolt shank when the easy-to-access caps 2 and 4 were removed from hot engines after run-in. Fig. 361: A reduced shank bearing cap bolt. Location of cracks and fracture on bolt shank was random. In this case, circumferential cracks were found adjacent to the threaded section. 1.5x. Fig. 362: Fracture surface of a failed bolt. Several crack origins can be seen at left on outer edge. These multiple origins occur in a stepwise fashion and have bright, faceted surfaces. Central region is fibrous and resulted from ductile overloading. At the right edge are shear lips formed during final separation. 4x. Fig. 363: Comparison of sulfide stress-corrosion failure produced in laboratory (left) with broken bolt removed from an engine. Note similarity of fracture surfaces (origins are at right in both cases). 1.5x (R.D. Zipp, J.I. Case, a Tenneco Company)

Fractographic analysis of sulfide stress-corrosion failures of bearing cap bolts in Fig. 361, 362, and 363. Although this analysis is of a failure induced in the laboratory, the mode is very similar to that of bolts that failed in engines. Fig. 364: Failure origin area with intergranular fracture continuous to the surface. SEM, 620x. Fig. 365: Approximately 0.4 mm (0.015 in.) from origin. Mode of crack propagation is intergranular. Note corrosion products and secondary cracking. TEM replica, 1560x. Fig. 366. Nonembrittled area in overload region exhibits primarily a dimpled-rupture mode of fracture. TEM replica, 3240x (R.D. Zipp, J.I. Case, a Tenneco Company)

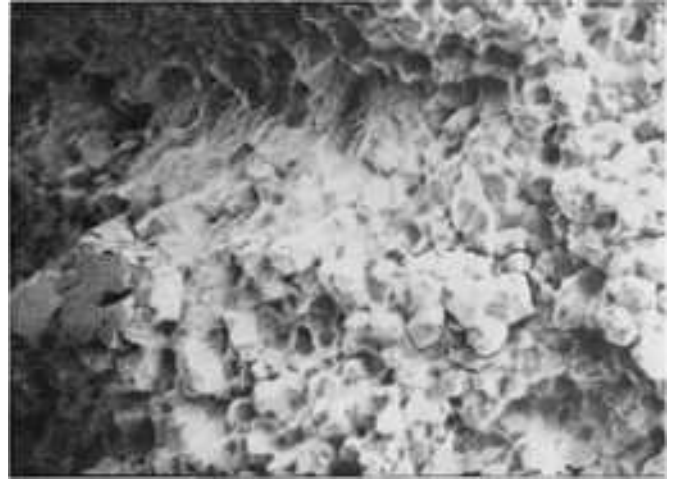
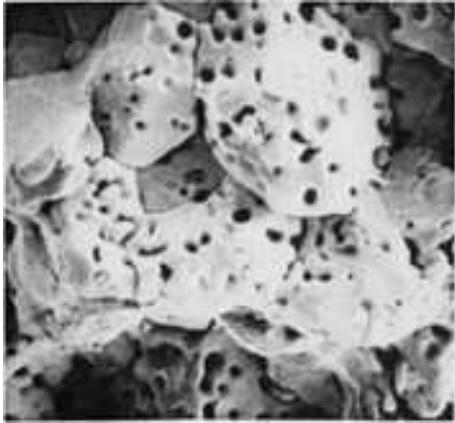
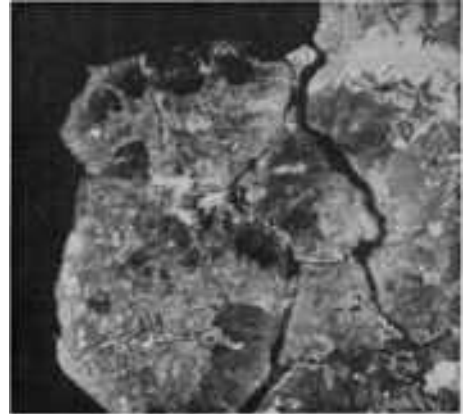
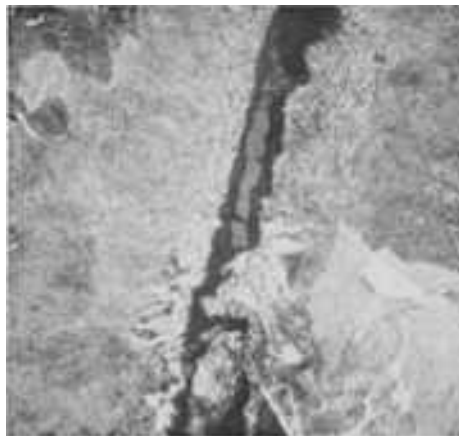
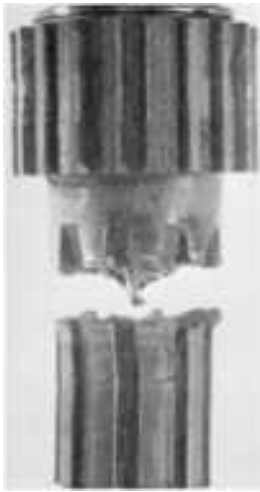
**Fig. 367**

Fracture of AISI 4146 axle due to improper induction hardening that caused burning (incipient melting). A surface hardness of 50 to 58 HRC was specified. Actual hardness: approximately 15 HRC. Fig. 367: Fracture surface of shaft. Fig. 368: Fractography of intergranular portion of fracture surface. SEM, 15 $\times$ . Fig. 369: Higher-magnification fractograph of intergranular portion of fracture surface (see Fig. 368) reveals partial melting of grain boundaries. Also note very large grain boundaries. SEM, 90 $\times$ . Fig. 370: Microstructure of intergranular region of fracture surface. 2% nital, 165 $\times$ . Fig. 371: High-magnification view of microstructure at burned grain boundary. Note decarburization, intergranular oxidation, and presence of spheroidal oxides. 2% nital, 920 $\times$  (Z. Flanders, Packer Engineering Associates, Inc.)

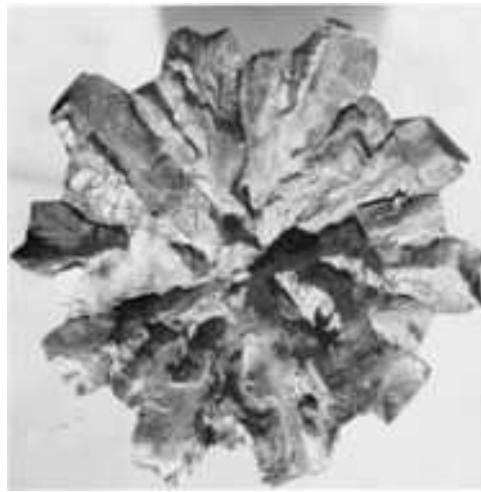
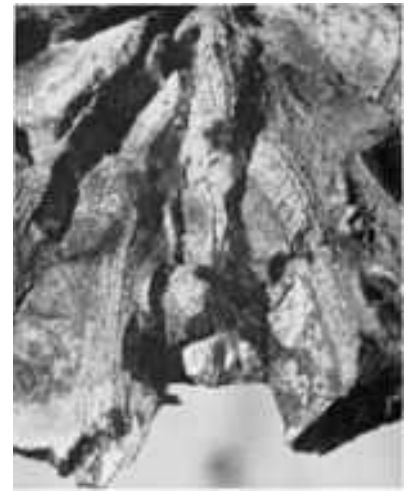
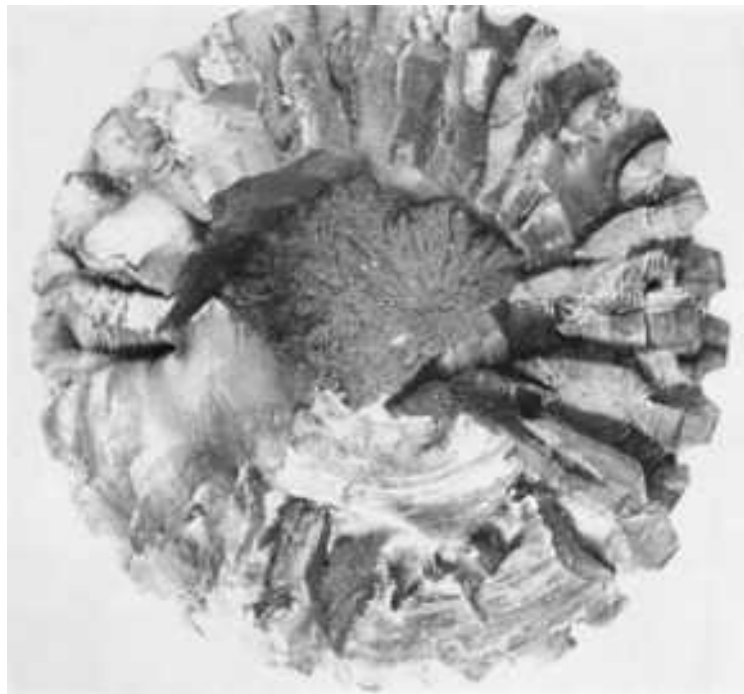
**Fig. 372**

Figure 372 shows a fractured AISI 4150 steel splined shaft heat treated to a hardness of 43 HRC. Note that there is a secondary transverse crack below the main fracture. Figure 373 is a view of one surface of the fracture in Fig. 372, showing a very complicated starlike pattern. Close examination of the many arms of the "star" reveals the presence of fatigue beach marks produced by crack fronts that propagated separately but simultaneously. Particularly evident are the beach marks on the arms at bottom, which are shown at higher magnification in Fig. 374. Sharp radii at the bases of the spline appear to have been the origins of the fatigue cracks. Fig. 372: 0.5 $\times$ . Fig. 373: 1.5 $\times$ . Fig. 374: 3.5 $\times$

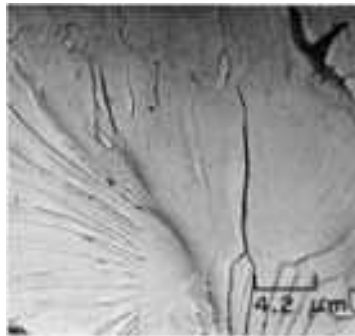
**Fig. 376** Surface of a tension-overload fracture in a specimen of AISI 4315 steel that was quenched from 980 °C (1800 °F) and tempered at 315 °C (600 °F). Note the large, equiaxed dimples. TEM p-c replica, 3600×

**Fig. 377** Surface of a transgranular cleavage fracture, caused by hydrogen embrittlement, in AISI 4315 steel heat treated same as Fig. 376. Note cleavage steps that originated at tilt boundaries. TEM p-c replica, 2400×

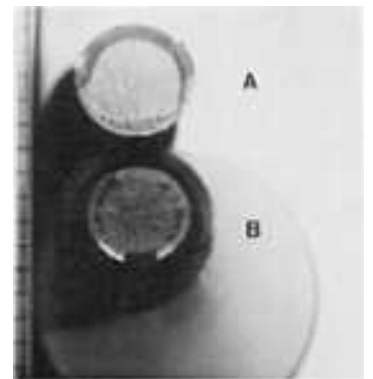
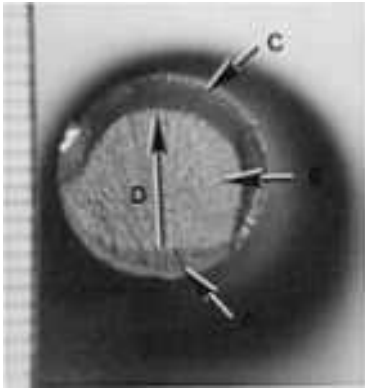
**Fig. 378**

How hydrogen damage affects fracture in AISI 4340. Shown are side views (Fig. 378) and fracture surfaces (Fig. 379) of 13-mm (0.505-in.) diam tensile specimens. Specimen A was tempered at 400 °C (750 °F) for 114 min in argon. Note specimen B's more ductile behavior in the tensile test. See also Fig. 380, 381, 382, 383, and 384. Both at actual size (S. Harding and S.W. Stafford, University of Texas)

Fractographic analysis of AISI 4340 specimen tempered in hydrogen (specimen A) in Fig. 378 and 379. Fig. 380: Fracture surface showing region of ductile crack growth and crack initiation site (A), region of rapid crack growth indicated by presence of radial lines (B), a shear lip (C), and the direction of crack propagation in the region of rapid crack growth (arrow D). 2.5 $\times$ . Fig. 381: Fractograph of region of subsurface crack initiation (B in Fig. 380). Note large transgranular crack and very small dimples. SEM, 550 $\times$ . Fig. 382: Fractograph reveals predominantly cleavage (transgranular) rupture (facet indicated by arrow) in hydrogen-embrittled specimen of AISI 4340. SEM, 220 $\times$  (S. Harding and S.W. Stafford, University of Texas)

Fractographic analysis of AISI 4340 specimen tempered in argon (specimen B in Fig. 378 and 379). Fig. 383: Fracture surface showing an area of microvoid coalescence and crack initiation at the central fibrous zone (A), radial lines emanating from the center and indicating rapid crack growth (B), and a shear lip (C). This was a typical cup-and-cone fracture. 3 $\times$ . Fig. 384: Fractograph reveals equiaxed dimples characteristic of ductile fracture in tension. 224 $\times$  (S. Harding and S.W. Stafford, University of Texas)

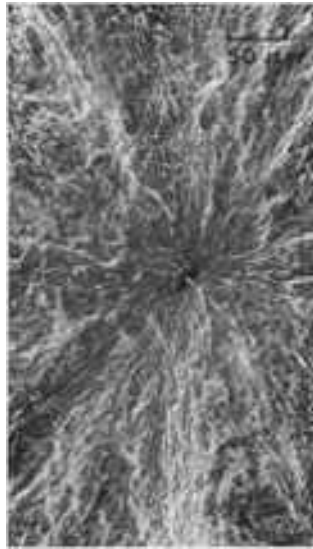
**Fig. 385** Surface of a fatigue fracture that occurred in tension-tension ( $R = 0.1$ ) in a test bar of electroslag remelt AISI 4340 steel heat treated to a hardness of 55 HRC. The origin of the fracture is an inclusion at the center of the "star" at right. See also Fig. 386, 387, 388, 389, and 390. SEM, 20×

**Fig. 386** A higher-magnification view of the center of the "star" in Fig. 385, showing the inclusion (dark, at center) that initiated the crack. Fine radial marks are evident. See also Fig. 387. SEM, 200×

**Fig. 389** Same fracture surface as in Fig. 385, but a view from the region of fast fracture. Typical dimples and local facets of quasi-cleavage. See also Fig. 390. SEM, 2000×

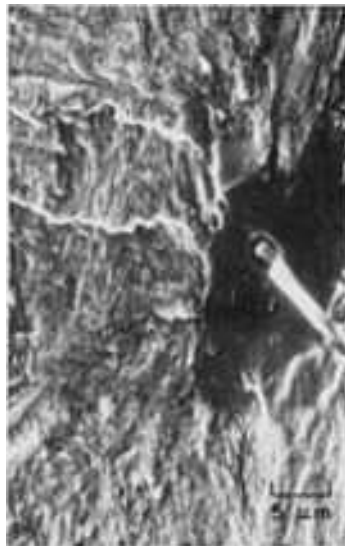
**Fig. 387** Higher-magnification view of the inclusion (fracture origin) shown at center in Fig. 386. Little evidence of fatigue striations is found this close to the origin. See also Fig. 388. SEM, 2000×

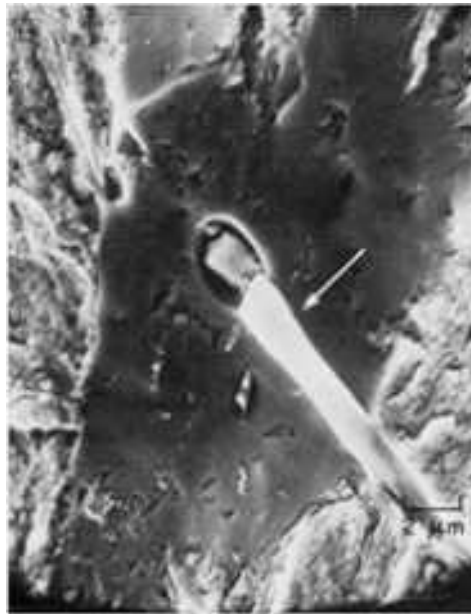
**Fig. 388** View, at still higher magnification, of the inclusion in Fig. 386 and 387, showing that the inclusion was fractured by cleavage. The cleavage surface bears a bright metal silver (at arrow). SEM, 5000×

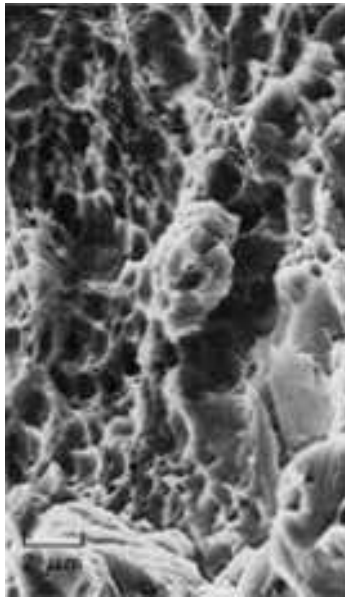
**Fig. 390** Higher-magnification view of the area within the rectangle in Fig. 389, showing more distinctly that the dimples are present in a wide variety of sizes. SEM, 5000×

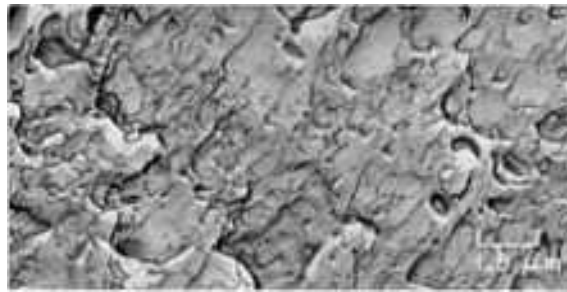
**Fig. 391** Surface of a fracture in an unnotched specimen of AISI 4340 steel that was broken in tension overload, displaying elongated and quite flat shear dimples. Note that some crude steps have formed, which suggests that there may have been some degree of pulsation in the applied stress during testing. TEM p-c replica, 6500×

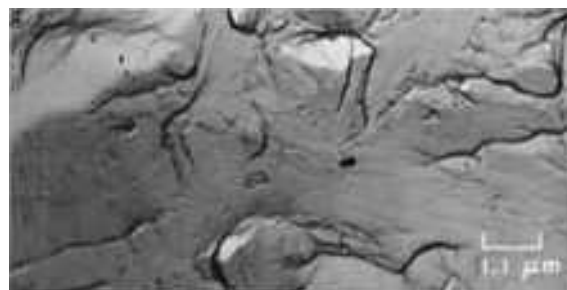
**Fig. 392** Surface of a fracture in a notched specimen of AISI 4340 steel that was broken in tension overload, showing scattered dimples. It is not certain whether the remainder of the surface in this area consists of quasi-cleavage facets or of large dimples that have undergone appreciable stretching. TEM p-c replica, 9300×

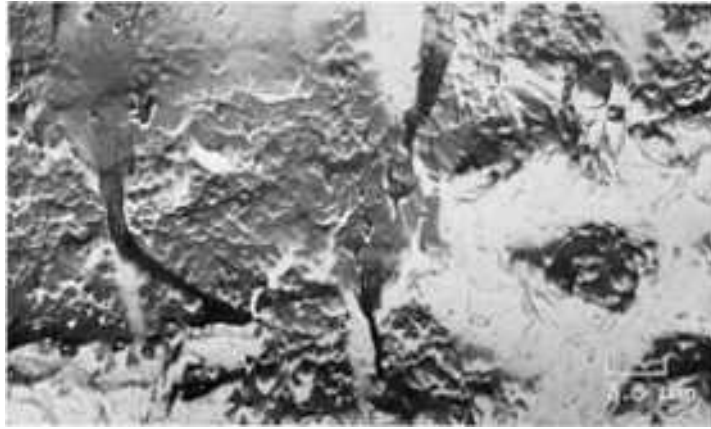
**Fig. 393** Surface of a fracture in a specimen of AISI 4340 steel that was broken by impact at room temperature, showing small dimples of quite uniform size, some of which (at right) are equiaxed. At left are elongated tear dimples pointing toward a tear ridge (at bottom). At upper left are regions in which considerable local stretching has occurred. Some secondary cracking may be present. TEM p-c replica, 3000×

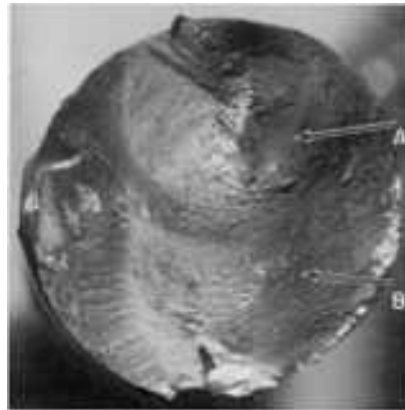
**Fig. 394** Torsion-overload fracture in AISI 4340 steel oil quenched from 845 °C (1550 °F) and tempered at 635 °C (1175 °F) to a tensile strength of 931 MPa (135 ksi). In general, the fracture surface is flat and shiny. See Fig. 395 and 396 for TEM views of areas A and B.

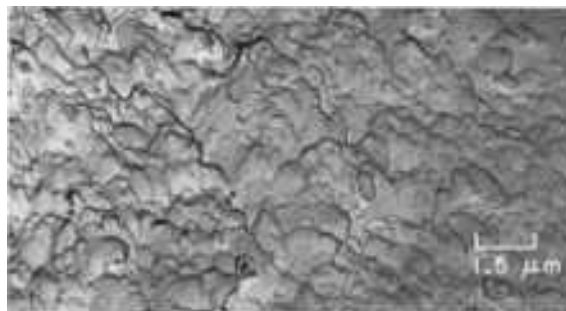
**Fig. 395** TEM p-c replica of an area near letter A (in region of final rupture) in the torsion-overload fracture shown in Fig. 394, showing dimples, some of which are slightly elongated but many of which are essentially equiaxed. 6500×

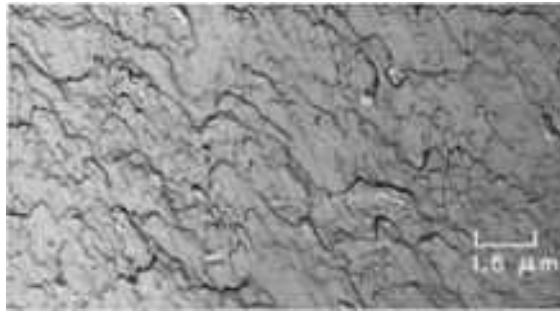
**Fig. 396 TEM p-c replica of an area near letter B in Fig. 394. The flat and noticeably elongated shear dimples present here are to be expected in this region, which in Fig. 394 (at lower magnification) shows an appreciable amount of torsional deformation. 6500×**

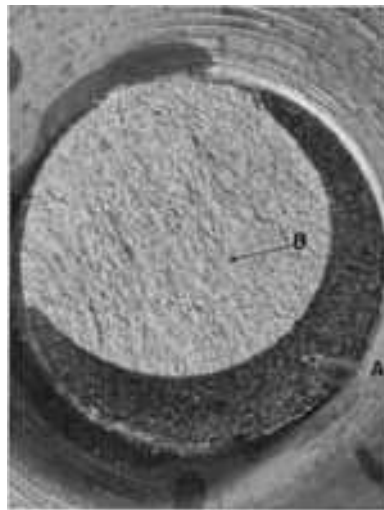
**Fig. 397 Impact fracture in AISI 4340 steel machined to a 50-mm (2-in.) diam, 38-mm ( $1\frac{1}{2}$ -in) long cylinder with a 13-mm ( $\frac{1}{2}$ -in.) diam, 25-mm (1-in.) long central projection from one end. Specimen was heat treated 45 min at 815 °C (1500 °F) and water quenched, but not tempered; then projection was broken by hammer blow. The dark crescent (A) is a quench crack, light area (B) is the impact fracture. See also Fig. 398, 399, 400, 401, and 402. 5×**

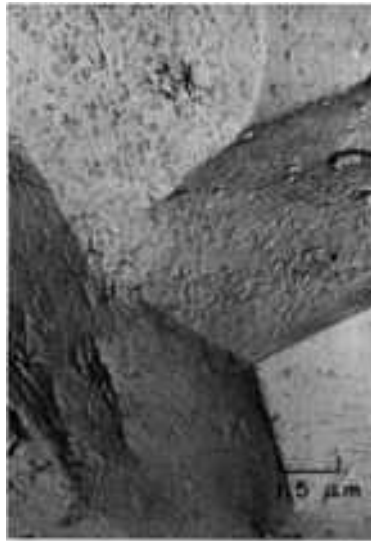
**Fig. 398 TEM p-c replica taken from area A (the quench-crack crescent) in the impact fracture surface shown in Fig. 397. Here, the crack is completely intergranular in nature, having faithfully followed the grain interfaces. Traces of oxidation are evident. See also Fig. 399 and 400. 6500×**

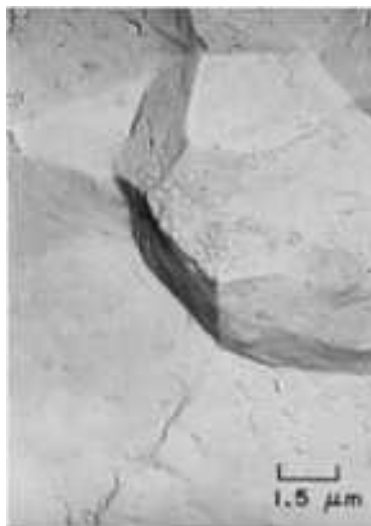
**Fig. 399 TEM p-c replica from a different region in area A (the quench-crack crescent) in the fracture surface shown in Fig. 397. Here, as well as in Fig. 398, the crack path has been along the grain interfaces. Scattered marks here resemble the hairline indications associated with either hydrogen embrittlement or stress-corrosion cracking. 6500×**

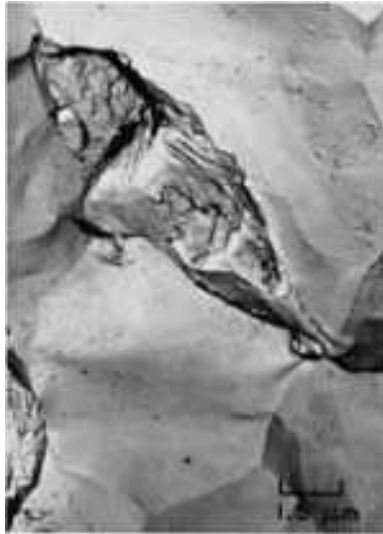
**Fig. 400 TEM p-c replica taken near the root of the quench crack, marked A, in Fig. 397. In addition to separated-grain facets, localized regions of transgranular tearing are visible. The grain facets are clean of oxidation, although they display a few hairline indications. 6500×**

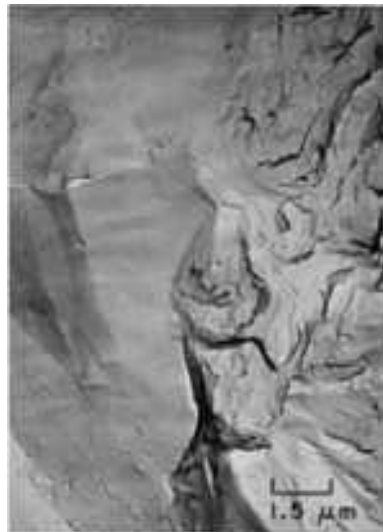
**Fig. 401 TEM p-c replica taken at the root of the quench crack, marked A, in Fig. 397, and the beginning of the impact fracture, marked B there. At left are the last vestiges of intergranular cracking, and at right is the beginning of quasi-cleavage cracking in this very brittle specimen. 6500×**

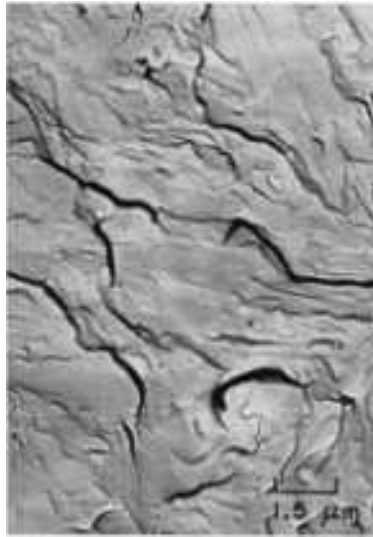
**Fig. 402** TEM p-c replica from deep within the impact fracture area, B, in Fig. 397, showing the quasi-cleavage characteristics of this brittle, untempered specimen. No large facets are visible; this suggests that the specimen had a fine grain size. Many steps exist in the crack path. 6500×

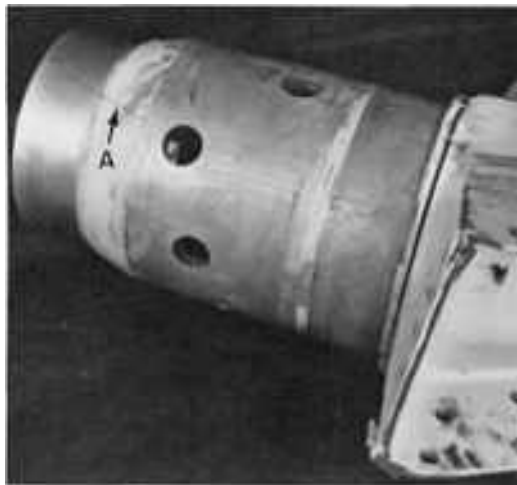
**Fig. 403** View of an aircraft horizontal tail-actuator shaft that was found during a preflight inspection to contain several cracks (one is shown at A). The shaft was forged from AISI 4340 steel, was heat treated to a minimum tensile strength of 1793 MPa (260 ksi) and a hardness of 50 to 53 HRC, and then was vacuum cadmium plated. Cracks were attributed to hydrogen embrittlement. See also Fig. 404, 405, 406, 407, 408, 409, 410, 411, and 412. 0.5×

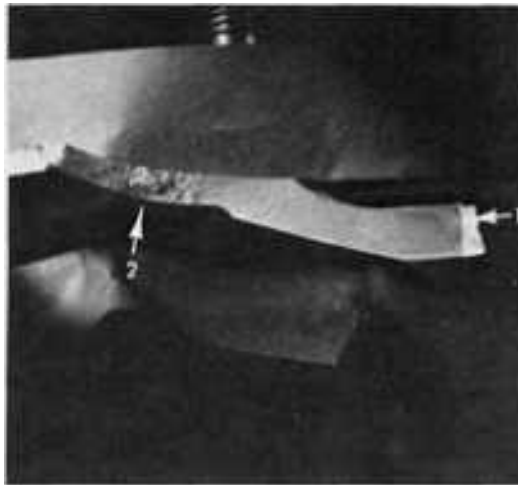
**Fig. 404** Surface of the crack visible at A in Fig. 403, opened for examination, showing two internal points of crack nucleation, which are marked 1 and 2 and are shown at higher magnification in Fig. 405 and 406. Neither this crack nor any other crack found in this shaft or in companion shafts showed evidence of the corrosion products (red rust) that would be expected if stress corrosion had been involved. Actual size

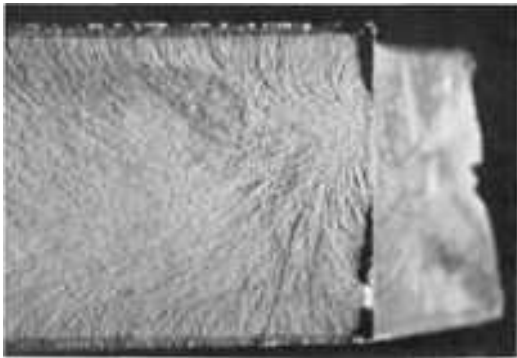
**Fig. 405**

Enlarged views of the internal points of crack nucleation shown in Fig. 404. In Fig. 405, which includes point 1, chevron marks indicate that direction of fracture was right to left; shear lips are present at the borders. Figure 406, which includes point 2, shows secondary cracking. See also Fig. 407, 408, and 409. Both at 7×

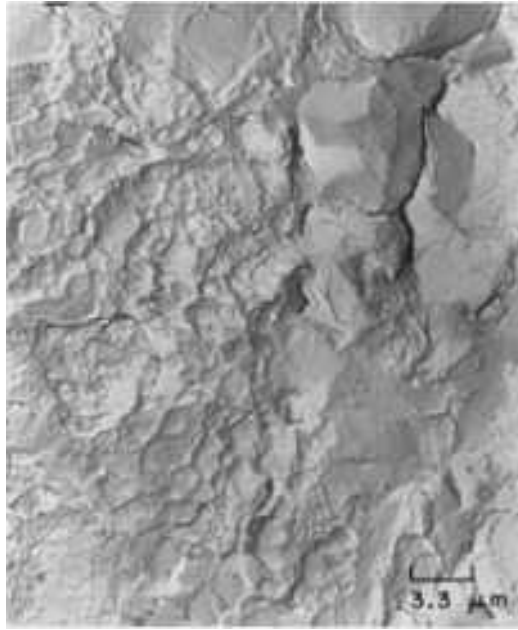
**Fig. 407 TEM p-c replica of a region near the right edge of the fracture surface in Fig. 405, showing a transition from intergranular facets (at right) to dimples (at left). This transition is typical of all cracks in the actuator shaft that originated near holes, in each instance, transition occurred at 0.5 to 1.8 mm (0.02 to 0.07 in.) from the edge of the hole. 3000×**

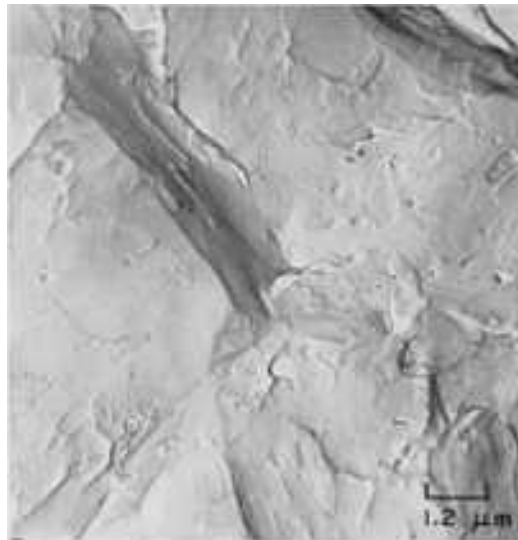
**Fig. 408 TEM p-c replica of a region centered on the crack-nucleation point visible near the right edge of the fracture surface shown in Fig. 405. The surface is intergranular and free of corrosion products, which is consistent with fracture caused by hydrogen embrittlement. 8000×**

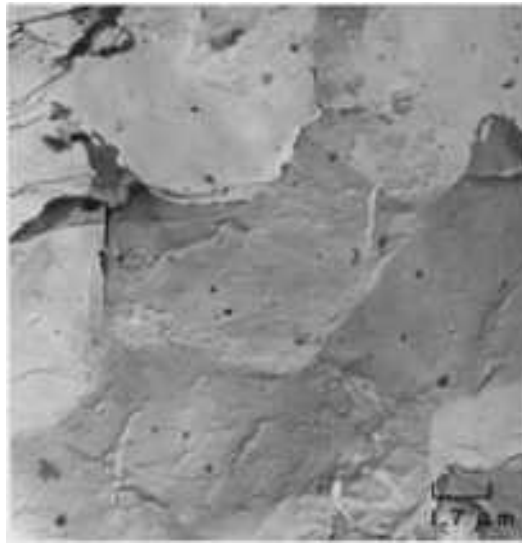
**Fig. 409** TEM p-c replica of a region containing the crack-nucleation site near point 2 in Fig. 404. The features that are visible in this region are the same as those in the region shown in Fig. 408, which further indicates that hydrogen embrittlement caused the cracks. 6000×

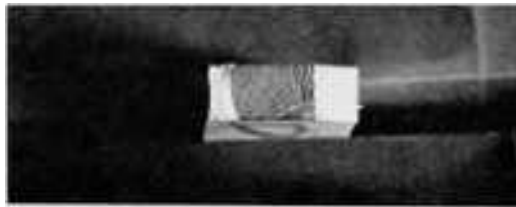
**Fig. 410**

Views, at two magnifications, of a crack 135° around the shaft from the crack at A in Fig. 403, opened for examination. The point of crack nucleation was internal. The crack then propagated both inward and outward, as shown by the chevron marks and shear lips. Fig. 410: Actual size. Fig. 411: 7×

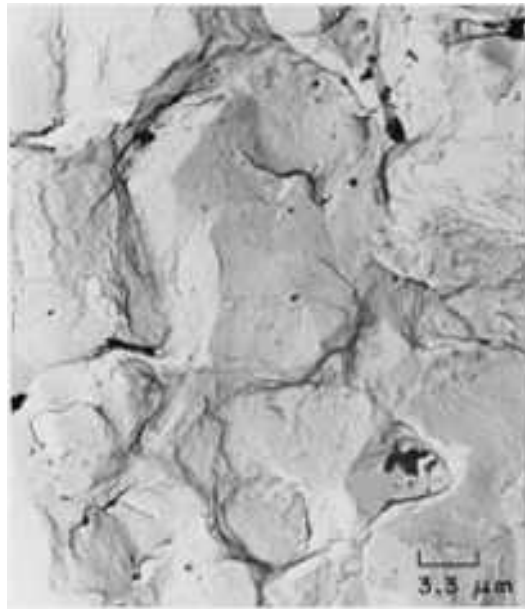
**Fig. 412** TEM p-c replica of a region containing a point of nucleation in a crack very similar to those shown in Fig. 404 and 411, in a companion actuator shaft. This surface shows all of the intergranular characteristics of fracture by hydrogen embrittlement seen in Fig. 408 and 409. 3000×

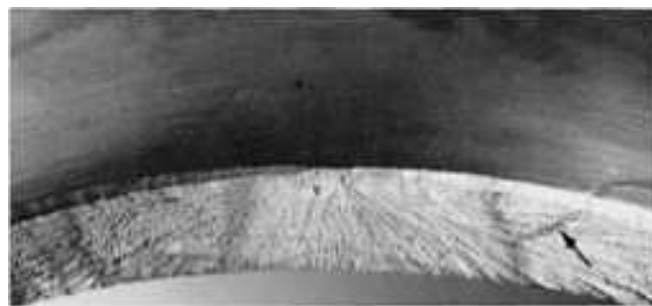
**Fig. 413** Surface of a low-cycle fatigue fracture in an aircraft landing-gear cylinder made of AISI 4340 steel that was hardened and tempered to a tensile strength of 1793 to 1931 MPa (260 to 280 ksi). The cylinder was stressed in the laboratory to its tensile strength four times and broke at a stress of 1103 MPa (160 ksi) during the final loading. Note the secondary crack (arrow) to the right of the crack origin (at center), representative of many that extended completely through the wall of the cylinder. See also Fig. 414, 415, 416, and 417. 2×

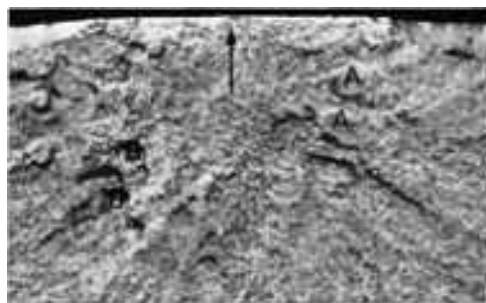
**Fig. 414** Higher-magnification view of the crack-origin area of the fracture surface in Fig. 413. Fracture originated at a small surface crack (visible at arrow) that was present prior to testing. The small flat-topped projections (at A's) and flat-bottomed depressions (at B's) were not found elsewhere in the fracture surface. See also Fig. 415, 416, and 417. 14×

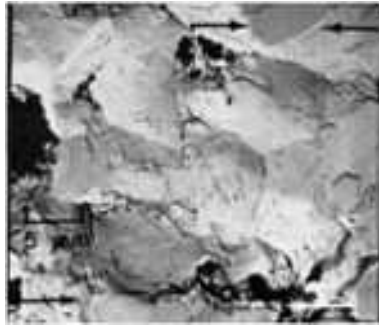
**Fig. 415 TEM p-c replica of a portion of the surface crack in Fig. 414, where fracture originated. Note rubbed areas between arrows. The facets are intergranular; the opaque particles lie 0.05 to 0.075 mm (0.002 to 0.003 in.) below the outer surface of the cylinder. 2000×**

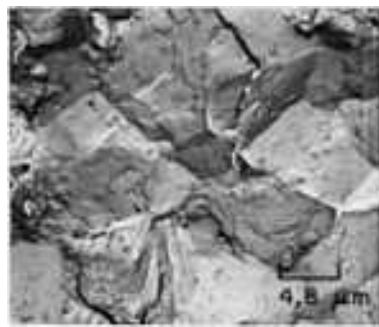
**Fig. 416 TEM p-c replica of the fracture surface in Fig. 414, showing a region 0.25 mm (0.01 in.) below the outer surface. The mixture of intergranular facets and dimples shown here is typical of some plane-strain fracture surfaces in AISI 4340 steel. 2100×**

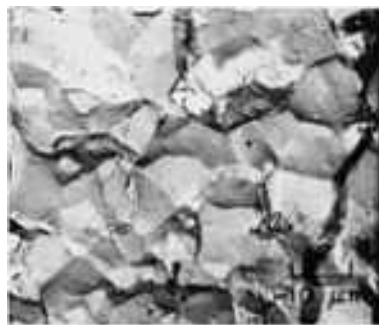
**Fig. 417 TEM p-c replica of the fracture surface in Fig. 414, showing a region at the bottom of a depression directly below the surface crack. In this entire area of projections and depressions (see Fig. 414), fracture was completely intergranular. 1000×**
