ASM HANDBOOK®

VOLUME  
12

Fractography

*Fractography*, was published in 1987 as Volume 12 of the *ASM Handbook*. The Volume was prepared under the direction of the ASM Handbook Committee.

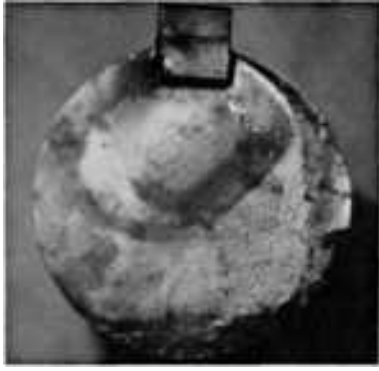
**Fig. 418**

Fatigue failure of shaft on bucket elevator used to handle asphalt. Fracture of the AISI 4340 part (330 HB) initiated at an area of fretting wear in the keyway. The bending stress was calculated at just 131 MPa (19 ksi), but the stress riser due to fretting increased this by a factor of 2 to 4. Fig. 418: Fracture surface of shaft with key in place. 0.35 $\times$ . Fig. 419: Origin of the fatigue crack was an area of fretting located halfway up the keyway. 0.98 $\times$ . Fig. 420: Sidewall of keyway. Arrow points to fretting. 1.05 $\times$  (Z. Flanders, Packer Engineering Associates, Inc.)

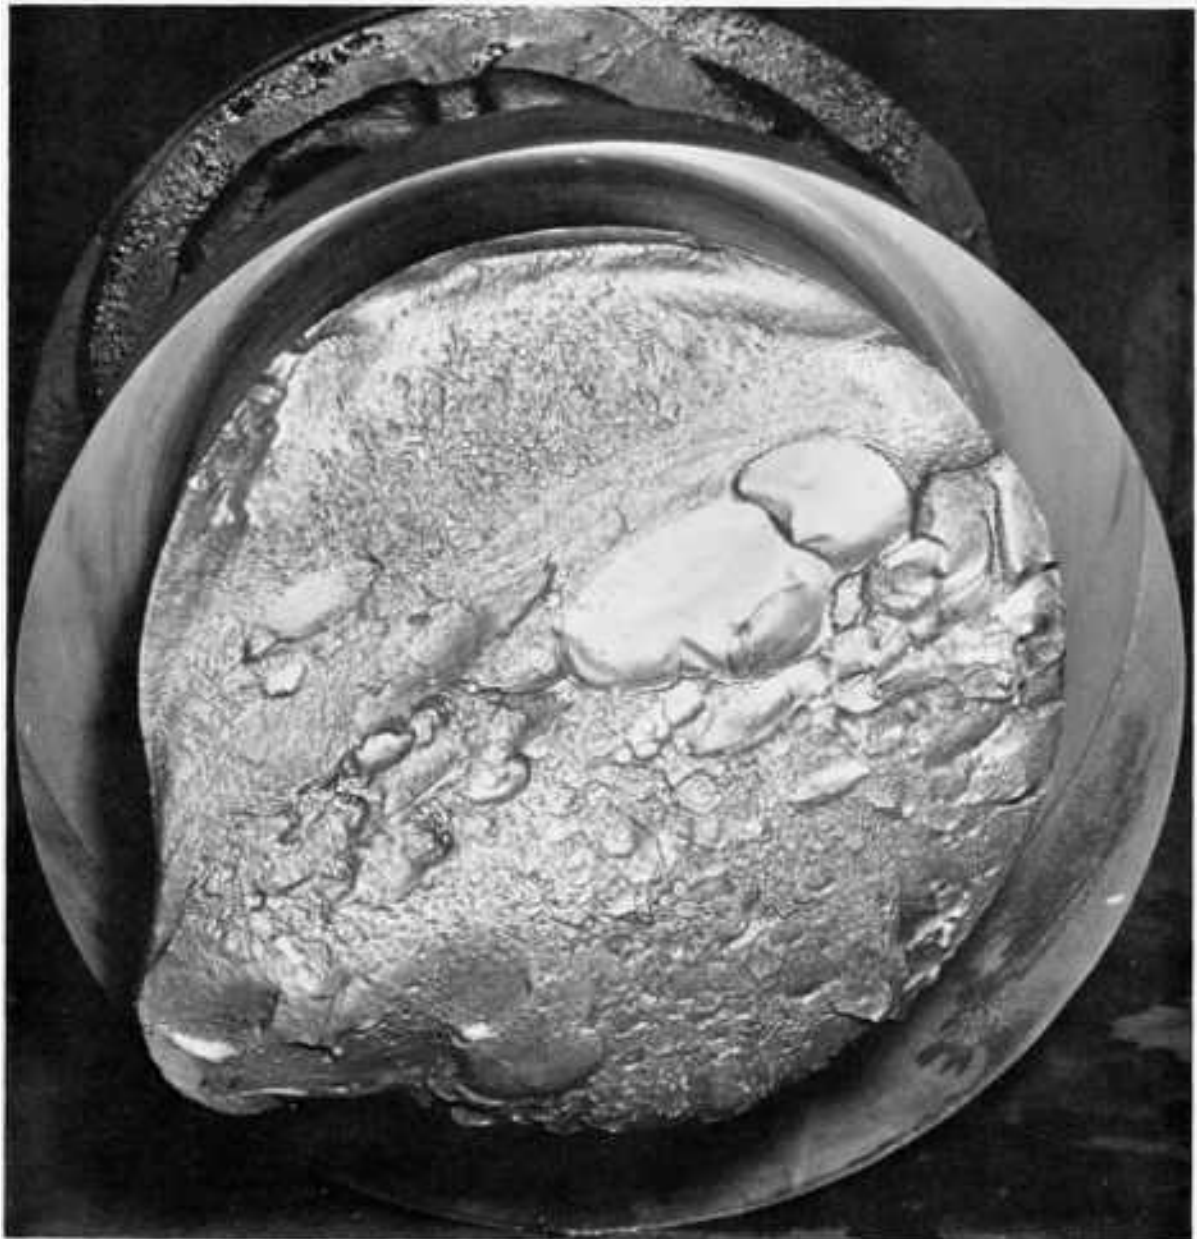
**Fig. 421 Surface of a fatigue fracture through a journal of a crankshaft for a 150-mm (6-in.) upsetting machine. The crankshaft was forged of AISI 4340 steel and was normalized to a yield strength of 593 MPa (86 ksi), a tensile strength of 807 MPa (117 ksi), 20.5% elongation, and a hardness of 232 HB. Specimens cut from the crankshaft and reheat treated in exact accordance with prescribed practice had a tensile strength of 945 MPa (137 ksi), 18% elongation, and a hardness of 277 HB. The increased tensile strength and hardness indicate that the original heat treatment of the crankshaft was improper and led to a short fatigue life. See Fig. 422 for a view of the mating fracture surface. Actual size**

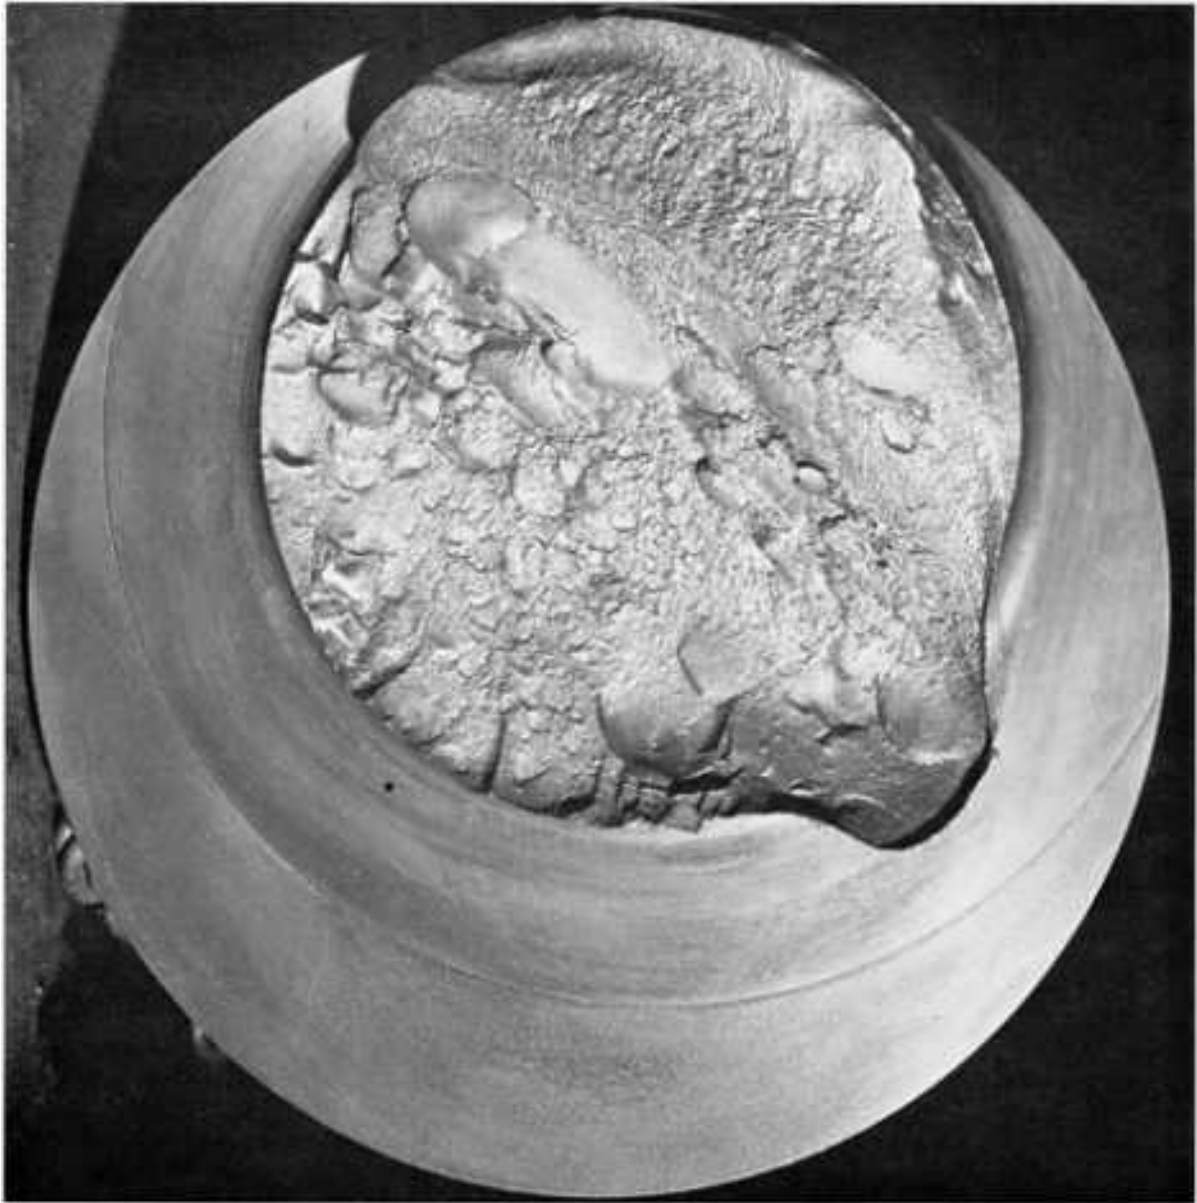
**Fig. 422 View of the mating fracture surface to that shown in Fig. 421. The illumination here is at a different angle from that in Fig. 421, with the result that in some locations it is difficult to determine which of the features are projections and which are depressions. It appears likely that there were several fatigue-crack nuclei around the journal perimeter; the principal nucleus probably was in the rubbed area at upper right here (upper left in Fig. 421). There is a possibility that the crankshaft contained forging flakes and that some of these flakes were exposed during machining of the journal and initiated the fatigue cracks. 0.88×**

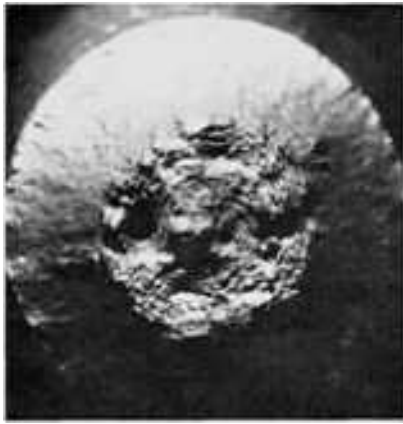
**Fig. 423**

Surfaces of tension-overload fractures produced at different temperatures in three unnotched specimens of AISI 4340 steel, heat treated to a hardness of 35 HRC. The specimen in Fig. 423 was tested at 160 °C (320 °F). A shear lip is visible, surrounding a fibrous region. The specimen in Fig. 424 was tested at 90 °C (195 °F). At this lower test temperature, a radial fracture zone formed around the fibrous region, which formed first; also, the shear lip here is smaller than that in Fig. 423. The specimen in Fig. 425 was tested at -80 °C (-110 °F). At this still lower test temperature, no fibrous region formed. Instead, fracture formed a radial zone that extends nearly to the specimen surface and terminates in a narrow shear lip. All at 15×

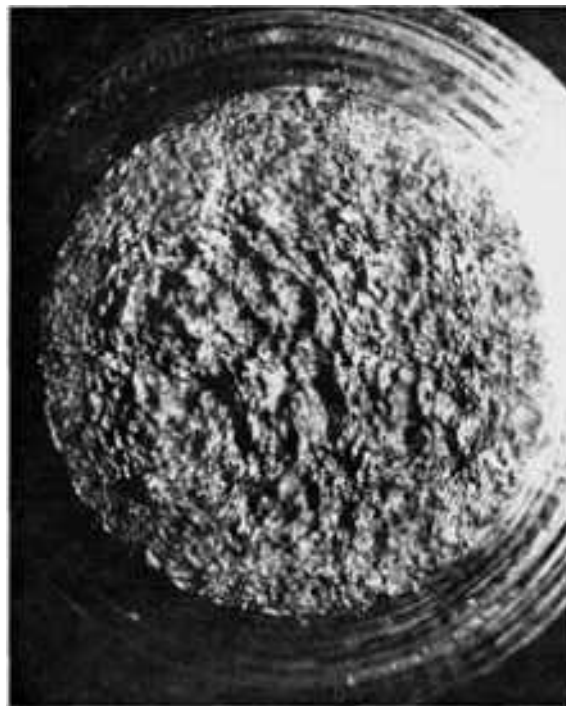
**Fig. 426** Tension-overload fracture in a notched specimen of AISI 4340 steel, heat treated to a hardness of 27 HRC and tested at -40 °C (-40 °F), showing a completely fibrous surface. See Fig. 427 and 428 for fractures in similar specimens tested at different temperatures. 17×

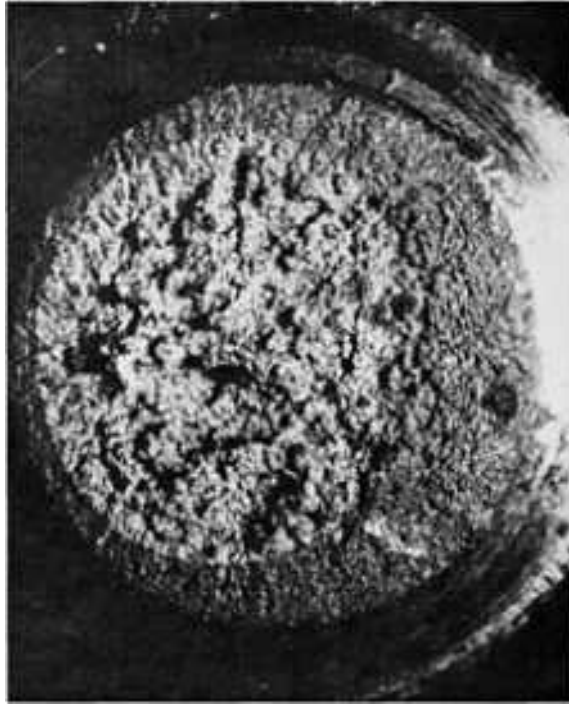
**Fig. 427** Surface of a tension-overload fracture in another notched specimen of AISI 4340 steel, the same as in Fig. 426, but tested at  $-120\text{ }^{\circ}\text{C}$  ( $-185\text{ }^{\circ}\text{F}$ ). Two distinctly different fracture-surface zones are visible; a fibrous zone, which originated at the notch, surrounds a radial region of final fast fracture.  $17\times$

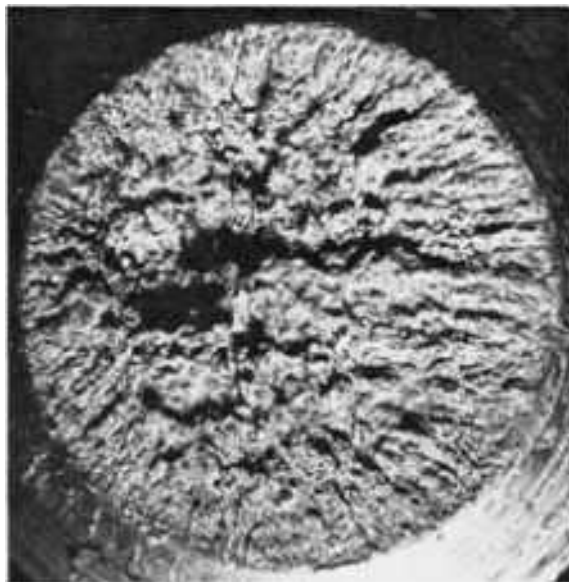
**Fig. 428** Surface of tension-overload fracture in a third notched specimen of AISI 4340 steel, the same as those in Fig. 426 and 427, but tested at  $155\text{ }^{\circ}\text{C}$  ( $-245\text{ }^{\circ}\text{F}$ ). At this low test temperature, a completely radial fracture was produced. The surface shows no fibrous zone, only radial marks.  $17\times$

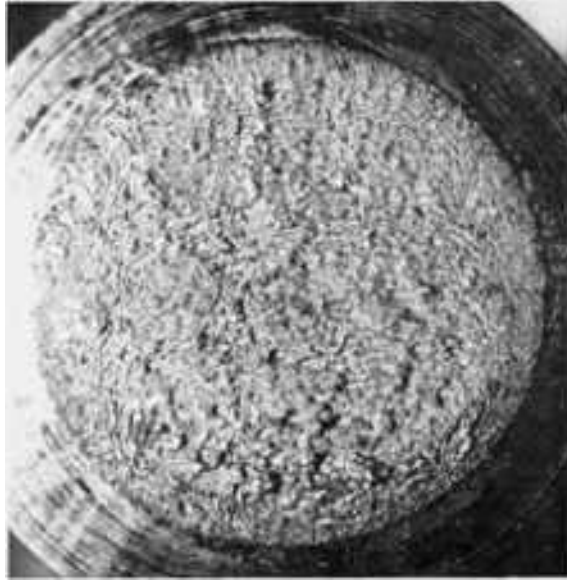
**Fig. 429** Tension-overload fracture in a notched specimen similar to those in Fig. 426, 427, and 428, but heat treated to a hardness of 35 HRC. Tested at  $-40\text{ }^{\circ}\text{C}$  ( $-40\text{ }^{\circ}\text{F}$ ). The surface shows only fibrous marks. See Fig. 430 and 431 for surfaces of fractures in similar specimens at different test temperatures.  $17\times$

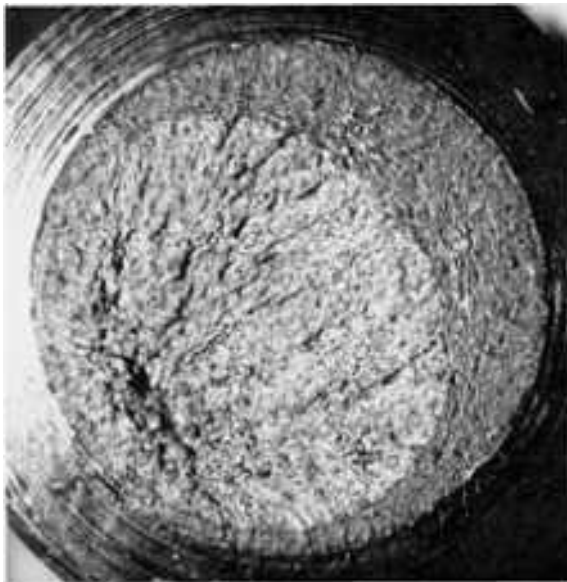
**Fig. 430** Surface of a tension-overload fracture in a notched specimen of AISI 4340 steel the same as the specimen shown in Fig. 429, but tested at  $80\text{ }^{\circ}\text{C}$  ( $-110\text{ }^{\circ}\text{F}$ ). A fibrous zone, which originated at the notch, surrounds a radial zone, which is off-center because of nonsymmetrical crack propagation.  $17\times$

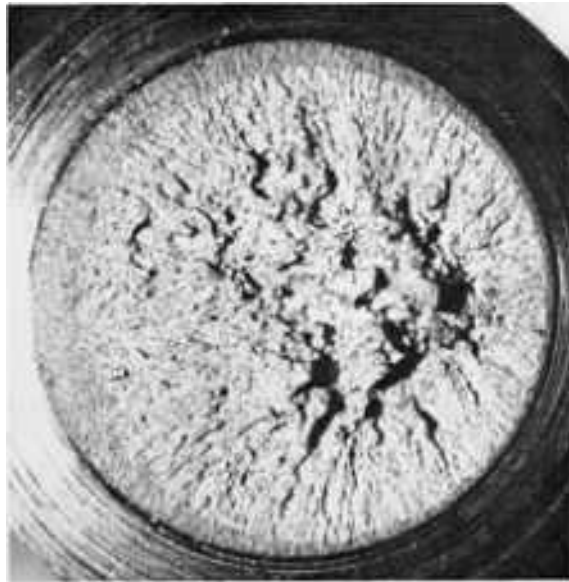
**Fig. 431** Tension-overload fracture in a notched specimen same as in Fig. 429 and 430, but tested at  $-155^{\circ}\text{C}$  ( $-245^{\circ}\text{F}$ ). Even at this very low temperature, a small annular zone of fibrous fracture was formed next to the notch. Final fast fracture produced the radial marks in the central region.  $17\times$

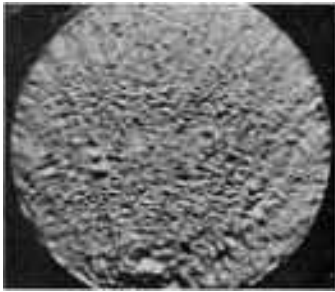
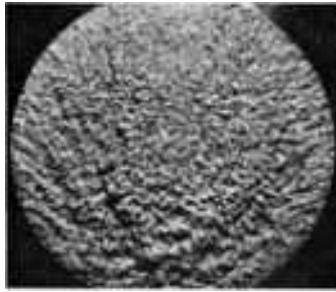
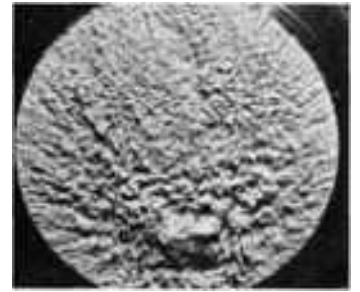
Shown above are fracture surfaces of three notched tensile-test specimens prepared from AISI 4340 steel that had been austenitized, quenched, and tempered at  $315^{\circ}\text{C}$  ( $600^{\circ}\text{F}$ ) to provide the following room-temperature properties: yield strength, 1558 MPa (226 ksi); unnotched tensile strength, 1758 MPa (255 ksi); notched tensile strength, 1765 MPa (256 ksi). The specimens were broken by tension overload at the temperature indicated beneath the fractographs. The fracture surface shown in Fig. 432 is completely fibrous. Lowering the test temperature from  $180^{\circ}\text{C}$  ( $356^{\circ}\text{F}$ ) to  $90^{\circ}\text{C}$  ( $194^{\circ}\text{F}$ ) resulted in the formation of a very narrow, obscure fibrous rim enclosing a zone of radial marks (see Fig. 433). Lowering the test temperature further, to  $26^{\circ}\text{C}$  ( $79^{\circ}\text{F}$ ), produced a fracture made up entirely of radial features (see Fig. 434). All at  $8\times$

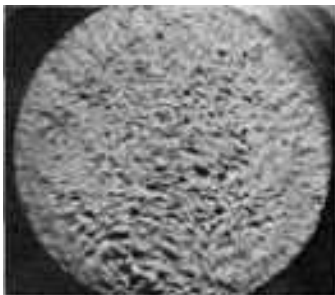
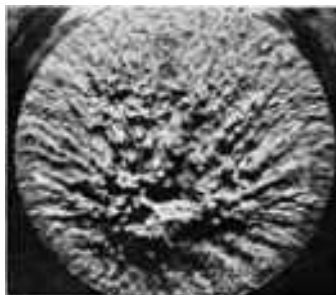
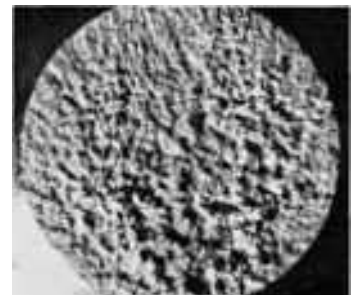
Shown above are fracture surfaces of three notched tensile-test specimens prepared from AISI 4340 steel that had been austenitized, quenched, and tempered at  $480^{\circ}\text{C}$  ( $895^{\circ}\text{F}$ ) to provide the following room-temperature properties: yield strength, 1234 MPa (179 ksi); unnotched tensile strength, 1310 MPa (190 ksi); notched tensile strength, 1903 MPa (276 ksi). The specimens were broken by tension overload at the

temperatures indicated beneath the fractographs. The specimen shown in Fig. 435 was broken at 0 °C (32 °F) but, in contrast to the specimen in Fig. 434, which was tempered at 315 °C (600 °F), yielded a completely fibrous fracture. The fracture shown in Fig. 436 which was produced at -80 °C (-112 °F), shows a fibrous rim surrounding a zone of radial marks. The fracture shown in Fig. 437, which was produced at -196 °C (-321 °F), shows only radial marks. All at 8×

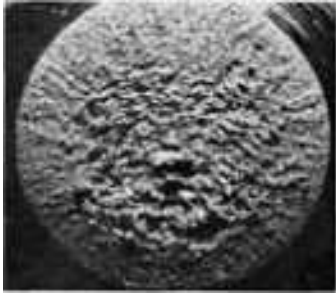
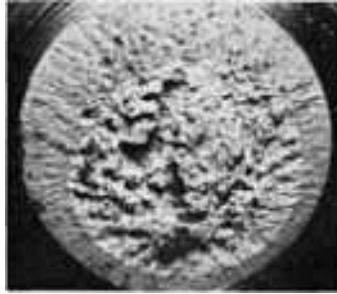
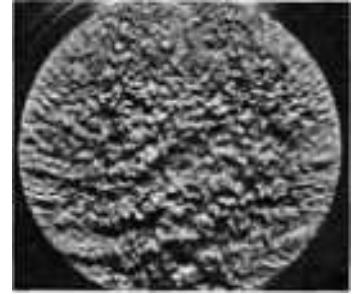
Fracture surfaces of three notched tensile-test specimens prepared from AISI 4340 steel that had been austenitized, quenched, and tempered at 650 °C (1200 °F) to provide the following room-temperature properties: yield strength, 917 MPa (133 ksi); unnotched tensile strength, 1014 MPa (147 ksi); notched tensile strength, 1489 MPa (216 ksi). The specimens were broken by tension overload at the temperatures indicated beneath the fractographs. The specimen shown in Fig. 438 was broken at -60 °C (-76 °F), but displays a completely fibrous surface. The fracture in Fig. 439 was produced at -130 °C (-202 °F); note the appreciable increase in the size of the fibrous zone, compared with that in Fig. 436, caused by the lower strength that resulted from tempering at 650 °C (1202 °F). The specimen in Fig. 440, which was broken at -196 °C (-321 °F), exhibits a fracture surface containing only radial marks. All at 8×

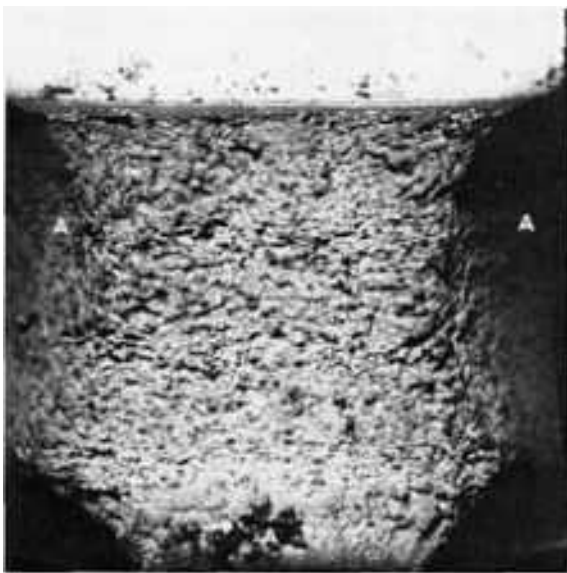
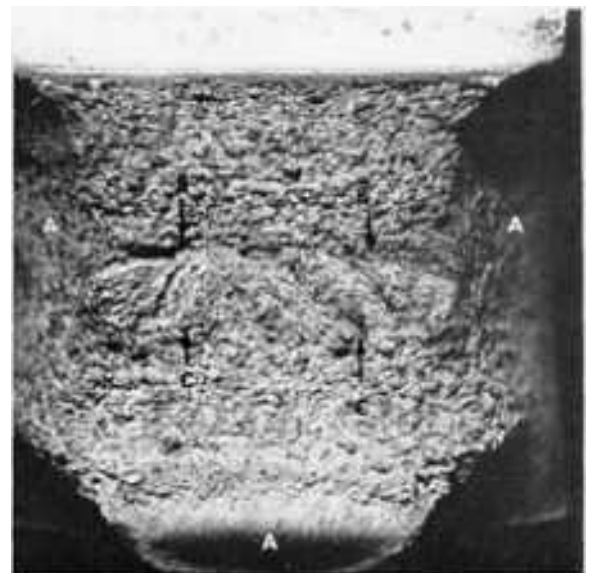
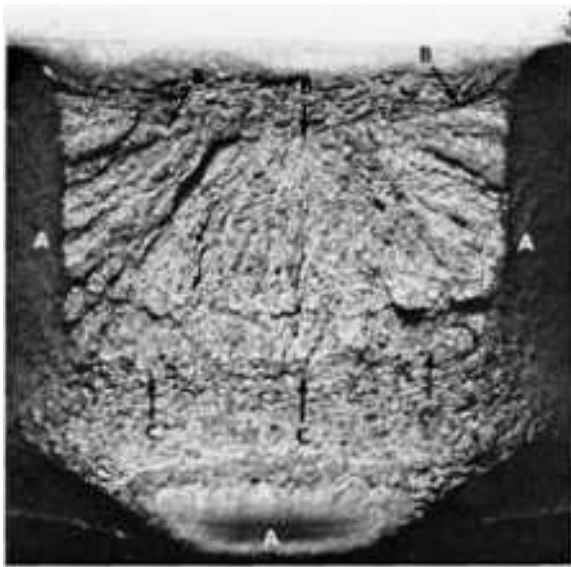
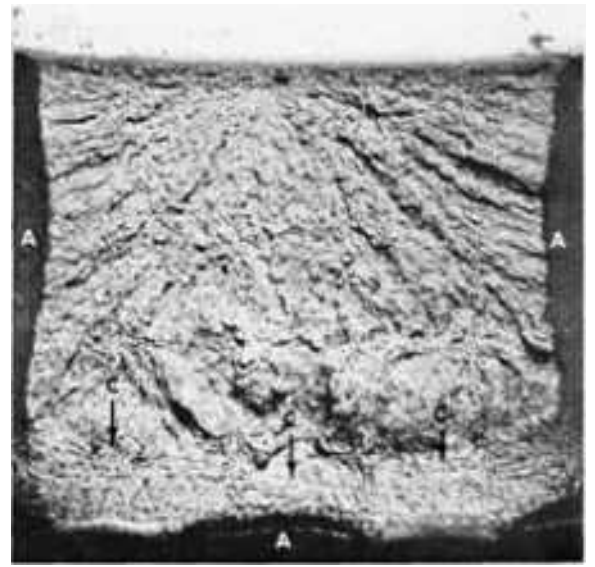
These four light fractographs show the surfaces of impact fractures in Charpy specimens of AISI 4340 steel heat treated to a hardness of 27 HRC and depict the changes in surface characteristics as test temperature was decreased. The specimen in Fig. 441, which was broken at -80 °C (-112 °F), shows a fibrous fracture surface containing shear lips (at A's). The specimen in Fig. 442 was broken at -90 °C (-130 °F). This temperature is close to the ductile-brittle transition temperature, as indicated by the presence of a small area of radial marks (between arrows B and arrows C) in the center of the otherwise fibrous fracture surface. Shear lips are present here also (at A's). The specimen in Fig. 443 was broken at -100 °C (-148 °F) and shows an area of radial marks (between arrows B and arrows C) much larger than that in Fig. 442, while retaining fibrous regions above arrows B (near the notch) and below arrows C. The shear lips here (at A's) are comparable to those in Fig. 441 and 442. The specimen in Fig. 444 was broken at -120 °C (-184 °F); its fracture surface contains a radial zone larger than that in Fig. 443, but still shows a small area of fibrous fracture below arrows C (opposite the notch). Also, the shear lips here (at A's) are appreciably smaller than those in Fig. 443. All at 10×

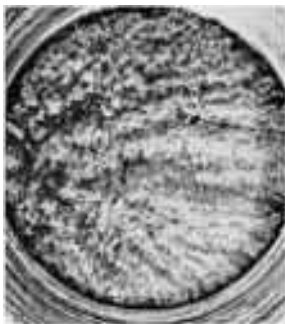
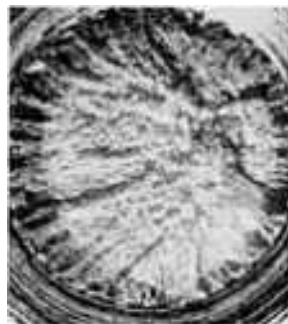
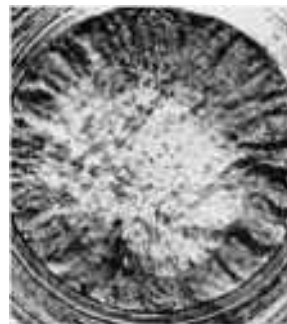
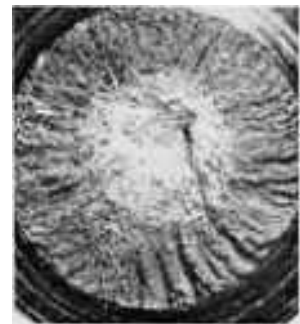
Surfaces of four tension fractures, which illustrate the effect of decreasing stress on the fracture-surface characteristics of notched specimens of AISI 4340 steel broken at room temperature. Notch radius was 0.025 mm (0.001 in.). Microstructure of all four specimens was tempered martensite. The specimen in Fig. 445 was broken by tension overload (notched tensile strength was 2006 MPa, or 291 ksi) and shows a relatively small fibrous zone at the right edge. The three other specimens were charged with hydrogen and then were subjected to sustained loading. The specimen in Fig. 446 broke in 1.65 h under a stress of 1379 MPa (200 ksi). The specimen in Fig. 447 broke after 5.35 h under a stress of 1034 MPa (150 ksi). The specimen in Fig. 448 fractured after 5.5 h under a stress of 689 MPa (100 ksi). Note that the progressive decrease in fracture stress from Fig. 445, 446, 447, and 448 was related to a progressive increase in the size of the fibrous zone. All at ~8×

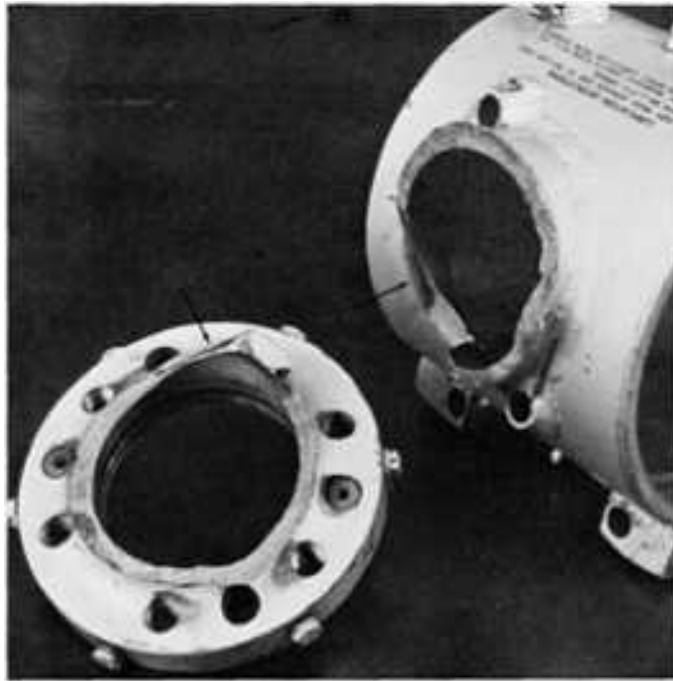
**Fig. 449** Mating segments of an aircraft propeller hub of quenched and tempered AISI 4340 steel that broke by fatigue, showing both surfaces of the fracture, which occurred at the welded joint between the barrel of the hub and the fitting for attachment of the hub to the hydraulic cylinder. Arrows indicate on each fracture surface the location of the fatigue-crack origin--at the toe of the weld bead, where a slight weld overlap had formed. See also Fig. 450. 0.5×

**Fig. 450** Fracture surface of the barrel portion of the broken hub in Fig. 449, showing the fatigue-crack origin. The fatigue crack was about 44 mm ( $1\frac{3}{4}$  in.) long, but had penetrated the hub wall completely for only about 3.2 mm ( $\frac{1}{8}$  in.) (arrows). Note shear lip at inside of hub wall on either side of the fatigue crack. 2×

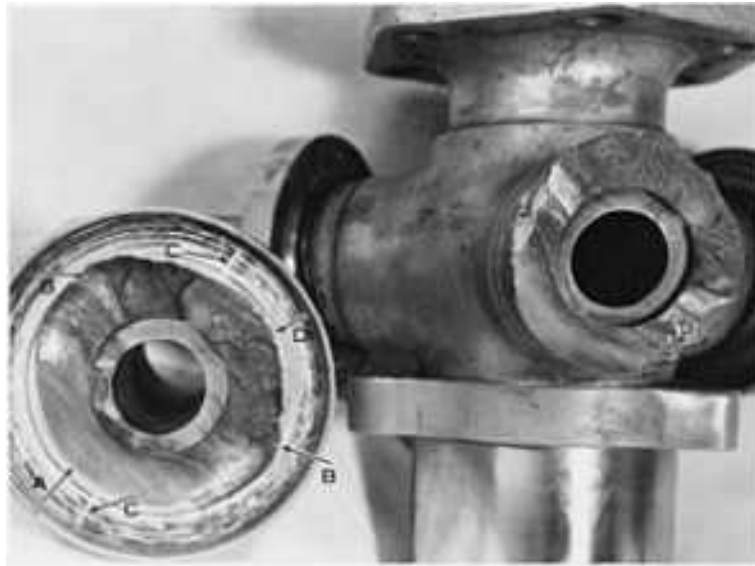
**Fig. 451** Mating surfaces of a fatigue fracture in a blade arm of a forged aircraft propeller-hub spider of AISI 4340 steel and through the central pilot tube of the arm. The fatigue crack originated in the fillet between the bearing-retention flange and the blade arm. Hardness of the forging was 35 HRC. The origin is at arrow A (lower left), at an inclusion. The fatigue crack penetrated as far as the locations indicated by arrows B before final fast fracture occurred. Alignment of the bearing-race parting line (arrows C) was not as specified. Arrow D indicates the region of final fast fracture. See Fig. 452 for a higher magnification view of this region. 0.6×

**Fig. 452** View of an area at arrow D in Fig. 451, in the region of final fast fracture. Fatigue patches are interspersed among areas of rapid crack advance, indicating that final fracture occurred in stages. 10×

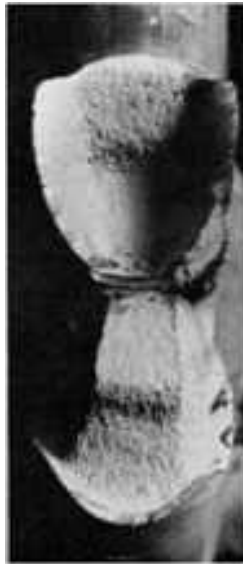
**Fig. 455** Matching fracture surfaces of an AISI 4340 steel helicopter bolt that was broken by notch bending. The fine markings are fibrous tear ridges. Note the very large shear lips. 2.5×

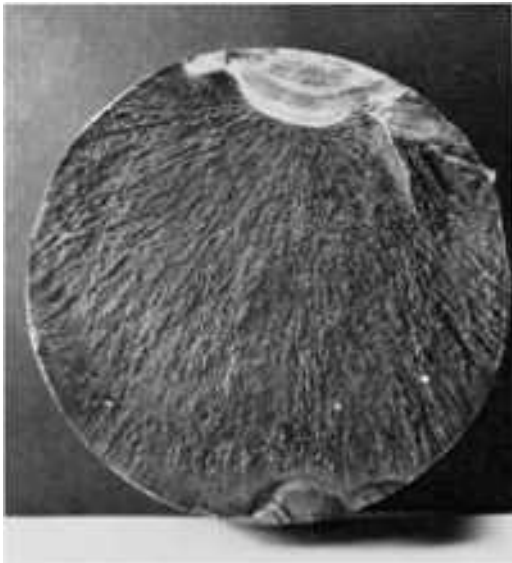
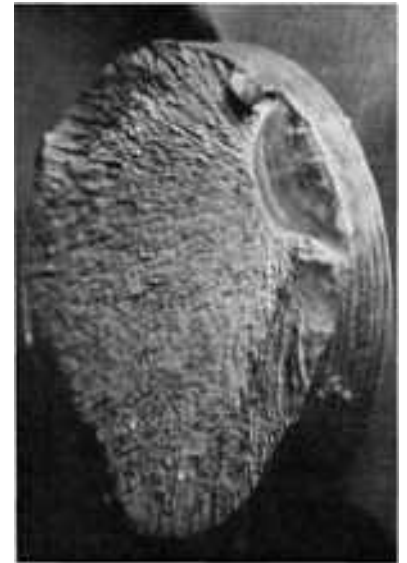
Two views of the surface of a fatigue fracture in a 145-mm ( $5\frac{3}{4}$ -in.) diam threaded piston rod of AISI 4340 steel heat treated to 341 HB. The full-face view in Fig. 453 shows plainly the beach marks in the region of the primary fatigue crack, at top. Secondary fatigue cracks are visible on either side of it, as well as the bottom. The oblique view in Fig. 454 reveals that the fatigue cracks began at the roots of the threads, the origin of the primary crack being two threads to the right of the abutting secondary cracks. Although these reduced-size views do not permit detailed scrutiny, it seems evident that the thread roots were too sharp, causing stress concentrations locally. Beyond the fatigue-zone limits, failure was by radial fibrous fast fracture. Fig. 453:  $\sim 0.5\times$ . Fig. 454:  $0.67\times$

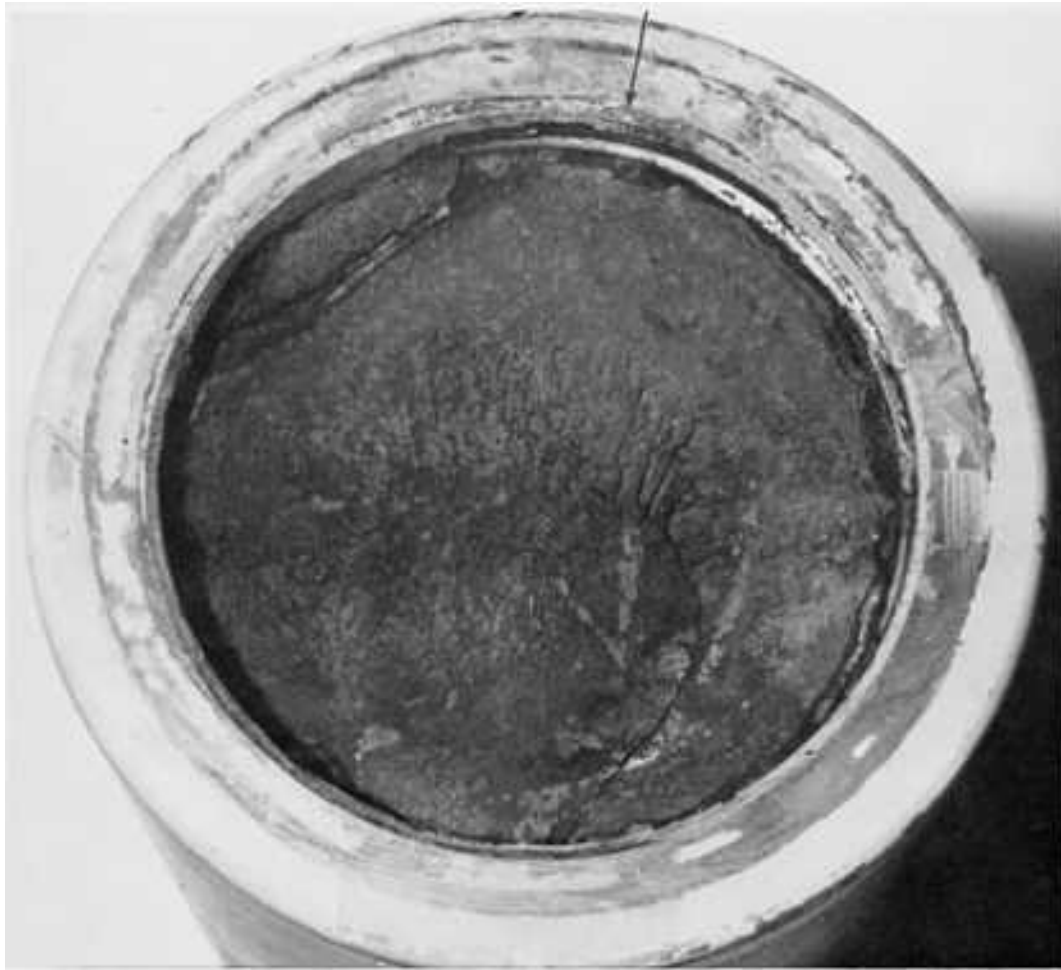
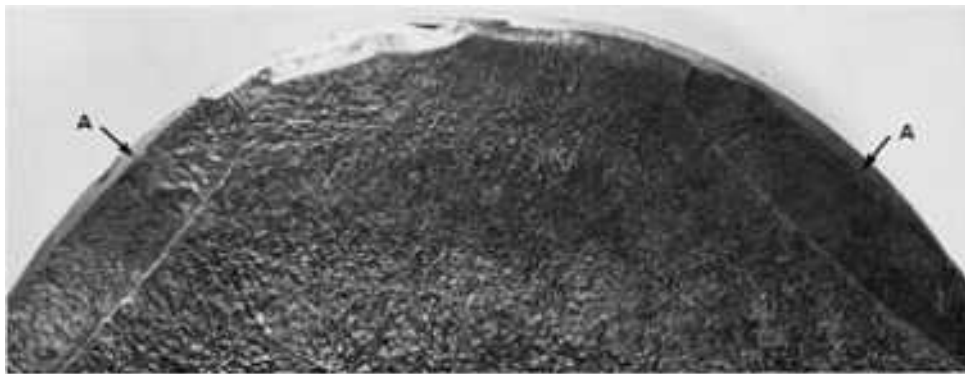
Fig. 456: View of a service fracture in a 125-mm (5-in.) diam suspension strut of a missile silo. AISI 4340 steel, heat treated to tensile strength of 1612.7 MPa (233.9 ksi), 11% elongation, and Charpy V-notch impact strength of 17.3 J (12.8 ft · lb). The fracture origin (arrow) is at a thread root, two full threads deep into the coupling. Actual size. Fig. 457: View of the origin in the mating fracture surface (Fig. 458). Two wedge-shaped pieces had been broken from the strut perimeter at symmetrical locations on either side of the origin (arrows A); one remained in the coupling and is visible in Fig. 456. 1.5×

Figure 458 is the mating fracture surface of the strut in Fig. 456. The fracture (origin at arrow) penetrated the strut at an angle, starting at the second thread within the coupling and emerging six threads lower on the opposite side. In both fracture surfaces, in the area opposite the origin, is a crudely circular crater with shear-lip borders. 1.3×. Figure 459 is a view of the threads near the origin. Note that the thread behind the fracture surface is partly stripped and there are corrosion pits on the threads. Fracture was ascribed to thread defects, corrosion, and excessive strength with low toughness. 7×

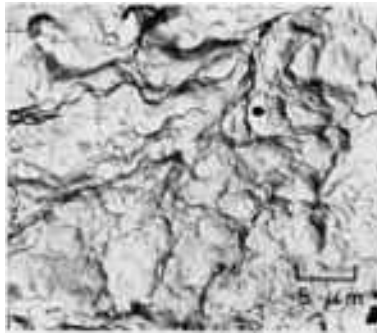
**Fig. 460** Surface of a tension-overload fracture in a notched specimen of AMS 6434 steel sheet that was broken at 27 °C (81 °F), showing small equiaxed dimples. The heavy curved lines are intersections of dimple surfaces. See also Fig. 461 and 462. TEM p-c replica, 2000×

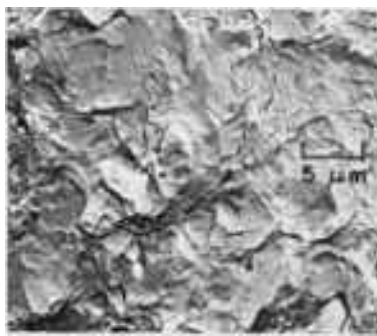
**Fig. 461** Surface of a tension-overload fracture in a notched specimen of the same AMS 6434 steel sheet as in Fig. 460, but broken at -73 °C (-99 °F). The dimples here are of the same size and nature as those in Fig. 460. See also Fig. 462. TEM p-c replica, 2000×

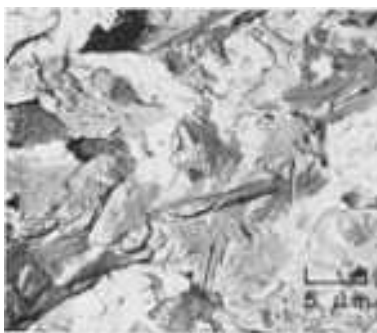
**Fig. 462** Surface of a tension-overload fracture in a notched specimen of the same AMS 6434 steel sheet as in Fig. 460 and 461, but broken at -190 °C (-310 °F), showing a mixture of scattered dimples and (at arrows) cleavage facets. TEM p-c replica, 2000×

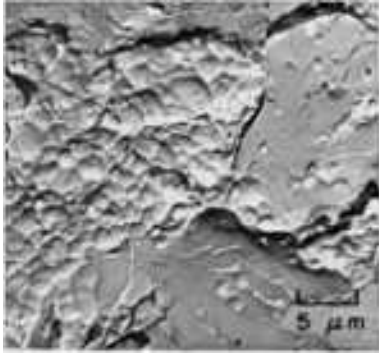
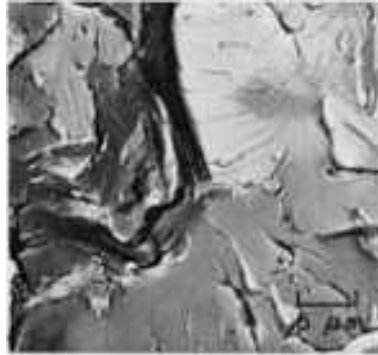
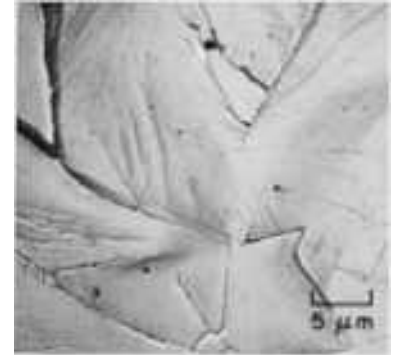
Surfaces of fractures in three pressure vessels made of AMS 6434 steel. Figure 463 shows equiaxed dimples, which resulted from tension overload, and quasi-cleavage facets. Figure 464 shows quasi-cleavage facets plus (at bottom left) a small region of dimples. Figure 465 shows cleavage facets in large ferrite grains; the facets contain many cleavage steps that originated at twist boundaries. TEM p-c replicas, all at 2000×

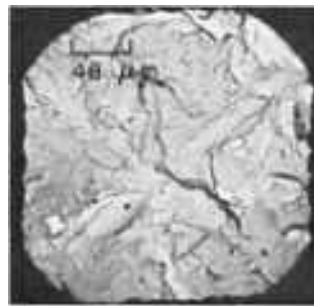
**Fig. 466** Impact fracture in a specimen of AMS 6434 steel quenched and then tempered at 205 °C (400 °F) to a yield strength of about 1550 MPa (225 ksi) and broken at -196 °C (-321 °F), showing a woody type of cleavage-fracture surface. TEM p-c replica, 210×

**Fig. 467** Impact fracture in a specimen of AMS 6434 steel (same properties as Fig. 466) broken at room temperature, showing fairly large equiaxed dimples, which are characteristic of tension-overload fractures. TEM p-c replica, 700×

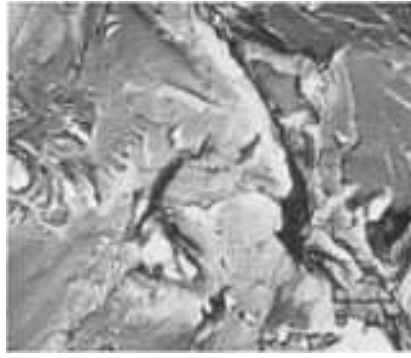
**Fig. 468** Fracture surface of an air flask of AMS 6434 steel that was broken in service. This complicated surface contains several quasi-cleavage facets. TEM p-c replica, 2000×

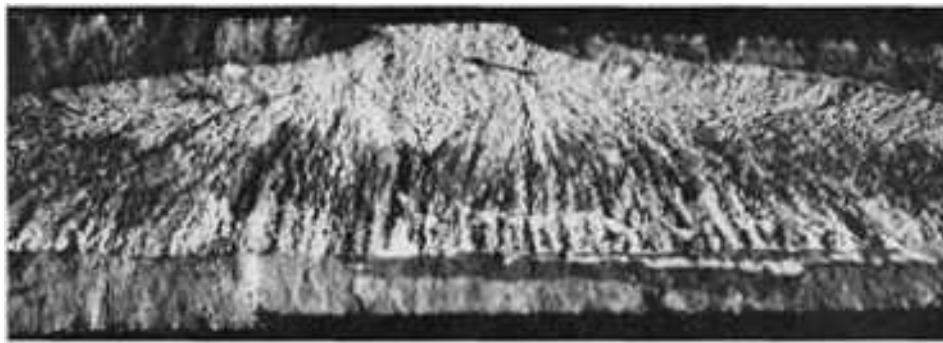
**Fig. 469** Surface of a fracture in a wall of a flask made of AMS 6434 steel tempered at 205 °C (400 °F) that was stressed while exposed to tap water, producing stress-corrosion cracking. See Fig. 470 for a higher-magnification view of the region at arrow. 15×

**Fig. 470** Higher-magnification view of fracture surface at arrow in Fig. 469, showing clearly the intergranular nature of the fracture, which resulted from stress-corrosion cracking. Grains generally are equiaxed, and the fracture has closely followed grain boundaries. TEM p-c replica, 3000×

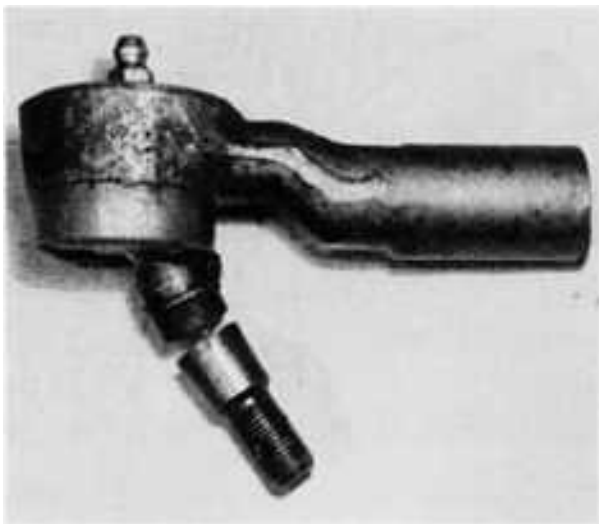
**Fig. 471**

Fracture of tie rod ball stud for automobile steering system due to high-cycle bending fatigue. The AISI 4615 part was carburized and tempered to 60 HRC on the surface. The stud was broken in the laboratory. Fig. 471: Broken ball stud. Actual size. Fig. 472: Fracture surface. 2.5× (General Motors Research Laboratories)

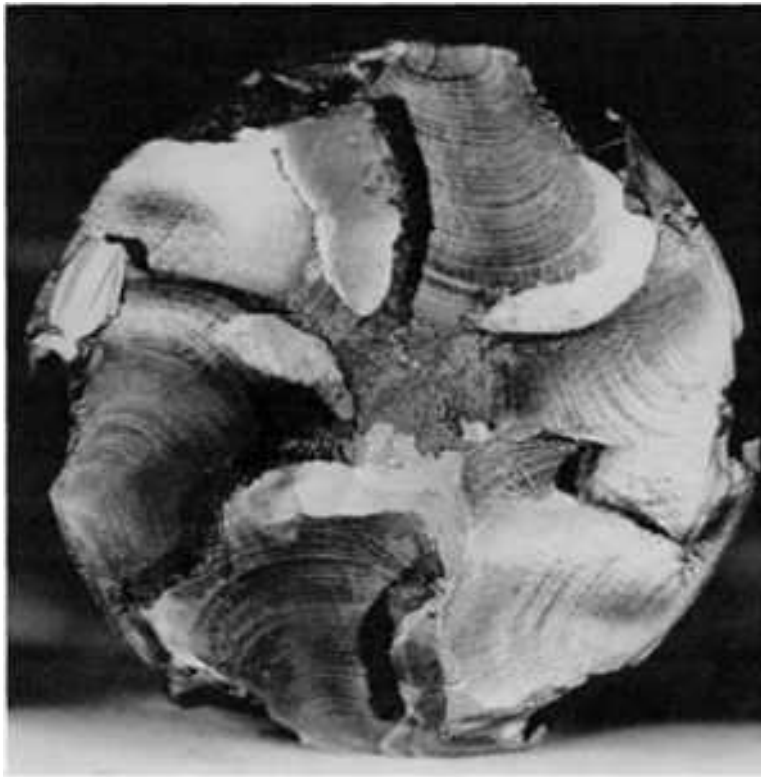
**Fig. 473 Rotating bending fatigue fracture of an AISI 4817 shaft, carburized and hardened to 60 HRC on the surface. Fracture initiated in six fillet areas around the periphery, near the runouts of six grooves. Each fatigue area propagated separately, but uniformly, inward to final rupture at the center. Cause of fracture was traced to grinding damage in the fillet. The bright and shiny flat areas are regions of postfracture damage produced by the rubbing together of the broken portions of the shaft. (D.J. Wulpi, Consultant)**

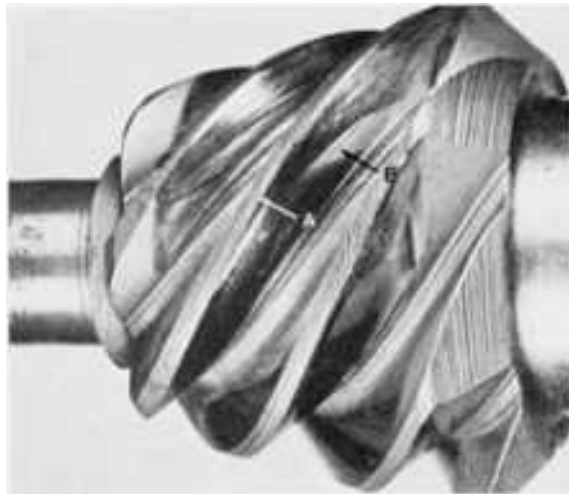
**Fig. 474 View of a carburized spiral gear of AISI 4817 steel, showing fine subcase fatigue cracks in the gear-tooth tips (such as at arrow A) and flanks (such as at arrow B); these cracks are evidence of the first stages of spalling fatigue, which originated near the case-core interface because the load-carrying capacity of the gear was exceeded. Compare with Fig. 475. Actual size**

**Fig. 475 Companion gear to that in Fig. 474 (carburized AISI 4817 steel) showing subcase fatigue fractures initiated by fine cracks similar to those in Fig. 474. Large fragments have spalled away from the teeth. Fatigue beach marks can be seen in these complex fracture surfaces, especially at upper right. Actual size.**

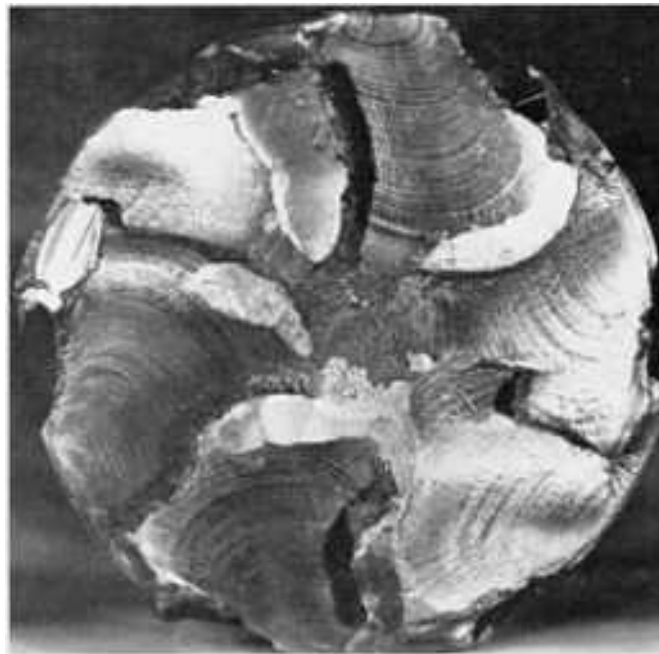
**Fig. 476 Surface of a fatigue fracture that began at six fillet areas around the periphery of a shaft, near the runouts of spiral grooves. The material is AISI 4817 steel; the shaft was carburized and heat treated to a surface hardness of 60 HRC. The fatigue cracks penetrated equally, indicating that stress concentrations at the six fillet areas were essentially equal.  $\sim 2.13\times$**

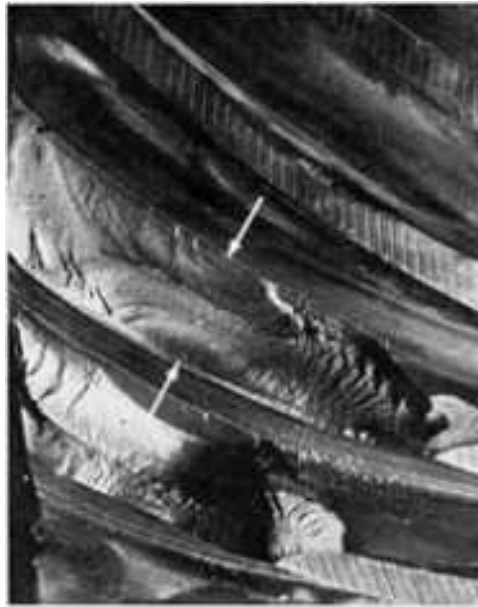
**Fig. 477** Fatigue fractures in a spiral bevel pinion gear of AISI 4820H steel, case hardened to a depth of 1.1 to 2.0 mm (0.045 to 0.080 in.). Case hardness, 56 HRC; core hardness, 30 HRC. Fatigue cracks began in tooth roots (which were not shot peened), often forming on either side of a tooth (arrows) and meeting in the middle of the tooth. A deeper case and shot peening of the entire gear were recommended. Actual size.

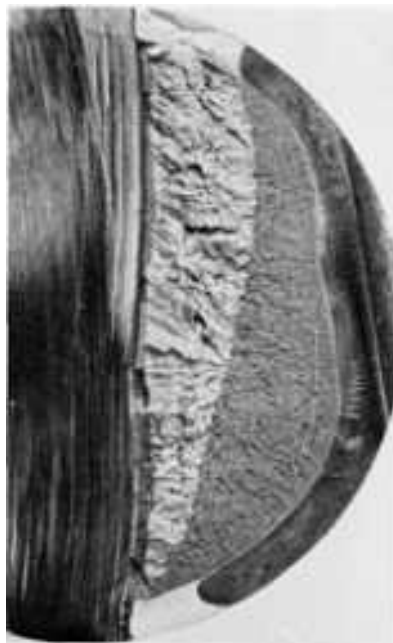
**Fig. 478** Case-hardened pin of AISI 5046 steel with a hardness of 61 HRC in the case, 248 HB in the core, showing fatigue zone. The pin was cut, then broken (light area at center). Sectioning of the pin revealed subcase fatigue cracking. 2.25x

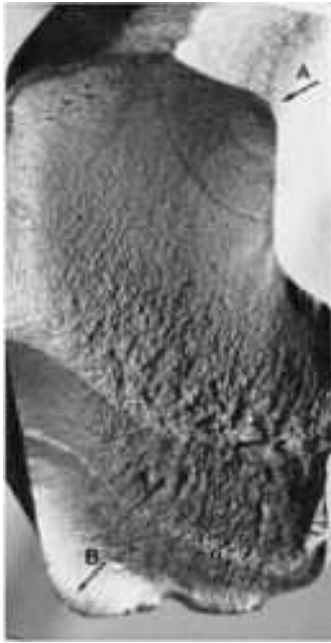
**Fig. 479**

Views of the mating fracture surfaces of a suspension component that was fabricated of AISI 5132 steel and that broke in a fatigue test. Note the two fatigue-crack origins, one at arrows A (top) and the other at arrows B (bottom). The crack that was initiated at the origin at arrows B is the earlier crack, as indicated by the well-rubbed surface near that origin. Both at 3×

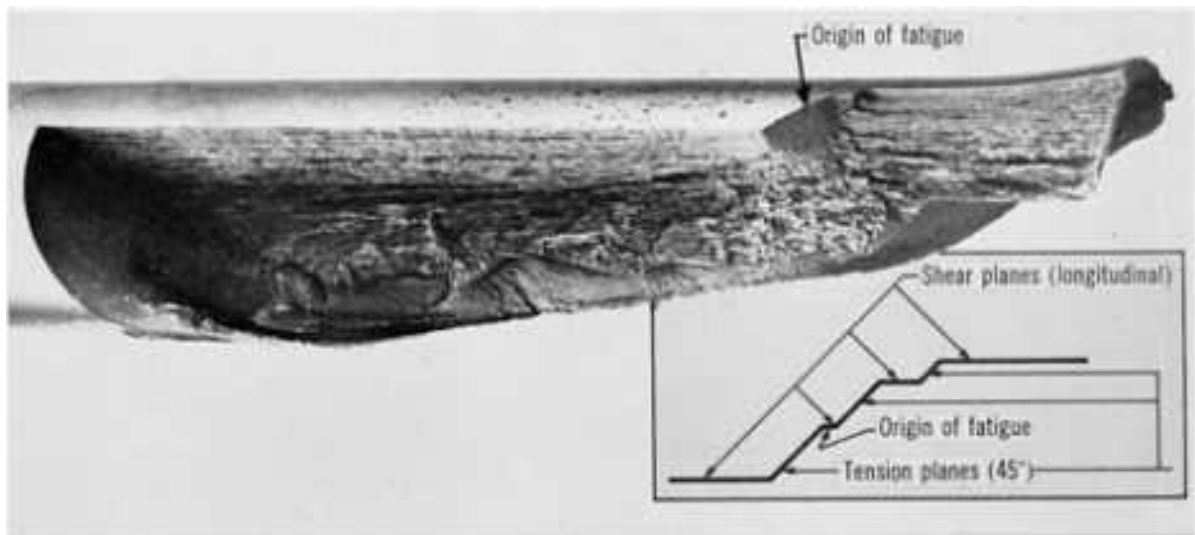
**Fig. 481** Surface of a torsional-fatigue fracture in the cylindrical portion of a 35-mm ( $1\frac{3}{8}$ -in) diam torsion-bar spring of AISI 50B60 steel heat treated to a hardness of 53 HRC. The fatigue crack originated in a very small (0.38 mm, or 0.015 in. long) facet (labeled "Origin of fatigue") on a longitudinal shear plane and progressed alternately on 45° tension planes and longitudinal shear planes, as indicated in the diagram. Note that the semicircular fatigue patch surrounding the origin lies in the 45° plane. 1.25×

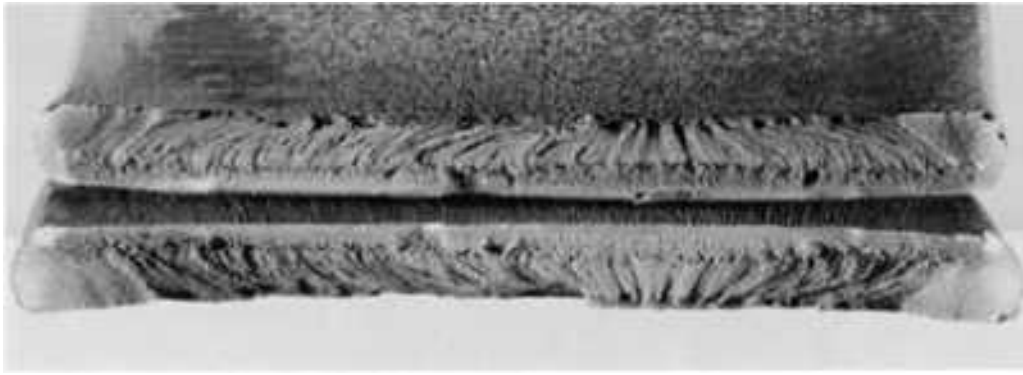
**Fig. 482**

Impact fracture of leaf spring at front connecting eye. The SAE 5160 part was quenched and tempered to 450 HB. The spring was broken in the laboratory by a single impact load in bending. Fig. 482: Matching fracture faces. Origin is at top of upper face and at bottom of lower face. 1.8 $\times$ . Fig. 483: Fractograph of origin side of fracture surface. Higher-magnification fractographs of zones I and II are shown in Fig. 482, 483, 484, 485, 486, 487, 488, 489, 490, 491, and 492. SEM, 35 $\times$  (General Motors Research Laboratories)

Fracture features in zone I of fractograph of SAE 5160 leaf spring (Fig. 482 and 483). Fig. 484: SEM, 300 $\times$ . Fig. 485: Enclosed area in Fig. 484. SEM, 1000 $\times$ . Fig. 486: Enclosed area in Fig. 485. Note numerous fine dimples. SEM, 10,000 $\times$  (General Motors Research Laboratories)

Fracture features in zone II of fractograph of SAE 5160 leaf spring (Fig. 482 and 483). Fig. 487: SEM, 300 $\times$ . Fig. 488: Enclosed area in Fig. 487. SEM, 1000 $\times$ . Fig. 489: Enclosed area in Fig. 488. Note numerous fine microvoids (dimples). SEM, 10,000 $\times$  (General Motors Research Laboratories)

Fracture features in zone II of fractograph of SAE 5160 leaf spring (Fig. 482 and 483). Field differs from that in Fig. 487, 488, and 489. Fig. 490: SEM, 300 $\times$ . Fig. 491: Enclosed area in Fig. 490. SEM, 1000 $\times$ . Fig. 492: Enclosed area in Fig. 491. SEM, 10,000 $\times$  (General Motors Research Laboratories)

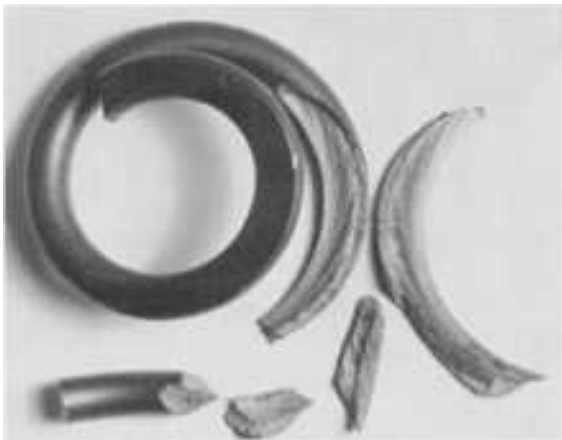
Fig. 493

Fracture of brake spring due to seam defect in material. The AISI 5160H wire was drawn to 155 mm (0.531in.) in diameter, hot wound, and quenched and tempered to 48 to 52 HRC. Fig. 493: Fractured brake spring. Note smooth, longitudinal split caused by seam. Actual size. Fig. 494: Close-up of one fracture face. 2 $\times$  (P.W. Walling, Metcut Research Associates, Inc.)

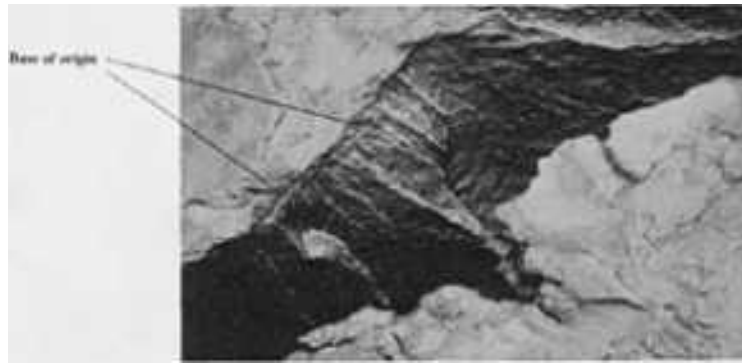
**Fig. 498** Fatigue crack origin on surface of spring was intentionally opened to reveal details of fracture initiation. Material: modified AISI 5160 (0.5% Cr, 0.1 to 0.2% V) wire. The spring was tested in the laboratory at stresses well in excess of those normally encountered in service. The surface-breaking portion of the fatigue origin is indicated on the fractograph. It initially appeared under the SEM as a faint line, transverse to the wire at the center, with each end at a slight angle. After intentional opening (see fractograph), the origin was shown to be roughly triangular in shape and defined by vertical ridges extending into the material. The balance of the fracture surface has a typical tensile failure pattern. SEM, 590 $\times$  (J.H. Maker, Associated Spring, Barnes Group Inc.)
