ASM HANDBOOK®

VOLUME  
12

Fractography

*Fractography*, was published in 1987 as Volume 12 of the *ASM Handbook*. The Volume was prepared under the direction of the ASM Handbook Committee.

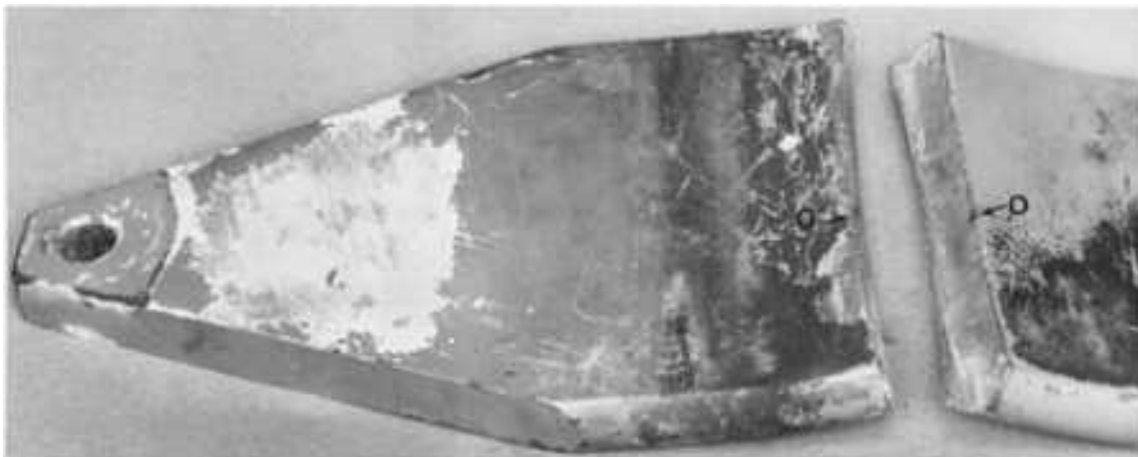
**Fig. 499** Fatigue fracture in an AISI 6150 steel spring leg of an aircraft main landing gear, heat treated to a minimum tensile strength of 1550 MPa (225 ksi) and a hardness of 49 HRC. Visual inspection of the fracture surfaces showed that the fatigue crack originated at the location marked by arrows O. The appearance of the external surface of the spring leg indicated that the part had been shot peened, but that peening had been inadequate. The dimensions of the spring leg conformed to specifications. See also Fig. 500, 501, 502, 503, and 504. 0.6 $\times$

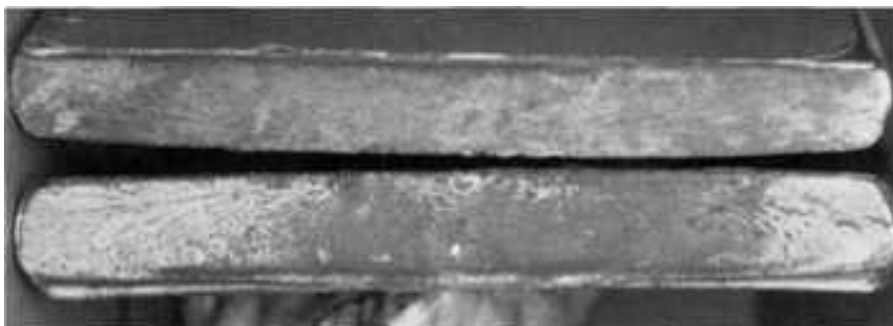
**Fig. 500** Mating fracture surfaces of the broken main-landing-gear spring leg in Fig. 499. A small fatigue zone

can be seen just to the left of center, at the edges shown adjacent here. This zone grew to a length of only about 5 mm (0.2 in.) and to a depth of slightly more than 2.5 mm (0.1 in.) before final fast fracture occurred. The remainder of each fracture surface shows features typical of rapid tearing. See Fig. 501 for a through-section of the spring leg. Actual size

**Fig. 502** A view of the fracture surface at bottom in Fig. 500, showing the fatigue zone at top center. Metallographic study of this region revealed partial decarburization to a depth of 0.71 mm (0.028 in.), which contributed to fracture. 4×

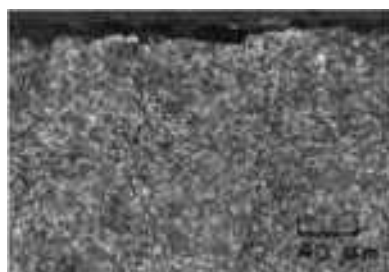
**Fig. 504** Another section through the spring leg in Fig. 499, showing a profile of the fatigue-crack surface (at top). Compare the smoothness of this surface with the irregularity of the fast-fracture surface in Fig. 501. 1% nital etch. 250×

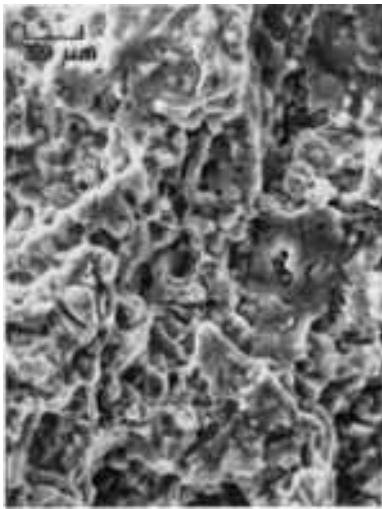
**Fig. 505**

Fracture surface of three specimens of AISI 52100 steel that were notched and broken by impact at  $-196^{\circ}\text{C}$  ( $-321^{\circ}\text{F}$ ), presented to show the effect of rapid heating in austenitizing. The specimen in Fig. 505 had been heat treated at  $845^{\circ}\text{C}$  ( $1555^{\circ}\text{F}$ ) for 20 min and oil quenched (a conventional heat treatment), then tempered at  $175^{\circ}\text{C}$  ( $350^{\circ}\text{F}$ ). The specimen in Fig. 506 had been given two austenitizing cycles of rapid heating to  $865^{\circ}\text{C}$  ( $1585^{\circ}\text{F}$ ), holding for 1 min and oil quenching, and then had been tempered at  $175^{\circ}\text{C}$  ( $350^{\circ}\text{F}$ ). The specimen in Fig. 507 had been heat treated at  $1095^{\circ}\text{C}$  ( $2005^{\circ}\text{F}$ ) for 10 min and quenched in warm oil, tempered for 3 h at  $370^{\circ}\text{C}$  ( $700^{\circ}\text{F}$ ), rapidly heated to  $845^{\circ}\text{C}$  ( $1555^{\circ}\text{F}$ ), held for 1 min and oil quenched, then tempered at  $175^{\circ}\text{C}$  ( $350^{\circ}\text{F}$ ). The successive decrease in size of cleavage facets and dimples in the three fractographs indicates successively decreasing size of acicular needles of martensite as a result of the different heat treatments. SEMs, all at 2250×

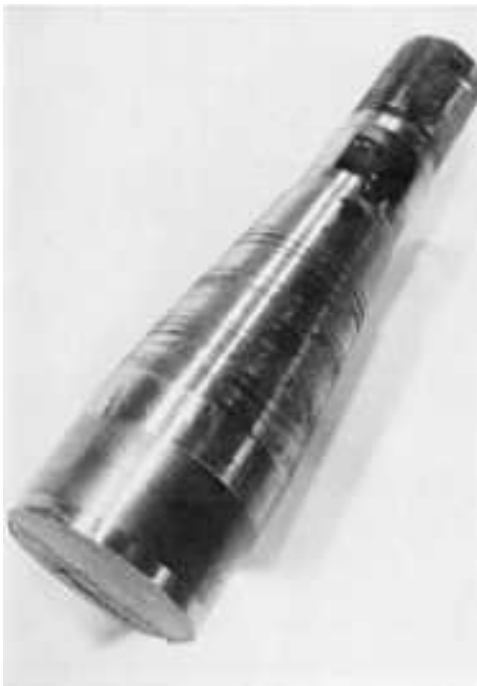
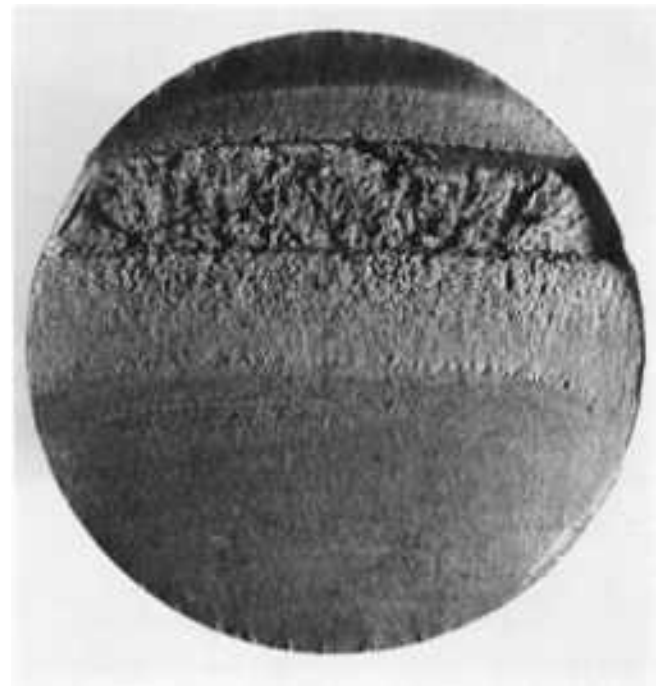
Fatigue fracture of truck front wheel spindle. The SAE 81B45 part was quenched and tempered to 30 HRC. Fig. 508: Broken wheel spindle. 0.9×. Fig. 509: Fracture surface. 2.5× (General Motors Research Laboratories)

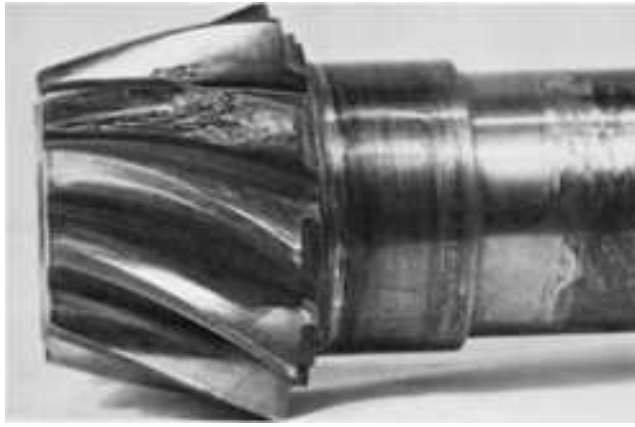
**Fig. 510 Bending-fatigue fracture in the heel of one tooth of a spiral bevel pinion of AISI 8617 steel, carburized and hardened to 57 HRC in the case. Fracture resulted from severe pitting. Note that pitting had begun in an adjoining tooth (near top). 0.75×**

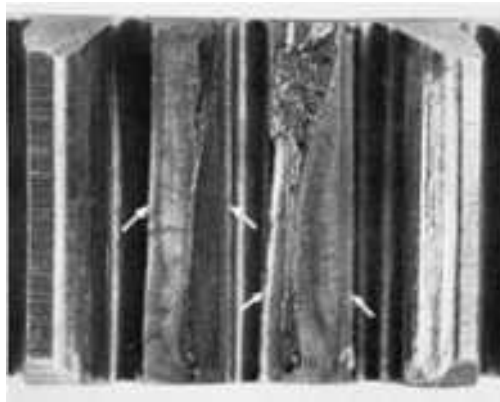
**Fig. 511 Bending-fatigue fracture in two teeth of a reverse idler gear of AISI 8617 steel, carburized and hardened to 60 HRC in the case. Arrows point to the root fillets on both sides of each tooth, where fracture began due to excessive stress in these locations. ~2×**

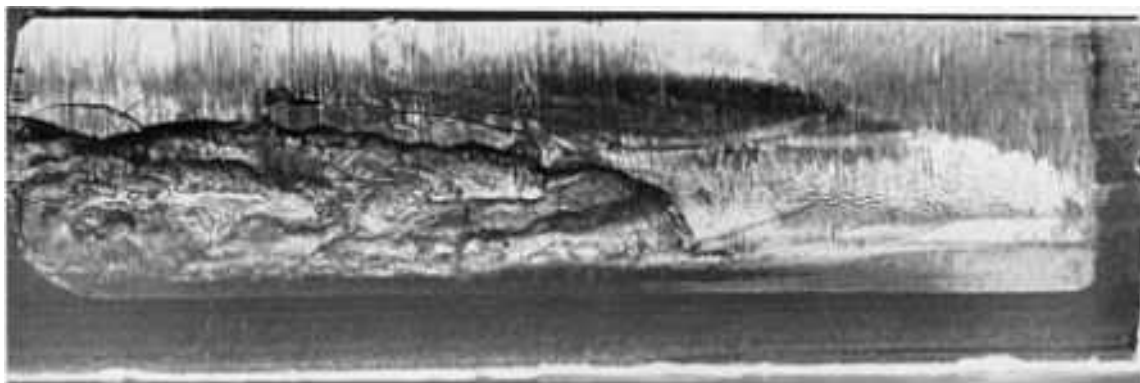
**Fig. 512 Surface of a spalling-fatigue fracture in a single tooth of a heavily loaded final-drive pinion of AISI 8620 steel, carburized and hardened to 60 HRC in the case, showing vertical scratches, which indicate that appreciable abrasive wear took place also. The surface ripples at right suggest that a small amount of plastic flow occurred under the applied load. ~4×**

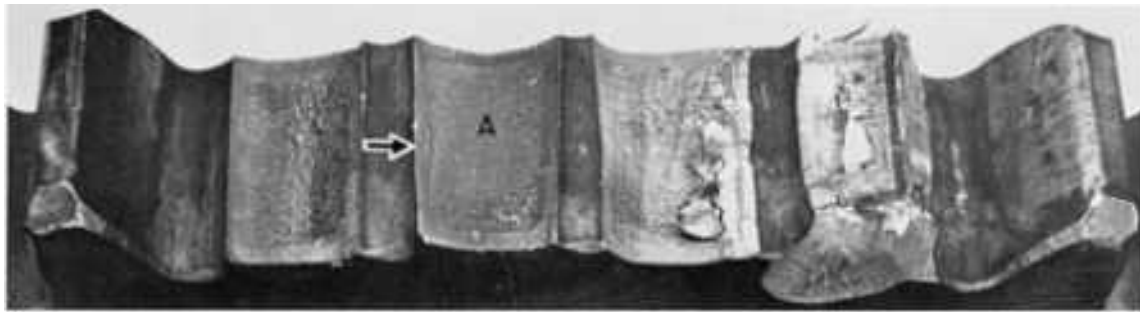
**Fig. 513 Bending-fatigue fractures in several teeth of a spur gear of AISI 8620 steel, carburized and hardened to 60 HRC in the case. The tooth marked A apparently broke first, as the result of a fatigue crack that originated in the fillet to the left of the tooth (arrow). After this tooth broke off, fracturing of the teeth on each side of it was accelerated. 2×**

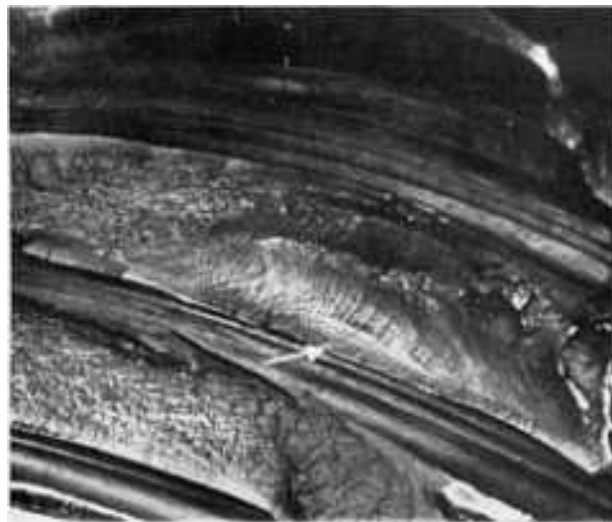
**Fig. 514 Surface of a bending-fatigue fracture in a tooth (upper tooth in this view) of a large spiral bevel pinion of AISI 8620 steel carburized and hardened to 60 HRC at the surface. The arrow marks the fatigue-crack origin, in the root fillet. The absence of this tooth resulted in fracture of the tooth below by overload. 1.65×**

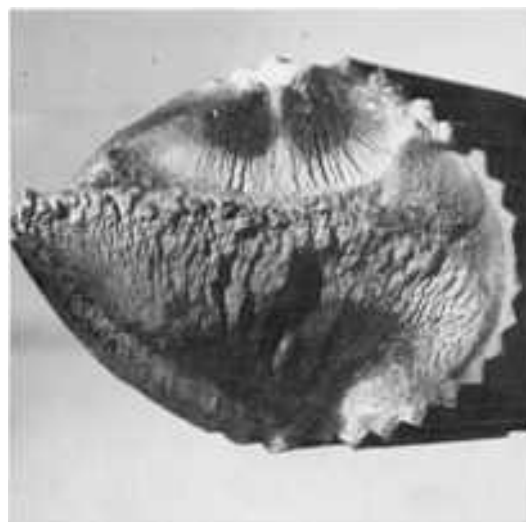
**Fig. 515 Surface of torsional-fatigue fracture in a splined shaft of AISI 8620 steel that was carburized and case**

hardened. Multiple fatigue cracks evidently formed at the roots of the splines and then joined to penetrate much of the case before final fast fracture occurred. 2×

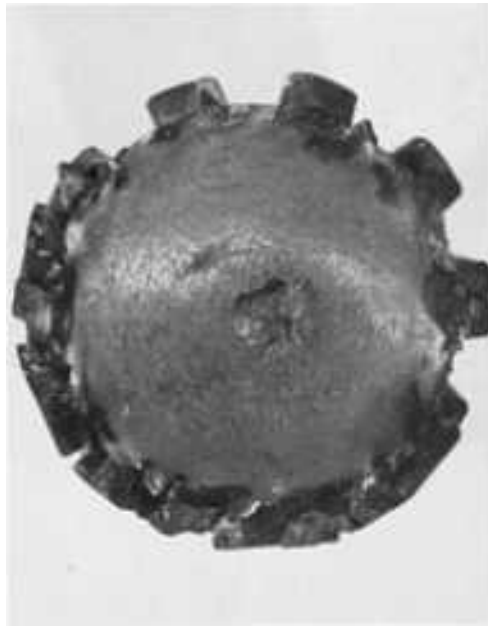
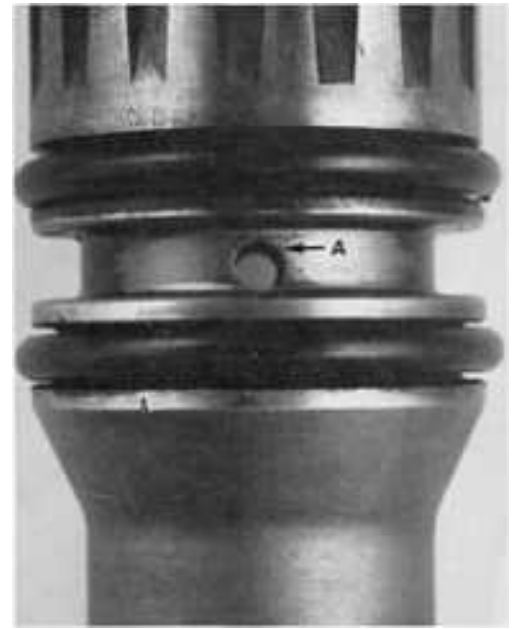
Figure 516 is a view of a broken splined shaft of AISI 8620 steel, surface carburized to a case depth of 1.07 mm (0.042 in.) and hardened to 63 to 65 HRC; core hardness was 96 HRB. Specified case hardness was 57 to 62 HRC. The fracture resulted from torsional overload. Figure 517 is a view of a surface of the fracture in Fig. 516. Brittle fracture of the splines occurred first; later, the soft, ductile core fractured in the transverse shear plane. Figure 518 is a view of the O-ring region of the shaft in Fig. 516. A 45° torsion crack is visible (at A) at the edge of an oil hole; this crack is proof of the torsional nature of the loading that was imposed on the shaft. Fig. 516: 0.25×. Fig. 517 and 518: 1.5×

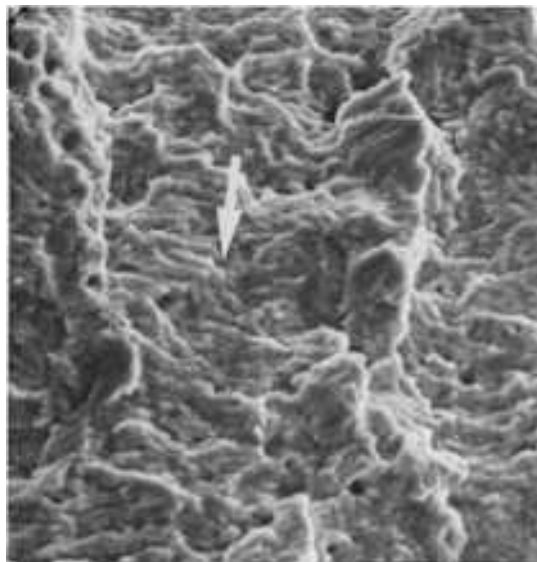
**Fig. 519** Fatigue striations in AISI 8620. The roughly horizontal ridges reveal how the crack front advanced with each load application. The crack propagated in the direction of the arrow. SEM, 2100× (D.J. Wulpi, Consultant)

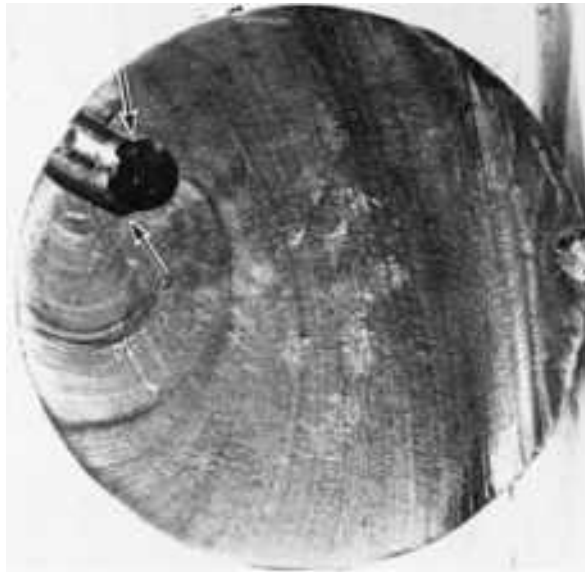
**Fig. 520** Surface of a fracture in an AISI 8640 boom-point pin that broke during service. Steel was quenched and then tempered to a hardness of 269 HB. Sharp corners of mismatched transverse grease holes provided stress concentrations that generated two fatigue cracks (arrows). Actual size.

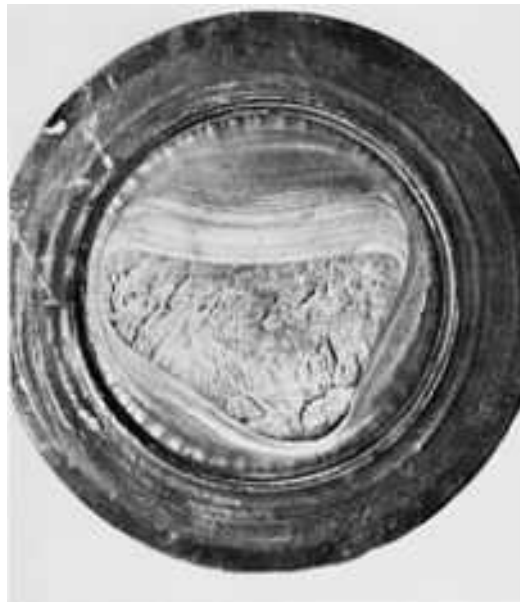
**Fig. 521** Surface of a fatigue fracture in a 200-mm (4-in.) diam axle of AISI 8640 steel with a hardness of approximately 30 HRC. Contained within a shrink-fitted collar (visible here), the nonrotating axle was subjected to bending stresses in three directions, which produced this unusual pattern of beach marks. 0.65×

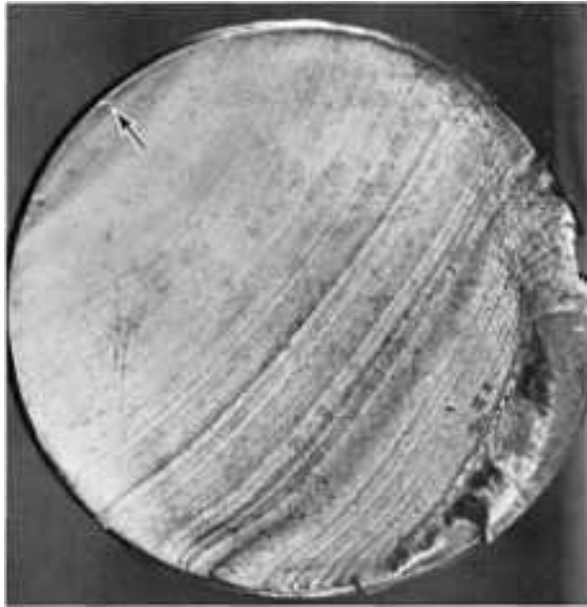
**Fig. 522** Surface of a fatigue fracture in a nonrotating axle of AISI 8640 steel with a hardness of approximately 30 HRC. Visible are beach marks, which indicate that the fatigue crack penetrated across more than 90% of the axle before final fast fracture occurred. The origin (arrow) was at a discontinuity in a cut thread.  $\sim 0.95\times$

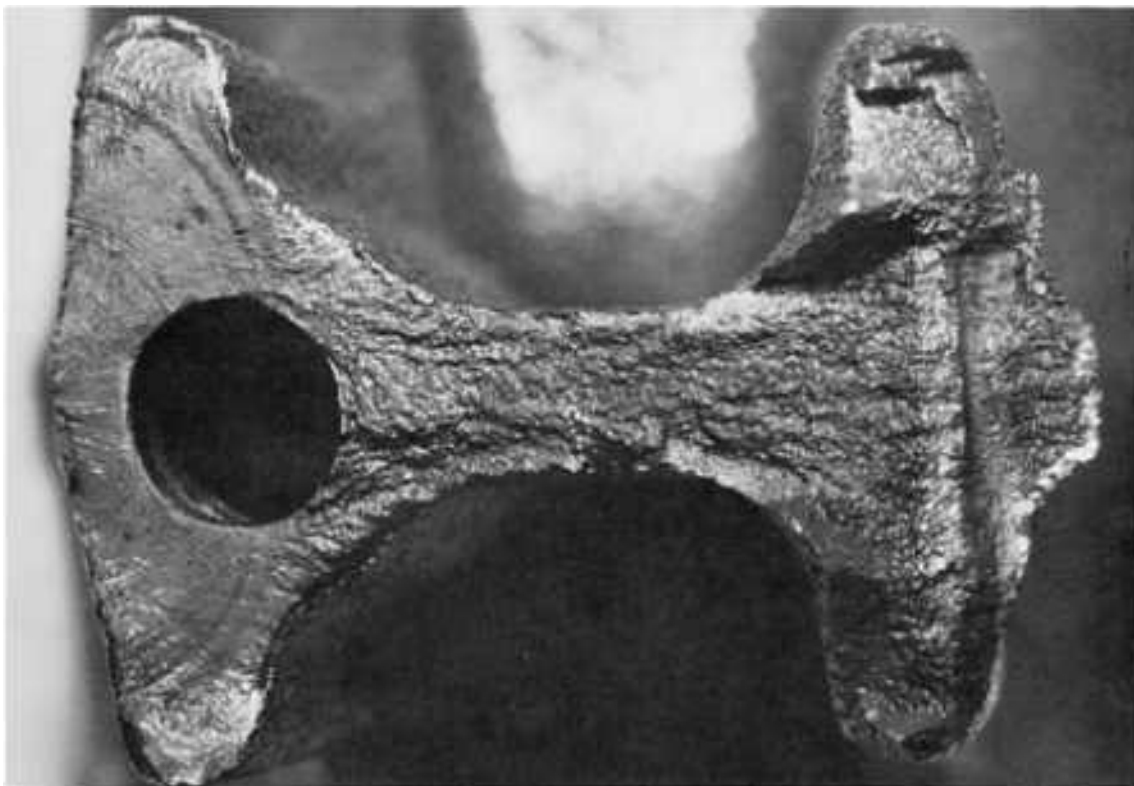
**Fig. 523** Surface of a fatigue fracture in a forged connecting rod of AISI 8640 steel with a hardness of 26 to 27 HRC throughout. The rod broke after approximately 84,000 km (52,000 miles) of service. The fatigue-crack origin is at the left edge, at the flash line of the forging, but no unusual roughness of the flash trim there was discovered. No metallurgical cause of the fracture was detected. The fatigue crack progressed about halfway around the oil hole at left before final fast fracture occurred. Note the pronounced shear lip at the right edge.  $\sim 7\times$

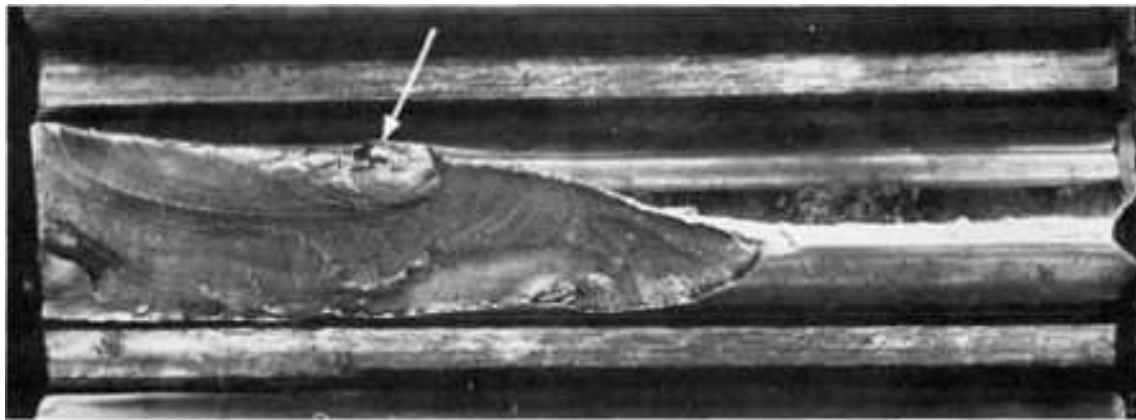
**Fig. 524** Surface of a bending-fatigue fracture in a tooth of a sprocket-drive pinion of AISI 8650 steel induction hardened to 58 to 60 HRC. The fatigue-crack origin is at a deep pit (arrow) in the tooth surface. Severe end loading produced other, smaller pits in the surfaces of the teeth. Beach marks indicate that the fatigue crack penetrated a large portion of the tooth before a piece broke off. 1.6×

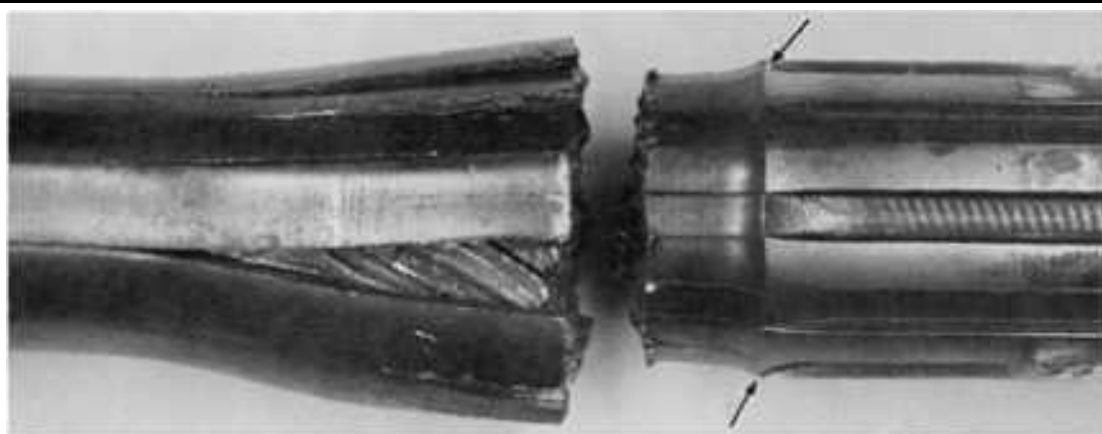
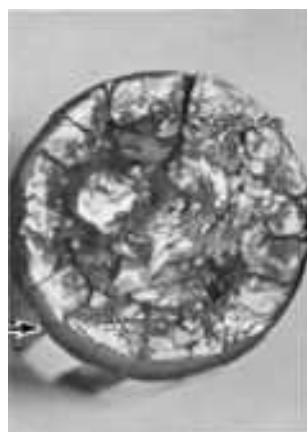
Figure 525 is a fatigue fracture in the splined main drive shaft of a lift truck. The material is heat treated AISI 8645 steel. Hardness was 44 HRC throughout, except at the surfaces of some of the splines, where the hardness was 38 HRC. There was no apparent reason for the low hardness of these splines; decarburization, which was suspected initially, was not revealed by metallographic examination. Note the longitudinal cracks in the portion at left. Experimentally broken longitudinal sections of the shaft showed very "woody" fracture surfaces. Figure 526 is a view of the fracture surface of the right portion of the shaft in Fig. 525. Sharpness of fillets is evident, such as at the arrows in both figures. See also Fig. 527, 528, and 529. Both at 1.25×

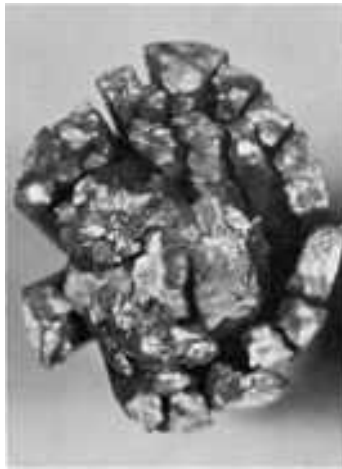
**Fig. 527** Fracture surface of the left portion of the shaft in Fig. 525, showing the badly mangled splines separated by longitudinal cracks, which are evident also in Fig. 525. 1.25×

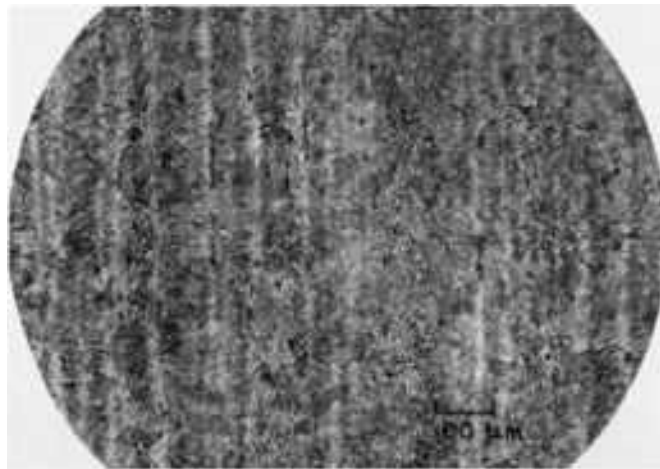
**Fig. 528** Longitudinal section through a spline of the shaft in Fig. 525, showing inclusions, banding, and some free ferrite. The cause of the fracture was improper design; corners at bases of splines had adequate radii for most of the spline length, but these radii were reduced, forming sharp angles, at points near where the splines blended with the shaft. 2% nital etch, 100×

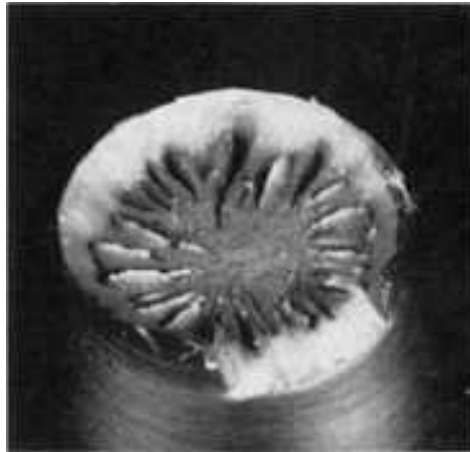
**Fig. 530** Tensile-overload fracture in an unnotched specimen of AISI 8740 steel; tensile strength, 1351 MPa (196 ksi). A cup-and-cone fracture with a fibrous zone containing radial features between the central fibrous region and the shear lip. See also Fig. 531 and 532. 9×

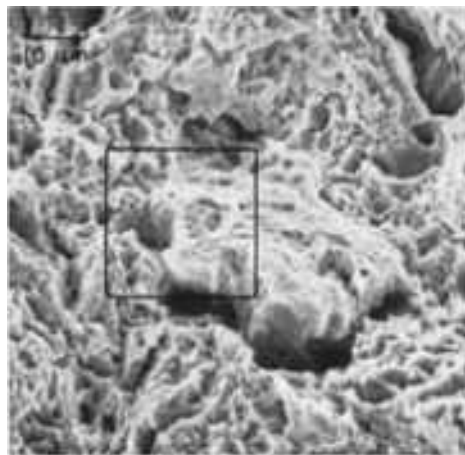
**Fig. 531** Area adjacent to one of the radial features in Fig. 530, showing dimples, which are typical of tensile-overload fracture. Note the scattered secondary cracks, which appear to be unusually deep. See also Fig. 532, a higher-magnification view of area in the rectangle. SEM, 1000×

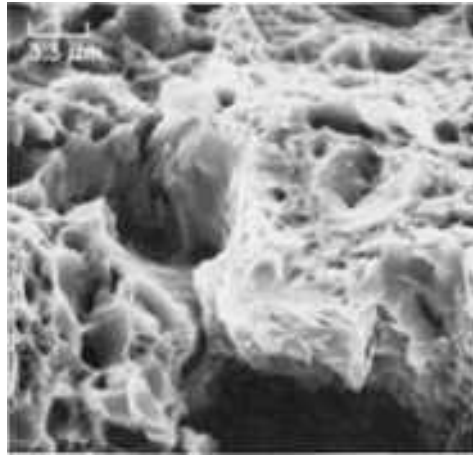
**Fig. 532** Area outlined by the rectangle in Fig. 531, shown at higher magnification. A wide range of sizes of the dimples is clearly visible. Unlike many other dimpled fractures, the one here appears to contain no evidence of inclusions. SEM, 3000×

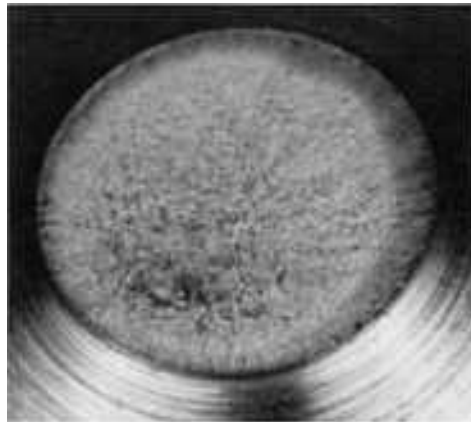
**Fig. 533** Surface of tensile-overload fracture in a notched specimen of AISI 8740 steel heat treated to a tensile strength of 2044 MPa (296.5 ksi). Fracture originated around the periphery of the specimen at the root of the notch. Radial features are evident. See also Fig. 534 and 535. 9×

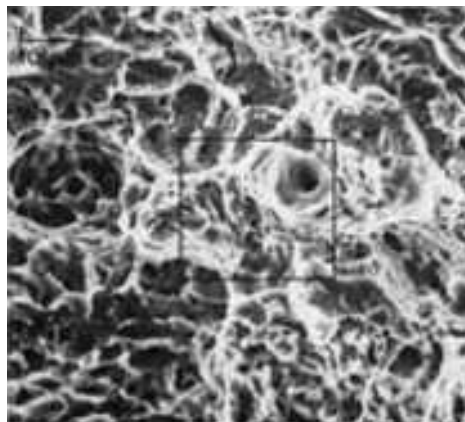
**Fig. 534** Area in the central final-fracture region in Fig. 533. The range of dimple sizes is similar to that in the unnotched fracture in Fig. 531, but only one secondary crack is evident, and it is of modest size. See Fig. 535 for a higher-magnification view of the area outlined by the rectangle. SEM, 1000×

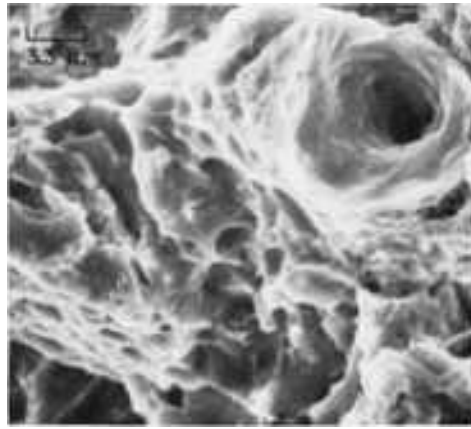
**Fig. 535** Higher-magnification view of the area in the rectangle in Fig. 534. Range in dimple size is more clearly evident here. Large dimple at upper right was presumably initiated by a large inclusion (not shown). SEM, 3000×

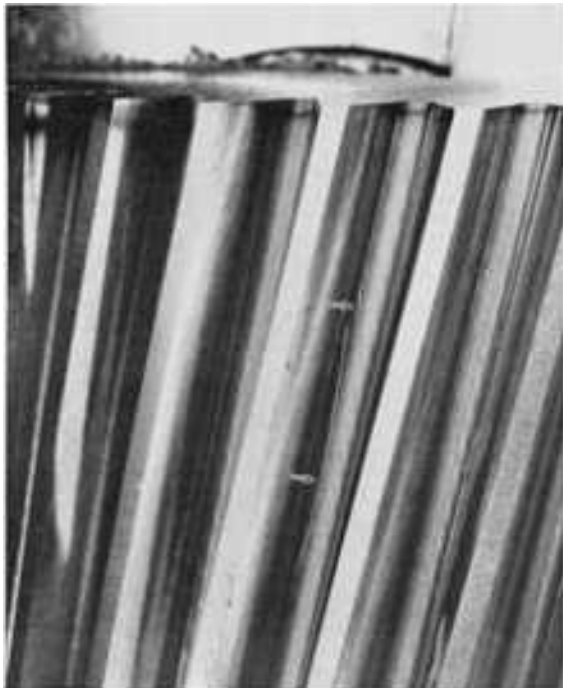
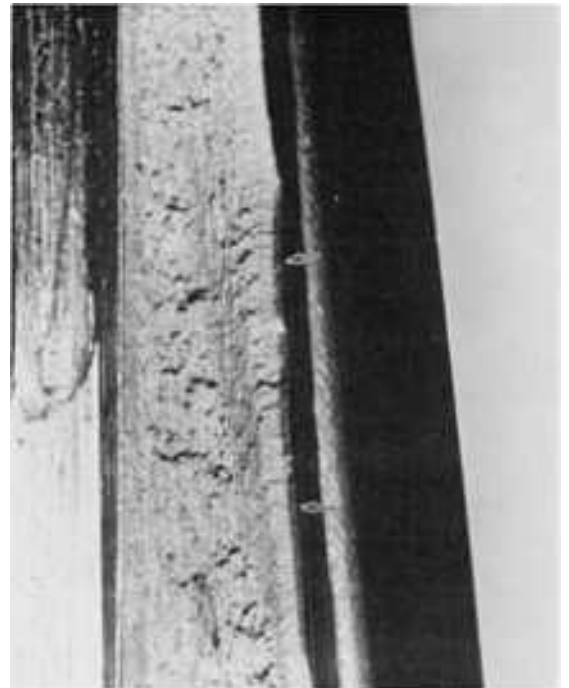
Grinding cracks in AISI 9310 helical pinion. Part was rough machined, carburized, hardened and tempered (56 to 58 HRC), and finish ground. Cracks, due to abusive final grinding, were discovered in a tooth root during nondestructive testing. Fig. 536: Helical pinion. Arrows point to cracks. 2×. Fig. 537: Fracture surface of opened crack (arrows) reveals a crack depth of 0.5 to 0.9 mm (0.020 to 0.035 in). 5× (P.J. Walling, Metcut Research Associates, Inc.)

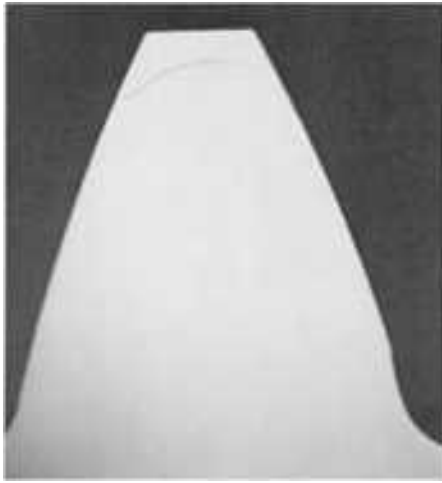
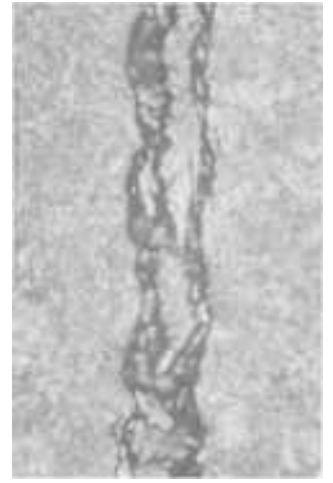
Quench crack in AISI 9310 spur gear. Part was rough machined, normalized and tempered, carburized, hardened and tempered (52 to 56 HRC), finish ground, and black oxide treated. A crescent-shaped surface crack was discovered 2.5 mm (0.1 in.) below the top land during nondestructive testing. Metallography revealed that the crack followed the case-core interface and was filled with metallic debris. Fig. 538: Gear active profile shows crack at top land. 5×. Fig. 539: Debris-filled quench crack. 2% nital, 750× (P.J. Walling, Metcut Research Associates, Inc.)

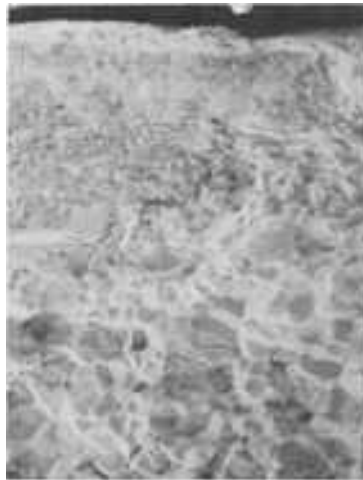
**Fig. 540** Brittle intergranular fracture of AISI 9254 due to quench cracking. The crack initiated at a seam, 0.15 mm (0.006 in.) deep. The seam wall is the irregularly textured area at top in the fractograph. SEM, 200× (J.H. Maker, Associated Spring, Barnes Group Inc.)

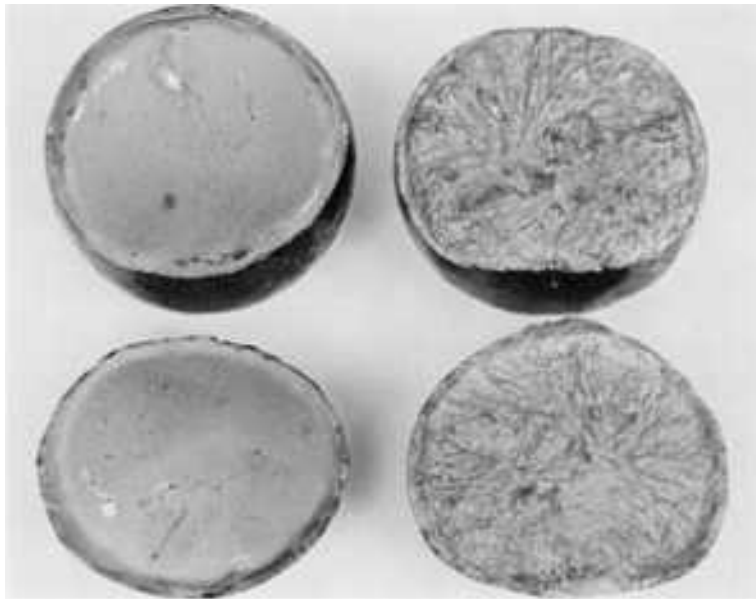
**Fig. 541 Mating fracture surfaces of commercial 75-mm (3-in.) diam grinding balls. Fracture was caused by severe ball-on-ball impacts in laboratory tests. Left top and bottom: Commercial forged and heat-treated low-alloy steel ball. Composition: 0.63% C, 0.90% Mn, 0.76% Si, 0.66% Cr, 0.018% P, and 0.011% S. Right top and bottom: Experimental manganese steel ball, cast and heat treated. Composition: 0.97% C, 5.3% Mn, 1.9% Cr, 1.0% Mo, 0.48% Si, 0.03% P, and 0.018% S. Outer rim of ball was under compression due to heat treatment and plastic deformation from impacts. (H.W. Leavenworth, Jr., U.S. Bureau of Mines)**

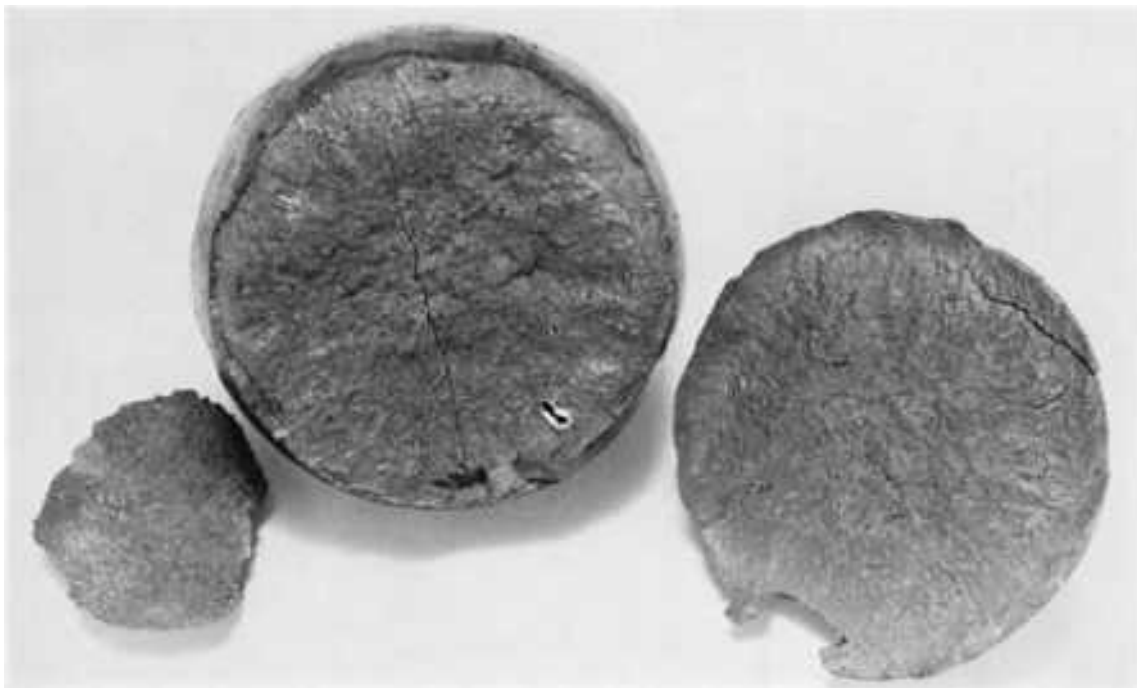
**Fig. 542 Catastrophic failure of 75-mm (3-in.) diam manganese steel grinding ball after 51,440 severe ball-on-ball impacts in a laboratory test. Composition: 1.21% C, 5.3% Mn, 1.8% Cr, 1.1% Mo, 0.46% Si, 0.1% Ni, and 0.1% Cu. Fracture initiated at an interior crack. (Note another such crack on the fracture surface at center.) The interior of the ball was under tension. The outer rim was under compression due to heat treatment and plastic deformation from impacts. (H.W. Leavenworth, Jr., U.S. Bureau of Mines).**

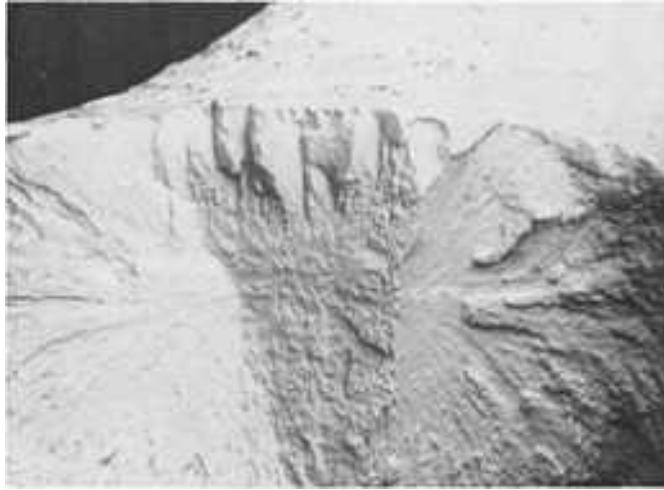
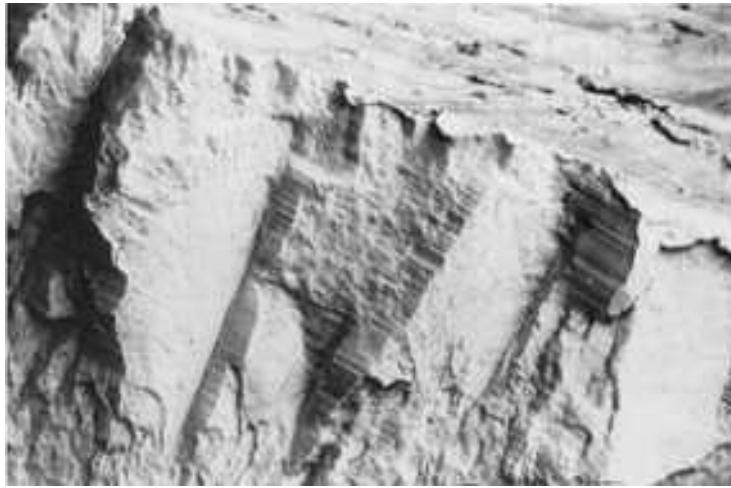
High-cycle fatigue fracture of valve spring for automobile engine. Material: Cr-V alloy steel (modified ASTM A232). Failure occurred during qualification testing at 17.56 million cycles. No material defect was found; stress-life combination was considered normal for this type of service. Fig. 543: Fracture surface near origin. Note "factory roof" features usually associated with high-cycle fatigue. SEM, 50 $\times$ . Fig. 544: Same as Fig. 543, but at higher magnification. SEM, 200 $\times$  (J.H. Maker, Associated Spring, Barnes Group Inc.)

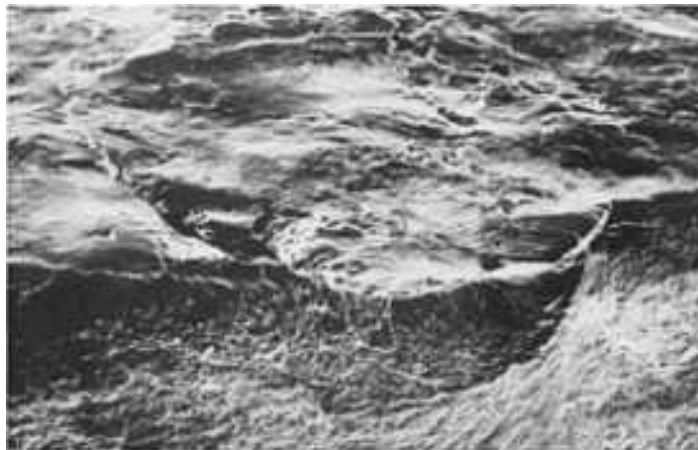
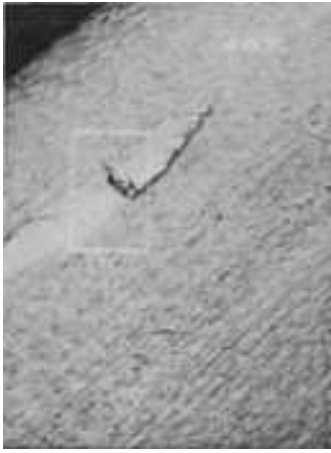
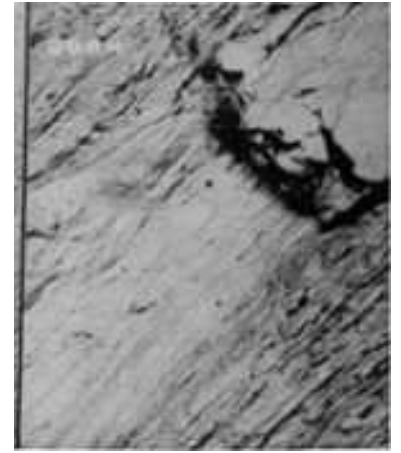
Fracture of compression spring after 4.3 million cycles in a laboratory test was caused by a large defect called a "scab." Failure origin was 45° away from the inner diameter of the spring, the point of maximum stress. Material: Oil-tempered and shot-peened modified Cr-V valve spring wire. Fig. 545: Large scab that caused spring failure. SEM, 200×. Fig. 546 and 547: Scabs are also called "button" defects, because the depression looks like a buttonhole and the material left in it resembles a button. They are commonly caused by mechanical damage at some stage in wire production before final draw. Material: Armco 17-7PH (UNS S17700) wire. SEM, 40× and 200×, respectively (J.H. Maker, Associated Spring, Barnes Group Inc.)

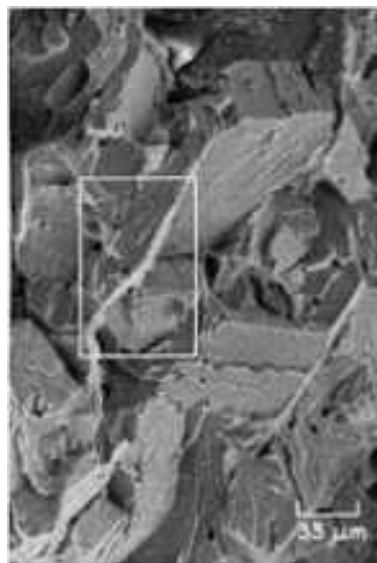
**Fig. 548** Charpy impact fracture in 0.18C-3.85Mo steel after heat treatment in an inert atmosphere at 1200 °C (2190 °F) for 1 h, followed by an ice/10% brine quench. Many quasi-cleavage facets are visible. See Fig. 549 (an enlargement of the area in the rectangle). SEM, 300×

**Fig. 549** Area outlined by the rectangle in Fig. 548, shown at higher magnification, which makes details of the quasi-cleavage more clearly evident. A few elongated dimples are present. Area in the rectangle here is shown at higher magnification in Fig. 550. SEM, 1000×

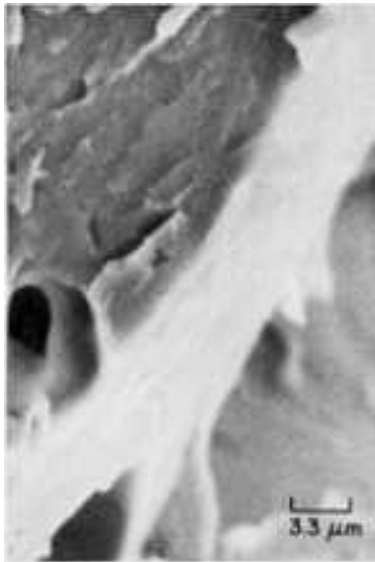
**Fig. 550** Area outlined by the rectangle in Fig. 549, shown at higher magnification. The bright tilted facet may be a grain boundary or a tear ridge. An inclusion is faintly visible in the dimple about midway along the left edge. SEM, 3000×

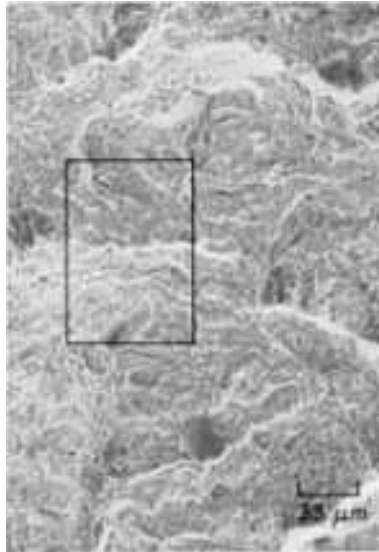
**Fig. 551** Charpy impact fracture in 0.41C-4.2Mo steel after the same heat treatment as that for the specimen in Fig. 548. This fracture occurred by dimpled rupture, although the impact energy was only one-third that of Fig. 548. See also Fig. 552 and 553. SEM, 300×

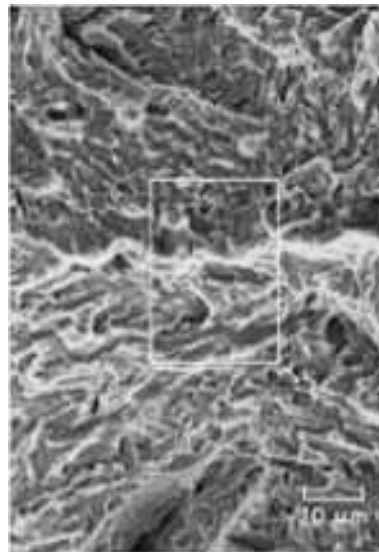
**Fig. 552** This view at higher magnification of the area outlined by the rectangle in Fig. 551 reveals that many of the dimples are highly elongated, exhibiting locally some features suggestive of cleavage. Area in rectangle here is shown enlarged in Fig. 553. SEM, 1000×

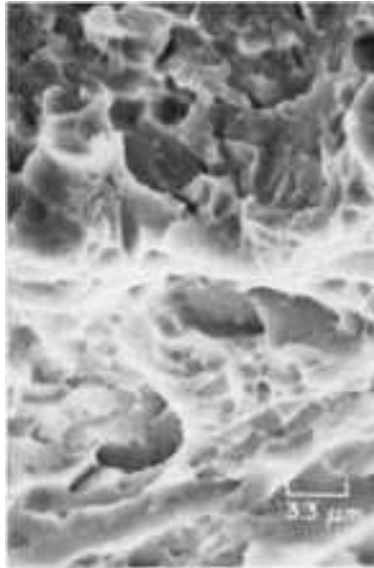
**Fig. 553** Area outlined by the rectangle in Fig. 552, shown at triple the magnification. At this enlargement, many extremely fine dimples are visible, formed along the margins of large voids. SEM, 3000×

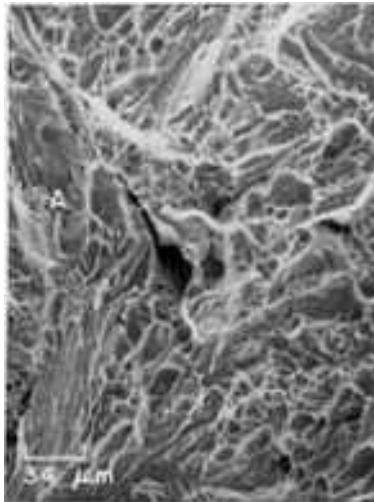
**Fig. 554** This specimen was austenitized at 1205 °C (2200 °F). Yield strength was 1413 MPa (205 ksi). There appear to be large facets of quasi-cleavage, such as at A; elsewhere, the surface contains rather large dimples. Note the large void near the center, SEM, 290×

These fractographs show the effects of various austenitizing treatments on characteristics of fractures in an experimental secondary-hardening steel containing 0.3% C, 0.6% Mn, and 5.0% Mo. All specimens were austenitized for 1 h at the temperatures indicated, quenched in ice-brine, and then refrigerated for 30 min in liquid nitrogen. Plane-strain fracture-toughness specimens were then tested at room temperature as part of a program to develop high levels of toughness in steels that also maintain ultrahigh tensile strength.

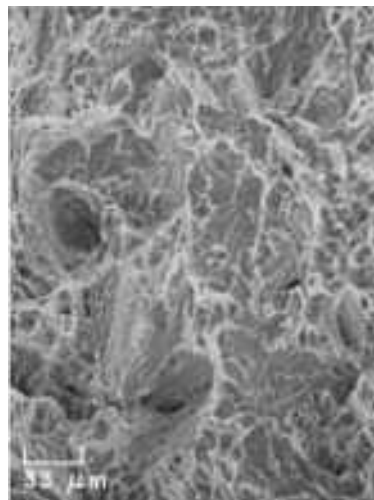
**Fig. 555** This specimen was austenitized at 1095 °C (2000 °F). This fracture, like that in Fig. 554, displays quasi-cleavage facets; some of them are apparently rather deeply indented. There are also intervening regions

showing clusters of equiaxed dimples. SEM, 300×

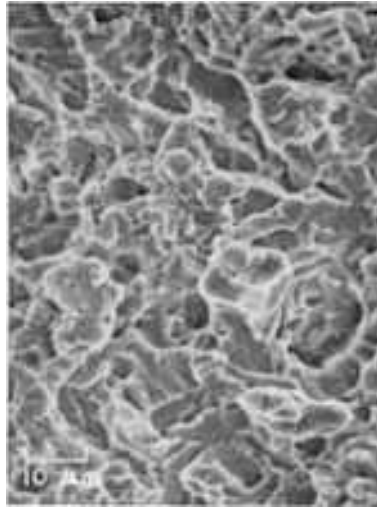
**Fig. 556** This specimen, austenitized at 980 °C (1800 °F), shows none of the quasi-cleavage facets observed in Fig. 554 and 555. There appear to be many scattered dimples, but most of the surface consists of small facets, seemingly caused by cleavage. SEM, 1000×

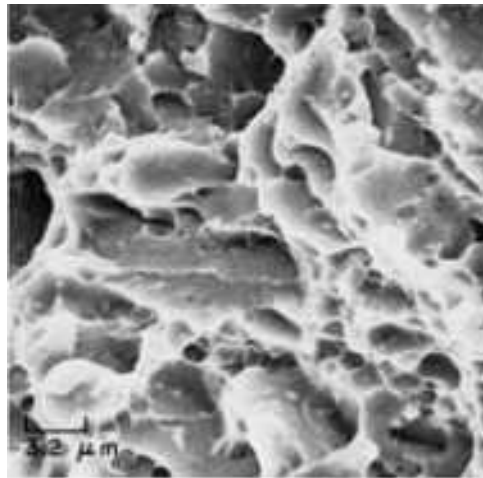
**Fig. 557** The specimen was austenitized at 870 °C (1600 °F). Yield strength was 1324 MPa (192 ksi). The fracture surface exhibits a wide range of dimple sizes. The heat treatment resulted in a plane-strain fracture-toughness ( $K_{Ic}$ ) value of 55 MPa  $\sqrt{m}$  (50 ksi  $\sqrt{in}$ ); this contrasted with a value of 121 MPa  $\sqrt{m}$  (110 ksi  $\sqrt{in}$ ) for the specimen in Fig. 554--probably because of incomplete solution of carbide particles of the lower austenitizing temperature for the specimen shown here. SEM, 3150×

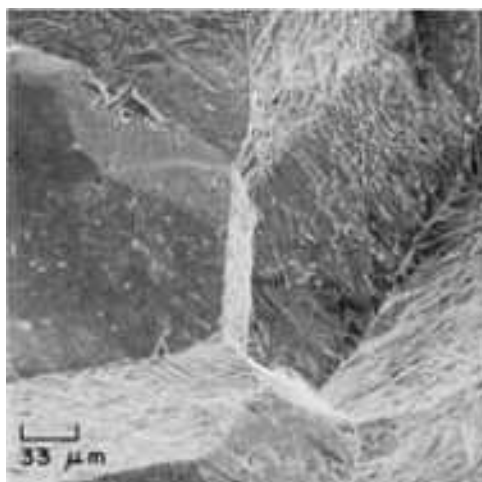
**Fig. 558** The heat treatment of this specimen was altered as follows: austenitized at 1205 °C (2200 °F) for 1 h, quench to 870 °C (1600 °F) and hold for 30 min, ice-brine quench, then refrigerate in liquid nitrogen. Fracture appears to have occurred by a combination of transgranular and intergranular cleavage. The  $K_{Ic}$  value of this specimen was even lower than that for the specimen in Fig. 557; the lower value is believed to

**be the result of a different distribution of carbide particles. SEM, 300×**

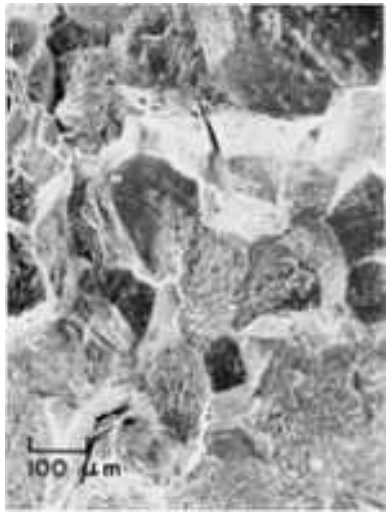
**Fig. 559** An area of the fracture surface in which the fracture appears to be intergranular, with secondary cracks between the grains. The lower portion of the area may contain dimples. SEM, 100×

These fractographs are of a fracture-toughness specimen of 0.4C-0.6Mn-5Mo secondary-hardening steel that was tested as part of a program to develop fracture toughness in high-strength steel (the same program that yielded Fig. 554, 555, 556, 557, and 558). This specimen was austenitized for 1 h at 1205 °C (2200 °F), ice-brine quenched, and refrigerated for 30 min in liquid nitrogen. Room-temperature yield strength was 1758 MPa (255 ksi). Plane-strain fracture-toughness ( $K_{Ic}$ ) value was 76 MPa  $\sqrt{m}$  (69 ksi  $\sqrt{in}$ )--appreciably less than the value for the lower-carbon (0.3% C) steel in Fig. 554, which was given the same heat treatment.

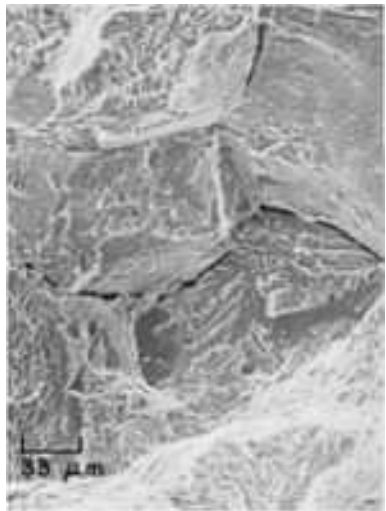
**Fig. 560** Another area of the fracture surface, shown at higher magnification. This area has many characteristics of an intergranular fracture. Grain surfaces exhibit fine dimples, but no river patterns. SEM, 300×

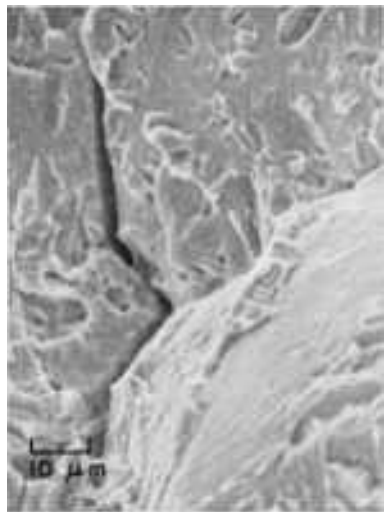
**Fig. 561 A third area of the fracture surface, at still higher magnification. This area shows a secondary crack penetrating deeply into the grain boundary. Small cleavage steps are evident. SEM, 1000×**

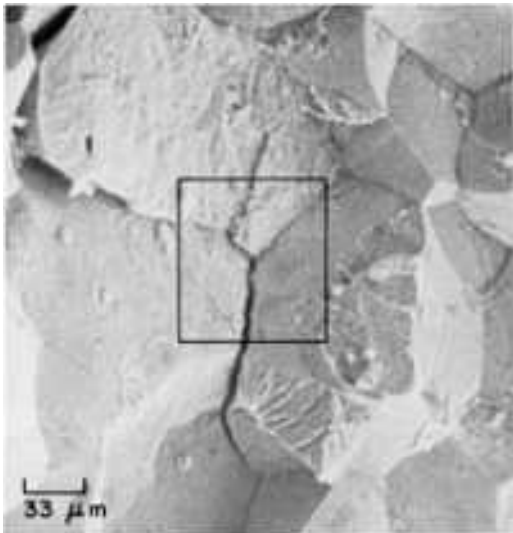
**Fig. 562 A V-notch Charpy impact fracture in a specimen of 0.42C-2.1Mo-5.2Co alloy steel that was not as tough as had been expected. The fracture has been largely intergranular, although three facets appear to be transgranular cleavage facets. Note the secondary grain-boundary crack. Area in rectangle is shown enlarged in Fig. 563. SEM, 300×**

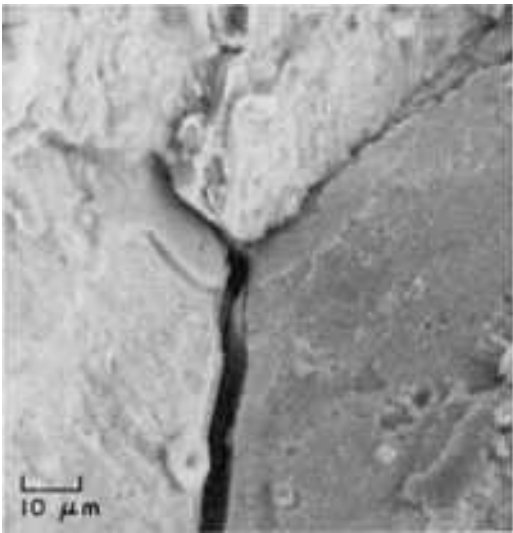
**Fig. 563 Area outlined by the rectangle in Fig. 562, shown at a higher magnification. The two facets in the lower portion are believed to be grain surfaces; facet in upper portion is believed to be transgranular cleavage facet. The cause of the low toughness of this specimen was quench cracking. Small rings visible here may be artifacts. SEM, 1000×**

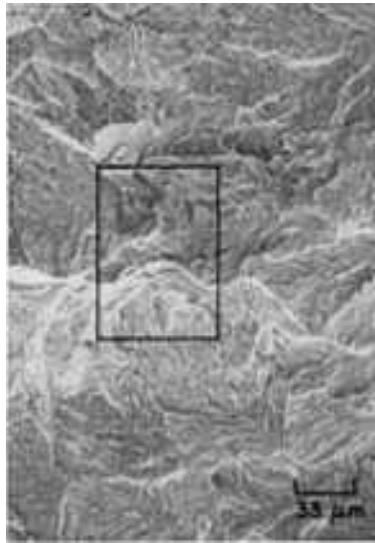
**Fig. 564** Charpy V-notch impact fracture in 0.43C-3.85Mo-9Co alloy steel that was heat treated in an inert atmosphere at 1200 °C (2190 °F) for 1 h, then quenched in an agitated solution of ice and 10% brine. It appears that fracture was by a shear process. See also Fig. 565. SEM, 300×
