ASM HANDBOOK®

VOLUME  
12

Fractography

*Fractography*, was published in 1987 as Volume 12 of the *ASM Handbook*. The Volume was prepared under the direction of the ASM Handbook Committee.

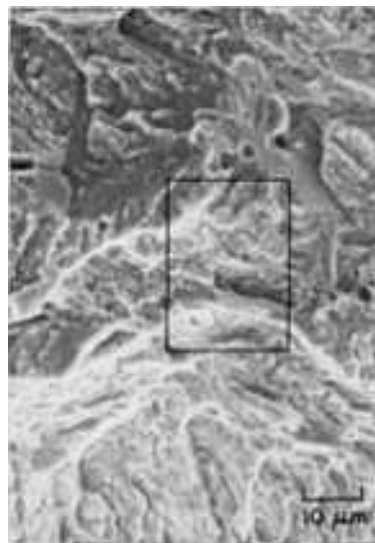
**Fig. 565** Higher-magnification view of the area within the rectangle in the Fig. 564, showing more clearly the shear deformation and some isolated dimples. There appear to be small regions of local cleavage. See Fig. 566 for a higher-magnification view of the area in the rectangle here. SEM, 1000×

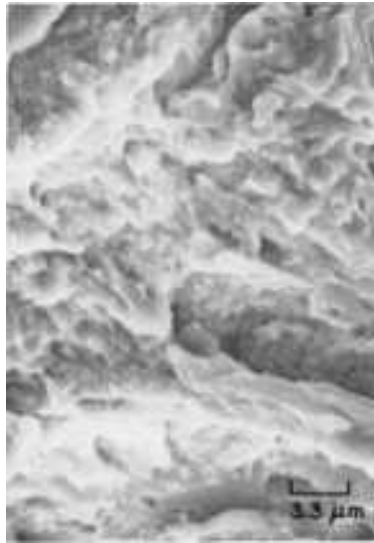
**Fig. 566** Higher-magnification view of the area within the rectangle in Fig. 565, which reveals additional small dimples that are not readily apparent at the lower magnification. See Fig. 567, 568, and 569 for the effects of tempering on the fracture surface. SEM, 300×

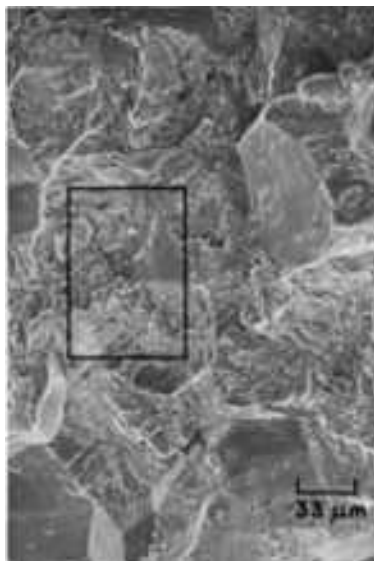
**Fig. 567** Charpy impact fracture in a specimen of the same alloy steel and given the same austenizing treatment as in Fig. 564, but then tempered for 1 h at 600 °C (1110 °F), which maximized secondary hardening, and air cooled. See also Fig. 568. SEM, 300×

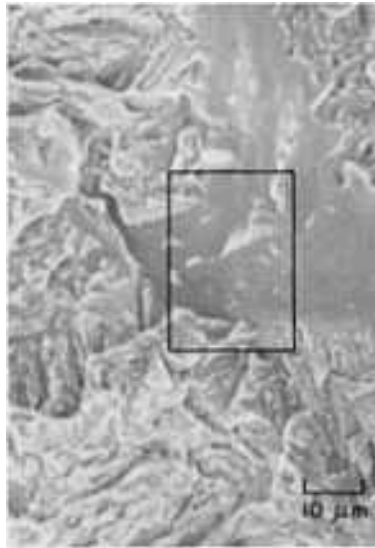
**Fig. 568** An enlargement of the area in the rectangle in Fig. 567. This specimen, which had the same yield strength as that of the as-quenched specimen in Fig. 564, fractured mainly by intergranular separation. See Fig. 569 for a higher-magnification view of the area in the rectangle here. SEM, 1000×

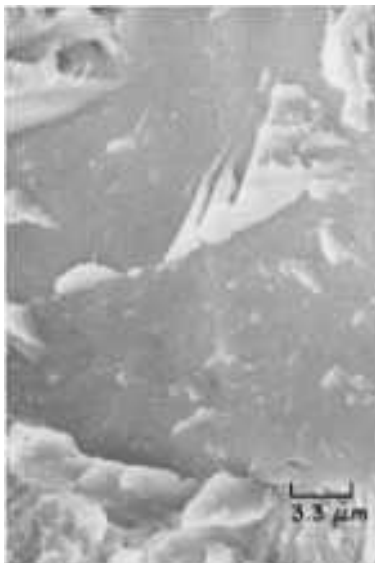
**Fig. 569** Higher-magnification view of the area in the rectangle in Fig. 568. A tongue-like formation is visible (at left center) on the flat surface of a grain. Tempering has produced embrittling networks of carbide particles. SEM, 3000×

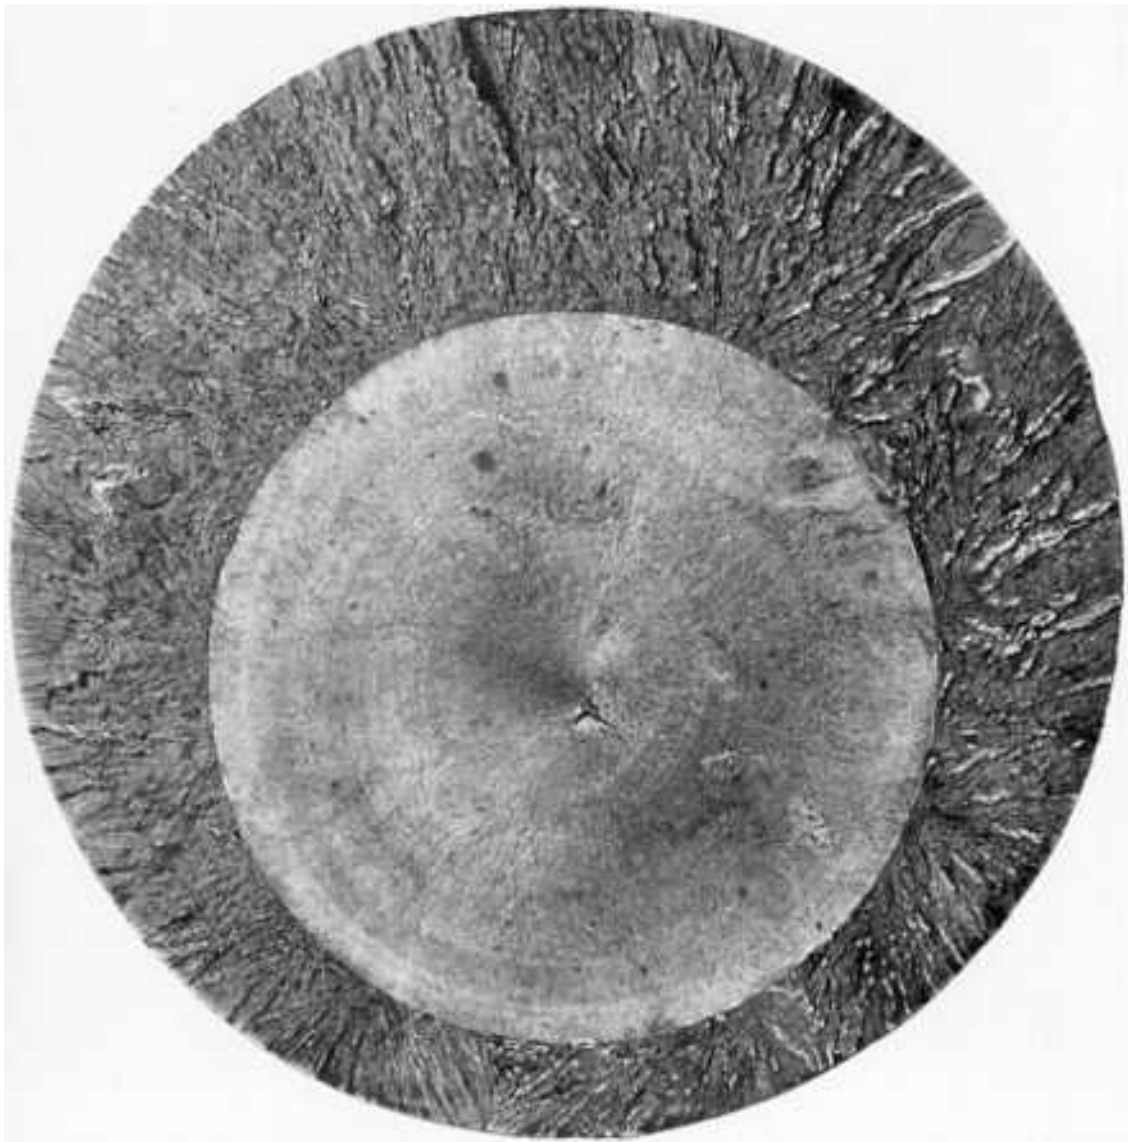
**Fig. 570 Surface of a fatigue fracture in a 200-mm (8-in.) diam piston rod of a steam hammer for forging. The rod was fabricated from 0.26C-0.70Mn-0.87Ni-1Cr steel and heat treated to a hardness of 24 HRC at the surface and 17 HRC at the center of the section. This is an example of the fracture caused by pure tensile fatigue, in which surface stress concentrations are absent and a crack may start anywhere in the cross section. In this instance, the initial crack formed at a forging flake slightly below center, grew outward symmetrically, and ultimately produced a brittle fracture without warning. 0.93×**

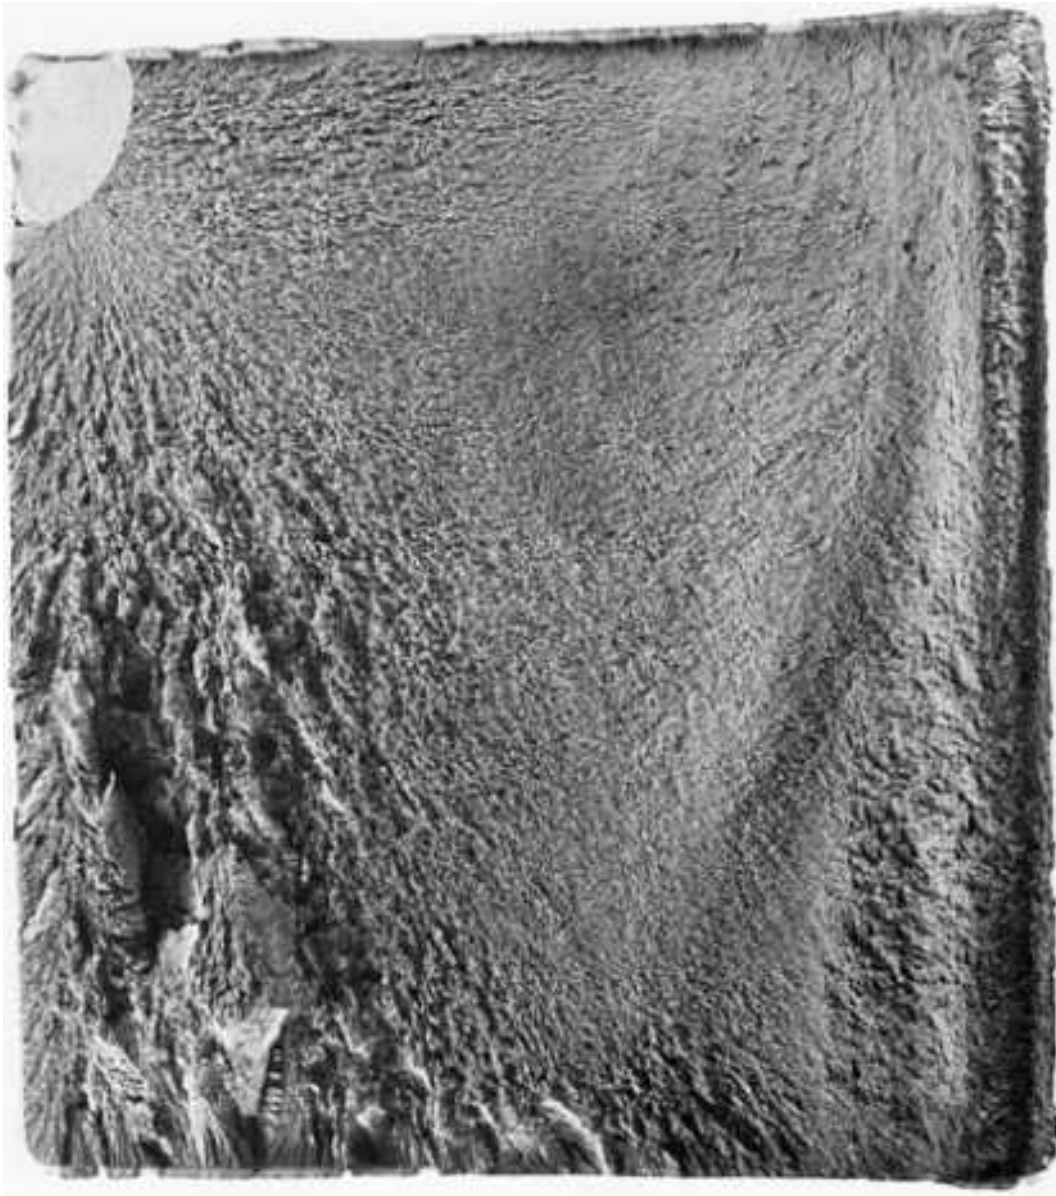
**Fig. 571 Surface of a fracture in an equalizer bar, which supports the front end of a tractor, fabricated from D6B steel and heat treated to a hardness of 45 to 47 HRC. The bar was put into service for 200 h and then returned to the laboratory, where it was flexed in fatigue to fracture at  $60 \times 10^3$  cycles. Note the very fine texture of the fatigue-crack zone at the upper left corner. It is concluded that because there are no beach marks beyond that small corner zone, the remainder of the fracture occurred in a catastrophic manner. Shear lips are evident along the top and right edges, and may also be present around the lower left corner. (D6B steel contains 0.45% C, 0.80% Mn, 1.00% Cr, 0.50% Ni, 1.00% Mo, and 0.10% V.) ~1.13×**

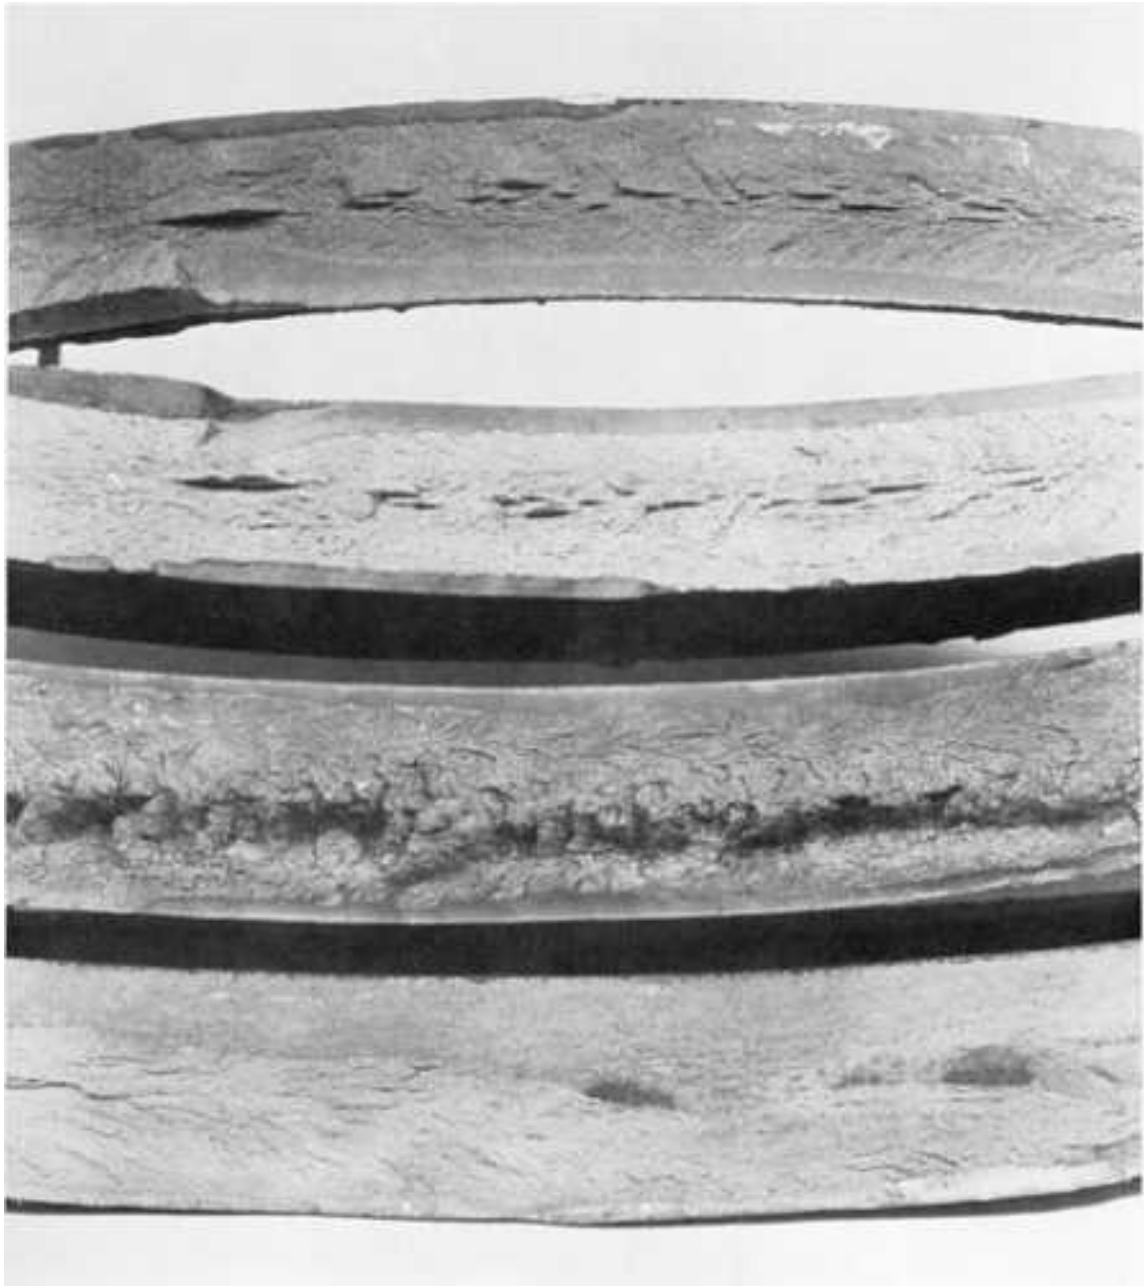
**Fig. 572 Four fracture surfaces of a hemispherical accumulator head of high-strength low-alloy steel (0.15% C, 0.8% Mn, 0.6% Cr, and 0.85% Ni) that broke into several pieces during pressure testing at room temperature. Hardness ranged from 28 to 39 HRC. Fracture originated at a thin spot in the wall, where banding was also present. At top are mating surfaces of a fracture near the origin, showing chevron marks and tongues, although tongues are more typical of low-temperature cleavage of iron-base alloys than of room-temperature cleavage. The fracture surface third from the top is very coarse-grained, whereas the surface at bottom is fine-grained and silky; the difference in appearance between these two surfaces may have resulted from a difference in rate of crack propagation. Actual size**

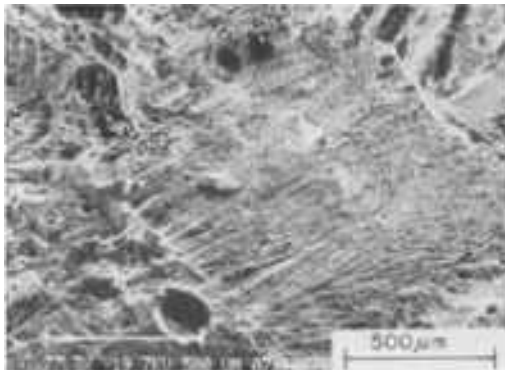
Fig. 573

Solidification cracking in laser-beam weldments of ASTM A372, class 6 (HY-80). Laser welds in 13-mm (0.5-in) thick plate were made at a travel speed of 13 mm/s (30 in./min) using a beam power of 10.6 kW and a heat input of 0.83 kJ/mm (21.2 kJ/in.). Weldment toughness was measured at room temperature on a subsized 13-mm (0.5-in.) thick dynamic tear (DT) specimen notched in the weld. Solidification cracking of the hard and brittle fusion zone (untempered martensite) resulted in low toughness values typically little higher than 76 J (56 ft · lb). Toughness of the 3% Ni base metal (quenched and tempered martensite) generally exceeded 470 J (350 ft · lb). The fractographs of the DT specimen surface reveal considerable solidification cracking as well as some scattered porosity. Fig. 573: SEM, 50×. Fig. 574: SEM, 850×. Fig. 575: SEM, 13,000× (D.W. Moon and E.A. Metzbower, Naval Research Laboratory)

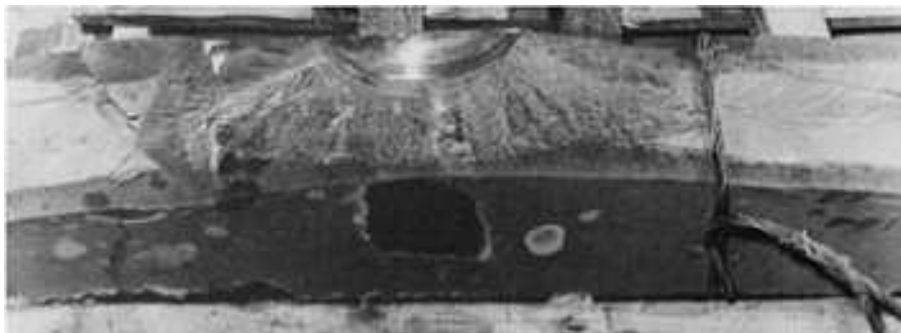
Fig. 576

**Intentional fracture by overpressurization of ASTM A508, class 2, pressure vessel. The intermediate test vessel (ITV) was fabricated as part of the Heavy Section Steel Technology (HSST) program at Oak Ridge National Laboratory, a government-sponsored effort aimed at gaging the toughness of nuclear pressure vessels. The ITV measured 1 m (39 in.) in outside diameter with a 150-mm (6-in.) thick wall and was designed for 67-MPa (9.7-ksi) internal pressurization. The preflawed vessel contained a semielliptical fatigue-cracked defect measuring 205 mm (8 in.) long and 65 mm ( $2 \frac{5}{8}$  in.) deep. Failure occurred at the 55 °C (130 °F) test temperature and an internal pressure of 198 MPa (28.7 ksi)--nearly three times the design pressure allowed by the ASME code and four times the probable operating pressure. Fig. 576: Fracture surface. Note machined and fatigue precracked flaw at top center. Region of fatigue sharpened notch had a dimpled morphology; farther away from the flaw, a cleavage morphology. Fig. 577: Schematic of fracture surface in Fig. 576. Initial failure was by ductile tearing. Flaw grew to approximately 500 mm (20 in.) long and 100 mm (4 in.) deep before onset of brittle propagation. (D.A. Canonico, C-E Power Systems, Combustion Engineering Inc.)**

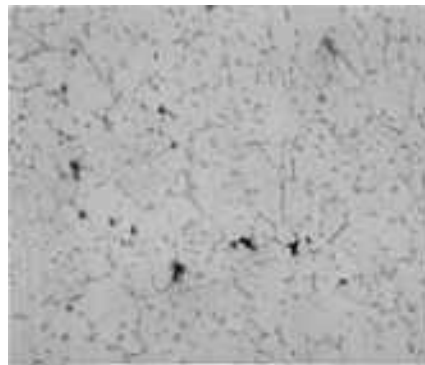
**Fig. 578 Creep failure of steam boiler superheater tube. Material: normalized and tempered ASME SA213, grade T22 (2.25Cr-1Mo steel). Cracking occurred at a hot spot due to long-time exposure to tensile stresses induced by the internal pressure and service temperatures up to 705 °C (1300 °F). Spheroidization of carbides in the ferrite matrix was caused by exposure to temperatures in the 650 to 705 °C (1200 to 1300 °F) range. The black voids at grain boundaries are typical of creep damage. 3% nital, 500× (J.R. Kattus, Associated Metallurgical Consultants Inc.)**

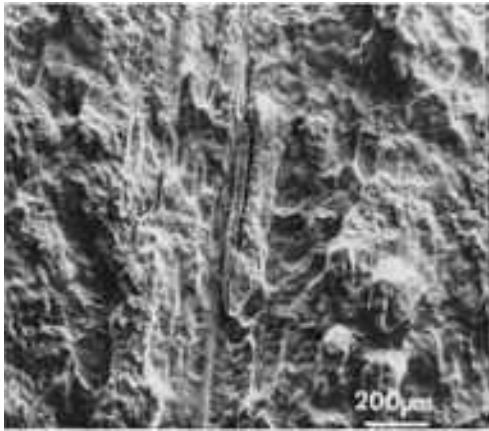
**Fig. 579**

Effect of inclusions on fatigue crack propagation (FCP) in ASTM A514F. The conventionally melted electric furnace steel was water quenched from 900 °C (1650 °F), tempered at 620 °C (1150 °F), water quenched, stress relieved at 595 °C (1100 °F), and then air cooled.  $\Delta K = 72 \text{ MPa } \sqrt{m}$  (65 ksi  $\sqrt{in}$ ). Fig. 579: Elongated features on T-L (standard transverse) orientation FCP test specimen. Direction of FCP is toward the top. This "streaking" in the FCP direction (and the major hot-rolling direction) is associated with inclusion formations present on the vertical faces of long protrusions or depressions, which also extend in the FCP direction. SEM, 53×. Fig. 580: Same as Fig. 579 but at higher magnification. See also Fig. 281, 282, and 283. SEM, 1055× (A.D. Wilson, Lukens Steel Company)

**Inclusions.** Discontinuities in the form of inclusions, such as oxides, sulfides, and silicates, can initiate fatigue fractures in parts subjected to cyclic loading (see, for example, Fig. 579 to 583 and Fig. 588 to 598 in the "Atlas of Fractographs" in this Volume, which illustrate the effect of inclusions on the fatigue crack propagation in ASTM A533B steel). In addition, such inclusions have been identified as initiation sites of ductile fractures in aluminum alloys and steels. At relatively low strains, microvoids form at inclusions, either by fracture of the inclusion or by decohesion of the matrix/inclusion interface.

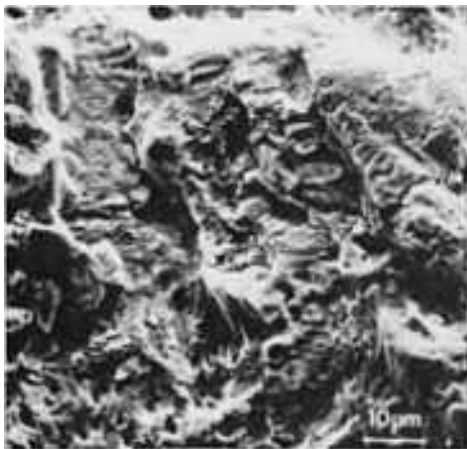
**Fig. 581**

Effect of inclusions on fatigue crack propagation (FCP) in ASTM A514F. Direction of FCP is toward the top. Fig. 581: Area of fracture surface not near inclusion formations shows primarily ductile fatigue striations. Also note secondary cracking. Through-thickness (S-T orientation) FCP specimen at  $\Delta K = 55 \text{ MPa } \sqrt{m}$  (50 ksi  $\sqrt{in}$ ). SEM, 1020×. Fig. 582 and 583: Through-thickness (S-L orientation)

fractures near inclusion formations at two levels of  $\Delta K$ . At the low 22-MPa  $\sqrt{m}$  (20-ksi  $\sqrt{in}$ ) level (Fig. 582), fatigue damage is by striation formation in the interinclusion material of an inclusion formation. At the high 55-MPa  $\sqrt{m}$  (50-ksi  $\sqrt{in}$ ) level (Fig. 583), ductile fracture (microvoid coalescence) of the interinclusion material occurs. See also Fig. 579 and 580. SEM, both at 1020 $\times$  (A.D. Wilson, Lukens Steel Company)

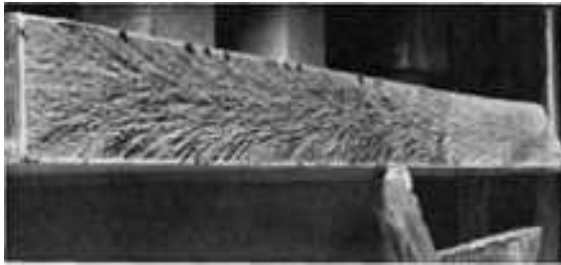
Fig. 584

Brittle fracture of tension flange for large box-girder bridge. The flange measured 75 cm (30 in.) wide and 55 mm ( $2 \frac{1}{4}$  in.) thick and was welded to a trapezoidal box girder. It was made of 55-mm ( $2 \frac{1}{4}$  in.) thick ASTM A517H plate. Failure occurred catastrophically across the full width of the flange as the concrete deck of the bridge was being placed. Fracture was arrested about 100 mm (4 in.) down the web of the girder. Ambient temperature: 14 °C (58 °F). Cause of fracture was inadequate toughness in the quenched and tempered 690-MPa (100-ksi) minimum yield strength steel. At the time, toughness in A517 was assumed and was not a specification requirement as it is now. Also, the then-current specification limited maximum thickness to 50 mm (2 in.). However, thicker plate was allowed for this application. Fig. 584: Fracture surface of flange. Chevrons point to origin at right. Fig. 585: Close-up of fracture origin (right) at weld between flange and cross bracing. Fig. 586 and 587: Photomicrographs of structure of failed flange near the surface (Fig. 586) and at the center (Fig. 587) of the 55-mm ( $2 \frac{1}{4}$  in.) thick plate. Both at 500 $\times$  (C.E. Hartbower, Consultant)

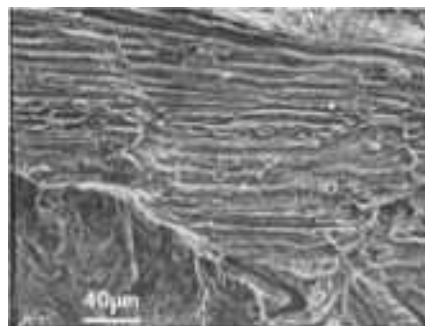
**Effect of inclusions on FCP in ASTM A533B.** The conventionally melted electric furnace steel was water quenched from 900 °C (1650 °F), tempered at 670 °C (1240 °F), air cooled, stress relieved at 595 °C (1100 °F), and then furnace cooled. FCP specimen tested in the through-thickness (S-T, S-L) orientations. Direction of fatigue crack propagation is toward the top. Fig. 588: Fracture surface of S-L oriented FCP test specimen. Fracture surface appearance due to inclusion formation on depressions or plateaus on the fracture surface. Figures 589, 590, and 591 show three kinds of MnS inclusions in type II MnS inclusion formations: highly elongated (Fig. 589), flattened or pancaked (Fig. 590), and small and round as a result of homogenization (Fig. 591). SEM, Fig. 589 and 590: 230×, Fig. 591: 200×. Fig. 592: Alumina (Al<sub>2</sub>O<sub>3</sub>) galaxies on the through-thickness fracture surface of A533B. SEM, 200×.  $\Delta K$  in Fig. 589, 590, and 592 = 25 MPa  $\sqrt{m}$  (23 ksi  $\sqrt{in}$ ); in Fig. 591, 58 MPa  $\sqrt{m}$  (53 ksi  $\sqrt{in}$ ). See also Fig. 593, 594, 595, 596, 597, and 598. (A.D. Wilson, Lukens Steel Company)

**Fig. 593 Effect of inclusions on fatigue crack propagation (FCP) in ASTM A533B.** Fractograph shows compact and well-dispersed type III MnS inclusions in calcium-treated electric furnace steel, through-thickness (S-L) orientation. Balance of inclusions were round, calcium-modified duplex types consisting of sulfide and aluminate phases. Decreasing the size and number of inclusions, and the number of inclusions formations, is responsible for the improved FCP behavior in the through-thickness orientations of calcium-treated steels. Direction of FCP is toward the top.  $\Delta K$  = 26 MPa  $\sqrt{m}$  (24 ksi  $\sqrt{in}$ ). See also Fig. 588, 589, 590, 591, 592, 594, 595, 596, 597, and 598. SEM, 300× (A.D. Wilson, Lukens Steel Company)

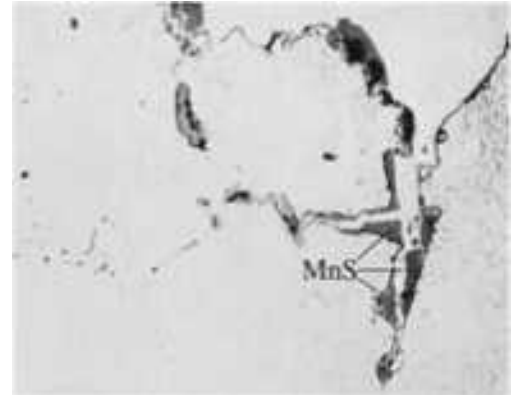
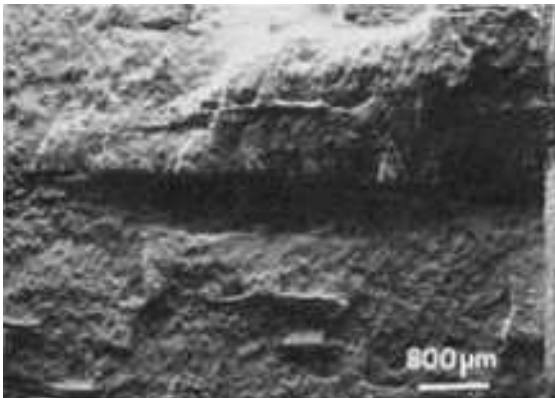
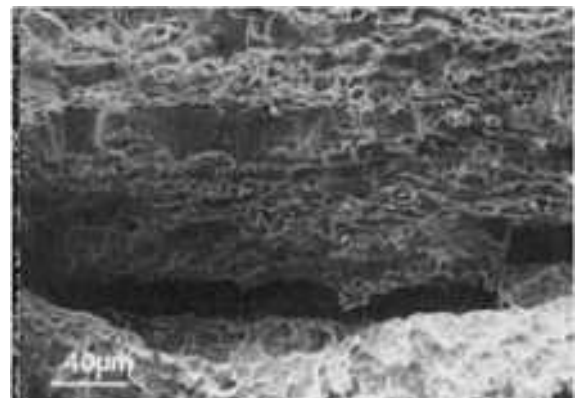
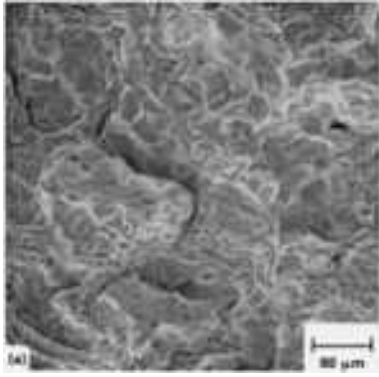
**Effects of inclusions on fatigue crack propagation (FCP) in ASTM A533B. In conventional electric furnace steel, protrusions perpendicular to the direction of FCP were noted on T-S and L-S fracture surfaces. The protrusions result from inclusion formations (type II MnS and  $\text{Al}_2\text{O}_3$ ) acting as crack deflectors. Figures show T-S orientation features. FCP direction is toward the top. Fig. 595: Protrusions on fracture surface. Fig. 596: Metallographic cross section reveals MnS inclusions on a protrusion. 170 $\times$ . Fig. 597: Protrusion. SEM, 15 $\times$ . Fig. 598: Protrusion with  $\text{Al}_2\text{O}_3$  galaxy. SEM, 28° tilt angle, 325 $\times$ . Fig. 597 and 598 at  $\Delta K$  of  $40 \text{ MPa } \sqrt{m}$  (36 ksi  $\sqrt{in}$ ). See also Fig. 588, 589, 590, 591, 592, 593, and 594. (A.D. Wilson, Lukens Steel Company)**

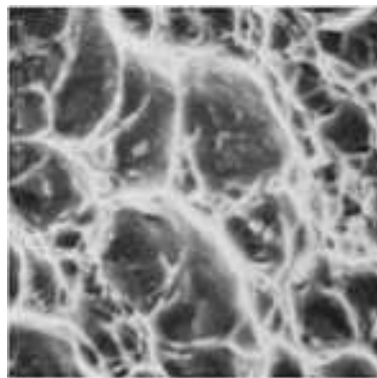
Cavitated intergranular fracture due to hydrogen of ASTM A533B. The specimen of pressure vessel steel--yield strength, 630 Mpa (91.5 ksi)--was exposed for more than 1000 h to temperatures above 550 °C (1020 °F) and gaseous hydrogen at a pressure greater than 17 MPa (2.5 ksi). Under these conditions, hydrogen diffuses into the steel, reacts with thermodynamically less stable carbides, and forms bubbles of methane gas along grain boundaries. Mechanical properties plummet and, under impact, failure occurs by rapid coalescence of the methane bubbles, each nucleated at a submicron carbide or inclusion, along prior-austenite grain boundaries. These cavitated intergranular fractures are common in steels used for hydrogen service (hydrocracking or coal conversion processes, for example) and resemble both failures in "overheated" steel, where reprecipitation of fine grain boundary sulfides due to an overly high austenitization temperature provides the source of the voids, and high-temperature creep cavitation fractures, where voids form at carbides and grow by vacancy coalescence and matrix creep. Fig. 599: Fracture surface of Charpy specimen. Note secondary cracking due to severe bubble coalescence along grain boundaries. SEM, 125×. Fig. 600: Same as Fig. 599, but at higher magnification. Note nucleus at bottom of each cavity. SEM, 3330× (R.H. Dauskardt and R.O. Ritchie, University of California)

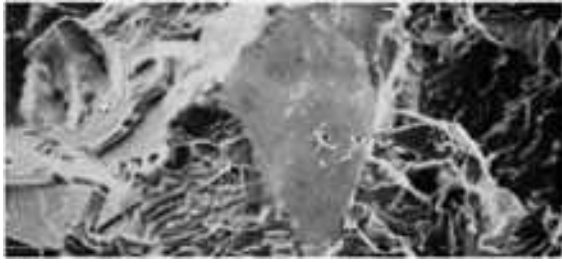
**Fig. 601** Elevated-temperature fracture surface of Cr-Mo-V alloy steel specimen tensile tested at failure at 500 °C (930 °F) and an initial strain rate of  $4.4 \times 10^{-5}$ /s. Composition of the hot-rolled steel plate: 0.29% C, 1.01% Cr, 1.26% Mo, 0.25% V, 0.01% Mn, 0.59% Si, 0.037% P, 0.004% S, and 0.006% Sn. Heat treatment: two-step austenitize 1 h at 1300 °C (2370 °F), followed by 1 h at 950 °C (1740 °F), air cool; temper at 700 °C (1290 °F) to 28 HRC. Failure resulted from the nucleation, growth, and eventual coalescence of grain-boundary cavities. The cavities nucleated on complex sulfides. SEM, 2500× (D.P. Pope, University of Pennsylvania, and S.-H. Chen, Norton Christensen)

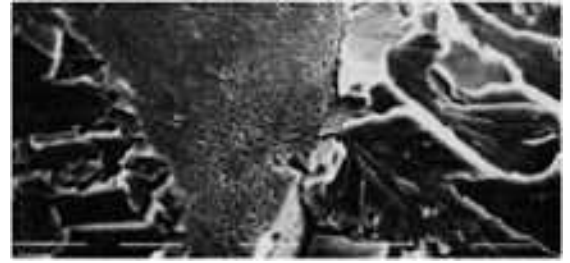
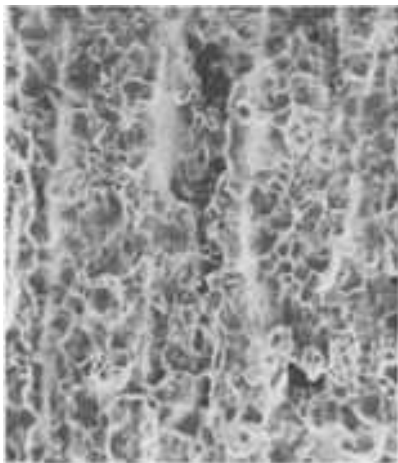
Possible explanation of why phosphorus enhances the ductility of Cr-Mo-V steel. Composition of the hot-rolled steel plate: 0.27% C, 0.99% Cr, 1.25% Mo, 0.25% V, 0.01% Mn, 0.04% Si, 0.038% P, 0.004% S, and 0.005% Sn. Heat treatment: austenitize 1 h at 1100 °C (2010 °F), air cool, temper at 700 °C (1290 °F) to 28 HRC. Fig. 602 and 603: Fracture surface of specimen tensile tested at 500 °C (930 °F) and an initial strain rate of  $4.4 \times 10^{-5}$ /s. Test interrupted at yield and specimen subsequently broken by impact at -100 °C (-150 °F) in a scanning Auger microprobe. At elevated temperatures and low strain rates, this steel (like many other metals) fails intergranularly by grain-boundary cavitation. However, the grain-boundary facet at the center of Fig. 602 (SEM, 300×) is not uniformly cavitated, as revealed by the higher-magnification view in Fig. 603 (SEM, 850×). Fig. 604 and 605: Phosphorus and Sulfur maps, respectively, of the facet in Fig. 602 (both at 350×). When overlapped, these maps show that phosphorus-rich areas correspond to uncavitated regions of the grain-boundary facet, and sulfur-rich areas correspond to cavitated regions. Thus, when phosphorus is added to Cr-Mo-V steel, site competition between phosphorus and sulfur reduces sulfur segregation and, consequently, sulfide precipitation on grain boundaries. And, because cavities in this steel nucleate principally on sulfides, a reduction in sulfide population on grain boundaries leads to an improvement in ductility. (D.P. Pope, University of Pennsylvania, and S.-H. Chen, Norton Christensen)

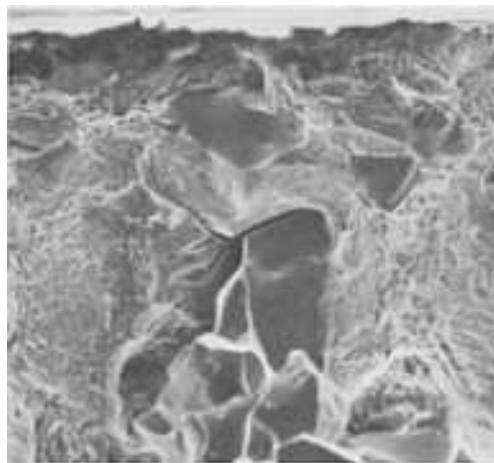
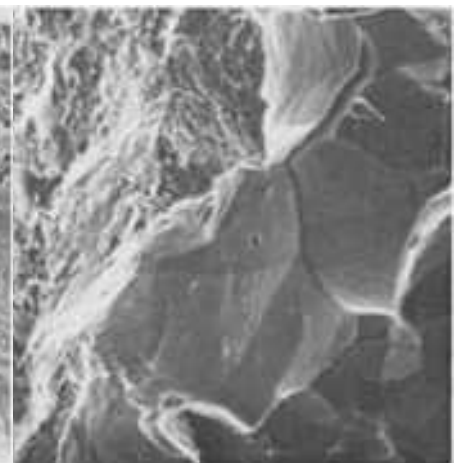
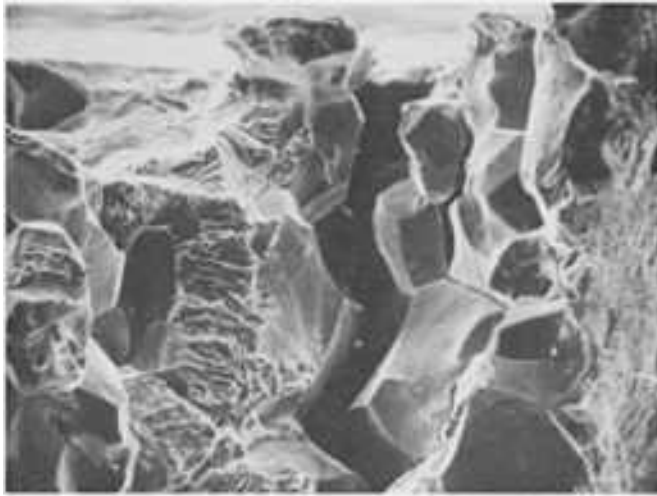
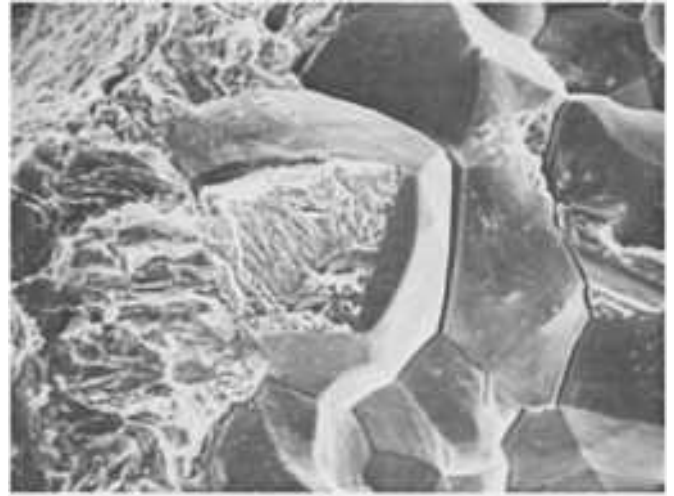
Effect of hydrogen environment on fracture of an antimony-doped Ni-Cr steel. Composition of the vacuum-melted alloy: 0.30% C, 3.5% Ni, 1.7% Cr, and 0.06% Sb. Samples were cut from 13-mm (0.5-in.) thick hot-rolled plate perpendicular to the rolling direction and heat treated by austenitizing for 1 h at 1025 °C (1875 °F) and tempering for 1 h at 600 °C (1110 °F) to a grain size of ASTM 3 and a hardness of 30 HRC. Samples were then aged to 100 h at 480 °C (895 °F) to allow antimony to segregate to grain boundaries. Notched samples were fractured in air and in 170 kPa (1.7 atm) of hydrogen gas by slow loading in four-point bending. Fig. 606: Banded fracture surface, with locally different compositions, of antimony-doped samples fractured in air. A similarly banded structure was observed on samples fractured in hydrogen. SEM, 40×. Fig. 607 and 608: Higher-magnification views of fracture surface to sample broken in air. Failure was by stress-controlled intergranular fracture in solute-rich bands and by strain-controlled microvoid coalescence in solute-depleted regions. Auger electron spectroscopy confirmed that intergranular fracture was due to enhanced antimony segregation. SEM, 320× and 640×. Fig. 609 and 610: Fracture surface at two magnifications of sample broken in hydrogen. In this case, solute-depleted regions failed by quasi-cleavage. SEM, 320× and 640× (M.J. Morgan and C.J. McMahon, Jr., University of Pennsylvania)

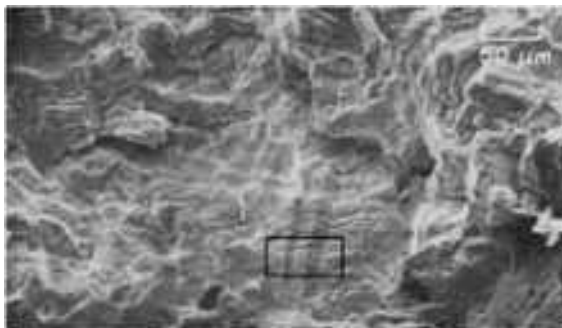
**Fig. 611** Surface of fatigue-crack fracture in a specimen of AISI type 301 stainless steel that was highly stressed, breaking in 2000 cycles. Crack growth was very irregular, with many pronounced offsets. At center, twin boundaries have affected crack propagation. Area in rectangle is shown at higher magnification in Fig. 612. SEM, 200×

**Fig. 612** A higher-magnification view of the area outlined by the rectangle in Fig. 611, which includes twin-boundary outlines. Several secondary cracks have formed at the roots of the fatigue striations. The striae, however, are not delineated well enough to permit a confident estimate of the spacing. SEM, 1400×

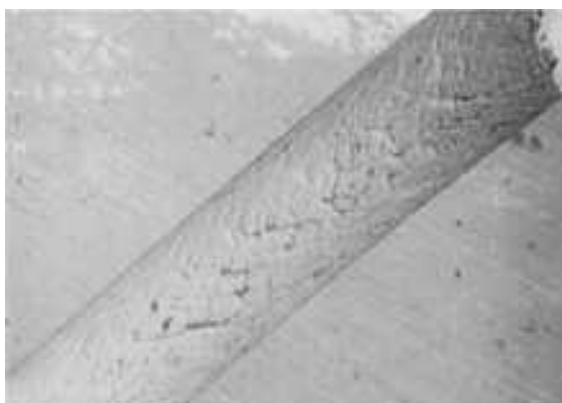
**Fig. 613** Fatigue fracture of AISI type 302 spring wire. Failure initiated at grain-boundary damage called "alligatoring," a condition resulting from overetching during acid cleaning. Alligatoring is always detrimental to fatigue resistance and in extreme cases (such as this one) can lead to fracture of small index springs during coiling. SEM, 50× (J.H. Maker, Associated Spring, Barnes Group Inc.)

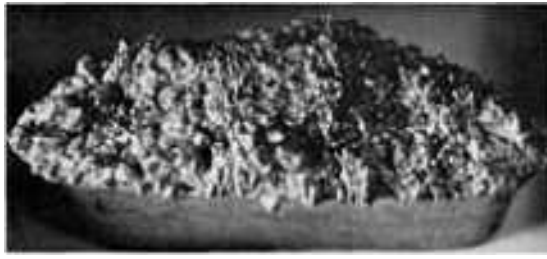
**Fig. 614** Surface of a "rock candy" fracture in a bloom of AISI type 302 stainless steel. An abnormally high silicon content and inadvertent overheating at 1355 °C (2475 °F) for 45 min after the first blooming-mill pass caused excessive grain growth; the second pass then resulted in intergranular fracture. See also Fig. 615. 0.67×

**Fig. 615** Higher-magnification view of fracture surface in Fig. 614. This bloom fractured during rolling, splitting apart and wrapping itself around the roll. Note lack of deformation of grains. The fracture surface was cleaned with  $\text{H}_2\text{SO}_4$  and was brightened with a solution containing  $\text{HNO}_3$  and HF. 1.5×

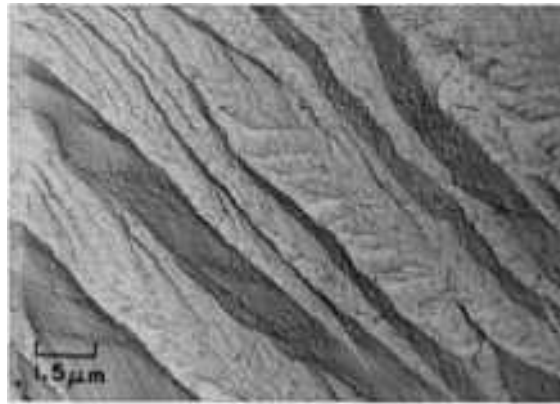
**Fig. 616 TEM p-c replica of an area near A, close to the notch, in the fracture in Fig. 618, showing definite cleavage steps and essentially no evidence of fatigue striations. A thin oxide film is present. See also Fig. 617. 6500×**

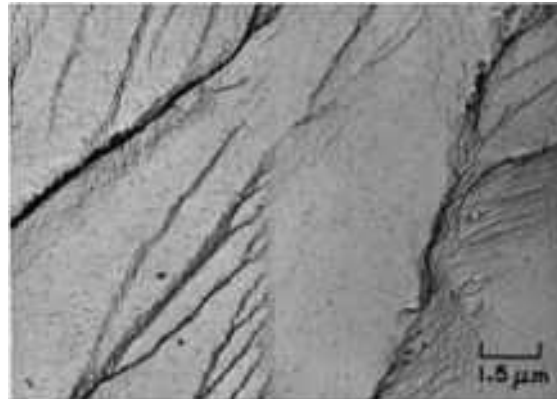
**Fig. 617 TEM p-c replica of another area near A in Fig. 618, also showing evidence of cleavage steps. The fine marks at right, which are essentially parallel to the cleavage direction, probably are not fatigue striations. See also Fig. 619, 620, 621, 622, 623, 624, 625, and 626. 6500×**

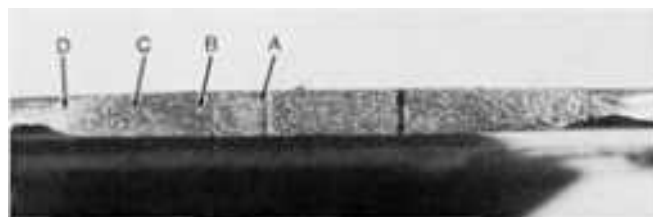
**Fig. 618 Surface of a high-cycle fatigue fracture in a notched specimen of AISI type 302 stainless steel sheet subjected at 425 °C (800 °F) to tensile stress cycled from 24.8 to 124 MPa (3.6 to 18 ksi) at 1000 cycles/min. Fracture occurred after 1,625,450 cycles. The notch in the specimen was a center hole 0.25 mm (0.01 in.) in radius and 5 mm (0.20 in.) wide. Fatigue area became purple; fast-fracture area became straw colored, with shear and necking. See Fig. 616, 617, 619, 620, 621, 622, 623, 624, 625, and 626 for views at A, B, C, and D. 5×**

**Fig. 619 TEM p-c replica of a third area near A in the fracture surface shown in Fig. 618. Here, fatigue striations are present in rather narrow and somewhat irregular patches. Some evidence of surface oxidation can be seen. 6500×**

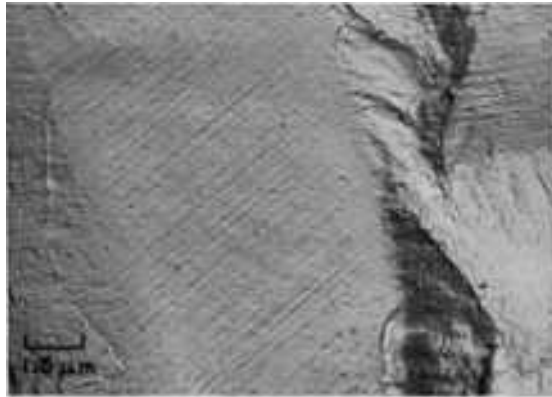
**Fig. 620 TEM p-c replica of a fourth area near A in the fracture surface in Fig. 618, showing flat facets quite suggestive of intergranular cleavage. The parallel marks may not be fatigue striations, but rather features associated with the oxide film. 6500×**

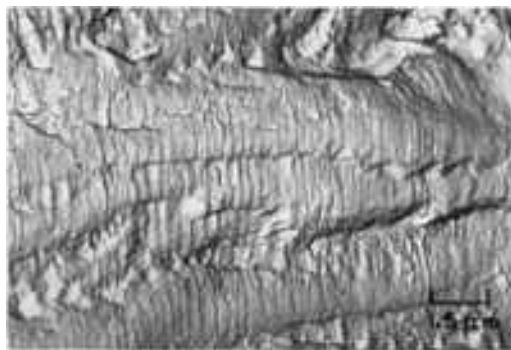
**Fig. 621 TEM p-c replica of a fifth area near A in the fracture surface in Fig. 618. This area is characterized by narrow patches of extremely sharp and distinct fatigue striations. Again, the oxide film is apparent. 6500×**

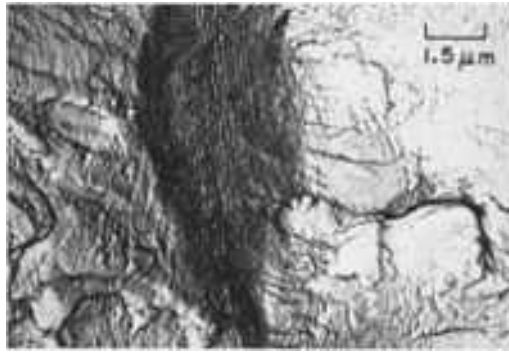
**Fig. 622 TEM p-c replica of a sixth area near A in the fracture surface in Fig. 618, showing distinct fatigue striations. The markings to the right of the dark region are believed to be cleavage steps, not fatigue striations. 6500×**

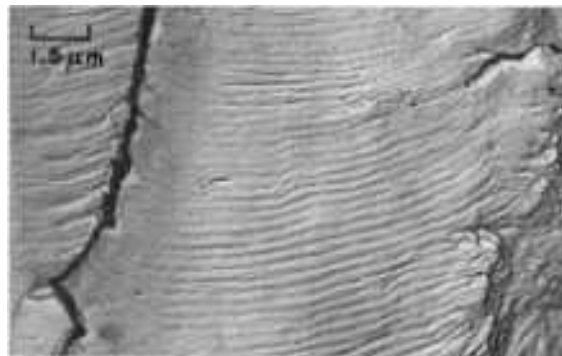
**Fig. 623 TEM p-c replica of an area at B, approximately 2.3 mm (0.09 in.) from the notch, in the fracture surface shown in Fig. 618. The heavy, black mark at left is the result of a sharp difference in level at the junction of two crack fronts. The fatigue striations here are regular and well developed. 6500×**

**Fig. 624 TEM p-c replica of an area at C, about 4.4 mm (0.175 in.) from the notch, in Fig. 618. Note that the fatigue striations here are more widely spaced than those in Fig. 623, which indicates that the effective stress increased as the crack penetrated into the specimen. Partly formed dimples are visible above and right of center. 6500×**

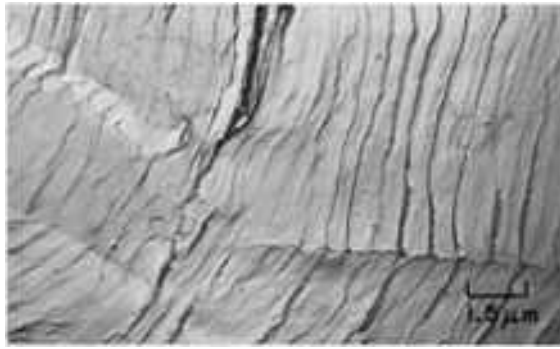
**Fig. 625** TEM p-c replica of another area near C in Fig. 618, showing a further increase in fatigue-striation spacing. A junction of two crack fronts is visible at lower right. Secondary cracks appear to have formed at some striations. 6500×

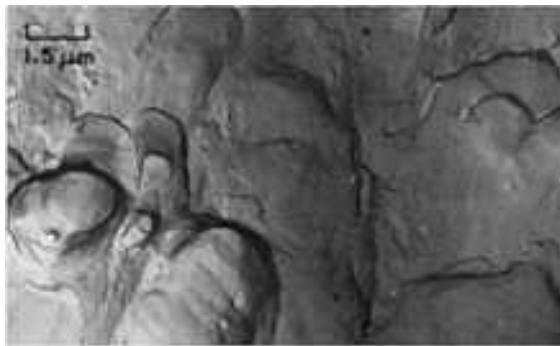
**Fig. 626** TEM p-c replica of an area at D, in the region of final fast fracture and about 11.7 mm (0.46 in.) from the notch, in Fig. 618. The elongated dimples confirm that final fracture was by shear. Fatigue striations ceased to form when this final stage of fracture began. 6500×

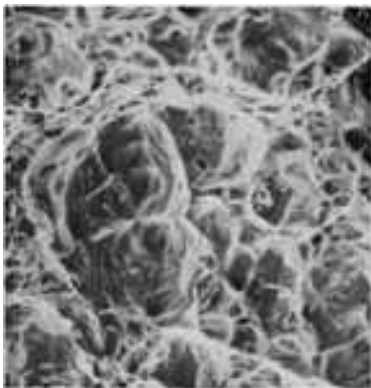
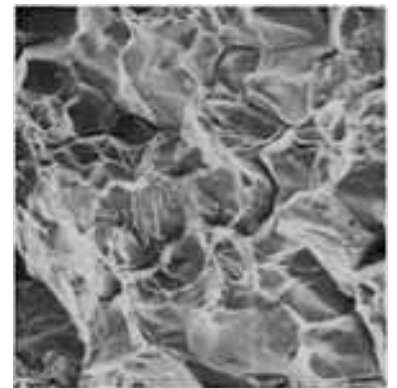
Effect of strain rate in creep crack propagation on fracture mode in an AISI type 304 stainless steel tested at 540 °C (1000 °F). A ductile-to-brittle transition occurred at very slow strain rates. Fig. 627: Microvoid coalescence (dimpled rupture) on fracture surface of sample tested at strain rate of 1.3 mm/min (0.05 in./min). SEM, 200×. Fig. 628: Brittle intergranular fracture surface of sample tested at 6 μm/min (240 μin./min). SEM 200× (J.E. Nolan, Westinghouse Hanford Company)

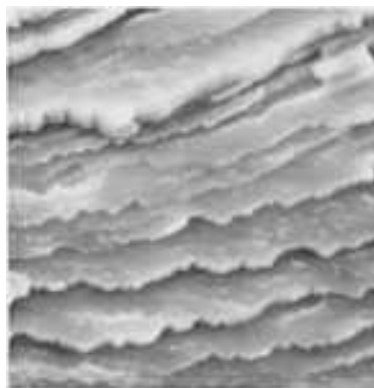
**Fig. 629 Stress-corrosion cracking facets on the fracture surface of an AISI type 304 sample tested under constant load in  $\text{MgCl}_2$  solution at 155 °C (310 °F). The steplike features are analogous to cleavage facets. See also Fig. 645. SEM, 3000× (R. Liu, N. Narita, C. Altstetter, H. Birnbaum, and N. Pugh, University of Illinois)**

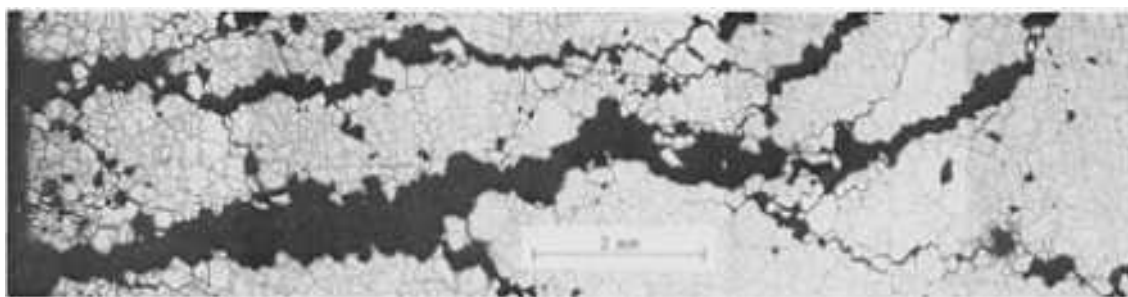
**Fig. 632**

**Failure of AISI type 304 tube due to chloride stress-corrosion cracking (SCC) from the outside in. The oil feed tube was used in a paper mill, where relative humidity was 100%. Cracks and evidence of corrosion were found under the coating of the painted side of the tube. No damage was noted on the other, unpainted side. Torsional stresses in service and chlorides in the paint (at a level of 6600 ppm) provided the conditions necessary for chloride SCC. Fig. 630: Crack on painted side of tube. Angle reveals influence of torsional stresses. Fig. 631: Stress-corrosion cracks extending from the outside diameter of the tube (at top) toward its inner diameter. 10% oxalic acid electrolytic etch; 28×. Fig. 632: Fractured tube. Branching of crack verifies that fracture occurred from the outside diameter (at top) in. 10% oxalic acid electrolytic etch; 28× (Z. Flanders, Packer Engineering Associates, Inc.)**

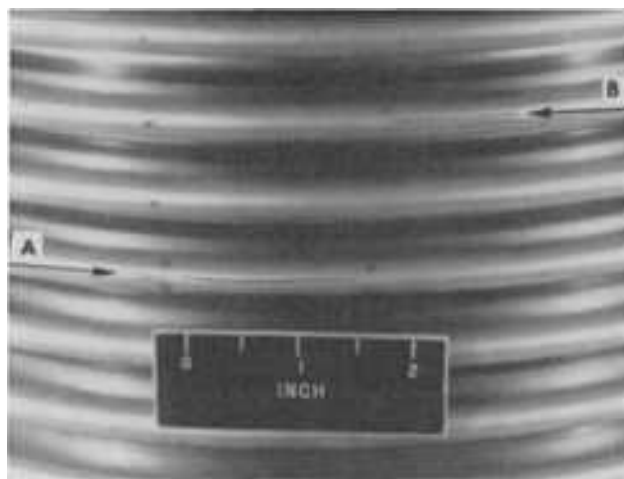
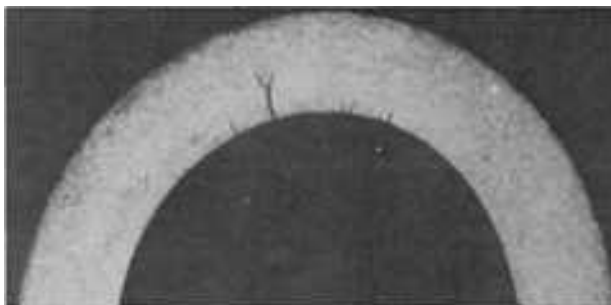
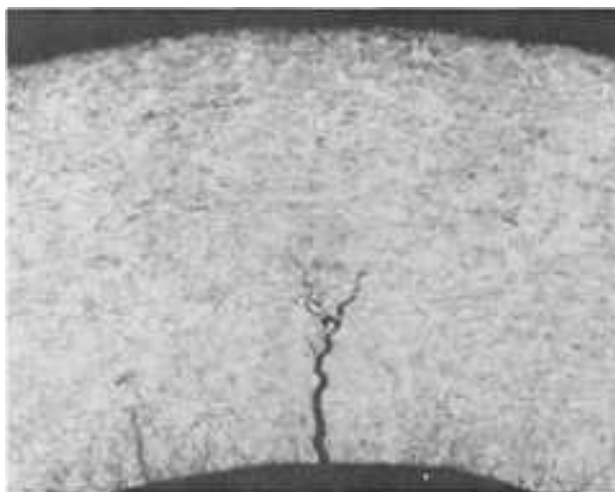
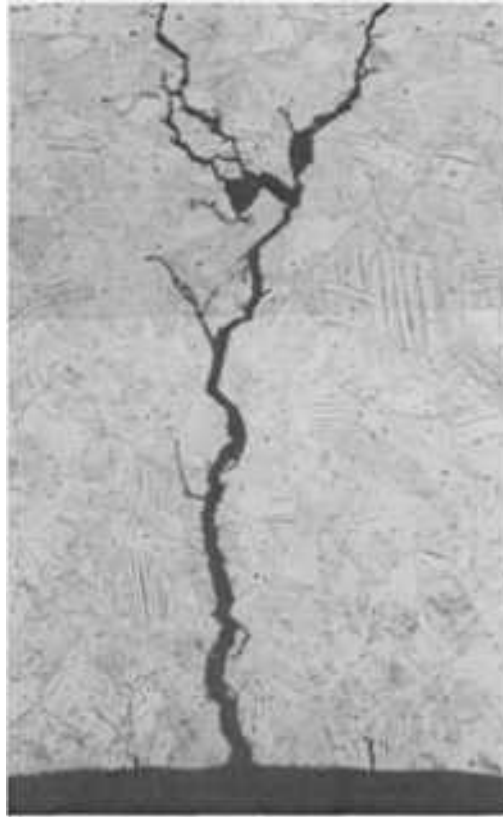
Hydrogen-embrittlement failure of AISI type 304 bellows. The component was made by rolling sheet into tube, seam welding, and then forming. Continuous pressurization with gaseous hydrogen at 172 kPa (25 psi) induced hydrogen embrittlement at roots of bellows convolutes, regions where residual stresses from forming were at a maximum. Fig. 634 and 635: Bellows assembly and hydrogen-induced circumferential cracks at A and B. Fig. 636, 637, and 638: Microstructure of fifth convolute cross section, showing twins, transgranular and intergranular fracture modes, and secondary cracking. Oxalic acid electrolytic etch, 10 $\times$ , 50 $\times$ , and 200 $\times$ , respectively (R.J. Schwinghamer, NASA Marshall Space Flight Center)

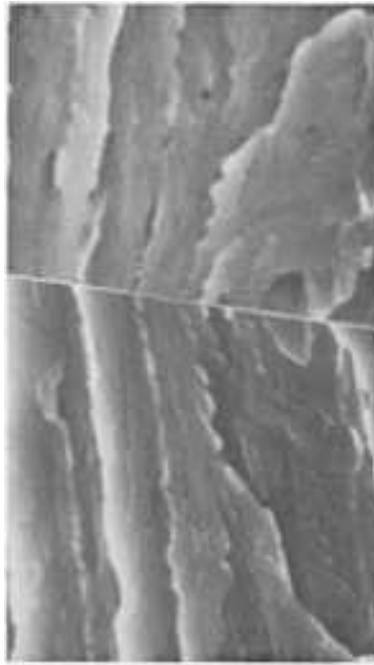
**Fig. 644**

Faceted fracture in hydrogen-damaged AISI type 304L. Hydrogen damage in type 304L supersaturated with hydrogen gas is most severe at -75 to -25 °C (-105 to -15 °F). The brittle fracture surfaces exhibit predominantly facets that form by parting along coherent twin boundaries, a process similar to cleavage. Although twin parting is unusual in face-centered cubic (fcc) alloys, similar facets have been observed in hydrogen-charged Tenelon (UNS S21400) and Nitronic 40 (UNS S21900) and in stress-corrosion cracking of type 304 in  $\text{MgCl}_2$ . Fig. 639: Ductility minimum in hydrogen-charged type 304L. Fig. 640: General view of fracture surface of sample tested at -75 °C (-105 °F). Note that facets are interconnected, are planar and flat, frequently exhibit steps 0.5 to 6.5  $\mu\text{m}$  high, always have one to three sets of slip traces, and (unlike cleavage fractures) never show river patterns. Fracture plane of the facets as determined by x-ray diffraction to be {111} plane in the fcc austenite. SEM, 170 $\times$ . Fig. 641: Slip traces (A) and steps (B) in type 304L sample tested at -75 °C (-105 °F). SEM, 950 $\times$ . Fig. 642: View of facet at an angle. Note steps and slip traces. Traces arise by intersection of deformation bands with coherent twin boundaries. SEM, 2000 $\times$ . Fig. 643: Microcracking along coherent annealing twin boundaries on longitudinal section of fractured type 304L sample. Twin-boundary traces lie at an angle of 60° to 90° from the tensile axis (vertical in photomicrograph). 1000 $\times$ . Fig. 644: Intentionally opened microcrack on polished longitudinal section. Note that features on crack face are identical to those on fracture surface facets (see Fig. 642), indicating that both facets and microcracks form by the same mechanism. SEM, 2000 $\times$  (G.R. Caskey, Jr., Atomic Energy Division, DuPont Company)

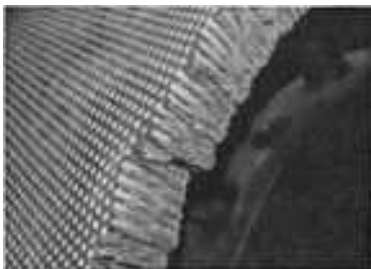
**Fig. 645** Hydrogen embrittlement of AISI type 304 tested under constant load in pure hydrogen gas at 100 kPa (1 atm) and 25 °C (75 °F). The two-part fractograph compares matching fracture surfaces. Note the quasi-cleavage-type facets. They generally exhibit more ductility (have a rougher surface) than classic cleavage facets. See also Fig. 629. SEM, 6000× (R. Liu, N. Narita, C. Altstetter, H. Burnbaum, and N. Pugh, University of Illinois)

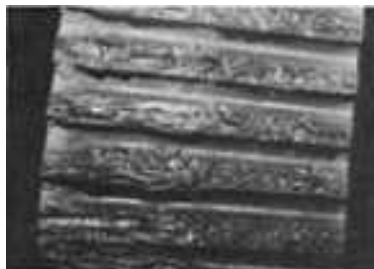
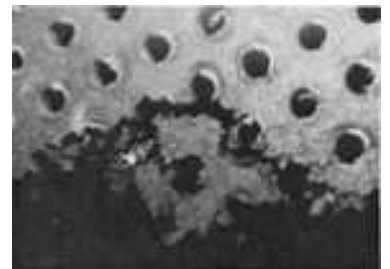
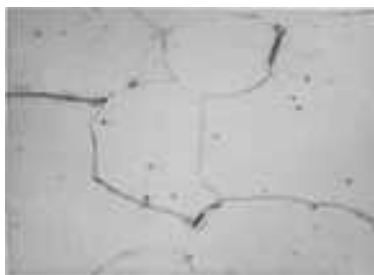
**In-service failure of a paper machine suction couch roll due to intergranular stress-corrosion cracking (SCC). The centrifugally cast roll was made of ACI CF-8M (~AISI type 316) and measured 8.8 m (29 ft) long and 1.2 m (49 in.) in diameter with a 65-mm (2.5-in.) wall thickness. Cracking initiated near the outside diameter of the roll, 2.7 m (9 ft) from the driven end, and extended roughly circumferentially 320° around the roll. An overall sensitized microstructure and no evidence of corrosive attack at the lightly stressed, undriven end of the roll indicated a stress-corrosion mode as opposed to plain intergranular corrosion. The specific corrosive agent was not identified. Fig. 646: Portion of crack surface (after mechanical separation). Cracks initiated at the drilled holes near, but not directly on, the outside diameter of the shell and then propagated from hole to hole and through the wall thickness. Fig. 647: Close-up of crack face reveals intergranular nature of failure. At the**

outside diameter (left) and 50 to 60% inward, the grain structure of the cast alloy is columnar. The remainder is predominantly equiaxed. Fig. 648: Evidence that cracking progressed from the outside to the inside diameter. Region of roll surface at center is completely separated, but is connected to the rest of the shell at the inside diameter. Fig. 649: Photomicrograph of structure near the inside diameter of the roll. Note intergranular cracking along sensitized, near-equiaxed grain boundaries. Ferric chloride etch, 20× (F.W. Tatar, Factory Mutual Research Corporation)
