ASM HANDBOOK®

VOLUME  
12

Fractography

*Fractography*, was published in 1987 as Volume 12 of the *ASM Handbook*. The Volume was prepared under the direction of the ASM Handbook Committee.

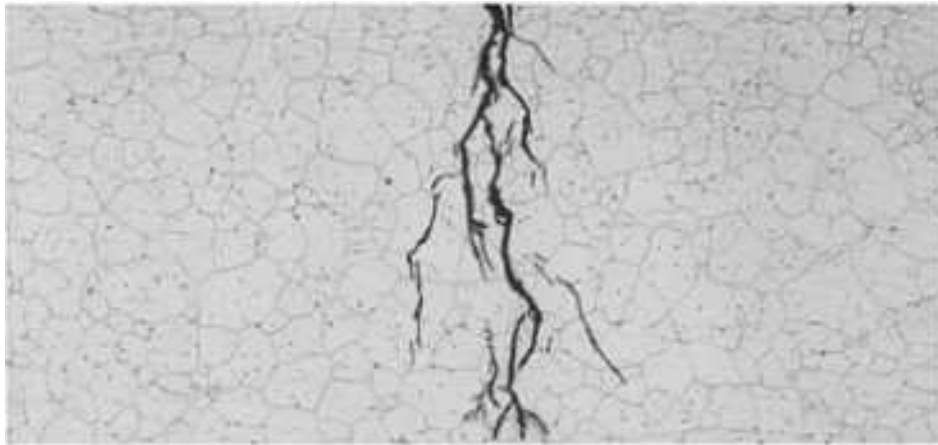
**Fig. 649**

Fig. 650 Failure due to chloride stress-corrosion cracking (SCC) of an AISI type 316 pipe. The pipe served as a vent for the preheater-reactor slurry transfer line in a coal-liquefaction pilot plant. Although no material flowed through the vent line--a "dead leg"--the service temperature was low enough to permit formation of an aqueous condensate on its inside surface. Extensive cracking originated at the inside wall of the pipe. Examination of an etched transverse section of the crack tip (shown here) revealed transgranular cracking with a branching pattern characteristic of chloride SCC. 200× (J.R. Keiser and A.R. Olsen, Oak Ridge National Laboratory)

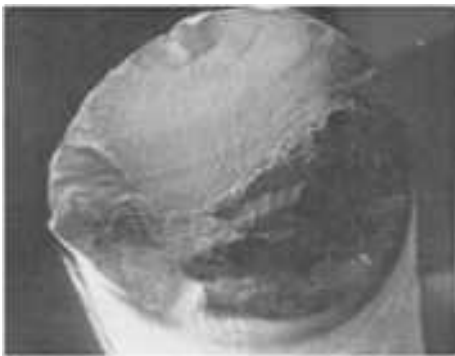
Fig. 651

Fatigue fracture of SIS 2343 (~AISI type 316L) wire due to cracking originating at corrosion pits. The wire was used for electrodes in an electrostatic precipitator that treated the gaseous effluent from a paper mill. Fig. 651:

Fracture surface. Note beach marks. SEM, 20×. Fig. 652: Close-up of fracture origin (arrow) in Fig. 651. SEM, 50×. Fig. 653: High-magnification view of fracture origin and associated corrosion pit. Wire surface is at top, fracture surface at bottom. SEM, 620×. Fig. 654: Region on surface of wire near location of fracture, showing two corrosion pits. SEM, 1000× (C.R. Brooks, University of Tennessee)

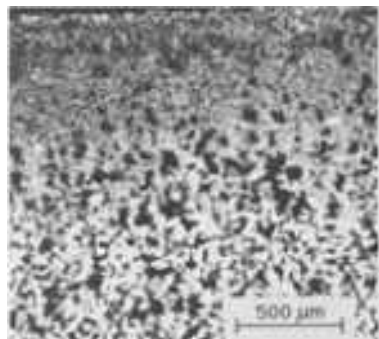
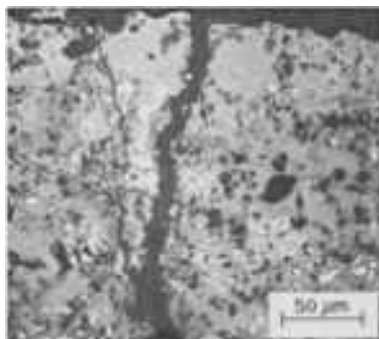
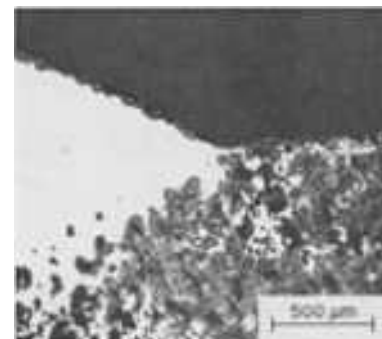
Brittle fracture due to severe carburization of a porous metal filter tube. The P/M type 316L tube (5-μm nominal filter grade) was used in a coal-gasification pilot plant to remove entrained ash and char particles from the raw-product gas stream. Failure occurred after being in service for 8 h at 540 °C (1000 °F) in contact with a gas stream having the following composition (in vol%): 30% H<sub>2</sub>O, 12.6% H<sub>2</sub>, 0.43% Ar + O<sub>2</sub>, 35.2% N<sub>2</sub>, 8.4% CO, 11.7% CO<sub>2</sub>, 1.0% CH<sub>4</sub>, and 0.105% H<sub>2</sub>S. Particulate matter in contact with the tube contained 32 to 34 wt% C. Carburization proceeded inward from the outside diameter of the tube in the direction of gas flow through the porous wall. Source of carbon was the char in the gas stream. Fig. 655: Section through tube wall, outside diameter at top. Outer third of tube thickness is almost completely transformed to mixed (Cr,Fe)<sub>23</sub>C<sub>6</sub> and (Cr,Fe)<sub>7</sub>C<sub>3</sub> carbides. Balance of thickness has partially transformed, particularly in the vicinity of pores. Carbon content of the bulk material was 0.22 wt%, compared with the 0.03 wt% max specified for type 316L. Carbon content at the outside diameter was 1.40 wt%. 35×. Fig. 656: Structure near through-wall crack at outside diameter of failed filter tube. Mixed carbides (gray phases) dominate. Only a very few small, light-colored islands of untransformed type 316L matrix remain. The volume increase associated with the formation of carbides has substantially reduced the amount of porosity (dark areas). 340×. Fig. 657: Outside diameter of failed filter tube at region containing an axial seam weld (at left). Note that only the surface of the nonporous type 316L filler metal was transformed to carbides. 340× (D.R. Diercks, Argonne National Laboratory)

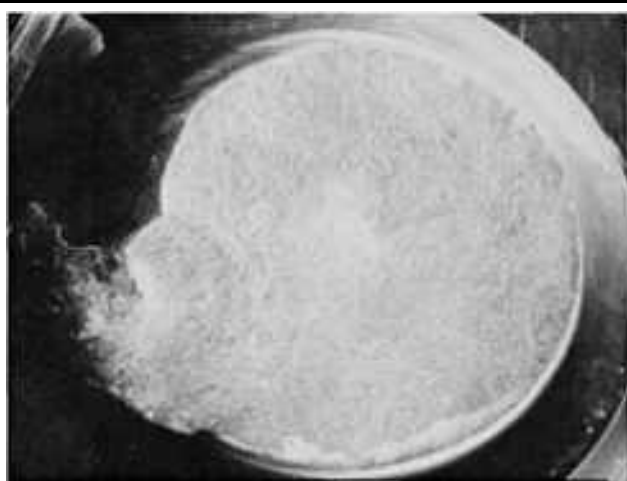
Fig. 658

Torsional overload fracture of cortical screw. The bone screw was machined from cold-worked AISI type 316L rod and then stress relieved. Its surface was electropolished and passivated. Fig. 658: Fracture surface of screw. SEM, 28×. Fig. 659: Close-up of edge of fracture surface. Note torsional shear bands and dimpled region typical of a ductile fracture. SEM, 117×. Fig. 660: High-magnification view of dimpled-rupture portion of fracture surface reveals elongated dimples characteristic of a torsional (shear) failure mode. SEM, 1170× (H.R. Shetty, Zimmer Inc.)

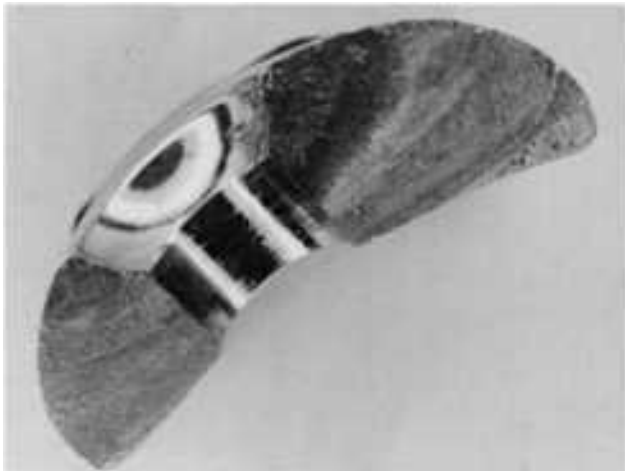
**Fig. 661**

Fatigue fracture of compression tube and plate (hip screw) orthopedic implant. The device was machined from an AISI type 316L hot forging. It was then mechanically polished, electropolished, and passivated. Fig. 661: Fracture surface. Note beach marks. 5.2×. Fig. 662: Fatigue striations on fracture surface. SEM, 1360×. Fig. 663: Region of dimpled rupture in ductile overload zone of fracture surface in Fig. 661. Note burnishing. See

also Fig. 670. SEM, 1040× (H.R. Shetty, Zimmer Inc.)

Fatigue crack nucleation at slip bands in the plate of a hip screw (compression tube and plate) surgical implant. Material and processing same as in Fig. 661, 662, and 663. Scanning electron photomicrographs are of the lateral (tension or screw-head-side) surface of plate subjected to fatigue loading. Fig. 664: Lateral surface of plate. Note slip-band activity and intrusions formed by slip bands. SEM, 187×. Fig. 665: Higher-magnification view of area on lateral surface of plate. Note microcracking at slip bands and the crack being formed at a grain-boundary triple point. SEM, 1160×. Fig. 666: Fatigue crack formed on lateral surface of plate. Growth is along slip planes. SEM, 983×. Fig. 667: Area on lateral plate surface near fracture origin. Features include slip-band cracking and crack growth along intersecting slip planes. SEM, 1400× (H.R. Shetty, Zimmer Inc.)

Fatigue crack nucleation in the plate of compression hip screw. Material and processing same as in Fig. 661, 662, and 663. This pair of scanning electron photomicrographs shows the medial (compression or bone-side) surface of the failed plate. Fig. 668: Medial surface near fracture origin. Ridges result from grain deformation. SEM, 86×. Fig. 669: Higher-magnification view of representative area in Fig. 668. Note slip-band activity and intersecting slip bands. See also Fig. 664, 665, 666, and 667. SEM, 859× (H.R. Shetty, Zimmer Inc.)

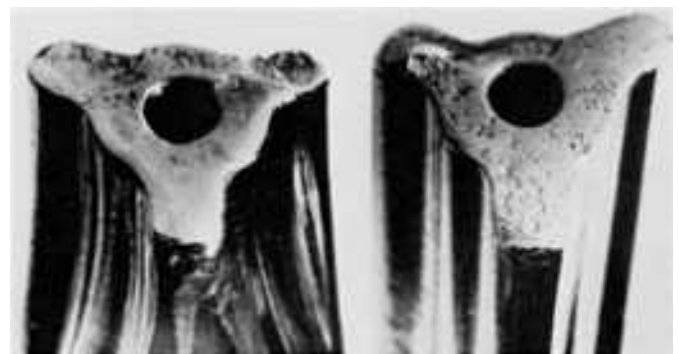
**Fig. 675**

Corrosive action of body fluids masks fracture surfaces of failed AISI type 316L Jewett nail (hip implant). Corrosion of fracture faces occurred because the patient remained mobile for an extended period after the implant failed. Fig. 674: Fractured Jewett nail. Fig. 675: Fracture surfaces after removal from femur. Corrosion and possibly some erosion due to rubbing together of the mating pieces have smoothed out the once-jagged fracture surface. Corrosion of the normally passivated stainless steel results when its protective oxide layer is ruptured by such processes as deformation exceeding the elastic limit of the material (component fracture) and

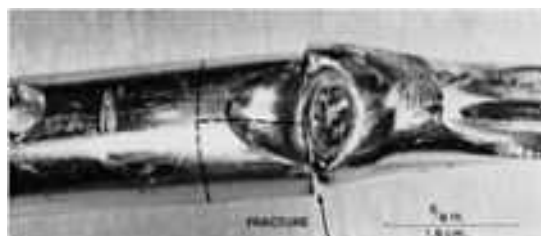
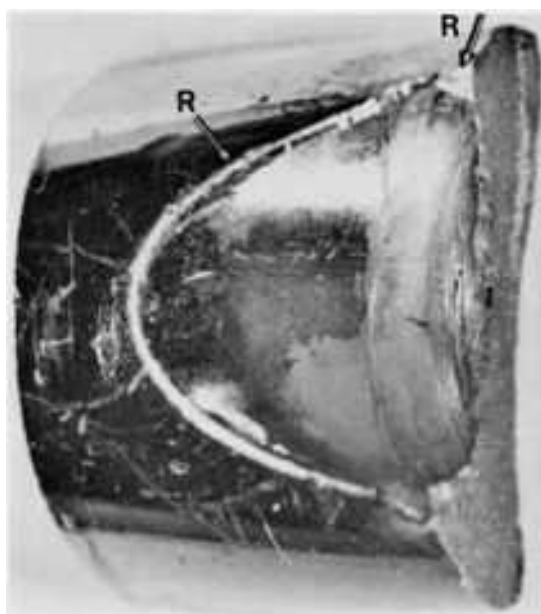
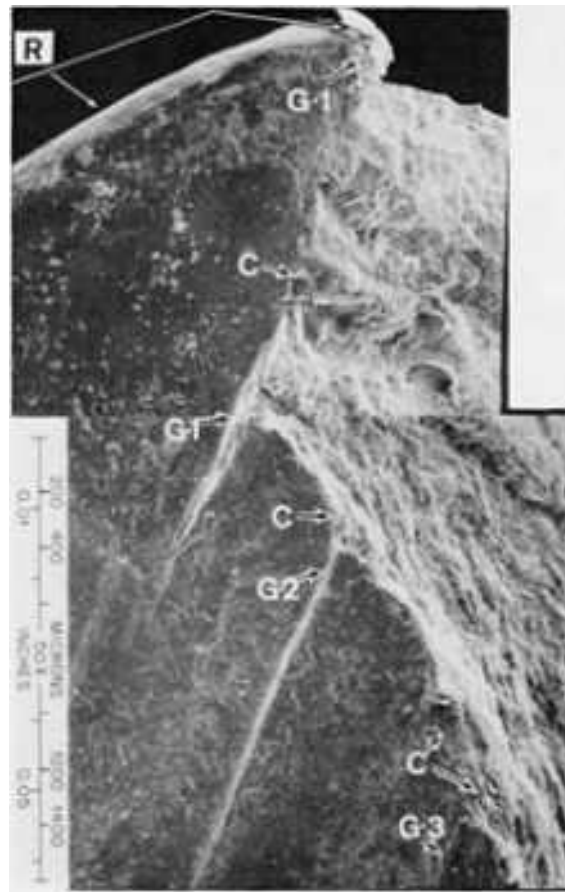
**Failure of AISI type 316L Jewett nail (hip implant) due to improper installation. Fig. 680: Fractured implant after removal from body. The threaded tip of an impactor-extractor tool is inserted by the surgeon into a hole in the chamfered portion of the implant located where the side plate (left) meets the tri-finned nail (right). During installation, the threaded tip of the tool broke off. The jagged edge of the broken tool then gouged the rim of the chamfer. Even so, the operation was judged a qualified success. The implant failed 4 weeks after installation. Fig. 681: Close-up of fractured Jewett nail. Broken tip of impactor-extractor is in nail portion of implant at right. Dashed lines show cutting planes for subsequent microscopic examination. Fig. 682: Plate end of fractured impact. Fracture originates on ridge (R) of chamfer. The chamfer-fracture surface interface is indicated by I (see Fig. 684, 685, 686, and 687). Fig. 683: Close-up of area near fracture origin R in Fig. 682. Tensile stress was concentrated at groove G1, created by fractured edge of impactor-extractor tool. Fracture propagated along this groove. Also note second and third grooves. (G2 and G3) and what appears to be corrosion (areas labeled C). SEM, 50× (R.J. Gray, Consultant)**

A secondary cause of the Jewett nail fracture in Fig. 680, 681, 682, and 683 may have been intergranular corrosion. Fig. 684: Close-up of chamfer-fracture surface interface (I in Fig. 682). SEM, 50×. Fig. 685: Higher-magnification view of region A on fracture face in Fig. 684. Note evidence of intergranular corrosion. In some cases, however, these "mud crack" patterns are believed to be dried body fluids that were not completely removed from the fracture surface during sample preparation (compare with Fig. 672). SEM, 500×. Fig. 686: Same as Fig. 685, but at higher magnification. SEM, 1000×. Fig. 687: Metallographic section transverse to fracture face lends support to contention that intergranular corrosion played a role in this fracture. Note how the "corrosion-etched grain size" in Fig. 686 is very similar to the etched grain size in this photomicrograph. 1000× (R.J. Gray, Consultant)

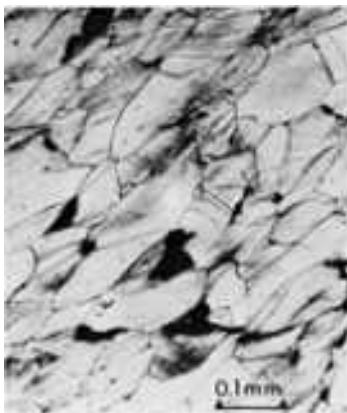
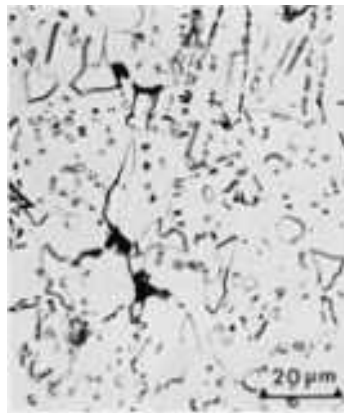
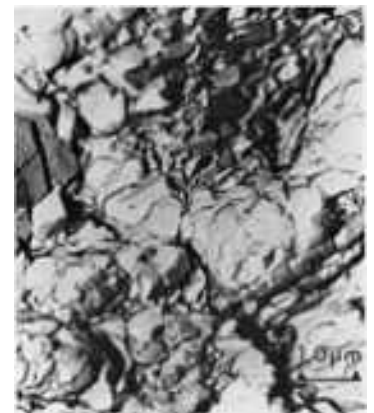
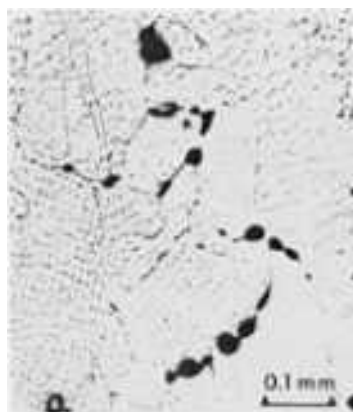
Microvoid linking by creep in AISI type 316. Intergranular creep fracture depends on the nucleation, growth, and subsequent linking of voids on grain boundaries to form two types of cavities: wedge-type cavities (Fig. 688, 689, 690) and isolated, rounded-type cavities (Fig. 691). Fig. 688: Wedge-type cavities in an AISI type 316 sample that failed by creep. These cavities are usually associated with cracking at grain-boundary triple points. 100×. Fig. 689: Wedge-type cavities (wedge cracks) form at triple points due to grain-boundary sliding and may be promoted by decohesion at interfaces between grain-

boundary precipitates and the matrix, as shown here in a type 316 sample. 600×. Fig. 690: Creep failure due to wedge cracking at triple points produces a rough fracture surface with identifiable grain-boundary precipitates. For example, carbides and  $\sigma$ -phase particles are found on the fracture surface of this type 316 stainless steel. TEM replica, 10,000×. Fig. 691: Rounded-type voids in type 316L weld metal. Sample failed in creep at high temperature. 100× (I. Le May, Metallurgical Consulting Services Ltd.)

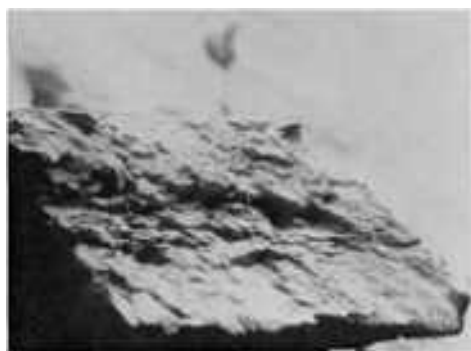
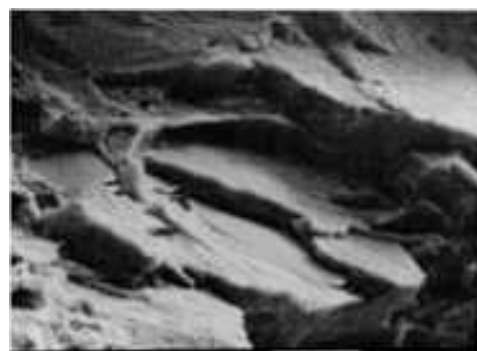
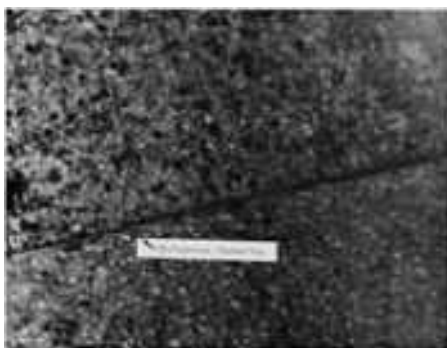
"Channel fracture" of irradiated AISI type 316. In this type of fracture, which is unique to highly irradiated materials, dislocation motion is confined to a few narrow zones or channels. The 20% cold-worked type 316 sample was irradiated at 385 °C (725 °F) to a neutron fluence of  $1.28 \times 10^{23} \text{ n/cm}^2$  ( $E_n > 0.1 \text{ MeV}$ ). Fig. 692: Fracture surface of sample after tensile testing at 205 °C (400 °F). Fracture mode is shear. SEM, 43×. Fig. 693: Higher-magnification view of fracture surface reveals the steplike topography of channel fracture. SEM, 1440×. Fig. 694: Extreme close-up of a single channel on the fracture surface in Fig. 693. Note the numerous voids and the narrow zone at center, where dislocations have produced elongated voids by shear. TEM thin foil specimen, 57,000× (J.E. Nolan, Westinghouse Hanford Company)

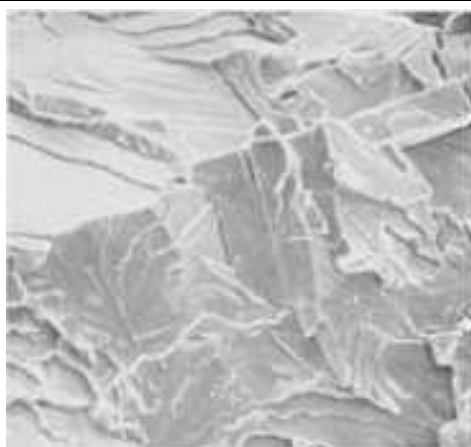
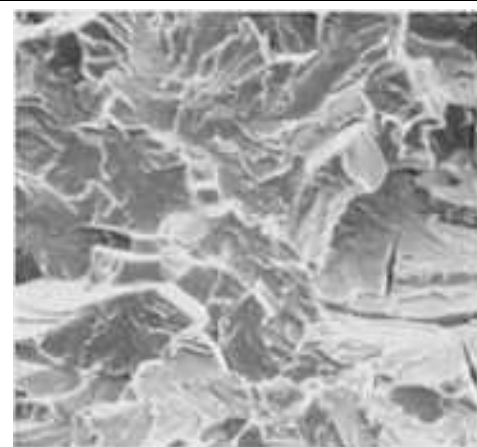
Ferritic iron-aluminum alloys have been proposed as substitutes for conventional chromium-bearing stainless steels, particularly the austenitic 300 series alloys with 15 to 28% Cr. Interest in these materials stems in large part from a desire to reduce U.S. dependence on imports of the strategic

material chromium. One drawback, however, is the brittle nature of iron-aluminum alloys, especially those with higher aluminum contents. Shown here are fractographs of the flat fractures from tensile samples of an experimental iron-aluminum alloy (Fe-8Al-6Mo-0.8Zr-0.1C). Fig. 695: Annealed 1 h at 825 °C (1515 °F), furnace cooled. Massive cleavage fracture (with 2% elongation) believed due to long-range order in the alloy. SEM, 750×. Fig. 696: Annealed 1 h at 825 °C (1515 °F), water quenched. Fracture surface reveals a finer cleavage structure and evidence of increased ductility, probably the result of short-range order. Alloy had 19% elongation. SEM, 750× (H.W. Leavenworth, Jr., U.S. Bureau of Mines)

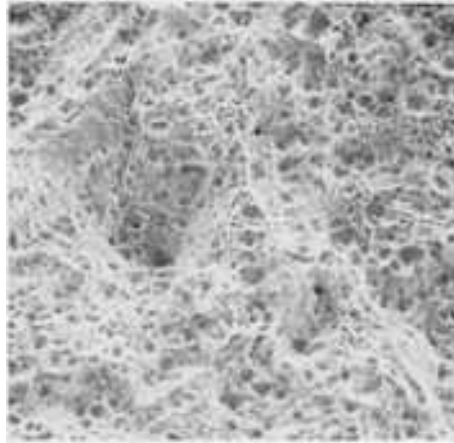
**Fig. 697** Substitution of iron-aluminum alloys is one potential way to reduce dependence on conventional austenitic stainless steels with their high contents of the strategic element chromium (see Fig. 695 and 696). Another, perhaps more promising, alternative is to develop alloys that contain lesser amounts of chromium. An example is Fe-8Cr-12Ni-4.5Si-1Al-1Mn-0.05C. A ductile fracture characterized by dimple rupture is obtained in this material after annealing for 1 h at 1100 °C (2010 °F) and air cooling. Credit for the high ductility goes to a microstructure of low-carbon martensite. SEM, 250× (H.W. Leavenworth, Jr., U.S. Bureau of Mines)

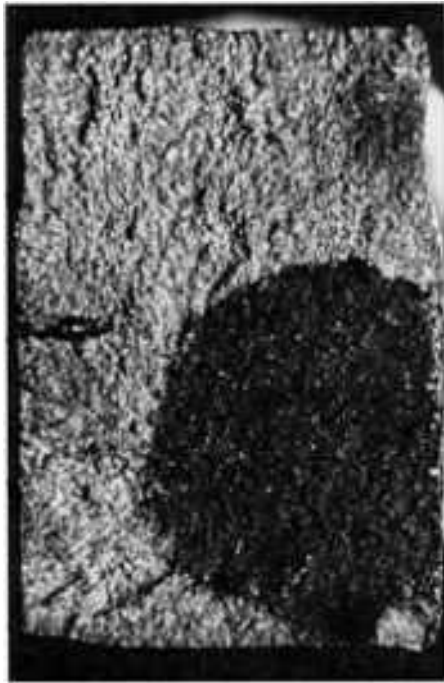
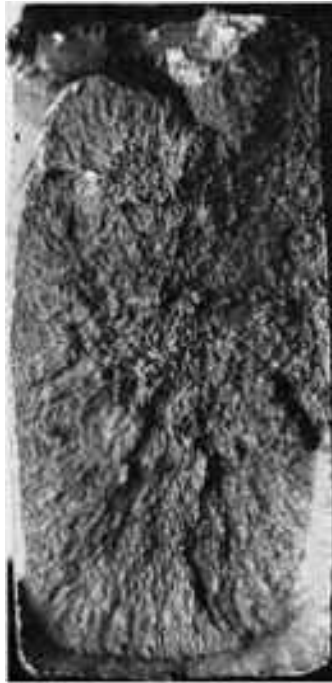
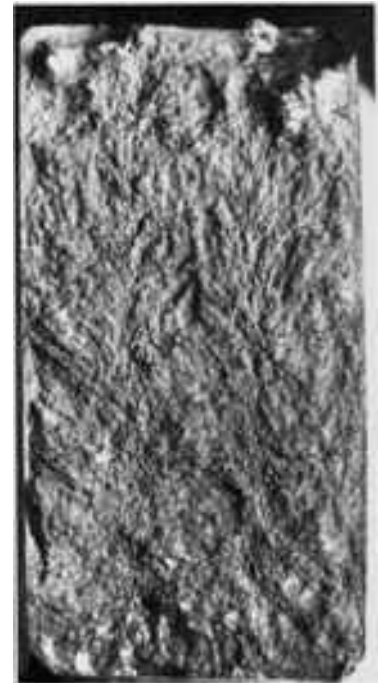
Surfaces of fractures in three AISI type 410 stainless steel links of a conveyor chain used in a food-processing operation. Heat treatment of the links had included box annealing at 995 °C (1825 °F) for 1 h, oil quenching, and tempering between 260 and 370 °C (500 and 700 °F) for 2 h. Measured hardness was 37 to 44 HRC. Service conditions included cleaning in water containing 2 ppm of chlorine at 70 °C (160 °F), cleaning in saturated steam at 120 °C (250 °F), cleaning in air at 120 °C (250 °F), and water cooling at 20 to 32 °C (68 to 90 °F). Figure 698 shows the dark, oxidized surface at a heat-treat crack; the remainder of the fracture surface is brittle and shows no shear lip. Fig. 699 shows a heat-treat crack (at top edge) and a shear lip (at bottom edge), with fast fracture between them. Figure 700 shows a very small heat-treat (right side at top edge) and portions of a shear lip (at left edge and at top edge left of crack). See also Fig. 701, 702, and 703. All at 8×

Polished and etched sections through secondary heat-treat cracks branching from the fractures in the conveyor-chain links in Fig. 698 and 700, showing the intergranular nature of the cracks. Figure 701 shows a crack in the link in Fig. 698. Note that the surfaces of this crack have oxide coatings; the short cracks branching from it were oxide induced. Figures 702 and 703 are views, at different magnifications, of a secondary crack in the link shown in Fig. 700. Again, oxide is present within the crack, as can be seen somewhat obscurely in Fig. 703. Note that this crack has branched to connect with nonmetallic inclusions. It is evident, from the presence of oxide on all crack surfaces, that both

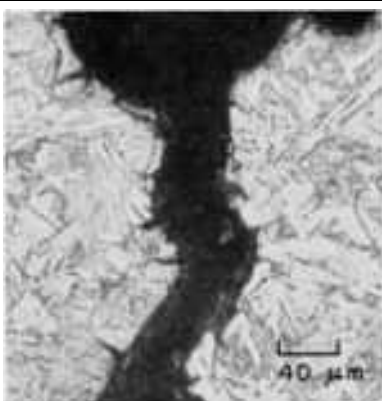
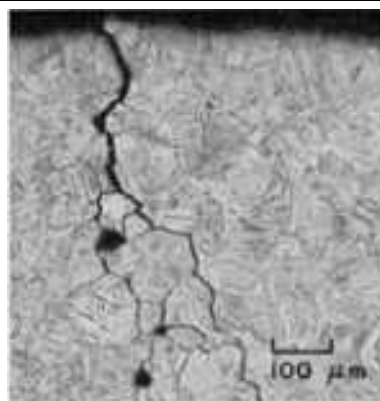
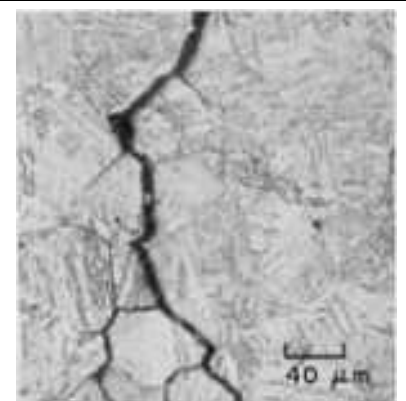
primary and secondary heat-treat cracks formed before the links were oil quenched from the annealing temperature. All etched in super picral. Fig. 701 and 703: 250×. Fig. 702: 100×

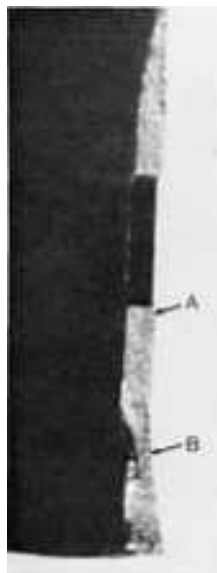
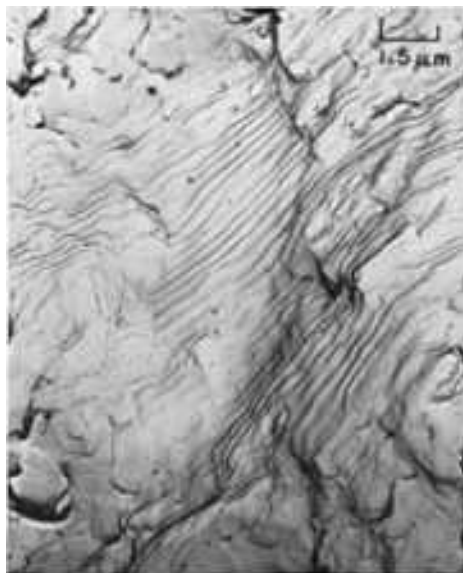
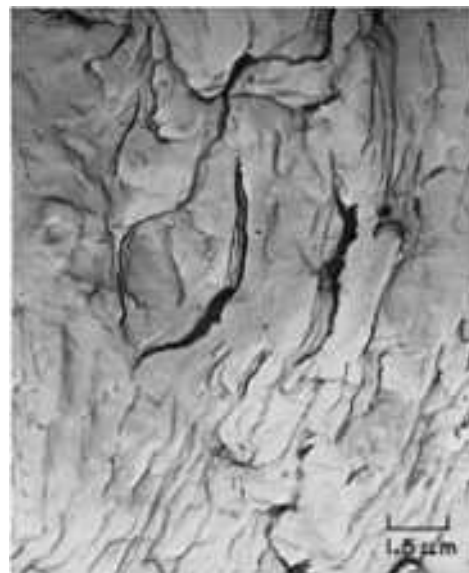
Figure 704 shows the surface of a high-cycle fracture in a  $140 \times 25 \times 1.3$  mm ( $5 \frac{1}{2} \times 1 \times 0.050$  in.) notched specimen of AISI type 431 stainless steel oil quenched from 1040 °C (1900 °F) and tempered at 275 °C (525 °F) to a tensile strength of 1241 to 1379 MPa (180 to 200 ksi). The notch consisted of a center hole 0.25 mm (0.01 in.) in radius and 5 mm (0.2 in.) long. The specimen was subjected to tensile stress that was cycled from 154.4 to 772 MPa (22.4 to 112 ksi) at 1000 cycles/min, and fracture occurred after 5700 cycles. Figures 705 and 706 are TEM p-c replicas of two areas at A in Fig. 704, immediately below the notch. In Fig. 705, fatigue striations are well developed, and suggestions of partly formed dimples are present at a few locations. In Fig. 706, fatigue striations are much less regular than in Fig. 705; again, there are suggestions of partly formed dimples. See also Fig. 707, 708, and 709. Fig. 704: 4.5×. Fig. 705 and 706: 6500×

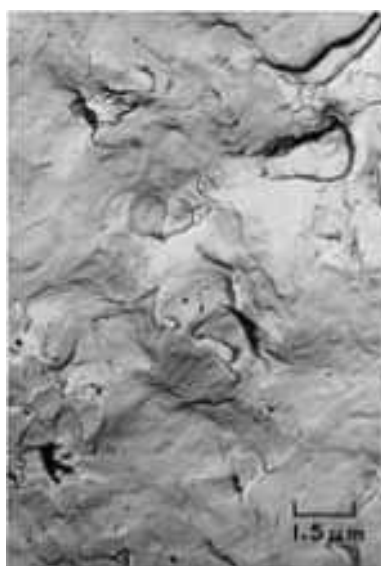
Fig. 707 TEM p-c replica of a third area at A in Fig. 704. This area exhibits faint but quite recognizable fatigue striations with spacings similar to those in Fig. 705. 6500×

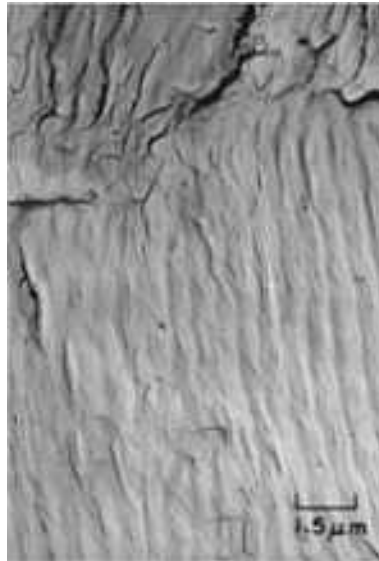
**Fig. 708 TEM p-c replica of a fourth area at A in Fig. 704. Regular, widely spaced fatigue striations resulted from increased stress due to reduced cross-sectional area. 6500×**

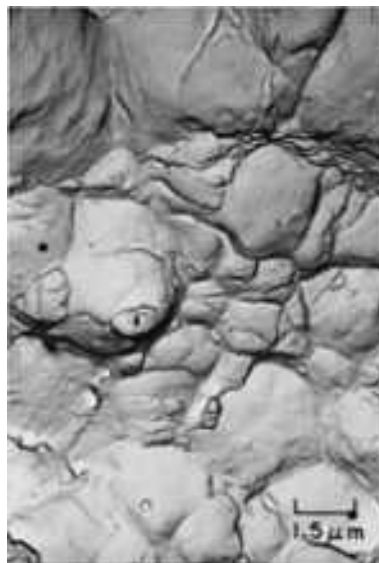
**Fig. 709 TEM p-c replica of an area at B in Fig. 704. The equiaxed dimples visible here resulted from tension overload during final fracture, but before final shear rupture. 6500×**

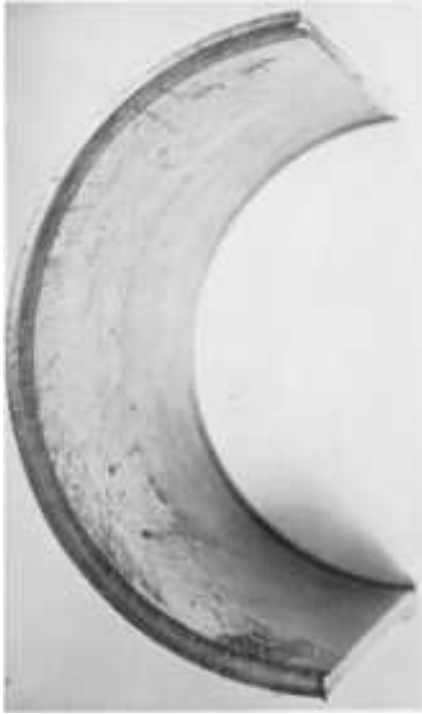
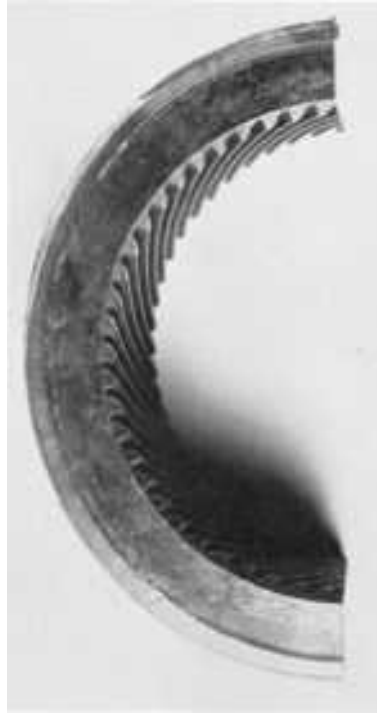
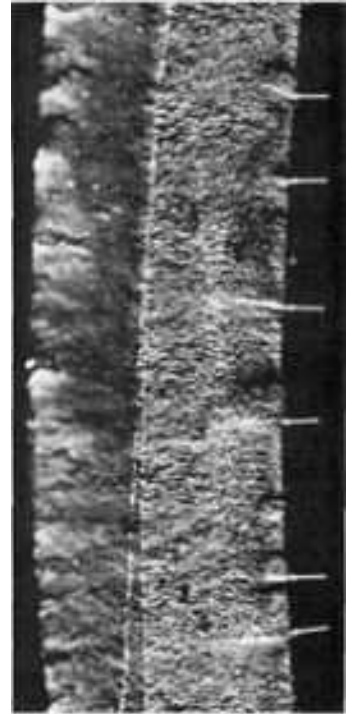
Figures 710 and 711 show the mating segments of a fractured AISI type 501 stainless steel torque cylinder from the hub socket of an aircraft propeller. Cracking originated at an internal fillet at a shoulder between the smooth bore (Fig. 710) and the internal spline (Fig. 711). Figures 712 shows clearly the inner fatigue zone and the outer zone of final tensile-shear fracture. The ratchet marks visible in Fig. 710 (at the bore) are shown more clearly in Fig. 712, a view that reveals many crack nuclei (at arrows). The fatigue cracks that propagated from these nuclei ultimately merged to form a common front. See Fig. 713, 714, 715, and 716 for TEM views of other regions of this fracture surface. Fig. 710 and 711: 0.8 $\times$ . Fig. 712: 10 $\times$

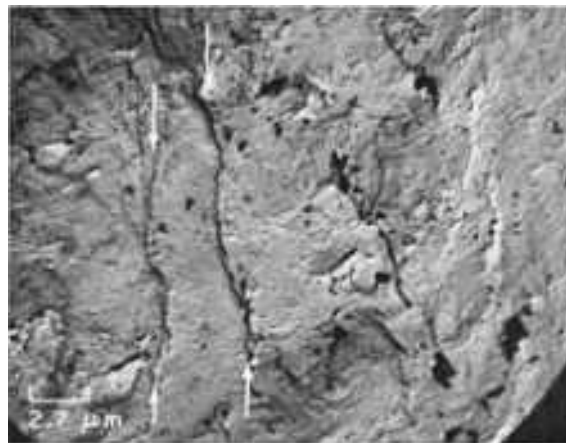
**Fig. 713** TEM p-c replica of the fracture surface in Fig. 710, showing a region about 30  $\mu\text{m}$  from a crack nucleus. Visible between the arrows are steps that separate fatigue patches. Fatigue striations are faintly visible within the patches. 3750 $\times$

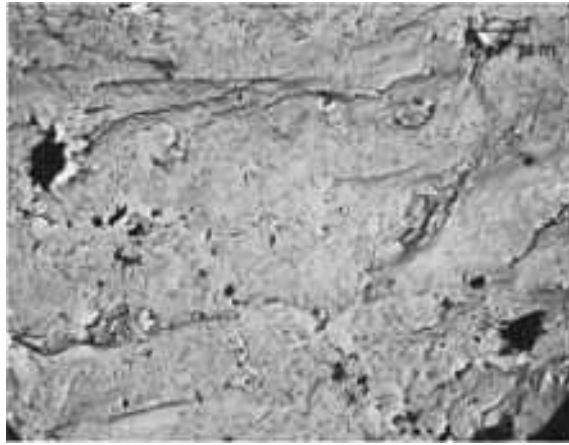
**Fig. 714 TEM p-c replica of the fracture surface in Fig. 711, showing a region about 30  $\mu\text{m}$  from the inner edge. This view shows generally flat fatigue patches that are separated by steps, but no fatigue striations are visible within the patches. 3750 $\times$**

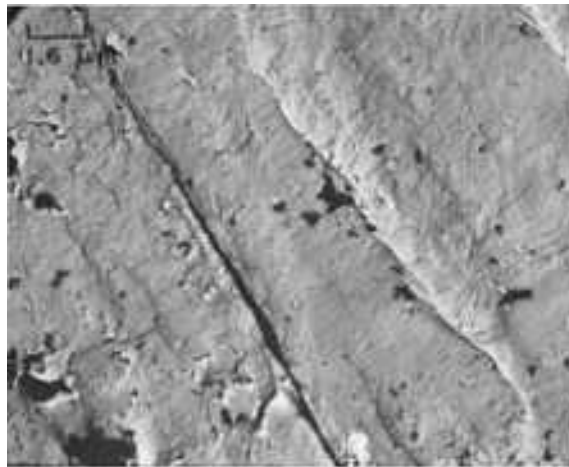
**Fig. 715 TEM p-c replica of the fracture surface in Fig. 710, showing a region in the fatigue zone, but near the zone of final tensile-shear fracture. This replica reveals fatigue patches separated by steps and containing faint fatigue striations. 6125 $\times$**

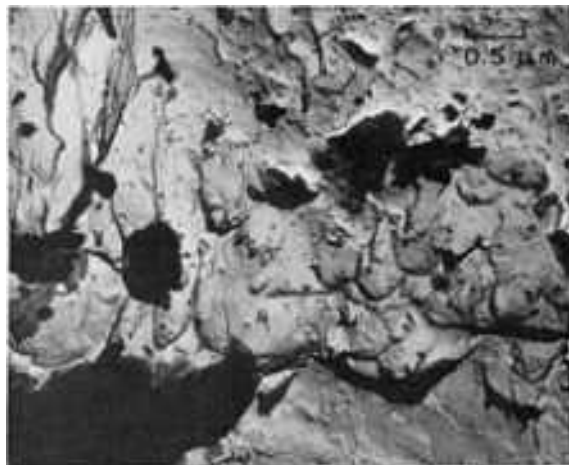
**Fig. 716 TEM p-c replica of a portion of the shear lip in the fracture surface in Fig. 710, showing shear dimples,**

which resulted when microvoid coalescence occurred during final tensile-shear fracture. The dark areas are probably rust or "dirt." 18750×

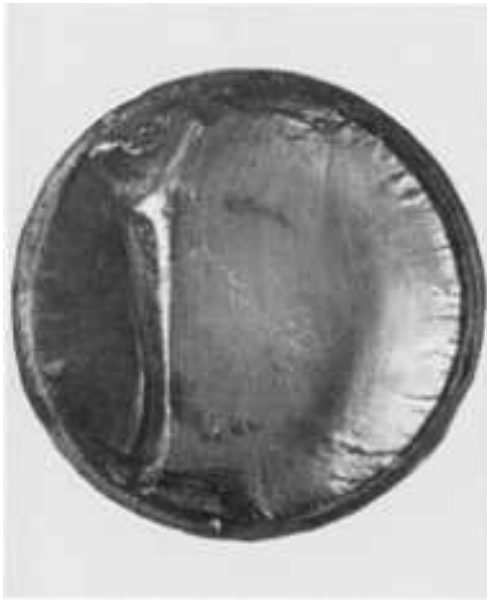
Surfaces of fatigue fractures in three automotive intake valves forged of Silcrome-1 steel (0.45% C, 3.25% Si, and 8.5% Cr) and heat treated. Figure 717 shows a transverse fracture in the stem of a valve with a hardness of 37 HRC. The stem rocked within the valve retainers, initiating many fatigue cracks around the periphery of the stem; these cracks later joined to form two main crack fronts. Very well-defined beach marks are visible in the fatigue zone at right. Figure 718 shows a transverse fracture in the stem of a valve with a hardness of 38 HRC. The stem rotated in the valve retainers, which initiated many fatigue cracks around the periphery of the stem; these cracks penetrated nearly a third of the way to the center of the stem before uniting into a single circumferential crack front. Figure 719 shows a fracture in the head of a valve with a hardness of 37 HRC. The fatigue-crack origin is at right, at the head-stem juncture. Note the peeled surface layer. Fig. 717 and 718: 10×. Fig. 719: 2×

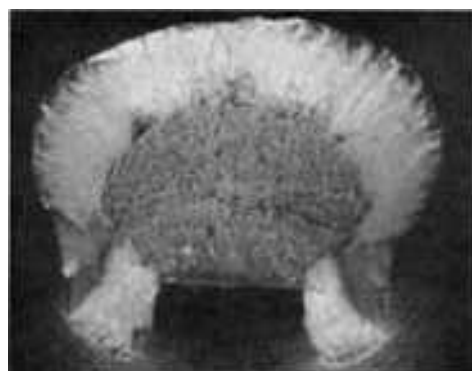
Fig. 720 A classic example of cup-and-cone tension-overload fracture in an unnotched specimen of 13-8 PH

stainless steel with tensile strength of 1634 MPa (237 ksi) and 47% reduction of area. There are circumferential secondary cracks at the base of the shear lip. See also Fig. 721. 9×

Fig. 721 SEM view of an area in the flat, central region of the fracture surface in Fig. 720, showing the equiaxed dimples of rather uniform size that are expected in this type of fracture. The scattered ridges produce the fibrous appearance seen at low magnification (Fig. 720). See also Fig. 722, a higher-magnification view of the area outlined by the rectangle. 1000×

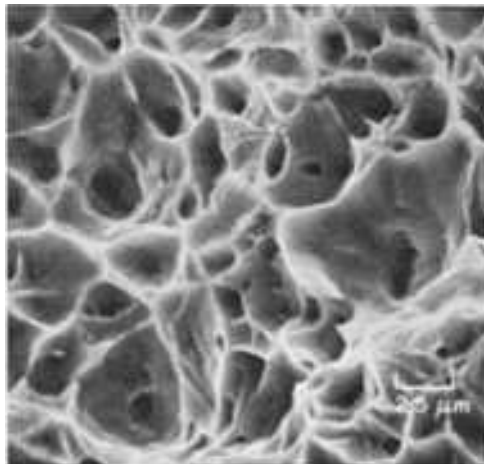
Fig. 722 Higher-magnification view of the area in the rectangle in Fig. 721, showing small dimples within dimples of moderate size, and very tiny voids in the membranes separating the dimples of moderate size. There are almost no inclusions. SEM, 4000×

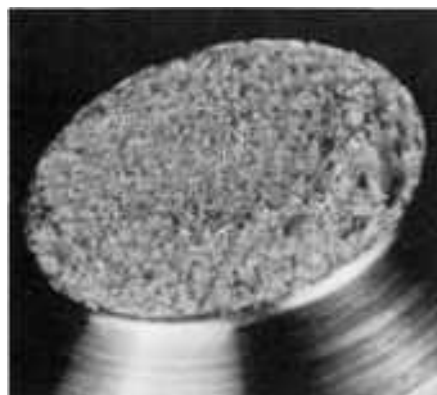
**Fig. 723** A typical tension-overload fracture in a notched specimen of 13-8 PH stainless steel with the same properties as those of the specimen in Fig. 720. The fracture surface appears uniformly fibrous, with a hint of a shear lip. See also Fig. 724. 9×

**Fig. 724** SEM view of an area of the fracture surface in Fig. 723, showing dimpled rupture in some regions (at left, for example) and, elsewhere, facets that suggest local quasi-cleavage without evidence of any conventional river patterns. See also Fig. 725, a higher-magnification view of the area in the rectangle. 1000×

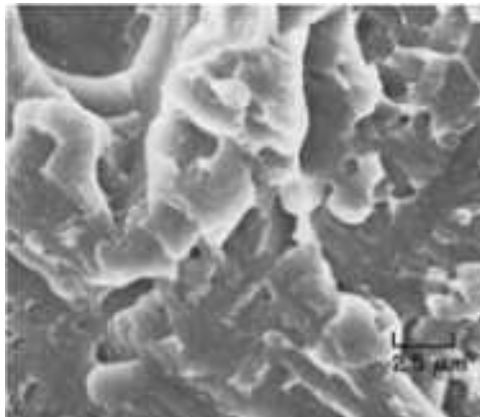
**Fig. 725** Higher-magnification view of the area in the rectangle in Fig. 724. This SEM view shows that in the fine-scale structure there do appear to be some delicate cleavage steps, particularly at right. 4000×

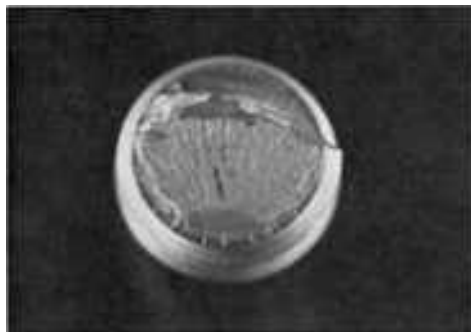
**Fig. 726** Low-cycle fatigue fracture in threaded specimen of 13-8 PH stainless steel (tensile strength): 1634 MPa, or 237 ksi; 47% reduction of area) tested in tension-tension ( $R = 0.1$ ) with maximum loading at 60% of tensile strength. Fracture, at 16,000 cycles, began at lower edge of crescent-shaped area at bottom. 6×

**Fig. 727 SEM view of the fracture surface in Fig. 726, taken at the rounded lip at the bottom edge of the crescent-shaped area. Even this close to the crack origin, there are no fatigue striations. The irregular surface displays ridges formed by a shear process. 4000×**

**Fig. 728 Another SEM view of the fracture surface in Fig. 726, taken in the region of final fast fracture. Fatigue fracture has given way to dimpled rupture. Two pockets, one at the left and one at the right, contain features that resemble localized quasi-cleavage. 4000×**

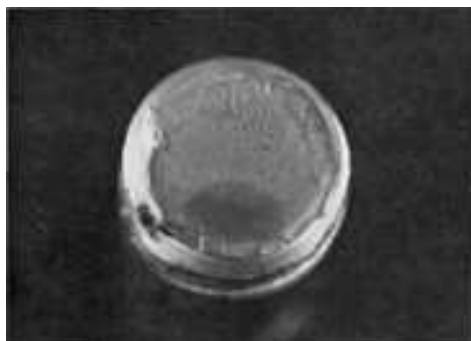
**Fig. 729 High-cycle fatigue fracture in threaded specimen of 13-8 PH stainless steel (same properties as for specimen in Fig. 726) tested in tension-tension ( $R = 0.1$ ) with maximum loading at 30% of tensile strength. Fracture occurred at 959,000 cycles. Note the crescent-shaped crack nucleus. See also Fig. 730 and 731. 6×**

**Fig. 730 SEM view of fracture in Fig. 729, taken as close as possible to the bottom edge of the origin region. This rough surface does not contain fatigue striations, but instead suggests a shear mechanism of fracture and bears considerable resemblance to Fig. 727. 4000×**

**Fig. 731 View of the fracture surface in the fast-fracture region in Fig. 729, showing basically equiaxed dimpled rupture, but also containing scattered features of quasi-cleavage. Some of the regions display heavy concentrations of extremely small dimples. SEM, 4000×**

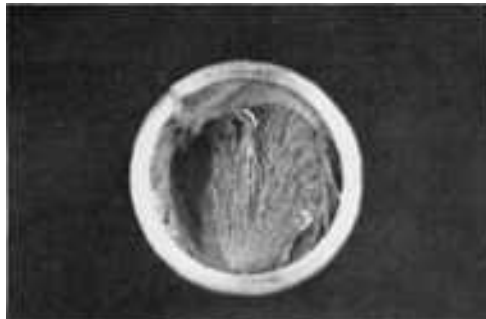
**Fig. 732 Surface of a fracture in a threaded specimen of 13-8 PH stainless steel (same properties as for the specimen in Fig. 726) that was heavily charged with hydrogen by plating without subsequent baking. The specimen broke during loading. The crack origin, visible at bottom edge, grew both circumferentially and radially. See also Fig. 733. 6×**

**Fig. 733 SEM view of a region of the fracture surface shown in Fig. 732, revealing none of the intergranular rupture characteristic of hydrogen embrittlement, but showing the equiaxed dimples of tension overload. See Fig. 734 for enlarged view of outlined area. 4000×**

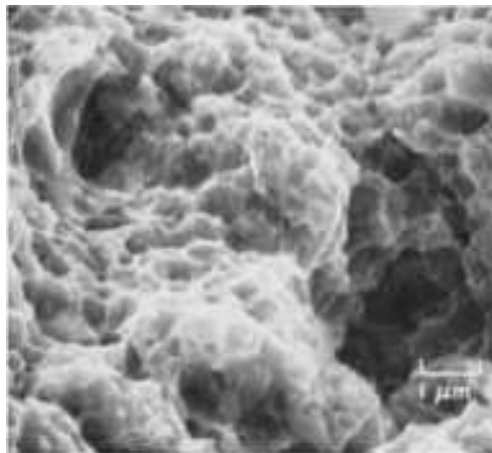
**Fig. 734 Higher-magnification view of the area in the rectangle in Fig. 733, showing clearly the very dense grouping of very small dimples around larger dimples. There is no evidence here of either grain-boundary facets or inclusions. SEM, 10,000×**

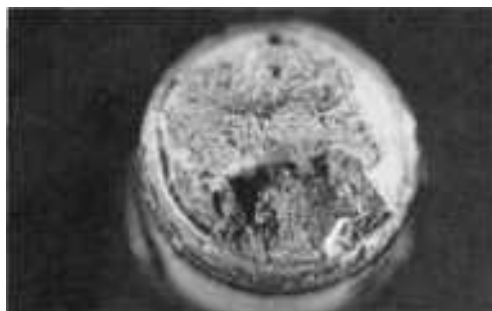
**Fig. 735 Stress-corrosion cracking fracture in threaded specimen of 13-8 PH stainless steel (same properties as in Fig. 726) loaded to 75% of tensile strength in a 3.5% NaCl solution. See also Fig. 736. 6×**

**Fig. 736 SEM view of crack origin area of fracture surface in Fig. 735, showing corrosion products that probably are oxides. Secondary cracks may or may not extend into the metal below. See also Fig. 737 and 738. 1000×**

**Fig. 738 Another higher-magnification view of the crack-origin area of the SCC fracture surface shown in Fig. 735, displaying a coating of a hydroxide corrosion product containing many fine secondary cracks. Compare with the area shown in Fig. 737. SEM, 4000×**

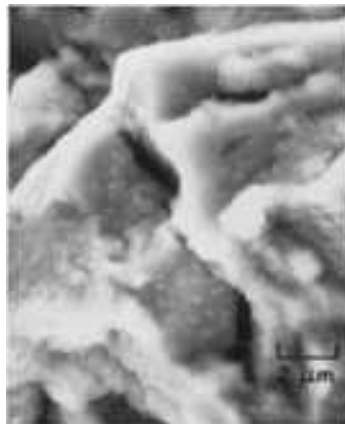
**Fig. 737 Enlargement of the area in the rectangle in Fig. 736. The oxide coating appears to be quite continuous, except for the scattered secondary cracks. Compare with Fig. 738. SEM, 5000×**

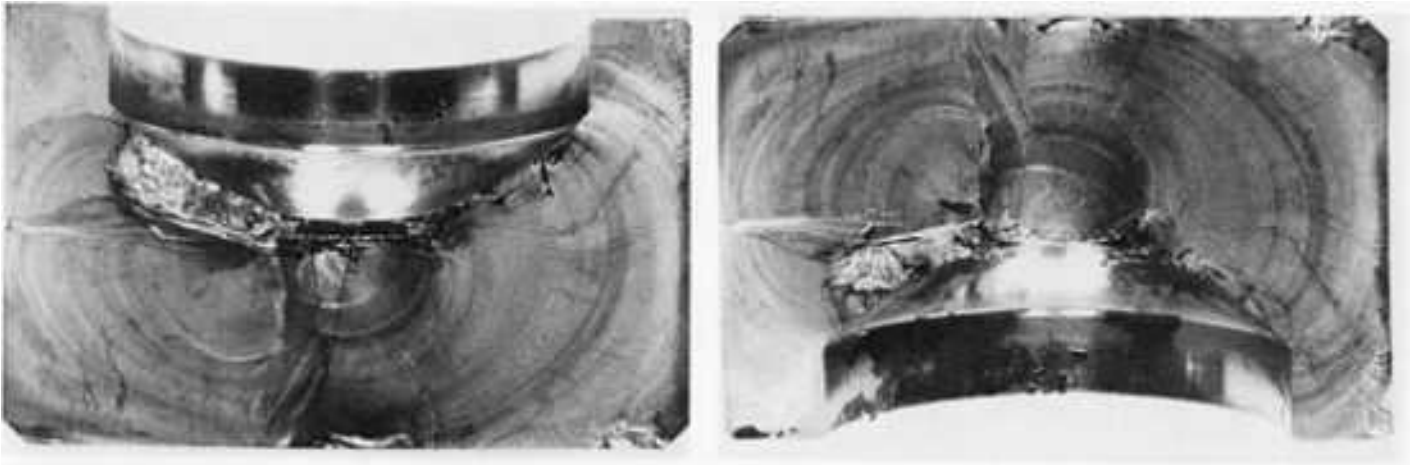
**Fig. 739** High-cycle fatigue fracture of the end cap for a high-pressure compressor used in a polyethylene process. The forging was made of Armco 15-5PH (UNS S15500), quenched and tempered to the H1075 condition. The end cap was located between the crosshead and plunger of the compressor, where it was subjected to repeated impacts by the tungsten carbide plunger. Failure initiated in a sharply radiused machining recess (see mating fracture surfaces). 1.55× (E.V. Bravenec, Anderson & Associates, Inc.)

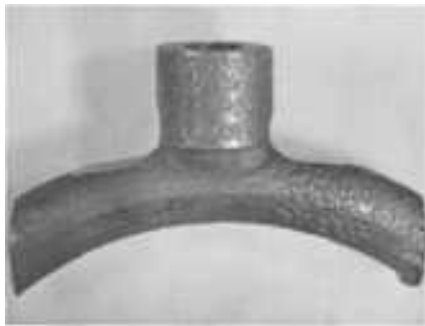
**Fig. 740**

Fracture of deflector yoke for aircraft main landing gear due to intergranular stress-corrosion cracking. Material: Armco 17-4PH (UNS S17400), 36 to 44 HRC. Seals were missing from both fractured and unbroken yokes. The inside of the broken part was filled with particulate matter, sand, and corrosion products, indicating that water had been present. Fig. 740: Unbroken deflector yoke. Note pitting. 4×. Fig. 741: Fracture surface. Box outlines area where evidence of intergranular attack was found. SEM, 12×. Fig. 742: Boxed area in Fig. 741. Note intergranular nature of corrosion. SEM, 145× (W.L. Jensen, Lockheed-Georgia Company)

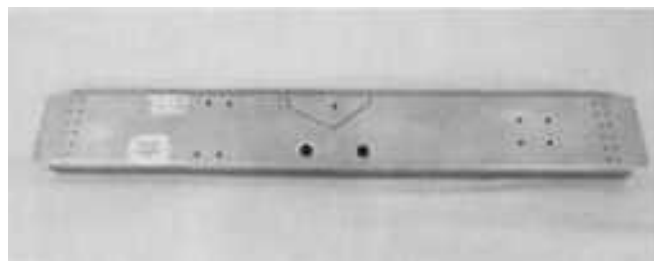
**Fig. 743**

Brittle intergranular fracture of Armco 17-7PH (UNS S17700) aircraft engine mount beam due to improper heat treatment. Hardness of the alloy in the specified TH1050 condition should have been 39 to 44 HRC, lower than the actual 46.5 HRC. Subsequent tensile testing of samples cut from the failed beam revealed identical tensile and yield strengths--1448 MPa (210 ksi)--and near-zero elongation. Other samples from the failed part were reheat treated according to TH1050 procedures and subsequently tensile tested. Properties of the reheat-treated material: tensile strength, 1407 MPa (204 ksi); yield strength, 1289 MPa (187 ksi); elongation in 50 mm (2 in.), 6.0%; hardness, 44 HRC. Fig. 743: As-received engine mount beam. Area of cracking is outlined (top center). 0.17 $\times$ . Fig. 744: Closer look at cracked area in Fig. 743. 0.8 $\times$ . Fig. 745: Fracture surface of opened crack. Note intergranular mode. SEM, 900 $\times$  (W.L. Jensen, Lockheed-Georgia Company)

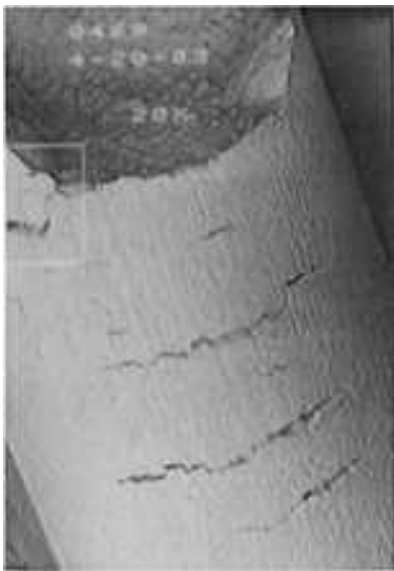
Fig. 746

Fracture of Armco 17-7PH (UNS S17700) spring due to presence of "cross-check" defect. The wire broke during coiling. Cross-checks are probably caused by lubricant breakdown during wire drawing. Fig. 746: Fracture surface (top) and surface of stainless steel wire. Origin is boxed. Note cross-check defects on wire. SEM, 20 $\times$ . Fig. 747: Higher-magnification view of fracture origin and associated cross-check. SEM, 100 $\times$  (J.H. Maker, Associated Spring, Barnes Group Inc.)

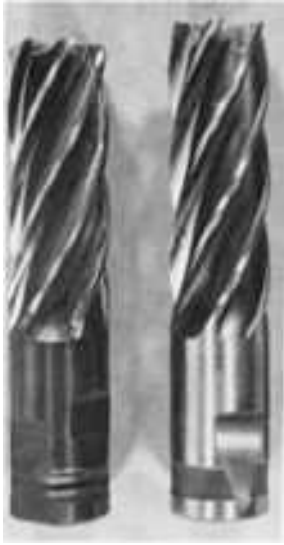
Fig. 748

Cracking of AISI M2 and M7 end mills due to improper rebuilding procedures. A robotic welding system was used to rebuild the worn cutting tools. Inadequate preheating and postweld heat treating resulted in a crack-prone weld-metal microstructure of brittle, untempered martensite. Fig. 748: As-received end mills with cracked flutes. 0.38×. Fig. 749: Fracture surface. G is the ground surface of the flute edge. 2.1×. Fig. 750: Close-up of area G in Fig. 749. Areas labeled B are regions of brittle fracture. 5×. See also Fig. 751. (W.L. Jensen, Lockheed-Georgia Company)

Fig. 751 Microstructure of as-deposited weld metal discussed in Fig. 748, 749, and 750, which consists of untempered martensite dendrites and a carbide eutectic in interdendritic regions. This a brittle structure that is prone to cracking during welding. See the brittle fracture regions labeled B in Fig. 750. 5% nital, 500× (W.L. Jensen, Lockheed-Georgia Company)

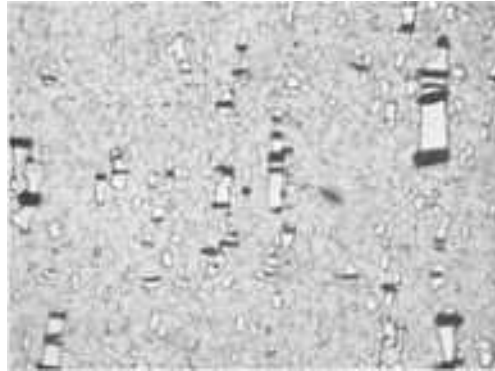
**Fig. 756 Brittle in-service failure of diesel engine injector plunger. The part was made of AISI D2 bar. Heat treatment: air cool from 995 °C (1825 °F), cool to -75 °C (-100 °F), doubled temper at 175 °C (350 °F). Microstructure consists of carbides of various sizes dispersed in a martensitic matrix. The larger carbides are cracked, indicating that the material had been embrittled at some stage during its thermomechanical processing history. 3% nital, 280× (J.R. Kattus, Associated Metallurgical Consultants Inc.)**

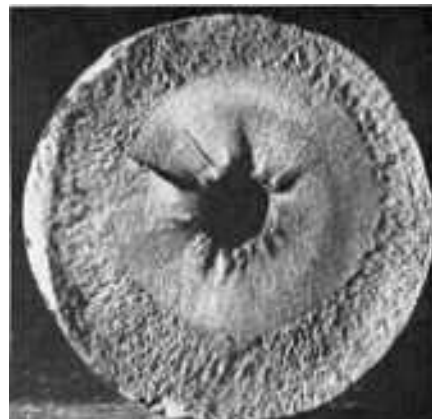
**Fig. 758 A Surface of a fatigue fracture that originated at the inside of a hollow drill of AISI W1 tool steel. Fracture initiation was attributed to distortion of the bore of the drill during the production of a hot upset joint. 1.8×**

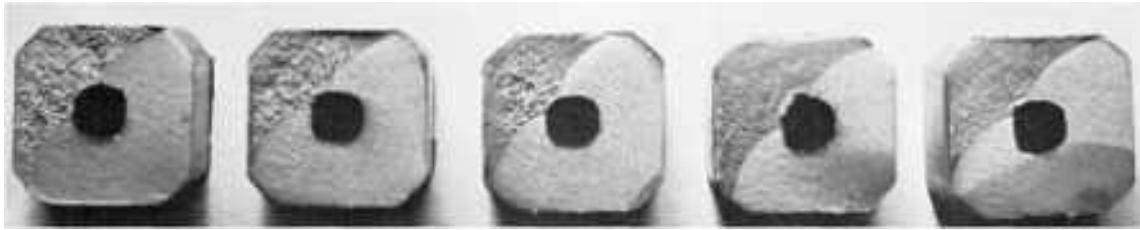
**Fig. 759 Five fatigue-fracture surfaces that were produced in reversed bending in pneumatic testing machine. The material is AISI W1 tool steel. The lighter areas of the fracture surfaces are the fatigue zones--all of which were initiated at the lower right corners. Note the lack of beach marks, which indicates that during each test the load amplitude and environment were uniform. The dark regions at the upper left corners are the regions of final fast fracture. 1.5×**

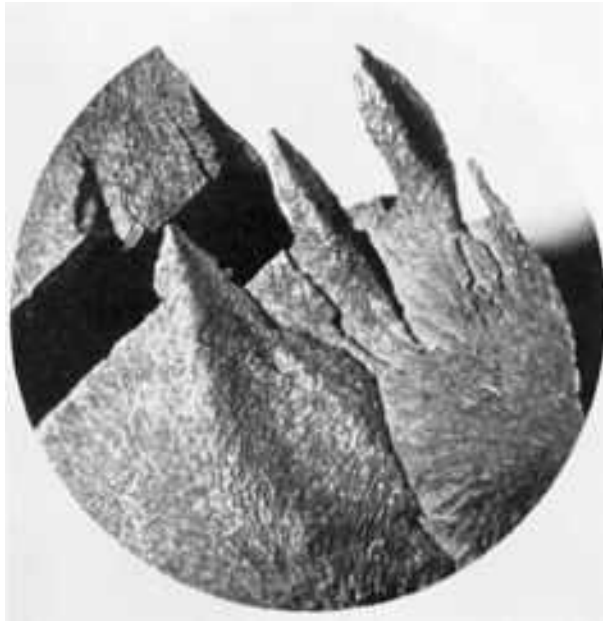
**Fig. 768 Surface of an impact fracture in a shear blade of AISI L6 tool steel heat treated to a hardness of 55 HRC. The impact generated the two crack fronts whose junction may be seen at the secondary fissure that enters the field of view at lower right; the radial markings on either side clearly meet this at divergent angles. A third and separate crack front (at top left) met these two crack fronts at the wide secondary crack beneath the projecting shards. 3×**

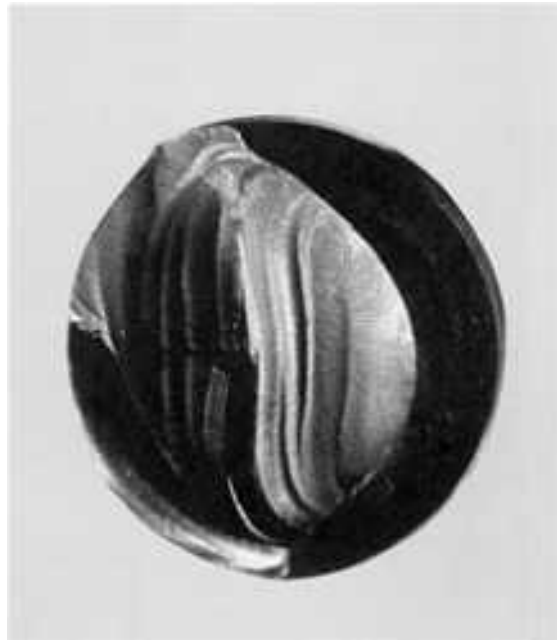
**Fig. 769 Surface of a low-cycle fatigue fracture in the collar of a rivet-heading tool of AISI S1 tool steel heat treated to a hardness of 56 to 58 HRC. Following the development of the smooth fatigue zone at right, fracture occurred in a few hours of service, generating the unusual beach marks at center and left. 2×**

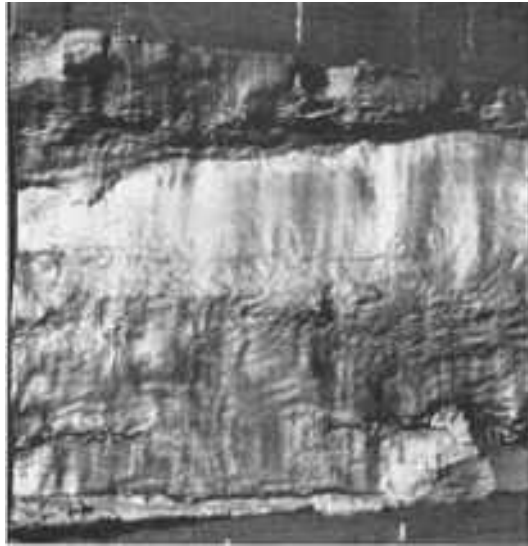
**Fig. 770** A "hammer-burst" fracture at the center of a 130-mm ( $5 \frac{1}{8}$ -in.) diam, 38-mm ( $1 \frac{1}{2}$ -in.) thick forged disk of AISI T1 tool steel. This longitudinal fracture shows a surface of either a lap or a cold shut; the appearance of such a fracture is often called "platy" or "laminated." 2.3×
