ASM HANDBOOK®

VOLUME  
12

Fractography

*Fractography*, was published in 1987 as Volume 12 of the *ASM Handbook*. The Volume was prepared under the direction of the ASM Handbook Committee.

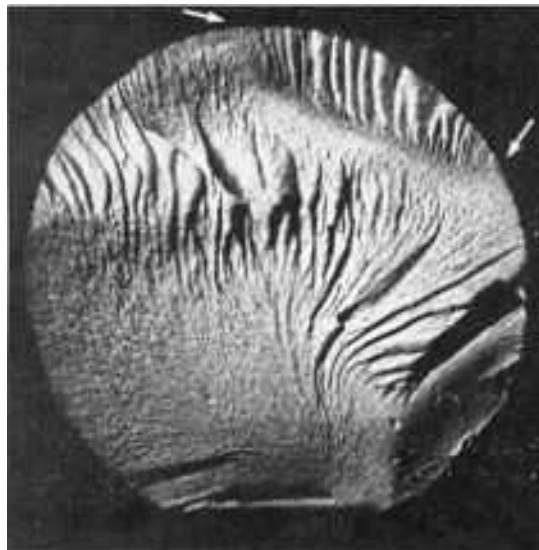
**Fig. 771** An impact fracture in a 32-mm ( $1 \frac{1}{4}$ -in.) diam notched bar of annealed AISI T1 tool steel broken for inspection by two hammer blows. The crack from the the first blow started at the notch at bottom and halted at the arrows, penetrating the area at top right only with the second blow. See also Fig. 772 and 773. 2.6×

**Fig. 772** An impact fracture in a 44-mm ( $1 \frac{3}{4}$  in.) diam notched bar of AISI T1 tool steel that was broken for inspection same as the bar in Fig. 771. The crack resulting from the first hammer blow, which started at the notch at right, shows the network of intersecting fine markings called "Wallner lines." The crack that resulted from the second hammer blow is at left. 1.9×

**Fig. 773** An impact fracture in a notched bar of AISI M3 class 1 tool steel broken for inspection as in Fig. 771 and 772. The crack from the first hammer blow originated in the notch at right (origin is readily located by tracing back to the beginning of the fan-shaped pattern of radial marks); this crack penetrated the area at left with the second hammer blow. 1.7×

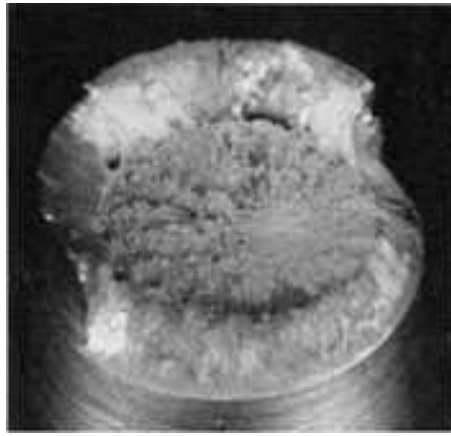
**Fig. 774** Tension-overload fracture in an unnotched specimen of AISI H11 tool steel heat treated to a tensile strength of 2041 MPa (296 ksi) and 48% reduction of area. Note radial features between fibrous origin (just right of center) and shear lip. See also Fig. 775 and 776 for higher-magnification views of this fracture. 9×

**Fig. 775** Another view of the fracture surface in Fig. 774, taken in the vicinity of the fracture origin, showing an unusually uneven array of dimpled facets with a scattering of large voids. See Fig. 776 for a higher-magnification view of the area in the rectangle. SEM, 1000×

**Fig. 777 Tension-overload fracture in notched specimen of AISI H11 tool steel (same heat treatment as in Fig. 774). Notched tensile strength ( $K_t = 3.5$ ) is 2665 MPa (386.5 ksi). A flat surface, partly bounded by a hairline shear lip. See also Fig. 778 and 779. 9×**

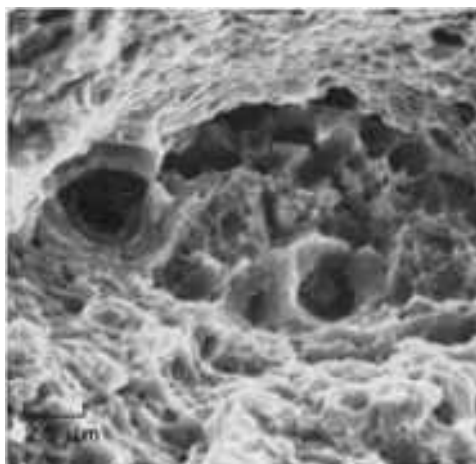
**Fig. 776** Higher-magnification view of the area in the rectangle in Fig. 775, showing one of the large voids and

clearly revealing dimples of various sizes both at the bottom and along the side walls of the void. SEM, 4000×

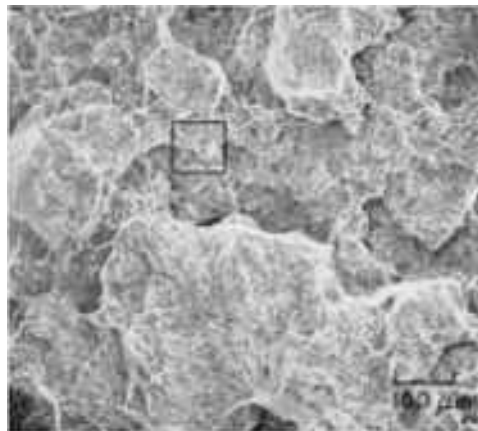
**Fig. 778 SEM view of the fracture surface in Fig. 777. This surface seems to be generally dimpled, but at this relatively low magnification the features that appear to be dimples are not adequately resolved. See also Fig. 779, an enlarged view of area in rectangle. 100×**

**Fig. 779** Higher-magnification view of the area in the rectangle in Fig. 778, showing dimples that are associated with local quasi-cleavage. Very little evidence of secondary cracking is present. Area in rectangle is shown at higher magnification in Fig. 780. SEM, 1000 $\times$

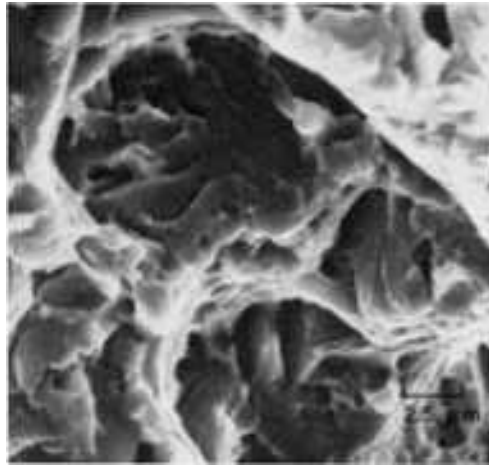
**Fig. 780** Higher-magnification view of the area in the rectangle in Fig. 779. Small quasi-cleavage facets are visible, both within and adjacent to the larger dimples. SEM, 4000 $\times$

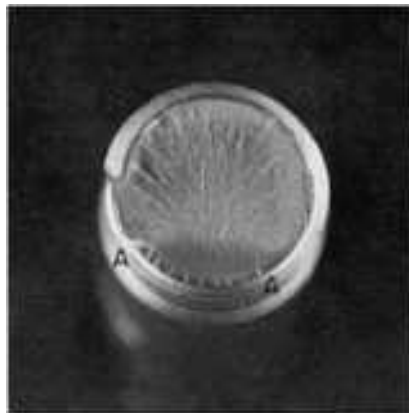
**Fig. 781** Low-cycle fatigue fracture in threaded specimen of AISI H11 tool steel (same heat treatment and tensile strength as in Fig. 774) that broke after 21,000 cycles of tension-tension ( $R = 0.1$ ); maximum load, 60% of tensile strength. Region A-A is fatigue portion of fracture. See also Fig. 782, 783, 784, and 785. 6 $\times$

**Fig. 782 SEM view taken near the outer edge of the crescent in Fig. 781. Evident are ridges that are attributed to mechanical damage during shear deformation. In this region, there appear to be no secondary cracks. 4000×**

**Fig. 783 View of the crescent in Fig. 781, showing a region farther from the outer edge than that in Fig. 782 and revealing ridges, formed during shear deformation, that have very irregular crests. SEM, 4000×**

**Fig. 784 Another view of the crescent in Fig. 781, showing a region still farther from the outer edge than that in Fig. 783. This region shows little evidence of conventional fatigue striations, but reveals small cleavage facets, many of which are separated by secondary cracks. SEM, 4000×**

**Fig. 785** View of the fracture surface in Fig. 781, showing a region in the zone of final fast fracture and revealing the equiaxed dimples expected in a tension-overload fracture. No secondary cracks are visible. SEM, 4000×

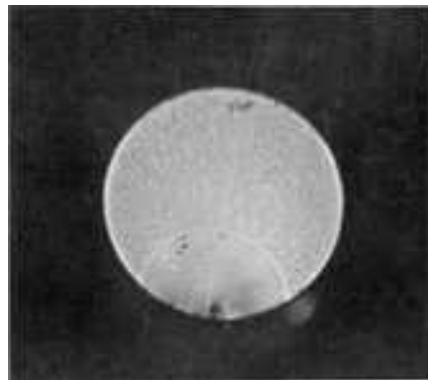
**Fig. 786** High-cycle fatigue fracture in AISI H11 tool steel heat treated to a tensile strength of 2041 MPa (296 ksi) and 48% reduction of area, which broke after 775,000 cycles of tension-tension ( $R = 0.1$ ) under a maximum load of 30% of tensile strength. The fatigue-crack origin is at the outer edge of the crescent-shaped region at bottom. See also Fig. 787 and 788 for higher-magnification views of this fracture. 6×

**Fig. 787** An area within the crescent-shaped (fatigue) region of the fracture surface in Fig. 786. The surface contains many pockmarks, which resemble dimples. There are no suggestions of fatigue striations. See Fig. 788 for an enlargement of the area in the rectangle. SEM, 1000×

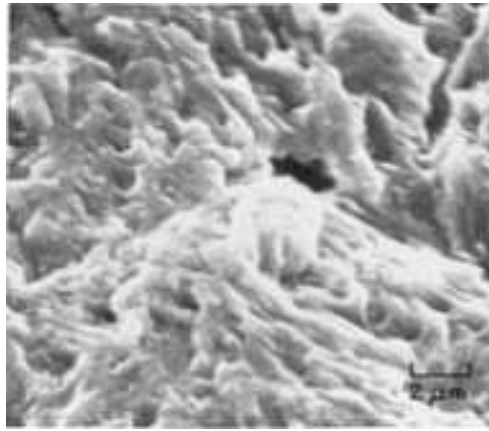
**Fig. 788 Higher-magnification view of the area in the rectangle in Fig. 787. Some of the contours suggest striations, but they are very localized. Some features resemble cleavage facets, but do not have the degree of flatness that is normally expected of cleavage. SEM, 5000×**

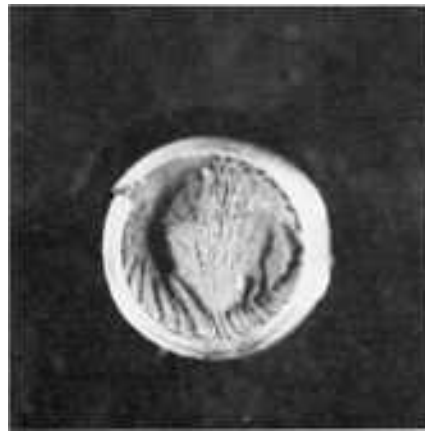
**Fig. 789 Fracture caused by hydrogen embrittlement in threaded specimen of AISI H11 tool steel (same heat treatment and tensile strength as in Fig. 786). Hydrogen impregnation was by plating. Fracture occurred before the full sustained load could be applied and progressed around the circumference of the specimen. See also Fig. 790 and 791. 6×**

**Fig. 790 SEM view of the fast-fracture region of the fracture surface in Fig. 789, showing an unusual type of surface for a specimen heavily charged with hydrogen. Fracture occurred primarily by microvoid coalescence; there is no evidence of intergranular rupture. Area in rectangle is shown at higher magnification in Fig. 791.**

**Fig. 792** Another view of the fracture surface in hydrogen-embrittled AISI H11 tool steel shown in Fig. 789. The surface consists almost entirely of dimpled rupture. A few facets are present and suggest possible local cleavage. See also Fig. 793. SEM, 4000×

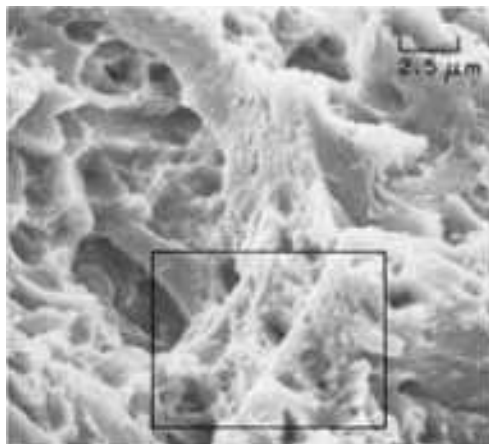
4000×

**Fig. 791** Higher-magnification view of the area in the rectangle in Fig. 790. Very fine dimples and large dimples are both present. A few features resemble cleavage facets, but the grain-boundary parting expected in hydrogen-embrittlement fractures is absent. SEM, 10,000×

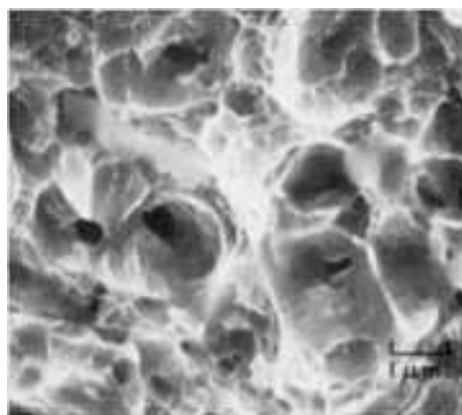
**Fig. 793** Higher-magnification view of a region of which most is contained within the rectangle in Fig. 792. This region, like the one shown in Fig. 791, exhibits a considerable range in dimple size and no trace of grain-

boundary parting. SEM, 10,000×

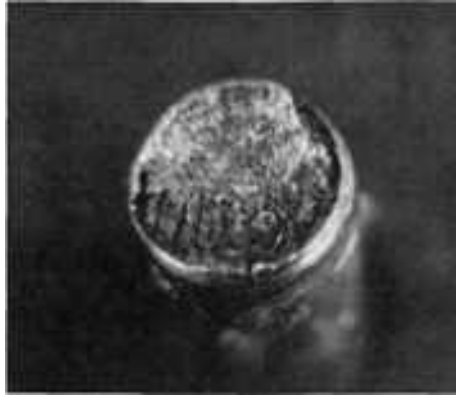
**Fig. 794** Fracture caused by stress-corrosion cracking in a threaded specimen of AISI H11 tool steel (same heat treatment and tensile strength as in Fig. 786) at a sustained loading of 75% tensile strength in a 3.5% NaCl environment at room temperature. Appreciable corrosion is evident. See also Fig. 795, 796, and 797. 6×

**Fig. 795** SEM view of the fracture surface in Fig. 794, showing fracture by grain-boundary cracking under NaCl attack. Some facets show no trace of corrosion. Deep secondary cracks are present. A few facets suggest quasi-cleavage. See also Fig. 796. 800×

**Fig. 797** High-magnification view of a region of the fracture in Fig. 794 not shown in Fig. 795, displaying grain-boundary facets and some corrosion. Some of the deep secondary cracks may be transgranular. SEM, 4000×

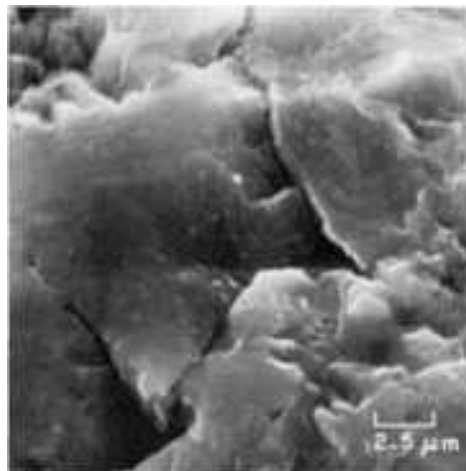
**Fig. 796** Higher-magnification view of the area in the rectangle in Fig. 795, showing secondary cracking, which appears to follow some grain boundaries. The large, smooth facets resemble transgranular cleavage more than they resemble grain-boundary rupture. SEM, 4000×

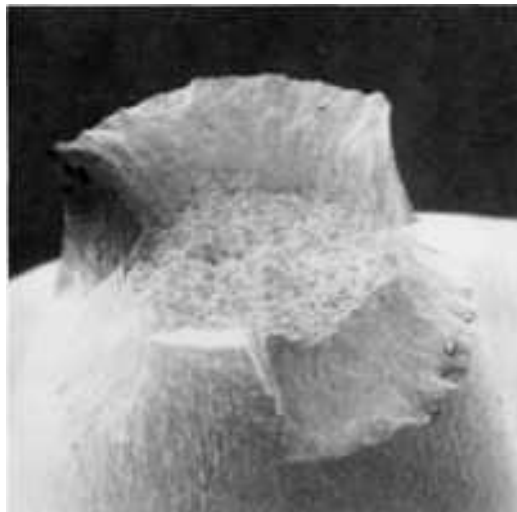
**Fig. 798** Surface of a fracture in a tensile-test specimen of 18% Ni, grade 300, maraging steel aged 3 h at 480 °C (900 °F), broken at room temperature. The crack-initiation zone (at center) is an example of extremely uneven fibrous fracture; there appear to be no radial marks leading to the base of the surrounding shear lip. The shear lip is of the pronounced type that is observed when a large reduction in cross-sectional area accompanies fracture. See also Fig. 799, 800, 801, and 802. 26×

**Fig. 799 SEM view of the fracture surface of the specimen of 18% Ni, grade 300, maraging steel in Fig. 798, showing a region in the area of transition from fibrous fracture in the central zone to fracture by shear in the surrounding lip. Visible in the lower portion of the fractograph are the equiaxed dimples (viewed obliquely) that are characteristic of fracture in pure tension; above are the elongated dimples of the shear lip. Note the horizontal boundary between these two types of fracture. See also Fig. 800 and 801. 1300×**

**Fig. 800 View of the shear-lip region of the fracture surface in Fig. 798. Microvoid coalescence here has produced shear dimples with characteristic elongated shape. Note the large voids, which formed at inclusions of Ti(C,N). The matrix did not adhere to these inclusions, which allowed the voids to open early in the fracture process and to grow large. See Fig. 801 for a higher-magnification view of the area in the rectangle. SEM, 520×**

**Fig. 802** An SEM view of the surface of the tensile-test fracture in 18% Ni, grade 300, maraging steel in Fig. 798, showing a portion of the central zone of the fracture, close to the origin. The surface here is composed of equiaxed dimples of two different sizes. The large dimples probably formed at Ti(C,N) particles; all the dimples were caused by particles of some sort. 290×

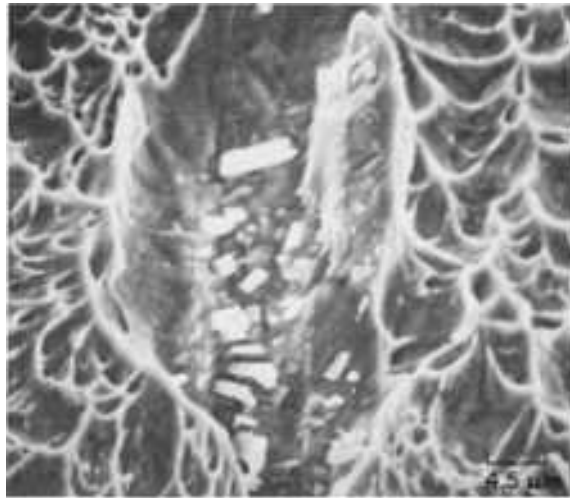
**Fig. 801** Higher-magnification view of the area in the rectangle in Fig. 800, showing one of the very large voids. Clearly visible is the array of Ti(C,N) inclusions that triggered the formation of this void. These may have been separate particles originally, or they may be segments of one or more larger particles that broke apart before the void opened. Except for a few tiny dimples visible here (lower right), the region in Fig. 800 was found to lack the dispersion of fine dimples normally present in surfaces of tensile-test fractures. SEM, 2200×

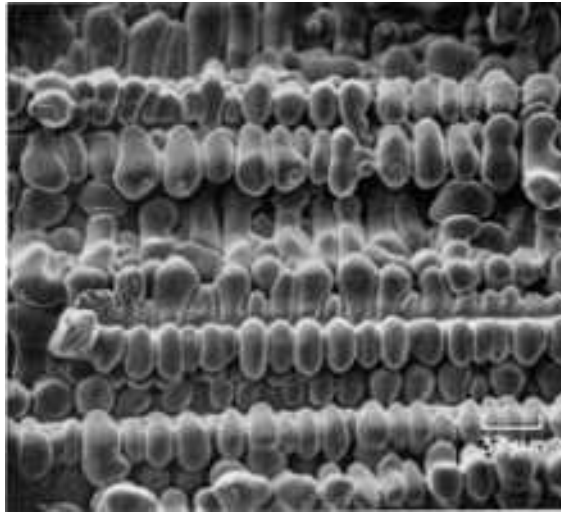
**Fig. 803** Surface of tensile-test fracture in a cast specimen of 18% Ni, grade 300, maraging steel, showing a region where the fracture intersected a shrinkage cavity and exposed dendrites whose growth during solidification was arrested by a lack of molten metal within the cavity. In this view, the primary dendrite arms are oriented horizontally. See also Fig. 804 and 805. SEM, 270×

**Fig. 804** Lower-magnification view of the exposed dendrites in the shrinkage cavity in the cast specimen of 18% Ni, grade 300, maraging steel in Fig. 803, showing dendrites that formed at different orientations. Had this casting been properly risered, the channels between the dendrite arms would have been filled, forming continuous metal. See also Fig. 805, which shows the area in the rectangle at higher magnification. SEM, 130×

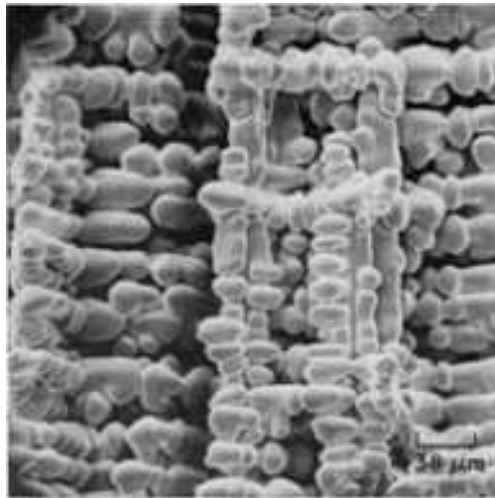
**Fig. 805 Enlarged view of the area in the rectangle in Fig. 804. Primary dendrite arms are oriented vertically here; secondary arms are at various orientations normal to the primary arms. Appreciable secondary-arm growth is evident, but the higher-order branching often found in castings has not occurred. SEM, 260×**

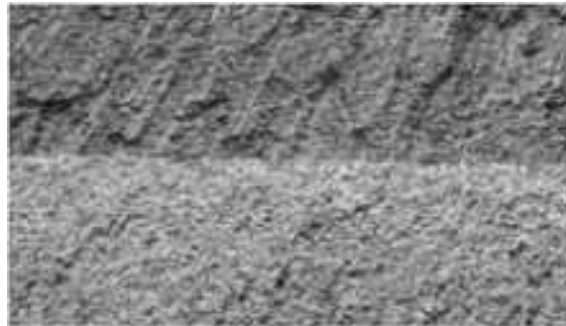
**Fig. 806 Fracture surface of a fracture-toughness specimen of 18% Ni, grade 300, maraging steel; the heat treatment of this specimen was not reported. This view shows entry of the fatigue crack from bottom, and sharp onset of final fast fracture at center. See also Fig. 807 and 808; compare with Fig. 809. SEM, 26×**

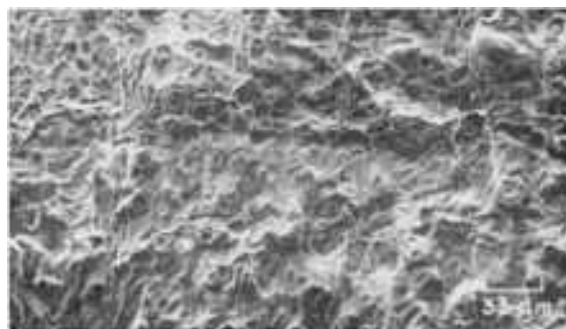
**Fig. 807 SEM view, at higher magnification, of the fracture surface shown in Fig. 806, with the fatigue-crack surface at bottom and the fast-fracture surface at top. Note the secondary cracks and lack of clear fatigue striations in the fatigue area. See also Fig. 808. 300×**

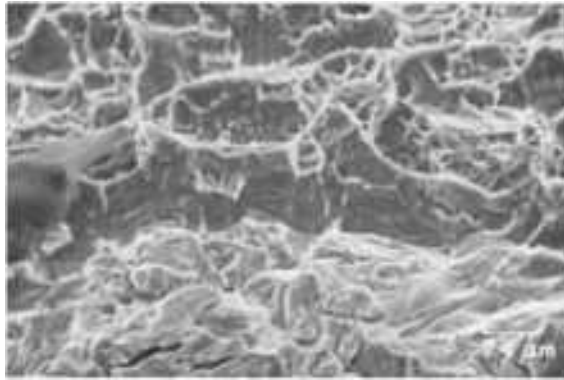
**Fig. 808** Same fracture surface in 18% Ni, grade 300, maraging steel as in Fig. 806 and 807, shown here at still higher magnification. At bottom, fatigue has produced numerous secondary cracks. Note the stretched zone at center, at the transition from fatigue to final fast fracture. SEM, 1350×

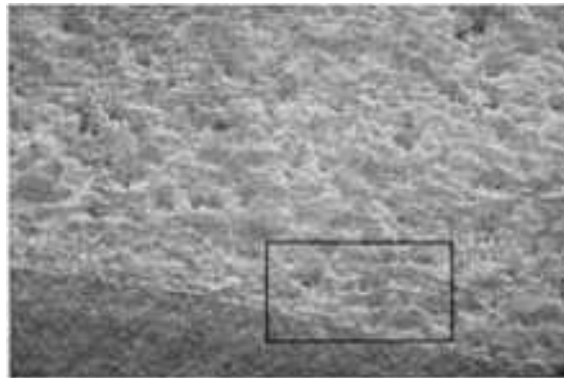
**Fig. 809** Fracture surface of a fracture-toughness specimen of 18% Ni, grade 300 maraging steel aged 3 h at 540 °C (1000 °F) and air cooled. Fatigue crack at bottom; ductile, tension-overload fracture at top. Note ridges, spaced at about 60  $\mu\text{m}$ , in ductile region parallel to crack front. See also Fig. 806, 810, and 811. SEM, 47×

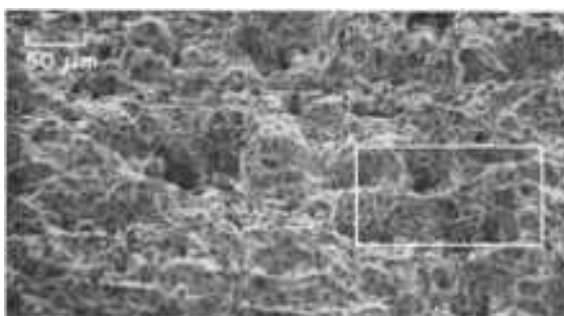
**Fig. 810** Higher-magnification view of the area in the rectangle in Fig. 809. Tension-overload dimples are clearly shown, but no details of the fatigue zone (bottom) are visible. The discontinuous nature of the ridges in the tension-overload region is evident. See Fig. 811 for enlarged, composite view of area in rectangle here. SEM, 200×

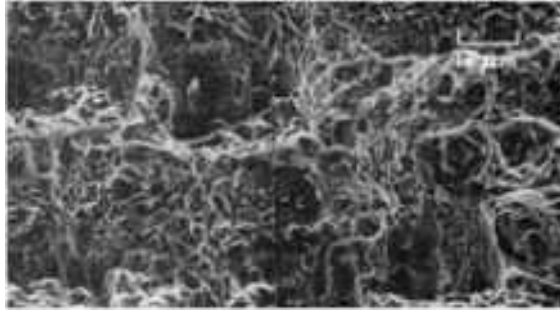
**Fig. 811 Composite of four SEM fractographs of the plane-strain region of the area of tension-overload fracture in the specimen shown in Fig. 809 and 810, taken from the area in the rectangle in Fig. 810. This shows more clearly the changes in surface orientation between the ridges. 600×**

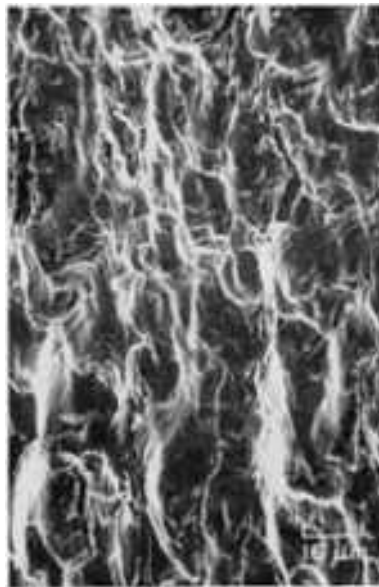
**Fig. 812 A low-cycle fatigue fracture (at about 3000 cycles) of 18% Ni, grade 300, maraging steel that had been annealed 1 h at 815 °C (1500 °F) and air cooled. There is no evidence of clearly defined striations, but there is a system of more or less parallel secondary cracks. See also Fig. 813 and 814. SEM, 640×**

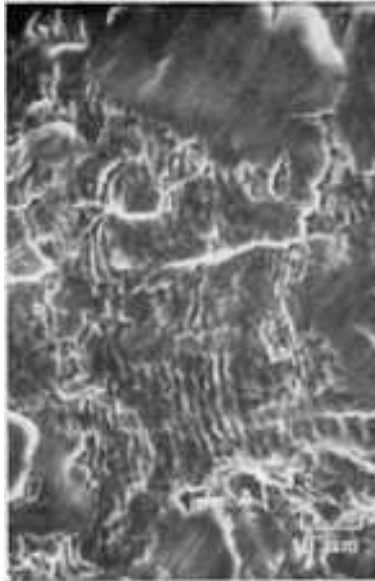
**Fig. 813** A view of a different area of the low cycle fatigue fracture of Fig. 812. Note that in this area quite regular striations are in evidence, many of them with fissures at their roots (as at A). Note also the several rubbed areas, particularly those at the top. See also Fig. 814. SEM, 1250 $\times$

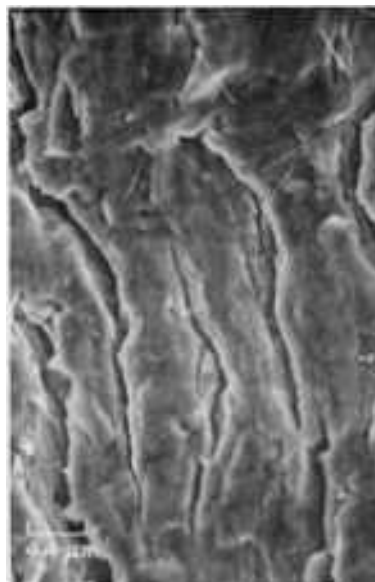
**Fig. 814** Same fracture as shown in Fig. 812 and 813, but an area at still another location, as seen at higher magnification. Here again is a system of repetitive fissures that appear to be quite deep and very irregular. There is little evidence of the conventional type of striations in this area. SEM, 2250 $\times$

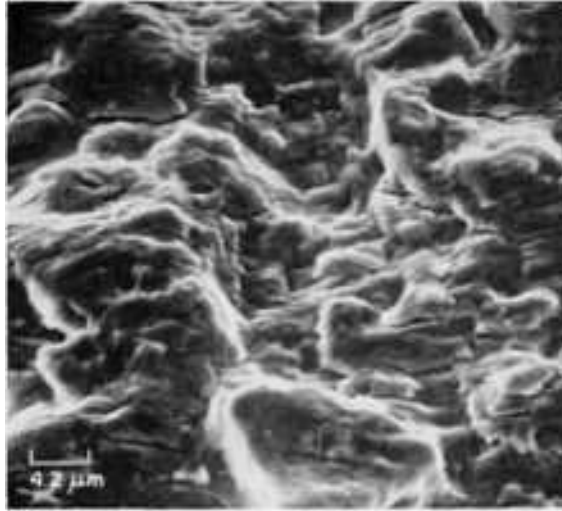
**Fig. 815** Surface of a low-cycle fatigue fracture (at about 1000 cycles) in 18% Ni, grade 300, maraging steel that had been aged at 480 °C (900 °F) for 3 h and air cooled. This fracture surface displays a progression of rather fine but extremely irregular striations, separated here and there by secondary cracks. SEM, 2400×

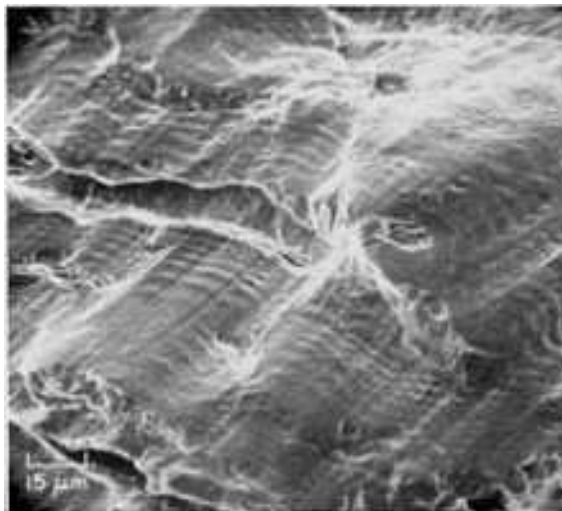
**Fig. 816** Low-cycle fatigue fracture of 18% Ni, grade 300, maraging steel (heat treatment not reported). This has relatively uniformly spaced fatigue striations with fewer secondary cracks than are seen in Fig. 812, 813, 814, and 815. The pattern of striations is similar to that produced by varied loading in service. SEM, 670×

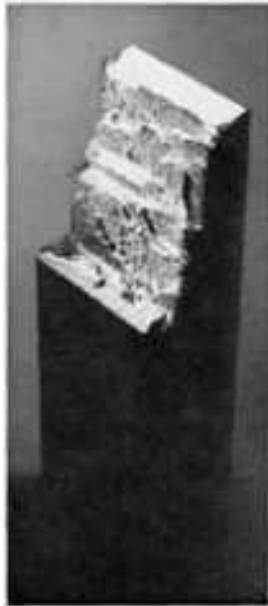
Fig. 817

Figure 817 shows a slow-bend fracture of a weld specimen made by gas tungsten-arc butt welding two 19-mm ( $\frac{3}{4}$ -in.) thick plates of 18% Ni maraging steel having a yield strength of 1724 MPa (250 ksi). A specimen  $48 \text{ mm}^2 \times 180 \text{ mm}$  ( $0.75 \text{ in.}^2 \times 7 \text{ in.}$ ) was cut across the weld. After the weld was ground flush, the specimen was notched and then fatigue-cracked in the center of the weld and parallel to the length of the weld. After being aged at 490 °C (915 °F), the specimen was broken at room temperature in slow, three-point bending. Fracture surface shows steps caused by splitting. A portion of one of these steps is shown at higher magnification in Fig. 818; the surface here exhibits a network of high-reflectivity area, one example being identified by the arrows. The remaining areas of the surface were relatively dull. See also Fig. 819, 820, 821, and 822. Fig. 817: Actual size. Fig. 818: 8×

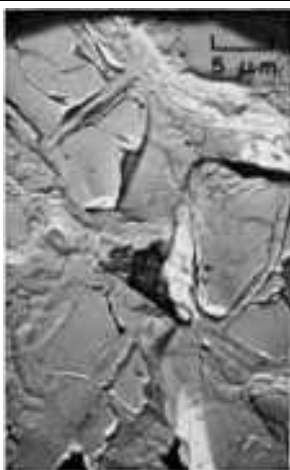
Fig. 819

Figures 819 and 820 are TEM views, at different magnifications, taken from one of the high-reflectivity areas in Fig. 818. The shiny aspect was due to flat platelets resulting from cleavage of particles of unidentified composition. Note that in both views there are tear dimples between the reflecting facets. Figure 821 reveals that the structure in the low-reflectivity area in this fracture surface consists of rather flat equiaxed dimples. Figure 822 is from a companion 18% Ni maraging steel weld specimen to the one in Fig. 817, 818, 819, 820, and 821; specimen here was hydrogen embrittled and then fractured by sustained loading at room temperature. This fracture surface shows dimples, together with quasi-cleavage facets that contain characteristic steps, river patterns, and tear ridges. Fig. 819, 821, and 822: TEM p-c replicas, all at 2000×. Fig. 820: TEM p-c replica, 5000×

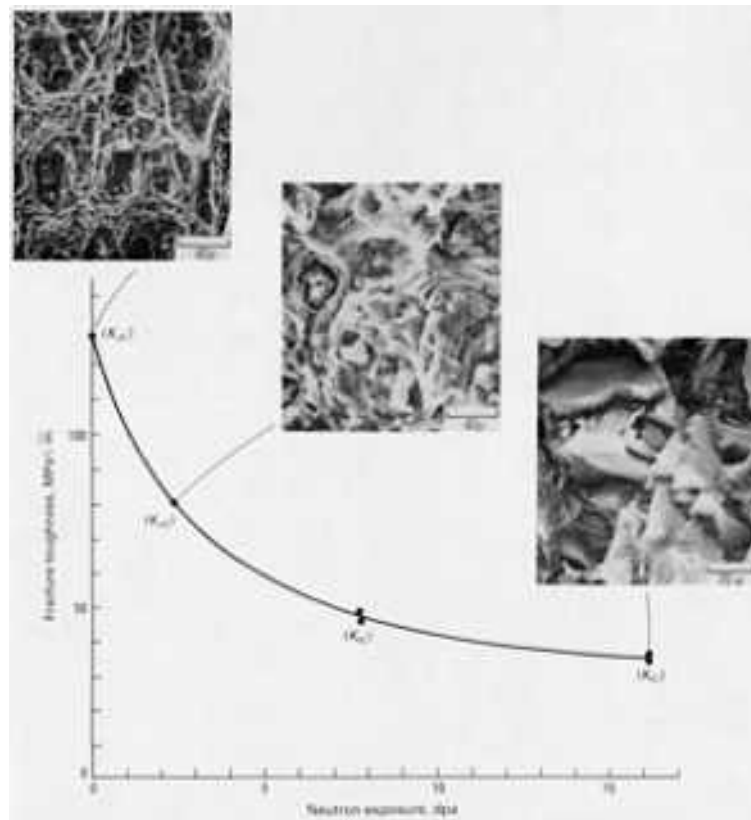
**Fig. 823** Effect of neutron irradiation on fracture mode and fracture toughness of the iron-nickel-base superalloy A-286 (UNS S66286). The plot of fracture toughness versus neutron exposure charts the degradation of  $K_{Ic}$  with increased irradiation. Note the fracture-mode transition from microvoid coalescence at no exposure to channel fracture in the highly irradiated condition. At the high exposure level, all dislocation activity was localized in a planar slip band, and cracking eventually initiated and propagated along the resultant dislocation channels, causing fracture toughness to fall off. (J.E. Nolan, Westinghouse Hanford Company)

- (e) Total includes two sulfur dot maps obtained by energy-dispersive x-ray spectroscopy (Fig. 825 and 827).
- (f) Total includes a graph of fracture toughness versus neutron irradiation that contains three superimposed electron fractographs (Fig. 823), a graph charting fatigue crack growth rate versus the stress intensity factor range that contains four superimposed electron fractographs (Fig. 846), and a schematic illustrating the selective area polishing technique (Fig. 847).
- (g) Total includes a tin distribution map obtained by energy-dispersive x-ray spectroscopy (Fig. 916).
- (h) Miscellaneous metals and alloys include tungsten, iridium, magnesium-base, iron-base, molybdenum-base, and tantalum-base materials.
- (i) Total includes two sulfur dot maps obtained by energy-dispersive x-ray spectroscopy (Fig. 1290 and 1292).

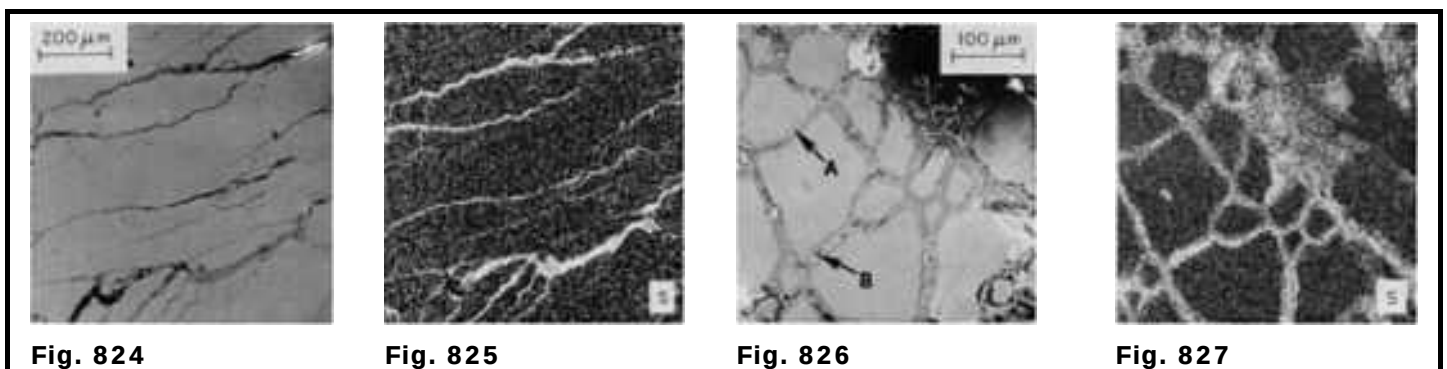
Failure due to sulfidation of a coupling for a hot-gas sampling line used in a coal-gasification pilot plant. The coupling was made of the iron-nickel-base superalloy RA-330 (UNS N08330), joined using Inconel alloy 182 filler metal (AWS A5.11, class ENiCrFe-3). It failed after 8500 h of service at a temperature of 870 to 980 °C (1600 to 1800 °F) in gas having this typical composition (in vol%): 56.9% H<sub>2</sub>O, 16.9% H<sub>2</sub>, 16.2% CO<sub>2</sub>, 8.0% CO, 1.9% CH<sub>4</sub>, and 0.1% H<sub>2</sub>S. Higher H<sub>2</sub>S levels may have been present on occasion. Sulfidation at the surface of the filler metal (~65% Ni) led to formation of the Ni<sub>3</sub>S<sub>2</sub>-Ni eutectic, which melts at 635 °C (1175 °F), well below the operating temperature of the coupling. This liquid phase penetrated the interdendritic regions of the weld metal and then the grain boundaries of the base metal. Fig. 824: Backscattered electron image of ENiCrFe-3 weld metal

showing severe interdendritic attack. SEM, 65×. Fig. 825: Sulfur map of field in Fig. 824 reveals high level of the element in interdendritic regions. Technique used was energy-dispersive x-ray spectroscopy (EDS). 65×. Fig. 826: Backscattered electron image of superalloy base metal adjacent to filler metal shows intergranular attack by  $\text{Ni}_3\text{S}_2\text{-Ni}$  (at B), most of which transformed to more stable chromium sulfide (at A). SEM, 130×. Fig. 827: Sulfur map of field in Fig. 826 reveals high levels of the element in grain boundaries. 130× (D.R. Diercks, Argonne National Laboratory)

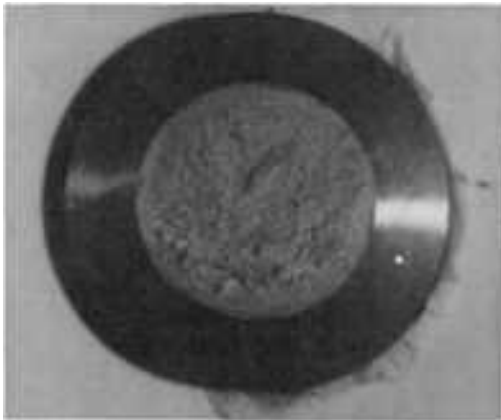
Fig. 828

Hydrogen-embrittlement fracture of a single-crystal nickel-base superalloy (CMSX-2) developed for gas turbine engine applications. Composition: 4.6% Co, 8.0% Cr, 0.6% Mo, 7.9% W, 5.6% Al, 0.9% Ti, 5.8% Ta, <0.1% Hf, 0.01% Zr, 0.005% C, remainder Ni. Heat-treated notched samples were stress relieved and then tensile tested in either helium (control samples) or hydrogen at 35 MPa (5 ksi) and room temperature. Cross-head speed, 2.12  $\mu\text{s}$ ; notched strength ratio  $\text{H}_2/\text{He}$ , 0.14. Fig. 828: Fracture surface of control sample tested in helium. 4.6× Fig. 829: Higher-magnification view of fracture surface in Fig. 828. Note ductile failure mode. SEM, 95×. Fig. 830: Fracture surface of samples tested in hydrogen. 4.6×. Fig. 831: Higher-magnification view of fracture surface in Fig. 830. Note brittle crystallographic cracking. SEM, 95× (R.J. Schwinghamer, NASA Marshall Space Flight Center)

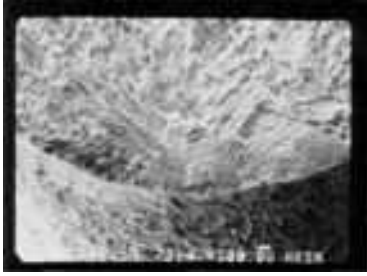
**Fig. 832**

Fatigue and creep fractures of case and hot isostatically pressed IN-738 tested in a salt environment (40%  $\text{MgSO}_4$ , 59%  $\text{Na}_2\text{SO}_4$ , 1%  $\text{NaCl}$ ) at 705 °C (1300 °F). Samples heat treated 2 h at 1120 °C (2050 °F), air cool; 14 h at 845 °C (1550 °F), air cool. Fig. 832: Fatigue fracture surface. Test conditions: 483 MPa (70 ksi)  $\pm$  207 MPa (30 ksi); 102,000 cycles at failure. Fractograph shows region of transgranular fracture initiation with characteristic "thumbprint" and river patterns pinpointing origin at surface (bottom). Failure was salt corrosion assisted. SEM, 29 $\times$ . Fig. 833: Fatigue fracture surface of salt-coated sample. Test conditions: 483 MPa (70 ksi)  $\pm$  345 MPa (50 ksi); 5000 cycles at failure. Fracture is transgranular with multiple surface origins. SEM, 13 $\times$ . Fig. 834: Fracture surface after stress-rupture testing at 896 MPa (130 ksi). Mechanism: salt corrosion-assisted intergranular fracture. Note grain-boundary, decohesion. SEM, 23 $\times$  (E.A. Schwarzkopf, J. Stefani, and J.K. Tien, Columbia University)

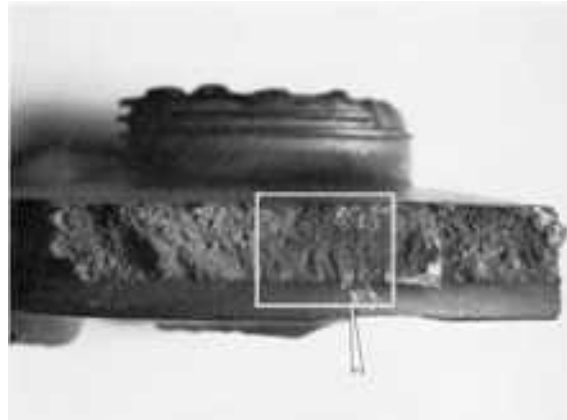
**Fig. 835** Segment of a fractured second-stage gas-turbine wheel, cast from alloy 713C, that broke from fatigue in service. (About half of the disk portion of the wheel was never recovered.) The fracture origin (at arrow) was in a grinding-relief groove adjacent to the wheel-balancing pad. Additional circumferential cracks, not adjuncts of fracture, were found elsewhere in the grinding-relief groove. See Fig. 836 for a higher-magnification view of the rectangular area. 2 $\times$

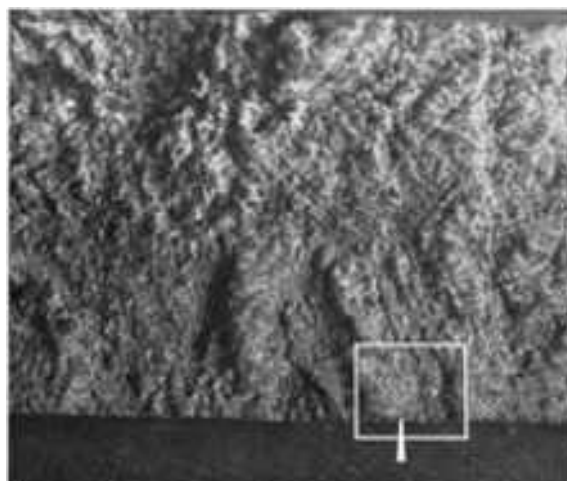
**Fig. 836 Crack-origin region in the rectangle in Fig. 835, at higher magnification. Arrow marks the probable location of the crack nucleus. The surface of the grinding-relief groove is below the fracture surface. Measurements of the radius of the bottom of the groove gave values that were about 70% of the average desired and about 87% of the minimum. The excessive sharpness of the radius may have been conducive to cracking. See also Fig. 837. 10×**

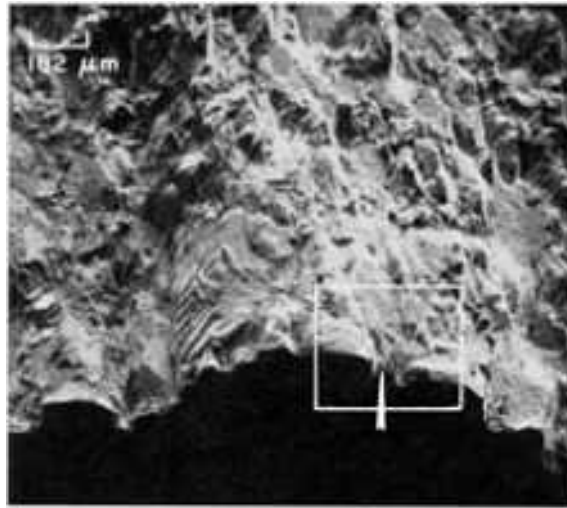
**Fig. 837 SEM view taken of the outlined area in Fig. 836 after the fracture surface, which contained many white, gelatinous particles as received at the laboratory, was cleaned ultrasonically in 18% HCl solution for  $1\frac{1}{2}$  min and then washed in acetone and blown dry. The interface between the fracture and the grinding-relief groove was carefully examined in the origin area, and only one probable crack origin was discovered--that marked by the arrow. Area in rectangle is shown at higher magnification in Fig. 838. 55×**

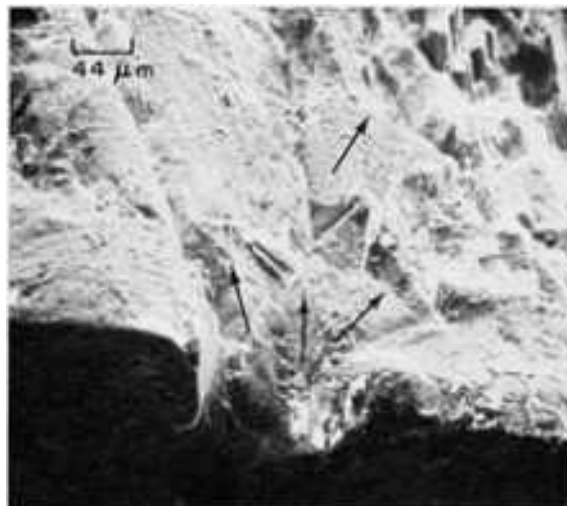
**Fig. 838 A view at higher magnification of the outlined area (containing the probable origin of fracture) in Fig. 837. Numerous patches of fatigue striations are visible; the arrows indicate the directions of fatigue-crack propagation from what appears to be a surface defect within the grinding-relief groove. The fatigue facets were found to be transgranular, giving way, outside of the dark, crescent-shaped fatigue-crack area visible in Fig. 835, to ductile dimples. SEM, 225×**

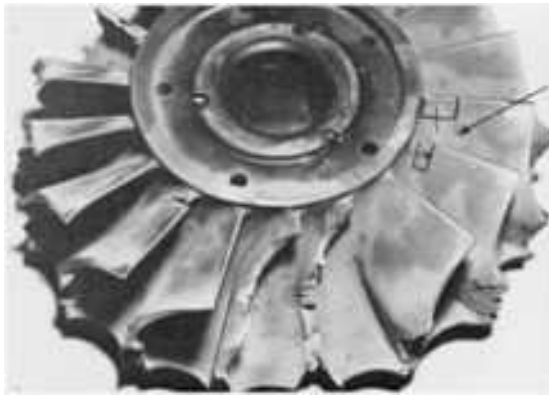
**Fig. 839** A gas-producer turbine rotor cast of alloy 713LC that fractured after 440 h of service, as the result of hot corrosion fatigue. Fracture was abrupt, with three blades being thrown off. See Fig. 841 for a view of the area near the arrow. See also Fig. 840 and 842. 0.5×

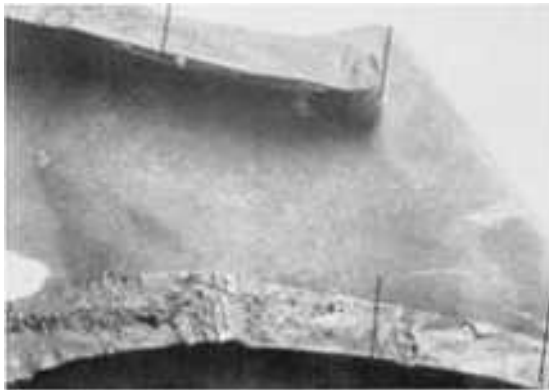
**Fig. 840** Fracture surfaces of the two broken turbine-rotor blades at the bottom in Fig. 839. Fatigue beach marks are faintly visible at right on the fracture surface of the lower blade. The region between the parallel black lines on each blade was examined by electron microscopy. 6×

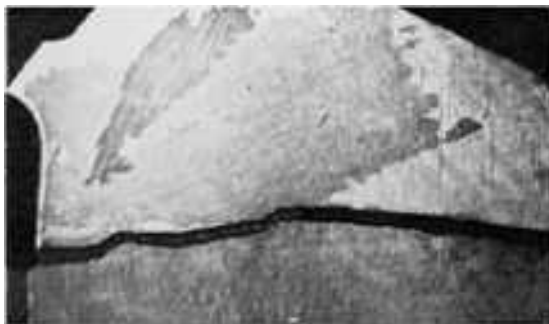
**Fig. 841** A macroetched view of a cracked turbine-rotor blade near the arrow in Fig. 839, displaying large columnar grains and a crack that initiated at the trailing edge (at left in this view) of the blade. This crack appears to have followed an intergranular path. Etched in 95 parts conc HCl, 5 parts 35%  $\text{H}_2\text{O}_2$ . 5.5×

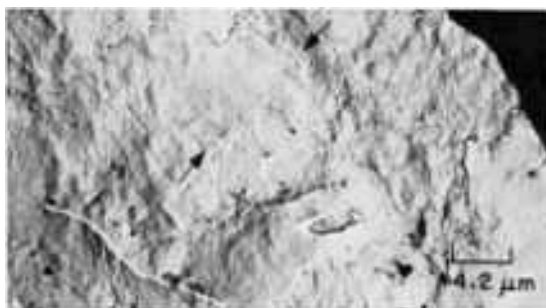
**Fig. 842** TEM p-c replica of a fracture surface of one of the turbine-rotor blades in Fig. 840. This view is typical of all the areas examined. A patch of fatigue striations is faintly visible at center between arrows. The fatigue crack is believed to have been initiated by hot corrosion, which was shown, by sectioning of blades, to exist at concentrations of lead. 2400×

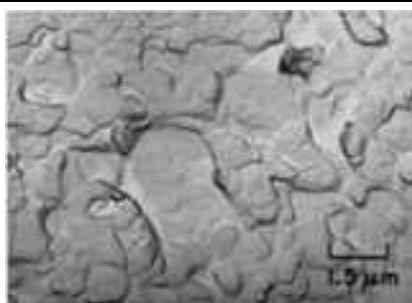
**Fig. 844**

Figure 843 shows the surface of a dendritic stress-rupture fracture in a cast specimen of IN-100 nickel-base alloy that was annealed at 1175 °C (2150 °F) and loaded at 980 °C (1800 °F) to a tensile stress of 97 MPa (14 ksi). The specimen broke after 49 h of testing. Figure 844 is a TEM p-c replica of an area at the arrow in Fig. 843, showing some evidence of intergranular separation and some facets of what appear to be cleaved particles (as at A) of intermetallic compounds. Figure 845 is a TEM p-c replica of another area at the arrow in Fig. 843, showing evidence of glide-plane decohesion (at A's) as well as smooth areas of stretching (as at B). Some surface oxidation apparently occurred after fracture. Fig. 843: 8×. Fig. 844 and 845: 6500×

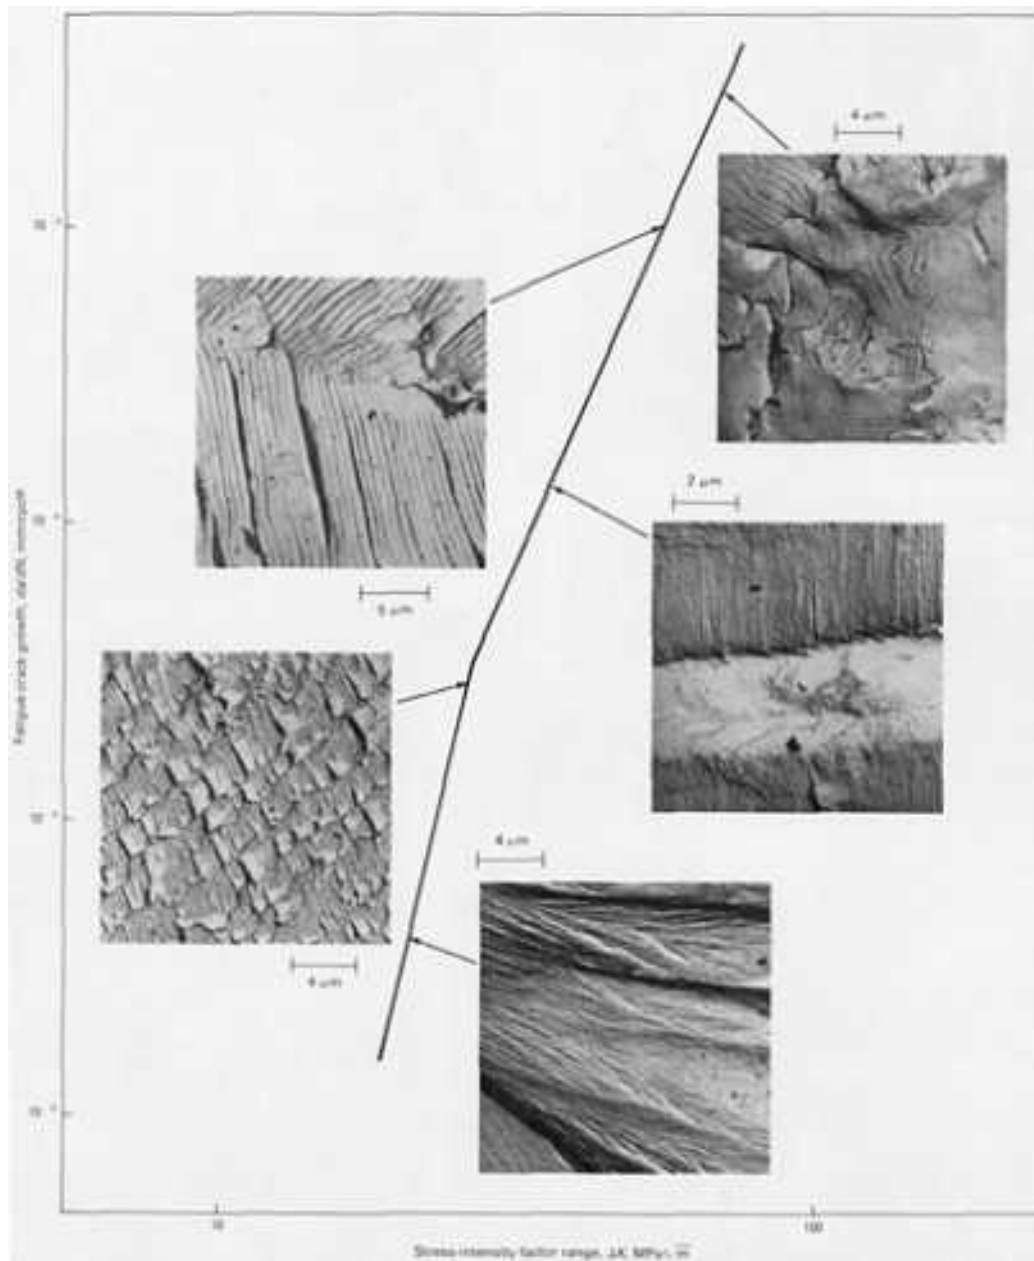
**Fig. 846 Fatigue fracture mechanisms in Incoloy alloy X750 (UNS N07750) as a function of the stress-intensity factor range,  $\Delta K$ . Test conditions: 24 °C (75 °F). 300 cycles/min.  $R = 0.05$ . The plot of fatigue crack growth rate,  $da/dN$ , versus  $\Delta K$  shows that at high  $\Delta K$ , the fatigue fracture surface exhibited well-defined striations and dimples. At progressively lower values of  $\Delta K$ , a combination of fatigue fissures (associated with small secondary cracks) and striations was observed. At low  $\Delta K$ , a highly faceted fracture surface resulted due to crystallographic fracture along intense slip bands. (J.E. Nolan, Westinghouse Hanford Company)**

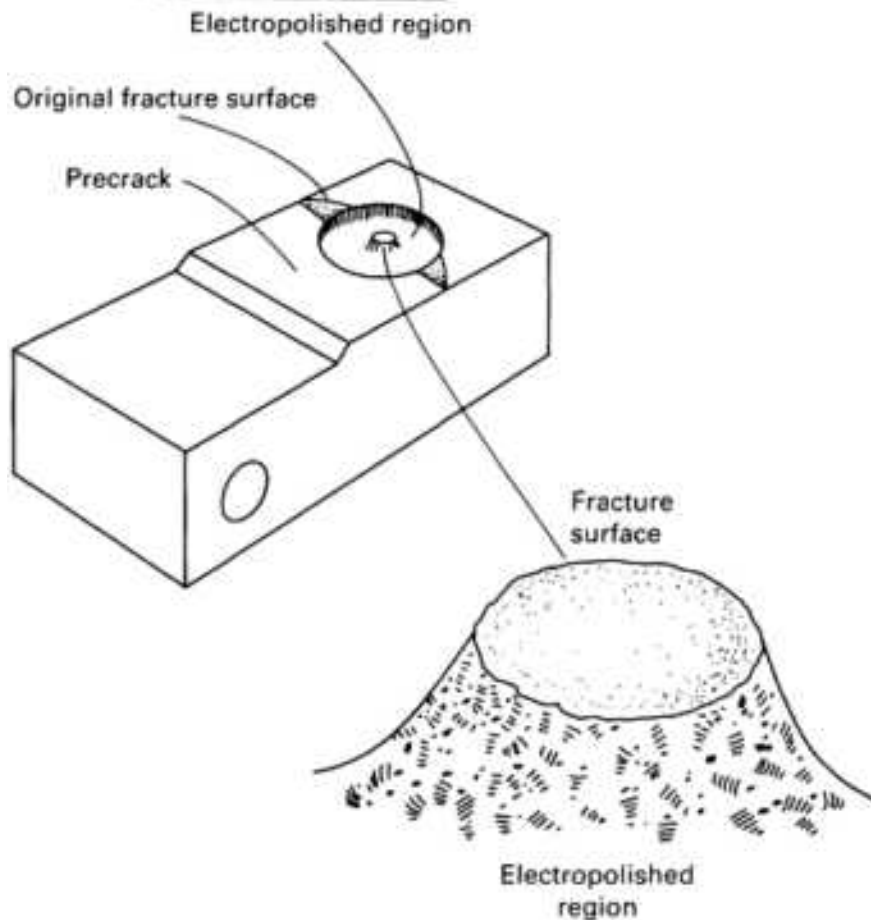
Fig. 847

Simultaneous metallographic-fractographic evaluation of an Inconel alloy 718 (UNS N07718) fracture-toughness test sample via selective-area electropolishing technique. The nickel-base alloy was conventionally heat treated. Fig. 847: Schematic of selective-area electropolishing. Use of method enables simultaneous study of both the fracture surface topography and the underlying microstructure. Fig. 848: Metallographic-fractographic profile (fracture surface at bottom left). SEM, 460×. Fig. 849: Higher-magnification view of field in Fig. 848. These profiles reveal a duplex microvoid coalescence morphology. Growth of the large primary microvoids, which nucleated at ruptured (Ni,Ti)C inclusions, was preempted as many smaller microvoids nucleated at δ-phase precipitates. SEM, 950× (J.E. Nolan, Westinghouse Hanford Company)

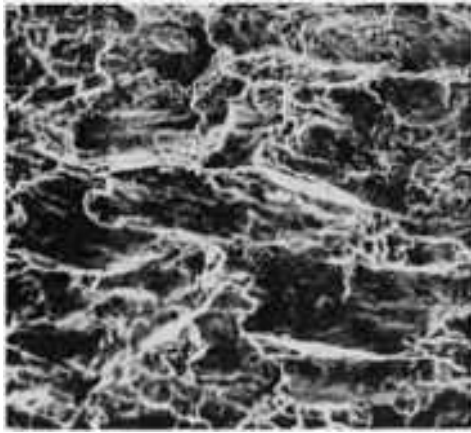
Fig. 850

Creep fracture in Inconel alloy MA754, a mechanically alloyed nickel-base superalloy stabilized by yttria. Fig. 850: Fracture surface of longitudinal creep specimen tested at 760 °C (1400 °F) and 207 MPa (30 ksi) for 84 h. Fracture was intergranular. Note delamination along longitudinal and transverse grain boundaries. SEM, 190×. Fig. 851: Fracture surface of long-transverse creep specimen tested at 980 °C (1800 °F) and 48 MPa (7 ksi) for 54 h. Fracture occurred along longitudinal grain boundaries (perpendicular to the applied stress). SEM, 50× (J.K. Tien, T.E. Howson, and J.E. Stulga, Columbia University)

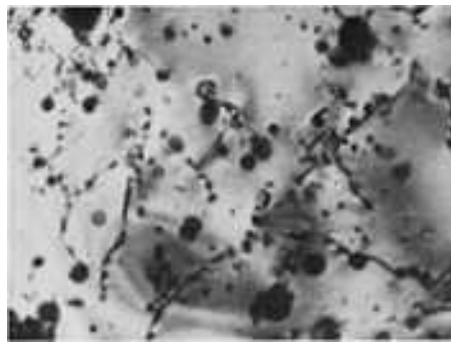
Fig. 852 "Departure side pinning" during creep of Inconel alloy MA754. The mechanically alloyed nickel-base superalloy is stabilized by yttria (0.8%  $Y_2O_3$ ). Samples were tested in creep to 2% strain at 760 °C (1400 °F) and 221 MPa (32 ksi) and then cooled on load. TEM examination revealed that dislocations were still associated with  $Y_2O_3$  particles--the departure side pinning phenomenon. Etched in 60% ethanol, 30% *n*-butanol, 10% perchloric acid (70%). TEM thin foil, 76,800× (J.K. Tien, V.C. Nardonne, and D. Matejczyk, Columbia University).

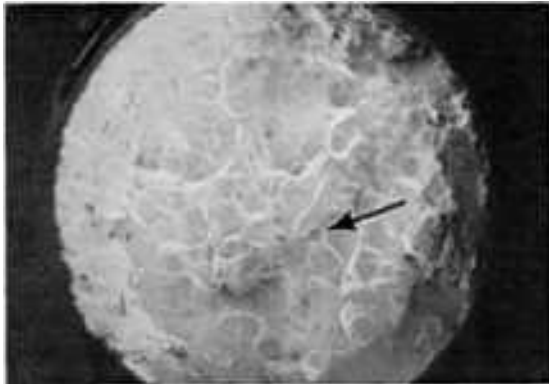
Effect of thermal cycling on fatigue fracture of single-crystal PWA 1480 with NiCoCrAlY applied by the low-pressure plasma spray process. Fig. 857: Fracture surface of coated sample tested at 1050 °C (1920 °F) in isothermal low-cycle fatigue. The NiCoCrAlY coating was very ductile at the test temperature and did not crack. The well-protected superalloy failed via multiple internal cracking originating at microporosity (arrow). SEM, 12.5 $\times$ . Fig. 858: High-magnification view of micropore at arrow in Fig. 857. SEM, 280 $\times$ . Fig. 859: Fracture surface of coated sample cycled between 650 and 1050 °C (1200 and 1920 °F) in a thermomechanical fatigue test. The NiCoCrAlY coating was placed in tension during the low-temperature portion of the test, which caused it to crack in a few cycles. The nickel-base superalloy--now exposed to the atmosphere--failed at multiple surface locations (arrow) rather than at internal micropores (as in Fig. 857 and 858). SEM, 21 $\times$ . Fig. 860: High-magnification view of fracture origin at arrow in Fig. 859. SEM, 260 $\times$  (R.V. Miner and S.L. Draper, NASA Lewis Research Center)

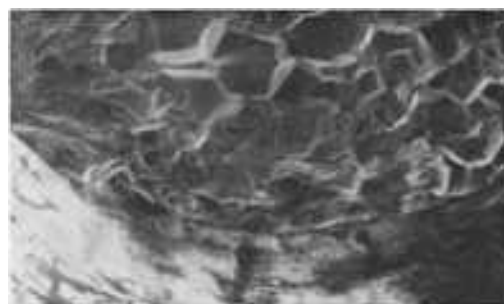
**Fig. 861** Fatigue fracture of the nickel-base superalloy Udimet 720 tested in a salt environment at 705 °C (1300 °F). Fatigue conditions: 690 MPa (100 ksi) ± 207 MPa (30 ksi) 10,500 cycles to failure. Salt coating: 40% MgSO<sub>4</sub>, 59% Na<sub>2</sub>SO<sub>4</sub>, 1% NaCl. Sample heat treatment: 4 h at 1170 °C (2140 °F), air cool; 4 h at 1080 °C (1975 °F), air cool; 12 h at 845 °C (1550 °F), air cool; 16 h at 760 °C (1400 °F), air cool. Fracture surface shows dual, transgranular fatigue origins. Initiation attributed to salt corrosion of grain boundaries located at surface and perpendicular to stress axis. Note salt coating on sample surface. SEM, 30× (E.A. Schwarzkopf, J. Stefani, and J.K. Tien, Columbia University)

**Fig. 862** Fatigue fracture of Udimet 720 tested in air at 705 °C (1300 °F). Heat treatment and other test conditions same as in Fig. 861. Cycles to failure: 338,000, compared with 10,500 for the sample tested in a salt environment (Fig. 861). Fracture surface shows a transgranular "thumbprint," with river patterns pinpointing initiation sites. The major origin is where a grain boundary intersects the sample surface. SEM, 25× (E.A. Schwarzkopf, J. Stefani, and J.K. Tien, Columbia University)

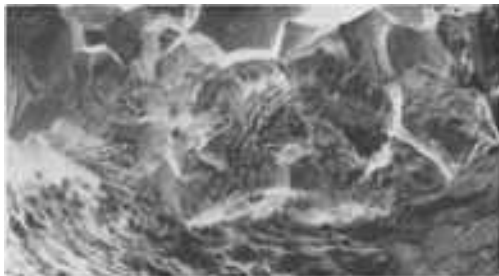
**Fig. 863**

**Fatigue fracture of Udimet 720 tested in a salt environment at 705 °C (1300 °F).** Sample heat treatment and salt composition same as in Fig. 861. Test conditions: 827 MPa ± 69 MPa (120 ksi ± 10 ksi), 5000 cycles to failure. **Fig. 863:** Fracture surface shows intergranular origin at grain-boundary triple point (near bottom) with subsequent transgranular propagation. Because origin is near the surface, corrosion may have had an effect on fracture initiation. River patterns in transgranular portion of fracture reveal crack path. SEM, 23×. **Fig. 864:** Higher-magnification view of fatigue fracture origin in Fig. 863. SEM, 82× (E.A. Schwarzkopf, J. Stefani, and J.K. Tien, Columbia University)

conditions same as in Fig. 863 and 864. Cycles to failure: 66,000, compared with 5000 for the sample tested in a salt environment (Fig. 863 and 864). Fracture surface shows multiple transgranular fatigue origins near edge of sample. River patterns reveal initiation sites at specimen surface and grain boundaries perpendicular to the stress axis. SEM, 40× (E.A. Schwarzkopf, J. Stefani, and J.K. Tien, Columbia University)

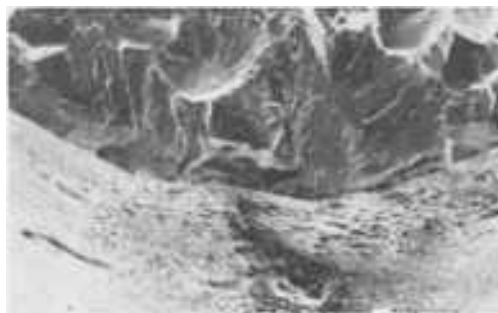
**Fig. 865** Fatigue fracture of Udimet 720 tested in air at 705 °C (1300 °F). Heat treatment and other test

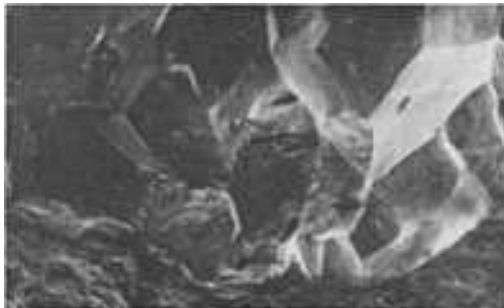
**Fig. 866** Creep fracture of Udimet 720 tested in a salt environment at 705 °C (1300 °F). Sample heat treatment and salt composition same as in Fig. 861. Test stress: 896 MPa (130 ksi). Fractograph shows salt-coated sample surface and intergranular stress-rupture surface. Note salt corrosion of grain boundaries that intersect the sample surface. SEM, 40× (E.A. Schwarzkopf, J. Stefani, and J.K. Tien, Columbia University)
