ASM HANDBOOK®

VOLUME  
12

Fractography

*Fractography*, was published in 1987 as Volume 12 of the *ASM Handbook*. The Volume was prepared under the direction of the ASM Handbook Committee.

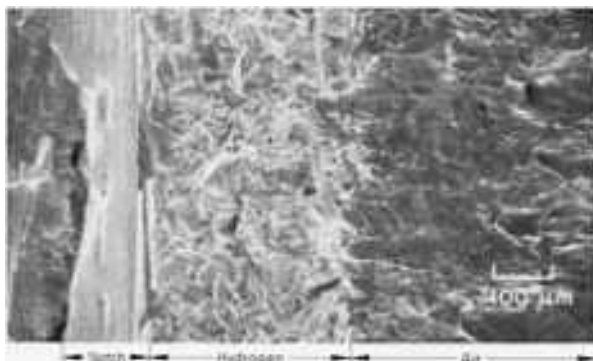
**Fig. 867** Surface of a fracture in a bend-test specimen of Nickel 201 containing 0.02% C, 0.35% Mn, 0.01% S, 0.35% Si, 0.25% Cu, 0.04% Fe, remainder Ni. After the material had been annealed, a specimen 19 mm ( $\frac{3}{4}$  in.) wide by 3.17 mm (0.13 in.) thick was prepared, a notch was machined in the side of the specimen, and a fatigue crack was produced in the root of the notch. The specimen was then loaded in three-point bending (77-mm, or 3-in., support span) to give a fixed displacement rate of 0.0015 μm/s. The test was performed at room temperature in a stainless steel chamber equipped for testing in vacuum, in hydrogen, or in air. During the first portion of the test, the chamber was filled with hydrogen, partway through the test, the hydrogen was replaced with air. In this view, the notch at the left, and just to the right of the root of the notch is a very shallow fatigue crack. The central region (light) is the portion of the fracture that was obtained in hydrogen, and the darker region of the right is the portion that was subsequently produced in air. See Fig. 868, 869, 870, and 871 for higher-magnification views of the portions produced in hydrogen and in air, and of the transition between them. SEM, 100×

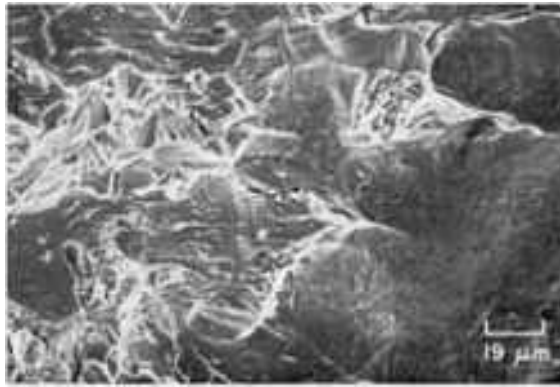
**Fig. 868** View of an area of the fracture surface in Fig. 867 that shows the transition from fracture in hydrogen (left) to subsequent fracture in air (right). Much of the fracture in hydrogen shows transgranular cleavage. In the portion produced in air, flow occurred after the crack front has passed. SEM, 540×

**Fig. 870** View of the fracture surface in Fig. 867, showing a region from the portion of the fracture that was produced in hydrogen. As in the left portion of Fig. 868, the fracture here is mainly by transgranular cleavage. Scattered regions of intergranular were reported, but are not visible here. See also Fig. 871. SEM, 500×

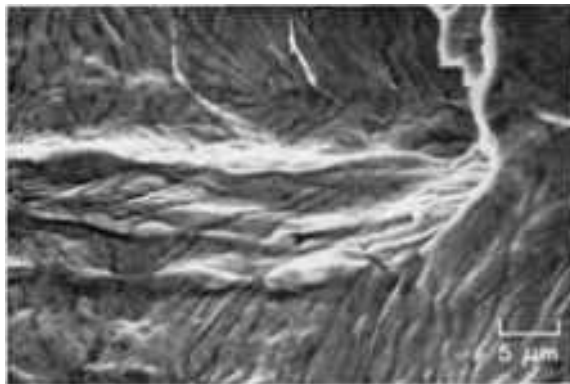
**Fig. 869** View of the fracture surface in Fig. 867, showing a region from the portion of the fracture that was produced in air. Visible are suggestions of dimples, but these features have been largely obscured by the effects of the secondary flow that occurred in this very ductile metal following passage of the crack front. SEM, 2000×

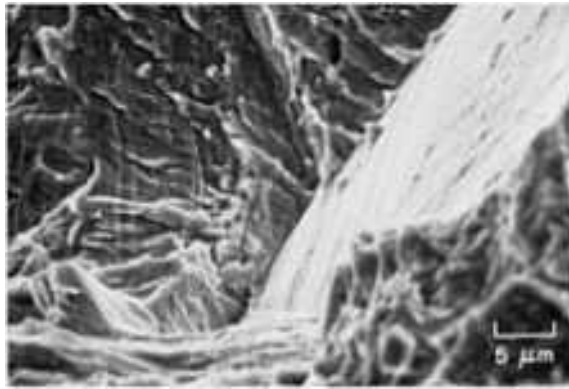
**Fig. 871** Higher-magnification view of the area in the rectangle in Fig. 870, showing the ledgelike character of the cleavage facets. In contrast, a suggestion of dimpled rupture is visible a bottom right. Note the small tongues on the bright facet at right. SEM, 2000×

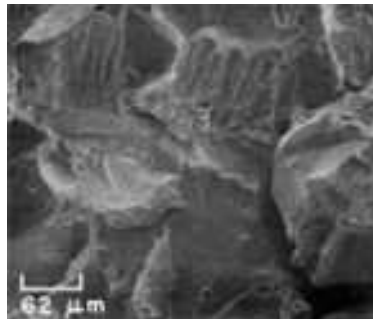
**Fig. 872** Fracture surface of a specimen of Duranickel, vacuum solution treated and quenched, aged 1 h at 500 °C (930 °F) and cooled in air. The specimen, which was notched, precracked, and slow-bend fracture-toughness tested in hydrogen, broke by combined cleavage and intergranular fracture. See also Fig. 873. SEM, 160×

**Fig. 873** A portion of the same fracture surface as that in Fig. 872, but at higher magnification, showing facets that contain cleavage river patterns (bottom right) and pyramid-shaped tongues (top left). SEM, 1000×

**Fig. 874** Fracture in Duranickel that, except for being aged 4 h, was heat treated and tested same as Fig. 872. Fracture here is more completely intergranular, with less cleavage, than Fig. 872. Both fractures show secondary cracks. See also Fig. 875. SEM, 95×

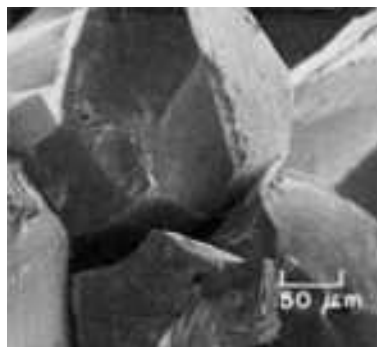
**Fig. 875** A view at higher magnification of the fracture in Fig. 874, showing it to be also a nearly wholly intergranular fracture, with deep secondary cracks at the grain boundaries. SEM, 200×

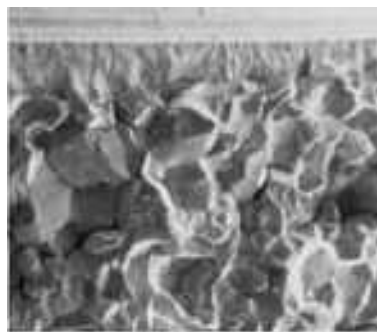
**Fig. 876** Fracture in Duranickel that, except for being aged 8 h, was heat treated and tested same as Fig. 872 and 874. Notch and fatigue precrack are at top. An example of sustained-load intergranular fracture in hydrogen. See also Fig. 877, 878, and 879. SEM, 20×

**Fig. 877** A similar but larger view of the fracture in Fig. 876, showing notch at top but no fatigue crack. Fine grains at notch were presumably cold worked in machining and recrystallized in aging. SEM, 80×

**Fig. 878** Same fracture as that shown in Fig. 876 and 877, but an interior area. One or two cleavage facets are seen. Most of the fracture is intergranular, with large secondary cracks. SEM, 95×

**Fig. 879** A highly magnified view of the fracture in Fig. 876, 877, and 878. Striations visible here show crack advances under constant bending deflection in hydrogen; compare with the fatigue striations in Fig. 880. SEM, 2000×

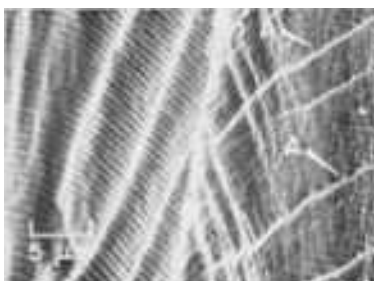
**Fig. 880** High-magnification view of the fatigue precrack produced in air at base of notch in specimen in Fig.

876. Compare fatigue striations here with crack-advance features in Fig. 779. White marks at A's here are fissures. SEM, 2000×

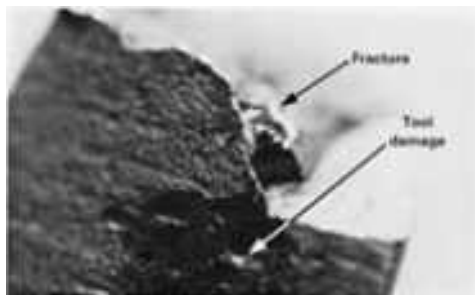
Fig. 881

Fatigue fracture of a cast Vitallium (Co-30Cr-7Mo) surgical implant (side plate of Jewett nail) due to improper insertion. A tool used by the surgeon to contour the plate prior to its insertion into the patient also accidentally damaged the surface of the implant, introducing microcracks that led to fracture. Fig. 881: Tool damage on surface of implant near fracture surface. 3×. Fig. 882: The Jewett nail broke across a screw hole. Radial marks on the fracture surface (shown here) reveal the fatigue crack origin near the top of the hole. 10× (C.R. Brooks and A. Choudhury, University of Tennessee)

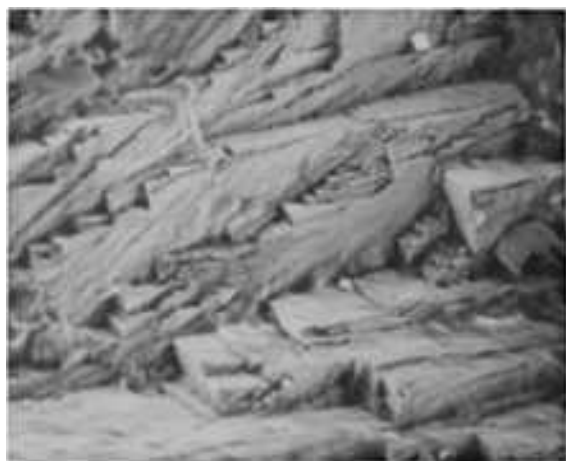
Fig. 883

Fatigue fracture of cast ASTM F75 alloy (Co-28Cr-6Mo). Material was solution treated prior to testing on a cantilever-beam machine. Fig. 883: "Stair step" fracture surface indicative of stage I fatigue. SEM, 515×. Fig. 884: Photomicrograph reveals stage I fatigue cracking. FeCl<sub>3</sub> electrolytic etch, 200× (R. Abrams, Howmedica, Division of Pfizer Hospital Products Group, Inc.)

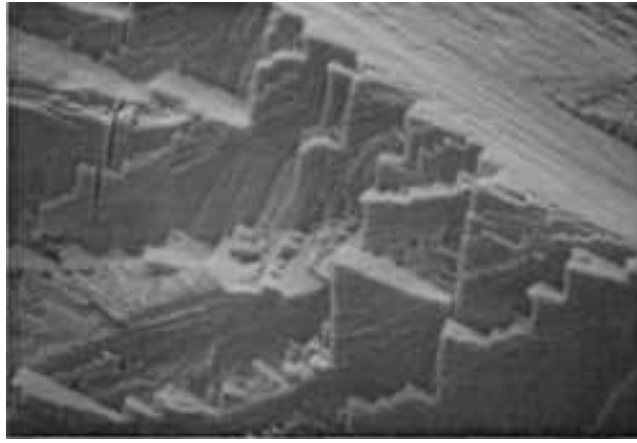
**Fig. 885 Fatigue fracture of cast ASTM F75 alloy (Co-28Cr-6Mo). Material was hot isostatically pressed and solution treated prior to constant force amplitude, flexural fatigue testing. Fractograph shows region of stage I fatigue, characterized by a slip/cross-slip "stair step" morphology. Additional information on cobalt-base alloys used for surgical implants and their corresponding fracture morphologies can be found in the article "Failure Analysis of Metallic Orthopedic Implants" in Volume 11 of *ASM Handbook*, formerly 9th Edition *Metals Handbook*. SEM, 532 $\times$  (R. Abrams, Howmedica, Division of Pfizer Hospital Products Group, Inc.)**

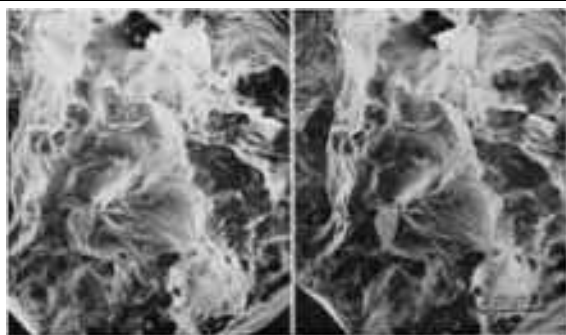
Fig. 886 Fracture at 425 °C (797 °F), 20 MPa (3 ksi). 11.5×

These stereo pairs of SEM fractographs, as well as those in Figures 892, 893, 894, 895, 896, and 897, are of fracture surfaces produced in specimens of high-purity copper (99.999% Cu) by creep testing to rupture at temperatures ranging from 425 to 642 °C (797 to 1188 °F) and at tensile stress ranging from 7 to 20 MPa (1 to 3 ksi). The material was continuously cast into 19-mm ( $\frac{3}{4}$ -in.) diam rod, swaged down to 14-mm (0.55-in.) diam, then machined into buttonhead specimens with gage sections 38 mm ( $1\frac{1}{2}$  in.) long and 6.4 mm ( $\frac{1}{4}$  in.) in diameter. Before being tested, each specimens was heat treated in the creep-test furnace, first for 1 h at 400 °C (750 °F) in hydrogen and then for 16 h at 800 °C (1470 °F) in purified helium. The testing also was done in purified helium. At low temperature or low stress, or both, the main mechanism of fracture was intergranular separation with accompanying microvoid coalescence, and the separated-grain facets oriented at high angles relative to the tensile axis. At high temperature or high stress, or both, the fracturing was transgranular and highly plastic. At intermediate combinations of test temperature and stress, the main mechanism of fracture was the same as at low temperature or low

stress (intergranular separation with accompanying microvoid coalescence), but the fracture surface was fairly smooth and had a fine texture. The specimen in Fig. 886, 887, and 888 was tested at 425 °C (797 °F) and 20 MPa (3 ksi) and attained to steady-state strain rate at  $2.0 \times 10^{-6}/\text{min}$ , fracturing in 76 h, 54 min. These views show a fine texture of dimples, which resulted from microvoid coalescence, on fairly smooth separated-grain facets. The area at  $\alpha$  in the center of Fig. 886 is shown at higher magnification in Fig. 887; note the uniform size of the dimples. Figure 888, which is of an area of the fracture different from that in Fig. 886, shows dimples with shapes that vary depending on orientation of the grain facets relative to the tensile axis. The specimen shown in Fig. 889 and 890 was tested at 440 °C (824 °F) and 15.5 MPa (2.25 ksi) and attained a steady-state strain rate of  $7.0 \times 10^{-7}/\text{min}$ , fracturing in 308 h, 30 min. These fractographs show two different areas of the fracture surface. The area shown in Fig. 889 displays separated-grain facets oriented at high angles relative to the tensile axis; the area shown in Fig. 890 (at higher magnification) clearly shows the small dimples on the grain facets.

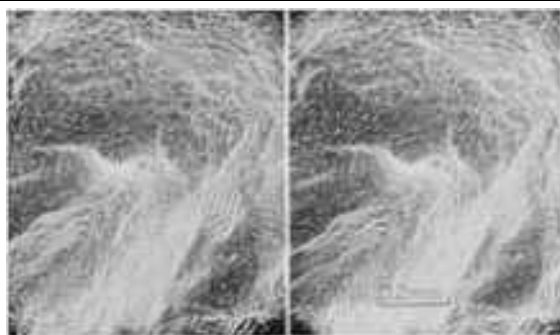
Fig. 887 Area at  $\alpha$  in Fig. 886, at higher magnification. 60×

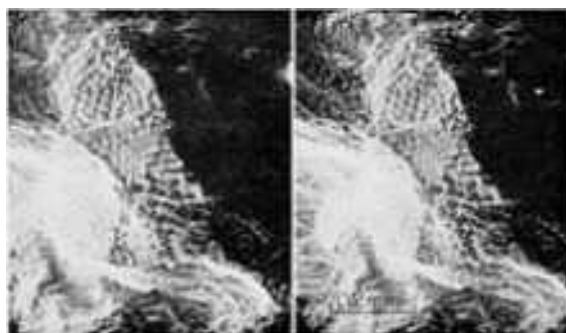
Fig. 888 A different area of the fracture in Fig. 886. 70×

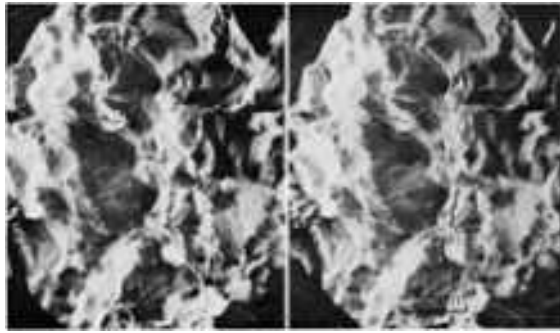
Fig. 889 Fracture at 440 °C (824 °F), 15.5 MPa (2.25 ksi). 11×

The specimen in Fig. 891 was tested at 525 °C (977 °F) and 10.3 MPa (1.5 ksi) and attained a steady-state strain rate  $5.0 \times 10^{-7}/\text{min}$ , fracturing in 300 h, 6 min; its fracture surface has larger and smoother facets than those in Fig. 889 and 890. At top in this view is a region that fractured by transgranular rupture accompanied by plastic flow. The specimen in Fig. 892, 893, and 894 was tested at 540 °C (1004 °F) and

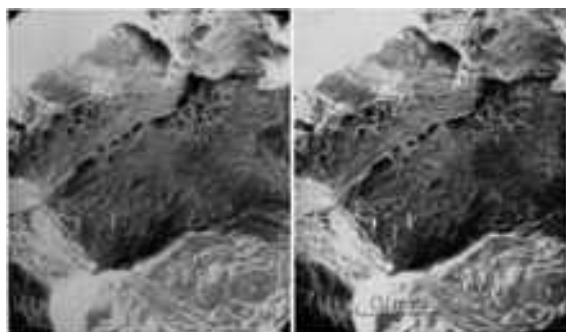
Fig. 890 A different area of the fracture in Fig. 889. 135×

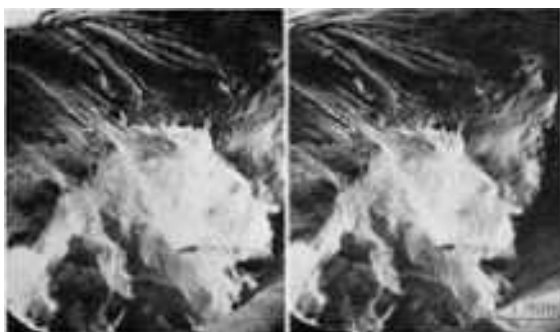
Fig. 891 Fracture at 525 °C (977 °F), 10.3 MPa (1.5 ksi). 12.5×

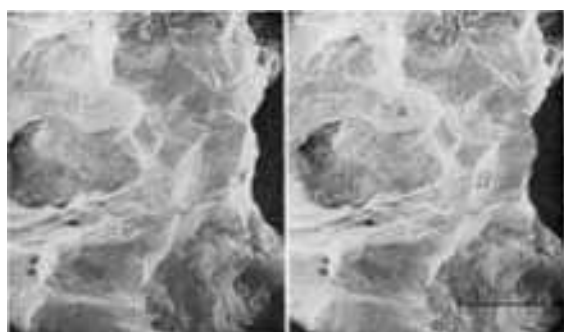
**Fig. 892** Fracture at 540 °C (1004 °F), 10.3 MPa (1.5 ksi). 11.5×

10.3 MPa (1.5 ksi) and attained a steady-state strain rate of  $1.65 \times 10^{-6}$ /min, fracturing in 67 h, 50 min. The fracture surface in Fig. 892 exhibits regions with a fine texture of dimples (such as at  $\alpha$  and  $\beta$ ), separated-grain facets (at top right) somewhat like those in Fig. 889, and highly plastically deformed features near the bottom edge of the large cavity at left center. Figure 893, from near the cavity in Fig. 892, shows different patterns of small dimples (at  $\alpha$  and  $\beta$ ) resulting from microvoid coalescence, and a region of extensive plastic flow (at bottom, adjacent to the large dimple). The dimples indicated by the arrow marked  $\alpha$  are shown at still higher magnification in Fig. 894. The small arrows in Fig. 894 points to thermally etched networks of microstructural boundaries, which intersect the dimple boundaries and indicate that there is no relationship here of the dimple surfaces to crystallographic planes. The specimen in Fig. 895 was tested at 602 °C (1116 °F) and 10.3 MPa (1.5 ksi) and attained a steady-state strain rate of  $4.8 \times 10^{-6}$ /min, fracturing in 40 h, 54 min; its fracture surface shows a region of intergranular fracture (above the center) similar to that in Fig. 889. Like the region at top in Fig. 891, the region in the lower half of Fig. 895 fractured by transgranular rupture accompanied by plastic flow. The fracture surface of the specimen in Fig. 896, which was tested at 642 °C (1188 °F) and 7 MPa (1 ksi) attaining a steady-state strain rate of  $2.0 \times 10^{-6}$ /min and fracturing in 129 h, 24 min, displays one region with a fine texture of dimples (at  $\alpha$ ). Extreme plastic flow, particularly at the grain just to the right of center, is seen in stereo to project out like a knife edge. Figure 897 is a view at higher magnification of the region at  $\alpha$  in Fig. 896, showing patterns of dimples of various sizes.

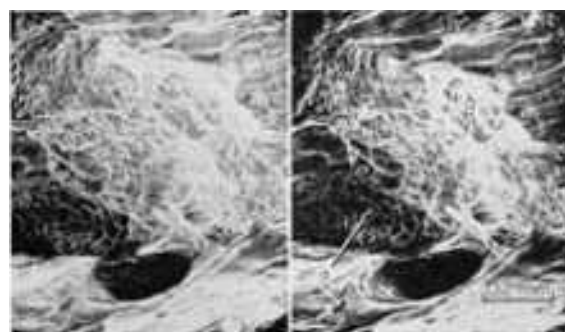
**Fig. 893** Area at bottom of cavity at left center in Fig. 892. 60×

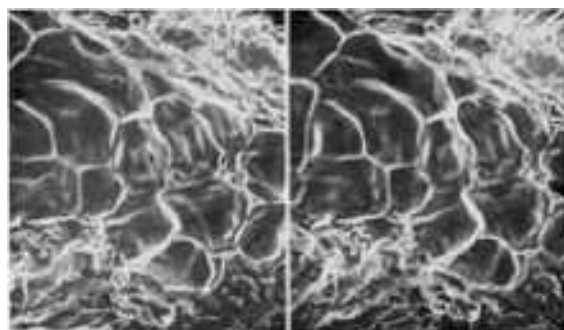
**Fig. 894** Dimples indicated by arrow marked  $\alpha$  in Fig. 893. 280×

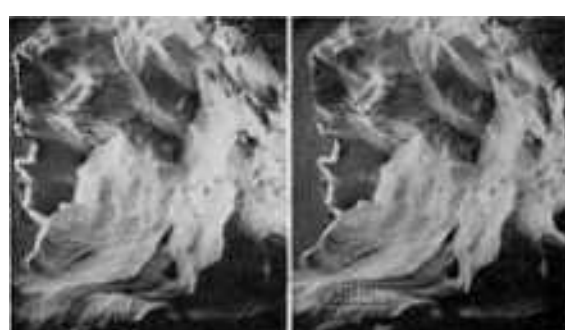
**Fig. 895** Fracture at 602 °C (1116 °F), 10.3 MPa (1.5 ksi). 11.5×

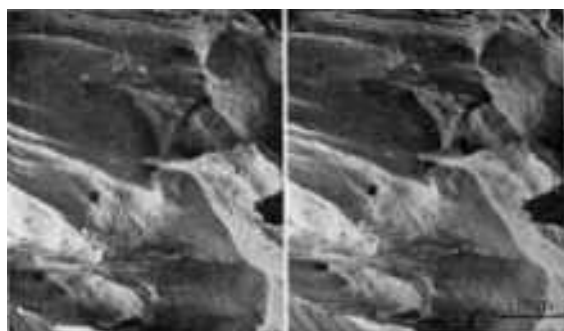
**Fig. 896** Fracture at 642 °C (1188 °F), 7 MPa (1 ksi). 12×

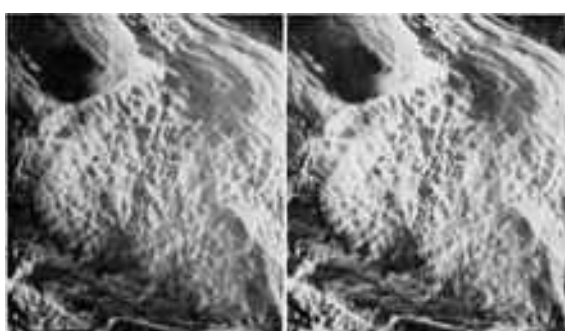
**Fig. 897** Region at  $\alpha$  in Fig. 896, at higher magnification. 60×

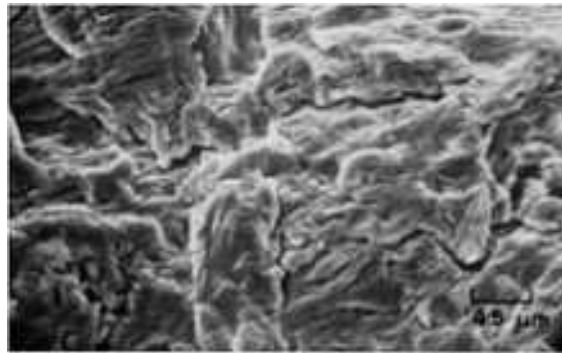
Fig. 898 Surface of a fatigue-test fracture in a notched specimen of OFHC copper that had undergone a 67% reduction in cross-sectional area by cold work before being tested in dry air. Region shown here is 3 mm (0.12 in.) from the notch, where slow crack growth caused irregular striations to form. Note the numerous secondary cracks. See also Fig. 899, 900, 901, and 902. SEM, 2200×

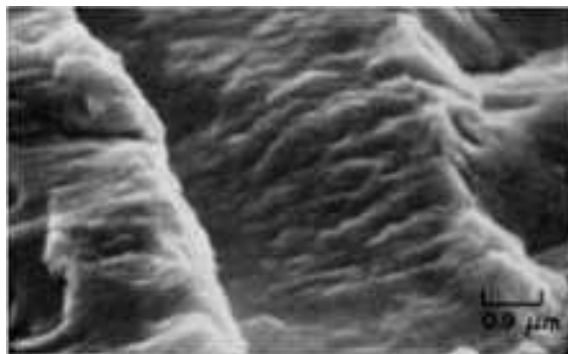
Fig. 899 Another region of the surface of the fatigue-test fracture in OFHC copper shown in Fig. 898, also 3 mm (0.12 in.) from the notch. At this higher magnification, the irregularity of the fatigue striations is clearly visible. There are no intergranular secondary cracks in this region, and there are no fissures between the fatigue striations. SEM, 11,000×

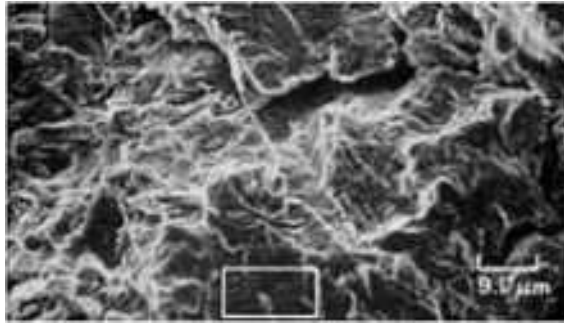
**Fig. 900** A region of the surface of the fatigue-test fracture in OFHC copper shown in fig. 898, 5 mm from the notch, where the rate of crack growth was greater than in the region in Fig. 898. Intergranular secondary cracks are clearly evident. Fatigue striations are not well resolved at this magnification. See Fig. 901 for a higher-magnification view of the area in the rectangle. SEM, 1100×

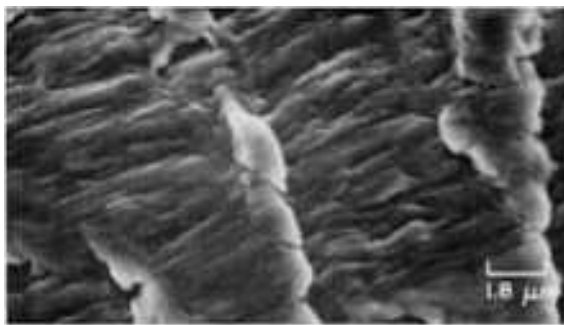
**Fig. 901** Higher-magnification view of the area in the rectangle at the bottom of Fig. 900. Here, many of the fatigue striations have resulted in small fissures, but show the same irregularity displayed in Fig. 899; however, the steps visible here (at center and near right edge) appear to be much smaller than the one in Fig. 899. SEM, 5500×

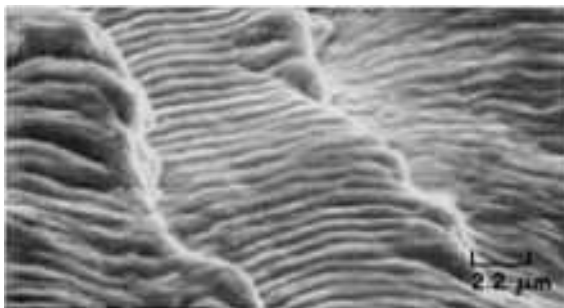
**Fig. 902** Region of the fatigue-fracture surface in Fig. 898, 899, 900, and 901, 20 mm (0.8 in.) from the notch, where the rate of crack growth had increased considerably. The result of this high rate of crack growth is the array of very regular fatigue striations visible here, which are more typical of aluminum than of copper. SEM, 4600×

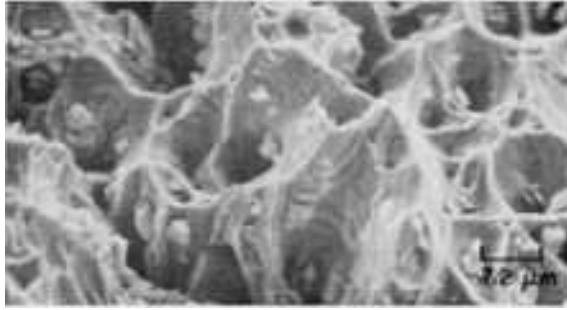
**Fig. 903** The surface of a tensile-overload fracture in a specimen of free-machining copper, showing large dimples. Scattered throughout the structure are particles of  $\text{Cu}_2\text{Te}$ . The tellurium was added to the alloy to improve its machinability (the particles of telluride act as chip breakers). SEM, 1390×

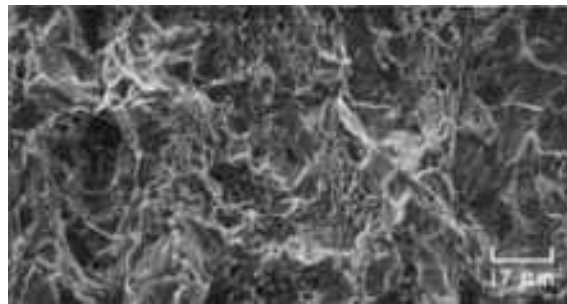
**Fig. 904** Fracture surface of an underaged fracture-toughness test specimen of Cu-2.5Be alloy that had been aged for  $1 \frac{1}{2}$  h at 260 °C (500 °F) prior to being tested in air. Tensile strength was 930 MPa (135 ksi). Fracture was transgranular and produced the wide variety of dimple sizes shown here. There are some large pores, but there is little evidence of secondary cracking. Compare with Fig. 905. SEM, 600×

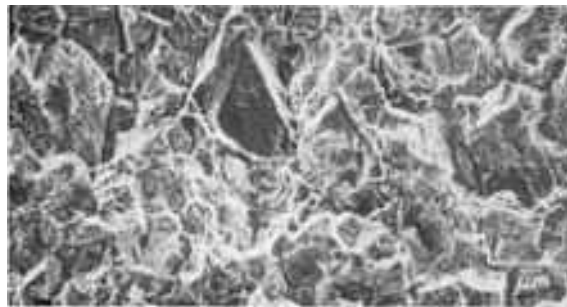
**Fig. 905** Fracture surface of a fully aged fracture-toughness test specimen of Cu-2.5Be similar to that in Fig. 904, but aged 3 h at 315 °C (600 °F) before being tested in air. Tensile strength was 1240 MPa (180 ksi). The dimples on the transgranular facets are much finer than in Fig. 904, and there is a network of secondary cracks that appear to be intergranular. One facet (at top center) appears to have formed by quasi-cleavage. SEM, 600×

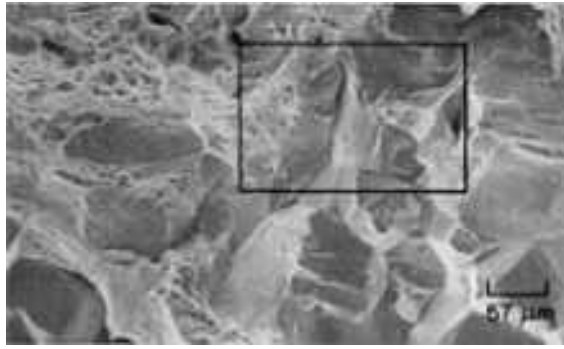
**Fig. 906** Tensile-overload fracture in a fracture-toughness specimen of 64Cu-27Ni-9Fe alloy that underwent spinodal decomposition during heat treatment for 10 h at 775 °C (1425 °F). The surface contains many intergranular facets with intervening regions of dimpled transgranular facets. See Fig. 907 for a higher-magnification view of the area in the rectangle. SEM, 175×

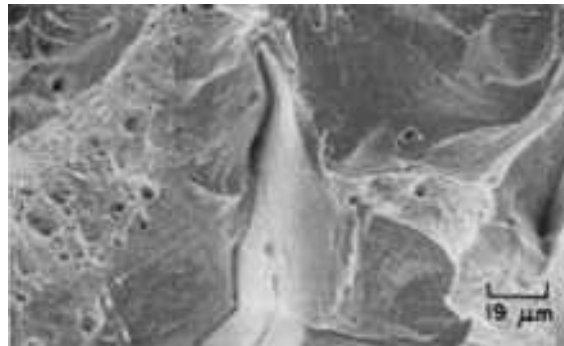
**Fig. 907** Higher-magnification view of the area in the rectangle in Fig. 906, revealing a fine structure of dimples, which resulted from microvoid coalescence, on the separated-grain facets. The regions of intergranular fracture here may have been caused by increased coarsening of the spinodal microstructure at the grain boundaries. SEM, 525×

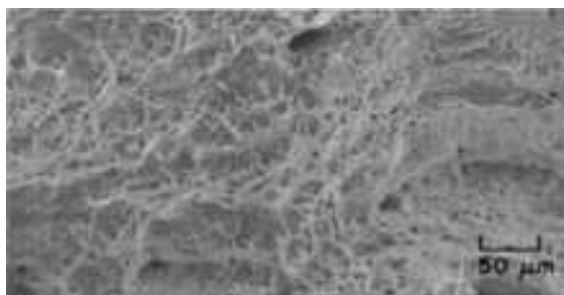
**Fig. 908** Tensile-overload fracture in a fracture-toughness test specimen of the same 64Cu-27Ni-9Fe alloy as in Fig. 906, but here spinodal decomposition occurred during heat treatment at 775 °C (1425 °F) for 100 h. Only dimpled transgranular facets are visible (no intergranular facets); this may be due to a coarser spinodal structure resulting from the longer heat treatment. SEM, 200×

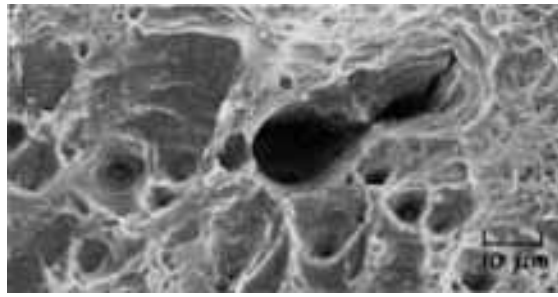
**Fig. 909** Surface of the fracture in a fracture-toughness test specimen of the same 64Cu-27Ni-9Fe alloy as in Fig. 906, 907, and 908, but which was heat treated at 775 °C (1427 °F) for 200 h. Very fine dimples can be seen among the larger ones. The large cavity at the center of this view is believed to have resulted from a localized separation at a grain boundary. SEM, 1000×

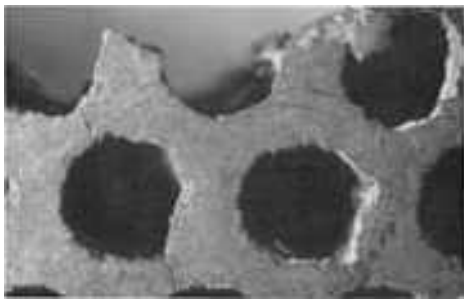
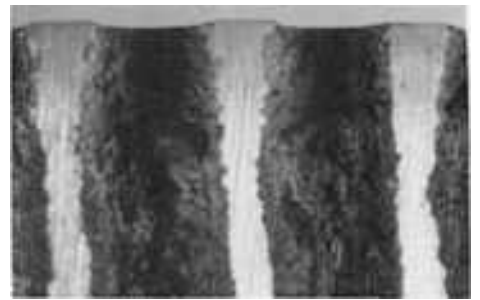
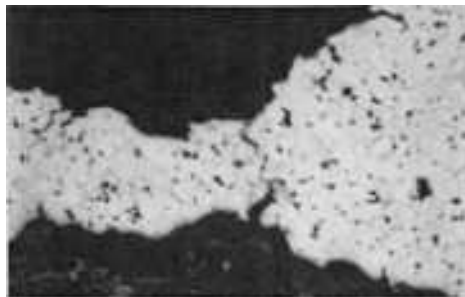
Failure of a paper machine suction couch roll due to corrosion fatigue. The roll shell was made of centrifugally cast bronze (Cu-5Sn-5Pb-4Zn) similar to UNS C83600. Wall thickness at time of failure was approximately 45 mm (1.85 in.). Corrosion of base metal lining the drilled holes in the perforated shell decreased the widths of the ligaments between holes, which effectively increased the stress acting on the remaining ligament widths during normal roll operation. The stress increase combined with the corrosive service environment led to the initiation and propagation of corrosion-fatigue cracks. Fig. 910: Outside diameter of bronze couch roll shell at location of primary crack (top). Note hole broadening due to corrosion and secondary cracking. 3.5×. Fig. 911: Cross section through wall thickness. Note deposit buildups in drilled holes and severe under-deposit corrosion of the bronze ligaments directly below but not at the roll surface (top). 3.5×. Fig. 912: Microstructure of cross section near and parallel to outside-diameter surface of couch roll (drilled holes at top and bottom). Note severe ligament corrosion and intergranular cracking, characteristics of corrosion fatigue in copper-base alloys. Potassium dichromate etch, 24.5× (F.W. Tatar, Factory Mutual Research Corporation)

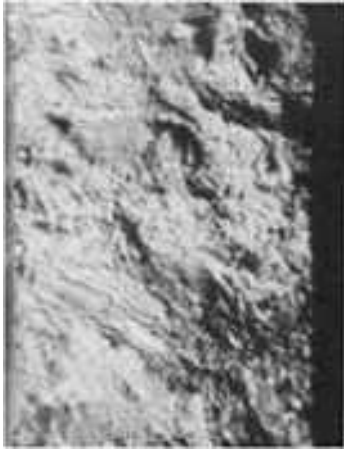
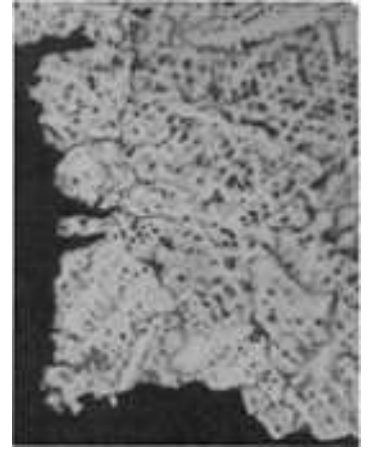
**Failure of a paper machine suction press roll due to stress-corrosion cracking (SCC).** The 90-cm ( $35\frac{5}{8}$ -in.) diam perforated roll was made of a centrifugally cast tin bronze (90Cu-10Sn-1Pb) similar to UNS C90500. A circumferential crack was discovered in the shell and its rubber cover after more than 4 years of operation. The crack extended around 90% of the circumference. Significant pitting corrosion, cracks that initiated at the bottoms of the pits, and the transgranular mode of crack propagation all pointed to SCC as the cause of failure. Corrosion fatigue was ruled out because cracks initiated via this mechanism propagate intergranularly in copper-base alloys (see Fig. 910, 911, 912). Fig. 913: Portion of crack face on a ligament between two drilled holes. Note transgranular fracture mode, 16 $\times$ . Fig. 914: Microstructure of cross section through crack face (bottom) of bronze shell. Note secondary cracking at bottoms of deep pits at drilled hole (left). Cracks are transgranular in the dendritic cast structure of the alloy and have many branches. Potassium dichromate etch, 33 $\times$  (F.W. Tatar, Factory Mutual Research Corporation)

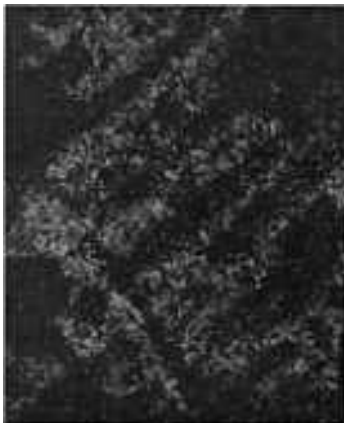
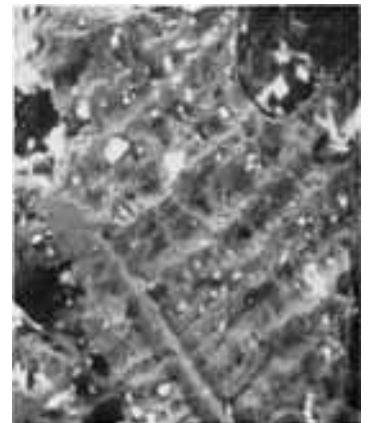
**Fracture of one of 1300 flange bolts that hold together sections of Philadelphia's William Penn statue.** The 25-Mg (27-ton) statue is more than 100 years old and is located atop city hall, 150 m (500 ft) above ground. The bolt was made of a tin bronze (Cu-10Sn) similar to UNS C90500. It measured 19 mm (0.75 in.) in diameter and 75 mm (3 in.) long, and had been used in the as-cast condition. Date of fracture was not known. Initial examination of the fracture surface disclosed features resembling fatigue striations, giving rise to concern about the imminent failure of the remaining bolts. However, an in-depth analysis revealed that the cause of fracture was a coarse, unsound cast structure containing many voids. The "striations" that suggested a fatigue mechanism were actually the result of long-term preferential corrosion by the urban atmosphere of the exposed, heavily cored structure of the fracture face. Fig. 915: Fracture surface of broken bronze bolt. Rippled appearance is not due to fatigue, but is instead the dendritic structure of the bronze as revealed via preferential corrosion (etching) by the atmosphere. SEM, 140 $\times$ . Fig. 916: Tin distribution map of field in Fig. 915 proves that "striations" really reflect the microstructure of the cast metal. 140 $\times$  (J.E. Hanafey, Lawrence Livermore National Laboratory)

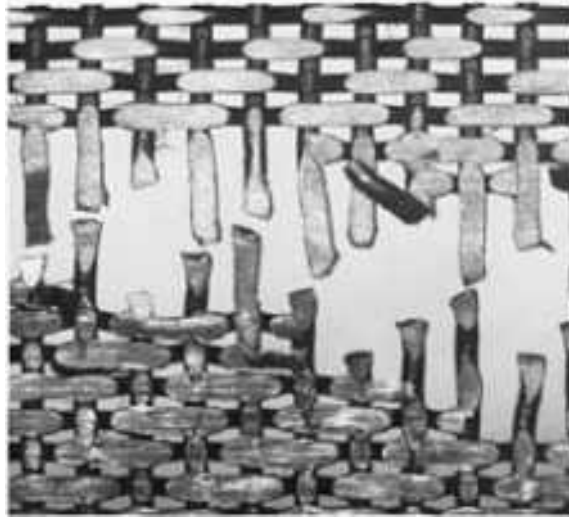
**Fig. 917 View of bottom of a Fourdrinier wire cloth of phosphor bronze C (C52100) that was removed from service after 14 days of operation. Heavy wear had occurred on both warp and shute (weft) wires. The fractures in the wires apparently occurred when the wires had worn almost completely through. The warp wires are shown horizontal in this view. 10×**

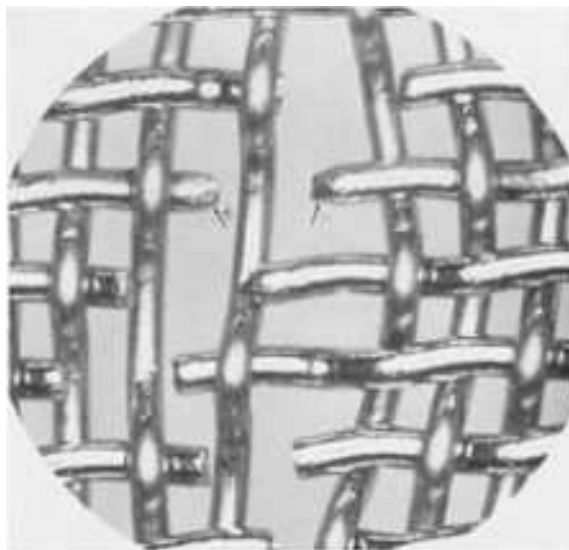
**Fig. 918 Top view of a break in a Fourdrinier wire cloth of phosphor bronze C, showing fractures in shute (weft) wires. All but one of the fractures occurred by fatigue; the exception (at arrows) shows the necked-down profile of a tension fracture, ~50×**

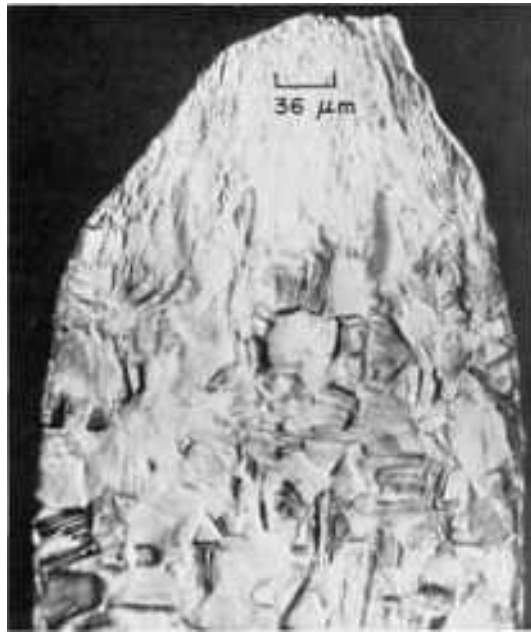
**Fig. 919** Longitudinal section through a tension fracture in a warp wire of a Fourdrinier wire cloth of phosphor bronze C. Slip lines are visible throughout the microstructure. Plastic flow and reduction in area at the fracture (top) were attributed to excessive warp tension,  $\text{FeCl}_3$  etch, 265×

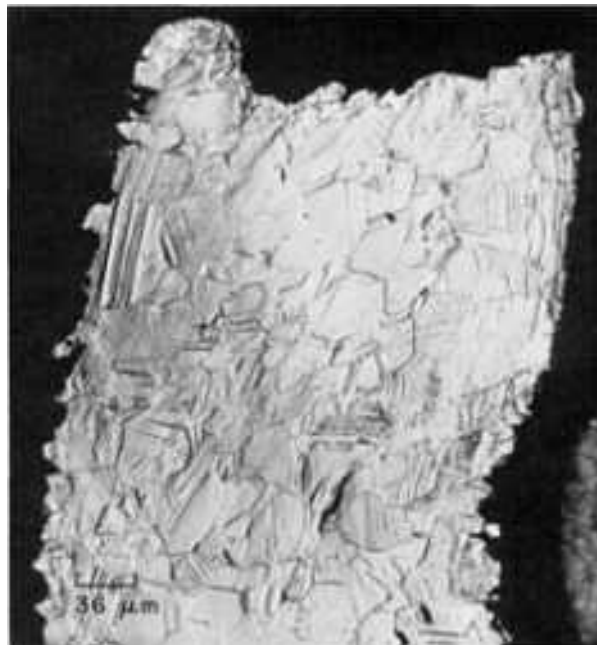
**Fig. 920** Longitudinal section through a fatigue fracture in a shute (weft) wire of Fourdrinier wire cloth of 80Cu-20Zn brass with 0.5% Sn added. The profile of the fracture is shown at top. Note corrosion pitting visible on the wire surface at left and at right,  $\text{FeCl}_3$ . 265×

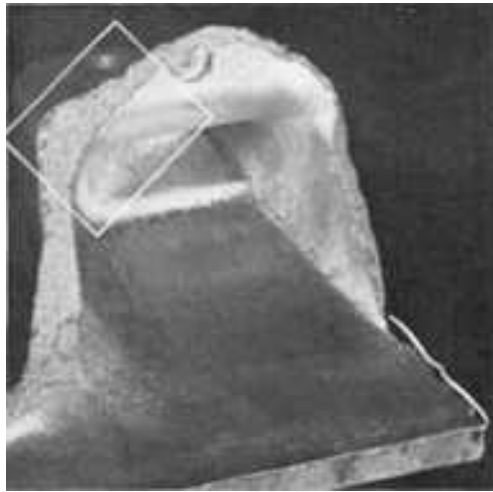
**Fig. 921** A portion of a fractured carrier tray and sand cast of an aluminum alloy intended to be 356.0-T6. Chemical analysis revealed that the copper and zinc contents were of an order of magnitude above the specified limits. The silicon content was approximately as dictated by the specification. The hardness measured 82 HB--appreciably above the 70 HB expected. Tensile strength was 179 to 193 MPa (26 to 28 ksi)--slightly below the specified minimum of 207 MPa (30 ksi). See Fig. 922 for the area in the rectangle and Fig. 923 for bracketed area at a magnification of 3×. Actual size

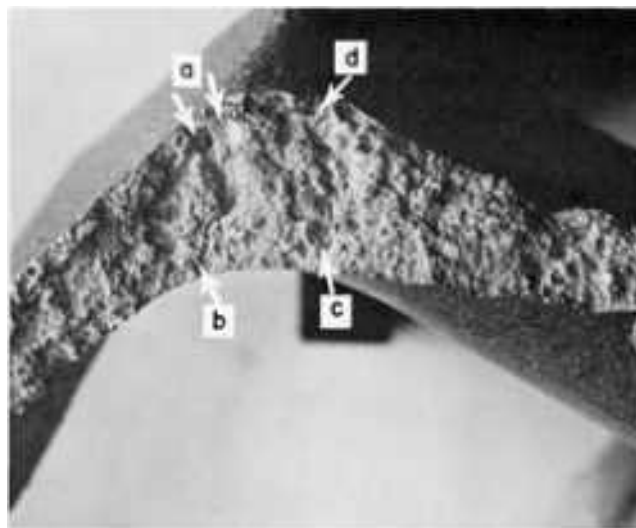
**Fig. 922** Fracture surface of the shoulder of the sand-cast carrier tray shown in the rectangle in Fig. 921. The appearance of this surface suggests that fracture occurred in a brittle manner. The two arrows at "a" indicate two large gas cavities. The arrows at "b," "c," and "d" identify sites that were examined with a scanning electron microscope. (SEM fractographs of these sites are shown in Fig. 924 and Fig. 925.) Note the absence of shear lips on the edges of this fracture surface, indicating a general lack of ductility. 3×

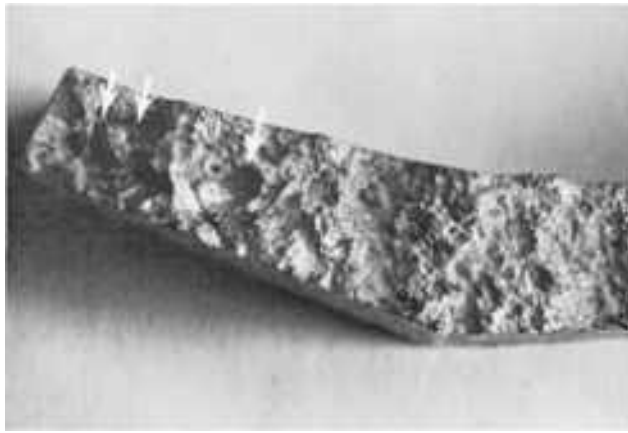
**Fig. 923** This fracture surface is from the bracketed edge of the sand-cast carrier tray in Fig. 921. Like the surface shown in Fig. 922, the one here exhibits the characteristics of brittle fracture, there being no sign of a shear lip at any of these edges. Again, there is evidence of porosity; the arrows point to quite large gas cavities. The cavities could have been caused by a reaction between the liquid metal and organic binders in the sand mold, or could have resulted from entrapped air being carried into the mold by undue turbulence in pouring the casting. 3×

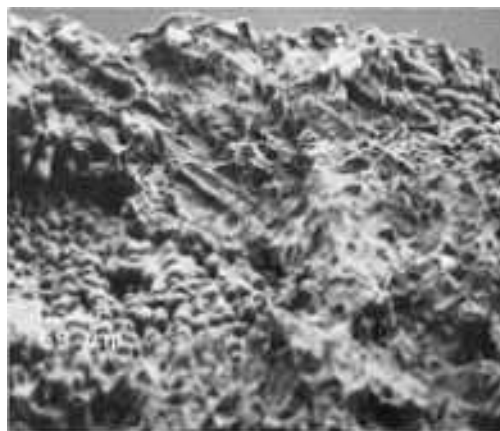
**Fig. 924** Area at the lower edge of the fracture in Fig. 922, as indicated there by arrow at "b". Two regions of shrinkage porosity, at upper right and lower left, contain dendrite lobes, which existed as "free surfaces" within the cavities after the available liquid metal solidified. This behavior can be caused by an excessively high pouring temperature (which exaggerates total contraction in freezing) or by failure to provide proper risers. SEM, 170×

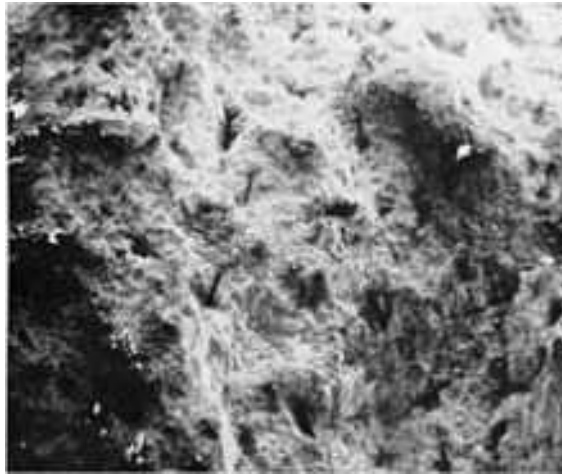
**Fig. 925** Area at arrow "c" near the lower edge of the fracture in Fig. 922. At the low magnification here, it is not possible to identify details of the mechanisms of fracture. However, this view does show many cavities, some of them resembling dark slits, indicating quite generally distributed shrinkage porosity. Smeared region at upper left indicates mechanical damage--probably in handling of the carrier tray after occurred. See also Fig. 926. SEM, 18×

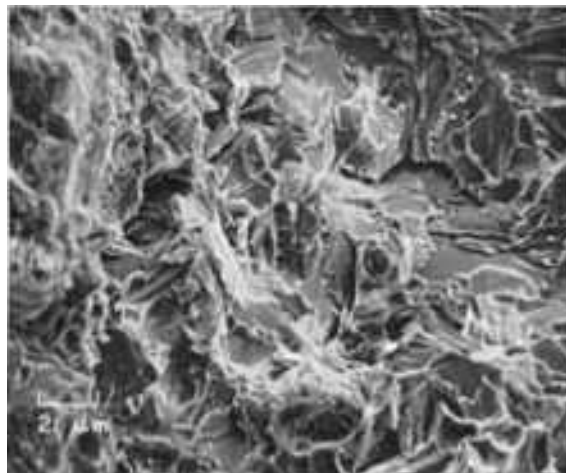
**Fig. 926** A portion of the same fracture area as that in Fig. 925 (area at arrow "c" in Fig. 922), as seen at higher magnification. This view shows a complicated array of facets separated in many instances by indications of isolated dimples. The degree of flow in microvoid coalescence, however, did not contribute materially to ductility, and overall fracture was brittle in nature. This region does not contain any of the shrinkage porosity seen elsewhere in this fracture, but many contain nonmetallic inclusions. SEM, 475×

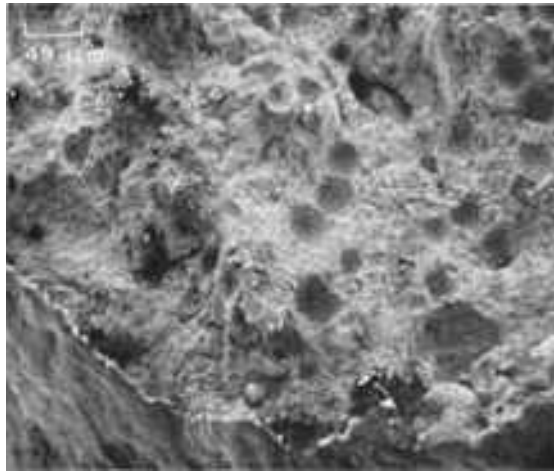
**Fig. 927** This SEM view was taken in the area marked by arrow "d" in the fracture shown in Fig. 922. This area exhibits distribution of very small cavities, believed to be gas pockets, that area of a much different order of magnitude from those indicated by arrows at "a" in Fig. 922. The latter were about 1.5 mm (0.06 in.) in diameter, whereas the cavities here are about 25  $\mu\text{m}$  across. At bottom and left, a small portion of the exterior surface of the casting is visible. See Fig. 928 for a view of this same fracture surface area at higher magnification. 205 $\times$

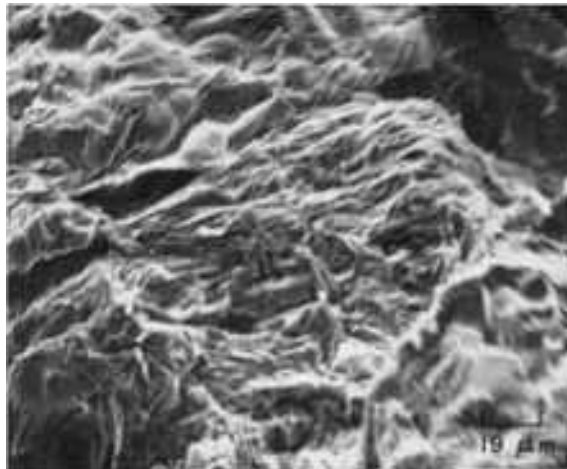
**Fig. 928** Enlarged view of a part of the fracture surface area in Fig. 927. Some features vaguely resemble fatigue striations, but it is doubtful that they were caused by fatigue inasmuch as they do not seem to have been formed in an orderly sequence (and there are no beach marks in Fig. 922 and 923). Instead, the surface is very tumbled, with no suggestion of fatigue patches, and many regions bear whiskerlike features resembling some form of cleavage step. Lacking a significant amount of dimples, this surface can be rated as a brittle fracture. SEM, 520 $\times$

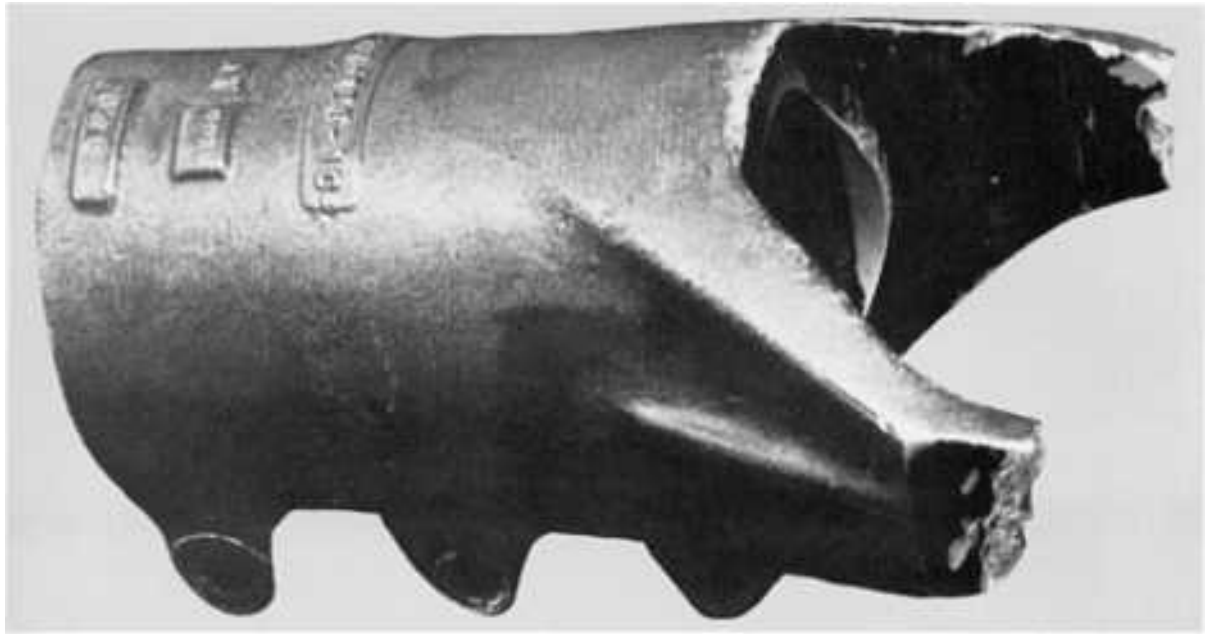
**Fig. 929** A broken extension-housing yoke, part of a helicopter tail-rotor drive assembly, that fractured by fatigue in service. The fracture occurred through the left and right lugs at the points of attachment to the tail boom. The yoke was cast from aluminum alloy 356.0 and heat treated to the T6 temper. Chemical analysis showed that the composition of the yoke conformed to specifications, except for silicon, which was 0.05% below the required minimum. Hardness measurements ranged from 48 to 52 HRB (or about 81 to 85 HB), which was above the required minimum. Details of the fractures are shown in Fig. 930, 931, 932, 933, 934, 935, 936, 937, and 938. Actual size

Both sides of each of the two lugs that were broken from the extension-housing yoke shown in Fig. 929. The inboard sides of the lugs are shown in Fig. 930; the outboard sides, in Fig. 931. Mechanical damage and loss of paint are evident. See also Fig. 932 and 933. Both at 2×

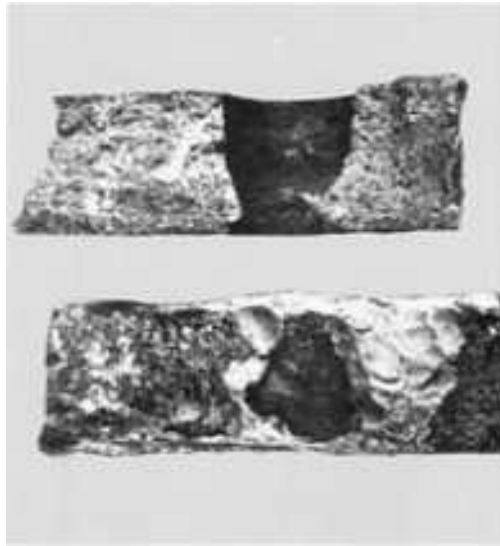
**Fig. 932 Views of (at top) fracture surfaces of the upper lug in Fig. 930 and 931 and (at bottom) the mating surface of the yoke. Yoke surface is greatly deformed by repeated impacts, which occurred after fracture. 3×**

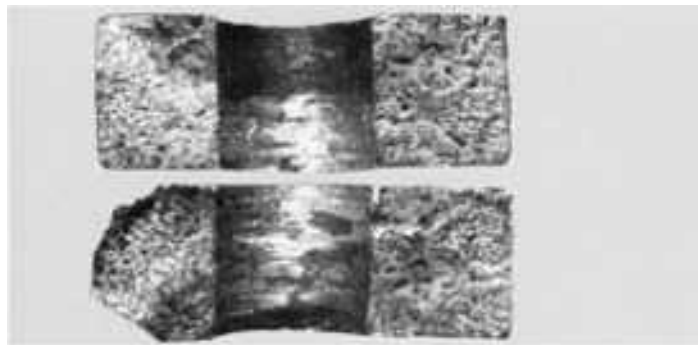
**Fig. 933 Views of (at top) fracture surfaces of the lower lug in Fig. 930 and 931 and of (at bottom) the mating surfaces of the yoke. Note discolored quadrant at top left corner of the bore of the lug (see also Fig. 934) and corresponding area in yoke fracture adjacent to bottom left corner of the bore. Edge of the discoloration is the beach mark of the fatigue crack that was the origin of final fracture. 3×**

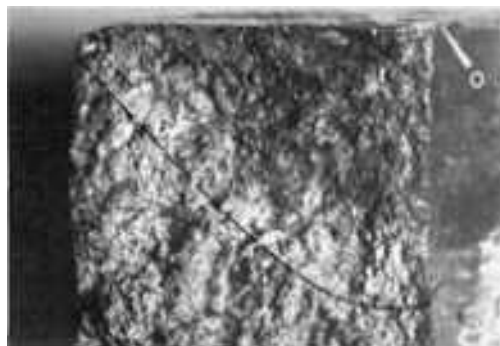
**Fig. 934 Enlarged view of one fracture surface of the lug in Fig. 933, more clearly showing the fatigue-crack region at top left corner of the bore. Crack was nucleated at corner marked by arrow at "O." Fatigue area extended approximately to dashed line. See also Fig. 935 and 936. 8×**

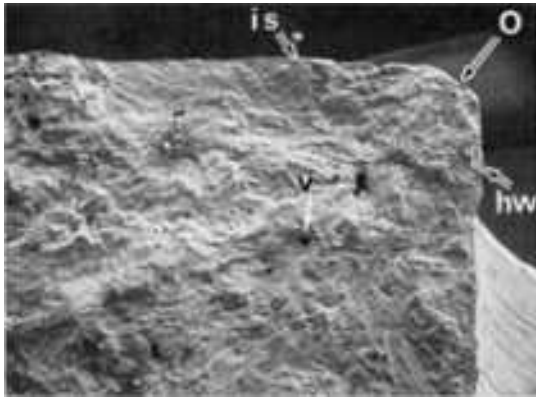
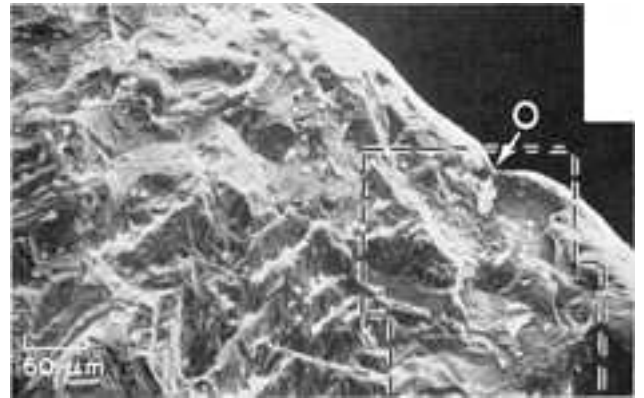
Two SEM views, at higher magnifications, of the fatigue-crack area of the lug fracture surface in Fig. 934. In the upper view (Fig. 935), arrow at "O" denotes the crack nucleus in the chamfer, arrow at "is" points to inboard side, arrow at "hw" indicates hole wall, and arrows at "v" point of voids. The lower view (Fig. 936) shows the area near the origin of the crack in Fig. 935 at higher magnification. In general, the crack propagated radially from point "O." See also Fig. 937. Fig. 935: 20×. Fig. 936: 200×

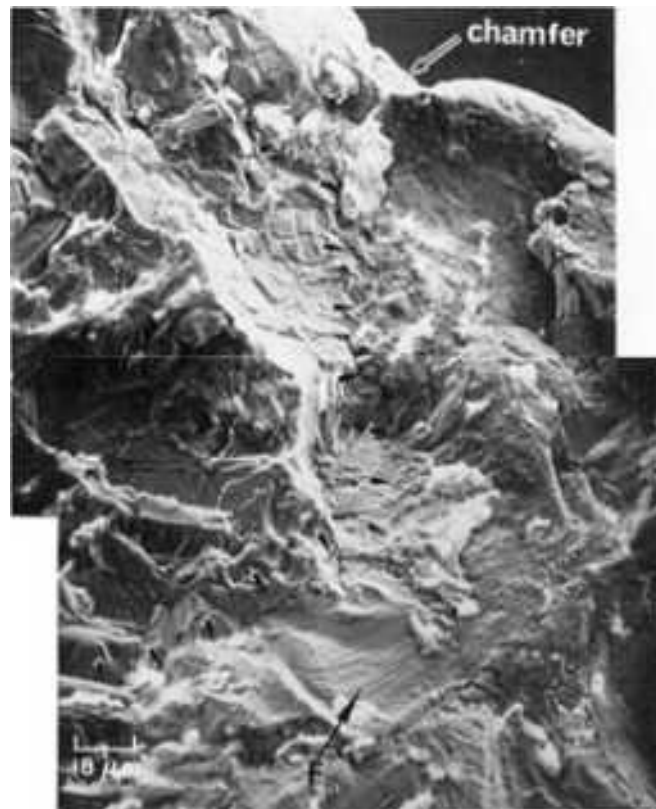
**Fig. 937** This is the area within the dashed lines in Fig. 936, shown at higher magnification. The initial crack opened at the chamfer (upper right corner). The onset of fatigue fracture is indicated by the small arrows running from upper middle to lower left. The arrow at F points to an area of typical fatigue striations. The initial phase of fracture was brittle. SEM, 550×

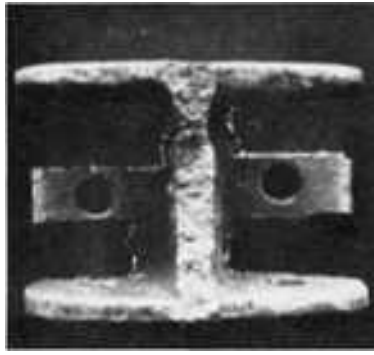
**Fig. 938** Fractured bell-crank fitting of cast aluminum alloy 356.0-T6. The fitting, which was from an aircraft rear horizontal elevator, fractured in a crash. No crack origin was found. See also Fig. 939, 940, 941, 942, 943, 944, 945, 946, 947, 948, 949, 950, 951, and 952. ~1.5×

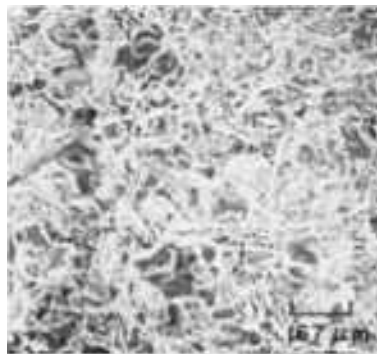
**Fig. 939** A more highly magnified view of the fracture in Fig. 938. The appearance here is typical of the entire fracture surface. There is little evidence of surface flow. See also Fig. 940. SEM, 60×

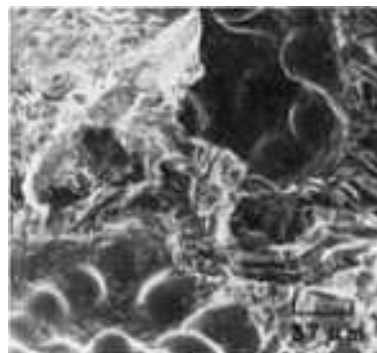
**Fig. 940** Many of the features of the fracture surface in Fig. 939 are associated with shrinkage cavities of the type shown here. The round knobs are exposed secondary arms of dendrites. SEM, 270×

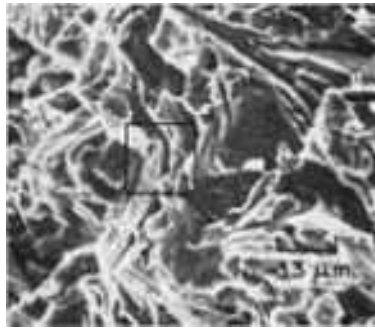
**Fig. 941** A cellular region that was found to be characteristic of the fracture surface in Fig. 938. Although some features faintly suggest dimples, the higher-magnification view in Fig. 942 reveals no dimples. SEM, 300×
