ASM HANDBOOK®

VOLUME  
12

Fractography

*Fractography*, was published in 1987 as Volume 12 of the *ASM Handbook*. The Volume was prepared under the direction of the ASM Handbook Committee.

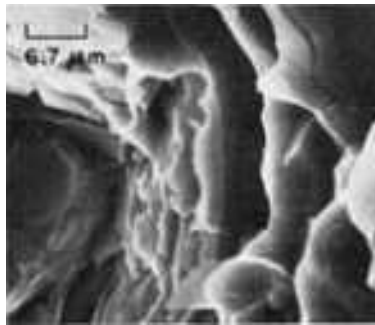
**Fig. 942** Higher-magnification view of the area in the rectangle in Fig. 941. There are no suggestions of dimples visible here, instead, the surface exhibits platelets that have been bent and cracked. SEM, 1500×

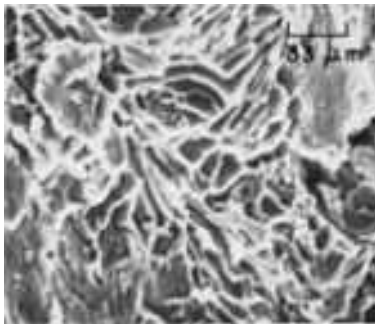
**Fig. 943** View at another location in the fracture surface in Fig. 938. Cellular structure shown here and in Fig. 941 is attributed to the microstructure resulting from the freezing patterns and heat treatment of the casting. SEM, 300×

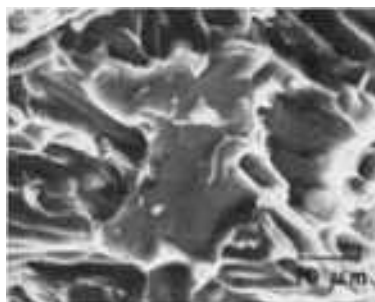
**Fig. 944** Another view of the fracture surface shown in Fig. 938. Again, no evidence of true dimples, but cellular structure only. There are many small inclusions on the surface; most are not bonded to the matrix. SEM, 1000×

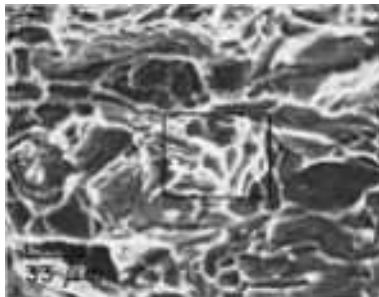
**Fig. 945** An overload fracture in a miniature tensile-test specimen cut from the fitting in Fig. 938, displaying the same type of cellular surface structure produced by the service fracture. See also Fig. 946. SEM, 300×

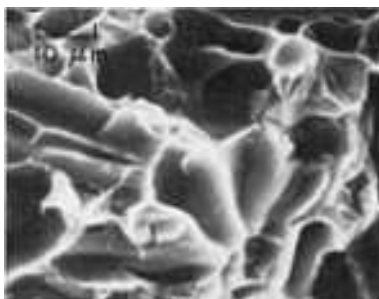
**Fig. 946** Higher-magnification view of the area in the rectangle in Fig. 945. Although the features here strongly resemble those shown in Fig. 942, close scrutiny reveals the presence of tiny dimples in the edges of some cells. SEM, 1000×

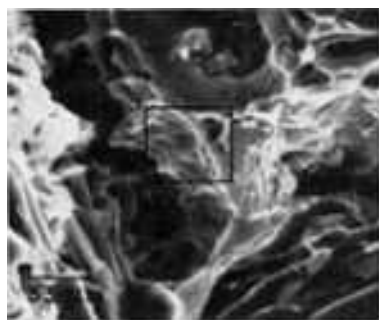
**Fig. 947** View of the fracture surface shown in Fig. 945, but at another location. In this area, there are small, clearly visible dimples clustered in the central, outlined region, which is shown at higher magnification in Fig. 948. SEM, 300×

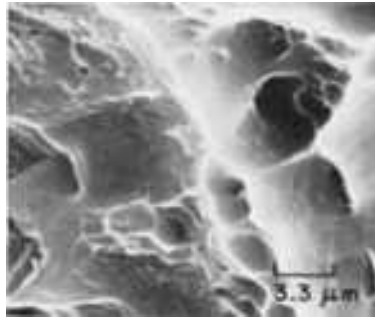
**Fig. 948** Higher-magnification view of the area in the rectangle in Fig. 947, showing small dimples of several sizes and suggesting that the service fracture shown in Fig. 938 (with no dimples) was not the result of simple overload. SEM, 3000×

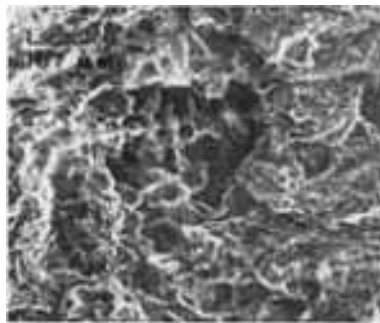
**Fig. 949** Surface of a fracture in a miniature impact-test specimen cut from the broken aluminum alloy 356.0-T6 bell-crank fitting shown in Fig. 938. The appearance here is very similar to that of the service fracture in Fig. 939. SEM, 60×

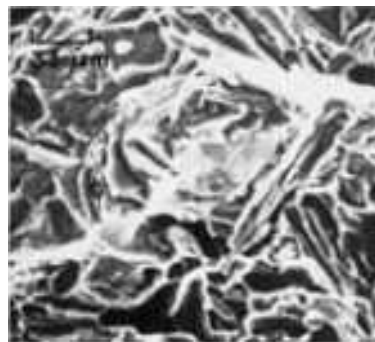
**Fig. 950** View of the fractured test specimen in Fig. 949, but at another location. The appearance here is quite similar to that of the service fracture in Fig. 943. SEM, 300×

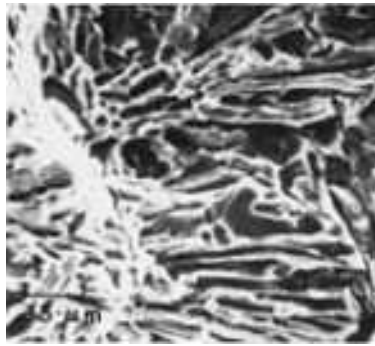
**Fig. 951** Another view of the fracture surface shown in Fig. 949 and 950. Compare with the view of the service fracture in Fig. 941 and note the marked resemblance. SEM, 300×

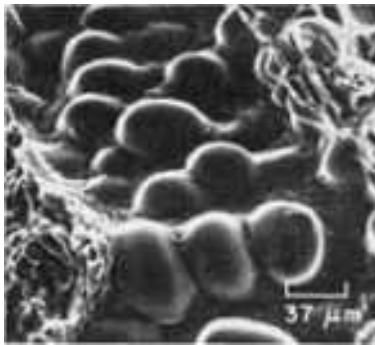
**Fig. 952** View of fracture surface in Fig. 949, 950, and 951, displaying a shrinkage cavity. Cavity is somewhat like those in Fig. 940, but with a much coarser dendrite cell structure. SEM, 270×

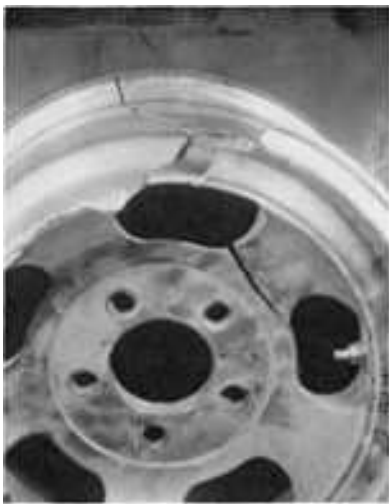
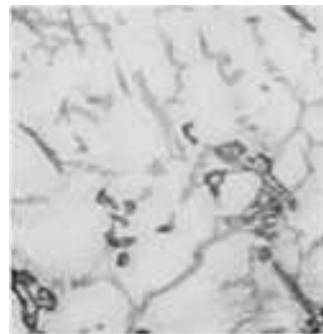
**Brittle fracture of die cast aluminum alloy 380.0 wheel. Failure initiated during normal operation at a cold shut defect in the as-cast part. Fig. 953: Wheel after failure. Distance between fracture surfaces indicates that residual stresses were present. Fig. 954: Portion of fracture surface showing cold shut defect. Fig. 955: Presence of sharp-edged silicon (light gray) in the microstructure of the aluminum alloy is evidence that heat treating to increase toughness and relieve residual stresses was not performed. 0.5% HF etch, 400× (R.W. Bohl, University of Illinois)**

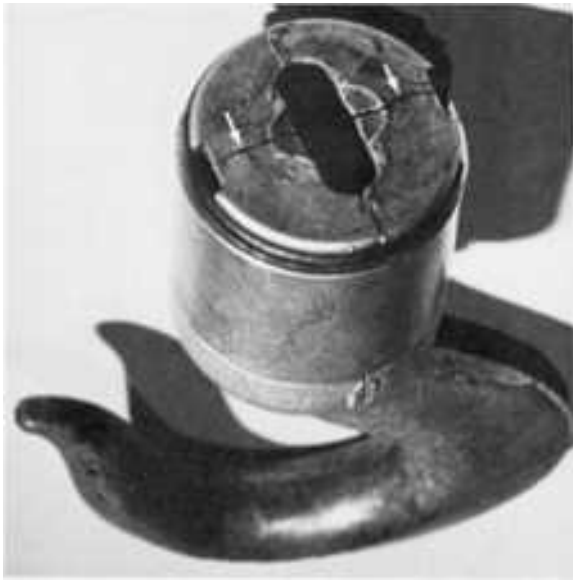
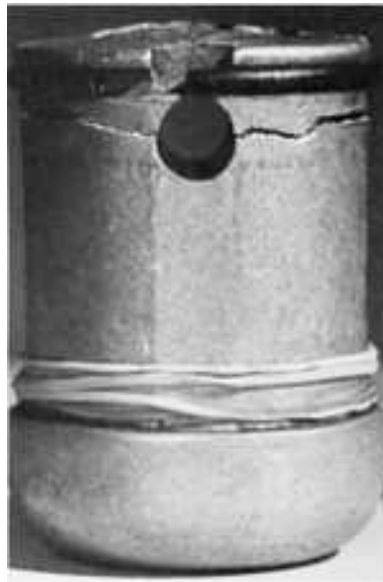
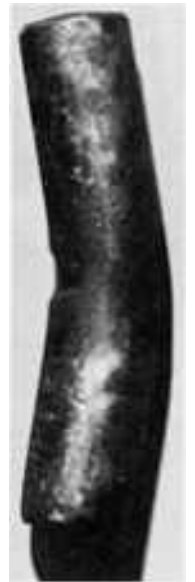
Fractures in a die cast aluminum alloy 518.0 housing of a chain-hoist hook, which is believed to have broken by overload in service. Figure 956 is a view of the reassembled hook components, showing a transverse fracture (arrows) in the top surface of the housing. This fracture, which preceded and instigated final fracture of the housing, was above and parallel to a steel retaining pin (shown in Fig. 958), which secured the hook to the hoist chain. Figure 957 is a side view of the housing, which consisted of two pieces held together by the retaining ring visible at top, showing the final fracture (roughly horizontal), the deformed retaining-pin hole (elongation of about 3% is indicated--a reasonable value for this alloy), and one end of the fracture in the top surface. See also Fig. 959 and 960. Fig. 956:  $\sim 1.1\times$ . Fig. 957:  $1.7\times$ . Fig. 958:  $2.4\times$

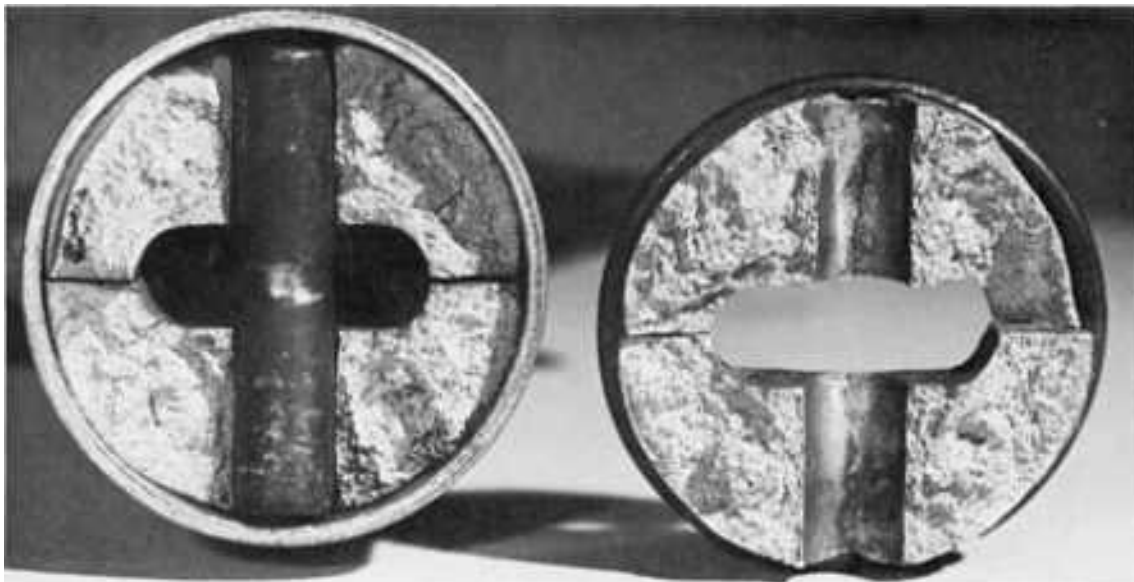
Fig. 959 Mating surfaces of the fracture in the side of the housing in Fig. 957. At right is the upper surface, with the retaining ring (shown at top in Fig. 957) still in place; visible in the bore of the retaining-pin hole is the fracture in the top surface of the housing (see Fig. 956). At left is the lower surface, with the retaining pin in place inside a collar.  $\sim 2.25\times$

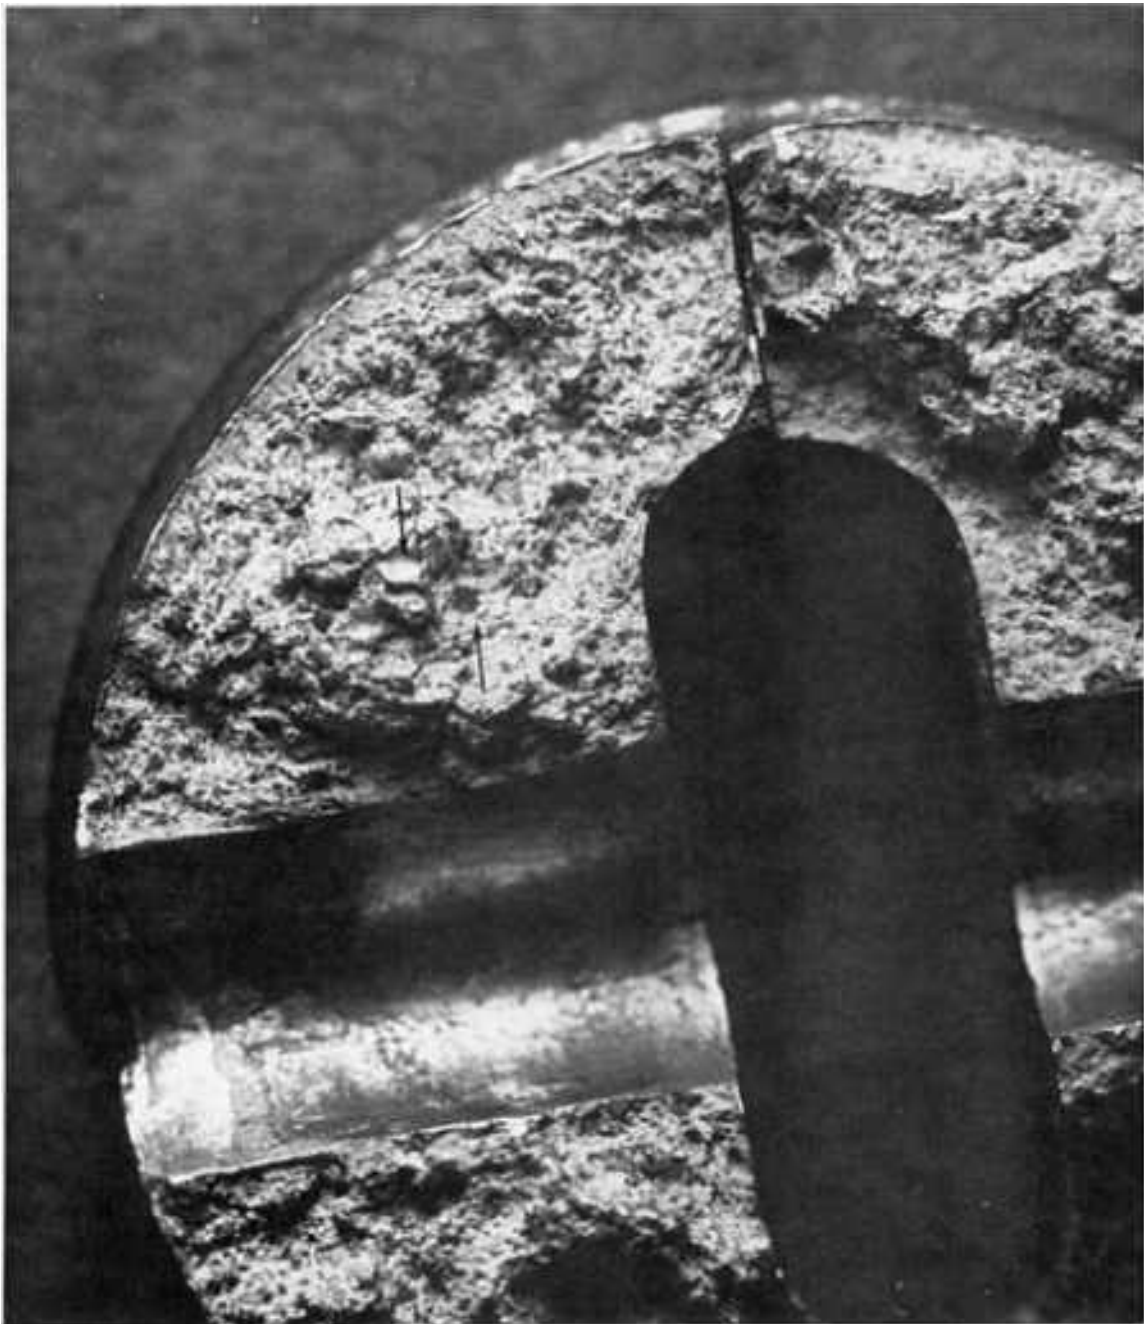
**Fig. 960 Enlarged view of the lower left portion of the top fracture surface (shown at right in Fig. 959) of the broken die cast housing in Fig. 956. Note gas cavities (at arrows), which are common interior features of satisfactory die castings. Bending of the retaining pin (see Fig. 958) is believed to have occurred after the transverse fracture of the top surface of the housing caused relocation of the load-bearing points on the pin. Low-cycle fatigue would have a likely cause of fracture, but no fatigue beach marks could be found. 7.5×**

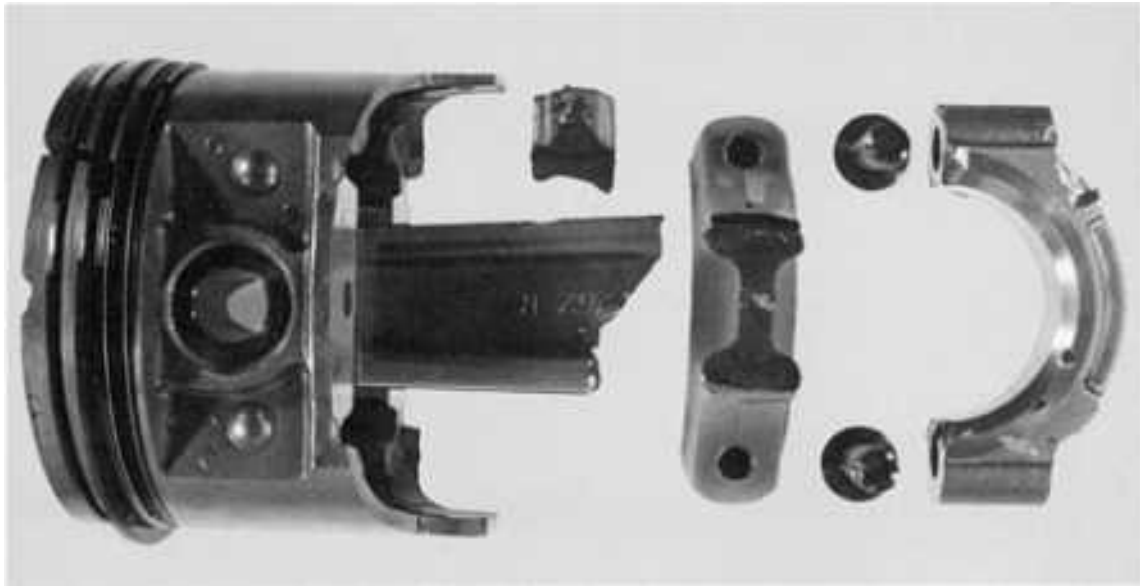
**Fig. 961 Components of an experimental automotive connecting rod that fractured by overload during testing. (Shown also is the piston used in test.) The cast rod had the following composition: 9.0% Si, 1.2% Fe, 3.7% Cu, 0.3% Mg, 0.5% Ni, 1.0% Zn, 0.2% Ti, remainder Al. Note that the shaft of the connecting rod suffered a compound fracture; the portion closest to the cap has a relatively straight, transverse fracture surface, and the portion connected to the piston shows a partially diagonal fracture, with the segment that broke away shown above the shaft. It is not known whether both fractures occurred in the shaft at the moment of initial fracture or whether the segment broke away later due to impact within the cylinder before the engine was shut off. The fracture surface visible here bears no features that in any way suggest a fatigue fracture. The 4340 steel bolts (left of cap at far right) also broke. See also Fig. 962 and 963. ~0.75×**

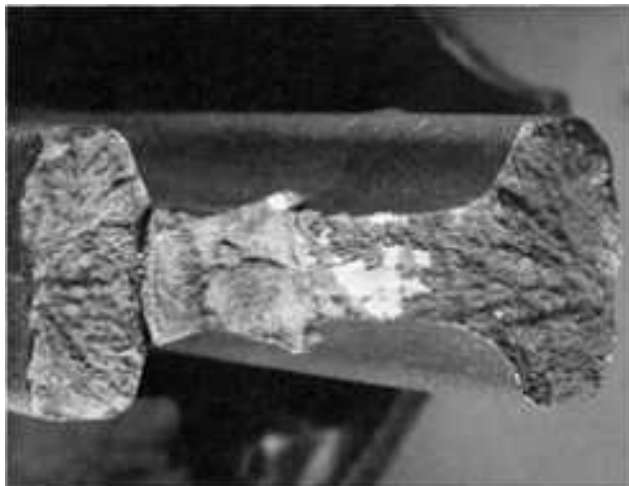
**Fig. 962 Fracture surface of the portion of the aluminum alloy connecting rod in Fig. 961 that was still attached to the piston after the test. It appears that each flange contains a chevron pattern, which suggests that there were two crack origins. This supports the theory that two successive fractures occurred in the rod. The mechanical damage in the right fracture surface indicates that the right origin probably led to the initial rupture. There are no indications of the beach marks that are characteristic of fatigue fractures. See also Fig. 963. 2×**

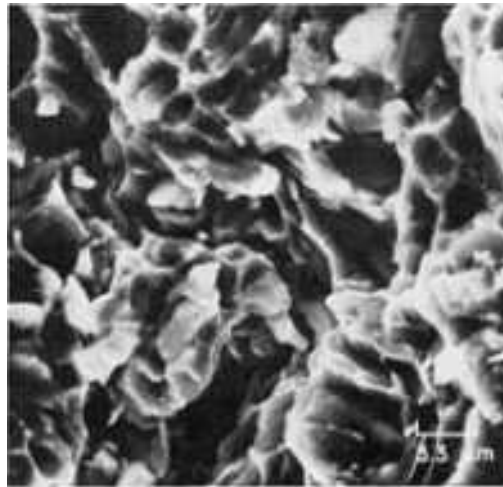
**Fig. 963 High-magnification view of one of the fracture surfaces of the fractured connecting rod shown in Fig. 961. It is evident that fracture was by dimpled rupture, which indicates that the fracture was caused by sudden overload. As in the views of about 0.75× in Fig. 961 and at 2× in Fig. 962, no indications of fatigue are visible here. The fracture appears quite "clean," with very little evidence of nonmetallic inclusions. SEM, 3000×**

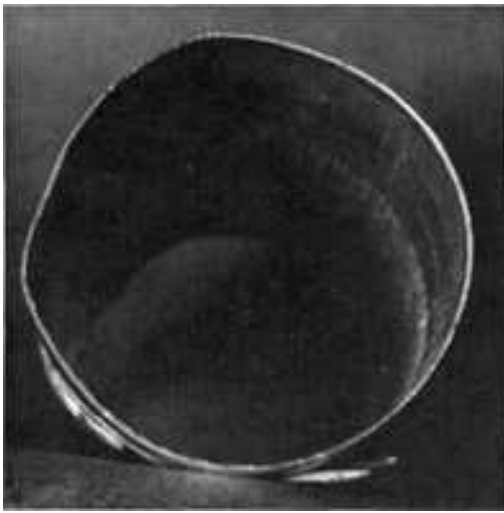
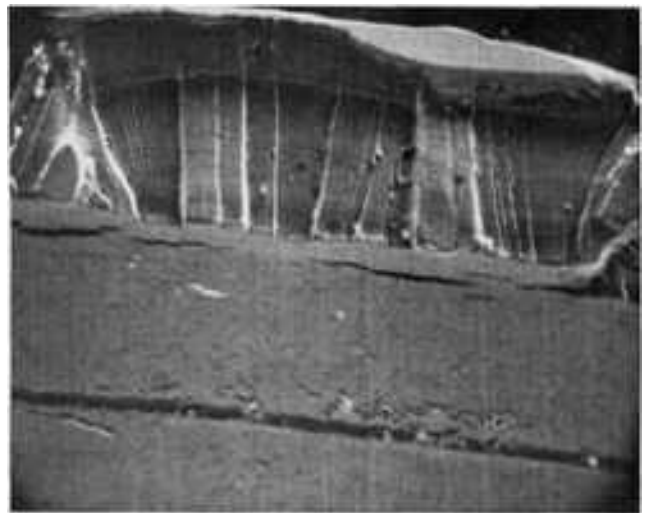
Photograph and SEM fractograph showing the fracture surface of a small portable cylinder used for storage of helium gas under pressure that exploded while at rest in storage. The cylinder was approximately 70 mm ( $2\frac{3}{4}$  in.) in diameter by 250 mm (10 in.) long and had been formed from a 0.75 mm (0.03-in.) thick sheet of aluminum alloy 1100. Normal pressure in the cylinder, when full of helium, was 2 MPa (300 psi); maximum pressure, 4 MPa (600 psi). The cylinder broke when the bottom separated from the sidewall with explosive force, leaving a very even fracture surface; separation was probably at the very bottom of the sidewall. Figure 964 shows the entire fracture surface of the sidewall at actual size. Figure 965 is a magnified view (40×) of a portion of that fracture surface, showing several fracture levels, separated by offsets, containing crack arrests. Rupture began at the inside of the cylinder wall and terminated in a pronounced ductile shear lip (at top in Fig. 965). Note the secondary stress-corrosion cracks in the inside surface of the wall (at bottom in Fig. 965), which are parallel to the fracture surface. See also Fig. 966 and 967.

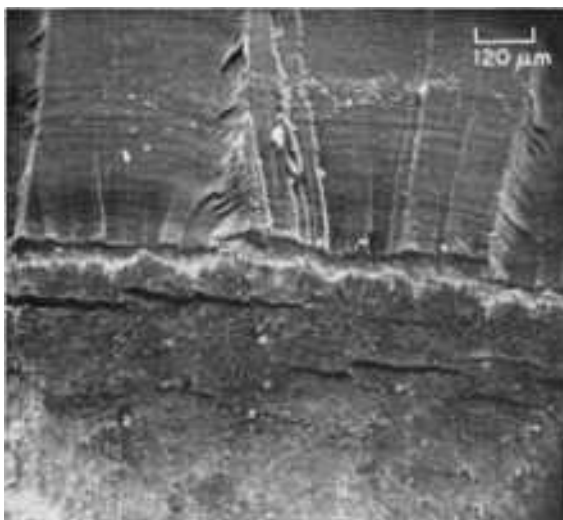
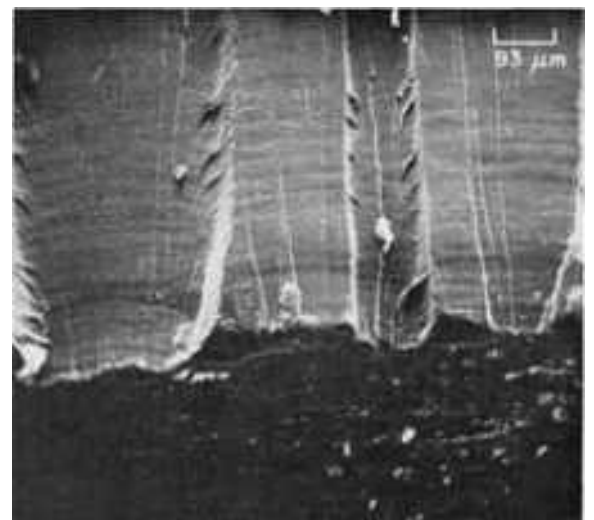
SEM views of two portions of the fracture surface of the cylinder in Fig. 964. These views, at higher magnification than Fig. 965, also show the crack arrests, the offsets between adjoining stress-corrosion-crack surfaces, and the numerous secondary cracks in the inside surface of the cylinder wall (at bottom) that are parallel to the fracture. In Fig. 967, numerous corrosion pits are also visible. These pits are probably due to condensation of water vapor at the bottom of the cylinder that was carried by the helium gas. (Light-microscope examination revealed that cracks formed at bottoms of corrosion pits.) It is likely also that the forming operation created large stress concentrations at the junction between the sidewall and the bottom of

the cylinder. Fig. 966: 83×. Fig. 967: 108×

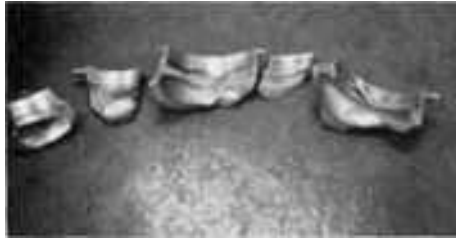
**Fig. 968** Pieces of the hub of a forged aircraft main-landing-gear wheel half, which broke by fatigue. The material is aluminum alloy 2014-T6. Tensile specimens from elsewhere in the wheel had tensile strength of 493.7 MPa (71.6 ksi) and 8.9% elongation in the transverse direction, and tensile strength of 466.1 MPa (67.6 ksi) and 8.0% elongation in the longitudinal direction. See also Fig. 969. ~0.1×

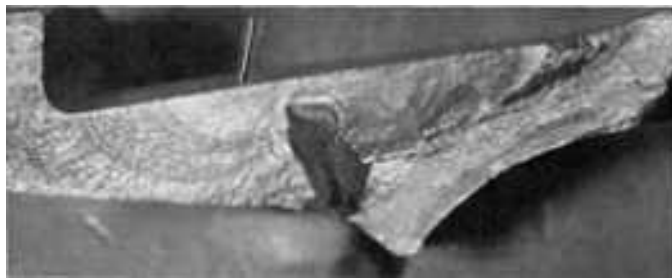
**Fig. 969** View of an area of one fracture surface of the broken hub in Fig. 968, showing the fatigue-crack origin. Visible are beach marks, which suggest that the origin is at the location marked by the arrow, presumably at one of several corrosion pits that were found on the surface of the hub. After having penetrated a short distance, the fatigue crack developed a step (dark facet); a second fatigue crack originated at one end of the step. 1.8×

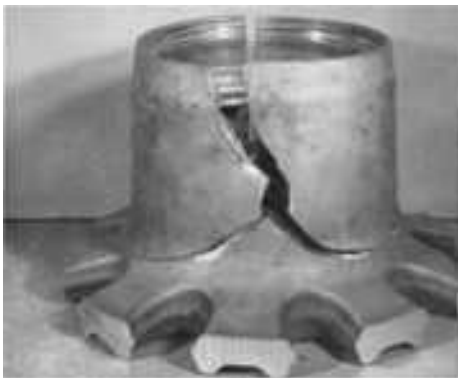
**Fig. 970**

Figure 970 shows the hub of a forged aluminum alloy 2014-T6 aircraft main-landing-gear wheel half, which broke in fatigue. A tensile specimen machined from the hub had tensile strength of 499.2 MPa (72.4 ksi), 12.1% elongation, and hardness of 143 to 150 HB, which are acceptable. The fatigue crack originated at the inside surface of the hub. Figure 971 shows a fracture surface of the broken hub, showing the fatigue-crack origin. Clearly visible are beach marks, which indicate that the fracture began as a radial fatigue crack in a plane containing the axis of the wheel. Later, the crack turned to form a circumferential separation between the hub and web of the wheel half, as shown in Fig. 970. See also Fig. 972 and 973. Fig. 970: ~0.17×. Fig.

**Fig. 973 Fracture surface of the broken hub in Fig. 970, showing an area of the circumferential separation between the hub and web. Bright flakes, similar to the defect that initiated the fatigue crack in Fig. 972, are visible at the arrows. These defects have been attributed to hydrogen damage. Actual size**

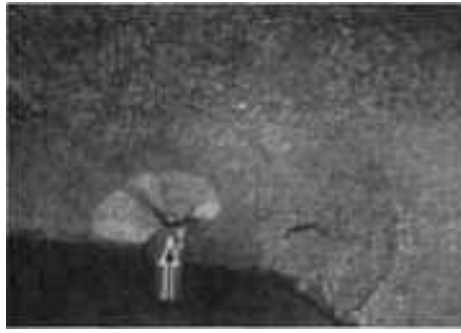
**Fig. 972 Enlarged view of the fatigue-crack origin in Fig. 971, which plainly shows the region of initial penetration (light area). At arrow is a forging defect usually known as a bright flake. Note that grain flow is approximately parallel to the flake. ~5×**

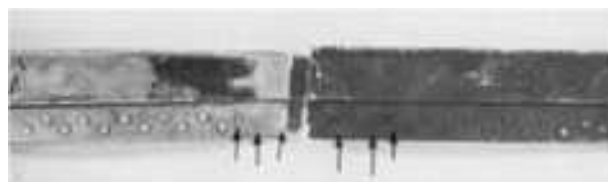
**Fig. 974 Top surface of an extruded aluminum alloy 2014-T6 bottom cap of an aircraft wing spar, showing a fatigue fracture (center) that intersected one of the rivet holes indicated by the arrows. Hardness tests near the fracture gave an average value of 85 HRB, which is acceptable. See also Fig. 975, 976, 977, 978, and 979. ~0.25×**

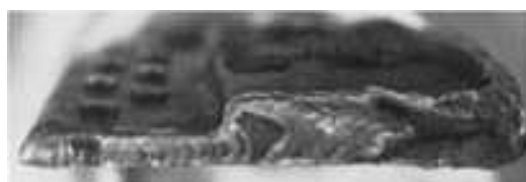
**Fig. 975 View of the fracture surface in Fig. 974. The rivet hole intersected by the fracture is abnormal, consisting of two overlapping holes (see Fig. 976). Beach marks, which are clearly visible, indicate that the fatigue crack began at the double-drilled rivet hole. 1.13×**

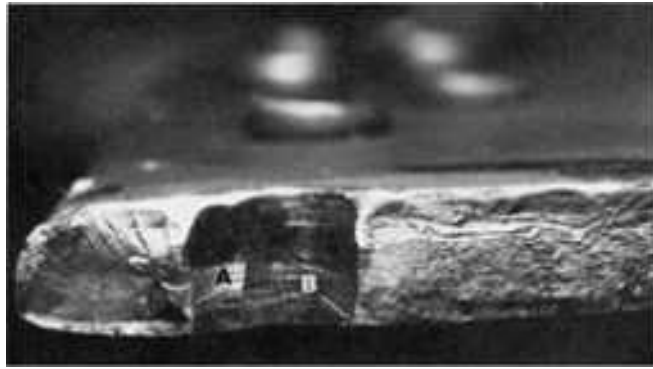
**Fig. 976 Higher-magnification view of the rivet-hole area of the fracture surface shown in Fig. 975. The double-drilled nature of the rivet hole is shown quite clearly here. Two fatigue cracks originated at this hole--one beginning at arrow A and growing to the left, and the other beginning at arrow B and growing to the right. 5×**

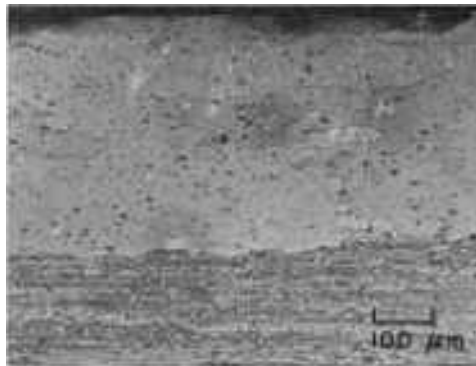
**Fig. 977 Polished and etched section through the cap in Fig. 974. At bottom is a fibrous interior structure typical of aluminum alloy extrusions. At top is one of the coarse-grained, recrystallized layers, 0.46 to 0.94 mm (0.018 to 0.037 in.) thick, at the top and bottom surfaces of the cap. Keller's reagent, 100×**

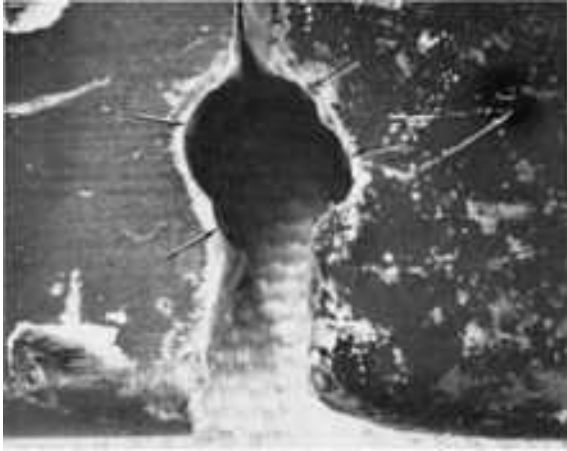
**Fig. 978**

Views of the top surface (Fig. 978) and bottom surface (Fig. 979) of the wing-spar cap in Fig. 974, with the mating fracture surfaces fitted together. The segment at right in each view was deformed after fracture, causing the gap. The double drilling of the rivet hole, noted in Fig. 975 and 976, is clearly shown (arrows). The edge distance, "e," was measured for each hole (as shown in Fig. 979 for the hole closer to the edge). Edge distance for the hole farther from the edge is about 8 mm ( $\frac{5}{16}$  in.)--the minimum allowed for rivets of the size used here (4 mm, or  $\frac{5}{32}$  in. diam). For the closer hole, edge distance is about 75% of the minimum value, which increased the stresses in that section to excessive levels. Both at 5×

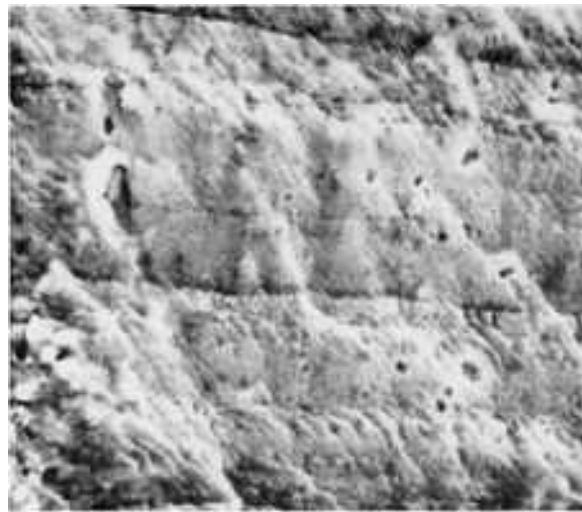
**Fig. 980** Fatigue fracture of an aluminum alloy 2014-T6 heat-treated forging. Details of the heat-treatment procedure were not available. Some machining was carried out on the forging prior to heat treatment. The aircraft structural component cracked in service. The horizontal lines on the fracture surface are grain boundaries. Fatigue striations are also visible, traversing the fracture face at roughly 60°. Note the absence of discontinuities at their intersections with the grain boundaries. SEM, 1800× (E. Neub, University of Toronto)

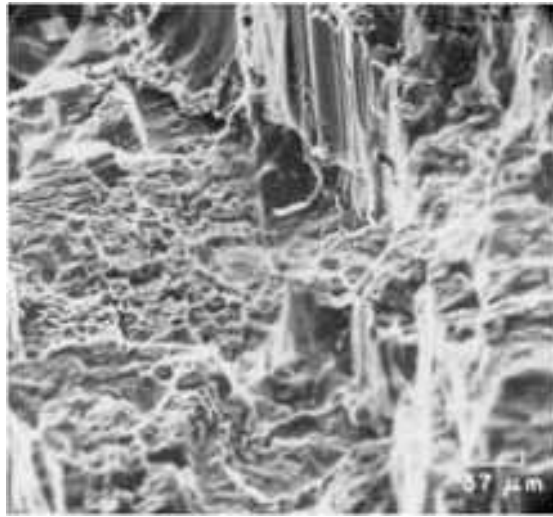
**Fig. 981** Fracture surface of a fatigue-test specimen of aluminum alloy 2024-T3, showing a portion of the region of final fast fracture. Stress-intensity range ( $\Delta K$ ) was  $21 \text{ MPa}\sqrt{m}$  ( $19 \text{ ksi}\sqrt{\text{in}}$ ); the stress was applied in an argon atmosphere at room temperature at a frequency of 10 cps. The area has voids that may be moderate-size dimples. The vertical face is apparently a very large tear ridge or cleavage step joining two areas of dimpled rupture. See also Fig. 982 and 983. SEM, 270×

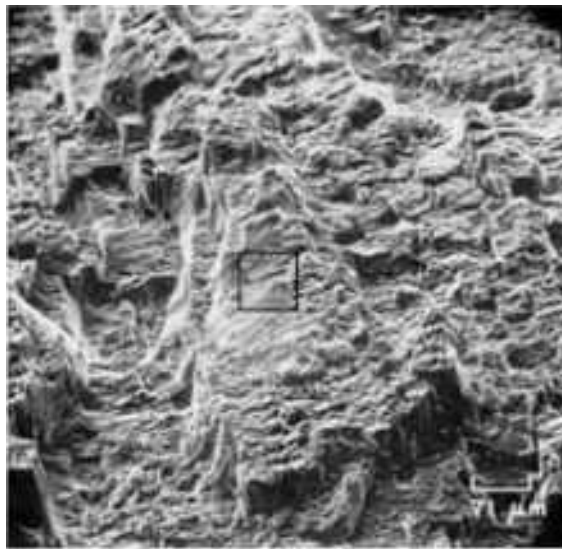
**Fig. 982** A different area of the fracture surface shown in Fig. 981. This also exhibits vertical faces that are tear ridges. The surface is covered with voids, but at this low magnification it is not possible to decide whether or not they are dimples. The smooth central area outlined by the rectangle is shown enlarged in Fig. 983. SEM, 140×

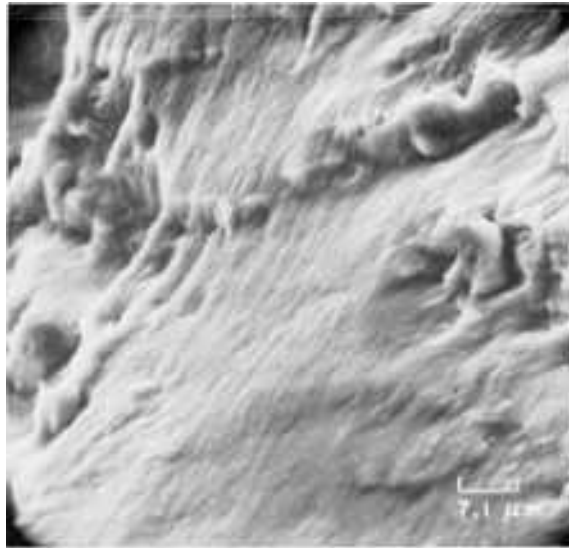
**Fig. 983** A view of the rectangle-outlined area of the fracture surface in Fig. 982, at higher magnification. With this enlargement, it is evident that the area is not truly smooth, but rather that it bears a uniform array of extremely fine fatigue striations. Near the right edge is a small area of minute dimples. SEM, 1400×

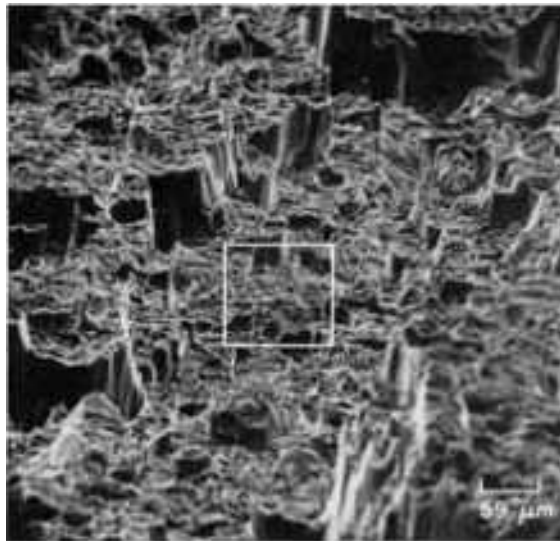
**Fig. 984** Fracture surface of a fatigue-test specimen of aluminum alloy 2024-T3 tested at 23 °C (73 °F) in argon. The fatigue crack, similar in appearance to the one in Fig. 982, was produced by a stress-intensity range ( $\Delta K$ ) of  $24.8 \text{ MPa}\sqrt{m}$  ( $22.6 \text{ ksi}\sqrt{in}$ ) at a frequency of 10 cps. Much of the surface shows features resembling dimples, but the vertical "cliffs" are probably delaminations along grain boundaries. See Fig. 985 for a higher-magnification view of the area in the rectangle. SEM, 170×

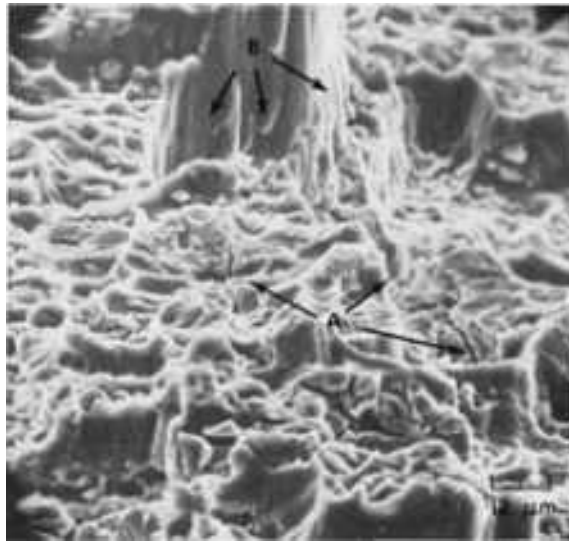
**Fig. 985** Area outlined by the rectangle in Fig. 984, as seen at higher magnification. This view provides a much clearer delineation of the fine details of the fracture surface and shows a combination of dimpled rupture and grain-boundary separation. Intergranular secondary fissures such as those marked by the arrows at A led to the formation of the vertical "cliffs" shown here (arrows at B) and in Fig. 984. Cracked and broken inclusions are visible at many locations. SEM, 850×

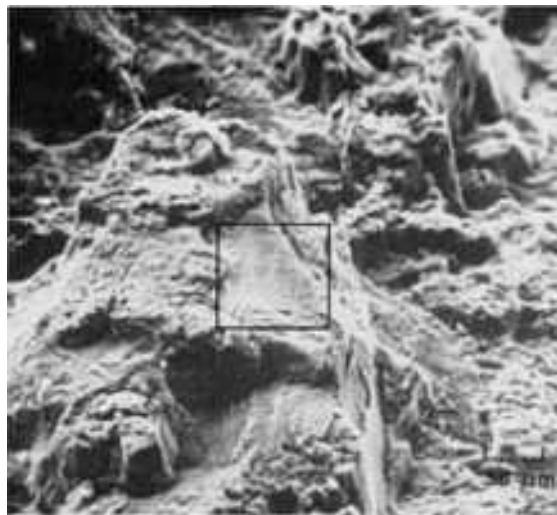
**Fig. 986** Fracture surface of a fatigue-test specimen of aluminum alloy 2024-T3 that was tested in an environment of a 3.5% solution of NaCl in water. The stress-intensity range ( $\Delta K$ ) was  $19.8 \text{ MPa}\sqrt{m}$  ( $18 \text{ ksi}\sqrt{in}$ ) at 10 cps. The central region of this view contains patches of well-defined fatigue striations. In adjacent regions, there appear to be faintly defined striae that have been obscured by corrosion. In other regions, it is uncertain whether fatigue or cleavage was active. See Fig. 987 for area in rectangle. SEM, 260×

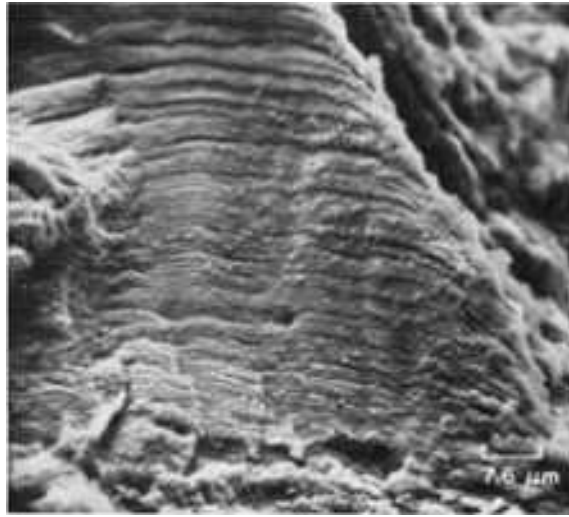
**Fig. 987** View at higher magnification of the area in the rectangle in Fig. 986, showing the fatigue striations in finer detail. Note that superimposed on the fine striations at somewhat irregular intervals is a system of fissures, or perhaps more pronounced striations; the presence of these features may reflect either a repetitive variation in strain amplitude or stress, or periodic interruptions in the applied stress cycle (which allowed locally increased corrosion), or both. SEM, 1320×

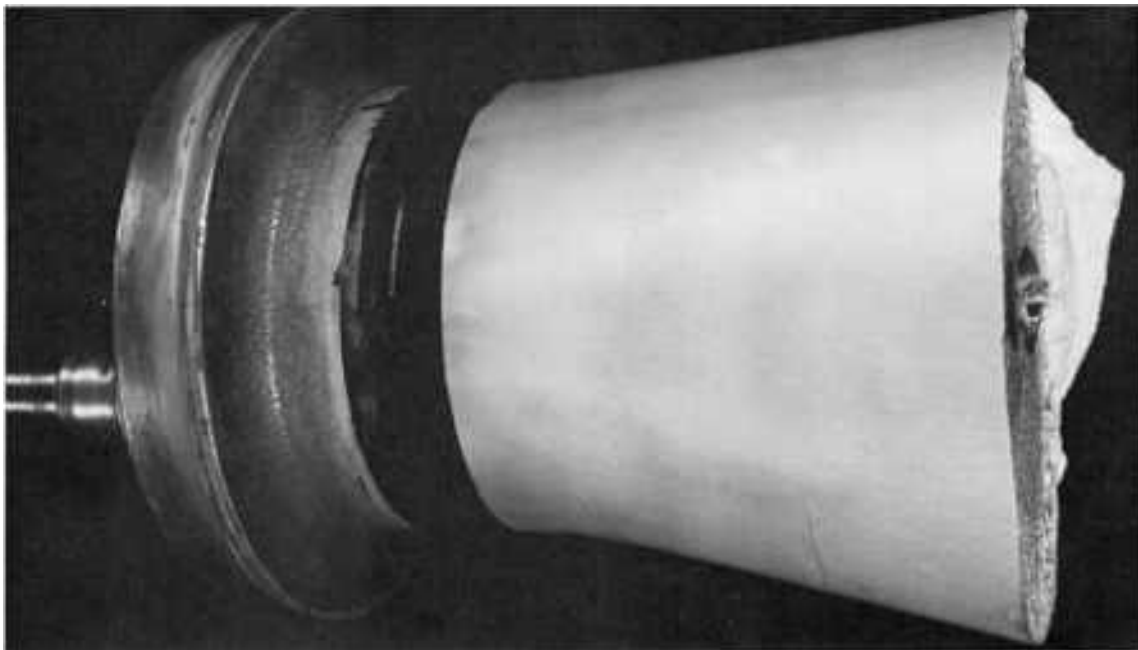
**Fig. 988** View of the shank end of a fractured aircraft propeller blade fabricated of aluminum alloy 2025-T6. The blade broke by fatigue, which originated at an interior cavity that was provided to contain a balance weight comprised of compacted lead wool. Chemical analysis established that the blade was within specified composition limits. Hardness measurements (500-kg load) yielded an average value of 107 HB, which was above the required minimum of 100 HB. See also Fig. 989. Actual size.

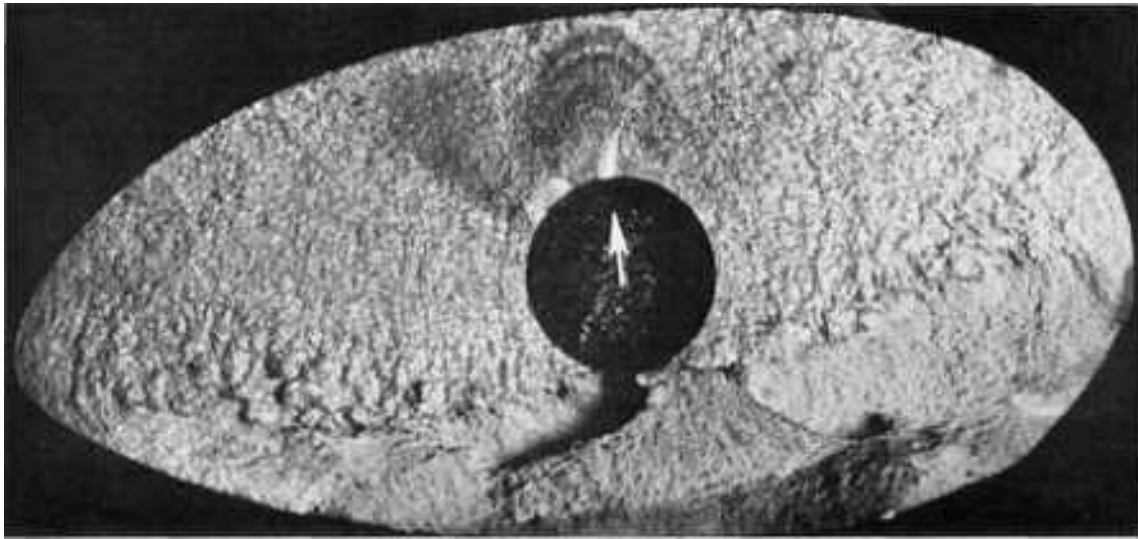
**Fig. 989** Fracture surface of the shank end of the broken aircraft propeller blade in Fig. 988. The balance-weight cavity is visible at center, with the fatigue-crack origin at the upper edge (arrow). The fracture originated at the beginning of the radius that formed one end of the cavity. Examination of the cavity surface revealed severe roughness caused by tool marks and by corrosion pits. The combined effect of these tool marks and corrosion pits was considered to be the cause of crack initiation. 1.75×

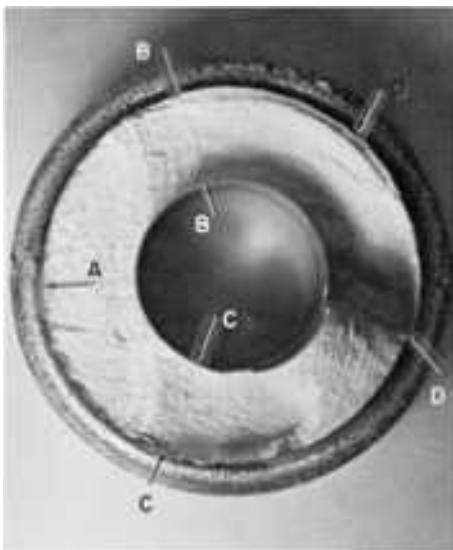
**Fig. 990**

Figure 990 shows the surface of a fatigue fracture near the hub of an aluminum alloy 2025-T6 aircraft propeller blade. The fracture originated in a shot-peened fillet. Small fatigue cracks joined to form the main crack at A, which propagated to B-B and C-C before final fast fracture occurred. Figure 991 shows a portion of the outside edge of the fracture surface in Fig. 990 between the arrows marked D, showing small, distinct fatigue cracks (at arrows) that had been present before final fast fracture. Figure 992 is a view of the shot-peened fillet of a companion propeller blade, showing small fatigue cracks. Depth of the cold-worked layer produced by shot peening was nonuniform and averaged about 0.038 mm (0.0015 in.), instead of the stipulated 0.14 mm (0.0055 in.) minimum, which afforded inadequate surface fatigue strength. See also Fig.

**Fig. 993 Surface of the shot-peened fillet of another companion propeller blade to that in Fig. 990, showing the same type of fatigue cracks as those in the propeller blade shown in Fig. 992. These cracks were present in large numbers in the fillet area. 20×**

**Fig. 994 A polished and etched section through the slot-peened fillet of the fractured blade in Fig. 990, showing two small fatigue cracks pulled open and blunted by plastic deformation. Note slip bands, which indicate that a slight amount of plastic flow occurred near cracks. Etched in Keller's reagent, 100×**

**Fig. 995** Another polished and etched section through the shot-peened fillet of the fractured blade in Fig. 990, showing a fatigue crack that grew from a surface flaw. The structure indicates that only very superficial shot-peening occurred here. Etched in Keller's reagent, 500×

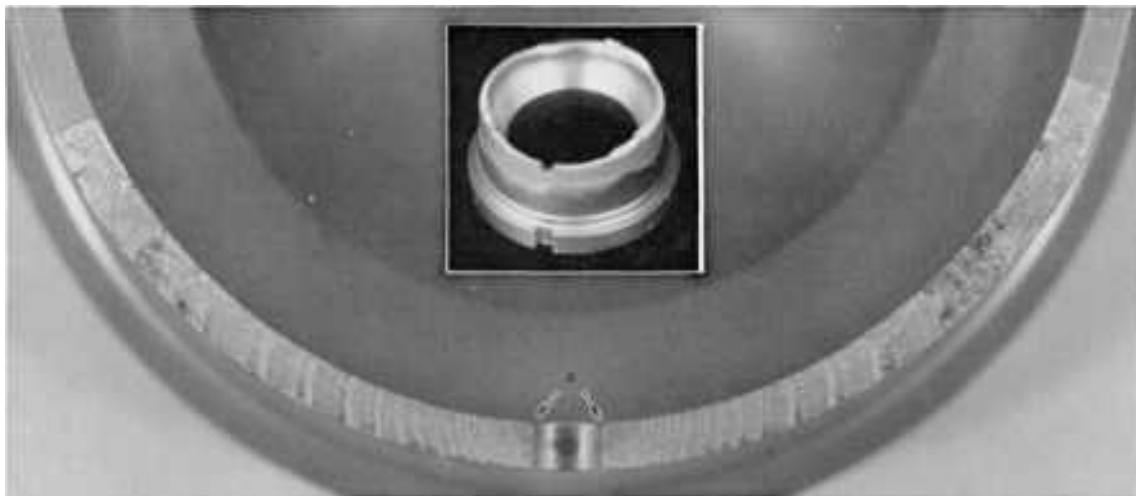
**Fig. 996**

Fatigue fracture of the aluminum alloy 7050-T7 cylinder head for an aircraft flight spoiler servo assembly. The end of the cylinder cracked after 1.25 million cycles in the endurance qualification test for the servo assembly. Five million cycles were required. Fracture initiated at the chambers on the inside diameter of a drain hole. Striations were observed within  $18\text{ }\mu\text{m}$  ( $0.0007\text{ in.}$ ) of the origin, indicating that fracture was caused by excessively high cyclic stresses. Source of the high stress was traced to an error in the computer-aided design (CAD) software. Fig. 996: Fracture surface with drain hole at bottom center. Note beach marks. "O" and corresponding arrows indicate fatigue origins.  $2.5\times$ . The as-received cylinder head is shown in the inset. Fig. 997 and 998: Close-ups of fatigue origins (arrows) in Fig. 996. SEM,  $26\times$  and  $23\times$  (W.L. Jensen, Lockheed-Georgia Company)

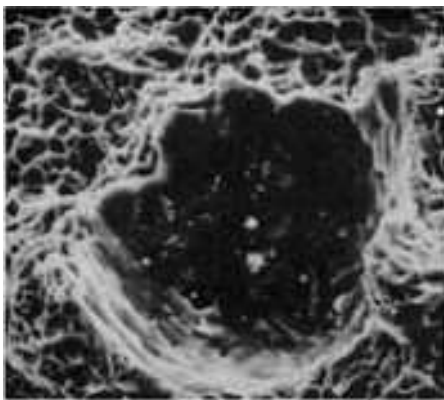
**Fig. 999**

Fractography of a laser beam weld in aluminum alloy 5456. The weld was made using a beam power of 11 kW, a speed of 15 mm/s (35 in./min), and a heat input of 0.74 kJ/mm (18.9 kJ/in.). Ductile fracture of the dynamic tear (DT) test sample occurred in the fusion zone due to softening of the zone and the presence of pores. Fig. 999: Fracture surface of aluminum alloy 5456 DT sample. Large pore is surrounded by microvoids. Failure mode was microvoid coalescence. SEM,  $850\times$ . Fig. 1000: Microstructure of alloy 5456 base metal. Elongated second-phase structures indicate rolling direction and strain-hardened nature of the material. Hardness: 87 HV. Etched in A-2 solution of Knuth system,  $500\times$ . Fig. 1001: Microstructure of fusion zone where fracture occurred. No elongation of second phases is evident. Hardness: 80 HV. Etched in A-2 solution of the Knuth system,  $1000\times$  (E.A. Metzbowyer and D.W. Moon, Naval Research Laboratory)

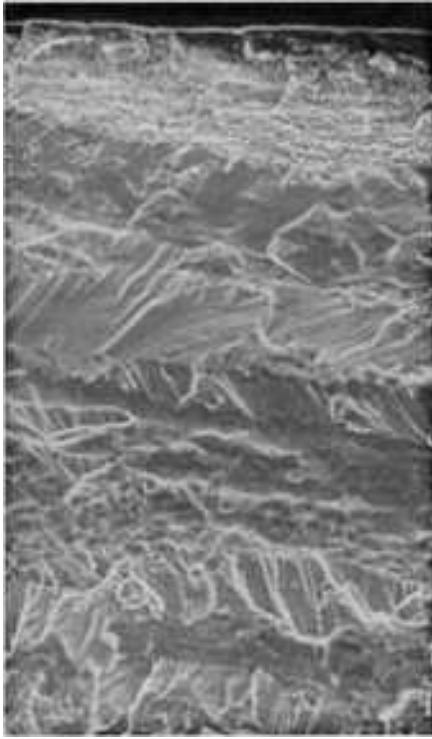
**Fig. 1002**

Fatigue fracture of an aluminum alloy 7075-T736 forging. The aircraft main landing gear component failed during a structural fatigue test. Cracking initiated at a dross inclusion at the surface of the part. Fig. 1002: Portion of fracture surface of aluminum alloy 7075-T736 forging. Dross inclusion is at top. Note its spongy appearance. SEM, 300×. Fig. 1003: High-magnification view of dross inclusion in Fig. 1002. It consists of octahedral spinel crystals ( $\text{MgAl}_2\text{O}_4$ ) embedded in a spongy cluster of granulated oxides. SEM, 10,000× (F.

**Fig. 1004** An aluminum alloy 7075-T736 aircraft main landing gear forging, similar to that described in Fig. 1002 and 1003, which was shot peened on its inner-diameter surface to enhance fatigue resistance. The shot-peened part withstood cycles far beyond the number required for acceptance. One effect of peening was to drive the fracture-initiation site to a location well beneath the surface of the forging. The dross inclusion that was the origin of this fracture is the thin black line in the center of the nearly circular fatigue crack initiation area. 4.5× (C. Bryant, De Havilland Aircraft Company of Canada Ltd.)

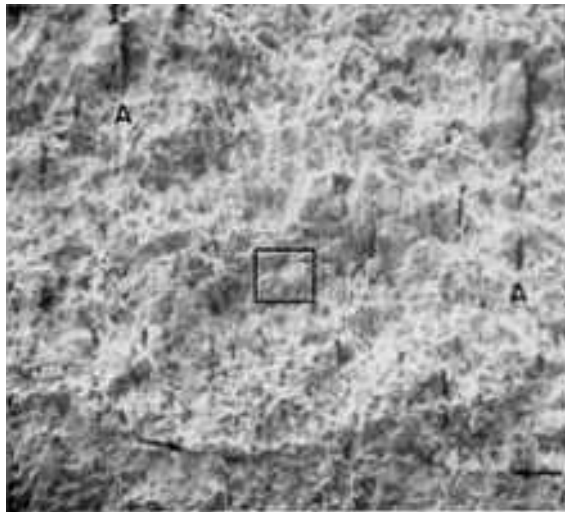
**Fig. 1005** Fracture surface of a fracture-toughness test specimen of aluminum alloy 7075-T6, showing the zone of transition from the fatigue-precrack region (below arrows) to the tension-overload plane-strain fracture region (above arrows). Specimen was aged 24 h at 120 °C (250 °F); tensile strength was 593 MPa (86 ksi), and uniform elongation was 13%. Note the appreciable number of vertical delaminations (as at A's), which probably are grain-boundary separations, caused by the transverse tensile stress in the plane-strain region. Area in rectangle is shown enlarged in Fig. 1006. SEM (gold shadowed), 50×

**Fig. 1006** Area outlined by the rectangle in Fig. 1005, as seen at ten times the magnification there. It is apparent that the matrix contained many second-phase particles that have undergone brittle fracture (arrows). The surface is quite complex, with some regions that appear to show clusters of minute dimples (A) and other regions that strongly resemble intergranular fracture (B's). At C is one of the numerous vertical fissures visible in Fig. 1005, presumably elongated during tension overload. See Fig. 1007 for a higher-magnification view of area in rectangle here. SEM (gold shadowed), 480×

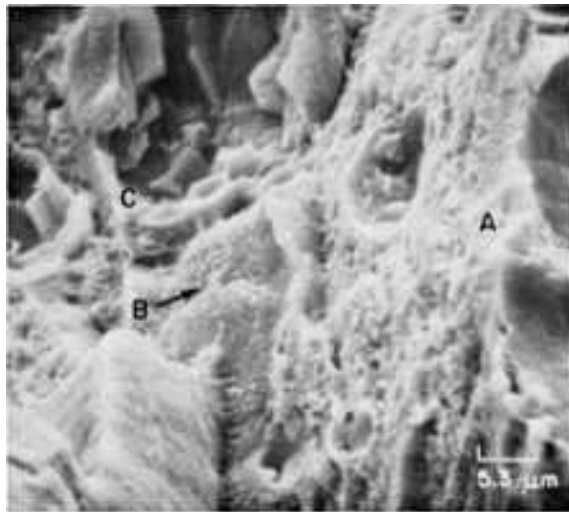
**Fig. 1007** Higher-magnification view of the area in the rectangle in Fig. 1006. At A is a region of extremely fine dimples, which are slightly out of focus. At B, there appear to be grain-boundary facets bearing small, very shallow dimples. At C are fragments of a number of second-phase inclusions, many of which have separated from their original pockets in the matrix. SEM (gold shadowed), 1900×

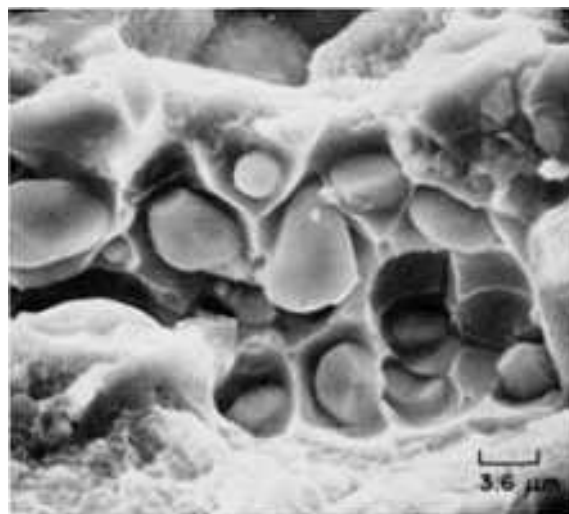
**Fig. 1008** Tension-overload fracture in the short-transverse plane of a specimen of aluminum alloy 7075-T6. At top and bottom are regions of quite small dimples. In the central portion of this view are large pockets in which the cleaved facets of intermetallic inclusions are visible. These inclusions, which are rich in iron and silicon, are only slightly bonded to the walls of the pockets. SEM, 2800×

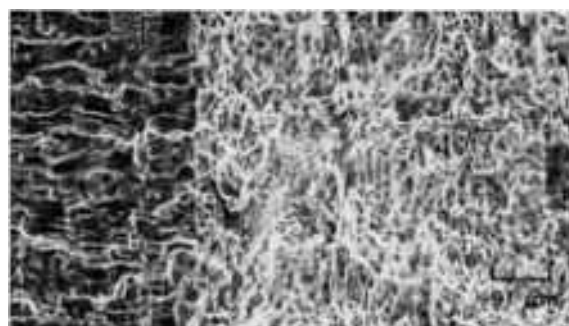
**Fig. 1009 Specimen of aluminum alloy 7075-T6 broken in a slow-bend fracture-toughness test in air. Dark area, at left, is the fatigue-precrack surface, which shows no fatigue striae. At right is the tension-overload fracture surface; here, the surface appears dimpled, although this is uncertain at only 110 $\times$ . See also Fig. 1010. SEM, 110 $\times$**

**Fig. 1010 A portion of the tension-overload fracture surface in Fig. 1009, as seen at ten times the magnification there, which reveals fine details. A number of medium-size dimples contain inclusions, some of which are broken. In contrast are the minute dimples visible at left and right in the upper portion of this view. SEM, 1100 $\times$**

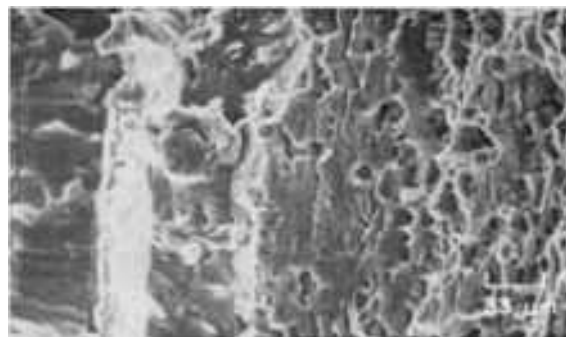
**Fig. 1011 View of the transition between a slow-bend fracture induced in mercury vapor (left of center) and one occurring in air (right of center) in a specimen of aluminum alloy 7075-T6. The fracture induced in mercury vapor appears to have occurred by cleavage; the fracture in air exhibits dimples, which increase in frequency toward the right side of this fractograph. SEM, 300 $\times$**

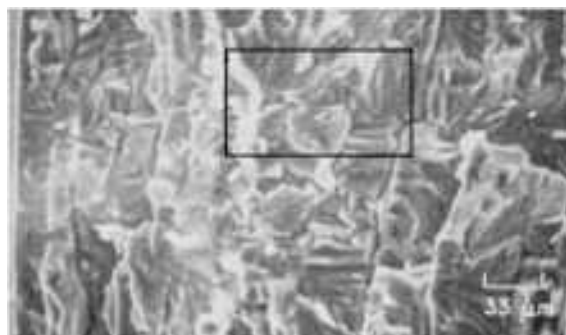
**Fig. 1012 Fracture surface of an aluminum alloy 7075-T6 specimen broken in a slow-bend fracture-toughness test in mercury vapor. Obviously, this is completely brittle fracture. Many facets show faint characteristics of quasi-cleavage. Note the large number of secondary cracks, possibly at grain boundaries, all of which are more or less parallel. Area in rectangle is shown enlarged in Fig. 1013. SEM, 300 $\times$**

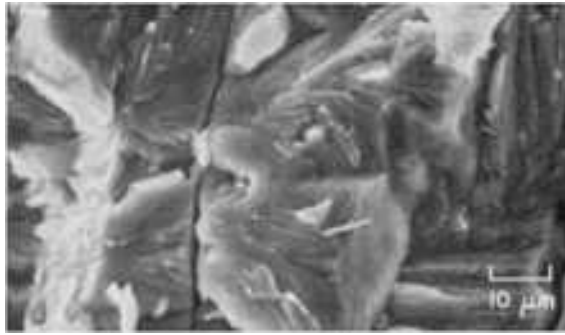
**Fig. 1013** Higher-magnification view of the surface contours in the rectangle that is shown in Fig. 1012. This reveals the cleavage river patterns quite clearly, note the changes in fracture direction at right. This view also reveals the depth and continuity of the secondary cracks. See also Fig. 1014. SEM, 1000×
