ASM HANDBOOK®

VOLUME  
12

Fractography

*Fractography*, was published in 1987 as Volume 12 of the *ASM Handbook*. The Volume was prepared under the direction of the ASM Handbook Committee.

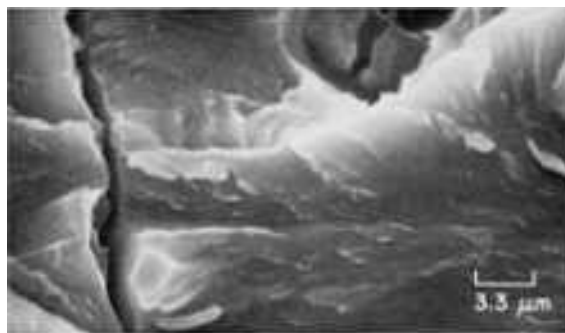
**Fig. 1014** Another view, at still higher magnification, at the fracture surface in Fig. 1012 and 1013. At top is what appears to be a pocket holding a cracked inclusion. The remainder of the surface shows cleavage facets plus projections that are somewhat similar to the tongues seen in cold fractures of iron. SEM, 3000×

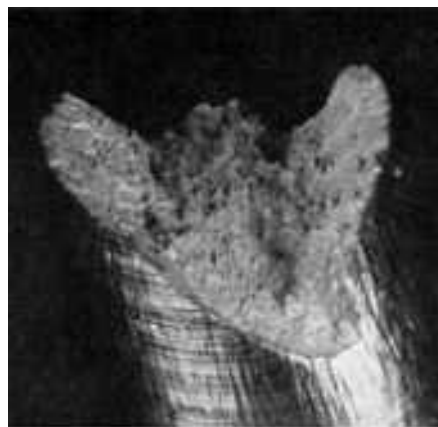
**Fig. 1015** Surface of a tension-overload fracture in an unnotched specimen of aluminum alloy 7075-T6 having a tensile strength of 520 MPa (75 ksi), with 22% reduction of area. Surface is coarsely fibrous; shear lip has formed two opposing lobes. See also Fig. 1016 and 1017. 9×

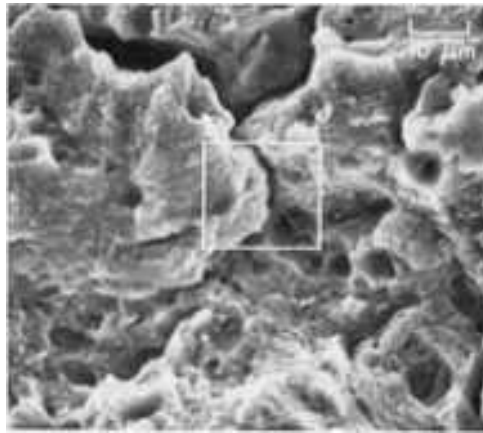
**Fig. 1016 SEM view of the central area of the fracture surface in Fig. 1015. Although this is a ductile rupture, it contains very deep secondary cracks. The major pores were sites of alloy second-phase particles that are no longer in place. See Fig. 1017 for an enlarged view of the area in the rectangle. 1000×**

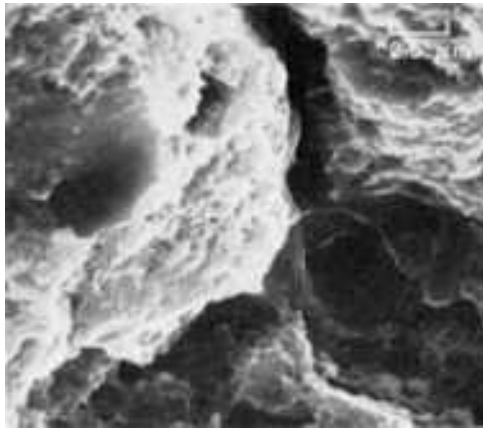
**Fig. 1017 Enlarged view of the fracture-surface area in the rectangle in Fig. 1016. The higher magnification here makes it possible to observed the fine size of the dimples, which in general is less than half a micron. This is remarkable uniformity of size in a fracture surface as rough as this one. SEM, 4000×**

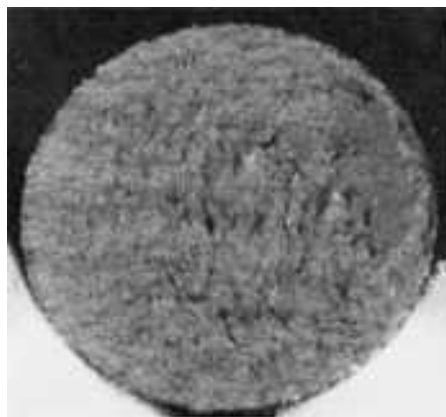
**Fig. 1018 Tension-overload fracture in notched specimen of aluminum alloy 7075-T6. Notched tensile strength, 750 MPa (109 ksi); unnotched tensile strength, same as in Fig. 1015. Surface is flat and coarsely fibrous. Considerable secondary cracking is evident, even at this low magnification. See also Fig. 1019 and 1020. 9×**

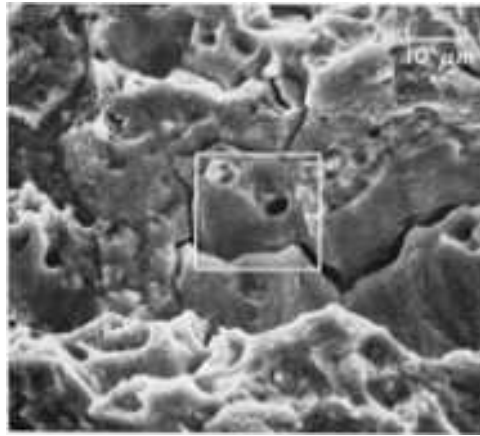
**Fig. 1019 SEM view of the interior of the fracture surface in Fig. 1018. This shows that in general the secondary cracking is intergranular, although the primary rupture is not. Numerous pores contain alloy second-phase particles. See also Fig. 1020. 1000×**

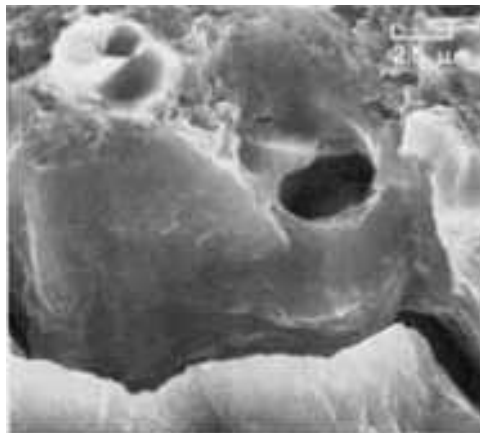
**Fig. 1020 Higher-magnification view of the area in the rectangle in Fig. 1019. This fourfold enlargement makes visible the fine dimples surrounding the particle sites. Note that the surfaces of the secondary grain-boundary cracks are remarkably smooth. SEM, 4000×**

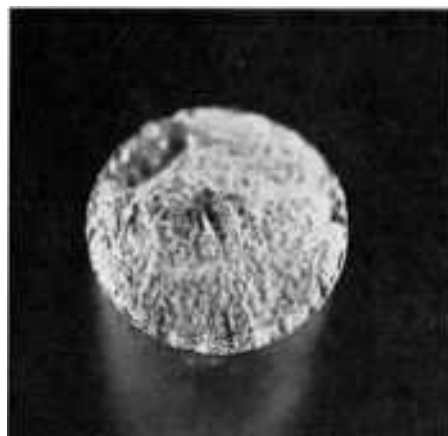
**Fig. 1021 Cone-shaped fracture surface produced by low-cycle fatigue in aluminum alloy 7075-T6 (same mechanical properties as in Fig. 1015). Loading was tension-tension with  $R = 0.1$  and a maximum loading of**

310 MPa (45 ksi). Fracture occurred at 26,000 cycles. See also Fig. 1022 and 1023. 6×

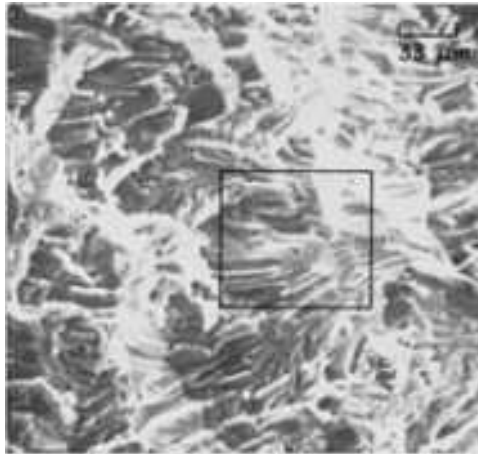
**Fig. 1022 SEM view of a very complex surface found near the outer edge of the fracture in Fig. 1021, believed to have formed principally by severe deformation by slip. There appears to be a complete absence of secondary cracks. See also Fig. 1023. 300×**

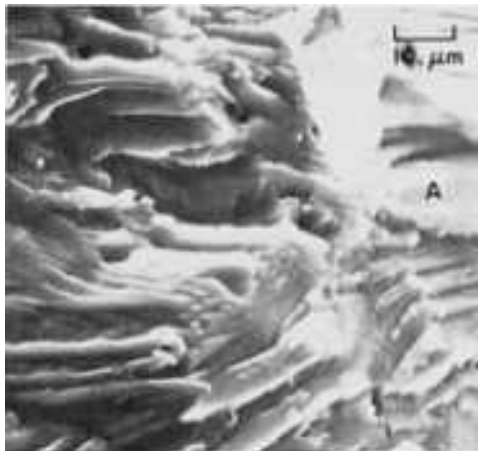
**Fig. 1023 View at higher magnification of the area in the rectangle in Fig. 1022. Fatigue striations with a spacing of about 0.5 μm were discerned at region A when magnified at 4000×, oriented at a slight angle counterclockwise to the vertical edge of this print. SEM, 1000×**

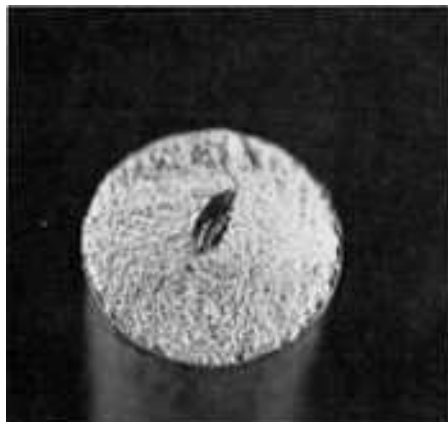
**Fig. 1024** High-cycle fatigue fracture in aluminum alloy 7075-T6 (same mechanical properties as in Fig. 1015) loaded in tension-tension with  $R = 0.1$  and a maximum loading of about 159 MPa (23 ksi). Fracture was at 548,000× cycles. Gouge near center is post-test mechanical damage. See also Fig. 1025. 6×

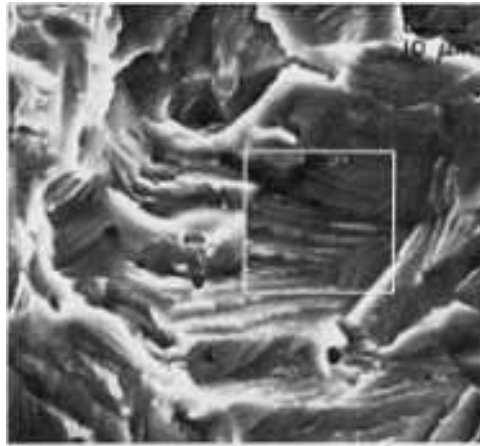
**Fig. 1025** View of the fracture surface in Fig. 1024 that is very similar to the view of the low-cycle fracture surface in Fig. 1023. It is believed that the steplike formations resulted from a slip mechanism. Secondary cracks are not visible. See also Fig. 1026. SEM, 1000×

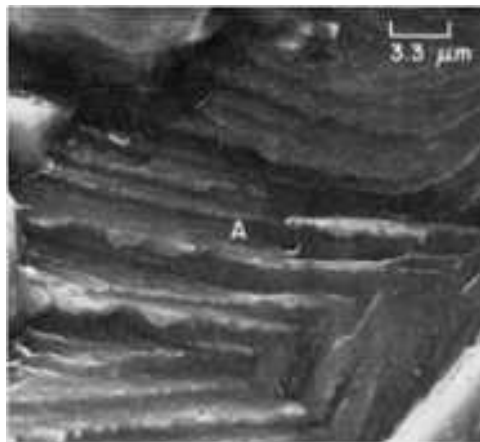
**Fig. 1026** Area outlined by the rectangle in Fig. 1025, as seen at triple the magnification there. Fatigue striations, which are about an order of magnitude smaller than the steplike formations, are faintly visible parallel with the edges of the "steps" as at area A. SEM, 3000×

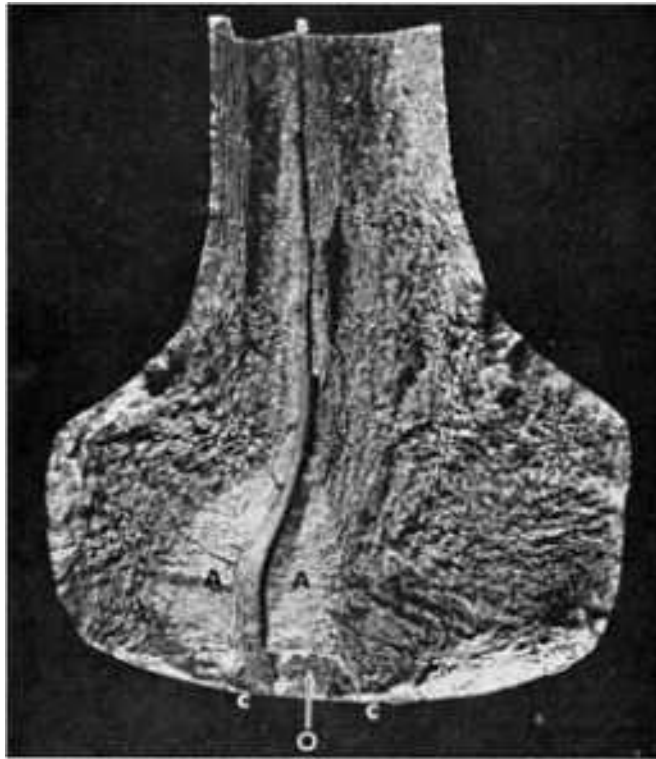
**Fig. 1027** Surface of a crack in an aircraft wing-spar carry-through forging of aluminum alloy 7075-T6. The crack was discovered during inspection after 5269 h of service and was opened up. The external surface at edge C-C had been machined after forging. The regions marked A contain fatigue features that originated at a flaw (marked B-B) extending the full length of the segment. Area at O is shown enlarged in Fig. 1028. See also Fig. 1029, 1030, 1031, 1032, 1033, and 1034. ~3.5×

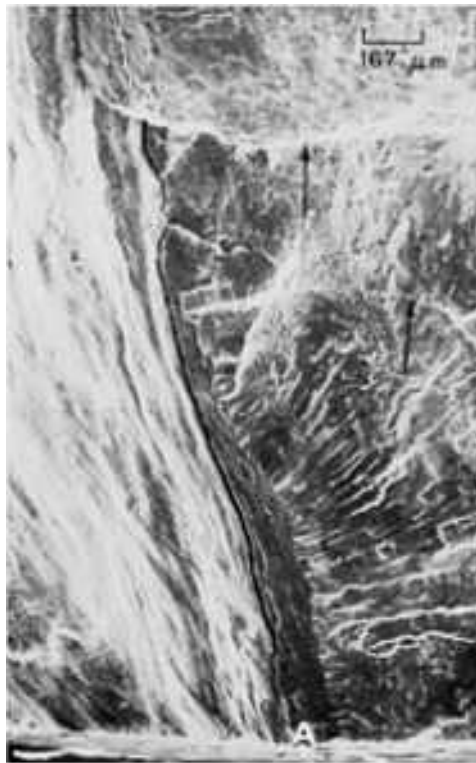
**Fig. 1028** SEM view, at higher magnification, of the area at O in Fig. 1027. At left of the boundary (dark line running up from A) is the surface of the flaw (B-B in Fig. 1027); at right of it is a fatigue surface (A at right in

**Fig. 1027). Note the beach marks just above mid-height in the fatigue surface (at arrows). 60×**

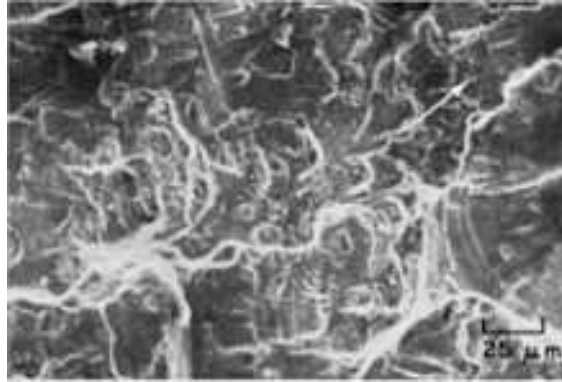
**Fig. 1029 A typical region in an area A of Fig. 1027. Fatigue striations that are nearly vertical (arrow) are faintly visible. These were found to be parallel to the flaw (B-B in Fig. 1027) in both A areas in Fig. 1027. Scattered dimples are evident in locations adjacent to the fatigue striations. See also Fig. 1030. SEM, 400×**

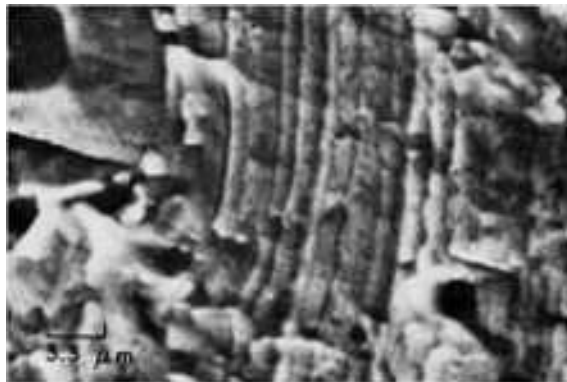
**Fig. 1030 Highly magnified view of fatigue striations typical of those in areas A in Fig. 1027. In general, these striations were parallel with the flaw B-B. Dimples characterized the remainder of the fracture. Inclusions near the flaw suggested that it was the result of a pipe not cropped from the ingot. SEM, 3000×**

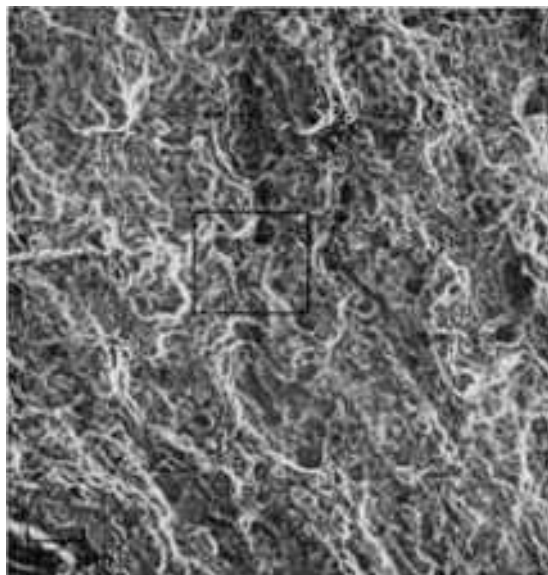
**Fig. 1031** Region of the overload portion of the fracture in Fig. 1027. This region, exhibiting dimples characteristic of ductile rupture, is representative of the entire fracture, except for areas A and flaw B-B in Fig. 1027. Large dimples contain visible inclusions. See also Fig. 1032. SEM, 80 $\times$

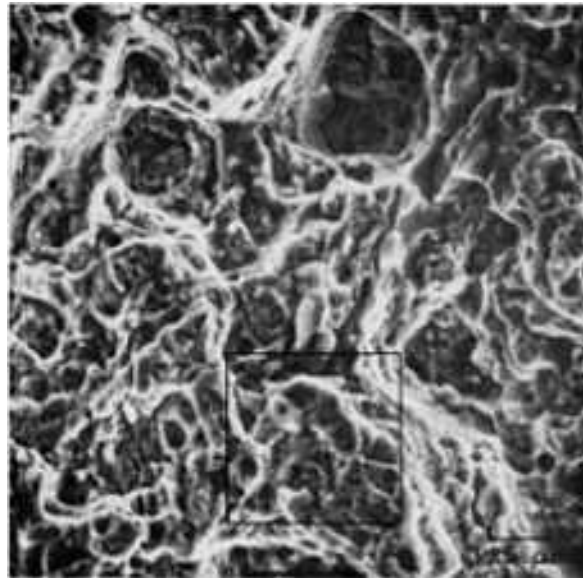
**Fig. 1032** Area in the rectangle in Fig. 1031, as seen at five times the magnification there. Large dimples show the inclusions that initiated them; fine dimples that are too small to be resolved at this magnification exist among the large dimples. See also Fig. 1033. SEM, 400 $\times$

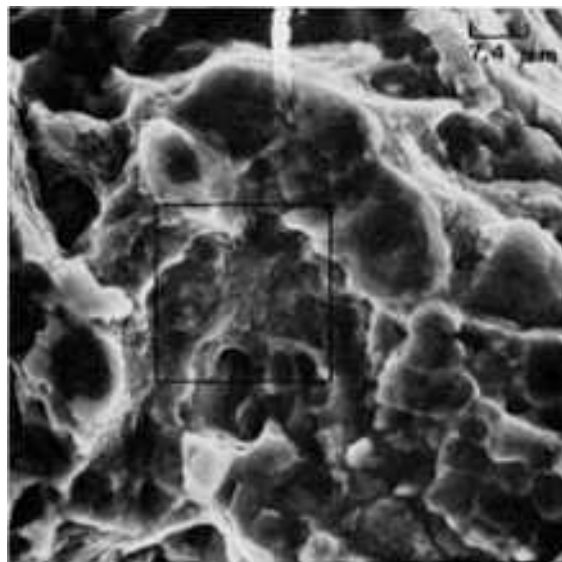
**Fig. 1033** View at still higher magnification of the area in the rectangle in Fig. 1032. The fine dimples can just be distinguished on the surfaces adjacent to the large dimples. Many alloy second-phase particles are discernible, although some are so deep within the dimples as to be nearly invisible. See also Fig. 1034. SEM, 1340 $\times$

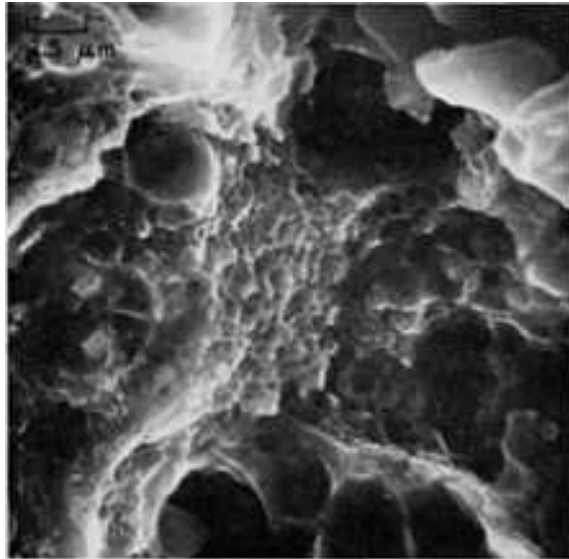
**Fig. 1034** Greatly magnified view of the fracture region in Fig. 1031, showing the area in the rectangle in Fig. 1033. The region at center is made up of equiaxed dimples of quite uniform size. Note that several dimples are too deep for their bottoms to be lighted by an exposure proper for most of the dimples. SEM, 4000×

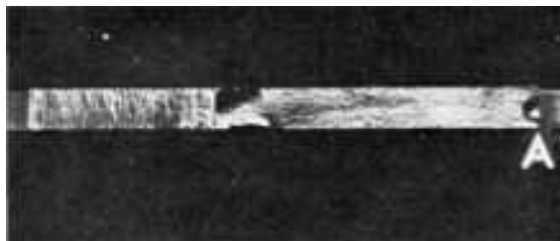
**Fig. 1035** Fatigue-fracture surface of a bomb-rack side plate fabricated of aluminum alloy 7075-T6. Saw marks at left were made in opening up the fatigue crack for study. Crack origin was found to be at the edge of an attachment hole (marked A, at right). See Fig. 1036 for a view of the area near A at 5×. Actual size

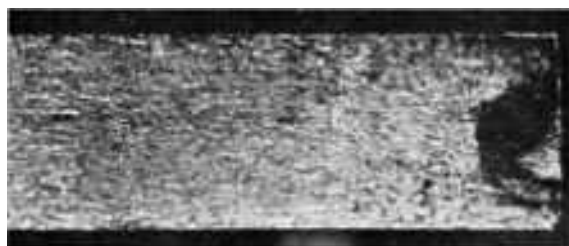
**Fig. 1036** Enlarged view of the area near A in Fig. 1035, showing corrosion (in dark area at right end) at the site of crack initiation. The side plate had been used as a fuel-tank support element in a 25-h ground-level qualification test of the tank in a corrosive environment under spectrum loading. See also Fig. 1037. 5×

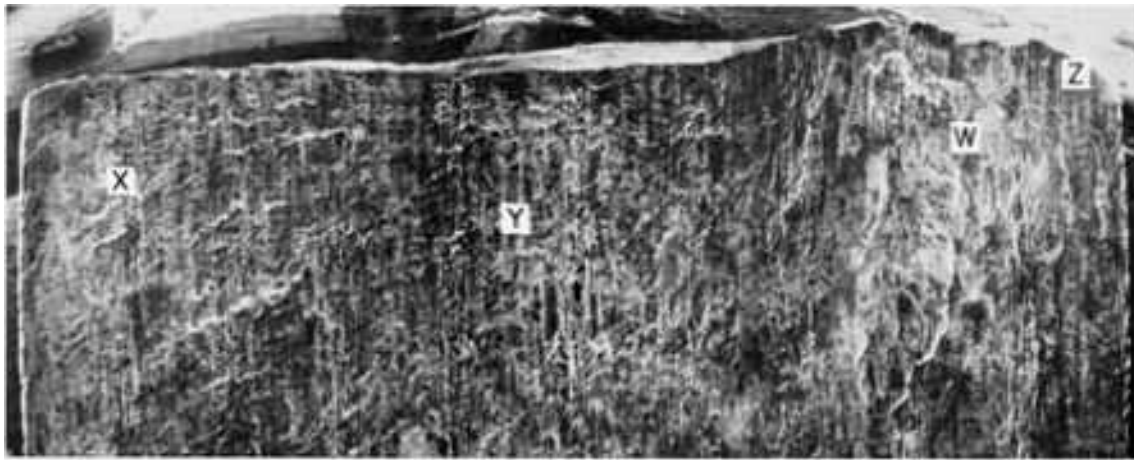
**Fig. 1037 Composite of three low-magnification SEM fractographs of the surface of the fatigue fracture at A in Fig. 1035 after ultrasonic cleaning. A small portion of the attachment hole is visible along the top of this view. The lack of beach marks here is perhaps due to the brevity of the test (25 h). Attempts to locate the exact point of crack initiation were not successful, because of the presence of tool marks at the edge of the attachment hole. It is believed, from the orientation of the fatigue striations at W, X, Y, and Z (see Fig. 1038, 1039, 1040, and 1041 for enlarged views of these areas), that the crack began at top right, near the edge of the attachment hole. 26×**

**Fig. 1038 Area Z in Fig. 1037, which shows clear, well-defined fatigue striations. Normals to the striations point to the crack origin at the nearby corner of the attachment hole. SEM, 670×**

**Fig. 1041** View of area X in Fig. 1037. This area, which is near the top left corner of the attachment hole, shows numerous fatigue facets that contain striations. SEM, 2000×

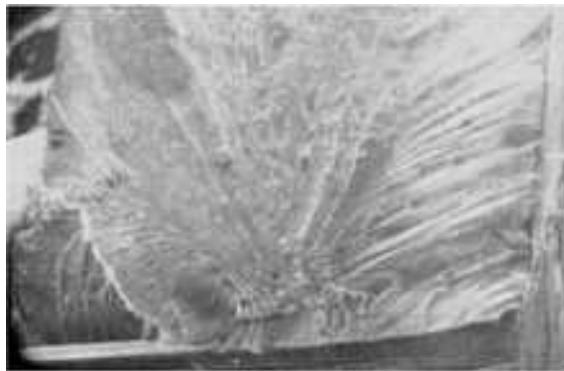
**Fig. 1042** Fatigue fracture in a notched plate specimen of aluminum alloy 7075-T6 subjected to cyclic stresses in air. (Notch is at bottom; sides of plate, at far left and right). It is apparent that the fracture consists of at least three cracks that formed on various planes and temporarily grew independently. SEM, 26×

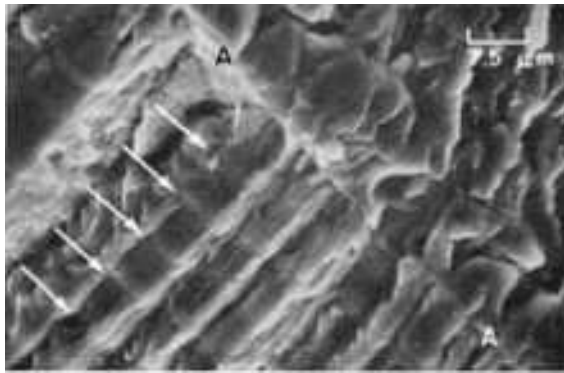
**Fig. 1043** Fatigue fracture in a specimen of aluminum alloy 7075-T6 tested in air. The surface exhibits a pattern of brittle, widely spaced striations (at arrows) that are nearly parallel to a grain boundary (A-A). The tensile component (wide, flat region) of each striation was formed by a cleavage fracture. SEM, 1325×

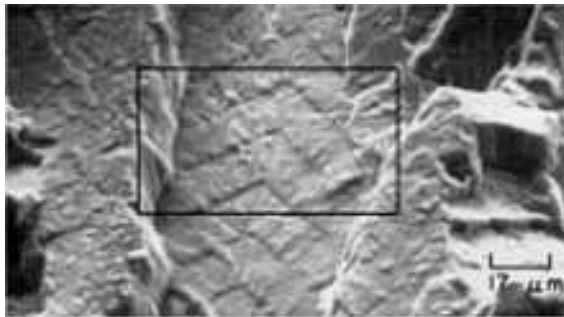
**Fig. 1044** Corrosion-fatigue fracture in a specimen of aluminum alloy 7075-T6 tested in distilled water. Surface exhibits fatigue striations. The unusual sharp angle in the striations defines the location of a nearly vertical grain boundary in the central grain. Area in rectangle is shown at higher magnification in Fig. 1045. SEM, 600×

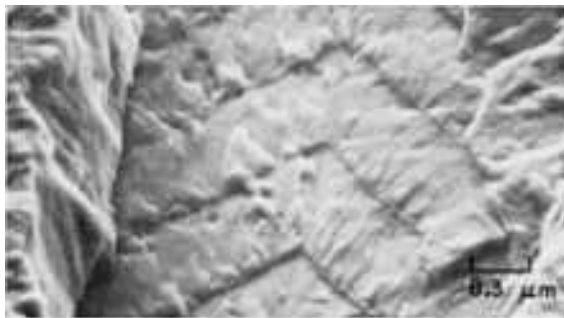
**Fig. 1045** View of the area in the rectangle in Fig. 1044, at double the magnification there. Observe the wide, flat regions of the fatigue striations; these regions have progressed by cleavage. The unusual angled shape of the striations is the result of adherence of the crack fronts to crystallographic directions. SEM, 1200×

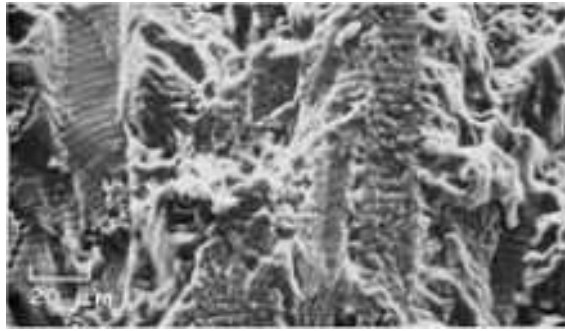
**Fig. 1046** Corrosion-fatigue fracture in a specimen of aluminum alloy 7075-T6 that was tested in a 3.5% NaCl solution. Surface shows two types of striations: at left and at lower right are grains with ductile striations, and between them lies a grain with pronounced brittle striations. See also Fig. 1047. SEM, 500×

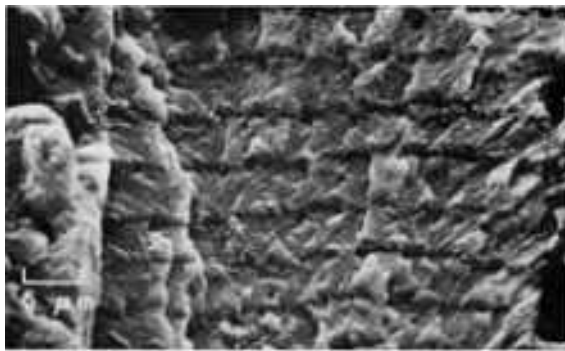
**Fig. 1047** Brittle striations in a corrosion-fatigue fracture in a specimen of aluminum alloy 7075-T6 that, like the specimen in Fig. 1046, was tested in a 3.5% NaCl solution. Striations (horizontal here) have very uniform spacing. SEM, 2000×

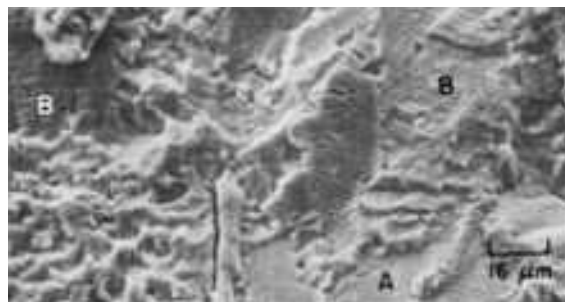
**Fig. 1048** Corrosion-fatigue fracture in aluminum alloy 7075-T6 tested in a 3.5% NaCl solution. During testing, specimen was subjected to an applied electrical potential of -0.700 mV as measured against a standard calomel electrode. A mixture of ductile striations (at A) and brittle striations (at B) is evident, with some fissures. See also Fig. 1049. SEM, 625×

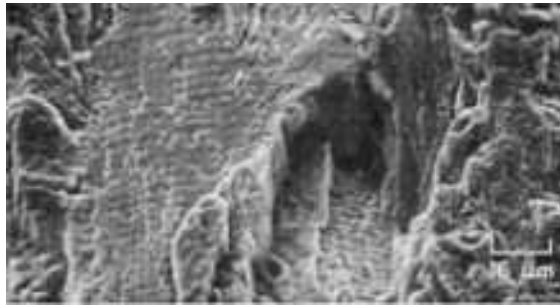
**Fig. 1049** Corrosion-fatigue fracture in a specimen of aluminum alloy 7075-T6 tested in a 3.5% NaCl solution and, during testing, subjected to an applied electrical potential of -1.200 mV (versus -0.700 mV for the specimen in Fig. 1048). Surface shows brittle striations with typical topography; no evidence of striation fissures. See also Fig. 1050. SEM, 640×

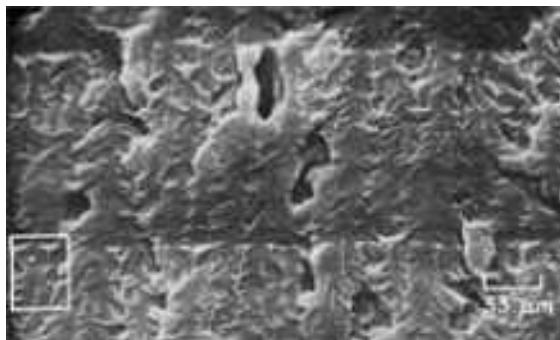
**Fig. 1050** Corrosion-fatigue fracture in a specimen of aluminum alloy 7075-T6 that, like the specimen in Fig. 1049, was tested in a 3.5% NaCl solution while subjected to an applied electrical potential of -1.200 mV. Note the extremely large striation spacing; only two readily apparent adjacent brittle-striation peaks are included in this view. See also Fig. 1051. SEM, 300×

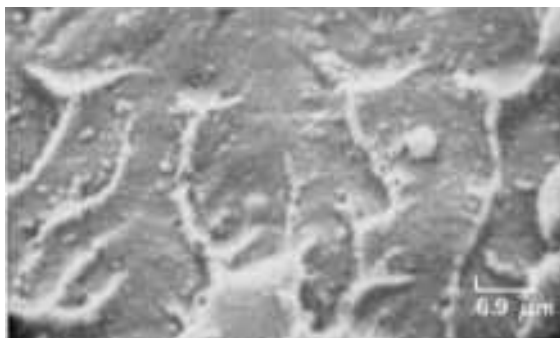
**Fig. 1051** Higher-magnification view of the fracture in Fig. 1050, showing an area of which the right half is outlined by the rectangle there. The wide, flat portion of a single striation is visible, beginning at the peak near the top. The surface configuration in this region of cleavage separation suggests a set of river patterns, exaggerated by corrosion products. SEM, 1450×

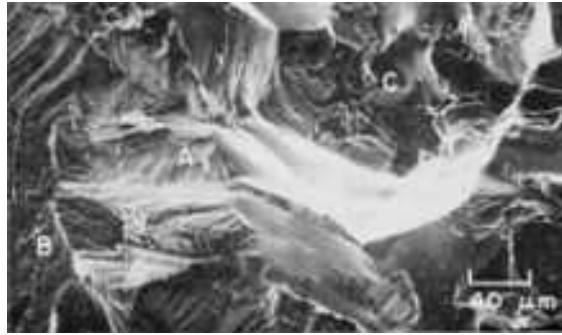
**Fig. 1052** Fatigue-fracture surface of a test bar cast from aluminum alloy 7075, aged to the T6 temper and then tested in a 3.5% NaCl solution. A diagonal region of fatigue striations is visible at A; this region abuts areas of intergranular fracture (at B) and interdendritic porosity (at C). SEM, 250×

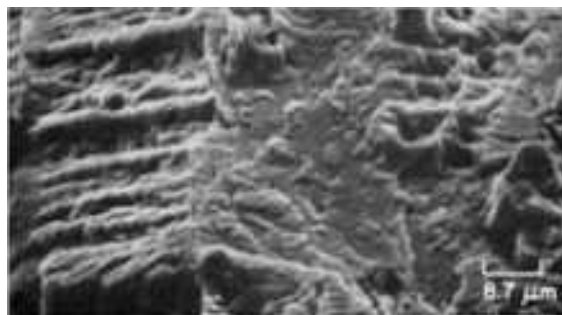
**Fig. 1053** Fatigue-fracture in a cast single-crystal specimen of aluminum alloy 7075 that was aged to the T6 temper and then tested in a 3.5% NaCl solution. Most of the view is filled with an interdendritic network of solidification porosity, which did not halt or blunt the fatigue crack. SEM, 250×

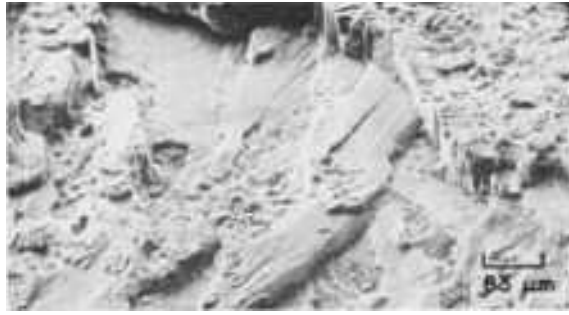
**Fig. 1054** Surface of a corrosion-fatigue fracture in a specimen of aluminum alloy 7075-T6 that was tested in a 3.5% NaCl solution. Shown here are portions of two grains that exhibit brittle striations; the difference in appearance of their striations is caused by the difference in grain orientation. The vertical dividing line is the boundary between the grains. SEM, 1150×

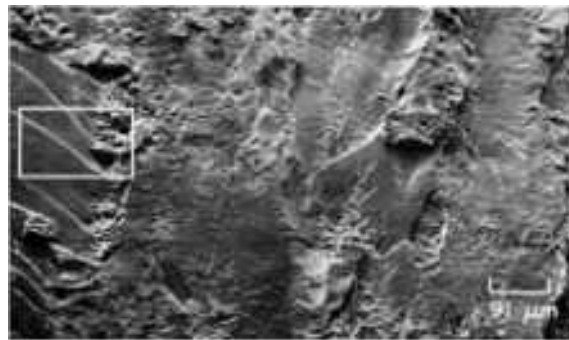
**Fig. 1055** An area of the corrosion-fatigue fracture surface of an aluminum alloy 7075-T651 that was tested in a 3.5% NaCl solution under a cyclic stress-intensity range ( $\Delta K$ ) of  $6.6 \text{ MPa}\sqrt{m}$  ( $6 \text{ ksi}\sqrt{in}$ ) at 10 cps. Ductile and brittle striations would be expected in such a fracture, but cannot be resolved at this magnification. See also Fig. 1056. SEM, 120×

**Fig. 1056** Another area of the fracture surface of which a portion is shown in Fig. 1055. This possesses similar features, but the surface is flatter, lacking the blufflike cleavage steps present in Fig. 1055. Again, fatigue striations are unresolved. See also Fig. 1057. SEM, 110×

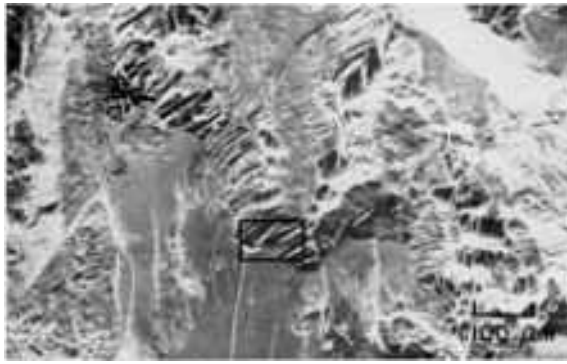
**Fig. 1057** Area in the rectangle in Fig. 1056, at higher magnification, showing the edge of the smooth area believed to possess patches of ductile striations. Compare these features with those of the 7475-T6 specimen (also tested in 3.5% NaCl) in Fig. 1058 and 1059. SEM, 560×

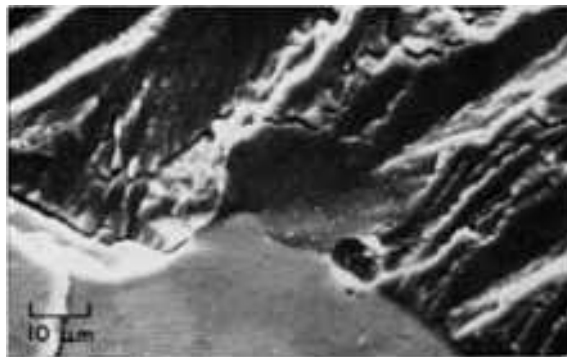
**Fig. 1058** Corrosion-fatigue fracture in aluminum alloy 7475-T6 tested in a 3.5% NaCl solution under a cyclic stress-intensity range ( $\Delta K$ ) of  $13 \text{ MPa}\sqrt{m}$  ( $12 \text{ ksi}\sqrt{in}$ ) at 10 cps, showing contrasting features: ductile striations (unresolved) in smooth regions; brittle striations in adjacent grains. See also Fig. 1059. SEM, 100×

**Fig. 1059** The area outlined by the rectangle in Fig. 1058, as seen at ten times the magnification there, which makes the fine fatigue striations in the smooth region clearly visible. Above are brittle striations forming, at a steep incline, what is in effect a cleavage step up to a second fracture level. SEM, 1000×

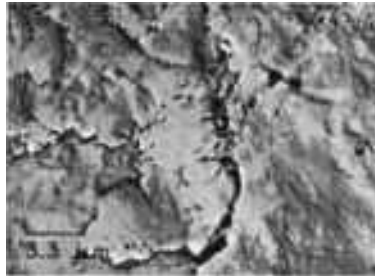
**Fig. 1065** Polished and etched section through the fractured aluminum alloy 7075-T6 bulkhead cap in Fig. 1060, showing the fracture surface in profile at left. Note change in grain flow produced during extrusion, from a longitudinal orientation at right to transverse at left; transverse orientation results in grains being parallel to the fracture surface, a condition that aggravates stress-corrosion cracking. Etched in Keller's reagent, 20×

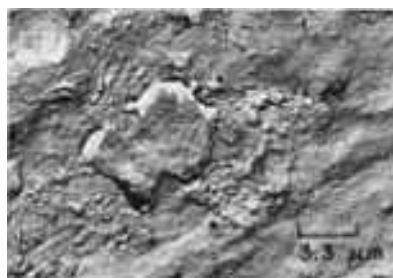
**Fig. 1066** TEM p-c replica of an area of the fracture surface in Fig. 1060 near the edge at which fracture was initiated, showing corrosion debris on a very flat intergranular surface. The original separated-grain facets have been corroded away. 3000×

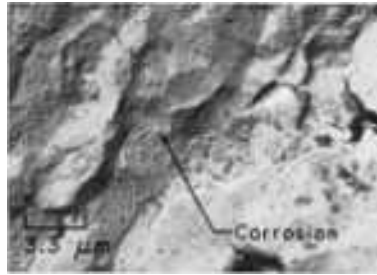
**Fig. 1067** TEM p-c replica taken from another area of the fracture surface in Fig. 1060 near the edge at which fracture was initiated. This area, like the one in Fig. 1066, shows that cracking was intergranular and was accomplished by severe corrosion. 3000×

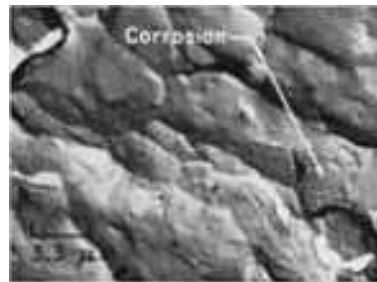
**Fig. 1068** TEM p-c replica of an area of the fracture surface in Fig. 1060 deeper into the fracture than Fig. 1066 and 1067; here, corrosion of the separated-grain facets is evident, although not as severe as in areas nearer the edge at which fracture was initiated. 3000×

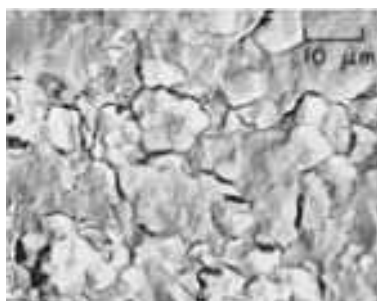
**Fig. 1069** Area of the fracture surface in Fig. 1060 still farther from the initiation edge than Fig. 1068. This surface, although still intergranular, is relatively free of corrosion products. In a portion of the fracture formed later, evidence of fatigue was found. Final fracture was by shear. TEM p-c replica, 3000×

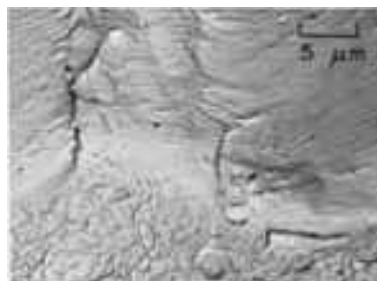
**Fig. 1070** TEM p-c replica of the surface of an intergranular fracture in an aircraft landing-gear component of forged aluminum alloy 7075-T6 that fractured as the result of stress-corrosion cracking. Note the secondary cracks between the grains. 1000×

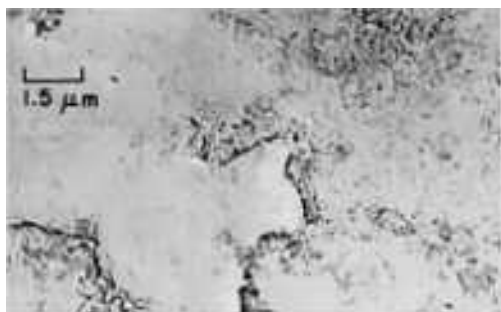
**Fig. 1071** TEM p-c replica of the surface of a fracture in a specimen of aluminum alloy 7075-T6 that first was

cracked by fatigue and then was broken by impact. Stretching and serpentine glide are evident at about mid-height, at the root of the fatigue crack; below are tear dimples formed on impact. 2000×

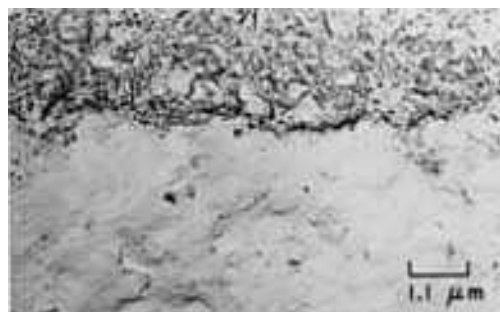
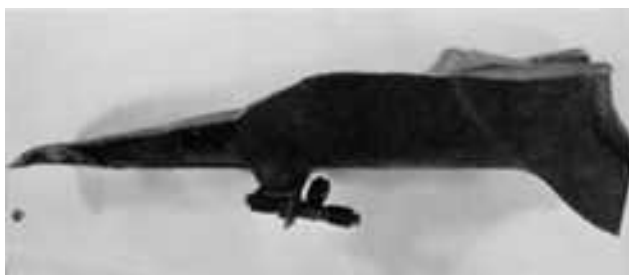
**Fig. 1072**

TEM p-c replicas of two areas of the surface of a fracture in a forged aluminum alloy 7075-T6 support for a cargo-door cylinder. The fracture, which originated at a cold shut, formed at an attachment hole that extended above and below the cold shut. These TEM replicas reveal that the fracture surface is flat and encrusted with oxide particles. Fig. 1072: 6500×. Fig. 1073: 9300×

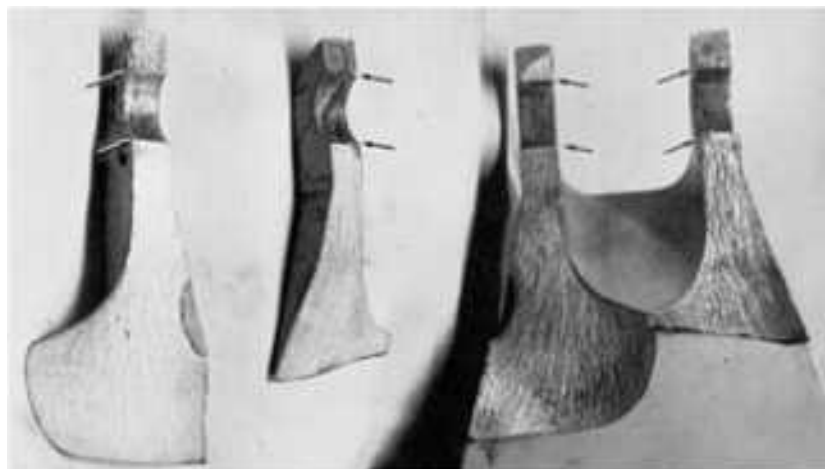
**Fig. 1077** Portion of a broken aircraft landing-gear actuator beam of Al alloy 7079-T6, showing stress-corrosion fractures (at arrow). 0.17×

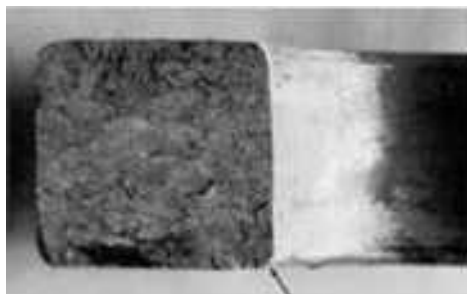
**Fig. 1078 Higher-magnification view of the surfaces of the stress-corrosion fractures shown in Fig. 1077. These fractures originated at the interior edges of boltholes in clevis-attachment lugs, at the locations designated by the arrows. An appreciable amount of evidence of both corrosion and secondary cracking was found at these origins. Visible are chevron marks, which also confirm these locations as the origins of fracture. 0.63×**

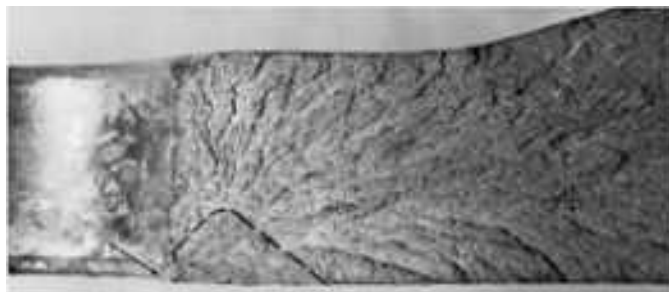
**Fig. 1079 Fracture surface outboard of the bolthole in the clevis-attachment lug at right in Fig. 1078. Entire surface is typical of stress-corrosion cracking. Origin is at arrow (lower right corner of surface). 4×**

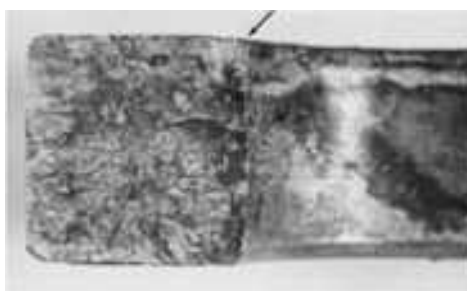
**Fig. 1080 Fracture surface inboard of the bolthole in the clevis-attachment lug in Fig. 1079. The primary stress-corrosion crack, which originated at arrow, is within the area enclosed by the dashed line (lower left). The remainder of this surface shows chevron marks typical of final fast fracture. 4×**

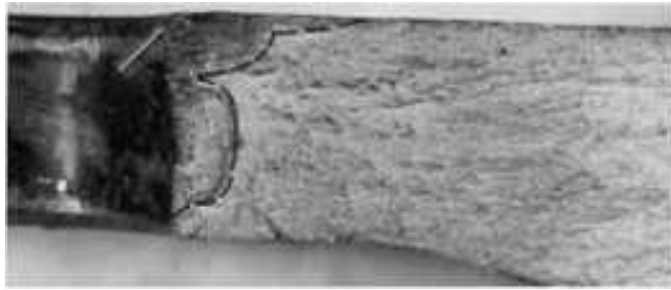
**Fig. 1081 Fracture surface outboard of the bolthole in the lug at left in Fig. 1078. Here, as in Fig. 1079, the entire surface is typical of stress-corrosion cracking. Origin is at arrow (upper right corner of surface). 4×**

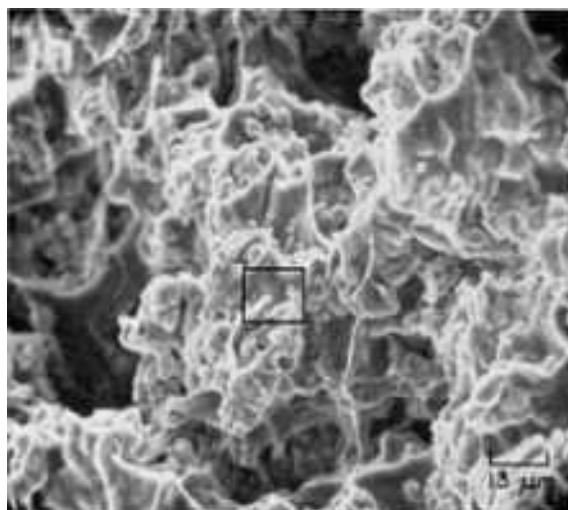
**Fig. 1083** Tensile-overload fracture in a specimen of a superplastic eutectic alloy containing 67% Al and 33% Cu. The material was cast, and the as-cast ingot was extruded at 430 °C (805 °F). Testing was performed at 0.025 mm/s (0.001 in./s) and at a controlled temperature of 450 °C (840 °F). The surface shows course dimples and an irregular contour. There is some suggestion of a shear lip, but it is not sharply defined. See also Fig. 1084. SEM, 70×

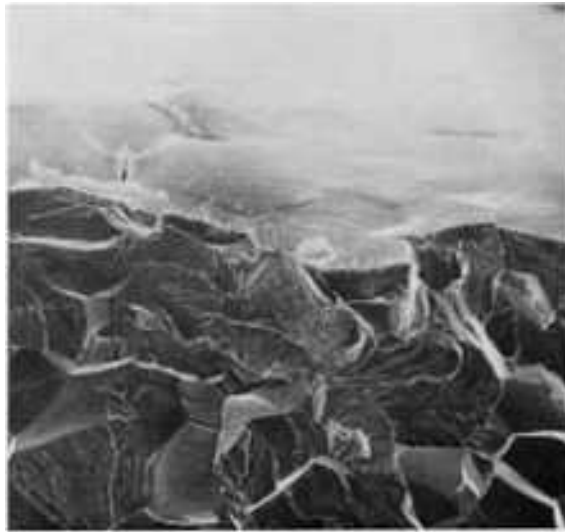
**Fig. 1088** Transgranular corrosion-fatigue crack propagation in a solution-treated and peak-aged Al-5.6Zn-1.9Mg sample tested in humid nitrogen gas. Compare with Fig. 1091 and 1092. SEM, 5000× (R.E. Ricker, University of Notre Dame, and D.J. Duquette, Rensselaer Polytechnic Institute)

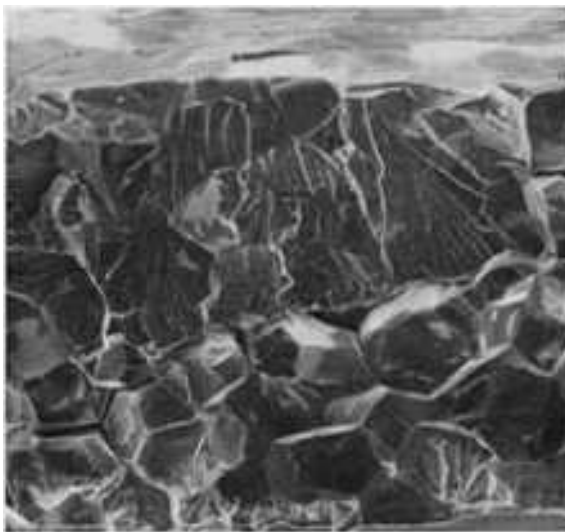
**Fig. 1089 The external surface (top) and the corrosion-fatigue fracture surface (bottom) of a solution-treated and peak-aged Al-5.6Zn-1.9Mg sample tested in high-purity deaerated water. SEM, 100× (R.E. Ricker, University of Notre Dame, and D.J. Duquette, Rensselaer Polytechnic Institute)**

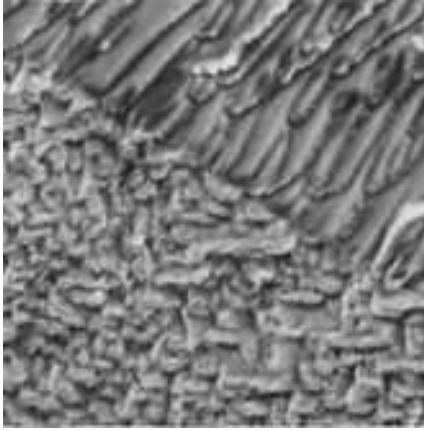
**Fig. 1090 The external surface (top) and the corrosion-fatigue fracture surface (bottom) of a solution-treated and peak-aged Al-5.6Zn-1.9Mg sample tested in deaerated 0.5 mol NaCl at a cathodic potential of -1.6 V (SCE). Compare with Fig. 1089, 1093, and 1095. SEM, 100× (R.E. Ricker, University of Notre Dame, and D.J. Duquette, Rensselaer Polytechnic Institute)**

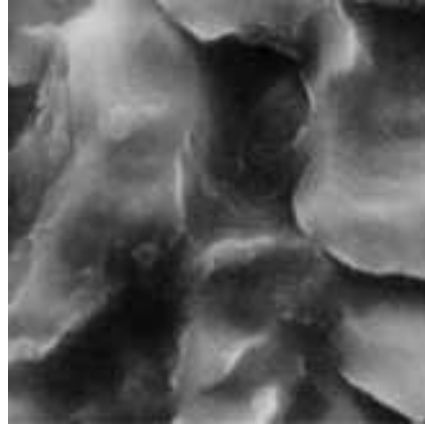
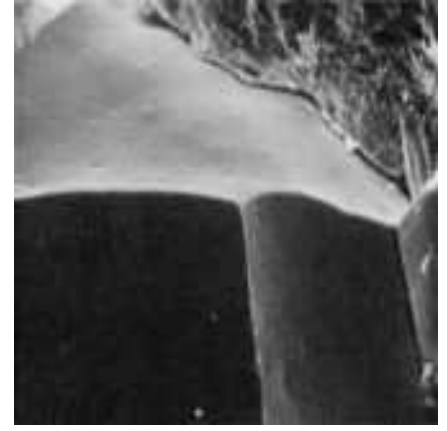
Fatigue crack propagation in a solution-treated and peak-aged Al-5.6Zn-1.9Mg sample tested in an inert environment (dry nitrogen gas). Compare with the examples in Fig. 1088, 1089, 1090, 1094, and 1095 of corrosion fatigue in this experimental alloy. Fig. 1091: Region of transgranular fatigue crack propagation. SEM, 500 $\times$ . Fig. 1092: High-magnification view of fine fatigue striations on a transgranular portion of the fracture surface. SEM, 10,000 $\times$ . Fig. 1093: Typical region of intergranular fracture in an Al-5.6Zn-1.9Mg alloy tested in an inert environment. SEM, 500 $\times$  (R.E. Ricker, University of Notre Dame, and D.J. Duquette,

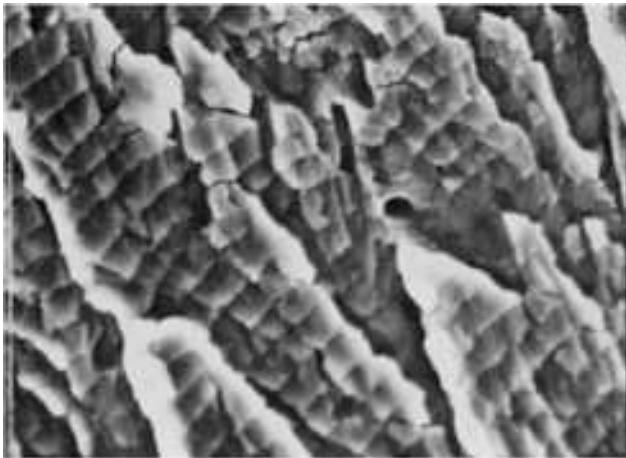
**Fig. 1094**

Corrosion-fatigue crack propagation in solution-treated and peak-aged Al-5.6Zn-1.9Mg tested in deaerated 0.5 mol Na<sub>2</sub>SO<sub>4</sub>. Fig. 1094: Region of transgranular crack propagation. Direction of crack growth is toward the top left. Compare with Fig. 1088, 1091, and 1092. SEM, 2000 $\times$ . Fig. 1095: Region of intergranular crack propagation. Crack growth direction is toward the top. Compare with Fig. 1093. SEM, 1000 $\times$  (R.E. Ricker, University of Notre Dame, and D.J. Duquette, Rensselaer Polytechnic Institute)

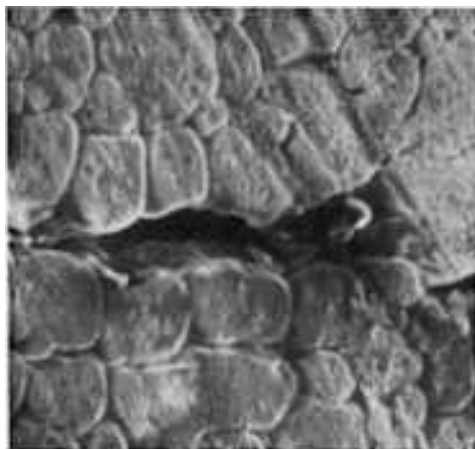
**Fig. 1096** Fracture along prior powder particle boundaries in cold-rolled Al-4.2Mg-2.1Li. The experimental P/M alloy was solution treated for 1 h at 510 °C (950 °F), water quenched, naturally aged, and then cold rolled to a 4% thickness reduction in one pass. The cracks at particle boundaries reflect the low ductility typical of aluminum-lithium alloys. SEM, 375× (R.E. Ricker, University of Notre Dame, and D.J. Duquette, Rensselaer Polytechnic Institute)

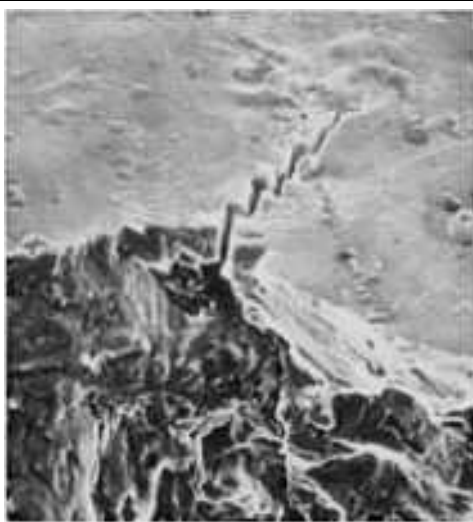
**Fig. 1097**

Corrosion-fatigue crack initiation and propagation in a solution-treated and peak-aged Al-4.2Mg-2.1Li P/M alloy tested in deaerated high-purity water. Fig. 1097: View of external surface (top) and fracture surface (bottom). SEM, 500×. Fig. 1098: Higher-magnification view of fracture surface. SEM, 1000× (R.E. Ricker, University of Notre Dame, and D.J. Duquette, Rensselaer Polytechnic Institute)

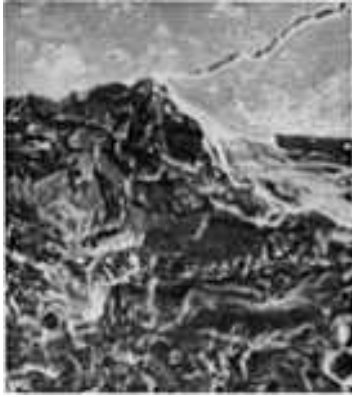
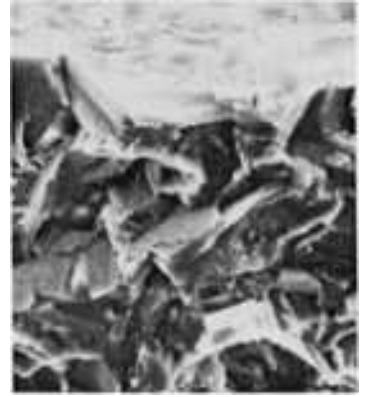
**Fig. 1099**

Corrosion-fatigue crack propagation in a solution-treated and peak-aged Al-4.2Mg-2.1Li P/M alloy tested in deaerated 0.5 mol Na<sub>2</sub>SO<sub>4</sub>. Fig. 1099: View of external surface (top) and fracture surface (bottom). SEM, 400×. Fig. 1100: Corrosion products on the fracture surface. SEM, 800× (R.E. Ricker, University of Notre

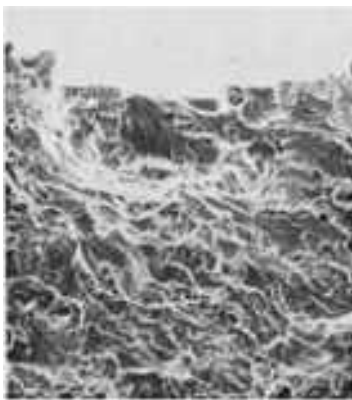
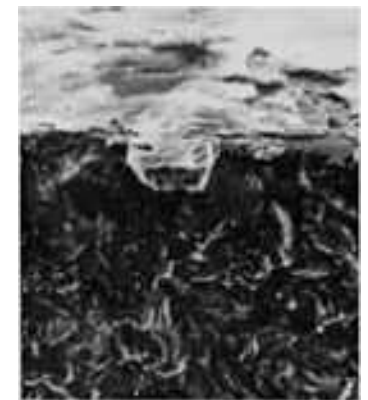
**Fig. 1101**

Corrosion-fatigue crack propagation and initiation in a solution-treated and peak-aged Al-4.2Mg-2.1Li P/M alloy tested in deaerated 0.5 mol NaCl at a cathodic potential of -1.6 V (SCE). Fig. 1101: View of external surface (top) and fracture surface (bottom). SEM, 200×. Fig. 1102: Corrosion products on both the external surface and the fracture surface. SEM, 200× (R.E. Ricker, University of Notre Dame, and D.J. Duquette, Rensselaer Polytechnic Institute)
