ASM HANDBOOK®

VOLUME  
12

Fractography

*Fractography*, was published in 1987 as Volume 12 of the *ASM Handbook*. The Volume was prepared under the direction of the ASM Handbook Committee.

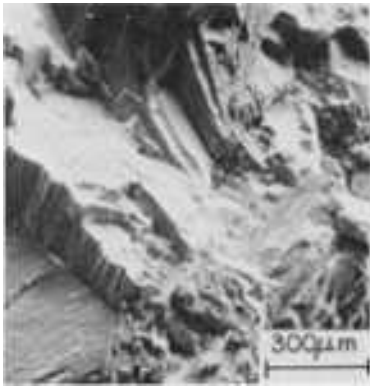
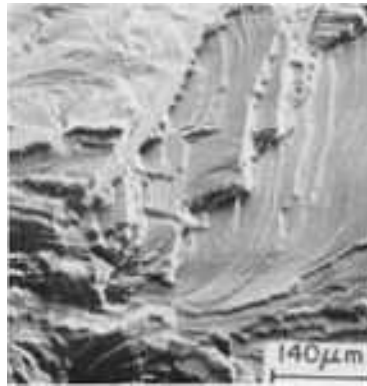
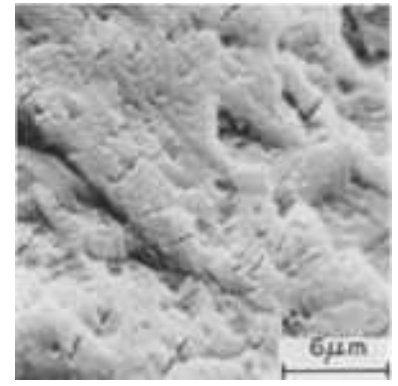
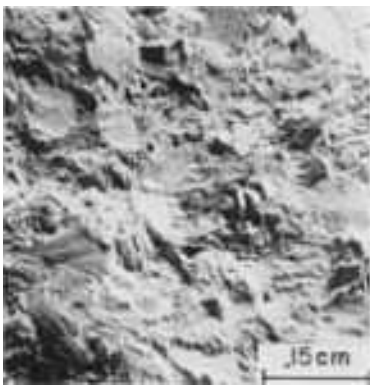
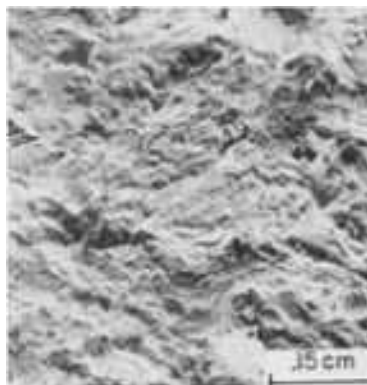
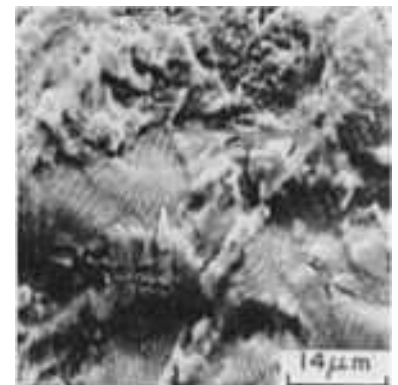
Fatigue crack growth fracture topography in a Ti-6Al-2Sn-4Zr-2Mo-0.1Si (Ti-6242, UNS R54620) forging,  $\alpha + \beta$  processed prior to  $\beta$  heat treatment and aging. Compact tension specimen tested in air at 25 °C (75 °F). As crack growth rate ( $da/dN$ ) and stress-intensity factor ( $\Delta K$ ) increased, the fracture surface changed from one characterized by large transgranular facets to one exhibiting intergranular facets and dimples. Crack growth direction is from left to right. Fig. 1103, 1104 and 1105: Fracture surface at low  $\Delta K$  ( $<25 \text{ MPa } \sqrt{m}$ , or  $23 \text{ ksi } \sqrt{in}$ ) and  $da/dN$  of  $0.005 \text{ } \mu\text{m/cycle}$ . Note large transgranular facets in Fig. 1103 and 1104. Intermixed with the facets were regions of pronounced secondary cracking (Fig. 1105). SEM; 60 $\times$ , 125 $\times$ , and 2900 $\times$ . Fig. 1106: At intermediate  $\Delta K$  (25 to  $38 \text{ MPa } \sqrt{m}$ , or  $23 \text{ to } 35 \text{ ksi } \sqrt{in}$ ) and a  $da/dN$  of  $0.1 \text{ } \mu\text{m/cycle}$ , the amount of faceting decreased, being replaced by more ductile modes of fracture. SEM, 12 $\times$ . Fig. 1107 and 1108: At high  $\Delta K$  ( $>38 \text{ MPa } \sqrt{m}$ , or  $35 \text{ ksi } \sqrt{in}$ ) and  $da/dN$  of  $0.5 \text{ } \mu\text{m/cycle}$ , the fracture surface was characterized by striations, microvoids, and dimples. SEM, 12 $\times$  and 1250 $\times$ . Fig. 1109 and 1110: Final separation occurred along prior- $\beta$  grain boundaries (Fig. 1109,  $da/dN = 20 \text{ } \mu\text{m/cycle}$ ), with the intergranular fracture surface exhibiting dimples (Fig. 1110, fast fracture region). SEM, 150 $\times$  and 3500 $\times$  (J.A. Ruppen and A.J. McEvily, University of Connecticut)

Same material as in Fig. 1103, 1104, 1105, 1106, 1107, 1108, 1109, and 1110, but tested in air at 540 °C (1000 °F). Crack growth direction is from right to left. Fig. 1111: At  $da/dN = 0.018 \mu\text{m}/\text{cycle}$ , the fracture surface was 100% faceted. The macroscopically smoother surface (compare with Fig. 1103) reflects the effect of oxidation. SEM, 150×. Fig. 1112: High-magnification view of a facet reveals parallel markings that indicate the underlying  $\alpha$ -platelet microstructure and highlight the tendency for crack propagation to occur perpendicular to the  $\alpha$  platelets. One of many small, parallel cracks is noted at A. SEM, 1500× (J.A. Ruppen and A.J. McEvily, University of Connecticut)

Same material as in Fig. 1103, 1104, 1105, 1106, 1107, 1108, 1109, 1110, 1111, and 1112, but tested in vacuum at room and elevated temperatures. Fracture surfaces were more ductile appearing, and striation formation was suppressed (compare with samples tested in air). Fig. 1113: At 25 °C (75 °F) and  $da/dN = 0.0051 \mu\text{m}/\text{cycle}$ , both the degree of faceting and the irregularity of the fracture surface were reduced (compare with Fig. 1104). Crack growth direction is from left to right. SEM, 1500×. Fig. 1114: At 540 °C (1000 °F) and  $da/dN = 0.0051 \mu\text{m}/\text{cycle}$ , the amount of faceting increased but not to the extent observed in samples tested in air (Fig. 1111). Crack growth direction is from right to left. SEM, 840× (J.A. Ruppen and A.J. McEvily, University of Connecticut)

Fatigue crack growth fracture topography in a Ti-6Al-2Sn-4Zr-2Mo-0.1Si (Ti-6242, UNS R53620) forging,  $\beta$  processed prior to  $\alpha + \beta$  heat treatment and aging. (Contrast with the  $\alpha + \beta$  forging in Fig. 1103, 1104, 1105, 1106, 1107, 1108, 1109, 1110, 1111, 1112, 1113, and 1114.) Compact tension specimen tested in air at room and elevated temperatures. Crack growth direction is from left to right in room-temperature fractographs, and from right to left in elevated-temperature fractographs. Fig. 1115 and 1116: At low  $da/dN$  (0.025  $\mu\text{m}/\text{cycle}$ ) and at 25 and 540 °C (75 and 1000 °F), respectively, the  $\beta$  forging exhibited a less irregular fracture surface consisting of smaller facets (compare with Fig. 1103 and 1111). Features in this microstructure-sensitive regime are related to the prior- $\beta$  grain size of the  $\beta$  forging and the colony size of the  $\alpha + \beta$  forging. SEM, 150 $\times$ . Fig. 1117 and 1118: At higher  $da/dN$  (2.5  $\mu\text{m}/\text{cycle}$ ) and at 25 and 540 °C (75 and 1000 °F), respectively, fracture modes were the same in both  $\beta$  and  $\alpha + \beta$  forged material, but the  $\beta$  forging exhibited elongated dimples corresponding to the underlying  $\alpha/\beta$  platelet microstructure (Fig. 1117) and more secondary cracking at elevated temperature (Fig. 1118). SEM, 350 $\times$  and 150 $\times$  (J.A. Ruppen and A.J. McEvily, University of Connecticut)

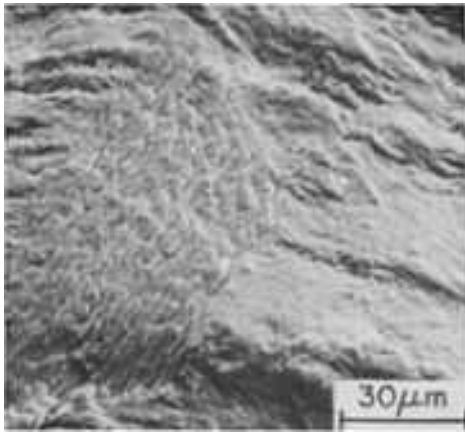
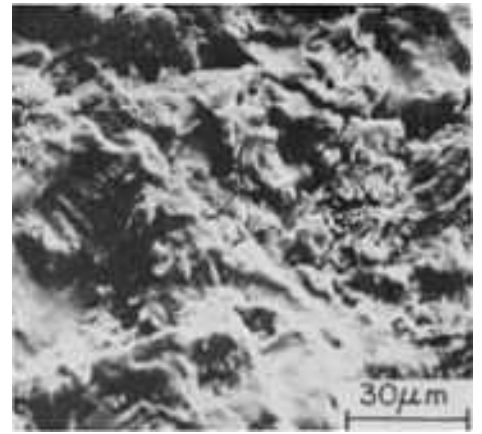
**Fig. 1119**

Same material as in Fig. 1115, 1116, 1117, and 1118, but tested in vacuum at room temperature. The  $\beta$  forging exhibited a sharp change in fracture appearance corresponding to a  $da/dN$  of  $0.1 \mu\text{m}/\text{cycle}$ . Crack growth direction is from right to left. Fig. 1119: Fracture surface at  $da/dN = 0.0076 \mu\text{m}/\text{cycle}$ . Crack growth is structure sensitive. SEM,  $700\times$ . Fig. 1120: Fracture surface at  $da/dN = 0.13 \mu\text{m}/\text{cycle}$ . Crack growth is now structure insensitive, characterized by a rougher surface with dimples and voids. SEM,  $700\times$  (J.A. Ruppen and A.J. McEvily, University of Connecticut)

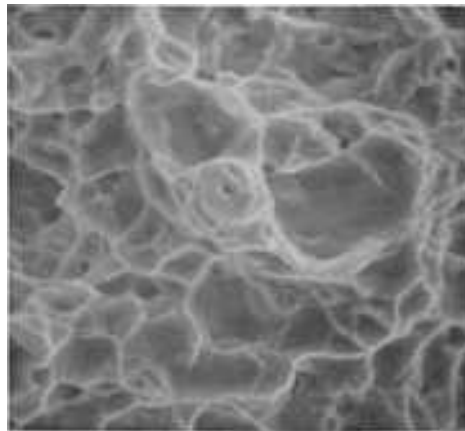
**Fig. 1121 Ductile overload fracture of a tensile specimen of Ti-6Al-4V ELI (ASTM F136, UNS R56401).** The wrought alloy was annealed for 1 h at  $760^\circ\text{C}$  ( $1400^\circ\text{F}$ ) and air cooled prior to testing. The fracture surface is characterized by essentially 100% dimpled rupture. SEM,  $1000\times$  (R. Abrams, Howmedica, Pfizer Hospital Products Group Inc.)

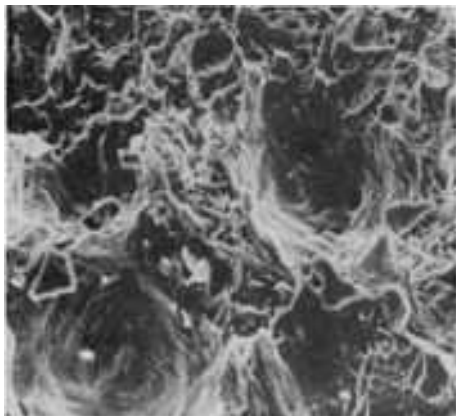
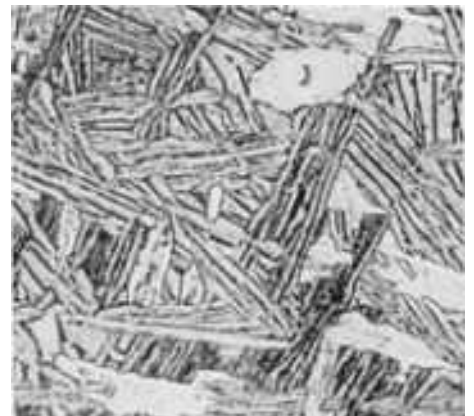
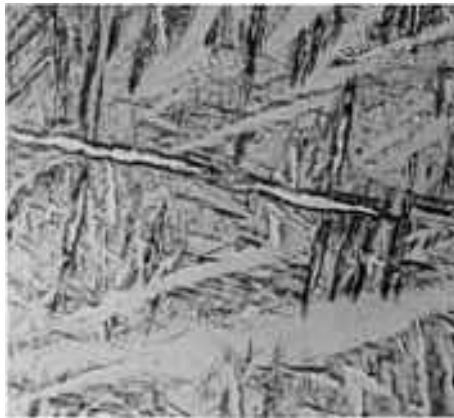
Ductile fracture of laser beam welded Ti-6Al-2Nb-1Ta-1Mo (Ti-6211, UNS R56210). A plate measuring 13 mm (0.5 in.) thick was welded using beam power of 8 kW, speed of 28 mm/s (65 in./min), and heat input of 0.29 kJ/mm (7.4 kJ/in.). Fig. 1122: Fracture surface of the dynamic tear test specimen indicates 100% ductile rupture via microvoid coalescence. Mechanical properties of the weld were excellent, even though some porosity is evident. SEM, 500 $\times$ . Fig. 1123: Microstructure of the titanium alloy base plate features the basketweave appearance of Widmanstätten  $\alpha$ . Primary  $\alpha$  and  $\beta$  phase are also present. Hardness: 32 to 40 HRC. Keller's etch, 1000 $\times$ . Fig. 1124: Microstructure of the fusion zone features needlelike martensitic  $\alpha$  surrounded by some  $\beta$  phase, and the boundaries of the elongated  $\beta$  grains present prior to cooling. Hardness: 32 to 38 HRC. Keller's etch, 500 $\times$  (E.A. Metzbower and D.W. Moon, Naval Research Laboratory)

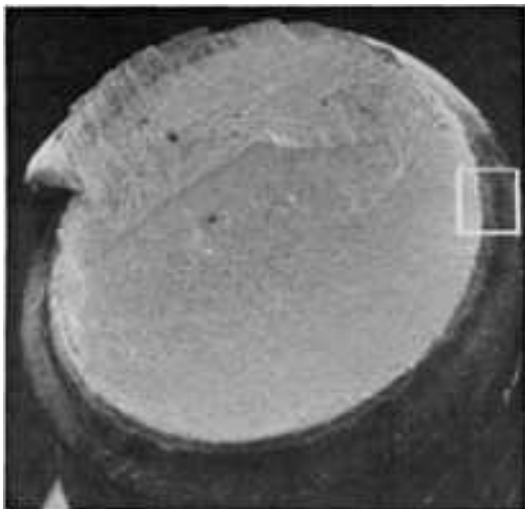
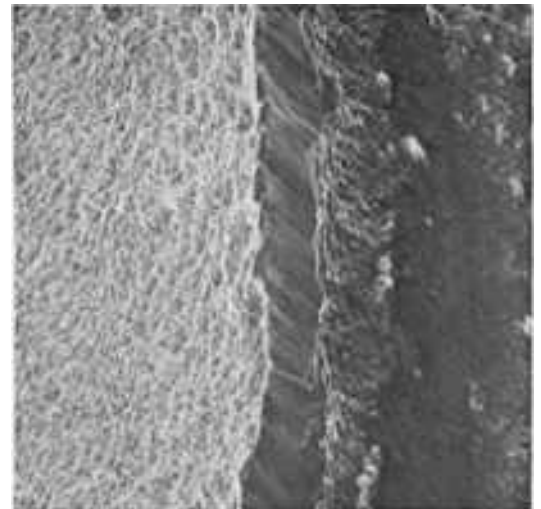
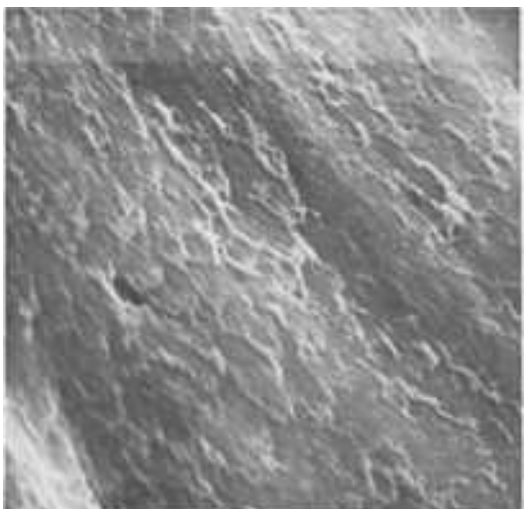
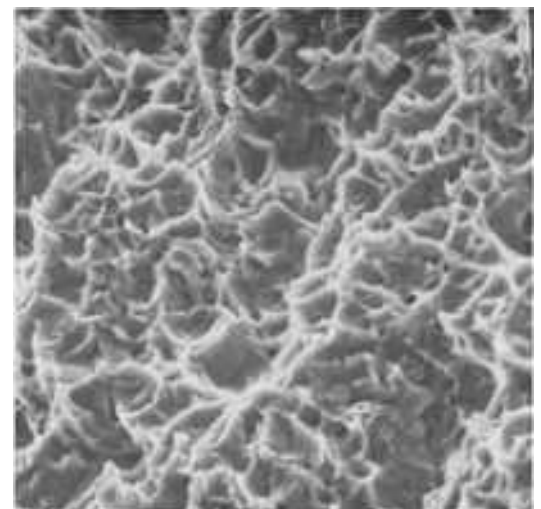
Fracture of Ti-6Al-4V (UNS R56400) threaded fasteners during installation due to the presence of high-

angle shear bands at thread roots. The nut (collar) of the aerospace fastener is designed to break in two when a specific installation torque is reached. The joint is then created by the remaining, tightened half of the collar and its mating threaded pin. In this case, however, the titanium alloy pins from a single manufacturer had been breaking before their collars "torqued off." Comparisons were made with pins produced by other manufacturers that did not fail during installation. The only significant differences observed were in the extent of shear-band formation and the orientation of shear bands near the roots of the rolled threads, both of which can be controlled by altering the tool-workpiece geometry. Shear-band formation was more extensive in the failed pins, and the bands are oriented at a higher angle to the pin axis. (More details are given in Fig. 1129, 1130, 1131, 1132.) Fig. 1125: Typical fracture surface of failed pin. Fracture was flat and propagated across the pin through a single thread root. SEM, 10 $\times$ . Fig. 1126: Boxed area in Fig. 1125. Note the relatively featureless shear band on the circumference of the fracture surface. It is at a 45 $^{\circ}$  angle to the pin axis. SEM, 100 $\times$ . Fig. 1127: Small, partially formed dimples on the shear-band portion of the fracture surface. SEM, 5000 $\times$ . Fig. 1128: Balance of fracture surface away from the shear band was typical of dimpled rupture in Ti-6Al-4V. The equiaxed shape of the dimples indicate that a tensile stress was operative. SEM, 1000 $\times$  (G. Hopple, Lockheed Missiles & Space Company, Inc.)

Shear-band formation in Ti-6Al-4V threaded fasteners that fractured during installation (see Fig. 1125, 1126, 1127, 1128). Shear bands form in thread roots of fasteners during the cold thread rolling process. In Ti-6Al-4V, they readily form during the highly localized plastic deformation that accompanies mechanical working at temperatures below 705  $^{\circ}\text{C}$  (1300  $^{\circ}\text{F}$ ). The role of shear-band orientation in fracture resistance is significant: A tensile stress is needed to initiate shear band fracture, and the higher the angle of the shear band to the pin axis, the greater the tensile component of the uniaxial stress applied to the fastener during installation. A suitably high tensile stress is required regardless of the extent of shear-band formation. Fig. 1129 and 1130: Void initiation and coalescence, respectively, in a shear band at a thread root adjacent to the

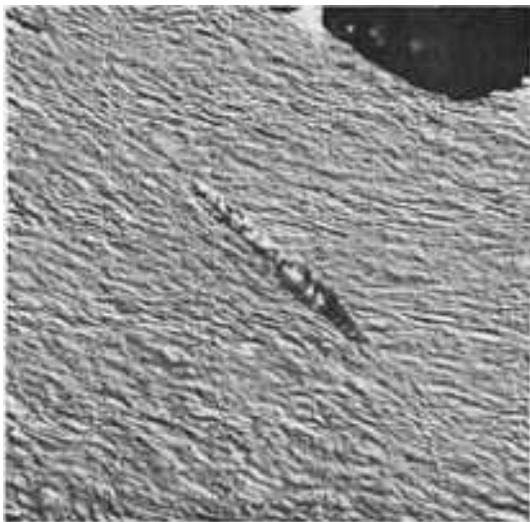
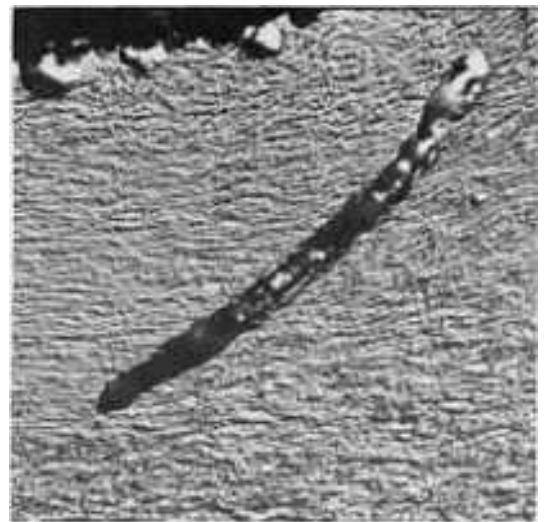
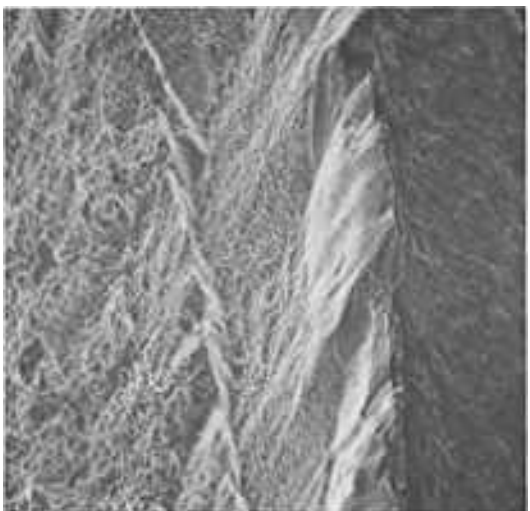
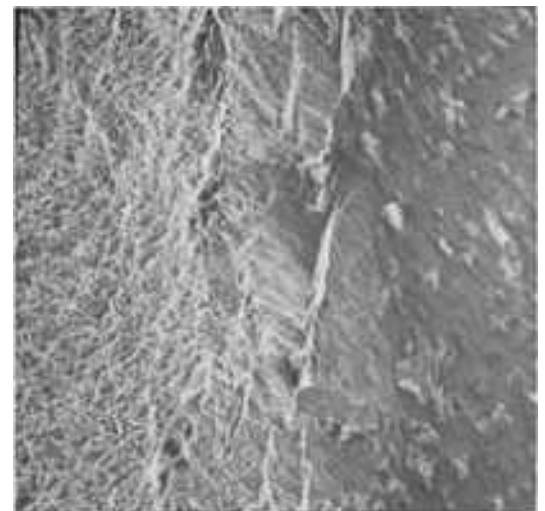
fracture. Rounded voids lend support to contention that tensile stress initiated fracture. Duplex etch, Kroll's solution and  $\text{H}_2\text{O}_2\text{-KOH}$ . Differential interference contrast microscopy, 500 $\times$ . Fig. 1131 and 1132: Comparison of shear-band orientation in tensile-tested Ti-6Al-4V fasteners made by producer of failed pins (Fig. 1131) and a producer of pins that did not fail during installation (Fig. 1132). Shear-band angles are higher--40° to 50° versus 20° to 30°--in the former. SEM, 200 $\times$  (G. Hopple, Lockheed Missiles & Space Company, Inc.)

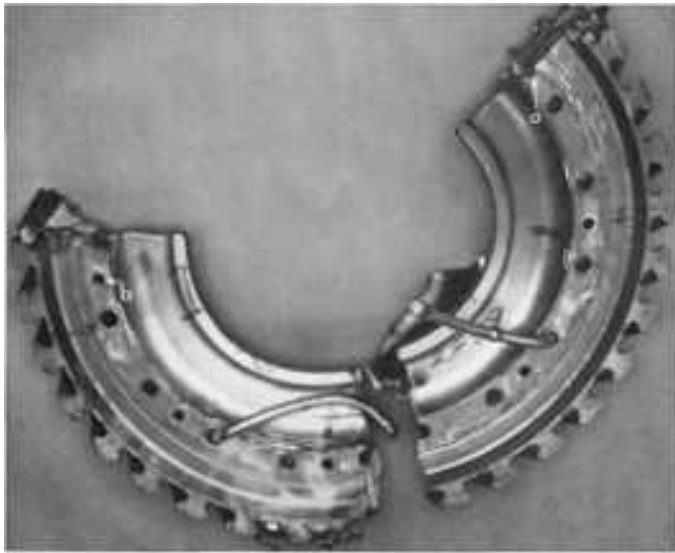
**Fig. 1133**

Figure 1133 shows two portions of a fractured titanium alloy Ti-6Al-4V second-stage compressor disk from a jet engine. Of the three radial fractures, the one at upper right, which passes through the bolthole marked "a," was found to be the primary fracture, exhibiting several fatigue-crack origins adjacent to the hole. The two other fractures showed no sign of fatigue. Figure 1134 shows a surface of the fracture through the bolthole at arrow "a" in Fig. 1133. Several fatigue cracks originated at locations within brackets "c" and "d." Deep tool marks in the bore of the hole are visible between arrows "e" and "f"; a section through the hole marked "b" in Fig. 1133 showed no such deep tool marks. Average tensile properties of two specimens cut from the disk were 1007 MPa (146 ksi) tensile strength, 17.5% elongation, and 39% reduction of area. See also Fig. 1135, 1136, 1137, 1138, 1139, and 1140. Fig. 1133: 0.2 $\times$ . Fig. 1134: 0.9 $\times$

**Fig. 1137** View of the bore of the bolthole at arrow "a" in the fractured titanium alloy Ti-6Al-4V compressor disk in Fig. 1133, showing more clearly the deep tool marks faintly visible in Fig. 1134, 1135, and 1136. The arrows mark locations of longitudinal secondary cracks in the bore of the hole. 15×

**Fig. 1138** View of the edge of the bolthole through which passed one of the secondary radial fractures (at left or at bottom) in the compressor disk in Fig. 1133. Note the irregular shear-overload cracks at the edge of the hole, which show no characteristics of fatigue, and the irregular secondary cracks in the bore. 4×

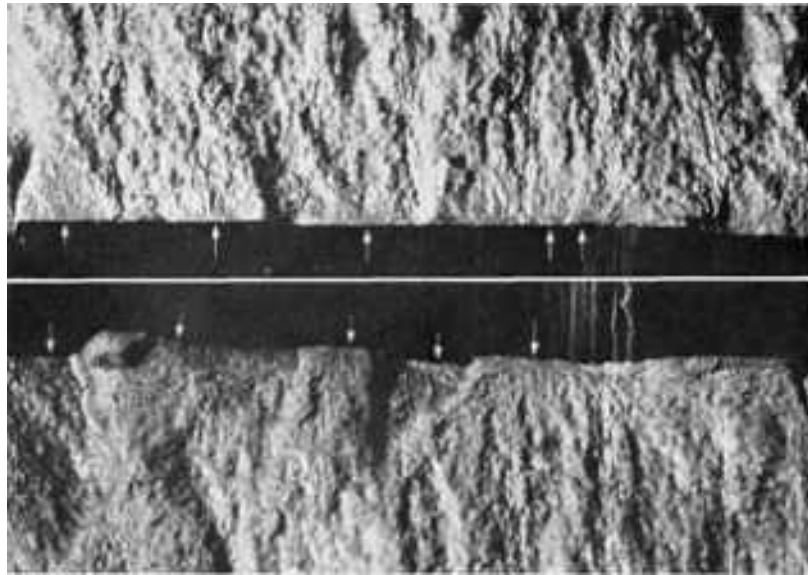
**Fig. 1135** Enlarged view of the fatigue-crack regions (indicated by brackets) at the edges of the bolthole in Fig. 1134. The cracks grew in both directions from the hole. 3 $\times$

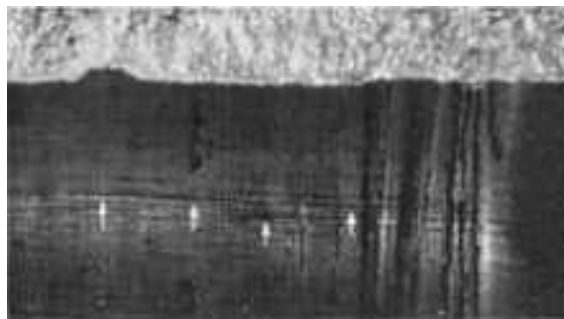
**Fig. 1136** Separate, higher-magnification views of the bracketed regions of the edges of the compressor-disk bolthole in Fig. 1134 and 1135, shown correctly aligned opposite each other. Visible are beach marks in several fatigue-crack zones (at arrows). These separate cracks penetrated only a short distance before joining to form common fronts, which then advanced toward both the rim and the bore of the disk. 8×

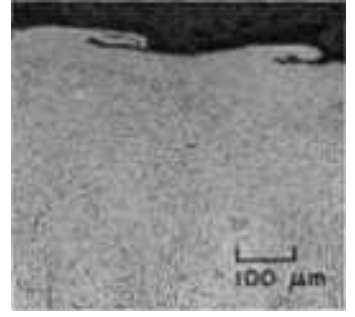
**Fig. 1139**

Figure 1139 shows a section through one of the fatigue-crack zones at one of the bolthole edges in Fig. 1136, taken transversely to the hole. The fracture surface is shown in profile at right, and the bore of the hole is shown in profile at top. Note the layer of cold-worked metal above the dashed line. Figure 1140 shows a section through the same general area as that in Fig. 1139, but taken longitudinally to the hole. Here, as in Fig. 1139, a cold-worked layer can be seen (at top); severe surface flow in the bore of the hole is also visible. This damaged condition of the bore surface, and the deep tool marks shown in Fig. 1137, probably caused

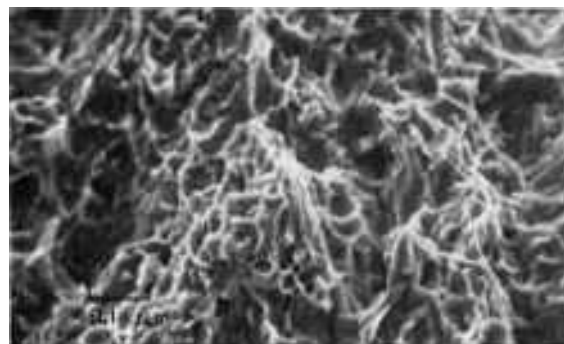
**Fig. 1141** Fracture surface of a ductile fracture-toughness specimen of titanium alloy Ti-6Al-4V that was solution treated for 40 min at 830 °C (1525 °F), water quenched, aged at 510 °C (950 °F), then loaded in three-point bending (in air). See also Fig. 1142, 1143, 1144, and 1145. SEM, 110×

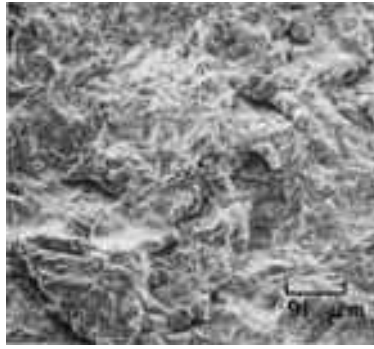
**Fig. 1142** Higher-magnification view of the fracture surface in Fig. 1141, typical of fractures produced in this alloy in air after various solution treatments. Entire surface shows dimpled fracture of fine, equiaxed  $\alpha$  phase that ruptured in ductile shear. SEM, 1100×

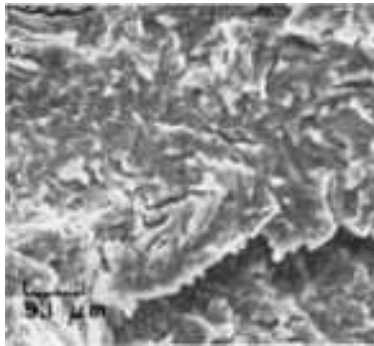
**Fig. 1143** Fracture surface of a specimen of Ti-6Al-4V alloy similar to the specimen shown in Fig. 1141 and having the same history, but tested in a hydrogen atmosphere. The principal features here are numerous secondary cracks. See also Fig. 1144. SEM, 110×

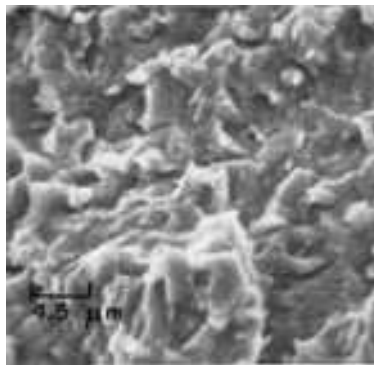
**Fig. 1144** Higher-magnification view of the fracture surface shown in Fig. 1143. The embrittlement of this specimen by hydrogen was slight (about 12%). Fracture was by a mixture of shear rupture and transgranular cleavage. See also Fig. 1145. SEM, 1100×

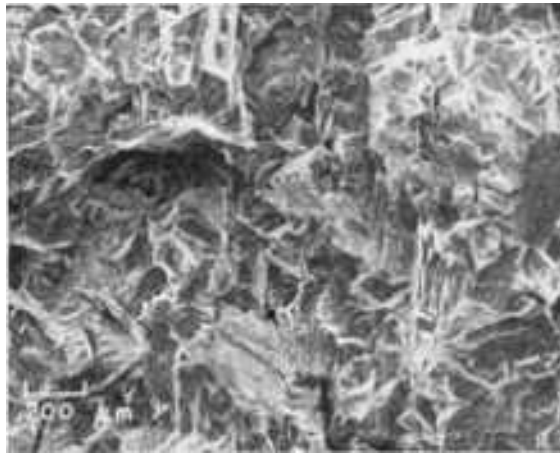
**Fig. 1145** Same fracture surface as in Fig. 1143 and 1144, but shown at even greater magnification. Many small secondary cracks are present among moderate-sized dimples. SEM, 2200×

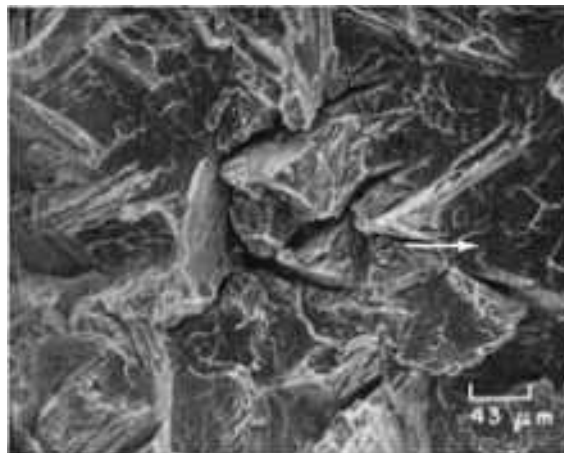
**Fig. 1146** A Ti-6Al-4V fracture-toughness specimen identical to that in Fig. 1155, except broken in hydrogen at 25 °C (77 °F). This fracture surface appears to be very brittle, showing intergranular secondary cracks that follow exceedingly angular paths. Note the larger cleavage facets. See also Fig. 1147. SEM, 50×

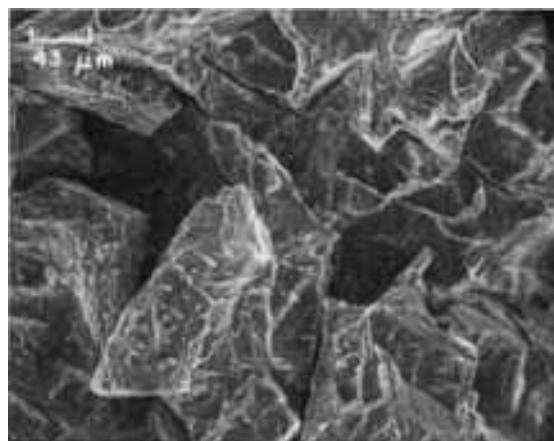
**Fig. 1147** Higher-magnification view of the fracture surface in Fig. 1146, showing quasi-cleavage facets and detailed river patterns. Note particularly the unusual concentric pattern of steps at arrow and compare it with the similar pattern of steps that is shown at higher magnification in Fig. 1148. SEM, 230×

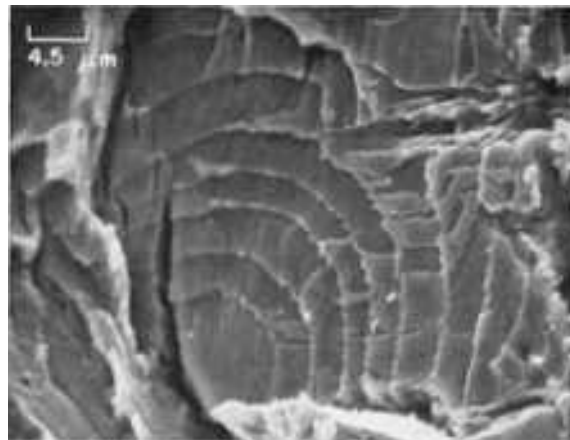
**Fig. 1148** Higher-magnification view of the fracture surface in Fig. 1146, showing an area different from that in Fig. 1147. As in Fig. 1146, the very angular secondary cracking is noteworthy and is believed to have been

influenced by interfaces between  $\beta$  phase and acicular  $\alpha$  phase. Note the fine parallel steps on the angular facets at bottom right. SEM, 230 $\times$

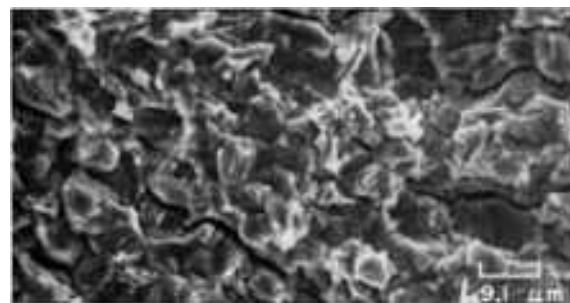
**Fig. 1149** Another view of the fracture surface in Fig. 1146, 1147, and 1148, at even higher magnification, showing a region containing a very unusual "terraced" facet that is similar to the area shown and discussed in Fig. 1147. It is possible that this relatively flat area was a prior- $\beta$  grain. Also note that the "terraces" have cleavage steps of their own. SEM, 2200 $\times$

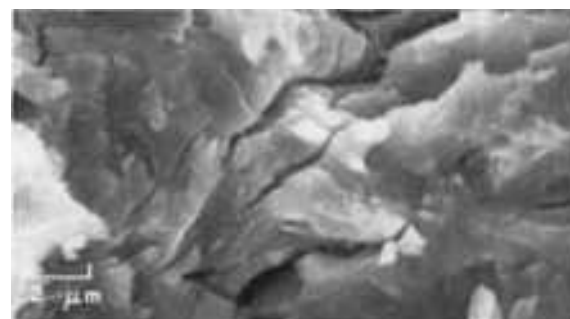
**Fig. 1150** Fracture surface of a fracture-toughness specimen of titanium alloy Ti-6Al-4V that was heat treated for 40 min at 955  $^{\circ}\text{C}$  (1750  $^{\circ}\text{F}$ ), stabilized and then tested at 25  $^{\circ}\text{C}$  (77  $^{\circ}\text{F}$ ) in hydrogen. (Stabilizing consisted of furnace cooling to 704  $^{\circ}\text{C}$  (1300  $^{\circ}\text{F}$ ) from the heat-treating temperature, holding 1 h, furnace cooling to 593  $^{\circ}\text{C}$  (1100  $^{\circ}\text{F}$ ), holding 1 h and air cooling. This treatment was used to secure a large grain size to increase the susceptibility of the alloy to slow-strain-rate embrittlement in hydrogen.) (Structure is continuous  $\beta$  phase with dispersed  $\alpha$  phase.) The deep secondary cracks are interpreted as following the boundaries between the grains of primary  $\alpha$  and the  $\beta$  matrix. See also Fig. 1151. SEM, 1100 $\times$

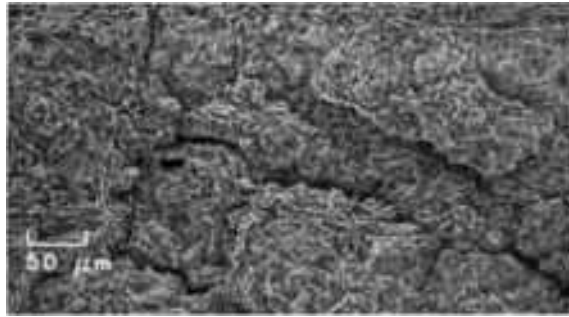
**Fig. 1151** View of the fracture surface in Fig. 1150, seen at higher magnification, which shows in greater detail the fine secondary cracks; these are transgranular, in contrast to the network of major secondary cracks. (Structure is continuous  $\beta$  phase with dispersed  $\alpha$  phase.) The fracture is brittle, but the facets are small and

irregular and have no detectable river patterns. SEM, 5000×

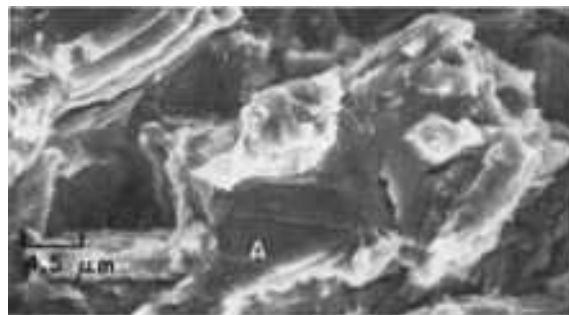
**Fig. 1152** Fracture surface of a fracture-toughness specimen same as in Fig. 1150, except this specimen received a 24-h soak at 955 °C (1750 °F) before undergoing the stabilizing treatment. (Stabilizing consisted of furnace cooling to 704 °C (1300 °F) from the heat-treating temperature, holding 1 h, furnace cooling to 593 °C (1100 °F), holding 1 h and air cooling. This treatment was used to secure a large grain size to increase the susceptibility of the alloy to slow-strain-rate embrittlement in hydrogen.) (Structure is continuous  $\beta$  phase with dispersed  $\alpha$  phase.) A gross network of secondary intergranular cracks is evident, providing steps that separate different levels of the main crack advance. See also Fig. 1153. SEM, 200×

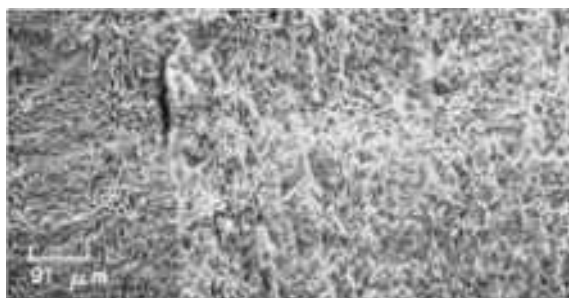
**Fig. 1153** View of the fracture surface in Fig. 1152, at 11 times the magnification there. (Structure is continuous  $\beta$  phase with dispersed  $\alpha$  phase.) Note the intricate rupture patterns. Some of the main cracks are believed to follow the interfaces between the continuous  $\beta$ -phase matrix and the dispersed acicular  $\alpha$  phase. Observe the "terraced" area at A; similar areas are visible in Fig. 1149. SEM, 2200×

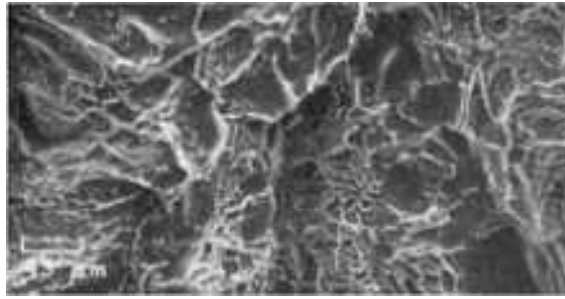
**Fig. 1154** Fracture surface of a fracture-toughness specimen of titanium alloy Ti-6Al-4V heat treated 40 min at 955 °C (1750 °F) and water quenched, aged at 510 °C (950 °F), and tested in hydrogen. (Structure is continuous  $\beta$  phase with dispersed  $\alpha$  phase.) The fatigue-precrack region is at left. The tensile-overload region, at right, closely resembles that of the specimen in Fig. 1158. SEM, 110×

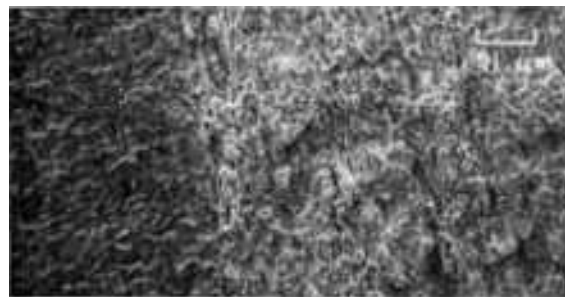
**Fig. 1155** Fracture surface of a fracture-toughness specimen of titanium alloy Ti-6Al-4V heat treated 40 min at 1040 °C (1900 °F), stabilized, and then tested in air at 25 °C (77 °F). (Stabilizing consisted of furnace cooling to 704 °C (1300 °F) from the heat-treating temperature, holding 1 h, furnace cooling to 593 °C (1100 °F), holding 1 h and air cooling. This treatment was used to secure a large grain size to increase the susceptibility of the alloy to slow-strain-rate embrittlement in hydrogen.) (Structure is continuous  $\beta$  phase with dispersed  $\alpha$  phase.) Note the tremendous range in size of the dimples. See also Fig. 1146, 1147, 1148, and 1149. SEM, 230 $\times$

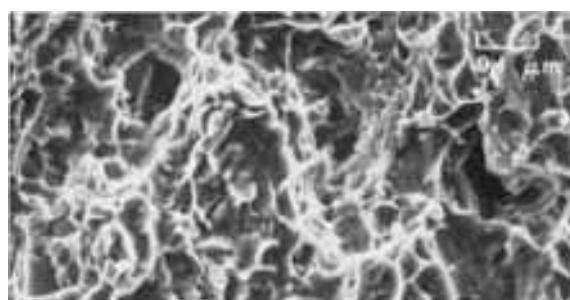
**Fig. 1156** Fracture surface of a specimen of titanium alloy Ti-6Al-4V mill-annealed sheet that was fracture-toughness tested in air. (Structure is continuous  $\alpha$  phase with dispersed  $\beta$  phase.) At left (dark) is fatigue-precrack region; at right is region of tensile-overload fracture, which is dimpled and has aligned elongated cavities suggesting localized slip. See also Fig. 1157. SEM, 110 $\times$

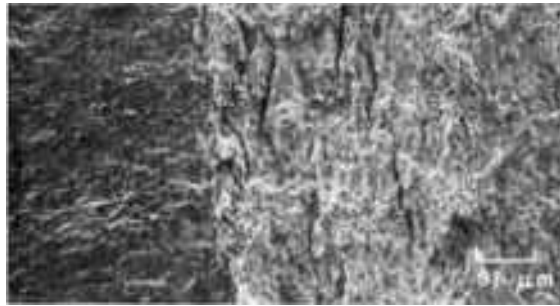
**Fig. 1157** Portion of the tensile-overload fracture region of the fracture surface in Fig. 1156, as seen at ten times the magnification there. (Structure is continuous  $\alpha$  phase with dispersed  $\beta$  phase.) This displays a rather uniform size of equiaxed dimples, shows essentially no inclusions, and contains no indication of secondary cracking; in summary, this is a thoroughly ductile fracture. SEM, 1100 $\times$

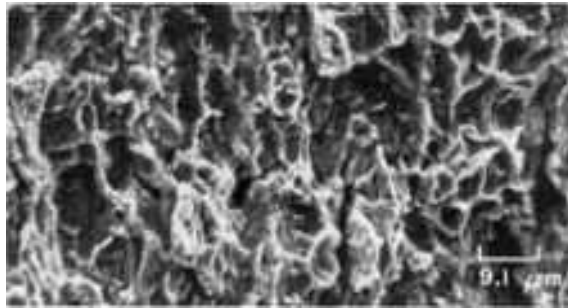
**Fig. 1158** Fracture surface of a specimen of the same material and condition as in Fig. 1156 (mill-annealed Ti-6Al-4V sheet), but fracture-toughness tested in hydrogen at 1 atm. (Structure is continuous  $\alpha$  phase with dispersed  $\beta$  phase.) The fatigue-precrack region (dark area at left), produced in air, is identical with that in Fig. 1156, but note the deep cracks among the dimples in the tensile-overload region at right. See also Fig. 1159. SEM, 110 $\times$

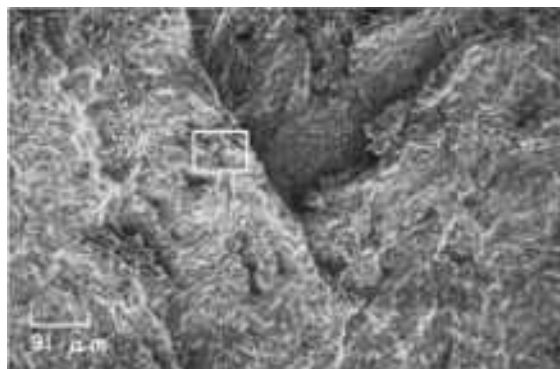
**Fig. 1159** View of the region of tensile-overload fracture in Fig. 1158, at ten times the magnification there. (Structure is continuous  $\alpha$  phase with dispersed  $\beta$  phase.) In spite of the effects of hydrogen, this region is quite similar in appearance to the tensile-overload region of the air-tested specimen in Fig. 1157. However, note that here there are many fine, parallel secondary cracks scattered throughout the dimpled surface. SEM, 1100 $\times$

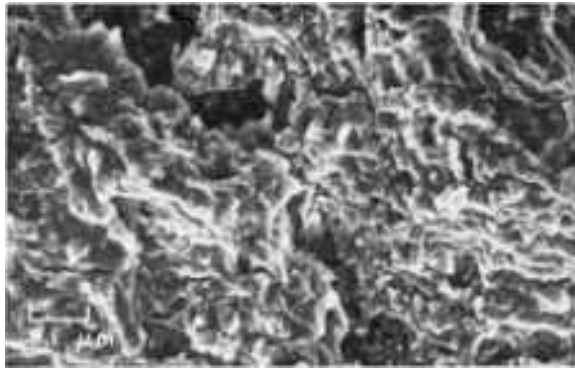
**Fig. 1160** Same as Fig. 1158, except that before being fracture-toughness tested in hydrogen, this specimen was heat treated at 705 °C (1300 °F) for 2 h and air cooled. (Structure is continuous  $\alpha$  phase with dispersed  $\beta$  phase.) In contrast to the fracture surface shown in Fig. 1158, no dimples are evident here. This surface exhibits giant steps. See also Fig. 1161. SEM, 110 $\times$

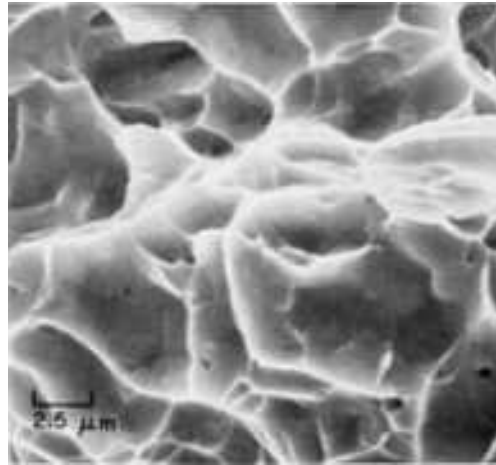
**Fig. 1166** Center of fracture surface in Fig. 1165. In contrast to the fracture surface of the unnotched specimen in Fig. 1163, dimples of various sizes are displayed here, and some secondary cracking is detectable.

See also Fig. 1167. SEM, 1000×

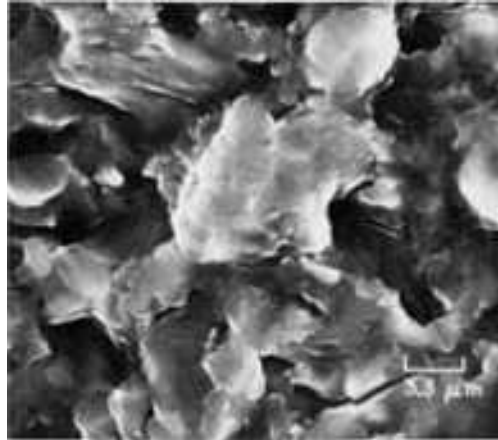
**Fig. 1169** View of the fracture surface in Fig. 1168, showing an area close to the edge of the crack origins. Many small voids, which bear little resemblance to conventional dimples, are visible among the small facets.

The area in the rectangle is shown enlarged in Fig. 1170. SEM, 1000×

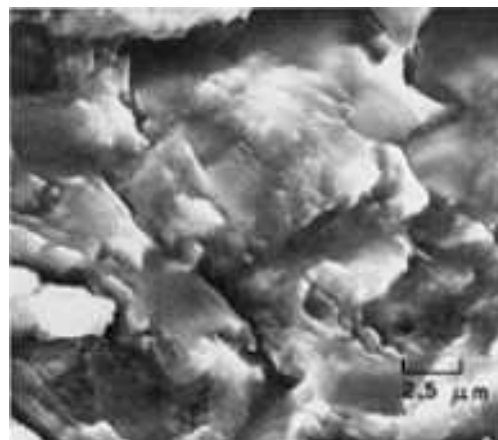
**Fig. 1171** Highly-cycle fatigue fracture in a specimen of titanium alloy Ti-6Al-4V (same mechanical properties as in Fig. 1162) that was tested in tension-tension ( $R = 0.1$ ) at maximum loading of 345 MPa (50 ksi), breaking in 937,000 cycles. The curved fatigue beach mark can be seen near bottom. See also Fig. 1172 and 1173. 6×

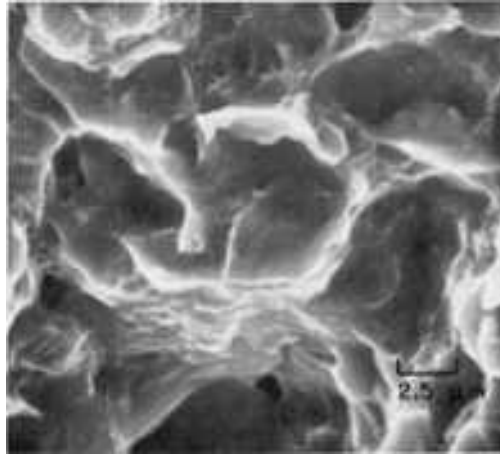
**Fig. 1172** View of fracture surface in Fig. 1171, showing an area at the curved beach mark. As in Fig. 1170,

the parallel fissures are not believed to be striations. See also Fig. 1173. SEM, 4000×

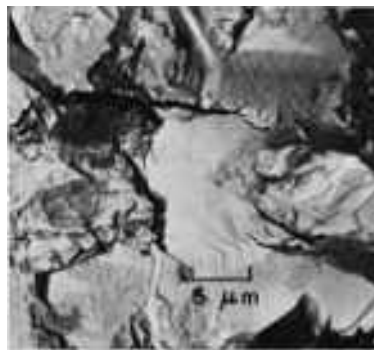
**Fig. 1173** Another view of the fracture surface in Fig. 1171, this one showing an area in the rapid-fracture region beyond the fatigue beach mark. Fine tear dimples are distinctly evident on the walls of the larger dimples. No fissures or secondary cracks are visible here. SEM, 4000×

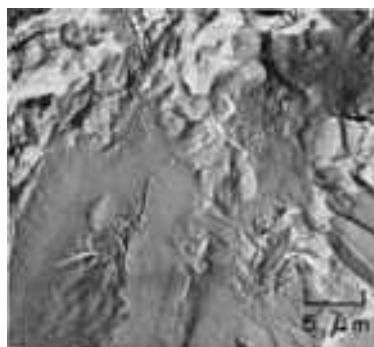
**Fig. 1174** Fracture resulting from stress-corrosion cracking in a specimen of titanium alloy Ti-6Al-4V that was stressed in methanol. The crack path is transgranular (by cleavage). See also Fig. 1175. TEM p-c replica, 2000×

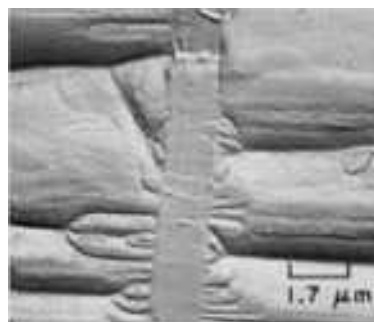
**Fig. 1177** Surface of a fracture in a specimen of titanium alloy Ti-7Al-1Mo-1V that was broken in a drop-weight tear test, consisting mostly of dimples. A feature that apparently is a tear ridge (vertical) is visible at far right. TEM p-c replica, 2000×

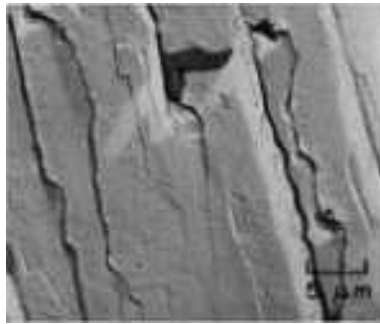
**Fig. 1178** Fracture produced by tension over-load in a specimen of titanium alloy Ti-7Al-2Nb-1Ta, showing staining and very large dimples. Vertical band at center is where crack initiated at a second-phase region and propagated to left and right. TEM p-c replica, 6000×

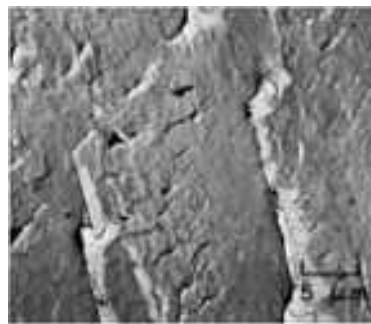
**Fig. 1179** Fracture resulting from stress-corrosion cracking in a chill cast specimen of titanium alloy Ti-7Al-2Nb-1Ta that was stressed in distilled water, exhibiting facets that were produced by essentially pure cleavage. TEM p-c replica, 2000×

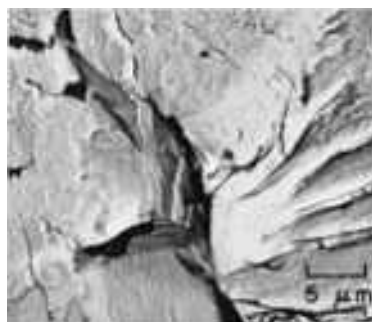
**Fig. 1180** Cleavage fracture in a specimen of titanium alloy Ti-7Al-2Nb-1Ta, produced by stress-corrosion cracking in methanol. Note the regular array of fissures, which are parallel to the crack front. See also Fig. 1181. TEM p-c replica, 2000×

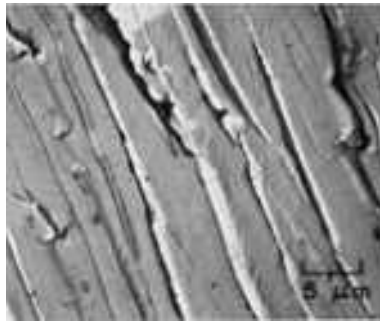
**Fig. 1181** Companion fractograph to that in Fig. 1180, from the same specimen, but taken at the stress-corrosion crack front. In general, the facets here show features of cleavage; in contrast, the facets at top center show what apparently are ripples. TEM p-c replica, 2000×

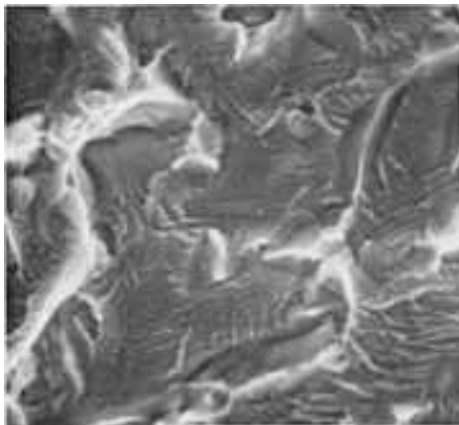
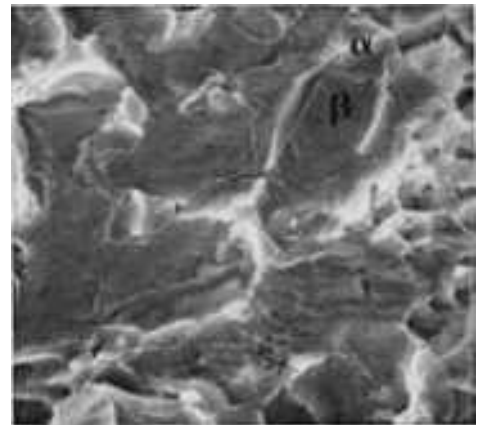
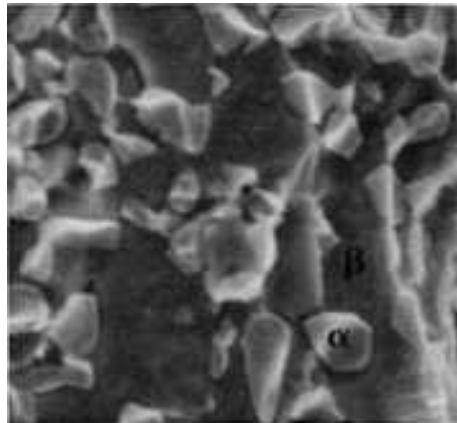
Tensile fractures at  $-196\text{ }^{\circ}\text{C}$  ( $-320\text{ }^{\circ}\text{F}$ ) in Ti-5.8Mn, an  $\alpha$ - $\beta$  alloy. Volume fraction  $\beta$ : 0.64. In all cases, 9-kg (20-lb) ingots were  $\beta$  forged to 75-mm (3-in.) billets, followed by  $\beta$  extrusion to 23 mm (0.92 in.) in diameter and  $\alpha$ - $\beta$  swaging to 16 mm (0.62 in.) in diameter. Etchant (when used): 17 mL benzalkonium chloride, 35 mL ethanol, 40 mL glycerine, 25 mL HF. Fig. 1183 and 1184: Same region unetched and etched, respectively, on fracture surface of alloy annealed 200 h at  $700\text{ }^{\circ}\text{C}$  ( $1290\text{ }^{\circ}\text{F}$ ) and water quenched. Alpha particle size:  $4.4\text{ }\mu\text{m}$ . Interalpha spacing:  $7.8\text{ }\mu\text{m}$ . True strain at fracture: 0.155. Visible are regions of ductile  $\alpha$  and brittle  $\beta$  matrix. Note deformation markings in  $\beta$  and voids in  $\alpha$ . SEM, 2100 $\times$ . Fig. 1185: Etched fracture surface of alloy annealed 24 h at  $700\text{ }^{\circ}\text{C}$  ( $1290\text{ }^{\circ}\text{F}$ ) and water quenched. Alpha particle size:  $2.35\text{ }\mu\text{m}$ . Interalpha spacing:  $4.17\text{ }\mu\text{m}$ . True strain at fracture: 0.10. Fracture is brittle except for some local  $\alpha$  ductility. SEM, 2000 $\times$  (H. Margolin and R.V. Vijayaraghavan, Polytechnic Institute of New York)

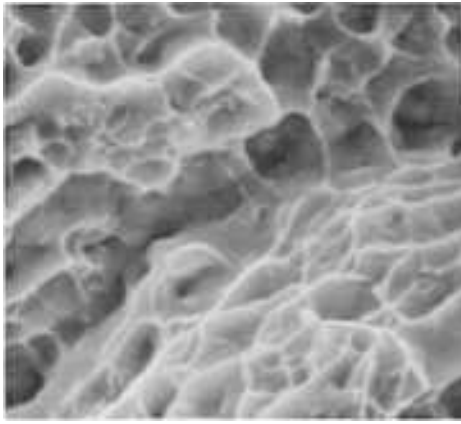
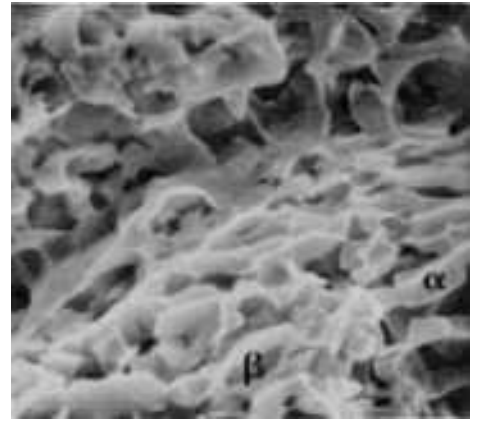
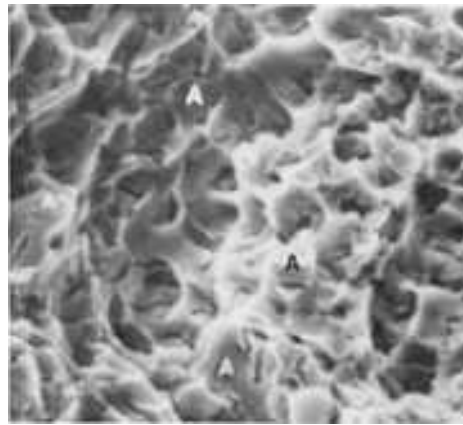
Tensile fractures at  $-196\text{ }^{\circ}\text{C}$  ( $-320\text{ }^{\circ}\text{F}$ ) in Ti-3.9Mn. Volume fraction  $\beta$ : 0.38. Beta particle spacing:  $2.1\text{ }\mu\text{m}$ . Interbeta spacing:  $4.5\text{ }\mu\text{m}$ . Processing and heat treatment same as in Fig. 1189 and 1190. Etchant (when used) same as in Fig. 1183, 1184, and 1185. Fig. 1186 and 1187: Unetched and etched, respectively, fracture surface of tensile specimen with prior strain at room temperature of 0.140. True strain of subzero fracture: 0.253. Material machined using coolant during final stages of specimen preparation. Compared with Fig. 1184 and 1185, average dimple size is smaller and there is comparatively less thinning of  $\beta$  at shear regions. SEM,  $3000\times$ . Fig. 1188. Etched fracture surface of specimen machined without coolant. True strain at fracture: 0.144. Cooling during machining substantially increases fracture strain. Fractograph is of region near origin, which was close to specimen surface. Note wavy nature of fracture propagation and large number of  $\beta$  particles at a dimple boundaries (A). Dark regions are  $\beta$  particles. SEM,  $1600\times$  (H. Margolin and R.V. Vijayaraghavan, Polytechnic Institute of New York)

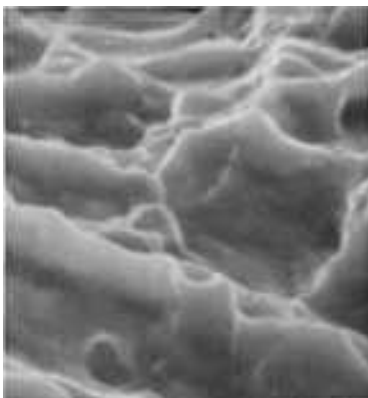
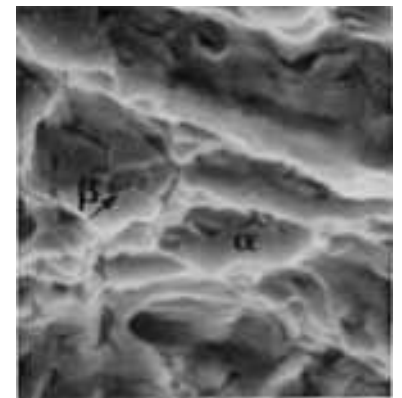
Tensile fracture at room temperature in Ti-3.9Mn, an  $\alpha$ - $\beta$  alloy with a  $\beta$  volume fraction of 0.38,  $\beta$  particle size of  $2.1\text{ }\mu\text{m}$ , and interbeta spacing of  $44.25\text{ }\mu\text{m}$ . Processing same as in Fig. 1183, 1184, and 1185. Heat treatment: anneal 24 h at  $700\text{ }^{\circ}\text{C}$  ( $1290\text{ }^{\circ}\text{F}$ ), water quench. True strain at fracture was 0.68. Note particles

inside voids. Fig. 1189: Unetched fracture surface. SEM, 3800 $\times$ . Fig. 1190: Etched fracture surface. Etchant same as in Fig. 1183, 1184, and 1185. SEM, 3000 $\times$  (H. Margolin and R.V. Vijayaraghavan, Polytechnic Institute of New York)

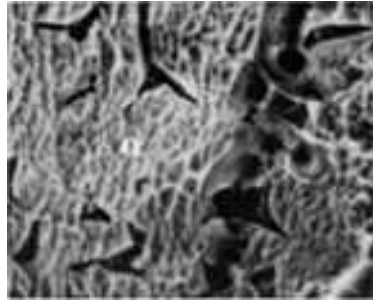
**Fig. 1191 Tensile fracture at -196 °C (-320 °F) in Ti-1.8Mn, an  $\alpha$  - $\beta$  alloy with a  $\beta$  volume fraction of 0.17. Beta particle size: 6.30  $\mu$ m. Interbeta spacing: 30.8  $\mu$ m. Material processed as in Fig. 1183, 1184, and 1185. Heat Treatment: 30 days at 780 °C (1435 °F); furnace cool over 3 days to 700 °C (1290 °F); 24 h at 700 °C (1290 °F); water quench. Fracture surface etched as in Fig. 1183, 1184, and 1185. Note shear dimples in  $\alpha$  and  $\beta$  (finer dimples in  $\alpha$ ). True strain to fracture: 0.90 (0.93 at room temperature). SEM, 1250 $\times$  (H. Margolin and R.V. Vijayaraghavan, Polytechnic Institute of New York)**

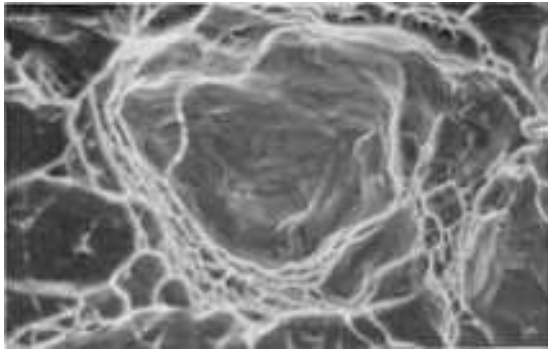
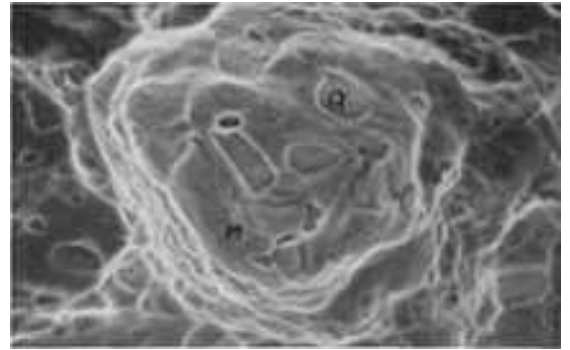
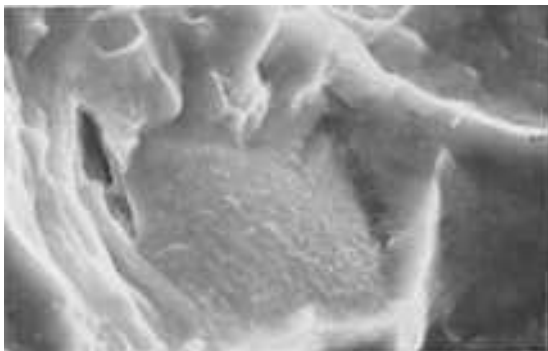
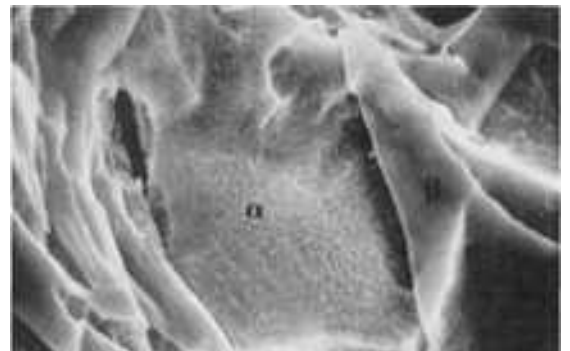
Tensile fractures at room temperature in Ti-5Mo-4.5Al-1.5Cr. The  $\alpha$  - $\beta$  alloy was processed as in Fig. 1183, 1184, and 1185. Etchant (when used) same in Fig. 1183, 1184, and 1185. Fig. 1192 and 1193: Unetched and etched, respectively, fracture surfaces of alloy having  $\alpha$  particles in a martensite matrix. Volume fraction  $\alpha$ : 0.30. Alpha particle size: 9.0  $\mu$ m. Interalpha spacing: 20.0  $\mu$ m. Fracture was ductile. Note shear at the boundary of the large void and particles inside the void. SEM, 570 $\times$  and 620 $\times$ . Fig. 1194 and 1195: Unetched and etched, respectively, fracture surfaces of alloy having  $\alpha$  particles in a retained  $\beta$  matrix. (Tilt slightly different in etched Fig. 1195.) Alpha particle size: 11.6  $\mu$ m. Interalpha spacing: 8.6  $\mu$ m. Note large void at  $\alpha$  -  $\beta$  interface close to shear. SEM, 3250 $\times$  (H. Margolin and R.V. Vijayaraghavan, Polytechnic Institute of New York)

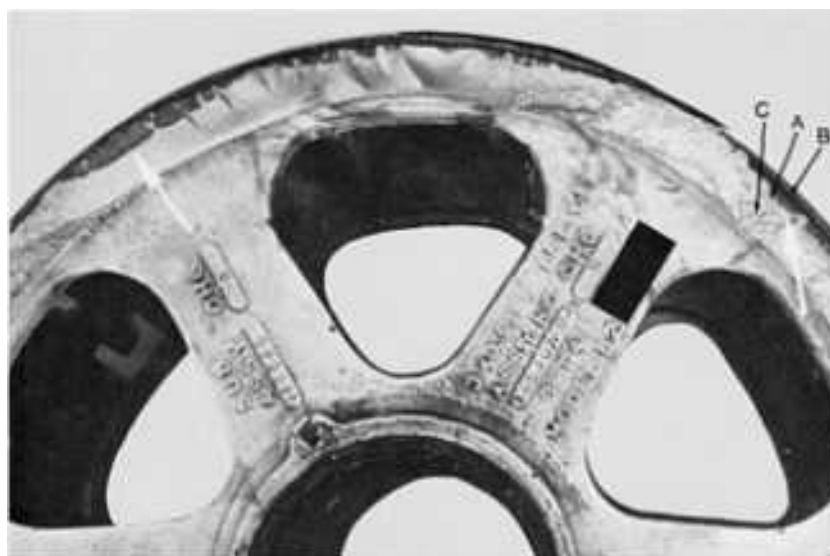
**Fig. 1196** Portion of an aircraft landing wheel of sand-cast magnesium alloy AZ81A-T4, showing a corrosion-fatigue fracture that occurred in service at the locking-ring channel. Nominal tensile strength was 276 MPa (40 ksi). The fracture extended halfway around the perimeter of the wheel. Many discolored, crescent-shaped fatigue-crack nuclei were found; two are indicated by white arrows. See Fig. 1197, 1198, 1199, and 1200 for TEM views of areas at A, B, and C. 0.3×

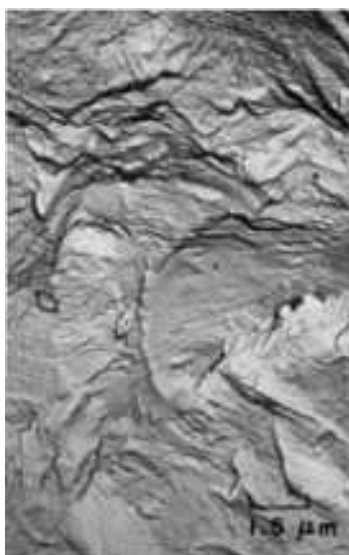
**Fig. 1197** TEM p-c replica of an area at the fatigue-crack nucleus at A in the fracture surface in Fig. 1196, showing "brittle" fatigue striations (such as at the arrow at left center). 6500×
