ASM HANDBOOK®

VOLUME  
12

Fractography

*Fractography*, was published in 1987 as Volume 12 of the *ASM Handbook*. The Volume was prepared under the direction of the ASM Handbook Committee.

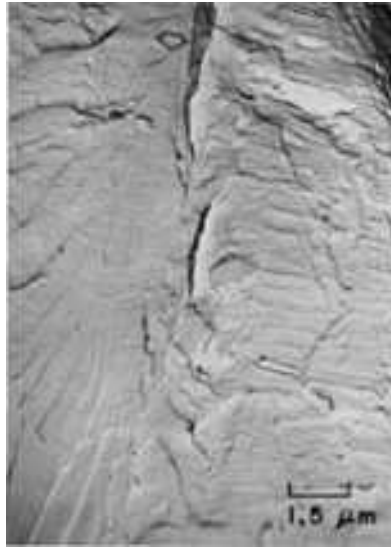
**Fig. 1198 TEM p-c replica of another area at A in Fig. 1196. Fine, roughly horizontal striations are visible in a fatigue patch at the arrow at top center; the marks at the right include widely spaced horizontal fissures. 6500×**

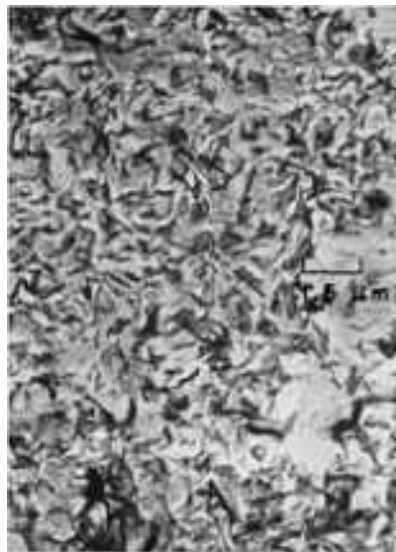
**Fig. 1199 TEM p-c replica of an area at B in Fig. 1196. In this area, the fracture surface is largely obscured by corrosion products. The few facets that are visible have essentially no distinguishable features. 6500×**

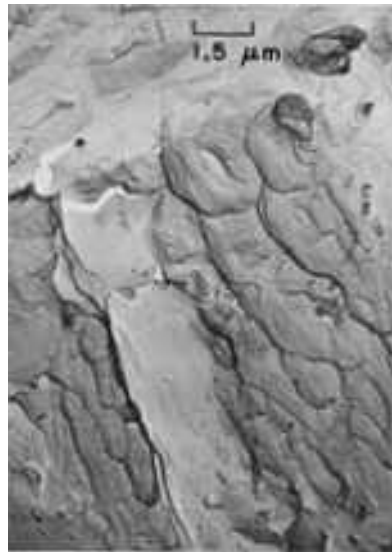
**Fig. 1200** TEM p-c replica of an area at C in Fig. 1196, in the region of final fast fracture. This area exhibits rather flat, elongated dimples. The region at left center in this view appears to have been stretched. 6500×

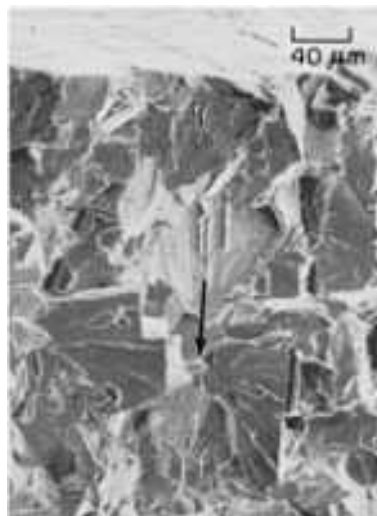
**Fig. 1201** Surface of a slow-bending fracture produced at -160 °C (-256 °F) in Fe-3.9Ni alloy deoxidized with aluminum and titanium, which was forged at 1260 °C (2300 °F), hot rolled at 1040 °C (1905 °F), annealed at about 1000 °C (1830 °F), and air cooled. Root of specimen notch is at top. Fracture was by cleavage that began at cracked Ti(C,N) particles (as at arrow). See also Fig. 1202. SEM, 250×

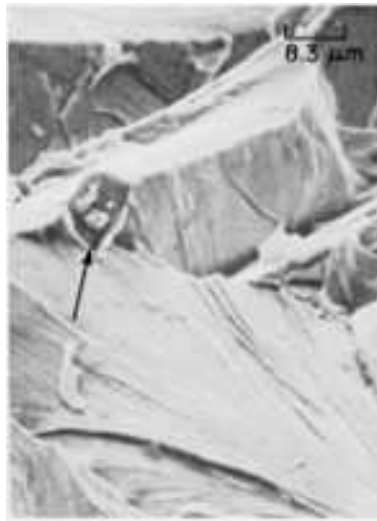
**Fig. 1202** Higher-magnification view of the slow-bending fracture in Fig. 1201. During testing, specimen temperature was controlled by an isopentane bath cooled with liquid nitrogen. Ferrite grain size, 30  $\mu\text{m}$ . The angle of the notch was 45°, and the nominal radius of the root of the notch was 0.25 mm (0.01 in.). The fracture originated at cracked Ti(C, N) particles (as at arrow). SEM, 1200 $\times$

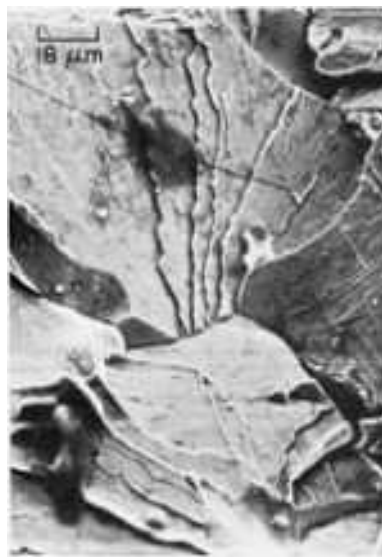
**Fig. 1203** Surface of a slow-bending fracture that was produced at -130 °C (-200 °F) in an Fe-0.3Ni alloy that had been melted, deoxidized, forged, rolled, and heat treated exactly the same as the higher-nickel alloy shown in Fig. 1201 and 1202. See also Fig. 1204, 1205, and 1206. SEM, 550 $\times$

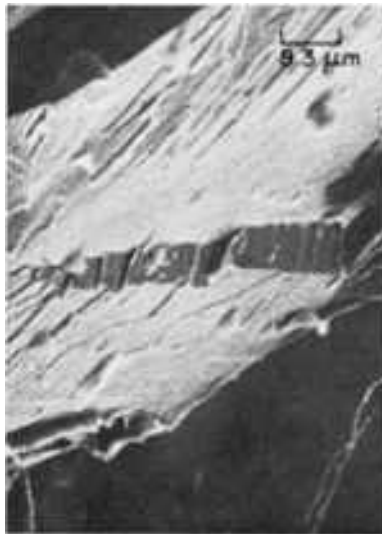
**Fig. 1204** Another view of the slow-bending fracture in Fig. 1201, showing a different region of the fracture surface at higher magnification. Here, as in the specimen shown in Fig. 1201 and 1202, fracture was by quasi-cleavage. Also shown is the intersection of a twin boundary with the cleavage plane. See also Fig. 1205. SEM, 1200×

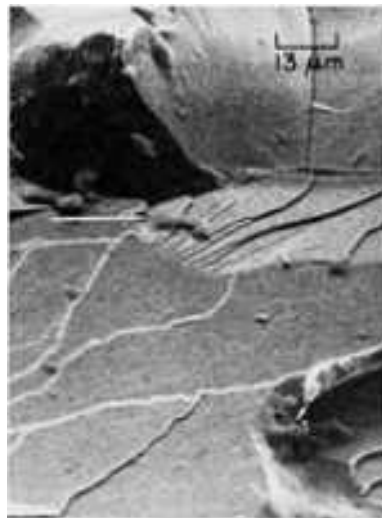
**Fig. 1205** Surface of a bending fracture in a specimen of the same alloy and the same history as that in Fig. 1203, showing assorted river patterns. Note twist boundary at center, which has generated several cleavage steps. Although the higher nickel content of the alloy in Fig. 1201 gave greater strength, the aspects of subzero impact rupture are about the same for both alloys. See also Fig. 1206. SEM, 750×

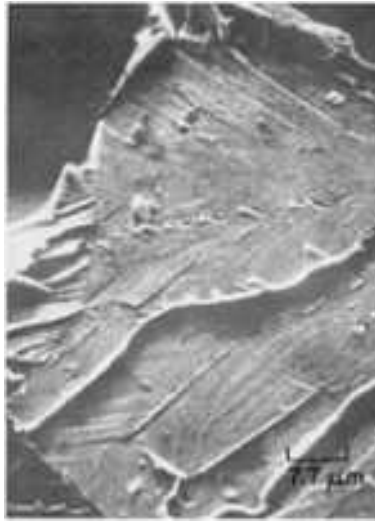
**Fig. 1206** Another view of the bending fracture in Fig. 1205, showing a different region at higher magnification. This region best demonstrates the difference between this Fe-0.3Ni alloy and the Fe-3.9Ni alloy in Fig. 1201 and 1202 by displaying many small "tongues," or microtwins, which are characteristic of Fe-0.3Ni and also of unalloyed (Armco) iron, but not of Fe-3.9Ni. SEM, 1300×

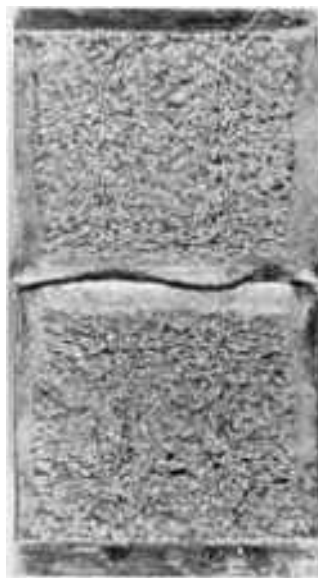
**Fig. 1207** Both fracture surfaces of a specimen that was not aged after austenitizing. See also Fig. 1208. 4.8× (Figures 1207, 1208, 1209, 1210, 1211, 1212, 1213, 1214, 1215, 1216, 1217, and 1218 present six related pairs of light and SEM fractographs of specimens of an Fe-12Ni-0.5Ti alloy intended for use at cryogenic temperatures. The series shows the effect on Charpy impact energy at -196 °C (-321 °F), and on fracture-surface characteristics, of the temperature of aging after austenitizing at 900 °C (1650 °F) for 2 h and air cooling.)

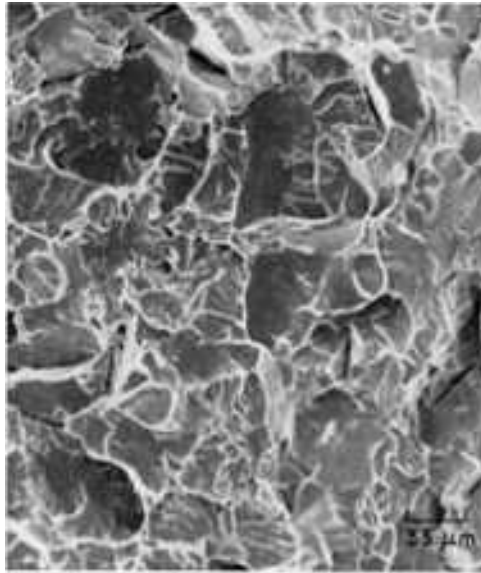
**Fig. 1208** This SEM fractograph of the unaged specimen in Fig. 1207 shows quasi-cleavage facets. The impact energy was less than 27 J (20 ft · lb). 300× (Figures 1207, 1208, 1209, 1210, 1211, 1212, 1213, 1214, 1215, 1216, 1217, and 1218 present six related pairs of light and SEM fractographs of specimens of an Fe-12Ni-0.5Ti alloy intended for use at cryogenic temperatures. The series shows the effect on Charpy impact energy at -196 °C (-321 °F), and on fracture-surface characteristics, of the temperature of aging after austenitizing at 900 °C (1650 °F) for 2 h and air cooling.)

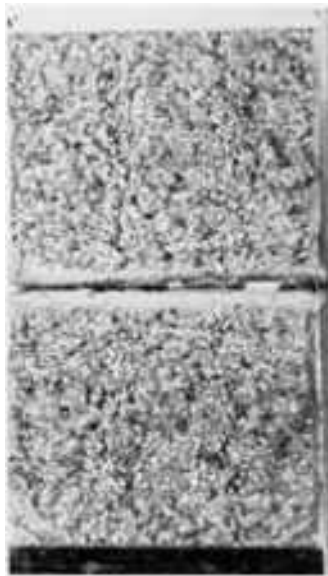
**Fig. 1209** Both fracture surfaces of a specimen aged at 650 °C (1200 °F) 2 h and air cooled. See also Fig. 1210. 4.8× (Figures 1207, 1208, 1209, 1210, 1211, 1212, 1213, 1214, 1215, 1216, 1217, and 1218 present six related pairs of light and SEM fractograph of specimens of an Fe-12Ni-0.5Ti alloy intended for use at cryogenic temperatures. The series shows the effect on Charpy impact energy at -196 °C (-321 °F), and on fracture-surface characteristics, of the temperature of aging after austenitizing at 900 °C (1650 °F) for 2 h and air cooling.)

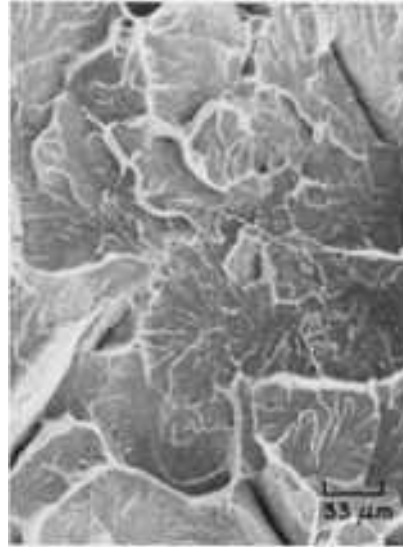
**Fig. 1210** This SEM view of the specimen in Fig. 1209 shows that aging at 650 °C (1200 °F) produced almost no change in fracture-surface characteristics from those of unaged specimen in Fig. 1207. Impact energy was less than 27 J (20 ft · lb). 300× (Figures 1207, 1208, 1209, 1210, 1211, 1212, 1213, 1214, 1215, 1216, 1217, and 1218 present six related pairs of light and SEM fractograph of specimens of an Fe-12Ni-0.5Ti alloy intended for use at cryogenic temperatures. The series shows the effect on Charpy impact energy at -196 °C (-321 °F), and on fracture-surface characteristics, of the temperature of aging after austenitizing at 900 °C (1650 °F) for 2 h and air cooling.)

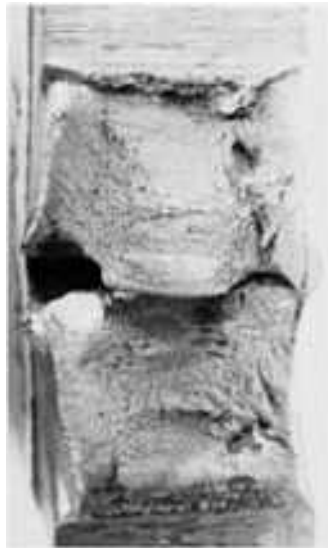
**Fig. 1211** Both fracture surfaces of a specimen aged at 700 °C (1290 °F) 2 h and air cooled. Impact energy was about 203 J (150 ft · lb). Much deformation accompanied fracture. See also Fig. 1212. 4.8× (Figures 1207, 1208, 1209, 1210, 1211, 1212, 1213, 1214, 1215, 1216, 1217, and 1218 present six related pairs of light and SEM fractograph of specimens of an Fe-12Ni-0.5Ti alloy intended for use at cryogenic temperatures. The series shows the effect on Charpy impact energy at -196 °C (-321 °F), and on fracture-surface characteristics, of the temperature of aging after austenitizing at 900 °C (1650 °F) for 2 h and air cooling.)

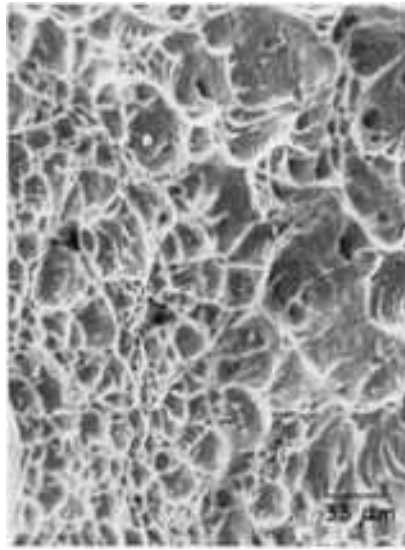
**Fig. 1212** This SEM fractograph of the specimen in Fig. 1211, which was aged at 700 °C (1290 °F), shows dimpled rupture instead of the quasi-cleavage facets observed in the specimens in Fig. 1208 and 1210. 300× (Figures 1207, 1208, 1209, 1210, 1211, 1212, 1213, 1214, 1215, 1216, 1217, and 1218 present six related pairs of light and SEM fractograph of specimens of an Fe-12Ni-0.5Ti alloy intended for use at cryogenic temperatures. The series shows the effect on Charpy impact energy at -196 °C (-321 °F), and on fracture-surface characteristics, of the temperature of aging after austenitizing at 900 °C (1650 °F) for 2 h and air cooling.)

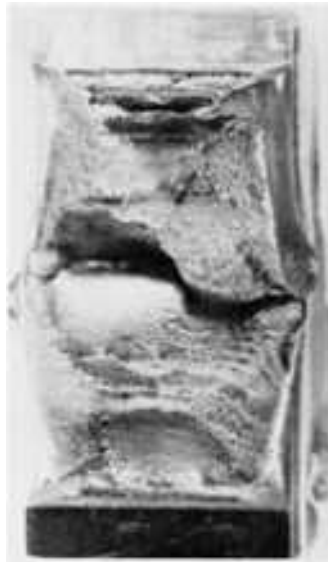
**Fig. 1213** Both fracture surfaces of a specimen aged at 750 °C (1380 °F) 2 h and air cooled. Impact energy was about 203 J (150 ft · lb); deformation is similar to that in Fig. 1211. See also Fig. 1214. 4.8× (Figures 1207, 1208, 1209, 1210, 1211, 1212, 1213, 1214, 1215, 1216, 1217, and 1218 present six related pairs of light and SEM fractograph of specimens of an Fe-12Ni-0.5Ti alloy intended for use at cryogenic temperatures. The series shows the effect on Charpy impact energy at -196 °C (-321 °F), and on fracture-surface characteristics, of the temperature of aging after austenitizing at 900 °C (1650 °F) for 2 h and air cooling.)

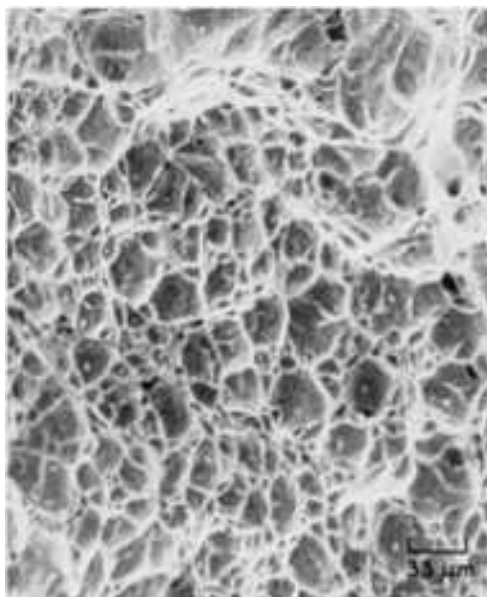
**Fig. 1214 SEM fractograph of the specimen in Fig. 1213. This fracture, like that of the specimen in Fig. 1212, shows dimpled rupture. 300× (Figures 1207, 1208, 1209, 1210, 1211, 1212, 1213, 1214, 1215, 1216, 1217, and 1218 present six related pairs of light and SEM fractograph of specimens of an Fe-12Ni-0.5Ti alloy intended for use at cryogenic temperatures. The series shows the effect on Charpy impact energy at -196 °C (-321 °F), and on fracture-surface characteristics, of the temperature of aging after austenitizing at 900 °C (1650 °F) for 2 h and air cooling.)**

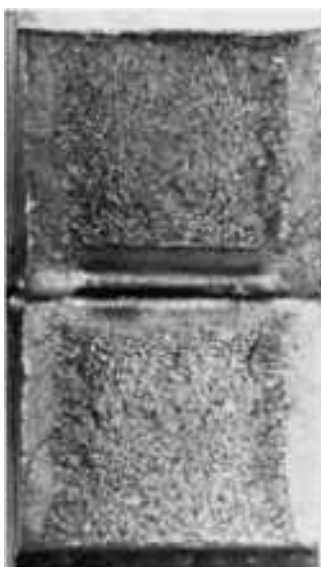
**Fig. 1215 Specimen aged at 800 °C (1470 °F) 2 h and air cooled. Unlike Fig. 1213, this fracture shows little deformation, and impact energy was less than 27 J (20 ft · lb). See also Fig. 1216. 4.8× (Figures 1207, 1208, 1209, 1210, 1211, 1212, 1213, 1214, 1215, 1216, 1217, and 1218 present six related pairs of light and SEM fractograph of specimens of an Fe-12Ni-0.5Ti alloy intended for use at cryogenic temperatures. The series shows the effect on Charpy impact energy at -196 °C (-321 °F), and on fracture-surface characteristics, of the temperature of aging after austenitizing at 900 °C (1650 °F) for 2 h and air cooling.)**

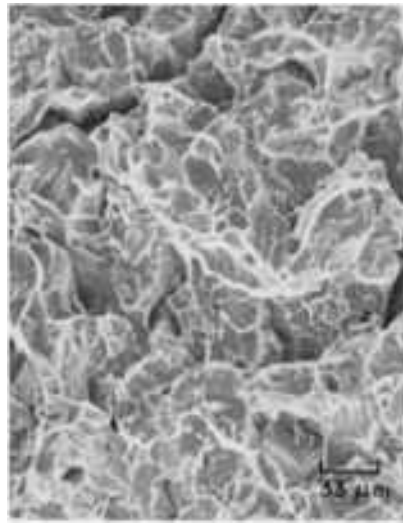
**Fig. 1216 SEM view of specimen in Fig. 1215. Fracture appears to have propagated by a mixture of intergranular separation and cleavage, yet shows indications of some dimples. Note the deep secondary intergranular cracks. 300× (Figures 1207, 1208, 1209, 1210, 1211, 1212, 1213, 1214, 1215, 1216, 1217, and 1218 present six related pairs of light and SEM fractograph of specimens of an Fe-12Ni-0.5Ti alloy intended for use at cryogenic temperatures. The series shows the effect on Charpy impact energy at -196 °C (-321 °F), and on fracture-surface characteristics, of the temperature of aging after austenitizing at 900 °C (1650 °F) for 2 h and air cooling.)**

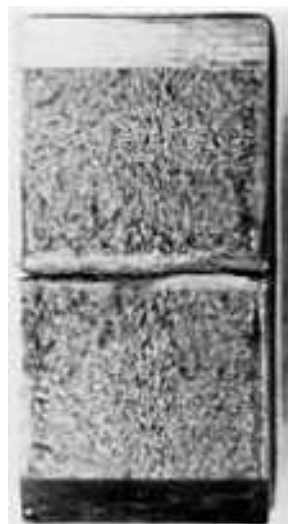
**Fig. 1217 Specimen aged at 850 °C (1560 °F) 2 h and air cooled. The fracture is much coarser than that of the specimen in Fig. 1215, but is similar to it in other respects. See also Fig. 1218. 4.8× (Figures 1207, 1208, 1209, 1210, 1211, 1212, 1213, 1214, 1215, 1216, 1217, and 1218 present six related pairs of light and SEM fractograph of specimens of an Fe-12Ni-0.5Ti alloy intended for use at cryogenic temperatures. The series shows the effect on Charpy impact energy at -196 °C (-321 °F), and on fracture-surface characteristics, of the temperature of aging after austenitizing at 900 °C (1650 °F) for 2 h and air cooling.)**

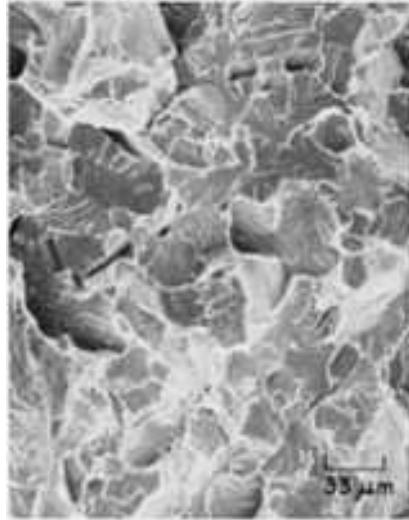
**Fig. 1218** This SEM fractograph of the specimen in Fig. 1217 shows that the fracture, like that in Fig. 1216, exhibits cleavage facets and short, deep intergranular cracks. This specimen also had impact energy of less than 27 J (20 ft · lb). (Figures 1207, 1208, 1209, 1210, 1211, 1212, 1213, 1214, 1215, 1216, 1217, and 1218 present six related pairs of light and SEM fractograph of specimens of an Fe-12Ni-0.5Ti alloy intended for use at cryogenic temperatures. The series shows the effect on Charpy impact energy at -196 °C (-321 °F), and on fracture-surface characteristics, of the temperature of aging after austenitizing at 900 °C (1650 °F) for 2 h and air cooling.)

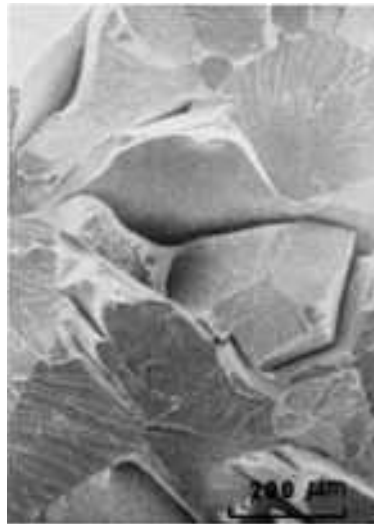
**Fig. 1219** Fracture surface in an iron-base alloy containing 7 at.% (6.4 wt%) Cr and 1 at.% (3.2 wt%) Ta, pulled in tension at room temperature after solution treatment for 1 h at 1320 °C (2410 °F) and water quenching, then aging at 700 °C (1290 °F) for 40 min and air cooling. Fracture was by transgranular cleavage believed to have originated at a grain-boundary network of Laves-phase Fe<sub>2</sub>Ta precipitate. See also Fig. 1220, 1221, and 1222. SEM, 100×

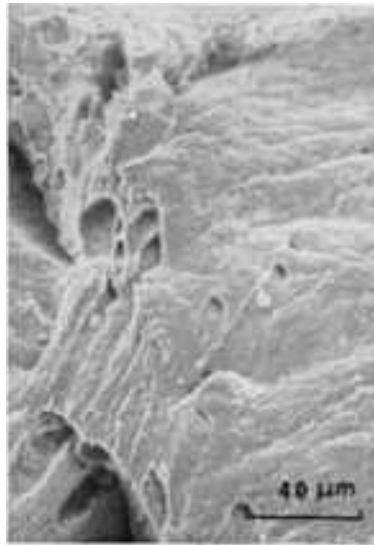
**Fig. 1220** Fracture surface in a specimen of the same Fe-Cr-Ta alloy, and with the same heat treatment, as in Fig. 1219, but tensile tested at 200 °C (390 °F). In addition to cleavage, this fracture shows features of quasi-cleavage, but the higher test temperature provided greater ductility and a number of elongated dimples made their appearance. See also Fig. 1221 and 1222. SEM, 500×

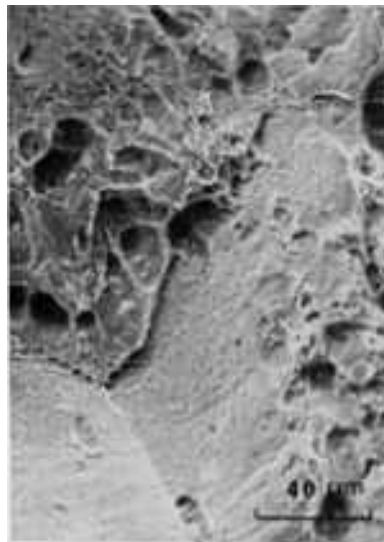
**Fig. 1221** Same Fe-Cr-Ta alloy, and with the same heat treatment, as in Fig. 1219 and 1220, but fractured by tension overload at 400 °C (752 °F). Its appearance suggests rupture along two grain boundaries (at bottom center), as well as an increased quantity of dimples compared with the number present in Fig. 1220. The dimples here are also much more equiaxed than those in Fig. 1220. See also Fig. 1222. SEM, 500×

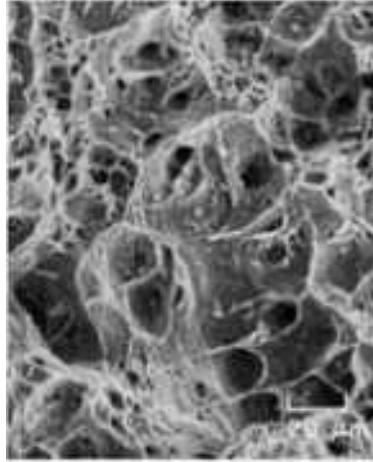
**Fig. 1222** Fracture surface in a specimen of the same Fe-Cr-Ta alloy, and with the same heat treatment, as in Fig. 1219, 1220, and 1221, but which was broken in tension at 600 °C (1112 °F). At this test temperature, the ductility was sufficient to eliminate completely both cleavage and intergranular mechanisms of failure, and fracture occurred entirely by microvoid coalescence. SEM, 500×

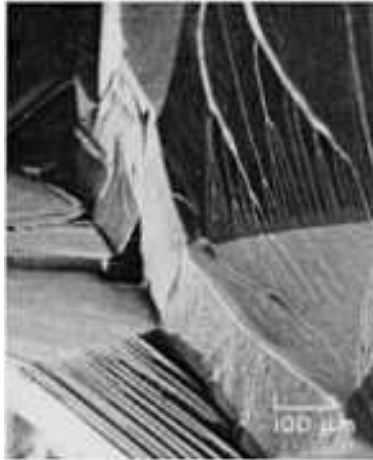
**Fig. 1223** Room-temperature tensile fracture by cleavage of an Fe-6.2Ta alloy solution treated 1 h at 1400 °C (2550 °F), water quenched, aged 1 h at 700 °C (1290 °F) and air cooled. Laves-phase  $\text{Fe}_2\text{Ta}$  precipitate, uniformly distributed in the matrix and believed present at grain boundaries, caused brittleness (<1% tensile elongation). See also Fig. 1224. SEM, 100×

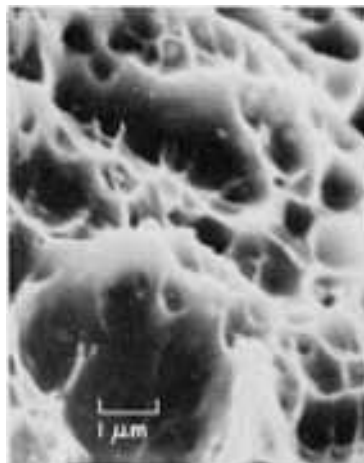
**Fig. 1224 Room-temperature tensile fracture in a specimen of the same alloy as in Fig. 1223, given the same heat treatment plus a spheroidizing treatment of 10 min at 1100 °C (2010 °F) and air cooling. Spheroidization of precipitates at grain boundaries and within grains, plus a finer grain size than in Fig. 1223, resulted in dimpled fracture and 22% tensile elongations. SEM, 10,000×**

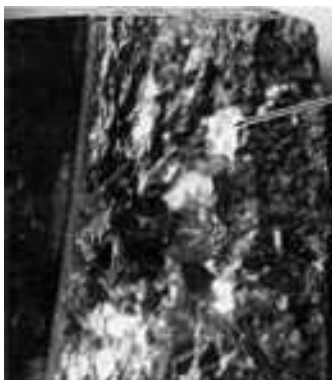
**Fig. 1225 Surface of a "rock candy" fracture in a notched as-cast specimen of Alnico alloy broken by impact at room temperature, showing large, shiny facets. The brittle nature of this specimen is reflected in its unnotched tensile strength of only 34 MPa (5 ksi). See also Fig. 1226, 1227, 1228, 1229, 1230, and 1231. 5.5×**

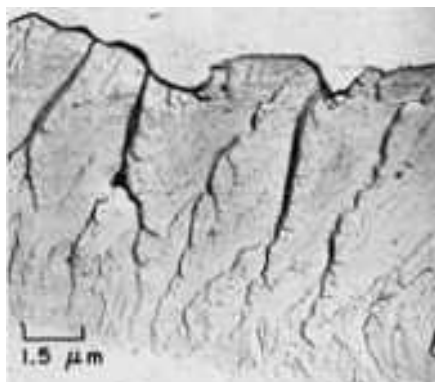
**Fig. 1226 TEM p-c replica of an area of the facet at the arrow in Fig. 1225, showing features resulting from transgranular cleavage. Pronounced cleavage steps in central region indicate that fracture progressed from bottom to top. The margins of this central region are believed to have formed at grain boundaries; the cause of the marked irregularity of the margin at top is not known. 6500×**

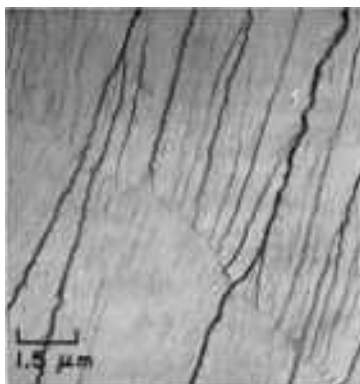
**Fig. 1227 TEM p-c replica at a second area of the facet at the arrow in Fig. 1225, showing features resulting**

from transgranular cleavage and cleavage steps that cross a tilt boundary extending from lower right to upper left. The approximate direction of crack propagation was from lower left to upper right. 6500×

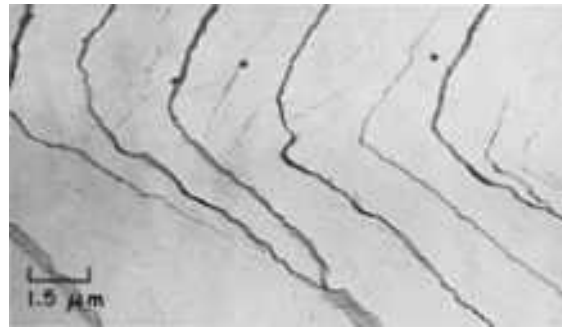
**Fig. 1228** TEM p-c replica of a third area of the facet at the arrow in the fracture surface shown in Fig. 1225. Although no sharp boundary is visible, it appears certain that the cleavage steps, which entered from the top in this view, cross a tilt boundary at mid-height, where they change direction. 6500×

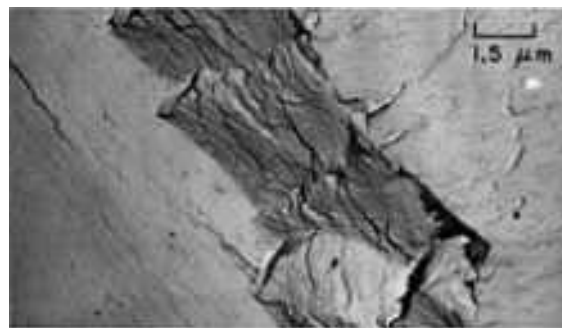
**Fig. 1229** TEM p-c replica of a fourth area of the facet at the arrow in Fig. 1225, showing evidence that here fracture occurred in two different directions and on two different levels. The appearance of the fracture region that connects these two levels (diagonal dark band) has been markedly affected by local microstructure. 6500×

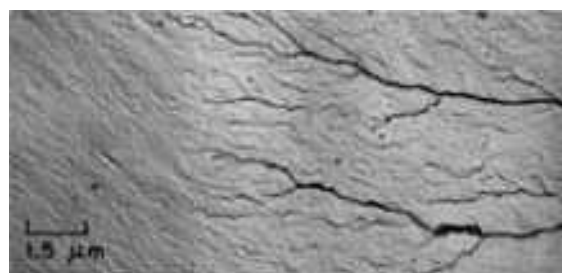
**Fig. 1230** TEM p-c replica of a fifth area of the facet at the arrow in Fig. 1225. The fracture entered this area from the left and, at a tilt boundary, began the formation cleavage steps, creating a river pattern "flowing" toward the right. 6500×

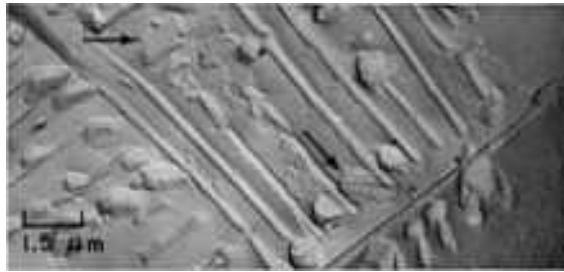
**Fig. 1231** TEM p-c replica of a sixth area of the facet at the arrow in Fig. 1225. This area contains features that could be cleaved second-phase particles or imprints of pulled-out particles. Also visible is a geometric array of rodlike second-phase particles. 6500×

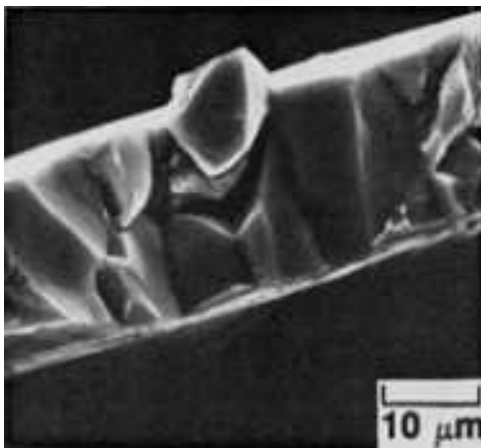
**Fig. 1232**

Fracture-mode transition in rapidly solidified ribbons of Fe-40Al (at.%). The material was made by chill block melt spinning. Samples were tested in tension, with the tensile force applied parallel to the ribbon length. Fig. 1232: Fracture surface of as-spun ribbon. Fracture mode is primarily intergranular. SEM, 1600×. Fig. 1233: Fracture surface of ribbon heat treated in helium for 1 h at 1000 °C (1830 °F). Fracture mode is primarily transgranular cleavage. SEM, 1600× (D. Gaydosh, NASA Lewis Research Center)

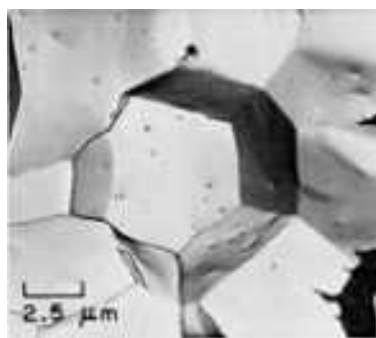
**Fig. 1234** A very clean intergranular fracture in sintered tungsten that was broken by impact. Note the several very flat separated-grain facets; small sintering pores can be seen in several of the facets. TEM p-c replica, 4000×

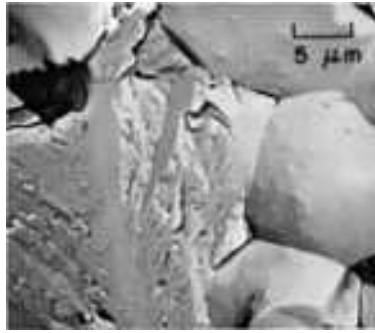
**Fig. 1235** Impact fracture in sintered tungsten that had been recrystallized, showing separated-grain facets (at right) and cleavage facets (at left); the cleavage facets exhibit twins in the {112} plane. TEM p-c replica, 2000×

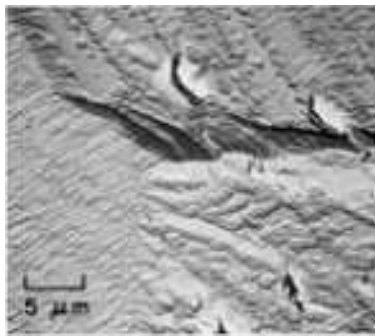
**Fig. 1236** Surface of an impact fracture in a single crystal of tungsten that was etched with  $\text{H}_2\text{O}_2$  after fracture. Cleavage along both the {100} and {113} planes is evident. TEM p-c replica, 2000×

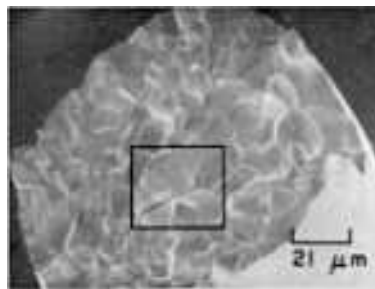
**Fig. 1237** Surface of a brittle, intergranular fracture, produced by bending, in a polycrystalline iridium wire (0.127-mm, or 0.005-in., diam) that had been annealed in vacuum for 2 h at 1200 °C (2190 °F). See Fig. 1238 for an enlarged view of the area in the rectangle. SEM, 470×

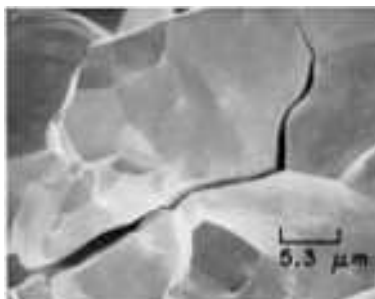
**Fig. 1238** Higher-magnification view of the area in the rectangle in Fig. 1237. This entire area exhibits separated-grain facets and shows no evidence of plastic flow. SEM, 1900×

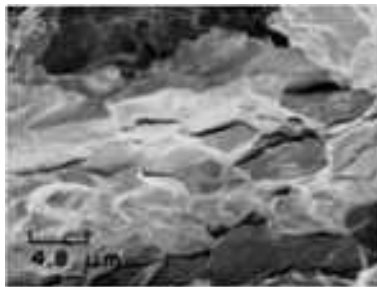
**Fig. 1239** Surface of a brittle, intergranular fracture, produced by bending, in an iridium sheet (rolled to a thickness of 0.076 mm, or 0.0003 in.) that had been annealed for 2 h at 1200 °C (2190 °F) in vacuum. Note the deep secondary cracks between the elongated grains. 2100×

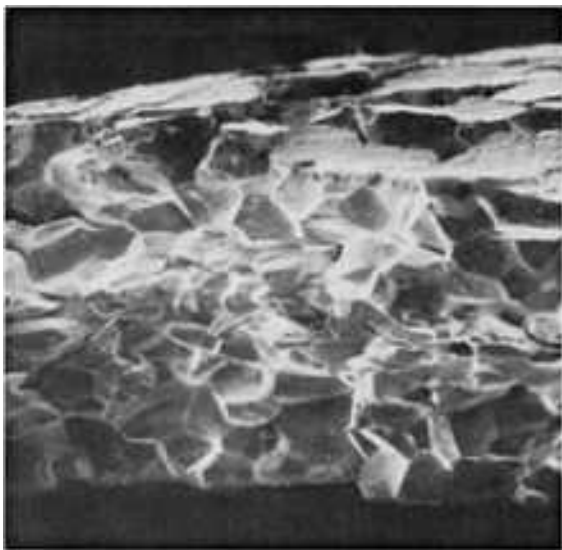
**Fig. 1240**

Intergranular fracture at elevated temperatures in DOP-26, a thorium-doped Ir-0.3W alloy. A high-rate biaxial punch test was used to fracture a disk specimen measuring 52 mm (2 in.) in diameter and 0.635 mm

(0.025 in.) thick. The intrinsic brittleness of iridium makes it unique among face-centered cubic metals. This ordinarily application-limiting property has been taken advantage of here to provide striking examples of exclusively intergranular fracture. Fig. 1240: Fracture surface of disk aged 18 h at 1500 °C (2730 °F) and then biaxially tested at 1440 °C (2625 °F). SEM, 115×. Fig. 1241: Another section of the fracture in Fig. 1240. SEM, 185×. Fig. 1242: Surface cracking in an iridium alloy disk annealed for 1 h at 1500 °C (2730 °F) and then biaxially tested at 1000 °C (1830 °F). SEM, 60×. Fig. 1243: High-magnification view of large crack near center of disk in Fig. 1242. SEM, 1000× (T.G. George, Los Alamos National Laboratory)

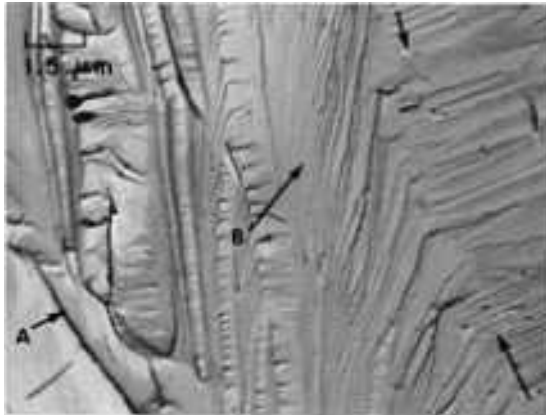
**Fig. 1245 TEM p-c replica of an area at the arrow in Fig. 1244. Here, the fracture surface shows transgranular cleavage. Tilt boundary at A; elsewhere, twist boundaries (between arrows) and suggestions of cleavage feather marks (at B). 6500×**

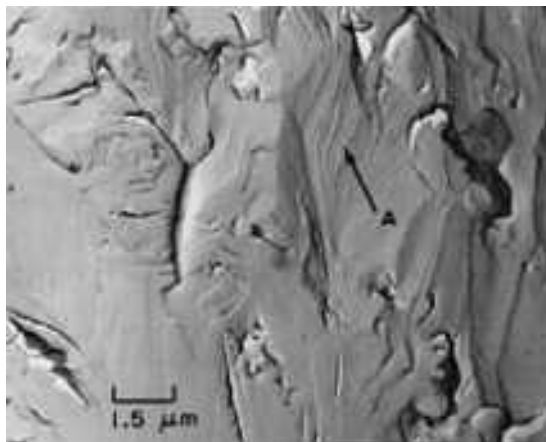
**Fig. 1246 TEM p-c replica of another area at the arrow in Fig. 1244. The features visible here are cleavage facets with involved steps but few clear river patterns. The features at A bear some resemblance to feather**

marks. 6500×

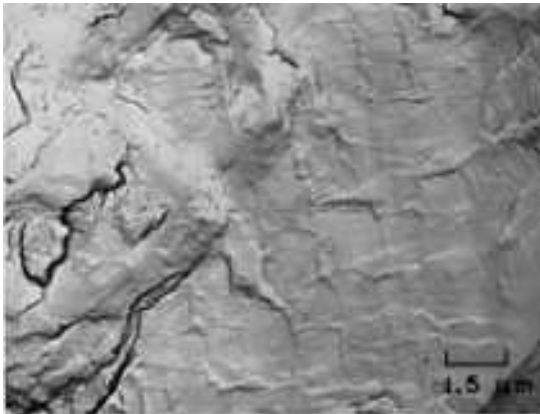
**Fig. 1248** TEM p-c replica of an area at arrow in Fig. 1247. A few fatigue striations are visible at top and at right. Remainder of surface here is unusual, consisting of what appear to be very flat-bottomed, shallow dimples. 6500×

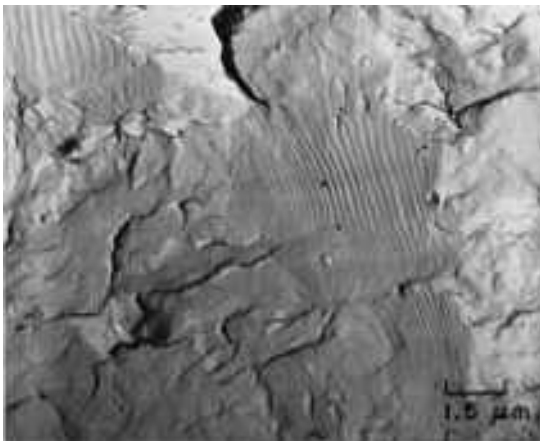
**Fig. 1249** TEM p-c replica of another area at the arrow in Fig. 1247, showing distinct fatigue striations at center and at upper left. Elsewhere, the surface bears scattered and indistinct marks that resemble fatigue striations. 6500×

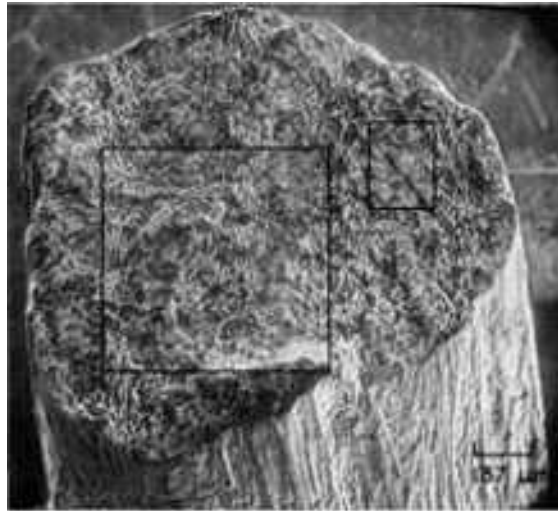
**Fig. 1250** Surface of a fracture in a longitudinal tensile-test specimen of a carbon (graphite)-magnesium composite having a tensile strength of 640 MPa (93 ksi). The approximate makeup of the composite was 40% graphite fibers and 60% magnesium matrix (99.5% pure), by volume. See Fig. 1251 and 1252 for higher-magnification views of the areas outlined by the large and small rectangles, respectively. See also Fig. 1254. SEM, 75×

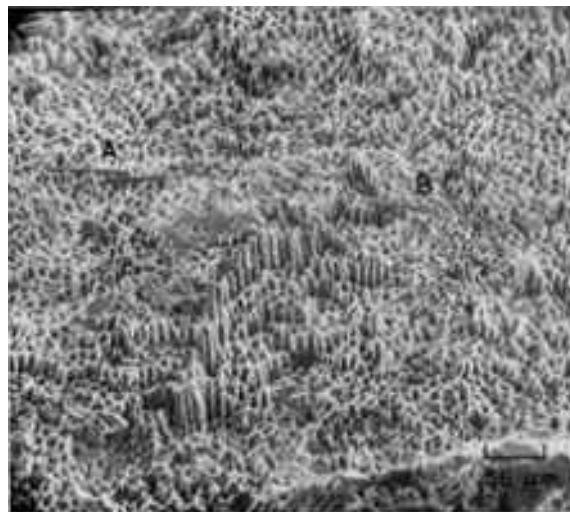
**Fig. 1251** Higher-magnification view of the area in the larger rectangle in Fig. 1250. At A are two transversely oriented features that appear to be graphite fibers that either are lying loose on the surface or were inadvertently misaligned during manufacture. The feature at B is probably a ridge. Much of the surface exhibits broken fibers, the ends of which are roughly in the same plane as the fracture in the surrounding matrix, but at center are exposed fibers with the appearance of "palisades." SEM, 180×

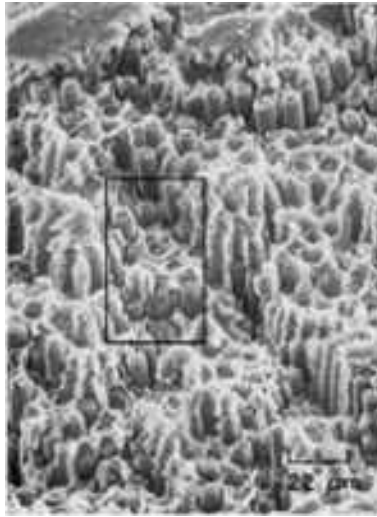
**Fig. 1252** Higher-magnification view of the area in the smaller rectangle in Fig. 1250, showing "palisades," some of which are the reverse of those in Fig. 1251 in that the fibers have broken at the bottom of the "palisades," exposing the sides of the holes in the matrix. See Fig. 1253 for an enlarged view of the area in the rectangle. SEM, 450×

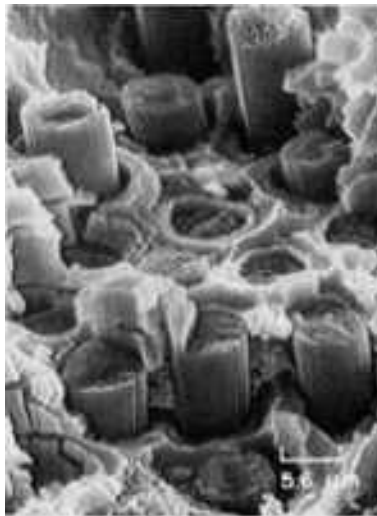
**Fig. 1253** Enlargement of the area in the rectangle in Fig. 1252, showing that the magnesium matrix fractured in a brittle manner; note the many transverse fissures in the sides of the holes. Note also that the surfaces of the holes in the matrix reflect faithfully the fluted contours of the graphite fibers. SEM, 1800×

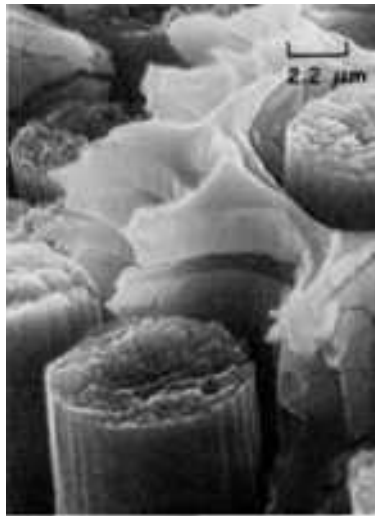
**Fig. 1254** View at higher magnification of an area of the fracture surface shown in Fig. 1250. The rough surfaces of the broken graphite fibers are clearly visible here. Also compare these rough surfaces with the smooth cleavage facets on the broken tungsten fibers shown in Fig. 1257. SEM, 4500×

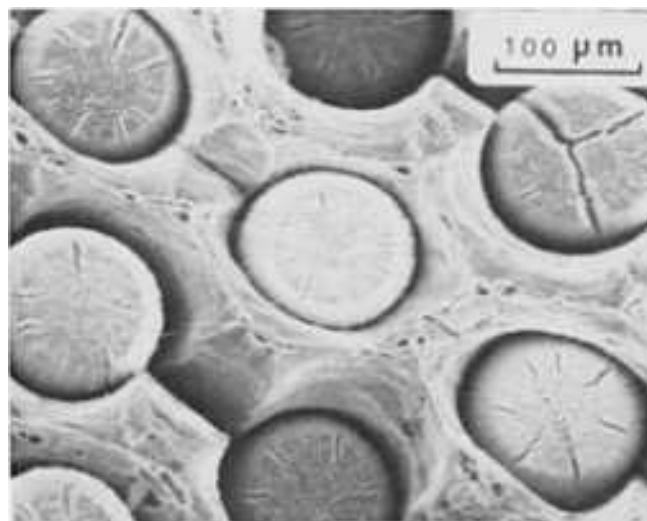
**Fig. 1255** Tensile fracture at room temperature in a unidirectionally reinforced composite consisting of 45 vol% NS-55 tungsten fibers in an aluminum alloy 6061 matrix. Fiber diameter: 110  $\mu\text{m}$ . Composite was fabricated by diffusion bonding alternating layers of metal foils and aligned fiber arrays for 30 min at 69 MPa (10 ksi) and 480 °C (895 °F). Tensile strength of the metal-matrix composite was in close agreement with rule-of-mixture values. (Compare with Fig. 1256 and 1257.) Fracture surface reveals interlaminar failure of the aluminum matrix (features of this type are usually obliterated in conventional metallography). Inadequate bonding between matrix foils may have been caused by thin surface oxides that did not dissolve during bonding. Also note separations at fiber-matrix interfaces. The absence of a reaction layer indicates that the strength of the composite derives primarily from mechanical locking. Both fiber-matrix and matrix-matrix interface separations were due to transverse tensile stresses resulting from necking of both fibers and matrix. Radial cracks propagating along fiber grain boundaries were caused by the circumferential stresses generated during reduction of the cross-sectional area ( $\sim 50\%$ ) during necking. Higher-magnification views revealed a fibrous, ductile fracture surface. SEM, 250 $\times$  (C. Kim, Naval Research Laboratory)

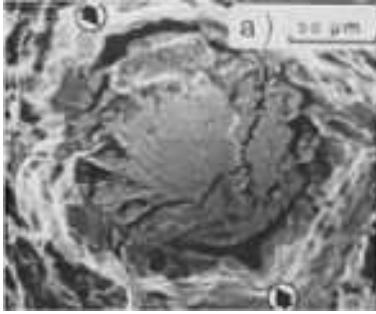
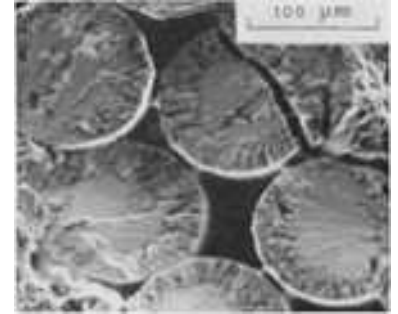
**Fig. 1256**

**Fig. 1257**

Tensile fracture at room temperature in a unidirectionally solidified composite consisting of 45 vol% NS-55 tungsten fibers in an AISI 1010 carbon steel matrix. Fiber diameter: 110  $\mu\text{m}$ . Composite was fabricated by diffusion bonding alternating layers of metal foils and aligned fiber arrays for 30 min at 69 MPa and 760  $^{\circ}\text{C}$  (1400  $^{\circ}\text{F}$ ). Tensile strength was considerably less than that predicted by the rule of mixtures. Compare with Fig. 1255. Fig. 1256: Typical fracture surface reveals adequate fiber-matrix diffusion bonding with the ductile matrix deformed around the fiber. The unbonded regions (arrows) are at points where the macroscopic pressure direction during bonding was tangent to the fiber circumference. The fiber failed in a brittle transgranular mode. However, each fiber had a 15- to 20- $\mu\text{m}$ -thick annular feature at its periphery consisting of numerous secondary fractures propagating along the boundaries of the elongated grains. The river pattern in the core of the fiber indicates that these secondary cracks originated inside the peripheral ring. Subsequent analyses revealed that the annular fracture surface feature corresponded exactly with an iron diffusion front. Cause of the lower-than-expected tensile strength of the composite was fiber embrittlement due to contamination by elemental iron. SEM, 300 $\times$ . Fig. 1257: Lower-magnification view of fracture surface in Fig. 1256 better shows annular rings on fiber surfaces. Major (transverse) fiber fractures originated at the circumference of the smooth interior core region. Note the inadvertent omission of a foil layer between two fiber layers. SEM, 150 $\times$  (C. Kim, Naval Research Laboratory)

Longitudinal cracking in the annular portion of the tungsten fiber fracture surface in Fig. 1256 and 1257 is revealed in these mating-surface fractographs (one is an inverted image). The transverse fracture proceeded toward the upper left of the fiber, and the intergranular longitudinal cracks propagated radially inward. The good matchups between the traces of the longitudinal cracks on the mating fracture surfaces indicate they nucleated independent of and prior to the transverse fracture. SEM, 2025 $\times$  (C. Kim, Naval Research Laboratory)

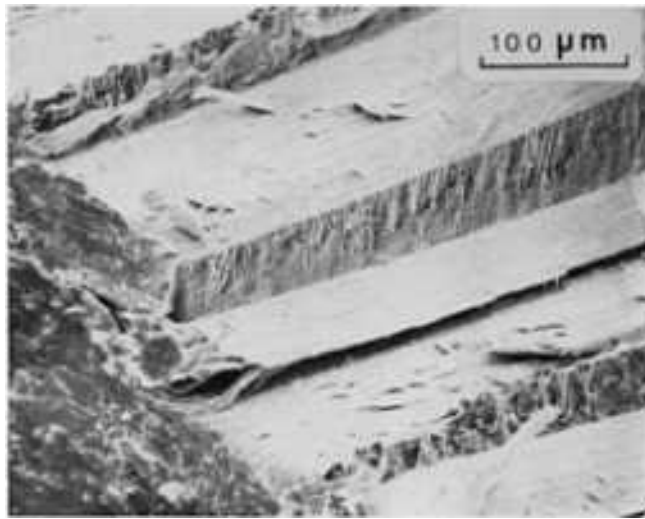
**Fig. 1260** Fracture due to fiber splitting in tungsten fiber reinforced metal-matrix composites. When the tungsten/aluminum and tungsten/steel composites in Fig. 1255, 1256, 1257, 1258, and 1259 fractured under transverse tension loading, the predominant failure mode was fiber splitting, as shown here for the 45 vol% tungsten/1010 steel composite. More than 80% of the fibers split. In the 45 vol% 6061 aluminum alloy matrix material, 70% of the fibers split. SEM, 250× (C. Kim, Naval Research Laboratory)

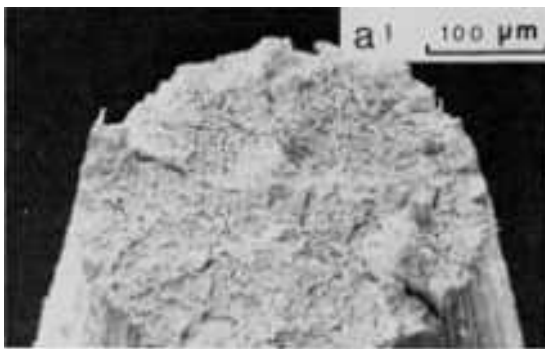
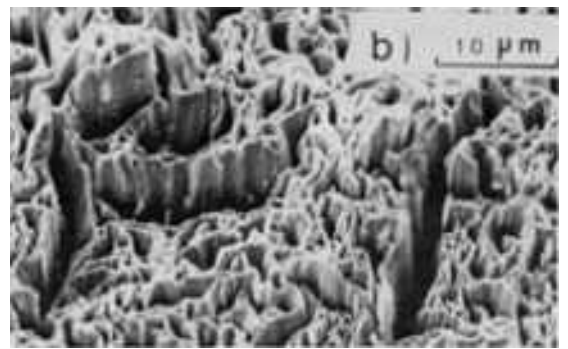
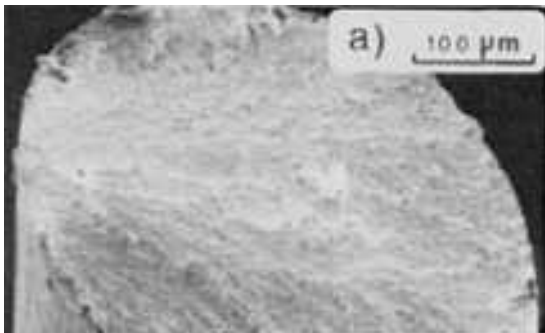
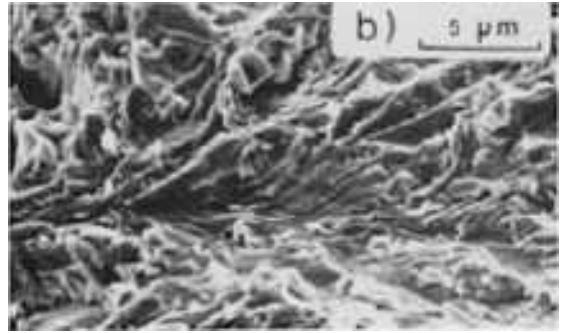
**Fig. 1261**

**Fig. 1262**

**Fig. 1263**

**Fig. 1264**

Ductile to brittle transition in 125-μm-diam NS-55 tungsten fibers. These are the fibers used to reinforce the steel and aluminum composites in Fig. 1255, 1256, 1257, 1258, 1259, and 1260. The transition is thought to be brought about by strain-induced grain-boundary migration and polygonization. Polygonization promotes brittle behavior by increasing the effective stress concentration at grain boundaries. Samples were isothermally annealed for 30 min and then tensile tested at room temperature. Fig. 1261 and 1262: Tungsten fiber annealed at 800 °C (1475 °F), which is below the transition temperature. Note considerable necking and the fibrous, ductile fracture surface. SEM, 210× and 2100× Fig. 1263 and 1264: Tungsten fiber annealed at 950 °C (1740 °F), which is above the transition temperature. Failure was brittle (no necking) and fracture surface is flat, exhibiting transgranular cleavage. SEM, 210× and 4150× (C. Kim, Naval Research Laboratory)

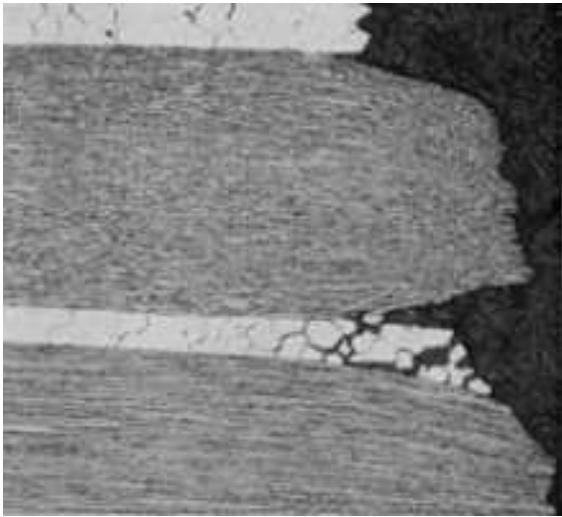
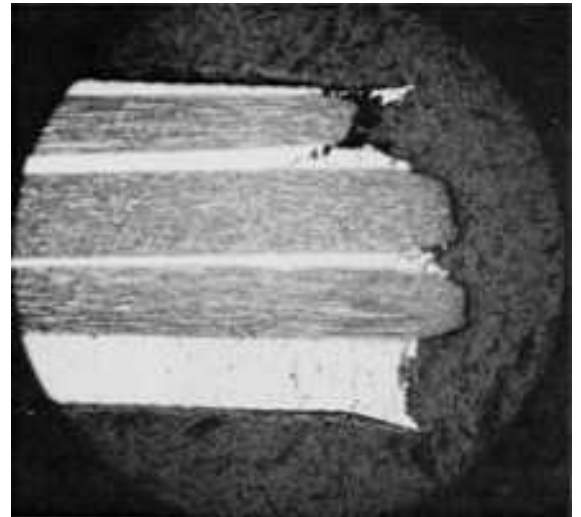
**Fig. 1265**

**Fig. 1266**

**Fracture of metal-matrix composite tensile specimen. The material was a Ni-15Cr-25W-2Al-2Ti alloy reinforced with 0.4-mm (0.015-in.) diam tungsten fibers. The composite was fabricated by slip casting matrix alloy powder around the fibers and then hot isostatically pressing the preform at 1095 °C (2000 °F). The fiber failed in a ductile manner, while the matrix failed in a brittle manner because of poor bonding between individual powder particles. Murakami's reagent, 25× and 100× (D.W. Petrasek, NASA Lewis Research Center)**

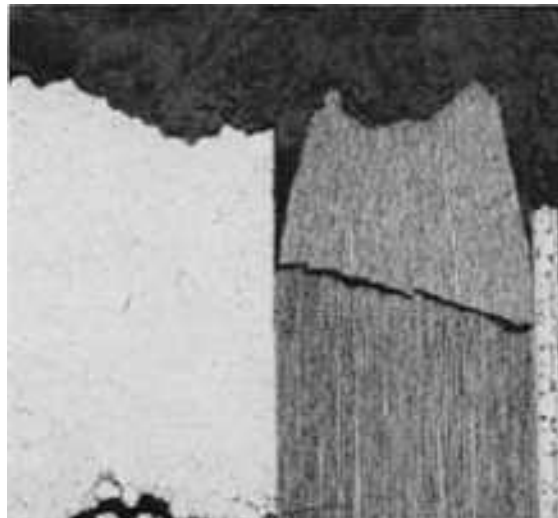
**Fig. 1267 Fracture of metal-matrix composite stress-rupture specimen. Matrix alloy and processing same as in Fig. 1265 and 1266. Reinforcing fibers, however, were W-1ThO<sub>2</sub>, 0.5 mm (0.02 in.) in diameter. Specimen failed after 17.5 h at 1095 °C (2000 °F) and 241 MPa (35 ksi). Necking indicates that fibers failed in a ductile manner. Compare with Fig. 1268. Murakami's reagent, 100× (D.W. Petrasek, NASA Lewis Research Center)**

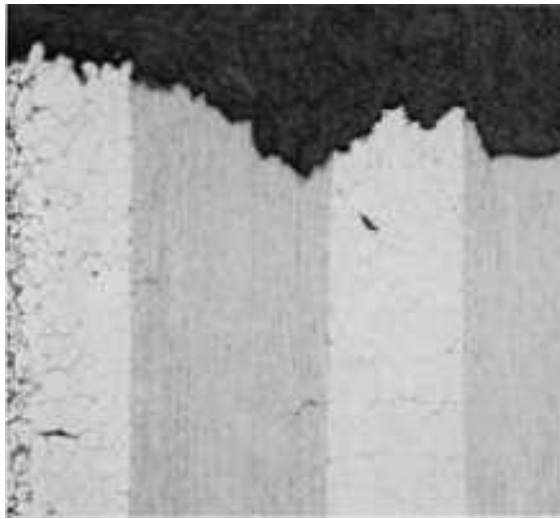
**Fig. 1268** Fracture of metal-matrix composite stress-rupture specimen. Material and processing same as in Fig. 1265 and 1266. The composite failed after 3 h at 1205 °C (2200 °F) and 103 MPa (15 ksi). Fibers failed in a brittle mode. Compare with Fig. 1267. Murakami's reagent, 100× (D.W. Petrasek, NASA Lewis Research Center)

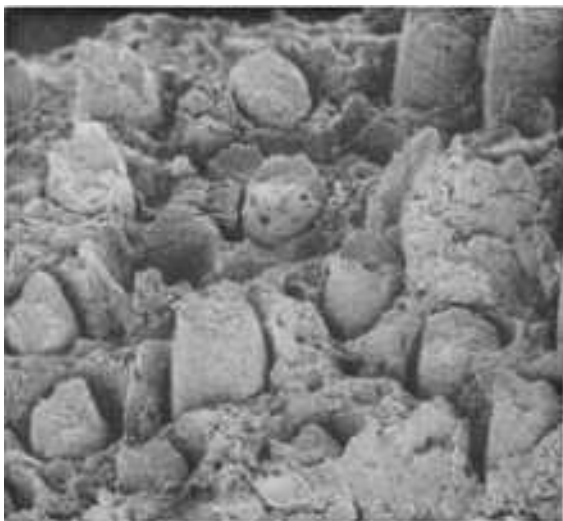
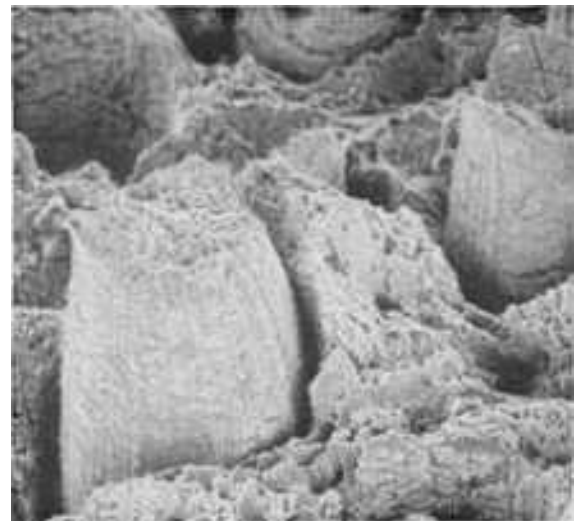
**Fig. 1269**

**Fig. 1270**

Fracture of metal-matrix composite low-cycle fatigue specimen. Material: Fe-24Cr-4Al-1Y matrix reinforced with W-1ThO<sub>2</sub> fibers, 0.2 mm (8 mil) in diameter. The composite was fabricated by applying a matrix alloy powder "cloth" to a fiber mat via use of a plasticizer. A monotape was then made by hot pressing at 1095 °C (2000 °F). Several monotapes were hot pressed together to form a panel, from which fatigue specimens were machined. The composite failed after 200 cycles at 760 °C (1400 °F). Cup-and-cone fiber fractures indicate a ductile failure mode. SEM, 100× and 250× (D.W. Petrasek, NASA Lewis Research Center)

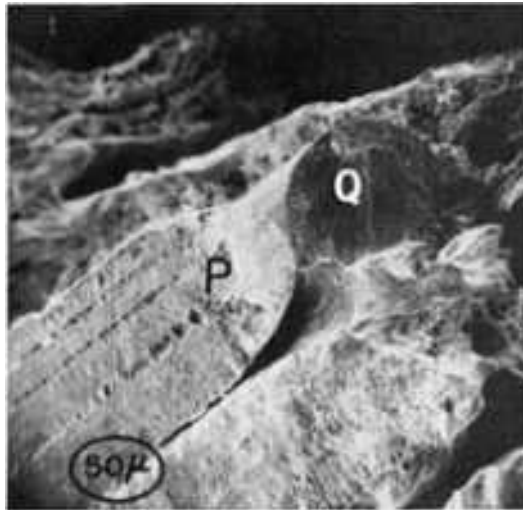
**Fig. 1271** Surface of a tension-overload fracture in a composite consisting of tungsten fibers in a silver matrix. The tungsten fiber marked P has undergone a ductile fracture with necking, whereas fiber Q has suffered a sharp, flat, transverse cleavage fracture. See also Fig. 1272. SEM, 320×

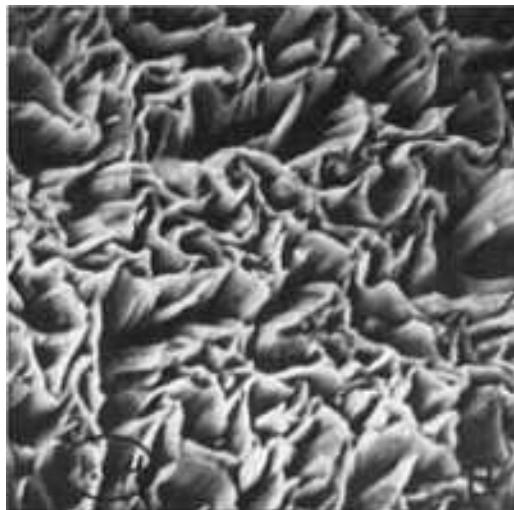
**Fig. 1272** Higher-magnification view of an area of tungsten fiber P in Fig. 1271. Deformation during fracture has thinned the walls of the dimples to sharp edges, which shows the highly ductile nature of the fracture. Note the uniformity in height of the walls. Compare with Fig. 1262. SEM, 10,000×

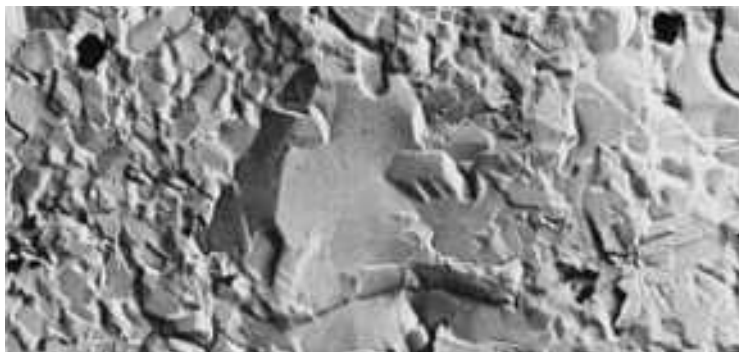
**Fig. 1273** Eta phase on the fracture surface of a 94WC-6Co alloy tested in four-point bending. The large, relatively smooth region in the center is  $\eta$  phase, a hard and brittle cubic compound-- $(Co_3W_3)C$ --that adversely affects fracture toughness of the cemented carbide. Some embedded carbide grains protrude from the phase; others appear to have been removed, exposing the sockets that contained them. In both cases, the fracture path followed  $\eta$ -WC interfaces. Microporosity associated with  $\eta$  phase formation during sintering may account for the apparent role of the phase as a site of fracture initiation. TEM cellulose acetate replica, 4300 $\times$  (S.B. Luyckx, University of the Witwatersrand, South Africa)
