ASM HANDBOOK®

VOLUME  
12

Fractography

*Fractography*, was published in 1987 as Volume 12 of the *ASM Handbook*. The Volume was prepared under the direction of the ASM Handbook Committee.

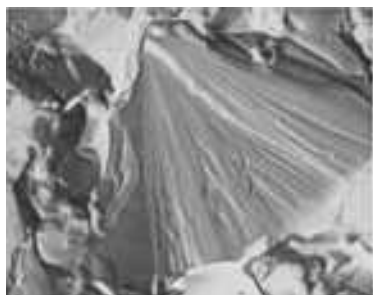
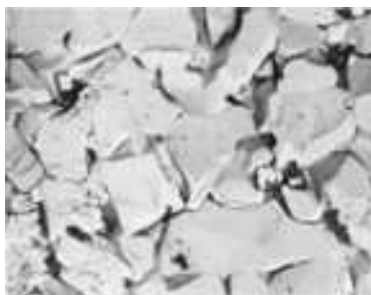
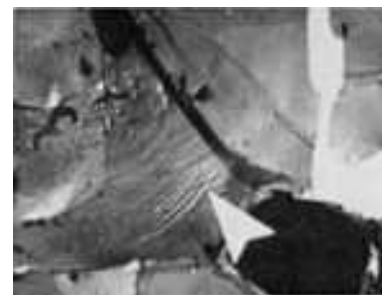
**Fig. 1274**

**Fig. 1275**

**Fig. 1276**

Brittle fractures of 97WC-3Co alloys tested in four-point bending. Fig. 1274: Transgranular (cleavage) fracture of a large, triangular WC grain. Note river patterns covering most of the grain surface. TEM Formvar replica, 11,200 $\times$ . Fig. 1275: Partly intergranular (smooth grains) and partly transgranular (rougher-appearing grains) fracture. Fracture was first etched in 5% HCl to remove the cobalt binder and reveal the role of WC in the fracture process. TEM Formvar replica, 4000 $\times$ . Fig. 1276: Partly intergranular (smooth grains) and partly transgranular fracture. The trapezoidal WC grain at center (transgranular fracture) exhibits Wallner lines (indicated by arrow), which result from the interaction between the advancing crack front and a simultaneously propagating elastic wave. Fracture surface was etched in 5% HCl to remove the cobalt. TEM Formvar replica, 12,000 $\times$  (S.B. Luyckx, University of the Witwatersrand, South Africa)

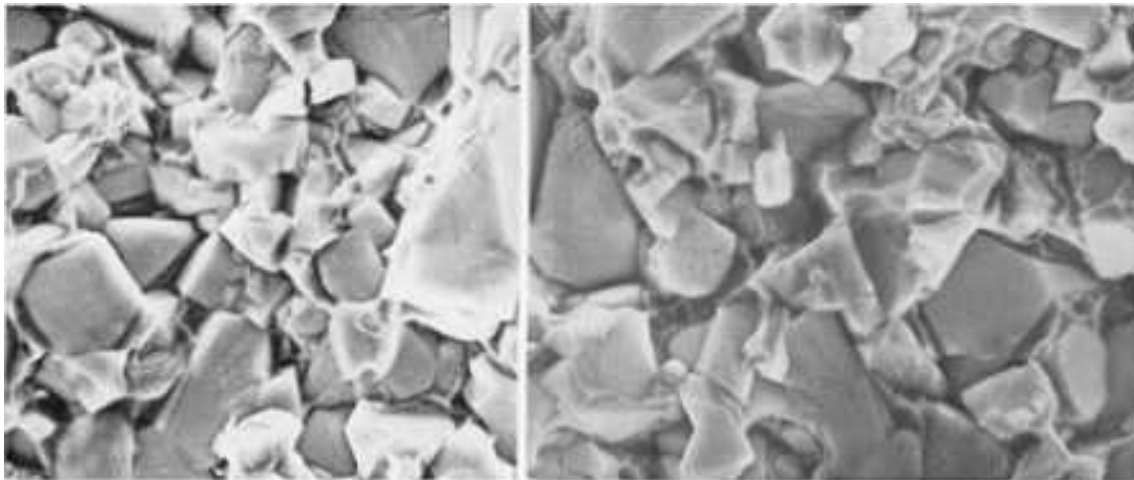
**Fig. 1277** Fracture in four-point bending of a 94WC-6Co alloy. Analysis of mating fracture surfaces (shown here) was needed to accurately gage the fractions of intergranular and transgranular cleavage. Crack propagation was primarily along WC-Co interfaces. Although fracture was brittle on a macroscopic scale, areas of ductile dimpled rupture are visible in the cobalt matrix. SEM, 2000 $\times$  (S.B. Luyckx, University of the Witwatersrand)

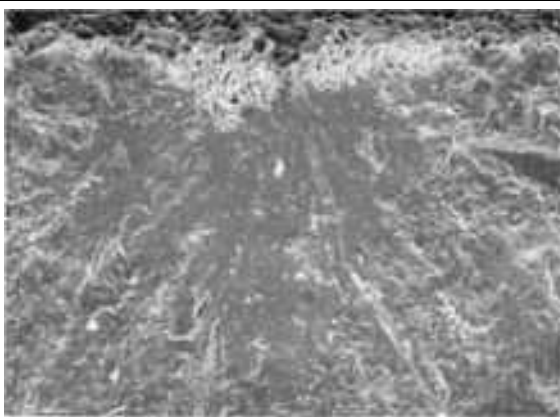
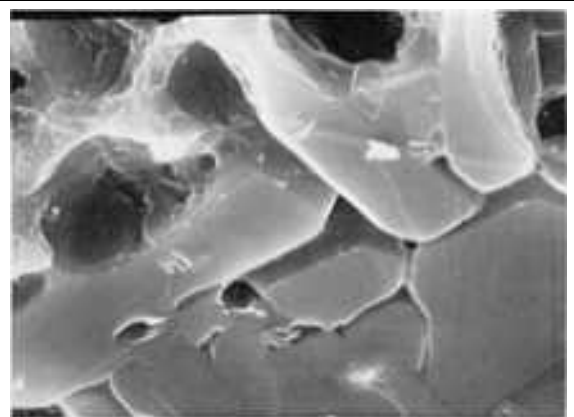
**Fig. 1278**

**Fig. 1279**

Fracture of  $\alpha$ -SiC initiated at corrosion pits. The boron- and carbon-doped SiC was injection molded and pressureless sintered. The sample was then coated with 2 mg/cm<sup>2</sup> (0.07 oz/ft<sup>2</sup>) Na<sub>2</sub>SO<sub>4</sub> and exposed for 48 h at 1000 °C (1830 °F) in 0.1% SO<sub>2</sub>/O<sub>2</sub> gas. Corrosion products were removed with a solution of 10% HF in water and the sample was broken in four-point bending at a strain rate of 0.5 mm/min (0.02 in./min). Fig. 1278: Fracture surface shows radial crack lines emanating from the origin, which was a corrosion pit (top). SEM (30° tilt), 115 $\times$ . Fig. 1279: Close-up of pit-ceramic interface reveals preferential grain-boundary attack in advance of the pit. SEM (30° tilt), 4300 $\times$  (J.L. Smialek and N.S. Jacobson, NASA Lewis Research Center)

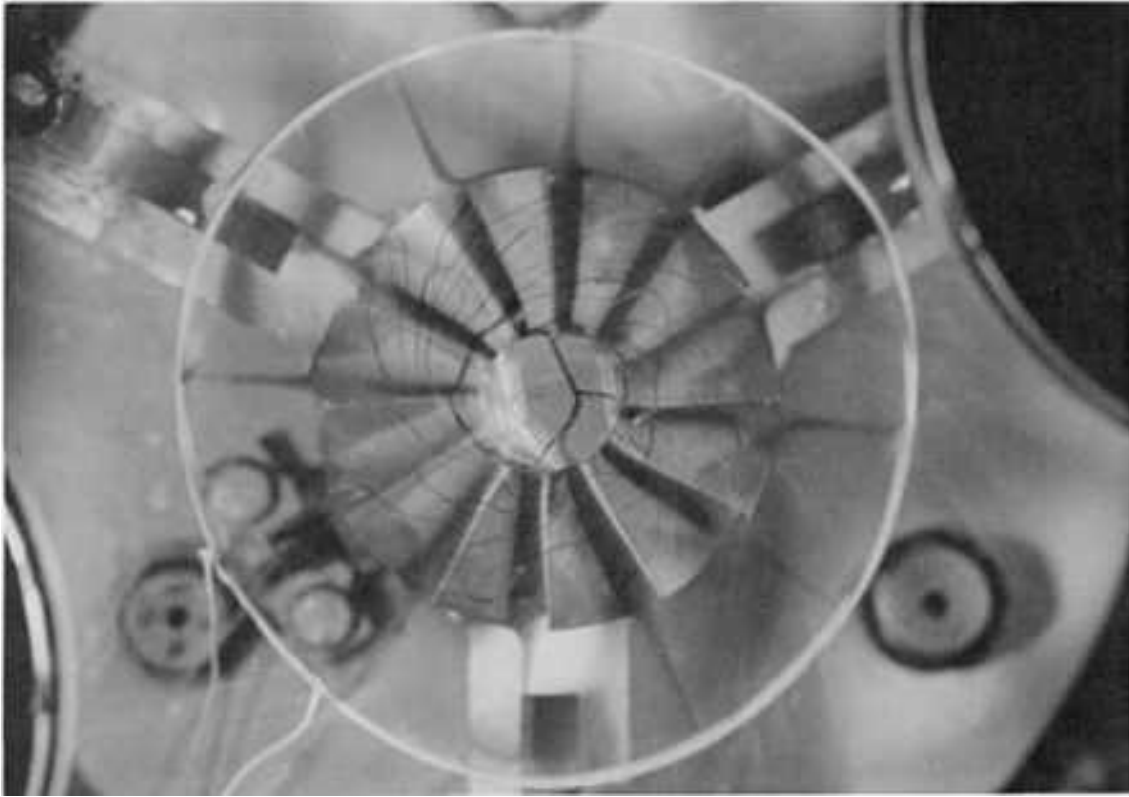
**Fig. 1280 Ceramic turbine rotor at moment of fracture in ambient spin test. Material: sintered  $\alpha$  -SiC. Test was run at 97,000 rpm--an average rotor tip speed of 560 m/s (1840 ft/s). The rotor was an 86,000 rpm design built as part of the Department of Energy's Advance Gas Turbine program. (Sohio Engineered Materials Company and Allison Gas Turbine Division, General Motors Corporation)**

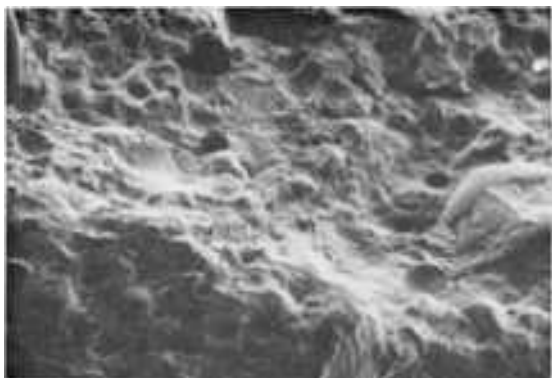
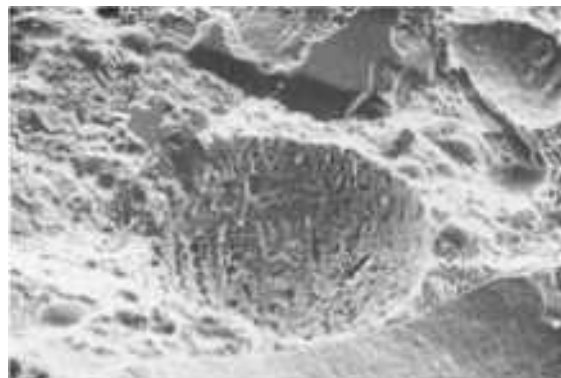
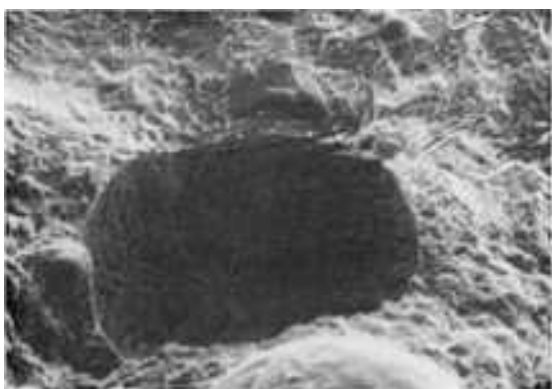
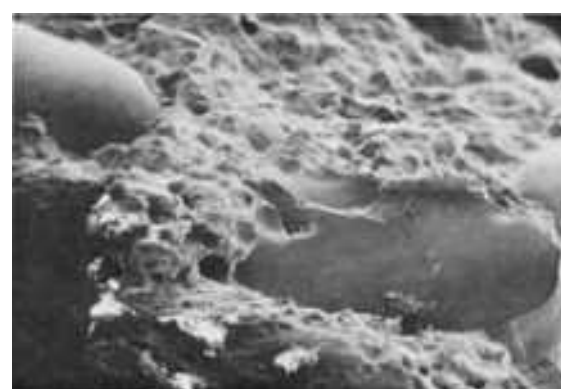
**Fig. 1281**

**Fig. 1282**

**Fig. 1283**

**Fig. 1284**

Fracture surface of a sulfur concrete featuring noninterconnecting voids. Its sulfur cement bonds well to the aggregate to form a dense concrete. (Compare with Fig. 1287, 1288, 1289.) Fig. 1281: Backscattered electron (BE) display of sulfur concrete with noninterconnecting voids, 17 $\times$ . Fig. 1282: Higher-magnification view of portion of field in Fig. 1281 has a noninterconnecting void at its center. BE image, 170 $\times$  Fig. 1283: The structure within a void region. BE image, 165 $\times$ . Fig. 1284: Fractograph shows aggregate embedded in the sulfur cement matrix. BE image, 17 $\times$  (H.W. Leavenworth, Jr., U.S. Bureau of Mines)

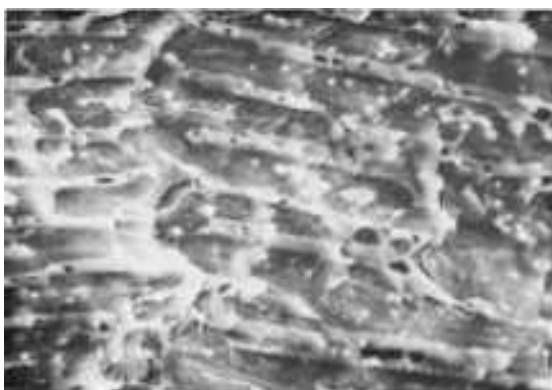
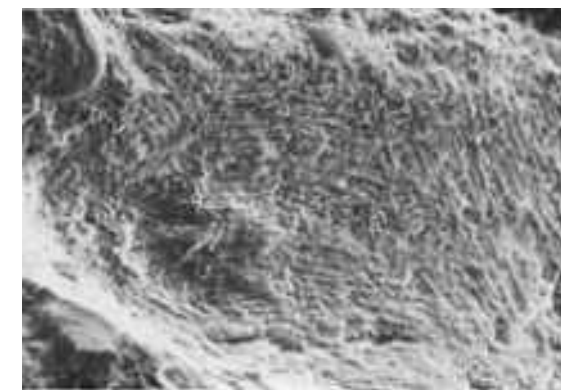
**Fig. 1285**

**Fig. 1286**

Backscattered electron (BE) fractographs of the inside of a noninterconnected void in the sulfur concrete shown in Fig. 1281. Fig. 1285: Note two-phase structure. BE image, 170 $\times$ . Fig. 1286: Higher-magnification view of field in Fig. 1285. The two phases consist of polymetric polysulfides and crystalline sulfur. BE image, 860 $\times$  (H.W. Leavenworth, Jr., U.S. Bureau of Mines)

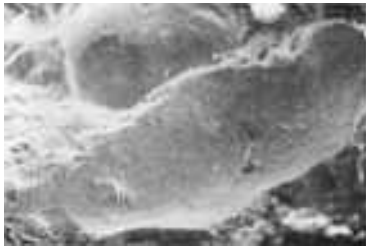
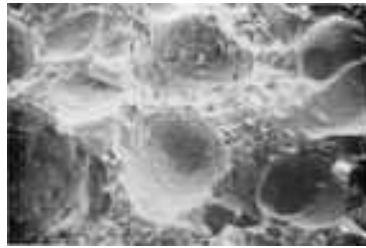
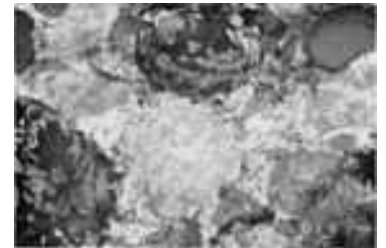
**Fig. 1287**

**Fig. 1288**

**Fig. 1289**

Fracture surface of a sulfur concrete having a high density of interconnecting voids, resulting in a porous, weak material. Aggregate used in this concrete had a polished-appearing surface that did not bond well to the sulfur cement. (Compare with Fig. 1281, 1282, 1283, 1284.) Fig. 1287: Smooth surfaces of interconnected voids that resulted from use of a polished aggregate. SEM, 120 $\times$ . Fig. 1288: Fractograph of sulfur concrete with high void density. SEM, 55 $\times$ . Fig. 1289: Backscattered electron image of field in Fig. 1288 reveals sulfur crystals in void regions. 55 $\times$  (H.W. Leavenworth, Jr., U.S. Bureau of Mines)

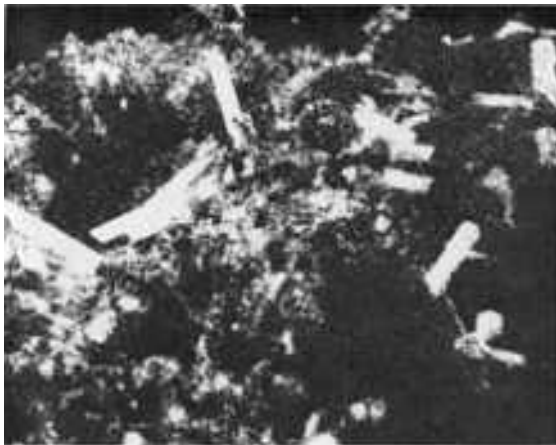
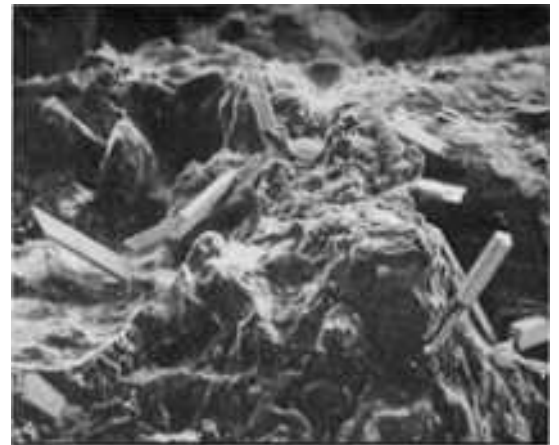
**Fig. 1290**

**Fig. 1291**

**Fig. 1292**

Fracture surface of sulfur asphalt showing distribution and morphology of sulfur within the asphalt phase. Faceted needles of crystalline sulfur form via unconfined growth into asphalt microvoid regions. Spherical sulfur particles are due to confined growth in the asphalt phase. Fig. 1290: K $\alpha$  x-ray map shows sulfur distribution in asphalt, 100 $\times$ . Fig. 1291: Backscattered electron (BE) image of field in Fig. 1290 reveals faceted, needlelike sulfur crystals, 100 $\times$ . Fig. 1292: Higher-magnification sulfur x-ray map. 1000 $\times$ . Fig. 1293: BE image of field in Fig. 1292 reveals spherical sulfur particles. 1000 $\times$  (H.W. Leavenworth, Jr., U.S. Bureau of Mines)

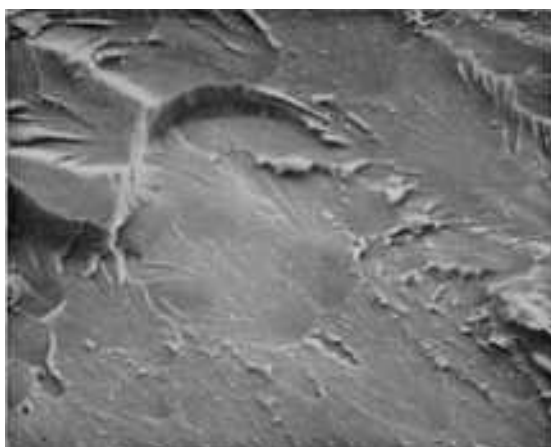
**Fig. 1294** Fracture surface of a Fiberite 934 epoxy resin specimen that failed in tension. The specimen was tested at 25 °C (77 °F) in the dry condition (see note below). Fracture, which initiated at an internal defect, progressed from lower right to upper left. The parabolic markings were produced by cavity nucleation and growth ahead of the advancing crack front. The beginning of the final region where tearing occurs is shown at upper left. SEM, 30° specimen tilt, specimen sputter coated with gold, 1000× (The epoxy specimens shown in Fig. 1294 and 1295 were of Fiberite's 934 epoxy resin, which is one of the standard "state-of-the-art" 175 °C (350 °F) cure epoxy resin systems used in high-performance aerospace composites. The epoxy was gravity cast at room temperature between glass plates and cured at 175 °C (350 °F) according to the manufacturer's recommendations. Tensile specimens were then cut from the cast sheet. Both of the specimens were tested "dry," which means that they were dried before testing in a vacuum oven at 80 °C (175 °F) until no further weight loss was detected. They were tested in a dry oven at the temperatures noted.)(L. Clements, San Jose State University, and J.C. Liu, Cornell University)

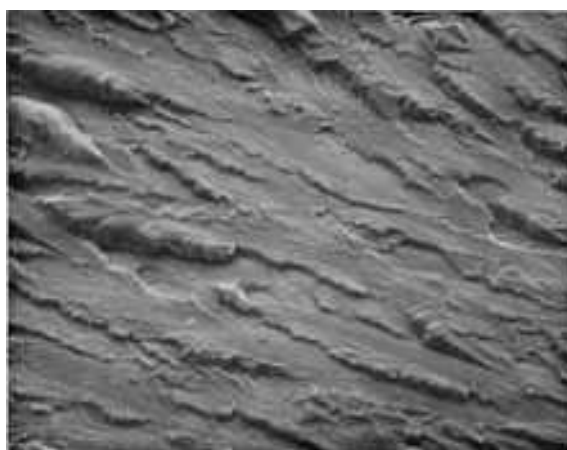
**Fig. 1295** Fracture surface of a Fiberite 93 epoxy resin specimen that failed in tension. The specimen was tested at 96 °C (205 °F) in the dry condition (see note below). As in Fig. 1294, fracture initiated at an internal defect and progressed from lower right to upper left. Shown is the final failure region where tearing occurred. This epoxy specimen is more ductile than the one tested at 25 °C (Fig. 1294). SEM (same conditions as in Fig. 1294), 200× (The epoxy specimens shown in Fig. 1294 and 1295 were of Fiberite's 934 epoxy resin, which is one of the standard "state-of-the-art" 175 °C (350 °F) cure epoxy resin systems used in high-performance aerospace composites. The epoxy was gravity cast at room temperature between glass plates and cured at 175 °C (350 °F) according to the manufacturer's recommendations. Tensile specimens were then cut from the cast sheet. Both of the specimens were tested "dry," which means that they were dried before testing in a vacuum oven at 80 °C (175 °F) until no further weight loss was detected. They were tested in a dry oven at the

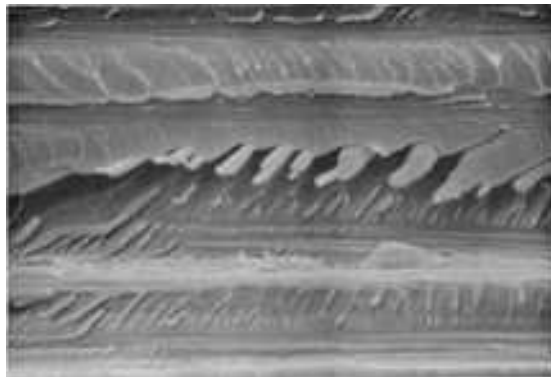
**Fig. 1296** Fracture surface of a transverse (90°) carbon/epoxy specimen that failed in tension. The specimen was tested in the dry condition at 25 °C (77 °F). The surface shows several common features of transverse tensile failure surfaces: (1) branching patterns left on resin when a single branched crack moved across resin, (2, 4, 7) areas where fiber pulled away from resin upon failure, (3) tongues of resin left when cracks moving through resin in two directions on two distinct levels came together, (5) impression of grooves in fiber that pulled away, and (6) branches emanating from debonding of fiber in area 5. SEM (same conditions as in Fig. 1294), 2000× (In transverse (90°) specimens such as those shown in Fig. 1296, 1297, 1298, and 1299, the fibers run perpendicular to the loading direction and thus parallel to the failure surface. Unlike homogenous, isotropic materials, composite failure surfaces are quite complex and will show a variety of different features in different locations. Transverse specimens, however, can usually be found to have a clearly predominant failure type. If the fiber/matrix interfacial bond is weak, such specimens will tend to fail by debonding (interface separation). If the interface is strong, however, matrix failure will be the predominant failure mode. Most current fiber/epoxy systems have a strong interfacial bond and fail by this mode. The exception is for aramid fibers, where the fiber itself is transversely weak and may fail by splitting. In such failures, some fibers will also be torn or broken, but these are few. There also will be some areas where the interface is weak, so some debonding may be seen, but it will not predominate.) (The composite specimens shown in Fig. 1296, 1297, 1298, 1299, 1300, 1301, 1302, 1303, 1304, 1305, 1306, 1307, 1308, 1309, and 1310 all consisted of *circa* 1978 Thornel 300 fibers in Narmco 5208 epoxy resin. The composites were all fabricated by lay-up of prepreg tape and were autoclave cured 175 °C (350 °F) according to the manufacturer's recommendations. Specimens were then end-tabbed and cut in accordance with the ASTM D3039. The 0° and 90° tensile specimens were tested in accordance with ASTM D3039, and the 0° flexural three-point-bend specimens were tested in accordance with ASTM D790. The composites were dried before testing in the same manner as the epoxy specimens described in Fig. 1294 and 1295. "Dry" specimens were tested as-dried and had essentially 0 wt% moisture. "Room" moisture specimens had about 0.6 wt% moisture, having been placed after drying in a chamber at 60 °C (140 °F) and 60% relative humidity for at least 2 months and then placed in a drawer in the laboratory for several months before testing. "Wet" specimens had about 1.5 to 2.0 wt% moisture, having been placed for several months in an environmental chamber at 60 °C (140 °F) and 100% relative humidity. The composites were tested at moisture conditions designed not to alter their conditioning, and at the temperatures noted.) (L. Clements, San Jose State University, and J.C. Liu, Cornell University)

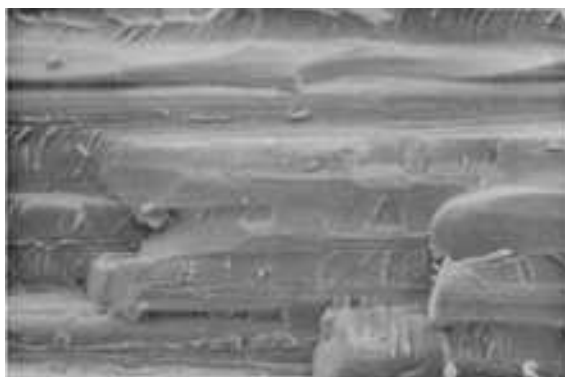
**Fig. 1297** Fracture surface of transverse (90°) carbon/epoxy specimen that failed in tension. The "room

moisture" specimen was tested at 25 °C (77 °F) at a moisture content of ~0.6 wt%. A few fiber breaks are shown in this fractograph. These are not common in transverse tensile failure surfaces (unless the fibers are somewhat misoriented). Note that the fibers fail at angles to the fracture surface that range from almost perpendicular to very oblique. Note that all fibers retain a great deal of resin on their surfaces, which indicates that the interfacial bond was strong and that the primary failure mode was resin failure. SEM (same conditions as in Fig. 1294), 1000× (In transverse (90°) specimens such as those shown in Fig. 1296, 1297, 1298, and 1299, the fibers run perpendicular to the loading direction and thus parallel to the failure surface. Unlike homogenous, isotropic materials, composite failure surfaces are quite complex and will show a variety of different features in different locations. Transverse specimens, however, can usually be found to have a clearly predominant failure type. If the fiber/matrix interfacial bond is weak, such specimens will tend to fail by debonding (interface separation). If the interface is strong, however, matrix failure will be the predominant failure mode. Most current fiber/epoxy systems have a strong interfacial bond and fail by this mode. The exception is for aramid fibers, where the fiber itself is transversely weak and may fail by splitting. In such failures, some fibers will also be torn or broken, but these are few. There also will be some areas where the interface is weak, so some debonding may be seen, but it will not predominate.) (The composite specimens shown in Fig. 1296, 1297, 1298, 1299, 1300, 1301, 1302, 1303, 1304, 1305, 1306, 1307, 1308, 1309, and 1310 all consisted of *circa* 1978 Thornel 300 fibers in Narmco 5208 epoxy resin. The composites were all fabricated by lay-up of prepreg tape and were autoclave cured 175 °C (350 °F) according to the manufacturer's recommendations. Specimens were then end-tabbed and cut in accordance with the ASTM D3039. The 0° and 90° tensile specimens were tested in accordance with ASTM D3039, and the 0° flexural three-point-bend specimens were tested in accordance with ASTM D790. The composites were dried before testing in the same manner as the epoxy specimens described in Fig. 1294 and 1295. "Dry" specimens were tested as-dried and had essentially 0 wt% moisture. "Room" moisture specimens had about 0.6 wt% moisture, having been placed after drying in a chamber at 60 °C (140 °F) and 60% relative humidity for at least 2 months and then placed in a drawer in the laboratory for several months before testing. "Wet" specimens had about 1.5 to 2.0 wt% moisture, having been placed for several months in an environmental chamber at 60 °C (140 °F) and 100% relative humidity. The composites were tested at moisture conditions designed not to alter their conditioning, and at the temperatures noted.) (L. Clements, San Jose State University, and J.C. Liu, Cornell University)

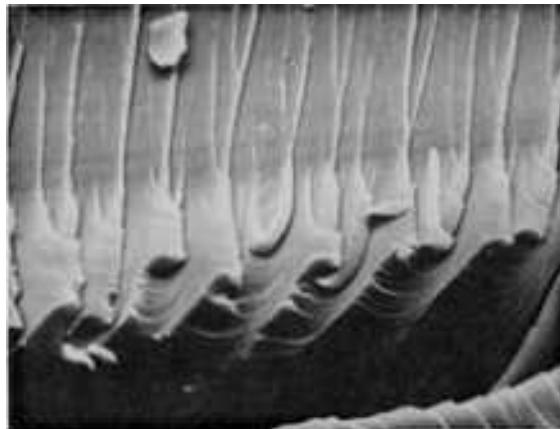
Fig. 1298 Fracture surface of a transverse (90°) carbon/epoxy specimen that failed in tension. The "wet" specimen was tested at 25 °C (77 °F) at a moisture content of 1.5 wt%. It was cycled five times between 74 and 25 °C (165 and 77 °F) at a relative humidity of 100% before testing. Fractograph shows one area of an epoxy-rich interlaminar region, between layers of fiber/resin tape. SEM (same conditions as in Fig. 1294), 2000× (In transverse (90°) specimens such as those shown in Fig. 1296, 1297, 1298, and 1299, the fibers run perpendicular to the loading direction and thus parallel to the failure surface. Unlike homogenous, isotropic materials, composite failure surfaces are quite complex and will show a variety of different features in different locations. Transverse specimens, however, can usually be found to have a clearly predominant failure type. If the fiber/matrix interfacial bond is weak, such specimens will tend to fail by debonding (interface separation). If the interface is strong, however, matrix failure will be the predominant failure mode. Most current fiber/epoxy systems have a strong interfacial bond and fail by this mode. The exception is for aramid fibers, where the fiber itself is transversely weak and may fail by splitting. In such failures, some fibers will also be torn or broken, but these are few. There also will be some areas where the interface is weak, so some debonding may be seen, but it will not predominate.) (The composite specimens shown in Fig. 1296, 1297, 1298, 1299, 1300, 1301, 1302, 1303, 1304, 1305, 1306, 1307, 1308, 1309, and 1310 all consisted of *circa* 1978 Thornel 300 fibers in Narmco 5208 epoxy resin. The composites were all fabricated by lay-up of prepreg tape and were autoclave cured 175 °C (350 °F) according to the manufacturer's recommendations. Specimens were then end-tabbed and cut in accordance with the ASTM D3039. The 0° and 90° tensile specimens were tested in accordance with ASTM

D3039, and the 0° flexural three-point-bend specimens were tested in accordance with ASTM D790. The composites were dried before testing in the same manner as the epoxy specimens described in Fig. 1294 and 1295. "Dry" specimens were tested as-dried and had essentially 0 wt% moisture. "Room" moisture specimens had about 0.6 wt% moisture, having been placed after drying in a chamber at 60 °C (140 °F) and 60% relative humidity for at least 2 months and then placed in a drawer in the laboratory for several months before testing. "Wet" specimens had about 1.5 to 2.0 wt% moisture, having been placed for several months in an environmental chamber at 60 °C (140 °F) and 100% relative humidity. The composites were tested at moisture conditions designed not to alter their conditioning, and at the temperatures noted.) (L. Clements, San Jose State University, and J.C. Liu, Cornell University)

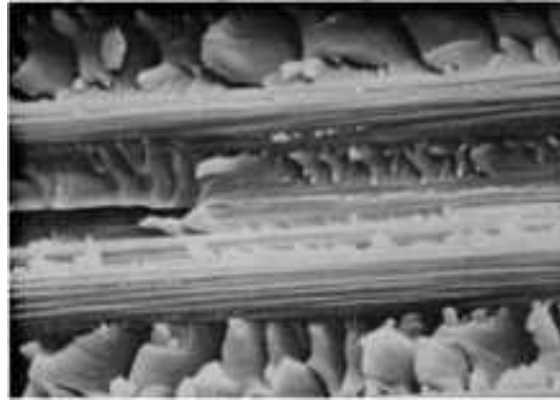
Fig. 1299 Fracture surface of a transverse (90°) carbon/epoxy specimen that failed in tension. The "wet" specimen was tested at 25 °C (77 °F) at a moisture content of ~1.5 wt%. Same pretest cycling as in Fig. 1298. Fractograph shows at (1) and (5) hackles formed when secondary cracks in the resin propagated as a crack front moved from left to right; at (2) and (4) bare fibers where interfacial debonding occurred upon failure; and at (3) an impression left in the resin by a debonded fiber (right side) and an area where two or more cracks intersected (left side). SEM (same conditions as in Fig. 1294), 2000× (In transverse (90°) specimens such as those shown in Fig. 1296, 1297, 1298, and 1299, the fibers run perpendicular to the loading direction and thus parallel to the failure surface. Unlike homogenous, isotropic materials, composite failure surfaces are quite complex and will show a variety of different features in different locations. Transverse specimens, however, can usually be found to have a clearly predominant failure type. If the fiber/matrix interfacial bond is weak, such specimens will tend to fail by debonding (interface separation). If the interface is strong, however, matrix failure will be the predominant failure mode. Most current fiber/epoxy systems have a strong interfacial bond and fail by this mode. The exception is for aramid fibers, where the fiber itself is transversely weak and may fail by splitting. In such failures, some fibers will also be torn or broken, but these are few. There also will be some areas where the interface is weak, so some debonding may be seen, but it will not predominate.) (The composite specimens shown in Fig. 1296, 1297, 1298, 1299, 1300, 1301, 1302, 1303, 1304, 1305, 1306, 1307, 1308, 1309, and 1310 all consisted of *circa* 1978 Thornel 300 fibers in Narmco 5208 epoxy resin. The composites were all fabricated by lay-up of prepreg tape and were autoclave cured 175 °C (350 °F) according to the manufacturer's recommendations. Specimens were then end-tabbed and cut in accordance with the ASTM D3039. The 0° and 90° tensile specimens were tested in accordance with ASTM D3039, and the 0° flexural three-point-bend specimens were tested in accordance with ASTM D790. The composites were dried before testing in the same manner as the epoxy specimens described in Fig. 1294 and 1295. "Dry" specimens were tested as-dried and had essentially 0 wt% moisture. "Room" moisture specimens had about 0.6 wt% moisture, having been placed after drying in a chamber at 60 °C (140 °F) and 60% relative humidity for at least 2 months and then placed in a drawer in the laboratory for several months before testing. "Wet" specimens had about 1.5 to 2.0 wt% moisture, having been placed for several months in an environmental chamber at 60 °C (140 °F) and 100% relative humidity. The composites were tested at moisture conditions designed not to alter their conditioning, and at the temperatures noted.) (L. Clements, San Jose State University, and J.C. Liu, Cornell University)

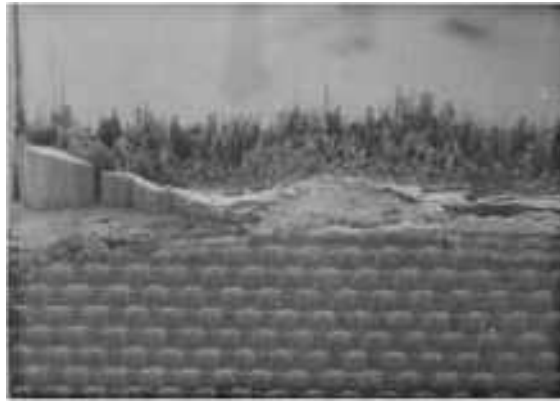
**Fig. 1300** Fracture surface of longitudinal ( $0^\circ$ ) carbon/epoxy specimen failed in flexure. The "wet" specimen was tested at  $96^\circ\text{C}$  ( $205^\circ\text{F}$ ) at a moisture content of  $\sim 2\text{ wt\%}$ . This fractograph shows a typical three-point-bend flexural failure surface. It illustrates the dramatic difference between the tensile and compressive sides of the failure surface. Note the long, protruding fibers on the tensile side, and the crushed, crumpled fibers on the compressive side. SEM (same conditions as in Fig. 1294),  $20\times$  (The composite specimens shown in Fig. 1296, 1297, 1298, 1299, 1300, 1301, 1302, 1303, 1304, 1305, 1306, 1307, 1308, 1309, and 1310 all consisted of *circa* 1978 Thornel 300 fibers in Narmco 5208 epoxy resin. The composites were all fabricated by lay-up of prepreg tape and were autoclave cured  $175^\circ\text{C}$  ( $350^\circ\text{F}$ ) according to the manufacturer's recommendations. Specimens were then end-tabbed and cut in accordance with the ASTM D3039. The  $0^\circ$  and  $90^\circ$  tensile specimens were tested in accordance with ASTM D3039, and the  $0^\circ$  flexural three-point-bend specimens were tested in accordance with ASTM D790. The composites were dried before testing in the same manner as the epoxy specimens described in Fig. 1294 and 1295. "Dry" specimens were tested as-dried and had essentially  $0\text{ wt\%}$  moisture. "Room" moisture specimens had about  $0.6\text{ wt\%}$  moisture, having been placed after drying in a chamber at  $60^\circ\text{C}$  ( $140^\circ\text{F}$ ) and  $60\%$  relative humidity for at least 2 months and then placed in a drawer in the laboratory for several months before testing. "Wet" specimens had about  $1.5$  to  $2.0\text{ wt\%}$  moisture, having been placed for several months in an environmental chamber at  $60^\circ\text{C}$  ( $140^\circ\text{F}$ ) and  $100\%$  relative humidity. The composites were tested at moisture conditions designed not to alter their conditioning, and at the temperatures noted.) (L. Clements, San Jose State University, and J.C. Liu, Cornell University)

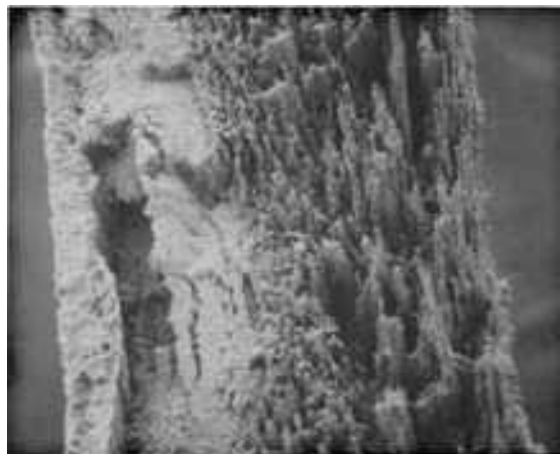
**Fig. 1301** A different view and higher magnification of the carbon/epoxy flexural specimen shown in Fig. 1300. Once again, the difference between the compressive (left) and the tensile (right) sides of the fracture surface is dramatic. SEM (same conditions as in Fig. 1294),  $50\times$  (The composite specimens shown in Fig. 1296, 1297, 1298, 1299, 1300, 1301, 1302, 1303, 1304, 1305, 1306, 1307, 1308, 1309, and 1310 all consisted of *circa* 1978 Thornel 300 fibers in Narmco 5208 epoxy resin. The composites were all fabricated by lay-up of prepreg tape and were autoclave cured  $175^\circ\text{C}$  ( $350^\circ\text{F}$ ) according to the manufacturer's recommendations. Specimens were then end-tabbed and cut in accordance with the ASTM D3039. The  $0^\circ$  and  $90^\circ$  tensile specimens were tested in accordance with ASTM D3039, and the  $0^\circ$  flexural three-point-bend specimens were tested in accordance with ASTM D790. The composites were dried before testing in the same manner as the epoxy specimens described in Fig. 1294 and 1295. "Dry" specimens were tested as-dried and had essentially  $0\text{ wt\%}$  moisture. "Room" moisture specimens had about  $0.6\text{ wt\%}$  moisture, having been placed after drying in a

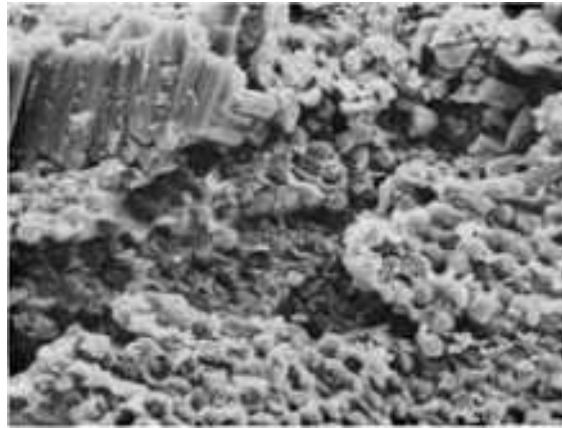
**Fig. 1302** Another view of the carbon/epoxy flexural specimen shown in Fig. 1300 and 1301. This fractograph shows a typical area in the compressive failure region at a higher magnification. Note the crushed and crumpled fibers. See also Fig. 1303. SEM (same conditions as in Fig. 1294), 500× (The composite specimens shown in Fig. 1296, 1297, 1298, 1299, 1300, 1301, 1302, 1303, 1304, 1305, 1306, 1307, 1308, 1309, and 1310 all consisted of *circa* 1978 Thornel 300 fibers in Narmco 5208 epoxy resin. The composites were all fabricated by lay-up of prepreg tape and were autoclave cured 175 °C (350 °F) according to the manufacturer's recommendations. Specimens were then end-tabbed and cut in accordance with the ASTM D3039. The 0° and 90° tensile specimens were tested in accordance with ASTM D3039, and the 0° flexural three-point-bend specimens were tested in accordance with ASTM D790. The composites were dried before testing in the same manner as the epoxy specimens described in Fig. 1294 and 1295. "Dry" specimens were tested as-dried and had essentially 0 wt% moisture. "Room" moisture specimens had about 0.6 wt% moisture, having been placed after drying in a chamber at 60 °C (140 °F) and 60% relative humidity for at least 2 months and then placed in a drawer in the laboratory for several months before testing. "Wet" specimens had about 1.5 to 2.0 wt% moisture, having been placed for several months in an environmental chamber at 60 °C (140 °F) and 100% relative humidity. The composites were tested at moisture conditions designed not to alter their conditioning, and at the temperatures noted.) (L. Clements, San Jose State University, and J.C. Liu, Cornell University)

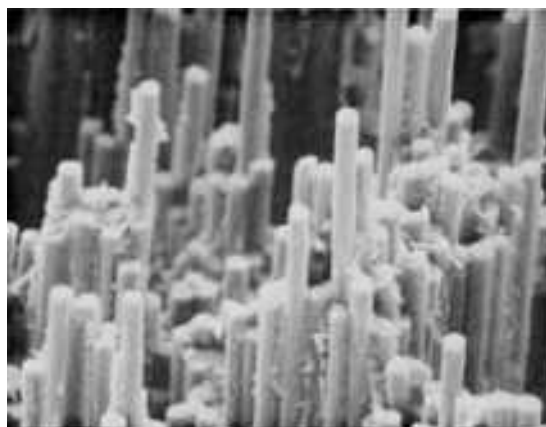
**Fig. 1303** A typical area in the tensile failure region of the carbon/epoxy flexural specimen shown in Fig. 1300 and 1301. Note the long, protruding fibers with some attached epoxy remaining. This area resembles typical regions in a specimen failed in pure tension. See also Fig. 1302. SEM (same conditions as in Fig. 1294), 500× (The composite specimens shown in Fig. 1296, 1297, 1298, 1299, 1300, 1301, 1302, 1303, 1304, 1305, 1306, 1307, 1308, 1309, and 1310 all consisted of *circa* 1978 Thornel 300 fibers in Narmco 5208 epoxy resin. The composites were all fabricated by lay-up of prepreg tape and were autoclave cured 175 °C (350 °F) according to the manufacturer's recommendations. Specimens were then end-tabbed and cut in accordance with the

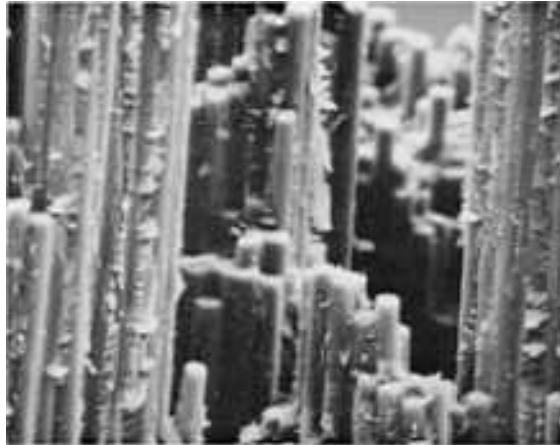
Fig. 1304 Fracture surface of a longitudinal (0°) carbon/epoxy specimen failed in tension. The specimen was tested in the dry condition (see below for explanation) at 25 °C (77 °F). The fibers are broken at many different levels; the fiber breaks are perpendicular to the fiber (and load) direction. There is substantial epoxy adhering to the fiber surfaces, indicating that the interfacial bond strength is fairly high. SEM (same conditions as in Fig. 1294), 500× (The composite specimens shown in Fig. 1296, 1297, 1298, 1299, 1300, 1301, 1302, 1303, 1304, 1305, 1306, 1307, 1308, 1309, and 1310 all consisted of *circa* 1978 Thornel 300 fibers in Narmco 5208 epoxy resin. The composites were all fabricated by lay-up of prepreg tape and were autoclave cured 175 °C (350 °F) according to the manufacturer's recommendations. Specimens were then end-tabbed and cut in accordance with the ASTM D3039. The 0° and 90° tensile specimens were tested in accordance with ASTM D3039, and the 0° flexural three-point-bend specimens were tested in accordance with ASTM D790. The composites were dried before testing in the same manner as the epoxy specimens described in Fig. 1294 and 1295. "Dry" specimens were tested as-dried and had essentially 0 wt% moisture. "Room" moisture specimens had about 0.6 wt% moisture, having been placed after drying in a chamber at 60 °C (140 °F) and 60% relative humidity for at least 2 months and then placed in a drawer in the laboratory for several months before testing. "Wet" specimens had about 1.5 to 2.0 wt% moisture, having been placed for several months in an environmental chamber at 60 °C (140 °F) and 100% relative humidity. The composites were tested at moisture conditions designed not to alter their conditioning, and at the temperatures noted.) (L. Clements, San Jose State University, and P.R. Lee, United Technologies)

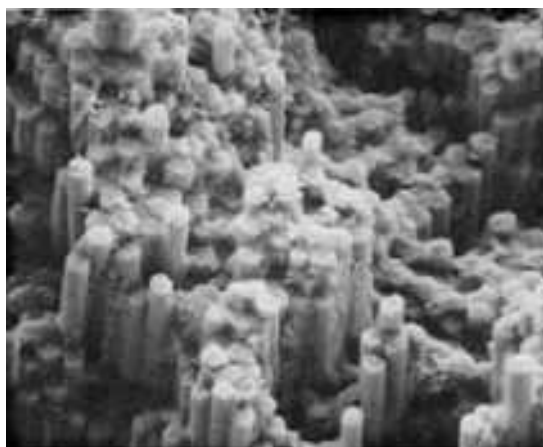
Fig. 1305 Same carbon/epoxy specimen as shown in Fig. 1304, but showing a somewhat less typical fracture area. Although the fibers still protrude at varying levels, the overall appearance is more flat than in Fig. 1304. There are also some holes where fairly short fibers have pulled out. SEM (same conditions as in Fig. 1294), 500 $\times$  (The composite specimens shown in Fig. 1296, 1297, 1298, 1299, 1300, 1301, 1302, 1303, 1304, 1305, 1306, 1307, 1308, 1309, and 1310 all consisted of *circa* 1978 Thornel 300 fibers in Narmco 5208 epoxy resin. The composites were all fabricated by lay-up of prepreg tape and were autoclave cured 175 °C (350 °F) according to the manufacturer's recommendations. Specimens were then end-tabbed and cut in accordance with the ASTM D3039. The 0° and 90° tensile specimens were tested in accordance with ASTM D3039, and the 0° flexural three-point-bend specimens were tested in accordance with ASTM D790. The composites were dried before testing in the same manner as the epoxy specimens described in Fig. 1294 and 1295. "Dry" specimens were tested as-dried and had essentially 0 wt% moisture. "Room" moisture specimens had about 0.6 wt% moisture, having been placed after drying in a chamber at 60 °C (140 °F) and 60% relative humidity for at least 2 months and then placed in a drawer in the laboratory for several months before testing. "Wet" specimens had about 1.5 to 2.0 wt% moisture, having been placed for several months in an environmental chamber at 60 °C (140 °F) and 100% relative humidity. The composites were tested at moisture conditions designed not to alter their conditioning, and at the temperatures noted.) (L. Clements, San Jose State University and P.R. Lee, United Technologies)

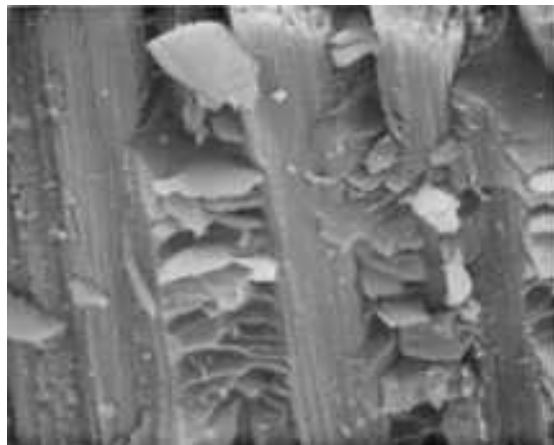
Fig. 1306 Fracture surface of a longitudinal (0°) carbon/epoxy specimen failed in tension. The specimen was tested at 25 °C (77 °F) in the dry condition. This fractograph shows the surface of some broken fibers and the associated hackles formed in the epoxy upon separation of the bundle from an adjacent one. The amount of epoxy remaining on the fibers indicated a fairly strong interfacial bond. SEM (same conditions as in Fig. 1294), 2000 $\times$  (The composite specimens shown in Fig. 1296, 1297, 1298, 1299, 1300, 1301, 1302, 1303, 1304, 1305, 1306, 1307, 1308, 1309, and 1310 all consisted of *circa* 1978 Thornel 300 fibers in Narmco 5208 epoxy resin. The composites were all fabricated by lay-up of prepreg tape and were autoclave cured 175 °C (350 °F) according to the manufacturer's recommendations. Specimens were then end-tabbed and cut in accordance with the ASTM D3039. The 0° and 90° tensile specimens were tested in accordance with ASTM D3039, and the 0° flexural three-point-bend specimens were tested in accordance with ASTM D790. The composites were dried before testing in the same manner as the epoxy specimens described in Fig. 1294 and 1295. "Dry" specimens were tested as-dried and had essentially 0 wt% moisture. "Room" moisture specimens had about 0.6 wt% moisture, having been placed after drying in a chamber at 60 °C (140 °F) and 60% relative humidity for at least 2 months and then placed in a drawer in the laboratory for several months before testing. "Wet" specimens had about 1.5 to 2.0 wt% moisture, having been placed for several months in an environmental chamber at 60 °C (140 °F) and 100% relative humidity. The composites were tested at moisture conditions designed not to alter their conditioning, and at the temperatures noted.) (L. Clements, San Jose State University, and P.R. Lee, United Technologies)

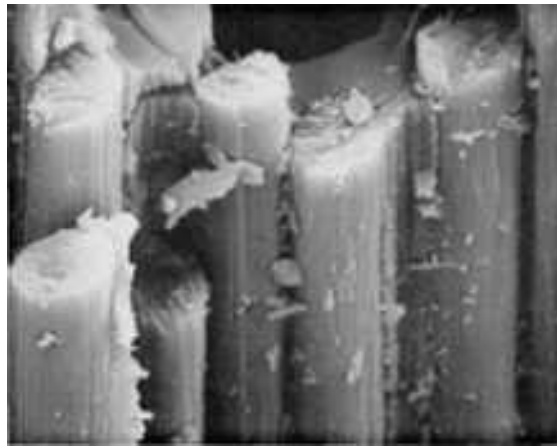
**Fig. 1307** Fracture surface of a carbon/epoxy "wet" specimen tension tested at 96 °C (205 °F) at a moisture content of ~2 wt %. Fractograph shows a bundle of fractured fibers, impressions of carbon fibers in remaining epoxy, and pieces of epoxy that have broken loose but not fallen away from the bundle. This fracture morphology is somewhat unusual in that the broken fiber surfaces are not exactly perpendicular to the fiber axis, which indicates that the failure was not 0° tensile in nature. SEM (same conditions as in Fig. 1294), 2000× (The composite specimens shown in Fig. 1296, 1297, 1298, 1299, 1300, 1301, 1302, 1303, 1304, 1305, 1306, 1307, 1308, 1309, and 1310 all consisted of *circa* 1978 Thornel 300 fibers in Narmco 5208 epoxy resin. The composites were all fabricated by lay-up of prepreg tape and were autoclave cured 175 °C (350 °F) according to the manufacturer's recommendations. Specimens were then end-tabbed and cut in accordance with the ASTM D3039. The 0° and 90° tensile specimens were tested in accordance with ASTM D3039, and the 0° flexural three-point-bend specimens were tested in accordance with ASTM D790. The composites were dried before testing in the same manner as the epoxy specimens described in Fig. 1294 and 1295. "Dry" specimens were tested as-dried and had essentially 0 wt% moisture. "Room" moisture specimens had about 0.6 wt% moisture, having been placed after drying in a chamber at 60 °C (140 °F) and 60% relative humidity for at least 2 months and then placed in a drawer in the laboratory for several months before testing. "Wet" specimens had about 1.5 to 2.0 wt% moisture, having been placed for several months in an environmental chamber at 60 °C (140 °F) and 100% relative humidity. The composites were tested at moisture conditions designed not to alter their conditioning, and at the temperatures noted.) (L. Clements, San Jose State University, and P.R. Lee, United Technologies)

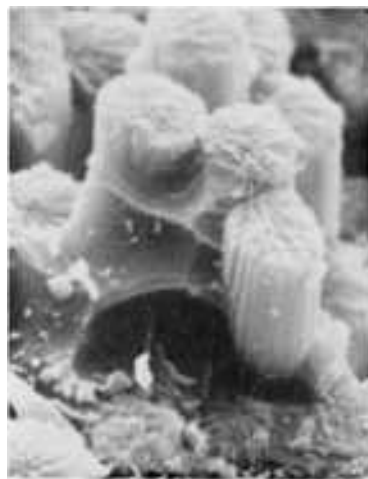
**Fig. 1308** Fracture surface of a longitudinal (0°) carbon/epoxy specimen that failed in tension. Specimen was tested at 25 °C (77 °F) in the dry condition. This fractograph shows typical tensile failure of the epoxy resin in a local resin-rich region. This results when fibers break and produce overload tensile failure in the resin. SEM (same conditions as in Fig. 1294), 2000× (The composite specimens shown in Fig. 1296, 1297, 1298, 1299, 1300, 1301, 1302, 1303, 1304, 1305, 1306, 1307, 1308, 1309, and 1310 all consisted of *circa* 1978 Thornel 300 fibers in Narmco 5208 epoxy resin. The composites were all fabricated by lay-up of prepreg tape and were autoclave cured 175 °C (350 °F) according to the manufacturer's recommendations. Specimens were then end-tabbed and cut in accordance with the ASTM D3039. The 0° and 90° tensile specimens were tested in

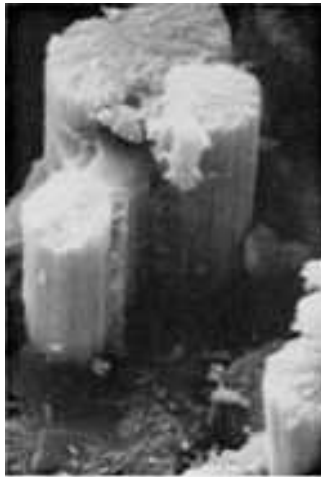
**Fig. 1309** Fracture surface of a carbon/epoxy "wet" specimen tested at 25 °C (77 °F) at a moisture contents of 2.0 wt%. Fractograph shows typical appearance of a local failure of two fibers where the fracture originated at the point of contact between the two fibers. SEM (same conditions as in Fig. 1294), 2000× (The composite specimens shown in Fig. 1296, 1297, 1298, 1299, 1300, 1301, 1302, 1303, 1304, 1305, 1306, 1307, 1308, 1309, and 1310 all consisted of *circa* 1978 Thornel 300 fibers in Narmco 5208 epoxy resin. The composites were all fabricated by lay-up of prepreg tape and were autoclave cured 175 °C (350 °F) according to the manufacturer's recommendations. Specimens were then end-tabbed and cut in accordance with the ASTM D3039. The 0° and 90° tensile specimens were tested in accordance with ASTM D3039, and the 0° flexural three-point-bend specimens were tested in accordance with ASTM D790. The composites were dried before testing in the same manner as the epoxy specimens described in Fig. 1294 and 1295. "Dry" specimens were tested as-dried and had essentially 0 wt% moisture. "Room" moisture specimens had about 0.6 wt% moisture, having been placed after drying in a chamber at 60 °C (140 °F) and 60% relative humidity for at least 2 months and then placed in a drawer in the laboratory for several months before testing. "Wet" specimens had about 1.5 to 2.0 wt% moisture, having been placed for several months in an environmental chamber at 60 °C (140 °F) and 100% relative humidity. The composites were tested at moisture conditions designed not to alter their conditioning, and at the temperatures noted.) (L. Clements, San Jose State University, and P.R. Lee, United Technologies)

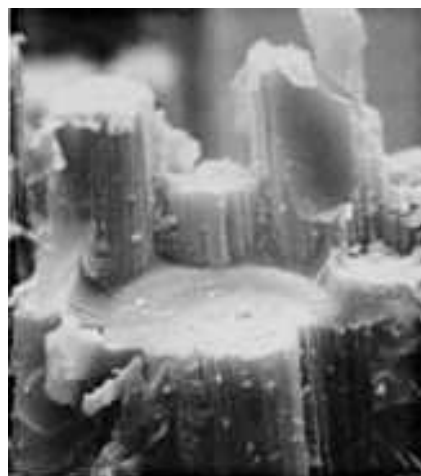
Fig. 1310 Fracture surface of a longitudinal (0°) carbon/epoxy specimen failed in tension. Specimen was tested in the dry condition at 96 °C (205 °F). The region surrounding the broken fiber at the center of the fractograph was extremely resin-rich. Note how the resin failure radiated from the fiber break and progressed to adjacent areas. This is an unusual fracture morphology in that fractured fibers rarely produce such a flat failure. SEM (same conditions as in Fig. 1294), 2000× (The composite specimens shown in Fig. 1296, 1297, 1298, 1299, 1300, 1301, 1302, 1303, 1304, 1305, 1306, 1307, 1308, 1309, and 1310 all consisted of *circa* 1978 Thornel 300 fibers in Narmco 5208 epoxy resin. The composites were all fabricated by lay-up of prepreg tape and were autoclave cured 175 °C (350 °F) according to the manufacturer's recommendations. Specimens were then end-tabbed and cut in accordance with the ASTM D3039. The 0° and 90° tensile specimens were tested in accordance with ASTM D3039, and the 0° flexural three-point-bend specimens were tested in accordance with ASTM D790. The composites were dried before testing in the same manner as the epoxy specimens described in Fig. 1294 and 1295. "Dry" specimens were tested as-dried and had essentially 0 wt% moisture. "Room" moisture specimens had about 0.6 wt% moisture, having been placed after drying in a chamber at 60 °C (140 °F) and 60% relative humidity for at least 2 months and then placed in a drawer in the laboratory for several months before testing. "Wet" specimens had about 1.5 to 2.0 wt% moisture, having been placed for several months in an environmental chamber at 60 °C (140 °F) and 100% relative humidity. The composites were tested at moisture conditions designed not to alter their conditioning, and at the temperatures noted.) (L. Clements, San Jose State University, and P.R. Lee, United Technologies)

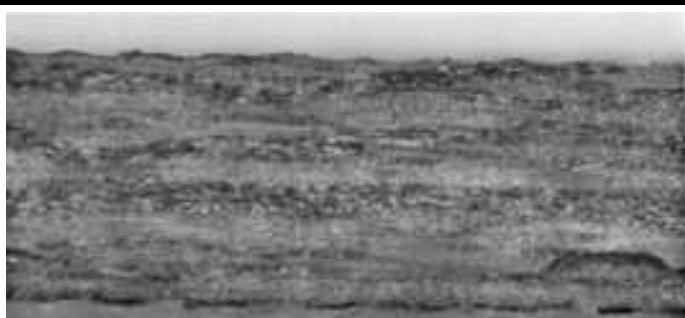
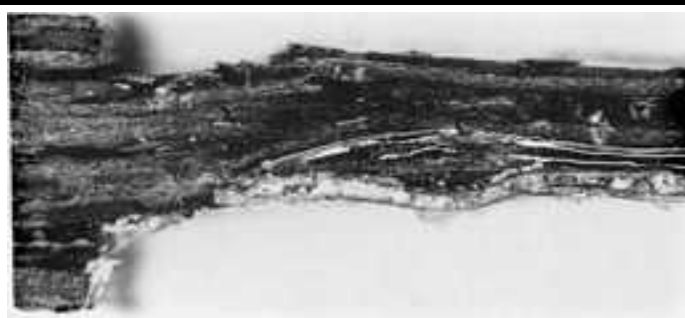
Fractures in short beam shear, compression, and flexure (three-point bending) of woven carbon fabric/phenolic prepreg composite panels. The flat laminate test specimens represent the ablative materials used on the Space Shuttle's solid rocket motor nozzle. Flexure and compression laminates were fabricated from four prepreg plies; shear specimens, from nine. Prepreg layups were vacuum bagged and cured for 5 h at 155 °C (310 °F) and 7 MPa (100 psi). Each pair of photos shows specimens before and after testing. The orientation is edge-on

(parallel to the plane of the laminate). Surfaces were milled. Fig. 1311 and 1312: Carbon/phenolic shear specimen before and after testing. White lines highlight the interlaminar shear failure in Fig. 1312. 25× and 10×. Fig. 1313 and 1314: Carbon/phenolic compression specimen before and after testing. Load was applied parallel to the plane laminate. Note ply buckling in Fig. 1314. 20×. Fig. 1315 and 1316: Carbon/phenolic flexure specimen before and after testing. 15× and 12× (R.J. Schwinghamer, NASA Marshall Space Flight Center)

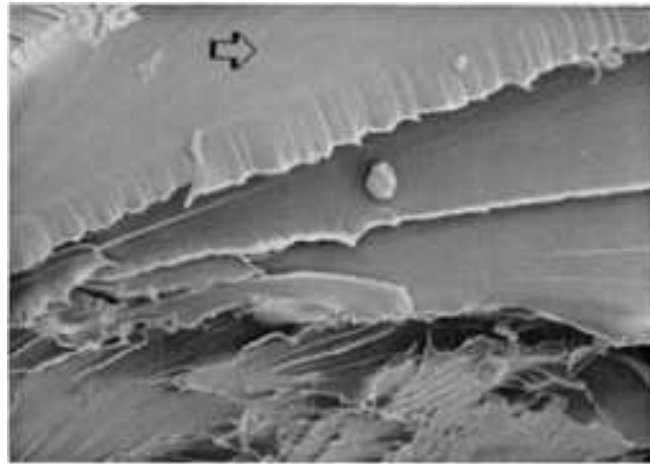
**Fig. 1317** Quasi-brittle fatigue crack propagation in 3.2-mm (0.13-in.) thick polycarbonate sheet. Arrow indicates direction of crack growth. At this thickness, polycarbonate shows features characteristic of both brittle (microcracking) and ductile (thinning and fibrillation) fracture. Note "river patterns" on the plane at top that formed during tearing. Irregular features similar to "tire tracks" at bottom left are formed during the fatigue process when randomly oriented microcracks are created on different planes in front of the notch. When the main crack propagates, it continuously switches from one microcrack plane to the other. SEM, 300× (A.S. Moet, Case Western Reserve University)

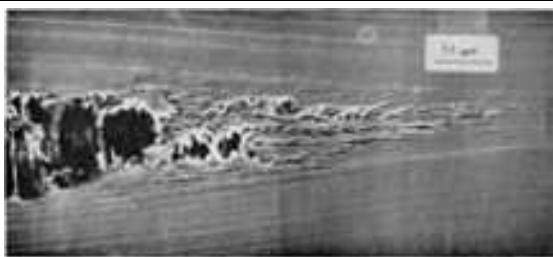
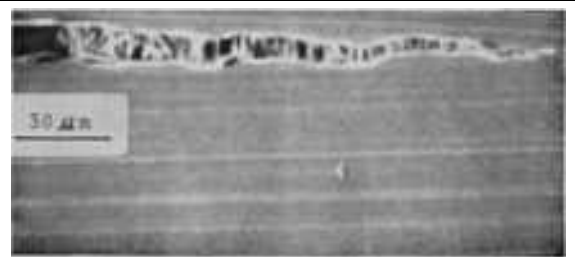
Crack-growth mechanisms in three-point bending of notched 0.4-mm (16-mil) thick specimens of linear polyethylene (density = 0.964 g/cm<sup>3</sup>). The notch, made by a razor blade, was held open during observation in the scanning electron microscope. Fig. 1318: Notched three-point-bend specimen after 215 min at 42 °C (110 °F) and constant load. Stress intensity = 0.30 MPa  $\sqrt{m}$  (0.27 ksi  $\sqrt{in}$ ). Note the craze-like damage zone emanating from the notch (far left). Damage zone propagated at 0.16  $\mu\text{m}/\text{min}$  prior to crack growth. SEM, 540×. Fig. 1319: Specimen in Fig. 1318 after 367 min at 42 °C (110 °F) and constant load. Stress intensity = 0.36 MPa  $\sqrt{m}$  (0.33 ksi  $\sqrt{in}$ ). Damage mechanism is microcrazing in advance of the propagating crack. SEM, 315× (N. Brown and X. Lu, University of Pennsylvania)

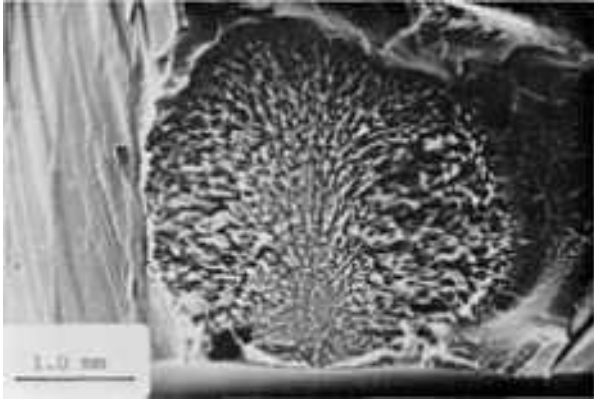
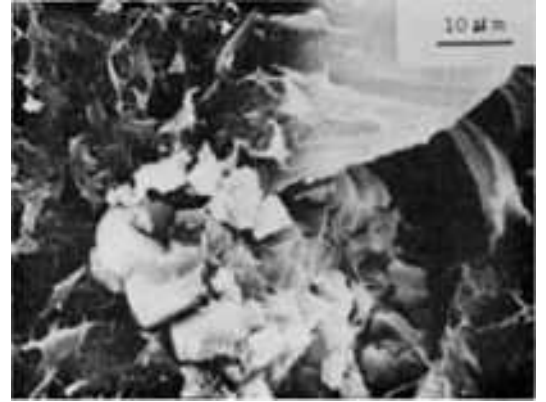
Failure of polyethylene copolymer pipe due to slow crack growth. The 60-mm (2.4-in.) diam, 6-mm (0.25-in.) wall thickness, extruded gas pipe (density  $0.937 \text{ g/cm}^3$ ) failed after 211 h in a laboratory test at  $80^\circ\text{C}$  ( $175^\circ\text{F}$ ) and an internal water pressure of 17 kPa (120 psi). Failure initiated near the inner surface of the pipe. Fig. 1320: Fracture surface near origin (exposed by sectioning). SEM,  $15\times$ . Fig. 1321: High-magnification view of failure origin reveals foreign particles. Spectroscopy determined that aluminum was present. Contaminants may have been aluminum oxide. SEM,  $1300\times$  (N. Brown, University of Pennsylvania)

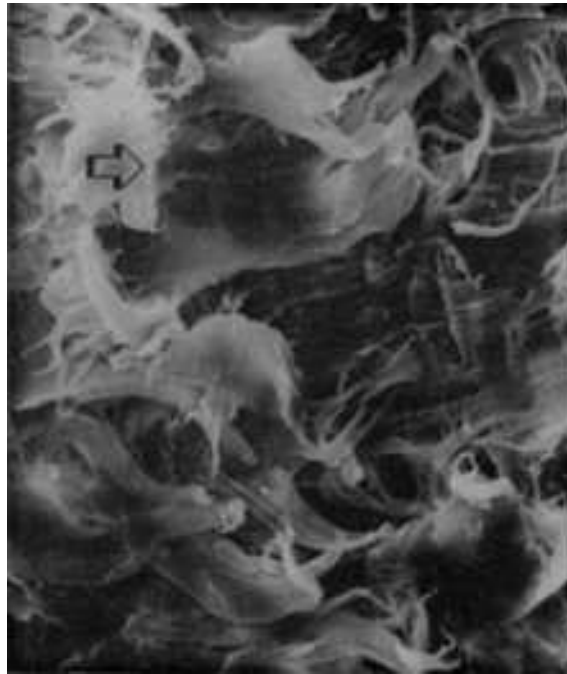
**Fig. 1322** Tearing and fibrillation in medium-density polyethylene tested in creep at room temperature. Arrow indicates direction of crack propagation. Fracture stress ( $\sigma_f$ ) = 15.5 MPa (2.25 ksi). Applied stress =  $0.37 \sigma_f$ . SEM,  $200\times$  (A.S. Moet, Case Western Reserve University)

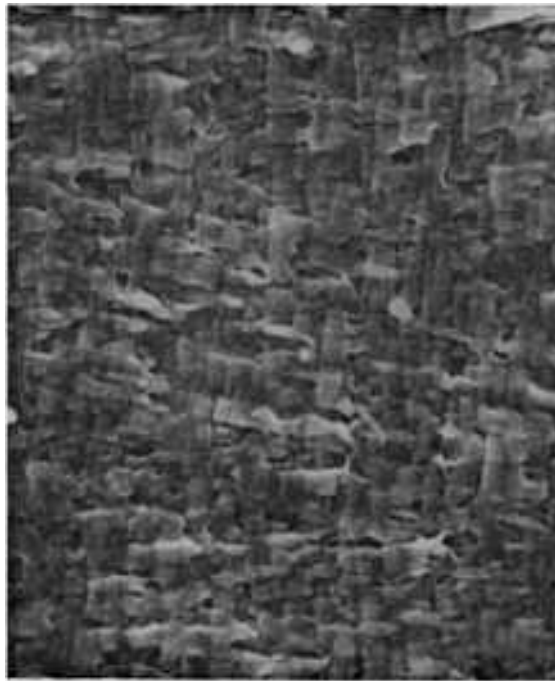
**Fig. 1323** Fatigue striations in medium-density polyethylene. Crack growth direction is left to right. Loading conditions:  $\sigma_{\min}/\sigma_{\max} = R = 0.5$ , where  $\sigma_{\max} = 0.3 \sigma_{\text{yield}}$  and  $\sigma_{\text{yield}} = 22.6 \text{ MPa (3.278 ksi)}$ ; frequency = 0.5 Hz. SEM, 200 $\times$  (A.S. Moet, Case Western Reserve University)
