ASM HANDBOOK®

VOLUME  
12

Fractography

*Fractography*, was published in 1987 as Volume 12 of the *ASM Handbook*. The Volume was prepared under the direction of the ASM Handbook Committee.

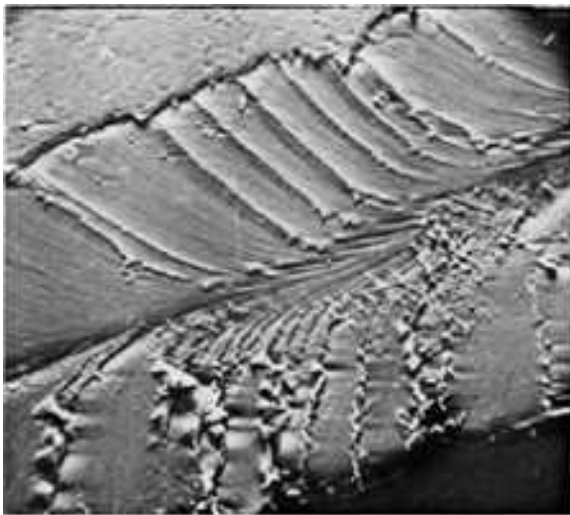
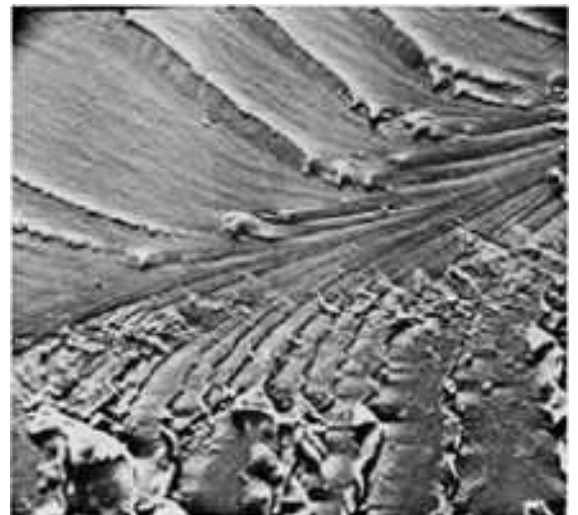
Chevronlike features on fracture surface of polyimide recorder belt point to origin of failure. The 75- $\mu\text{m}$  (3-mil) thick belt was used on Spacelab I. Cause of failure was traced to a design deficiency. SEM, 120 $\times$  and 240 $\times$  (R.J. Schwinghamer, NASA Marshall Space Flight Center)

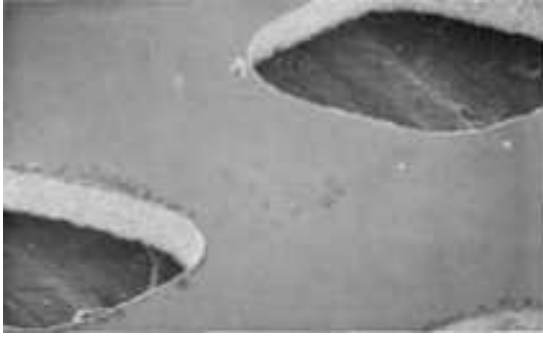
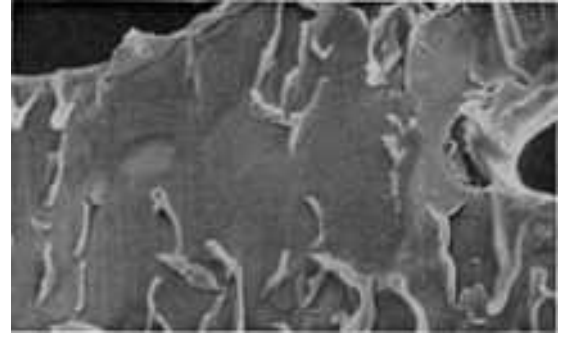
Effect of exposure to the atomic oxygen environment found in low earth orbit (LEO) on a silver solar cell interconnect. The pure silver foil, 40  $\mu\text{m}$  (1.5 mil) thick, was exposed to the LEO environment for 40 h at 100 °C (210 °F) in the spacecraft velocity direction. The sample was flown on Space Shuttle flight 8. The original surface of the interconnect (Fig. 1326) was converted to an oxide of silver (Fig. 1327). Both reflectivity and electrical conductivity decreased as a result. SEM, 3800 $\times$  (R.J. Schwinghamer, NASA Marshall Space Flight Center)

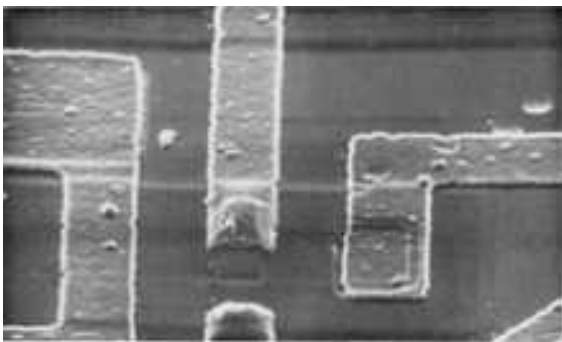
**Fig. 1328**

Integrated circuit (IC) defects. Material: pure aluminum vacuum deposited on Si/SiO<sub>2</sub>. Fig. 1328: Oxide flaws under the metallized layer on this IC produced a thin oxide layer that promoted voltage "punchthrough" and failure (center). SEM, 800 $\times$ . Fig. 1329: Shown here is a base emitter for input transistors. The cracklike defect at center was caused by electrical discharge across the junction. SEM, 3360 $\times$  (R.J. Schwinghamer, NASA Marshall Space Flight Center)

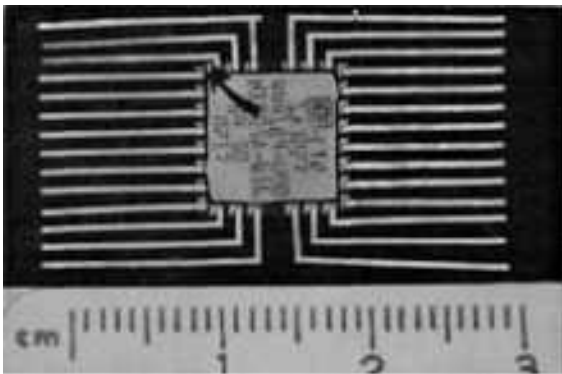
**Fig. 1330**

Fatigue failure of L-shaped electronic flat pack leads due to cyclic, eccentric loading during ultrasonic cleaning. The 0.13-mm (5-mil) thick Alloy 42 (42Ni-58Fe) leads were nickel electroplated, soldered (Cu-Ag alloy) to tungsten, and then gold plated. Fig. 1330: A 28-lead electronic flat pack. Cracking was predominantly observed in the smallest L-shaped leads (arrow). 2.5 $\times$ . Fig. 1331: Cracks in L-shaped leads were found in the solder and near the edge of the solder in both top and bottom fillets (arrows). See also Fig. 1332, 1333, and 1334. SEM, 300 $\times$  (T. O'Donnell, P. Tung, A. Shumka, R. Ruiz, and J. Okuno, California Institute of Technology)

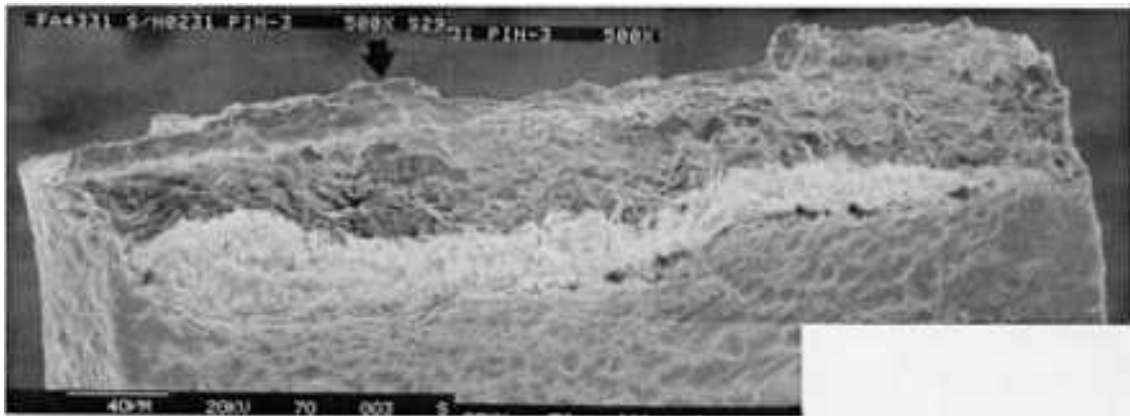
**Fig. 1332**

SEM fractographs of a failed electronic flat pack lead. Fig. 1332: Cracks on both the top and bottom lead surfaces. The solder surface and post-cracking solder zone corrosion products are noted in the foreground. The extent of corrosion indicates solder thickness on the lead solder side. This lead was mechanically overloaded to reveal the fracture surface. SEM, 400 $\times$ . Fig. 1333: Low-angle close-up of the lead fracture across the thickness of the lead (arrow in Fig. 1332). Postfracture corrosion in foreground; center to top, fatigue. SEM, 2000 $\times$ . Fig. 1334: High-magnification view of the mixed fracture mode showing evidence of the fatigue striations. SEM, 800 $\times$  (T. O'Donnell, P. Tung, A. Shumka, R. Ruiz, and J. Okuno, California Institute of Technology)

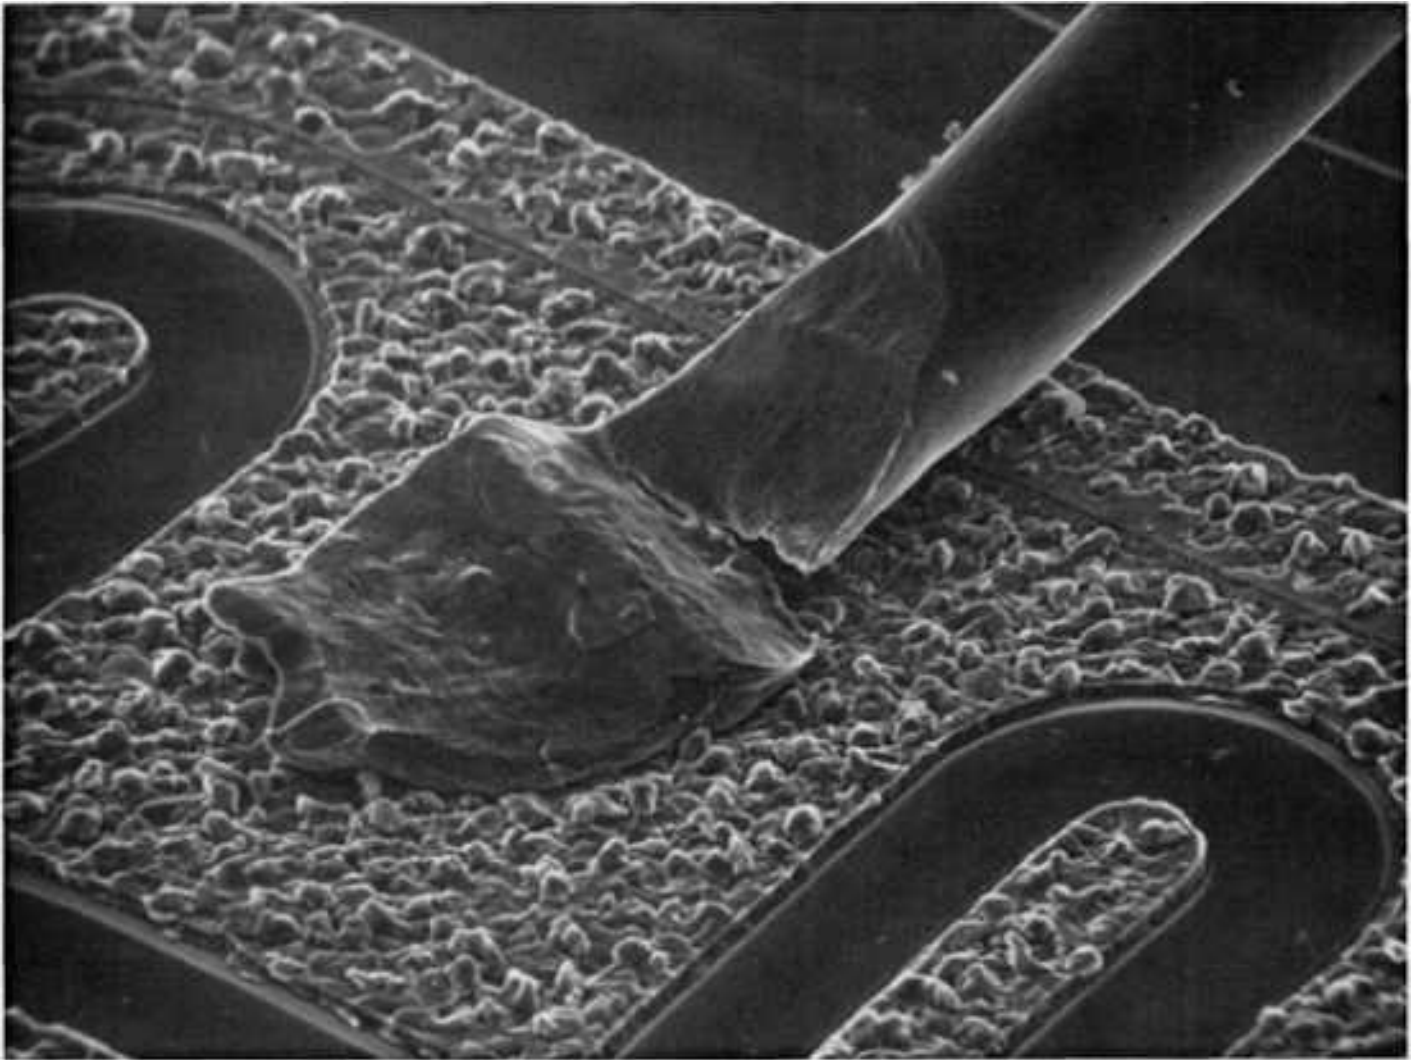
**Fig. 1335** Fatigue failure of an ultrasonically bonded aluminum transistor base lead, 25  $\mu\text{m}$  (1 mil) in diameter. The transistor was power cycled until bond failure occurred. SEM, 1500 $\times$  (R.J. Schwinghamer, NASA Marshall Space Flight Center)

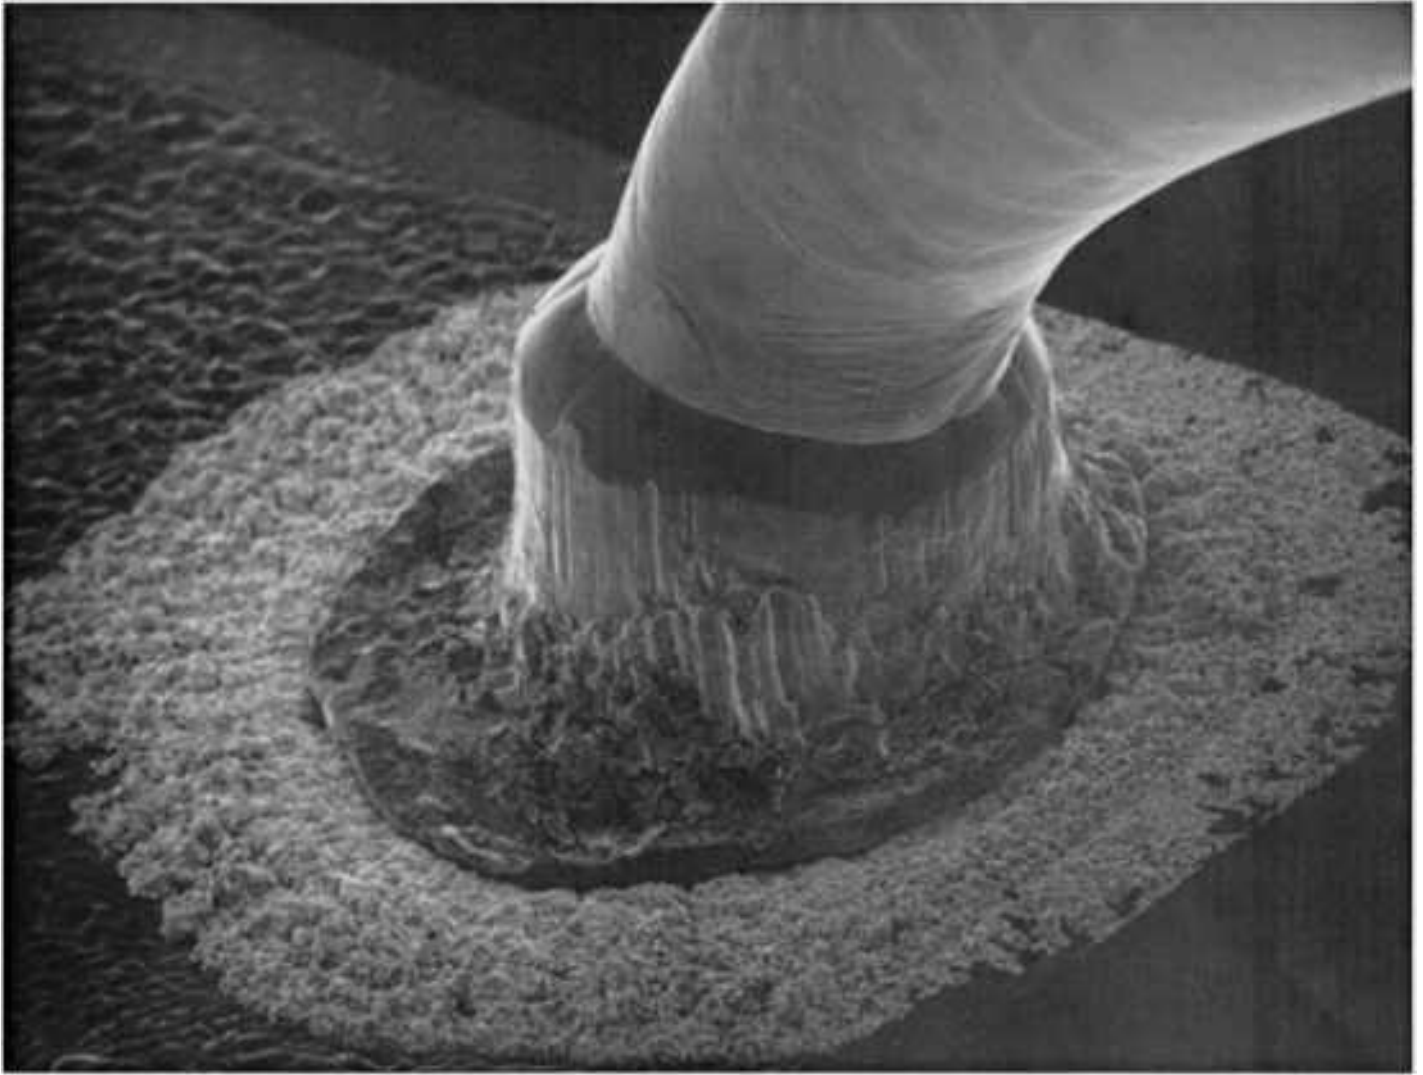
**Fig. 1336 Thermocompression ball bond defect between a gold wire, 25  $\mu\text{m}$  (1 mil) in diameter, and vacuum-deposited aluminum. Note the relatively thick intermetallic layer that formed during power cycling. SEM, 2750 $\times$  (R.J. Schwinghamer, NASA Marshall Space Flight Center)**

**Fig. 1337 Same type of ball bond as in Fig. 1336. In this case, intermetallic formation weakened the bond, causing it to lift. SEM, 2700 $\times$  (R.J. Schwinghamer, NASA Marshall Space Flight Center)**

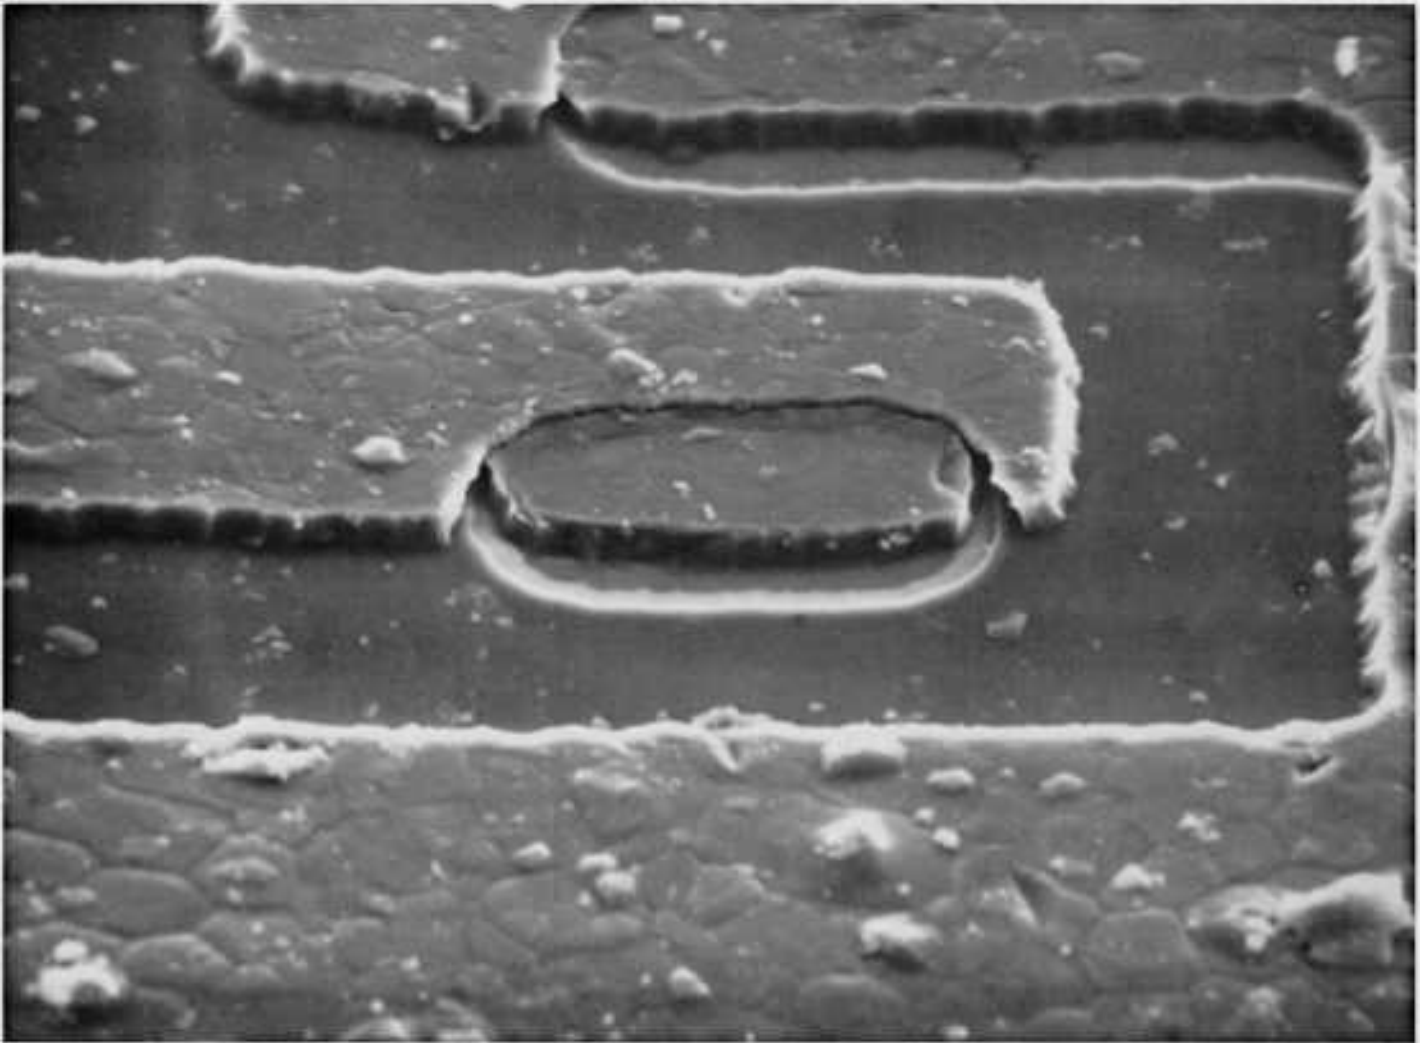
**Fig. 1338** Misregistration of vacuum-deposited aluminum at an ohmic contact window allowed etchant to tunnel around the perimeter of the window, resulting in poor step coverage. The metallized layer was deposited on Si/SiO<sub>2</sub>. SEM, 5850× (R.J. Schwinghamer, NASA Marshall Space Flight Center)

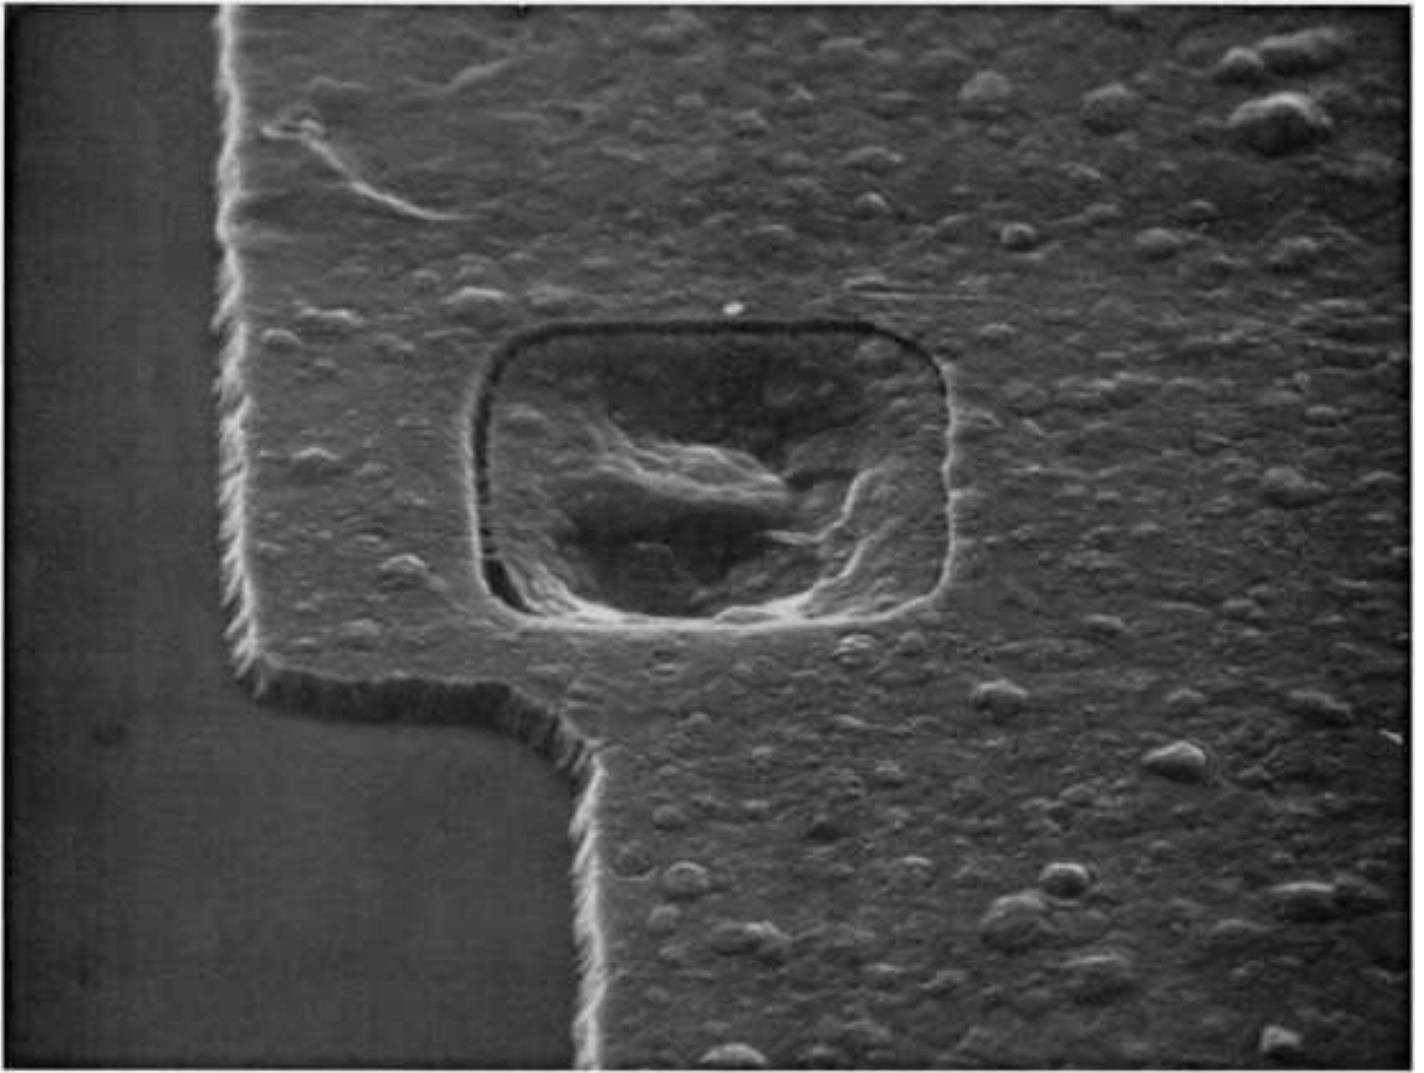
**Fig. 1339** Discontinuous flow of vacuum-deposited aluminum over an oxide step at an ohmic contact window. The metallization was applied to Si/SiO<sub>2</sub>. SEM, 6000× (R.J. Schwinghamer, NASA Marshall Space Flight Center)

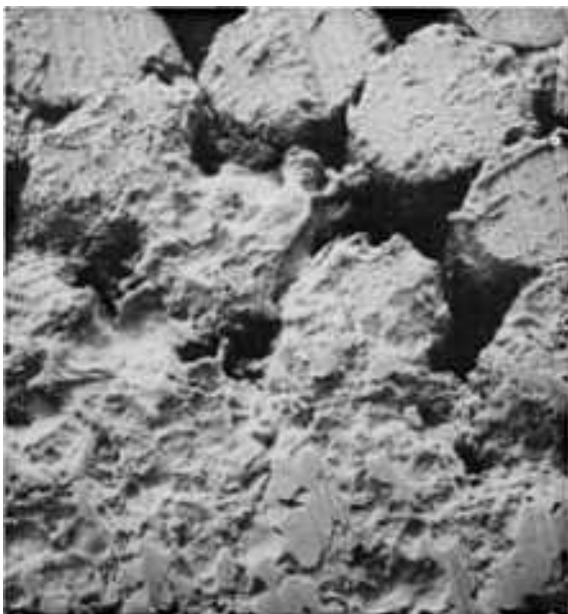
**Fig. 1340**

Failure of brush/slip ring assembly due to arcing. This failure mechanism is always associated with interfacial melting and a high rate of metal transfer in both directions across the interface. Brushes were made of 0.13-mm (5-mil) diam high-purity silver wires; the slip ring, of oxygen-free copper (UNS C10100). Sliding was performed in humidified CO<sub>2</sub>, which acted as a lubricant. Failure occurred at a high current of 50 A. Fig. 1340: Silver brush ends alloyed with copper as a result of interfacial melting. SEM, 215×. Fig. 1341: Same as Fig. 1340, but at higher magnification. SEM, 370×. Fig. 1342: Pits on copper slip ring caused by arcing. SEM, 1800 ×. Fig. 1343: Same as Fig. 1342, but at higher magnification. SEM, 3600× (M. Garshasb and R.W. Vook, Syracuse University)
